The Church of St. Andrew, Walberswick (WLB 014); Record of an Archaeological Evaluation & Excavation

SCCAS Report No. 2007/195; Oasis No. suffolkc1-33407

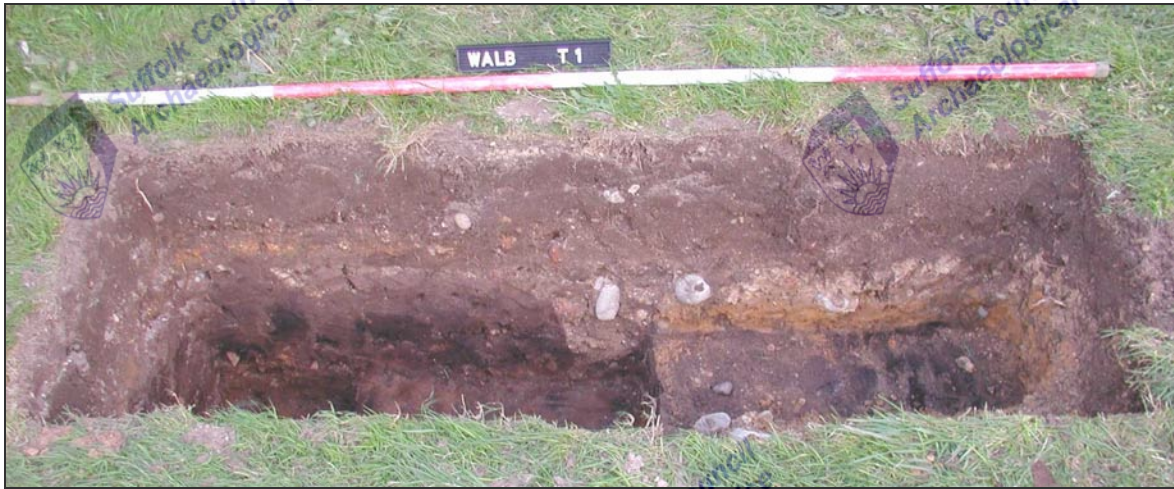
Plate 1: West side of Trench 1

A sequence of layers and a possible incised feature were recorded (Fig. 3 & Plate 1). For the southernmost 0.6 metres of the trench the *c.*0.26 metre thick layer of topsoil (0002) gave way an intermittent spread of orange sand (0003) with a maximum thickness of 0.05 metres. Below this, a *c.*0.10 metre thick layer (0006) comprising mottled grey sand with mortar flecks was recorded with an uneven interface with the underlying podsolised naturally occurring sand subsoil. At *c.*0.70 metres from the southern end of the trench a *c.*0.30 metres wide linear feature (0004), with a rounded v-shaped profile, was seen in section to cross the trench. While clear in the trench sides it was not recognised during the excavation and also not in the subsequent pipe-trench and, as a result, its lateral persistence must be questioned. The fill of this feature (0005) comprised loose sandy mortar with occasional flint cobbles. While the base of 0004, where it cut the natural subsoil and layer 0008, to the north, was well defined, its relationship with layer 0006, to the south, and 0007, to the north, was less clear.

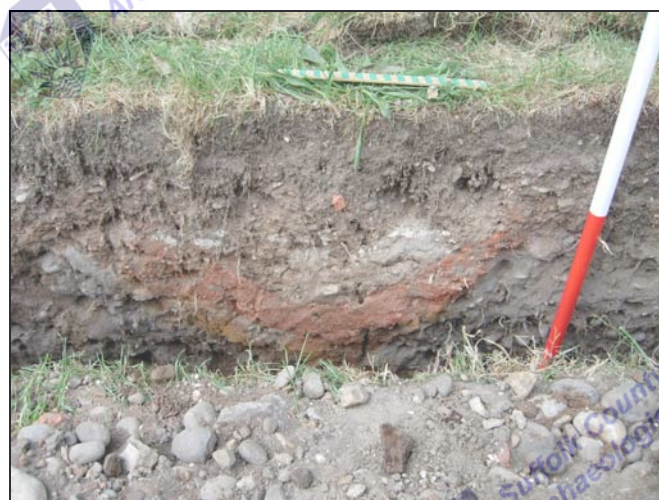
Plate 5 Pipe-trench, feature 0024

a round bottomed feature (0024) was seen to cut the grey/brown silty, stony sand layer 0023 (same as 0019 in Trench 3) below the topsoil (Fig. 5 & Plate 5). In section, the feature was 0.6 metres wide with a depth of 0.30 metres, measured from the base of the topsoil. The feature was lined with a c.0.18 metre thick layer of very sandy clay (0025), the upper surface of which was heat-reddened to a depth of up to 0.10 metres. The fill above the lining

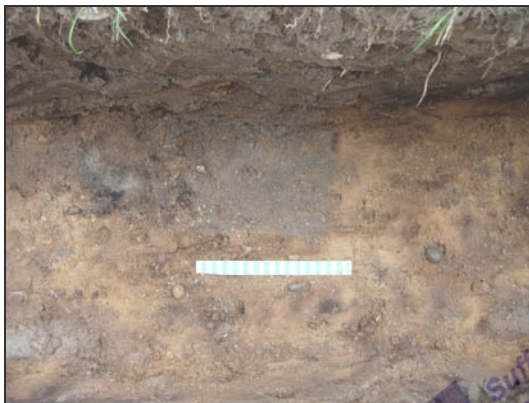
Plate 6 Pipe-trench, Grave 0027

Four other features were recorded in the pipe-trench that had not previously been seen. One of these was the toed brick footing of the standing building at the southern end of the trench, clearly not part of the original medieval building. The remaining three features were all thought to be graves (0027, 0028 & 0029) (Fig. 6 & Plates 6 & 7), although no human remains were encountered as excavation was halted at the level of the naturally occurring subsoil. Grave 0027 was a square-ended and continued out under the eastern edge of the trench and was located towards the southern end some 2 metres from the standing building. Grave 0028, 2 metres to the north, exhibited a more rounded western end, and clearly cut Grave 0029 immediately to the north, both running under the eastern edge of the trench and clipped by its western edge.
