Barn at White House, Stradbroke, Suffolk

Historic Building Record

Barn at White House, Diss Road, Stradbroke, Suffolk

An Archaeological Record

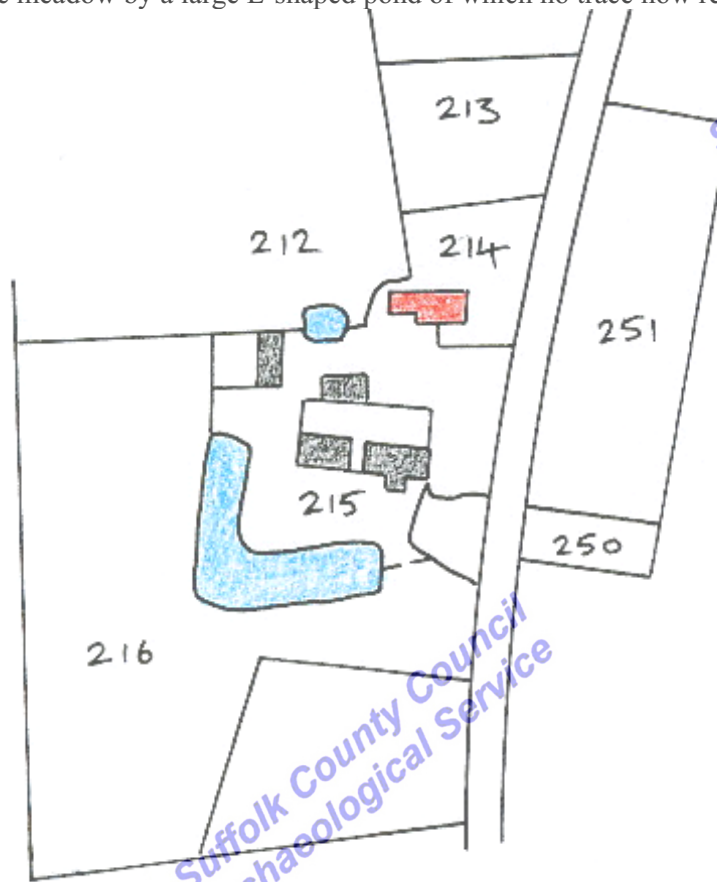
Figure 2.

The site in 1840, redrawn from the Stradbroke tithe map (Suffolk Record Office) The barn and stable of *circa* 1600 appear to be shown as detached structures with an enclosed horse yard and shelter to the north. The apportionment refers to the numbered areas as follows: 212. Wash House Meadow (so-named as it lay beyond the wash house or service wing to the west of the farmhouse); 213. Little Hempland; 214 & 215. Premises; 216. Neathouse Meadow (presumably because it lay beyond the cow house when viewed from the farmhouse, i.e. the building in the north-western corner of the yard); 250. Stackyard.

The farmhouse is shown with its existing outline on the Stradbroke tithe map of 1840 (figure 2) along with four detached outbuildings to the south. The accompanying apportionment gives the total extent of the farm as 142 acres, with 109 acres of arable land and 33 of pasture. Such a holding was large by the standards of its day, but the property was a tenanted farm in the ownership of Giles Borrett and the occupation of William Girling. Borrett was of an old Stradbroke family whose ancestor of the same name gave 3 acres and 2 roods of land for the relief of the poor in 1667 (noted in White's Suffolk Directory of 1844). The 1840 farm buildings include a barn with a central, south-facing porch on the same site as the present barn, and a slightly smaller detached building to the west. This detached building is almost certainly the stable which now adjoins the rebuilt barn under the same roof. An enclosed yard to the north may have operated as a stable yard but the northern wall of the shed against its northern boundary is shown as open-sided on the Ordnance Survey of 1905 (figure 4) and was probably a cart lodge rather than a horse shelter. A third shed in the north-western corner of

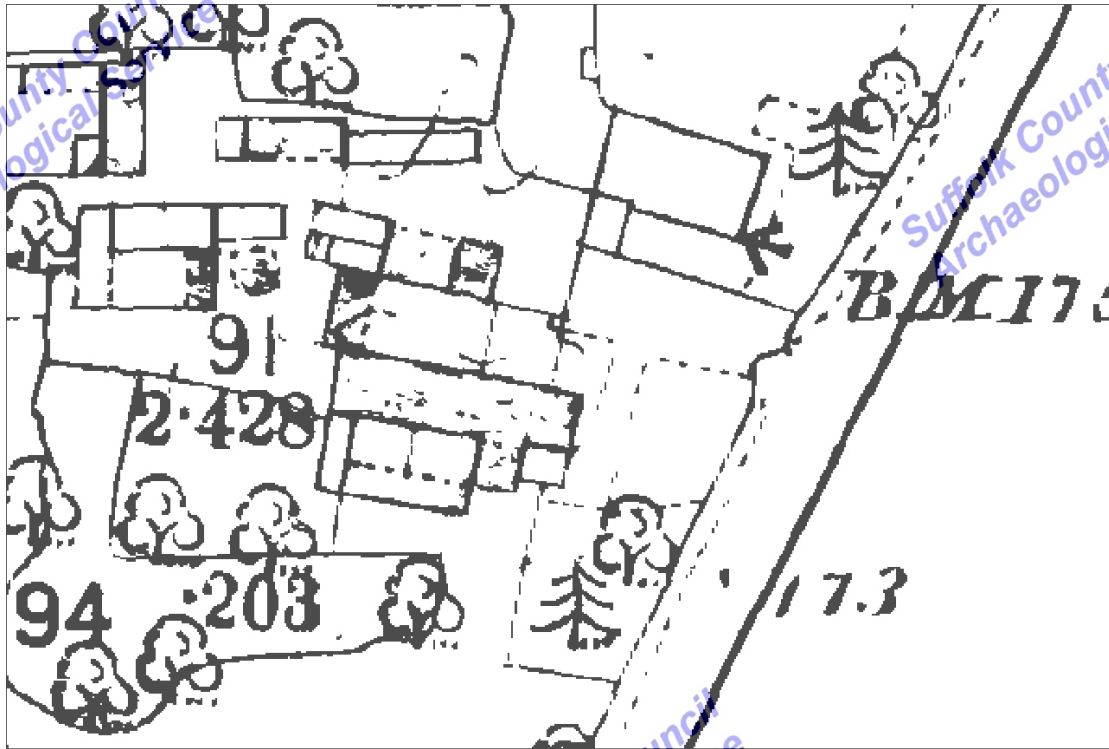
Figure 3

First Edition 25 inch Ordnance Survey of 1886

The farm complex had been extensively redeveloped since 1840, with the addition of numerous buildings and yards. The surviving combined barn and stable is shown, and the roof scars of the adjoining sheds were still visible at the time of inspection

The situation had changed almost beyond recognition by the Ordnance Survey of 1886 (figure 3) which shows an exceptionally sophisticated complex of new yards and sheds. This mid-19th century transformation, which probably occurred in the 1850s or 1860s, is typical of Suffolk farms, which had previously focused on arable production, buoyed by the high price of grain during and after the Napoleonic wars, but were forced to diversify into mixed animal husbandry after the repeal of the Corn Laws in 1846. This date fortunately coincided with the arrival of the railway in Stradbroke, which opened up new urban beef and dairy markets. The detached barn and stable shown in 1840 had, most unusually, been rebuilt as the single structure which is all that survived on the site at the time of inspection. The roof scars of the adjoining sheds shown in 1886 were still visible on the weatherboarding, and much of the complex in figures 3 and 4 had evidently been present when conversion work began, but unfortunately nothing more remained to permit any detailed analysis of its original layout and function.

southern elevation (bay A) preserves the roof scar of a demolished shed (presumably that shown in figures 3 & 4), and similar features are visible on the northern wall where the boarding was not tarred and had apparently been protected within another demolished shed or covered yard.

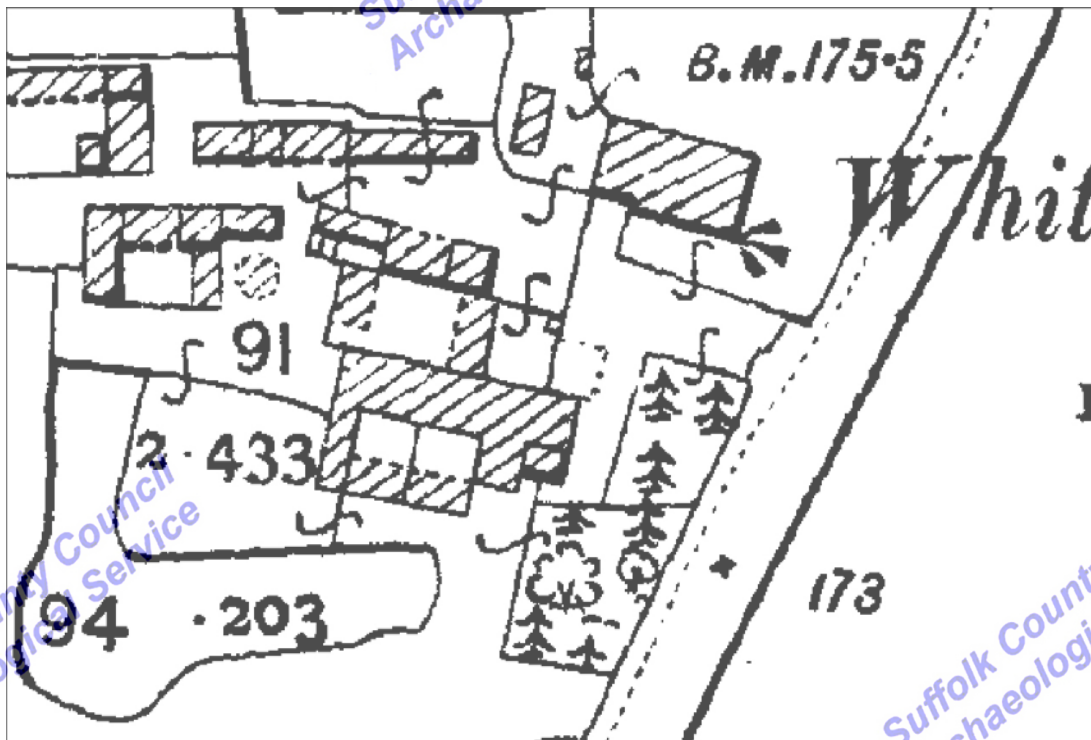
Figure 4

Second Edition 25 inch Ordnance Survey of 1905, showing the demolished sheds in more detail. The open sides of animal yard shelters and lodges are indicated by broken lines, and the circular feature was probably a horse mill.

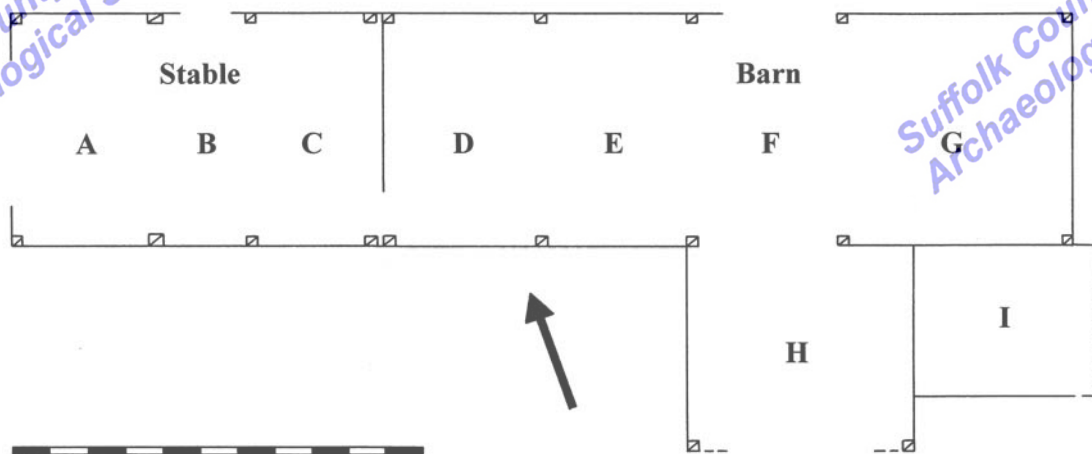
Figure 5

Schematic Block Plan of Barn (scale in metres)

Identifying each bay and unit for ease of reference in the text and photographic record. H indicates the porch and I a lean-to brick shed.

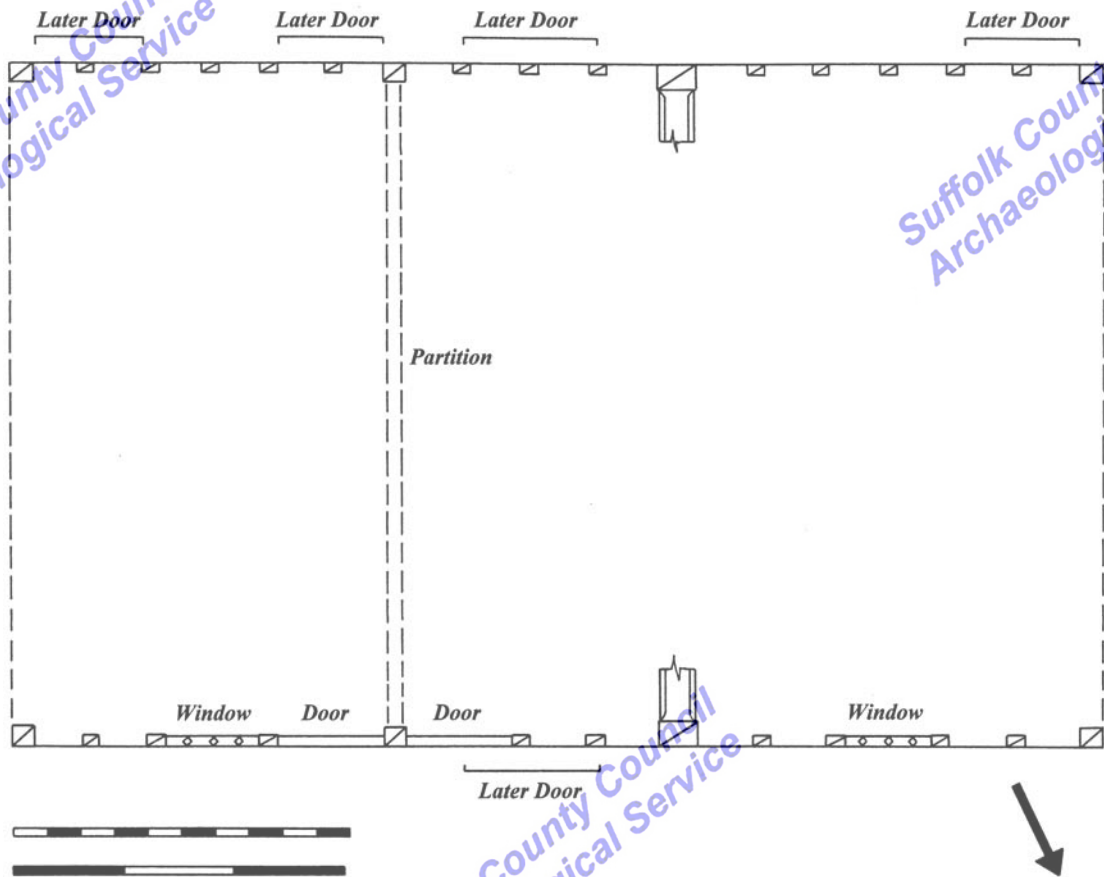
Figure 6
Ground Plan of Late-16th or Early-17th Century Stable (Scales in feet (top) & metres).
The width of the structure is not certain

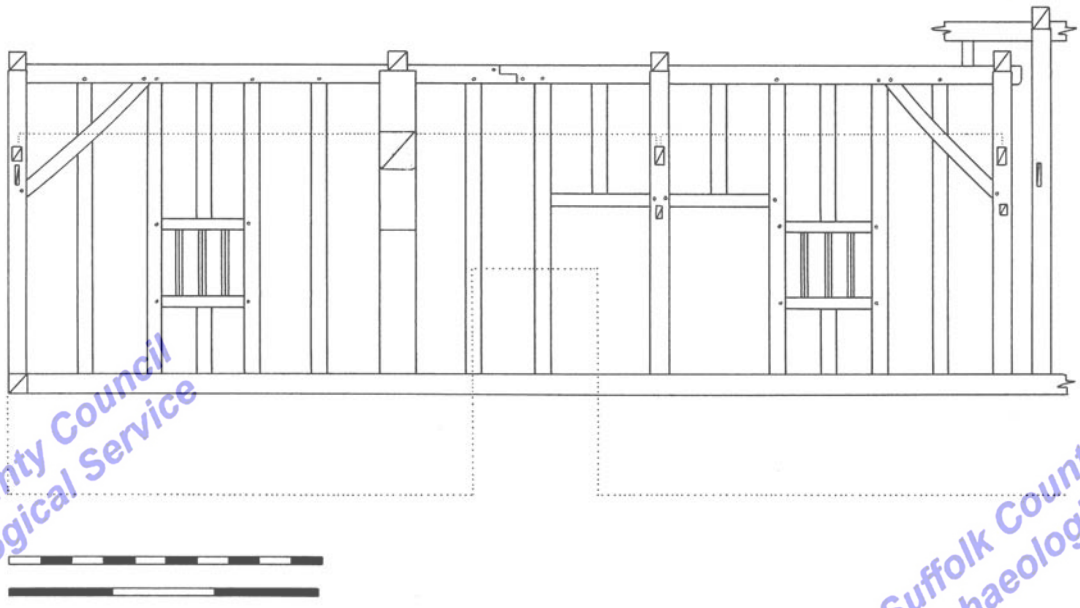
Figure 7
Original Internal Front (Northern) Elevation of Late-16th or Early-17th Century Stable.
Bays A-C as marked in figure 5. (Scales in feet (top) & metres)

Note to Figure 7 below:

The level of the ceiling is indicated by a dotted line, as is the outline of the 19th century central door and brick plinth. The present sill beam is a 19th century replacement and the original walls may have been slightly taller. The corner post of the barn is shown to the right with part of the 19th century roof-plate

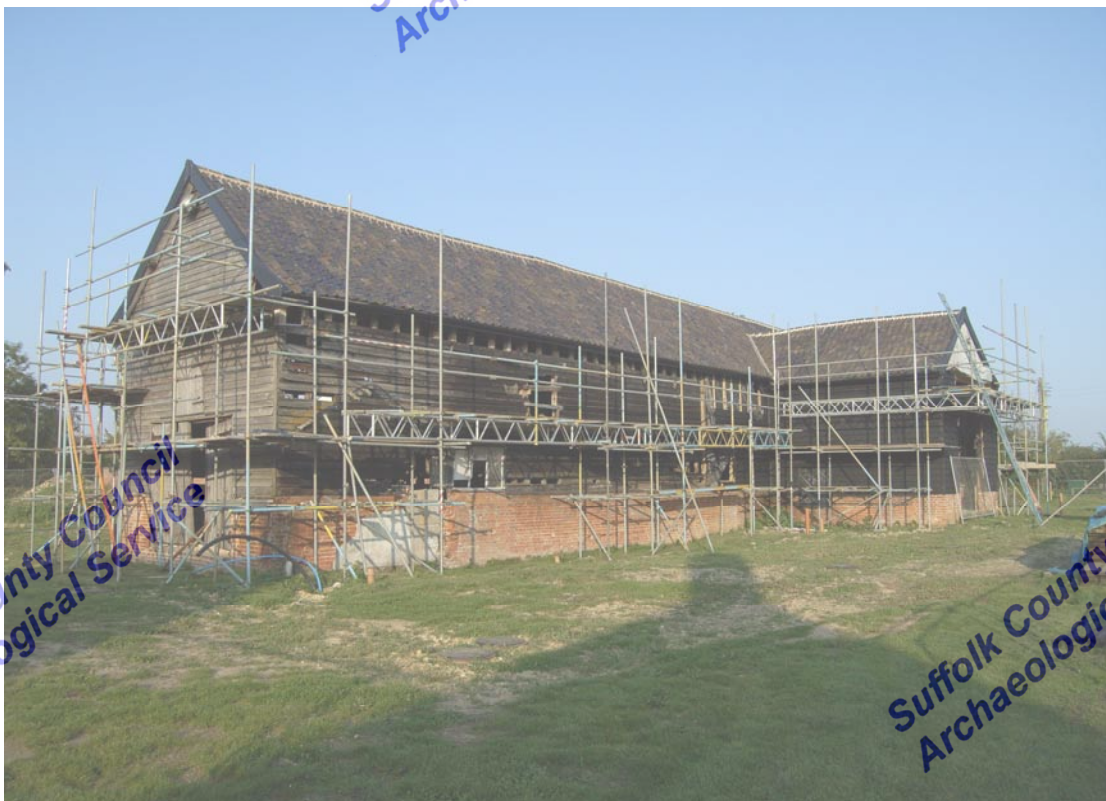
A2.2 Exterior from south-west showing roof scar of demolished southern shed to left

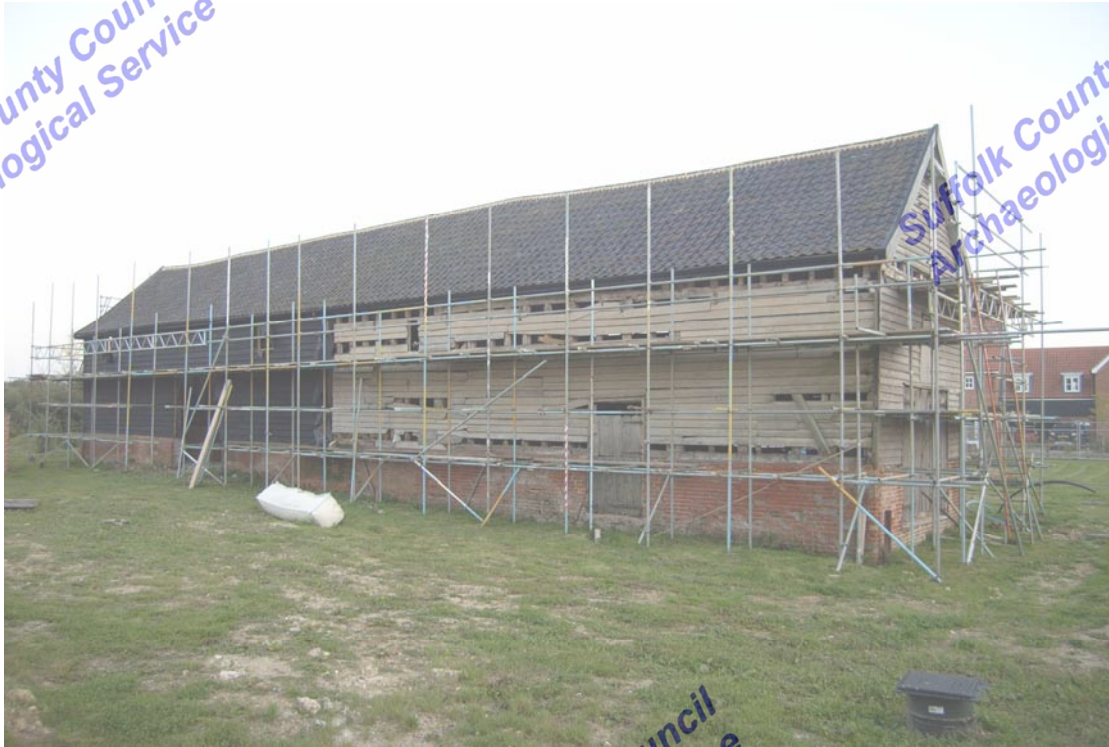
A2.3 Northern external elevation from north-west showing old whitewashed weatherboarding to right (formerly enclosed by a recently demolished shed) with recently renewed stained boarding to left

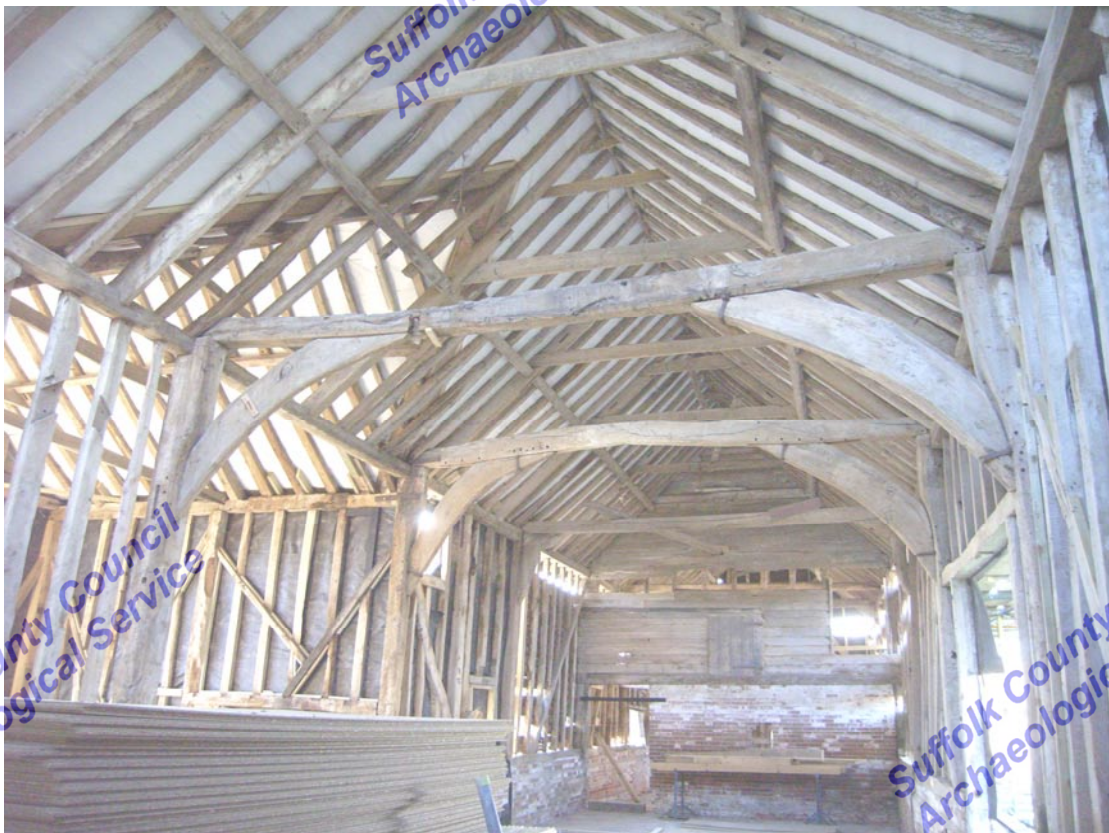
A2.4 General view of barn interior from east showing re-used tie-beam arch-braces flanking bay F with porch to left and brick and boarded partition to stable in rear.

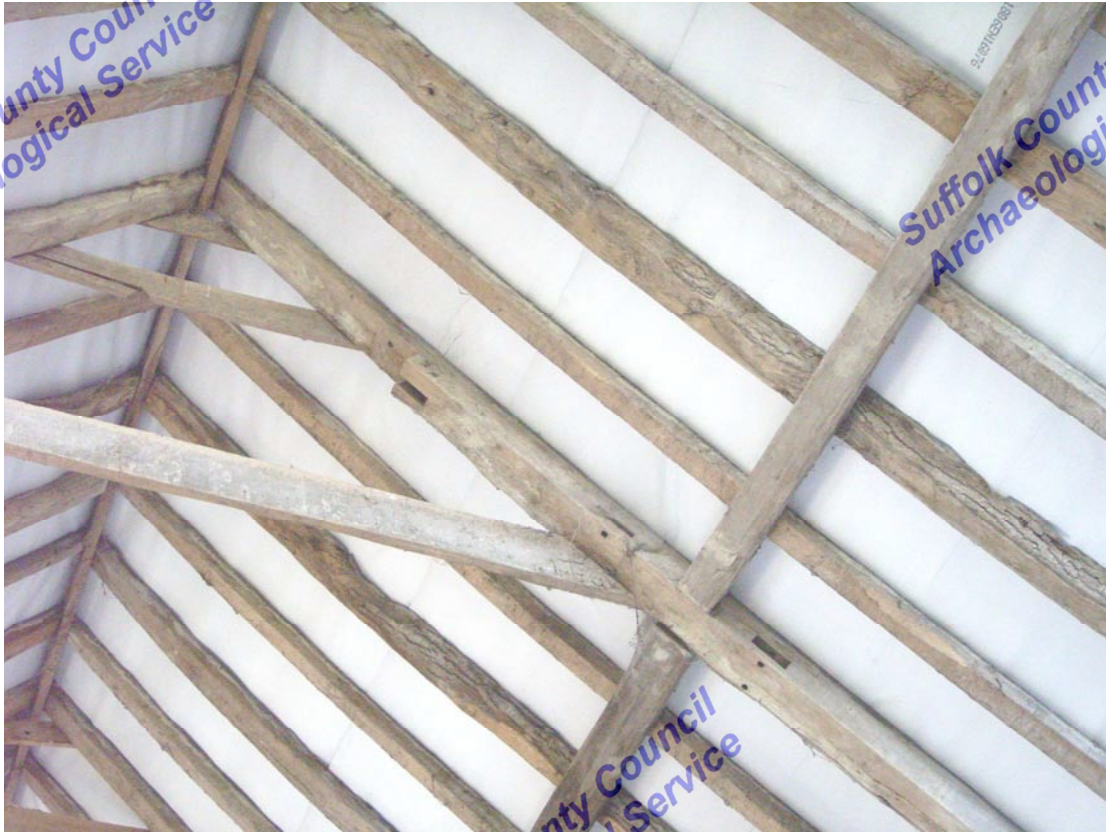
A2.5 Detail of 19th century butt-purlin roof structure showing re-used 17th century principal rafter with empty mortises for an upper tier of clasped purlins with wind-braces and a lower tier of butt-purlins

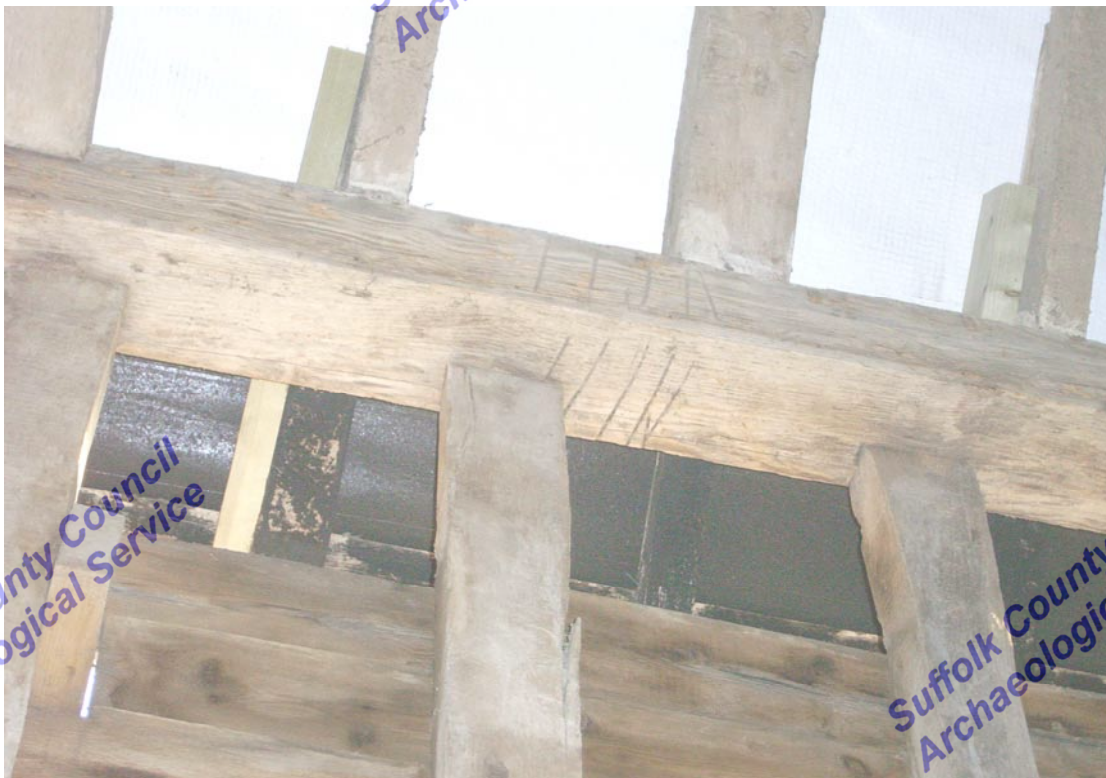
A2.6 One of several Baltic timber marks on the 19th century pine roof-plates in both elevations

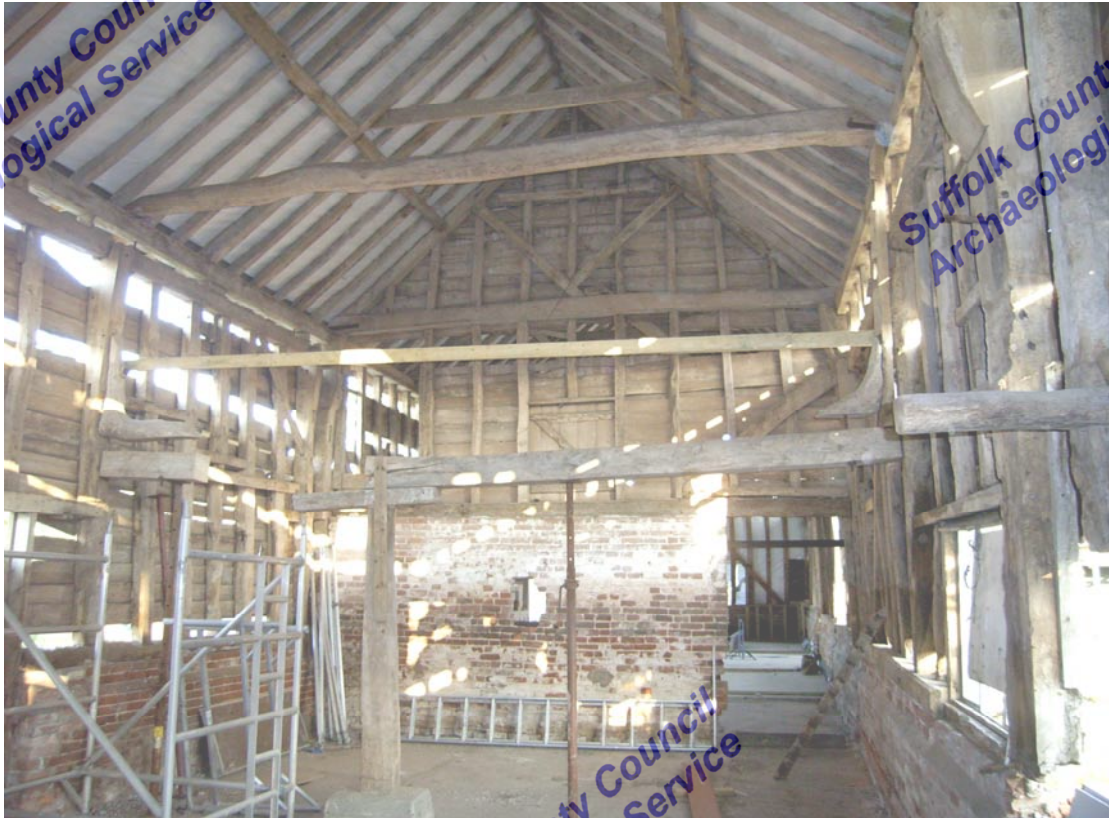
A2.7 General view of stable interior from west showing remains of removed ceiling with partition to barn in rear

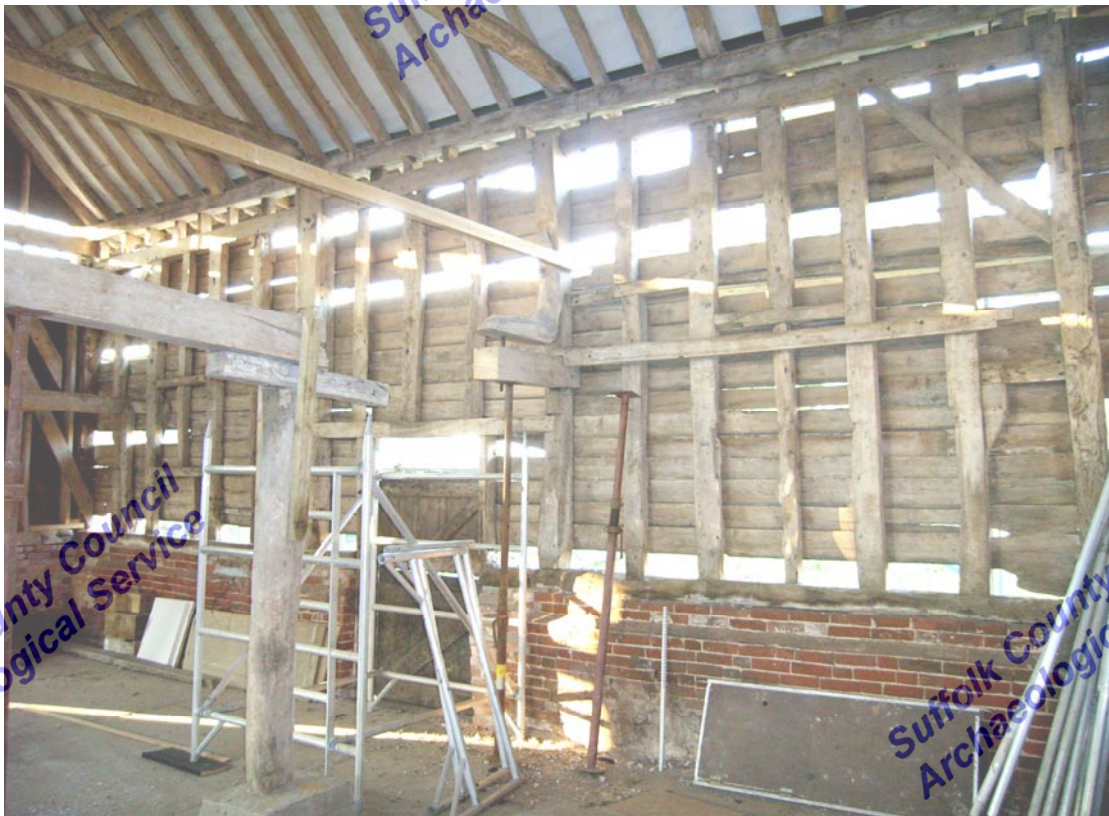
A2.8 Northern internal elevation of stable from south-east, showing bays A-C from left to right. The entire structure raised on a brick plinth and provided with a new, higher roof-plate

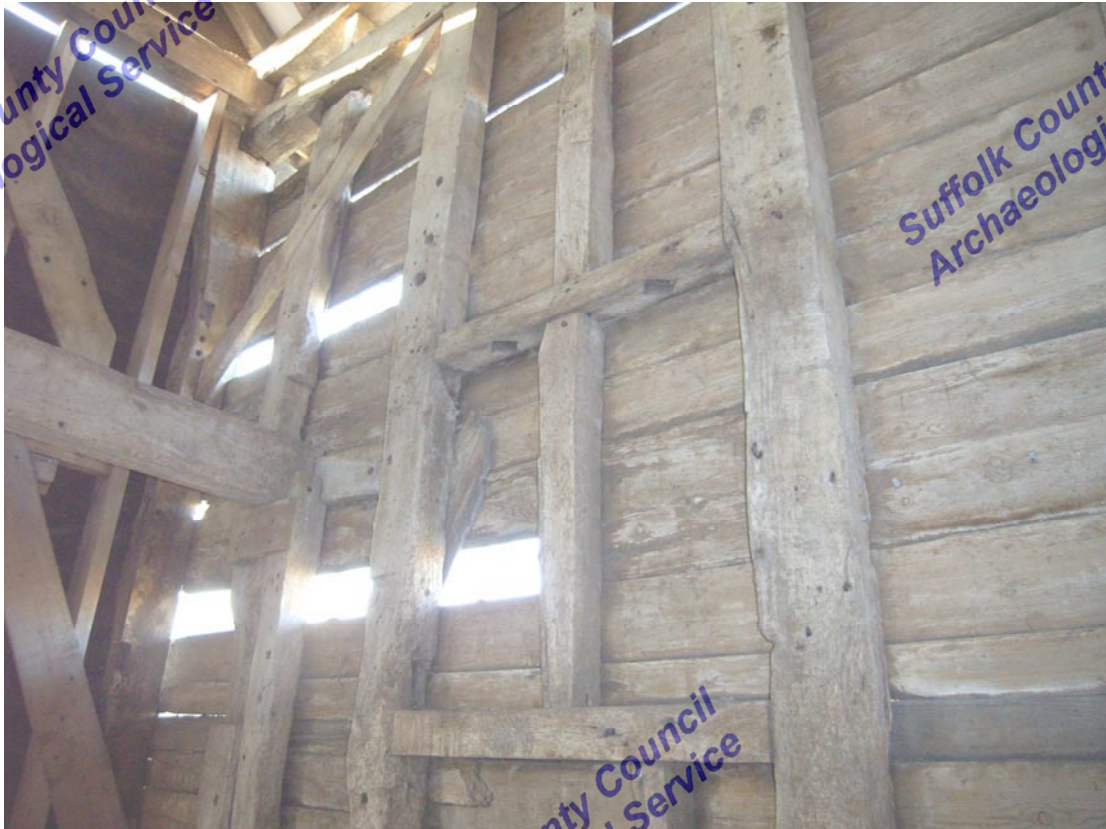
A2. 9 Lintel of 17th century stable window lintel with empty mortises for three diamond mullions in bay A with original internal wall brace top-left (the empty sill mortises are visible above the present secondary sill)
