Glebe Farm, Ellough, Suffolk

Historic Building Record

**Glebe Farm Barn,
Church Road, Ellough,
Suffolk**

An Archaeological Record

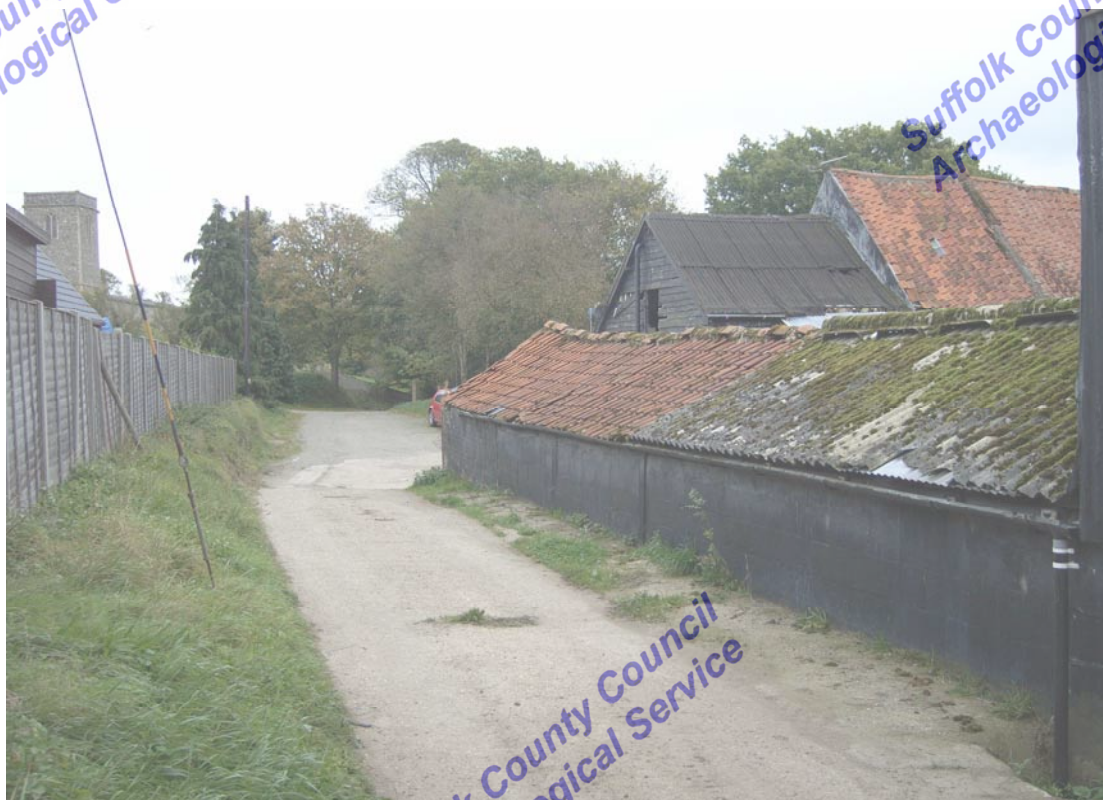
A2.1 General view of entrance to site from west showing All Saints church and fence of Gartley House to left, the barn to right and the detached shed (10) in centre

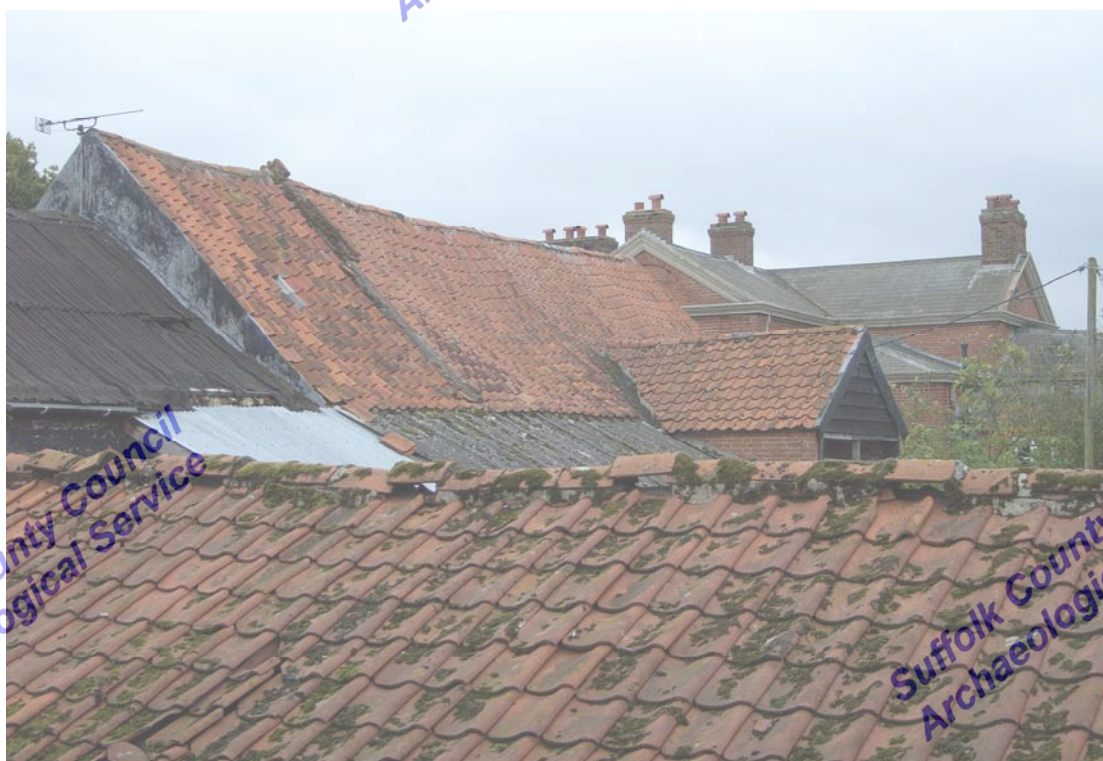
A2.2 General view of site from north-east showing the barn roof with the detached shed (10) in foreground and the Rectory in rear

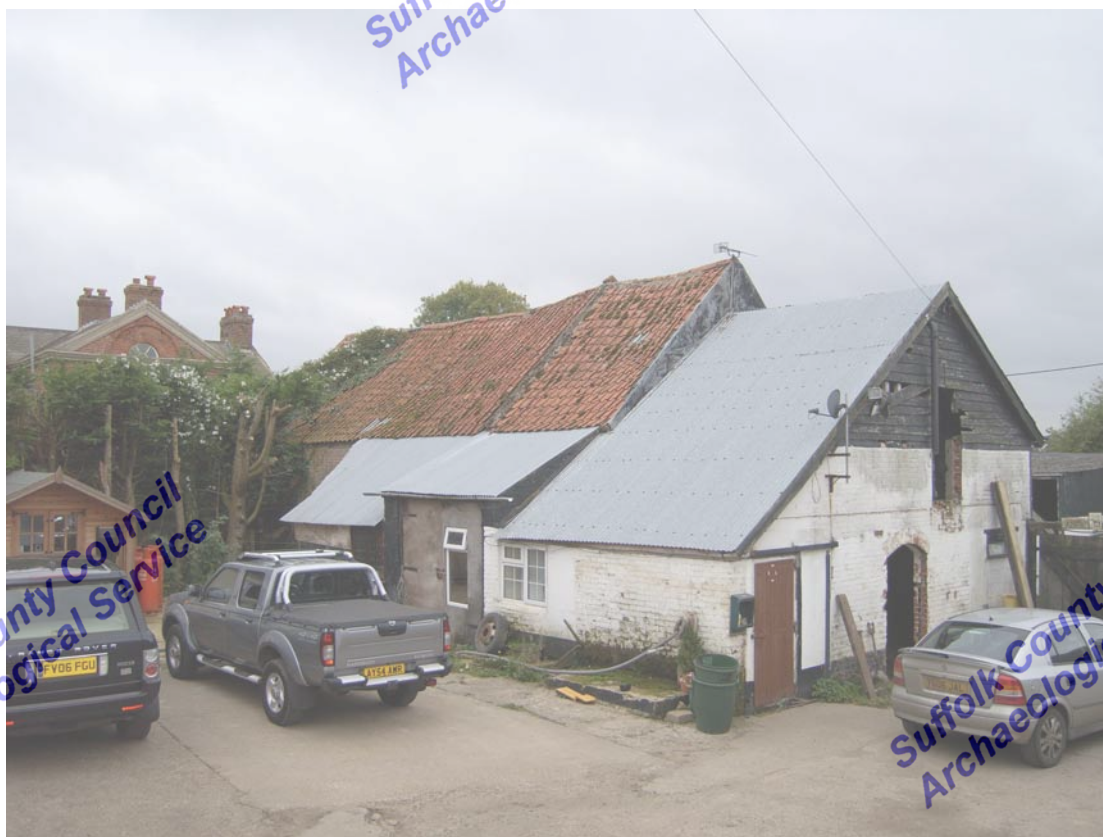
A2.4 Exterior of barn from north-east showing extension (7-9) to right and northern gable of Rectory to left

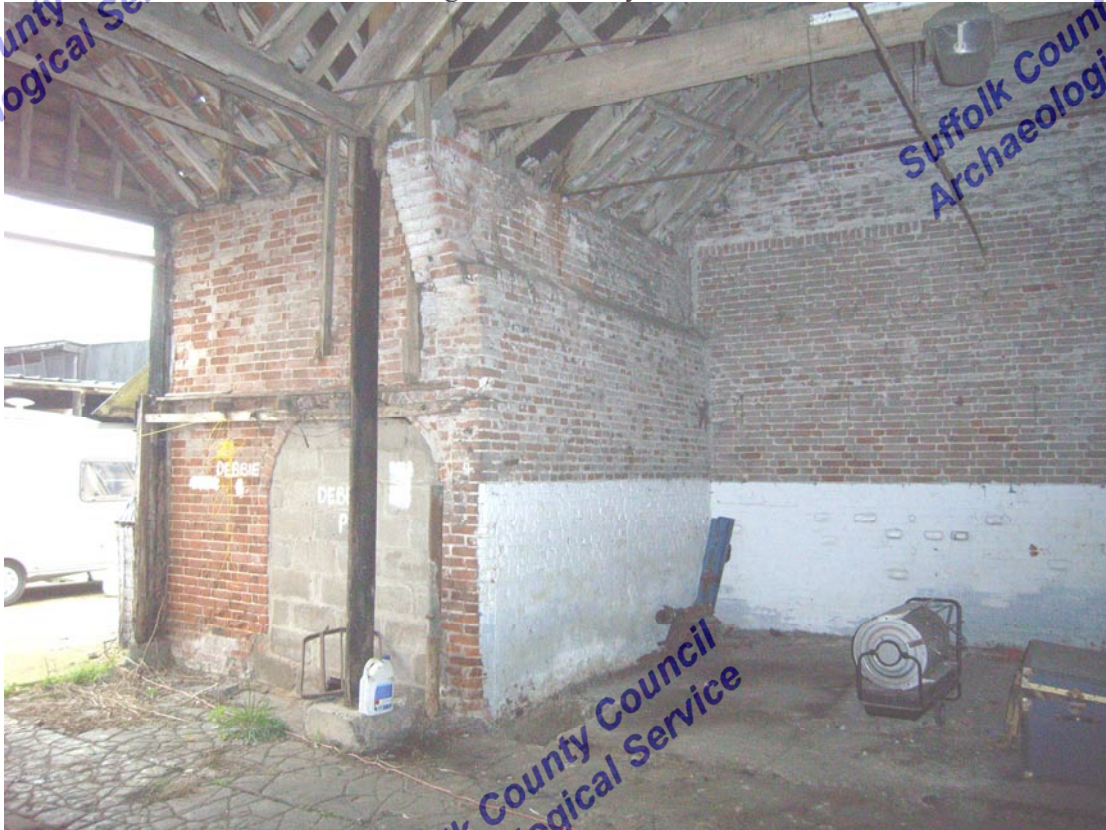
A2.5 Interior of barn (1) from south-east showing western porch to left with blocked arched entrance to lean-to shed (5)

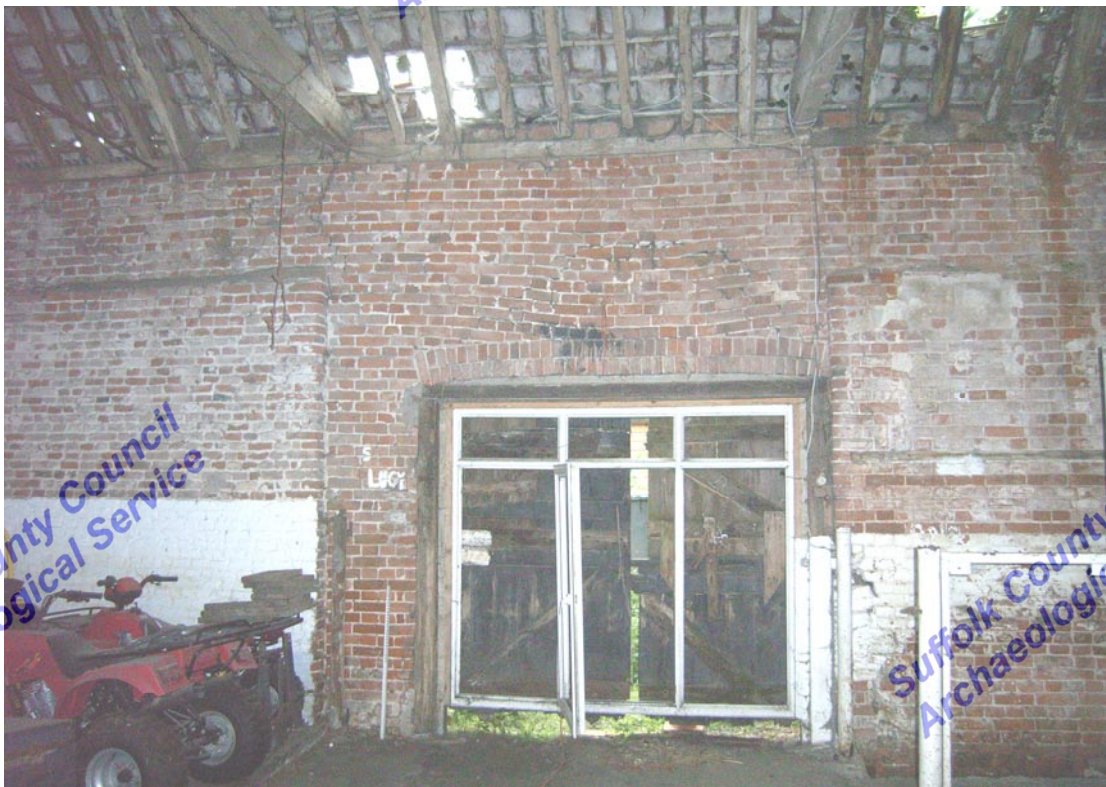
A2.6 Interior of eastern elevation of barn showing arched entrance in central bay with earlier brickwork to left

A number of anomalies in the brickwork of the main external walls suggest they incorporate parts of an earlier barn on the same site. For no apparent reason these walls reduce from 35 cm in width to 23 cm (14 ins to 9 ins) at a height of 3.2 m (10.5 ft) above the present concrete floor, and are laid in English bond in contrast to the Flemish bond elsewhere. The brickwork to the north of the western porch is entirely different in character, with bricks of less regular size, shape and pigment in the manner of the late-17th century, and the northern side-elevation of the porch abuts the main wall with a straight joint. Curiously, the same reduction in thickness and the same change of bonding occurs to the south of the porch, but the brickwork here is consistent with the 19th century structure and the porch's southern side-elevation is fully integrated. It would appear that the walls of the earlier structure were entirely rebuilt to the south but retained their former profile. The central bay of the eastern elevation contains a low, arched door of 2.4 m in width (8 ft) opposite the full-height western entrance of 3.3 m (11ft), but this door is off-set to the south within a wall of 23 cm brickwork that blocks a wider aperture in the original structure. This eastern door is part of the *circa* 1830 reconstruction as its brickwork is integral with the narrow upper wall but not that of the earlier wall to the north, and it seems that the older barn was raised in height by some 32 cm (2.5 ft) and provided with new lateral partitions and a new roof.

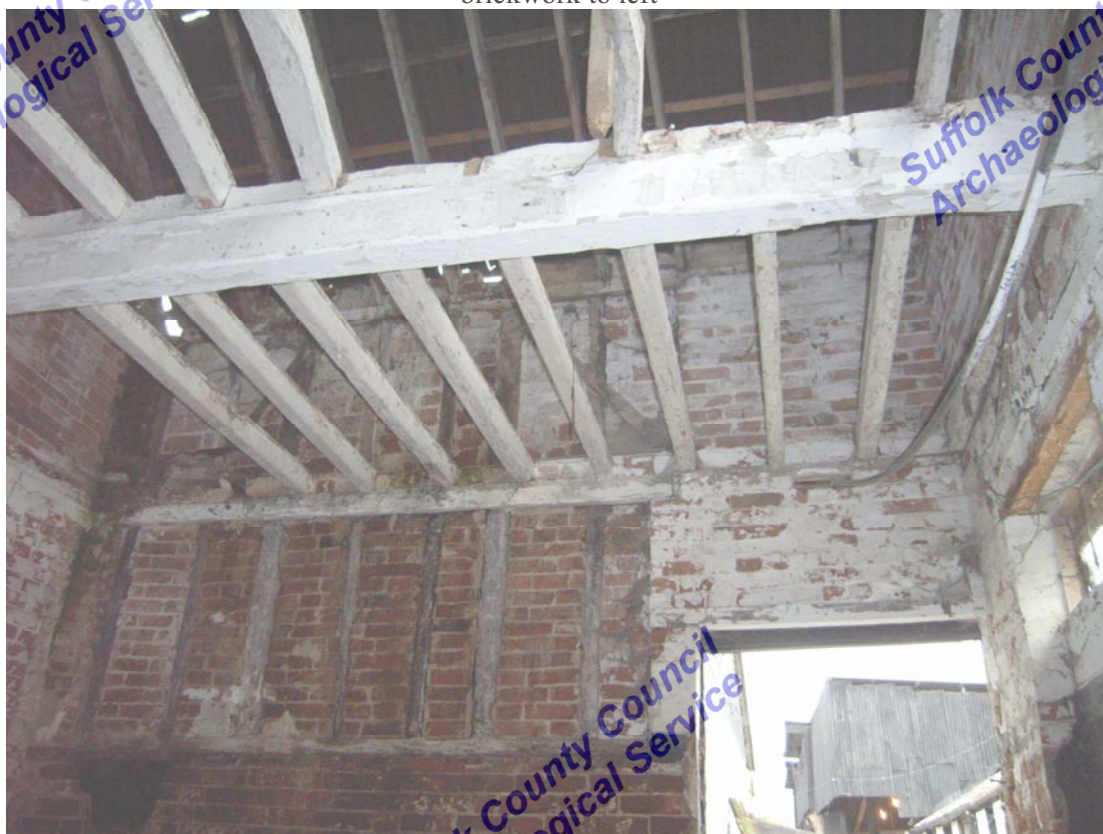
A2.7 Interior of northern shed (8) from east showing original external gable to left and joists of former loft. The western door is secondary.

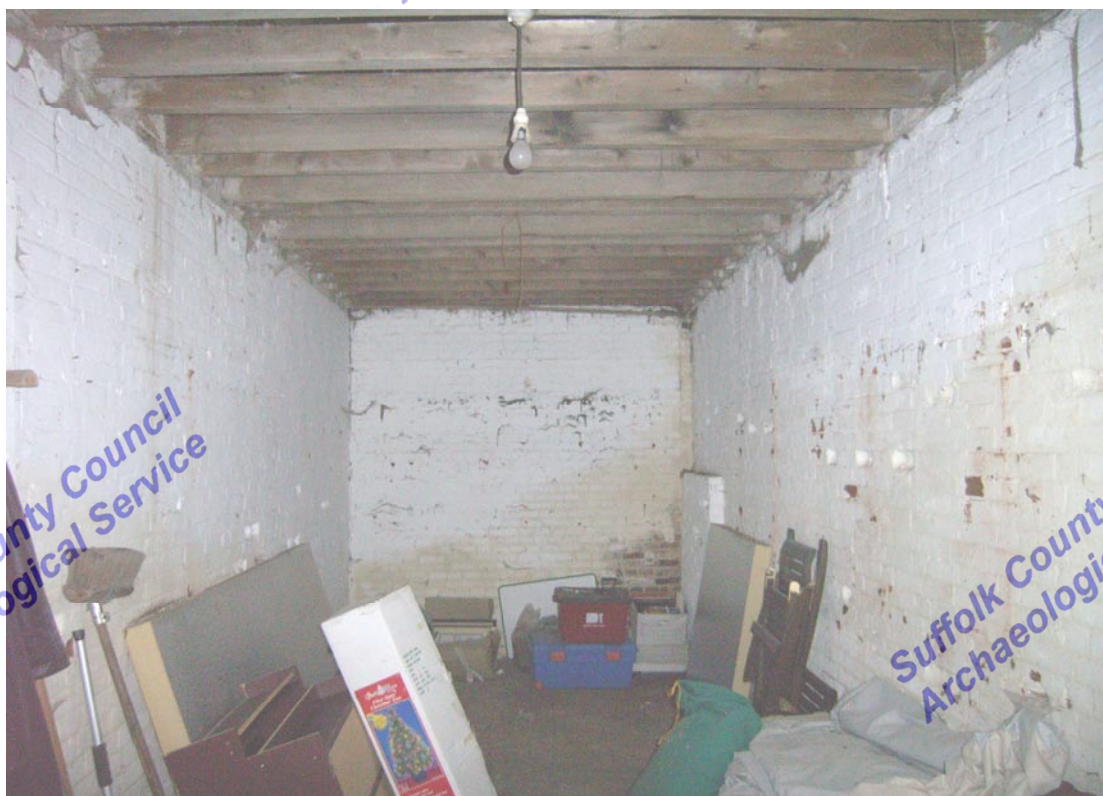
A2.8 Interior of original narrow shed (3) to north of barn, viewed from east and showing replaced joists of loft

The shed at the northern end of the barn is unusually narrow at 2.75 m (9 ft) in axial length by 8 m (26 ft) in width, including a lean-to porch which projects beyond the eastern wall of the barn. It retains an original floor of white bricks but the joists of its loft have been renewed in softwood of 20th century appearance. An original loft loading door is respected by the brickwork of the northern gable. Sheds attached to barns in this way typically operated as stables, but this example is too narrow for such a purpose and was probably designed as a vehicle shed. This interpretation is supported by the orientation of its entrance, which faces east towards the main approach. The roof of the shed is divided from that of the barn by a brick partition which penetrates the roof (which retains its original pantiles), but the main walls span both areas. A brick lean-to projects from the shed porch and returns to meet the wall of the barn with a distinctive angle as shown in figure 6, respecting the present entrance to the barn but overlapping the jamb of its wider predecessor (the edge of which is visible in the south-western corner of the shed). This lean-to shed probably served as an equipment

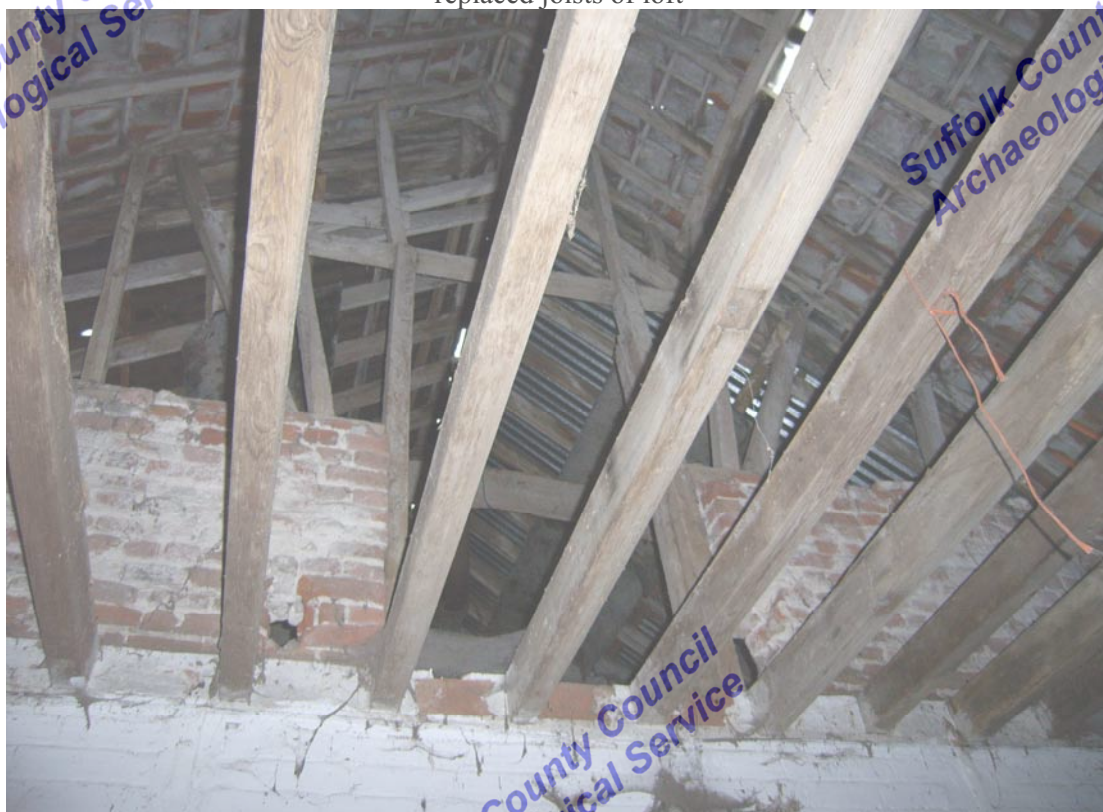
A2.9 Interior of shed (3) from south showing the original loft door in the northern gable above the renewed ceiling joists.

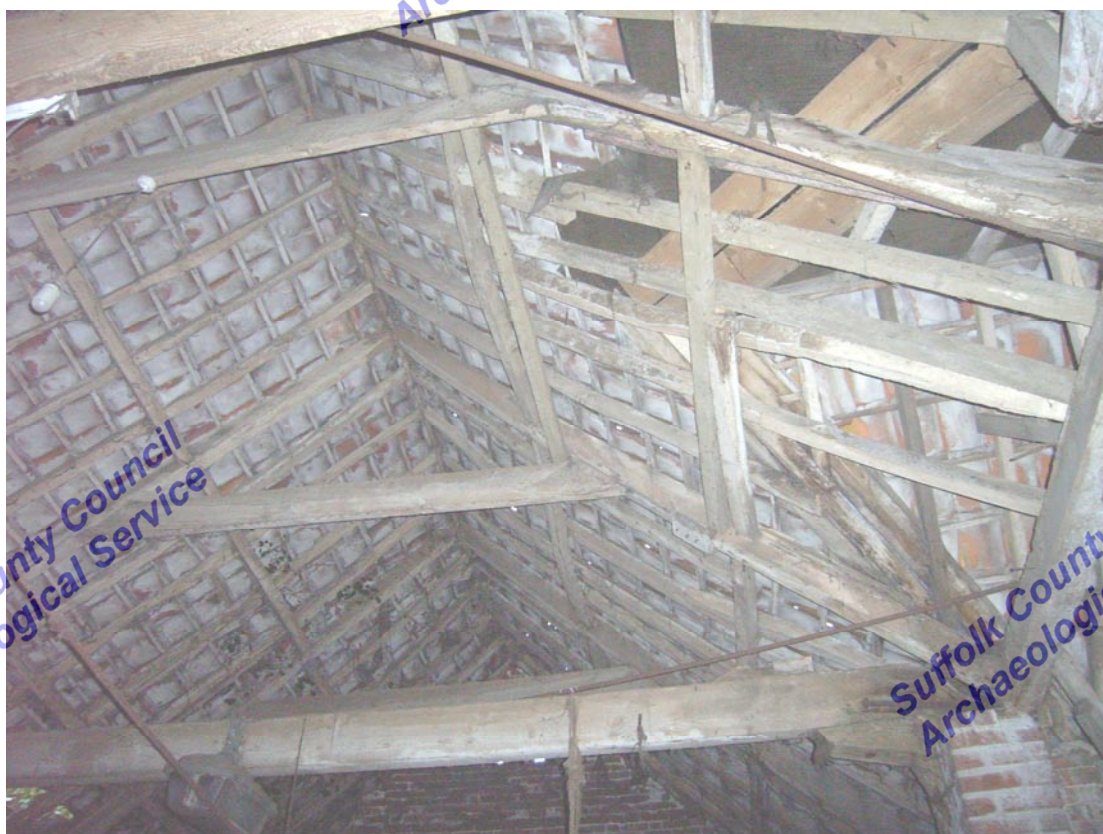
A2.10 Interior of barn from north showing porch to right and roof structure with two tiers of butt-purlins and a ridge-piece

The barn at Glebe Farm is a red brick structure on a north-south axis which consists of a three-bay barn to the south and a narrow shed to the north. The entire building extends to 14.6 m in length by 6.5 m in overall width (48 ft by 21.5 ft), but the barn possesses a central gabled porch which extends by a further 3 m to the west (10 ft) and the shed is entered by a lean-to porch which projects 2.2 m (7 ft) to the east. The walls rise to 4 m at the eaves, and the barn roof contains two tiers of butt-purlins with a ridge piece.
