**Hall Farm Barns,
Higham,
Suffolk,
HIG 019**

Historic Building Record

December 2009

Hall Farm Barns, Upper Green, Higham, Suffolk

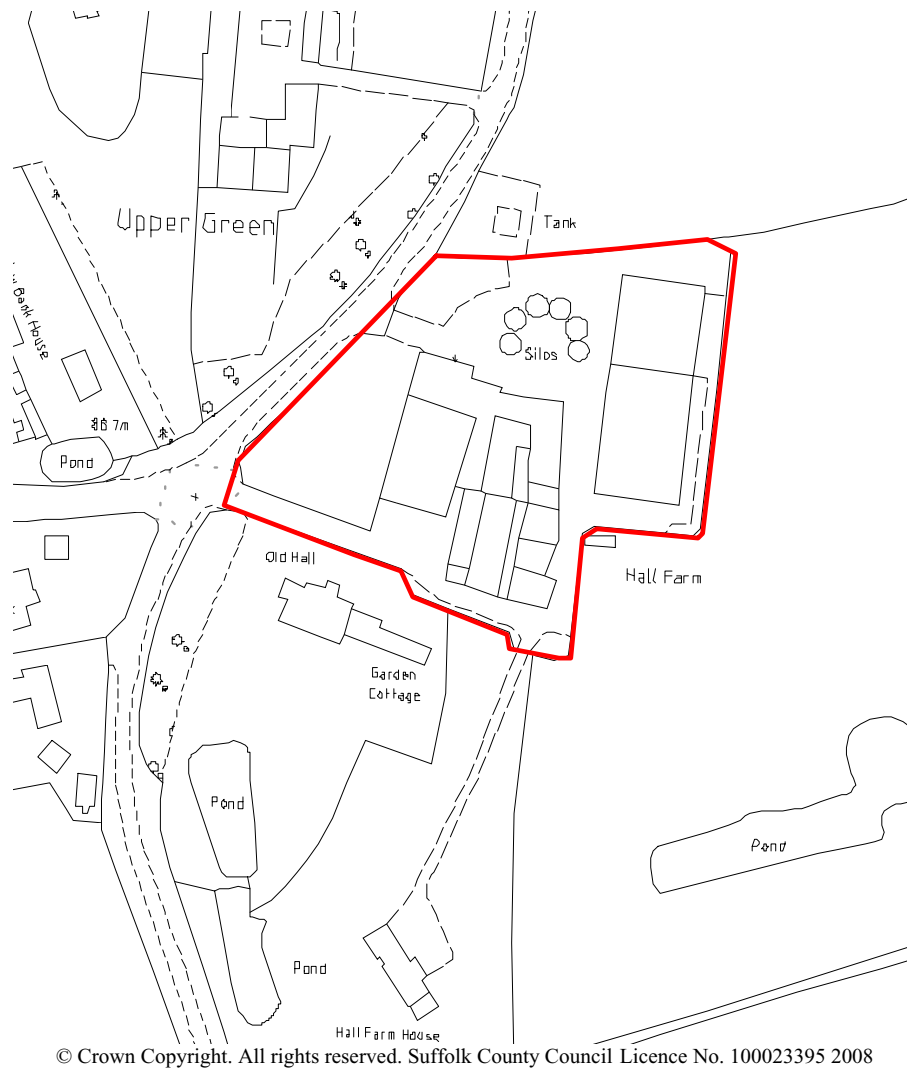
Figure 1
Current Ordnance Survey Site Plan
Outlining the historic farm complex in red (including a 20th century piggery and grain silos to the north-east) and showing the 19th century farmhouse immediately to the south (Old Hall). The newly-built modern farmhouse is shown at bottom centre (Hall Farm House).

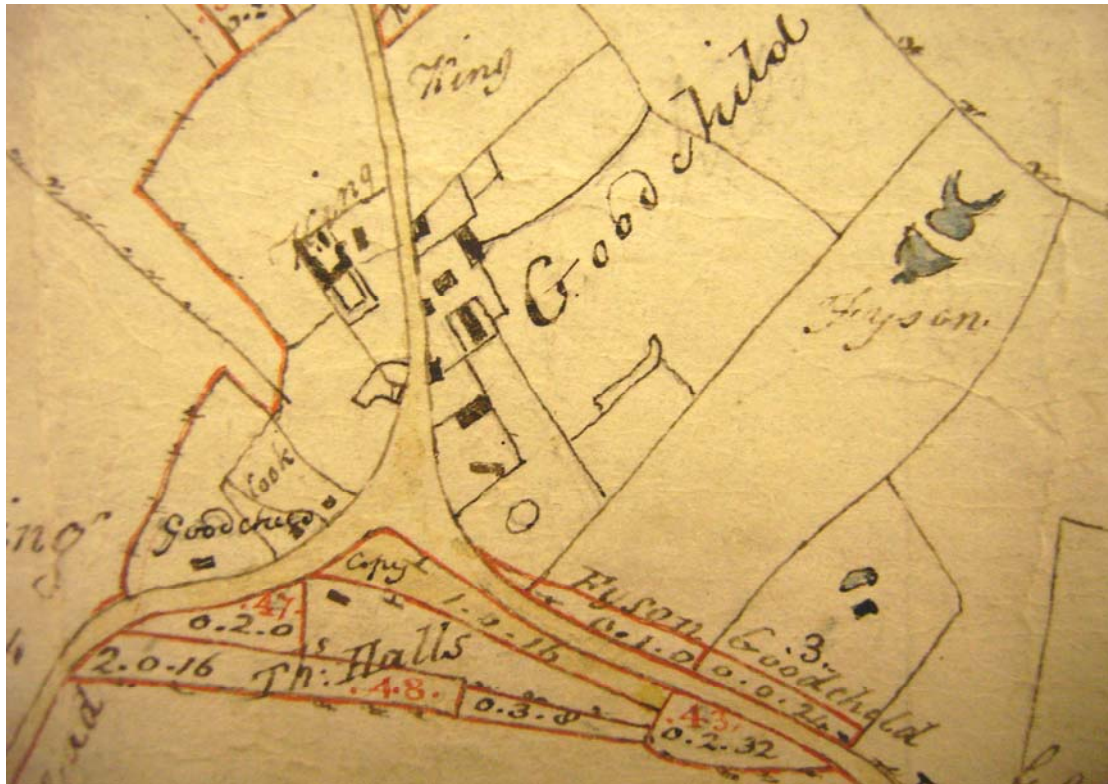
Figure 2

Enclosure map of the 'Hamlet of Higham in the parish of Gazeley', 1823. (SRO). The scattered buildings shown here bear little relationship to the existing structures and probably represent an earlier farm complex that was entirely redeveloped after the enclosure. North is shown towards the top left-hand corner.

The barn does not appear on the enclosure map of 1823 (figure 2) and the original structure is consistent with a date of *circa* 1830. The original roof may well have been thatched or pantiled with a steeper pitch. The south-eastern bay of the aisle was partitioned from the rest of the interior during the refurbishment and now forms a passage to the adjoining shed (building 2); it preserves a number of harness hooks and was almost certainly created as a tack room for the adjoining stable (building 8). The barn has operated as a store and tractor garage for some years and contains a floor of concrete and bitumen with no evidence of a threshing surface in the central bay. Its fabric remains largely intact after its late-19th century remodelling, although some losses have occurred in the framing of the northern elevation (particularly to the west of the porch). There is evidence of 19th century lean-to sheds that flanked the porch but these no longer survive.

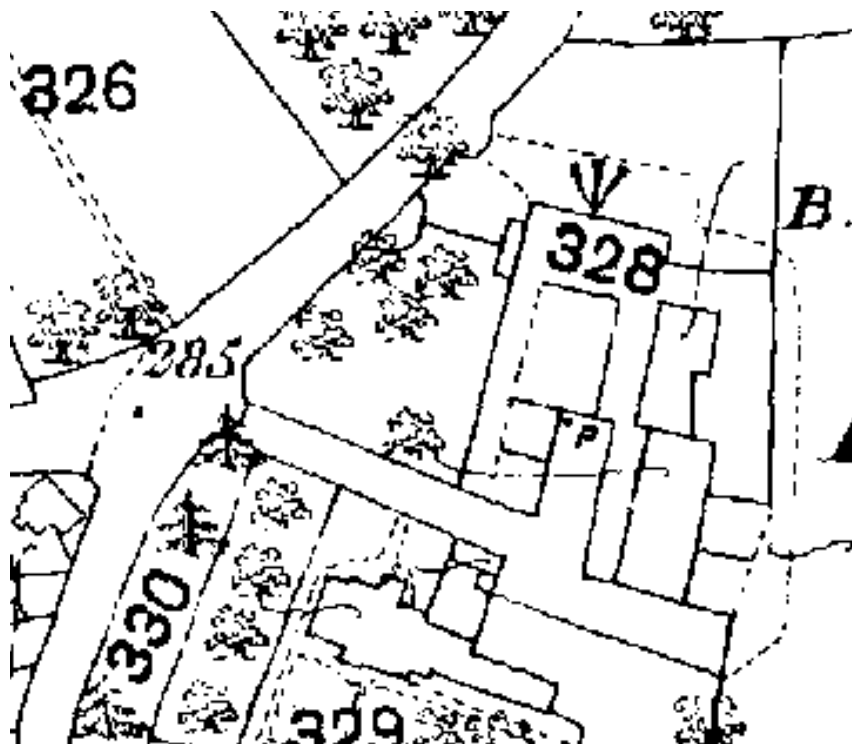
Figure 3.

First edition 25 inch Ordnance Survey of 1884, showing the farm complex much as it remains today.

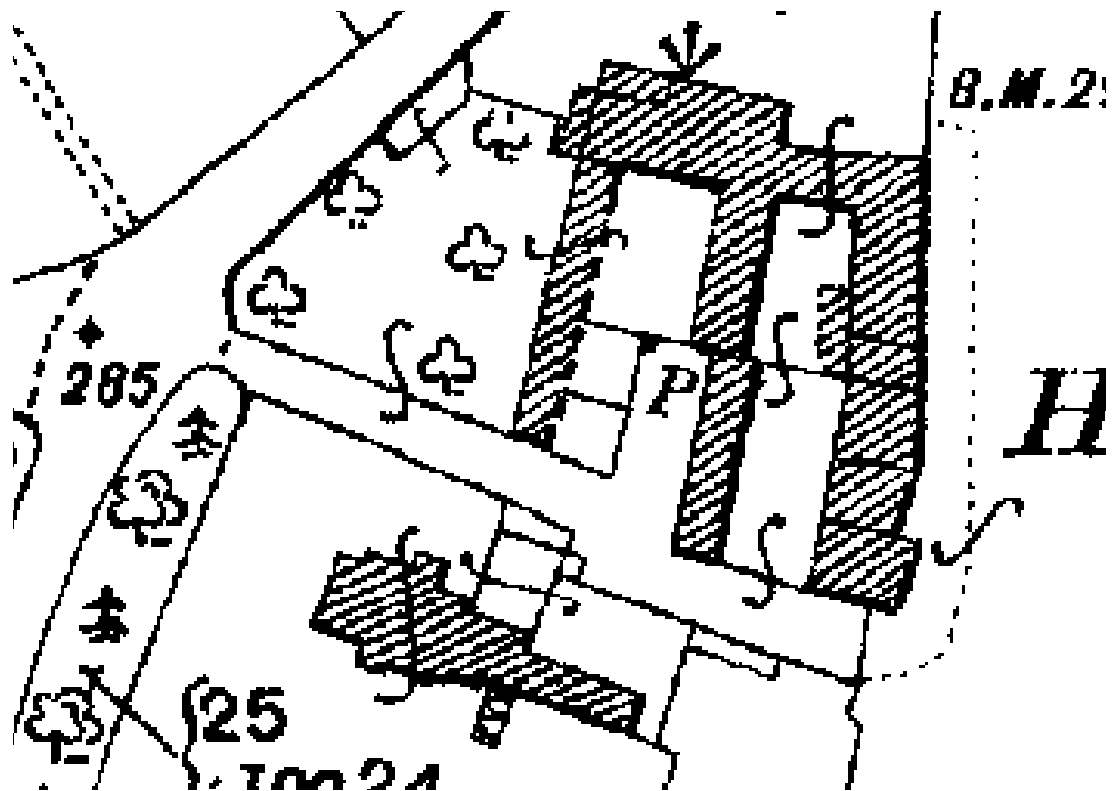
Figure 4

Second Edition 25 inch Ordnance Survey of 1904.

Showing the present buildings in more detail. The western barn (building 1 in figure 5) is shown with now-demolished lean-to sheds flanking its northern porch, and the open eastern elevation of the western shelter shed (9) is indicated as such by a broken line. With the exception of the central shed (7), which has been largely rebuilt, this complex remained substantially intact at the time of the time of inspection.

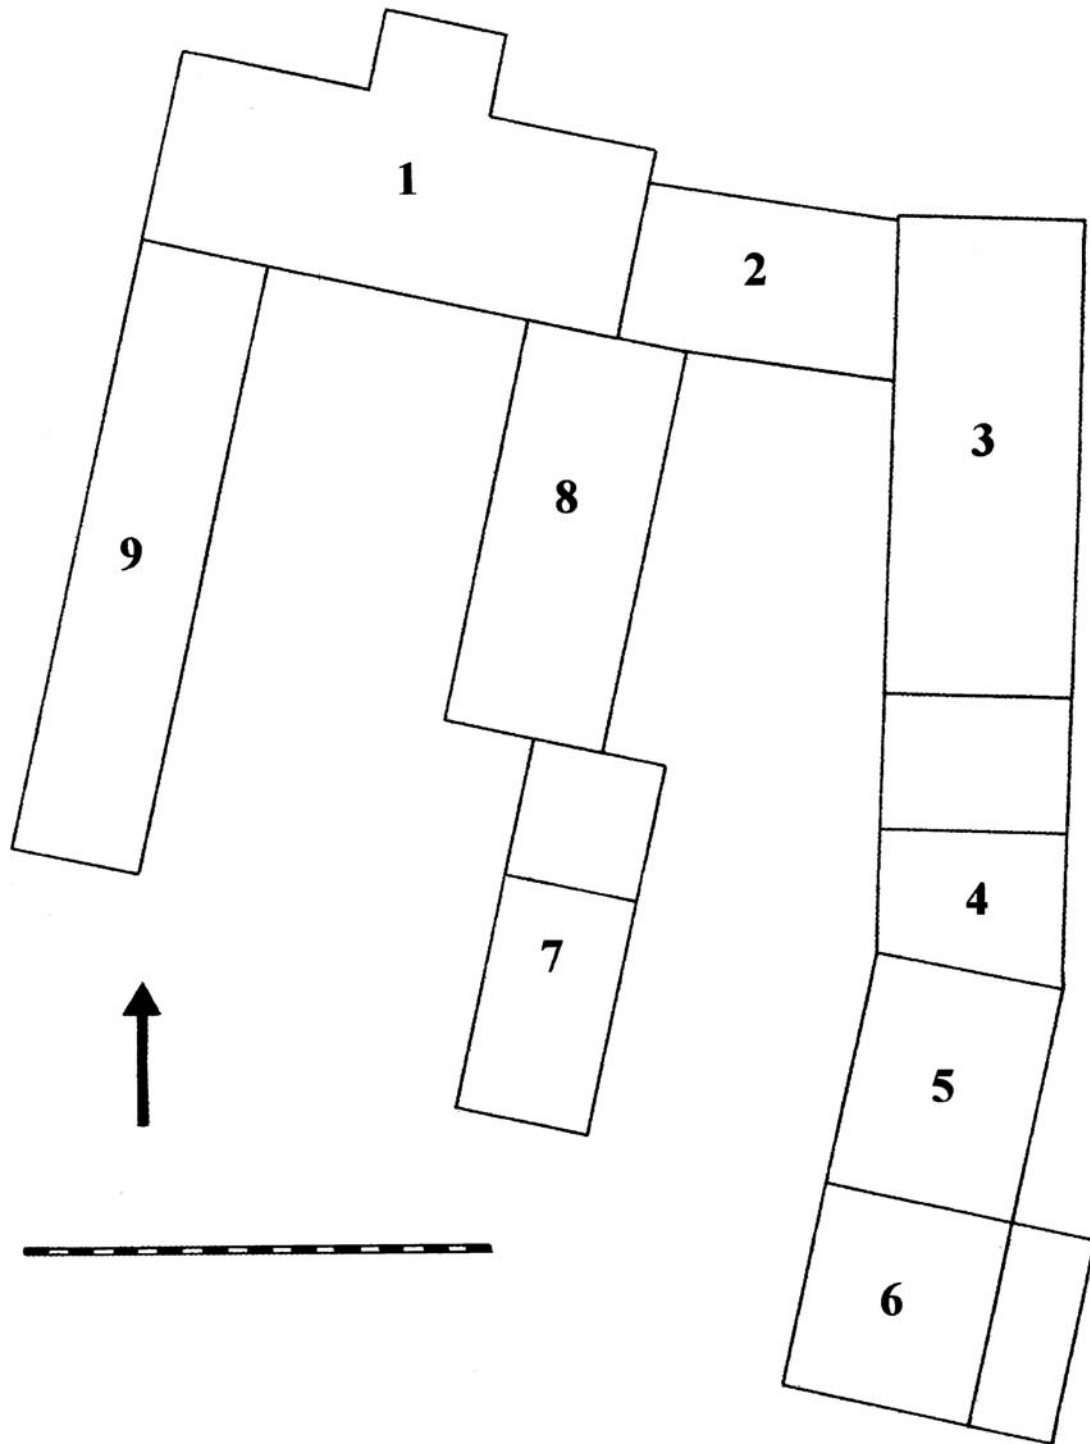
Figure 5

Block plan of site, based on the Ordnance Survey, showing the historic components of the site as detailed below. Scale in metres.

1. Five-bay barn with rear (southern) aisle and central northern porch. Timber-framed with vertical boarding on tall plinth of brick and clunch. *Circa* 1830, but slate roof with king-post trusses rebuilt in *circa* 1870.
2. Single-storied enclosed vehicle shed with double doors to north. Pantiled roof. Clunch with northern façade of dressed flint. *Circa* 1870.

3. **Five-bay timber-framed and weatherboarded barn with tall plinth of dressed flint. Original central entrance in eastern elevation but now with double doors in northern gable. Slate roof structure of prefabricated king-post trusses with unusually late arch-braces to tie-beams. Circa 1870.**

4. **Single-storied shed of brick rubble with eastern façade of dressed flint. Northern section open-sided to east and southern section open-sided to west (the latter now enclosed to form stables). Secondary roof of corrugated asbestos. Circa 1870.**

5. **Single-storied shed of brick rubble. Originally open-sided to east (probably as a cart lodge) but now enclosed to form stables. Secondary roof of corrugated asbestos roof. Circa 1870**

6. **Two-storied granary of clunch and brick rubble with external elevations of dressed flint. Slate roof. Circa 1870 with later 19th century lean-to extension of red brick to east.**

7. **Single-storied shed of red brick and clunch with secondary roof of corrugated asbestos. Probably an enclosed cow shed but much altered when converted into an open-sided shelter shed in 20th century. Now open-sided to east with small enclosed stable to north. Circa 1870**

8. **Single-storied enclosed shed of clunch with external elevations of dressed flint. Pantiled roof. Probably designed as a stable with door and louvered windows to western yard but later converted into a cow shed. Internal feed store or chaff box to south and access to tack room in south-eastern corner of adjoining barn (1). Circa 1870.**

9. **Single-storied shelter shed of clunch with red-brick dressing, open-sided to east. Truncated to south. Pantiled roof. Circa 1870.**

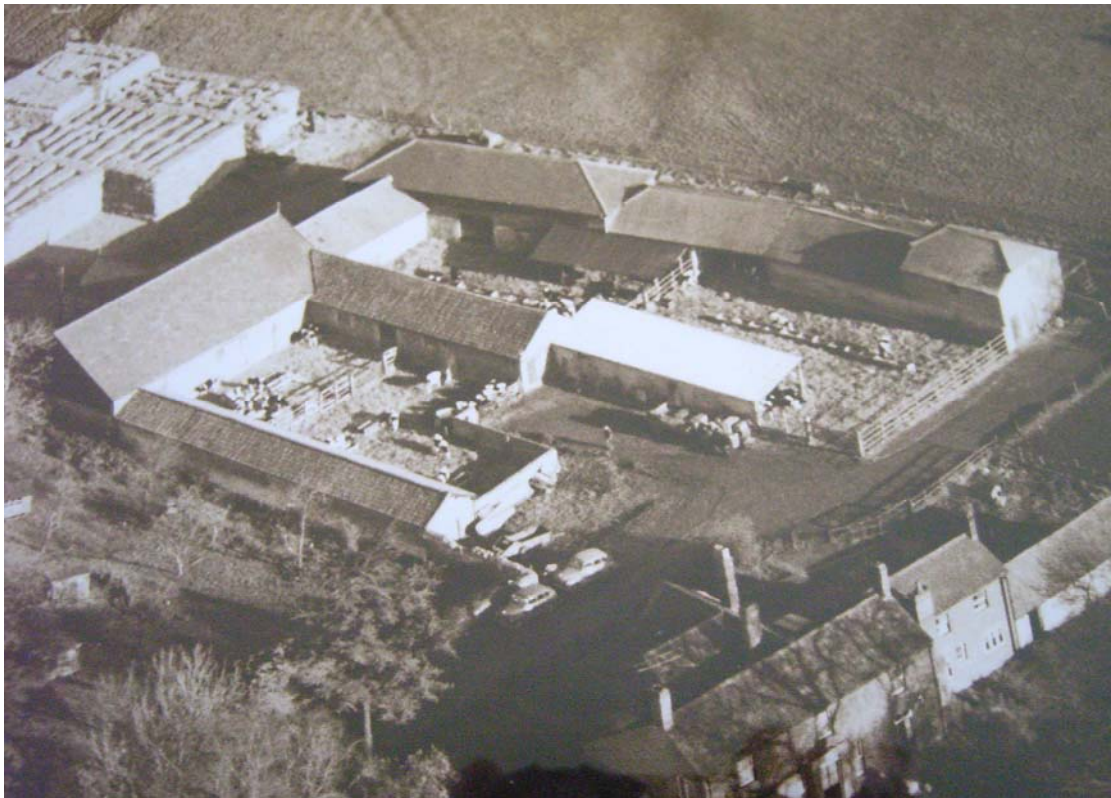
A2.1 October 1965. Aerial view of site from south-west showing historic farm buildings and cattle in all yards before the addition of the present yard roofs. The farmhouse is visible in the bottom right-hand corner. Original in possession of owner.

1. Aerial view of site from south-west showing cattle in yards & farmhouse to right (October 1965).
2. Aerial view of site from south-west showing cattle in yards (October 1965).

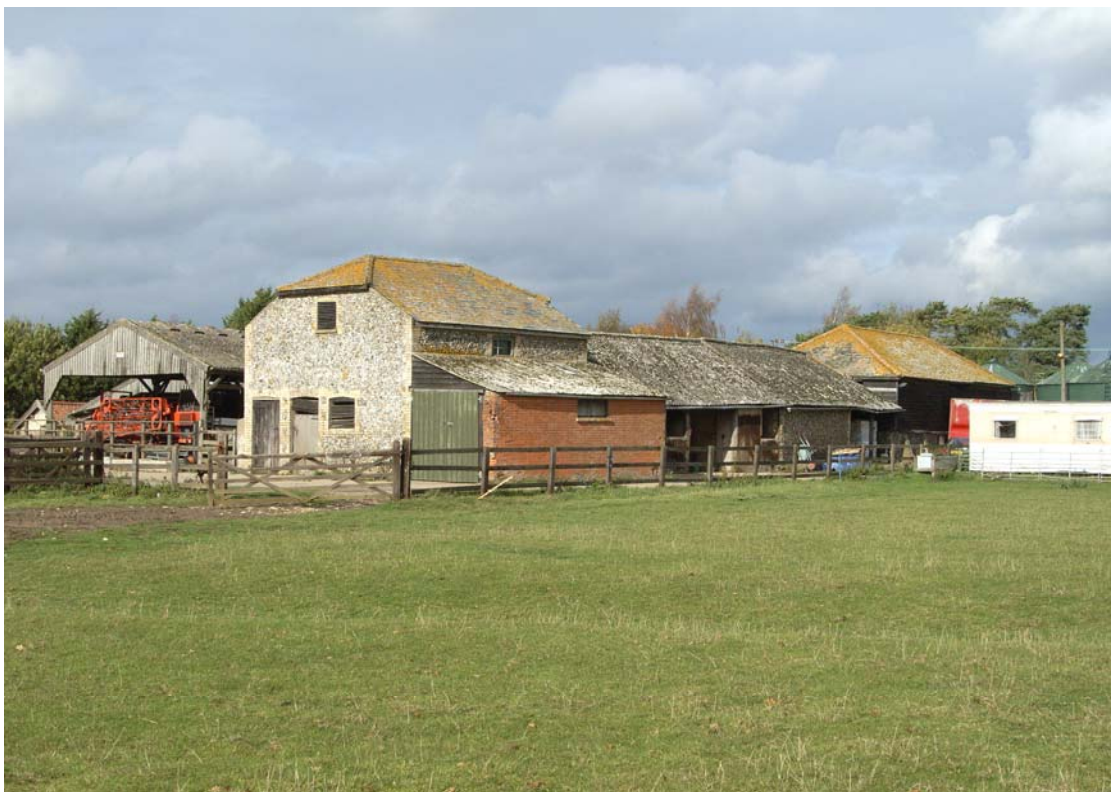
A2.2 General view of site from south-east showing granary (6) to left and barn (3) right

3. General view of site from paddock to south-east showing modern piggery to right.
4. General view of site from south-east showing granary (6) to left and barn (3) right.

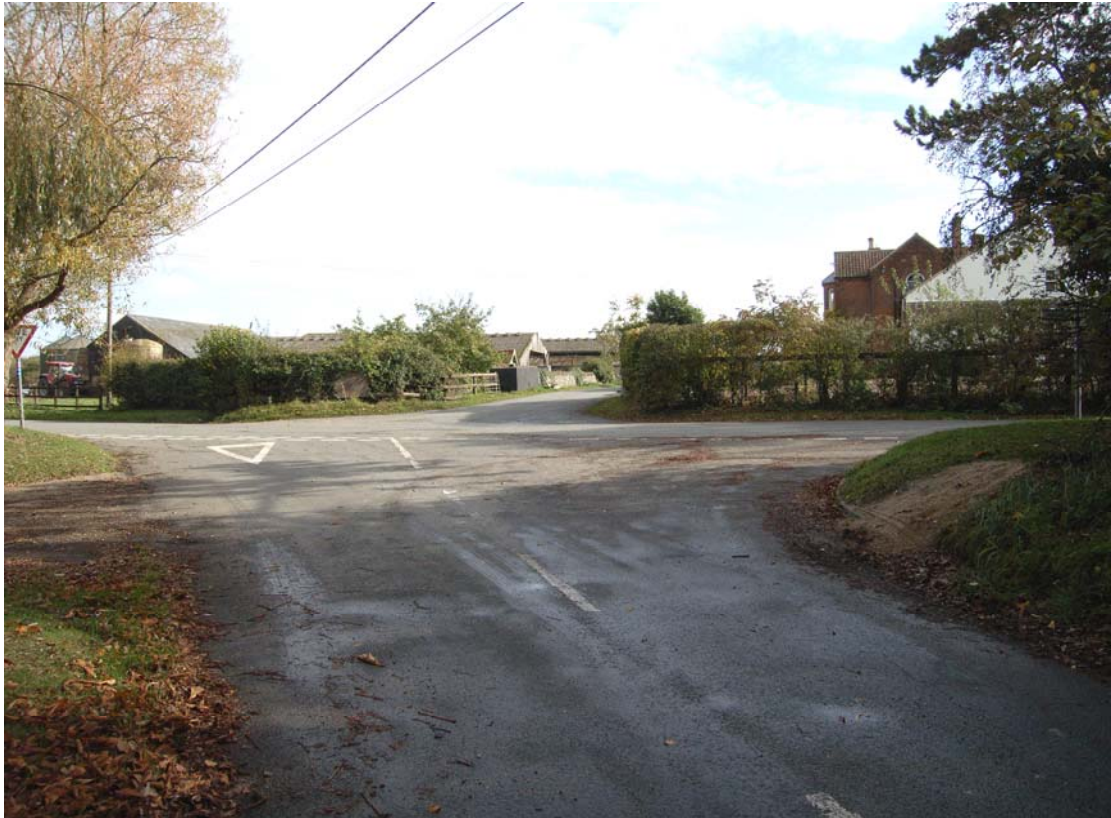
A2.3 General view of site entrance from road junction to west showing farmhouse to right and historic farm complex to left.

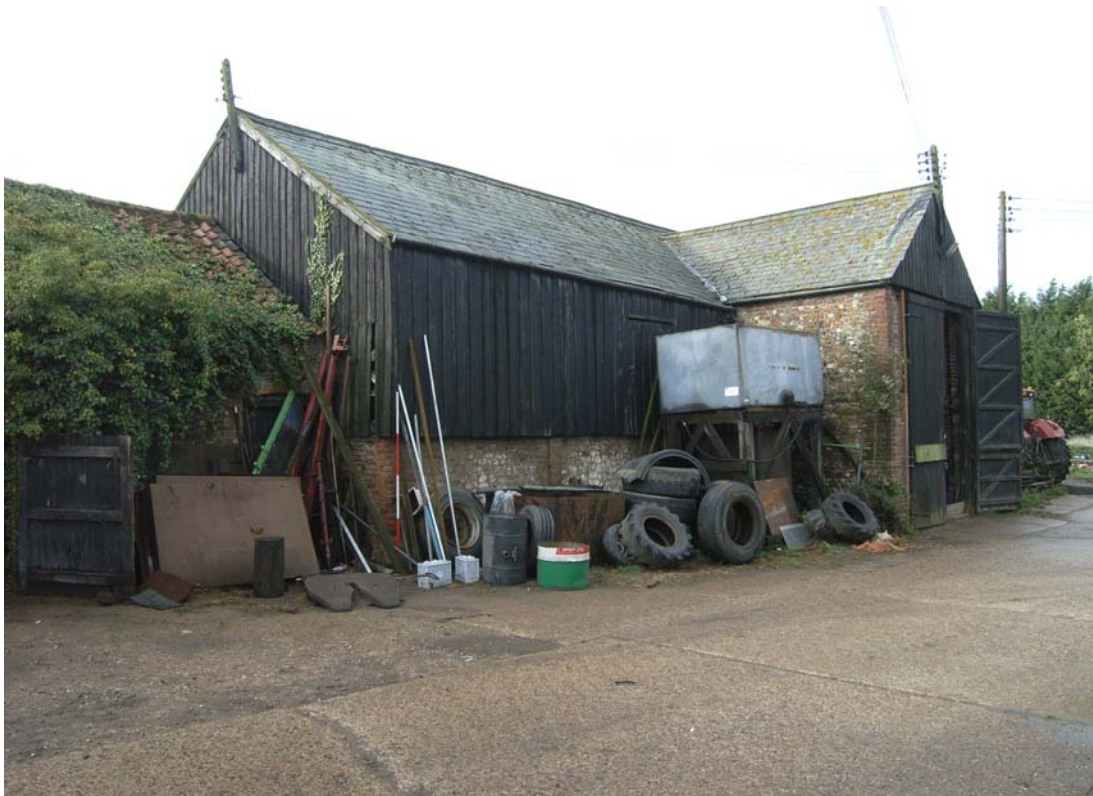
A2.4 Western Barn (1). Exterior from north-east showing slate roof with northern porch and tall plinth of clunch and flint rubble. The vehicle shed (2) is visible to the left

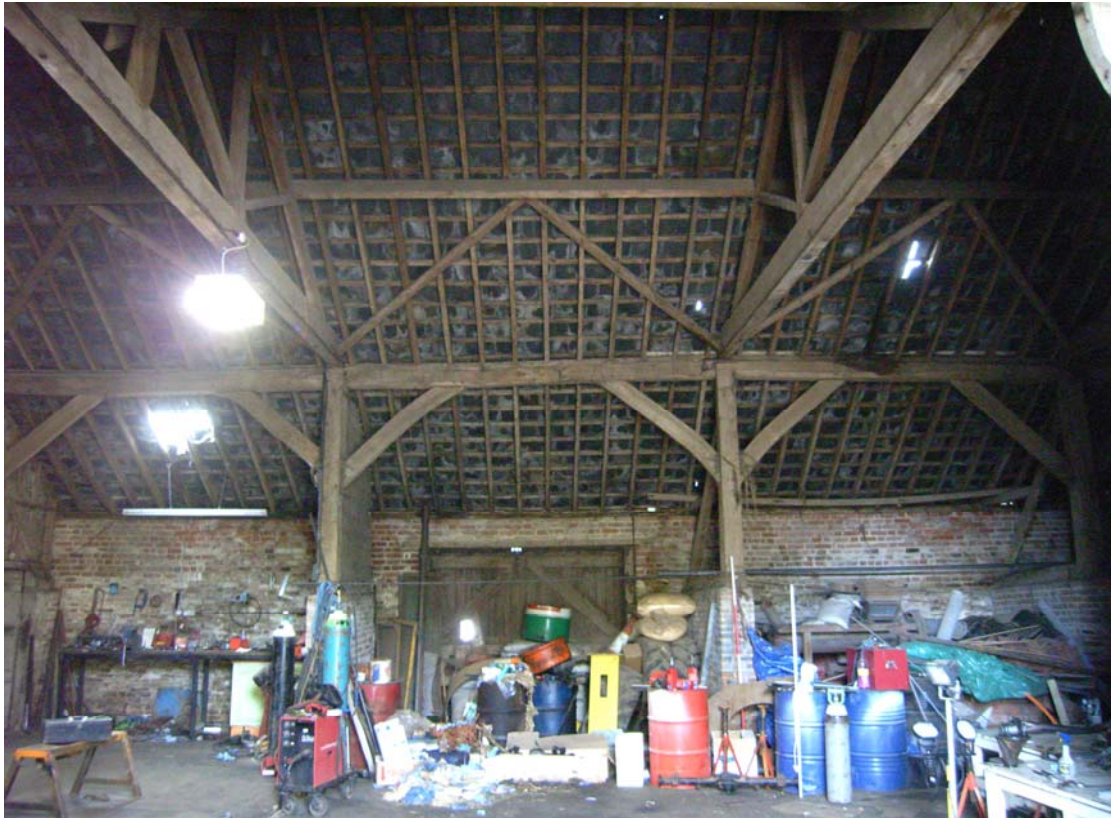
A2.5 Western Barn (1). Interior of the aisled southern elevation showing central door to yard. The tie-beams and roof structure are late-19th century replacements and the storey posts contain mortises for arch-braces as in the eastern barn (3).

The rear aisle is divided into storage bays by tall plinths of irregular brickwork beneath sill-beams which support the deal arcade posts. These posts retain a series of original plank-

sectioned arcade-braces but lack the braces which originally rose to the tie-beams (as indicated by empty mortises). The present tie-beams lack equivalent mortises, however, and the entire slated roof structure of pre-fabricated king-post trusses is evidently a later replacement. The present external cladding of vertical boards is also secondary, and the survival of lath-and-plaster to the external studwork suggests the barn was formerly rendered. The uniform brickwork of the southern elevation is also significantly different from the rest of the building and was probably rebuilt as part of the site's major refurbishment in *circa* 1870.

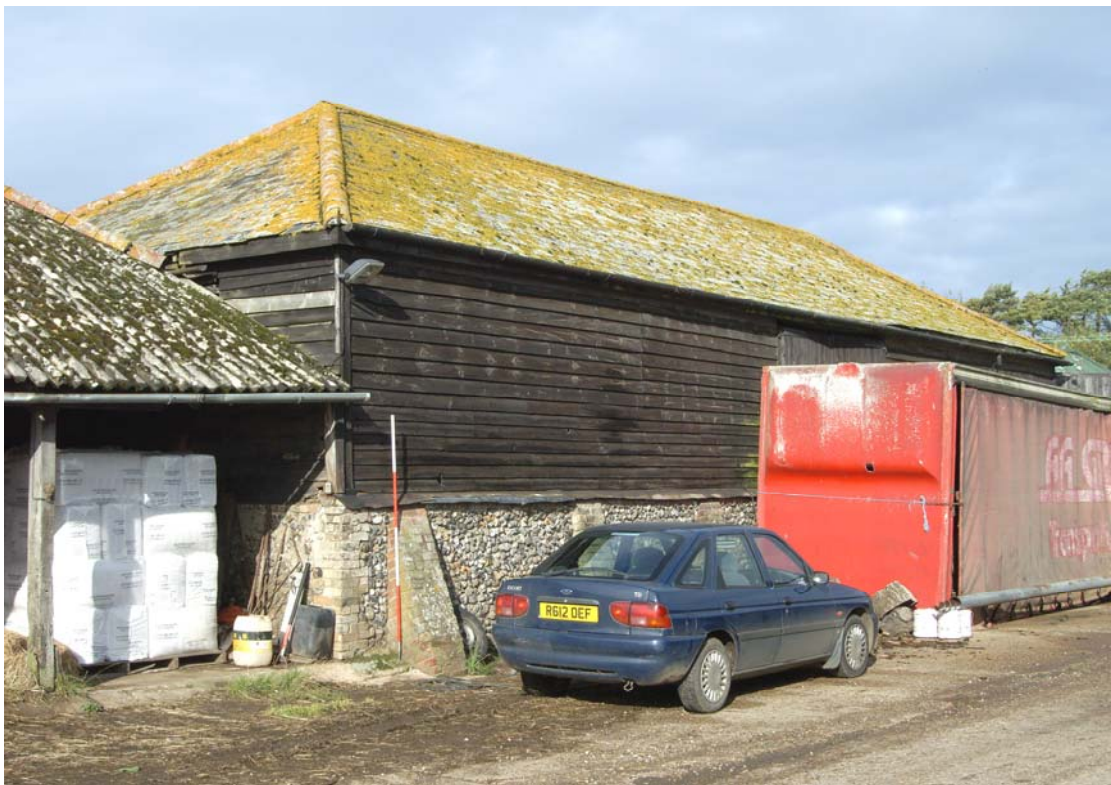
A2.6 Eastern Barn (3). Exterior from south-east showing slate roof, hipped gables & tall flint plinth.

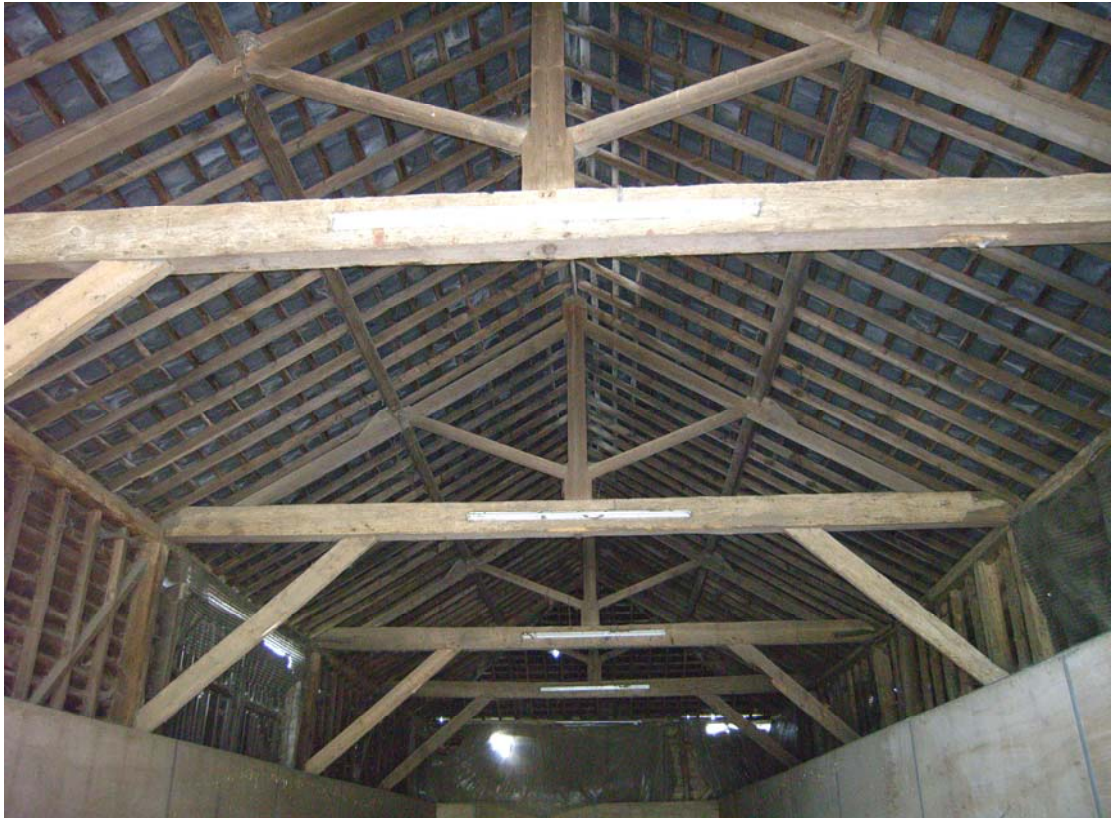
A2.7 Eastern Barn (3). Original roof structure seen from northern gable showing king-post trusses with intact braces to tie-beams.

The eastern barn remains largely intact and original, unlike the western barn, with the principal exception of the double doors in its northern gable which are insertions of the late-20th century. It also contains five bays but is aligned on an approximately north-south axis and extends to 20 m in length by 7.2 m in overall width (66 ft by 23.5 ft). It is not aisled and rises to 4 m at its eaves on a 1.5 m high plinth of neatly dressed flint (13 ft and 5 ft respectively). The tarred and weatherboarded studwork is largely of deal with straight primary bracing and the hipped slate roof consists of pre-fabricated king-posts of typical late-19th century type. Unusually for a barn of this period the storey posts are linked to the tie-beams by tenoned and pegged braces in the medieval traditional rather than by standard bolted knee-braces. These braces remain completely intact. The internal walls are now largely hidden by late-20th century boarding but the outline of the original entrance doors in the central bay of the eastern elevation is still visible, as is that of a smaller door to the yard immediately opposite. This barn formed part of a major rebuilding of the farm complex in *circa* 1870.

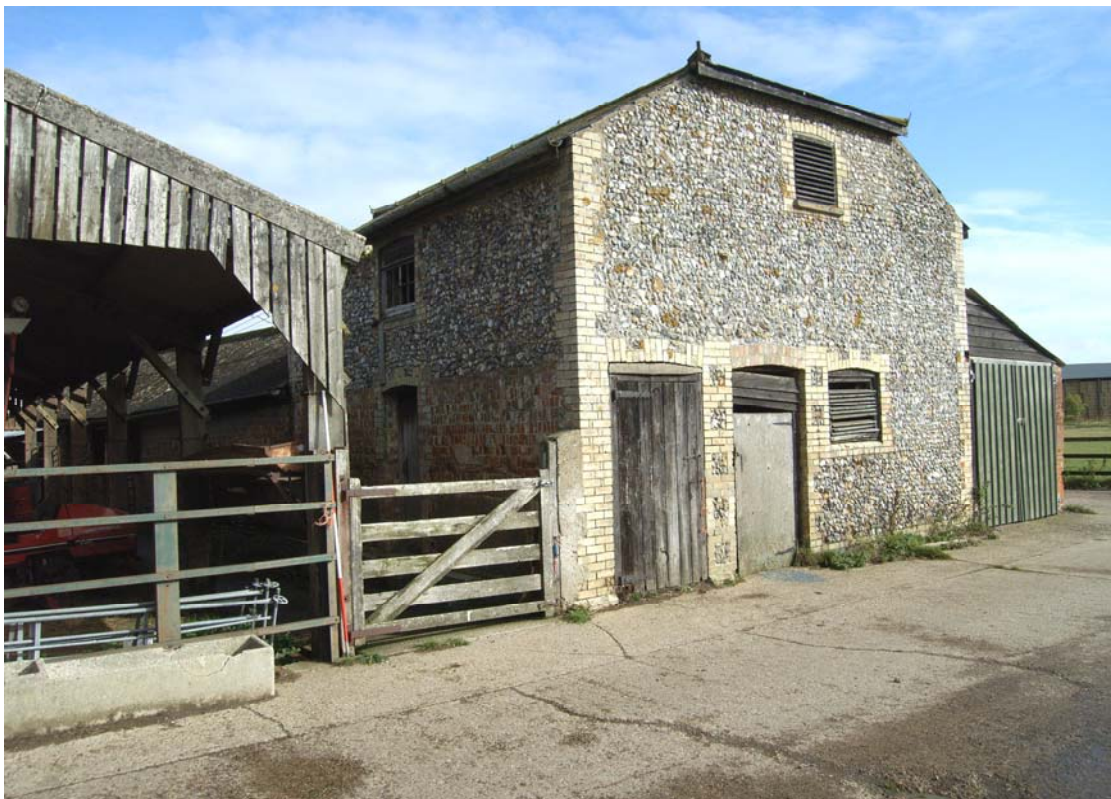
A2.8 Granary (6). Exterior from south-west showing 20th century covered yard to left. The left-hand door of the southern gable opens onto an original internal stair.

The south-eastern corner of the complex is occupied by a two-storied granary with a half-hipped slate roof and external walls of flint dressed with Gault brick. The inner walls consist of clunch and brick rubble, but the ground storey of the western elevation is built entirely of brick headers set on edge and may survive from an older structure. This earlier fabric extends into the adjacent shed (5) and may represent the remains of a mid-19th century shelter shed (perhaps contemporary with the western barn). The building extends to 7.6 m in length by 7.3 m in width (25 ft by 24 ft) on a north-south axis and rises to 4.7 m (15.5 ft) at its eaves, with an internal ceiling of tall-sectioned joists sealed by lath-and-plaster beneath its floorboards. The original layout of the lower storey is no longer apparent, but it was lit by a louvered window in its southern gable and entered by doors to both the south and north. It may have served as a feed store. The upper storey is lit by an original louvered window in its southern gable and by glazed windows to the west and east. It is reached by an original internal stair in its south-western corner which rises from a dedicated external door in the gable. Vertical grooves in a series of extant wall posts reveal the former presence of boarded grain bins, but at the time of inspection the chamber contained only the chute of a 20th century feed mill in its north-western corner. The granary is typical of the 1870s and formed part of the site's refurbishment at that period.

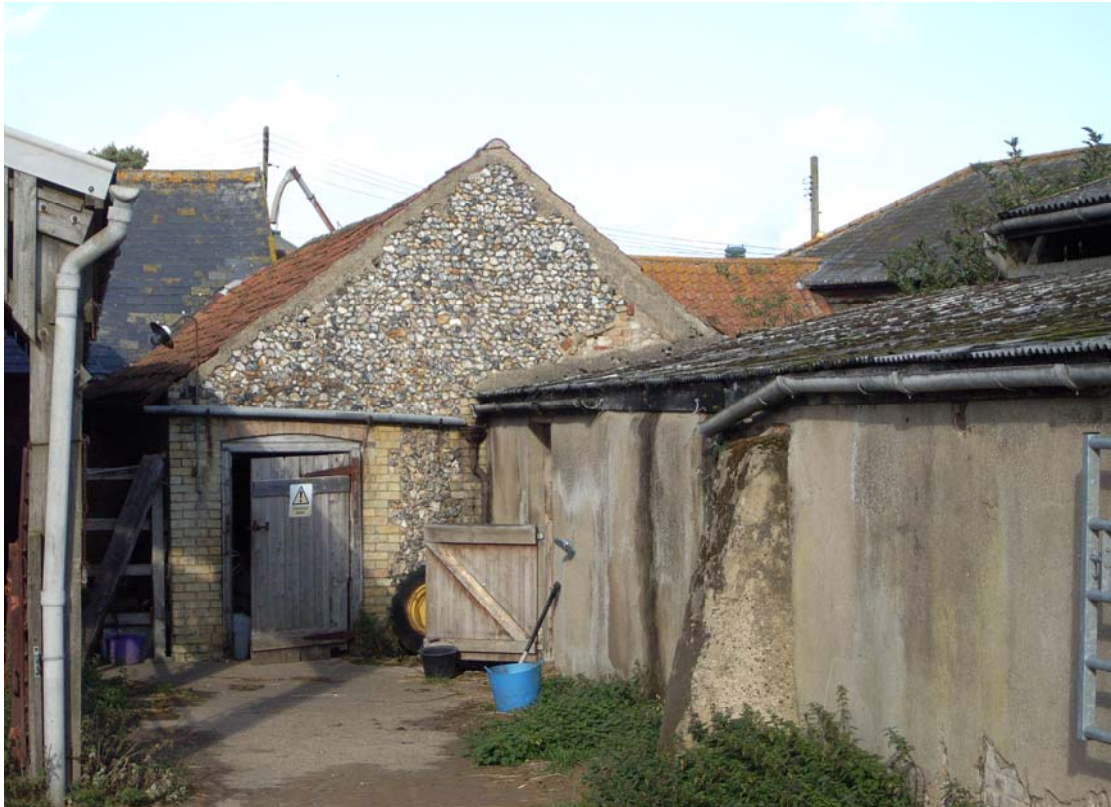
A2.9 Stable (8). External southern gable dividing the western and eastern yards, and showing fragmentary shelter shed (7) to right with the slate roofs of the western and eastern barns (1 & 3) to left and right respectively.

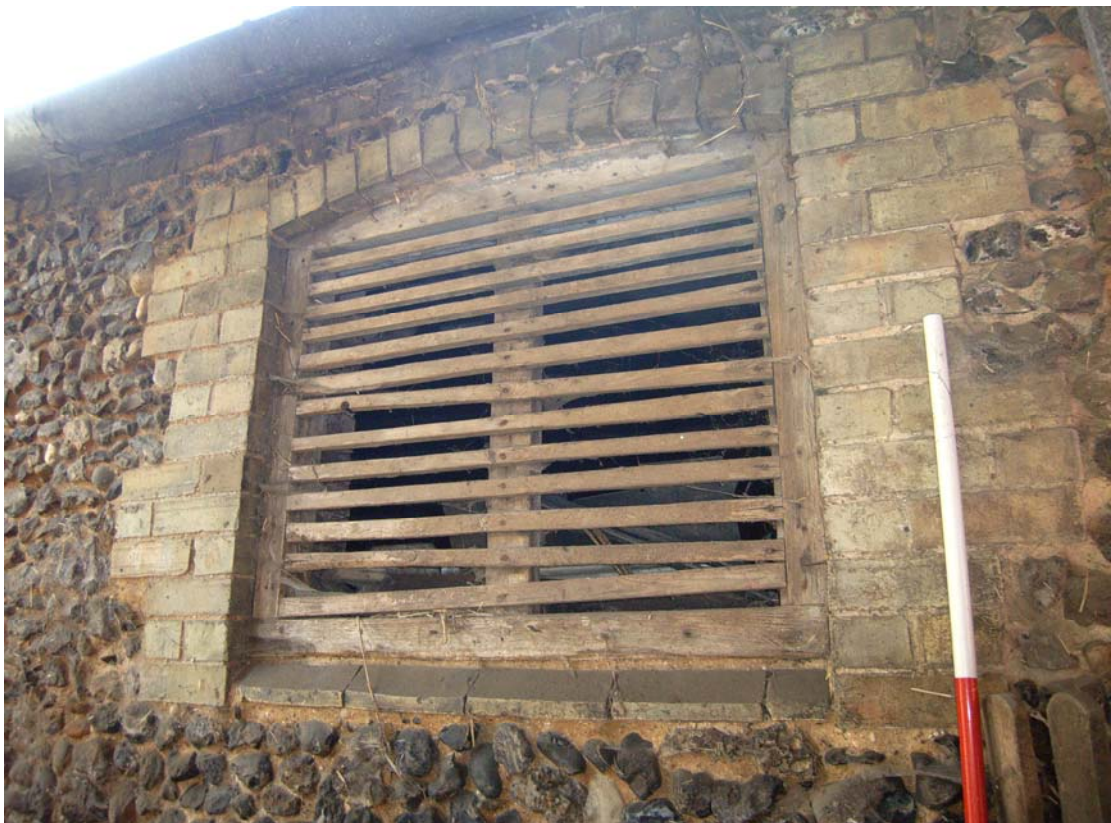
A2.10 Stable (8). Detail of northern louvered window in western exterior.

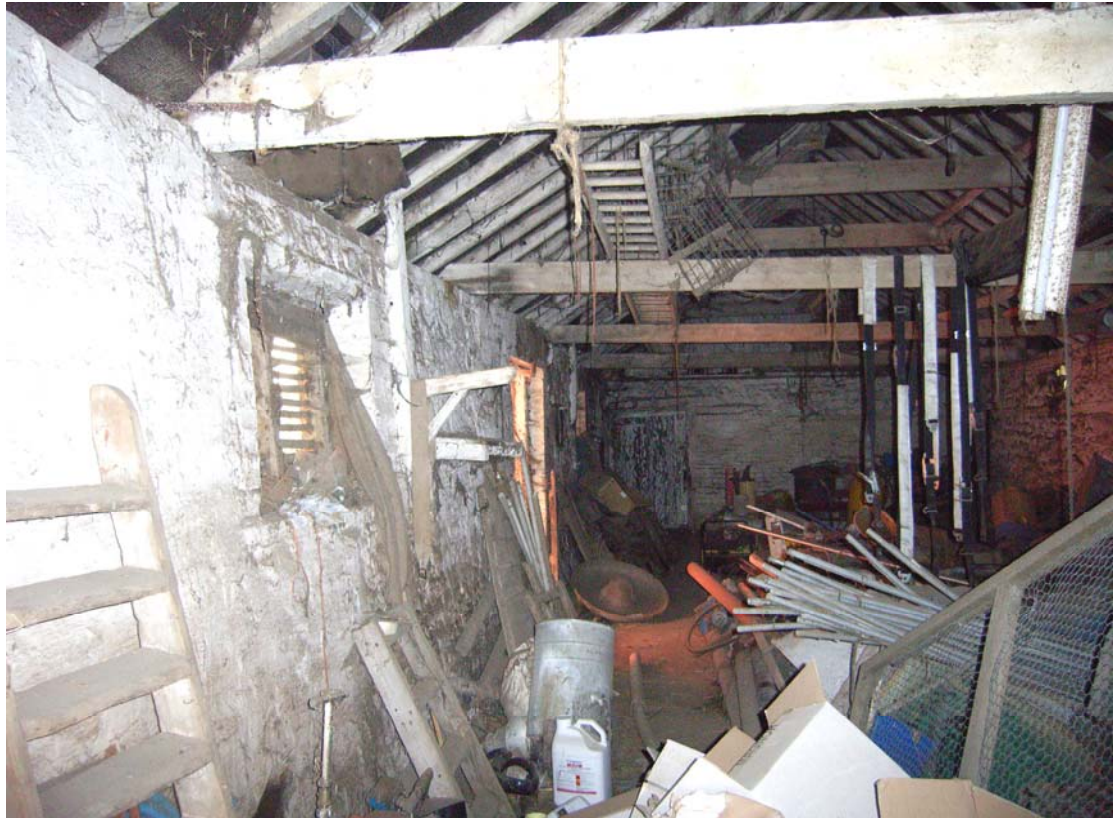
A2.11 Stable (8). Interior from south showing harness hooks, yard door and louvered windows to left. The door in the rear (northern) gable opens into a tack room in the corner of the western barn (1).

The enclosed former cattle yards adjoining the principal barns to the north of the complex are divided by a substantial single-storied pantiled shed of clunch and brick rubble with external elevations of flint with Gault brick dressings. Like the granary and the eastern barn this appears to have formed part of the refurbishment of the site in *circa* 1870, and extends to 18 m in length by 5.8 m in overall width on a north-south axis (59 ft by 19 ft). Although converted into a cow shed during the 20th century it was probably designed as a stable and retains a number of wooden harness hooks at the southern end of its western elevation and in a narrow tack room that was inserted into the south-eastern corner of the earlier barn. A contemporary compartment of 3.5 m in length (13 ft) in the shed's own south-eastern corner may have operated as a chaff box or feed store but latterly served as the farm's chemical store. The presence of box-like stores of this kind is typical of 19th century stables without hay lofts, and is consistent with the lack of any other obvious stable on the site. A manger and hay rack would have been attached to the eastern internal elevation, which lacks doors and fenestration, while the western elevation contains a central doorway flanked by a pair of original louvered windows. With the exception of the aforementioned harness hooks, no historic fixtures or fittings survive.

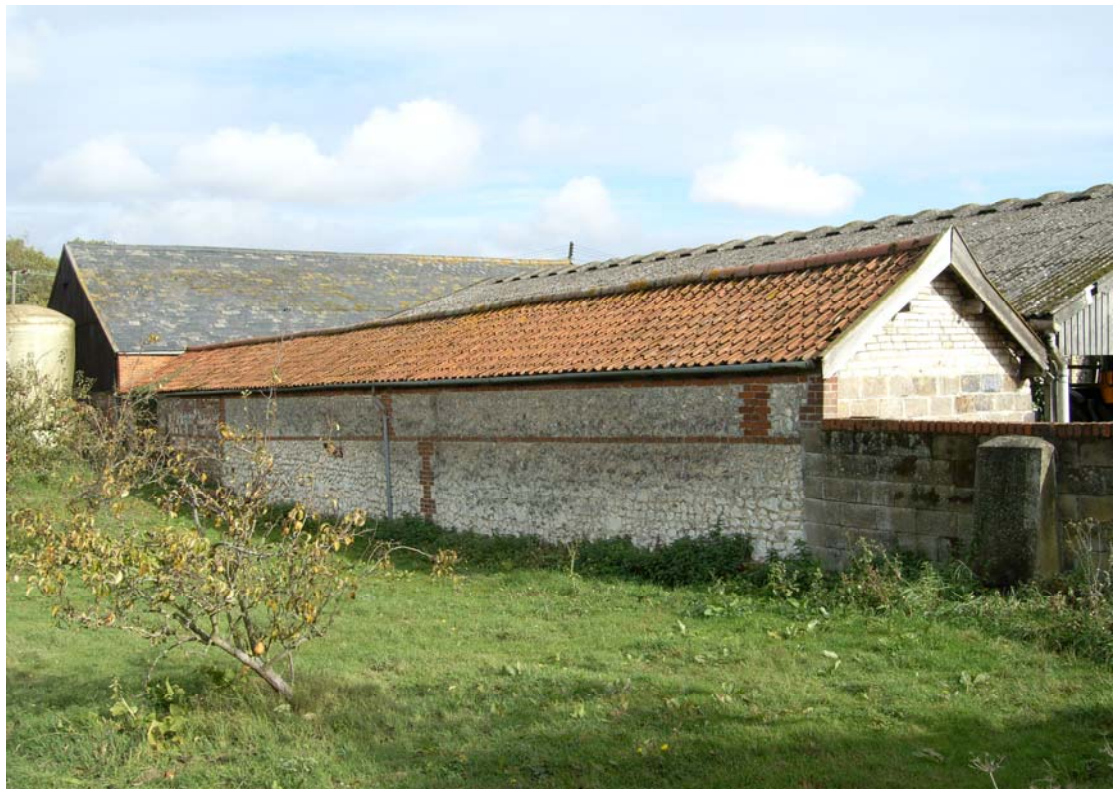
A2.12 Shelter shed (9). Exterior from south-west showing clunch construction with brick dressing and slate roof of western barn (1) to left.

The western side of the complex is formed by a pantiled shelter shed with an open arcade to the east which has been truncated to the south but still extends to an impressive 26 m in length by 4.25 m in width (86 ft by 14 ft). Its eaves rise to 2.2 m (7ft) and it now contains a variety of mid-20th century metal cattle troughs and hay racks. The western elevation, which is visible from the nearby road, is neatly constructed in clunch with dressings of red brick, although its northern end contains a higher proportion of flint and brick and may have been rebuilt.
