**River's Farm Barn,
High Street,
Sproughton, Suffolk
SPT 037**

Historic Building Record

River's Farm Barn, High Street (B1113), Sproughton, Suffolk

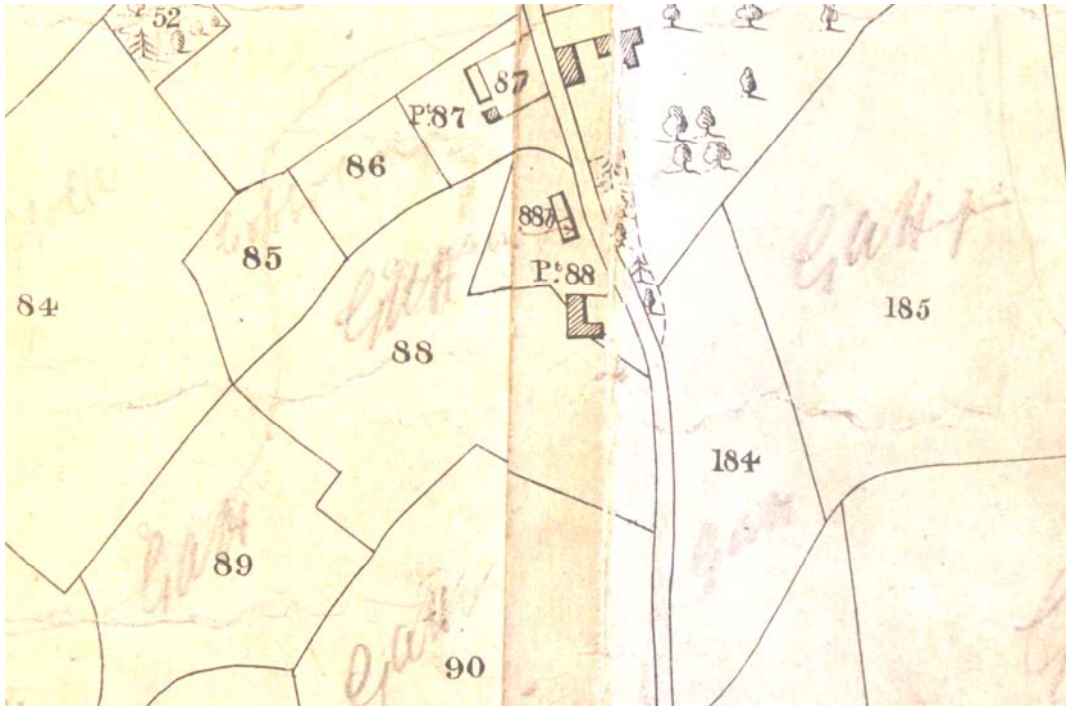
Figure 2

Sproughton title map of 1838 (Suffolk Record Office) showing an L-shaped outbuilding on the site of the present barn complex & a pair of semi-detached cottages to the north.

River's Farm Barn adjoins the western side of Sproughton High Street (the B1113) at the southern entrance to the village, and lies on the eastern edge of a picturesque valley of wet pasture. The present building does not appear on the Sproughton tithe map of 1838 (figure 2) when an earlier structure on the same site belonged to Red House Farm on the Hadleigh Road 800 m to the east. The house to the north of the barn had presumably formed River's Farm in the past, but was already a pair of tenements in separate occupation.

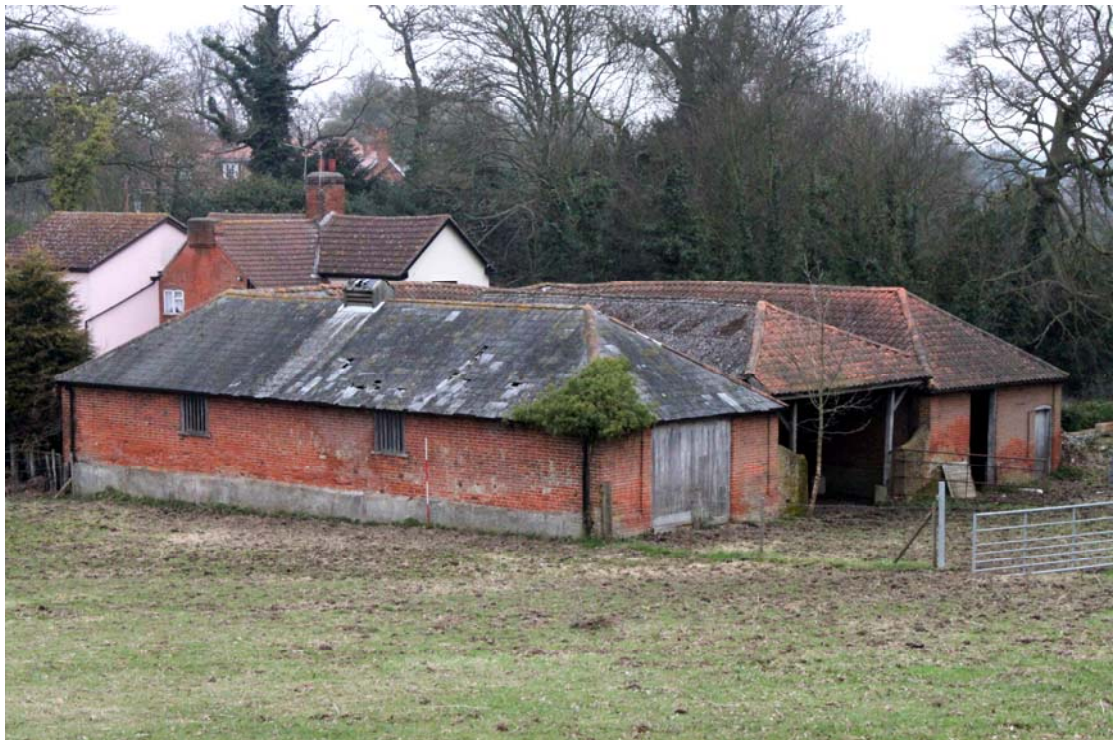
Illus. 2. Exterior of barn complex seen from adjoining high pasture to south-west showing original slate roof of feed barn (1) to left and secondary pantiles of 20th century yard roof in centre (5) and shelter shed with feed store (3 & 4) to right.

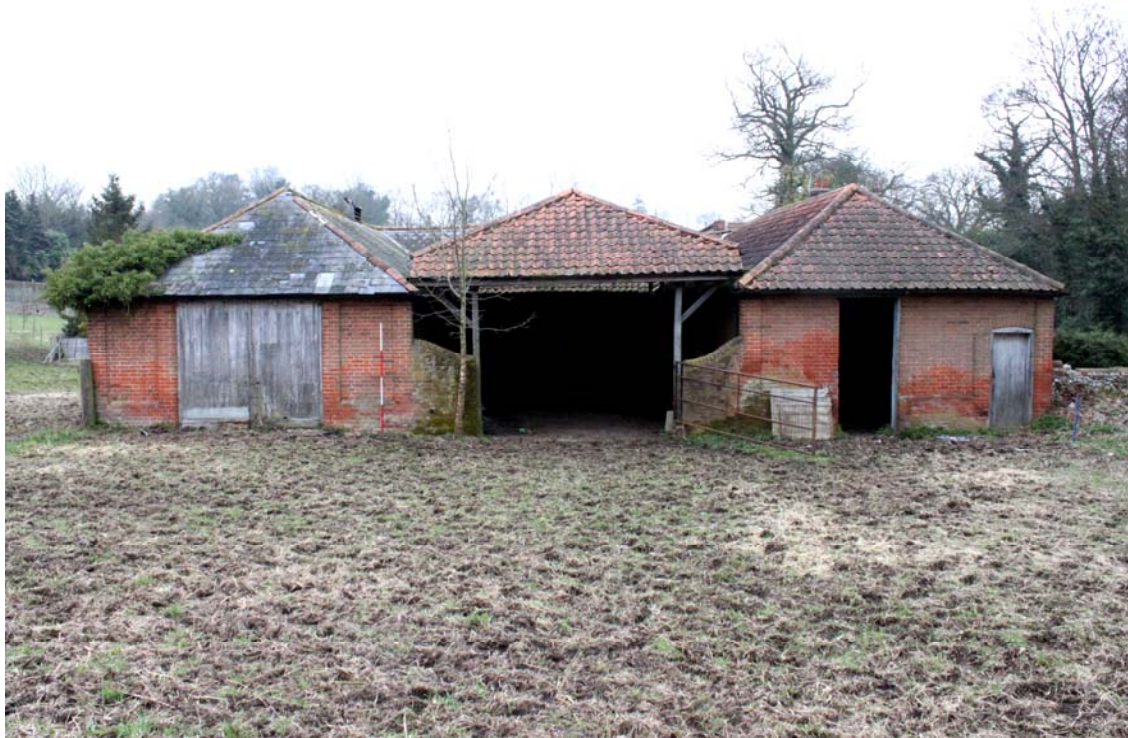
Illus. 4. Southern facade of barn complex showing 20th century of formerly open cattle yard (5) in centre, milling barn (1) with original double-doors to left and feed store (4) to right. The larger of the two doors to the feed store is secondary.

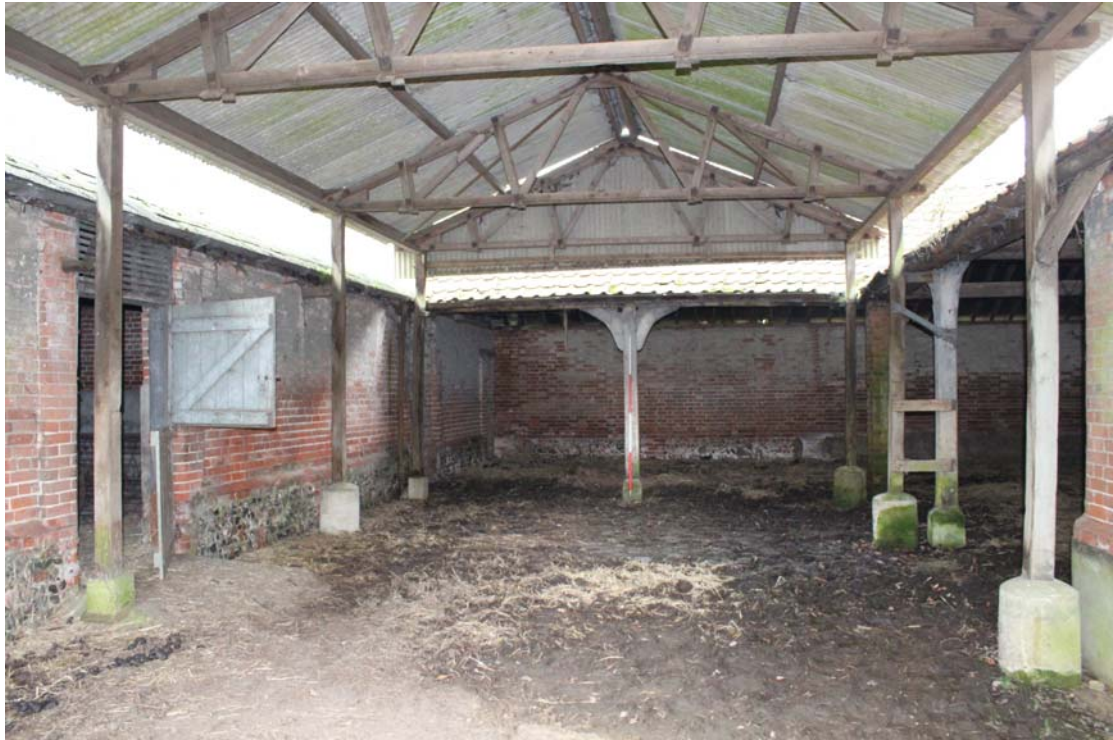
Illus. 5. Interior of covered yard (5) from south showing open arcade of shelter shed (3) in centre and to right, with curved corner of feed store (4) to extreme right and side door to barn (1) to left. The 'daisy wheel' apotropaic symbols lie to the extreme left.

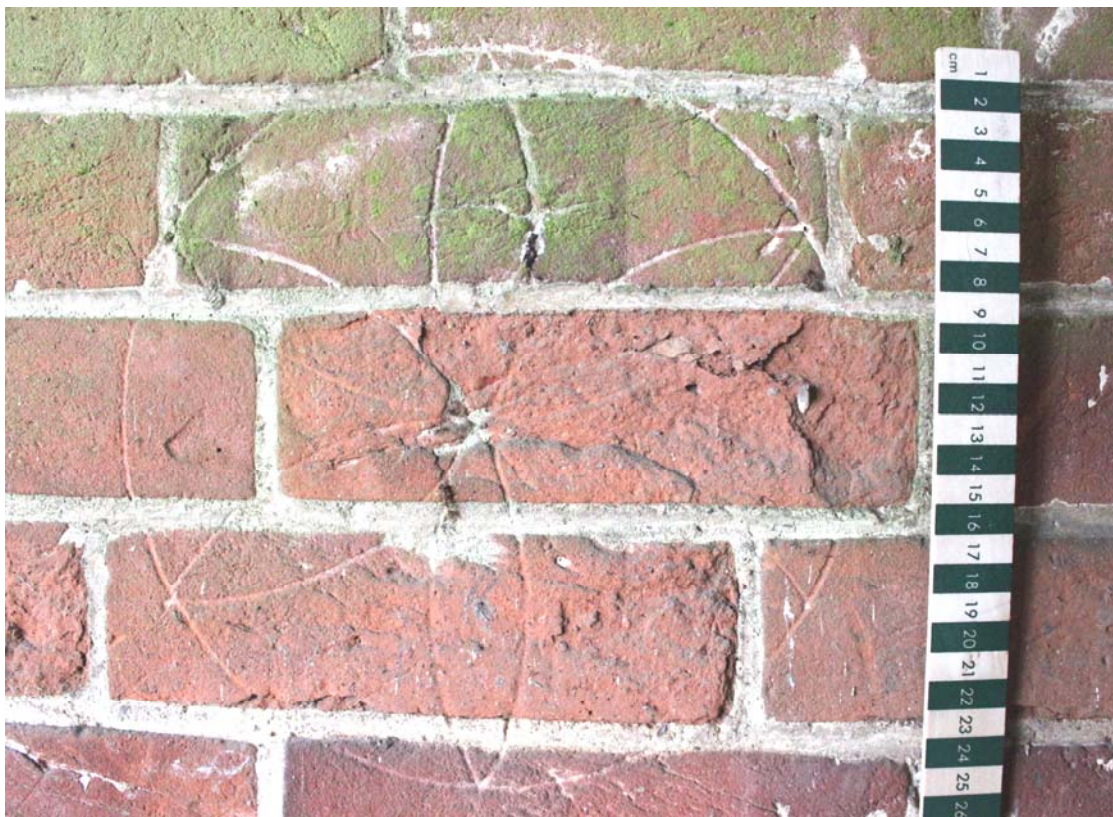
Illus. 6. Detail of 'daisy wheel' apotropaic (evil-averting) mark inscribed on brickwork at southern end of eastern exterior of barn (1) close to the yard entrance.

The complex contains several inscriptions of historic interest, including the date mentioned above. Two large and well-defined ‘daisy wheels’ have been cut with a pair of compasses into the yard wall between its entrance and the inner door to the barn. These represent well-known apotropaic (evil-averting) symbols that are often found on both domestic and agricultural buildings from the late Middle Ages onwards. Designed to protect crops and stock against ‘evil spirits’ their appearance in a relatively late context such as this demonstrates the longevity of the superstition in Suffolk. A number of pencil and chalk inscriptions on the brickwork and internal doors of the barn (notably to the west of the southern entrance and on the side-door) record the types and quantities of grain stored in the barn in the mid and late-20th century. A sack dryer was inserted into the northern half of the building at much the same time (an early form of grain dryer involving the blowing of hot air through a concrete honeycomb beneath sacks of wet grain). A chalk arrow points in the direction of the ‘Garden Field Barley’ and beans and oats are also recorded.

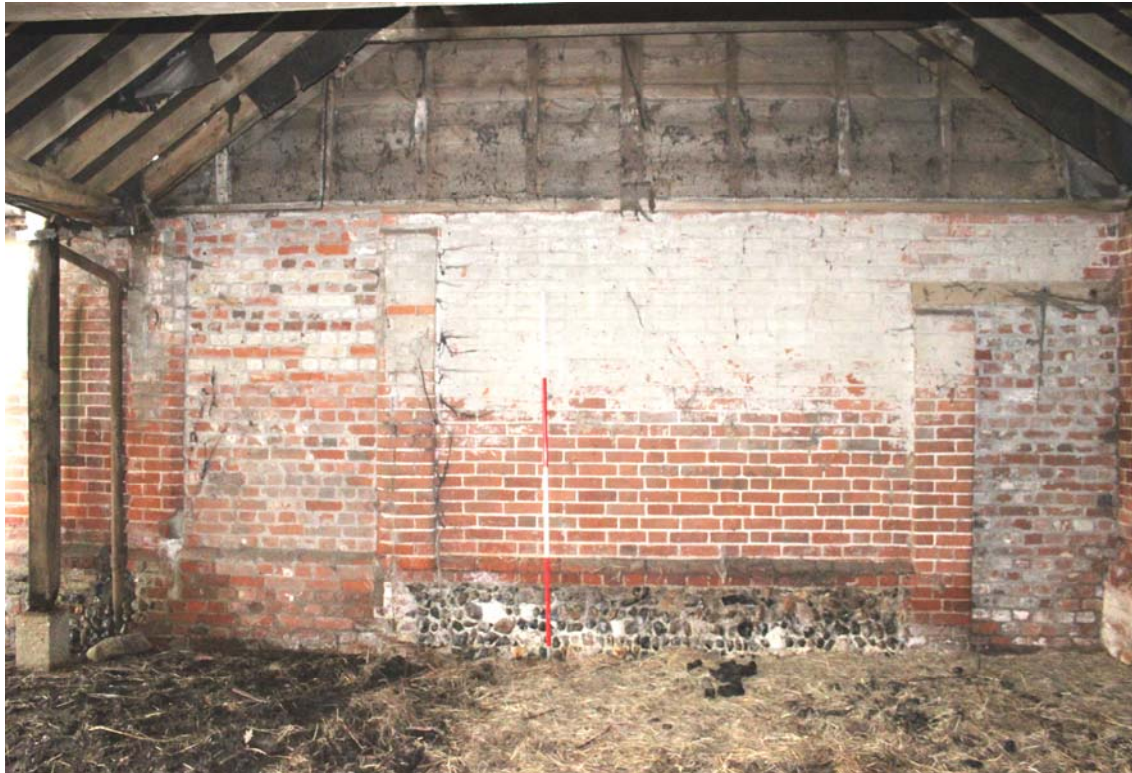
Illus. 7. Eastern exterior of calf shed (2) seen from shelter shed (3) to east showing flint plinth between blocked original doors to right and left.

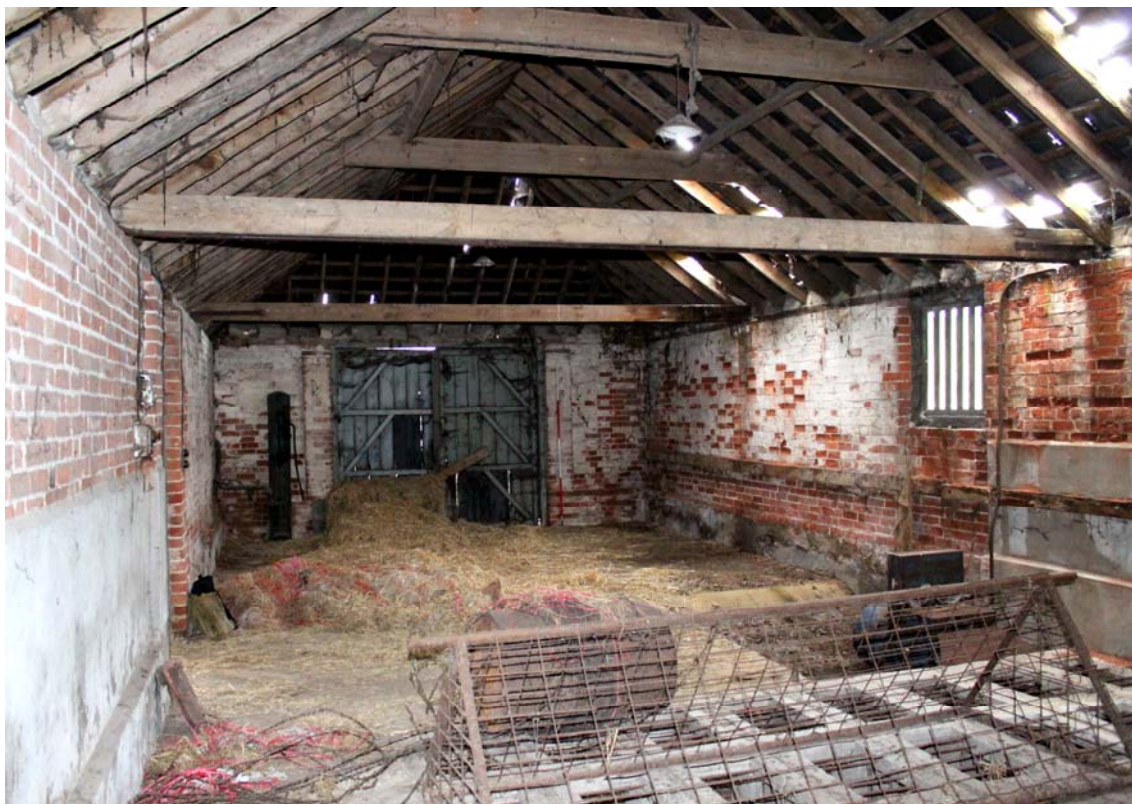
Illus. 8. Interior of barn (1) from north showing 20th century grain dryer in foreground with original gable doors (with decorative cast-iron brackets) and water pump in rear. The sliding louver to the right is also an original feature.

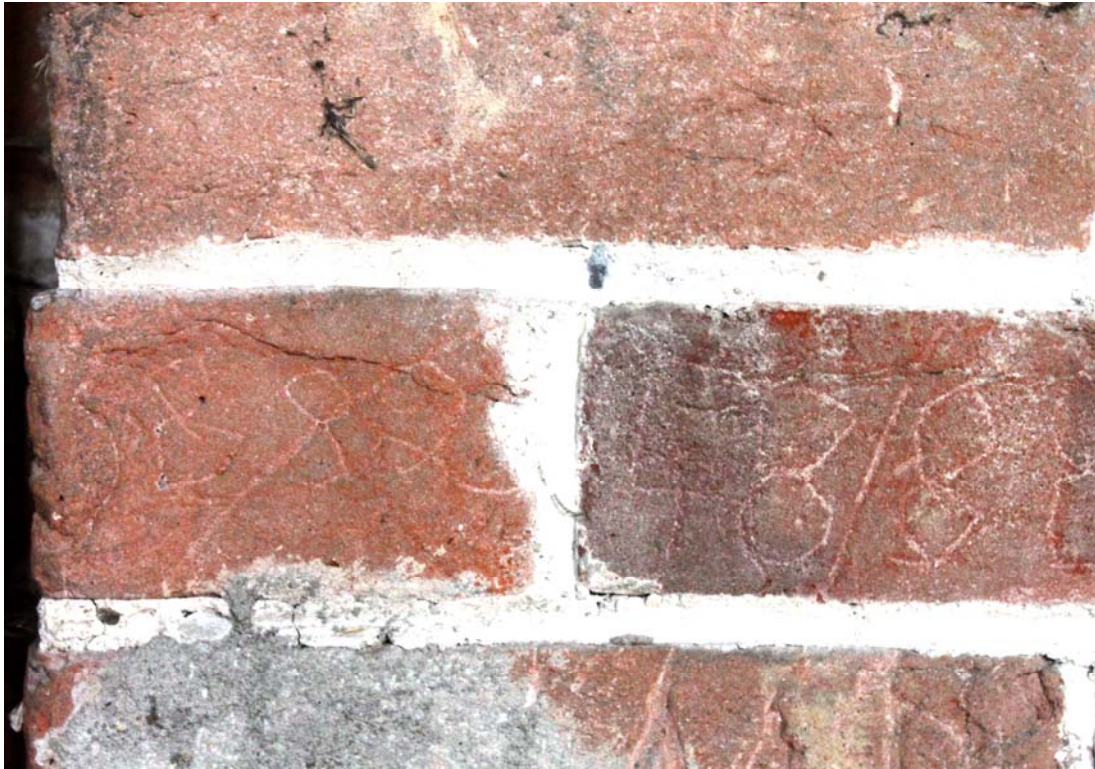
Illus. 9. Detail of inscribed date 1882 on internal brickwork to north of door between barn (1) and yard (5).

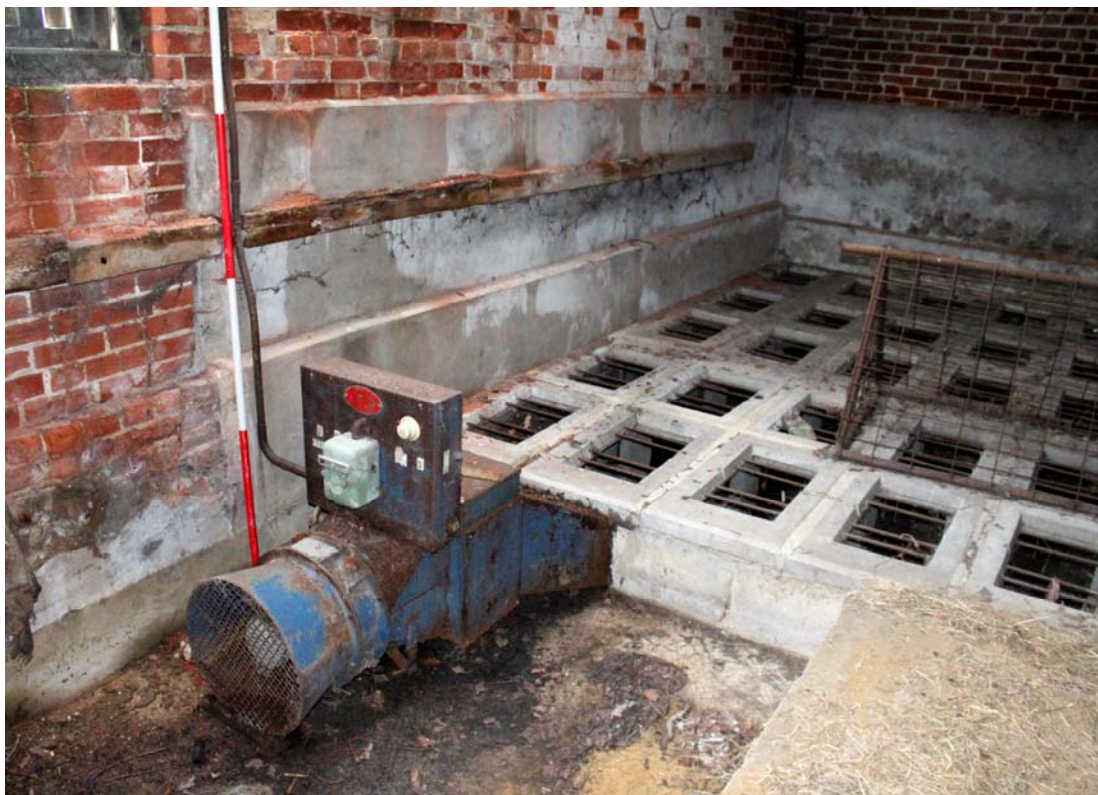
Illus. 10. Detail from south of mid-20th century grain sack dryer in floor of barn (1).
