**Mousehall Barn,  
Flowton Road,  
Flowton, Suffolk  
FLW 014**

**Historic Building Record**

# **Mousehall Barn, Flowton Road, Flowton, Suffolk**

## **Historic Building Record**

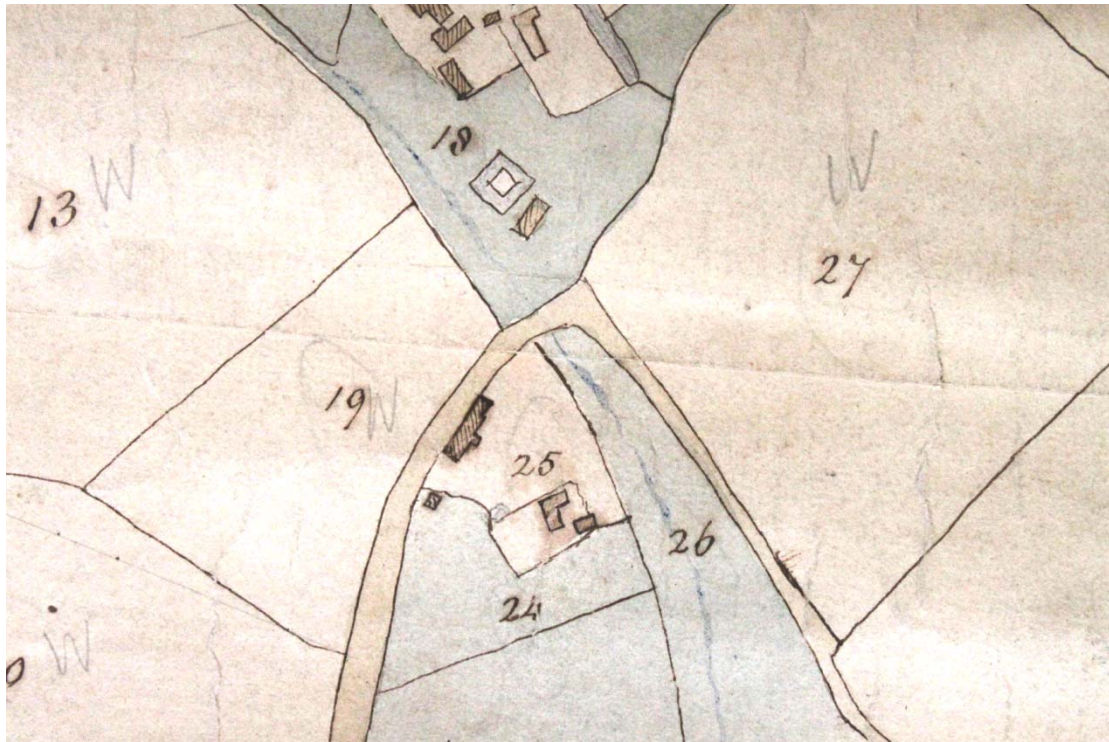
**Figure 2**

The site on the Flowton tithe map of 1839 (Suffolk Record Office) showing the barn to the south-west of a sharp bend in the road with Valley Farm, to the north. The square moat lay in an area (18) described as 'Four pightles (paddocks) and a dufhouse'.

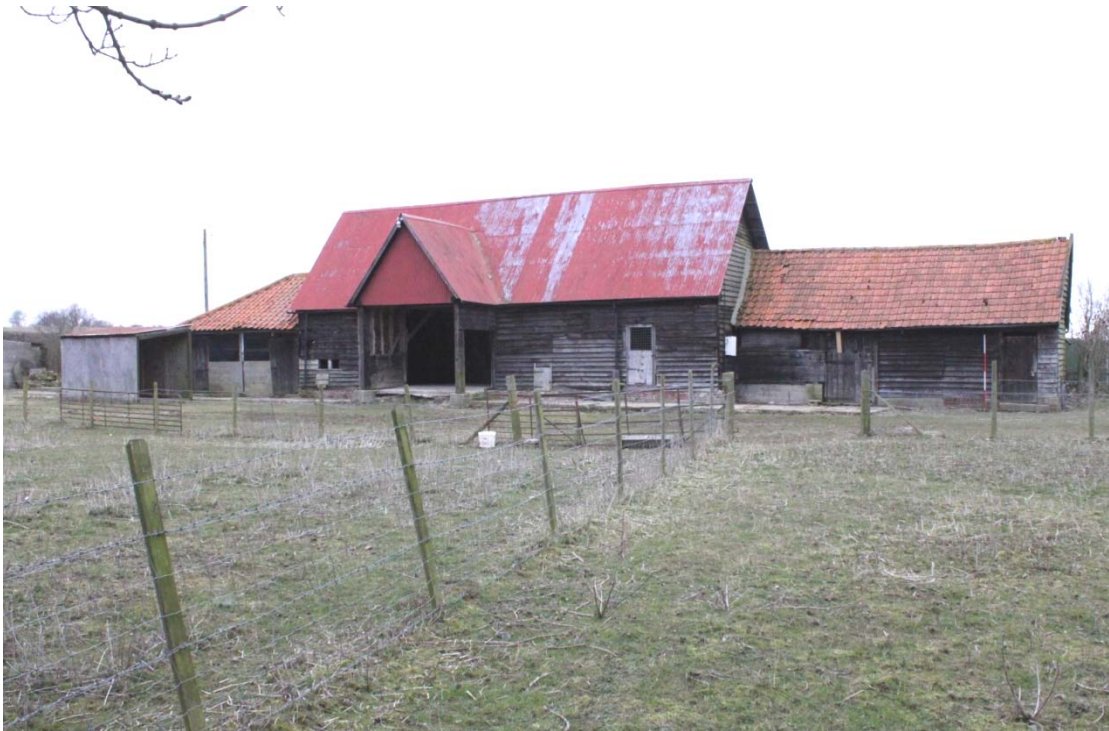
**Illus. 1. General view of site from paddock to east showing main barn (1) with gabled porch to entrance bay between former shelter shed (3) to left and cow house (2) to right.**

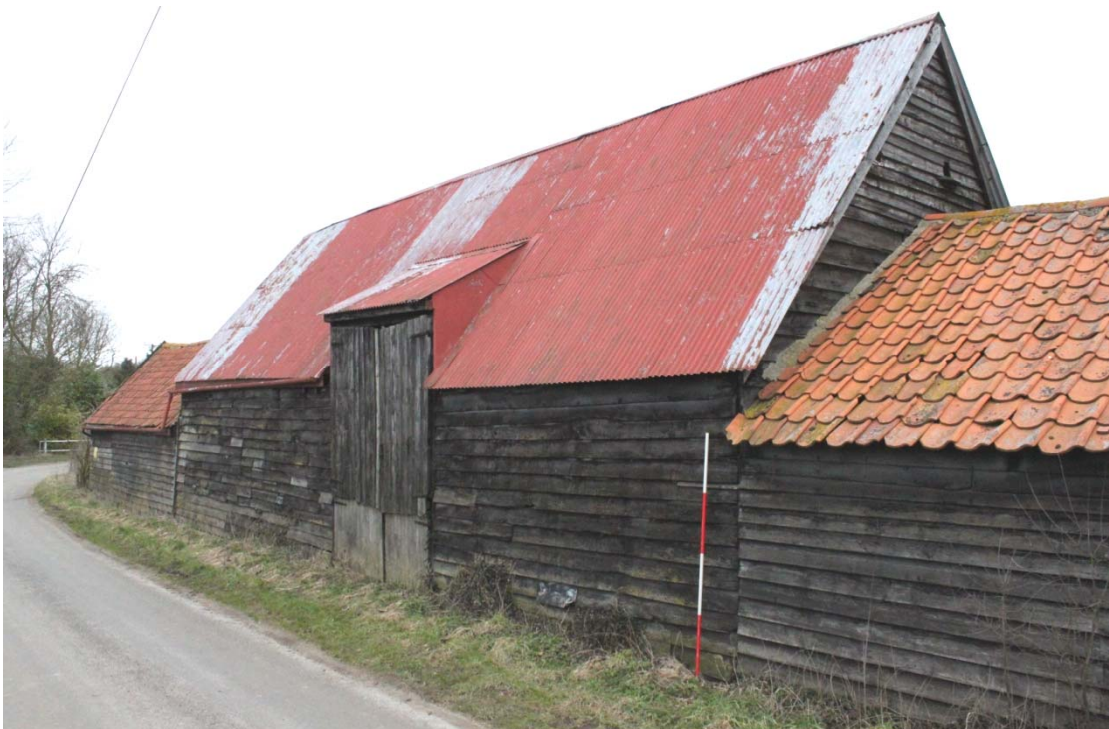
**Illus. 2. Western exterior of barn (1) from Flowton Road to south-west showing pentice roof above entrance doors with pantiled sheds to left and right. The steep pitch of the barn's roof was designed for thatch but is now covered with corrugated iron.**

7. Western exterior of barn from Flowton Road to south-west showing pentice roof above entrance doors.
8. Exterior of barn doors in western roadside elevation showing pentice roof.

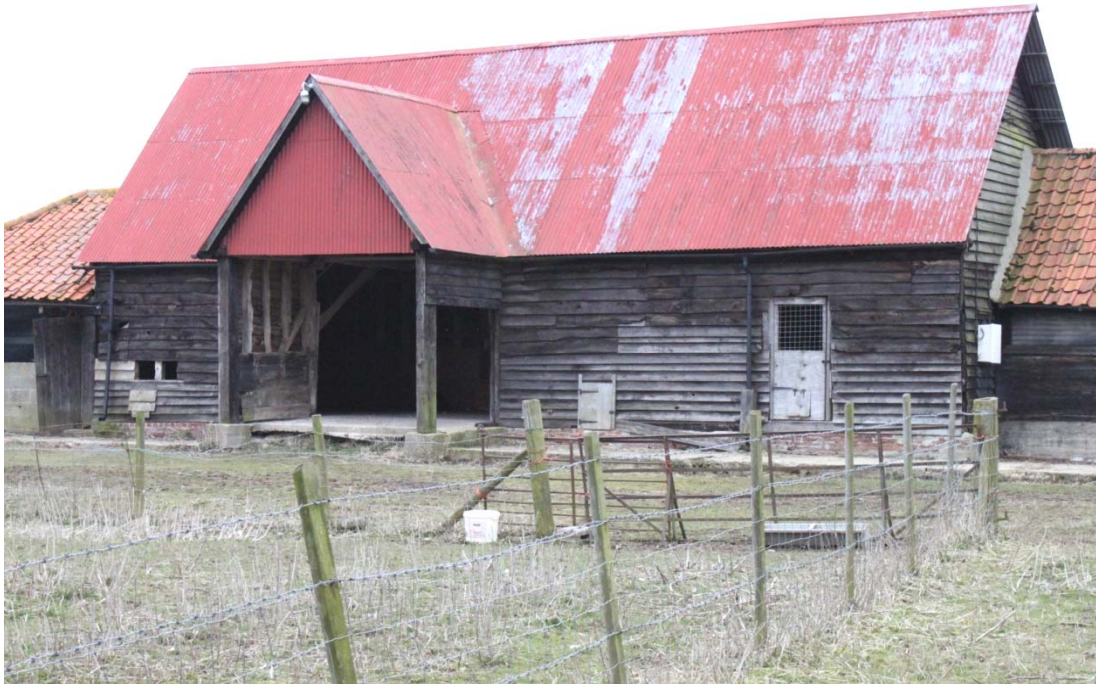
**Illus. 3. Exterior of main barn (1) showing original gabled porch of penultimate southern bay to left and site of demolished lean-to shed against eastern elevation to right.**

9. Eastern exterior of main barn showing gable porch to left and site of demolished lean-to right.
10. Eastern exterior of main barn from south-east showing gabled porch with former shelter shed (3) to left.

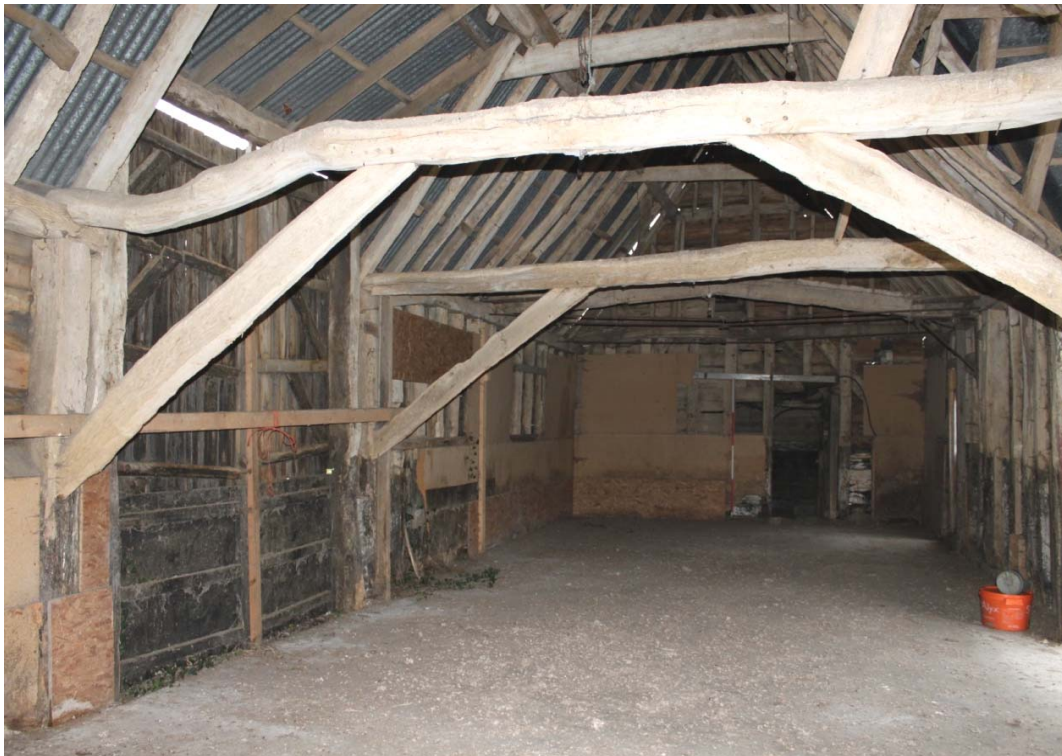
**Illus. 4. Interior of main barn (1) from south showing the low arch-braces to the tie-beams flanking the entrance bay with roadside western doors to left. The north-eastern brace has been removed.**

26. Internal western elevation of cow shed (2) showing narrow studwork.
27. Roof structure of cow shed (2) from north showing wire-mesh hay loft.
28. Interior of barn from south showing low arch-braces flanking entrance bay.

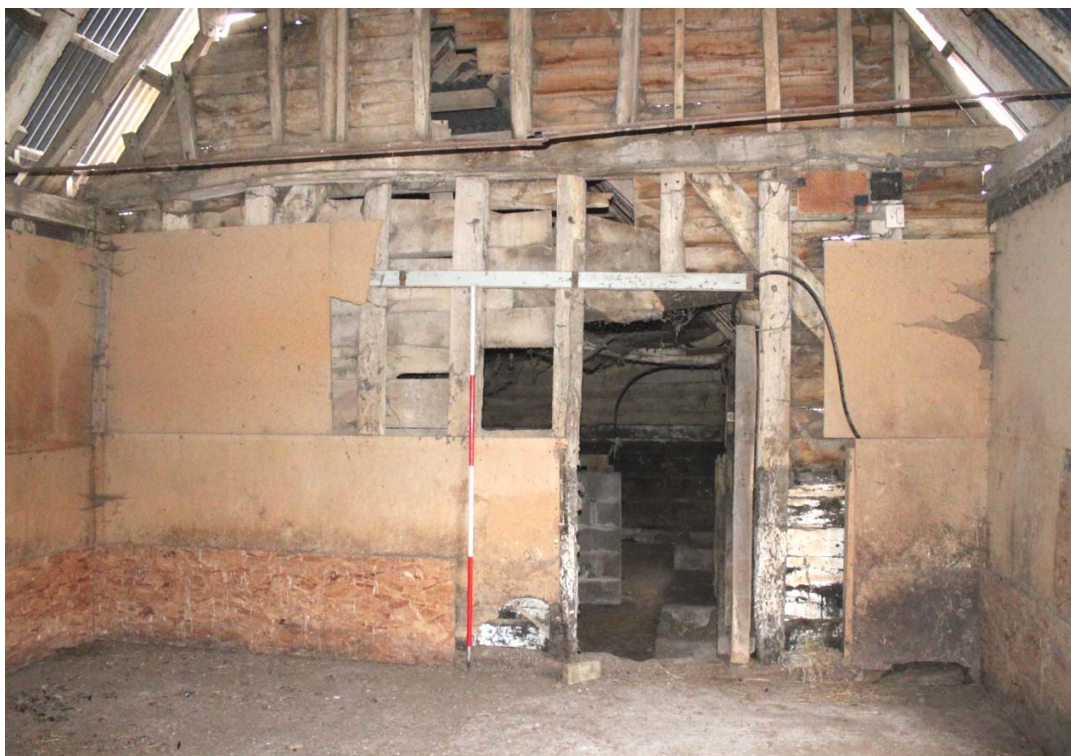
**Illus. 5. Internal northern gable of barn showing original externally trenched braces behind modern boarding to right and left with door to cow shed (2). This gable is all that survives *in situ* of the early- to mid-17<sup>th</sup> century barn on the site**

29. Interior of barn from north showing lack of arch-braces to northern open truss and entrance bay in rear.
30. Internal northern gable of barn showing original external trenched braces & door to cow shed (2).

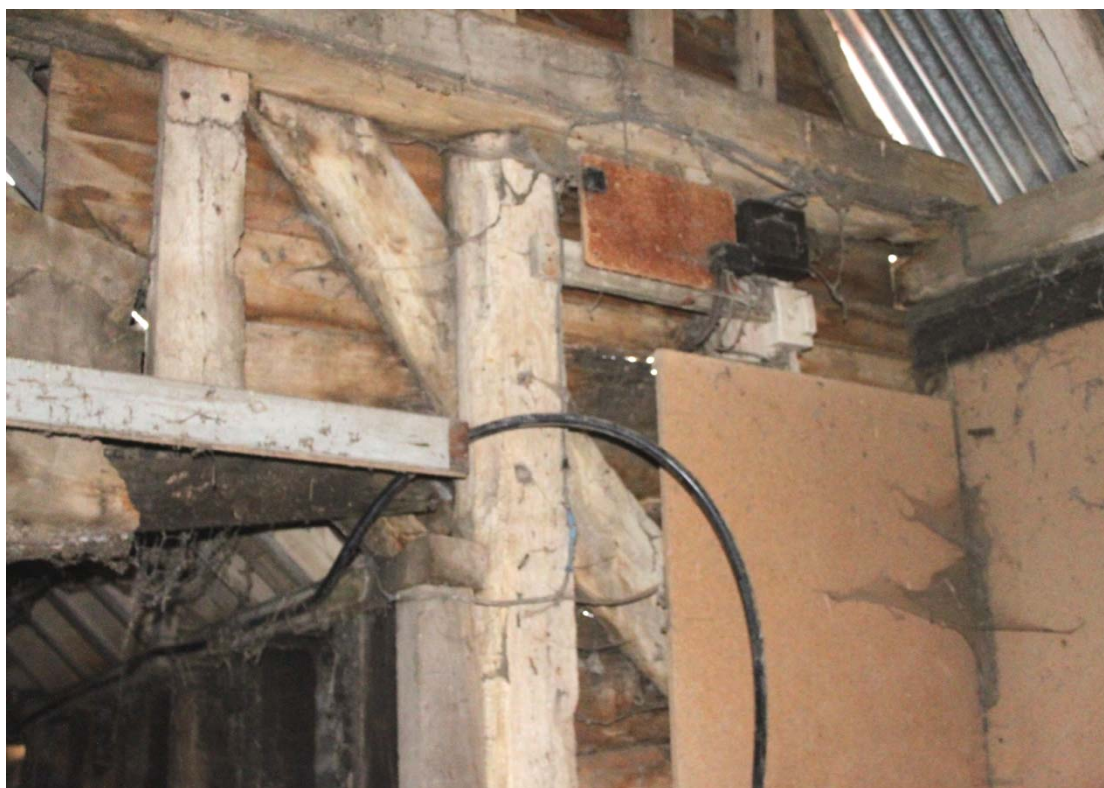
**Illus. 6. Detail of externally trenched 17<sup>th</sup> century brace in north-eastern corner of barn, showing door to cow-shed (2) adjoining northern gable to left.**

31. Detail of northern internal gable of barn showing nailed wind-braces.
32. Detail of externally trenched brace in north-eastern corner of barn.
33. Detail of north-western corner of barn showing externally trenched brace.

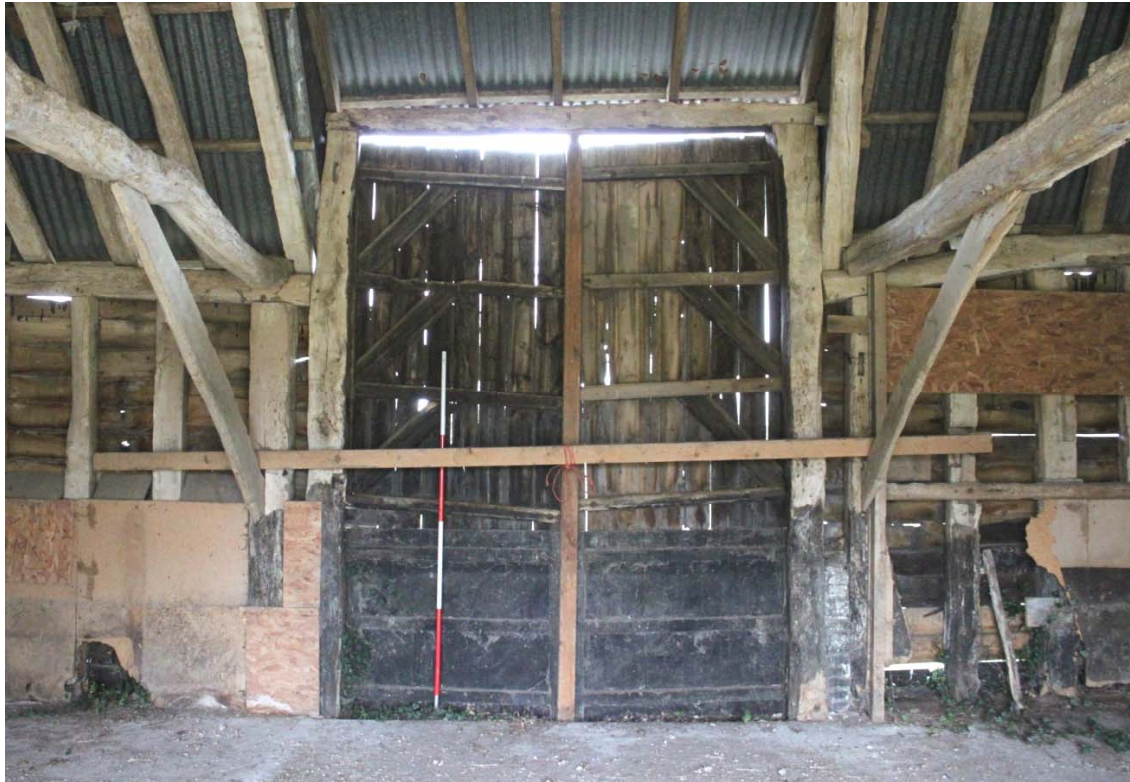
**Illus. 7. Western interior of penultimate southern bay showing half-hung roadside entrance doors interrupting roof-plates with un-jowled but arch-braced storey posts to left and right. This entrance may have formerly possessed a vertical gable. The floor is of modern concrete with no trace of a threshing floor**

43. Detail of primary brace and unpegged stud in western interior of southern bay.
44. Western interior of penultimate southern bay showing entrance doors interrupting roof-plates.

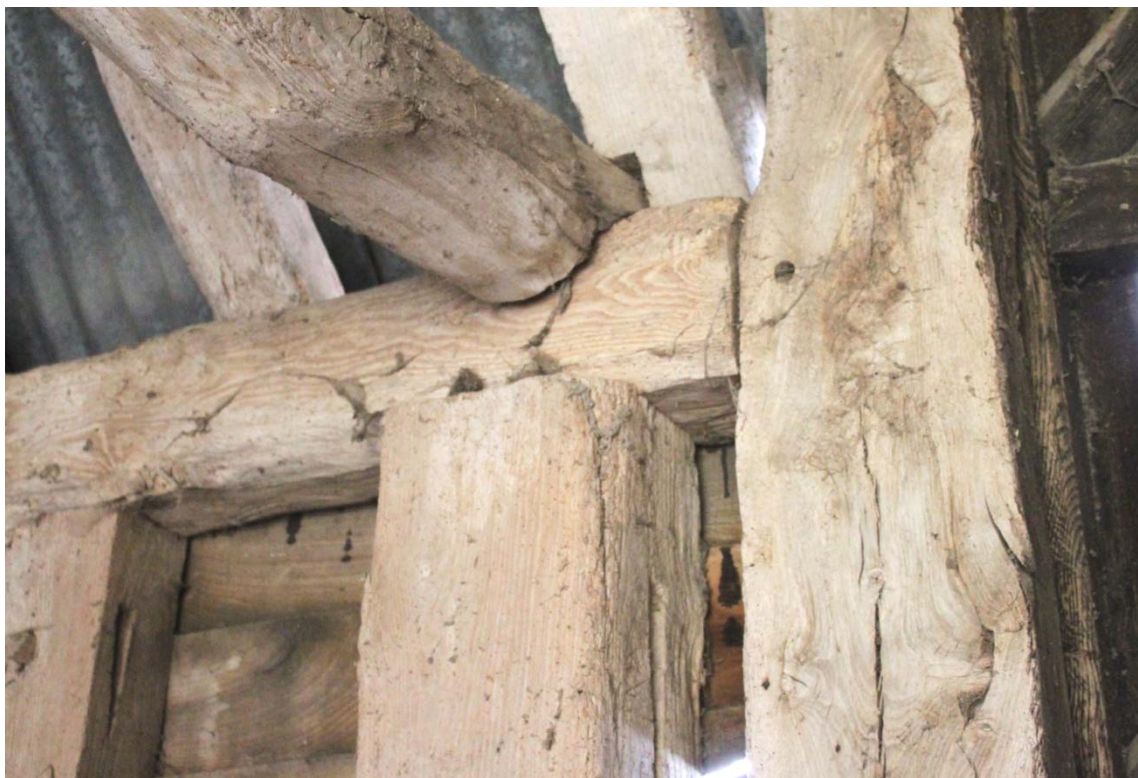
**Illus. 8. Detail of un-jowled storey post to south of western entrance and roof-plate tenoned to door jamb.**

45. Detail of un-jowled storey post to south of western entrance and roof-plate tenoned to door jamb.
46. Interior of barn from south showing profiles of low arch-braces to western elevation.

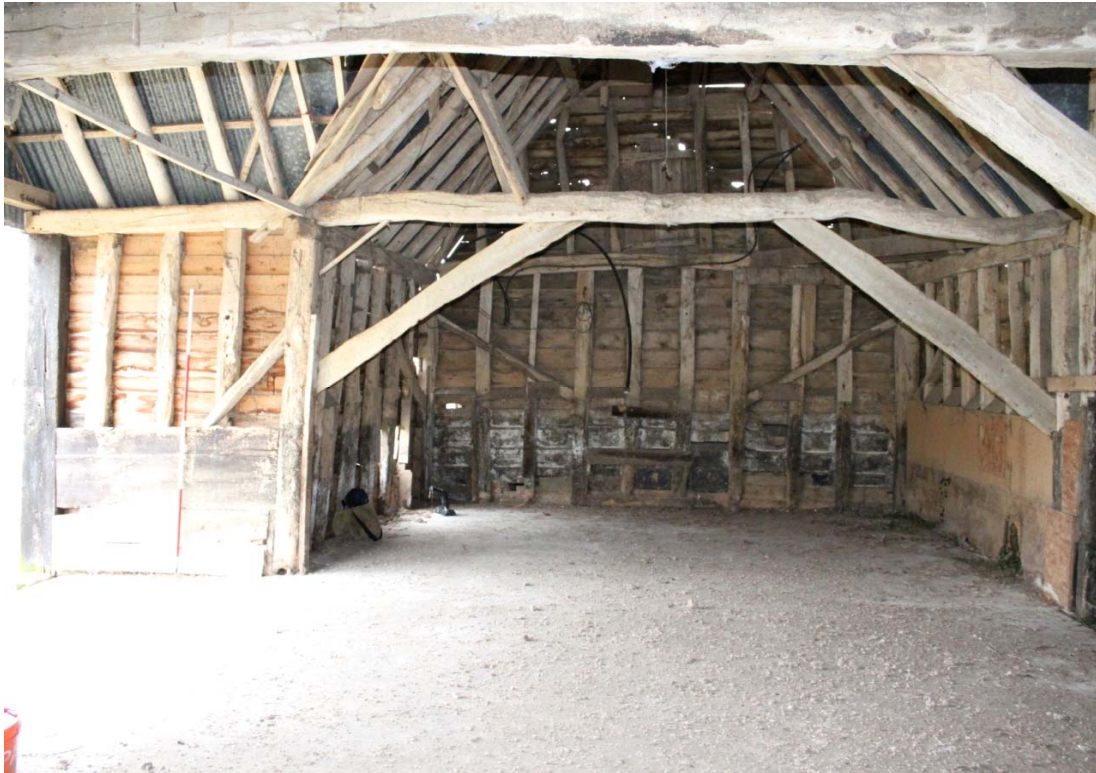
**Illus. 9. Entrance bay of bay from north showing tie-beam of open truss continuing to form roof-plate of eastern porch to left. The straight primary bracing of the southern gable in rear contrasts with the earlier trenced bracing of the northern gable.**

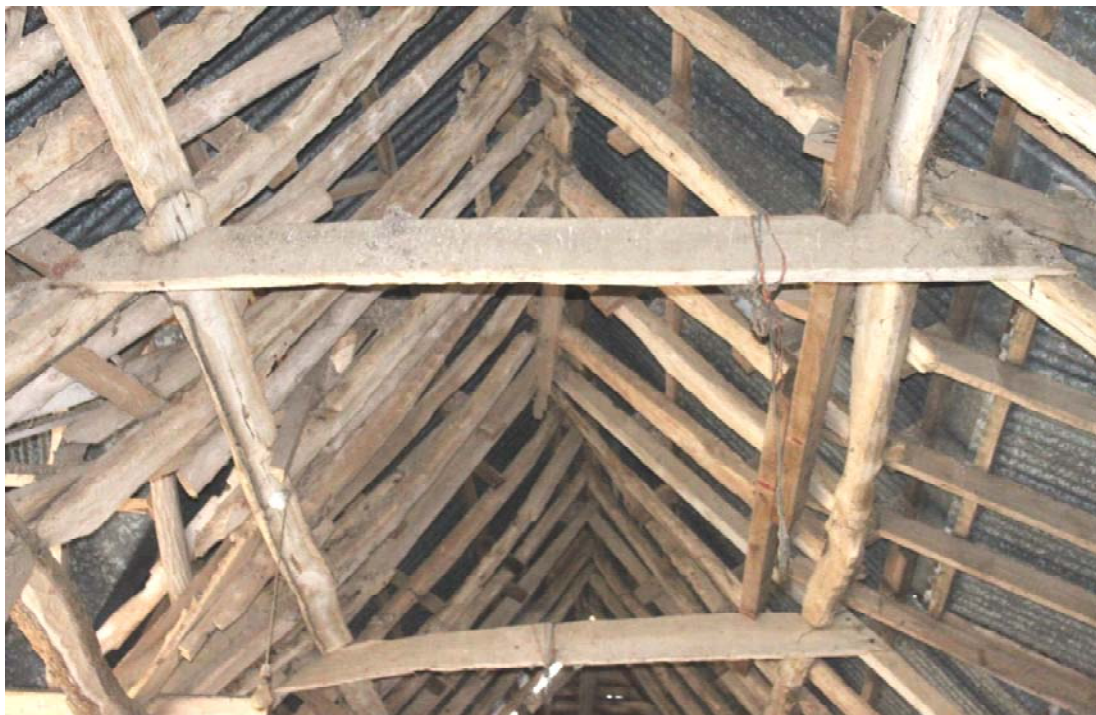
**Illus. 10. Detail of roof structure from north showing nailed collars and clasped-purlins with the eastern porch to left and the softwood rafters of the 20<sup>th</sup> century pentice roof above the roadside entrance to right.**
