**Newsam Green Farm**

**Leeds**

Archaeological Building  
Recording

Report no. 2561  
June 2021

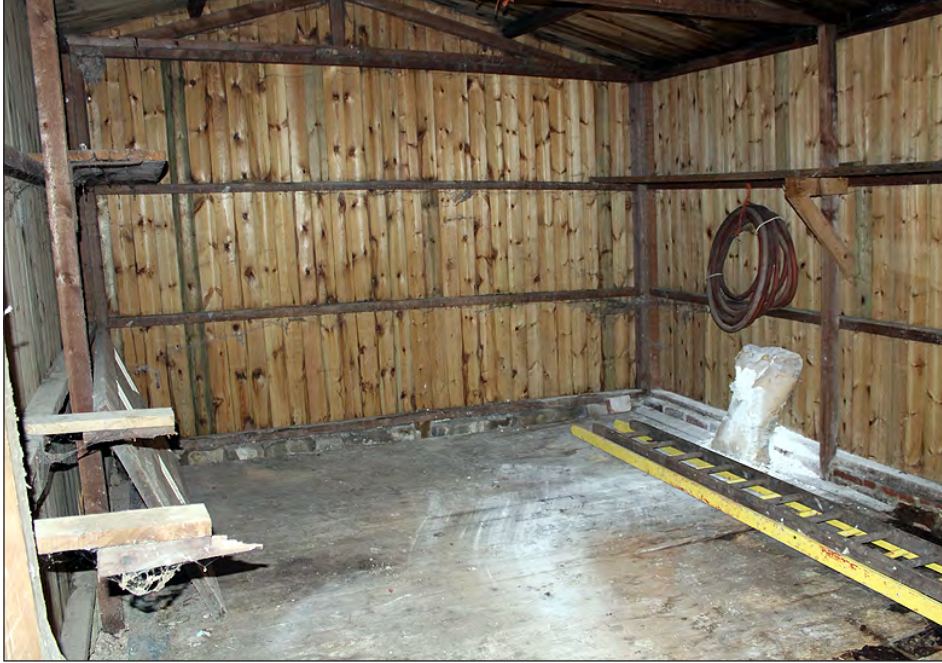
*Plate 11. Building 1, interior. View looking northwest*

The interior (Plate 11) comprises a single open space with raised floorboards. The structure appears to have been utilised as a workshop.

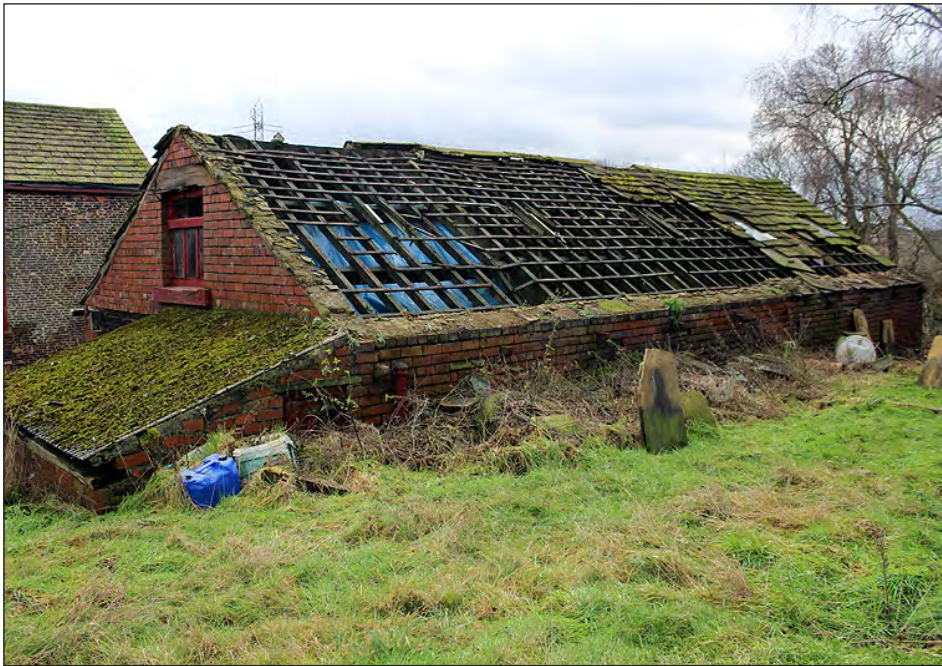
*Plate 12. Building 2. North and east elevations. View looking southwest*

Building 2 (Plates 12 and 13) is located to the east of Building 1, and is abutted by it. The building is also east-northeast to west-southwest aligned, but is stepped back to the north slightly. It is positioned against a bank on its north side and is constructed of brick laid to a six-course Common bond. It is a single storey structure and has a pitched stone slate roof laid with diminishing courses. The building is first depicted on the 1921 25-inch OS map and was constructed as a stable block and comprises a large room with a small tack room located at the west end.

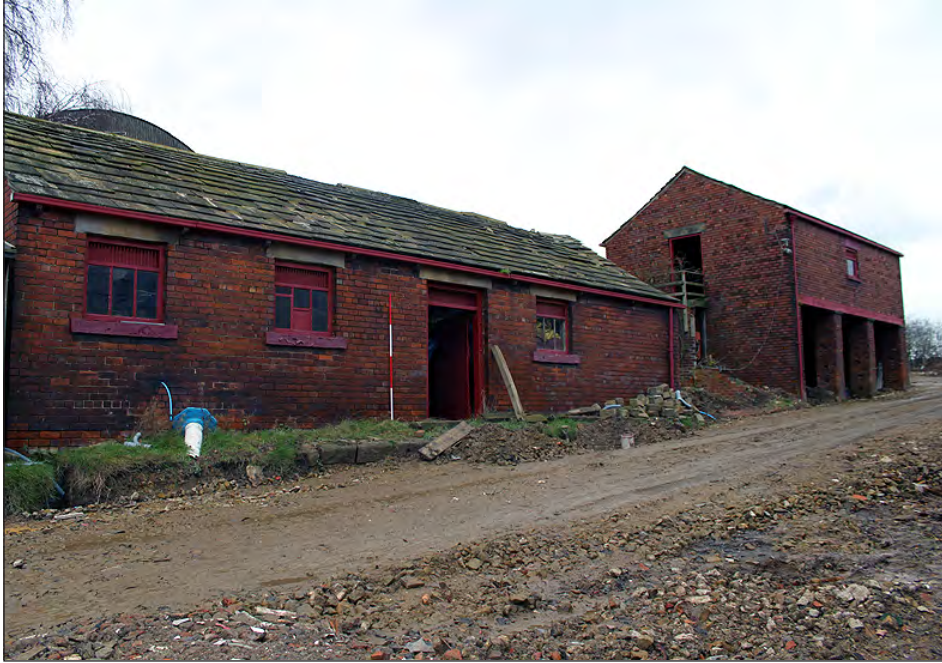
*Plate 13. Building 2. South elevation. View looking northeast*

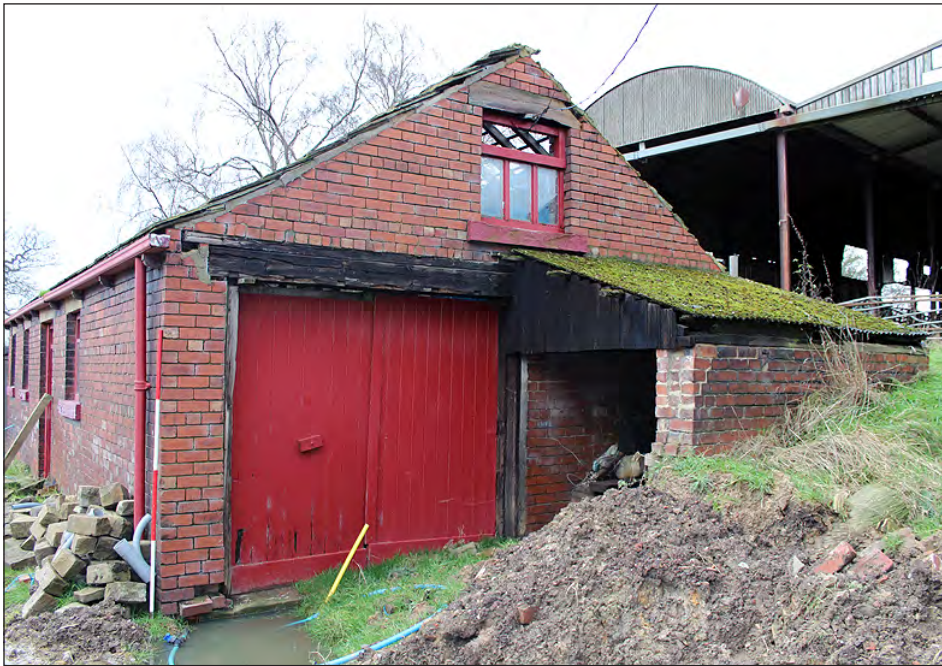
*Plate 14. Building 2. East elevation. View looking northwest*

Against the elevation there is a lean-to structure (Plate 14). The brickwork indicates that the structure is of contemporaneous construction, but the east side wall has been shortened in length and the south wall removed and a corrugated roof added. The altered lean-to is now open on the south side and has a small high window just above the bank level on the north side elevation. Within the structure there is a brick base (Plate 15) which appears to be a later addition and was likely a base for a fuel tank. Historic mapping indicates that the east side lean-to extended the full width of the building, and perhaps was used as a narrow loose box or feed store.

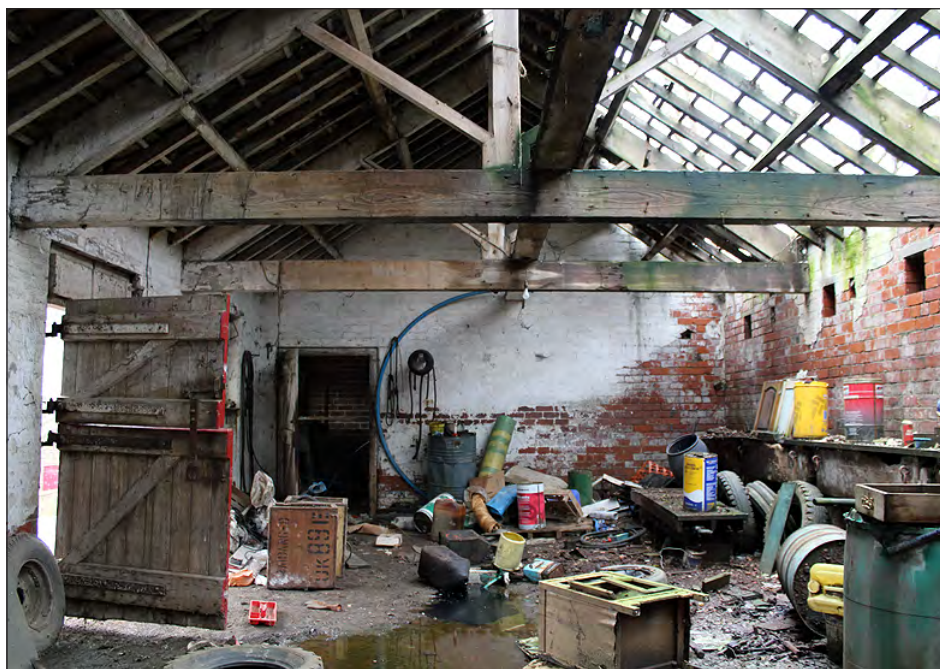
*Plate 16. Building 2, interior. Stabling area. View looking west-southwest*

Within the large room of the structure (Plate 16) along the length of the north side wall are six long salt glazed high troughs set on brick piers (Plate 17). Sockets for the timber hayrack are visible at the north ends of the east and west walls above the troughs. The stalls were formerly positioned along the north wall with the passageway located along the south wall. The stall partitions no longer remain in-situ, although scaring indicates that the stall width matched the width of each trough. Along the south wall are timber harness racks/pegs (Plate 18). Remnants of lime wash remain on the walls and the floor of the stable block comprises stone setts.

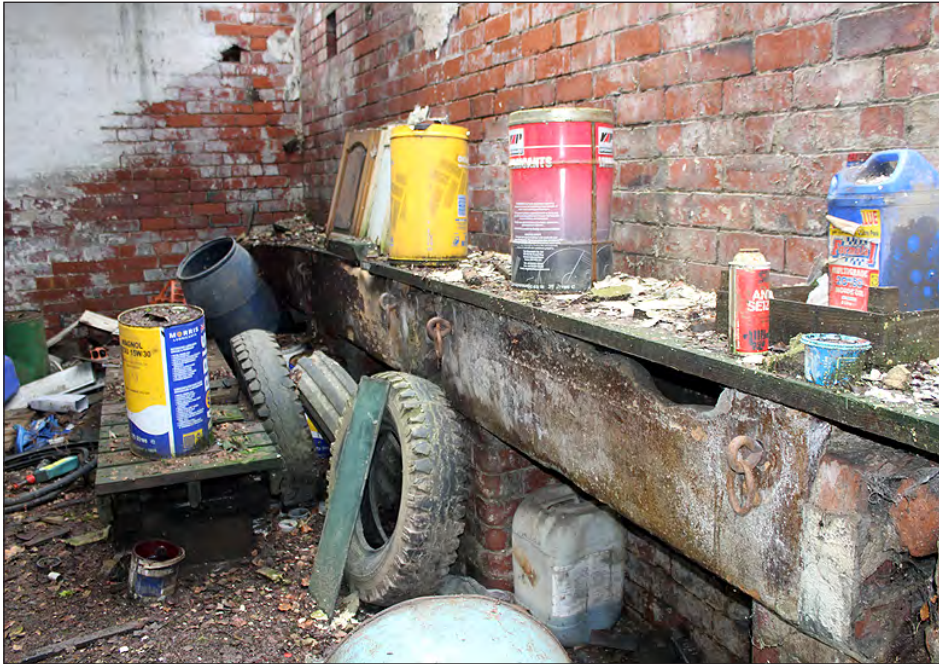
*Plate 17. Building 2, interior. Troughs along north wall of the stable. View looking northwest*

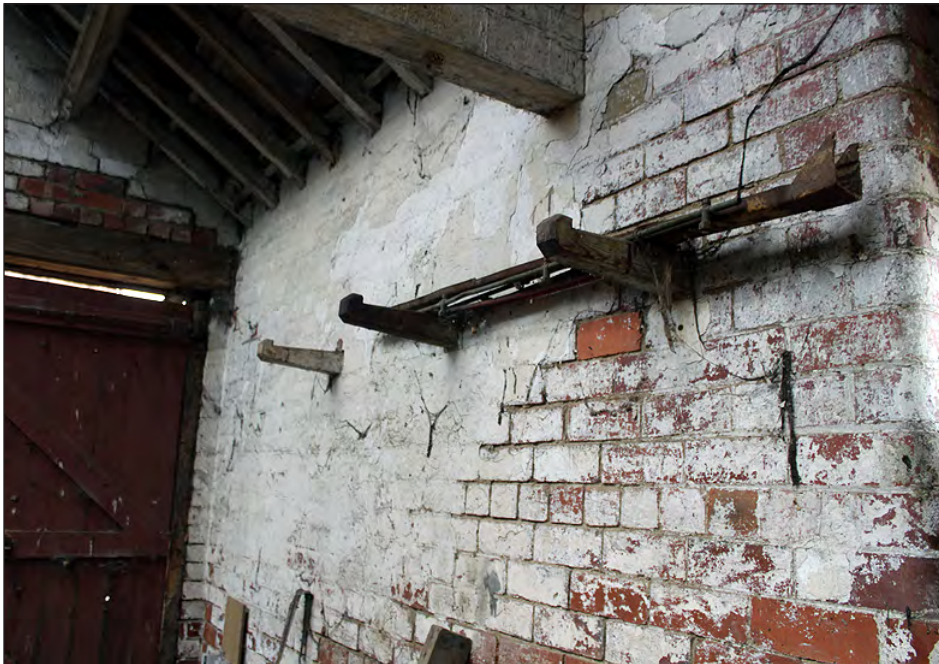
*Plate 18. Building 2, interior. Harness rack along south wall of the stable. View looking southeast*

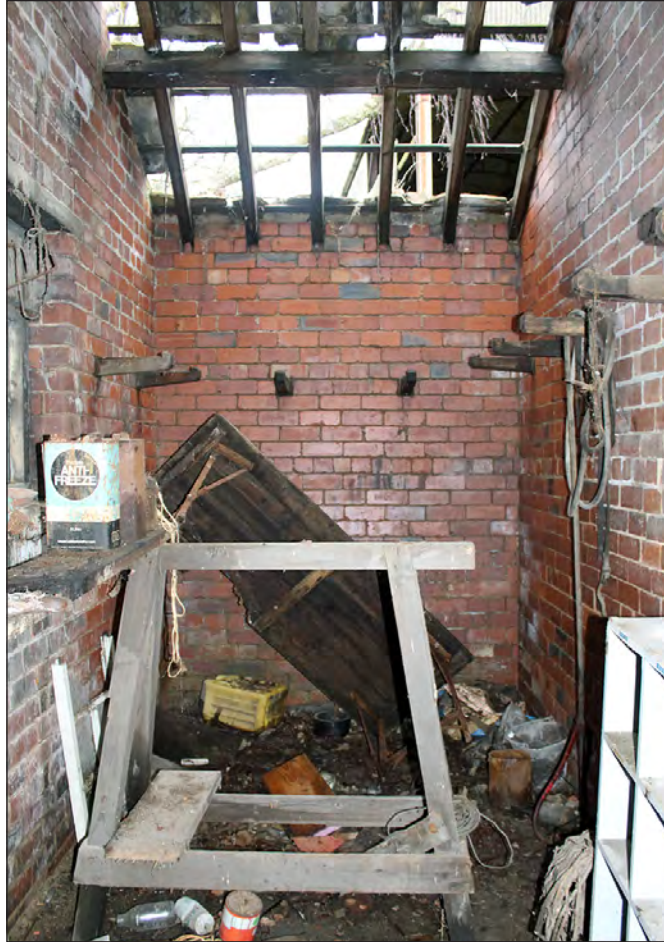
*Plate 19. Building 2, interior. West side tack room. View looking north-northwest*

The west end room was formerly a small tack room (Plate 19). Timber harness racks/pegs are present along the north, east and west walls. Notably none of the original timber pegs

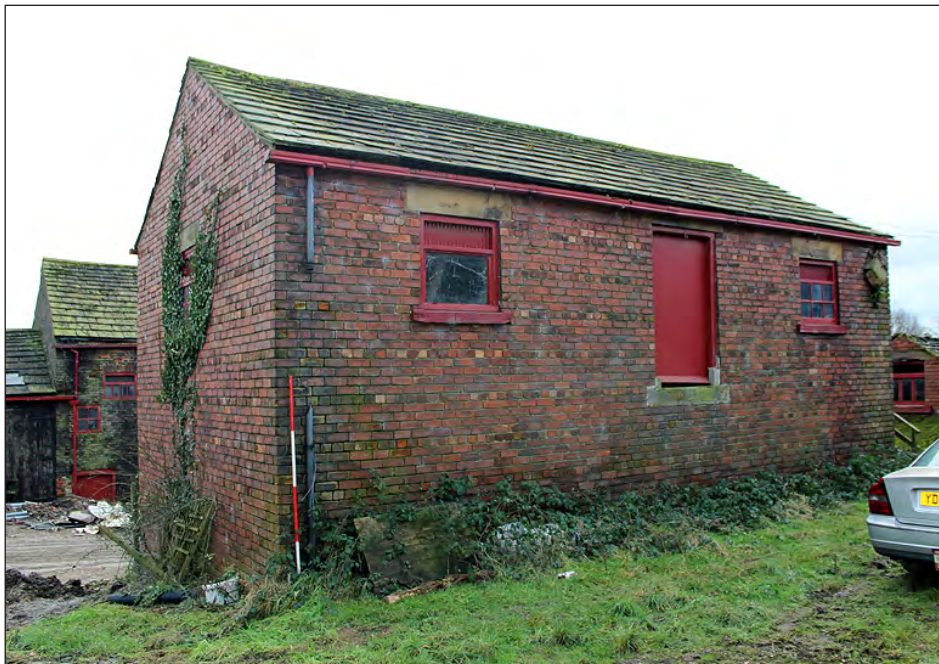
*Plate 20. Building 3. North and east elevations. View looking southwest*

The north elevation (Plate 20) was partially set into the bank, a taking-in door is centrally located at first floor level, and to either side there is a window. The west side window retains its original glazing and comprises a six pane lower section, with grille above. The timber shutters for the ventilation grilles remain in situ internally and the window sills externally appear to be painted timber.

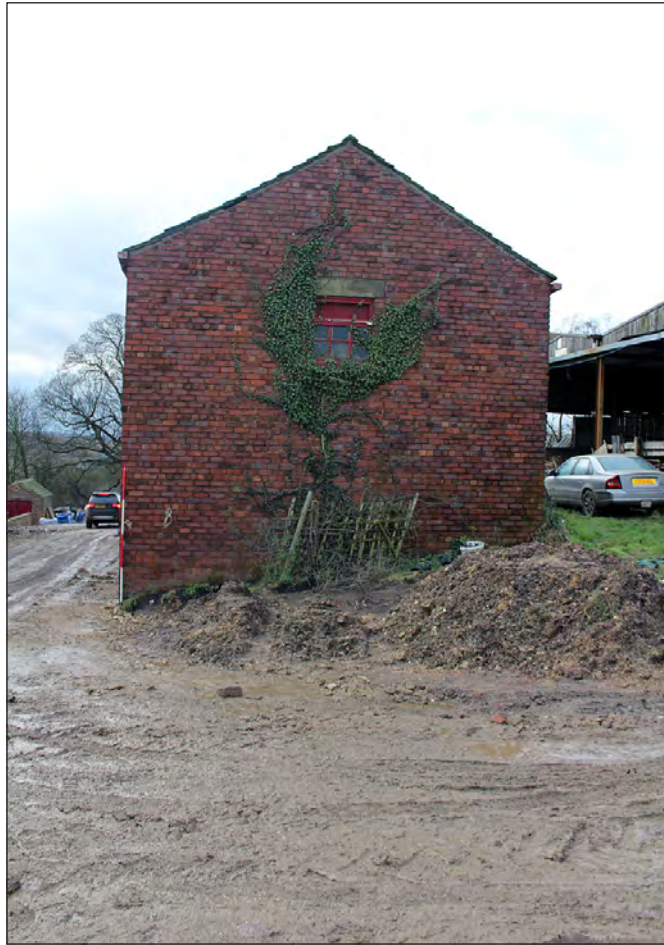
*Plate 21. Building 3. East elevation. View looking west-southwest*

The east gable elevation (Plate 21) has a window opening centrally located at first floor level, and it is fitted with its original window.

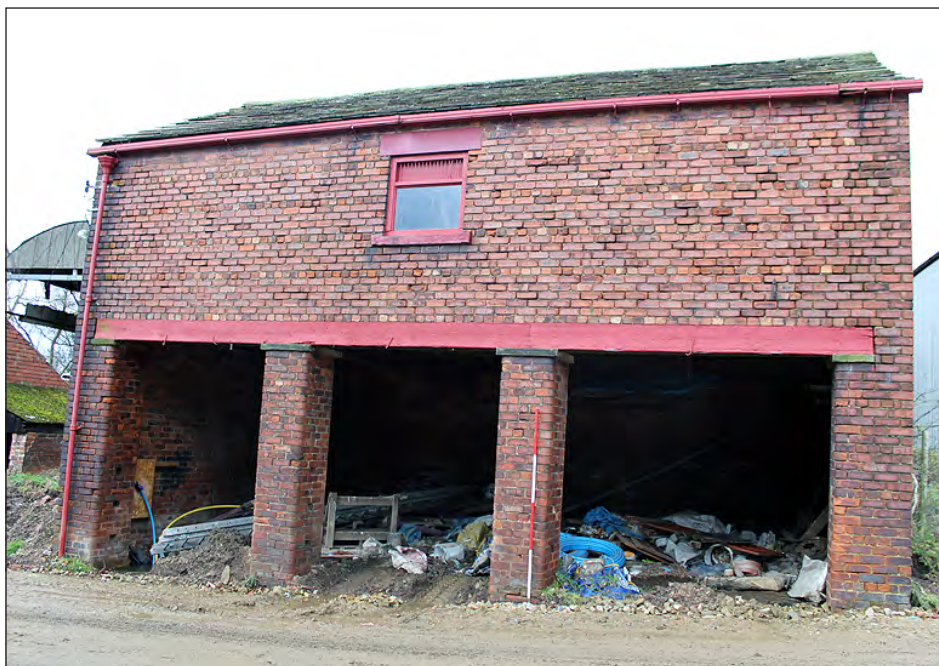
*Plate 22. Building 3. South elevation. View looking north-northwest*

The south elevation (Plate 22) fronts the trackway and comprises three open cart bays at ground floor level. The piers have square profiles and their corners are constructed of bullnose bricks. Sockets within the piers indicate gates rather than full height doors were originally fitted in the openings. At first floor level, centrally located, there is a window. The light section of the window has a replacement single pane of glazing but the original ventilation grille above the light remained. Guttering is present along the north and south elevation and was supported by metal brackets.

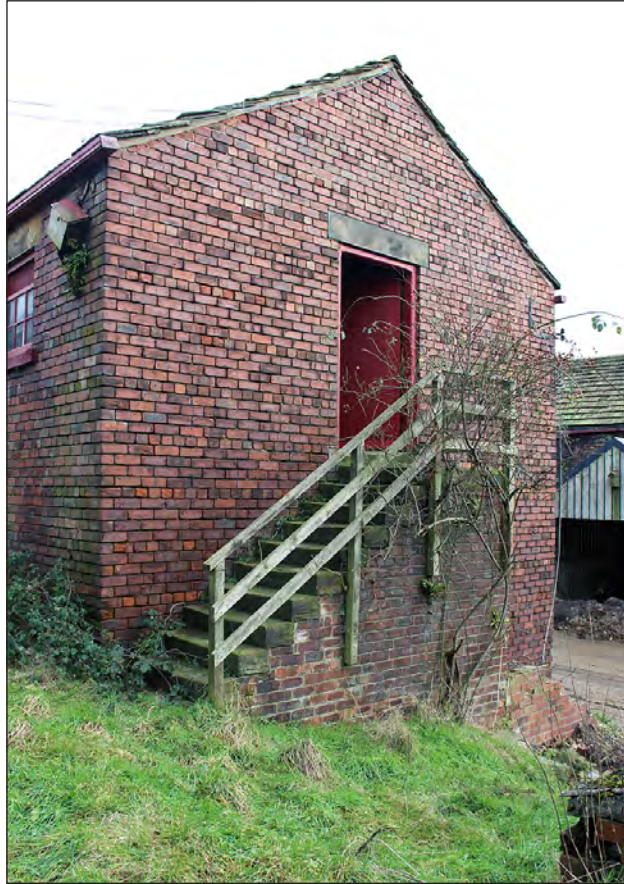
*Plate 23. Building 3. West elevation. View looking southeast*

Against the west elevation (Plate 23) there is a flight of steps leading to the former first floor granary. The steps are constructed of stone and modern timber railing had been added. The timber plank and batten door into the granary appeared to be original and the strap hinges are hung on pintles. Under the stairs is a space for storage (Plate 24). Demolished brick walls and steps leading down to the south indicate a small extension to the area, which would have extended the under stair storage space. The extension is first depicted in the 1934 OS map.

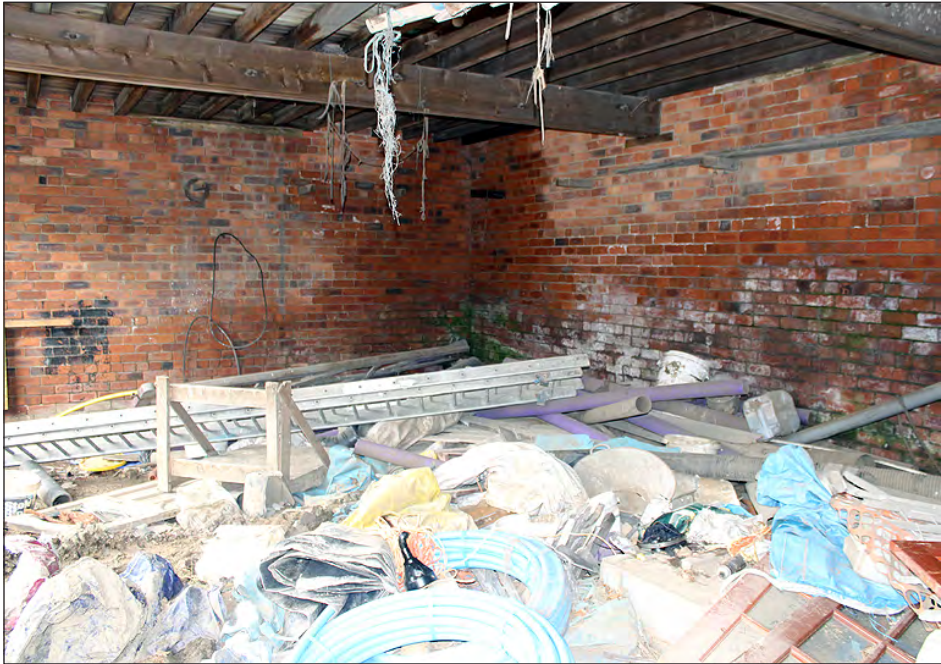
*Plate 25. Building 3, interior. Ground floor. View looking northwest*

The ground floor of the building (Plates 25 and 26) is open with fabricated timber cross beams and floor joist of the first floor appearing original. The floorboards were tight-fitting and a small grain chute was observed (Plate 27). At first floor level (Plates 28 to 33) the building also is a single open space. The window sills and door reveals are constructed of bullnose bricks on the interior side. In the southwest corner of the room there is a timber partition forming a probable grain bin.

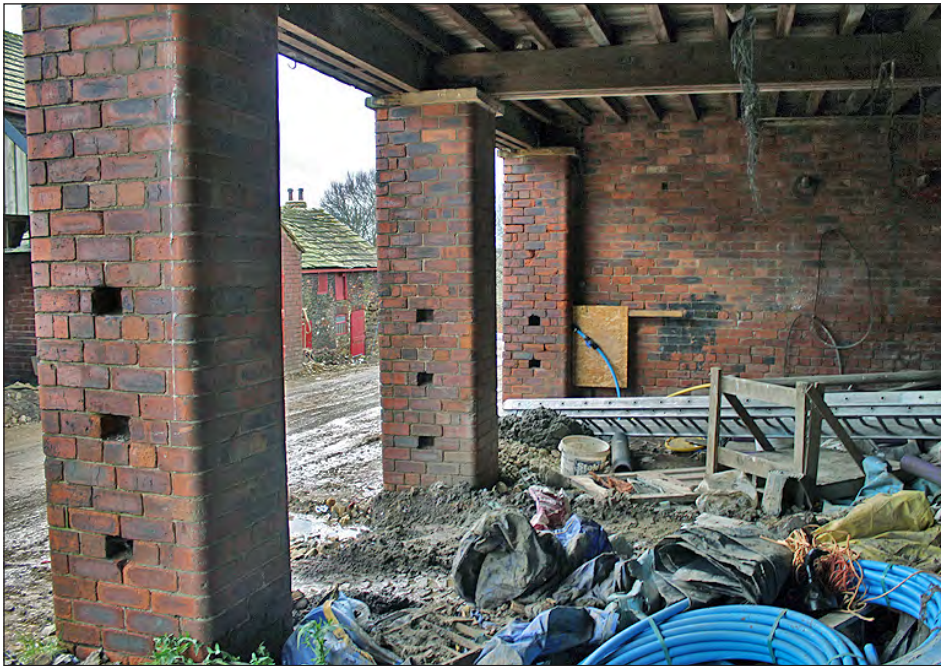
*Plate 26. Building 3, interior. South side of the ground floor. View looking west-southwest*

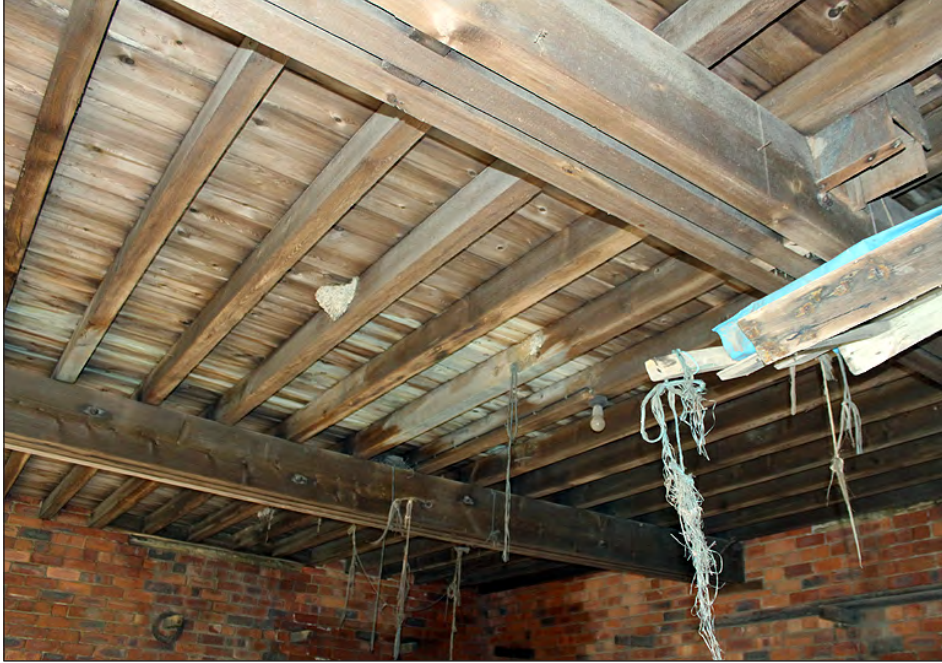
*Plate 27. Building 3, interior. Ground floor ceiling. View looking northwest*

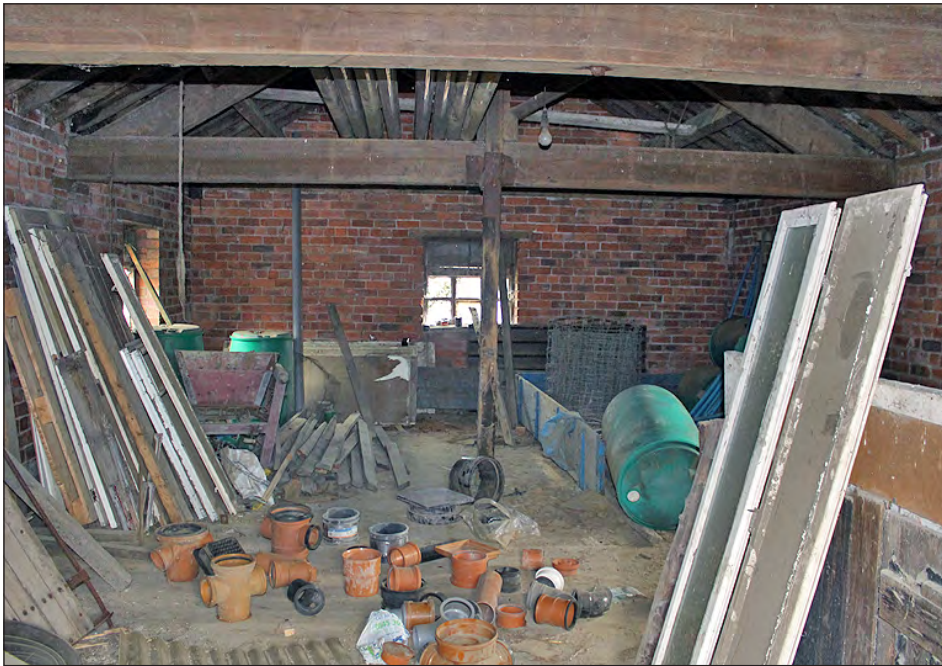
*Plate 28. Building 3, interior. East side of the first floor. View looking east-northeast*

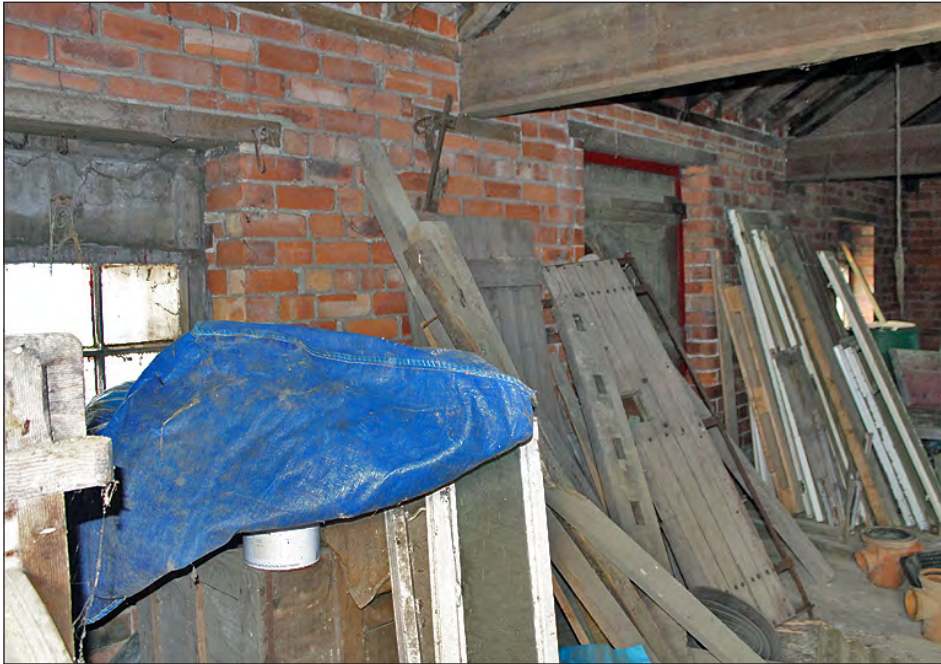
*Plate 29. Building 3, interior. North elevation of the first floor. View looking northeast*

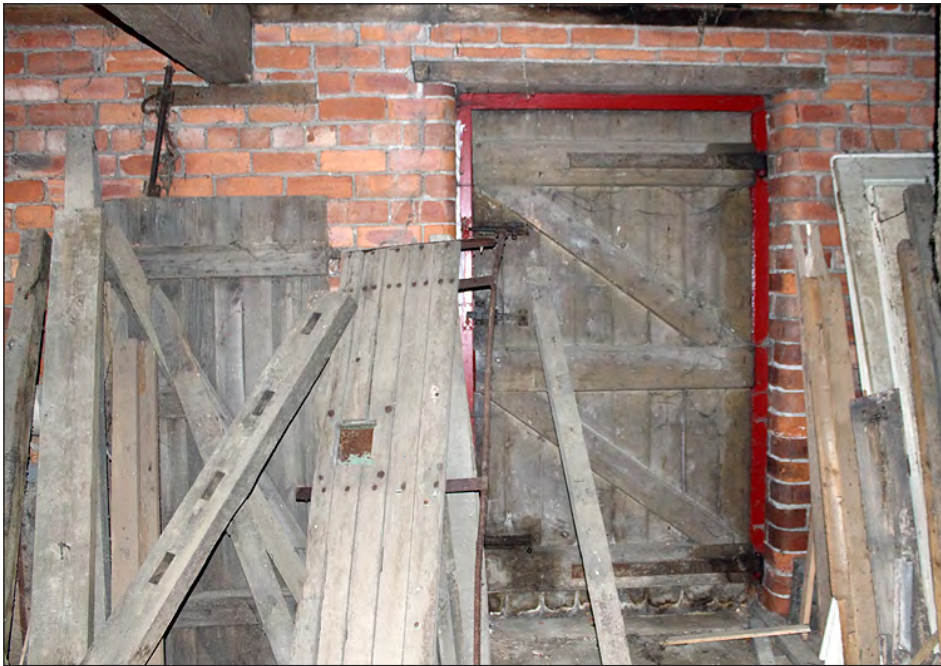
*Plate 30. Building 3, interior. Taking-in door on the north wall of the first floor. View looking north-northwest*

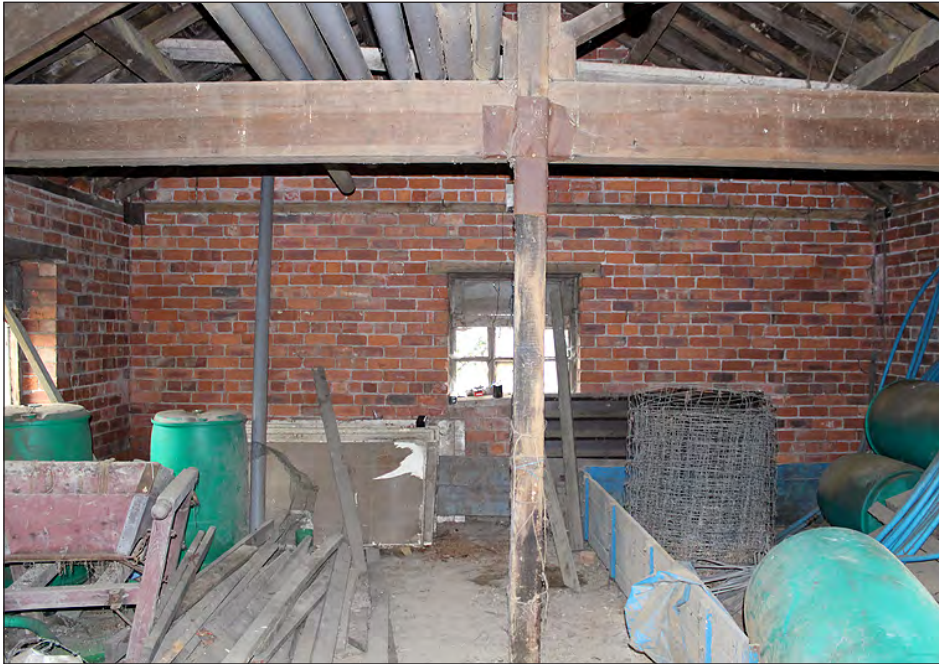
*Plate 31. Building 3, interior. East elevation of the first floor. View looking east-northeast*

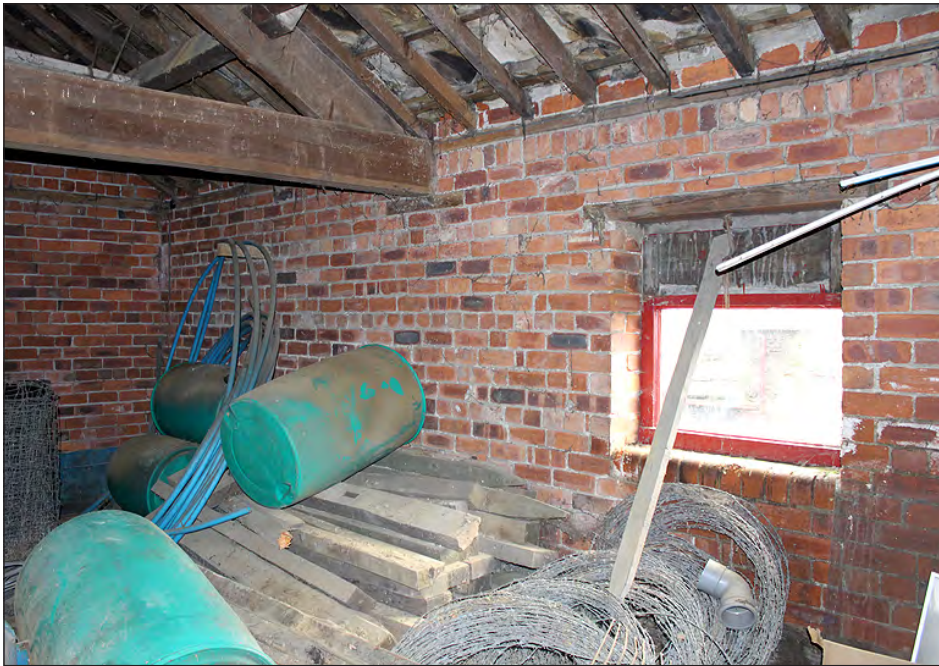
*Plate 32. Building 3, interior. East end of the south elevation of the first floor. View looking southeast*

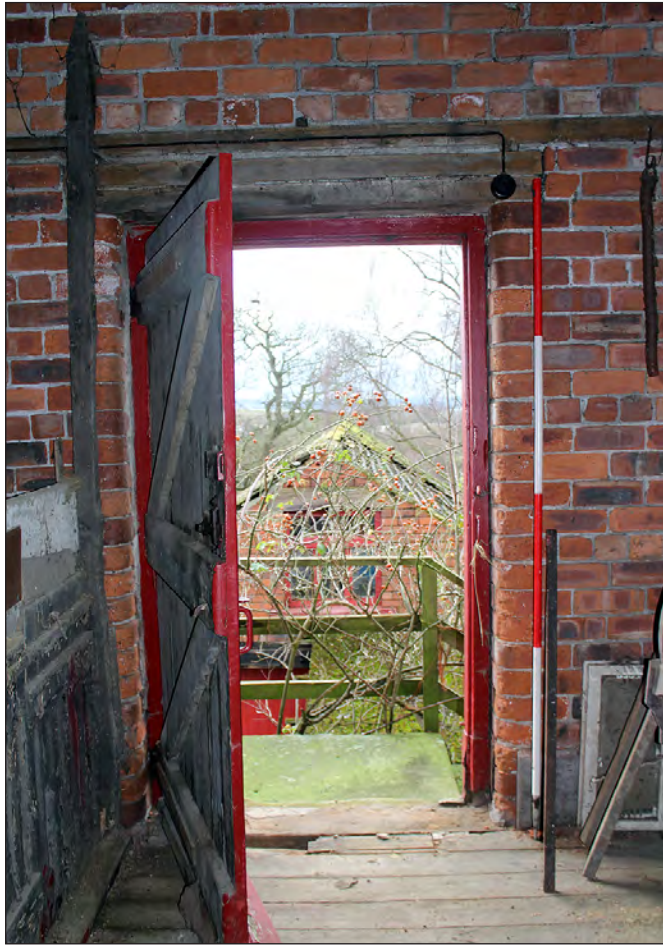
*Plate 33. Building 3, interior. West elevation of the first floor. View looking west-southwest*

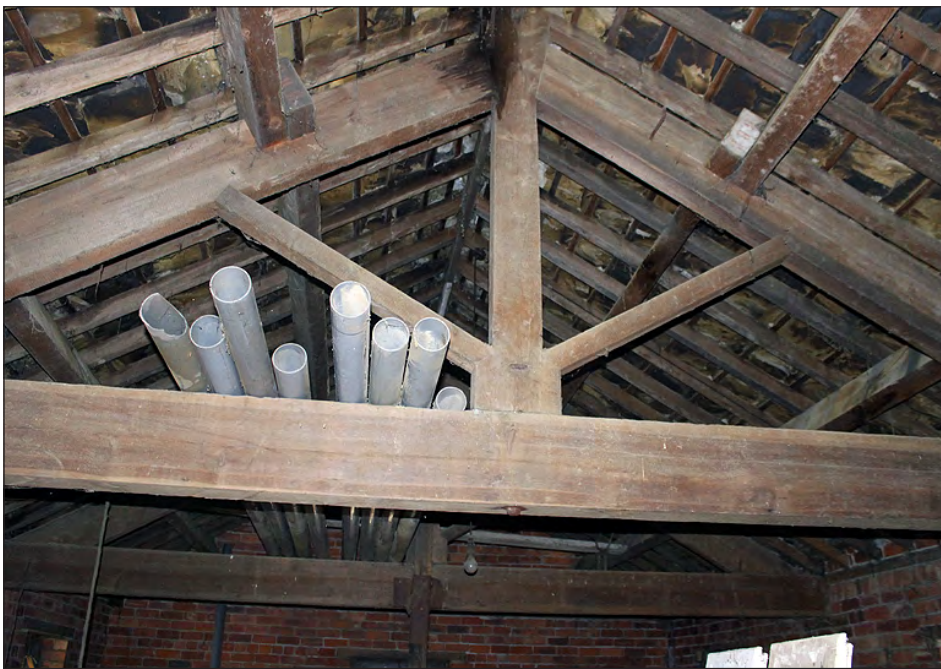
*Plate 34. Building 3, interior. Roof structure. View looking east-northeast*

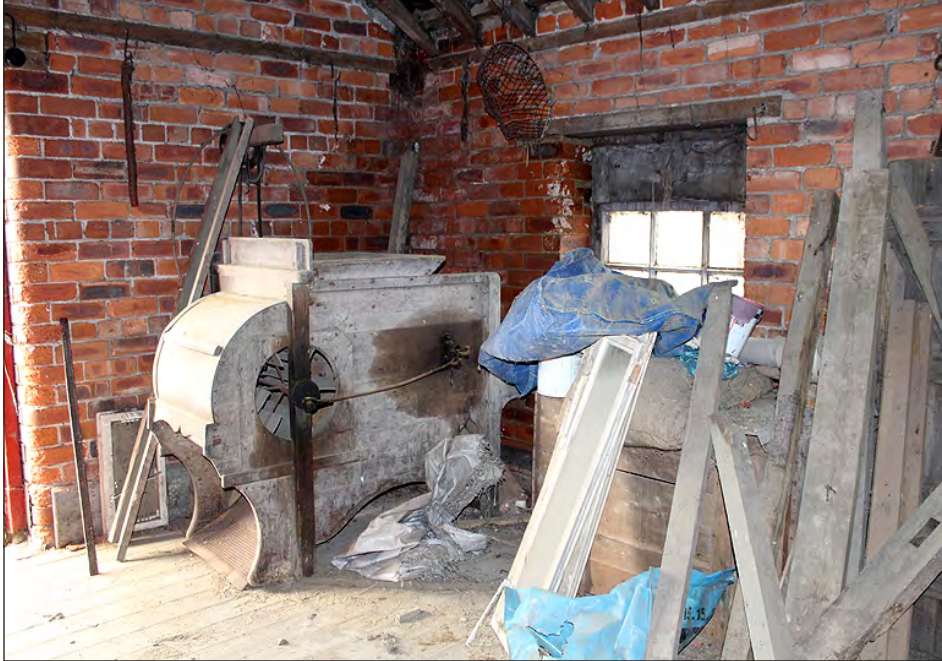
*Plate 35. Building 3, interior. Winnowing machine. View looking northwest*

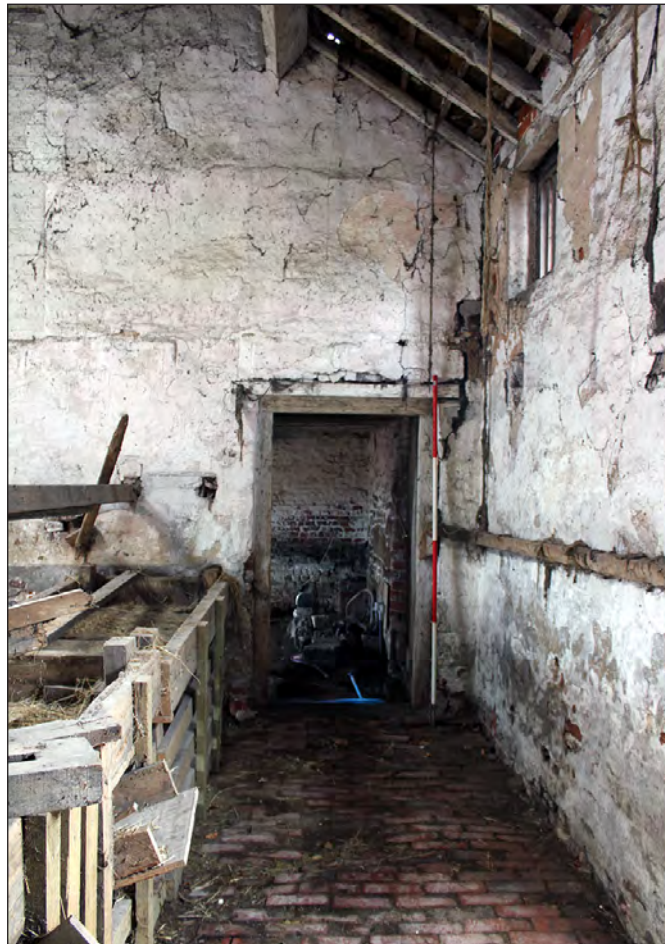
*Plate 49. Building 4, interior. East side room. View looking north-northwest*

The east side room (Plate 49) is accessed from doorways on the north and south elevations, and is also accessed through doorways at the north ends of the east and west elevation and at the south end of the east elevation. The north and west walls of the room have been rendered and all of the walls have a degraded lime wash finish.

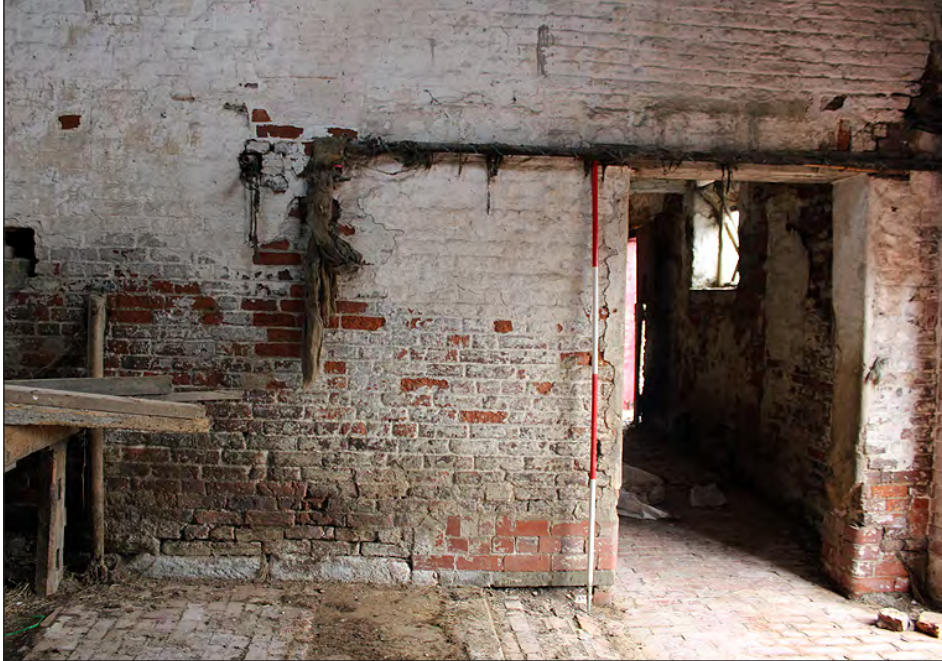
*Plate 50. Building 4, interior. View along the north wall of the east side room. View looking west-southwest*

The north elevation has a later inserted doorway, pitching window, and airbricks. The upper four courses of brickwork of the elevation indicate the structure was repaired and rehung in the 20th century. A 20th-century formed feeding passage (Plate 50) is located along the north side of the building. This passage continues along the length of Building 5 to the east.

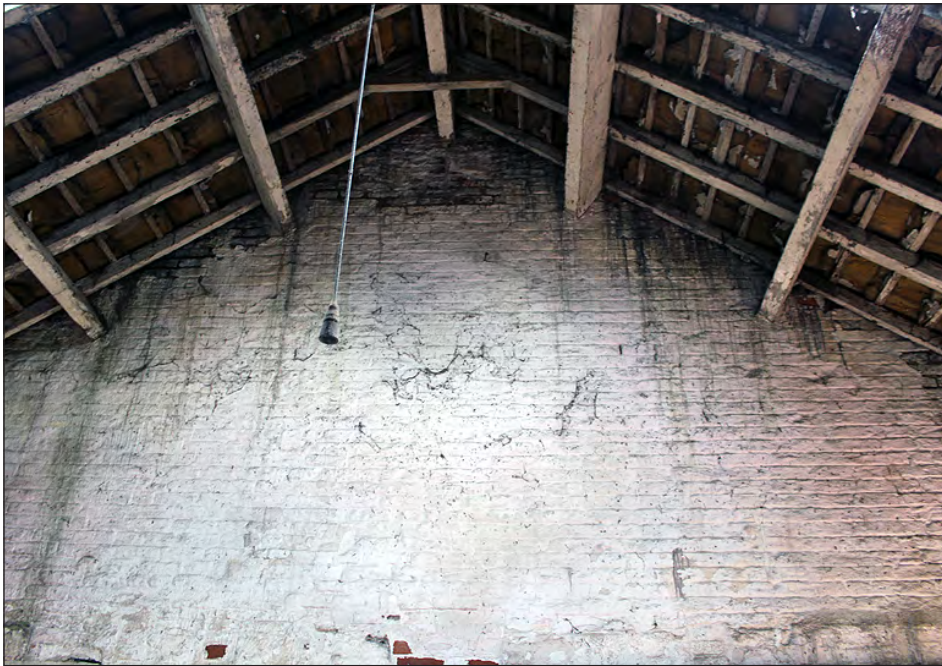
*Plate 51. Building 4, interior. South end of the east elevation of the east side room. View looking east-northeast*

The openings on the east elevation (Plate 51) are later insertions, and appear to date to the late 19th century. Towards the apex of the east elevation (Plate 52) a blocked opening, original to the construction of the threshing barn (Building 5), can be seen. In places possible blocked ventilators can be seen, but are largely obscured by the lime wash.

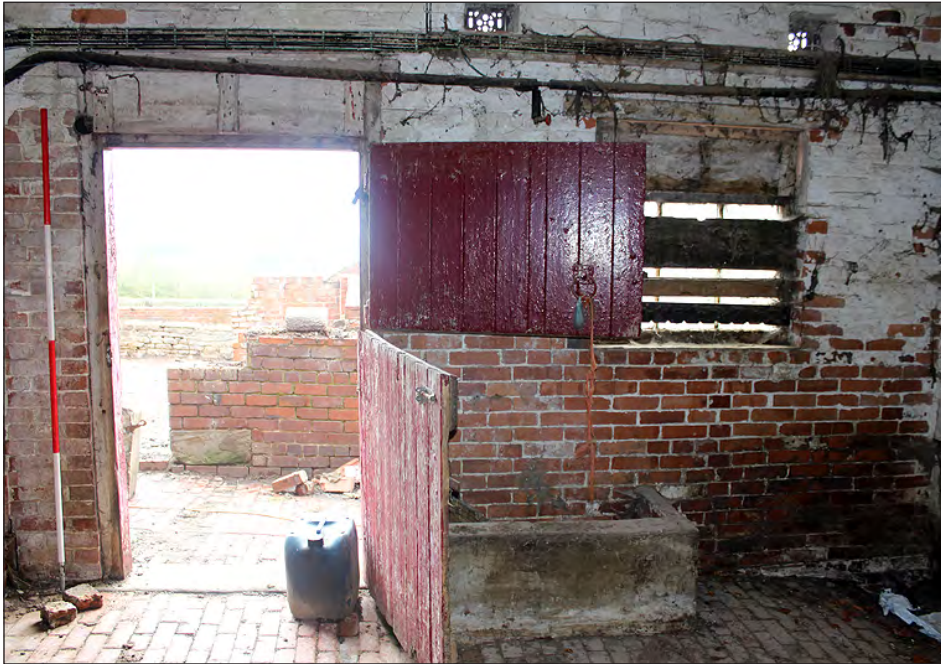
*Plate 52. Building 4, interior. Upper section of the east elevation of the east side room. View looking east-northeast*

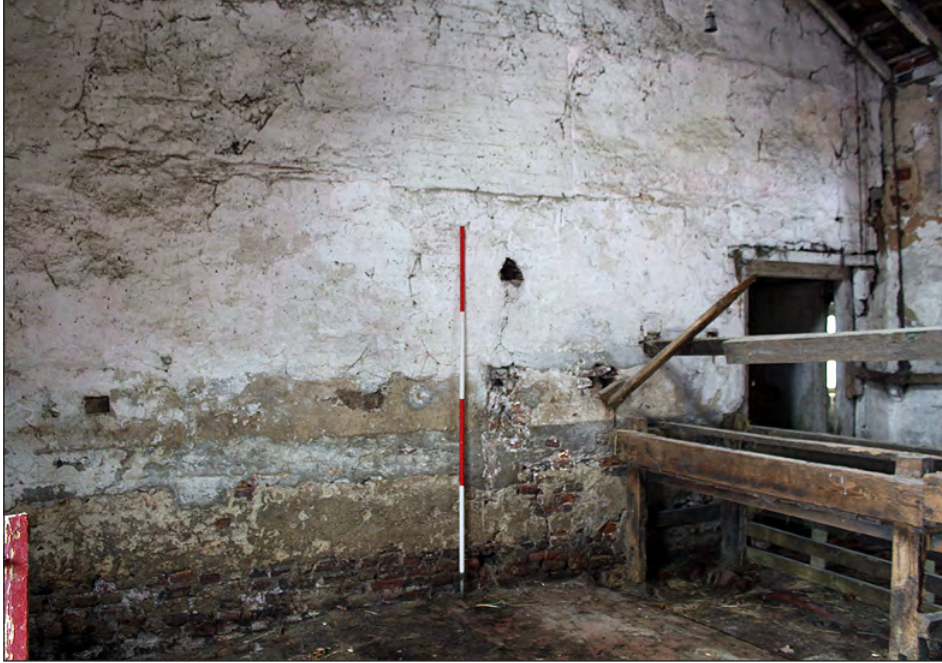
*Plate 54. Building 4, interior. Trough against the south elevation of the east side room. View looking southwest*

The south elevation is a 20th-century rebuild and is abutted by a brick built water trough (Plate 54).

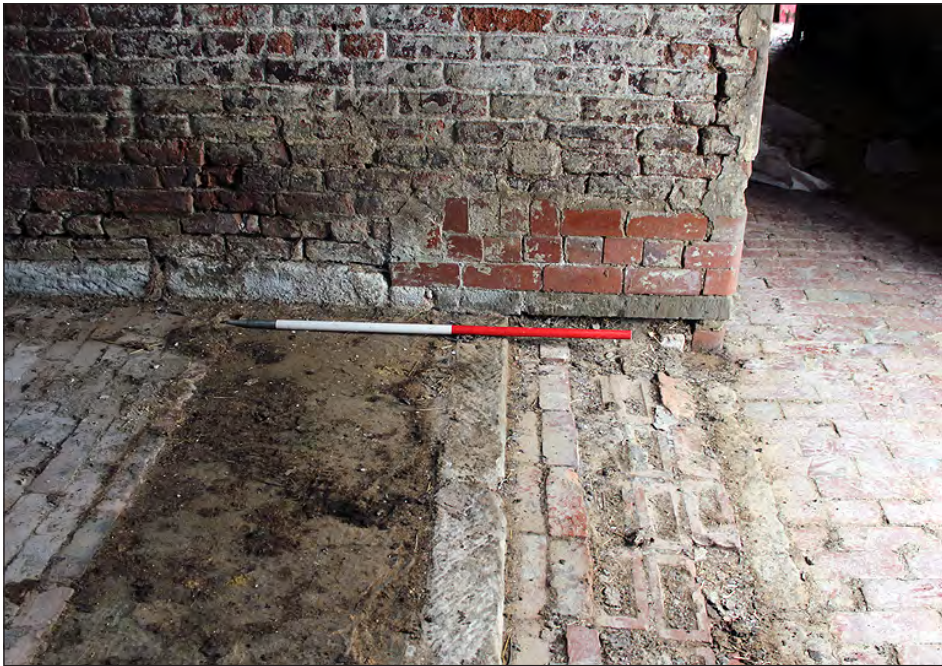
*Plate 55. Building 4, interior. West elevation. View looking northwest*

The west partition wall (Plate 55) of the room, displays scaring which indicates the former location of troughs and potentially scaring relating to stall partitions, the spacing of which suggests three stalls were located to the south side of the doorway on the elevation.

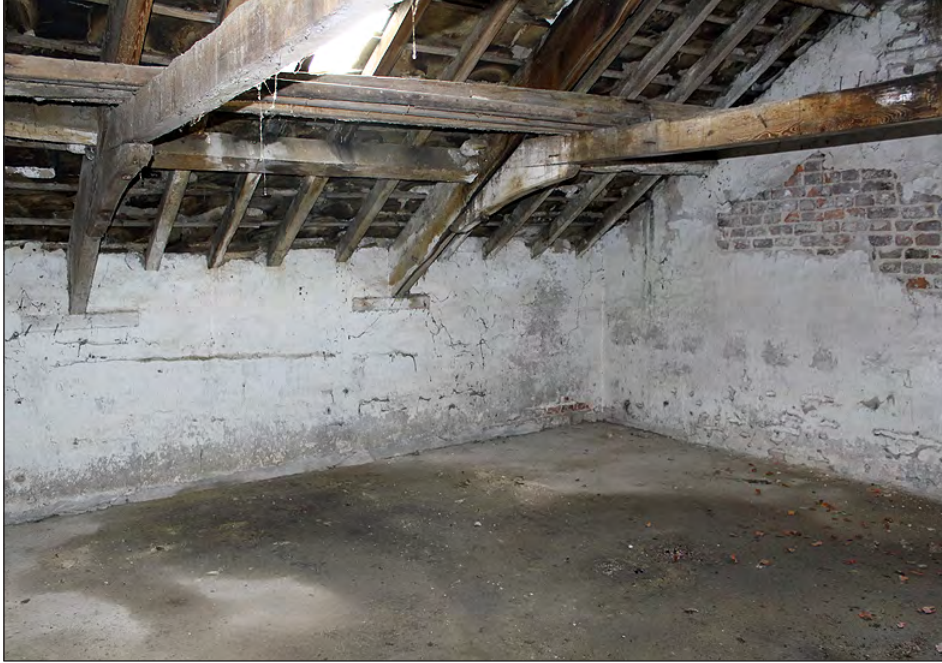
*Plate 58. Building 4, interior. Mangers within the east side room. View looking southwest*

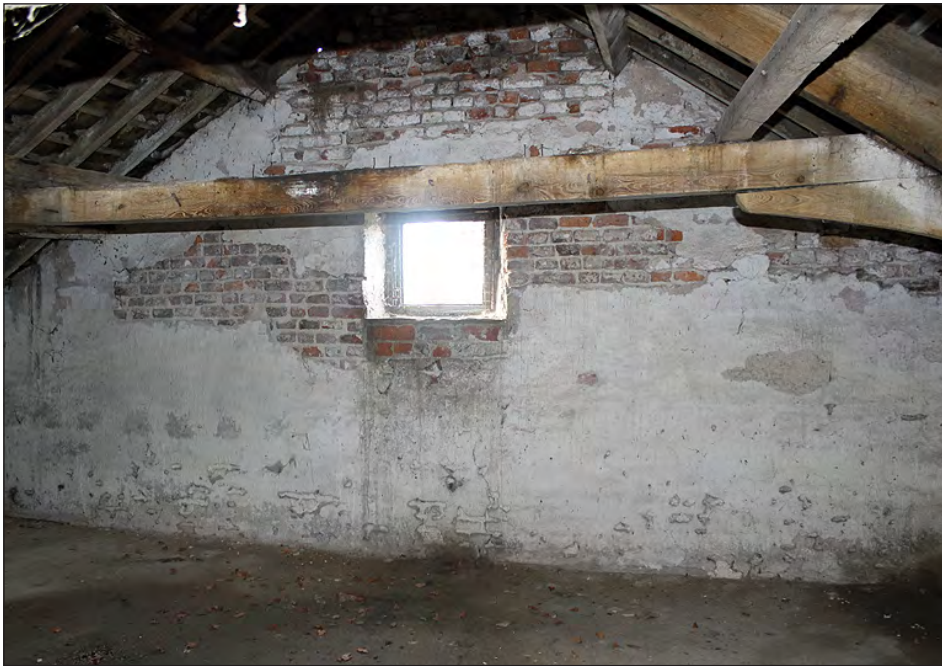
*Plate 59. Building 4, interior. First floor. View looking southwest*

The first floor of the west side room is now accessed from the external south side of the building though the centrally located archway leading to a staircase against the west side of the partition wall between the room. This access is a mid to late 19th-century addition. The first floor (Plate 59) is essentially a half storey which utilises the loft space of the building. The north, south and west walls of the room have been rendered and all of the walls have a lime wash finish. The window on the west wall has been altered (Plate 60) and is fitted with a

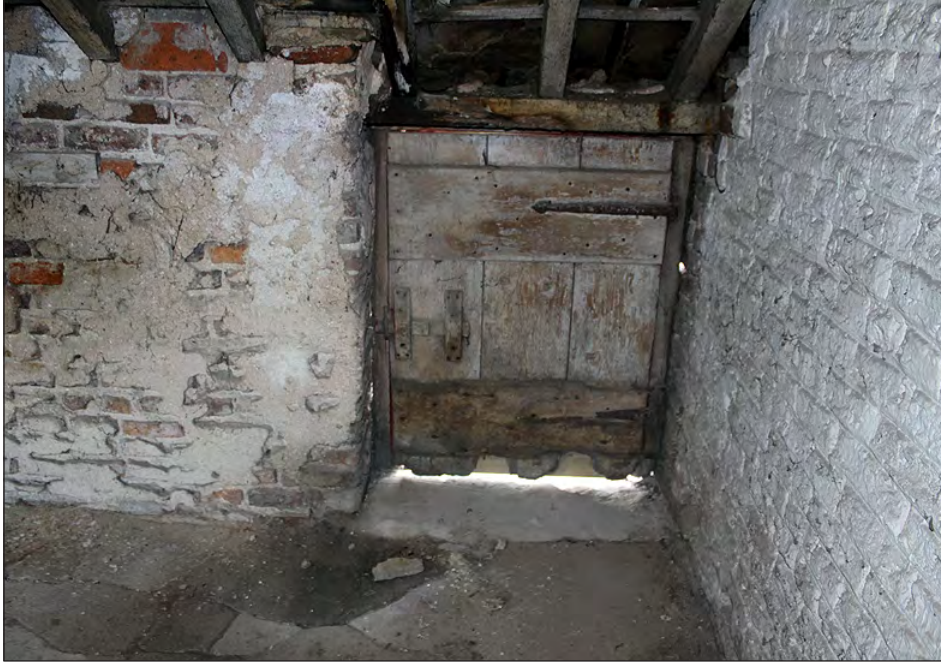
*Plate 60. Building 4, interior. West elevation of the first floor. View looking west-southwest*
