**Newsam Green Farm**

**Leeds**

Archaeological Building  
Recording

Report no. 2561  
June 2021

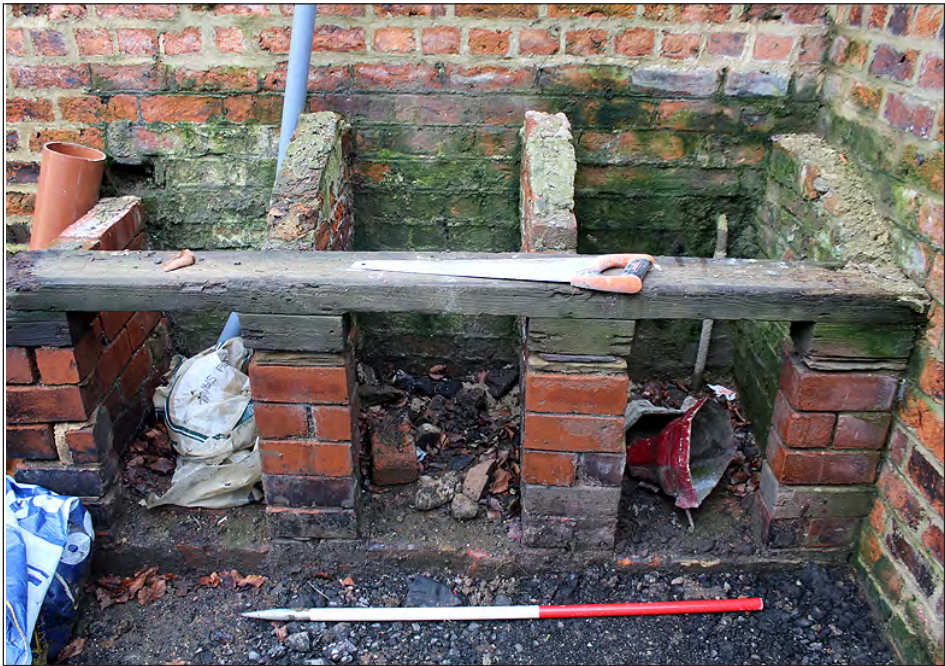
*Plate 67. Coal shed interior. View looking north-northwest*

The shed building abutting the west side extension appears comprises a single small open space. The interior (Plate 67) walls of the structure have a black staining, and the shed has been interpreted as a probable coal shed. Abutting the north rear yard wall and shed is a low brick built structure with three bays (Plate 68). Scaring indicates the structure formerly had a lean-to roof. It is constructed of 20th-century machine made bricks. The purpose of the structure was not clear, but perhaps they were kennels for small terrier sized dogs.

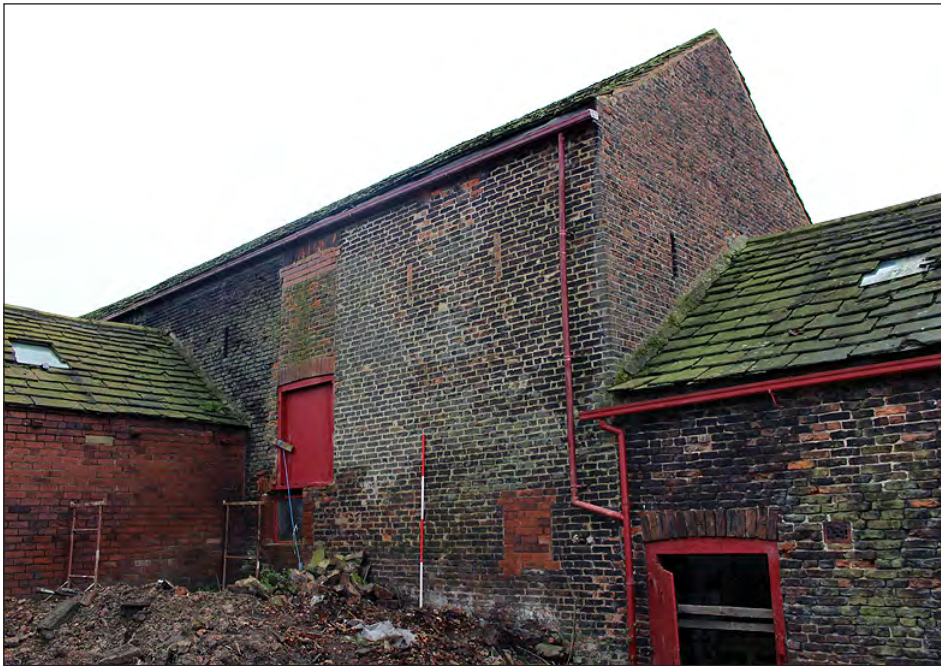
*Plate 69. Buildings 5 and 6. North elevation. View looking southwest*

The north elevation (Plates 69 to 73) exhibits a single phase of construction, but displays evidence of alterations and episodes of repointing and small patches of repair. Centrally located there are two garage/workshop extensions, which partially obscure the north elevation, but the elevation could still be viewed from within these structures. The north elevation had a centrally located threshing door, which was flush with the wall. The large opening had a timber lintel and had been partially blocked in with late 19th-century brick to form a smaller opening. The smaller opening was still relatively tall in height at *c.* 2.50m, with a cambered arch head formed of contemporary brick voussoirs. This opening was

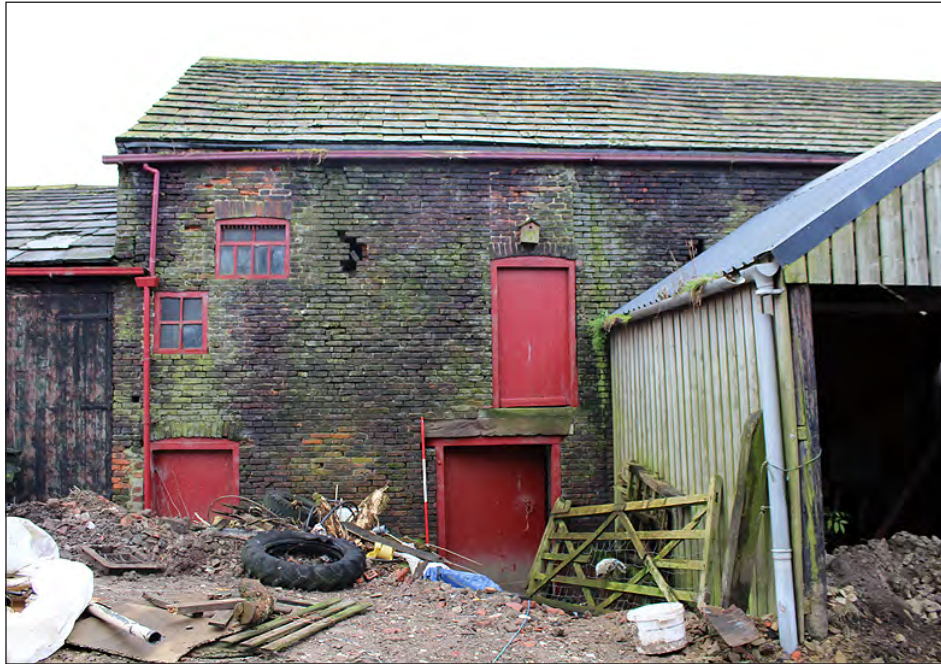
*Plate 70. Building 5. West end of the north elevation. View looking southeast*

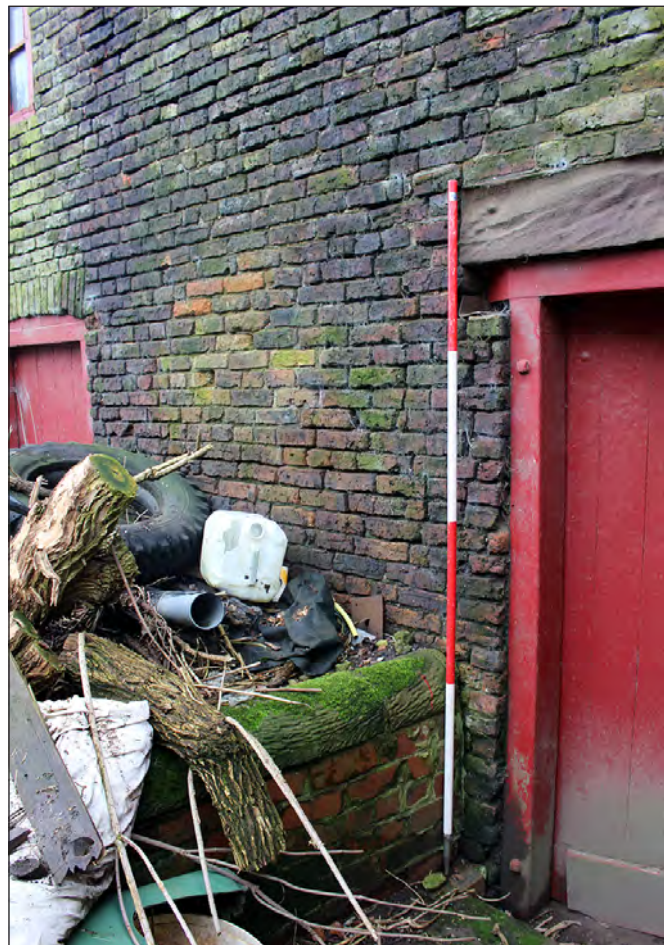
*Plate 72. Building 5. Wall abutting north elevation towards the east end. View looking south-southeast*

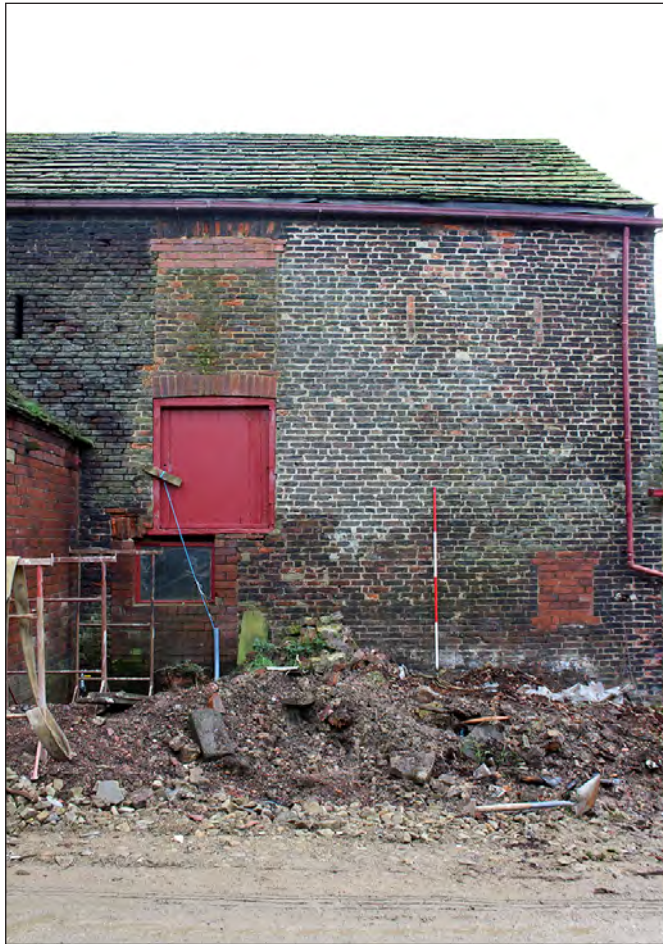
*Plate 73. Building 5. West end of the north elevation. View looking south-southeast*

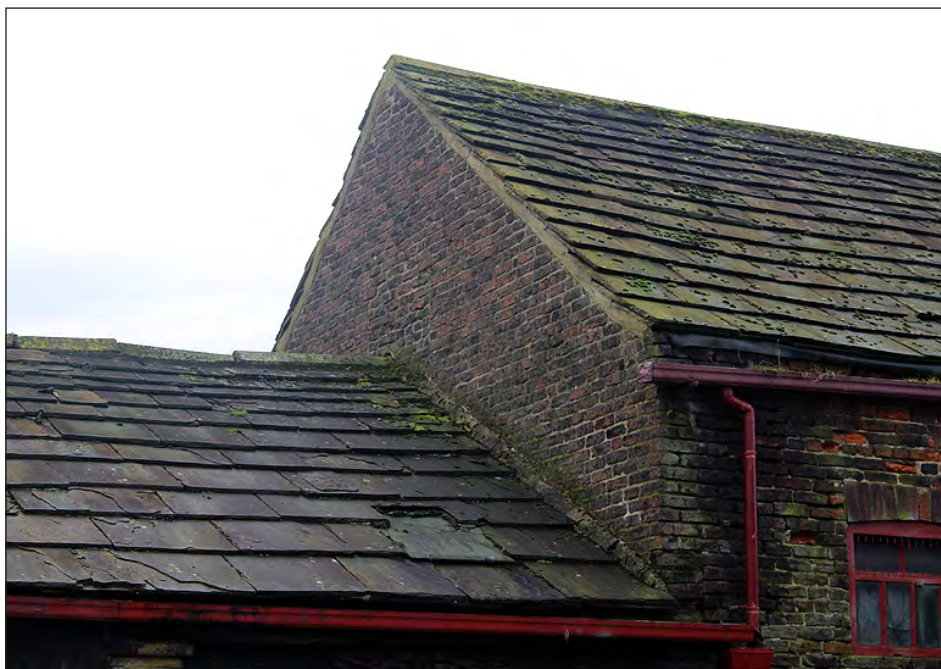
*Plate 74. Building 5. East elevation. View looking southwest*

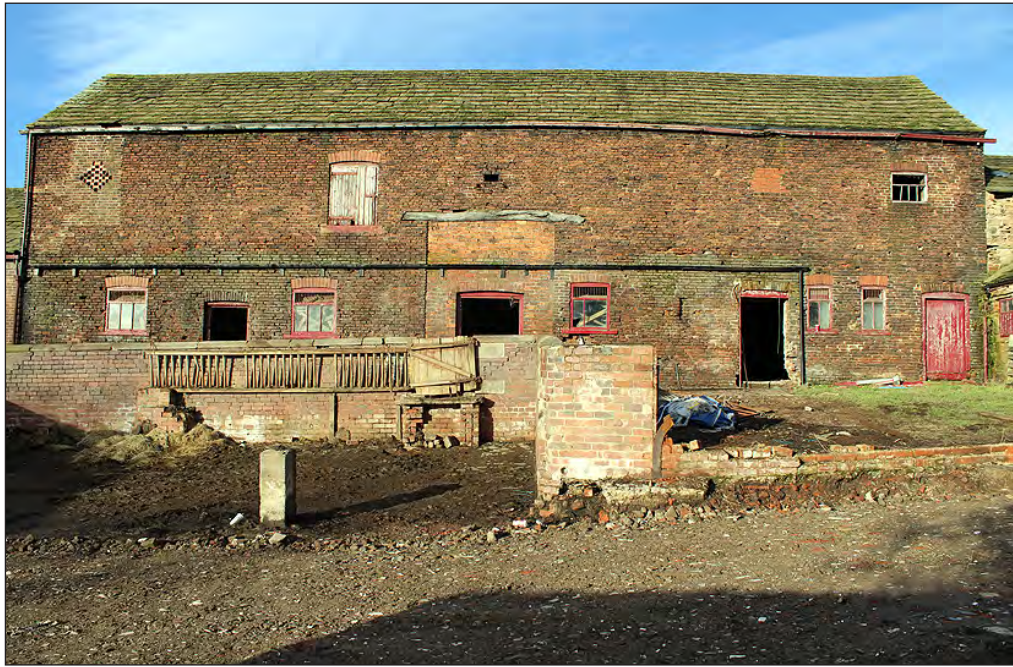
*Plate 75. Building 5. South elevation. View looking north-northwest*

The south elevation (Plate 75) was formerly blocked by the 20th-century cowsheds covering the fold yard. These had been removed prior to the visit allowing full visibility of the elevation. The guttering associated with the shed currently remains along the elevation. The elevation had a large central threshing door (Plate 76) with a timber lintel, and at the base of the opening to either side there was roughly dressed stone pieces (Plate 77). Like the north side threshing door, this doorway had been partially blocked with late 19th-century bricks and now forms a smaller wide doorway. The opening has a cambered flat arch and is fitted with a 20th-century door. Originally the elevation had seven diamond shaped ventilators at first floor level, positioned central to each bay. Narrow vertical ventilators would have also been present at ground floor level, of which only one was open and another to the west side of the threshing door appeared to be blocked. The remainder of the ground floor ventilators had been widened into windows or doorways but the elevation potentially had ten equally spaced ventilators along the elevation (Plates 78 and 79).

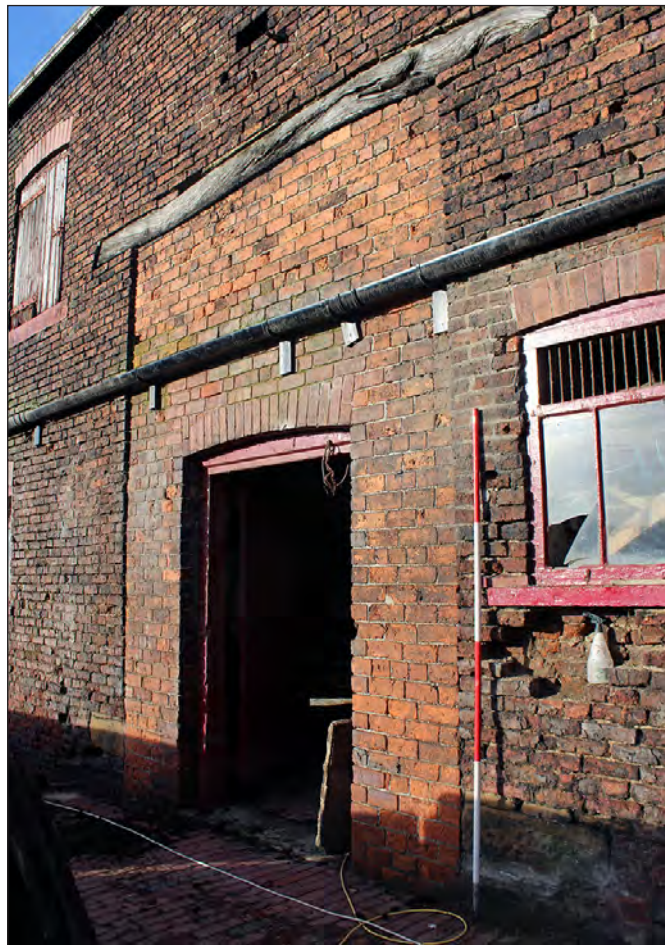
*Plate 76. Building 5. South elevation, showing the threshing door. View looking northwest*

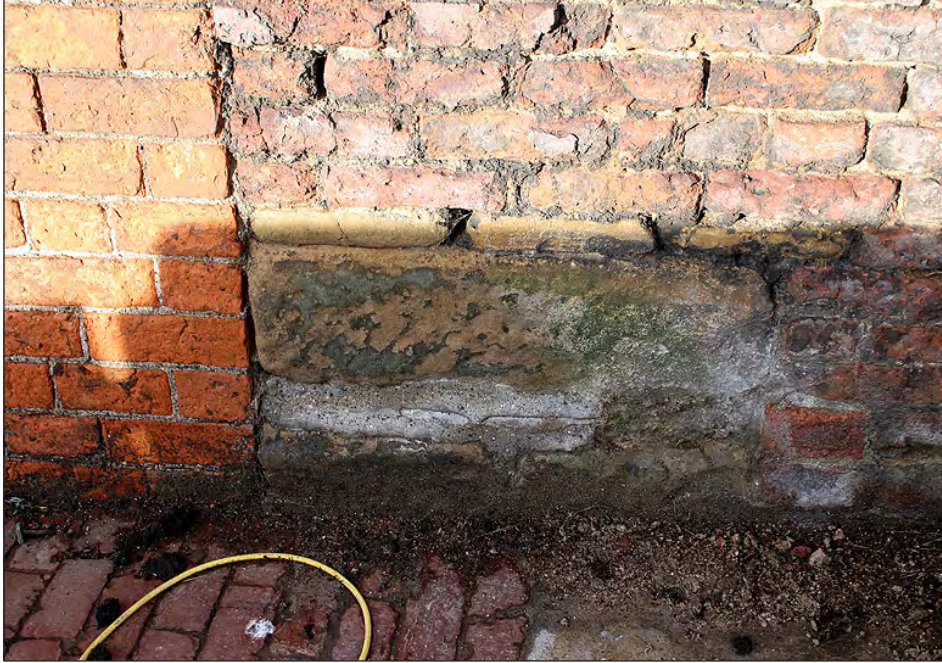
*Plate 77. Building 5. Stone masonry to the east side of the threshing door opening. View looking north-northwest*

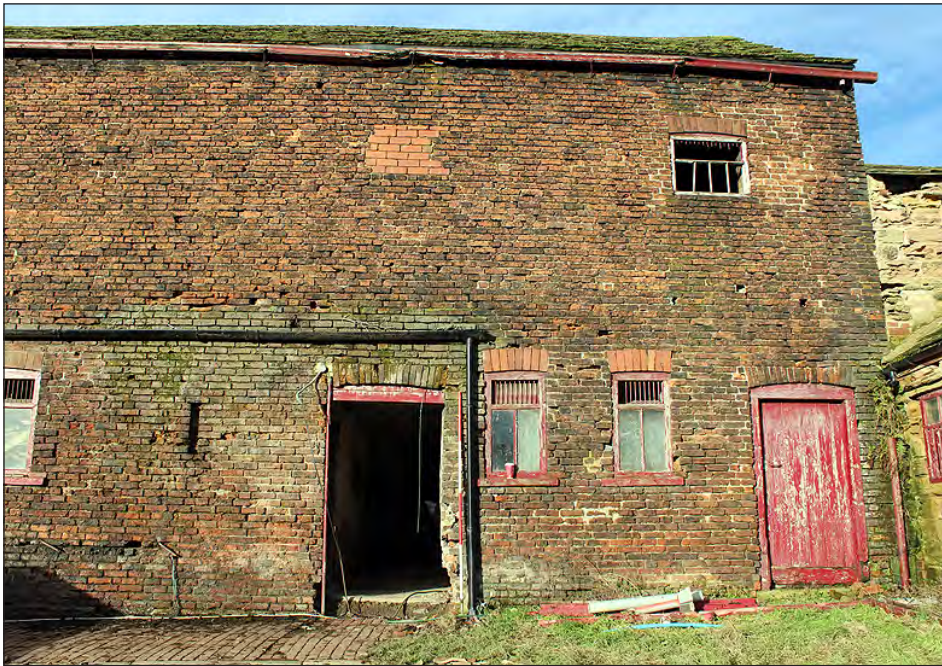
*Plate 78. Building 5. East end of the south elevation. View looking north-northwest*

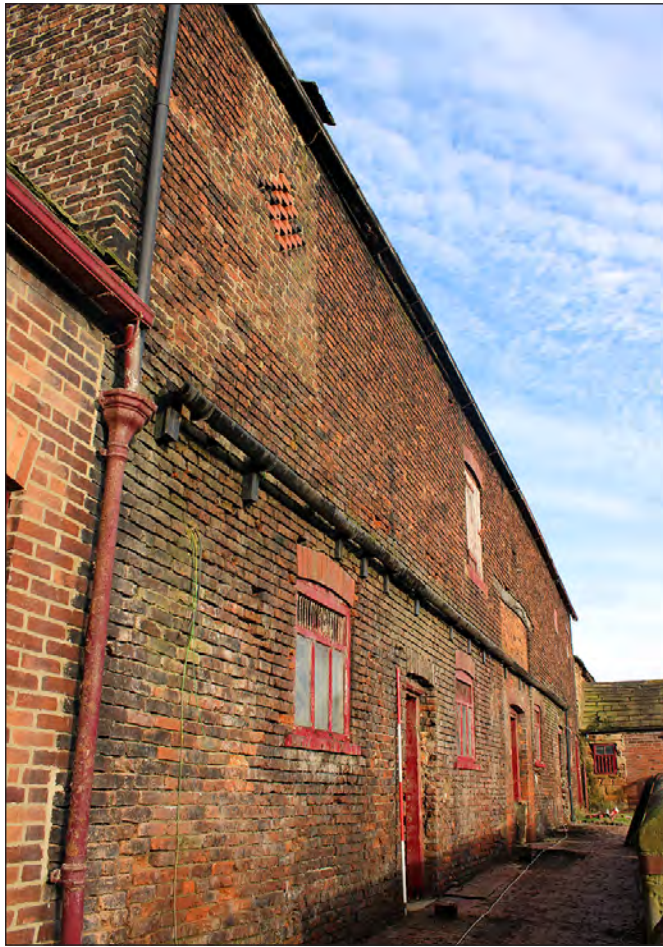
*Plate 79. Building 5. View along the south elevation. View looking northeast*

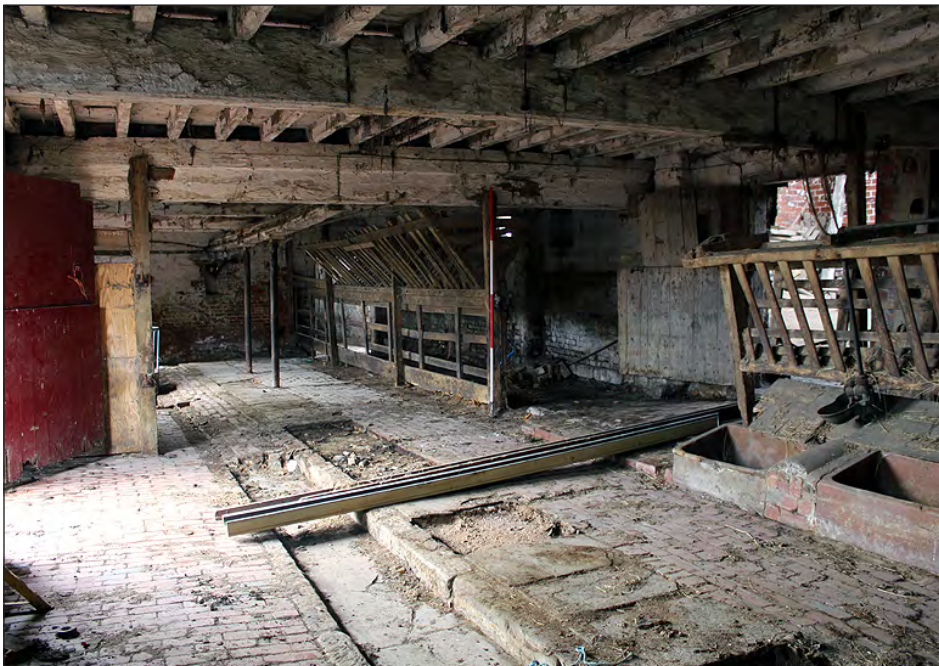
*Plate 80. Building 5, interior. Ground floor west side room. View looking west*

The west side room (Plate 80) now appears as a cowshed, and was likely in use for animal housing from the late 19th century. At this time a long feeding passage (Plates 81 and 82) was formed along the north side wall of the building and extended into Building 4, and a manure passage was located along the south side wall. The south side of the passage is lined by timber mangers forming a partition. The central section of the mangers (Plate 83) is open but scaring suggests it originally extended the full length of the room. At the base of the mangers are salt glazed troughs, and these remain at the east end of the room (Plate 84).

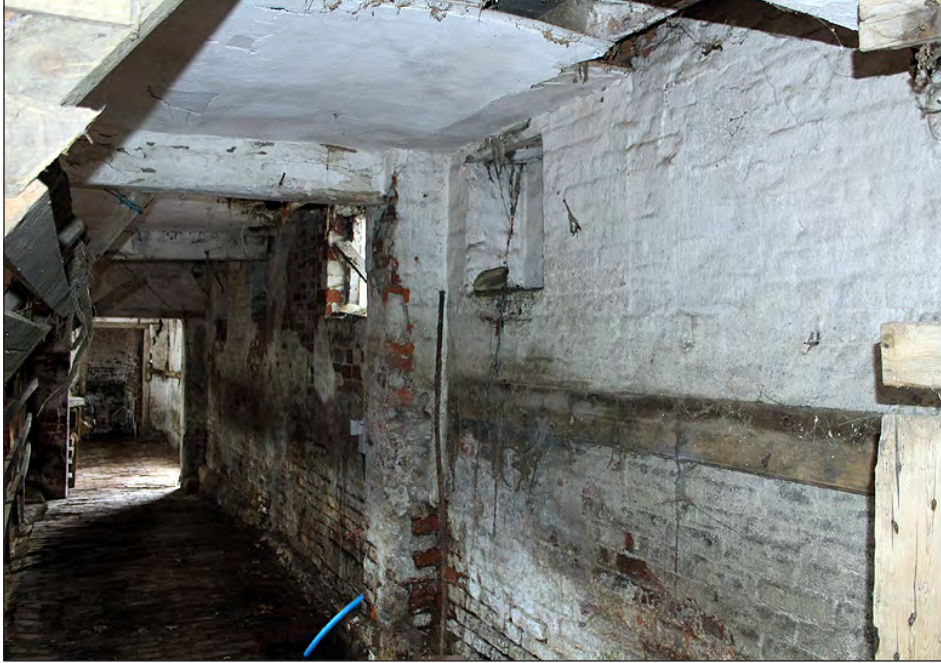
*Plate 81. Building 5, interior. Ground floor west side room, view along north elevation. View looking west-southwest*

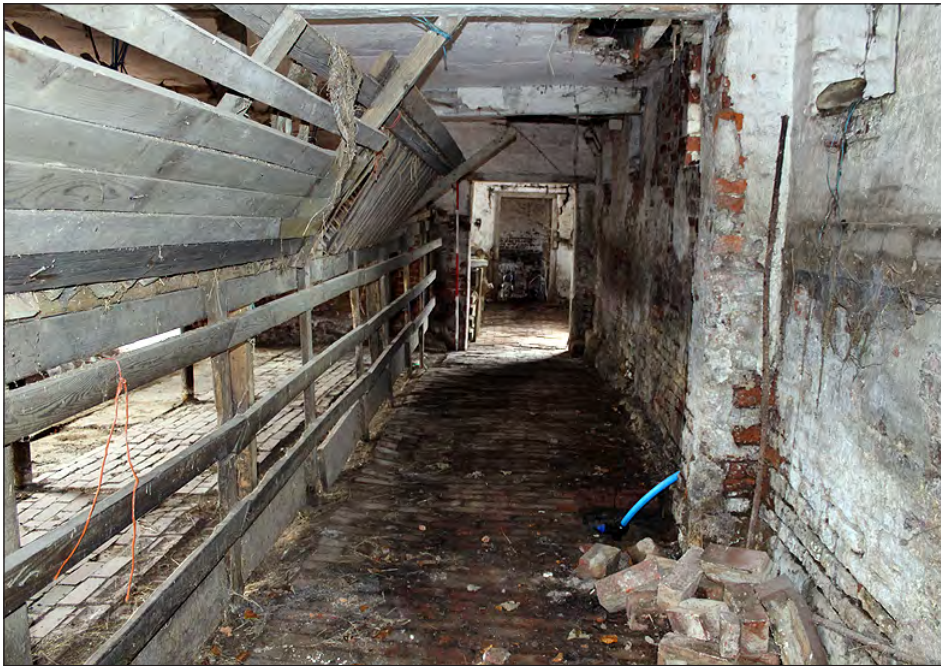
*Plate 82. Building 5, interior. Ground floor west side room, view along feeding passage. View looking west-southwest*

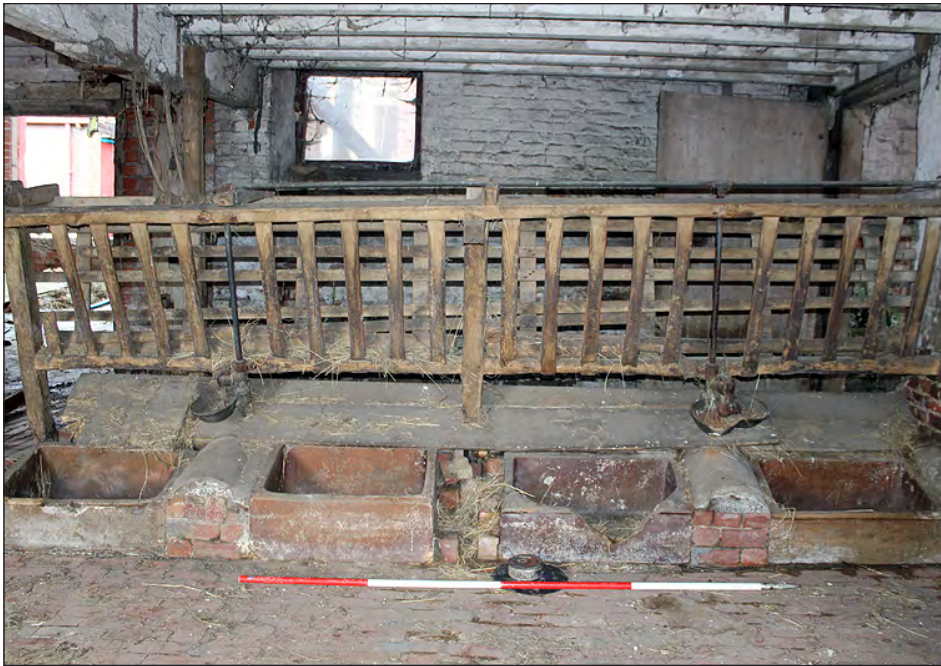
*Plate 83. Building 5, interior. Ground floor west side room, feeding troughs and mangers. View looking east-northeast*

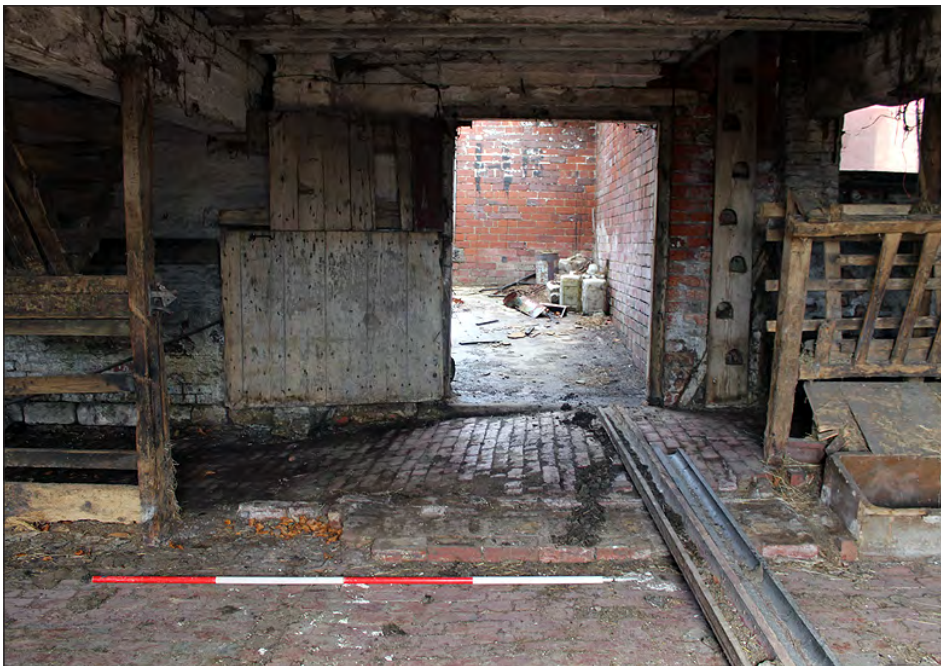
*Plate 84. Building 5, interior. Ground floor west side room, north side threshing door. View looking north-northwest*

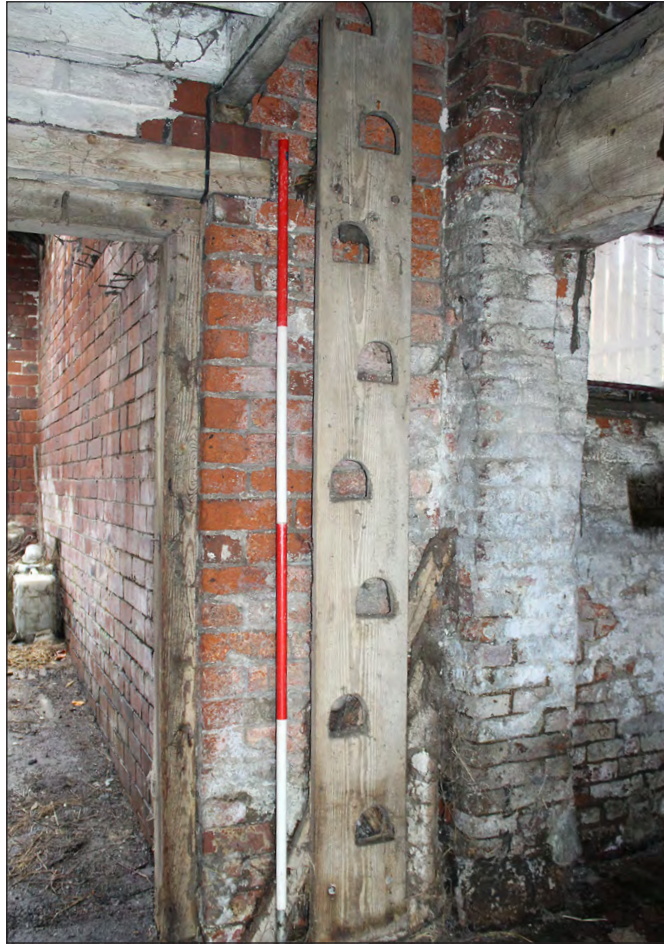
*Plate 85. Building 5, interior. Ground floor west side room, showing Jacob's ladder. View looking north*

On the north elevation to the east side of the threshing door there is a later inserted 19th-century pine Jacob's ladder (Plate 85).

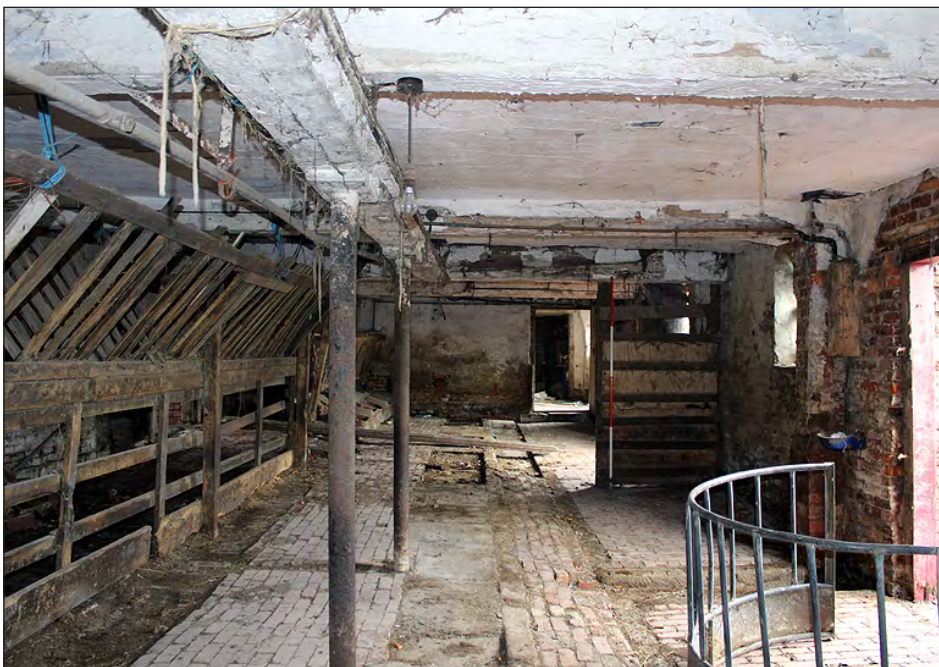
*Plate 86. Building 5, interior. Ground floor east end of the west side room. View looking east-northeast*

The east elevation (Plate 86) comprises a partition wall constructed of handmade bricks and appears to be early 19th century in date. At the north (Plate 87) and south end of the elevation there are two later inserted doorways, both likely late 19th century in date.

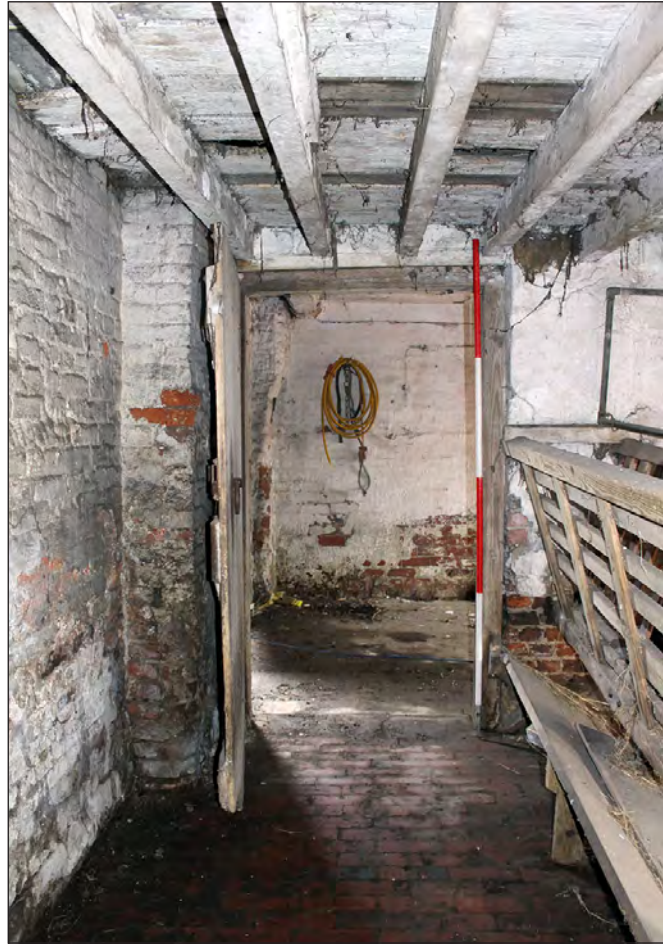
*Plate 87. Building 5, interior. Ground floor west side room, north side doorway on the east elevation. View looking east-northeast*

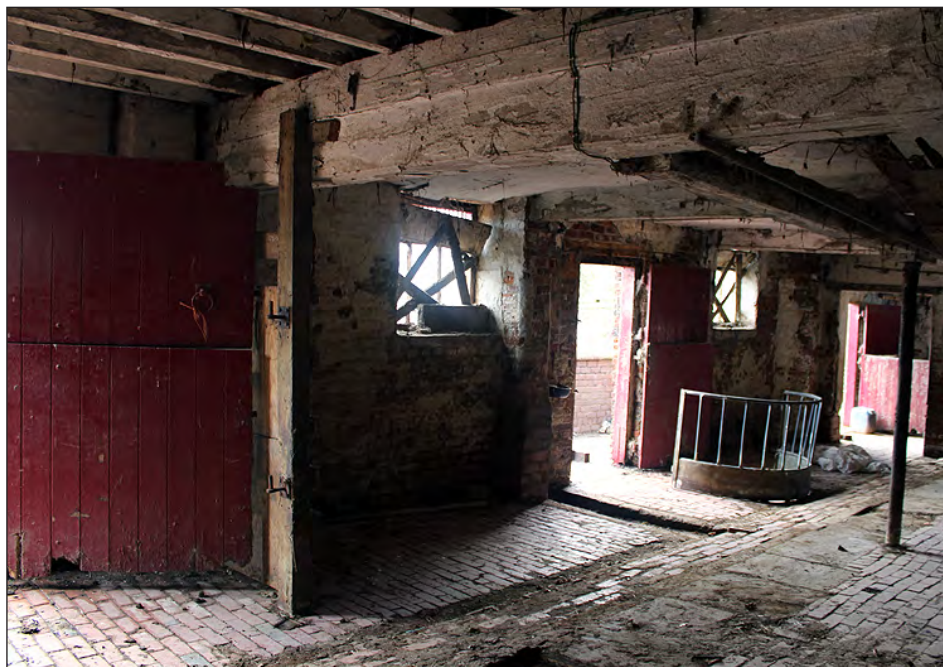
*Plate 88. Building 5, interior. Ground floor west side room, south elevation. View looking southeast*

On the south elevation a 20th-century timber partition was present extending a short distance into the room on the west side of the threshing door (Plate 88), and there are two pintels on the northernmost timber, indicating a gate formerly hung here. This partition and its associated gate likely correlate to the removal of the central manger section of the feeding passage. The blocked doorway at the west end of the elevation is clearly visible (Plate 89). The south side threshing door (Plate 90) potentially has recesses at either side, marking the location where boards were once placed across the threshing door (Plate 91).

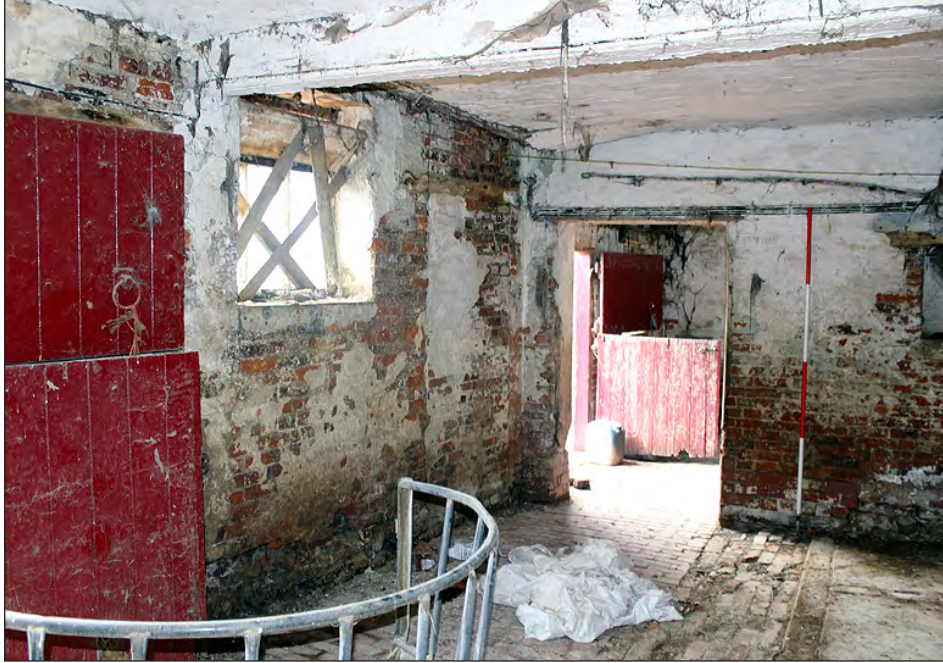
*Plate 89. Building 5, interior. Ground floor west side room, south and west elevations. View looking west-southwest*

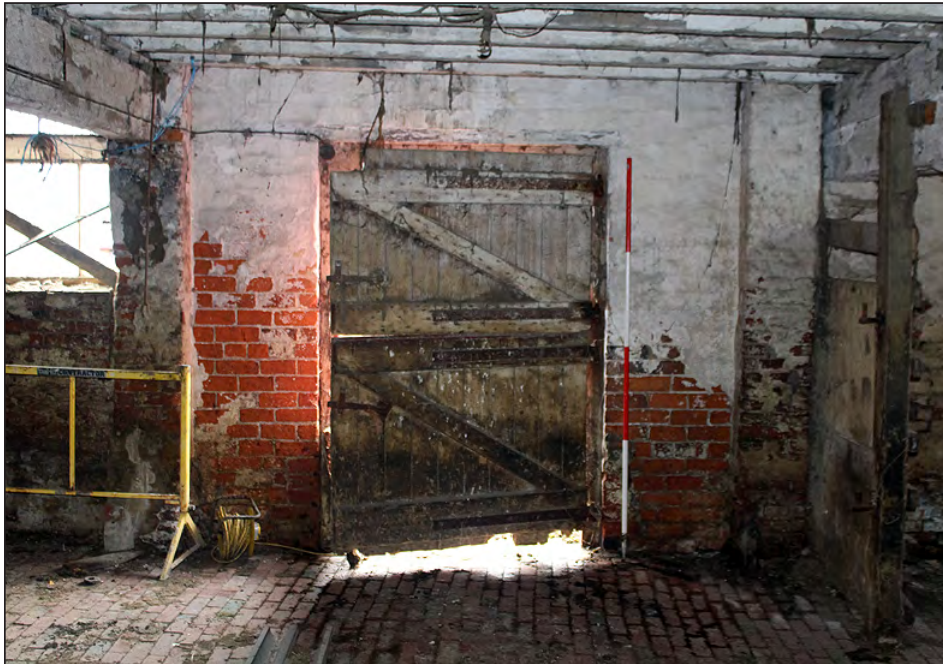
*Plate 90. Building 5, interior. Ground floor west side room, south side threshing door. View looking south-southeast*

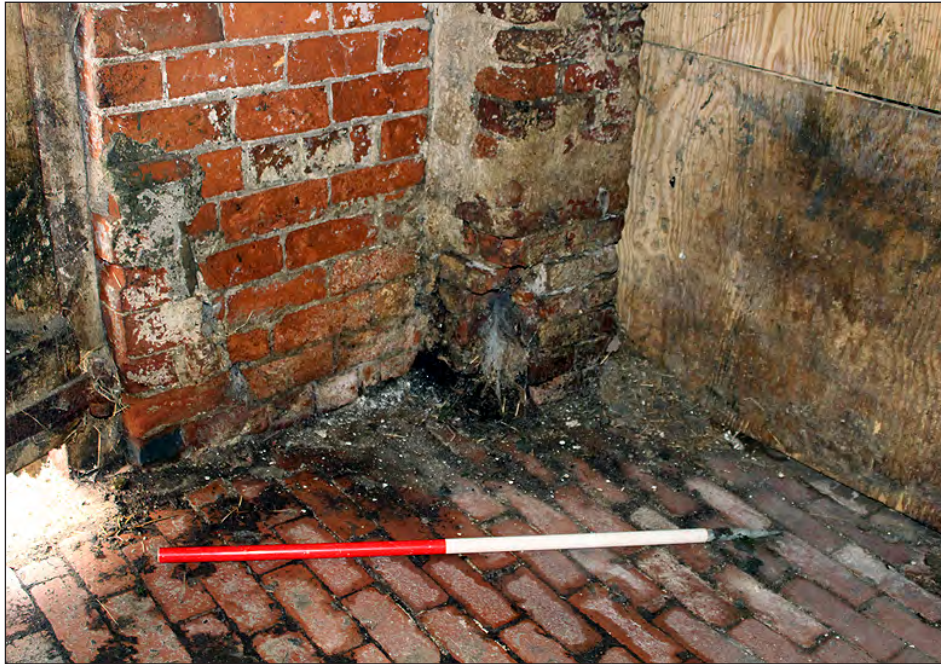
*Plate 91. Building 5, interior. Ground floor west side room, south side threshing door. Showing probable recess for a board across threshing door. View looking north-northeast*

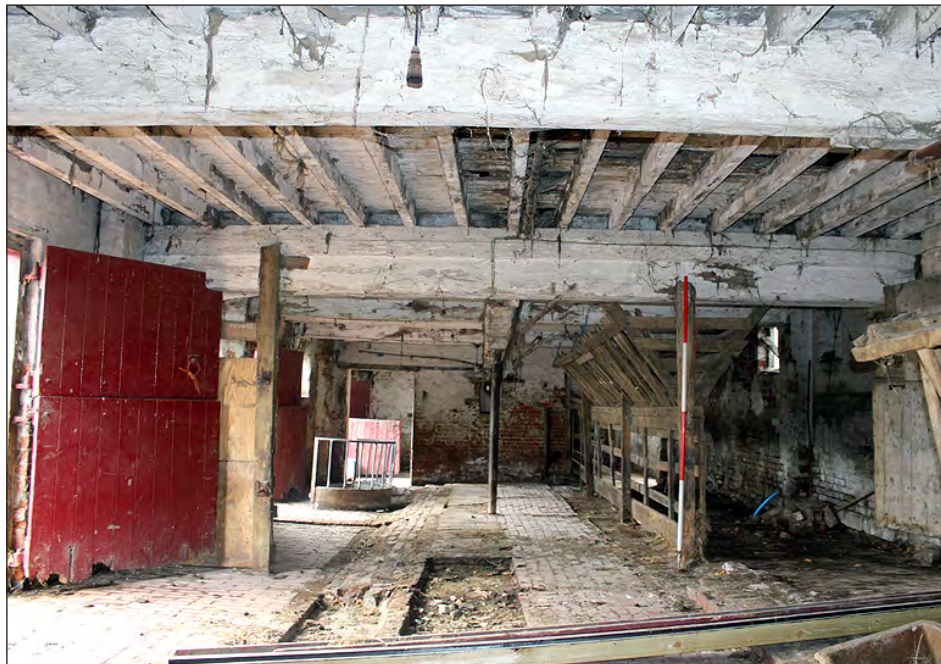
*Plate 92. Building 5, interior. Ground floor, west end of the west side room. View looking west-southwest*

At the north and south end of the west elevation (Plate 92) there are doorways leading into Building 4, both openings are late 19th century in date.

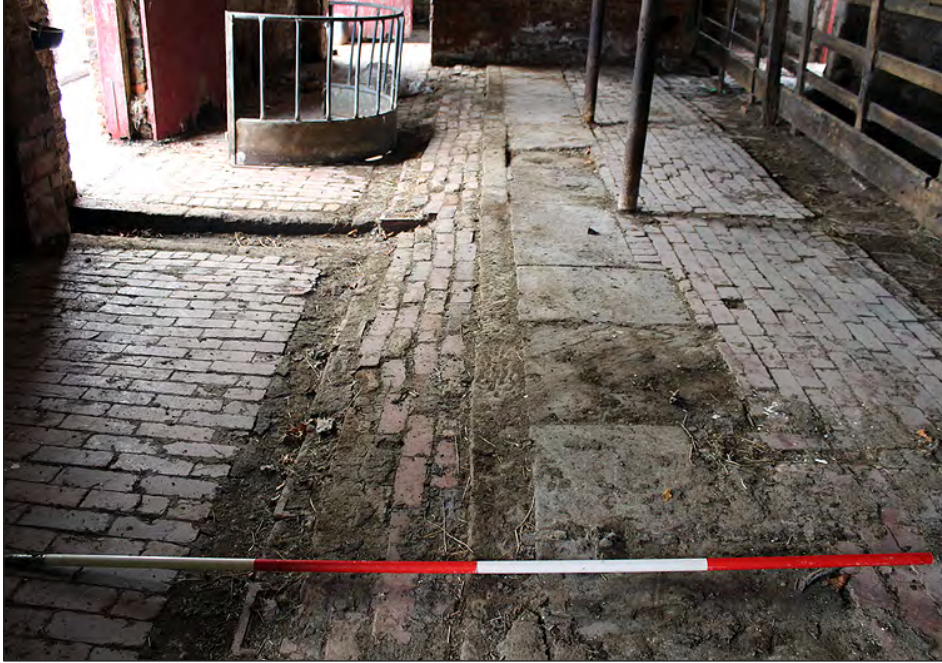
*Plate 93. Building 5, interior. Ground floor west side room, floor surface. View looking west-southwest*

The floor (Plate 93) of the room slopes north to south, and the north side feeding passage slopes east to west. The extant floor surface is predominately brick, and there is a row of flagstones roughly centrally located. The bricks are laid north to south in the areas of the manure and feeding passages and the bricks are east to west aligned in the central area of the room. A drain was formerly located between the central area and manure passage, which is lined with kerb stones. Towards the west end the drain returns (Plate 94) to the south and exits the building. The drain has been infilled with early 20th-century frogged and stamped Armitage bricks. The extant floor surface appears to date to the late 19th century.

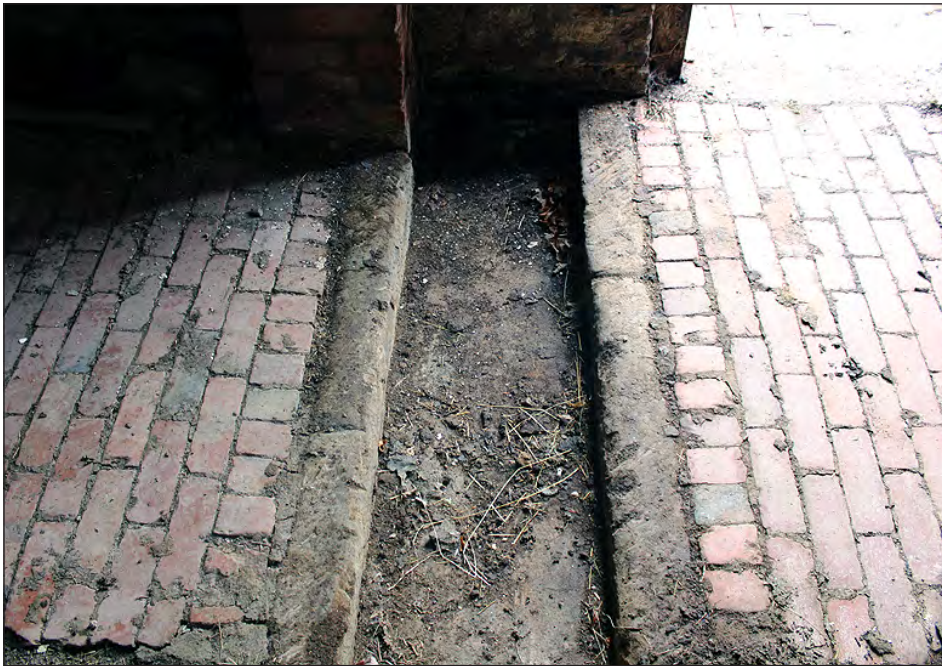
*Plate 94. Building 5, interior. Ground floor west side room, floor surface drainage channel. View looking south*

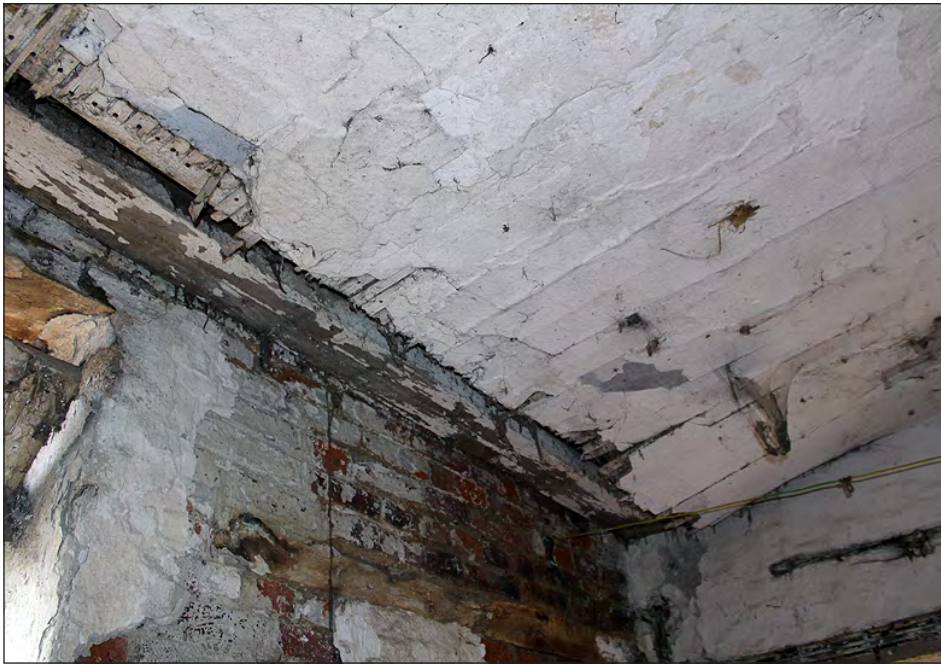
*Plate 95. Building 5, interior. Ground floor west side room, ceiling. View looking southwest*

The ceiling (Plates 95 and 96) of the room comprises four large cross beams embedded into the north and south walls of the structure, which support floor joist for the first floor above.

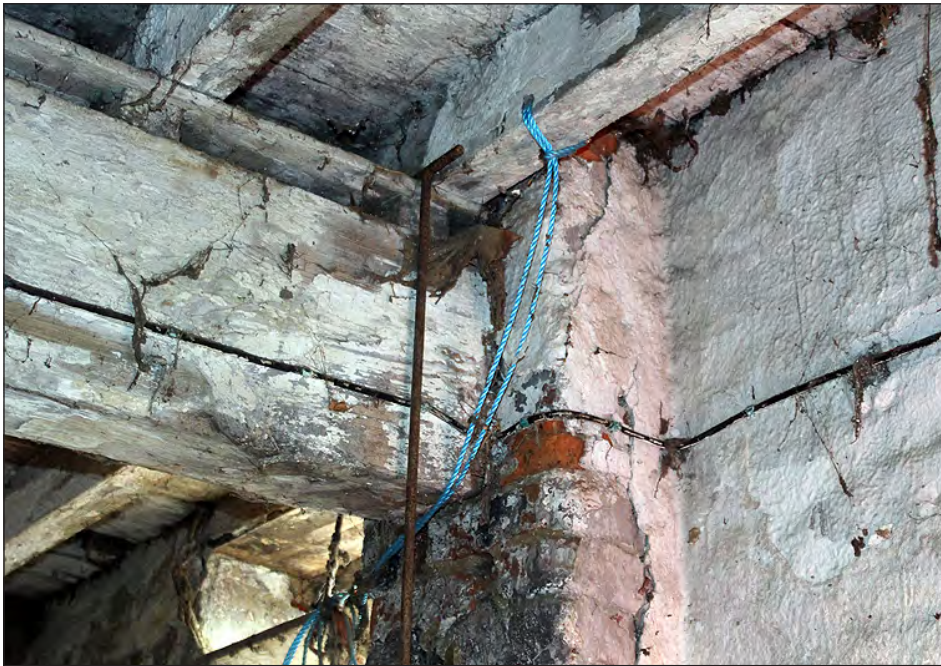
*Plate 96. Building 5, interior. Ground floor west side room, ceiling cross-beam and joists. View looking southeast*

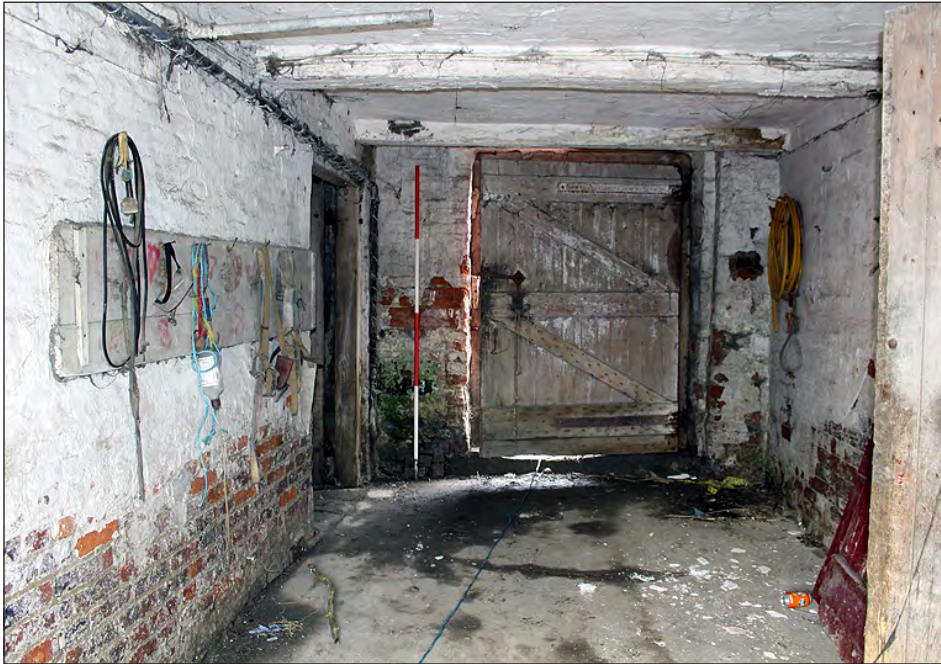
*Plate 97. Building 5, interior. Ground floor, north side of the cross-passage. View looking north-northwest*

Located to the east of the west side room is a narrow room which formed a cross-passage (Plates 97 and 98). This room once formed a larger room with the adjoining room to the east, a partition between the two rooms was added in the late 19th century. The room has a degraded painted lime wash finish, but the bricks are still visible in places allowing the walls to be phased. The doorway at the south end of the east elevation (Plate 99) leads to the manure passage of the main barn room. Recent graffiti on the door (Plates 100 and 101) indicates that the barn was also used for lambing. The floor of the room is concrete and the ceiling had a lathe and plaster finish.

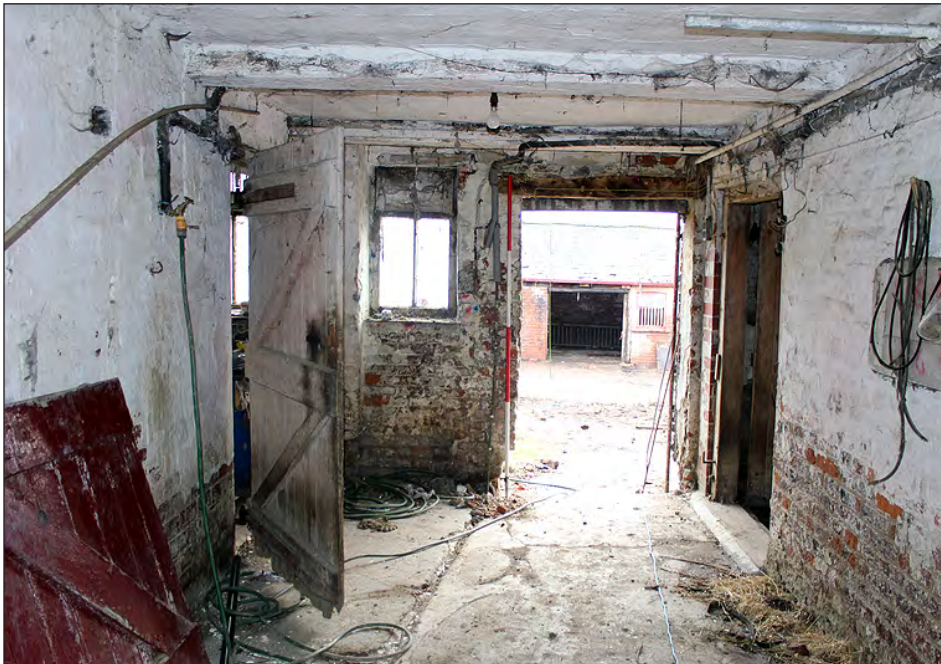
*Plate 98. Building 5, interior. Ground floor, south side of the cross-passage. View looking south-southeast*

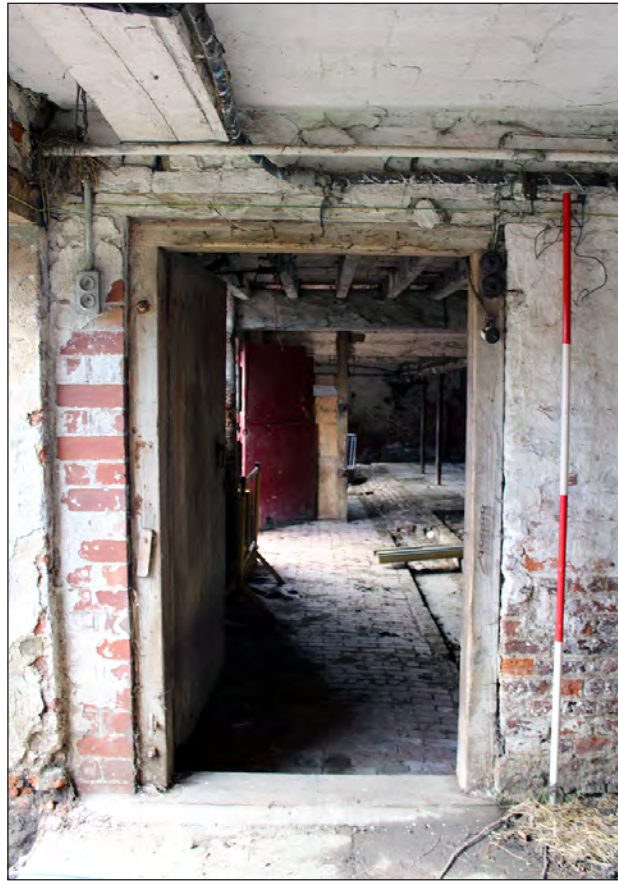
*Plate 99. Building 5, interior. Ground floor cross-passage, south side doorway leading to west side room. View looking west-southwest*

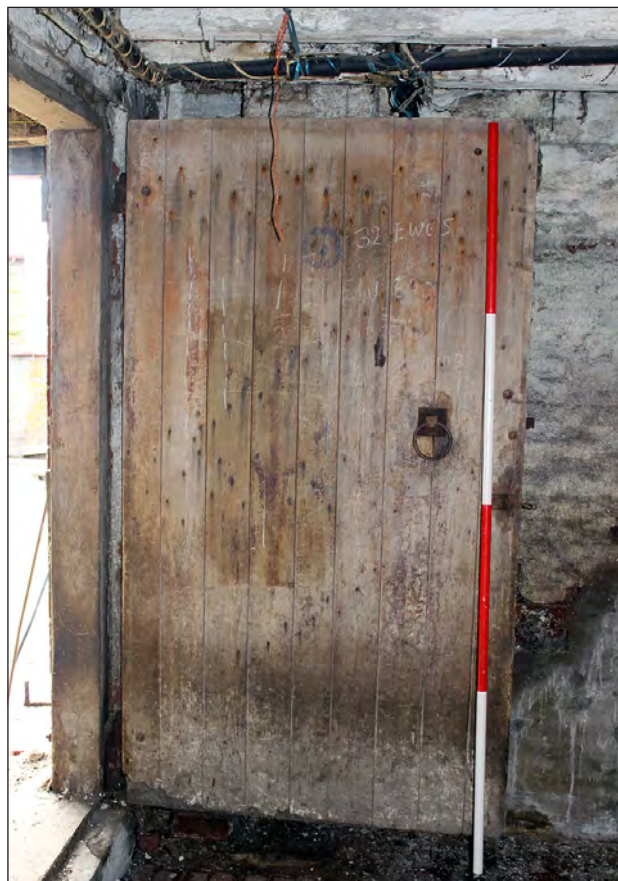
*Plate 100. Building 5, interior. Ground floor cross-passage, south side door. View looking south-southeast*

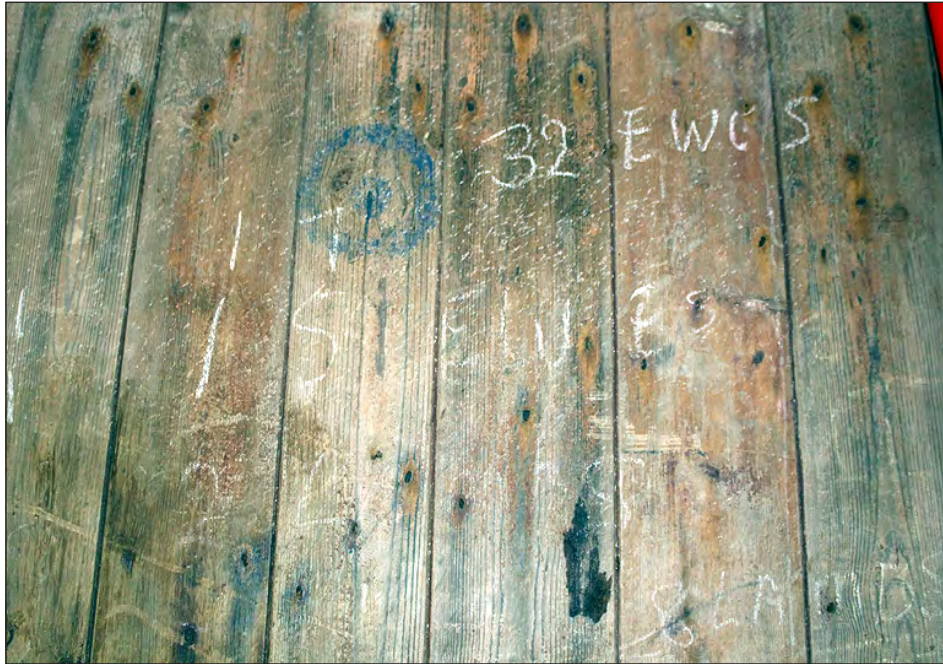
*Plate 101. Building 5, interior. Ground floor cross-passage, graffiti on the south side door. View looking south-southeast*
