**Newsam Green Farm**

**Leeds**

Archaeological Building  
Recording

Report no. 2561  
June 2021

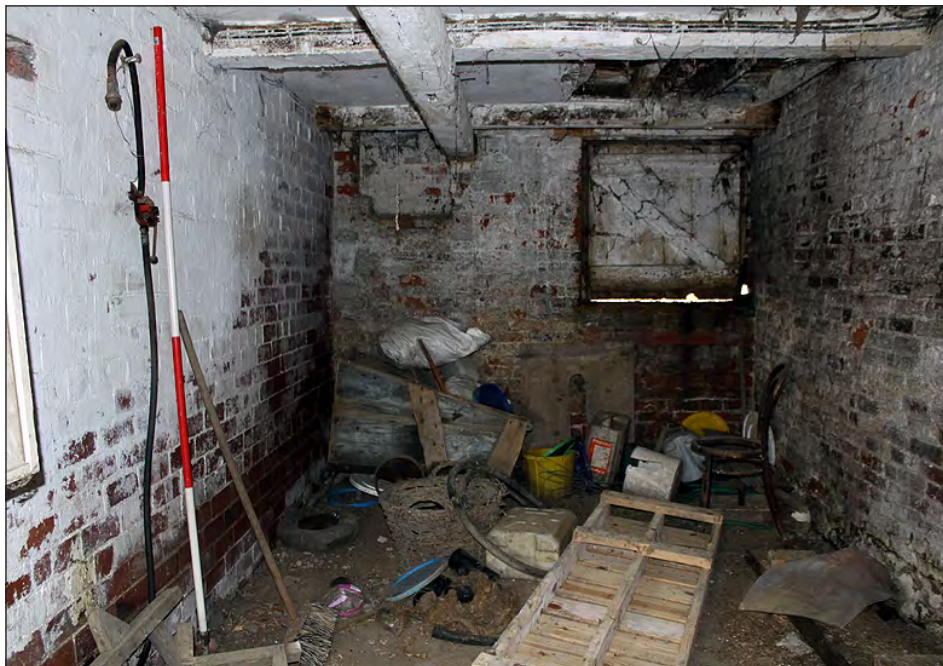
*Plate 102. Building 5, interior. Ground floor, north end of the east side room. View looking north-northwest*

The east end room (Plates 102 to 104) of Building 5 appears to have been used as a store, the walls have a degraded lime wash finish. The lower half of the later inserted doorway on the north elevation has been blocked with early 20th-century brickwork. The floor of the room is concrete and the ceiling has a lathe and plaster finish.

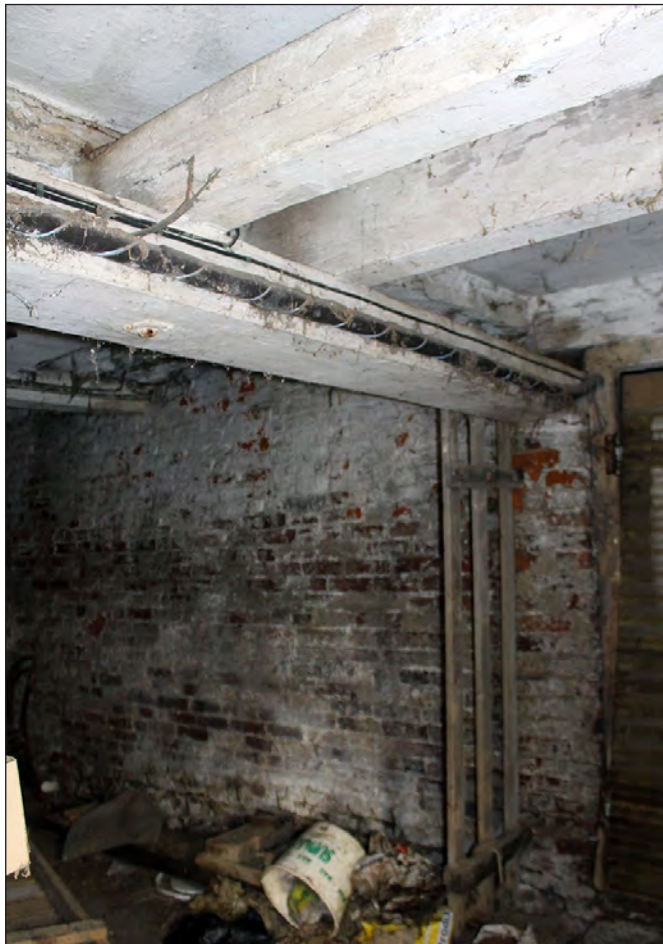
*Plate 103. Building 5, interior. Ground floor east side room, east elevation.  
View looking north*

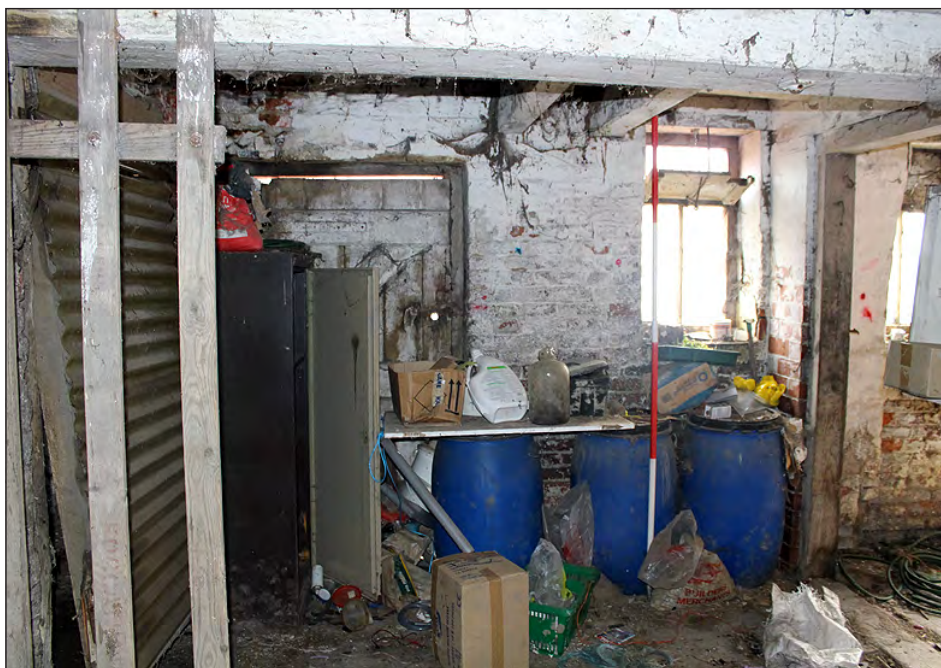
*Plate 104. Building 5, interior. Ground floor east side room, south elevation.  
View looking south-southeast*

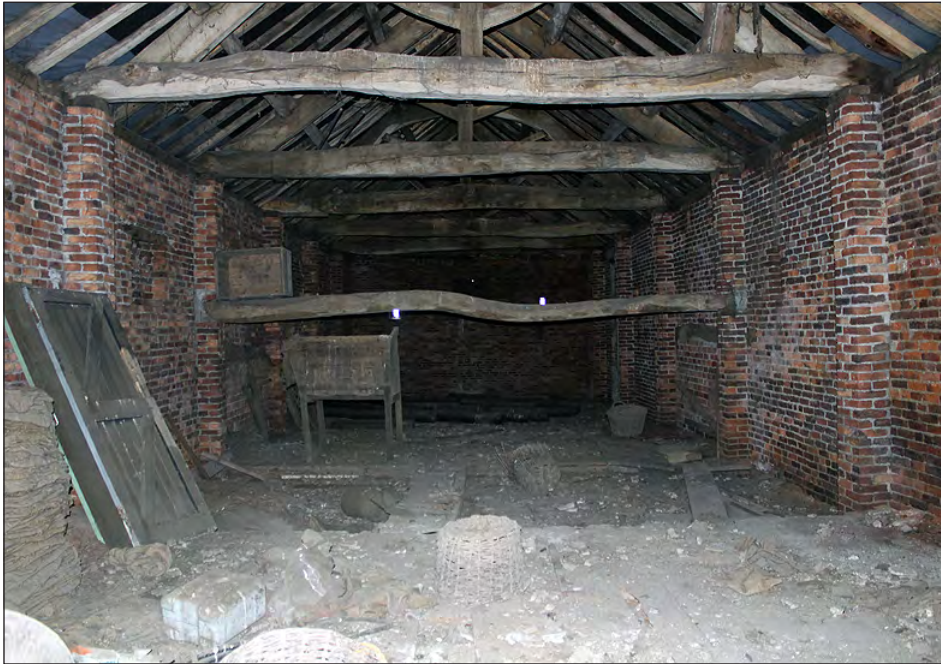
*Plate 105. Building 5, interior. First floor. View looking west-southwest*

The first floor (Plates 105 to 110) of Building 5 comprises a large open space. Originally the central bay of the room would not have had a first floor. The walls did not have a lime wash finish suggesting that the lime washing of the interior of the building did not occur until livestock were housed within it. The floor of the room comprised original floorboards, but the floor in the centre bay was likely a late 19th-century addition. The first floor was presumably first used to store grain and hay and/or straw and appears to have been used for mechanically processing feed and storage from the late 19th-century.

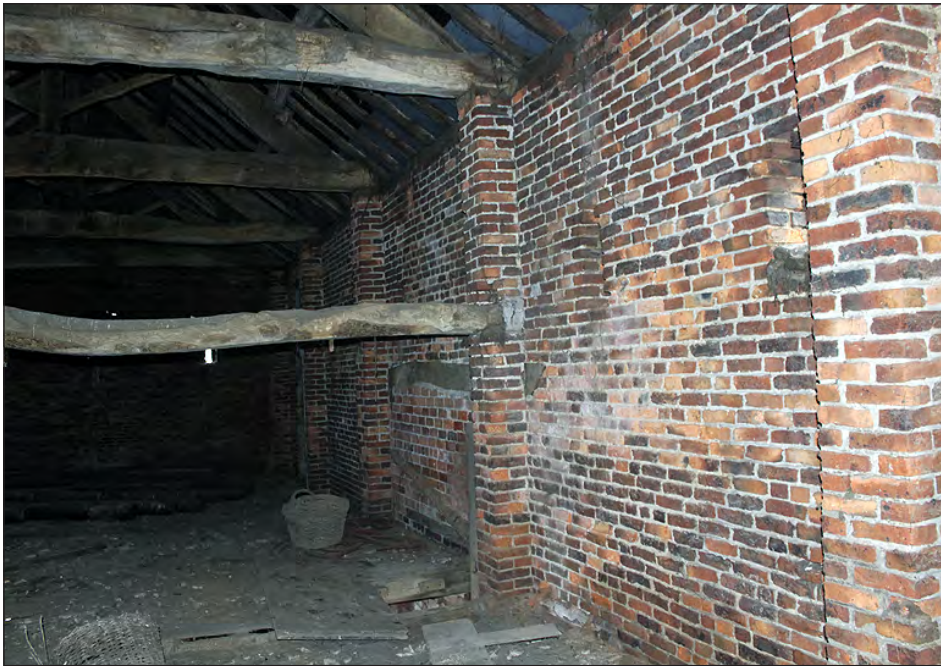
*Plate 106. Building 5, interior. First floor, north elevation. View looking west*

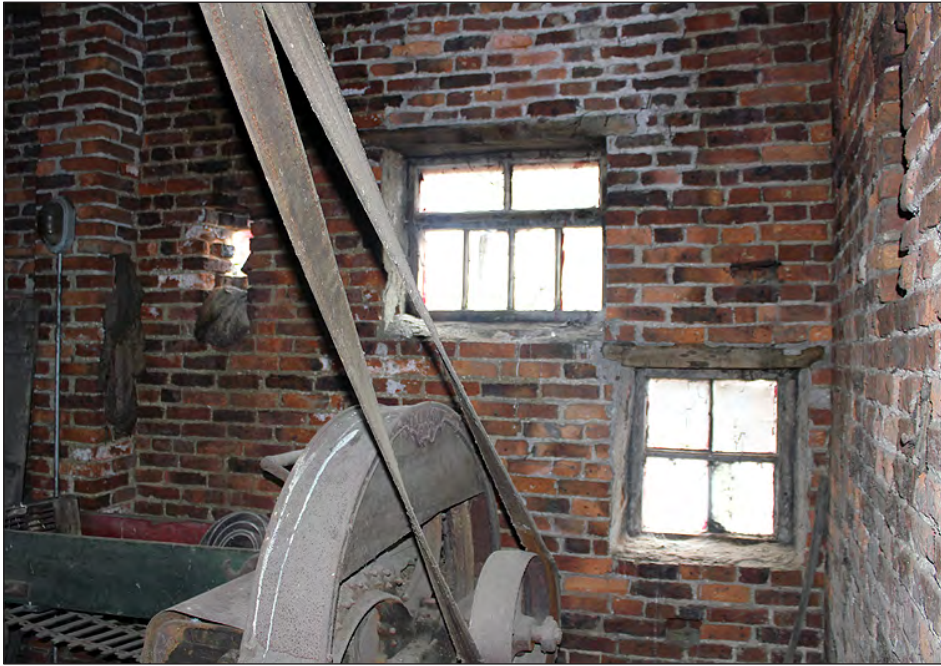
*Plate 107. Building 5, interior. First floor, east end of the north elevation.  
View looking north-northwest*

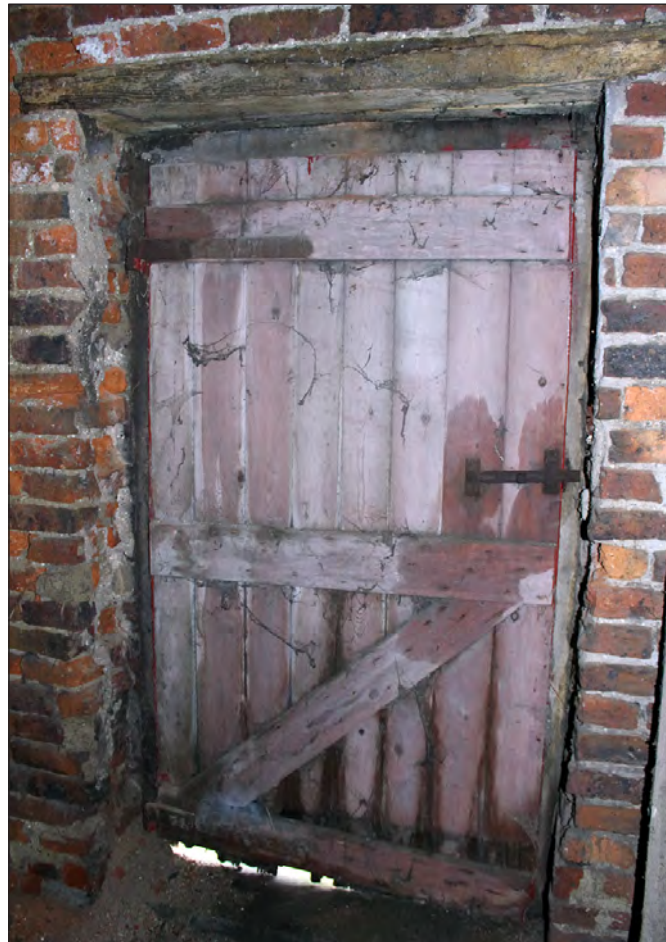
*Plate 108. Building 5, interior. First floor, north elevation taking-in door.  
View looking north-northwest*

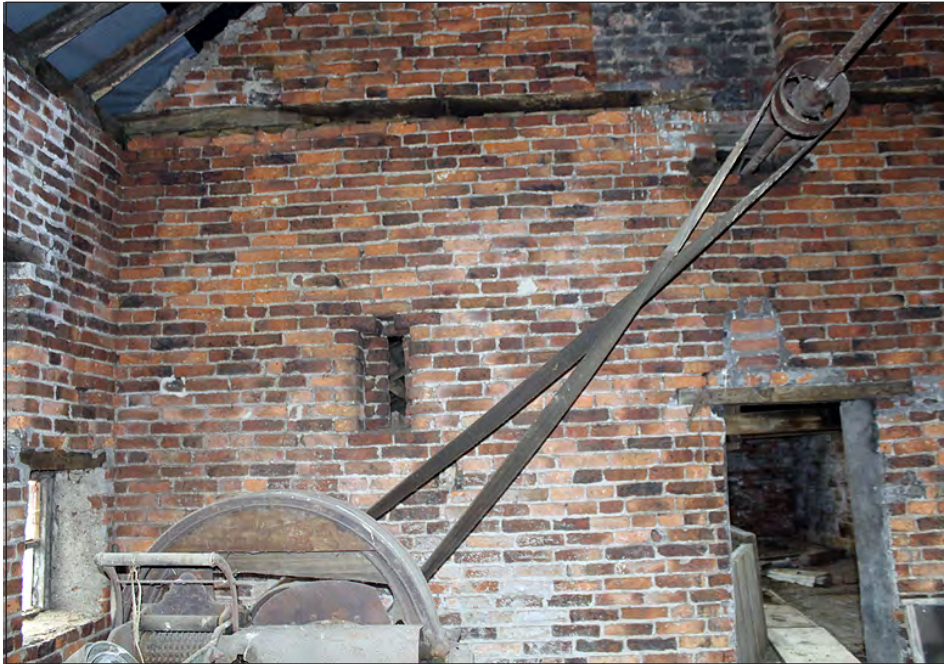
*Plate 109. Building 5, interior. First floor, north side of the east elevation. View looking east-northeast*

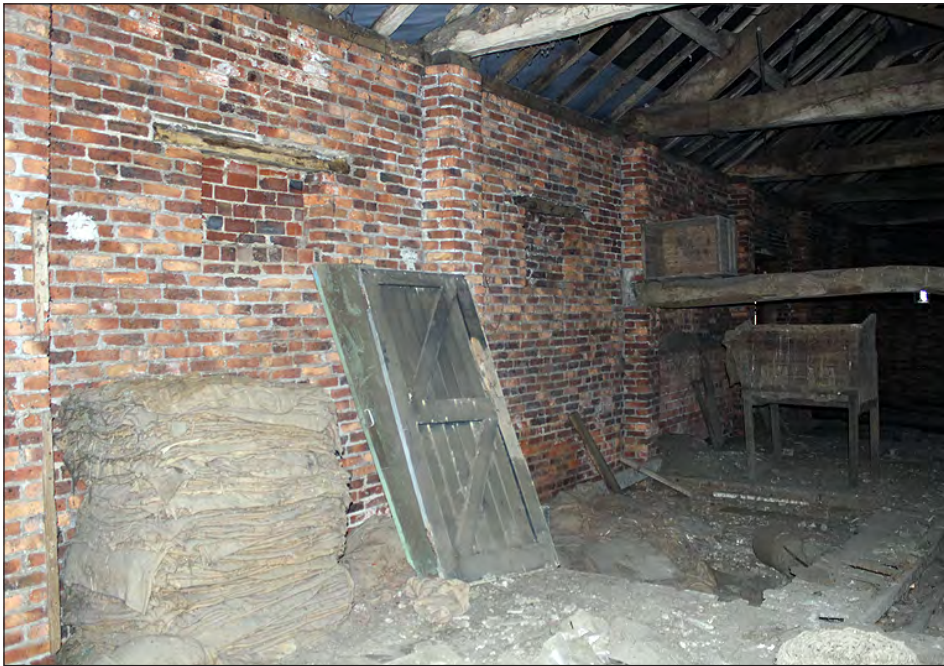
*Plate 110. Building 5, interior. First floor, south elevation. View looking southwest*

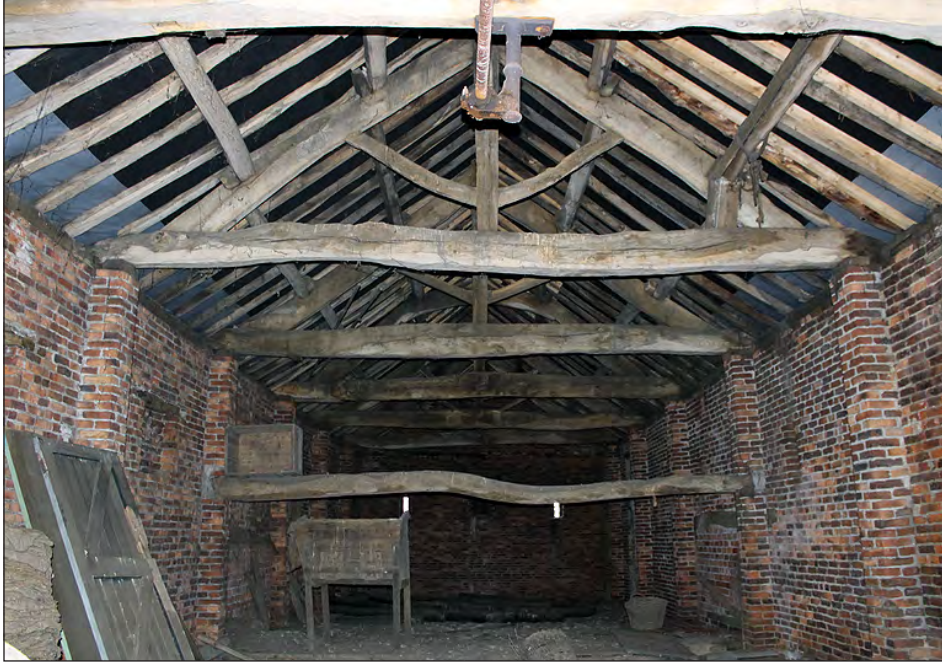
*Plate 111. Building 5, interior. Roof structure. View looking west-southwest*

The barn has a seven bay pitched roof structure (Plates 111 and 113). The stone slate tiles have been rehung but the majority of the original mid-18th-century rafters and trusses remain in situ. The six original King-post trusses rest on top of brick piers built along the north and south wall of the building and on the timber wall plate on top of the elevations. The west end truss and the third (from the east) truss have had their king-posts and struts replaced, presumably when the roof was rehung in the 20th century. The principal rafters, tie-beams and struts have a mortice and tenon joint with the King-posts. There are two rows of side purlins to each side, which pass through the principal rafters, but no pegs could be seen. The common rafters sit flush on the purlins and on top of the east and west elevations. The fourth truss from the east appears to have a different form, and instead of the principal rafters joining at the apex they appear to curve and form a high collar.

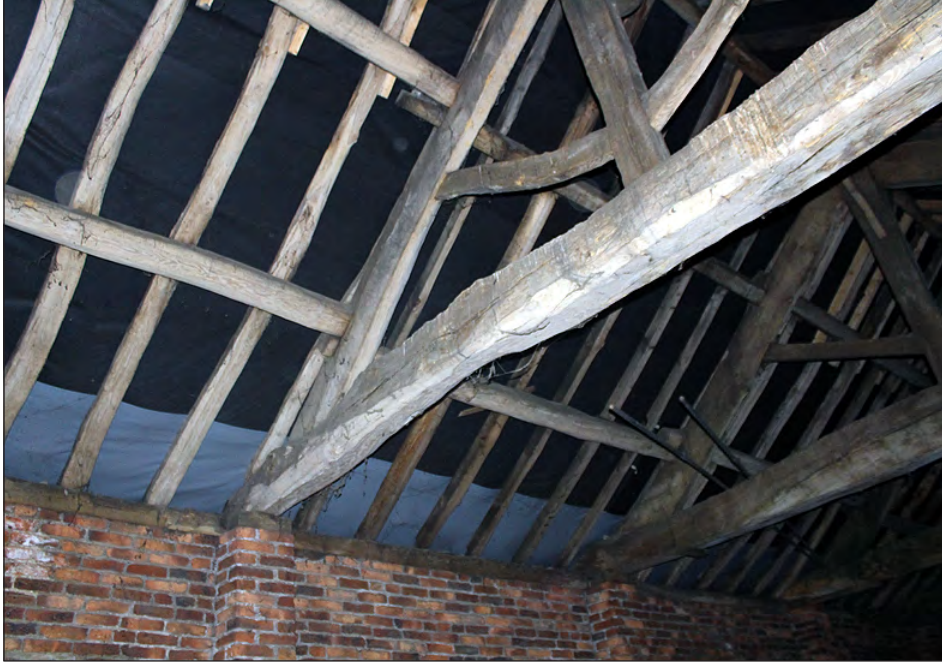
*Plate 112. Building 5, interior. Roof truss. View looking east-northeast*

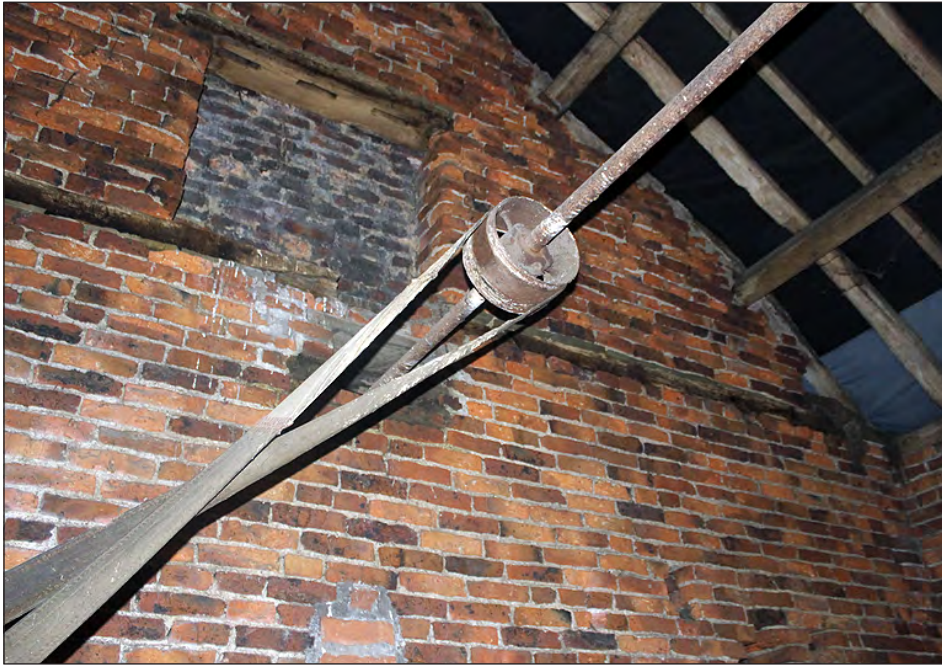
*Plate 114. Building 5, interior. Albion chaff cutter machine. View looking north-northwest*

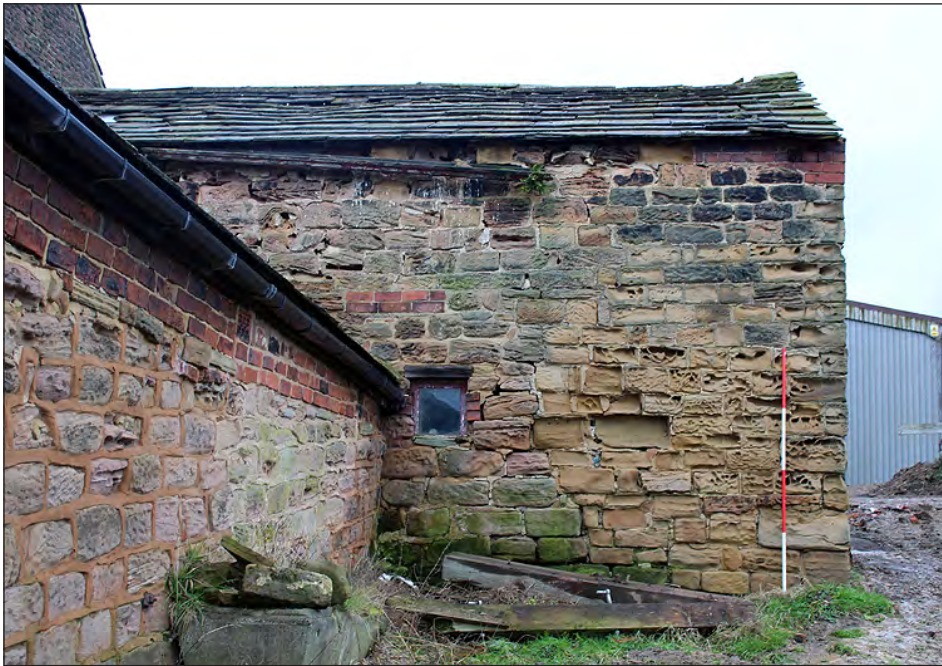
*Plate 131. Building 6. South elevation. Building 7. East elevation. View looking northwest*

The south elevation (Plates 131 to 133) of the structure comprises stone masonry. The elevation has been repointed and repaired historically, but appears to indicate the location of an earlier two storey structure. The stones forming the elevation are roughly dressed, and unlike the stone remains encountered on Building 4 they have been brought roughly to course. The elevation is abutted by Building 7 at the west side. There is a later inserted small window at ground floor level towards the east side. At the west end of the elevation, visible within building 7, there is an area of rubble stone masonry which appears to represent an infilled doorway or window. Internally within Building 6 this area has been infilled with brick.

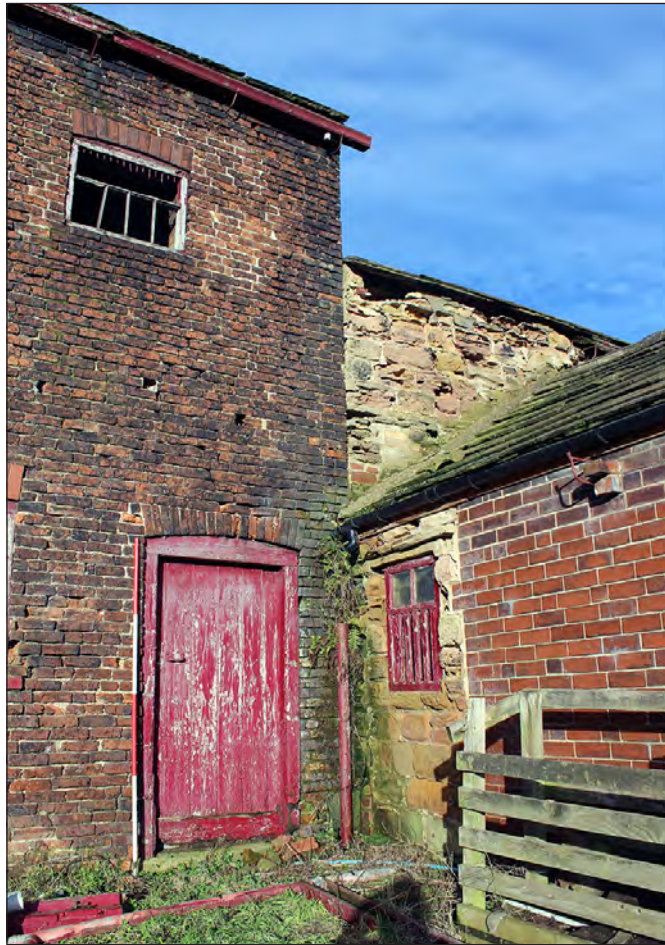
*Plate 132. Building 6. East side of the south elevation. View looking north-northwest*

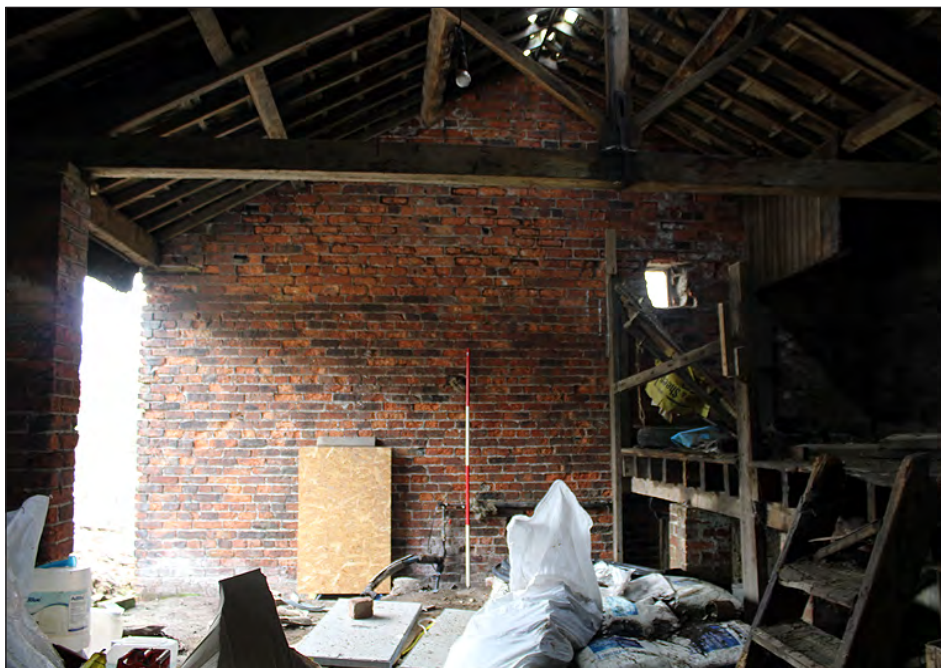
*Plate 133. Building 6. West side of the south elevation. View looking north*

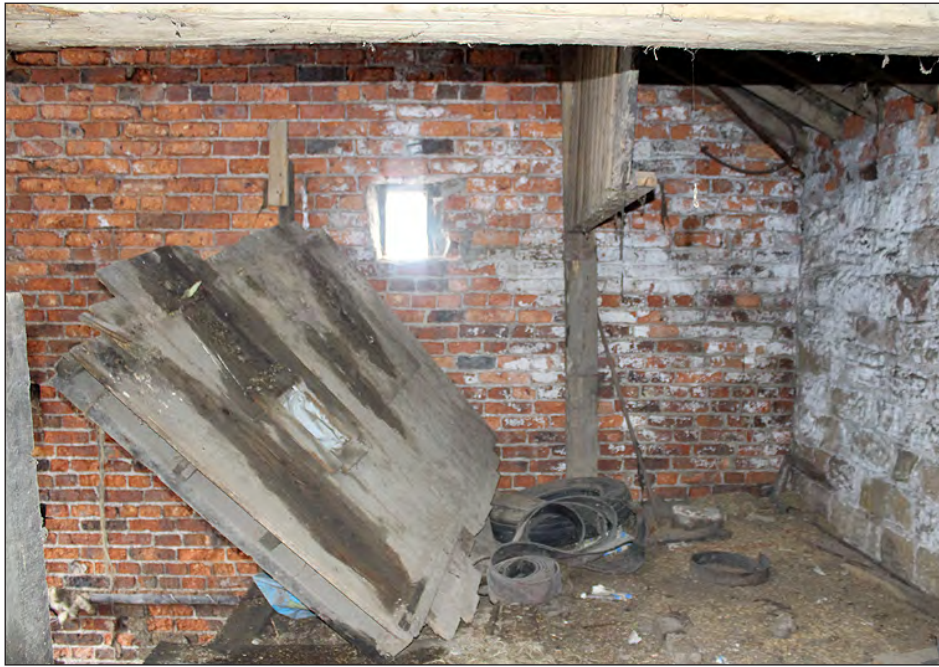
*Plate 134. Building 6, interior. East elevation. View looking east-northeast*

The interior (Plate 134) of the cartshed comprises a large single space at ground floor level which has a dropped passageway along its rear south elevation. The level of the passage is consistent with the ground floor level of Building 6 and the ground floor level of the cartshed is consistent with the trackway. Along the south elevation, a mezzanine platform has been added, which is supported on four brick piers of a probably late 19th-century date. It seems likely that the addition of the mezzanine platform relates to the mechanisation of the threshing barn (Building 6). Lime washing appears to have been isolated to the southern area of the building, as indicated by the degraded lime wash on the walls of the passageway and the mezzanine platform area (Plate 135). The lime wash was fairly layered on the masonry suggesting the earlier stone structure (Plates 136 and 137) had also been lime washed.

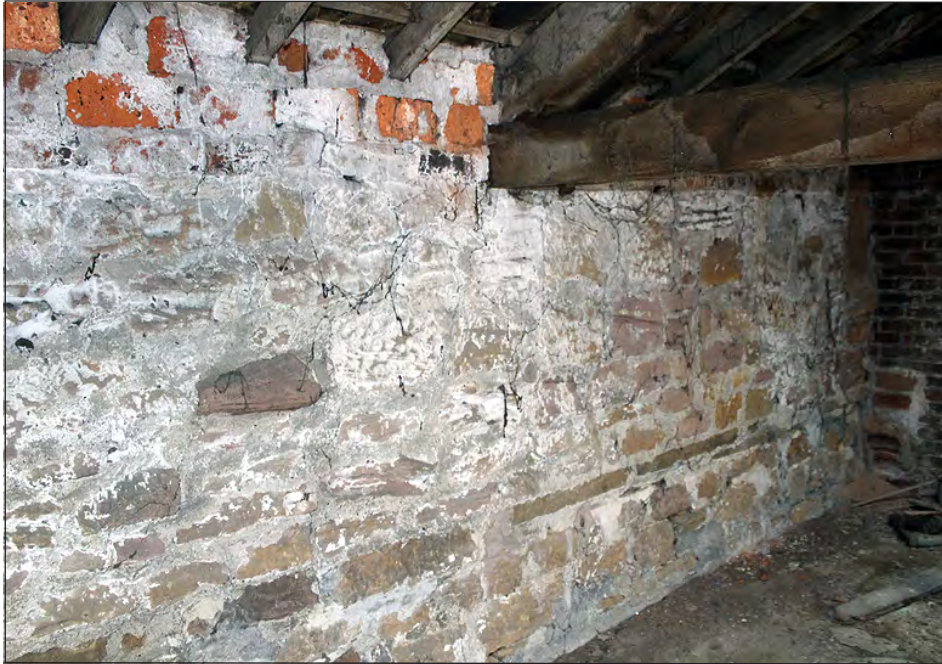
*Plate 136. Building 6, interior. South elevation at passageway level. View looking southwest*

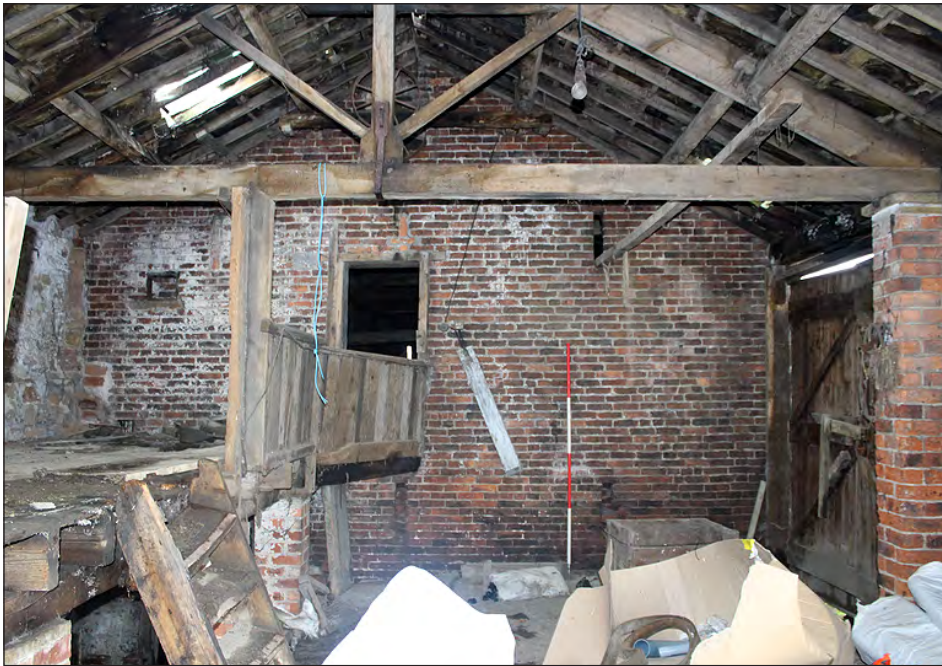
*Plate 137. Building 6, interior. South elevation at mezzanine level. View looking southwest*

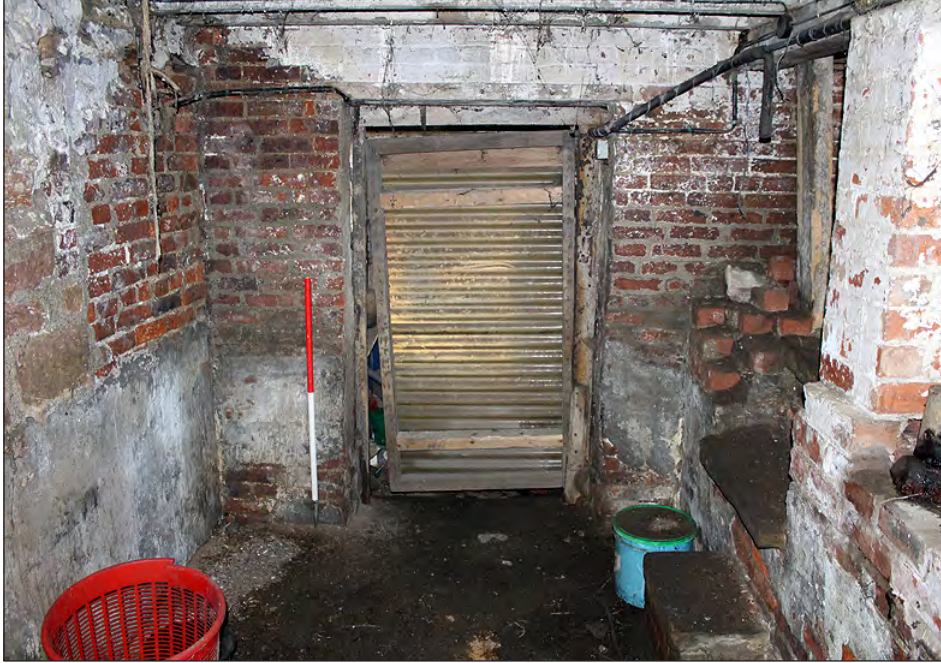
*Plate 138. Building 6, interior. West elevation. View looking west-southwest*

The west elevation (Fig. 6; Plate 138) of the structure has a doorway (Plate 139) at the dropped passageway level which leads into Building 5, and there is a later inserted doorway (Plate 140) at the mezzanine platform level leading into the first floor granary area of Building 5. The opening was presumably put in place when the mezzanine was added. At the

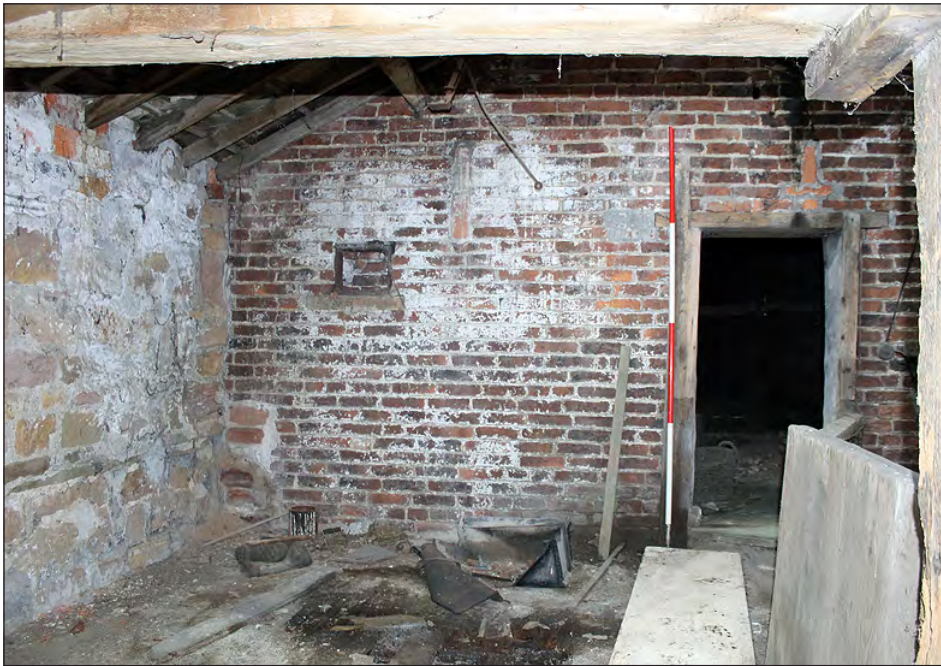
*Plate 139. Building 6, interior. West elevation at passageway level. View looking west-southwest*

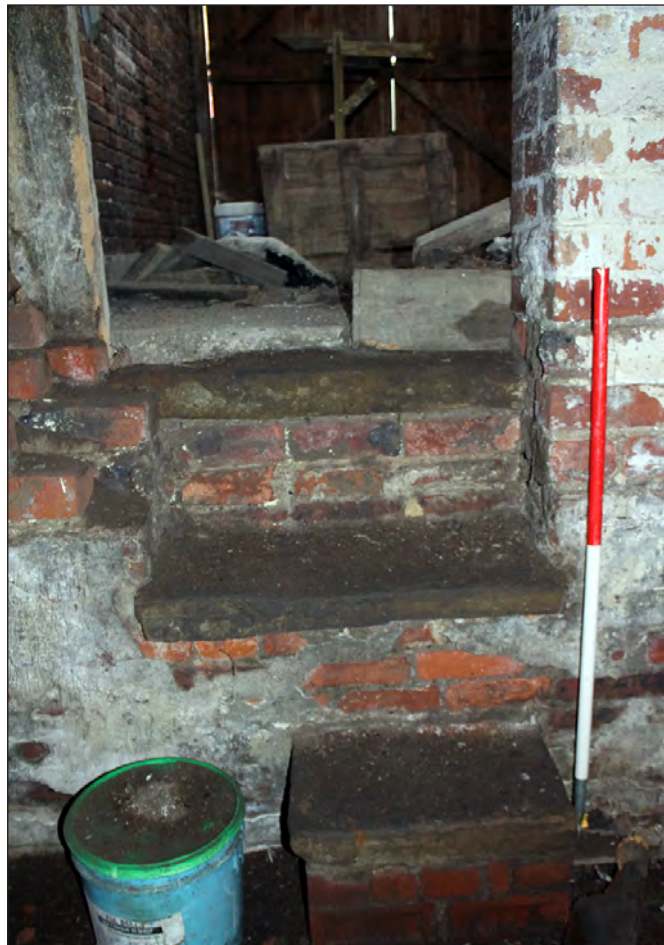
*Plate 141. Building 6, interior. Passageway. View looking east-northeast*

At the east end of the passageway (Plate 141) there is a small closed off area, which had been partially lined with timber planks. The purpose of the feature was not clear but potentially relates to the mechanisation of the building.

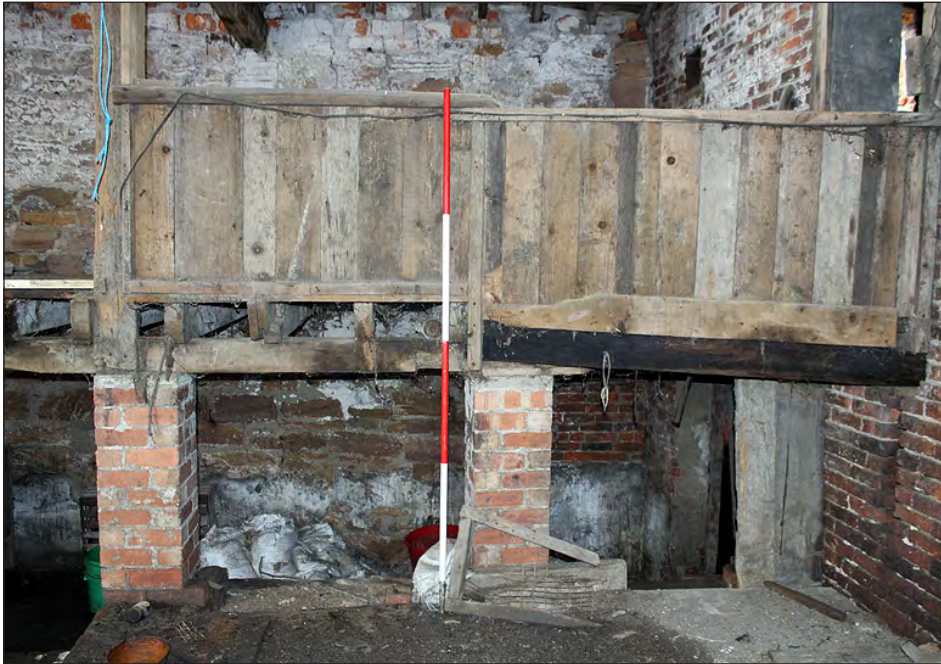
*Plate 142. Building 6, interior. Passageway steps. View looking north-northwest*

At the west end of the passageway on the north side there were three stone steps (Plate 142). The steps embedded within the wall appear to be contemporary with the construction of Building 6 in the mid-19th century, but the first lower step is a later insertion, and is constructed of machine made brick and has a stone tread. These steps permit access from the cartshed floor level to the dropped passage level.

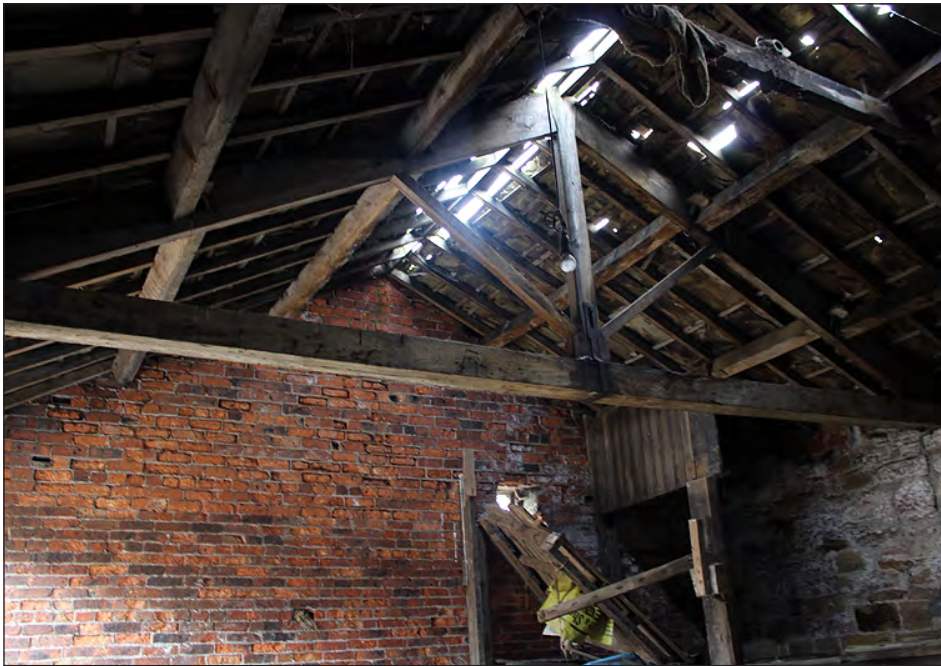
*Plate 143. Building 6, interior. Mezzanine. View looking south-southeast*

The mezzanine platform (Plate 143) is constructed of timber floorboards and joists set on a beam which is supported by the brick piers. The north side of the platform at the west end has been fitted with a half-height timber plank partition. The platform is accessed from timber lean-to steps, centrally located within the room.

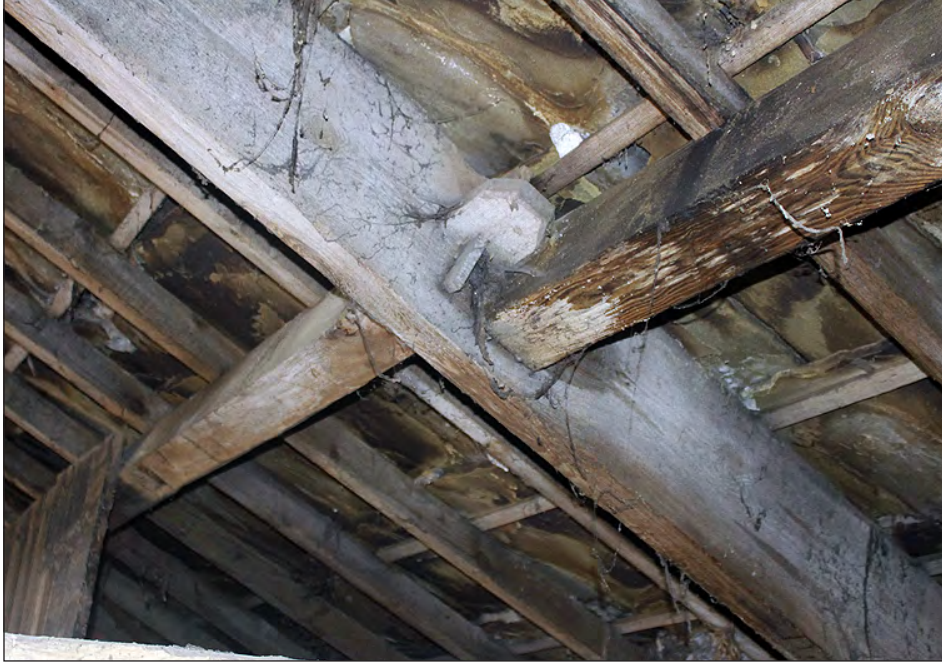
*Plate 144. Building 6, interior. Roof structure. View looking southeast*

The roof structure of the building comprises two 19th-century King-post trusses (Plate 144), which rest on the brick piers of the cartshed north elevation and are tied into the south elevation masonry. The principal rafters and the tie-beams have a mortice and tenon joint with the King-posts, and iron straps are attached to the tie-beam and King-posts. The struts have a mortice and tenon joint with the King-posts, and a mortice and tenon joint with the principal rafters. There are two rows of side purlins to each side. These pass through the principal rafters with a pegged mortice and tenon joint (Plate 145). The common rafters sit flush on the purlins and rest on a beam along the north elevation and are tied into the brickwork of the south elevation. Each truss has been incised at the base of the King-post joint and adjoining pieces with Roman numerals (west to east).

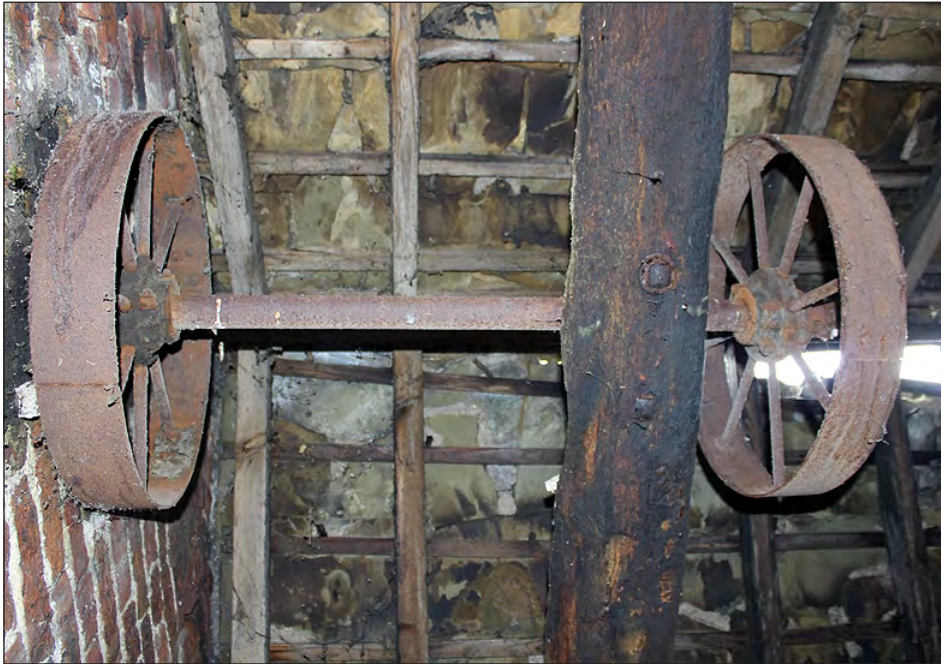
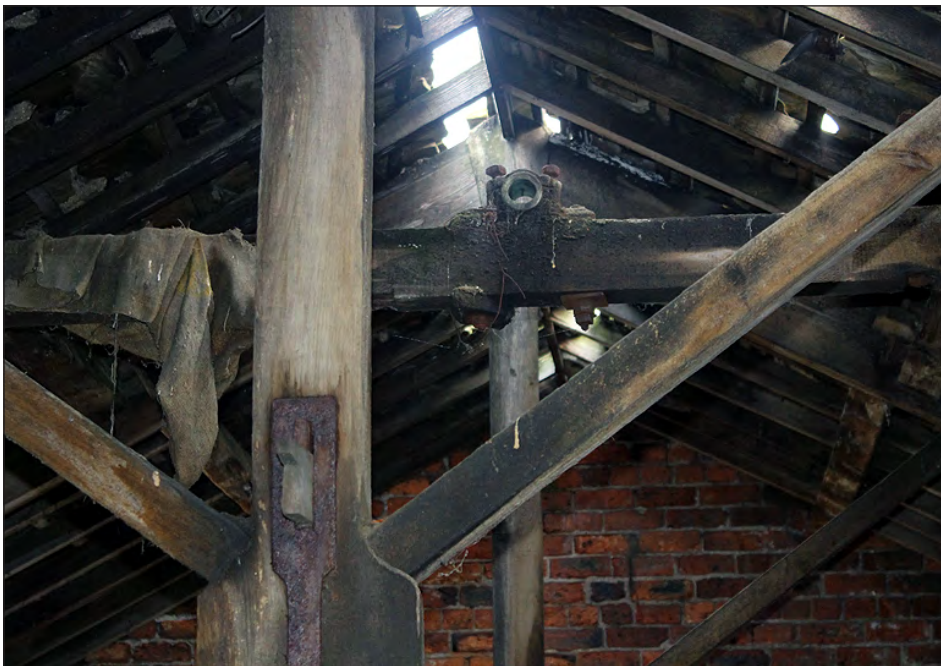
*Plate 146. Building 6, interior. In situ line shaft and wheels. View looking west-southwest*

*Plate 147. Building 6, interior. In situ line shaft and wheels. View looking north-northwest*

The drive shaft (Plates 146 and 147) is supported on a beam attached to the upper side purlins with iron plates and bolts. Presumably the shaft went through a bearing block attached to the upper face of the timber beam, but this was not visible. Centrally located between the two trusses there is an additional beam attached to the upper side purlins with iron plates and bolts. Offset to the south side of the centre of the beam there is a bearing block (Plate 148). Its alignment and size indicates the drive shaft would have extended to the east through the bearing block and continue to the engine determined to have been positioned at the east side of the building on the machine base.

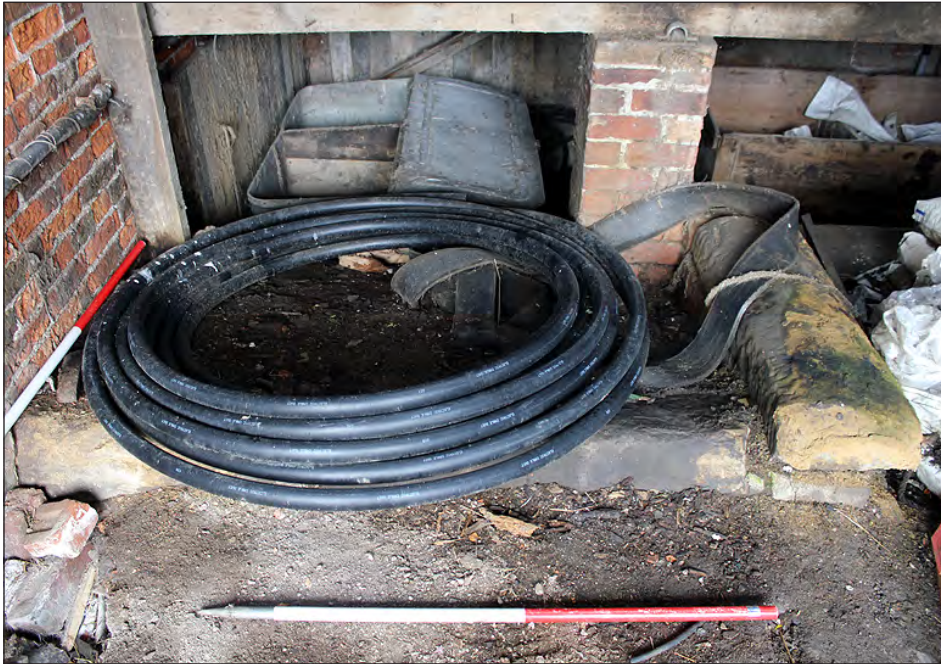
*Plate 148. Building 6, interior. In situ plumbers block bearing for a line shaft, leading to former engine location. View looking northeast*

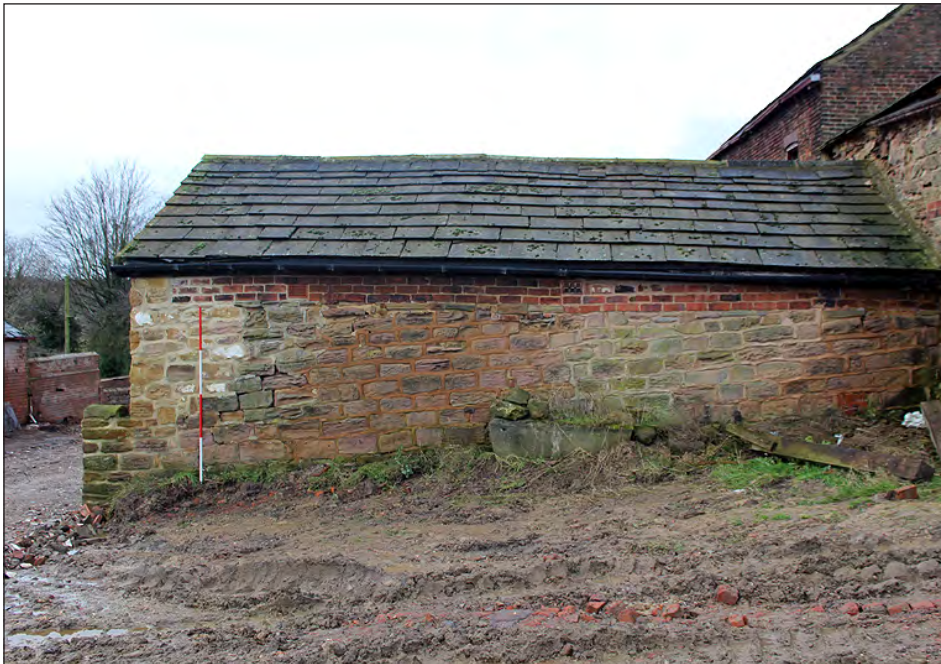
*Plate 149. Building 6, interior. Engine base. View looking southeast*

The floor surface of the ground floor is earthen but possibly overlay a brick or stone surface. The ground gradually sloped to the south. In the southeast corner of the ground floor, directly to the north side of the passageway, there is a stone machine base (Plate 149). The alignment of the base and drive shaft suggest this is the probable location of a portable engine. The base

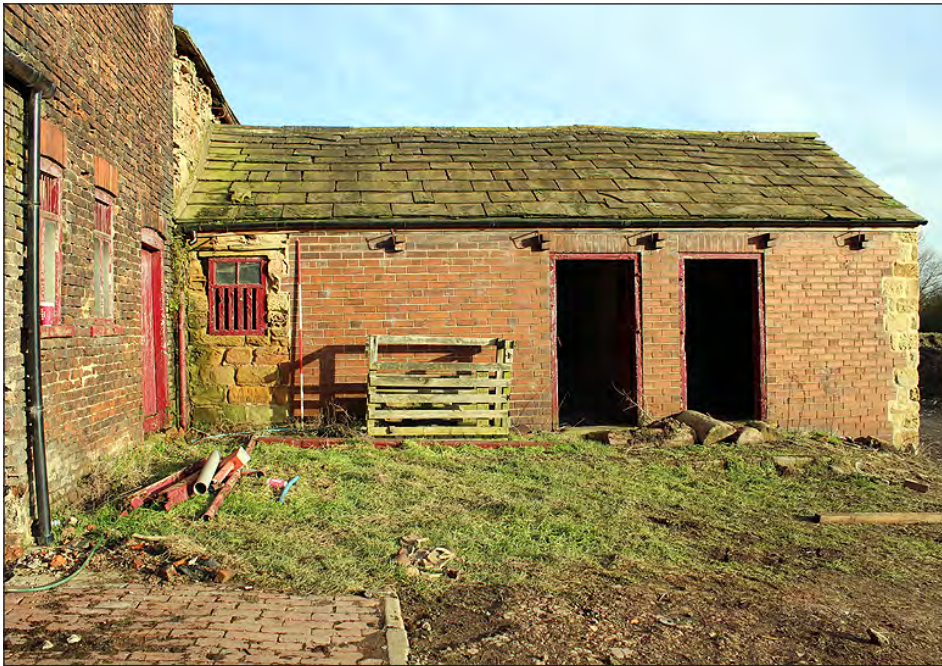
*Plate 152. Building 7. West elevation. View looking east-northeast*

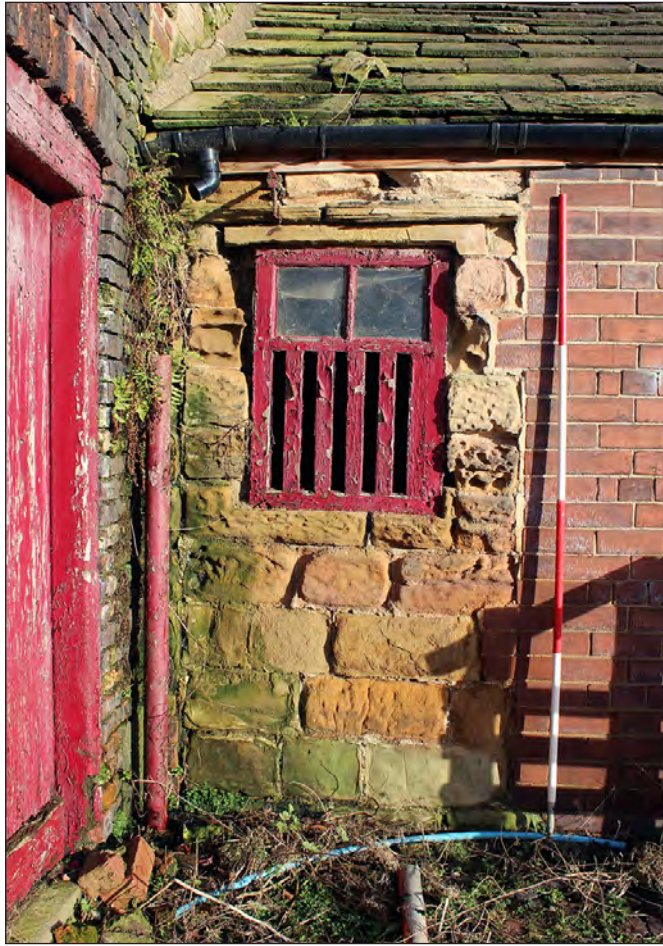
*Plate 153. Building 7. North end of west elevation. View looking east-northeast*

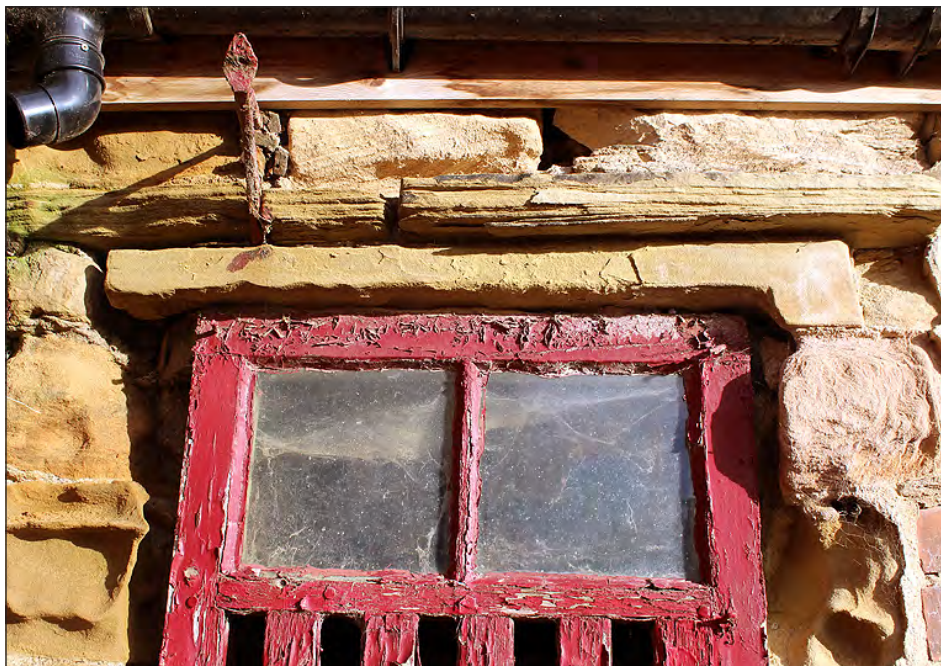
*Plate 154. Building 7. North end of west elevation, showing window detail. View looking east-northeast*

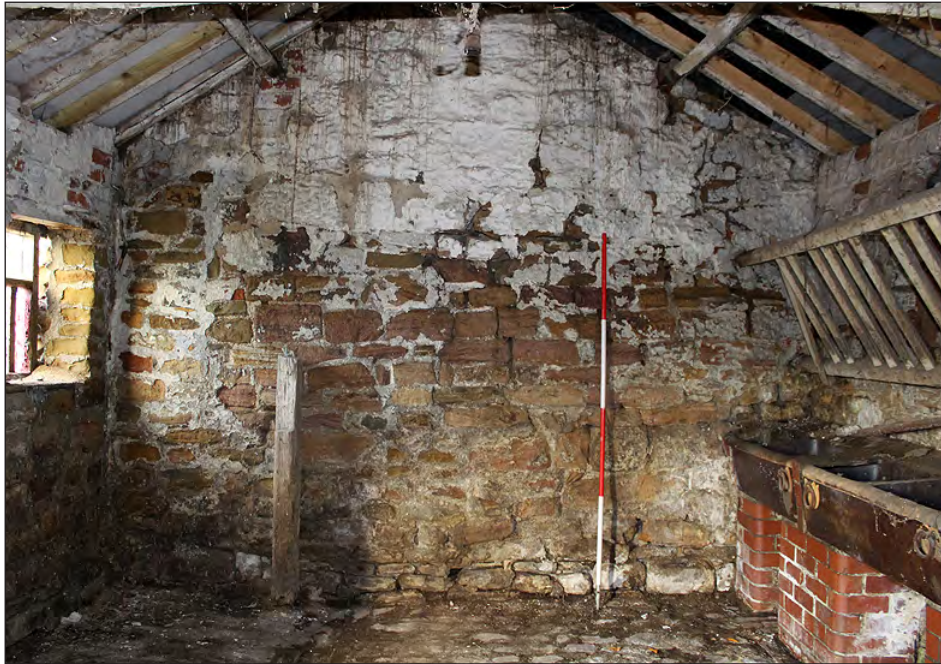
*Plate 155. Building 7, interior. North elevation of north side room. View looking north-northwest*
