**Newsam Green Farm**

**Leeds**

Archaeological Building  
Recording

Report no. 2561  
June 2021

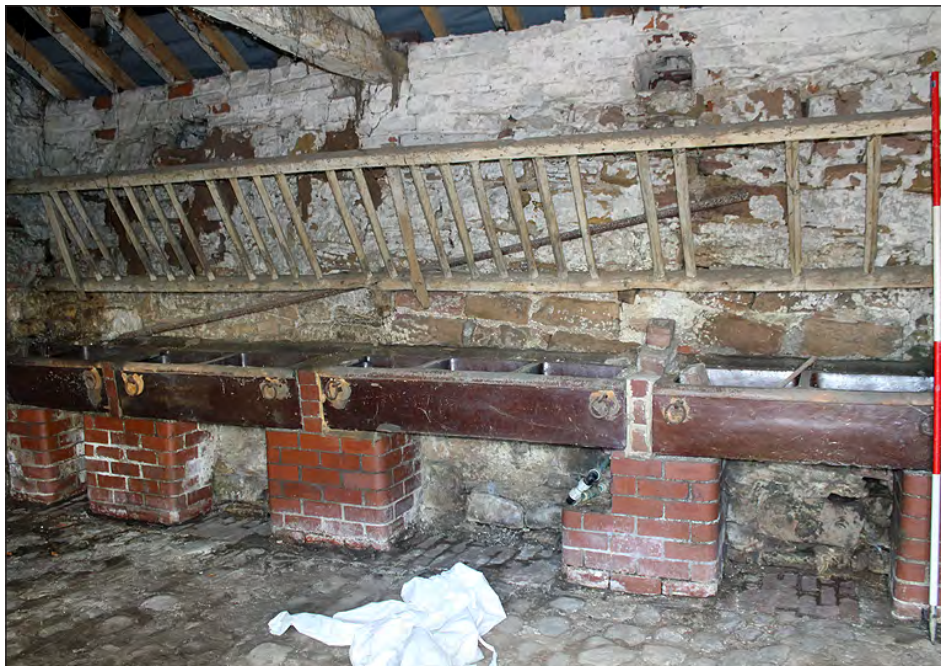
*Plate 156. Building 7, interior. East elevation of the north side room. View looking northeast*

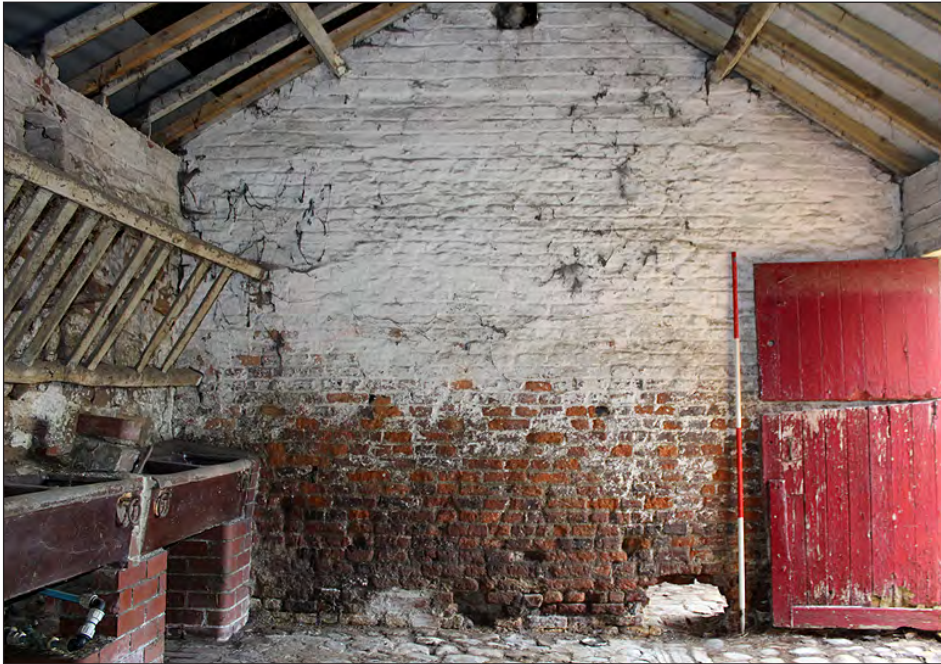
*Plate 157. Building 7, interior. South elevation of the north side room. View looking south-southeast*

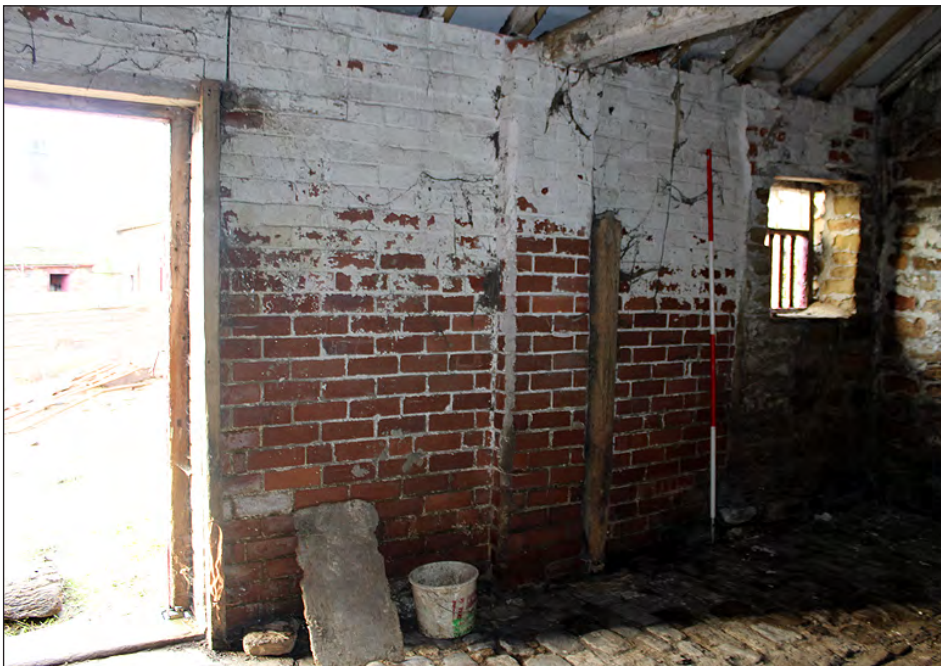
*Plate 158. Building 7, interior. West elevation of the north side room. View looking northwest*

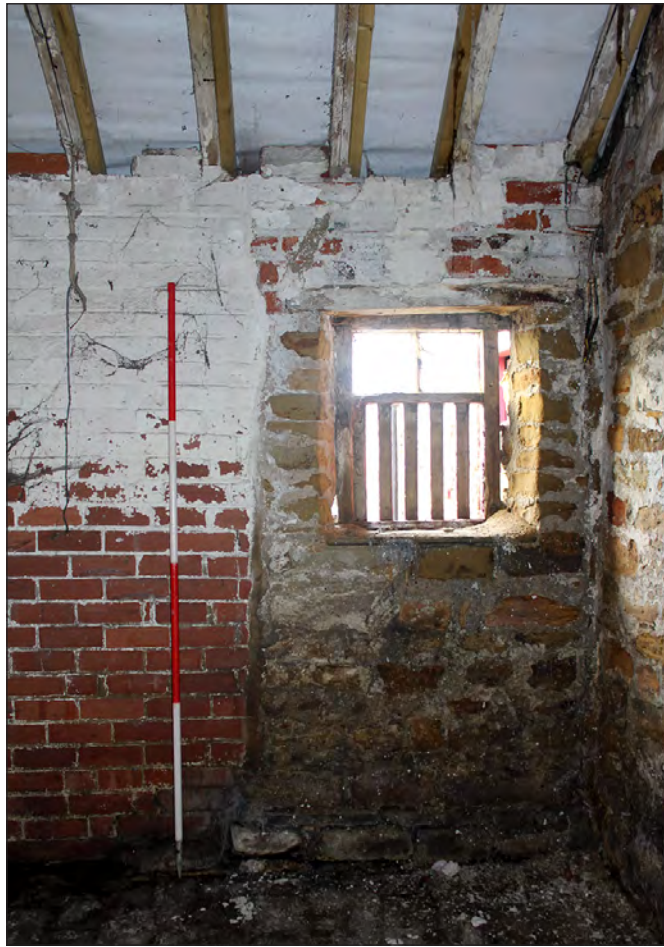
*Plate 159. Building 7, interior. North end of the west elevation of the north side room. View looking west-southwest*

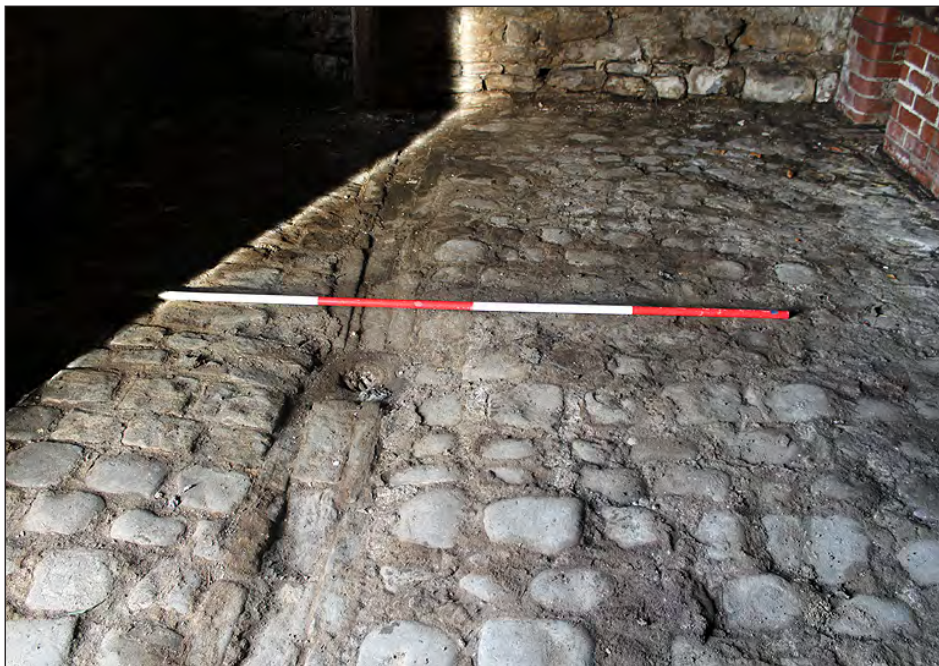
*Plate 160. Building 7, interior. Floor surface of the north side room. View looking north-northwest*

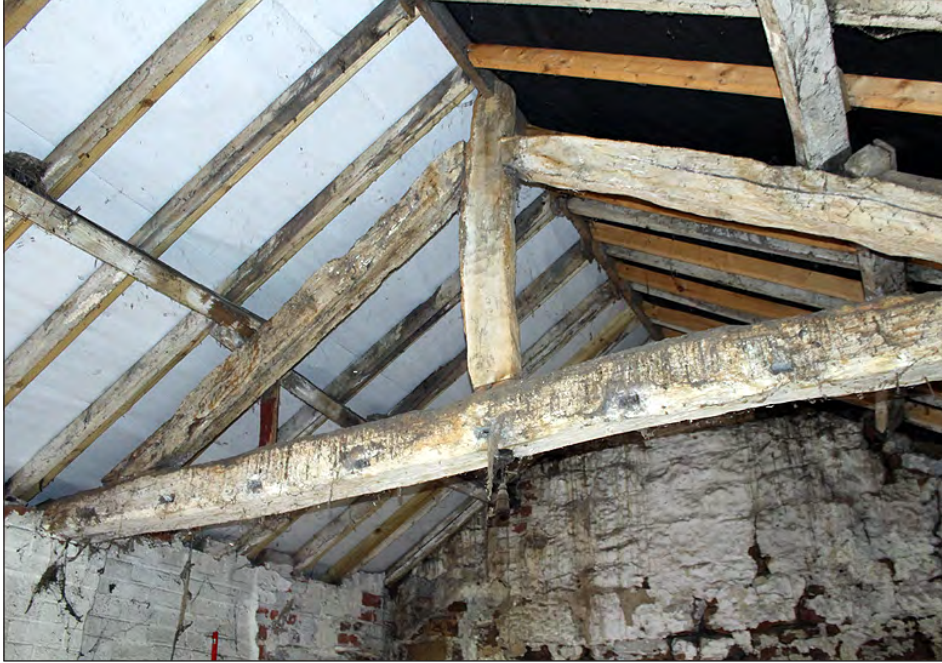
*Plate 161. Building 7, interior. Roof structure of the north side room. View looking northwest*

The roof of the structure (Plate 161) comprises a single King-post truss without struts in the north side room. The truss has been tied into the east side brickwork and rests on top of the west side brick pier. The form of the truss is fairly rudimentary and potentially is original to the stone structure. The tie-beam of the truss has sockets on both its north and south facing sides, indicating the location of ceiling beams. The roof has been repaired in the 19th century and more recently, with the purlins and common rafters reflecting this. The principal rafters and the tie-beam have a mortice and tenon joint with the King-post. There is a single row of side purlins to each side, which rest on top of the principal rafters. The common rafters sit flush on the purlins and rest on east and west elevations.

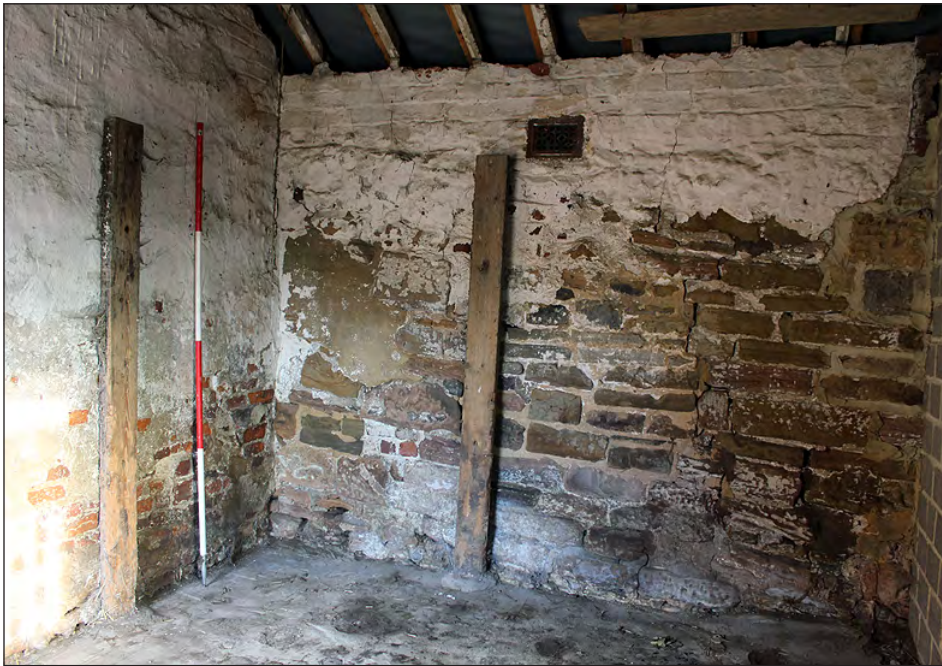
*Plate 162. Building 7, interior. South side room. View looking northeast*

The south side room (Plate 162) had a lime wash finish on its north, east and west walls, which had been rubbed off on the lower sections of the elevations. Remains of the stone sett surface (Plate 163) were visible, but had been covered with a concrete skim on the east side. The stone drain channel identified within the north side room continued into the south.

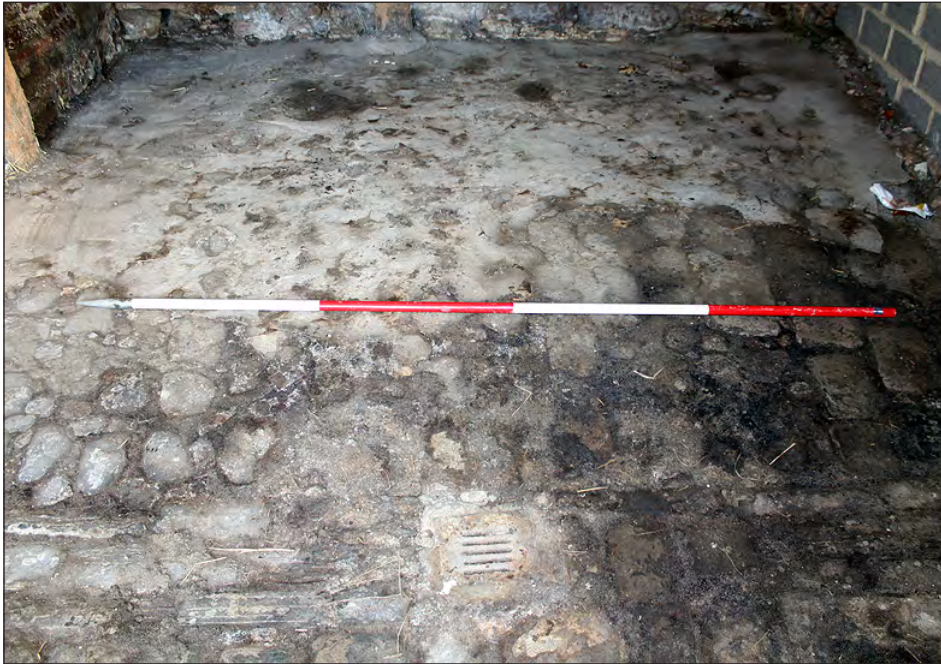
*Plate 163. Building 7, interior. Floor surface of the south side room. View looking east-northeast*

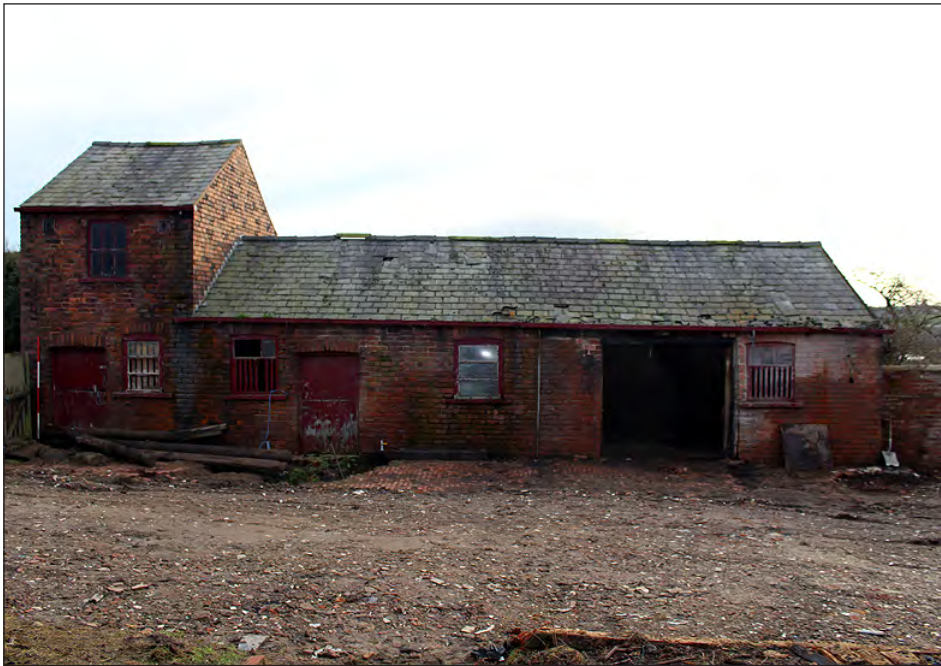
*Plate 164. Building 8. North elevation. View looking south-southeast*

Building 8 (Plate 164) forms the south side of the fold yard and is an east-northeast to west-southwest aligned structure. It is constructed of machine made bricks laid to a six-course Common bond Flemish variant, and has a grey slate roof which appears to be Welsh slate.

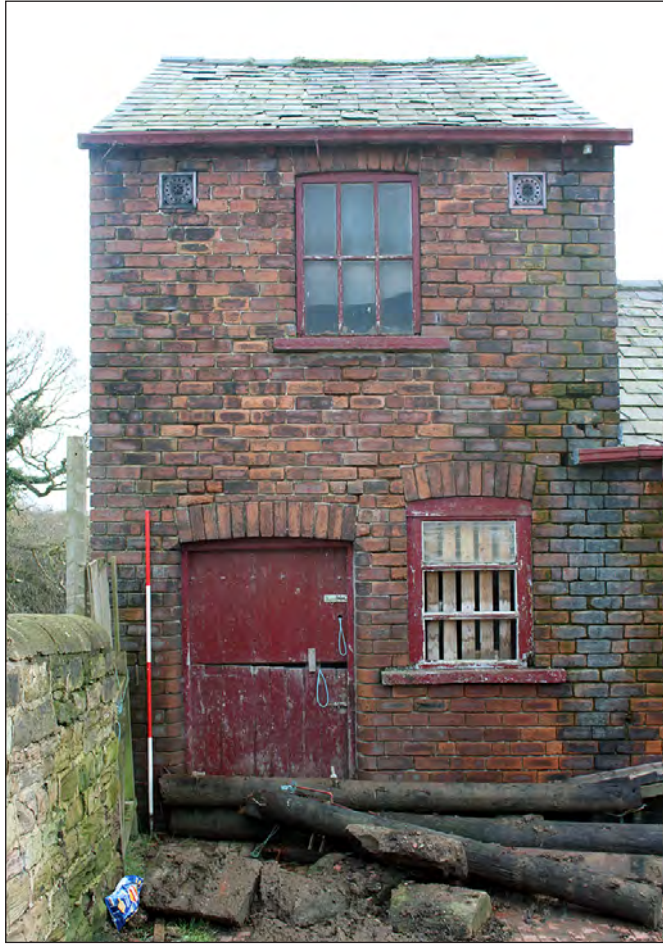
*Plate 165. Building 8. East end of the north elevation. View looking south-southeast*

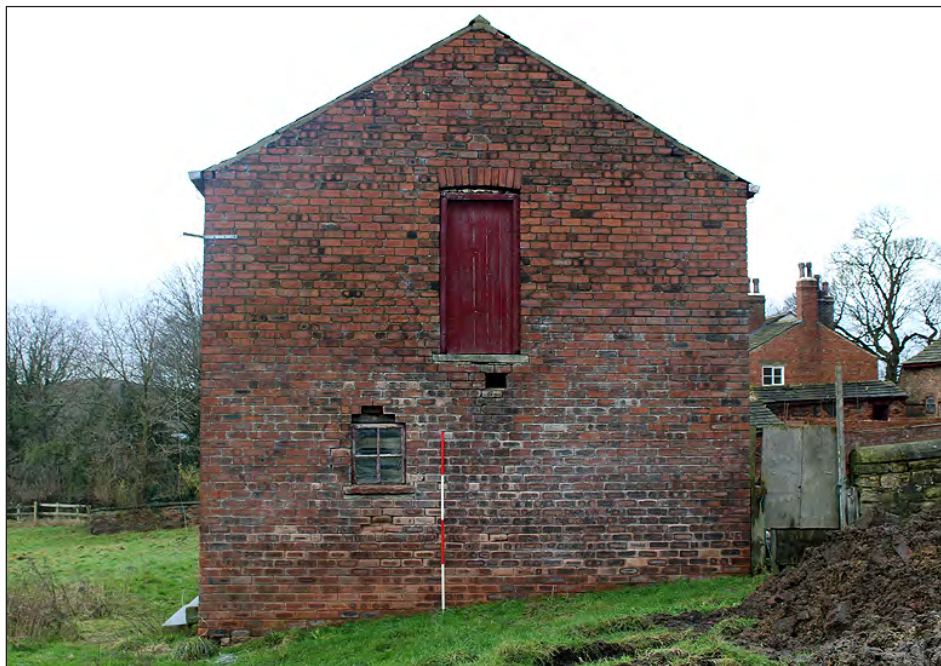
*Plate 166. Building 8. East elevation. View looking west-southwest*

The east gable end elevation (Plate 166) has a centrally located taking-in door at first floor level. The opening has a cambered brick arch and a plank and batten door is hung here. At ground floor level there is a small window, off-set from centre to the south, and appears to be a later insertion. The opening is fitted with a four light window set in a timber frame.

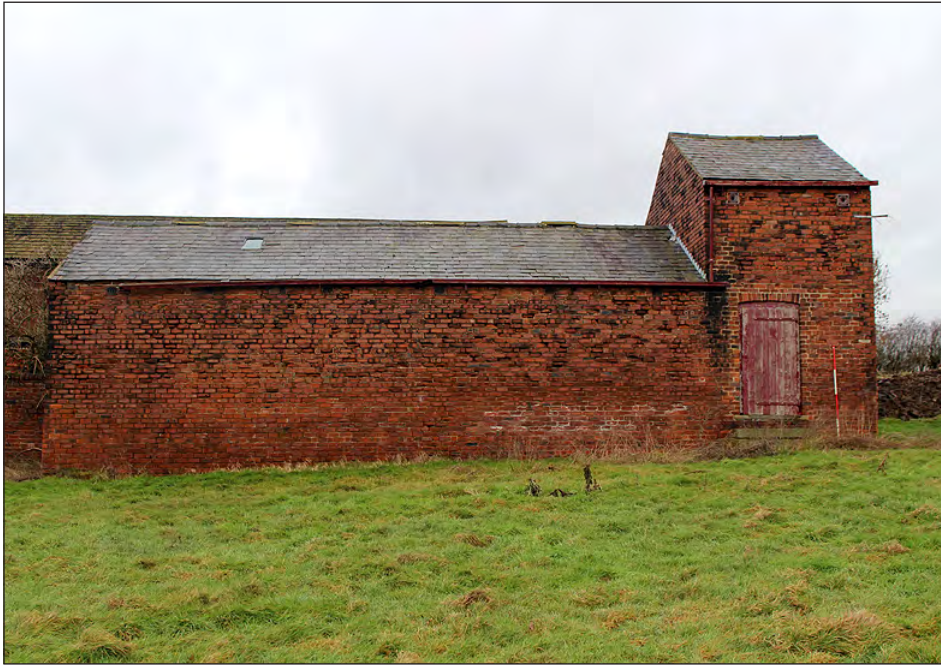
*Plate 167. Building 8. South elevation. View looking north-northwest*

The south elevation (Plates 167 and 168) has a stone plinth (Plate 169) underlying the brickwork, which likely continues around the whole base of the structure. The elevation appears to have not had any openings originally, and the only features would have comprised two glazed square airbricks (Plate 170) towards the top of the two storey section of the elevation. There is a later inserted doorway located at the east end within the two storey element of the structure, which is accessed via two stone steps (Plate 171). The opening has a flat cambered arch and the opening is fitted with a plank and batten door with the strap hinges positioned on the exterior side.

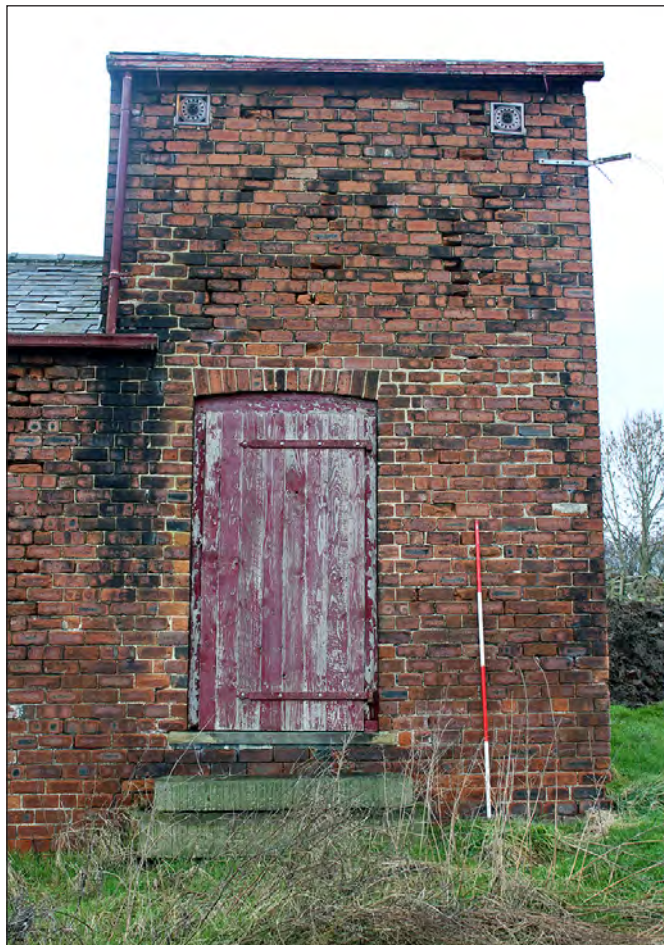
*Plate 168. Building 8. East end of the south elevation. View looking north-northwest*

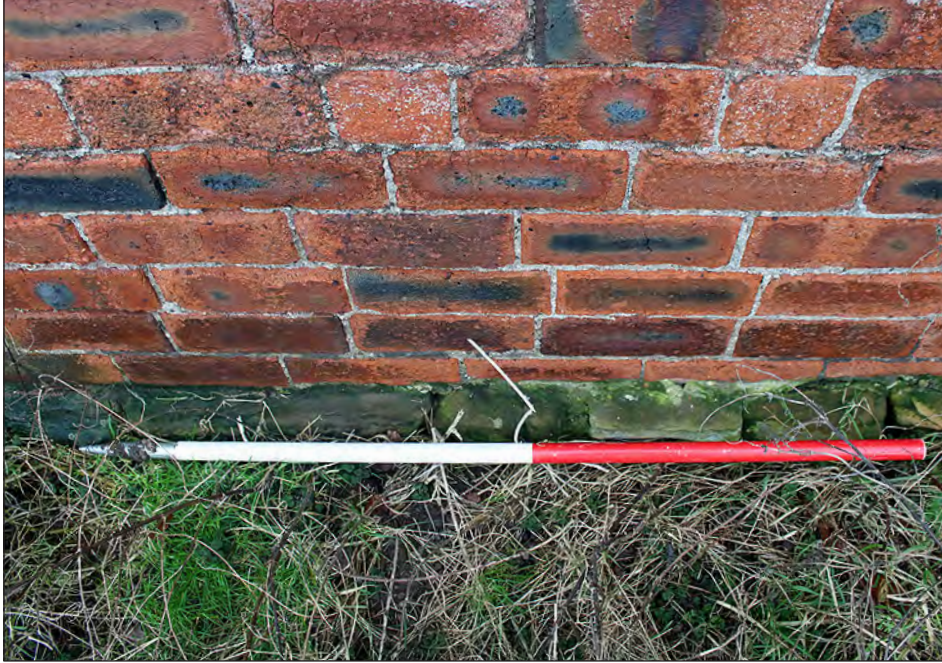
*Plate 169. Building 8. South elevation, showing stone plinth. View looking north-northwest*

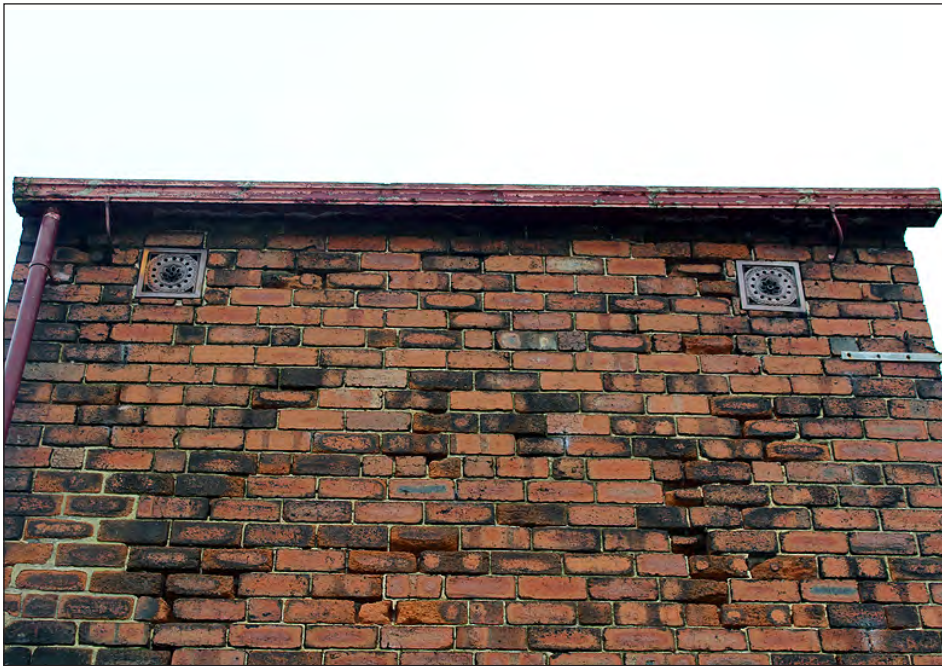
*Plate 170. Building 8. South elevation, showing ceramic air brick vents. View looking north-northwest*

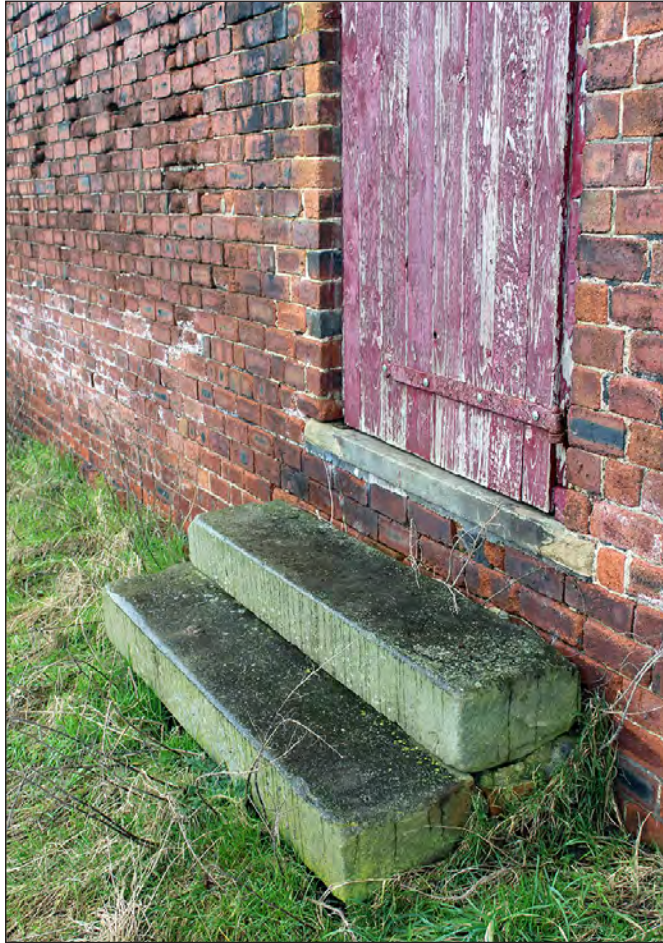
*Plate 171. Building 8. South elevation, stone steps. View looking northwest*

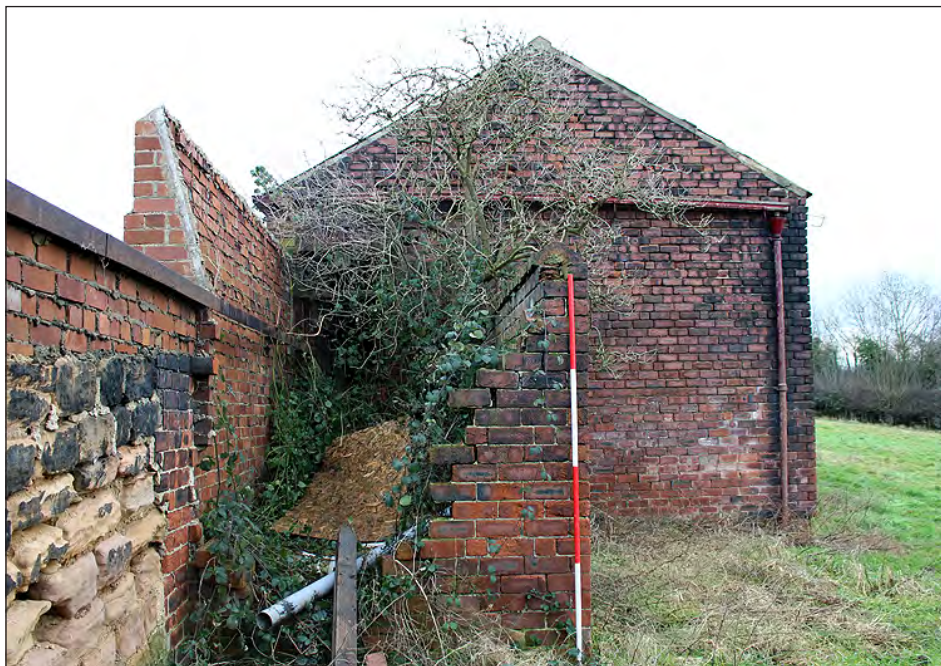
*Plate 172. Building 8. West elevation. View looking east-northeast*

The west gable end elevation (Plate 170) has a doorway located at the north end, which appears to be original. Located to the south side of the doorway there is a high L-shape wall (Plate 172) which appears contemporary with the structure. The wall is capped with humped bricks and marks the former location of the south boundary of the fold yard. The west end return of the wall has collapsed or been knocked through. Directly to the north a later secondary boundary wall of the fold yard has been constructed, forming a rectangular shaped enclosed space between the two walls, which does not appear to have been roofed over at any time.

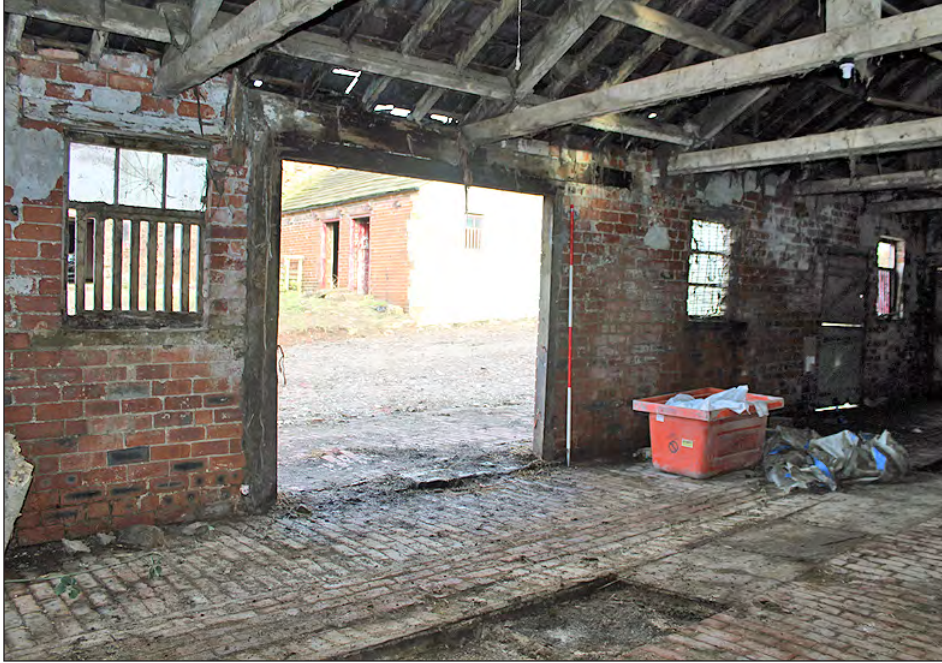
*Plate 173. Building 8, interior. North elevation of the west side room. View looking northeast*

The west side interior (Plates 173 and 174) comprises a large open space utilised as a cow house. The brick walls have a degraded lime wash finish (Plate 175). The east partition wall of the room has a doorway located at the north and south end (Plate 176) both of which are original. Scaring on the floor and the east and west walls indicate the location of a low trough with a feeding passage located along the south wall of the room (Plate 177). Above the trough scaring sockets for a timber manger structure (Plate 178) can be seen on the east and west elevation. The doorway located at the north end of the west elevation now leads to an enclosed space (Plate 179), which formerly was part of the fold yard where it formed a walled lobby with an entrance to the cow house which was later separated from the yard by a wall on its north side. The floor (Plate 180) of the room comprises brickwork lain on the animal housing side and flagstones are lain along the feeding passage.

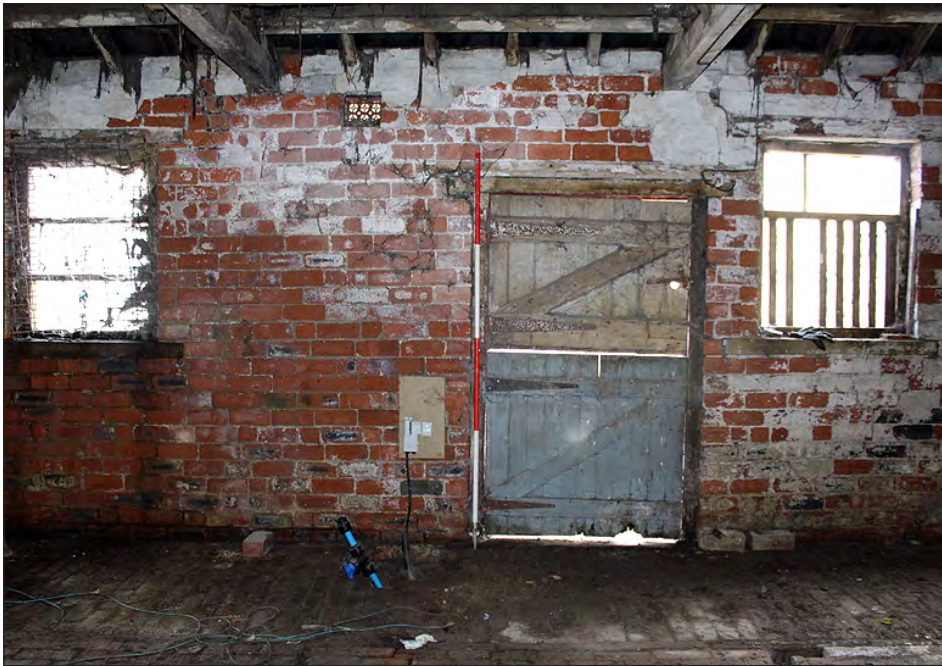
*Plate 174. Building 8, interior. East end of the north elevation of the west side room. View looking north-northwest*

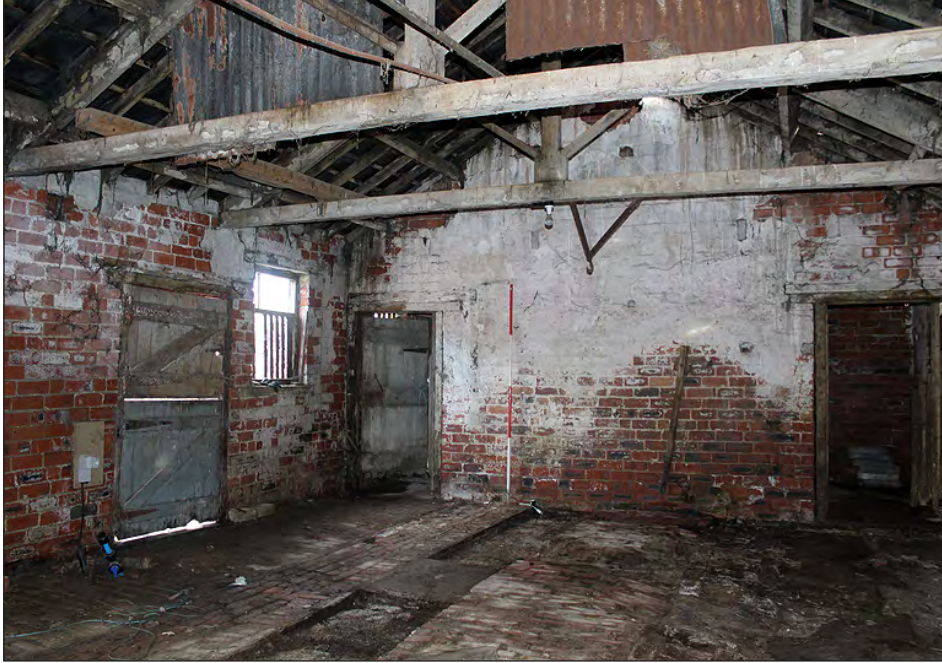
*Plate 175. Building 8, interior. North and east elevations of the west side room. View looking northeast*

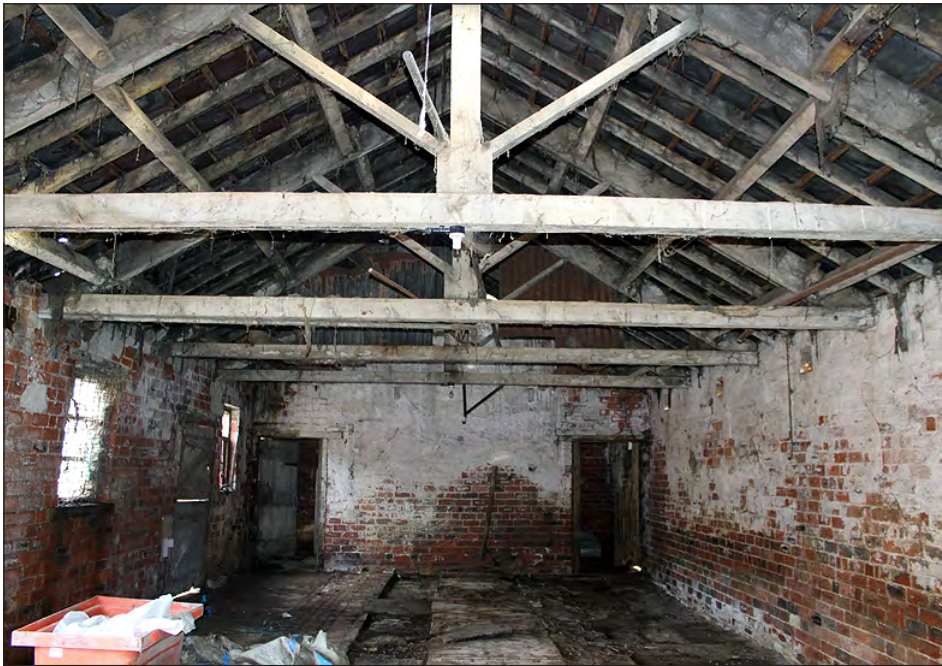
*Plate 176. Building 8, interior. East elevation of the west side room. View looking east-northeast*

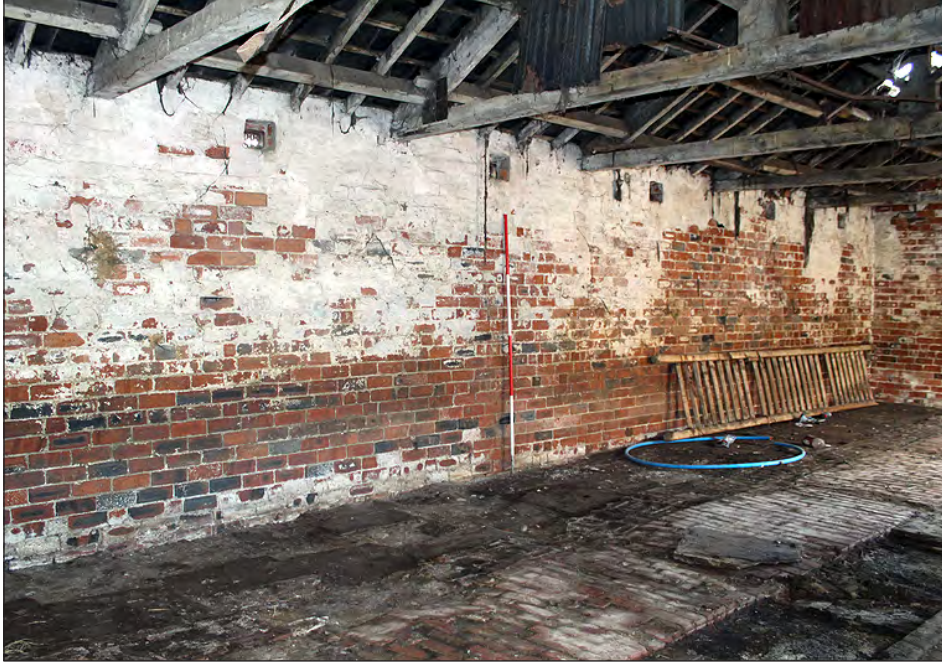
*Plate 177. Building 8, interior. South elevation of the west side room. View looking southwest*

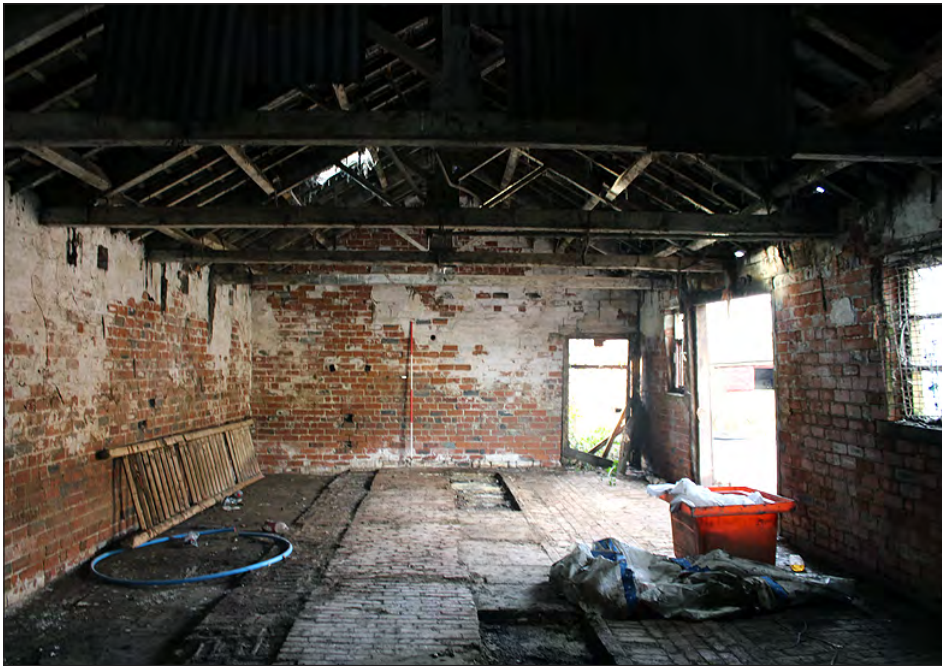
*Plate 178. Building 8, interior. West elevation of the west side room. View looking west*

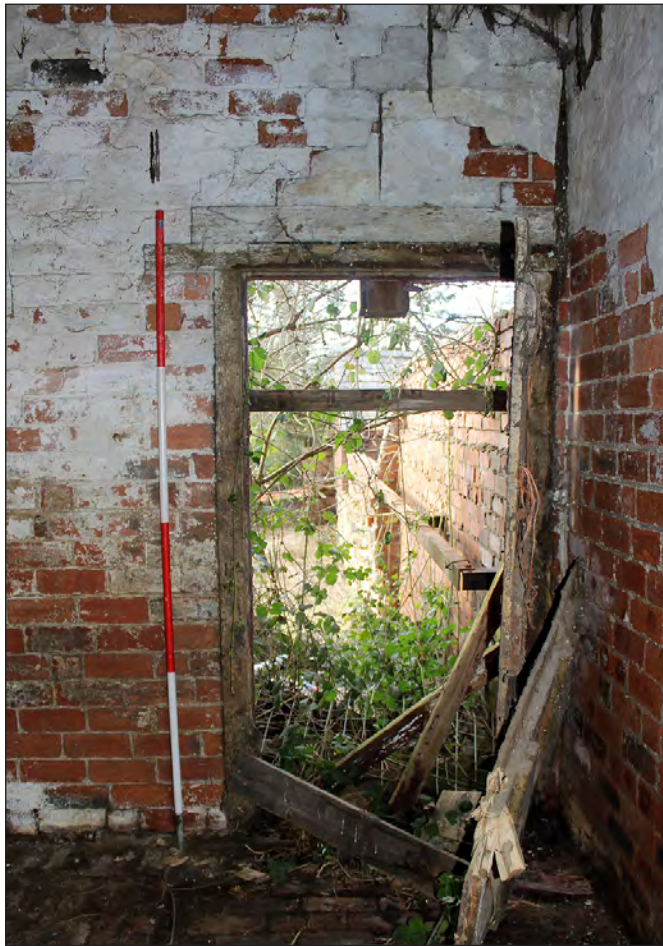
*Plate 179. Building 8, interior. West elevation of the west side room, showing doorway. View looking west-southwest*

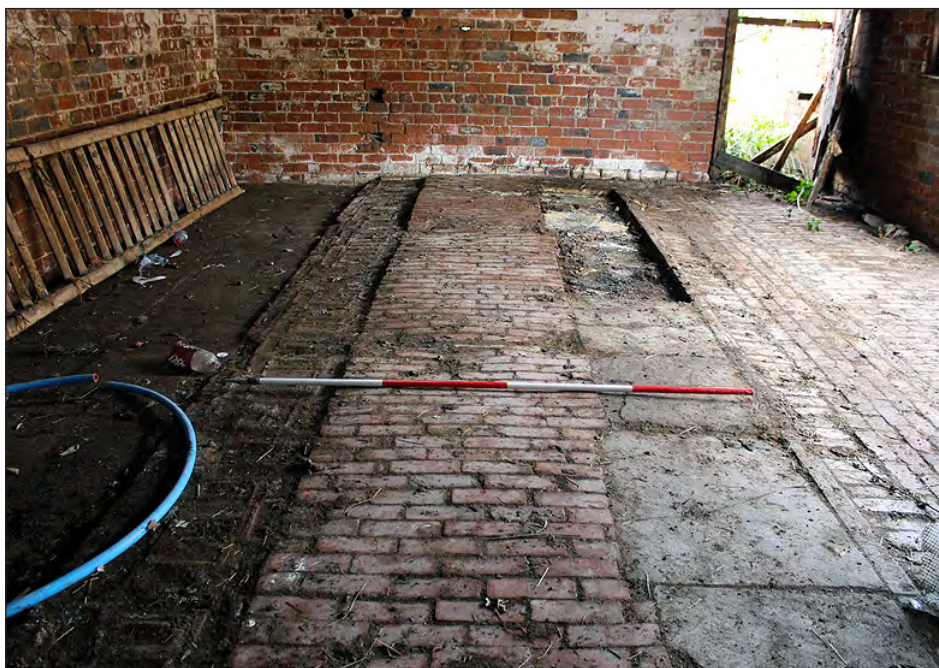
*Plate 180. Building 8, interior. Floor surface of the west side room. View looking west-southwest*

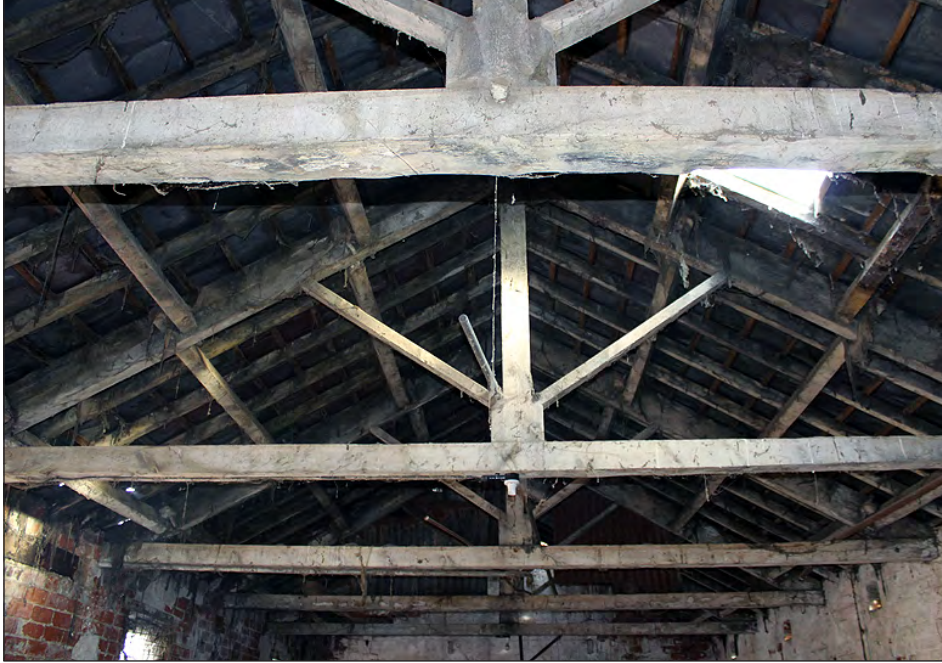
*Plate 181. Building 8, interior. Roof structure of the west side room. View looking east-northeast*

The roof structure of the west side room comprises five bays formed by four King-post trusses. The trusses are tied into the north and south elevations, the principal rafters and the tie-beams have a mortice and tenon joint with the King-posts. The struts have a mortice and tenon joint with the King-posts, and a mortice and tenon joint with the principal rafters. There are three rows of side purlins to each side, which pass through the principal rafters with a pegged mortice and tenon joint (Plate 181). The common rafters sit flush on the purlins and are tied into the brickwork of the north and south elevations. Each truss has been incised at the base of the King-post joint and adjoining pieces with Roman numerals (east to west).

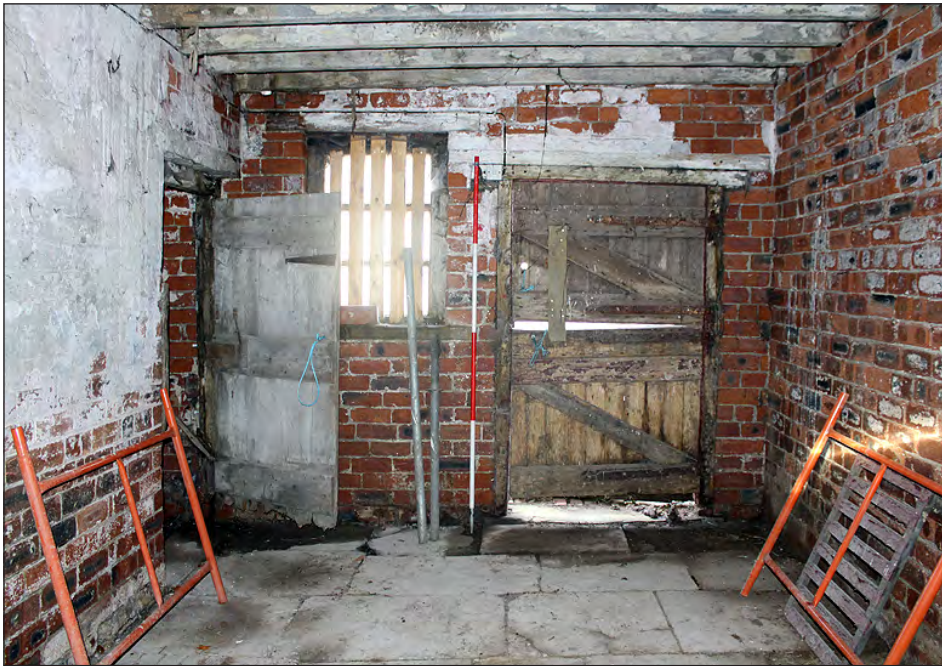
*Plate 182. Building 8, interior. North elevation of the ground floor east side room. View looking north-northwest*

The ground floor room (Plates 182 to 184) of the two storey structure has a degraded lime wash finish. Against the South elevation there is a pine Jacob's ladder (Plate 185) leading to the first floor hayloft. Attached to the west partition wall (Plate 186) of the room there appears to be a small patress plate, which may be an anchor point for a machine, but this was not clear. The floor (Plates 187 and 188) of the room is constructed of flagstones, and there was an area of brickwork against the west partition wall which appears to form the base (Plate 189) for a machine. The ceiling (Plate 190) appears original to the construction of the building and comprises tightly lain floorboards over joists. The purpose of the room was not clear, but potentially was used as a feed store.

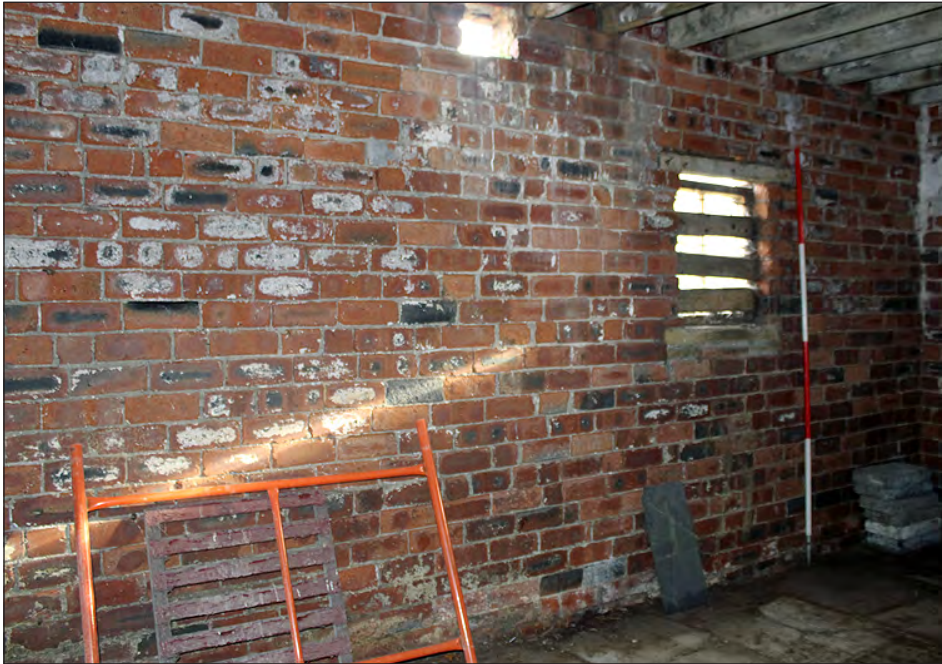
*Plate 183. Building 8, interior. East elevation of the ground floor east side room. View looking northeast*

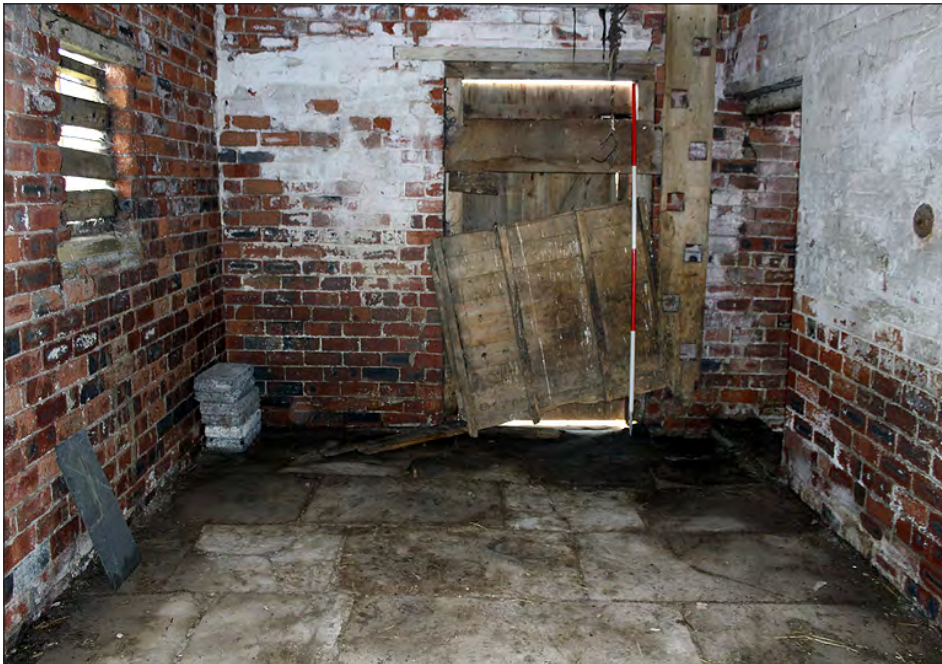
*Plate 184. Building 8, interior. South elevation of the ground floor east side room. View looking south-southeast*

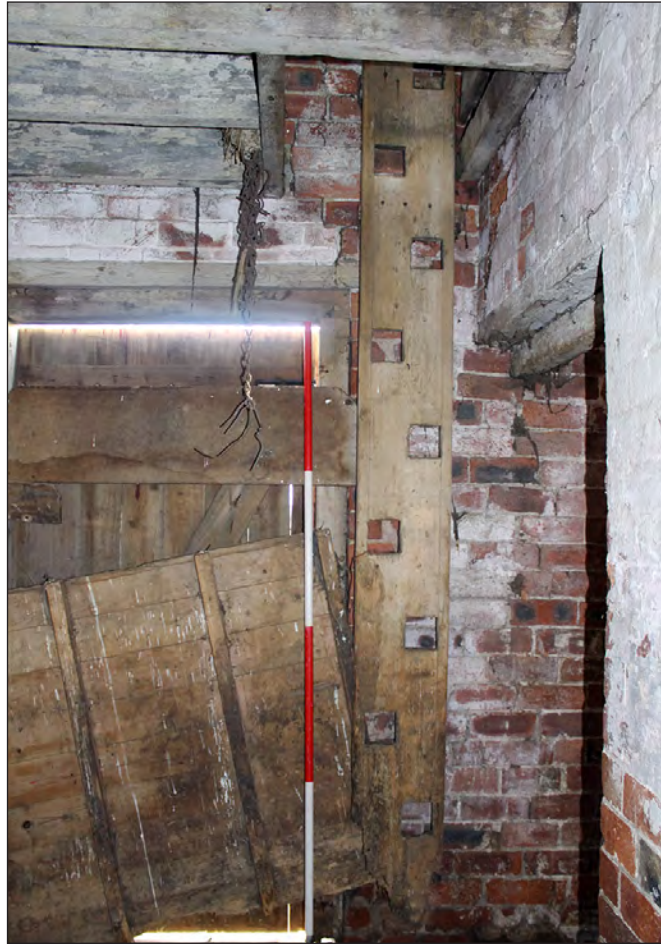
*Plate 185. Building 8, interior. South elevation of the ground floor east side room, showing Jacob's ladder. View looking south-southeast*

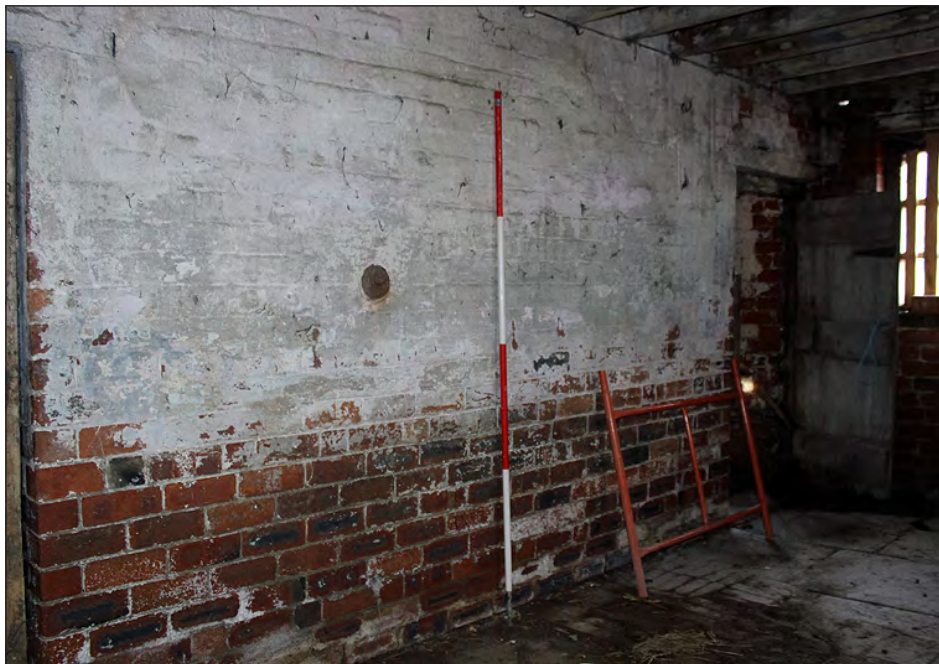
*Plate 186. Building 8, interior. West elevation of the ground floor east side room. View looking northwest*

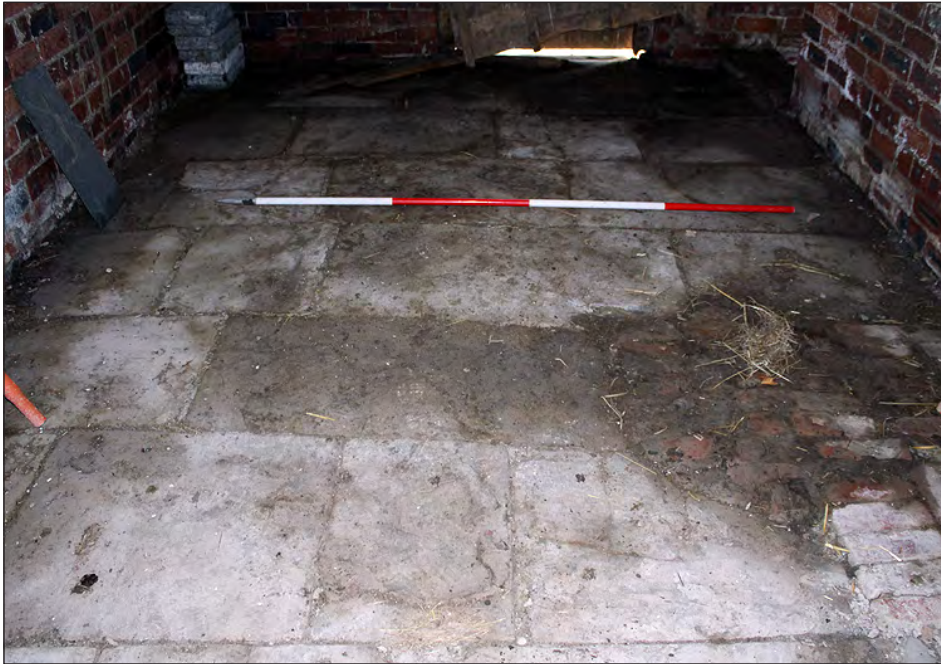
*Plate 187. Building 8, interior. Floor surface of the east side room. View looking south-southeast*

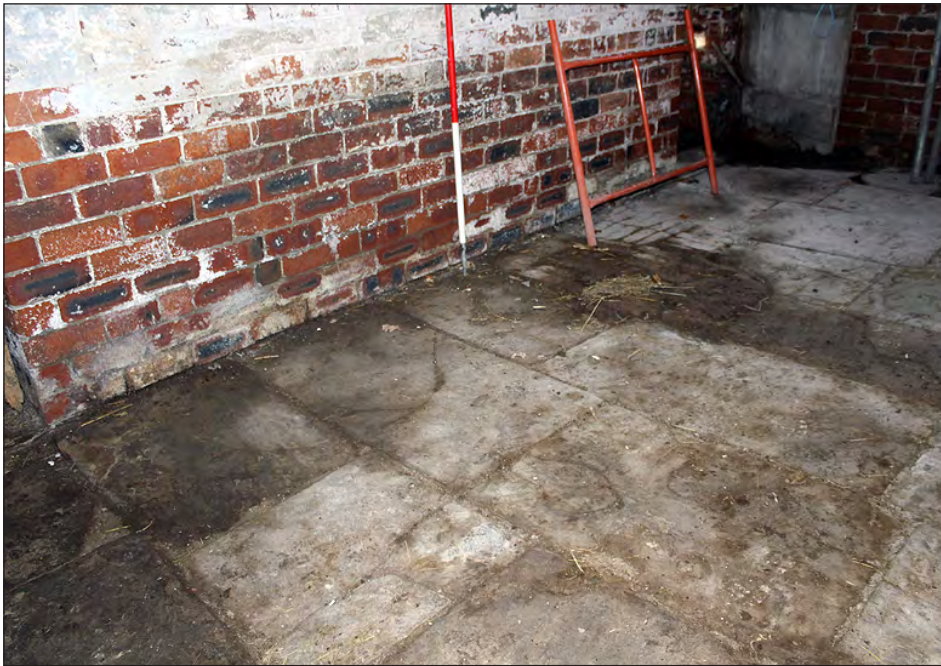
*Plate 188. Building 8, interior. Floor surface of the east side room. View looking northwest*
