**Newsam Green Farm**

**Leeds**

Archaeological Building  
Recording

Report no. 2561  
June 2021

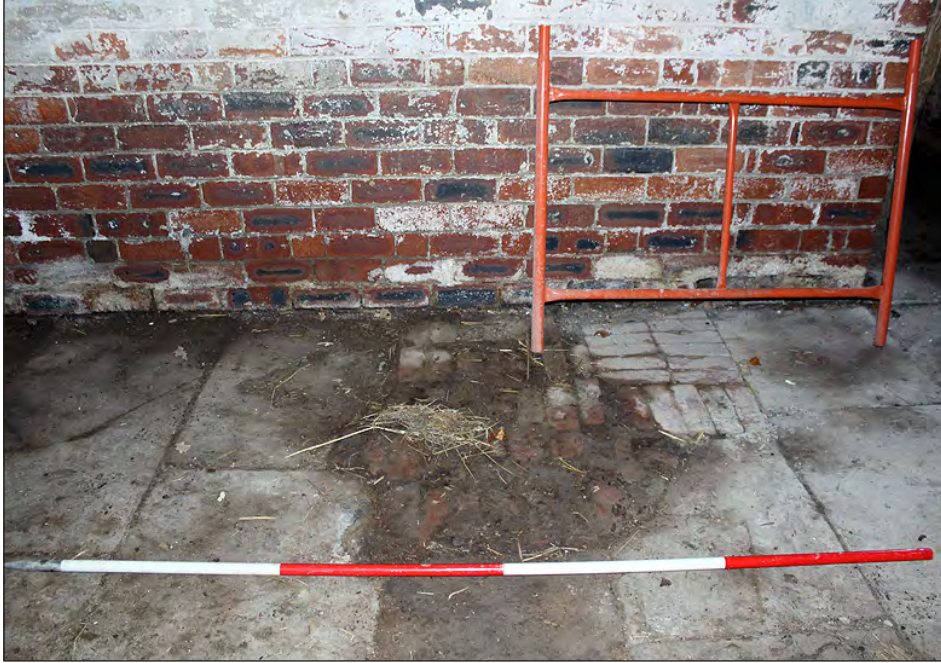
*Plate 189. Building 8, interior. Floor surface of the east side room, showing probable brick machine base. View looking west-southwest*

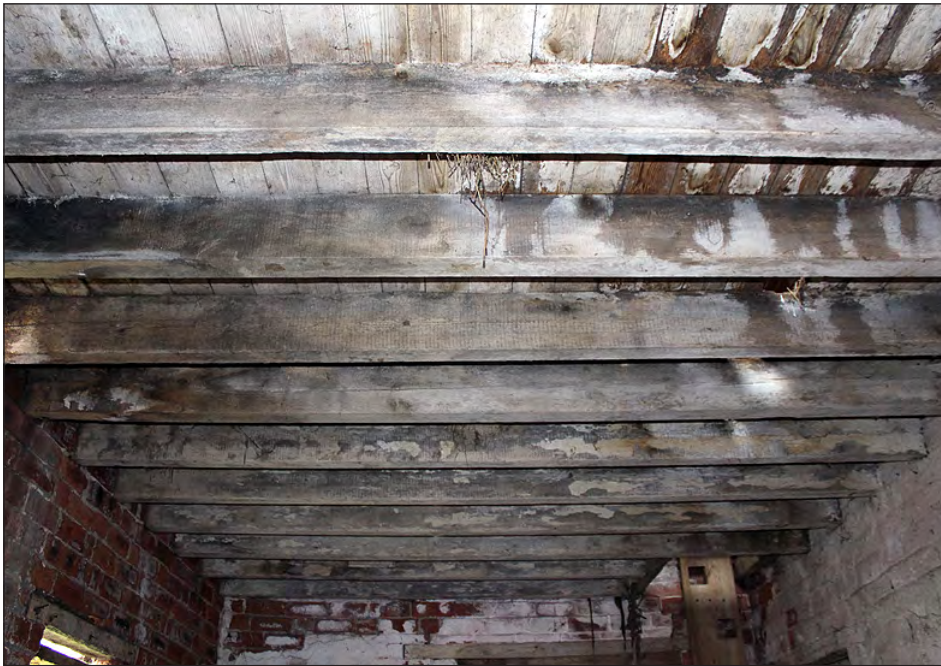
*Plate 190. Building 8, interior. Ceiling of the east side room. View looking south-southeast*

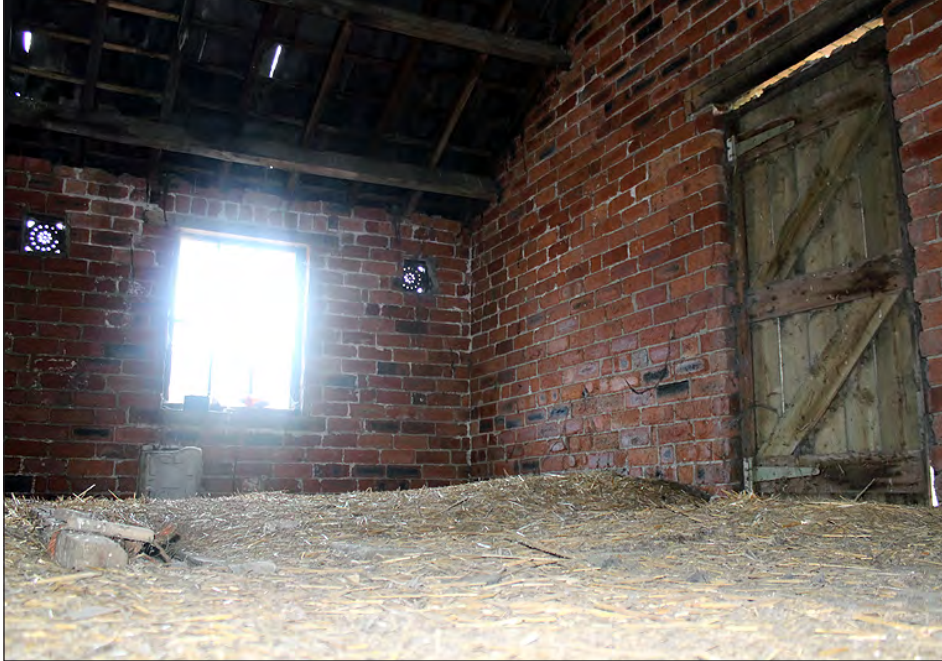
*Plate 191. Building 8, interior. First floor of the east side room. View looking north*

The first floor room (Plate 191) is open to the rafters. The walls did not have a lime wash finish and the room appears to have functioned as a hayloft. Hinges on the east side taking-in door (Plate 192) indicate the doorway is a later replacement. The roof structure of the two storey structure comprises three side purlins which are tied into the east and west walls. The common rafters sit flush on the purlins and are tied into the brickwork of the north and south elevations.

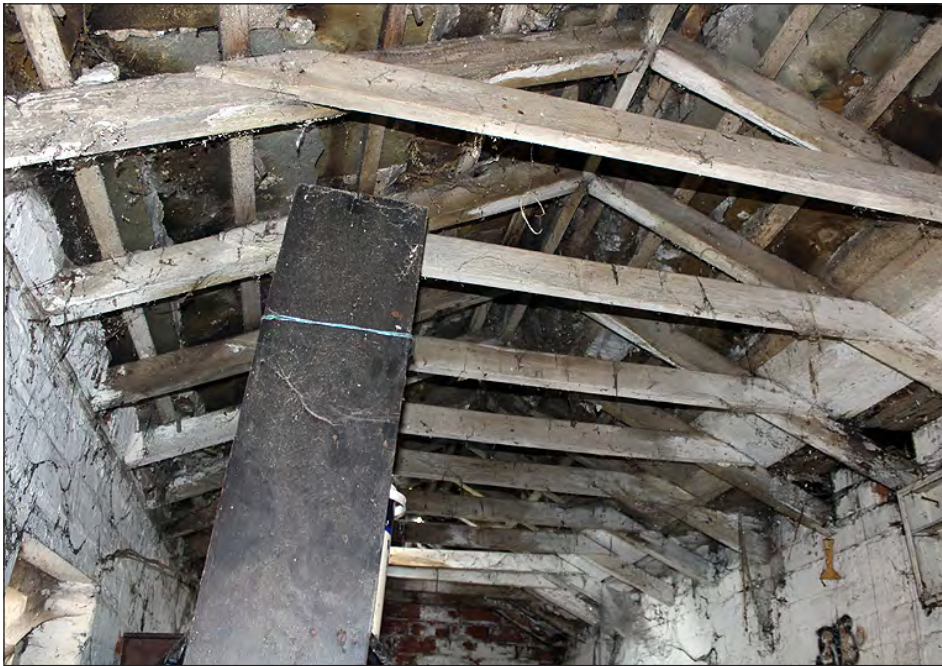
*Plate 232. Building 11, interior. First floor roof structure. View looking south-southeast*

The first floor room (Plates 230 and 231) comprises a single room open to the rafters. The walls of the room had a painted lime wash finish. The floor of the room is constructed of floorboards which appeared contemporary with the alterations to the building. The roof (Plate 232) structure appears early 20th century in date and comprises rows of common rafters braced with a high collar. The common rafters are tied into the east and west elevations.

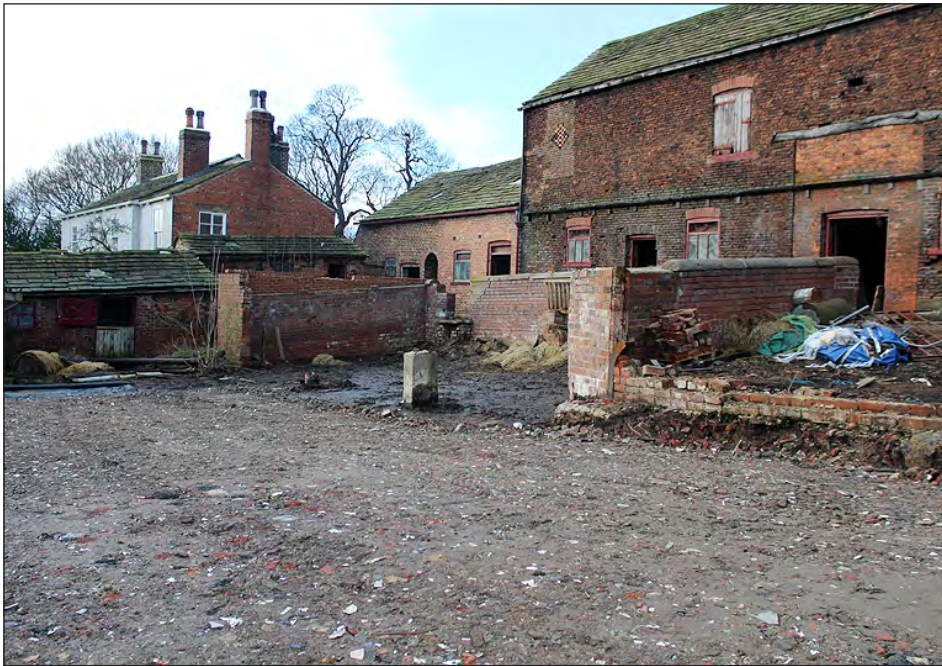
*Plate 234. General view of the yard. View looking west*

The fold yard (Plate 234) of the farmstead appears to have originally gradually sloped from the principal barn range on the north side down to the south side and was later stepped when a secondary smaller enclosed yard area was constructed in the early 20th century. Within this lowered area, the yard surface comprises stone setts (Plate 235). Stone setts are also present to the front sides of Buildings 9 and 10 (Plate 236). Brick had been utilised along the yard frontage of Building 8 (Plates 237 and 238), and is contemporary with the late 19th-century structure. Along the west side of Building 7 a raised causeway (Plate 239) constructed of stone setts is present, and along the east side of the principal barn range there is a brick built causeway (Plates 240 and 241) which appears to be late 19th century in date.

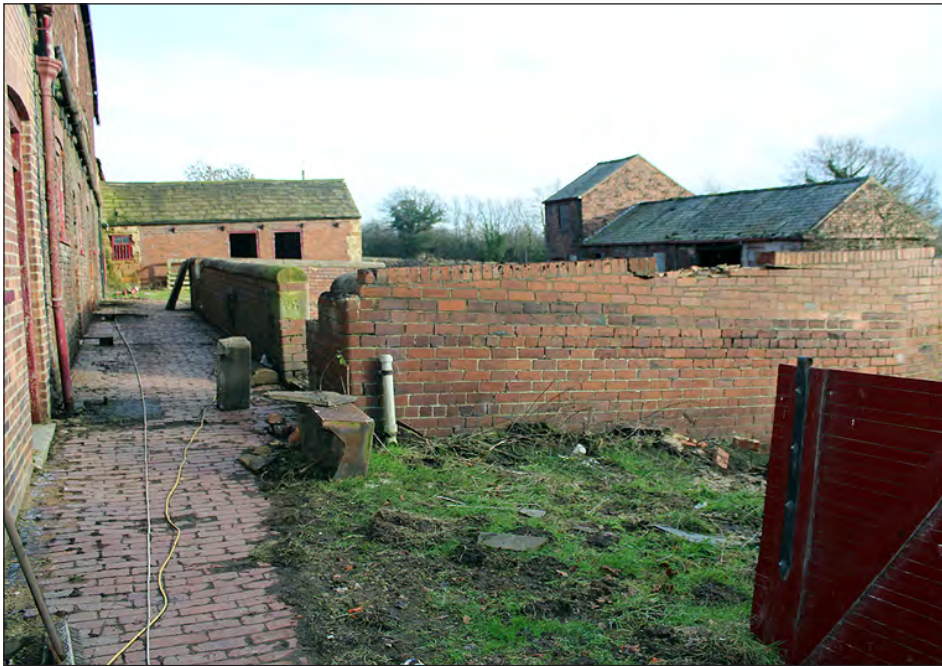
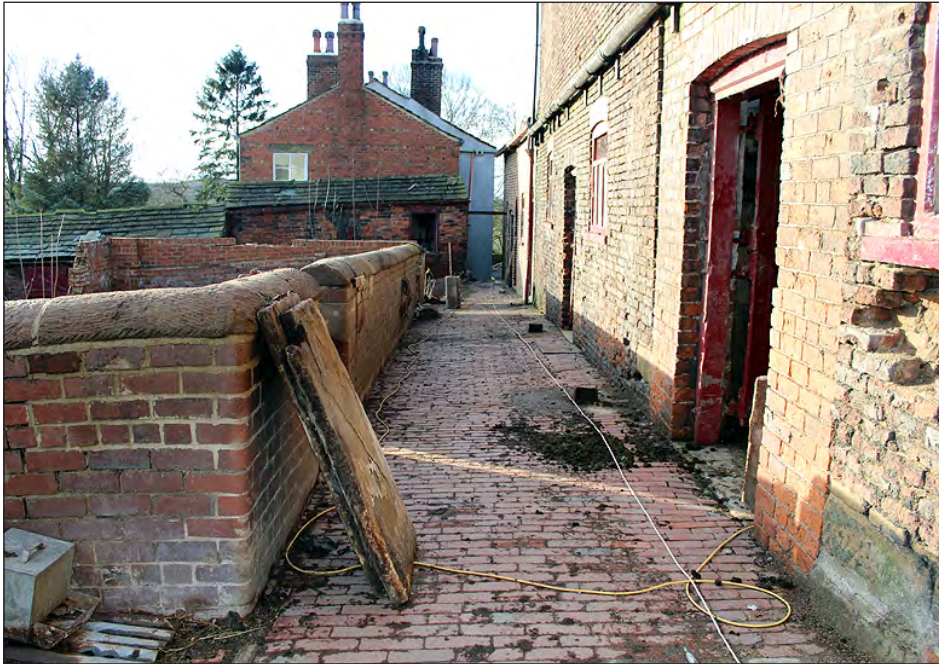
*Plate 240. Causeway along south side of Buildings 4, 5 and 6. View looking east-northeast*

*Plate 241. Causeway along south side of Buildings 4, 5 and 6. View looking west-southwest*

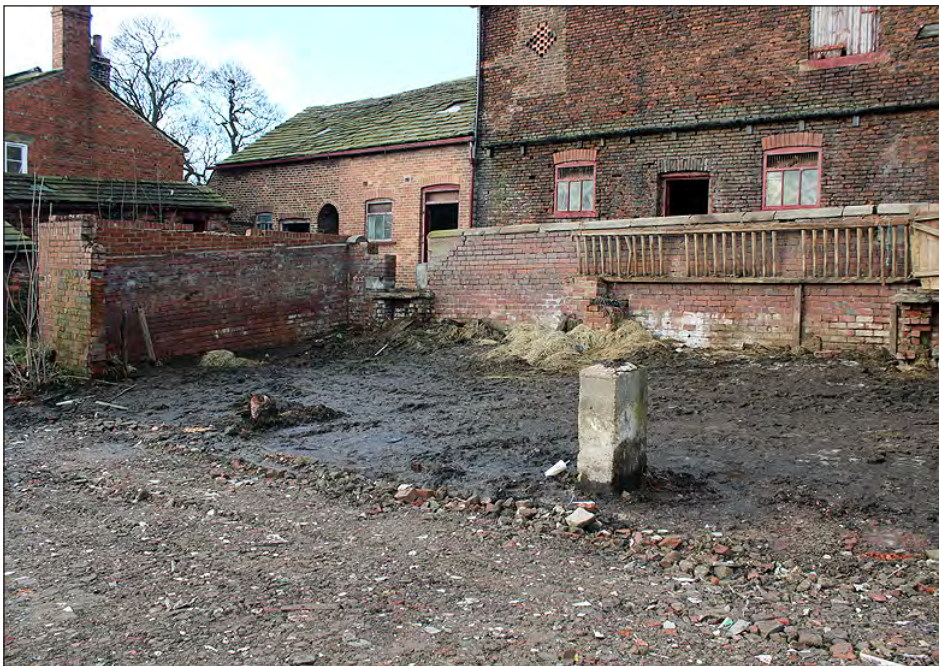
*Plate 242. Former location of shed within yard. View looking northwest*

Within the yard area there is an early 20th-century walled enclosure (Plate 242). It is U-shape in plan and is open on its south side and presumably was gated. The wall is constructed of machine made bricks lain to a six-course Common bond and is capped with a semi-circular capping stone. The north wall (Plate 243) of the enclosed space has a gated entrance at the east and west end, where scaring indicates a short flight of steps were formerly positioned at each gate allowing access down into the enclosed yard space which is stepped down from the causeway along the front of the principal barn range. Remnants of a timber hayrack are also present along the elevation. The east elevation (Plate 244) of the enclosed yard has been repaired and a return wall (Plate 245) extending to the east is now present. It is constructed of machine made bricks of a later 20th-century date.

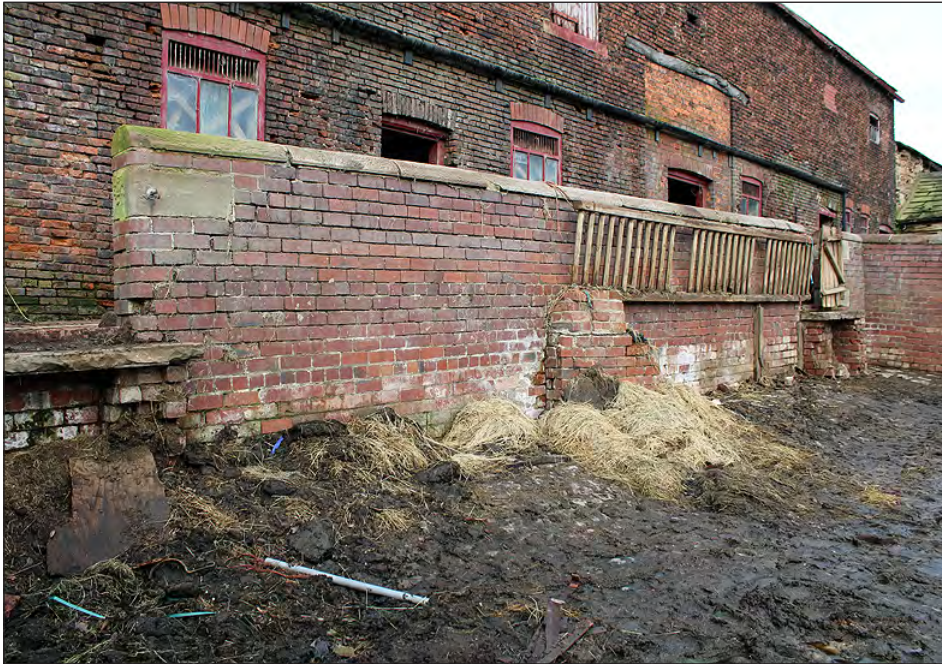
*Plate 243. North wall of former shed within yard. View looking northeast*

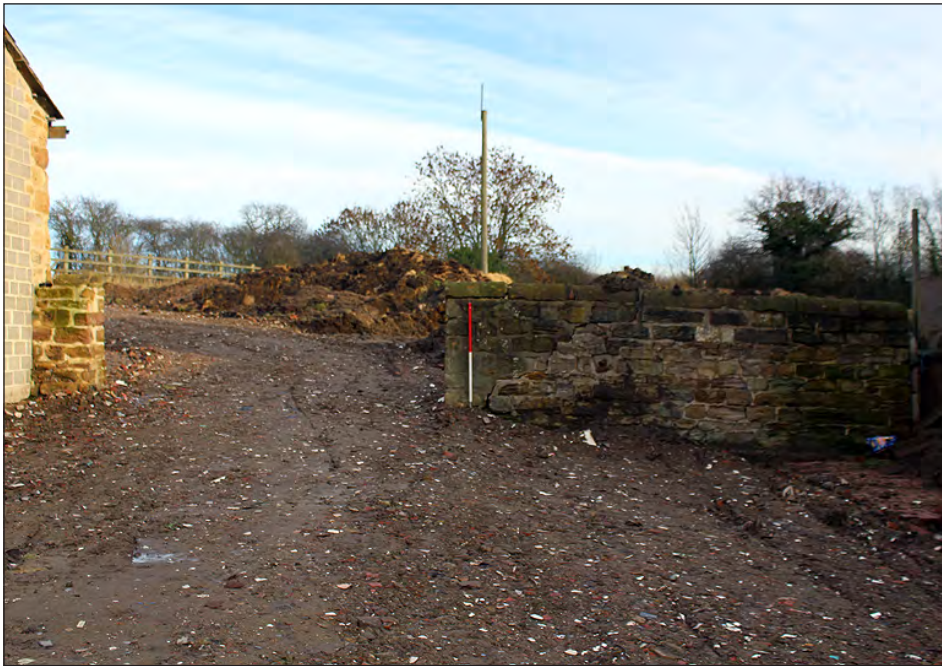
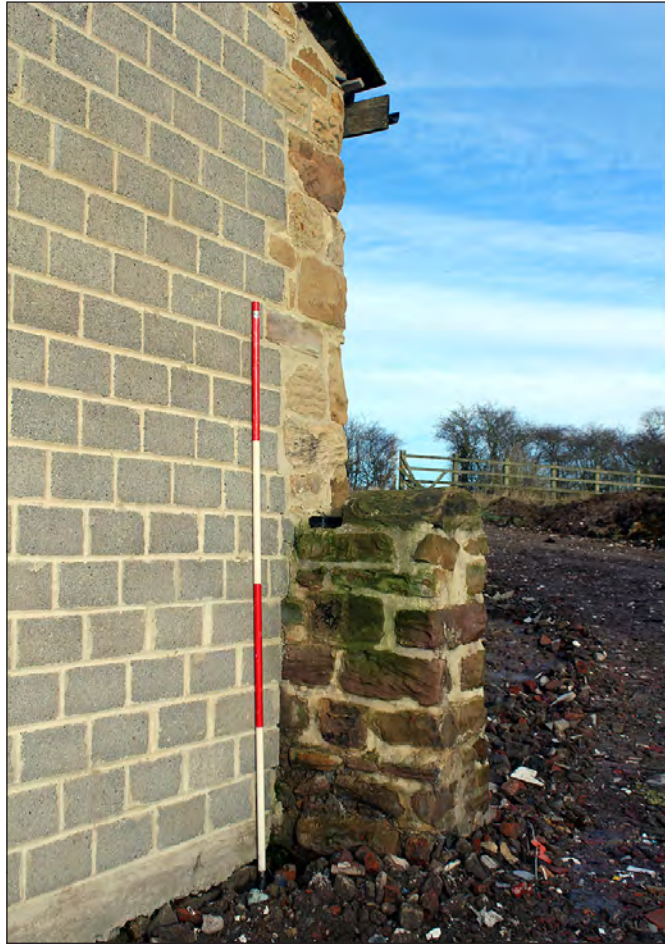
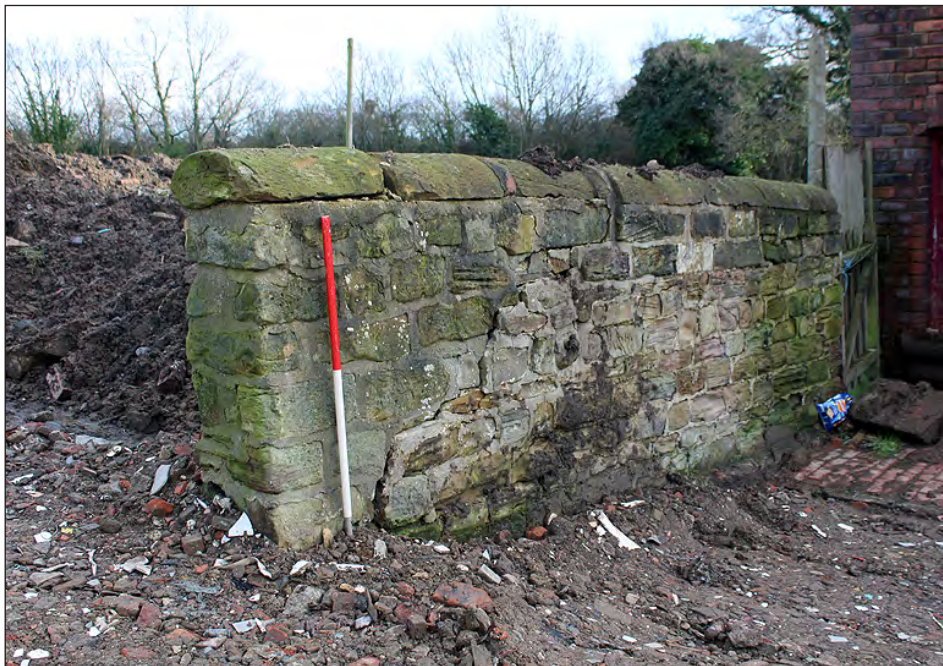
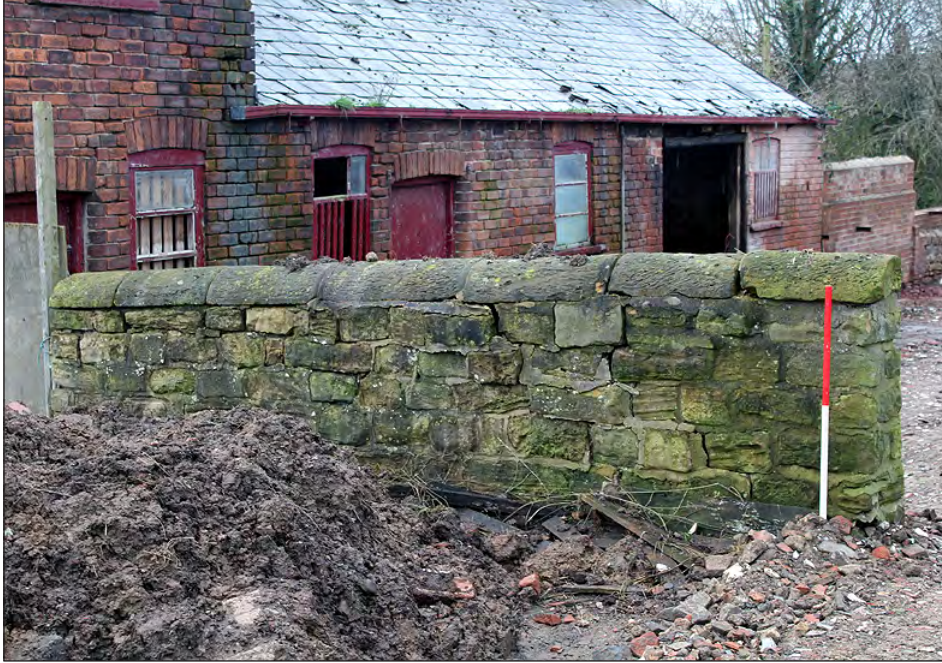
*Plate 246. East wall of yard. View looking east-northeast*

*Plate 247. East wall of yard. View looking east-northeast*

*Plate 248. East wall of yard. View looking southeast*

*Plate 249. East wall of yard. View looking southwest*

The boundary wall of the fold yard is constructed of stone and bricks and displays several phases on repair, repointing and rebuilding. The east side wall (Plates 246 to 249) is constructed of roughly dressed stone pieces and is capped with semi-circular capping stones. There is a break in the wall where access into the fold yard is gained. It was not clear what date the wall was constructed.

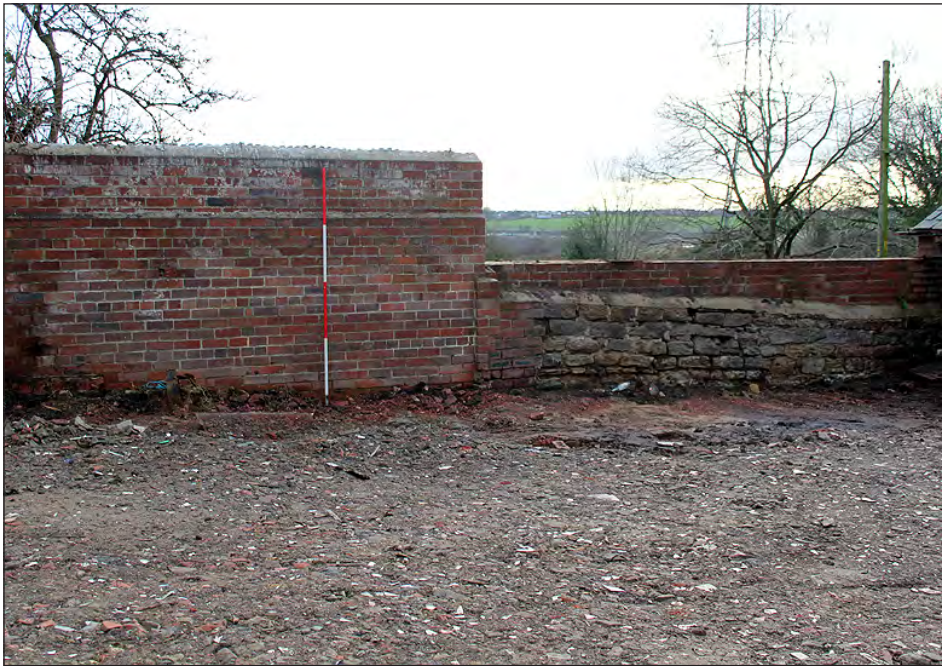
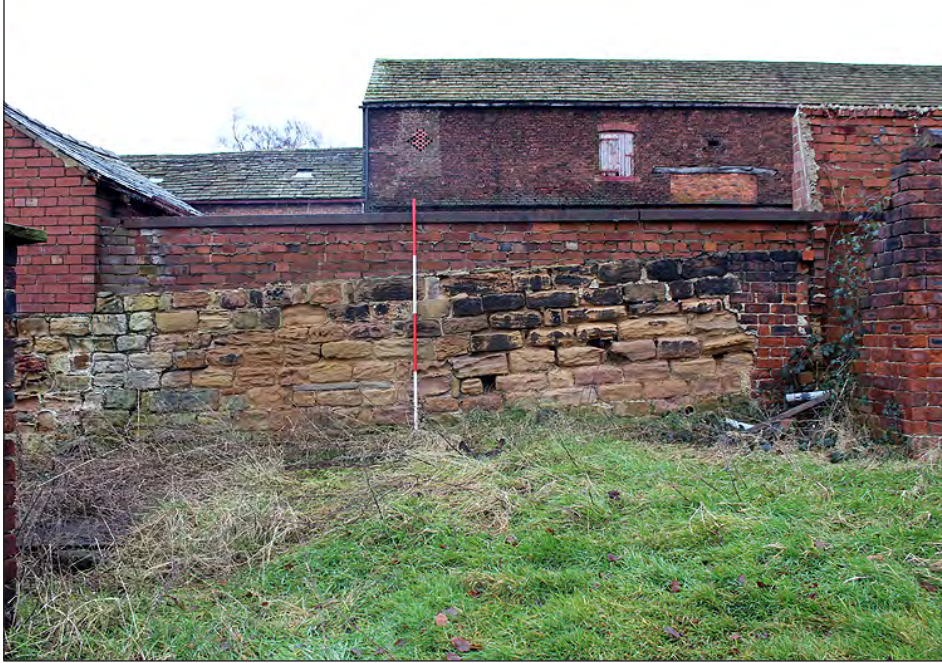
*Plate 250. South wall of yard. View looking south-southeast*

*Plate 251. South wall of yard. View looking north-northwest*

The south wall (Plates 250 and 251) displays two phases of construction, the first phase is constructed identically to the east side wall, this section of wall was constructed in the late 19th century and perhaps uses the materials of the earlier wall shown on the 1847 tithe map in this area, which dog legged in plan form. Partially overlying this wall and extending a short distance to Building 8 are machine made bricks dating to the early 20th century.

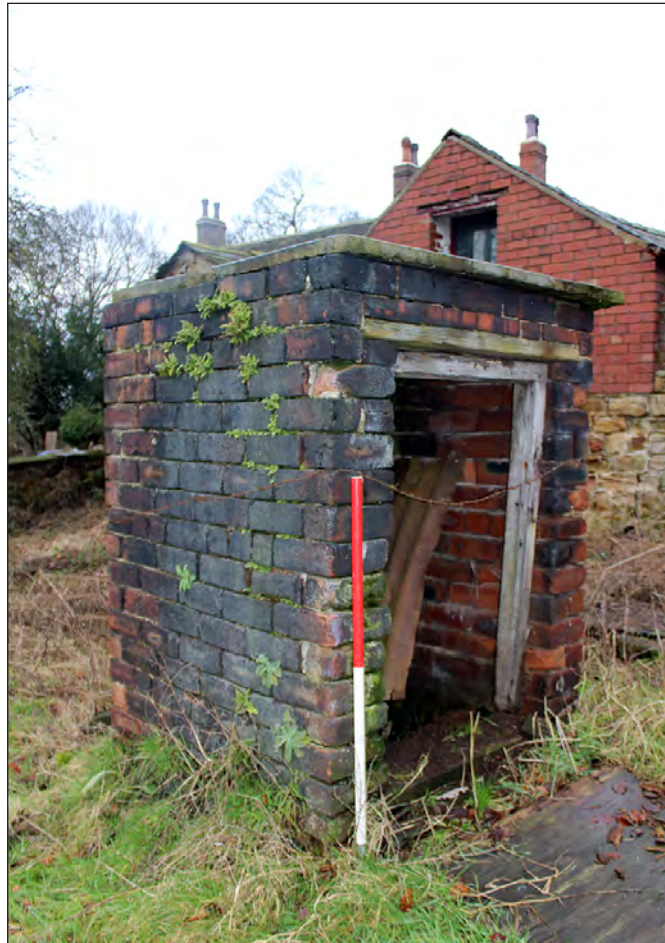
*Plate 252. Well structure. View looking northwest*

Located to the south side of the south wall there is a well (Plates 252 and 253). It is constructed of machine made bricks and that are contemporary with late 19th-century structures at the site.
