**An Archaeological Watching Brief
On land at St. Nicholas' Church,
Bringham, Leicestershire
(NGR: SP 841 921)**

ULAS Report No 2009-076.

An Archaeological Watching Brief on Land at Bringham Church, Bringham, Leicestershire (NGR: SP 841 921)

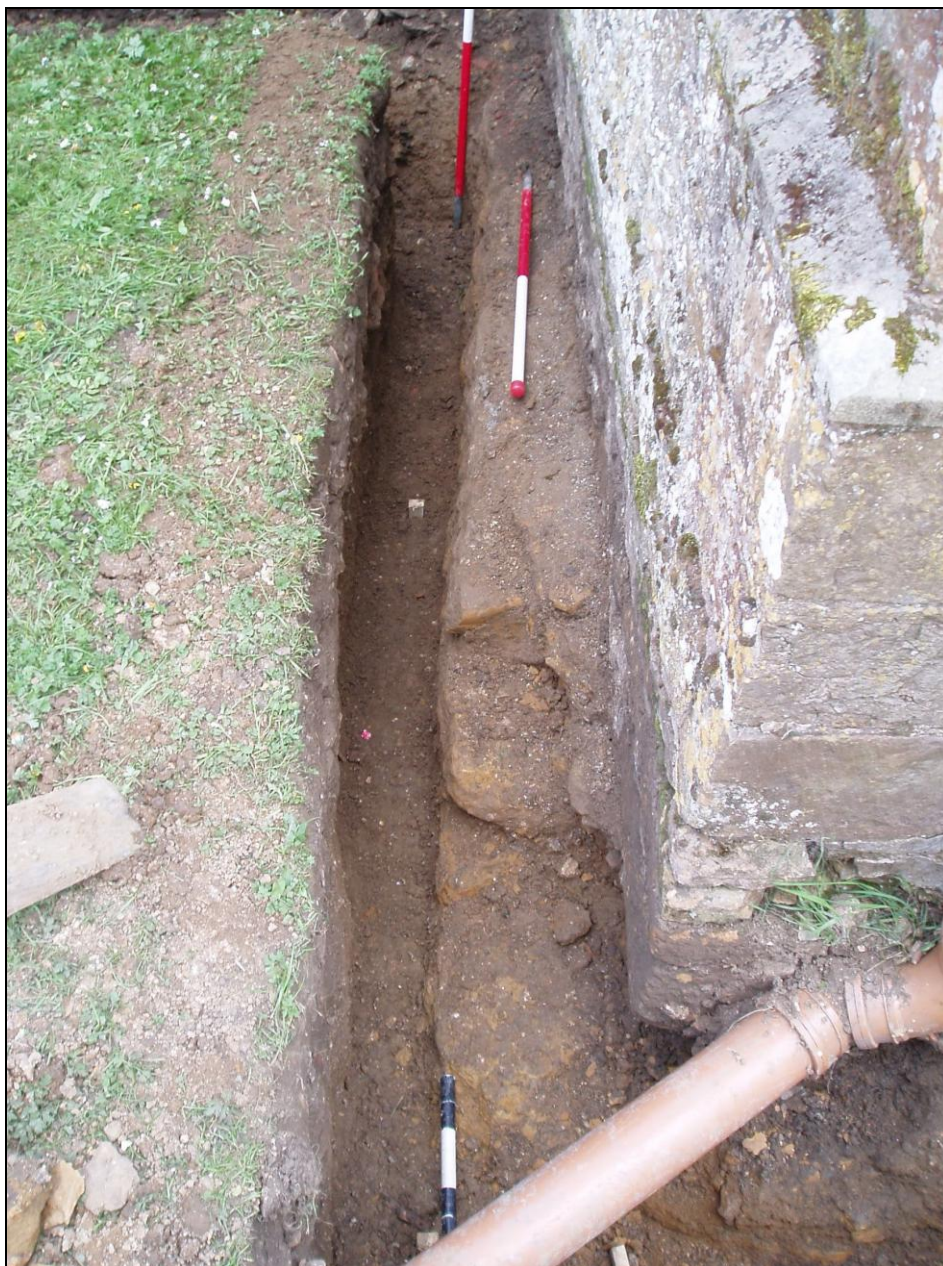
Figure 6 foundations of north aisle looking south

On the second day excavations continued going down into the subsoil and reached a maximum depth of *c.*0.85m at the western end to *c.*0.6m at the eastern end of the church. The excavations revealed the sandstone foundations along the extent of the northern edge of the Church (figs 4, 5, 6 & 10) and of particular interest along the northern edge of the tower (fig. 10) was observed some ashlar limestone blocks (5) (fig 10) (see discussion below).

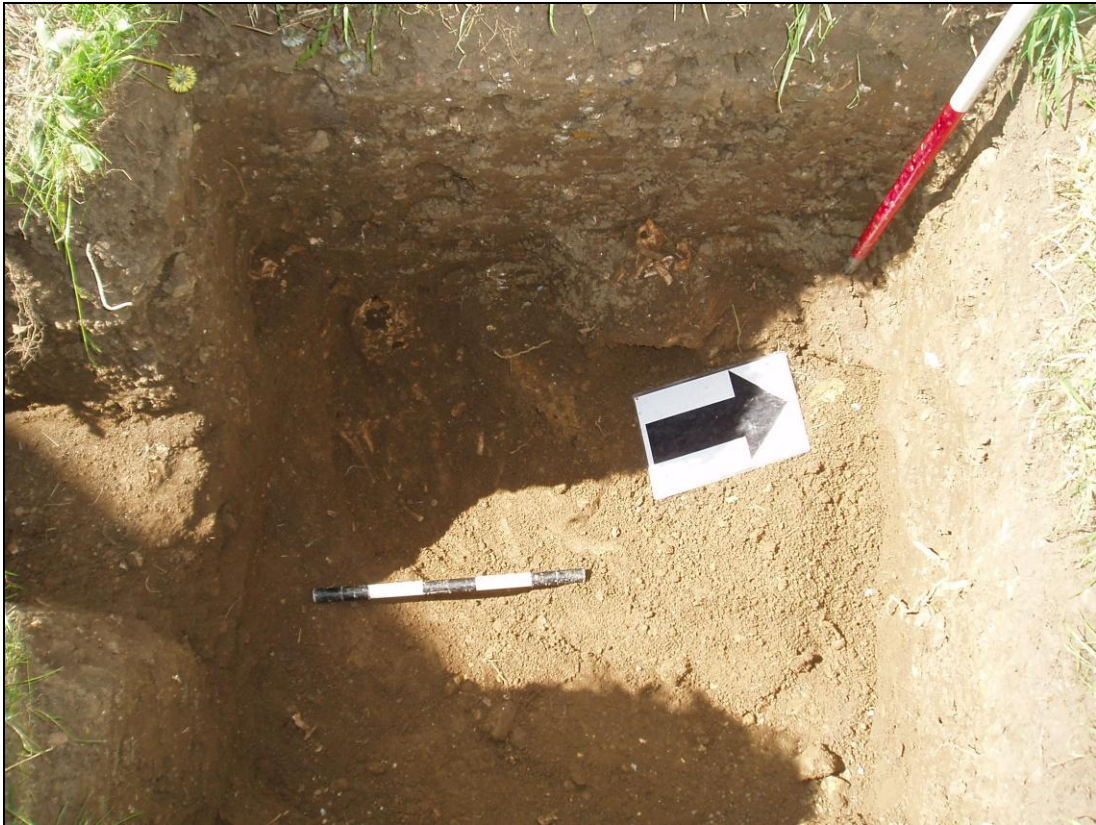
Figure 8 Soak away containing burials looking east

On the final day of the watching brief the soakaway was excavated. Within the soakaway trench, two burials were located, (2) and (3) within what appeared to be a single cut [1], (figs 7, 8 and 9). These were excavated by hand and recorded. The bones were then given to the keeping of the church warden for reburial. The cranium of the skeleton (2) appeared to be that of a female. Fragments of lead and wood remained within the burial fill, suggesting that the coffin was constructed out of these materials. No other finds or features were located within the burial fills (1) and (2). The date for the burials is uncertain although a 19th century date is likely.

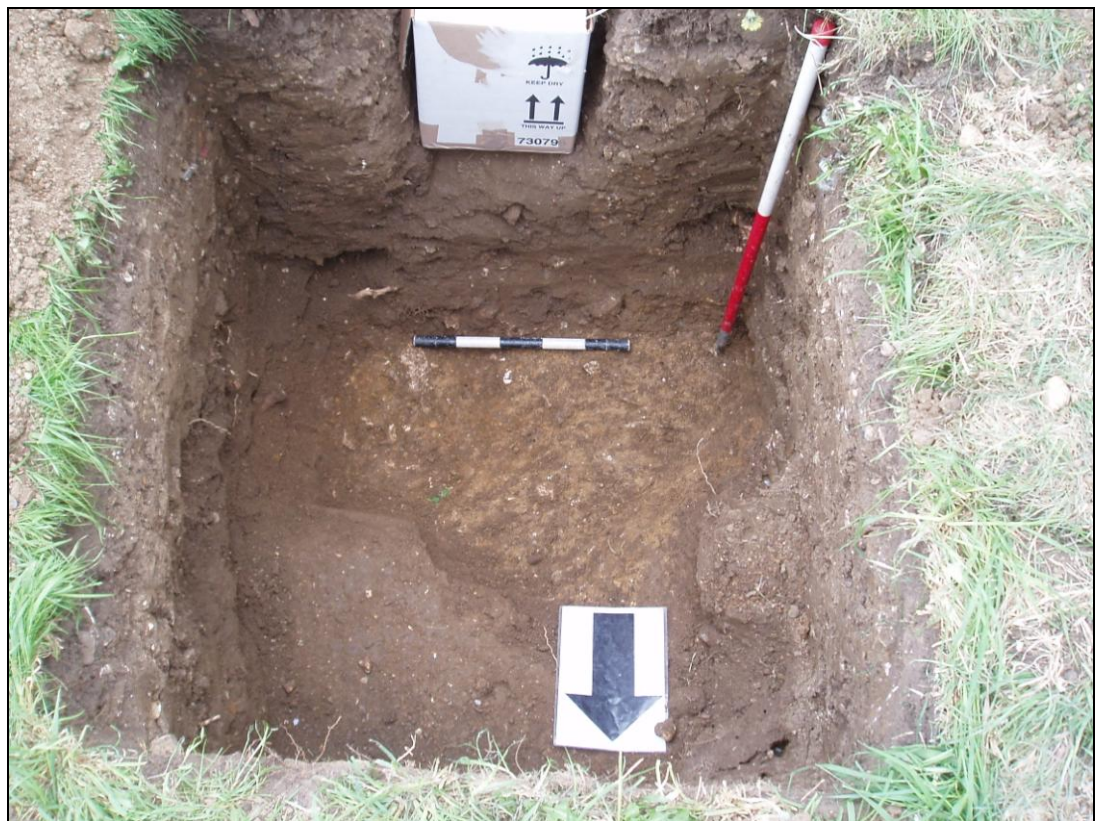
Figure 9 Soak away containing burial cut [01] looking north

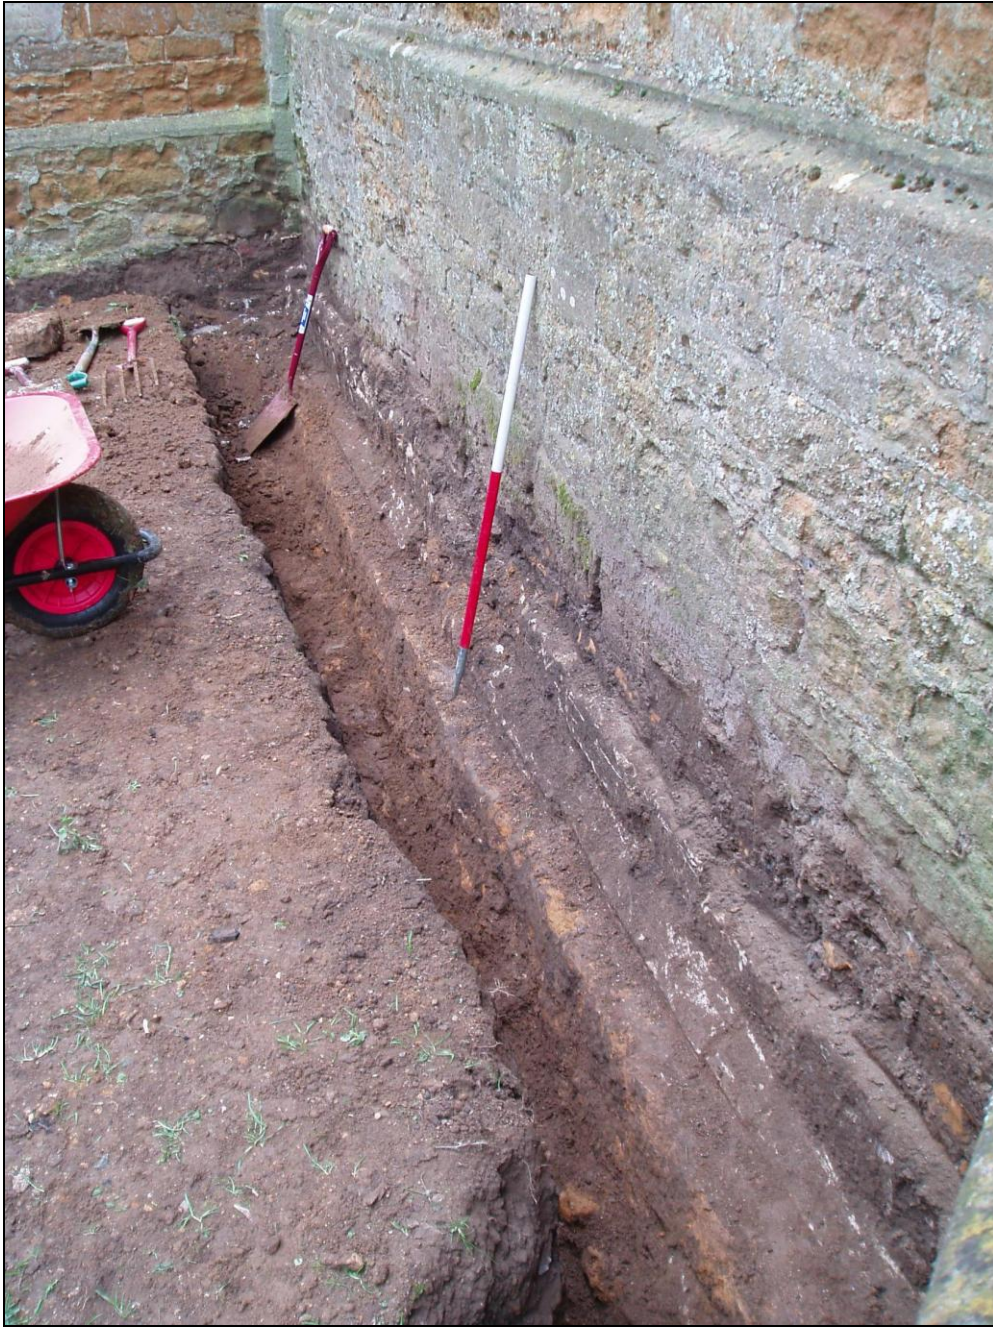
Figure 10 ashlar limestone blocks (5)

There are a number of smooth-faced ashlar limestone blocks around 100mm in height, set just below the first outward step (5) (fig. 10). Below this is the most unusual feature, several lengths of limestone with a splayed front edge. There are 3 stones to the west, around 700mm long and 2 stones further to the east, 610mm and 680mm long. The stones are *c.*135mm in height, with a *c.*45° angled front which projects about 100mm. A peculiar feature is a small 'V' groove cut in the short vertical face below the angled slope. This 'V' groove is around 5mm deep on the stones to the west, but significantly smaller, *c.*3mm deep on the stones to the east. The stones are all of a high quality, shelly oolitic limestone of local type.

At first sight, the angled stones have the appearance of a projecting plinth course, suggesting that this section of stonework was above ground, and was later buried by raised ground level. Examination, however, shows this is unlikely to be the case. The rest of the stepped footing is roughly built, with irregular outward steps, quite wide in places, which are wholly inconsistent with the construction of a plinth built of well-formed, canted ashlar. The stones are all set in earth, not lime mortar, and are clearly built to form a stepped foundation, not intended to be exposed to view or the weather.

The dressed stones are thus re-used, not made for the purpose. Are they a later insert, or an original part of the construction of the tower? If inserted later, they would have been put in as part of an underpinning operation, to strengthen the tower foundation. It seems unlikely that they were inserted in this way as such long stones would involve digging out lengthy sections underneath the tower wall. An underpinning operation would be more likely to use smaller-sized rubble stone (like the rest of the footing), as this would be much easier to handle and get into place. Although the stepped footing is of irregular character, this is normal in such situations, and does not suggest later re-working, but a single build.
