**A Level 2 Historic Building Record  
And watching brief at Middle Farm  
House and  
Associated Barns  
Main Street,  
Upper Benefield,  
Northamptonshire**

ULAS Report No. 2017-005  
©2017

**A Level 2 Historic Building Record  
and watching brief at Middle Farm House  
and Associated Barns,  
Main Street, Upper Benefield,  
Northamptonshire.**

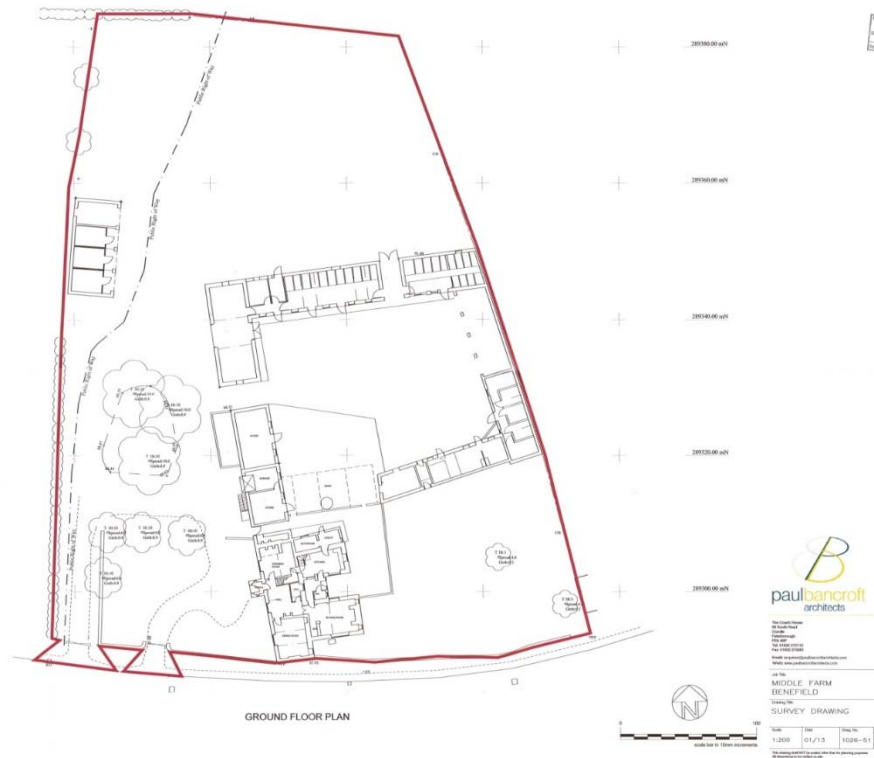
Figure 2: Middle Farm site layout

Farm House at bottom of plan. Plan supplied by Paul Bancroft Architects

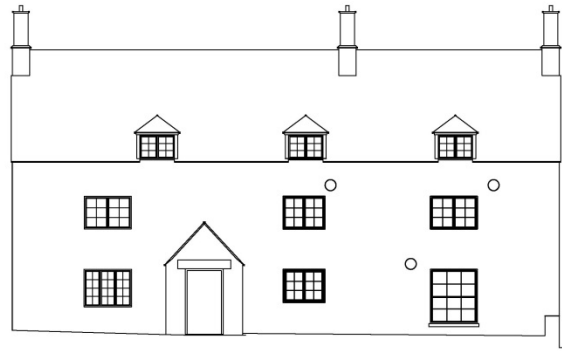
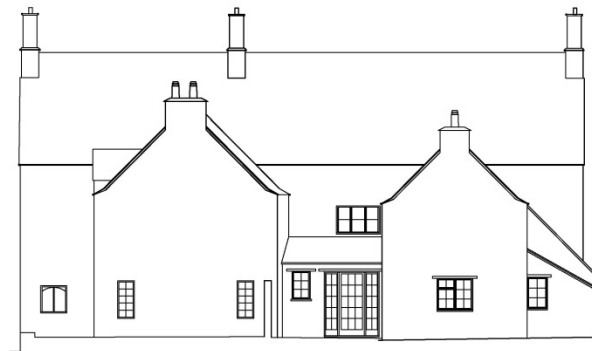
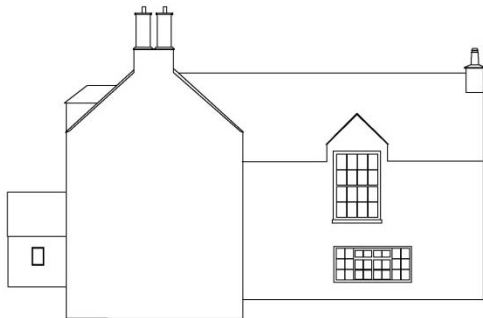
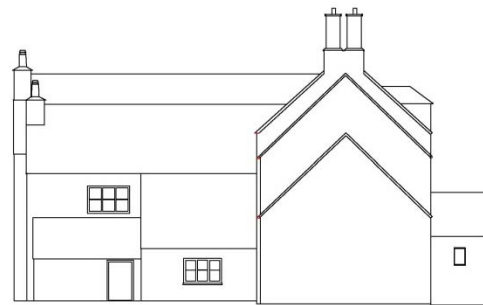
Figure 9: Middle Farm House elevations  
Modified from plans supplied by Paul Bancroft Architects

Farmhouse, west facing elevation

Farmhouse, east facing elevation (inside yard)

Farmhouse, south facing elevation

Farmhouse, north facing elevation

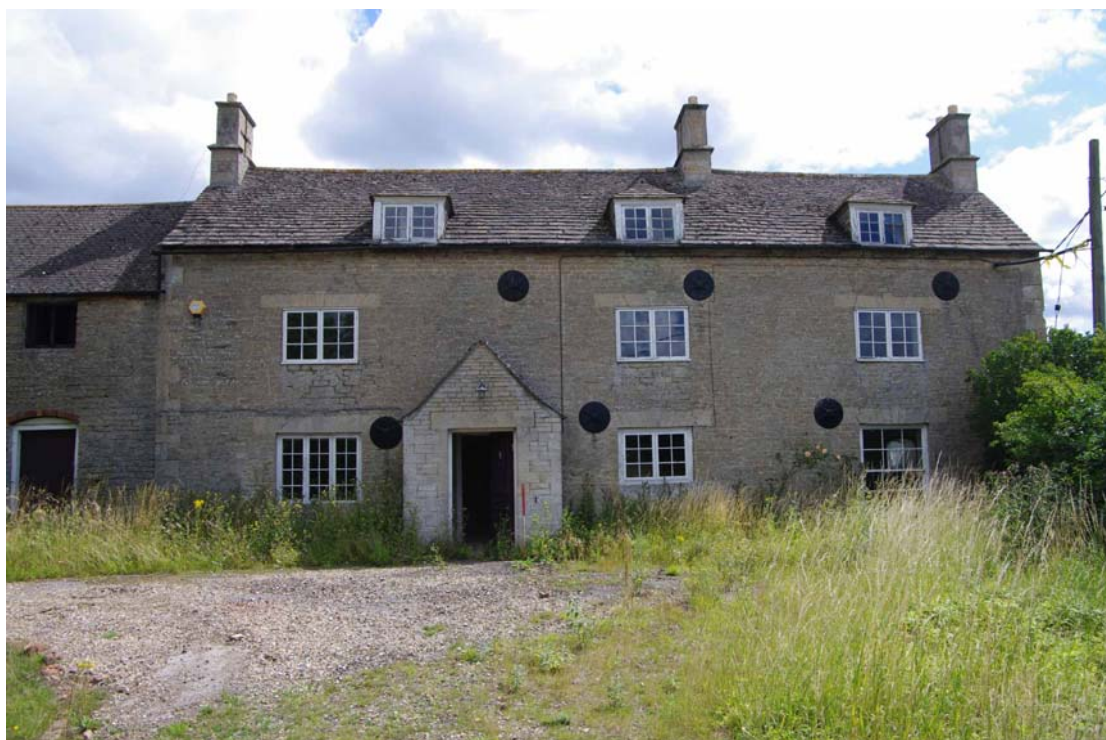
Figure 10: Farm house, west facing elevation  
Looking east.

In keeping with a principal elevation the west facing elevation has a dressed stone frontage (Fig. 10). Ashlar long and short quoins are built into each corner. The ground floor doorway is slightly offset to the north giving the impression of possible remodelling from an earlier pair or trio of smaller houses - the later 18th century was a time of symmetry and style and a new elevation would be expected to be balanced. This is possibly suggested by the listing information which indicates that the house was once a three-unit plan. There is however no evidence of any blocked openings or joints except where the barn to the north butts against the northern gable end of the house. It was not possible to see if the ashlar stonework was an added skin over an earlier wall.

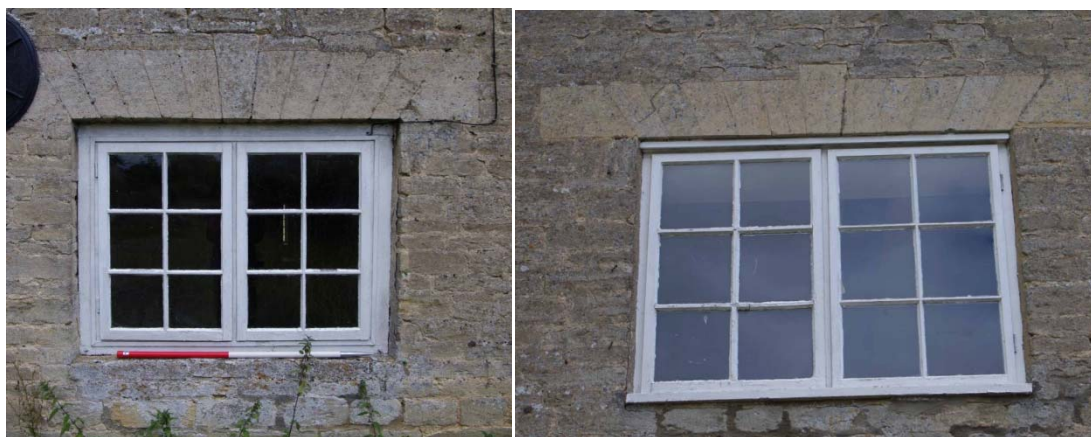
Figure 11 Farm house window details  
Left: ground floor, right: first floor  
1m scale

The southernmost ground floor sash window extends almost to the ground and may have at one time been a doorway. The remaining windows are relatively small and rectangular with gauged limestone lintels. They all have wooden frames pegged at the corner joints (Fig.11). A stone gabled porch over the doorway matches the style and building materials of the house but is a later addition as it is not keyed into the stonework of the house and probably dates to the mid-19th century (Fig.12).

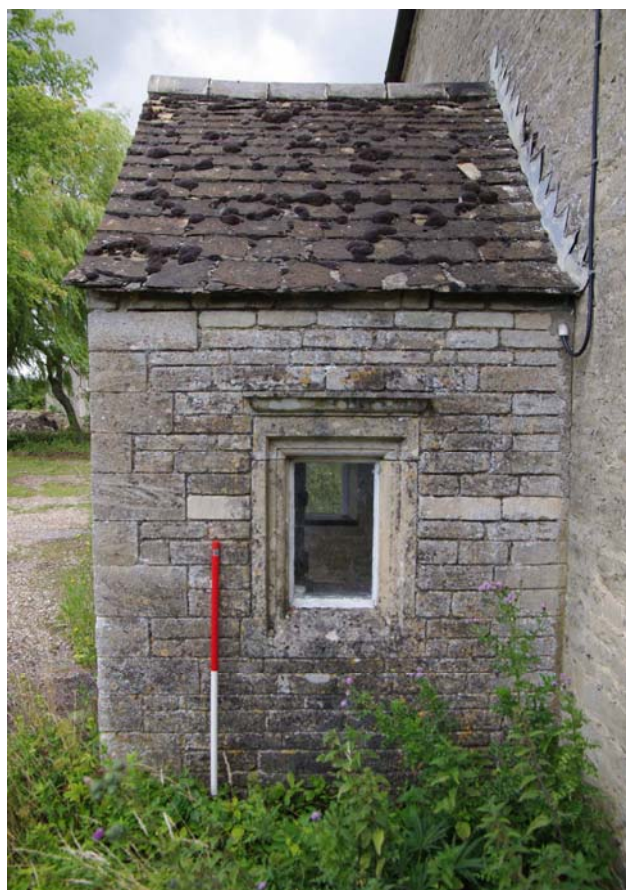
Figure 12: South facing elevation of porch  
Looking north, 1m scale

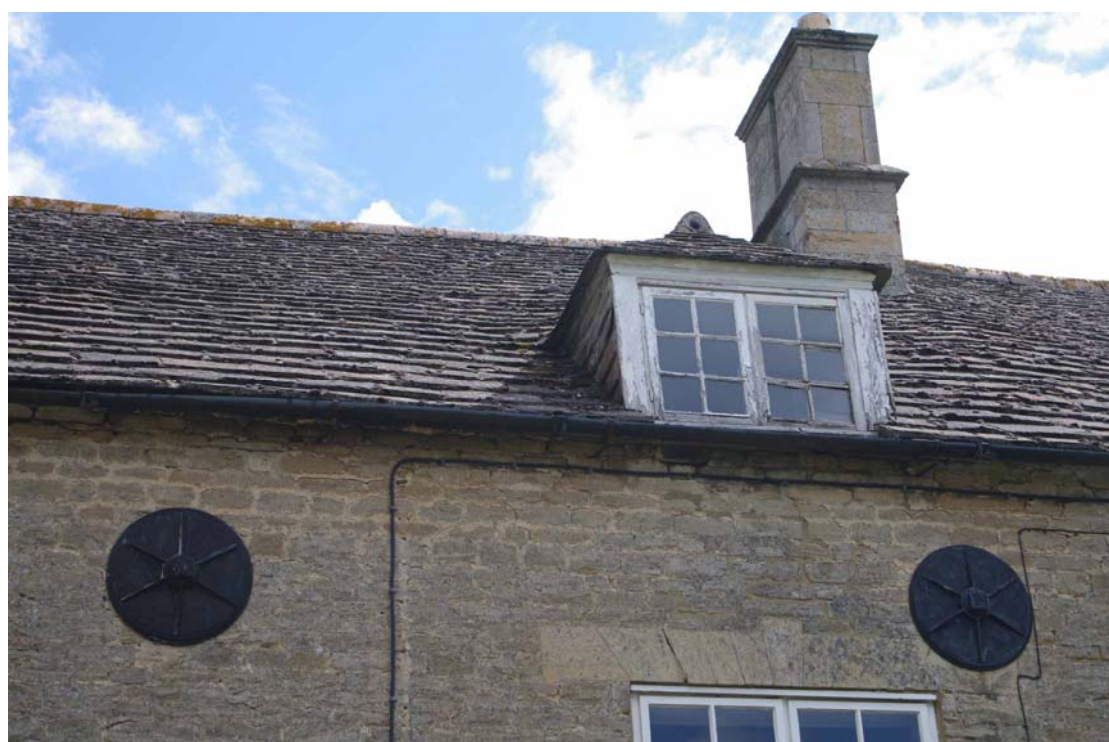
Figure 13: West facing elevation, dormer window detail

The three ashlar chimney stacks are slightly offset which again may suggest that the building began life as a three-unit building. Three low dormer windows are set into the roof at eaves level and have wooden casement window frames and Collyweston slate roofs (Fig. 13).

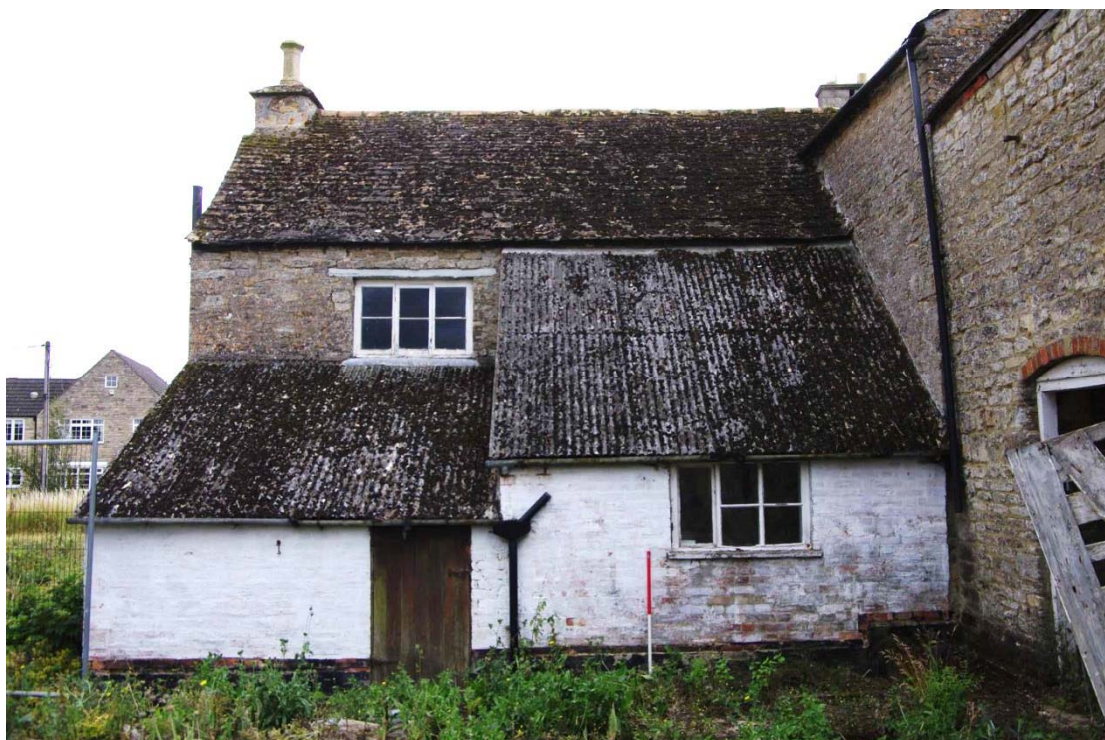
Figure 14: Farm House north facing elevation  
Looking south, 1m scale

Much of the north facing gable end of the main house building is obscured by the adjacent barn (Building G) which has been built against it (Fig. 14). A narrow covered passageway between the house and the adjacent barn incorporates what appears to have been used as a coal storage area (see plan figure 20) with a blocked doorway leading into the house (Fig. 15). This doorway would have led into the space to the east of the large fireplace in room G1 and is discussed in more detail below. No more of this elevation can be seen although it clearly pre-dates the adjacent barn.

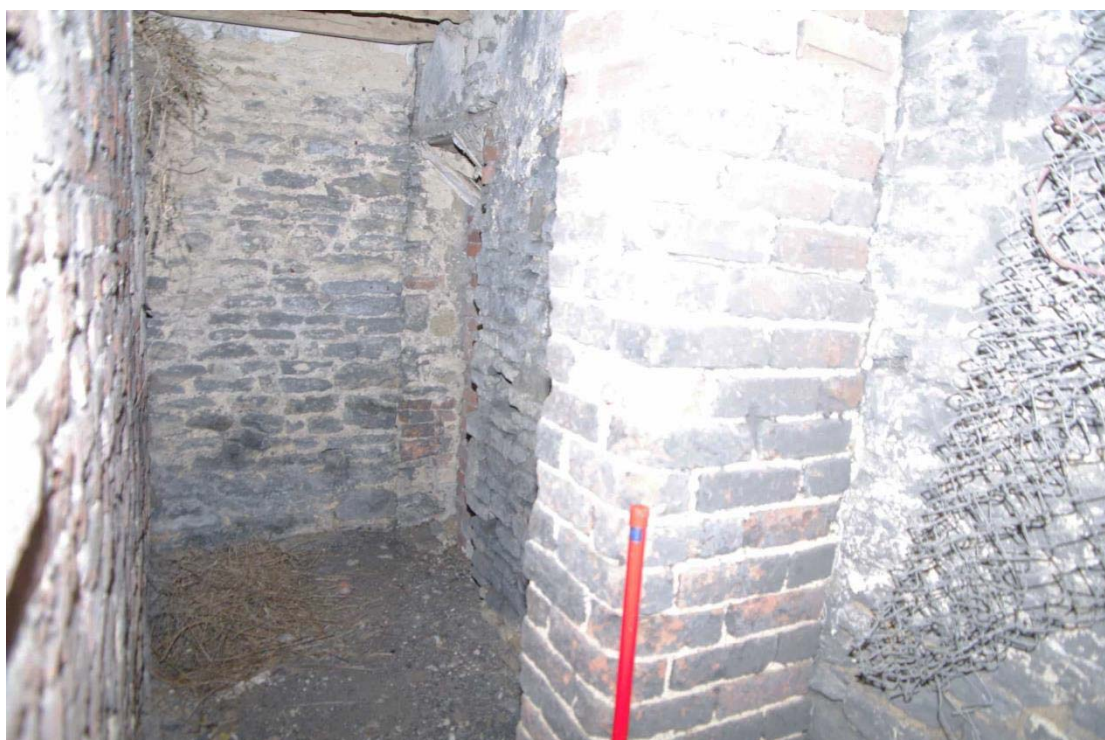
Figure 15: Farm House north facing elevation gable end blocked ground floor doorway. Looking south-east

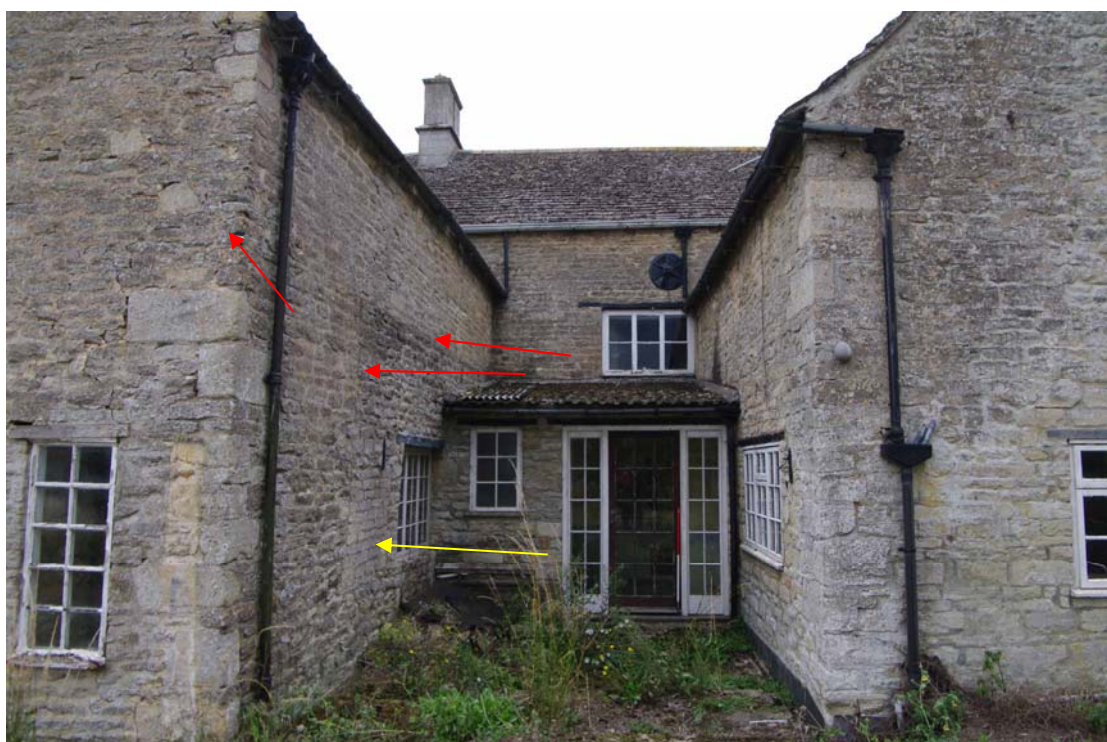
Figure 17: Farm House rear wings showing extension to south wing  
Looking west, 1m scale. Yellow arrow shows blocked window. Red arrows show  
joint in walls on southern wing

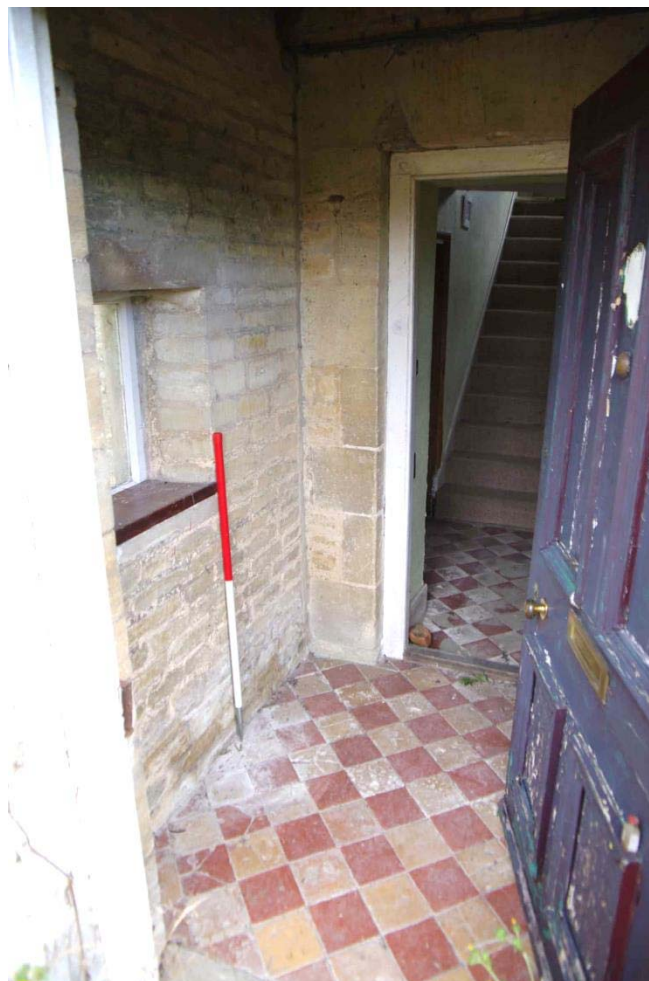
Figure 21: Porch and hall floors  
Looking north-west, 1m scale

The main doorway into the house is through the stone gabled porch on the west facing elevation. The porch has red and cream 6 inch quarry tiles which match those in the hallway (G2) and which appear to be 19th century in date (Fig. 21). As noted above the porch appears to be butt-jointed onto the house suggesting that it is a later addition.

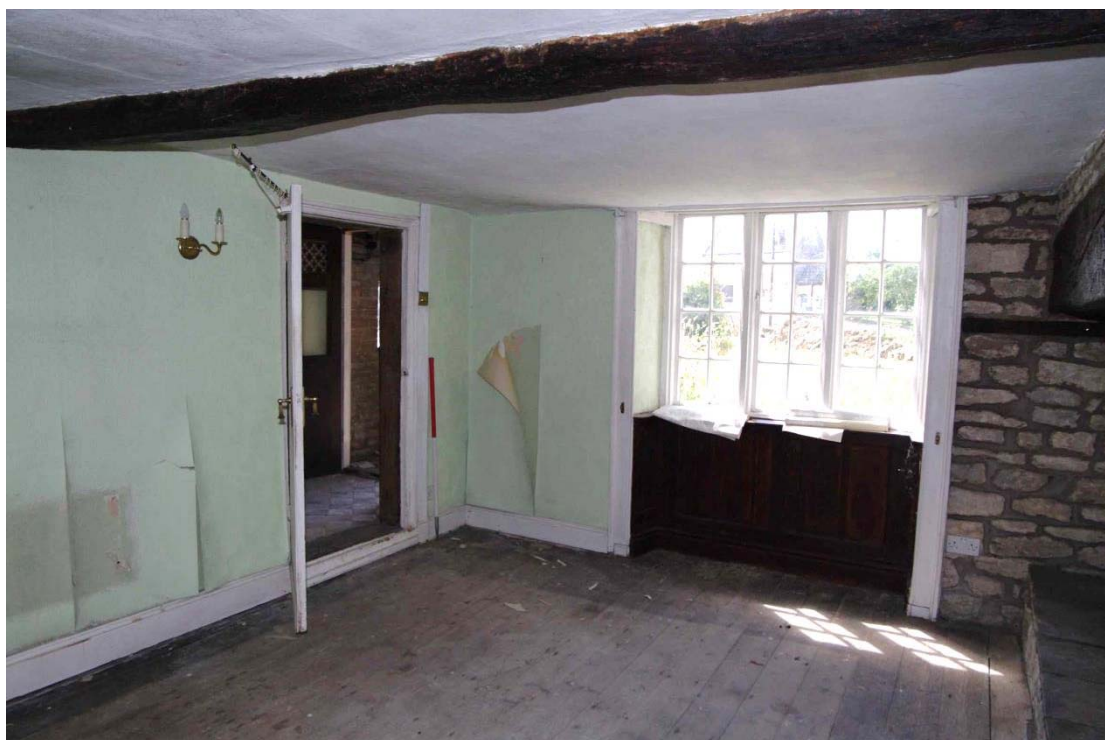
Figure 22: Ground floor, Room G1  
Looking south-west, 1m scale

Room G1 is the northernmost ground floor room of the house. It is a rectangular room with floorboards set slightly lower down (100mm) than the tiles in the hallway (Fig. 22). The wooden-framed window sits on a narrow masonry wall which is significantly thinner than the main walls and which indicates that this may have once been a doorway before the front of the house was modified. There is a space either side of the window for shutters but these have been removed. The room has a large open fireplace on the north wall with a substantial bressumer beam supporting the chimney stack and the first floor bedroom wall (Fig. 23). Along the front of the beam are a number of wooden pegs to hang items along its front. The fireplace and surrounding stonework have been stripped of plaster and repointed and the current fire sits on a raised plinth with a relatively small flue aperture. The plinth and the small size of the fireplace in such a large opening suggest that some remodelling has taken place relatively recently. The fireplace is offset to the west leaving a recess on the eastern side which is where the blocked doorway could be seen on the north facing gable end.

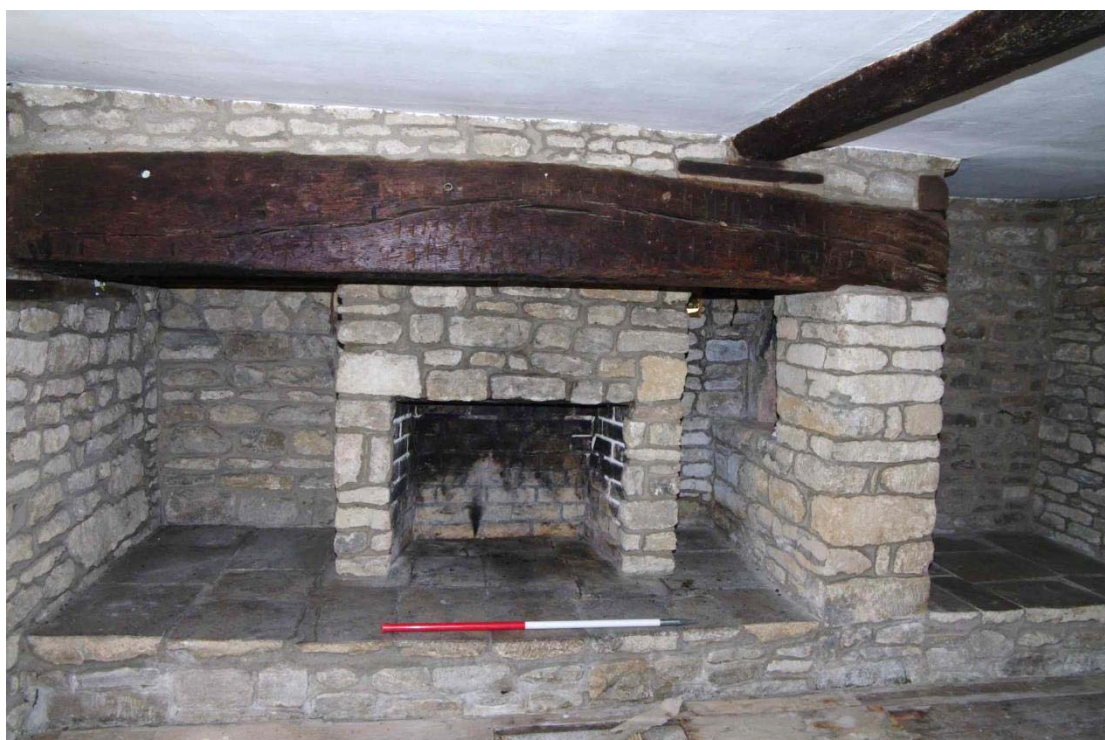
Figure 23: Ground floor, Room G1 fireplace  
Looking north, 1m scale

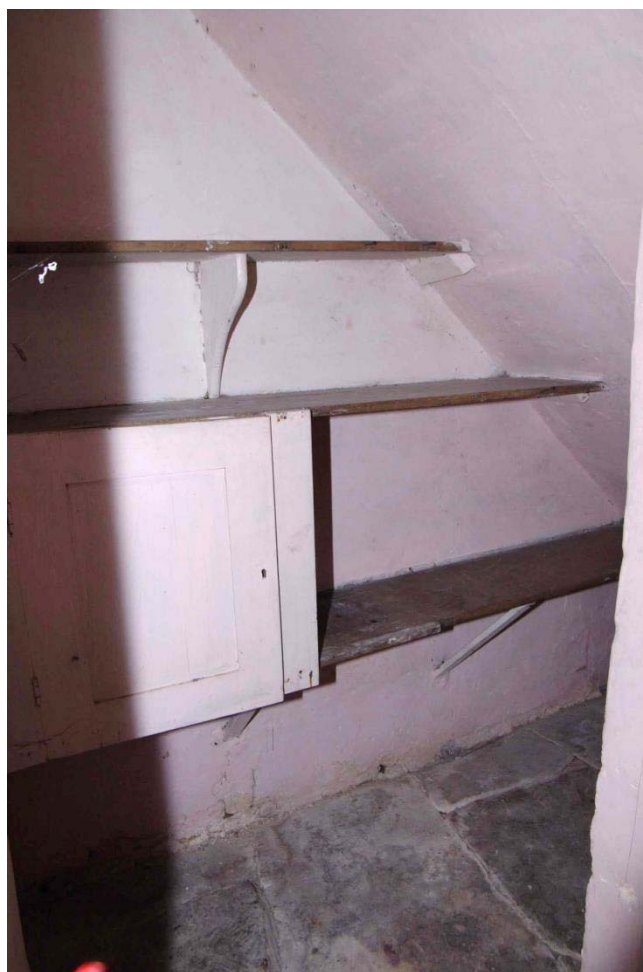
Figure 24: Ground floor, Room G1. Pantry below stairs  
Looking south-west

A low moulded skirting board only survives along the southern wall and may not be original. A pair of doors in the south-east corner lead to the kitchen (G6) and to a small cupboard or pantry below the stairs. The pantry has a limestone flagstone floor and board shelves supported by wooden struts. The flagstones appear to continue below the floorboards in the Room G1 and seem likely to be the original flooring (Fig. 24).

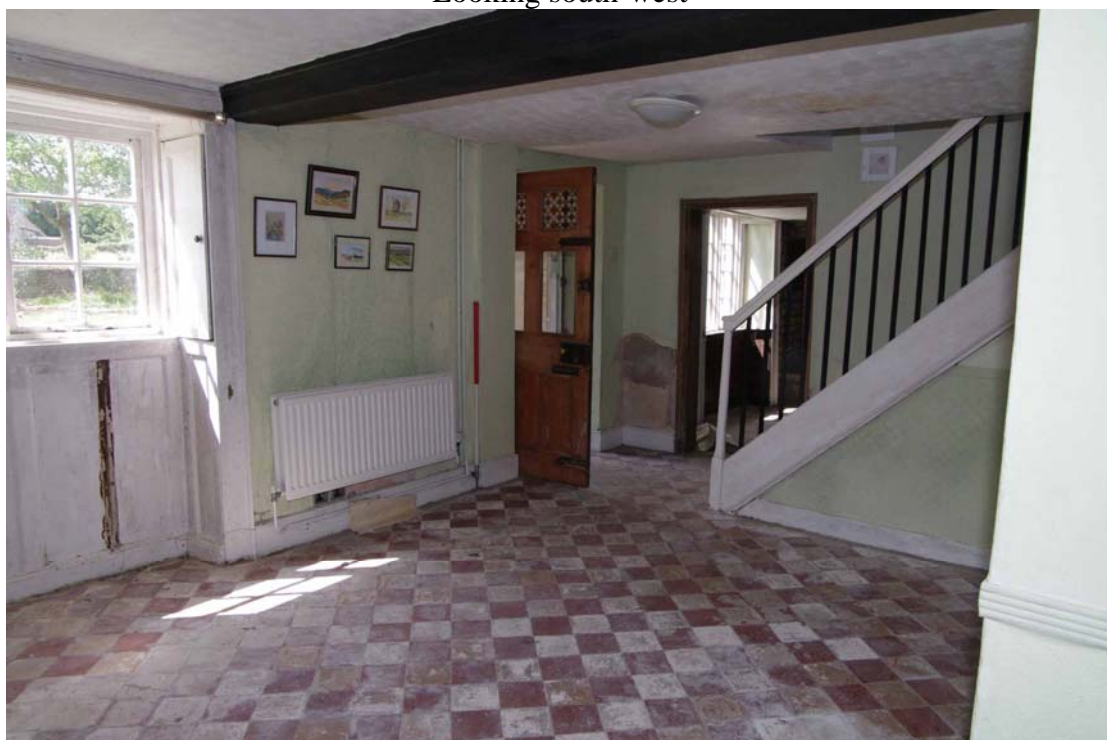
Figure 25: Ground floor, Room G2. Hall  
Looking north-west, 1m scale

Room G2 forms the hallway of the house from which all of the other rooms and main stairs lead off. As noted, the 6 inch square quarry tiles match those in the porch and may be a 19th century addition. The wide six-panelled front door has clear glass with stained glass upper panels (Fig. 25). The casement window still has its three-leafed single panel shutters intact which appear to be of late 18th century design and have an iron closure bar set on a central pivot (Fig. 26). The brick-built fireplace on the south wall has thin hand-made bricks which are likely to date to the mid to late 18th century (Fig. 27). The plasterwork around the chimney breast has been stripped to reveal the bricks. A beaded beam runs from east to west across the room and continues into a small pantry built into the corner formed by the east wall and stairs. The pantry walls are likely to be a later insertion as the beading on the beam only stops when it reaches the main east wall. The floor of the pantry has large flagstones as seen in Room G1 and not quarry tiles which suggests that the pantry has a similar 19th century date as the tiles. A window on the east wall in the pantry was an outside window but now looks into Room G5 which is the modern extension built between the two wings. The skirting boards are the same all around the room including around the inserted pantry showing that they date to a similar time as the pantry and quarry tiles. The main staircase is opposite the entrance doorway. The stairs have stick balusters and a plain newel post typical of the early 19th century.

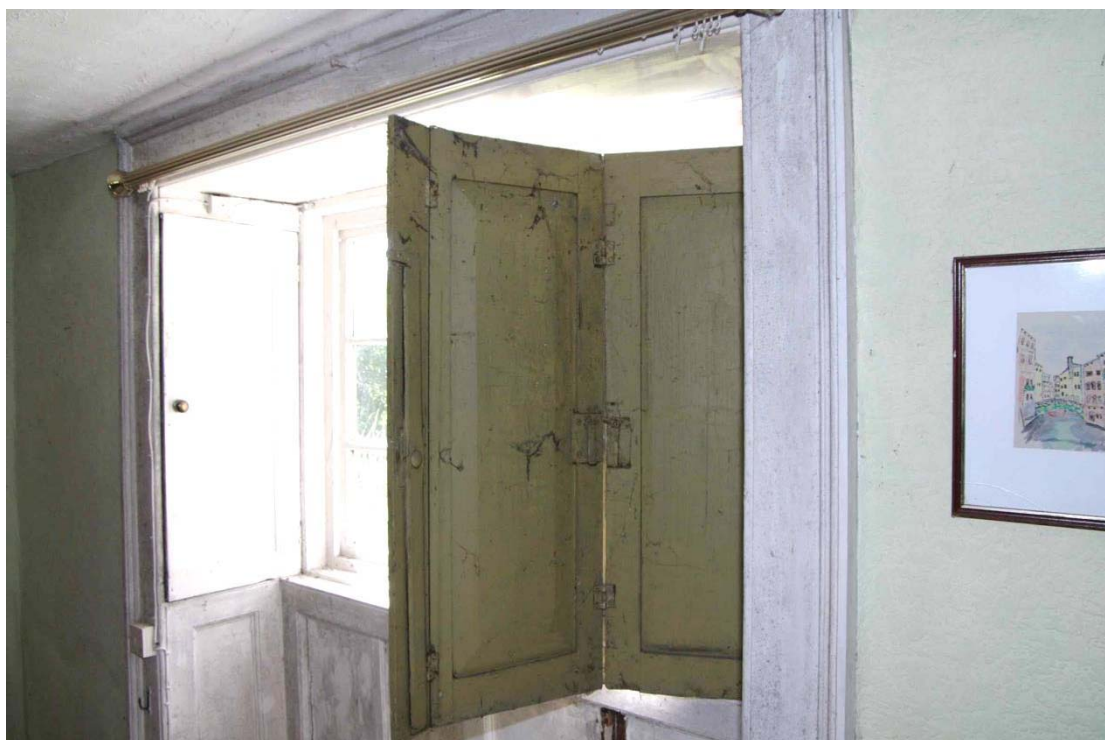
Figure 26: Ground floor, Room G2. Shutter detail  
Looking south-west. Note pivoting locking bar

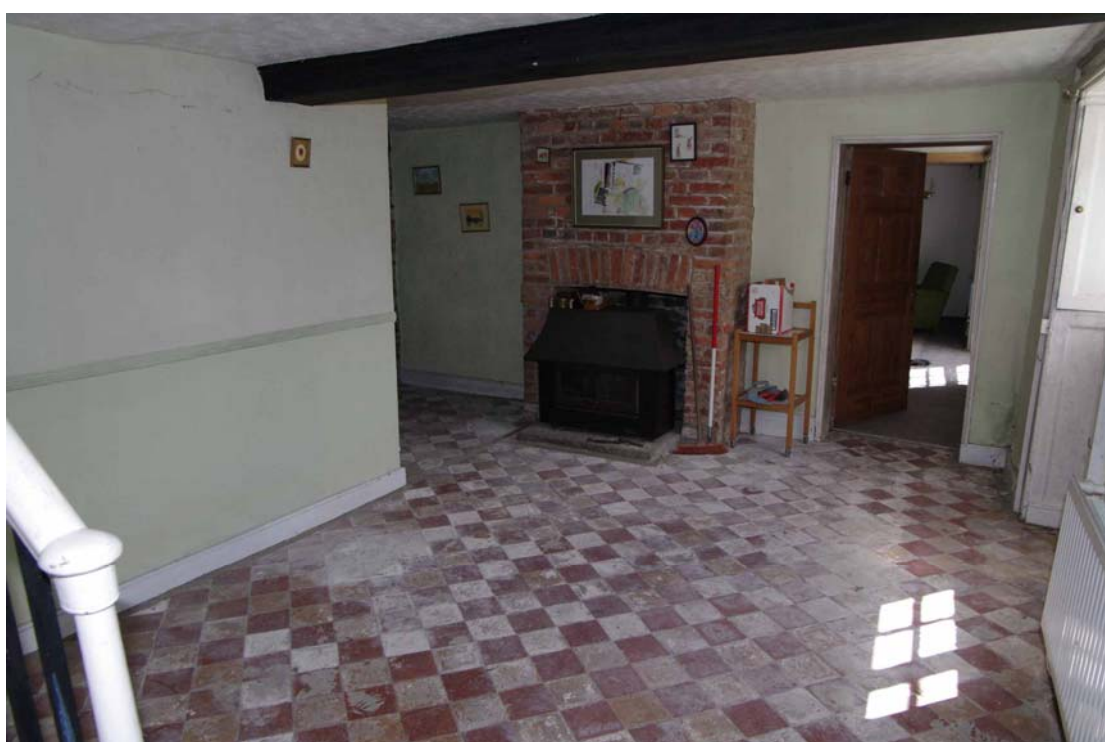
Figure 27: Ground floor, Room G2. Hall  
Looking south-east, 1m scale. Note inserted pantry on left of picture

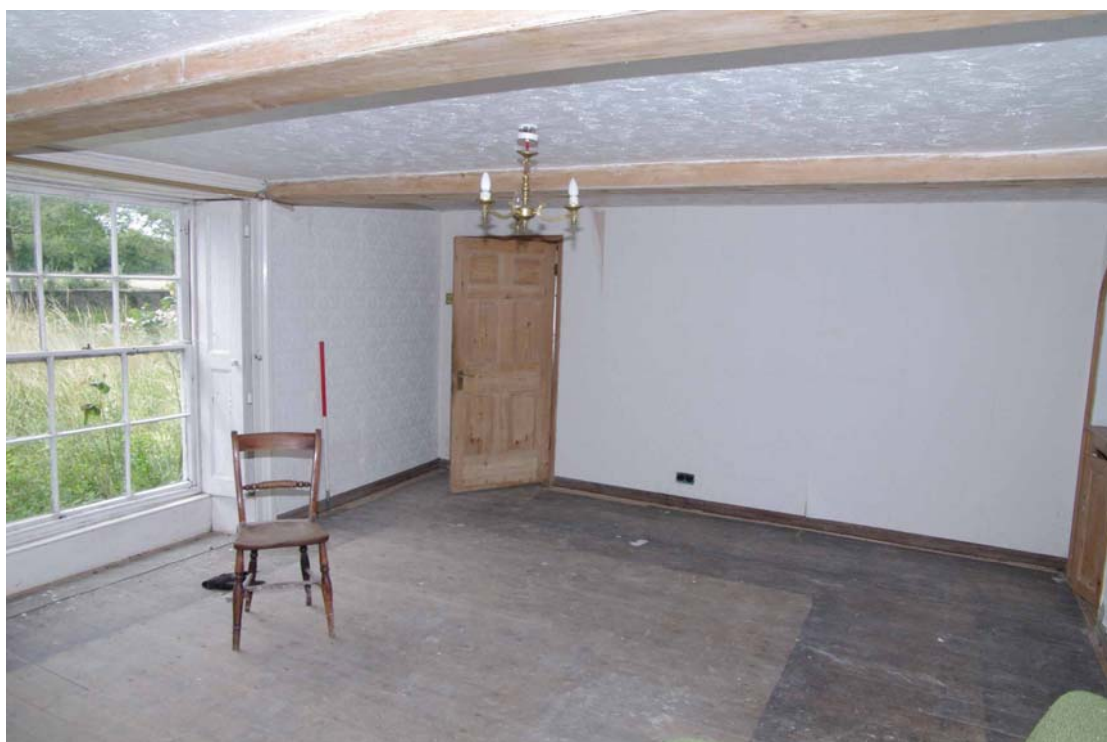
Figure 29: Ground floor, Room G3  
Looking north-west, 1m scale. Note arched niche on right

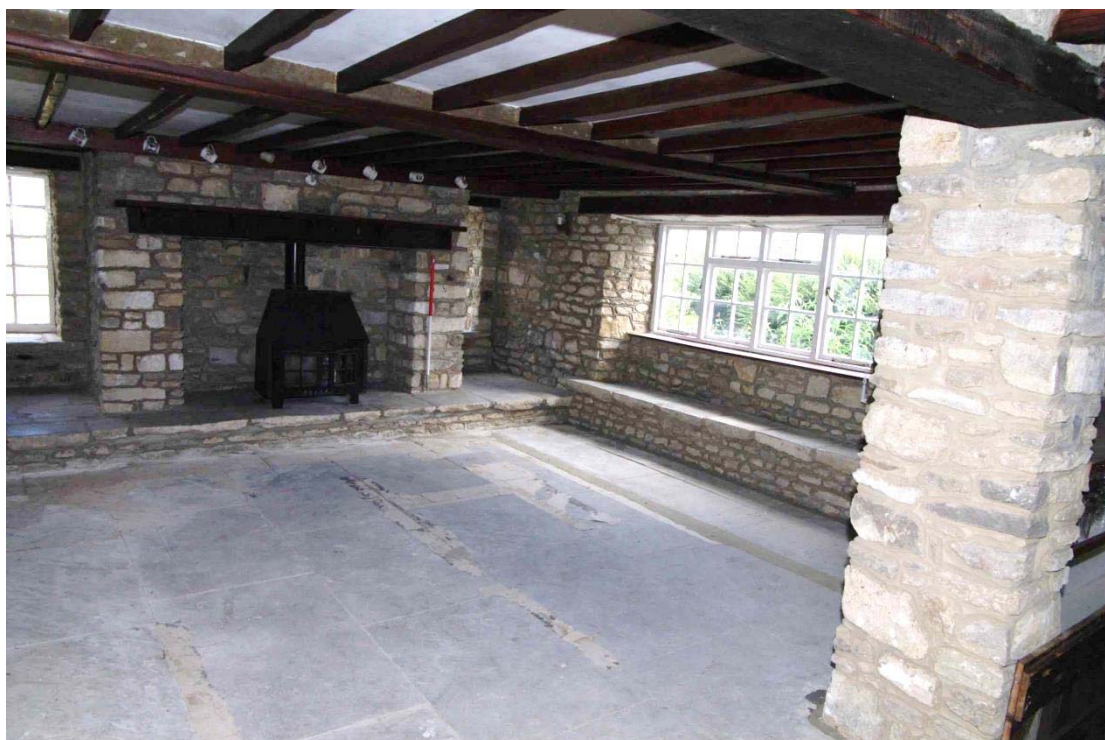
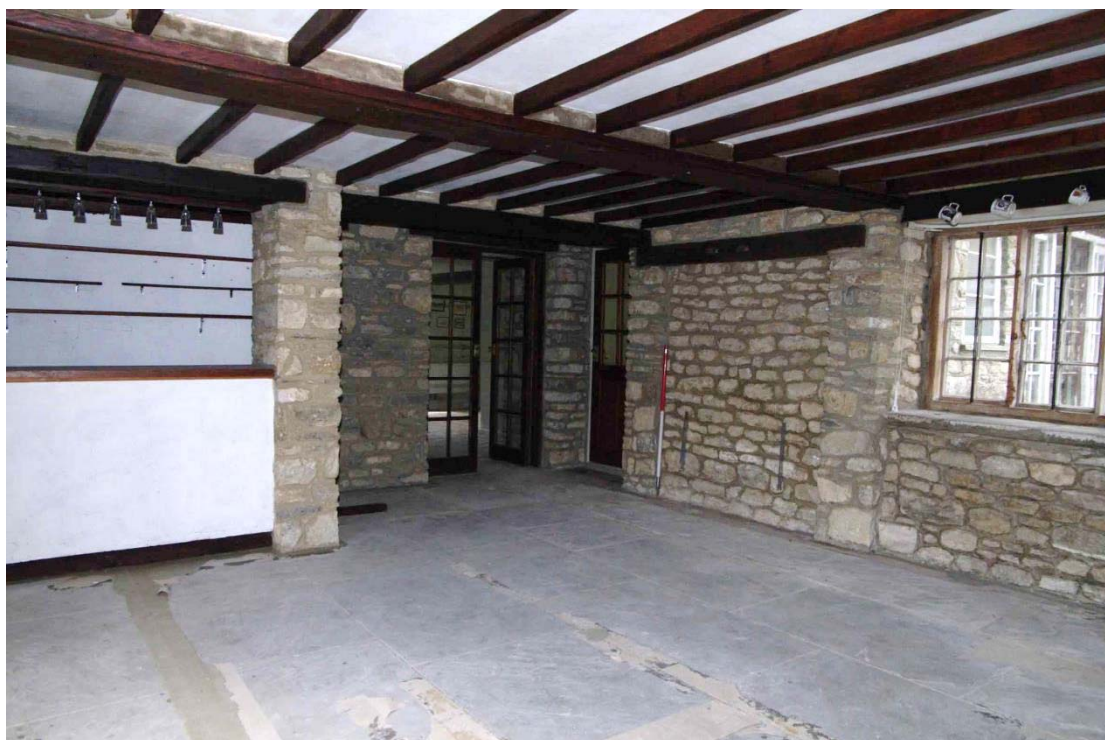
Figure 31: Ground floor, Room G4  
Looking south-east, 1m scale. Cover to cellar steps just visible on right of picture

Figure 32: Ground floor, Room G4  
Looking north-west, 1m scale. Cellar steps behind bar on left

Room G4 fills the ground floor of the south wing. It has been modernised by stripping the wall plaster down to bare stone and building a low plinth around the south and east walls (Figs 31 and 32). The floor has flagstone on which do not appear to be as worn as those seen in Rooms G1 and 2 so may be a later insertion. The wide fireplace has a modern stove set into the grate. The wooden beam running from north to south may be modern, or masking the original, as it is fixed in place with modern bolts. The first floor joists have been exposed. On the north wall the stripped stonework allows the blocked and modified window to be seen as was discussed above. However, the

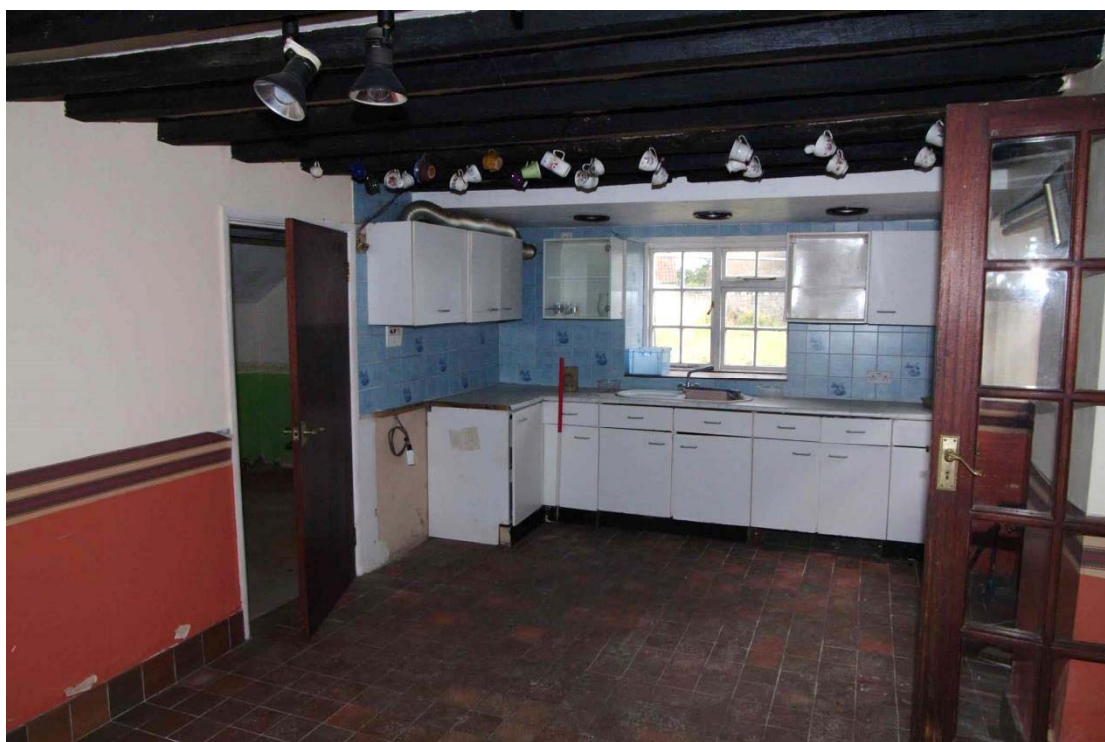
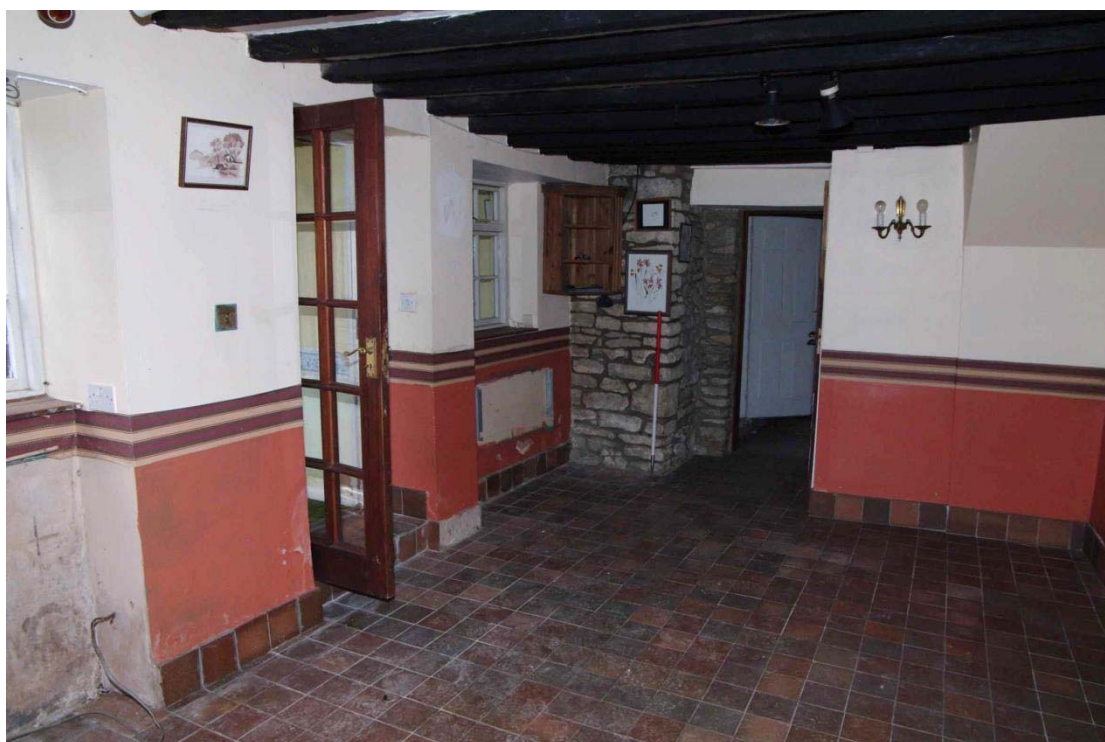
Figure 34: Ground floor, Room G6  
Looking east-north-east, 1m scale. Door to Room G7 on left, G5 doorway on right

Figure 35: Ground floor, Room G6  
Looking south-west, 1m scale

Room G6 is presently used as the main kitchen and fills the ground floor of the northernmost of the two wings (Figs 34-35). The room width splays outwards towards the east (see plan Fig. 20). The splay is caused by the slight change in angle of the east wall of the main house which may be the result of earlier rebuilding or alterations. The floor tiles and kitchen fittings are all modern and mask any earlier details. As in Room G4 the ceiling has been removed to expose the floor joists. A low doorway on the north wall leads into the lean-to extensions G7 and G8 whilst a door in the south-west corner leads into Room G1. In the north-west corner of the room is an enclosed stair case with narrow wooden treads leading up to the first and second floors (Fig. 36). The narrow nature of the stairs, which curve round to the east, suggests that they were built for servants.

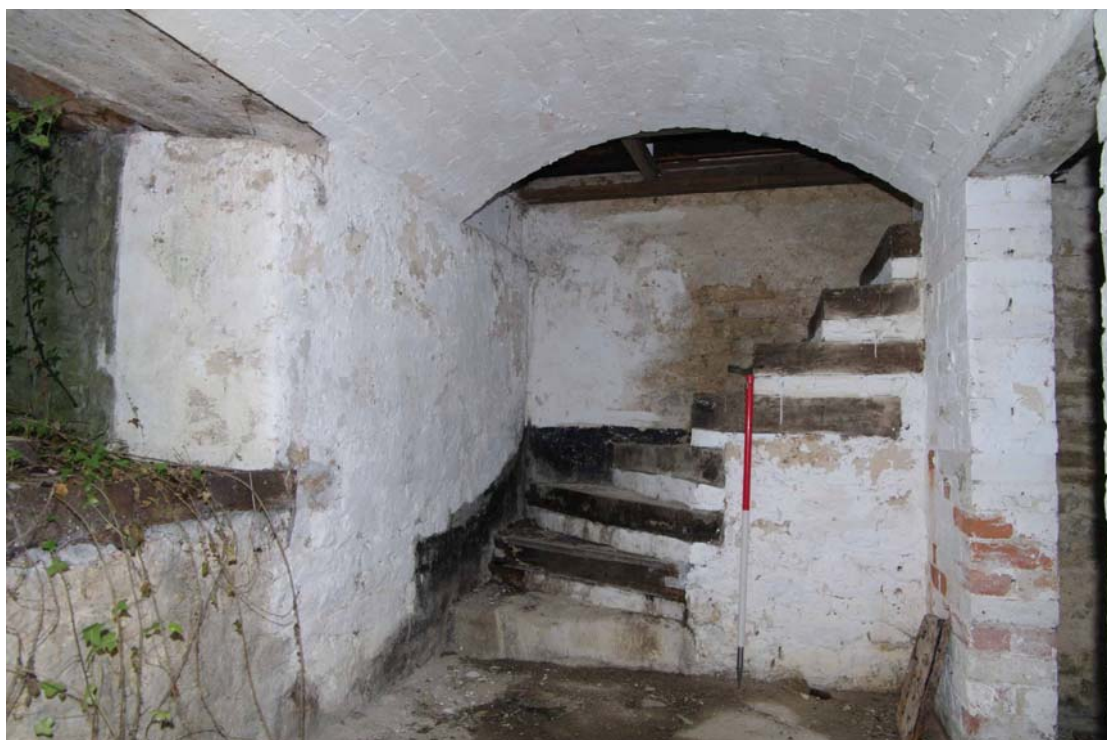
Figure 38: Cellar, south room  
Looking west, 1m scale

The small cellar only fills the space below Room G4. The wall is lined with limestone rubble and limestone flagstones are used on the floor (Figs 38 and 39). The space is divided into two by an east to west brick wall and the ceiling of each has a brick barrel vault. Around the floor on the northern room is a low stone plinth. A recessed opening on the north and south walls allows a small amount of light and ventilation into the cellar. There are no cellars below any of the other ground floor rooms.

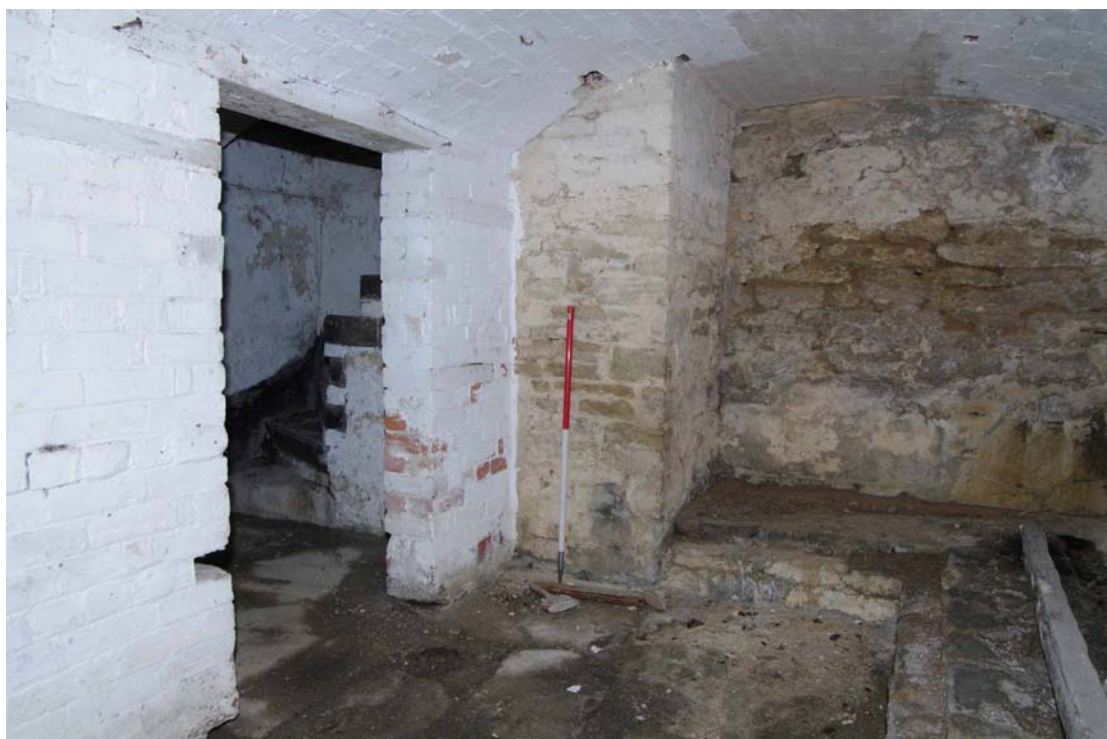
Figure 39: Cellar, north room  
Looking south-west, 1m scale

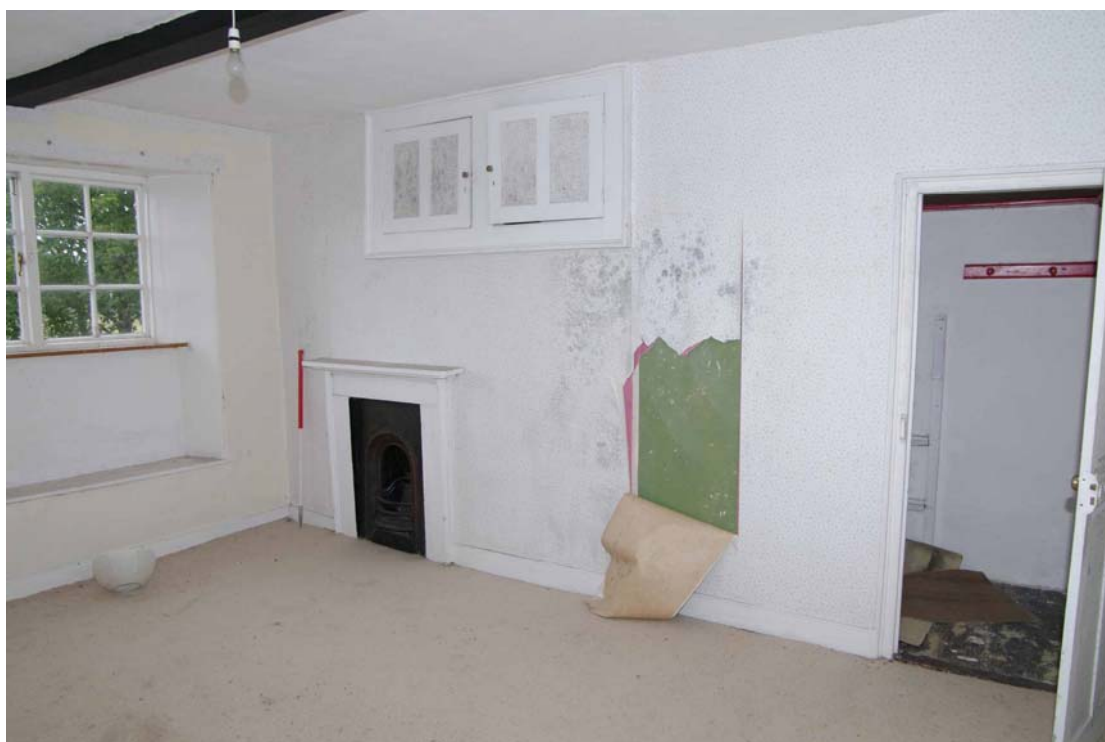
Figure 41: First floor, Room F1  
Looking north-west, 1m scale

Room F1 is set at the northern end of the house. It is slightly shorter than the ground floor Room G1 directly below due to the massive chimney breast above the ground floor fireplace (Figs 41 and 42). The casement window on the west wall is set into the upper half of a larger recess (see Fig. 41) and has a chamfered east to west beam set into the wall above it. Around the window recess is a single beaded moulding to break the sharp angle of the plaster. The door into the room is set at an angle in order to accommodate the doorway into Room F3 in the northern rear wing. The door is four-panelled and is likely to be early to mid-19th century with fittings to match (Fig. 43). The framing around the doorway is built using wooden boards. In the north wall, which is supported by the bressumer on the floor below, is a small, probable 19th century, fireplace with recessed cupboards set into the wall above it. To the east of the fireplace is a large walk-in cupboard which fits around the large chimney breast. Inside the cupboard are two sets of wooden coat pegs fixed to wooden battens which are consistent with 18th century examples (Fig. 44). Peeling wallpaper reveals the plaster was painted a pale green before the first layers of wallpaper were applied.

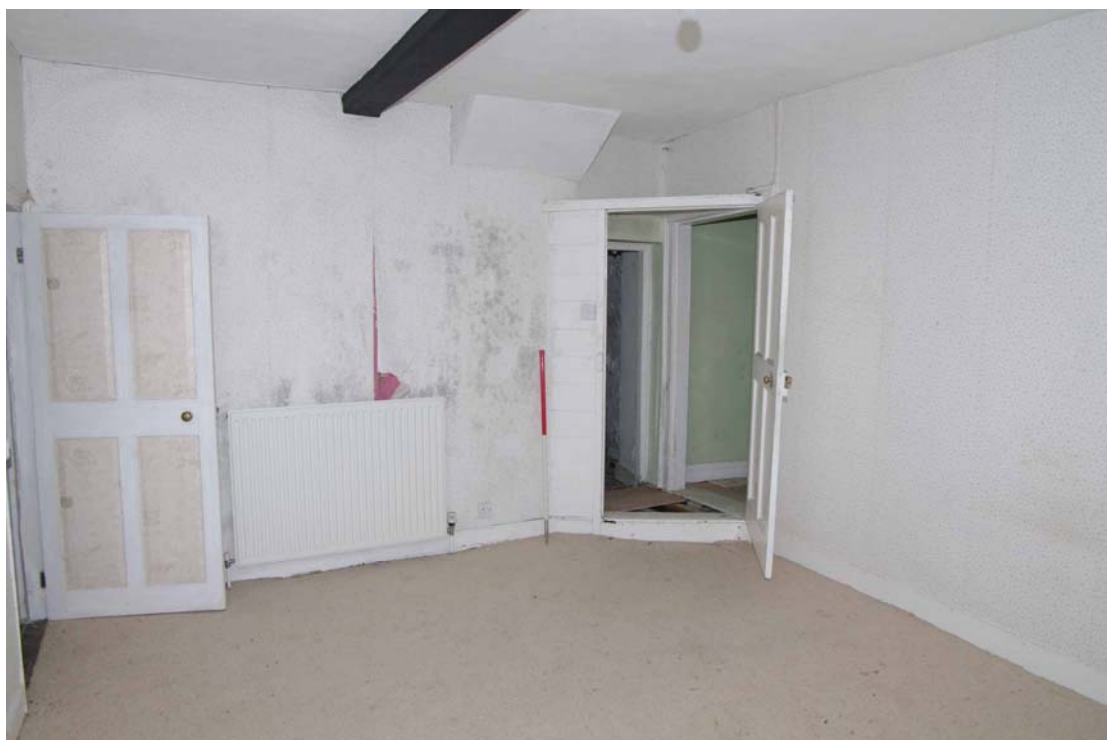
Figure 42: First floor, Room F1  
Looking north-east, 1m scale
