**A Level 2 Historic Building Record  
And watching brief at Middle Farm  
House and  
Associated Barns  
Main Street,  
Upper Benefield,  
Northamptonshire**

ULAS Report No. 2017-005  
©2017

**A Level 2 Historic Building Record  
and watching brief at Middle Farm House  
and Associated Barns,  
Main Street, Upper Benefield,  
Northamptonshire.**

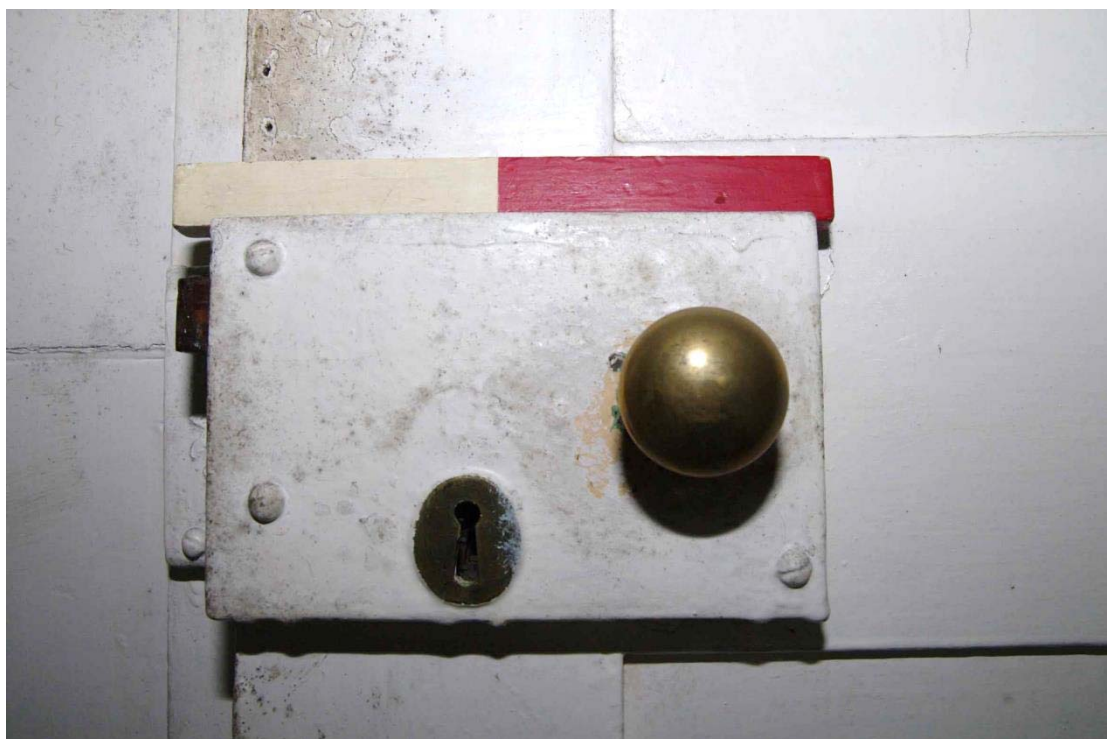
Figure 43: First floor, Room F1. Door lock detail  
20cm scale

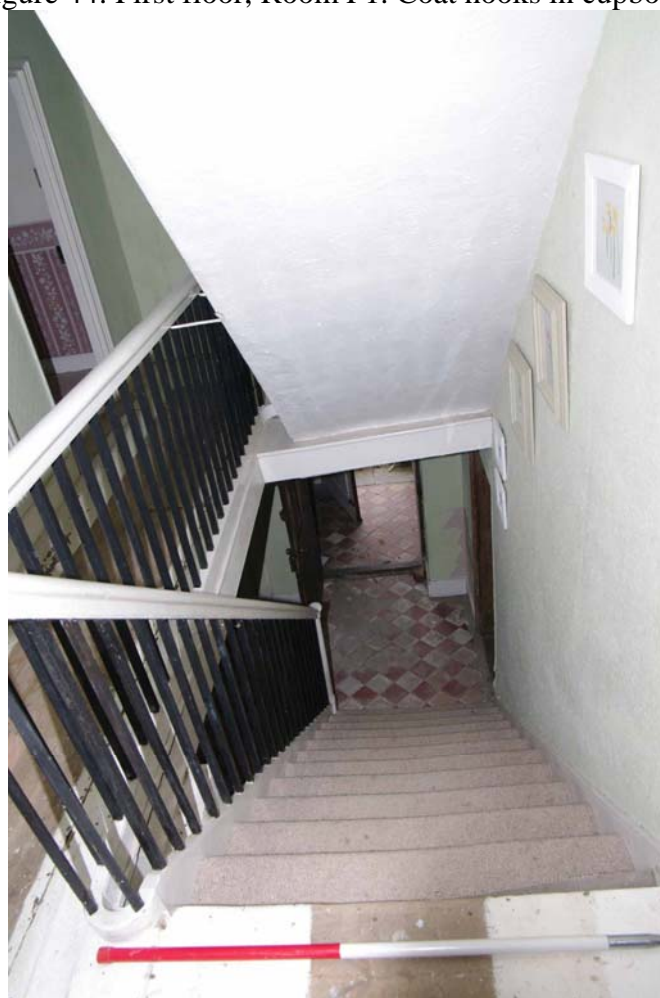
Figure 45: First floor, Room F2. Staircase  
Looking west, 1m scale

Room F2 consists of the staircase, landing and corridor leading to the other rooms (Figs 45 and 46). The stairs also lead up to the attic rooms. An awkwardly shaped space to the north-east of the stairs leads into Rooms F1 and F3.

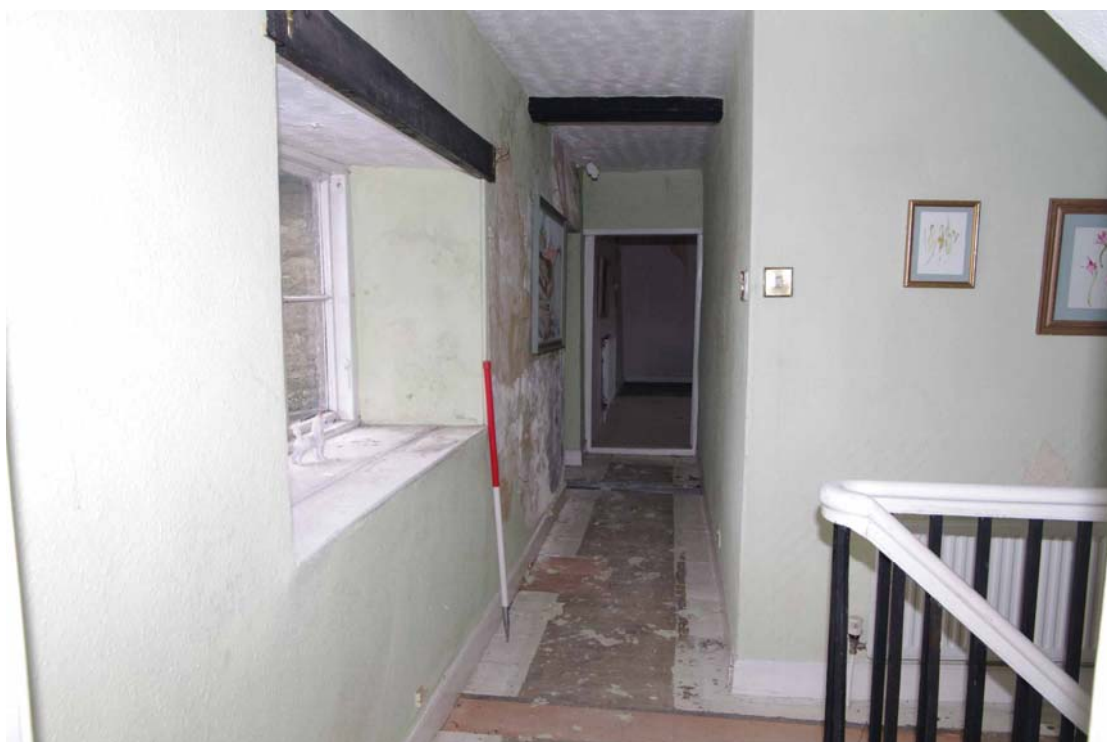
Figure 46: First floor, Room F2  
Looking south, 1m scale

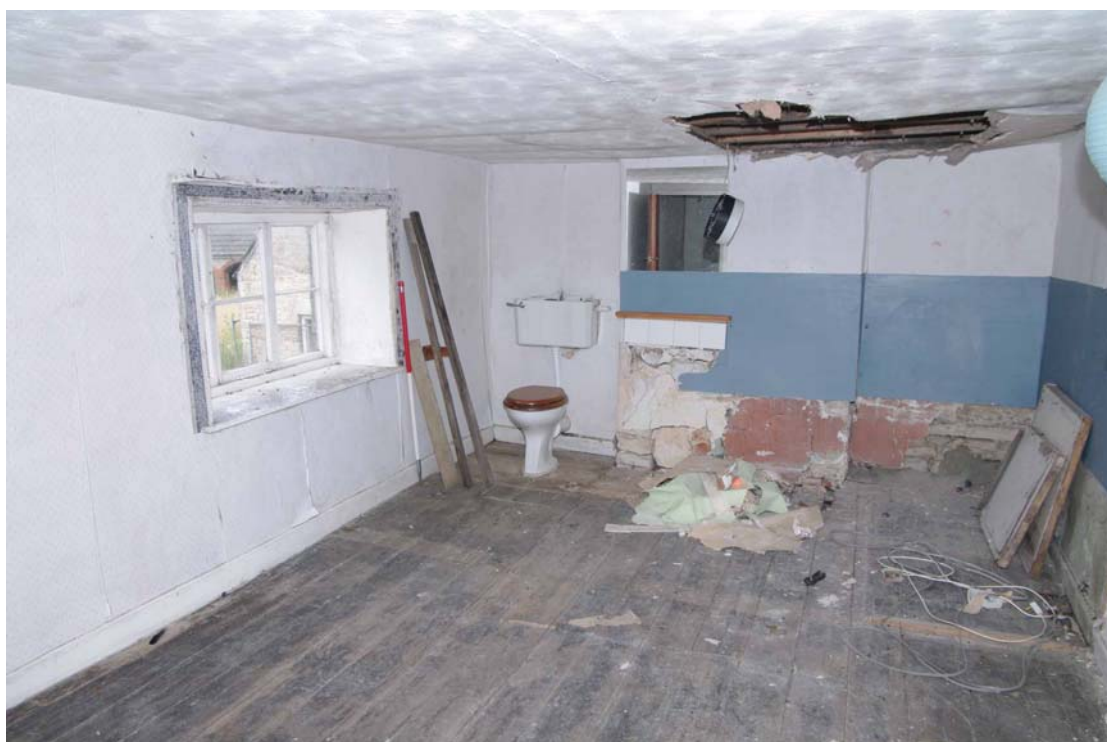
Figure 47: First floor, Room F3  
Looking south-east, 1m scale

Room F3 is the first floor room of the northern rear wing and, until recently, has functioned as the toilet and bathroom (Figs 47 and 48). The floor level is slightly lower than the main house resulting in a shallow step down from Room F2. The 0.17m wide floorboards appear to have machine cut or stamped nails which are likely to date to the 19th century. Unlike the main house the ceiling is much lower which may suggest that this room was for domestic staff or younger members of the family. The narrow staircase from Room G6 is behind a small door in the north-west corner which means that the occupants of this room would have suffered from a lack of privacy unless an internal wall has since been removed. The narrow stairs continue upwards to the attic rooms (Fig. 49). There is evidence in the east wall of a small blocked opening for a fireplace which has been removed. Both doors are modern late 20th century as are the door fittings.

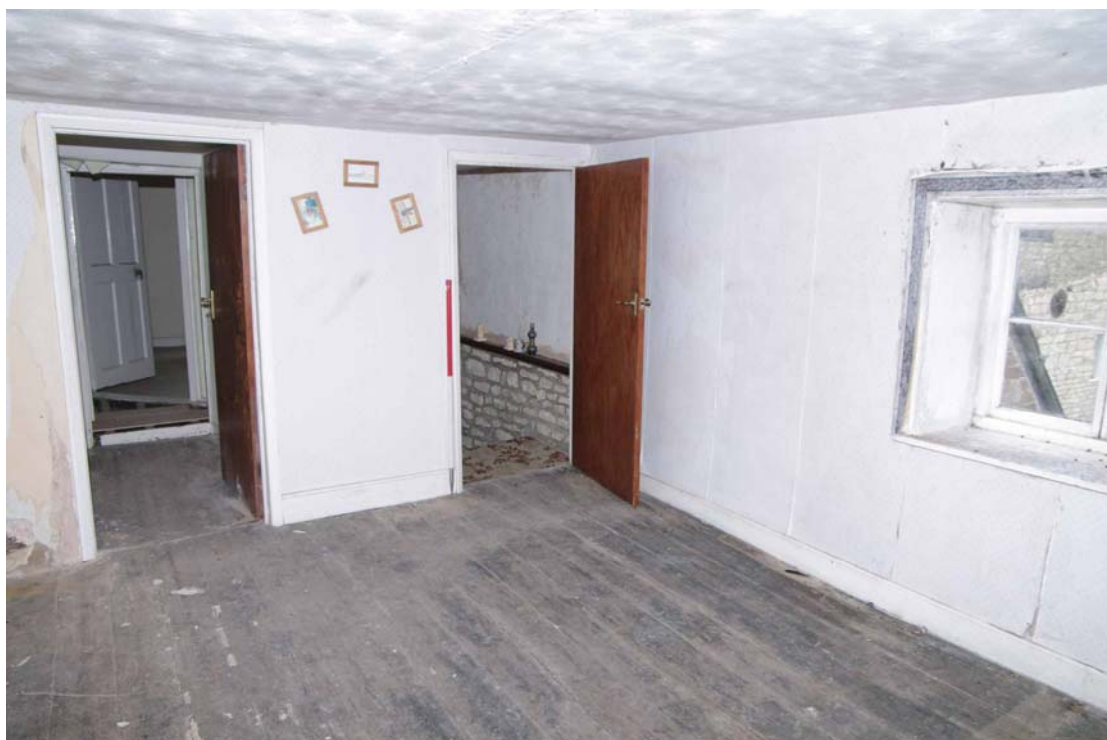
Figure 48: First floor, Room F3  
Looking north-west, 1m scale

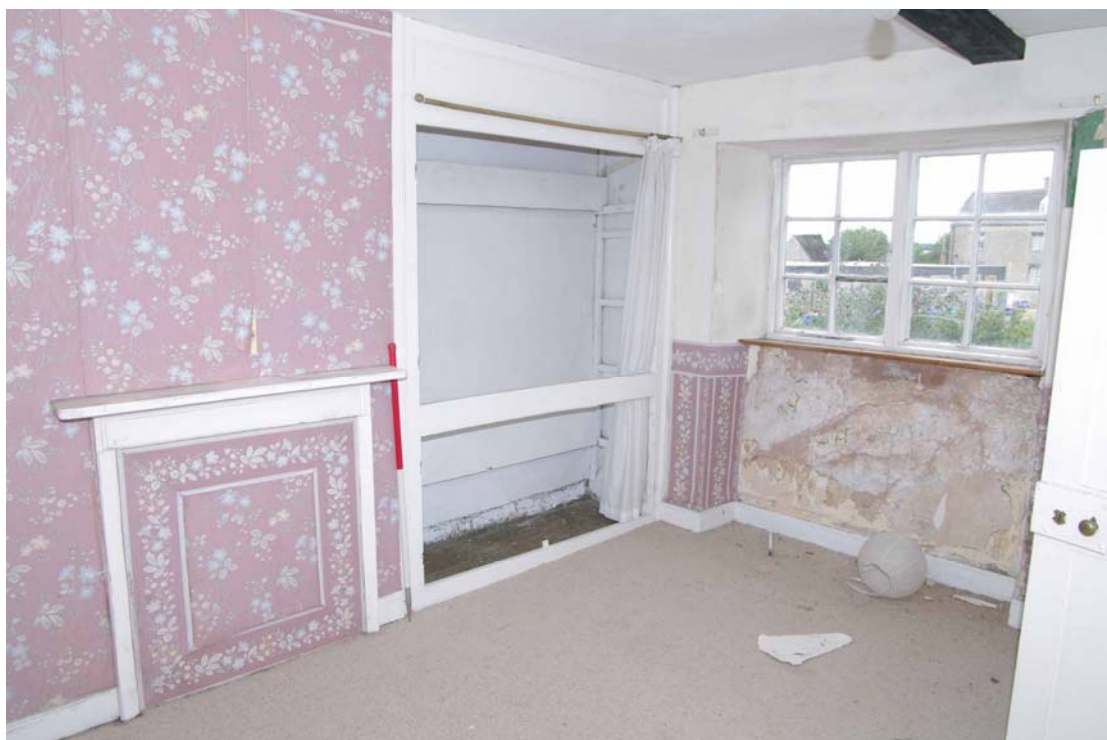
Figure 50: First floor, Room F4  
Looking south-west, 1m scale

Room F4 has a wooden framed partition wall forming its north and eastern walls which create a fairly small rectangular room with a blocked offset fireplace on the south wall (Figs 50 and 51). The recess on the west side of the chimney breast appears to have once been a long shallow cupboard as there are traces of shelf supports. The doors for this cupboard are missing. The window is set in a full-height recess as seen in Room F1. The four-panelled door and catch are the same as in Room F1 and Rooms F5 and 6.

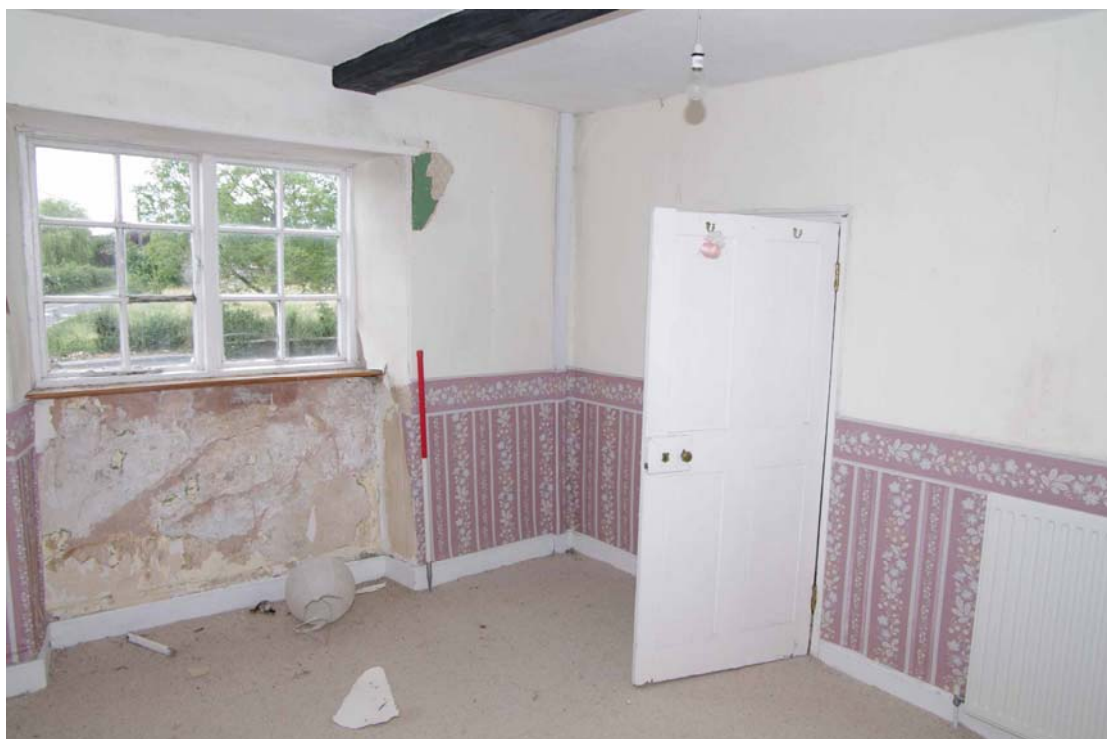
Figure 51: First floor, Room F4  
Looking north-west, 1m scale

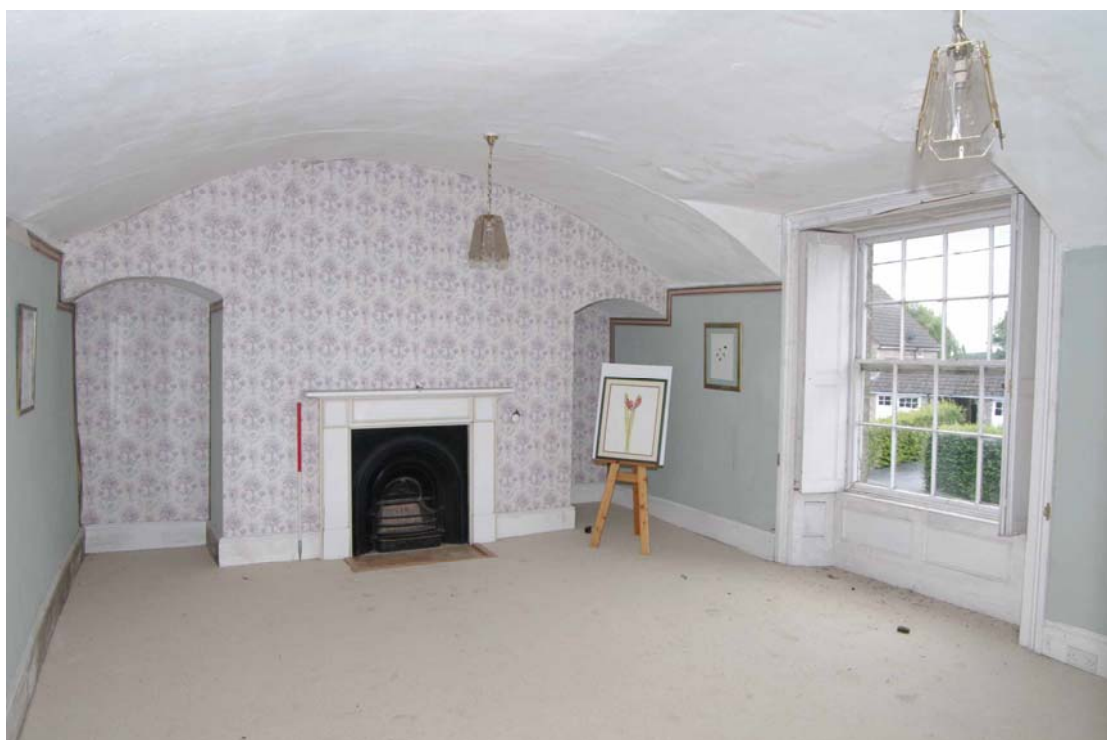
Figure 52: First floor, Room F5  
Looking south-east, 1m scale

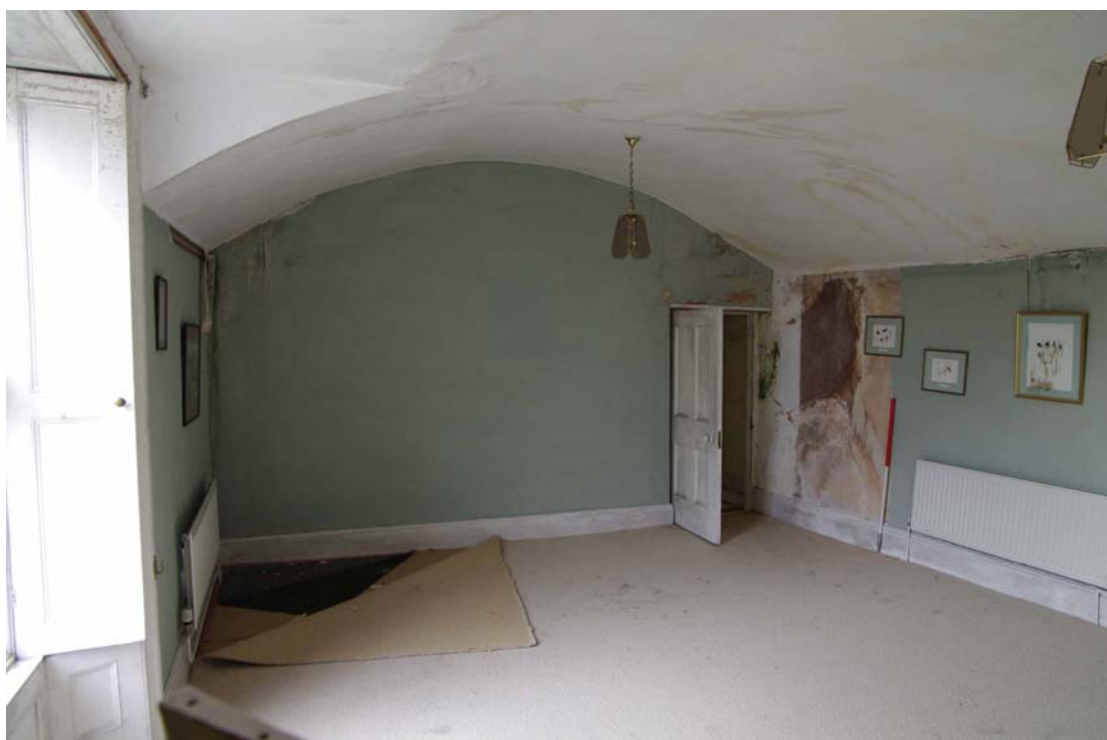
Figure 53: First floor, Room F5  
Looking north-west, 1m scale

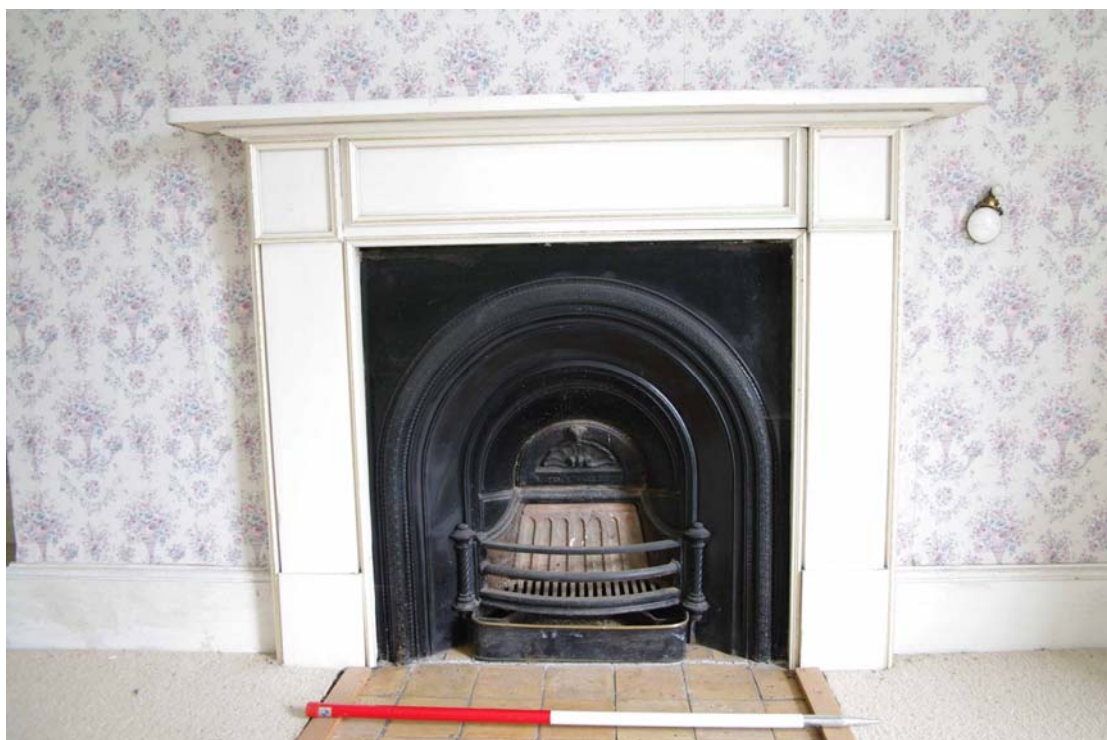
Figure 54: First floor, Room F5. Fireplace  
Looking west, 1m scale. Note bell pull to right of fireplace

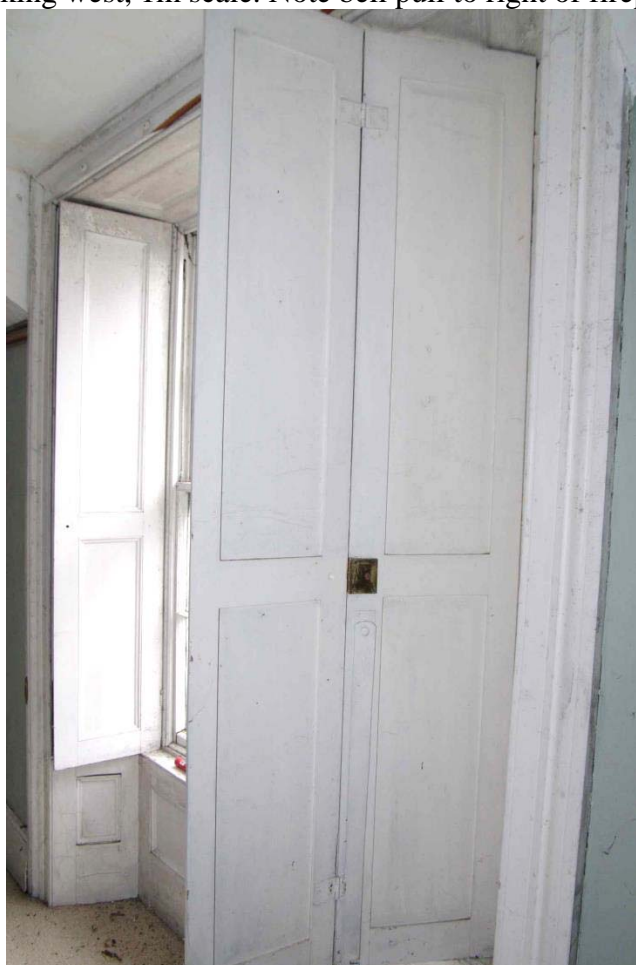
Figure 55: First floor, Room F5. Shutter detail

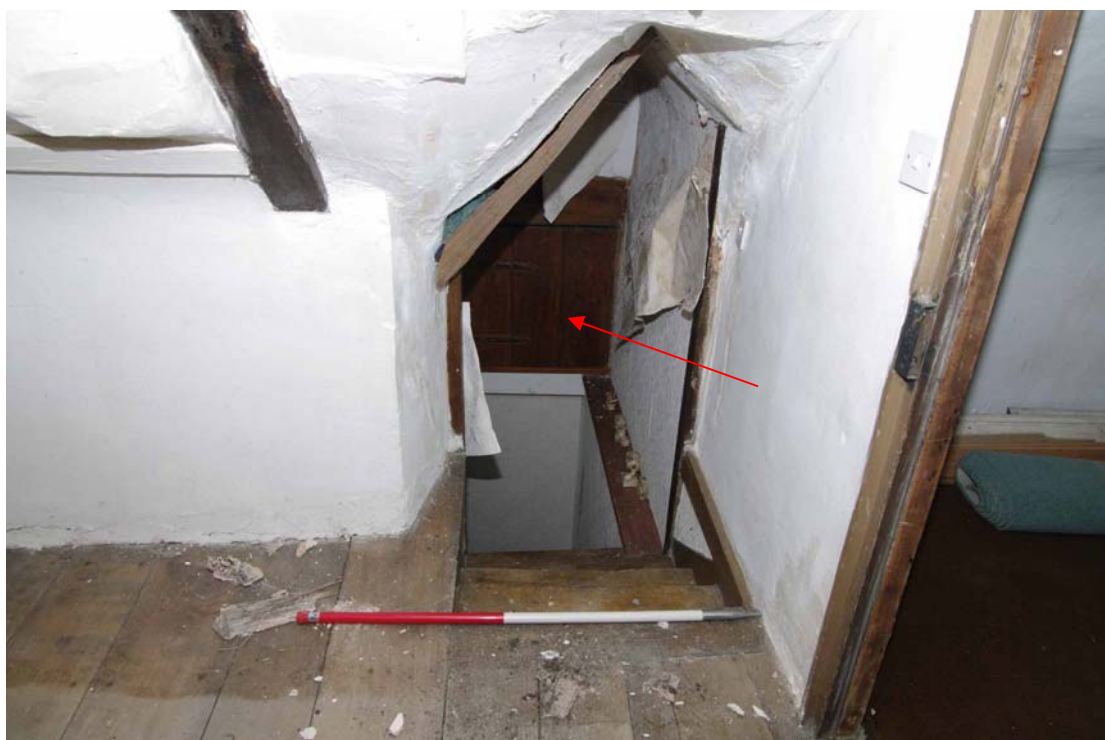
Figure 57: Second floor. Servant's staircase up from F3 into Room S1  
Looking east, 1m scale. Note access hatch (arrowed) to roof space of north wing

Only the main house has a second floor which is built into the roof space (Fig. 56). The narrow servant's staircase partially uses the roof space of the northern wing in order to gain enough headroom to enter Room S1. A small access hatch is located above these stairs but it was not deemed safe to enter this area during the survey (Fig. 57). It was not possible to investigate the roof structure in either wing.

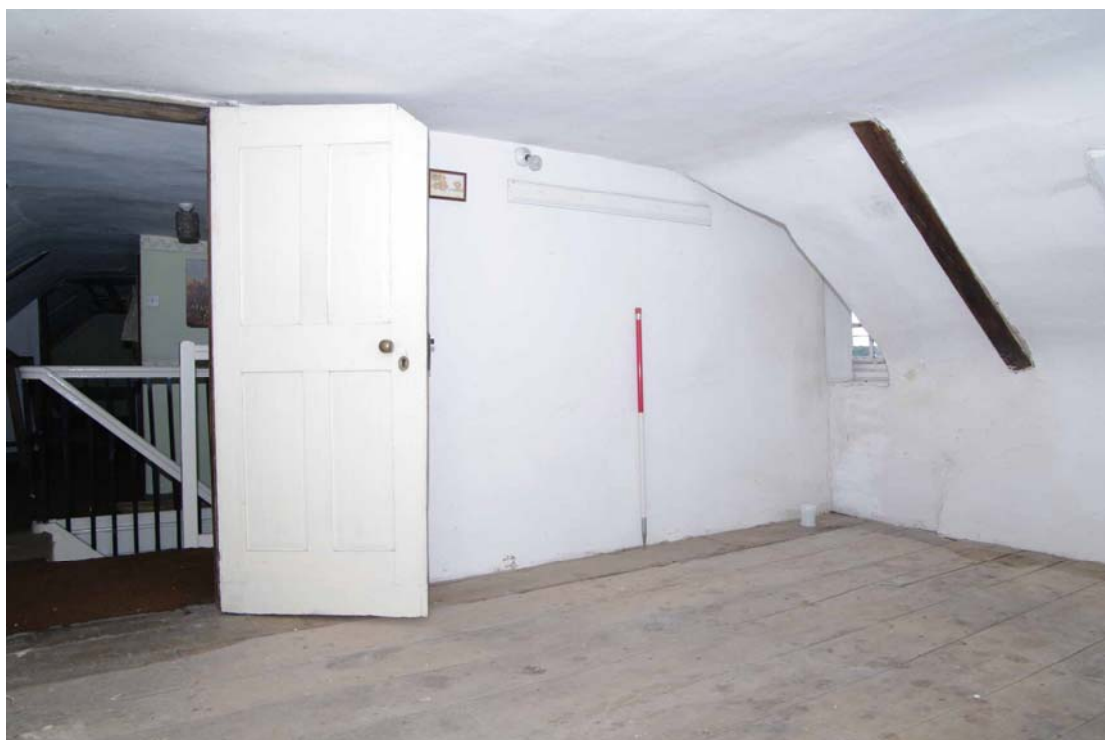
Figure 58: Second floor, Room S1

Looking south-west, 1m scale. Note batten with sawn-off wooden hooks above scale. Also note bisected dormer window lighting this room and the adjacent room

Room S1 has a low ceiling which follows the roofline and has partially exposed principal rafters (Figs 58 and 59). A plaster and lath wall on the south side of the room bisects the dormer window which it shares with the adjacent room and creates a quite dark space. The door on the south wall has four panels but does not have any moulded detail around the panels as seen on the doors on the first floor. The top corner of the door has been sawn off in order to fit the angle of the sloping ceiling but the doorframe is square which leaves a gap when the door is shut. The stairs down to Room F3 are open and would create quite a hazard in the dark. The floorboards are a range of widths with many tapering and which appear to be offcuts. A chamfered batten on the south wall has had its wooden coat hooks sawn off but they were presumably similar in style and date to those seen elsewhere in the house. There is no evidence of a blocked fireplace in the chimney breast.

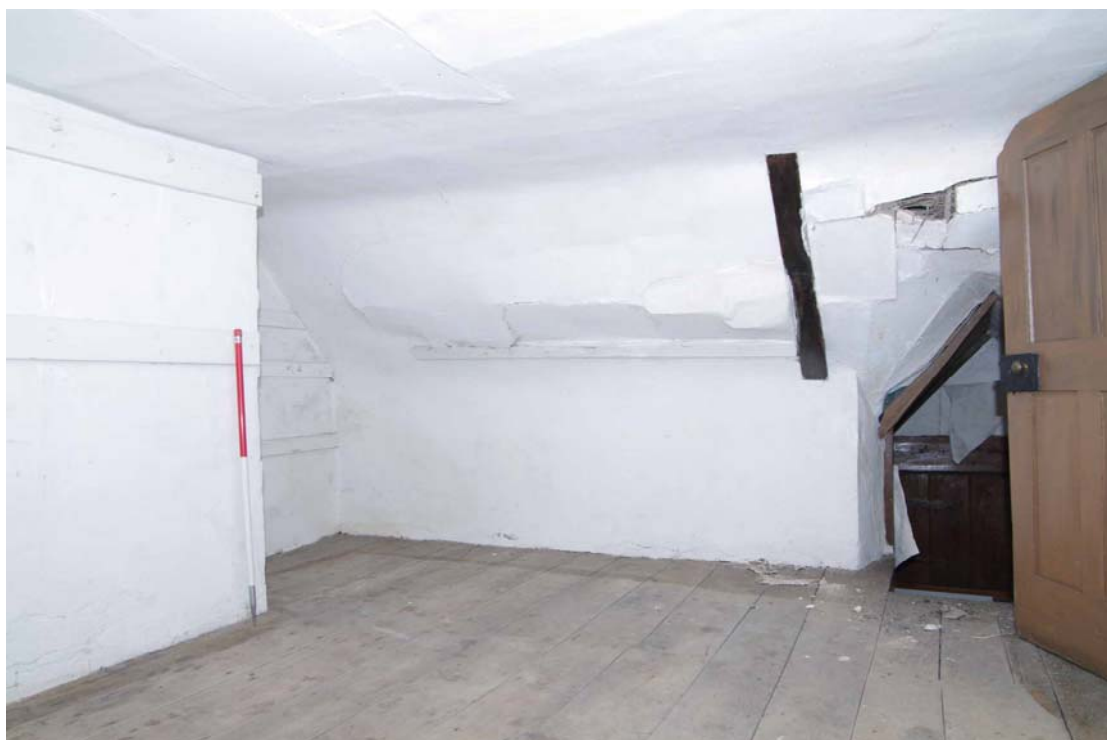
Figure 59: Second floor, Room S1  
Looking north-east, 1m scale. Stairs down to F3 to left of door

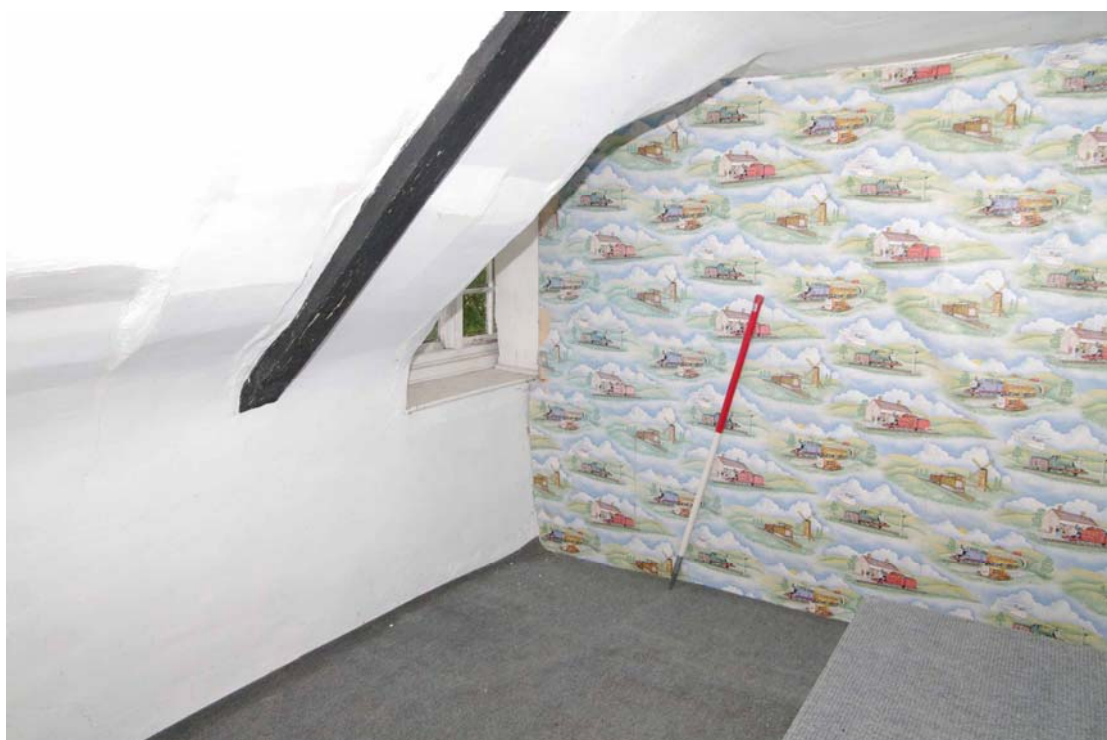
Figure 60: Second floor, Room S2  
Looking north-west, 1m scale

Room S2 is a small room fitted into the space above the main staircase and the dormer window which is partially shared with Room S1 (Fig. 60). It has a plain two-panelled door with a probable mid-19th century spring locking latch mechanism (Fig. 61). On the east wall is a leaded window which allows light into the stairwell and landing but minimises any privacy that the occupant of S2 may have wished for (Fig. 62).

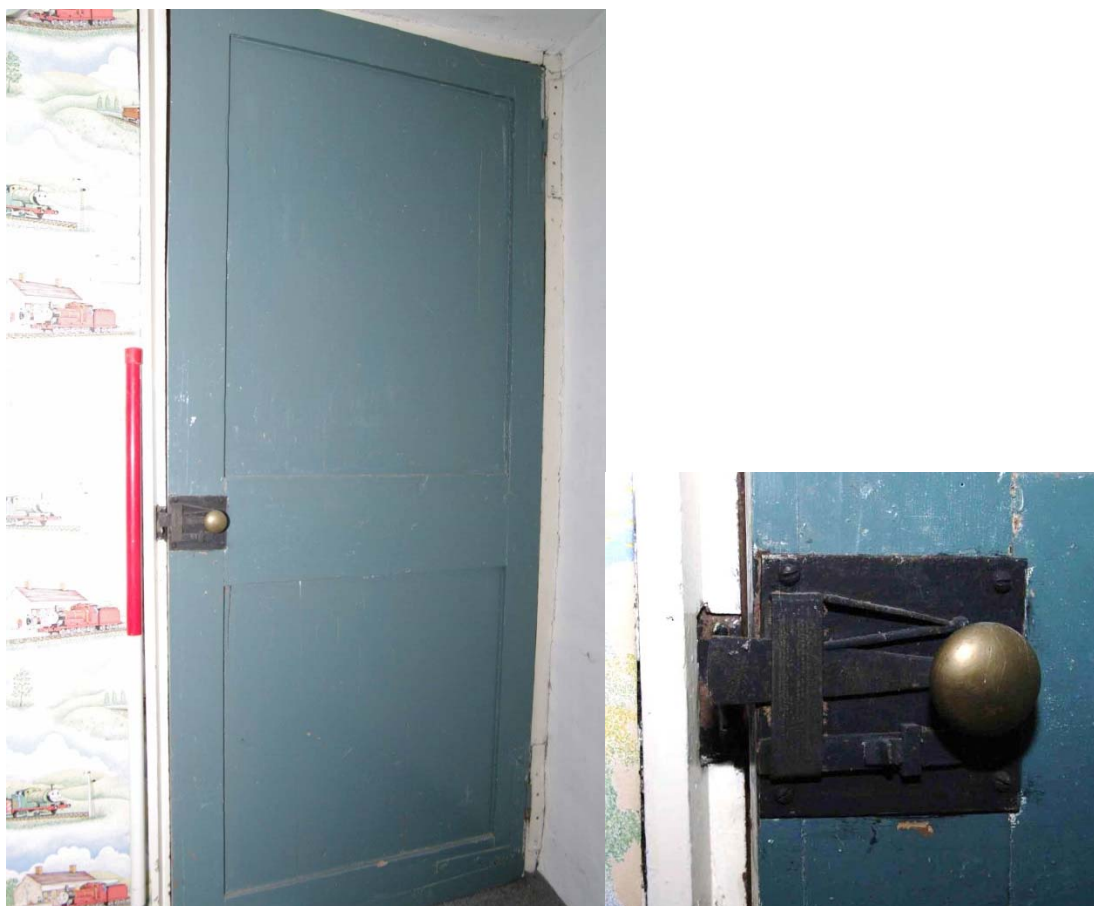
Figure 61: Second floor, Room S2. Door detail  
Looking east, 1m scale. Latch close-up on right

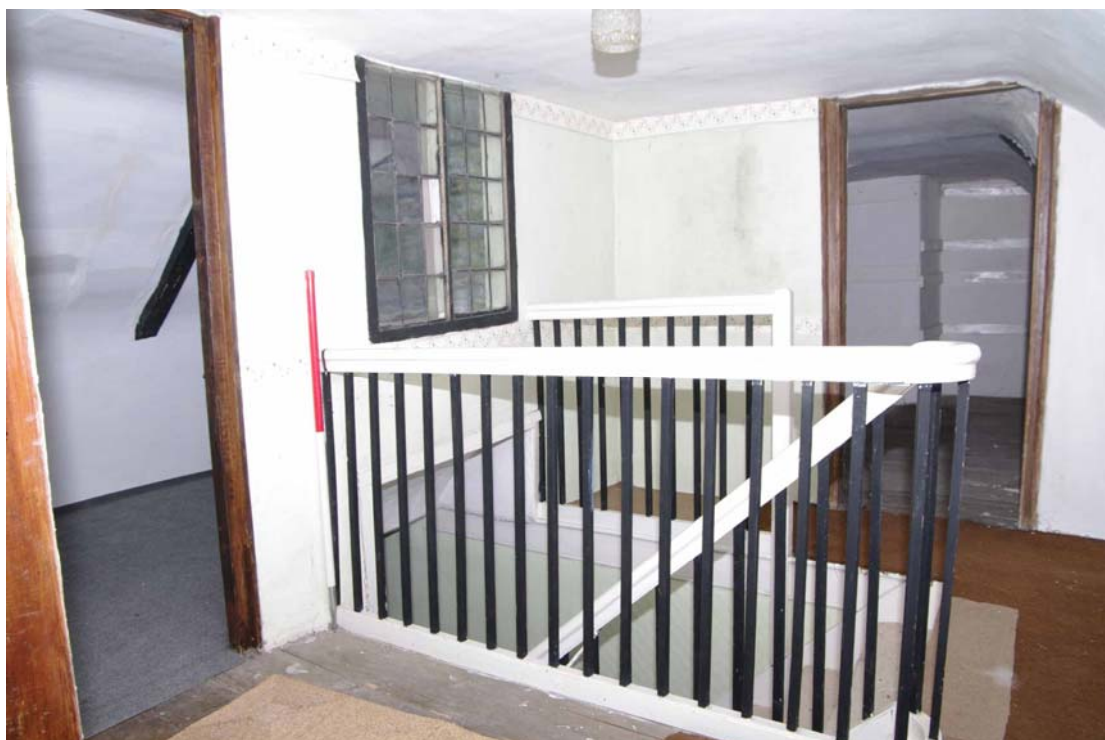
Figure 62: Second floor, outside Room S2  
Looking north-west, 1m scale. Door to room S1 on right

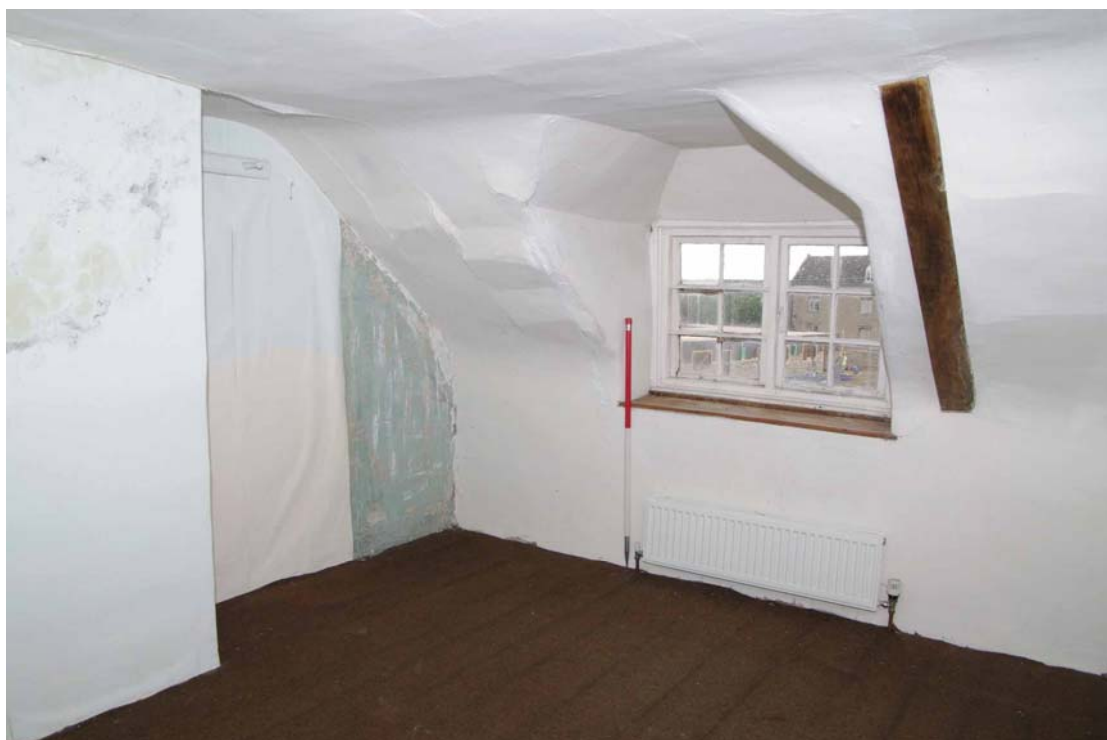
Figure 63: Second floor, Room S3  
Looking south-west, 1m scale

Room S3 is large enough to have its own dormer window and has the same plain door and lock as in Room S2 (Fig. 63). The chimney breast on the south wall does not have

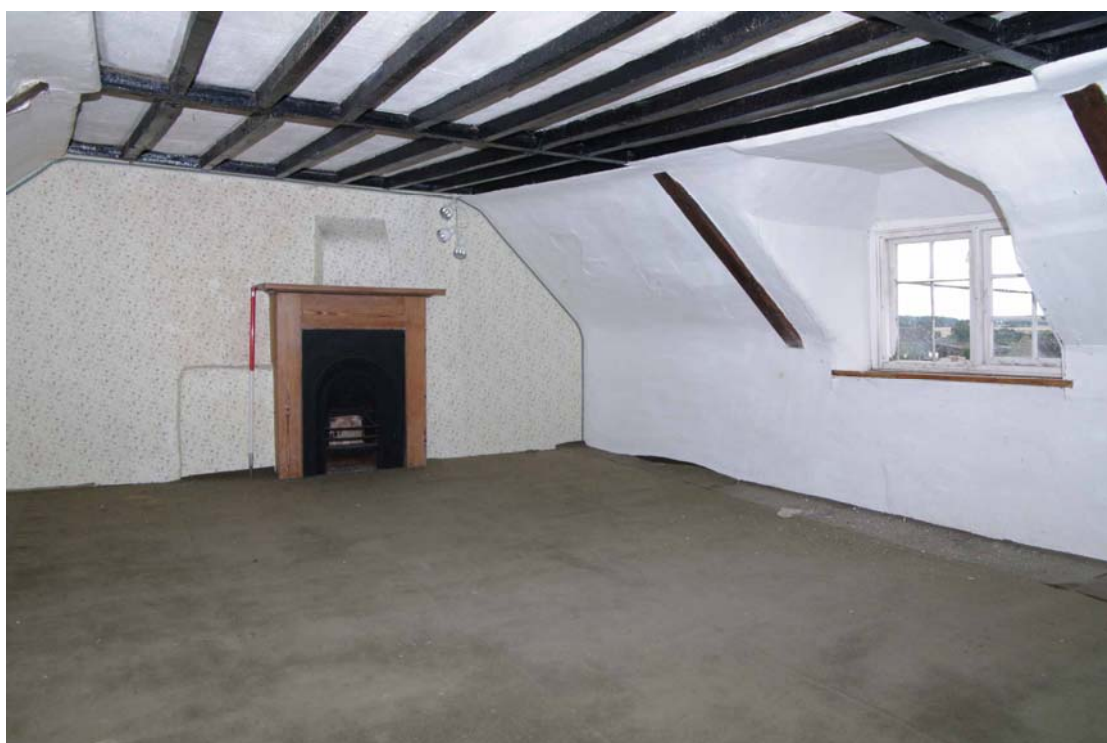
Figure 64: Second floor, Room S4  
Looking south-west, 1m scale

This is the largest and most well-appointed of the attic rooms. It has a fireplace at the south end and the door frame is shaped to accommodate the shape of the ceiling unlike in Room S1 (Figs 64 and 65). The door however is still the two-panelled plain variety. The ceiling has had the plaster removed to expose the timbers which are unlikely to have been on show when first built. There is no evidence of the removal of any dividing walls.

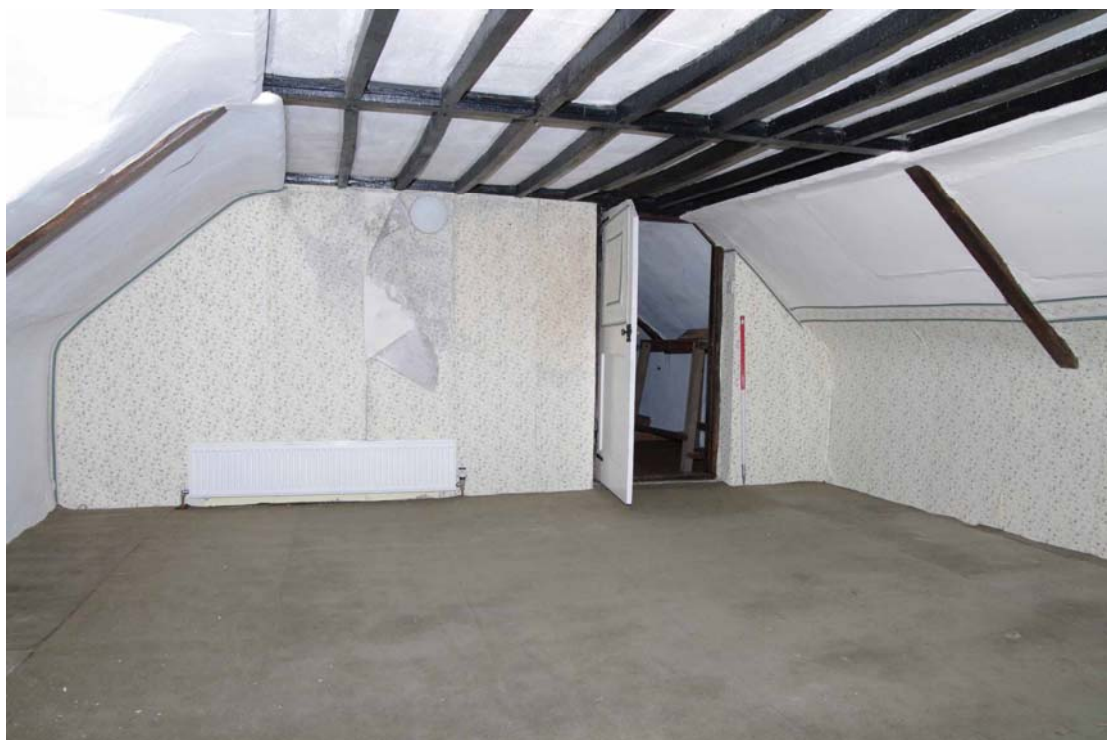
Figure 65: Second floor, Room S4  
Looking north-east, 1m scale

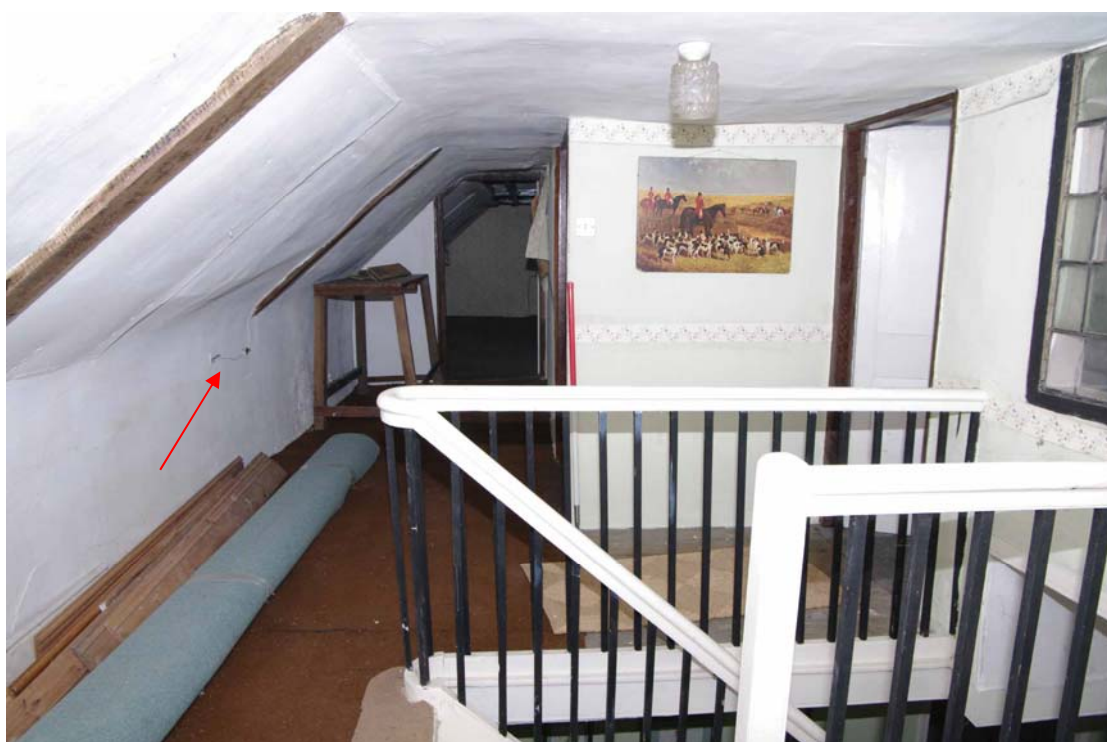
Figure 66: Second floor, landing S5  
Looking south, 1m scale. Arrow indicates location of bell pull. Main staircase in foreground. Room S2 on right of picture.

Room S5 is the landing which connects the second floor attic rooms and into which the main staircase enters (Fig. 66). The only natural light comes from the leaded light in the wall of Room S2. Low down on the eastern wall is the remnant of the bell-call system consisting of a wire and the spring from which the bell was suspended (Fig. 67). There is a curved mark in the plaster showing where the bell used to swing and rub. Presumably its location on the landing would be heard by all occupants on this floor which suggests that everyone here was part of the domestic staff.

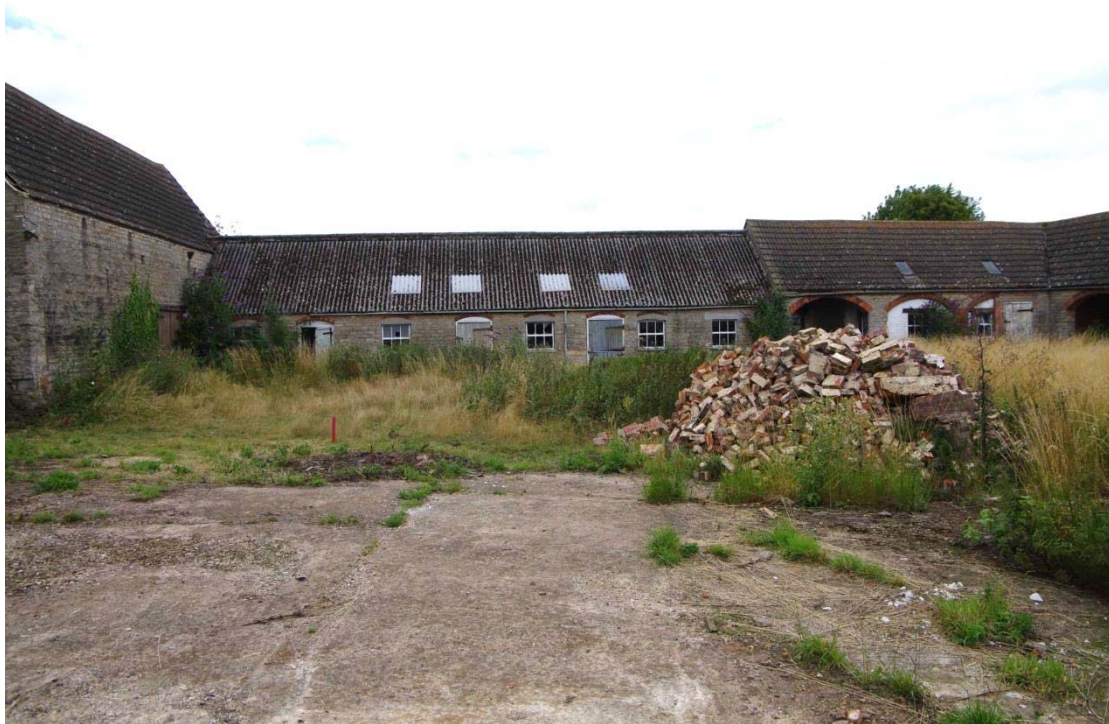
Figure 70: North range, south facing elevation  
Looking north

The north range of buildings is divided into two distinct components identified as ranges B and C in Figure 68 above (Fig. 69). Both are built from coursed limestone rubble and have mid to late 20th century roof coverings (Fig. 70). The western component (Building B) butts against the adjacent barn (Building A) to the west and has straight joints between the two buildings indicating non-continuous building phases. Building B has a corrugated sheet roof covering which has a lower ridge height than Building C to the west (Fig. 71). It is difficult to ascertain if Buildings B and C have the same construction date as they are separated by a wide covered gateway which has the same cement-tiled roof of Building C. However, no clear joint can be seen in the masonry on the gateway supporting pillars.

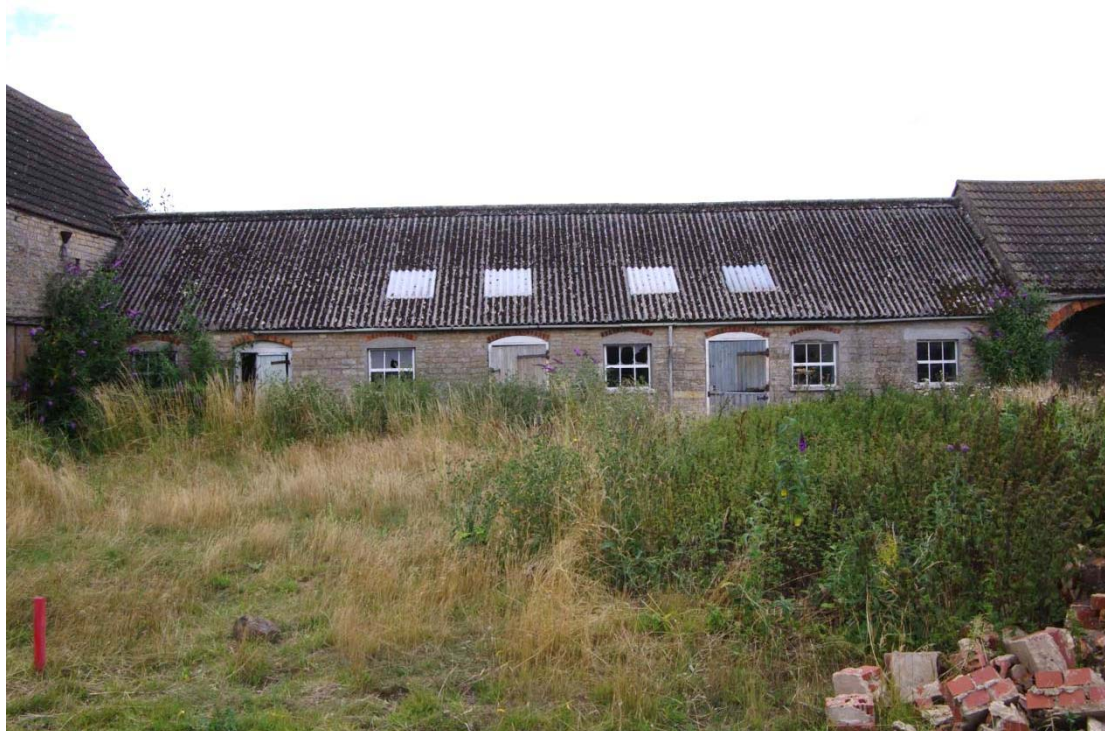
Figure 71: North range, western half of south facing elevation  
Looking north

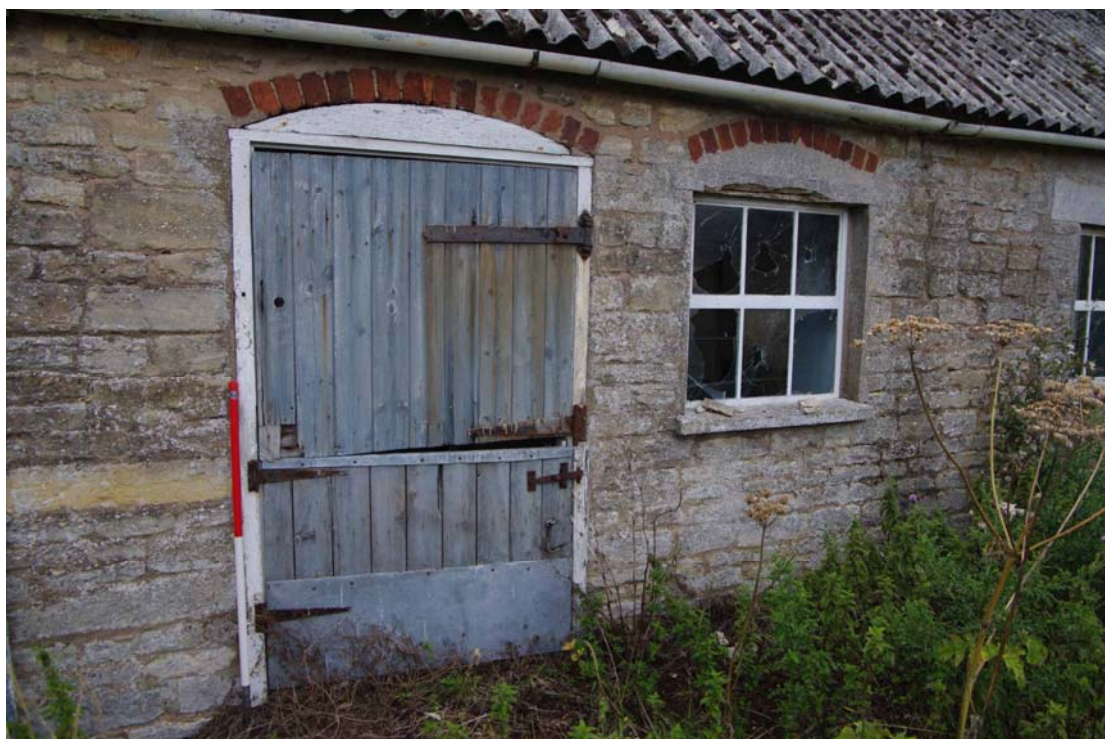
Figure 72: North range south facing elevation door and window detail  
Looking north, 1m scale

The south facing elevation of Building B has a series of rectangular windows and doors with arches above them formed by a single course of red brick headers. All of the openings appear to be original although the easternmost window has a concrete lintel suggesting a probable rebuild at some stage. The stable doors are made of narrow planks with strap hinges of mid-19th century design (Fig. 72). The east facing

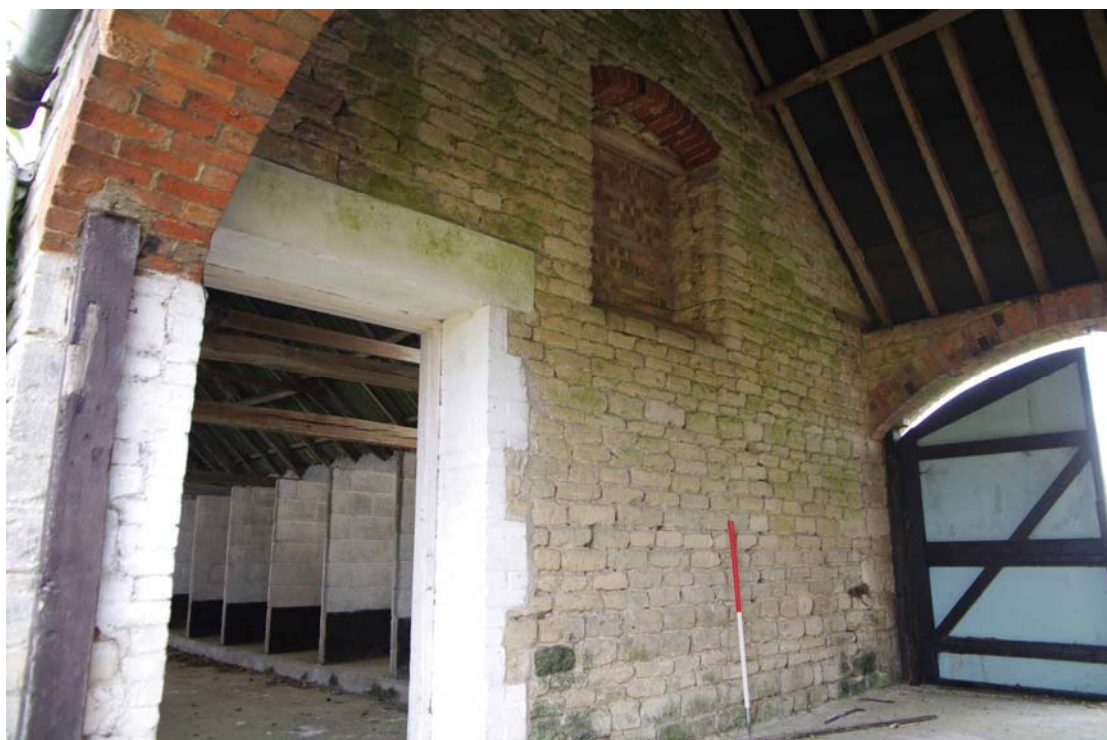
Figure 73: North range, east facing elevation of Building B  
Looking north-west, 1m scale. Note blocked window

elevation which looks into the covered gateway between this building and Building C has a blocked window set into the gable end (Fig. 73). The ground floor doorway on this elevation has brick jambs.
