**A Level 2 Historic Building Record  
And watching brief at Middle Farm  
House and  
Associated Barns  
Main Street,  
Upper Benefield,  
Northamptonshire**

ULAS Report No. 2017-005  
©2017

**A Level 2 Historic Building Record  
and watching brief at Middle Farm House  
and Associated Barns,  
Main Street, Upper Benefield,  
Northamptonshire.**

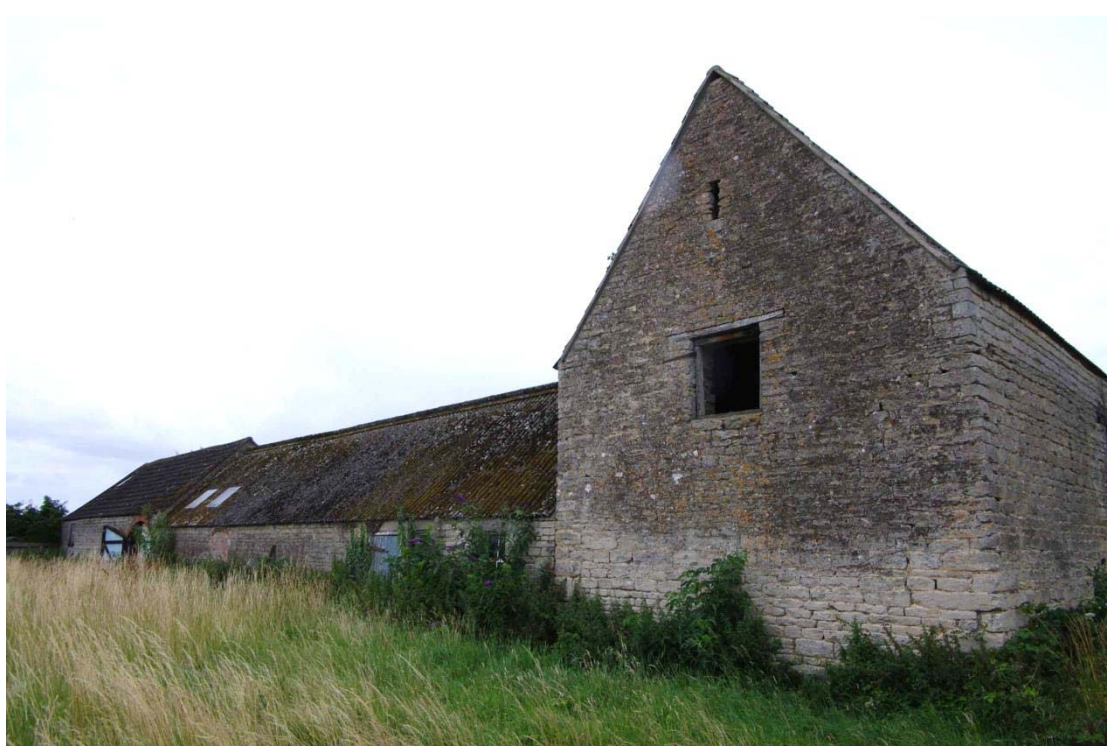
Figure 74: North range, north facing elevation  
Looking south-east. Building A on right, Building C on far left

The north facing elevation of Building B clearly shows the joint between it and Building A to the west which again may suggest slightly different building phases (Fig. 74). Two small windows and a door match the style of those on the south facing elevation but these do not have the arched brick heads. A blocked doorway towards the eastern end of the elevation has a brick arched head.

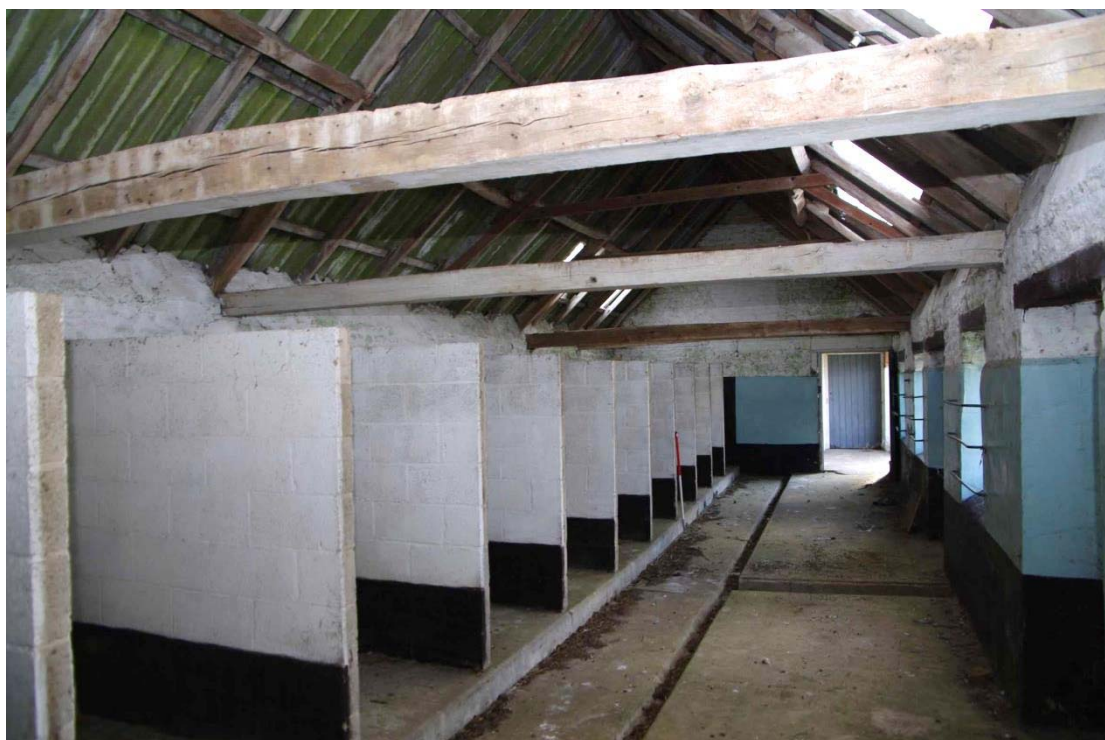
Figure 75: North range, Building B inside  
Looking north-east, 1m scale

Inside Building B the main space is divided into eleven stalls which are separated by modern breeze block walls (Fig. 75). The floor is concrete and was probably laid in the late 20th century at the same time as the breeze block stalls. One of the stalls obscures the doorway on the north wall, hence the reason for it being blocked. A brick-walled room has been inserted into the western end of the building and appears to be a later addition. The room is open to the raftered roof which is supported by tie beams and collars attached to the principal rafters (Fig. 76). The purlins are joined to the principal rafters using mortice and tenon joints which are also pegged. The use of joints and pegs suggests a mid-19th century design. The windows have metal bars set horizontally which were presumably intended to prevent animals pushing against them and damaging the window.

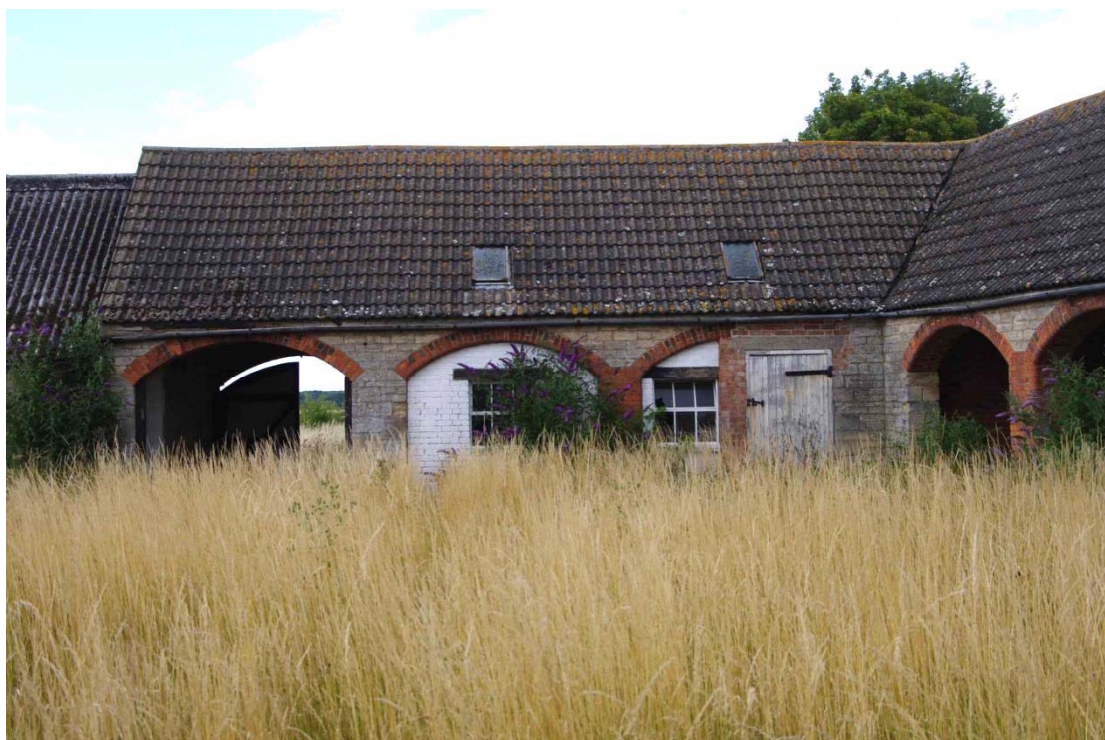
Figure 77: North range south facing elevation, Building C  
Looking north

Building C began life with three open arches on the south facing elevation (Fig. 77). The west opening forms the gateway out to the open fields as discussed but the two arches to the east have been blocked with brickwork into which windows and a doorway have been inserted. The open cart shed Building D obscures the eastern end of Building C. The north facing elevation of Building C is relatively plain and contains the gateway arch with a rectangular window at the eastern end which has been partially blocked to reduce its size (Fig. 78). There is no indication that the building extended northwards at this point as suggested on the 1885 Ordnance Survey map. It is possible that the map shows a small outbuilding which necessitated partially blocking the rectangular window.

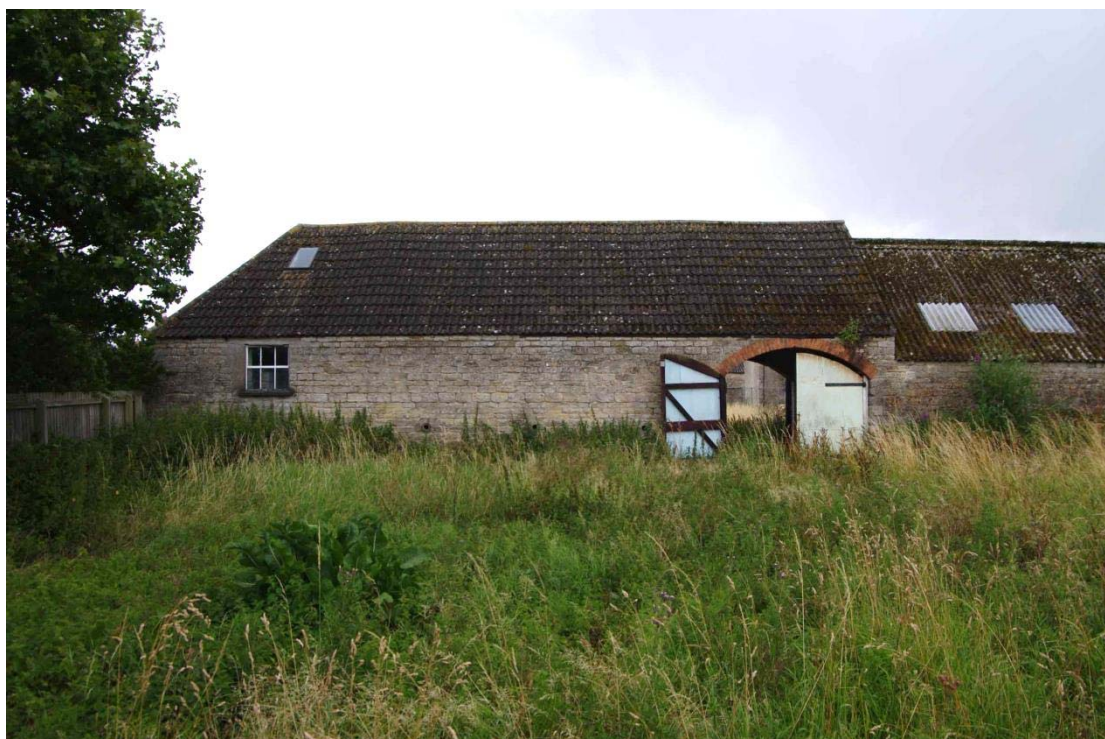
Figure 78: North range, north facing elevation, Building C  
Looking south

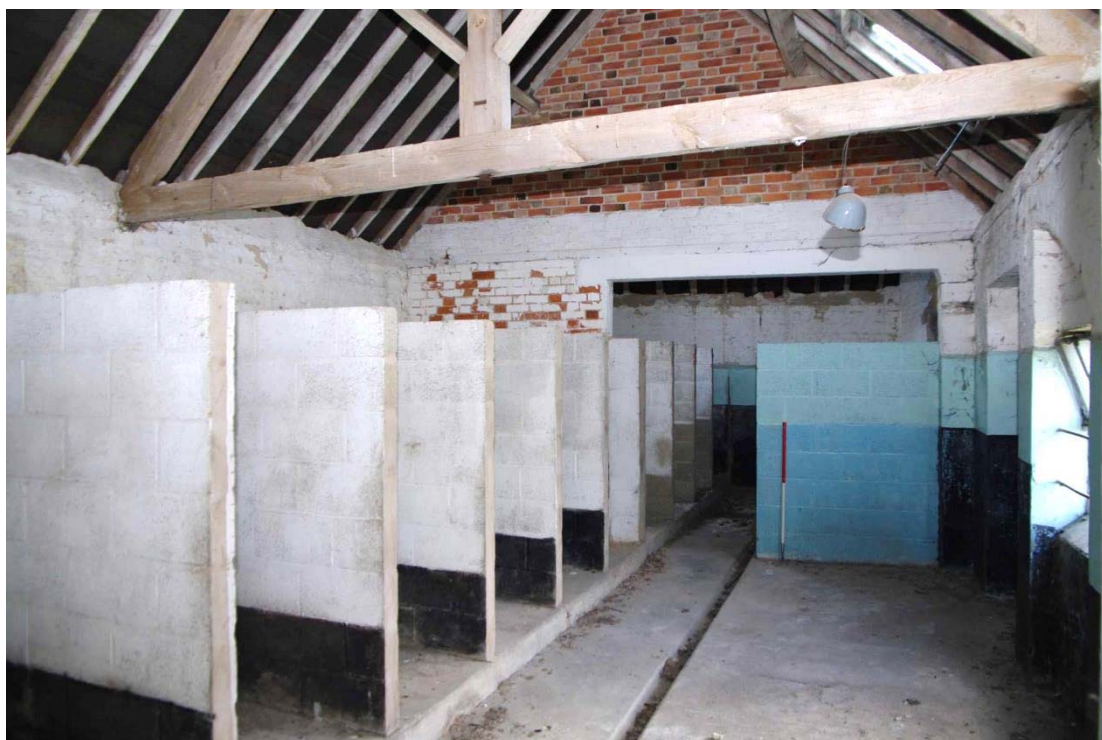
Figure 79: North range, Building C inside  
Looking north-east, 1m scale. Note supporting brick wall

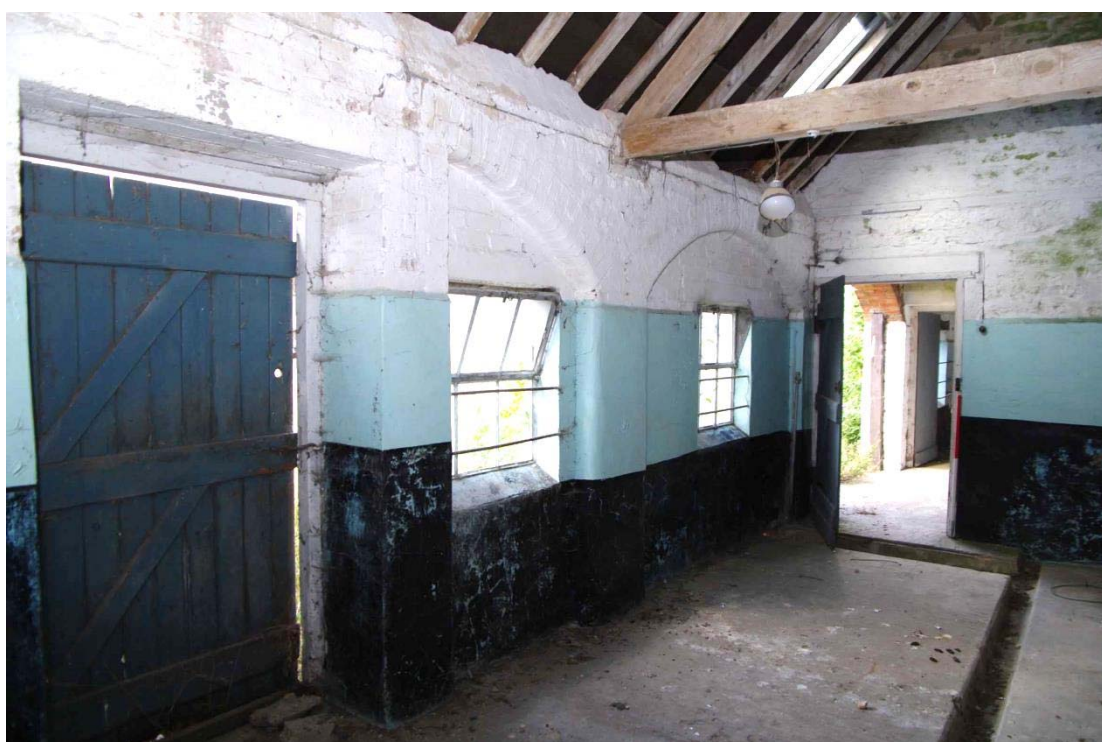
Figure 80: North range, Building C inside  
Looking south-west, 1m scale

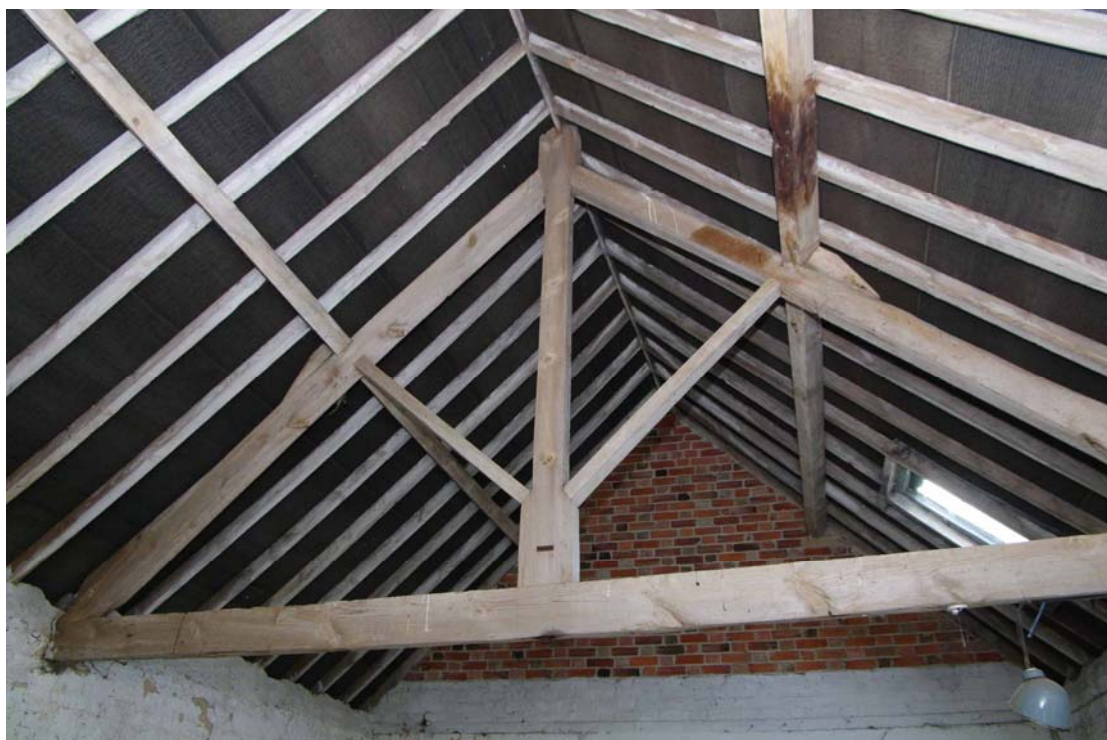
Figure 81: North range, Building C roof detail  
Looking north-east

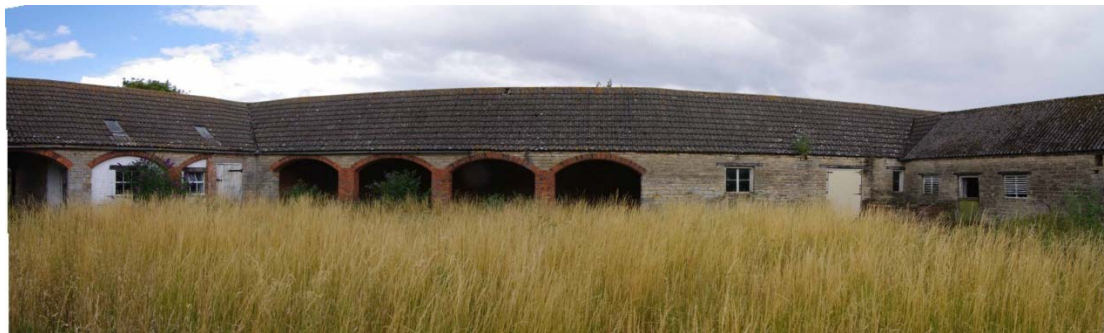
Figure 83: Panoramic view of East range  
Looking east. Image created from two photographs

The west facing elevation of Building E continues seamlessly from Building D despite the slight dip in the ridgeline (Figs 83 and 87). The doors and windows have flat timber lintels which have small stop chamfers. The wide door is a modern replacement but the fixed wood-framed windows appear to be original. The window frames are also pegged with wooden dowels and at least some of the wood has been

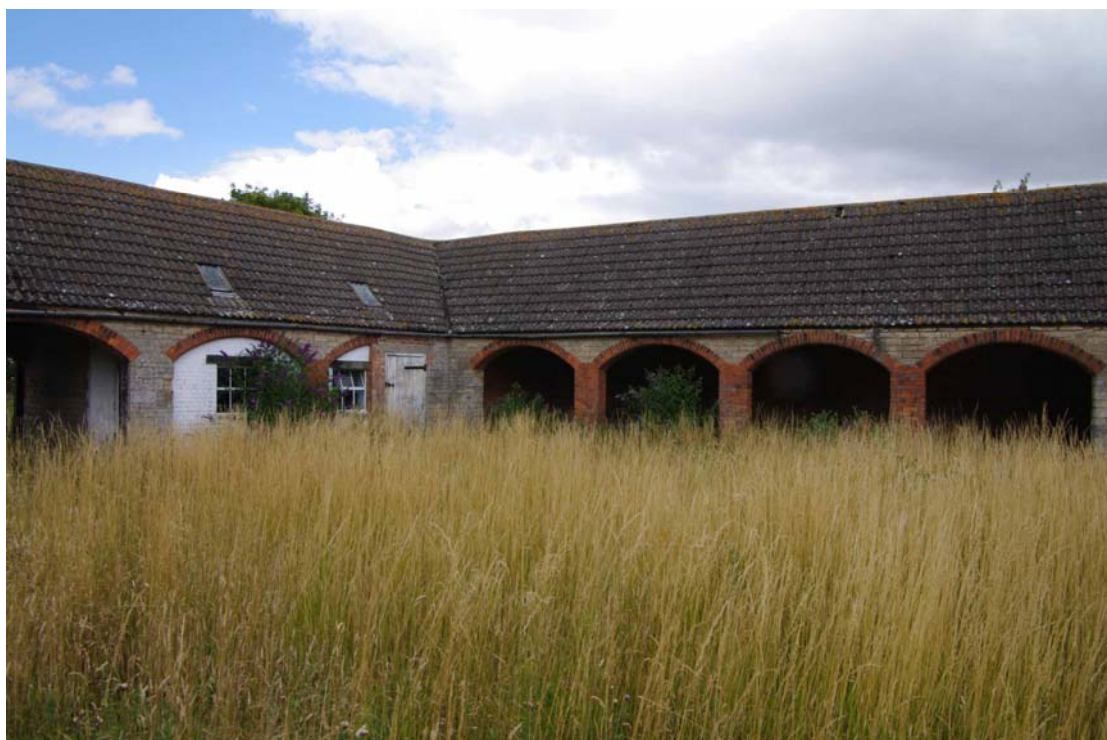
Figure 84: East range, Building D  
Looking north-east

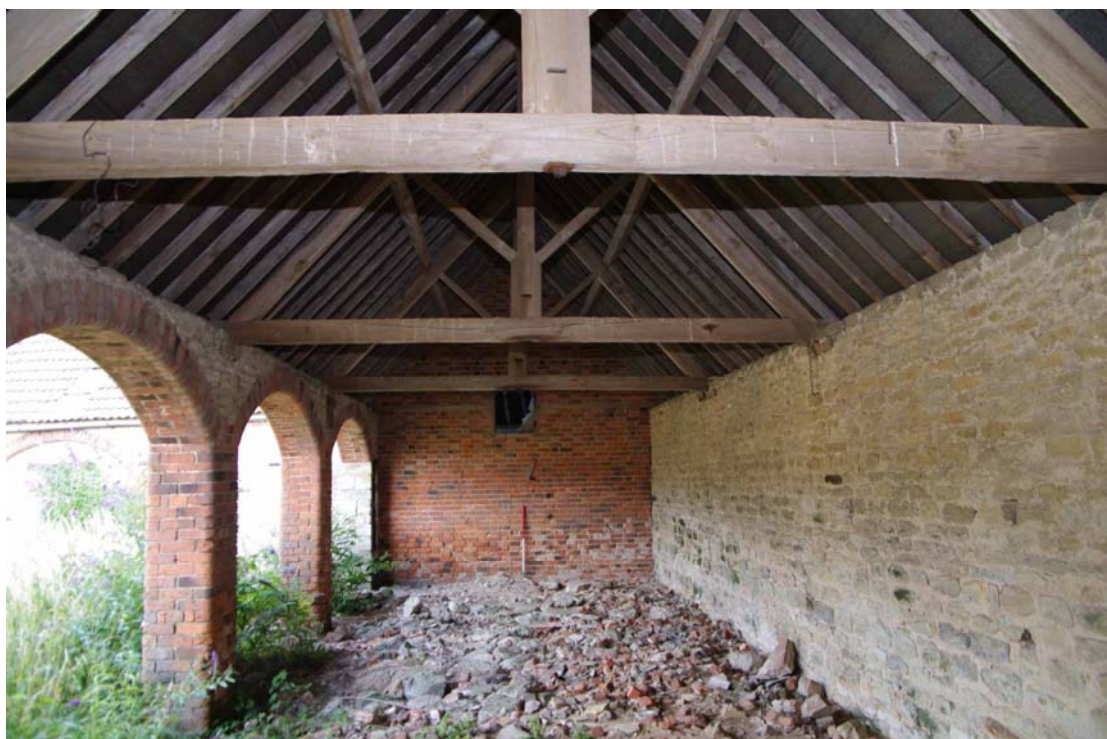
Figure 85: East range, Building D inside  
Looking north, 1m scale

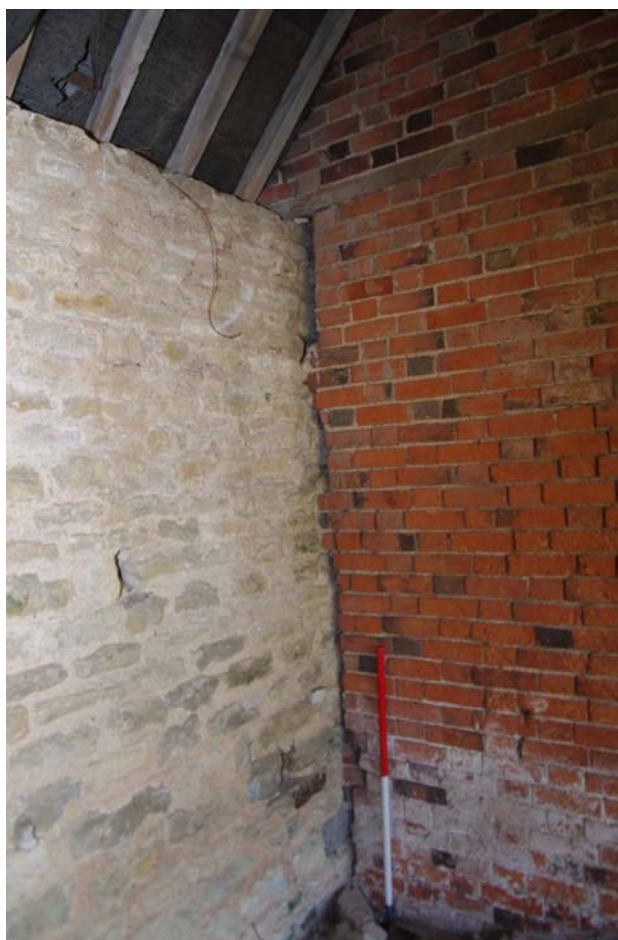
Figure 86: East range, Building D bonding between brick and stone walls  
Looking south-east, 1m scale

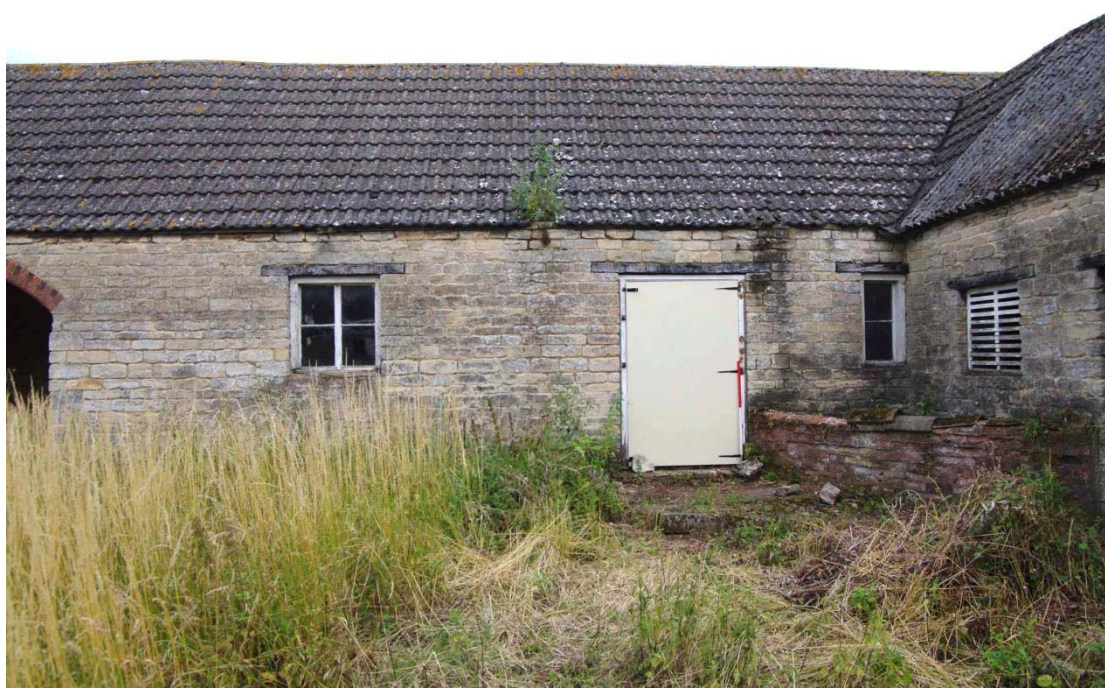
Figure 87: East range, Building E  
Looking east

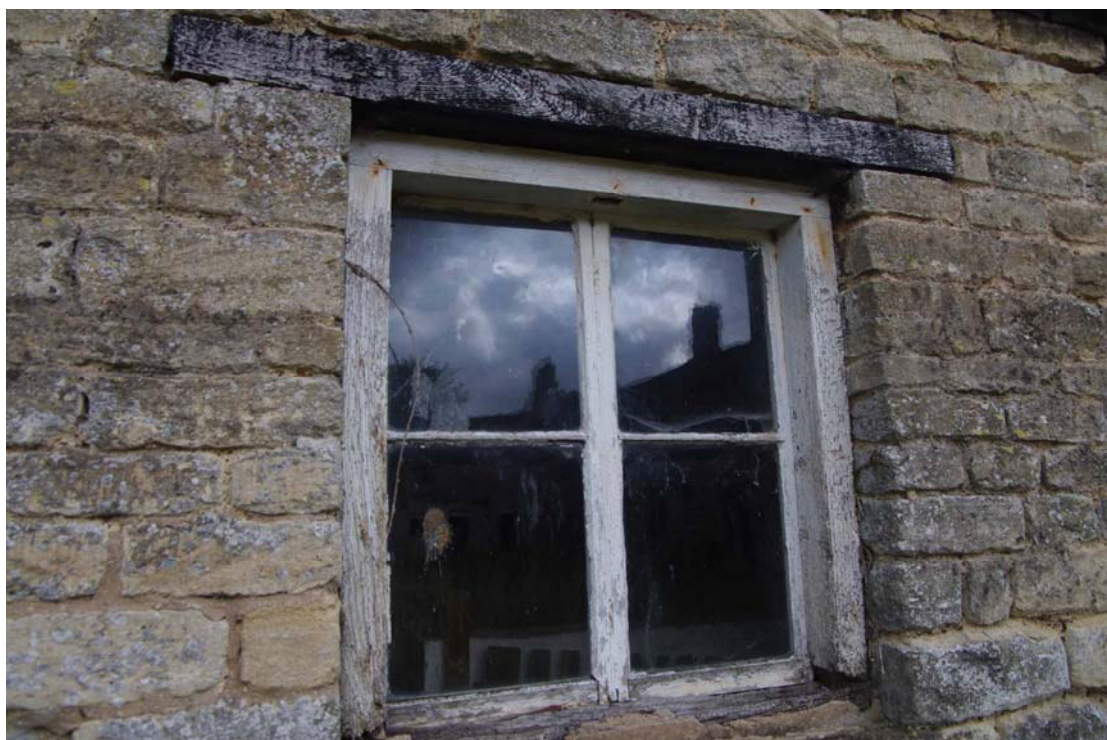
Figure 88: East range, Building E window detail  
Looking south-west. Note pegged frame and mortice hole at top of frame and  
chamfered lintel

re-used from elsewhere as there are some redundant mortice holes (Fig. 88). A brick-built trough runs across the corner between the east and south ranges. The south facing gable end elevation of the east range is set slightly proud of the southern range of buildings and has an open window or hayloft type doorway set at eaves height in the gable end (Fig. 89). It is not clear but there appears to be a joint between Building E and Building F to the west.

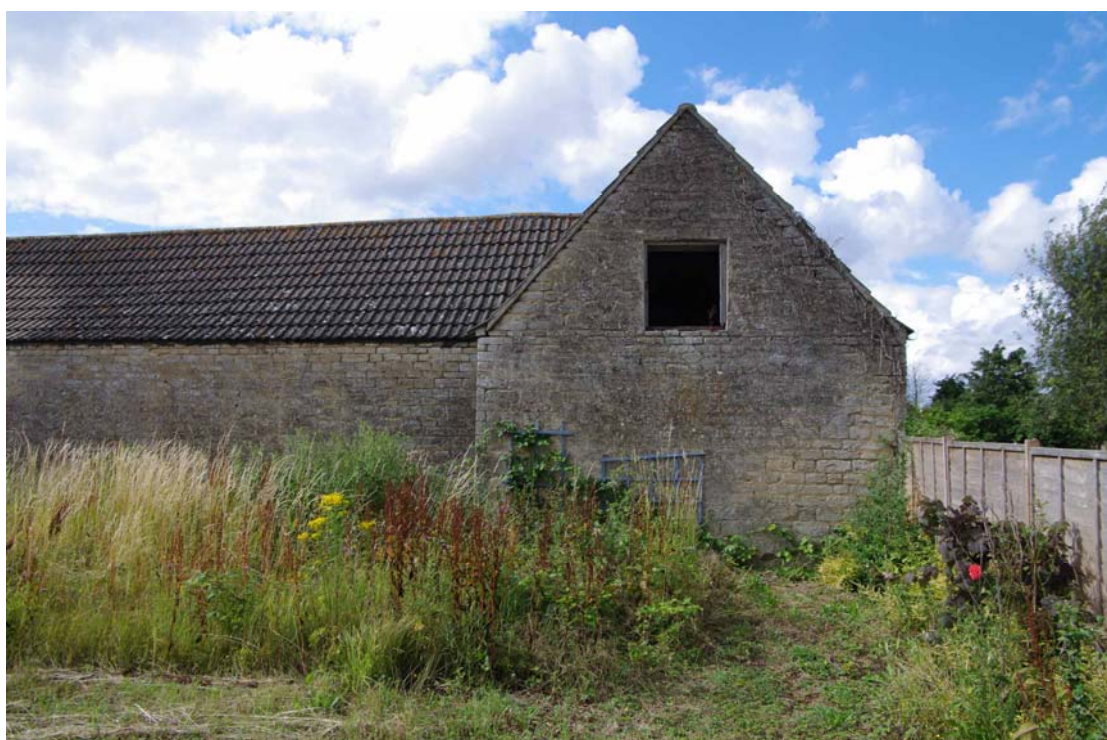
Figure 89: East range, Building E south facing gable end  
Looking north

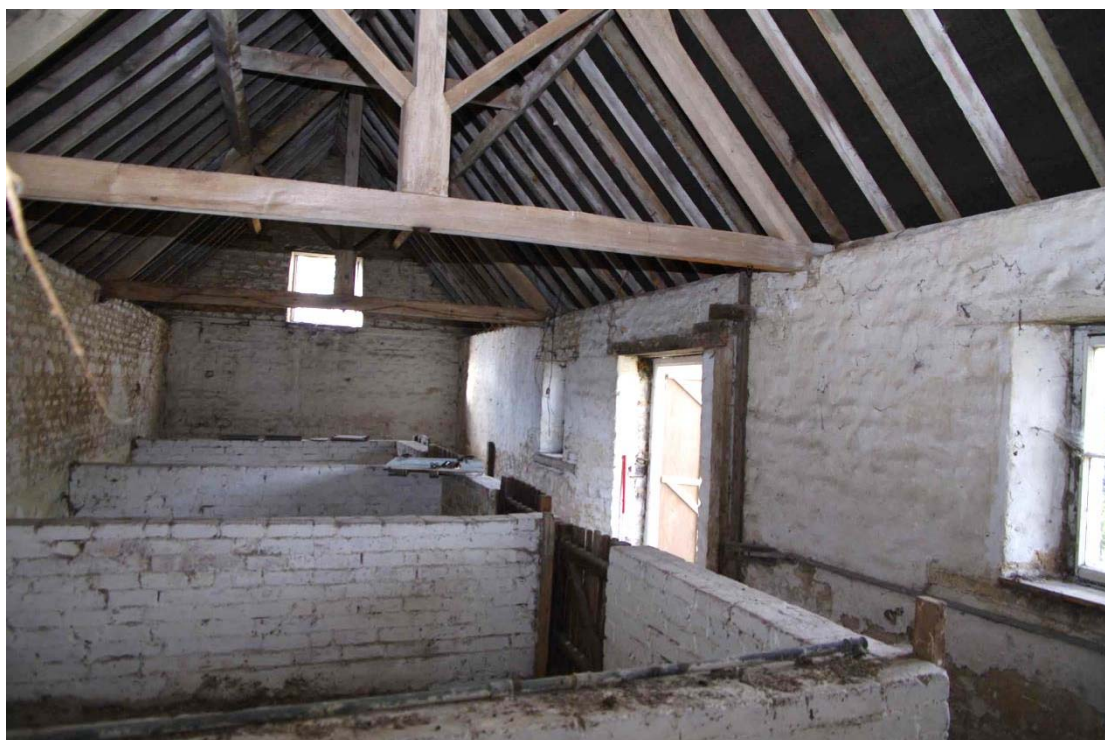
Figure 90: East range, Building E inside  
Looking south-west, 1m scale

Inside Building E the space has been divided up into five animal pens which are separated by substantial low brick walls with wooden gates (Fig. 90). The roof structure is the same as in Buildings C and D.

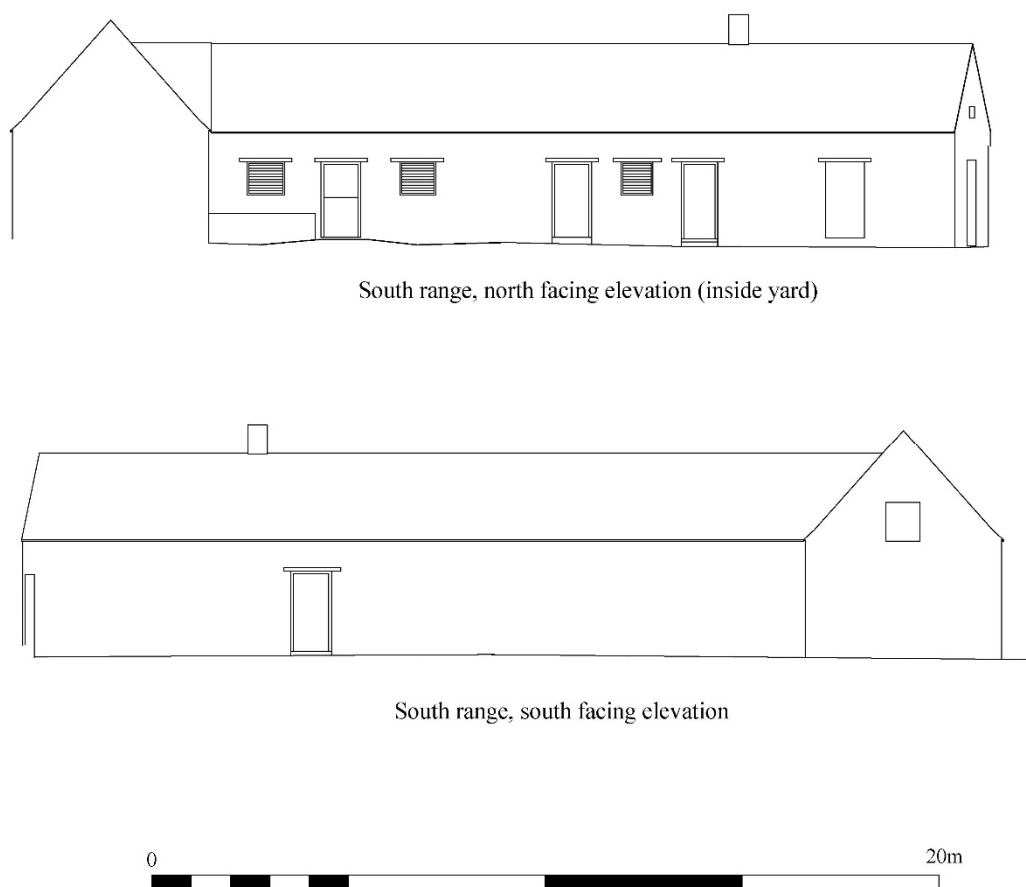
**Figure 91: South range elevations**  
 Modified from drawings supplied by Paul Bancroft Architects

The north facing elevation which faces into the yard has a number of single doorways and rectangular window openings (Figs 91 and 92). The windows and doors have stop-chamfered lintels matching those on the east range. Similarly the door and window frames are also pegged with wooden dowels. Instead of fixed glazing the windows on this elevation have wooden slats to allow for ventilation (Fig. 93). A doorway towards the west end of the elevation has been created from a former window. This side has a corrugated sheet roof covering whereas the south facing roof has cement tiles. A single brick-built chimney breaks the ridgeline towards the west end of the range.

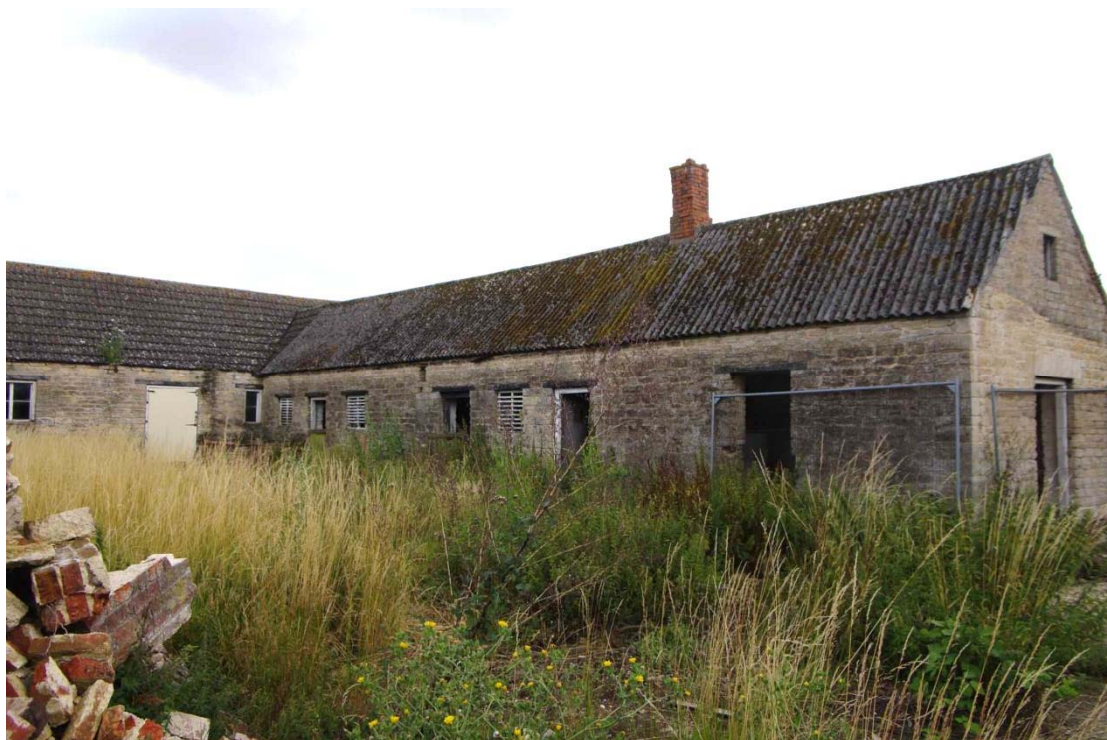
Figure 92: South range, north facing elevation  
Looking south-east

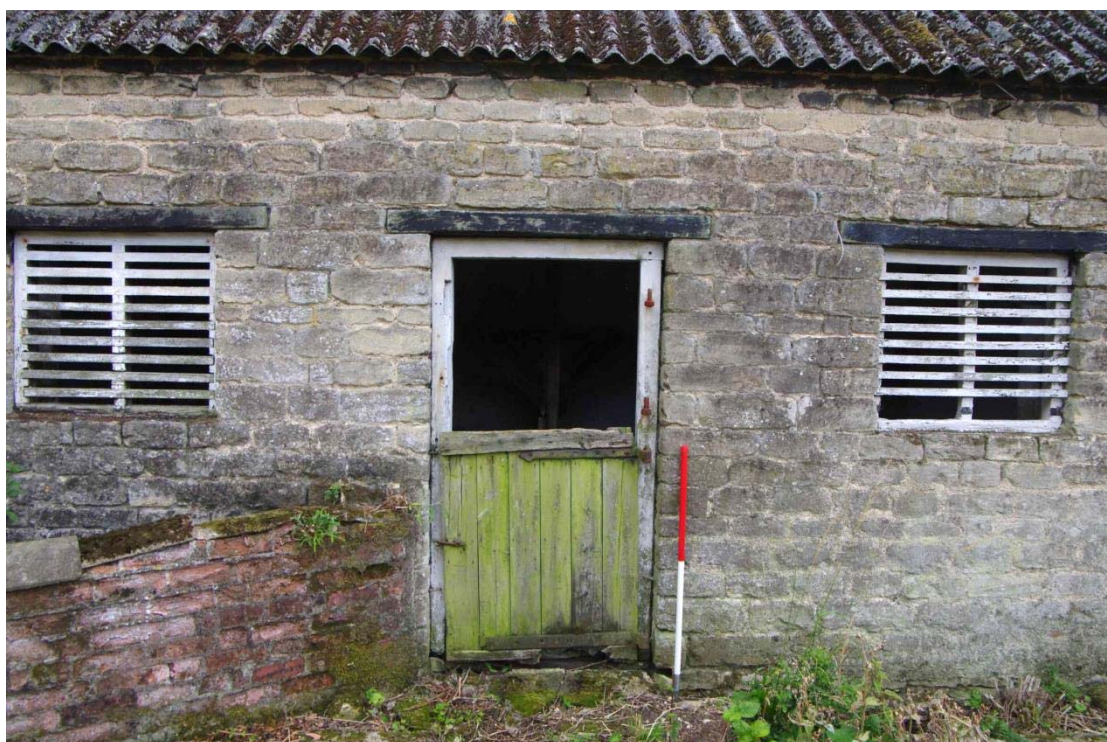
Figure 93: South range north facing elevation door and window detail  
Looking south, 1m scale

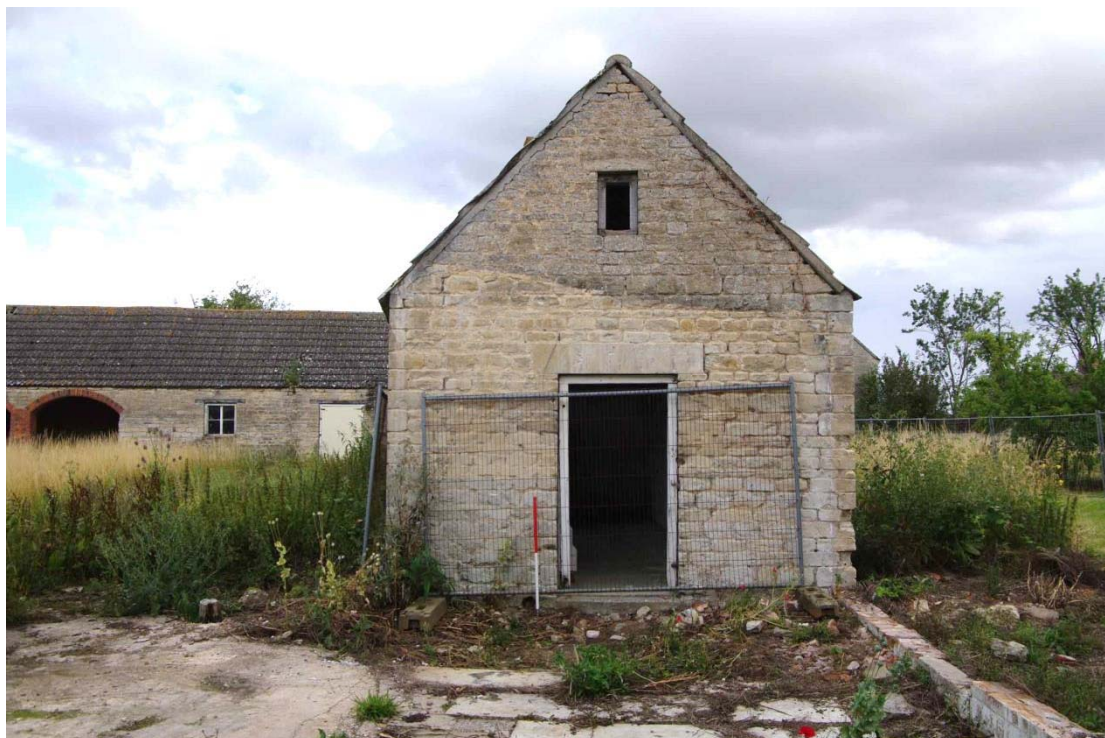
Figure 94: South range west facing elevation  
Looking east, 1m scale

The west facing gable elevation has a single doorway and a small rectangular window set high in the gable end (Fig. 94). Both the door and window have limestone lintels and wooden frames. The gable is built at a slight angle to the rest of the range in order to create a parallel face to the rear of the house and the opposite range of buildings. The roofline of the recently demolished modern structure can be clearly seen running in a line above the doorway. In front of this elevation is the concrete floor and stub of a brick wall belonging to the demolished building.

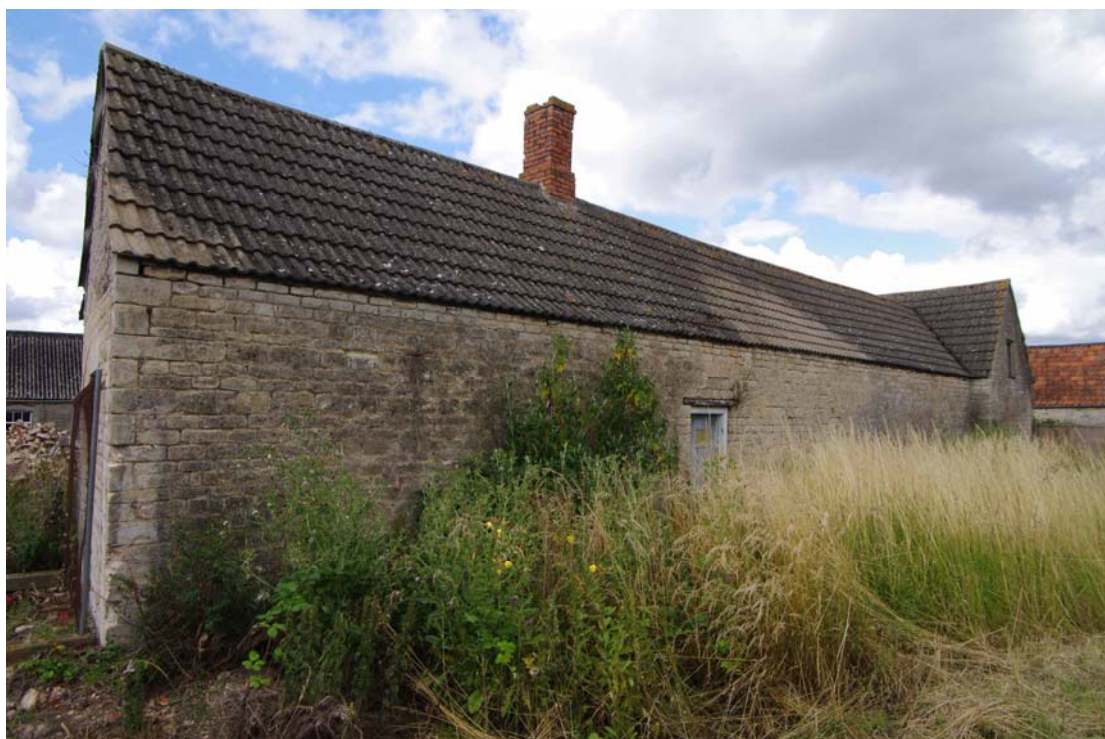
Figure 95: South range south facing elevation  
Looking north-east. Note slight projection of the east range gable at the right of the picture

The south facing elevation has a single doorway opening to the south with no indication of any other former openings (Fig. 95). The south gable end of the east

range extends beyond the wall line of the south range by approximately 0.4m and the stone courses of the two ranges do not appear to match. As noted above the roof covering on this side is of cement tiles which match the covering on the north, east and west ranges.

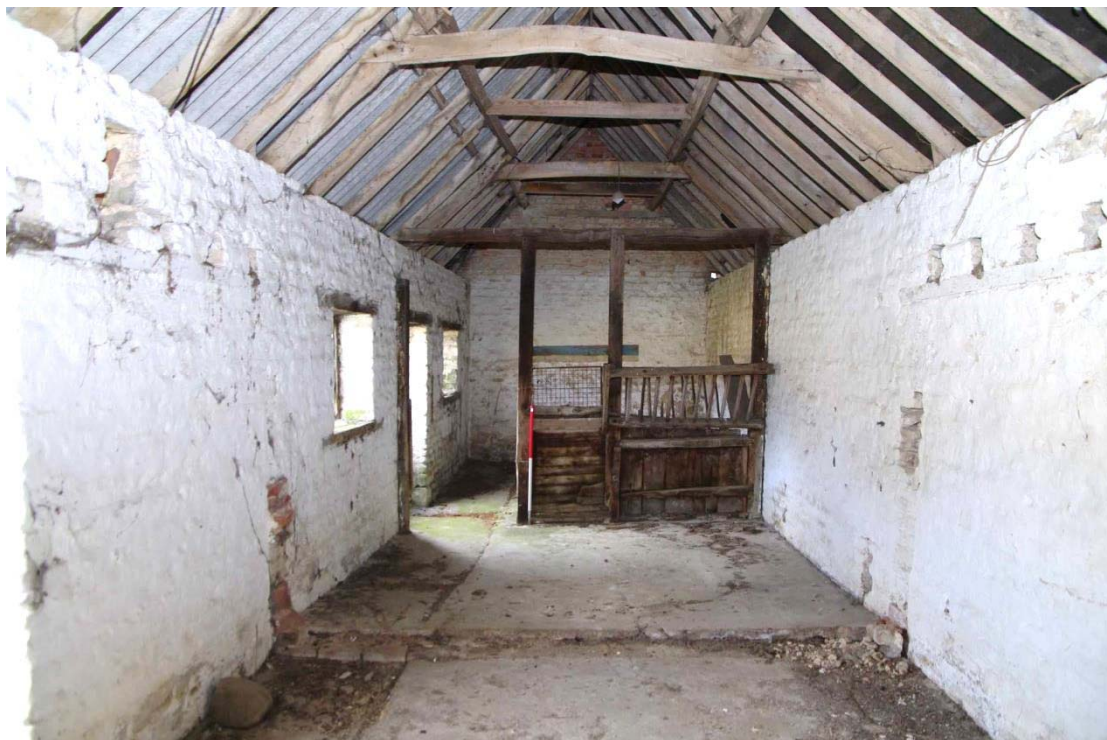
Figure 96: South range, west end inside  
Looking east, 1m scale

Inside the south range the eastern side forms a large open space with two doorways leading out into the yard (Figs 96 and 97). There is a wooden byre near to the west end but otherwise no internal fittings survive (Fig. 98). The roof structure in the western end of the building is different from the rest of the farm buildings and has the purlins morticed and pegged into the principal rafters (Fig. 99). The tie-beams are lap-jointed to the principals just below the joints with the purlins. Many rafters show signs of re-use or modification. A pair of brick-built walls divides the range into two parts and creates a corridor leading through the building to the doorway on the south facing elevation (Fig. 100). The corridor has the remnants of wall plaster on and did have a ceiling with joists which has since decayed. This may have acted as a hayloft floor as there are empty sockets for more joists in the walls of the main room (see Fig. 97). The western end of the south range consists of a small room which has had its fireplace removed leaving the chimney breast still in place higher up the wall (Fig. 101). The roof structure in this room is different to the rest of this range and consists of two raking struts supporting the purlins using birds-mouth sockets (Fig. 102). The struts rest on a large truss and are also held by a tie-beam close to the purlins.

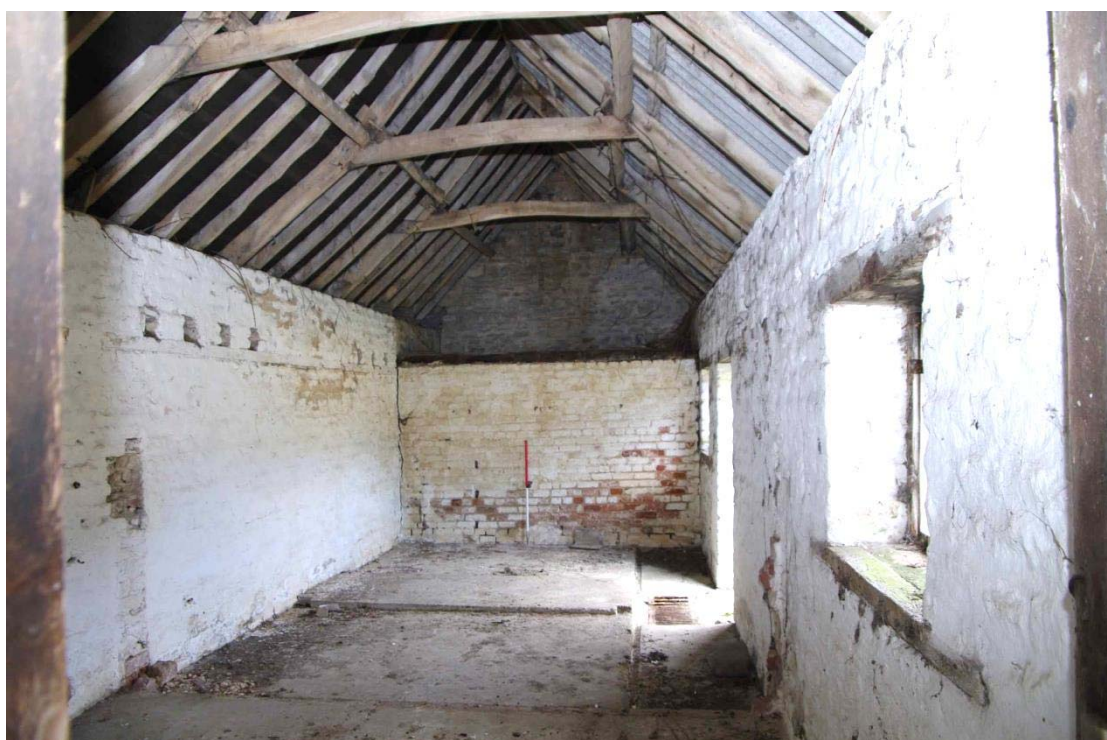
Figure 97: South range, west end inside  
Looking west, 1m scale

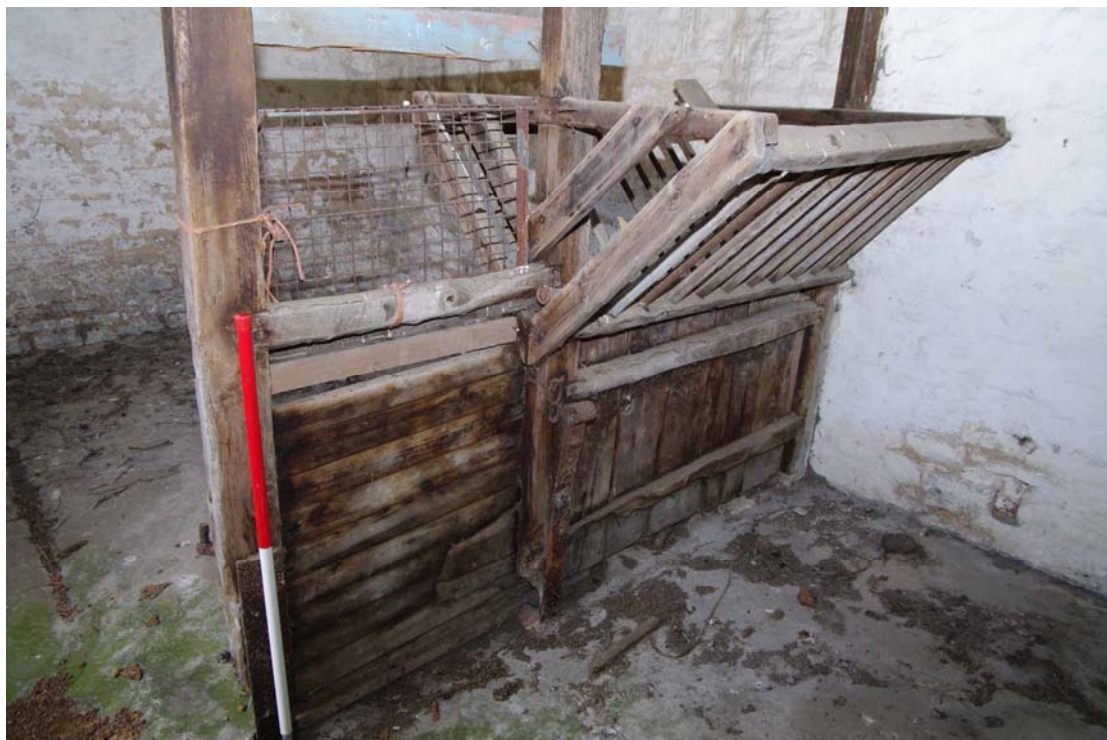
Figure 98: South range, west end byre  
Looking south-east, 1m scale

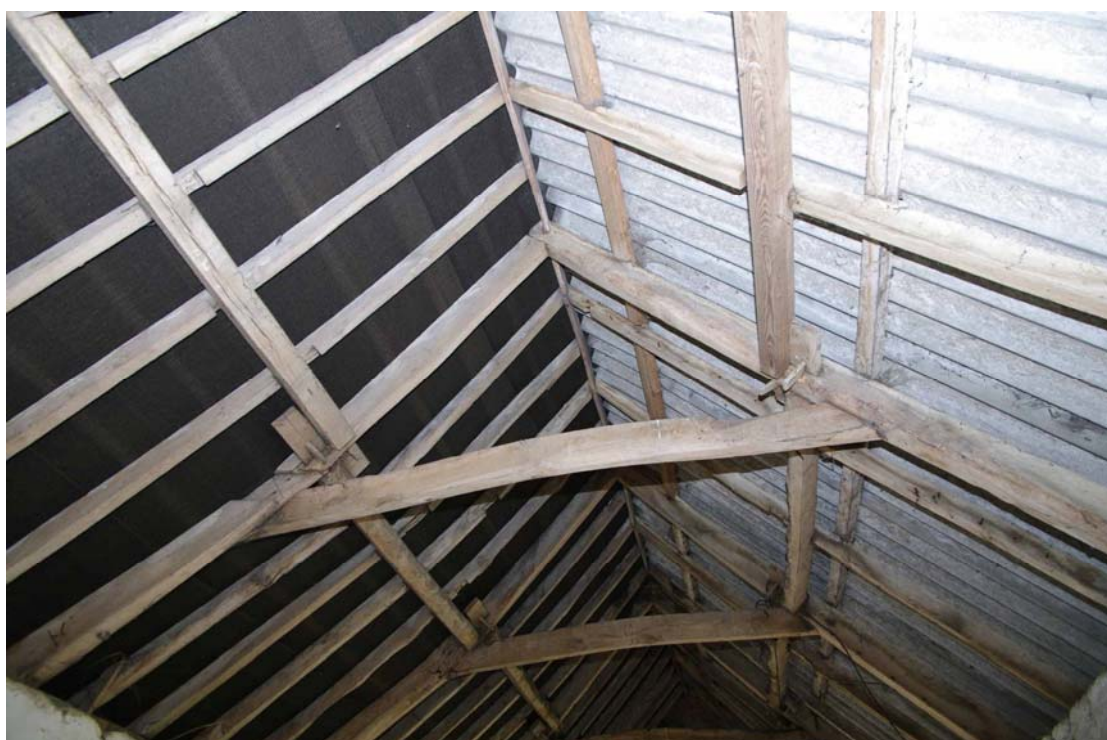
Figure 99: South range, west end roof detail

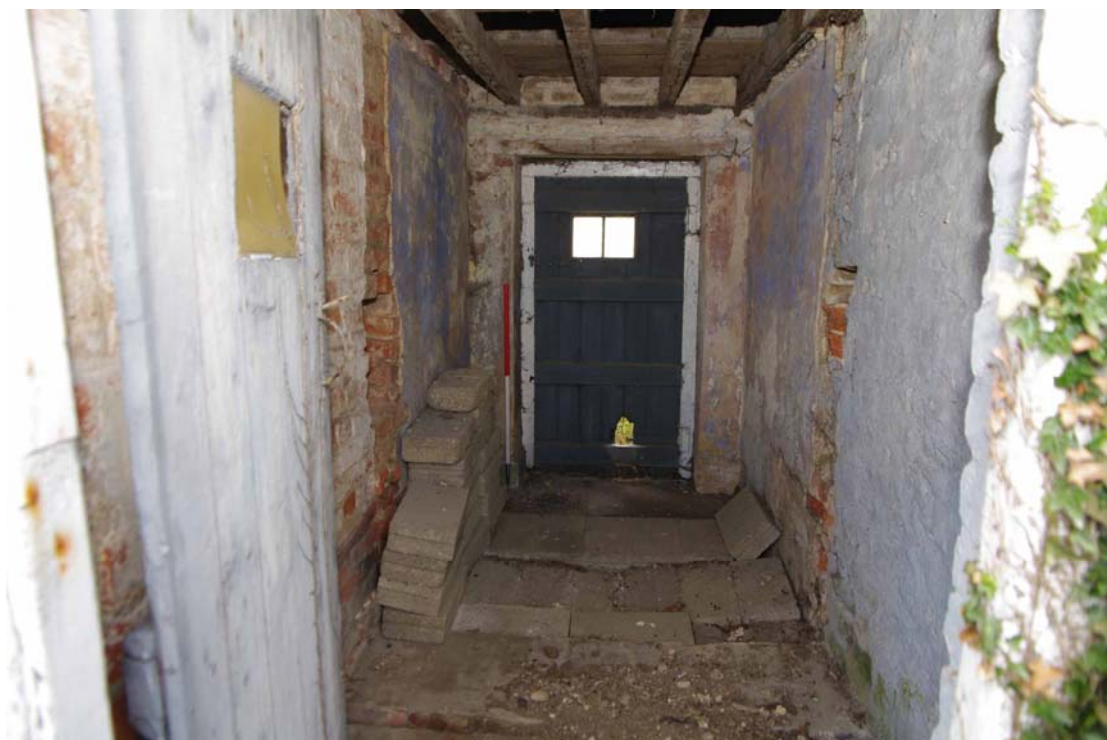
Figure 100: South range corridor  
Looking south, 1m scale

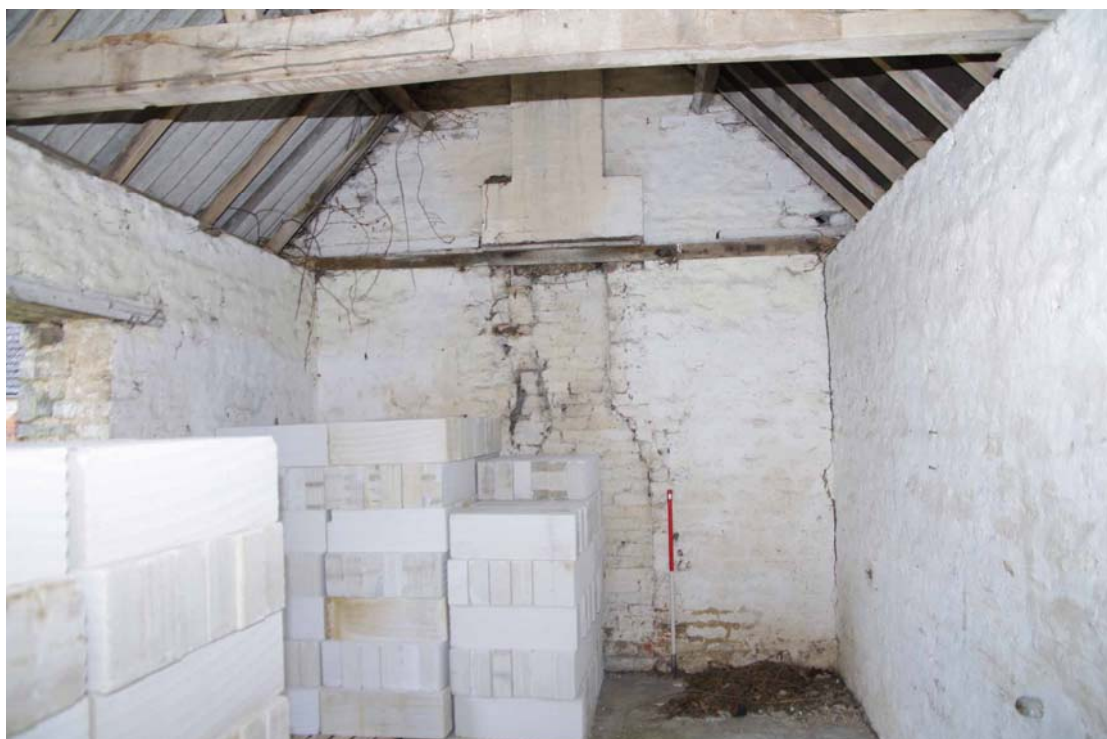
Figure 101: South range, west end room  
Looking east, 1m scale. Ranging pole is to right of removed fireplace
