**A Level 2 Historic Building Record  
And watching brief at Middle Farm  
House and  
Associated Barns  
Main Street,  
Upper Benefield,  
Northamptonshire**

ULAS Report No. 2017-005  
©2017

**A Level 2 Historic Building Record  
and watching brief at Middle Farm House  
and Associated Barns,  
Main Street, Upper Benefield,  
Northamptonshire.**

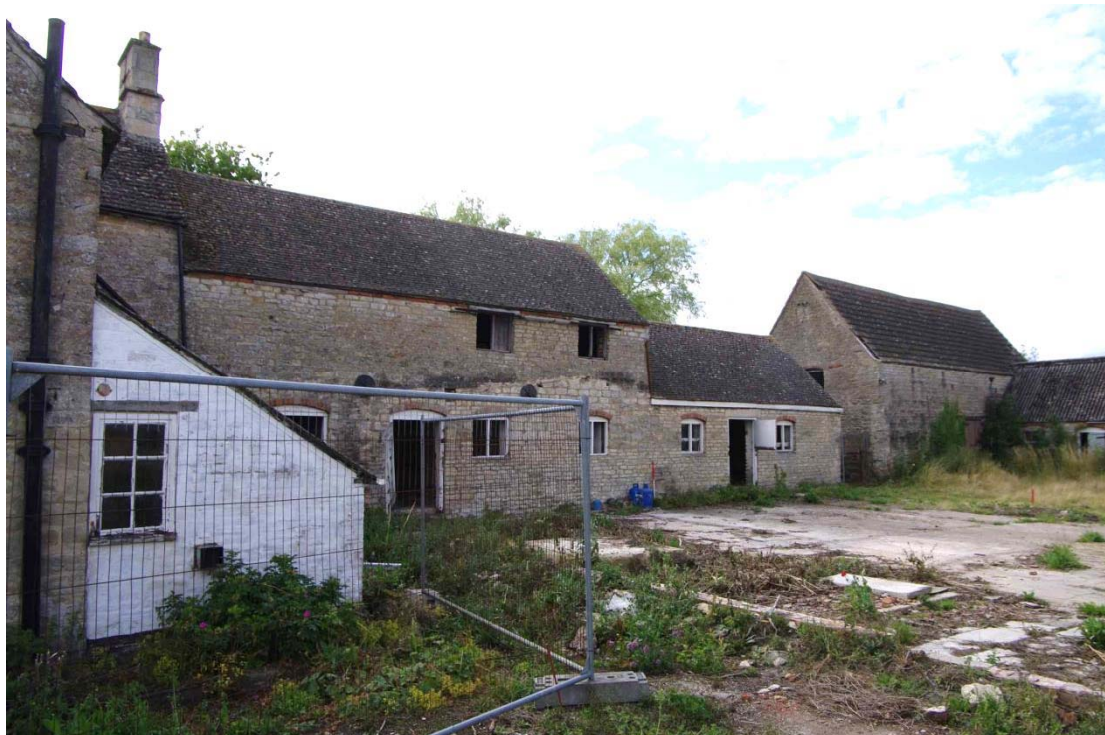
Figure 103: West range, east facing elevation  
Looking north-west, 1m scale

The west range of buildings is attached to the northern end of the house and consists of buildings A and G (Figs 102 to 104). Building A is attached to the west end of the north range and is separated from Building G by a small alleyway. Once again the building materials of coursed limestone rubble and cement roof tiles on this range match the other ranges.

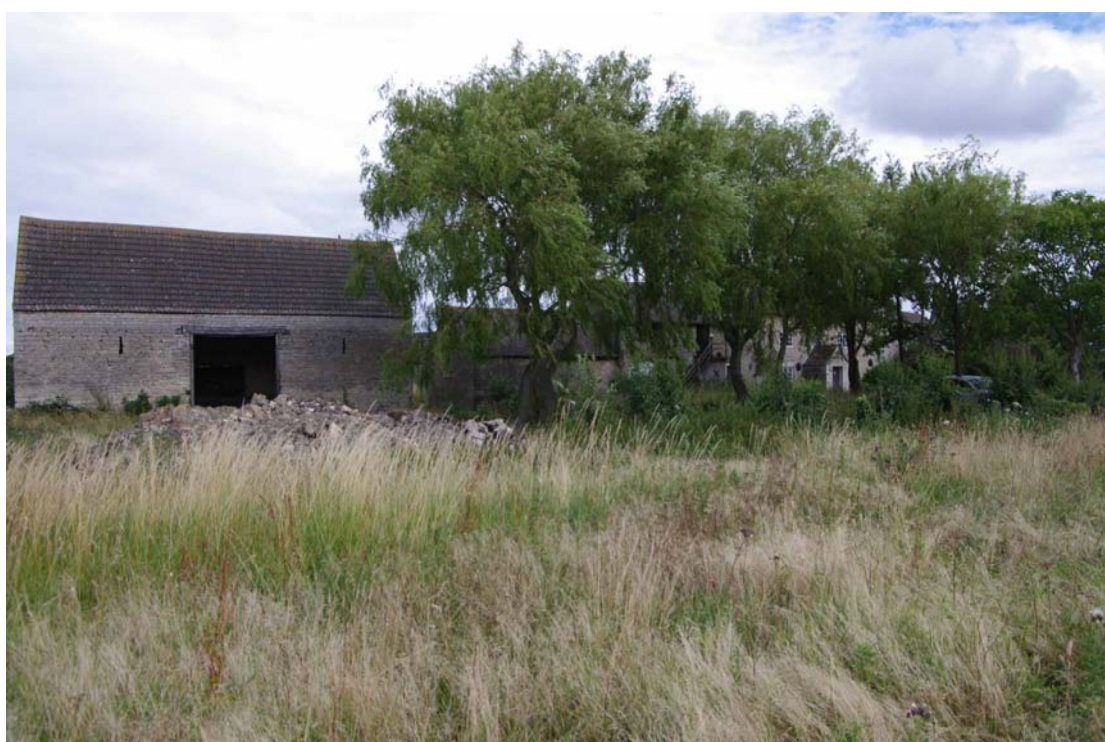
Figure 104: West range, west facing elevation  
Looking south-east. Pond in foreground

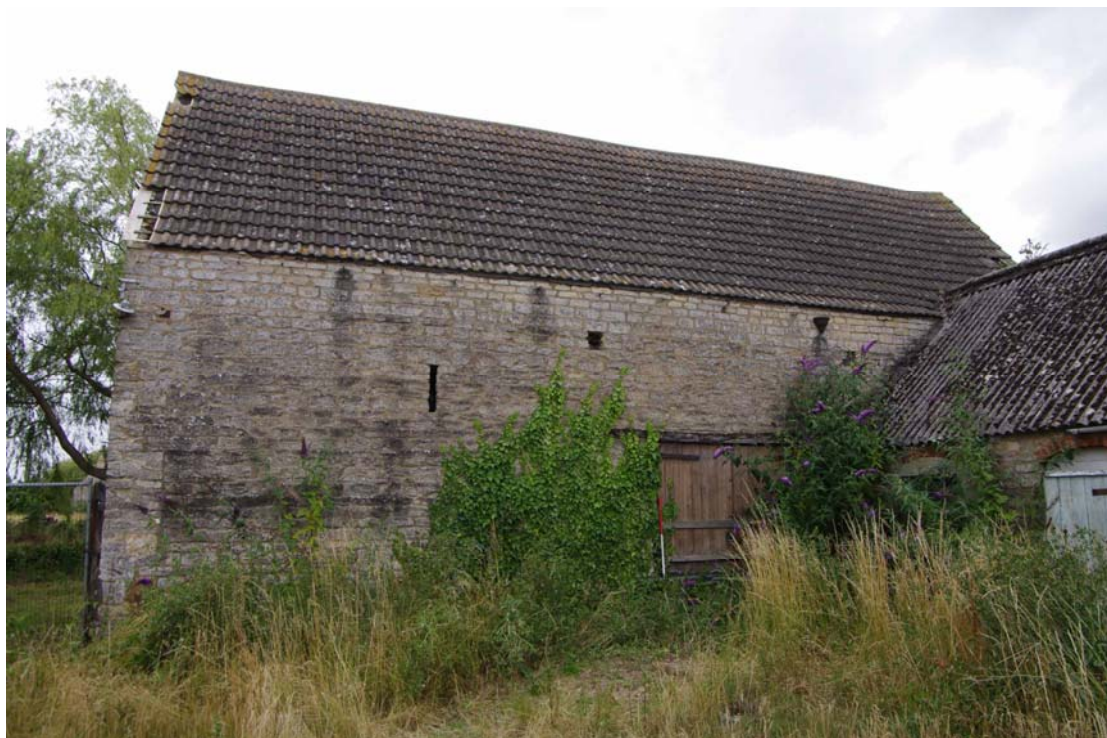
Figure 105: West range, east facing elevation of Building A  
Looking west, 1m scale

The east facing elevation of Building A faces into the yard and is partially obscured on its north end by the north range buildings. A slight difference in the stonework can be seen running across the elevation approximately 0.75m below the eaves (Fig. 105). This difference may be due to repointing but the stones used below the eaves appear to be larger and more regular in shape and as such could represent a later rebuild to increase the roof height. A low but wide doorway is set opposite the double doors on the west facing elevation in the style of threshing doors. The only other opening on this elevation is a single slit ventilation hole set just below the change in stonework. A possible blocked window is indicated by a straight vertical joint close to the south corner but the extent of this feature is not clear if indeed it is a former window.

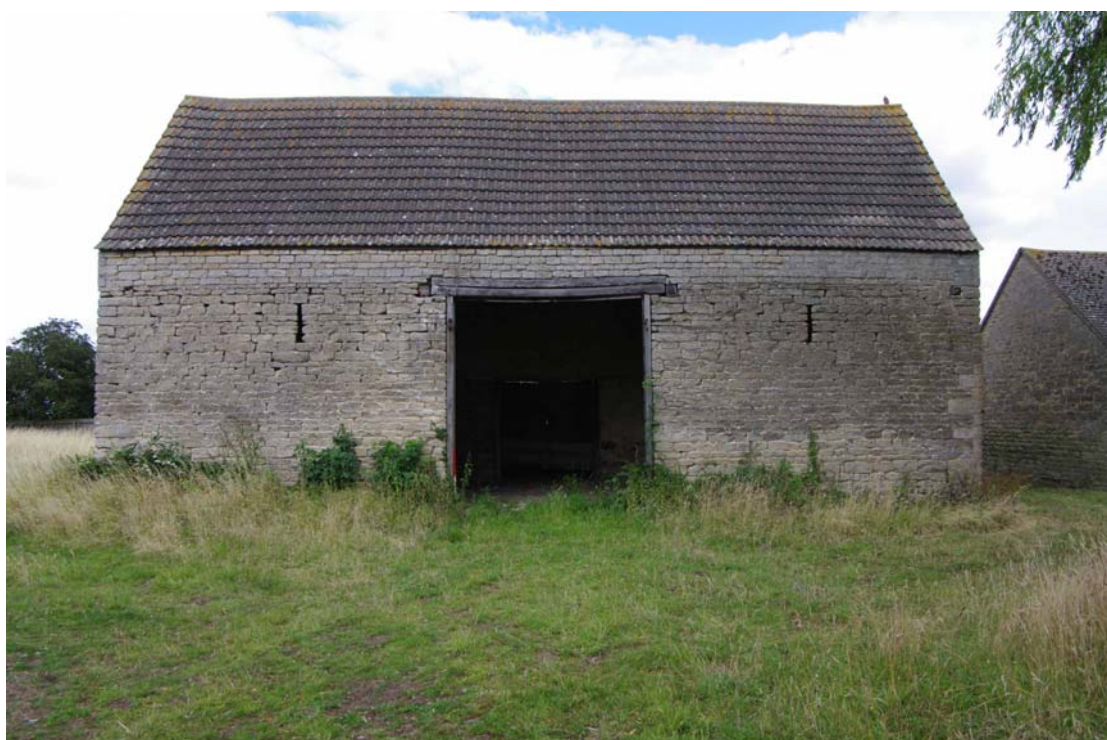
Figure 106: West range, west facing elevation of Building A  
Looking east

The west facing elevation has a much larger double doorway which extends as far as the line of rebuilt stones below the eaves which is also present on this elevation (Fig. 106). The doorway with its stop-chamfered timber lintel is the only opening on this side although there are two slit ventilators either side of the door. The doors have been removed leaving only the cast metal sockets for what were likely to have been late 19th century strap hinges.

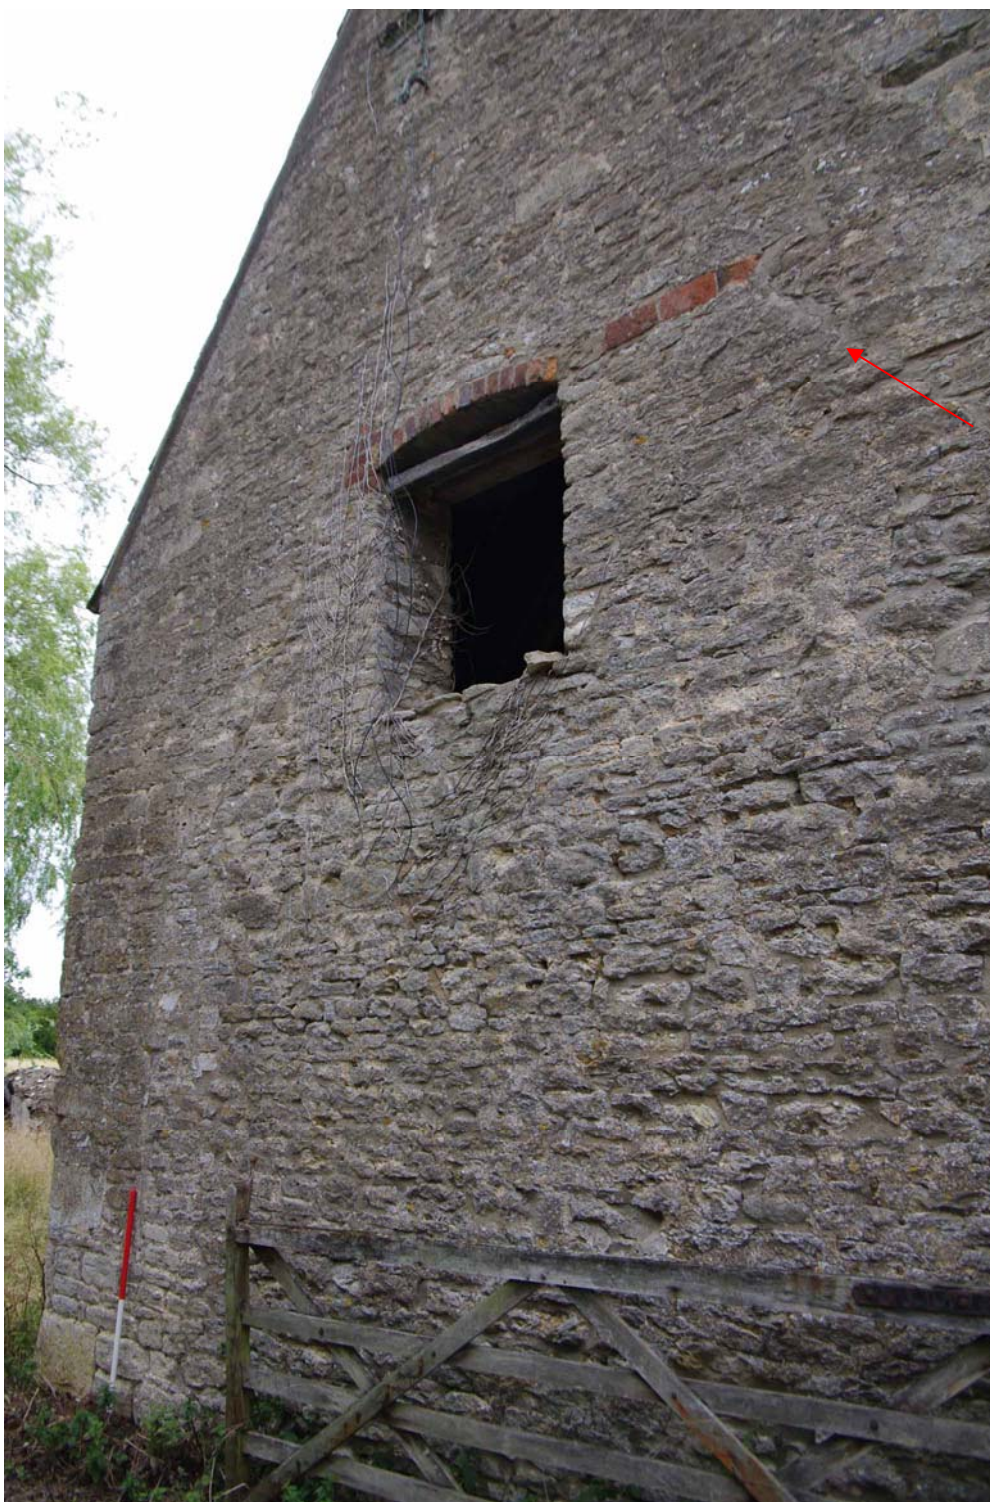
Figure 107: West range, south facing elevation of building A  
Looking north west. Note joint of earlier gable (arrowed), 1m scale marks the vertical  
joint of the earlier gable wall

The south facing gable end elevation gives clear evidence of a major rebuilding of the whole of Building A. Two straight vertical joints can be seen running up the wall to a height of 2.7m and is 1.07m from the west corner and 0.45m from the east corner making a smaller wall of 4.62m in width compared to the present 6.14m wide wall (Fig. 107, see also drawing in Fig. 69). The sloping joint of the old roofline is also evident showing that the present building has been widened and raised in height. Within the outline of the original gable end is a rectangular opening, possibly a hayloft door, with a brick arched head. Three bricks are also set into the wall at this point but their function is unclear.

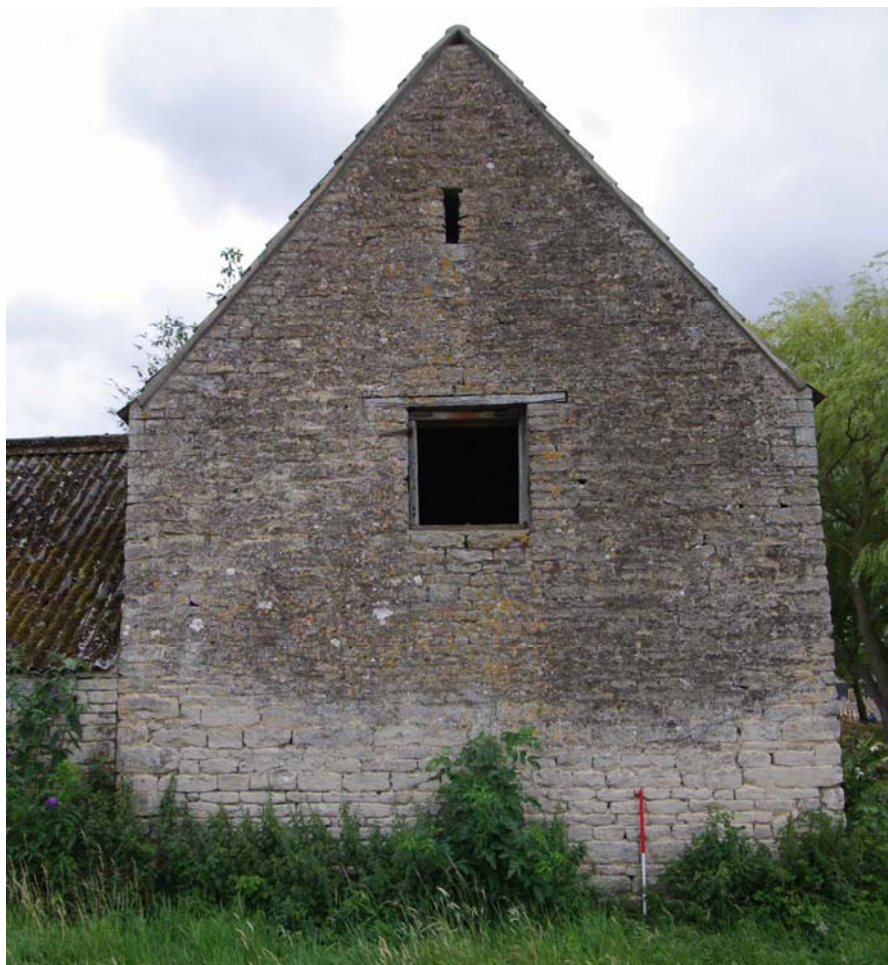
Figure 108: West range, north facing elevation of Building A  
Looking south, 1m scale

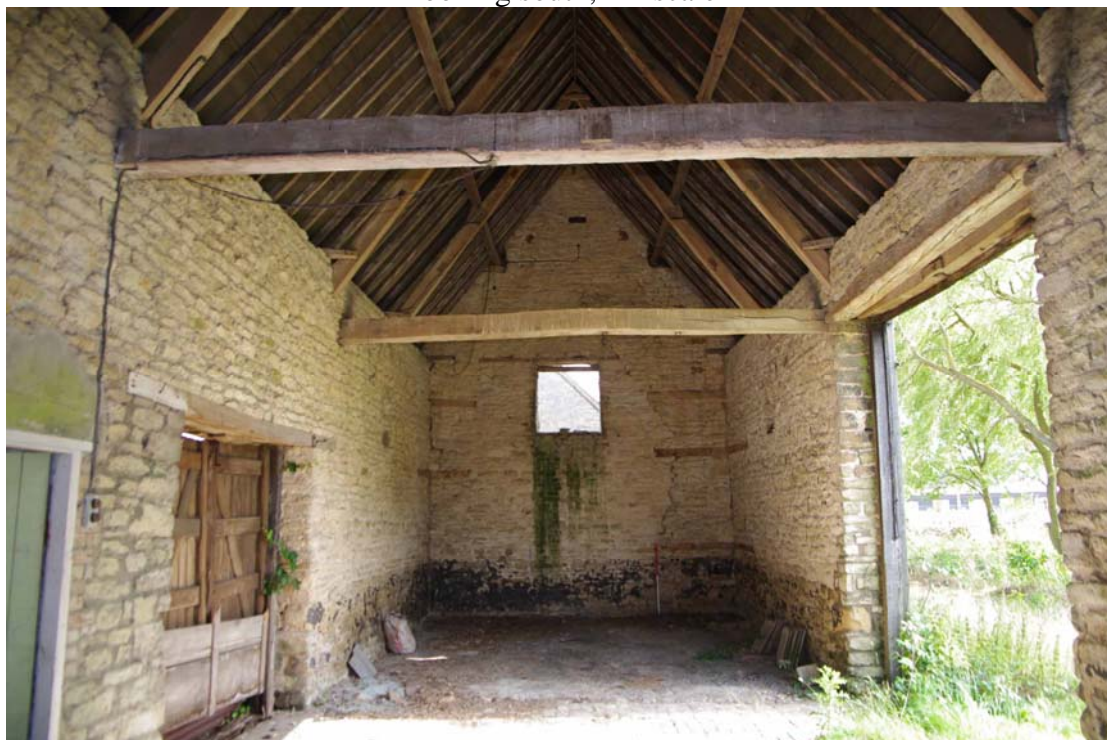
Figure 109: West range, Building A inside  
Looking south, 1m scale. Note joint of former gable end starting close to scale

Inside Building A the cracks in the south wall are visible showing the outline of the joint of the former gable end and the enlarged wall (Fig. 109). Once again it is difficult to spot any joints on the north wall although there is still a hint of the old roofline on the east side. The floor is of brick and tends to drop towards the west side of the building. A single doorway to the north of the eastern double doors leads into the Building B of the north range. The roof structure is dominated by two large east to west timber trusses set into the walls below wall-plate level (Fig. 110). The principal rafters are also set into the masonry and have small wooden bracers attached to them at wall-plate height. A tie-beam is lap-jointed and pegged to the principals at the point where the relatively slight purlins sit on cleats on the backs of the principals. A small

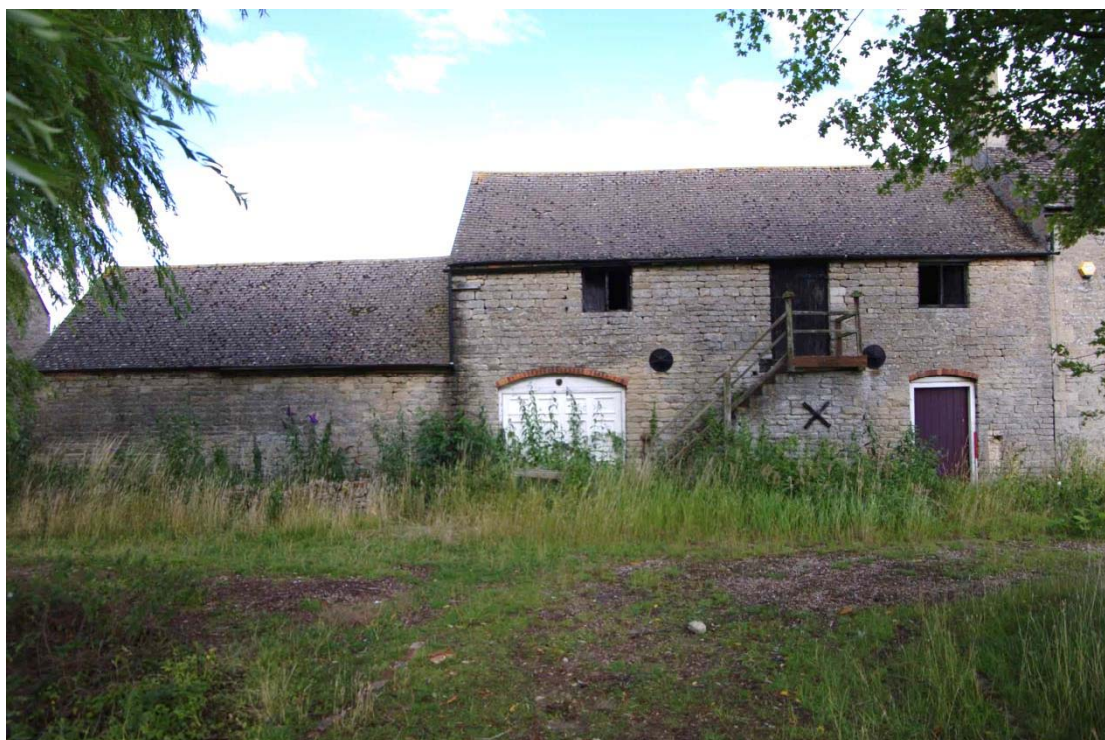
Figure 112: West range, west facing elevation of Building G adjacent to house  
Looking east, 1m scale

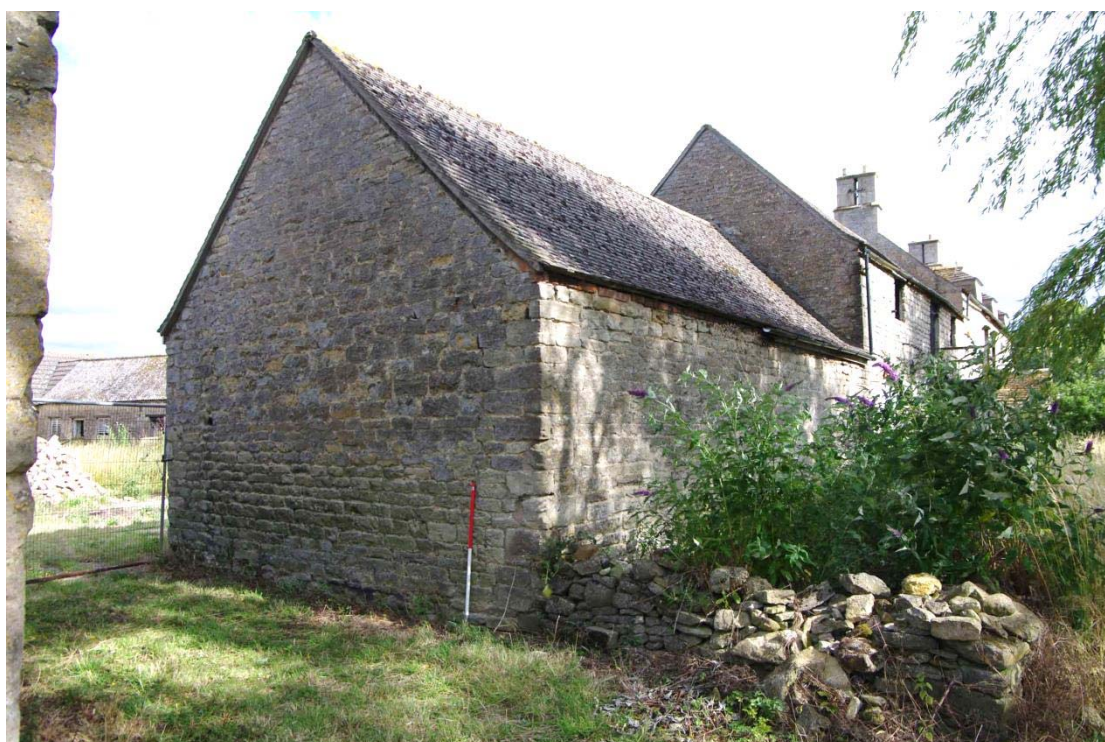
Figure 113: West range, north facing gable end of Building G  
Looking south-east, 1m scale. Corner of Building A on extreme left

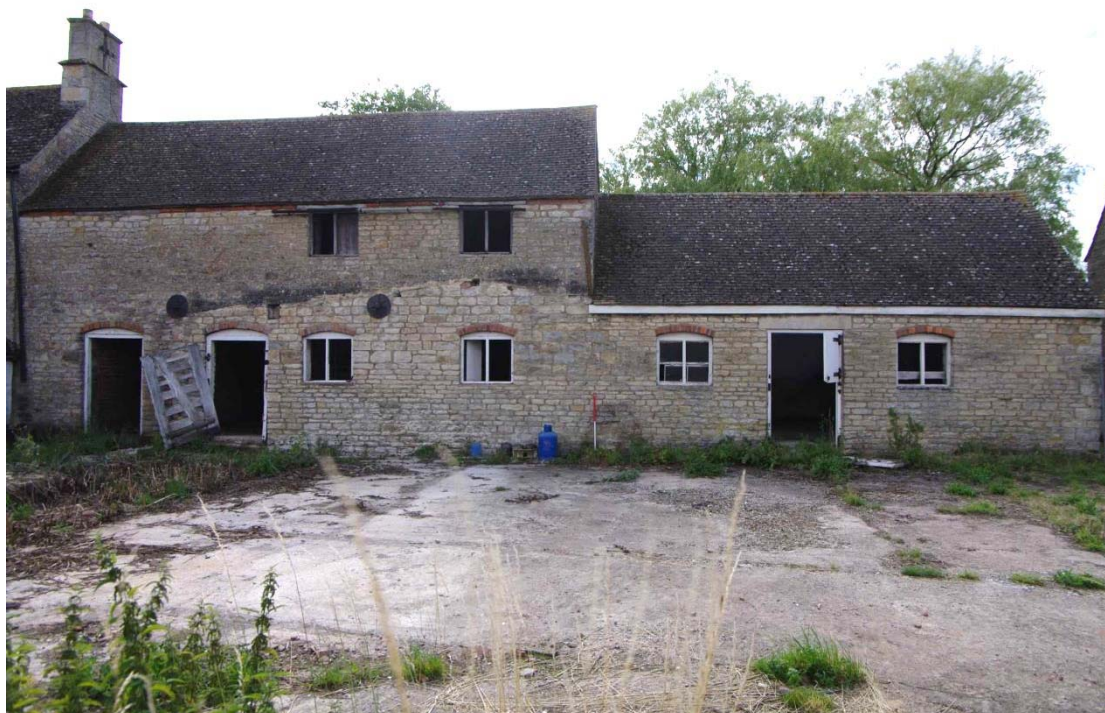
Figure 114: West range, east facing elevation of Building G  
Looking west, 1m scale. Note scar of recently demolished lean-to

The east facing elevation of Building G which looks into the yard has wooden-framed windows which have dowel-pegged joints and arched brick headers on the ground floor as seen on the west facing elevation (Figs 114 and 115). The stable doorway in the single-storey part of the range has a large stone lintel in place of a brick arch. A small rectangular window on the first floor at the south end of the range has been blocked with coursed limestone rubble.

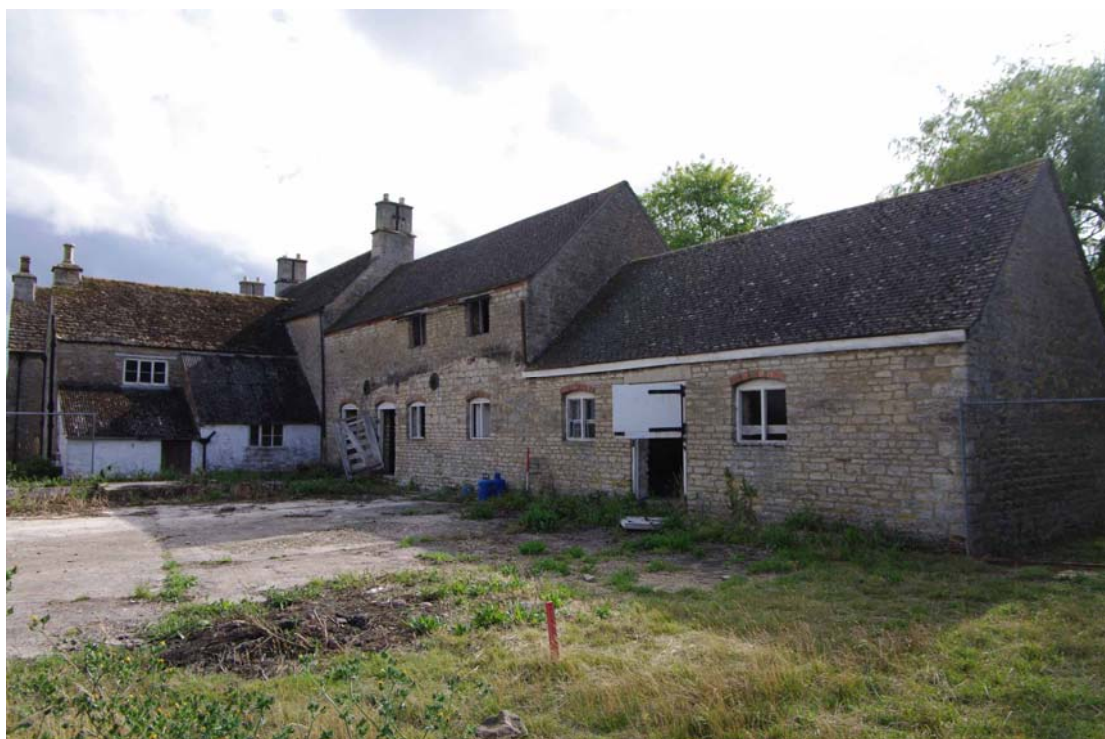
Figure 115: West range, east facing elevation of Building G  
Looking south-west towards house

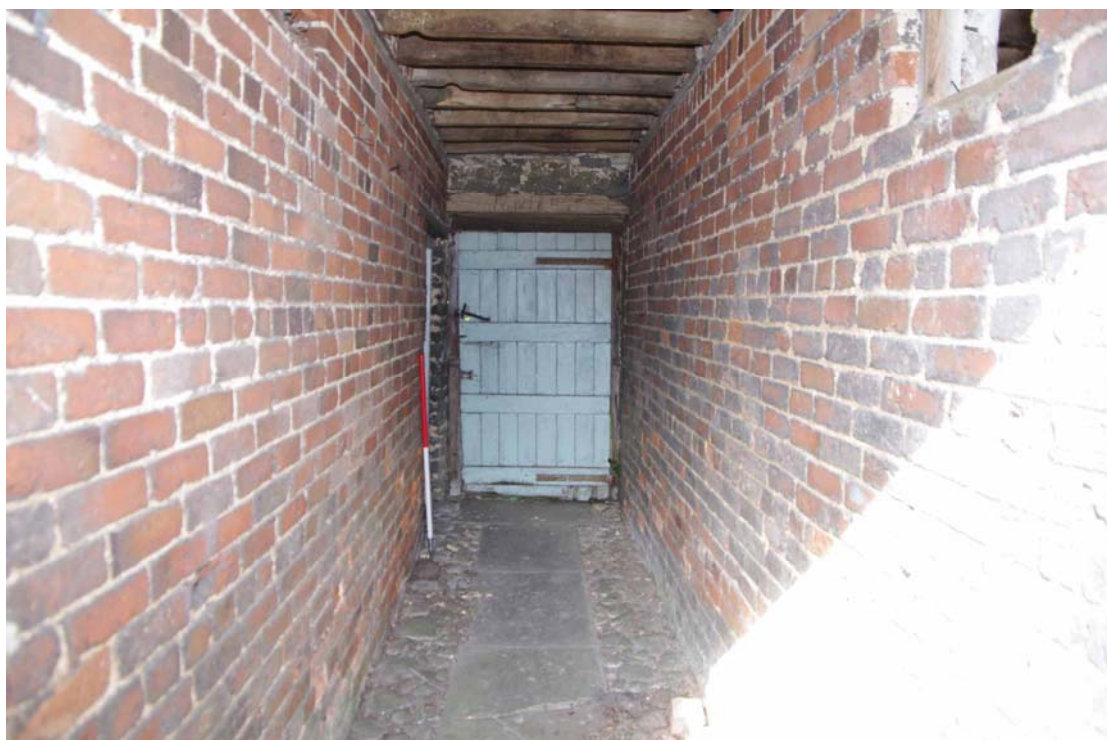
Figure 116: West range, passageway through Building G  
Looking west, 1m scale. Entrance to the coal store and north end wall of house just behind the 1m scale

Inside Building G a stone flagged brick-walled passageway runs straight through the building from east to west close to where the range joins the house (Fig. 116). This passageway incorporates the house coal store and partially blocks the doorway noted on the north elevation of the house in the earlier discussion (see Fig. 15). To the north of the passageway is a stable and adjoining tack room which has had a modern garage door replacement for the earlier door (Figs 117 and 118). The tack room still has two wooden racks for saddles and a row of wooden pegs for other paraphernalia. Two large chamfered east to west beams support the floor joists of the first floor in the stable room whilst in the tack room the joists appear to be relatively recent replacements. The tack room window has two single leaf shutters made from planks and battens with strap hinges (Fig. 119). The northernmost room of Building G is a large open room with a floor which slopes down towards the east (Fig. 120). Marks in the whitewash on the west wall show where a byre has been removed which used to run the whole length of the wall. The roof structure has two substantial trusses embedded into the wall and tie-beams are lap-jointed and nailed to the principal

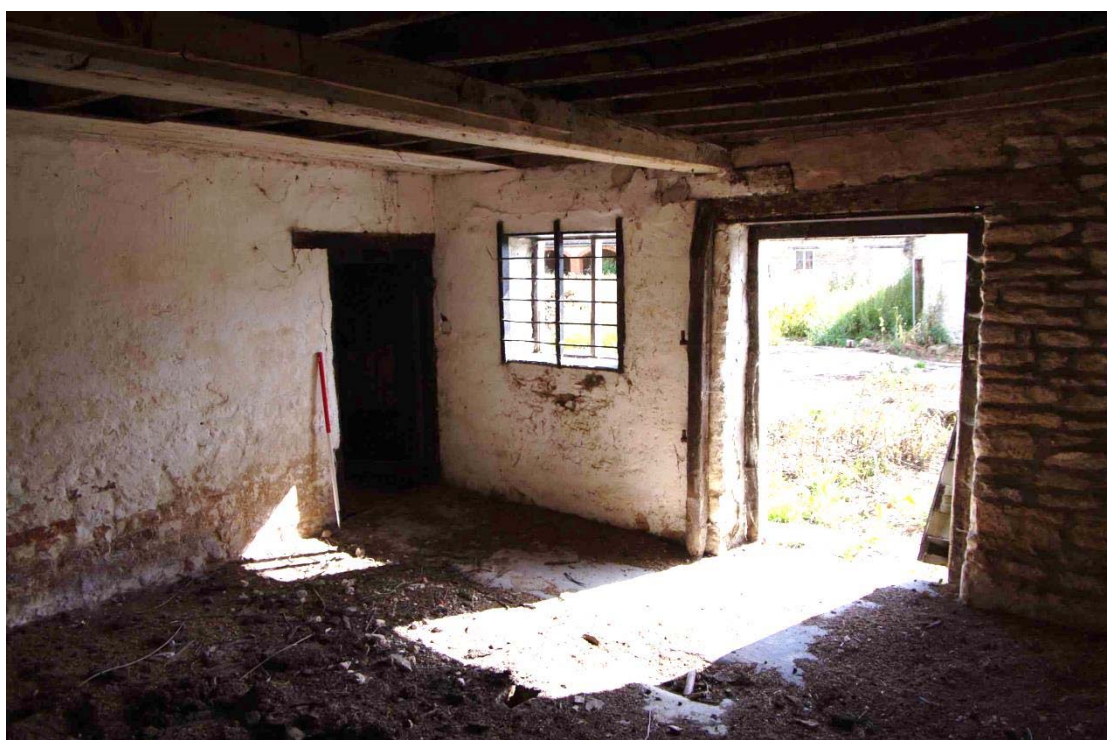
Figure 117: West range, ground floor of Building G. Southernmost room  
Looking north-west, 1m scale

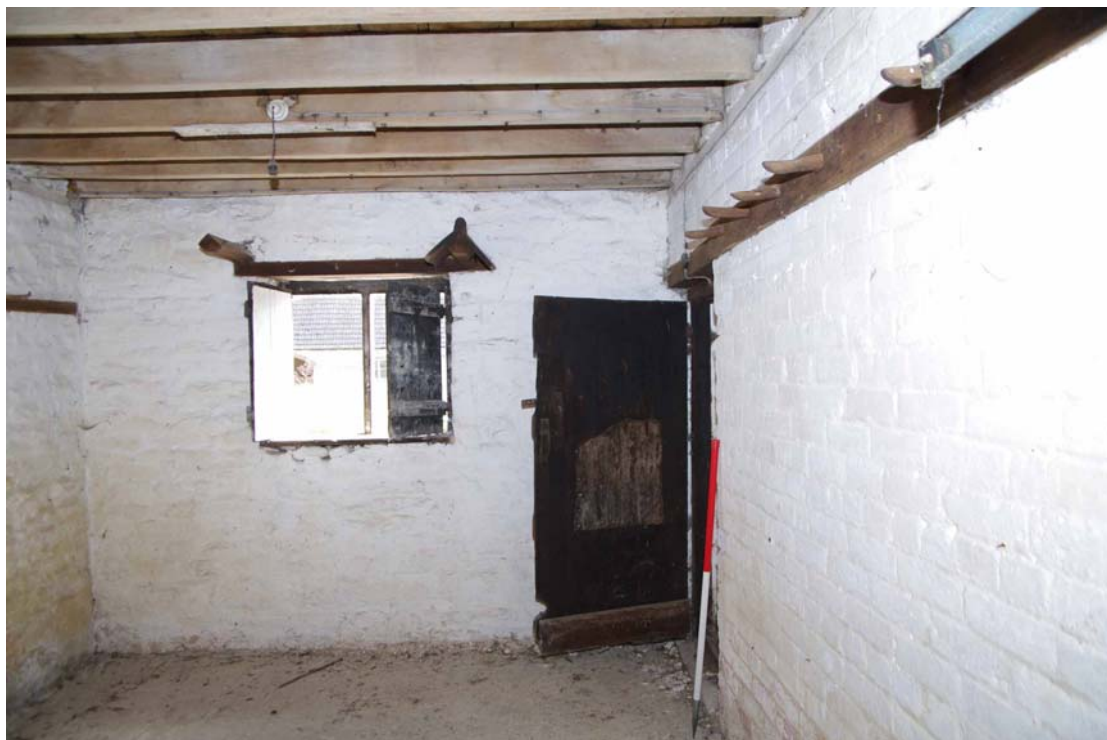
Figure 118: West range, ground floor of Building G. Tack room  
Looking west, 1m scale

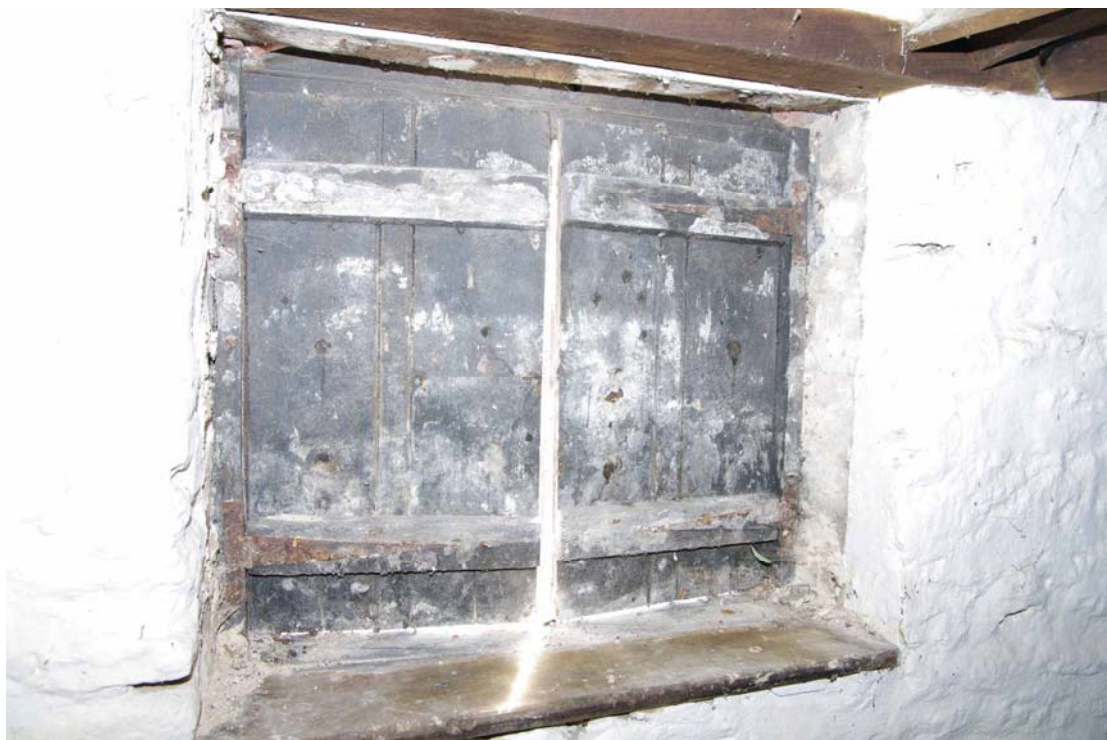
Figure 119: West range ground floor, Building G. Tack room shutters  
Looking west

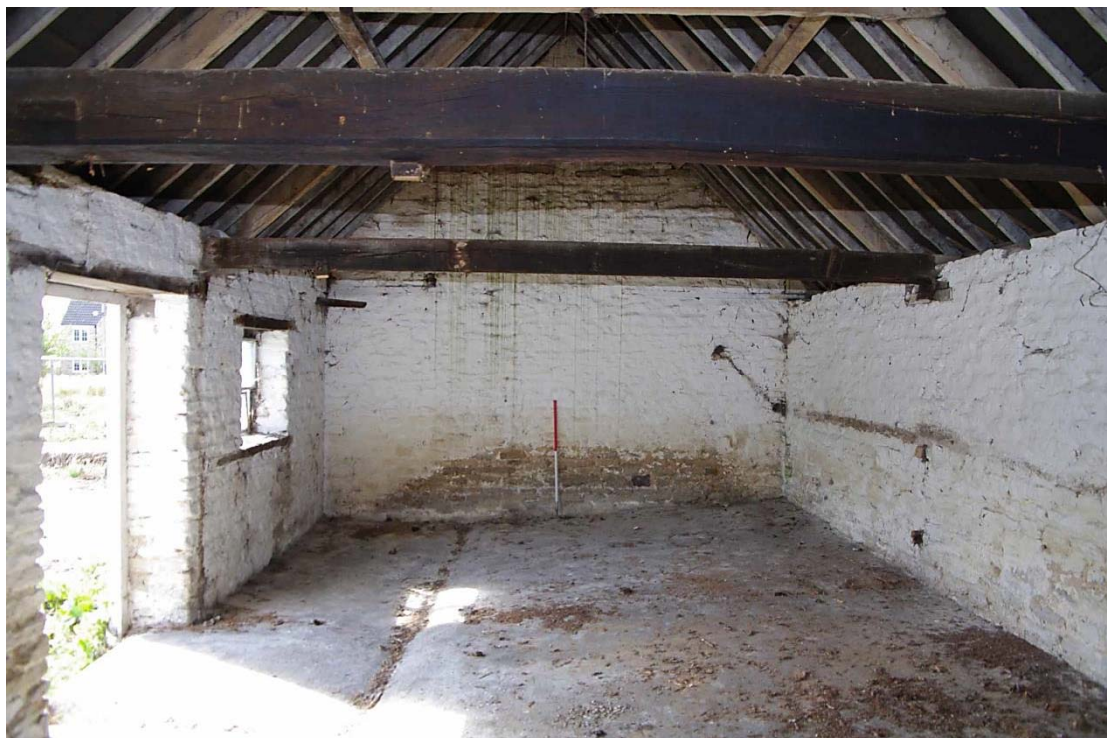
Figure 120: West range, north end of Building G  
Looking south, 1m scale. Note marks in paint showing position of byre on right

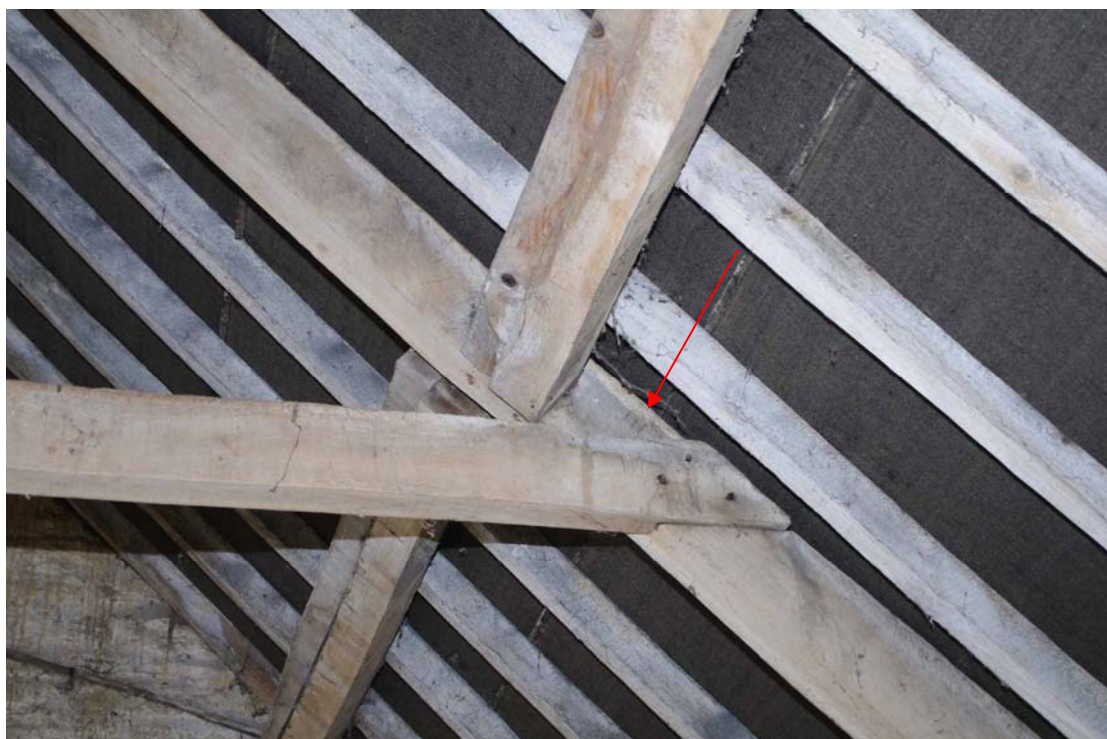
Figure 121: West range, north end of Building G. Roof detail  
Carpenter's Roman numeral marks arrowed

rafters which have carpenters marks in the form of Roman numerals identifying each principal. The rather slender purlins are joined to the principals with mortice and tenon joints and have had an additional timber batten attached to their upper sides for strength (Fig. 121).

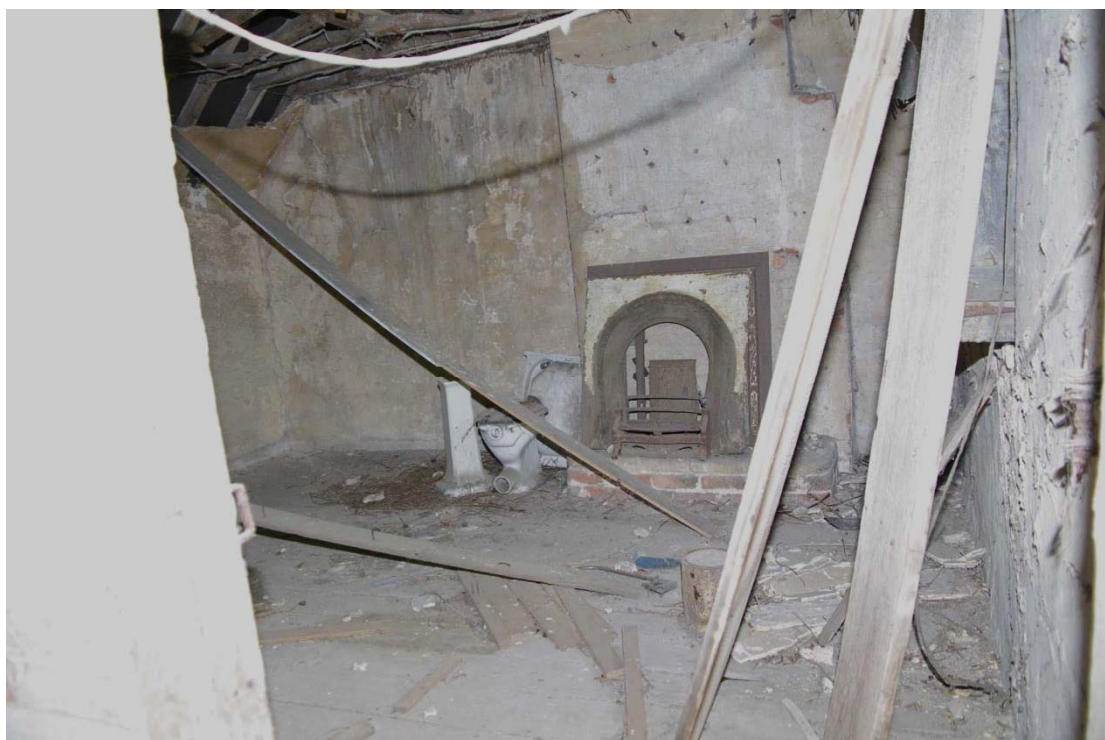
Figure 122: West range, first floor of Building G. Southern room  
Looking south-east from outside doorway

The first floor of Building G can only be reached via the outside stairs on the west facing elevation. The floorboards were in a dangerous state of repair so an inspection of this floor was only made from the threshold at the top of the stairs. The first floor is divided into two rooms of unequal size (Figs 122 and 123). The smallest room is to the south of the entrance door and has remnants of a ceiling and has wall plaster still in-situ. At the south wall is a fireplace and chimney breast (Fig. 122). There is no sign of a chimney breaking the roofline outside which indicates that the fire was out of use before the present roof covering was put on. Access was difficult but there does not appear to be any marks on the wall plaster where the blocked window on the east wall is indicating that it was plastered after the window was blocked. The larger of the two rooms, to the north, is open to the roof which is supported by common rafters (Fig. 123). The windows of this room have single leaf shutters similar to the ones in the tack room below.

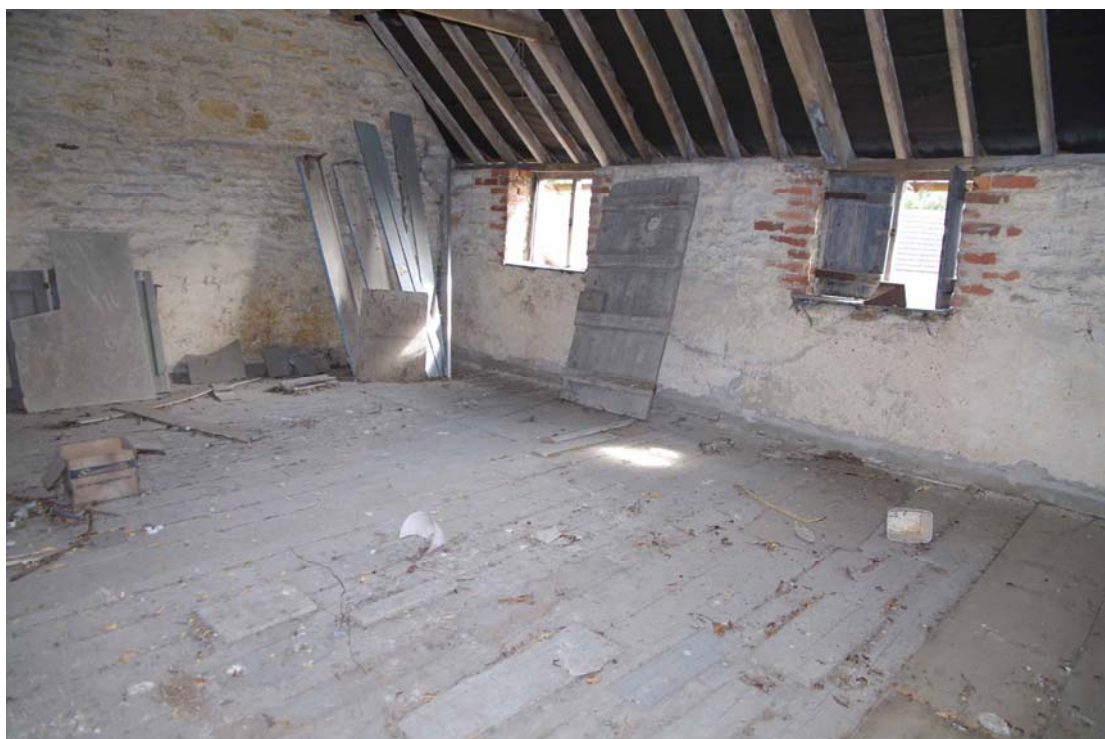
Figure 123: West range, first floor of Building G. North room  
Looking north-east from entrance doorway

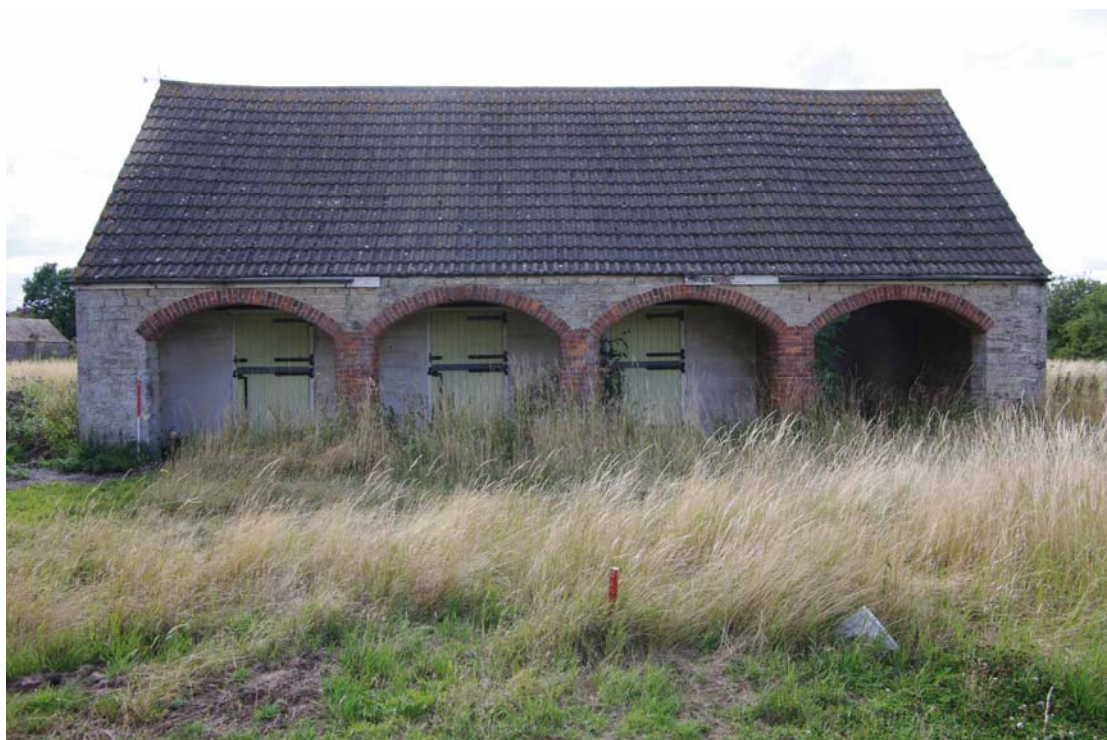
Figure 125: Cart shed (Building H), east facing elevation  
Looking west, 1m scale

The east facing elevation is the principal elevation and has four equally sized brick arches which also have brick pillars similar in style to those on the north and east range buildings (Figs 124 and 125). Both the north and south facing elevations have flat gable ends pierced only by a narrow ventilation window set just below the ridgeline (Fig. 126). The west facing elevation has a single doorway with a flat wooden lintel which opens out to the fields to the west of the complex (Fig. 127).

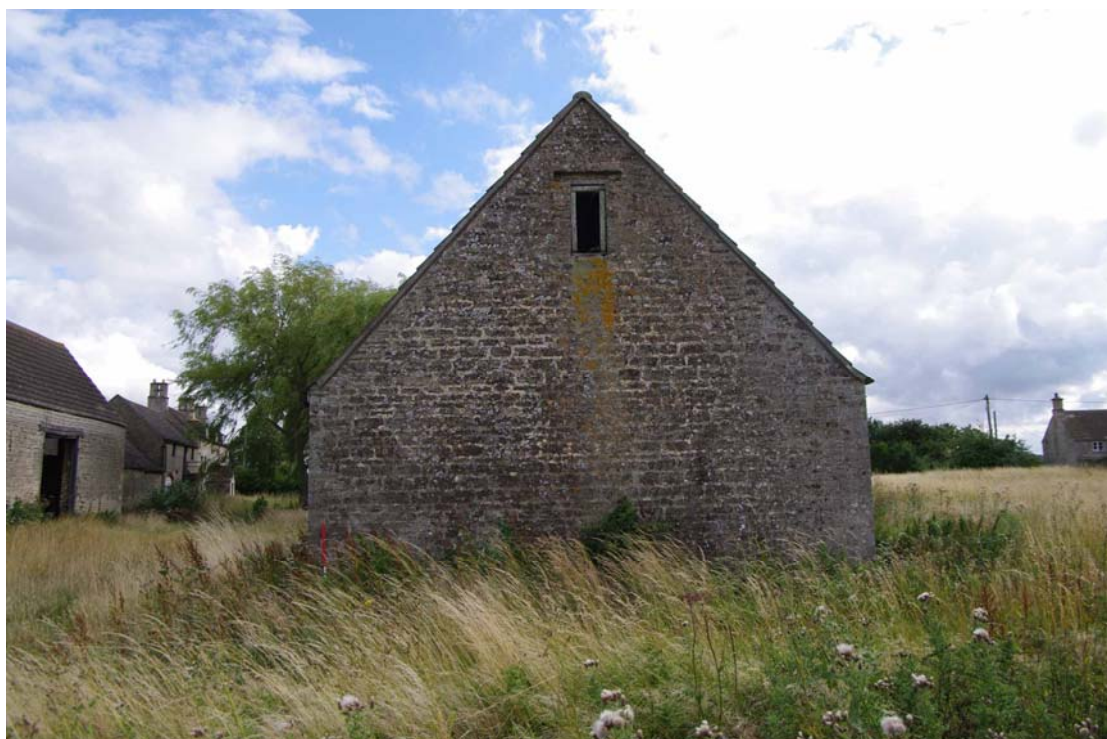
Figure 126: Cart shed (Building H), north facing elevation  
Looking south, 1m scale

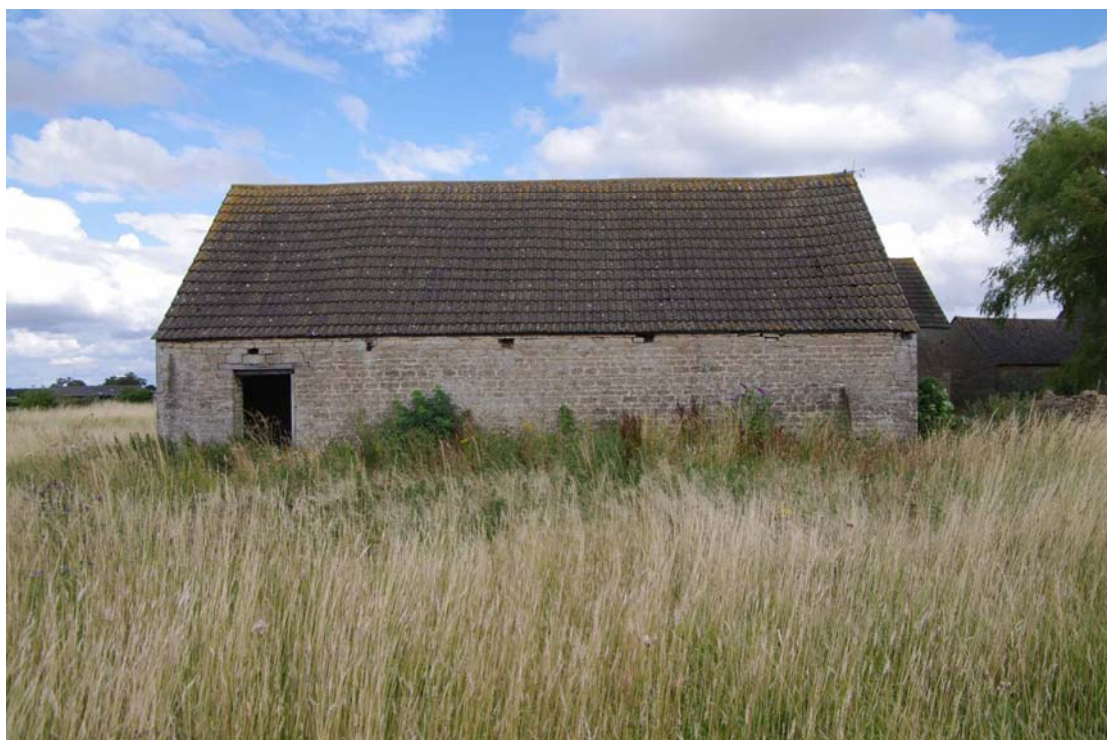
Figure 127: Cart shed (Building H), west facing elevation  
Looking east

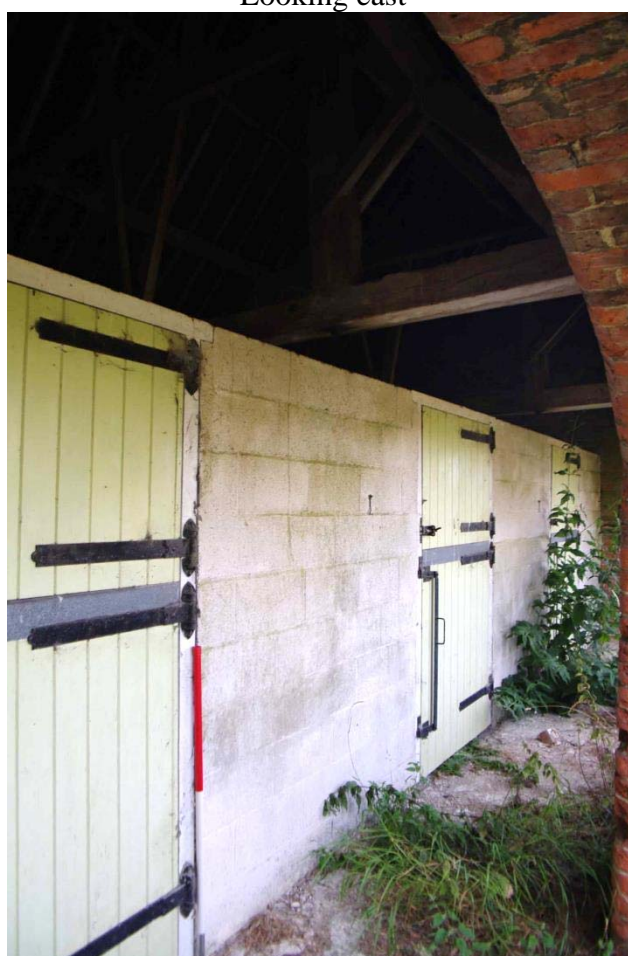
Figure 128 Cart shed (Building H), internal modifications  
Looking north-west, 1m scale

The inside of the cart shed has been heavily modified from an open shed to create three large stables and an open area at the north end (Fig. 128). The stables have been built using modern breeze blocks and have brick and concrete floors laid on a new plastic membrane. The northernmost space is open to the front archway and to the smaller door on the western wall. It is divided by a full-height brick wall which appears to be part of the original design (Fig. 129). The roof structure appears to be of late 19th century design and has bolted and nailed joints. The roof truss supports two queen posts which join the shortened principal rafters. A tie-beam bolted to the top of the queen posts supports the slender purlins which in their turn support the common rafters. To add stability a pair of centrally located raking struts rises up from the truss to support a higher line of purlins which also have collars to hold them apart (Fig. 130).

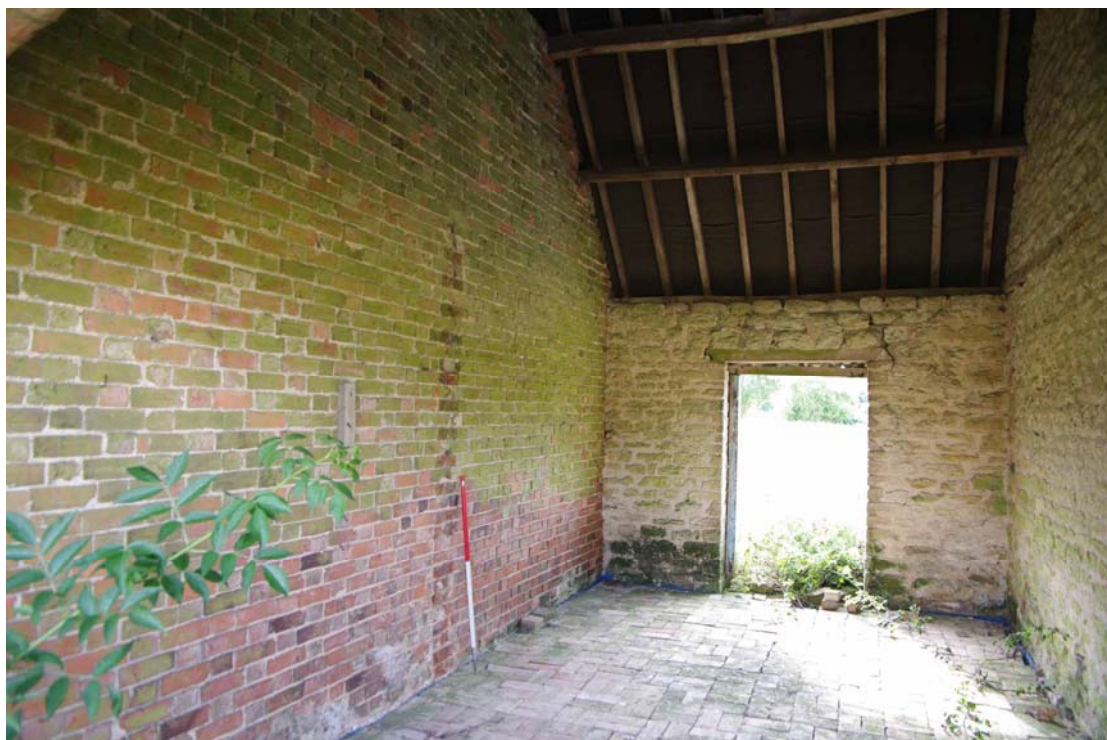
Figure 129: Cart shed (Building H), north end  
Looking west, 1m scale
