**A Level 2 Historic Building Record  
And watching brief at Middle Farm  
House and  
Associated Barns  
Main Street,  
Upper Benefield,  
Northamptonshire**

ULAS Report No. 2017-005  
©2017

**A Level 2 Historic Building Record  
and watching brief at Middle Farm House  
and Associated Barns,  
Main Street, Upper Benefield,  
Northamptonshire.**

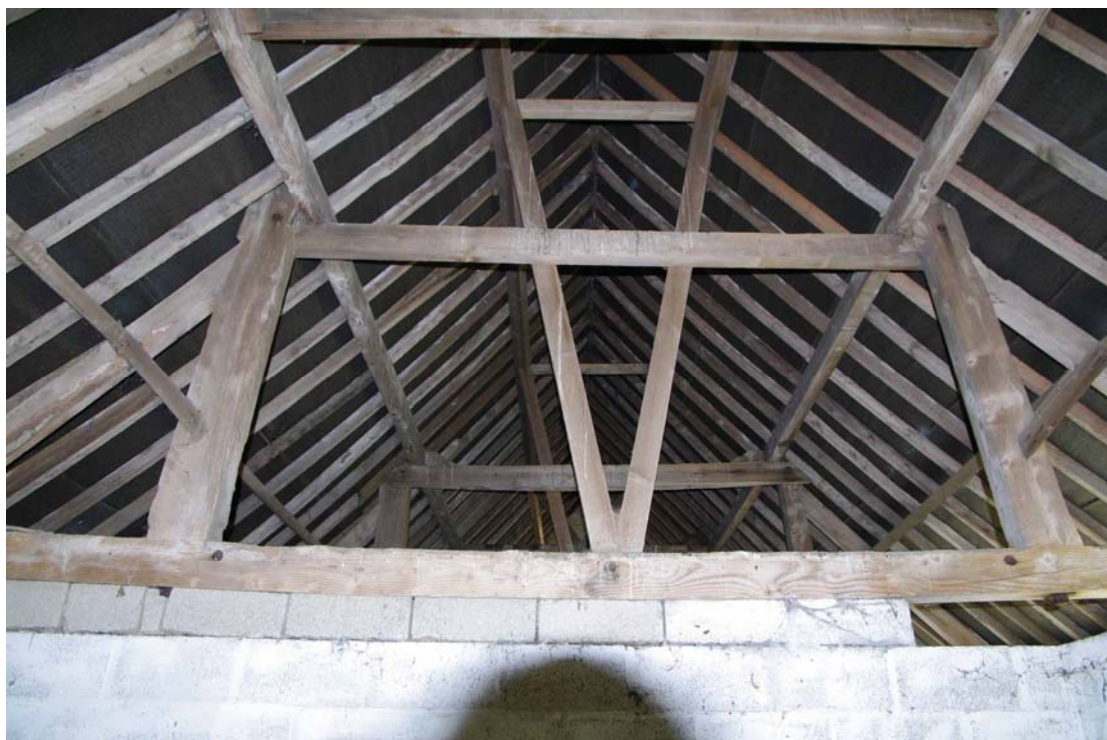
Figure 130: Cart shed (Building H), roof detail  
Looking north

The inside of the cart shed has been heavily modified from an open shed to create three large stables and an open area at the north end (Fig. 128). The stables have been built using modern breeze blocks and have brick and concrete floors laid on a new plastic membrane. The northernmost space is open to the front archway and to the smaller door on the western wall. It is divided by a full-height brick wall which appears to be part of the original design (Fig. 129). The roof structure appears to be of late 19th century design and has bolted and nailed joints. The roof truss supports two queen posts which join the shortened principal rafters. A tie-beam bolted to the top of the queen posts supports the slender purlins which in their turn support the common rafters. To add stability a pair of centrally located raking struts rises up from the truss to support a higher line of purlins which also have collars to hold them apart (Fig. 130).

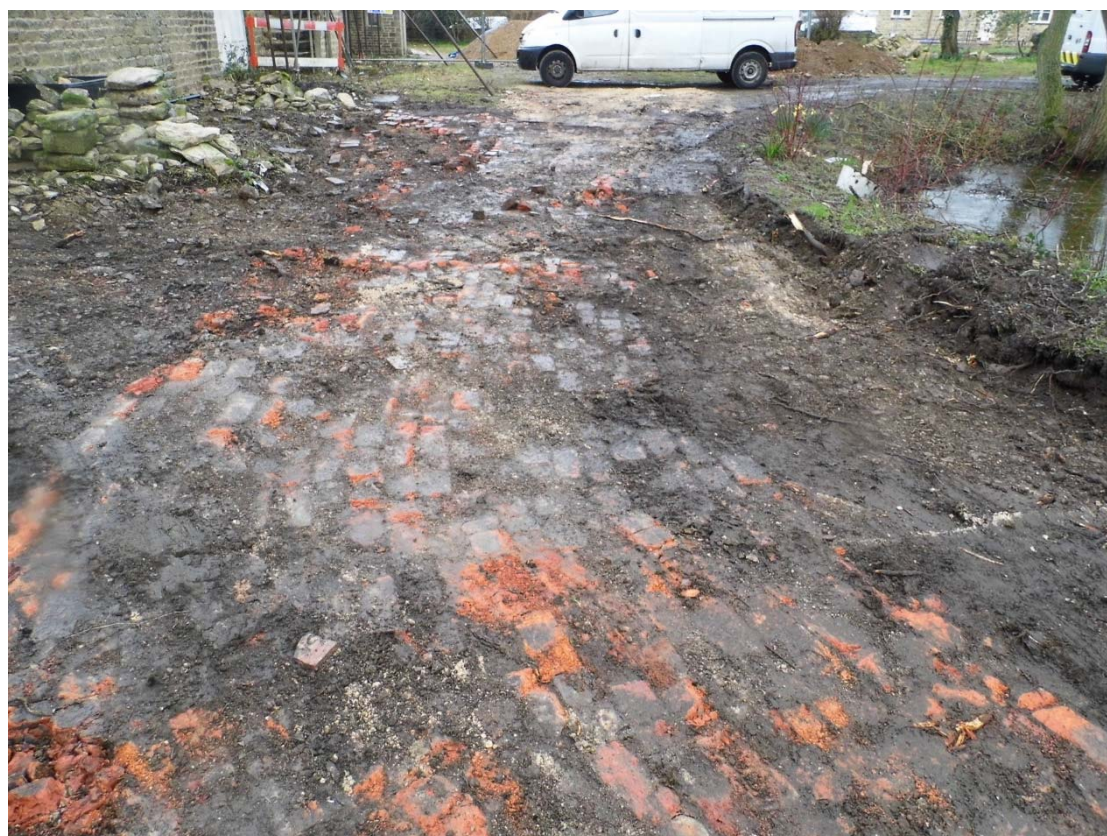
Figure 132: Stripped eastern arm of driveway, looking south

The stripping of the west side of the driveway revealed a mixture of soil, gravel and brick rubble. The eastern side when stripped revealed a lain brick surface (Fig. 132).

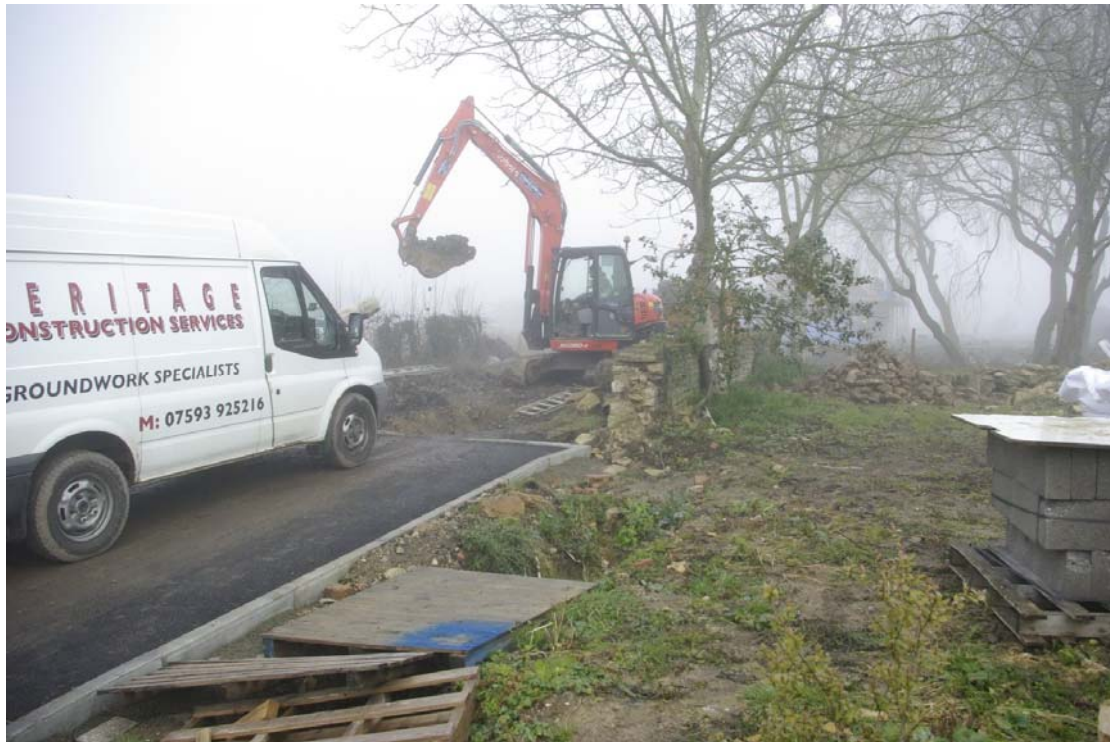
Figure 133: Work in progress on drain trench, looking north-west

A visit took place on 11th March 2016 during the excavation of a drain trench through the main driveway into the site (Fig. 133).

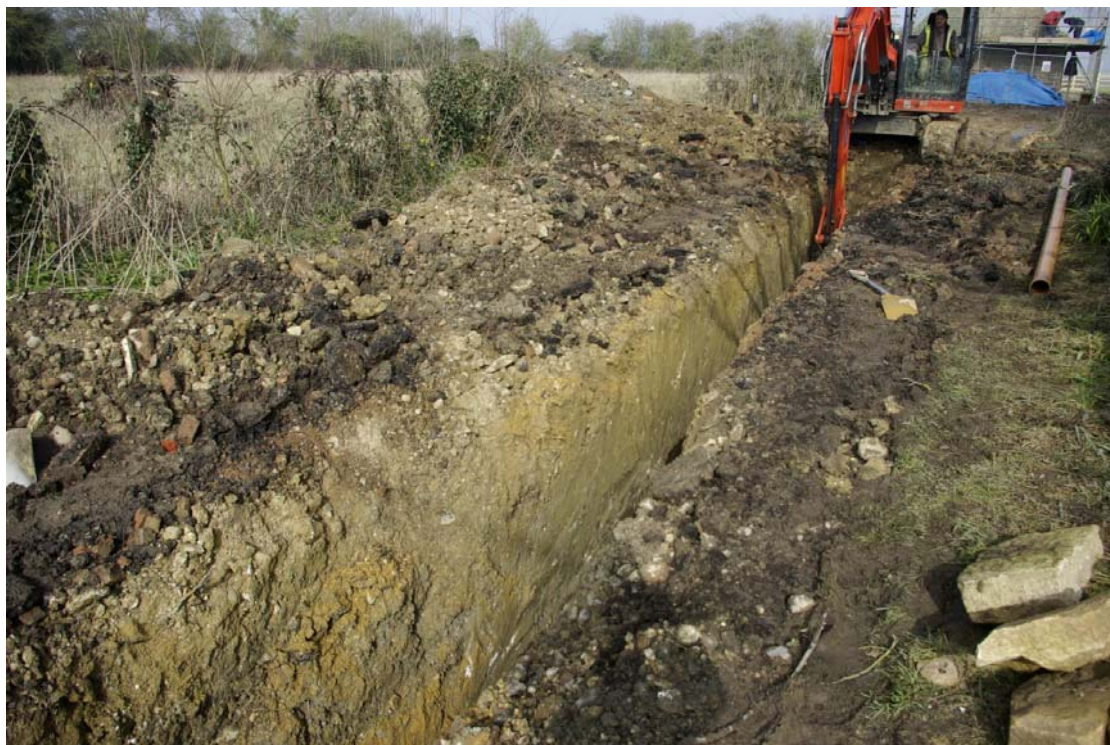
Figure 134: Partially finished trench, looking north north-west

The trench was excavated using a small tracked excavator fitted with a narrow flat bucket, to a depth of around 2m. The upper layers revealed during the excavations consisted of disturbed ground of yellow brown clay with ceramic building material, stones and soil (Fig. 134).

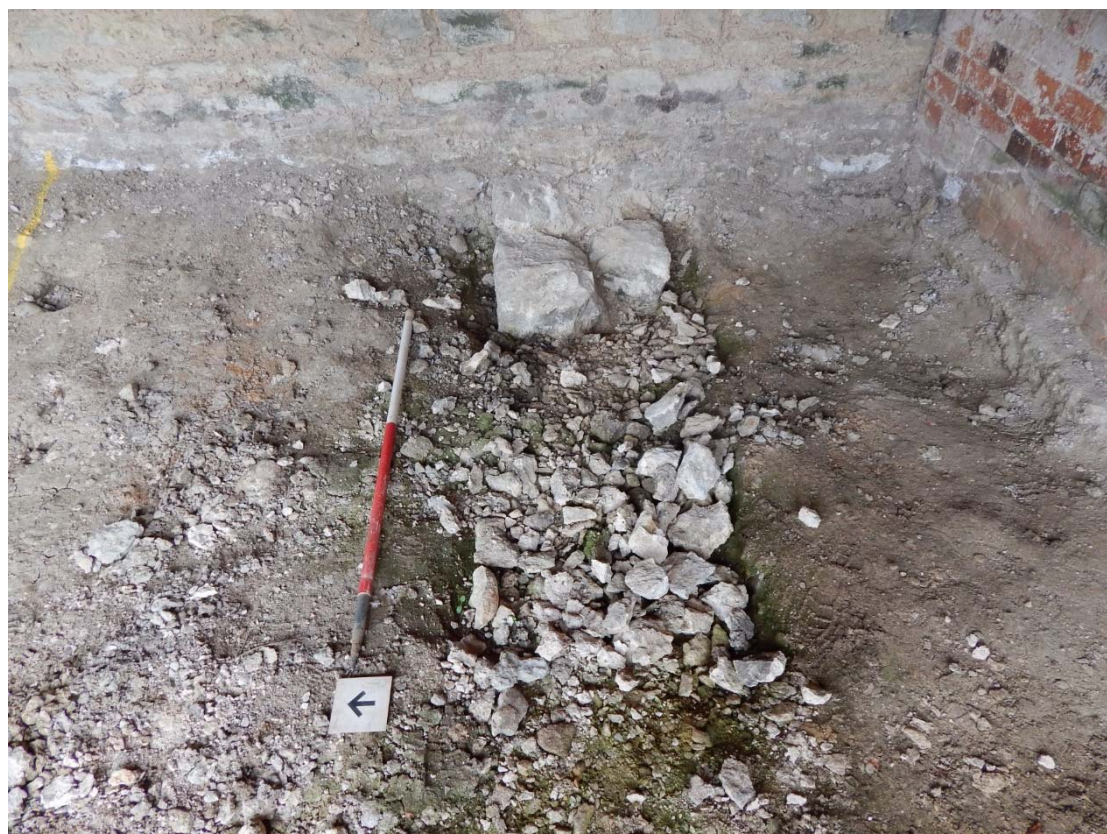
Figure 135: Section of wall revealed in Building D

The interior of Building D had been recently stripped inside. A section of wall foundation was observed here, measuring 4.2m in length, 0.6m in width and was located around 0.8m from the brick wall at the southern end of this building, and therefore would end in the centre of the open archway at the western side of the building, suggesting that the arches and brick walls of this building were a later insertion (Fig. 135).

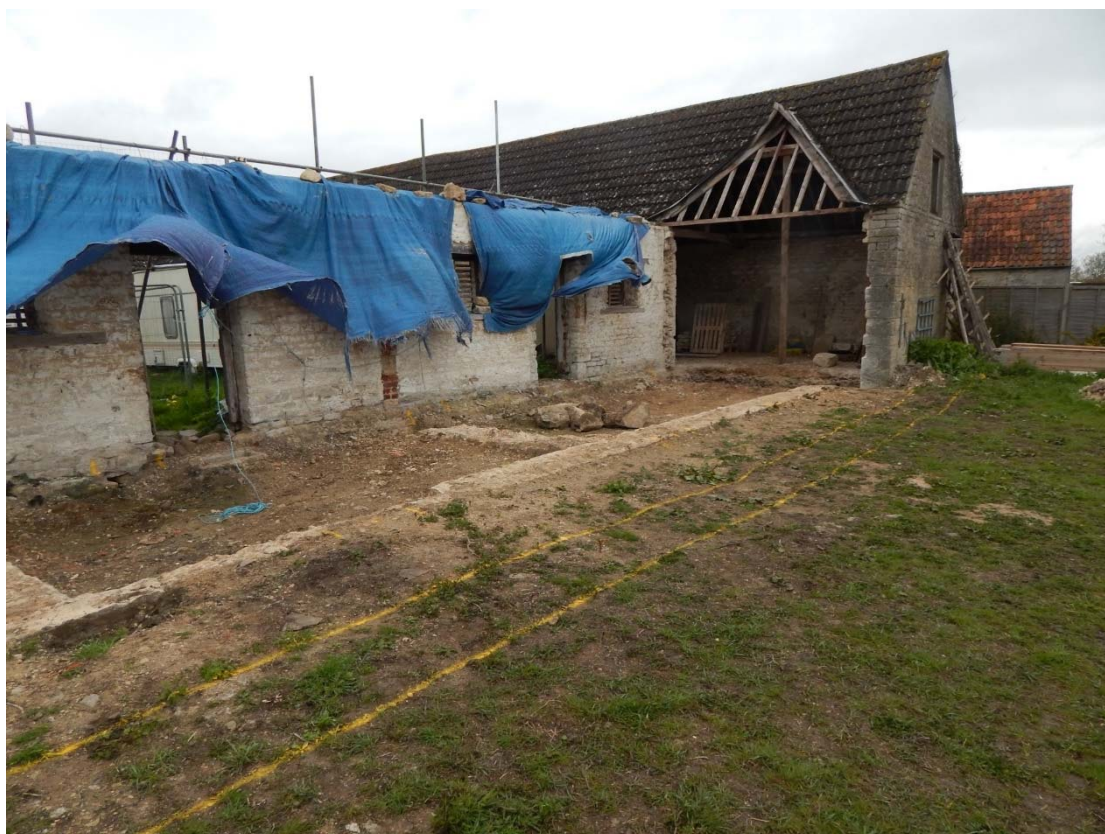
Figure 136: Post excavation view of Buildings E & F (Unit 1), looking east north-east

The southern wall of Building F had been demolished. The new building to be constructed from the conversion of Building F was to be wider than the original build and therefore the building was to be widened here by around 1m, so that new foundation trenches were on the garden area to the south of Building F and therefore the soil here was deeper (Fig. 136).

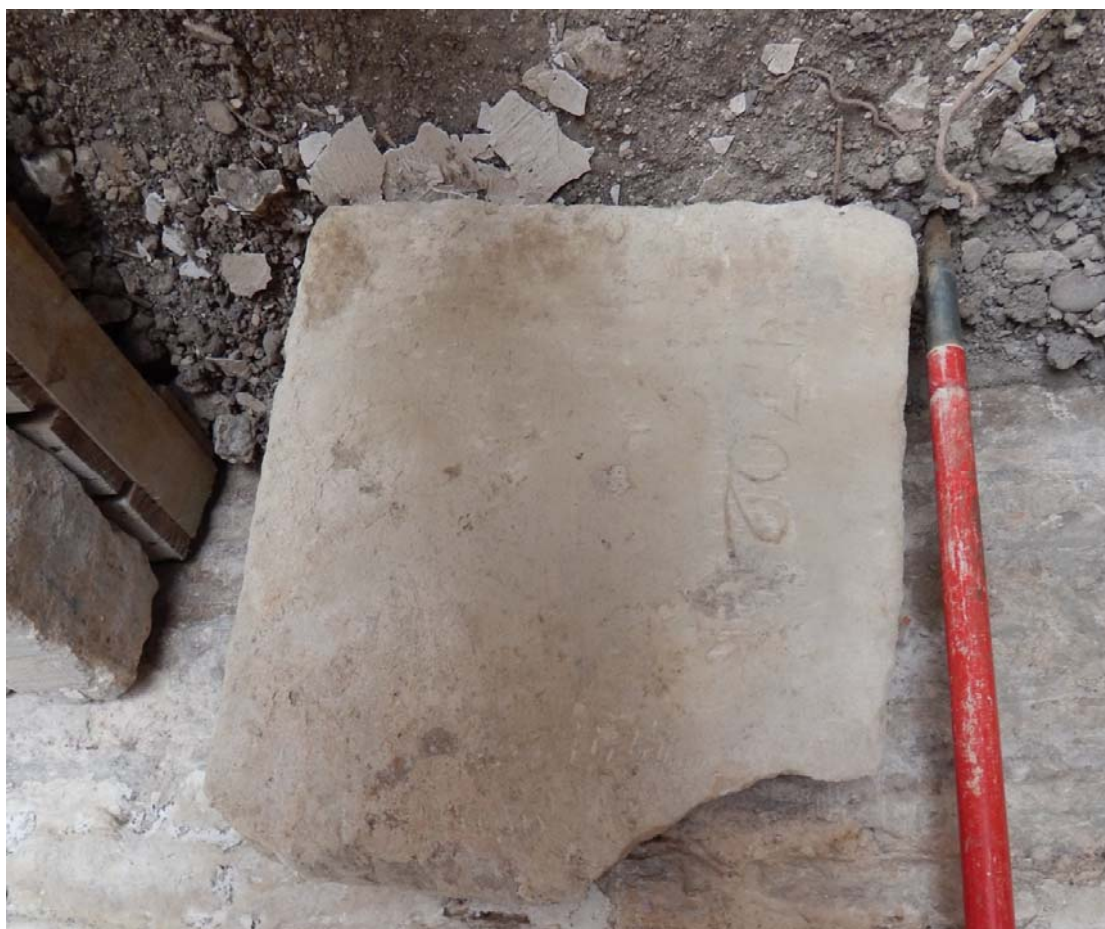
Figure 137: Slab with inscribed date

While part of the wall of Building E was being demolished a large slab of limestone was recovered from the rubble with a date of 1702 carved into it. It appears to have been re-used from an earlier structure (Fig.137).

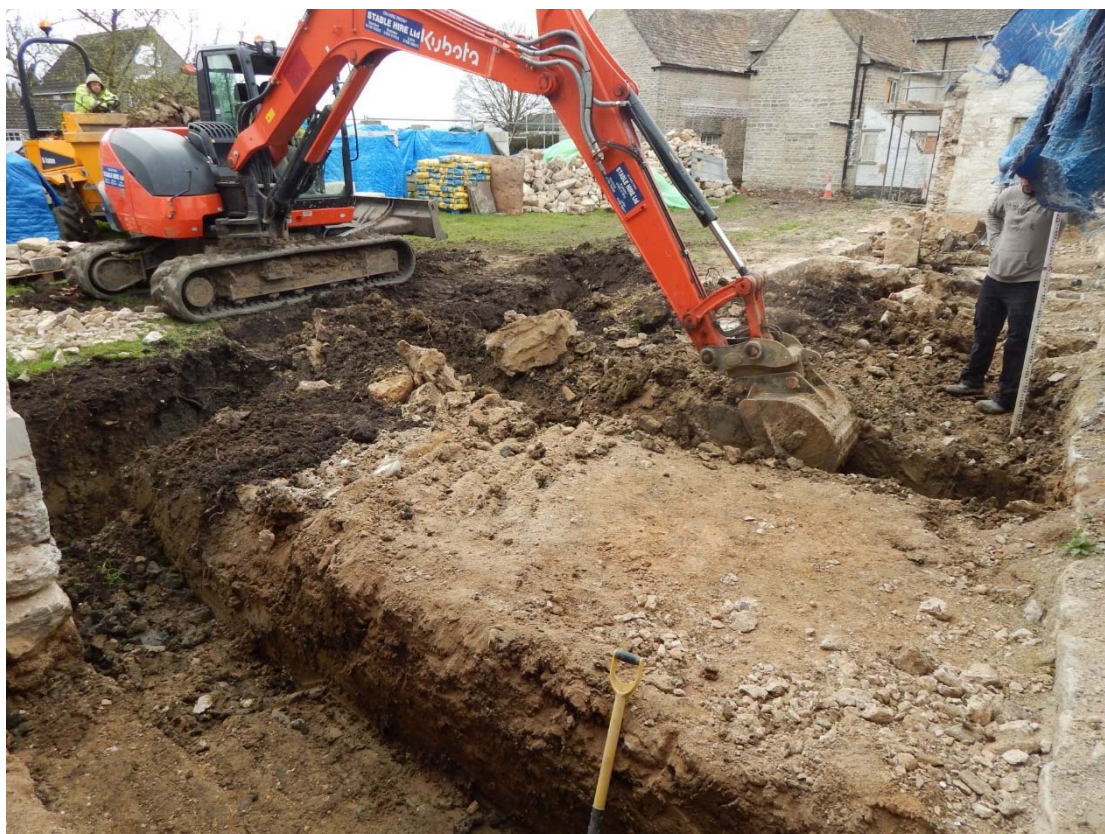
Figure 138: Work in progress on Building F, looking south-west

inner wall trenches consisted of a layer of rubble straight on top of the natural clay (Figs 138 - 139). No archaeological remains were identified.

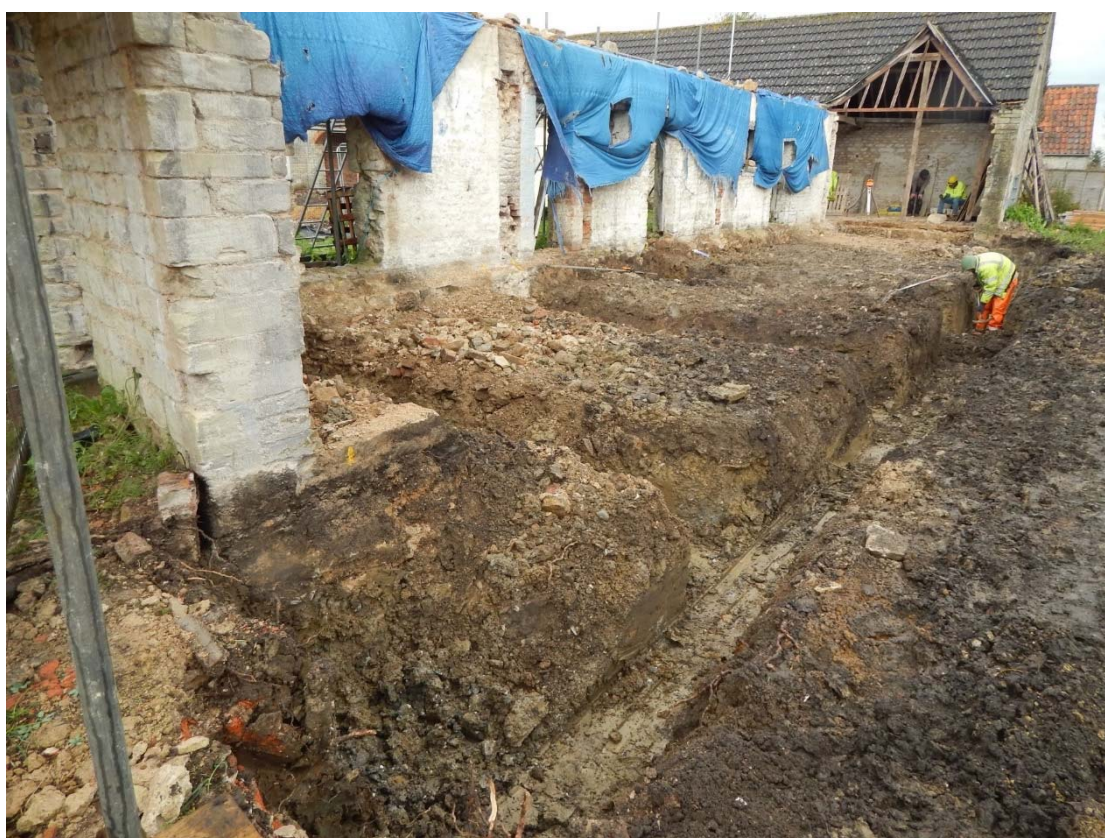
Figure 139: Completed foundation trenches Building F, looking east north-east

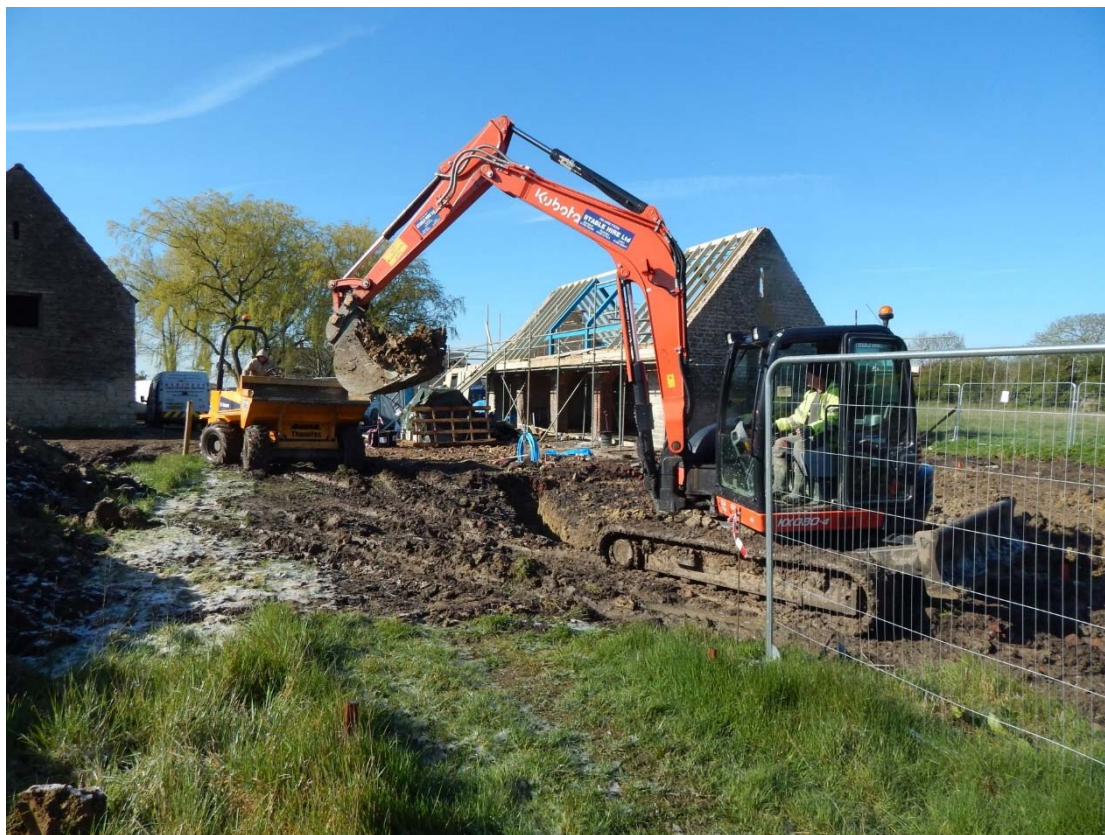
Figure 140: Work in progress on Unit 3, Building H, looking south

The final archaeological observations were carried out on the 27th-28th April 2016 during excavations for the foundation trenches for the extension to Unit 3 (Building H), a former barn in the north-west corner of the site (Fig. 140).

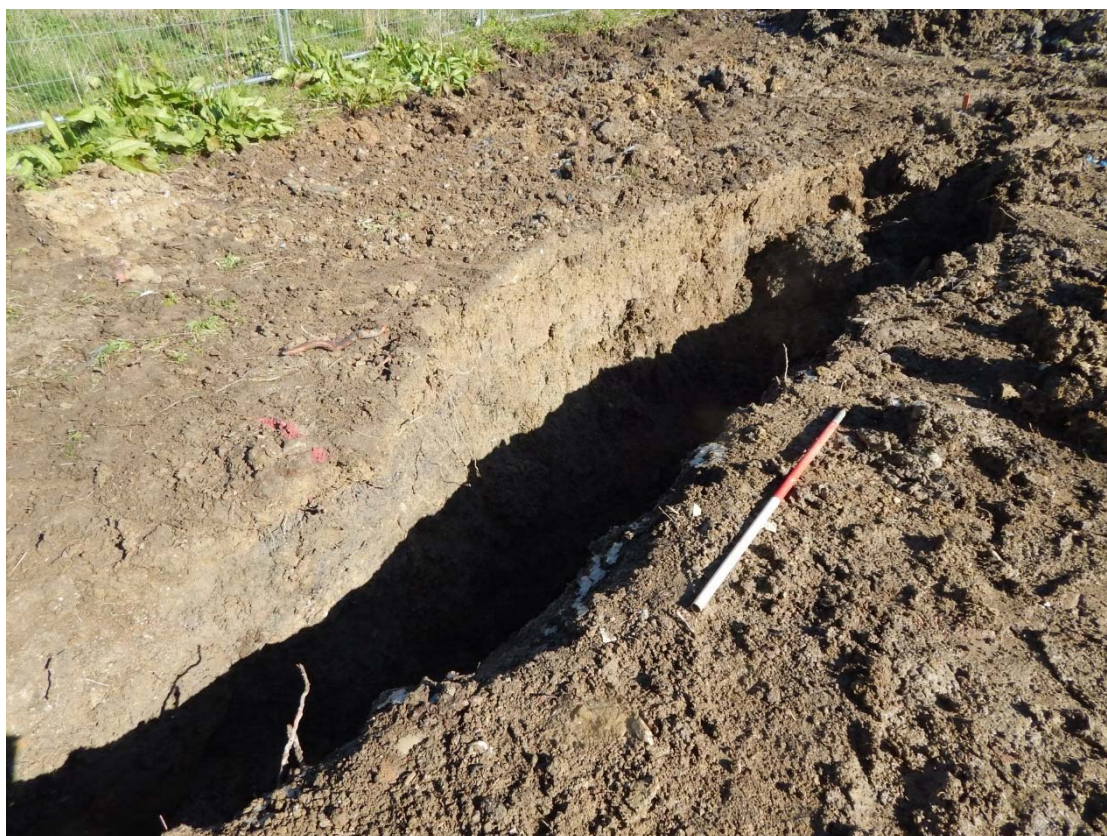
Figure 141: Disturbed area, looking north-west

No features were seen, except for a large disturbance along westernmost trench at northern end for about 5m, visible only in the east facing section. Within this lay a grey organic layer, also containing modern brick (Fig.141).

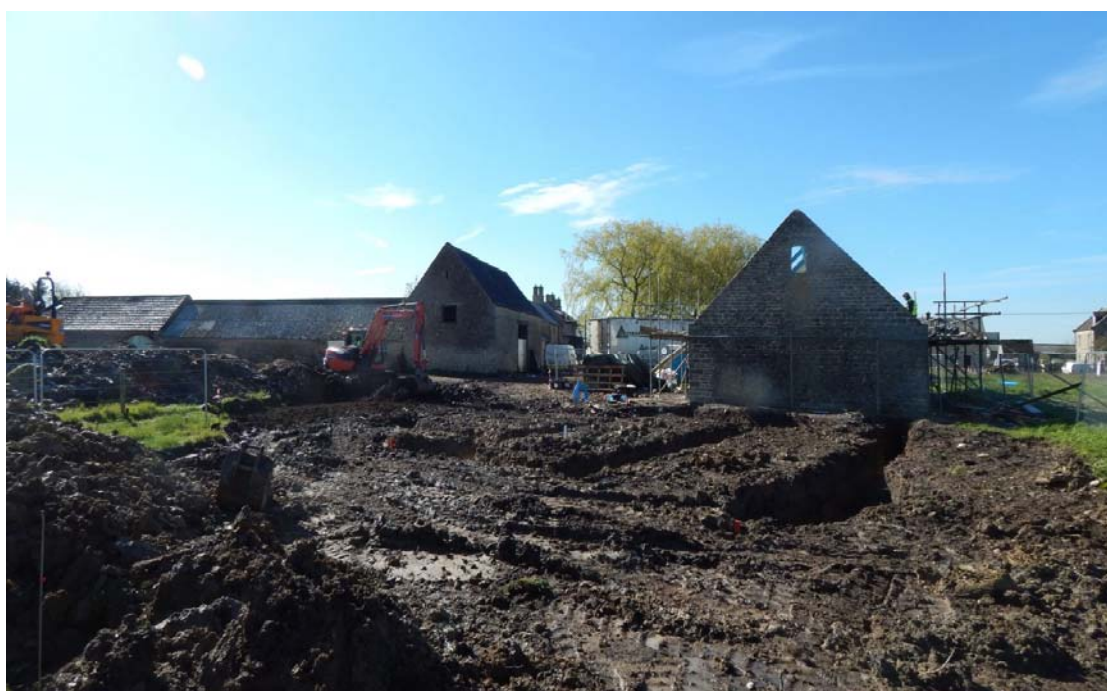
Figure 142: The finished trenches at Unit 3, looking south

No further features were identified on the site and no further visits were undertaken (Fig. 142).
