**An Archaeological Watching Brief  
conducted during a scheme of  
groundworks at All Saints Church,  
Kirkby Mallory, Leicestershire.**

**NGR: SK 45480 00294**

**ULAS Report No. 2016 - 143  
©2016**

**Client: Belfry Ltd.**

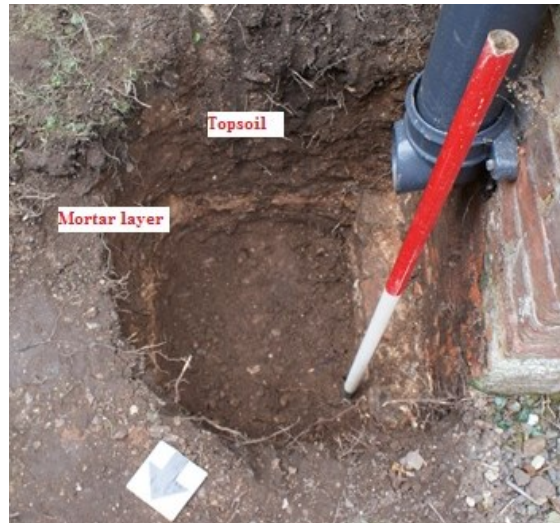
Figure 11: Drainage gully G6 alongside north porch

The site was visited on four occasions between the 31<sup>st</sup> of August and the 7<sup>th</sup> of September. Initial work involved the hand excavation of the gullies on the north side of the church at the same time as excavation of the soakaway running away to the south east of the site. The gullies on this north side had very similar make-up visible in section, although features were found in the base of two of them. A dark greyish-brown mixed deposit overlay a crushed mortar layer and this generally extended to the granite footings of the church. (Fig. 11)

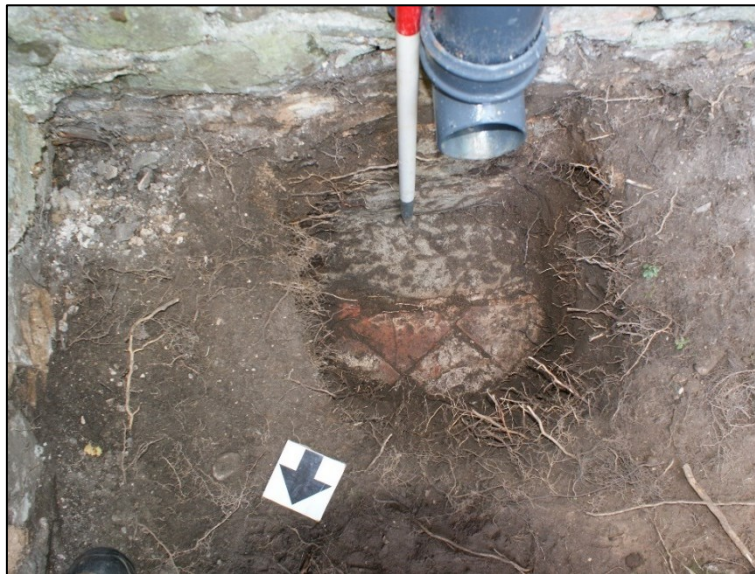
Figure 12: Tiled floor in G4 now outside the church

In most instances below the mortar layer was a reddish-brown sandy-silt with occasional gravel. However in G4 at the junction between the porch and the nave, a tiled floor was evident butting up to a grey sandstone plinth (Fig. 12).

The groundworks provided a series of snapshots into the development of All Saints Church. The gullies provided evidence of a prior floor surface outside the present line of the nave and footings for walls, no longer present, at the eastern end of the church. It is likely that the floor and wall on the north side relate to the demolition of the north aisle recorded in the early 18<sup>th</sup> century. The remnants of the arches to the aisle are visible in the present north wall, these having been blocked to create the replacement north wall (Fig. 21).

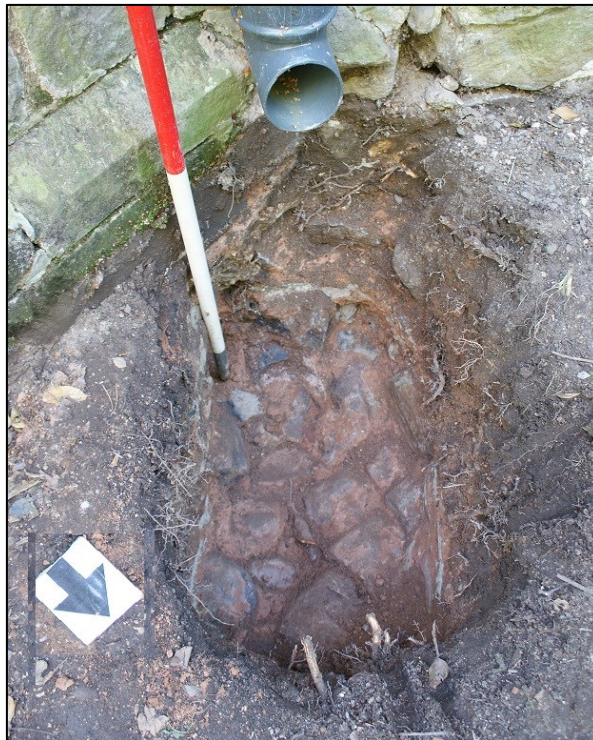
Figure 13: Packed granite and limestone base to G10

In G10 a packed granite and limestone base was visible. This had the appearance of wall core material, although for core, it was well mortared together (Fig. 13).

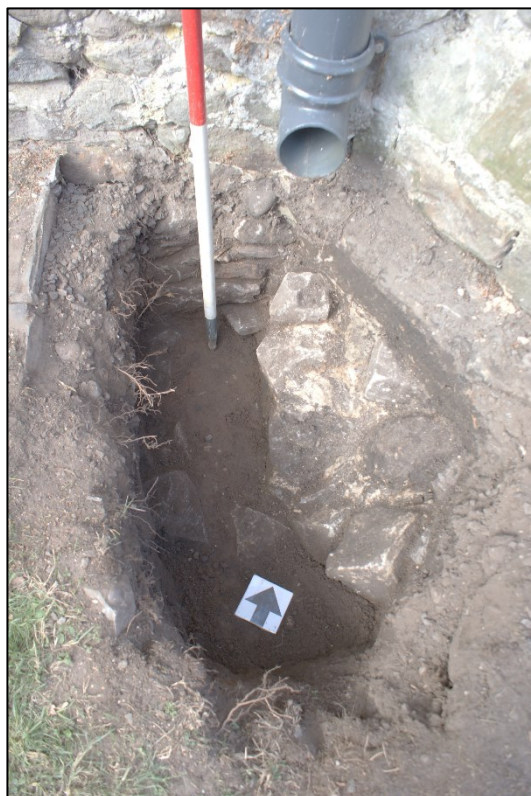
Figure 14: Footings alongside south-east buttress.

On the southern side of the church the ground was more recently disturbed with modern concrete drains having been inserted at most points. There was no mortar layer evident as on the north side. Some footings were observed, however in G3. These footings were of granite, limestone and large boulders bound in a mortar, lighter than that on the north east corner. The stones appeared to mirror the line of the buttress, but were slightly offset, perhaps an earlier buttress on a slightly different alignment or substantial footings to the current buttress (Fig. 14).

There is less conclusive proof for previous church building on the south side of the church. The footings found here are most likely to relate to an earlier buttress on this south-east corner. The east wall demonstrates several episodes of repair, there having been obvious movement here (Figure 22).

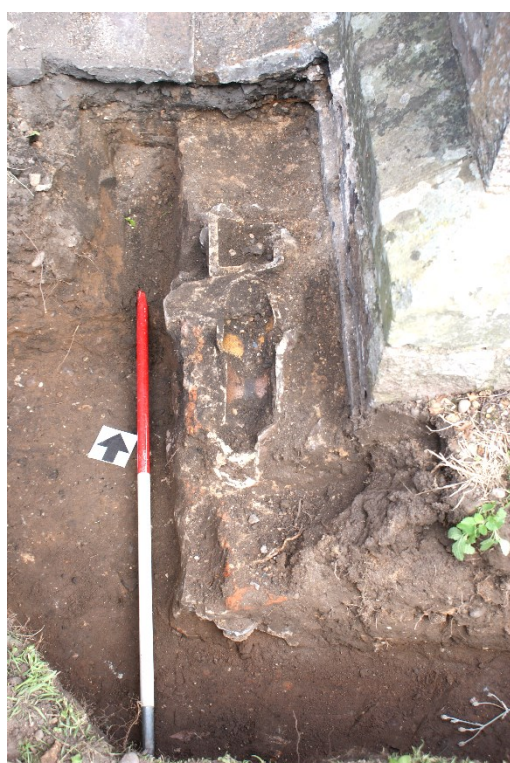
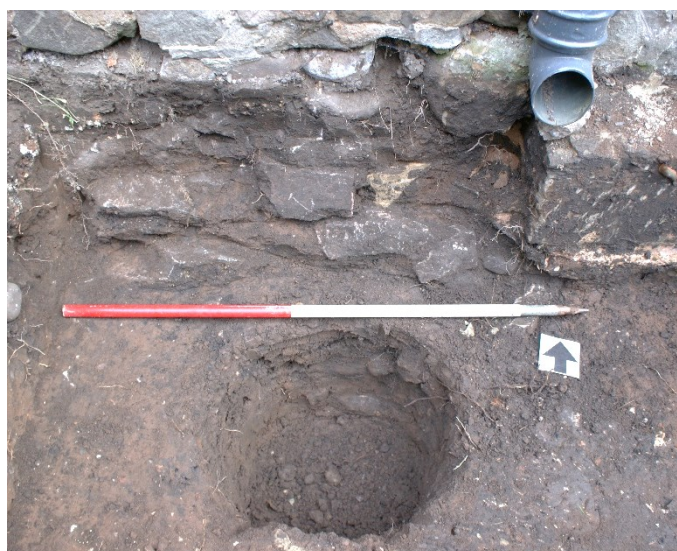
Figure 15: G1 and G2 on the south side of the church, both photographs showing where ceramic drains have been removed, looking north.

There were no burials observed during trenching on the south side of the site, although the excavations did skirt along the edge of a number of headstones. As mentioned earlier there was much disturbance from earlier drainage trenches and although some charnel was recovered there were no complete burials. The footings of the nave were granite along this southern side and there was no evidence of the grey sandstone found on the northern side. Where not disturbed, the subsoil at the base of the trenches was a reddish-brown sandy-silt with occasional pebbles, as on the north side (Fig. 15).

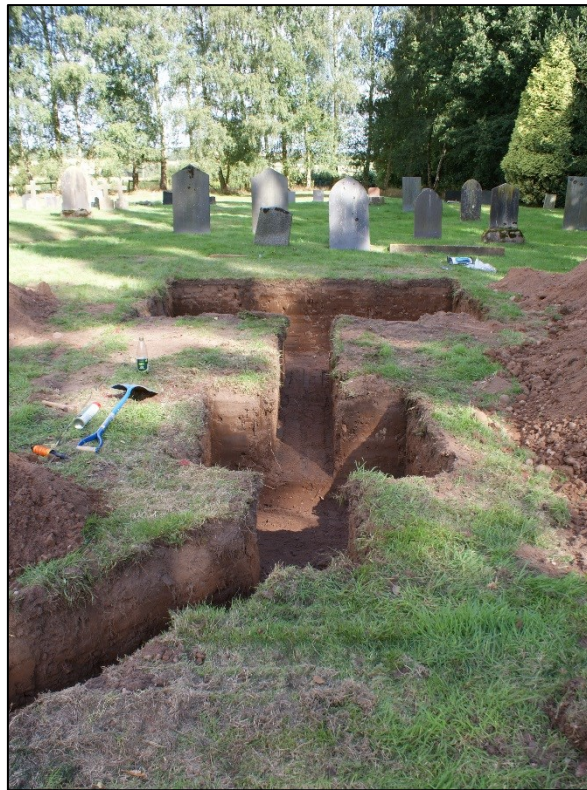
Figure 16: South-eastern soakaway (A) and associated trenches, looking east.

Two soakaways were excavated to the south-east and north-east of the church. Areas where no headstones existed were chosen, in an attempt to minimise disturbance of burials. The south-eastern soakaway (A) measured 3.6m by 2.2m and was excavated to a depth of 1.00m. The soakaway was connected by a linear trench to a manhole trench of 1.40m by 1.40m which reached a depth of 0.80m. A further trench was then excavated to connect the manhole trench to G3 on the south east corner of the church (Fig. 16).

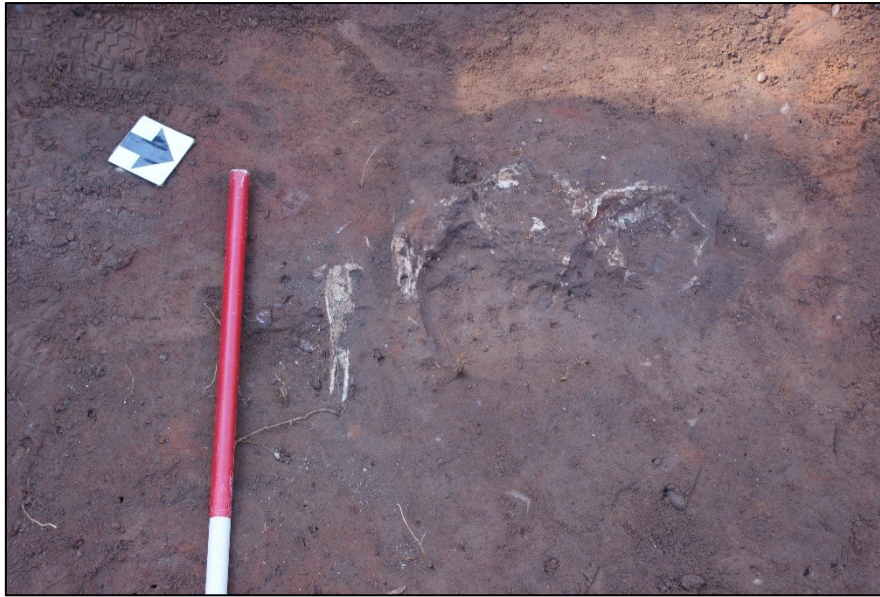
Figure 17: Double infant burial at the base of the south-eastern soakaway, looking west.

The average topsoil depth in this area of trenching was 0.20m and burial soil to a depth of 0.80m. Grave cuts were not easily visible and only disarticulated bone was found between a depth of 0.60m and 0.80m. A burial of two infants together (SK1 and SK2) was found at a depth of 1.00m (Fig. 17). Preservation was poor, not only in terms of complete burials but also in terms of charnel where only long bones and skulls were evident. The burial soil was a light orangish-brown silty-sand with occasional pebbles and the nature of this soil, or soil conditions were not favourable for bone preservation. Only disarticulated long bones were found in the remainder of the trenching on this side of the church.

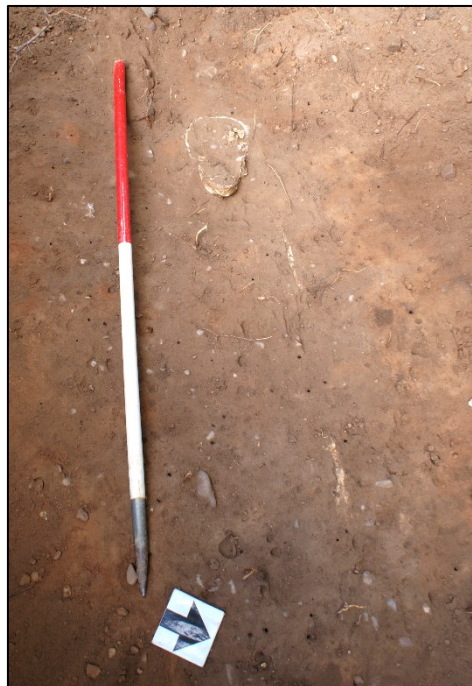
Figure 18: Juvenile burial in soakaway 'B'

The north-eastern soakaway (B) measured 3.0m by 3.0m and was excavated to a depth of 0.9m. The manhole trench measured 1.2 by 1.2 and was excavated to a depth of 0.80m. A pipe trench of depth 0.6m ran from here towards the north door of the church. The depth of the soakaway was reduced to 0.9m to account for the fact that two skeletons were exposed at this depth and left *in-situ*. Two further burials one adult (SK3) and one juvenile (SK4) were recorded and removed at heights above this. Preservation was slightly better than in soakaway 'A' but still relatively poor (Fig. 18).

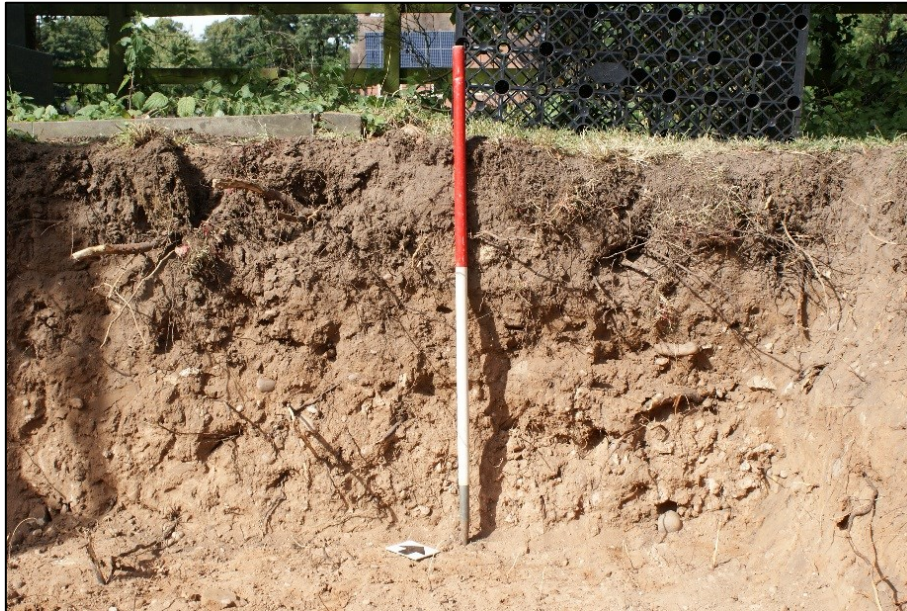
Figure 19: Section of soakaway 'B' showing pit fill of mortar, plaster and slate waste

The average topsoil depth in this area was 0.40m, there was a slight rise in the ground level at this point. The base of the soakaway had revealed a cut for a pit filled with plaster, mortar and slate fragments. This area had clearly been used for the dumping of building refuse, hence the slight mound (Fig. 19). Burials had been cut into this waste material clearly post-dating this dumping event. Some of the plaster was painted and decorated (Fig. 20) and clearly came from the demolition of a nearby building.

The aisle appeared to run the full length of the church, if you use these blocked arches as a guide. The grey sandstone footings appear to coincide with the work blocking the nave. It is also possible that the pit filled with building material relates to the demolition of the aisle and the painted plaster once decorated the aisle or nave.
