Archaeological attendance
during groundworks at
St. Mary's Church,
Melton Mowbray,
Leicestershire
(SP 75276 19029)

DAC Ref: 2014/000167

ULAS Report Number 2017-026

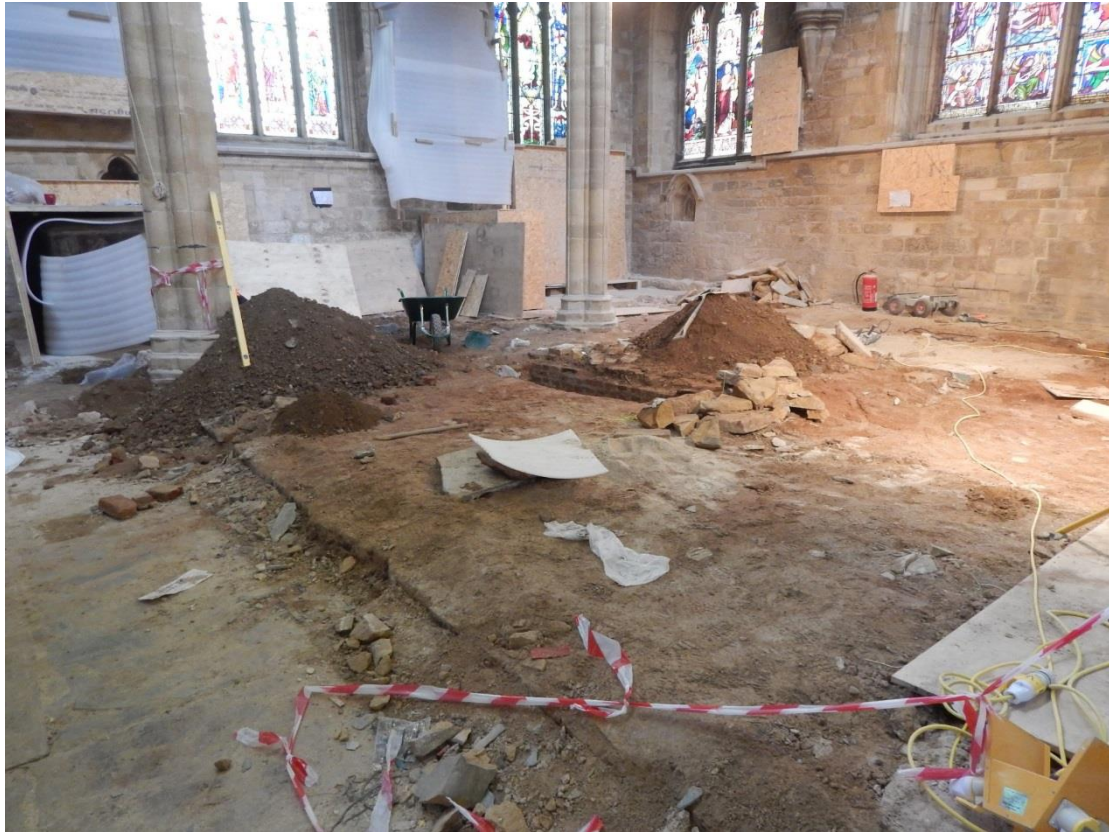
Figure 7: South transept after removal of ledgers and slabs

After the removal of the floor slabs and ledgers in the south transept it was clear that the graves here were largely intact as the floor levels of the transept were around 0.30m above the floor level of the nave and had not been disturbed by the reduction of the level of the floor by Scott in the 1850s (Figures 7 & 8).

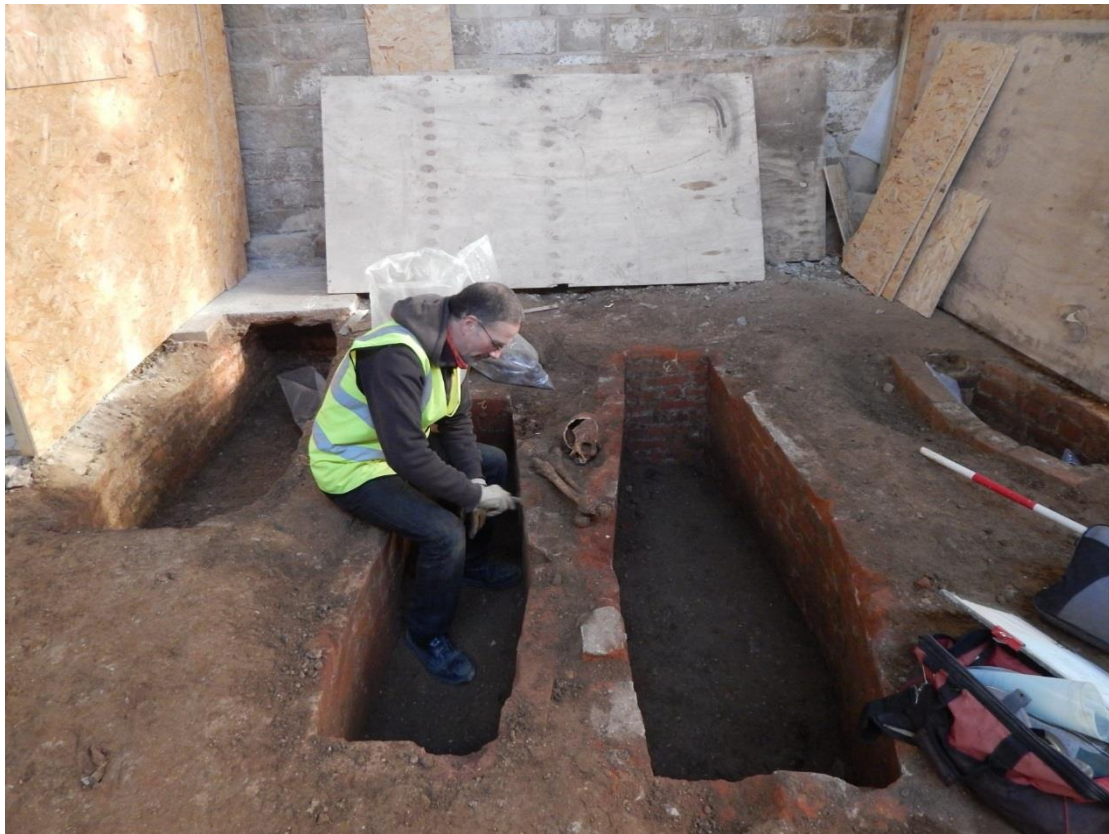
Figure 9: Work in progress on brick-lined graves (Gr 1-4), south transept

At the eastern end of the transept was a group of four brick-lined graves (Gr. 1-4), with Grave 1 partially obscured by a slab. All the graves were 'single-break' coffin shaped with Graves 1 and 3 of a similar size (approximately 2.4m by 0.80m) (Figure 9). Grave 2 was slightly smaller (2m by 0.70m), whereas Grave 4 was clearly a child's grave measuring only 1m by 0.70m (Figure 10). The ledgers across this section of the floor were associated with former vicar Thomas Middleton and his wife Dorothy (died 1811) and children, including Maria Middleton who died aged 38 days (d.1798).

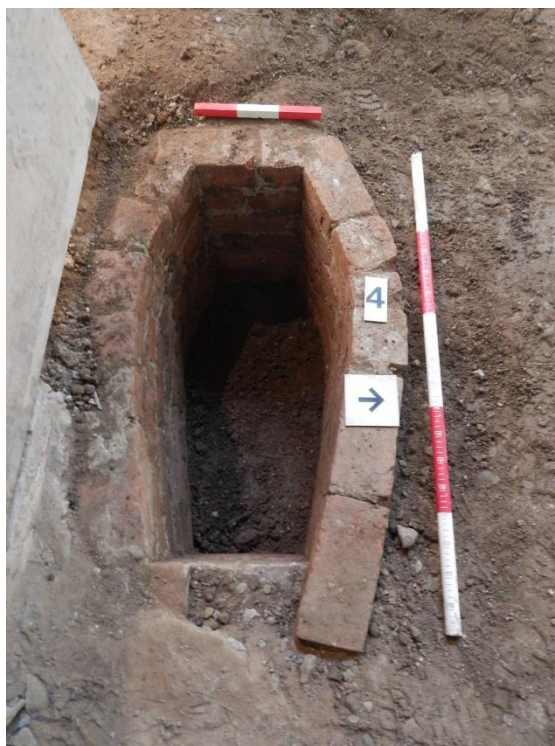
Figure 10: Grave 4, post excavation, looking west

The soil within the graves was loose sandy silt with patches of clay with pieces of slate, brick, mortar, and disarticulated human remains, which were clearly charnel as they mainly consisted on long-bones and skulls, with Grave 2 containing at least 4 complete femurs and Grave 4 containing only adult remains. The remains of a wooden coffin

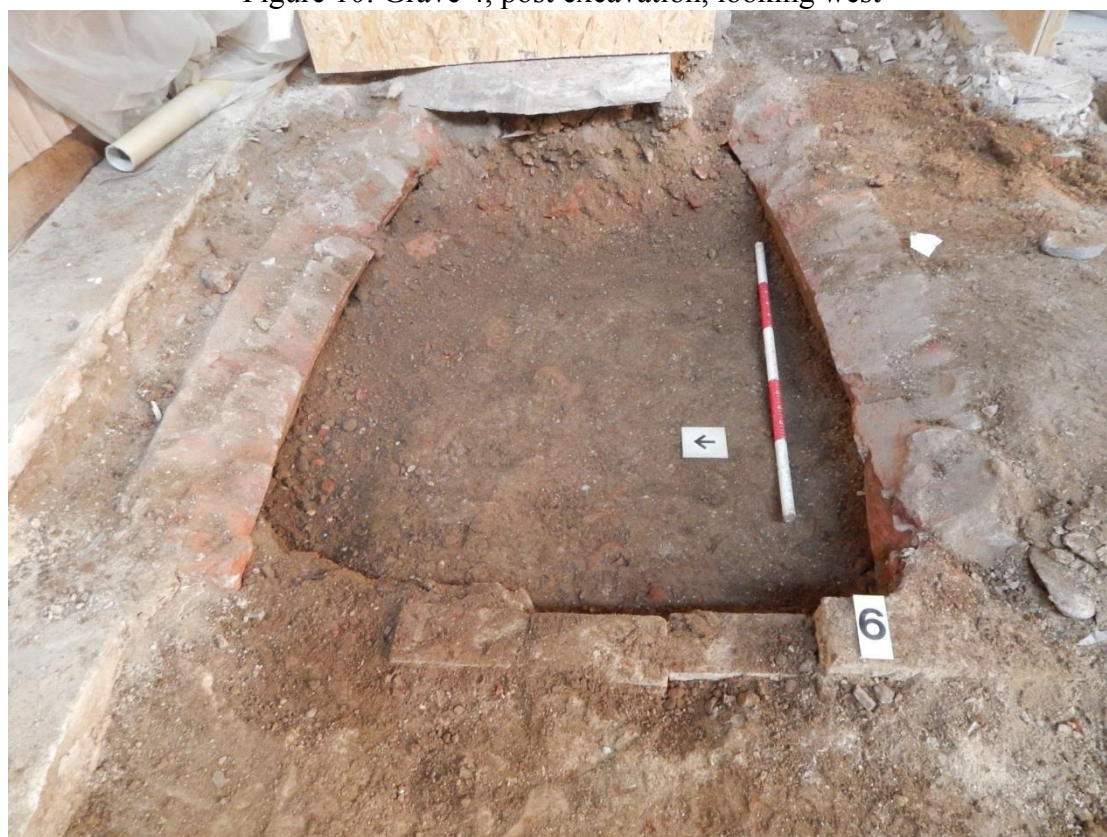
Figure 11: Vaulted feature (Gr. 6), looking east

Further to the north of the urn was a brick lined feature that appeared to be part of a damaged vaulted grave (Gr. 6), slightly obscured by the furniture to the east. The visible areas of the feature measured 1.8m by 1.8m and although the feature contained similar soil to the other graves it contained fewer human remains and considerably more brick and stone (Figure 11). A similar feature (Gr. 14) lay around 9m to the south at the opposite end of the south transept, although this was mainly obscured by remaining ledgers and concrete here.

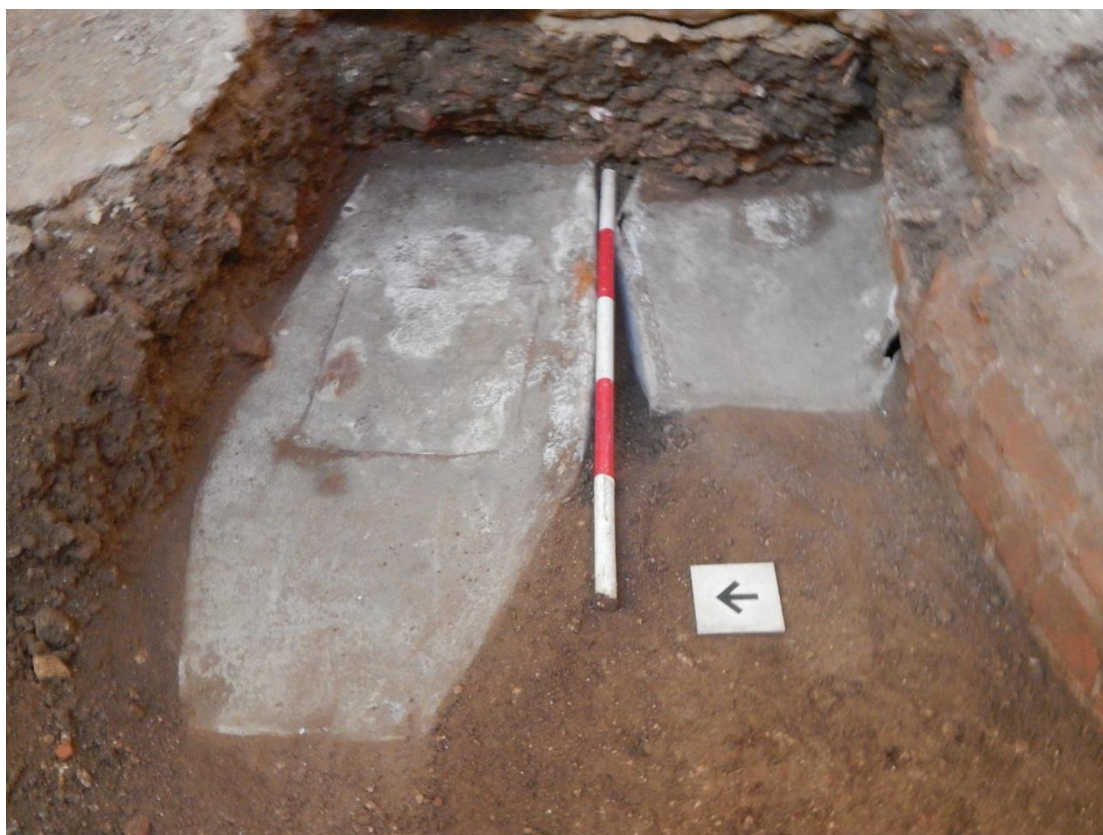
Figure 12: Partially obscured lead coffins, looking east.

While this area was being cleaned prior to being photographed, three lead coffins were exposed, partially obscured by the remaining ledgers and slabs here (Figure 12). Although below the finished working level, they were cleaned and photographed and will remain in situ.

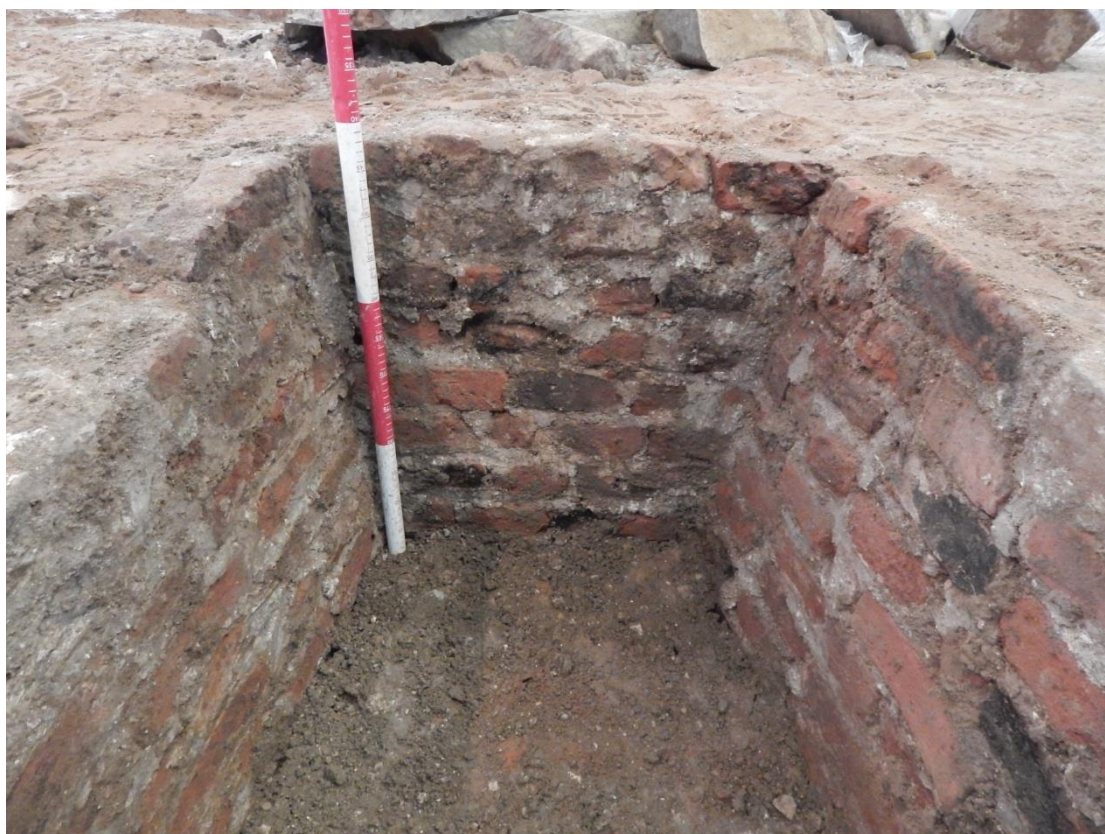
Figure 13: Typical coursing within brick lined graves in south transept (Gr. 5)

A further single brick-lined grave (Gr. 5) lay to the west of Graves 1-4 under the ledger of Penelope Grant and Mary Treadwell. This was of similar size to Graves 1 & 3 (albeit a little wider) and also contained a considerable amount of charnel, mainly segments of long bones (Figure 13).

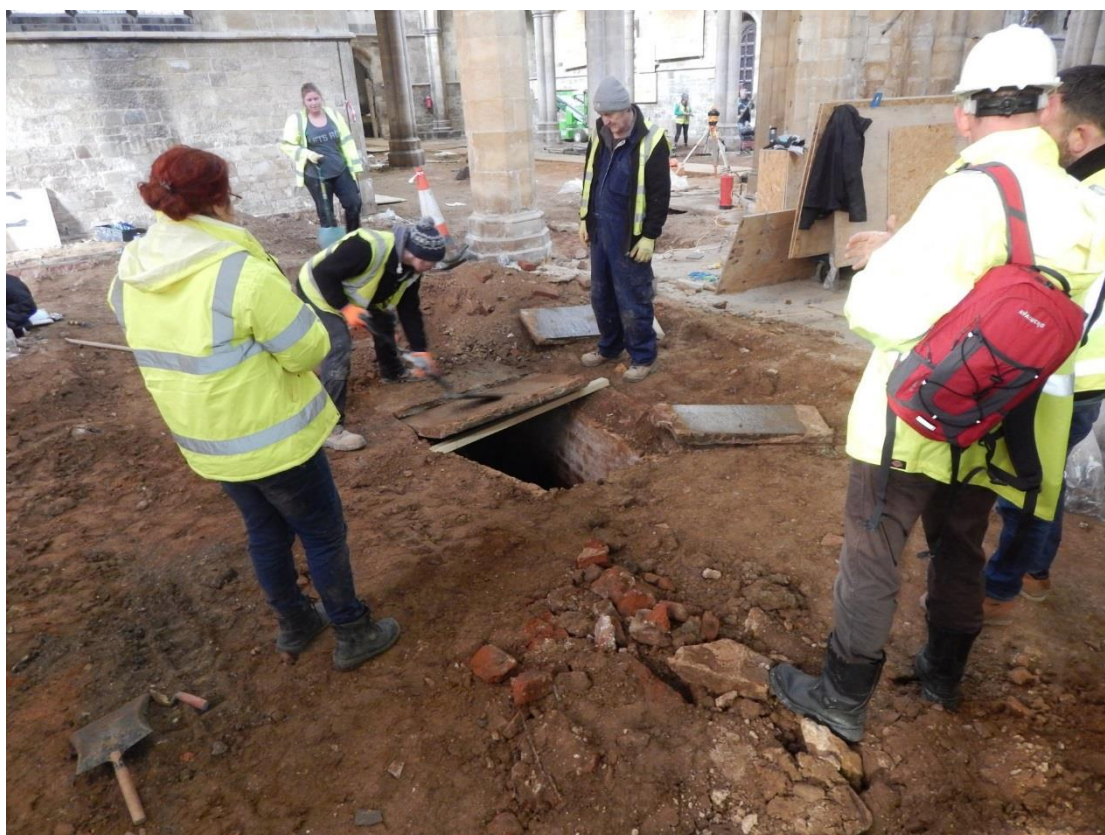
Figure 14: Work in progress lifting slabs over Grave 7, looking north-west

Much of the central area of the south transept did not contain any features. However, to the north-west of Grave 5 just below the finished working level were four mortared slate slabs. The slabs were lifted to reveal a large brick lined and white washed chamber measuring around 2.4m by 1.2m and around 1m deep (Figure 14). A damaged lead coffin lay submerged by ground water at the base.

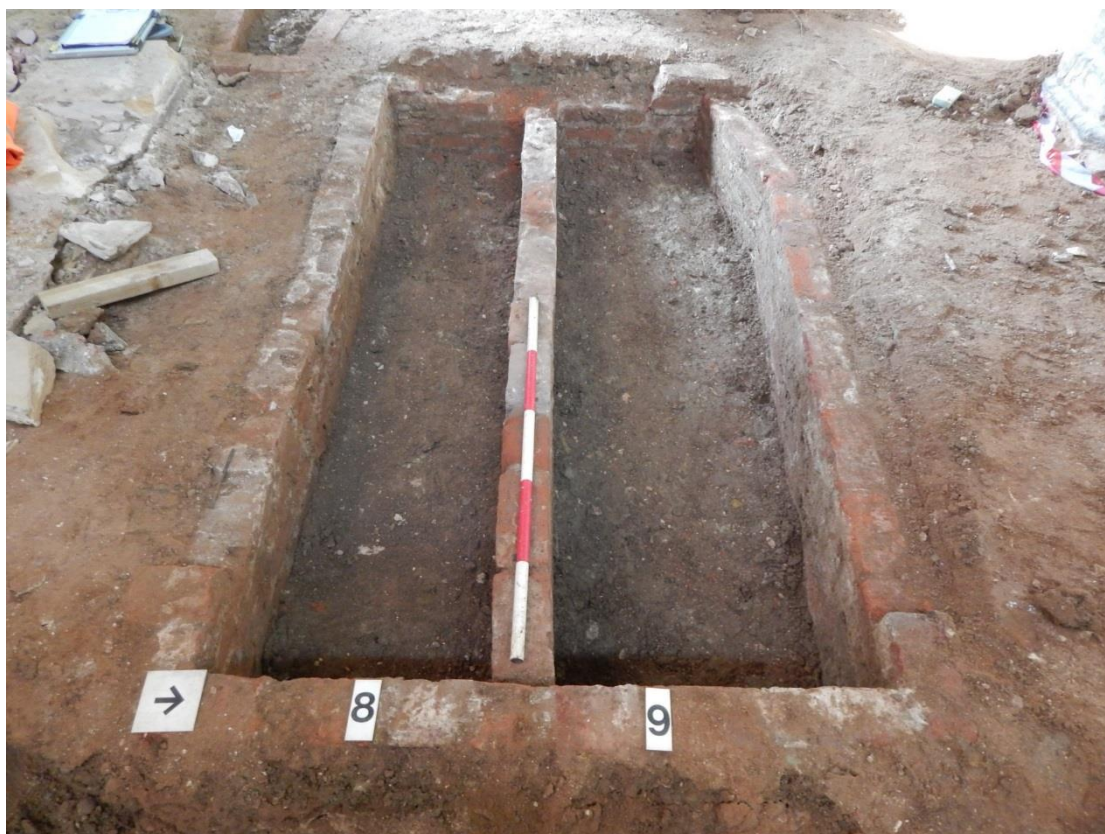
Figure 15: Graves 8 & 9, post excavation, looking west.
Grave 15 lay under debris to the south

The western side of the south transept contained a further nine brick-lined graves. Four of these were of the typical single break shape (Graves 10-12, 12a, 13 and 16), whereas three were broadly rectangular and co-joined (Graves 8, 9 and 15) (Figure 15). Most contained at least some charnel remains, although generally fewer remains than in the eastern group, with the occasional nail or piece of coffin furniture. Often the soils would be more clayey in composition (this was particularly apparent in Graves 8, 9 and 15), which may be due to a high water table here or localised flooding from a leaking roof.

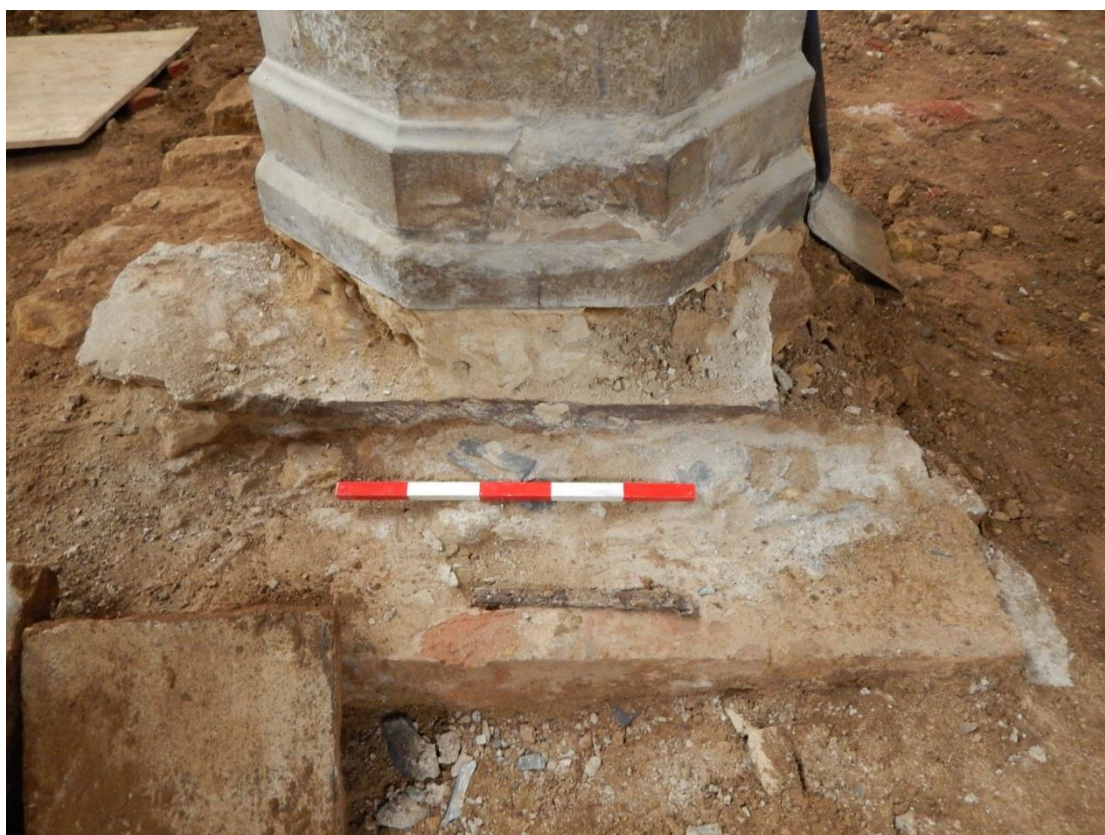
Figure 16: Damaged pillar foundation in south transept, looking south

The reduction of the surface here to the required level by machine followed the recording of the brick lined graves within the south transept. The machining revealed the lead coffin close to Grave 6, plus Grave 12a and Grave 16. The foundations of the four pillars within the south transept were also revealed. The foundations consisted of rough limestone blocks of various sizes. This confirms the evidence from Test Hole 3 of the evaluation (Thomas 2014). The pillar at the north-western edge of the south transept had been truncated and undermined along the northern edge where the floor level had been lowered in the nave (Figure 16).

The foundation of the pillars for the vaulted roof of the transepts were exposed during the final groundworks here. The pillar at the north-western edge of the south transept had been truncated and undermined along the northern edge where the floor level had been lowered in the nave. The ground reduction in the south transept also revealed that the south wall of the transept had been underpinned with blue bricks at some time, confirming the evidence from Test Hole 4 excavated during the previous evaluation.

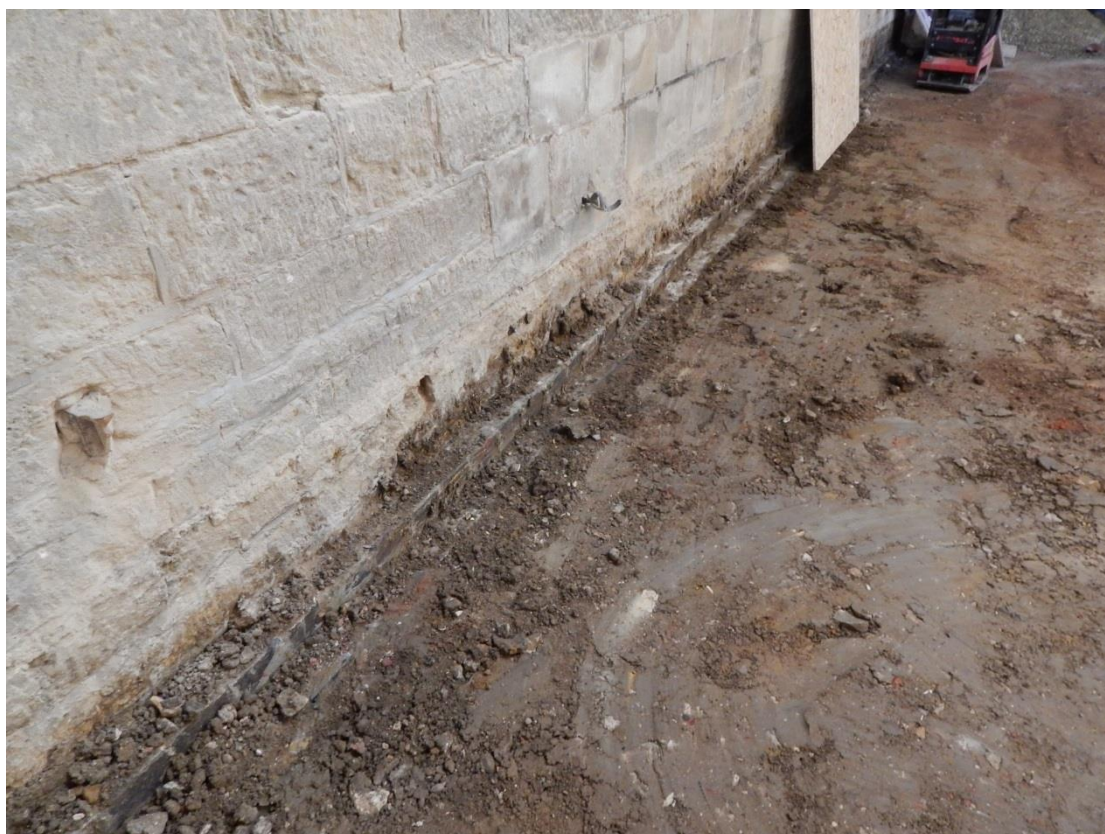
Figure 17: Blue bricks underpinning south wall of south transept, looking south-west

The ground reduction in the south transept also revealed that the south wall of the transept had been underpinned with blue bricks at some time. This also confirms the evidence from Test Hole 4 excavated during the evaluation (Figure 17).

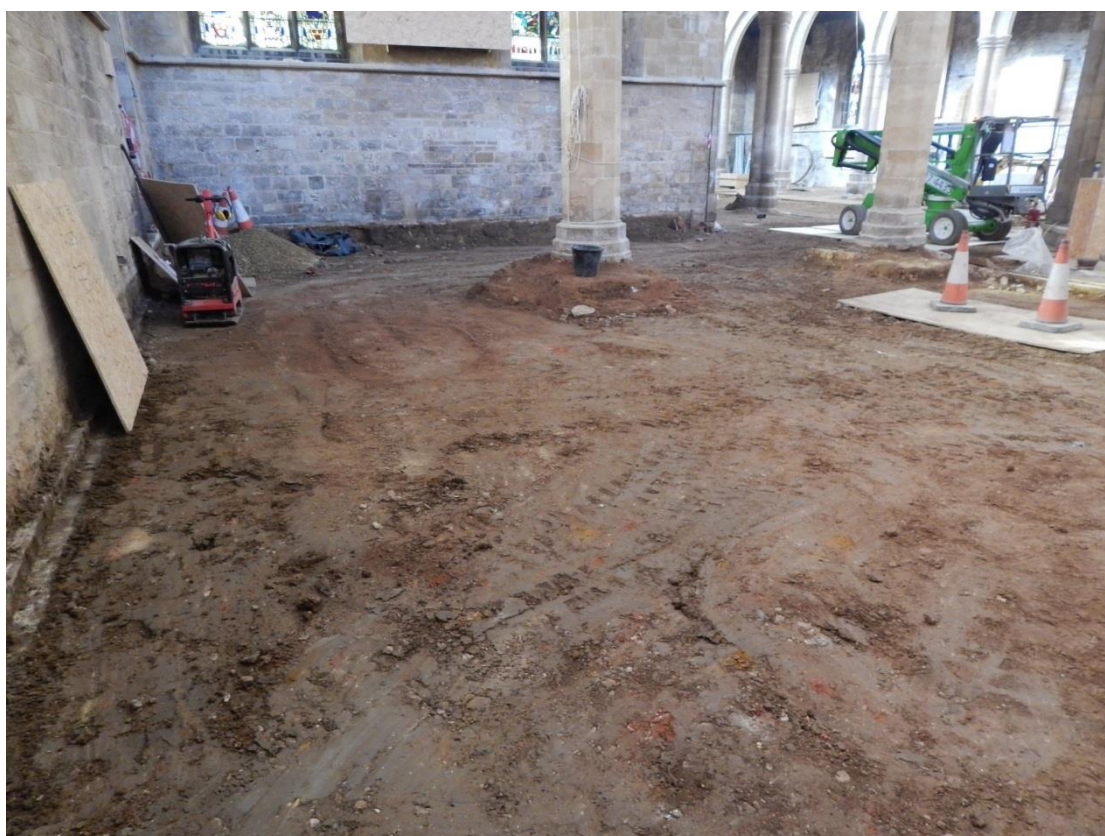
Figure 18: The south transept area after stripping and compacting, looking north-west

After the south transept area had been reduced the ground was compacted to the required level (Figure 18).

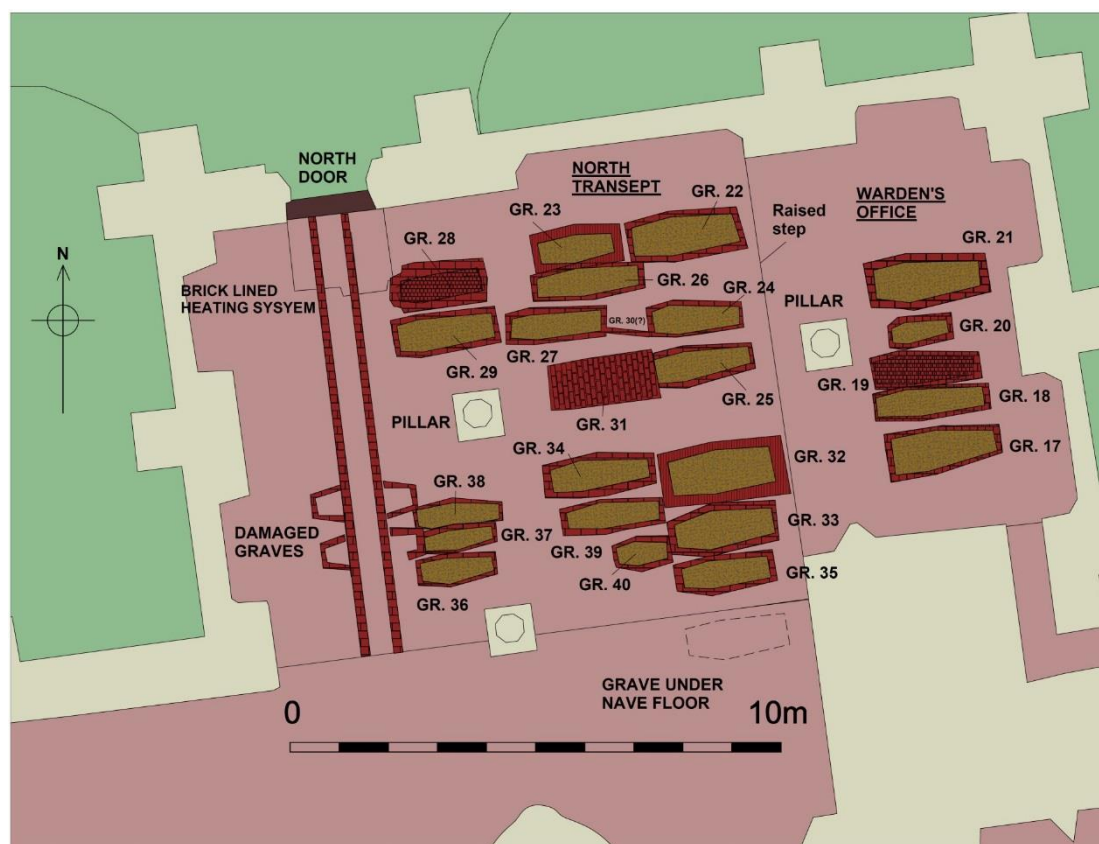
Figure 19: Plan of north transept showing position of brick lined graves

From 16th February 2017 the ledgers and slabs were lifted on the north transept including those within the warden's office that lies on the eastern side of the transept (Figure 19). The floor here was around 0.20m higher than the rest of the transept and so any graves exposed here had to be excavated to a depth of around 0.70m and the human remains within them were collected for reburial. The screen that lay between the warden's office and the rest of the transept had been removed prior to the lifting of the slabs.

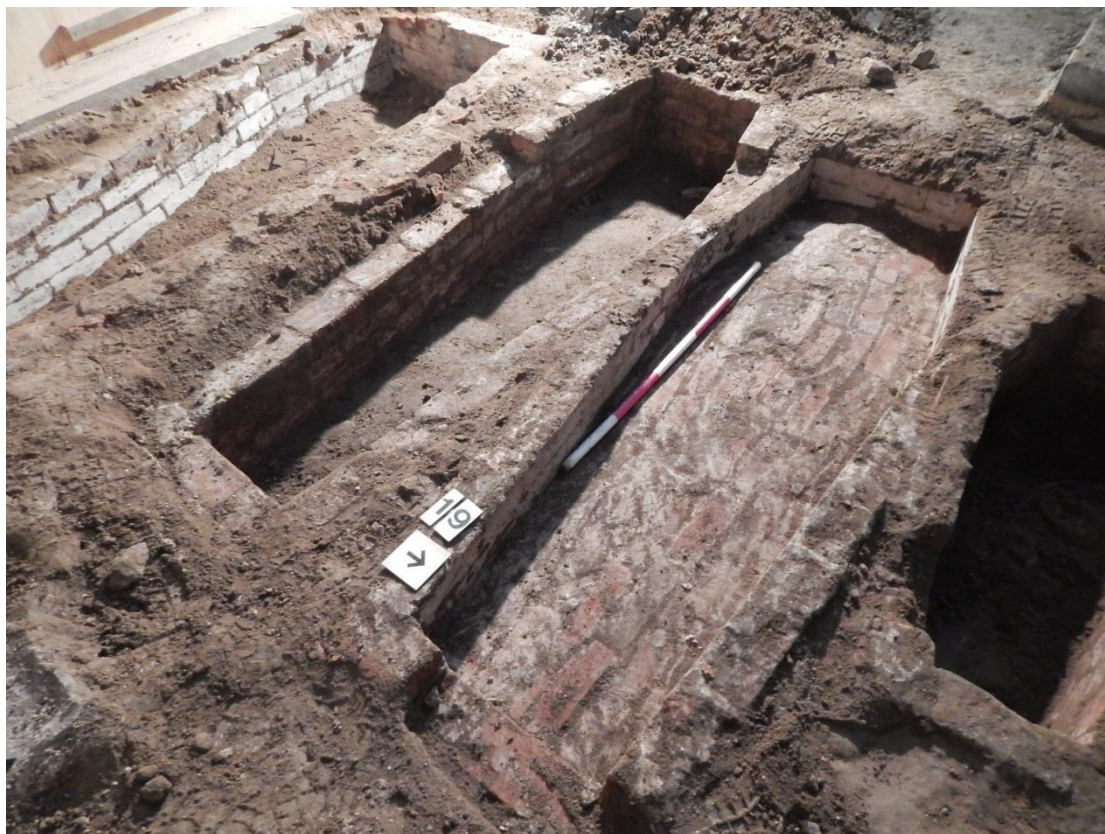
Figure 20: Graves 17-20, with Grave 19 prior to removal of vaulting, looking south-west

Grave 19 was brick vaulted and sealed at the time of excavation (Figure 20). As the vaulting lay above the finished ground level the vaulting was removed to make sure the contents would not be disturbed by the subsequent lowering of the ground level.

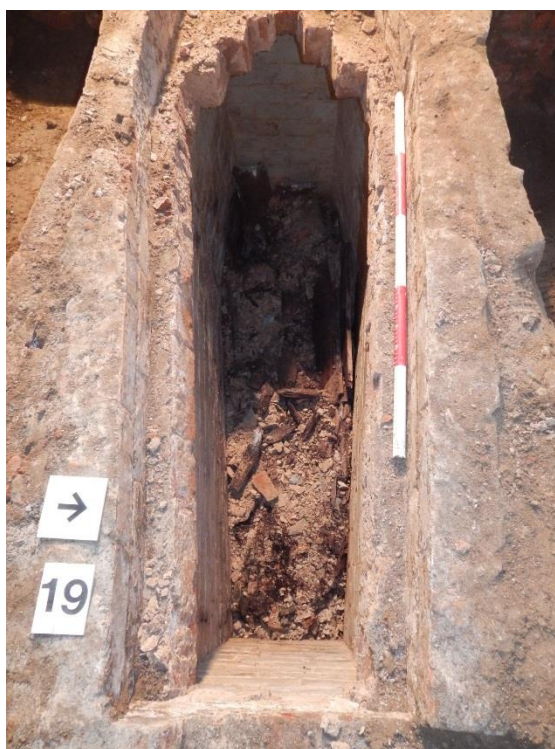
Figure 21: Grave 19 after removal of vaulting showing coffin pieces in situ

Within the chamber was a rotted wooden coffin (Figure 21), and a number of pieces of wood that had been used to provide a support or 'centre' for when the brick vaulting had been constructed (Figure 22). As the coffin lay below the finished ground level it was not disturbed and the grave was subsequently filled in during machining.

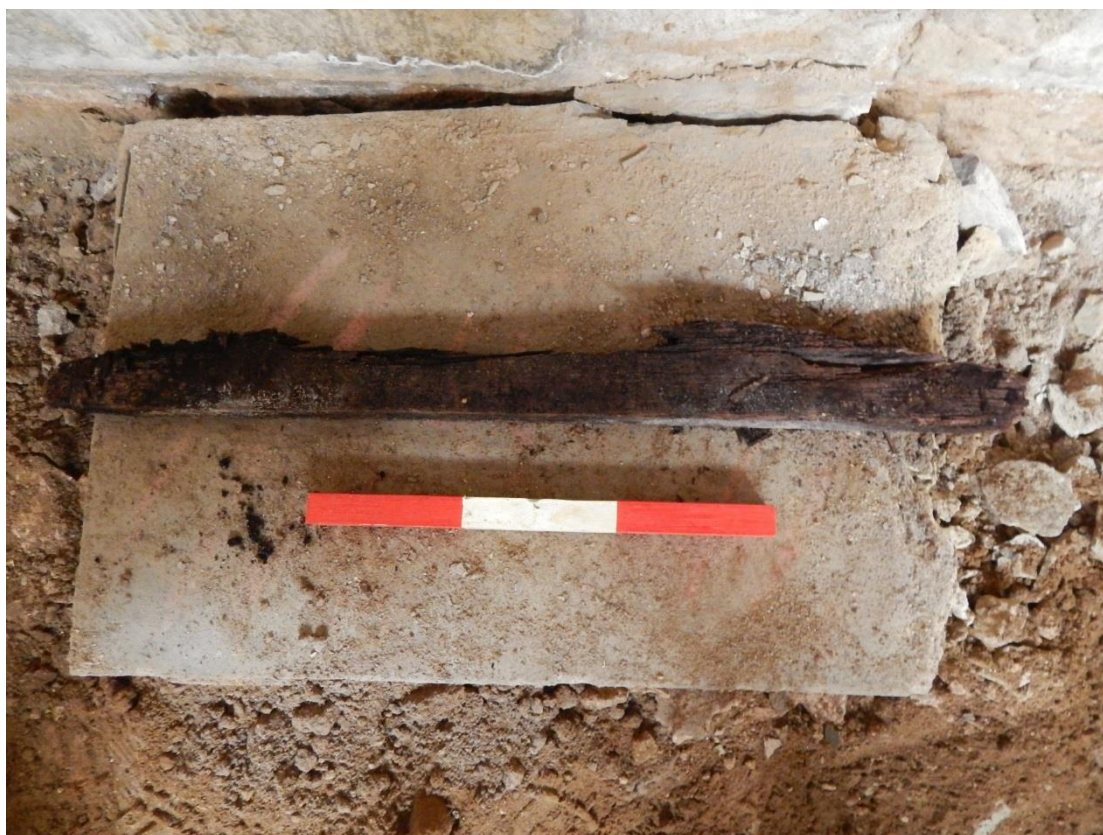
Figure 22: Wooden 'centre' for vaulting retrieved from Grave 19

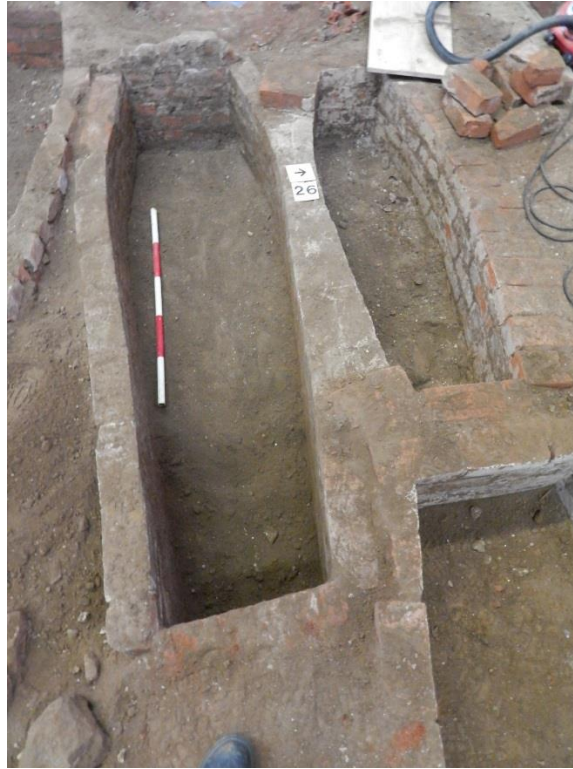
Figure 23: Post excavation shot of Graves 26 and 23, with top course of Grave 23 removed

upper course was lain perpendicular to the lower courses. This upper course also lay over the upper course of Grave 26, which lay to the direct south (Figure 23).

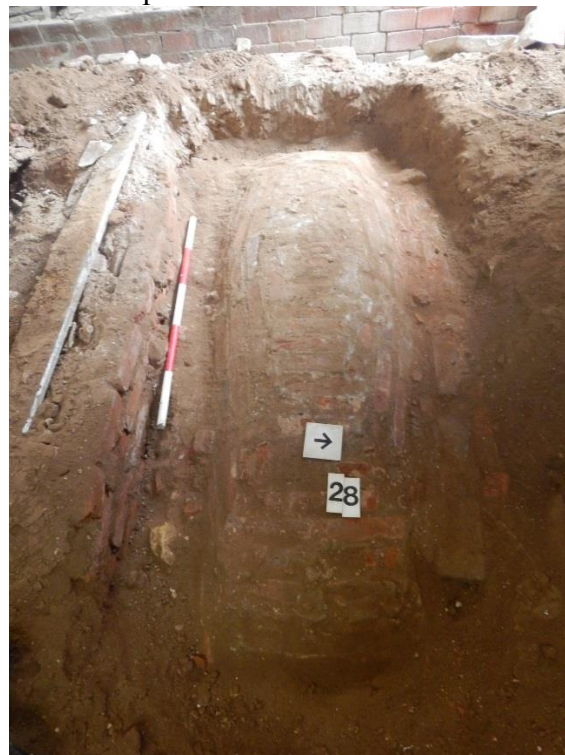
Figure 24: Grave 28 with vaulted cover

Close to the north door of the north transept was a further intact vaulted grave (Grave 28), similar in design to Grave 19 within the warden's office, but with more of a dome shape to the vaulting (Figure 24). With the vaulting lying above the finished level the

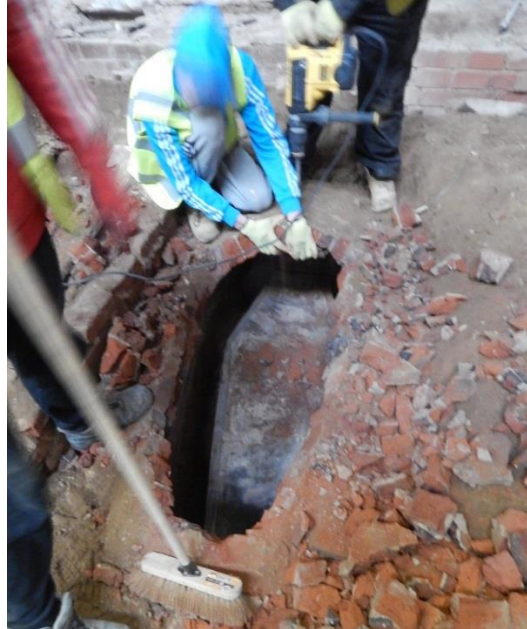
Figure 25: Work in progress on Grave 28, looking west

brickwork had to be removed and this was undertaken by the groundworkers employing a large drill to break the brick-work and mortar (Figure 25).

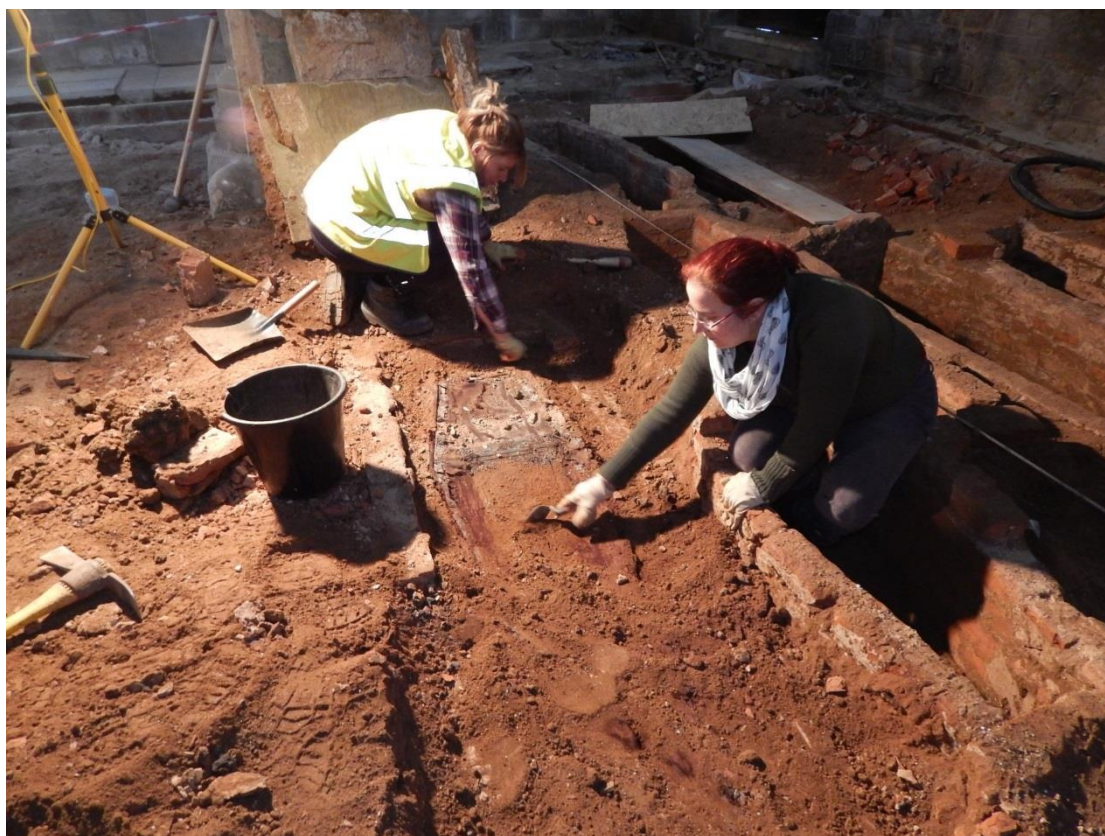
Figure 28: Work in progress cleaning up coffin within Grave 31, looking west

A drill was employed to break up the brickwork, revealing four slate slabs of similar size and thickness to those over the large chamber in the south transept (Grave 7) (Figure 27). The removal of these revealed a wood and velvet covered coffin around 30mm below the surface, within a rectangular brick lined grave (Grave 31) (Figure 28).

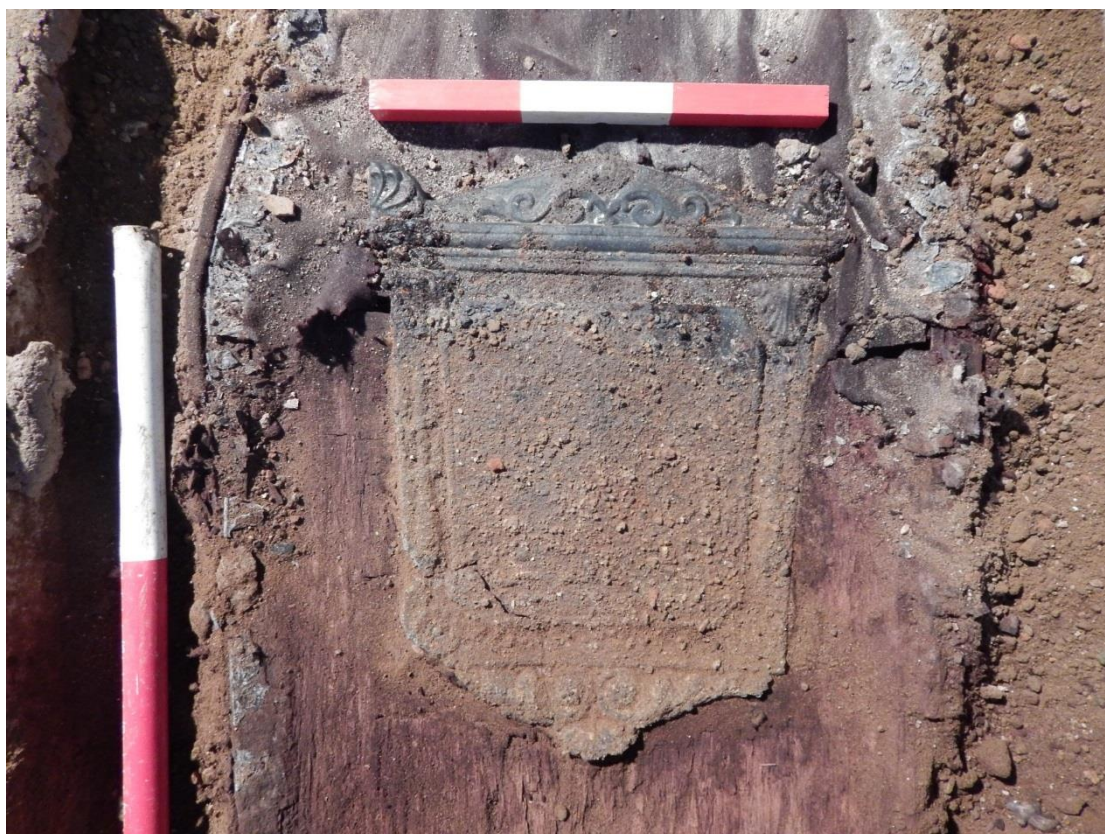
Figure 30: Detail of front of coffin, showing velvet, eroded escutcheons and rusted depositum plate

The coffin was revealed as multiple shelled, with a rotted wooden coffin covering a lead coffin within (Figure 29). The front of the coffin was covered in velvet, which had largely rotted away. Rusted tin (?) escutcheons fixed the velvet in place at the edges of the coffin and the chest area was decorated with a rusted tin depositum plate, which could not be read (Figure 30).

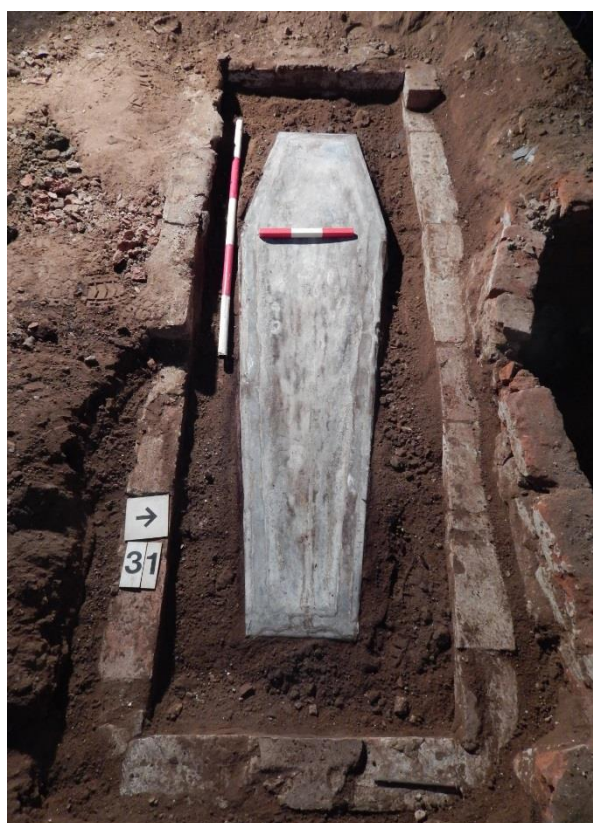
Figure 31: Lead coffin within Grave 31

The lead coffin beneath the rotted wood appeared intact and unadorned (Figure 31). A test area was excavated to below the depth of the coffin and revealed that the coffin sat upon a further stone slab, most likely the cover of a further burial below.
