**Archaeological Attendance and
Recording during groundworks at
St Peter's Church,
Main Street,
Tilton on the Hill,
Leicestershire.**

NGR: SK 74341 05655

ULAS Report No. 2018-169
©2018

For: PCC of St Peter's Church, Tilton on the Hill

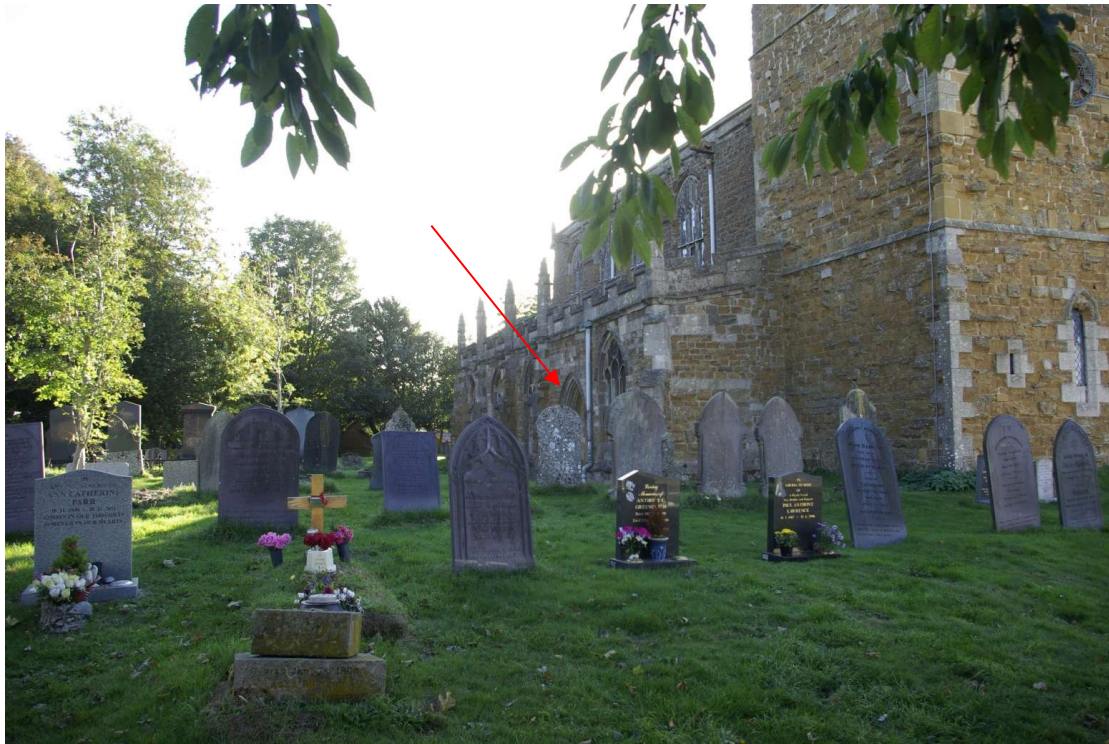
Figure 4 North side of the north aisle
Looking south-east. 1m scale. Red arrow points to the blocked north door

The church and churchyard lie within the Conservation Area of Tilton on the Hill which mainly focuses on the area immediately around the church along with the historic village core around Main Street. The church is Grade I listed with the listing information being reproduced in the ULAS Written Scheme of Investigation (the WSI). Of most significance for this programme of work is that the earliest parts of the present church building date to the 12th century, this being evident in the south chancel door and tower. The spire is of the Decorated period (approx. 1250-1350) as is the south aisle. The north aisle and arcade were rebuilt at a similar time slightly further to the south, so that the nave is not centred on the tower and chancel. The chancel was remodelled and the clerestory was added in the Perpendicular period (approx. 1350-1550). A restoration was carried out in 1854 by R.C. Hussey. It is not clear if any of these phases of work left any structural remains beyond the limits of the present church building. A blocked doorway can be seen on the north facing elevation of the north aisle which might suggest that other buildings were once present here (Fig. 4). Alternatively this may be the "heathen" north door which has since been blocked.

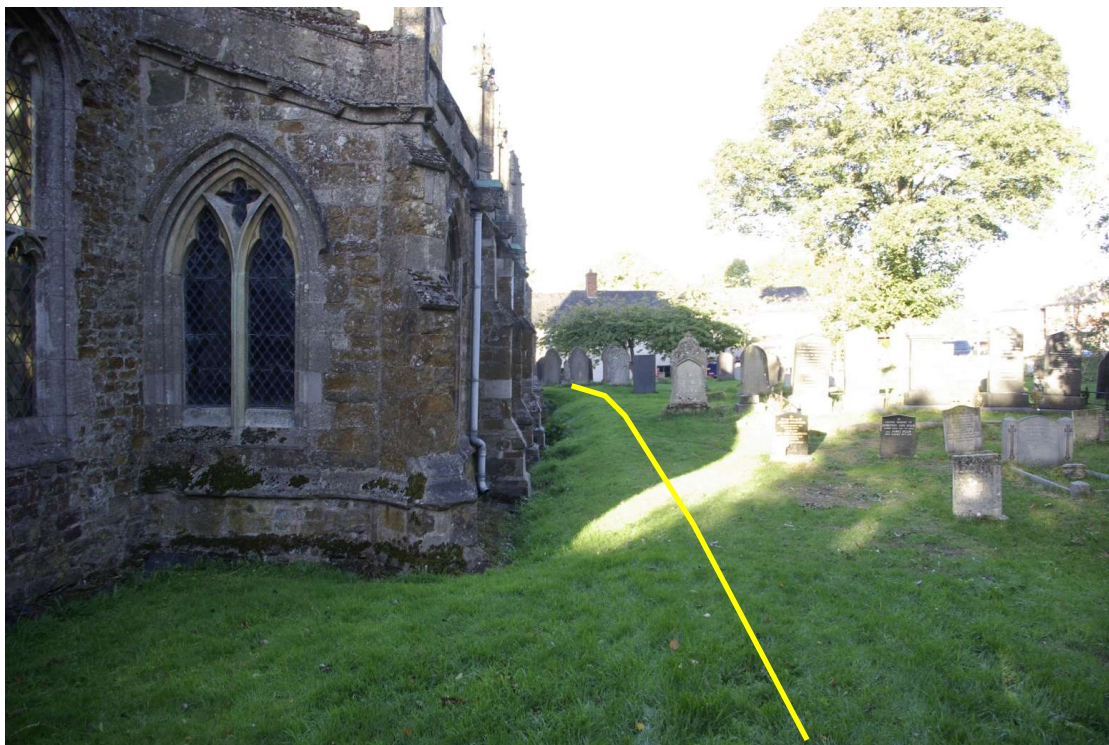
Figure 5 North side of the north aisle
Yellow line shows approximate line of pipe trench. Note difference in height of
grassed churchyard and the base of the church walls

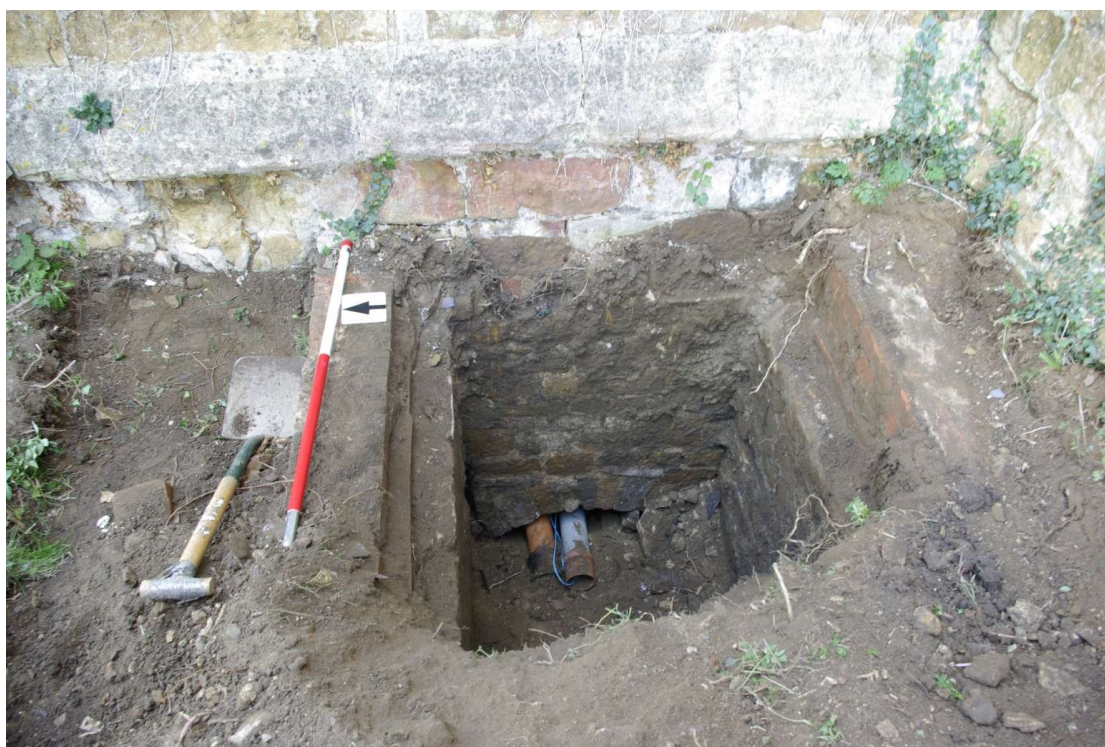
Figure 9 Archway from inside the church into backfilled boiler house
Looking east. 1m scale. North aisle wall at top of picture, tower wall on right

The new internal toilet and sewer pipe had already been installed by different contractors who had backfilled the internal cellar after running the new sewer and water pipes through the existing archway approximately 1.6m below present ground level in the north aisle west wall (Fig. 9). The new pipe running from the arch was quite difficult to locate and an initial exploratory slot was dug to the north of the boiler house wall which revealed the top of a possible articulated burial which appeared to have been cut by the construction of the north aisle. The burial, which was just over 1.2m below current ground level, was not disturbed by this work and was re-covered with soil. The 19th century external boiler house was a brick and stone-built structure butting against the north aisle west wall and had been backfilled with late 20th century debris along with apparently scavenged soil from elsewhere in the churchyard. This backfill consisted of a homogenous grey-brown silty sandy clay similar in nature to the rest of the churchyard soil.

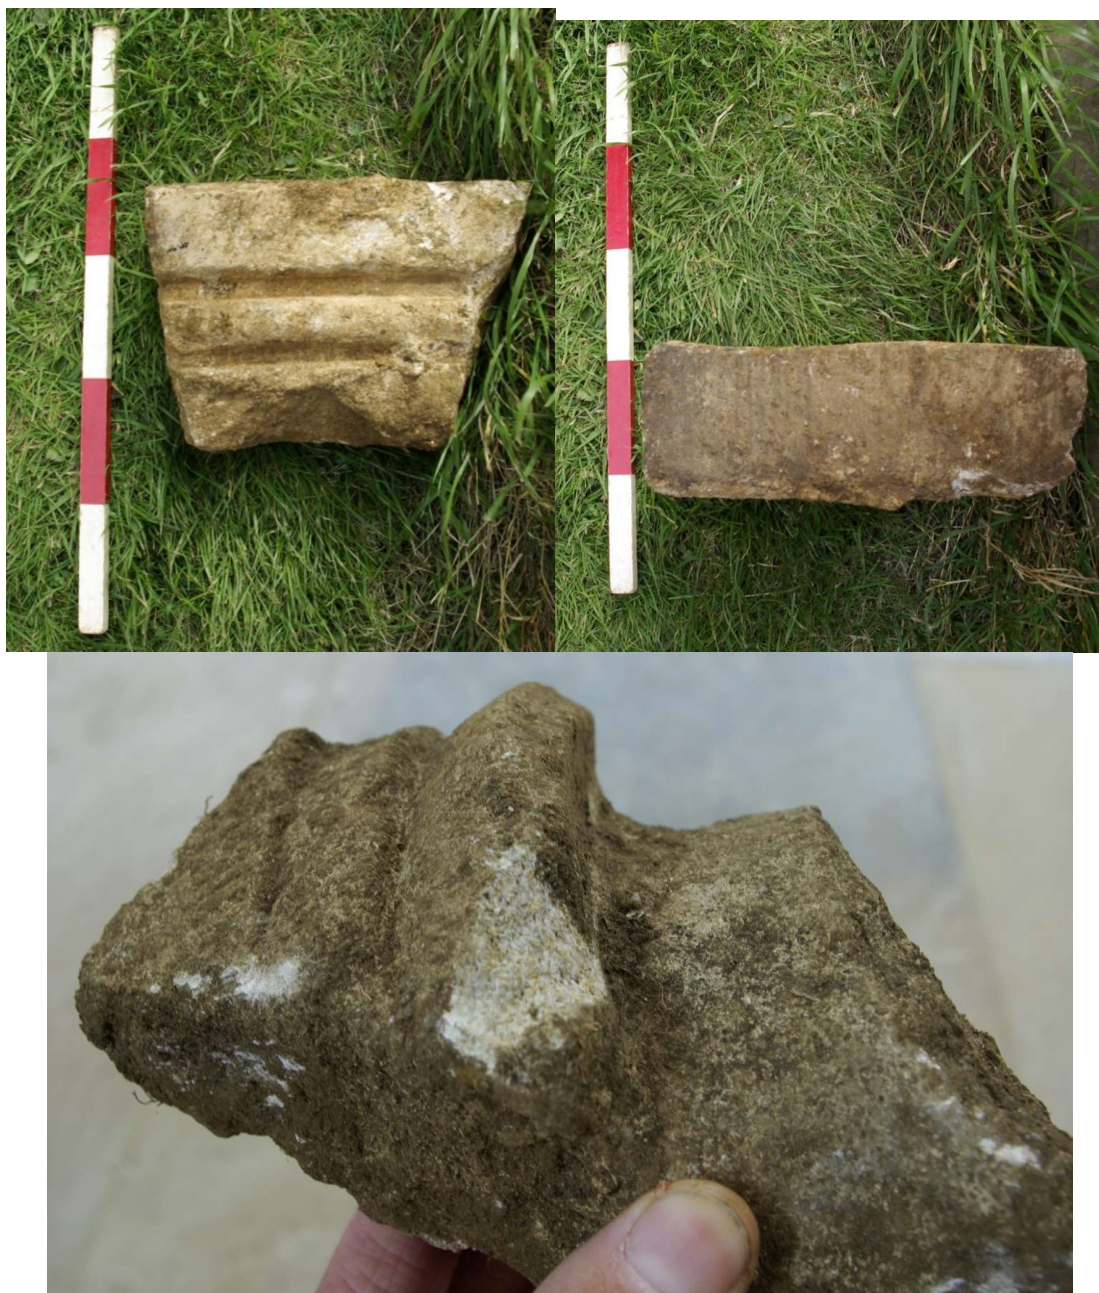
Figure 10 Worked stone recovered from boiler house wall
Top left: possible glazing slots. Top right: dressed face of the same stone. 0.5m scale
Lower picture: fragment of moulded shaft

Because the archway and new pipes were so deep where they exited the church the rest of the sewer pipe leading to Oakham Road had to be correspondingly deep in order to create the necessary fall. A slot also had to be cut through the north wall of the boiler house to bring the new pipes into the church yard. A number of dressed pieces of limestone were observed within this wall which appears to have incorporated any available stone to construct it. This stone may have originated from earlier phases of church building or it may have been deliberately imported onto the site to build the boiler house. Of note among these stones was a fragment of dressed stone with possible glazing slots cut into it (Fig. 10). Another small fragment appeared to be part of a narrow circular shaft moulding, again made of limestone. The dressed stones were replaced back in the trench with the excavated spoil but the stone shown in Figure 10 below and the moulded shaft fragment were retained by the Churchwardens.

The worked stone is interesting and may be remnants from earlier parts of the church building. It may be possible that the dressed stone is from elsewhere although it does appear to be from a relatively high-status building which has glazing. The fragment of moulded shaft is very small making it difficult to identify but it would appear to have been broken from a larger piece of moulded stone removed from the earlier building during the remodelling of the chancel and clerestory in the late 14th century.

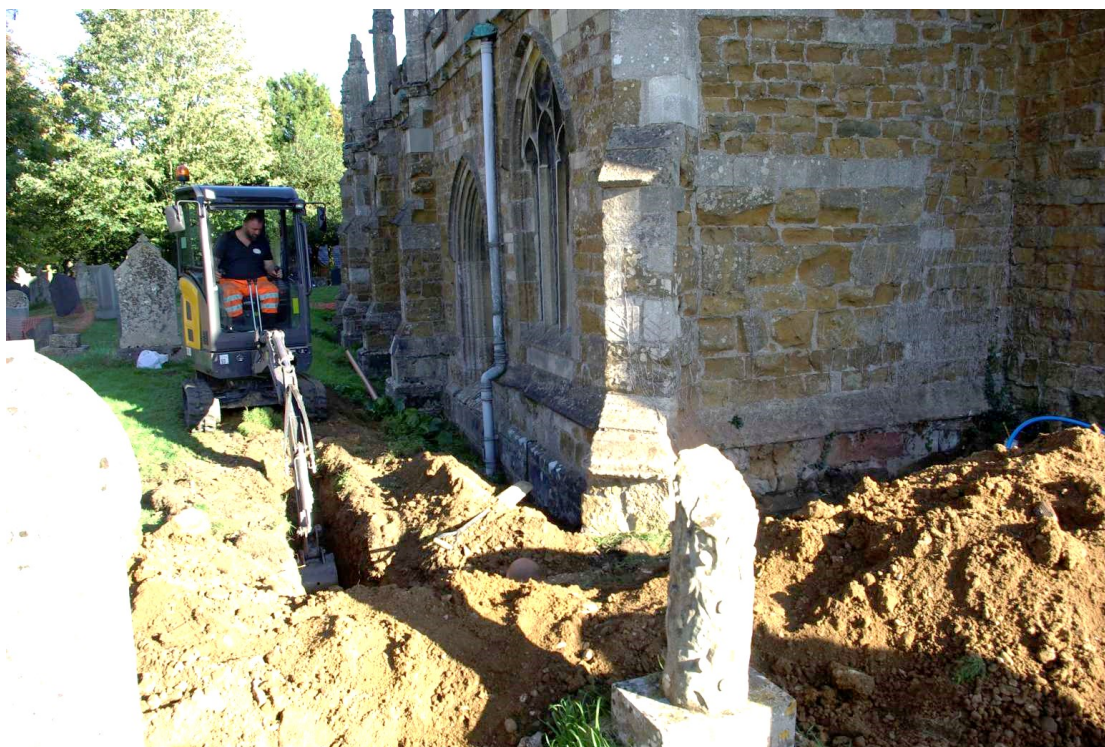
Figure 11 Sewer trench being excavated eastwards
Looking east

The new sewer trench was then excavated northwards beyond the building line of the church before turning eastwards along the edge of the grassed slope (Fig. 11). The trench, with a depth between approximately 1.6 and 1.9m below current ground level, encountered a modern plastic rainwater pipe running out from the church gutters at around 1m below current ground level. A number of stone-filled soakaways served these pipes. The rainwater pipe was reinstated before backfilling the trench.

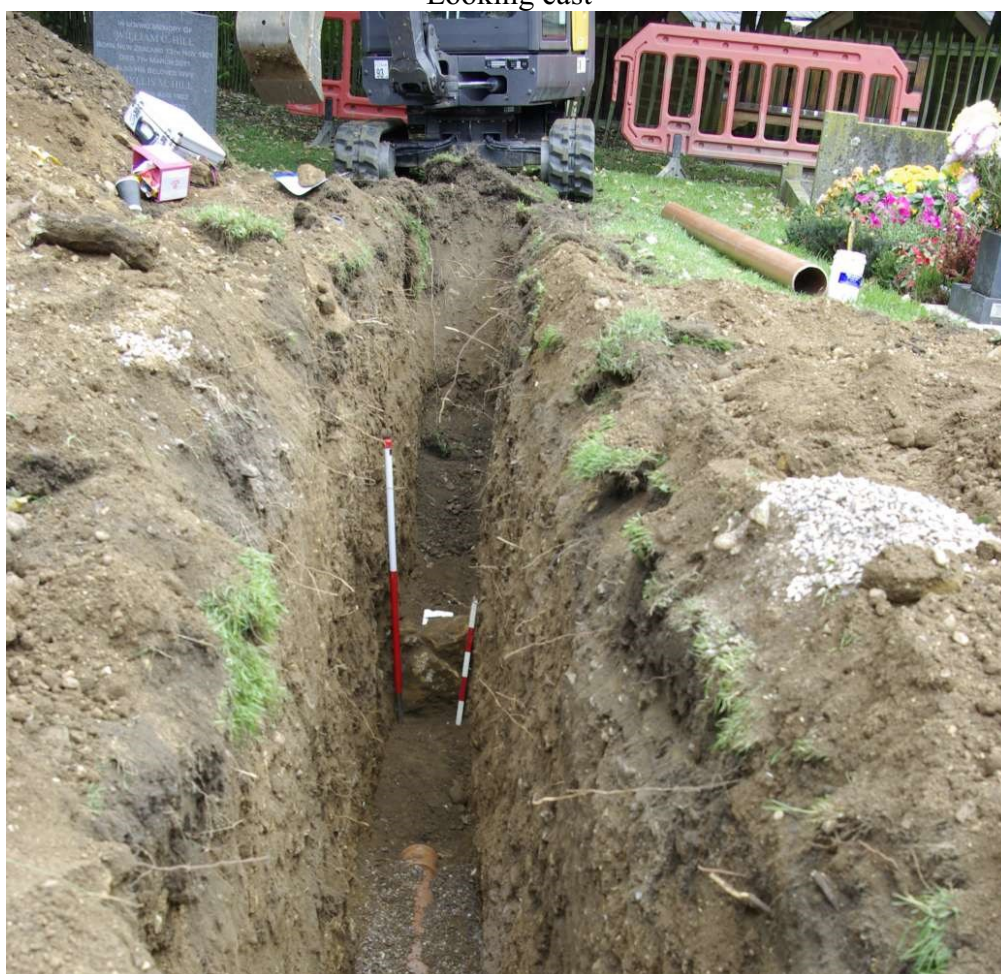
Figure 12 North to south wall
Looking east. 1 and 0.5m scales

No archaeological features or deposits were encountered along the trench as it ran alongside the north aisle wall. However, approximately 4m beyond the north end of the north aisle the top of a drystone wall was observed 1.55m below current ground level (Figs. 8, 12 and 13). This 0.2m wide and 0.4m high wall, built from unworked locally sourced ironstone, consisted of four courses resting on the natural sandy gravel substratum 1.95m below current ground level. No apparent construction cut for this north to south oriented wall could be seen nor were any datable finds recovered from around it. The top of the wall was just over 0.2m higher than the road level which was

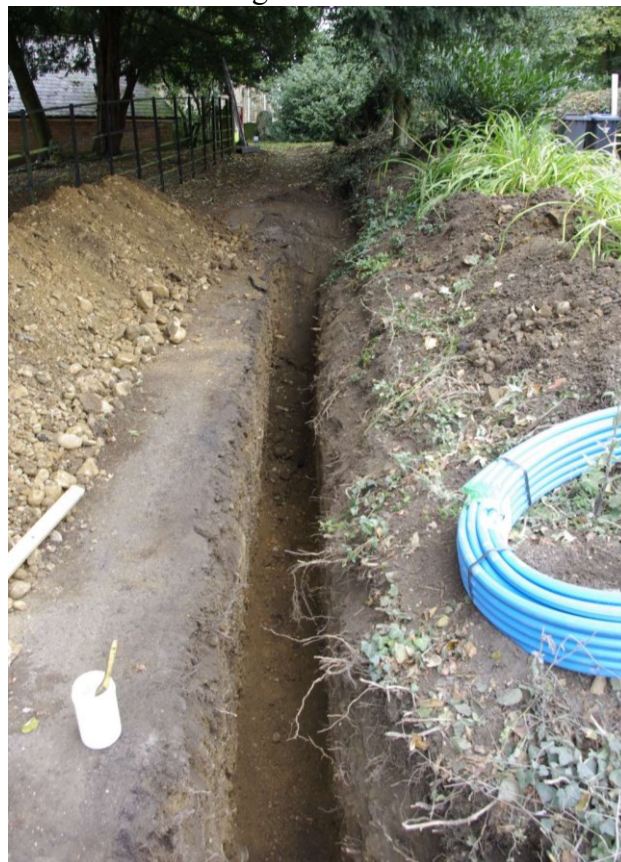
Figure 14 Trench along pathway to Oakham Road
Looking west

To the east of the circular soakaway feature the ground dropped down alongside a narrow pathway leading to Oakham Road. At the eastern edge of the main churchyard the pathway passed through a gap between the churchyard boundary fence and a drystone wall. Within the upper fill of the trench were a number of unworked ironstone fragments which may be part of this boundary wall which may have been partially demolished to create the pathway. No other evidence of this possible boundary were found. However, to the east of the wall the homogenous mid brown silty sandy clay only extended down to 1m below current ground level which may suggest some difference in use either side of the wall. Below this was the natural substrata consisting of yellow-brown sandy silty clay and gravel with areas of densely-packed ironstone brash. Some fragments of human bone were still to be found in the upper fill all the way down to the road. No archaeological features or deposits were seen in this section of the trench.
