**A Level 2 Historic Building Recording and
Archaeological Attendance and Recording (watching brief) at
St. Andrew's Church, Main Street,
Carlton,
Leicestershire
NGR: SK 39650 04980**

**ULAS Report No 2021-109
©2021**

Site Name: St. Andrew's Church, 30 Main Street, Carlton, Leicestershire.

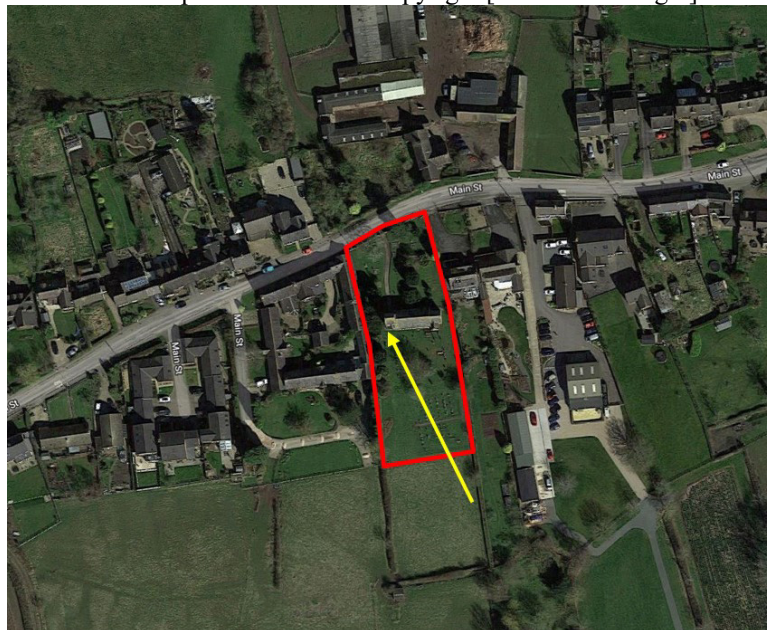
Figure 2 Aerial view of site
Red outline highlights both the churchyard and the cemetery. Yellow arrow points to the location of the extension

The churchyard forms a roughly rectangular plot covering an area of around 2800m² and is similar in plan to other property plots facing onto Main Street (Fig. 2). The site consists of two cemeteries (the original Churchyard, which is now closed for burials, and the adjacent Parish Cemetery) both within a single space.

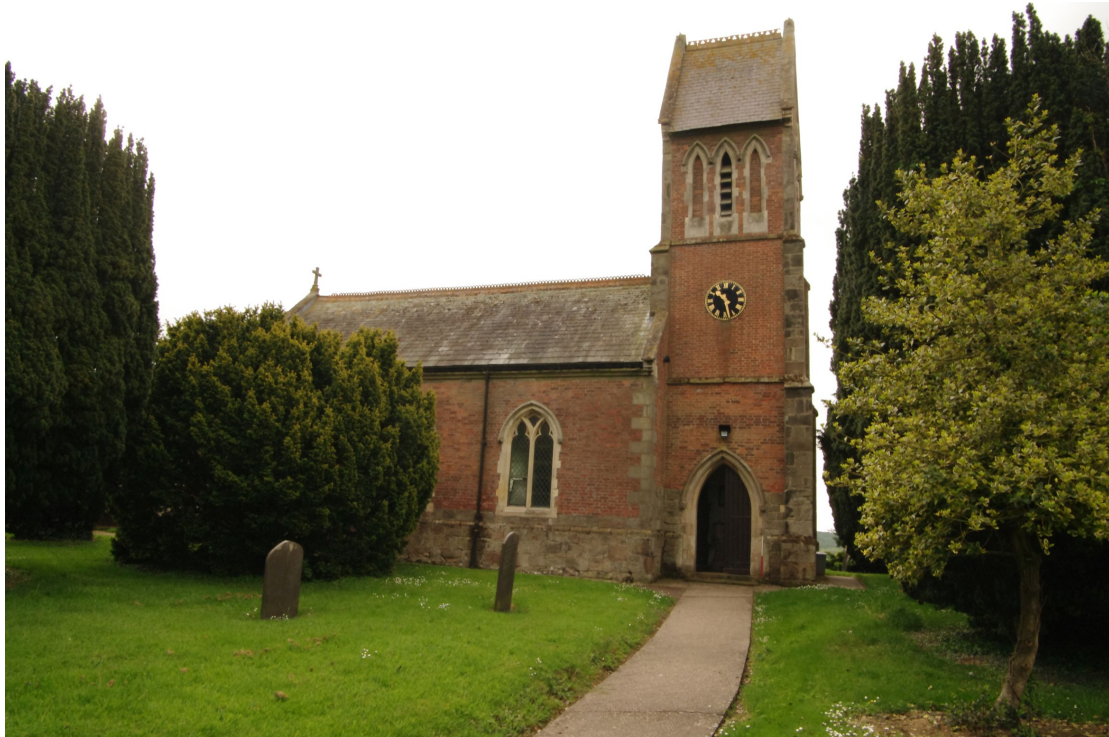
Figure 7 North facing elevation of tower
A new access ramp will be added to cross the raised step into the doorway. No significant excavations will be involved for this work

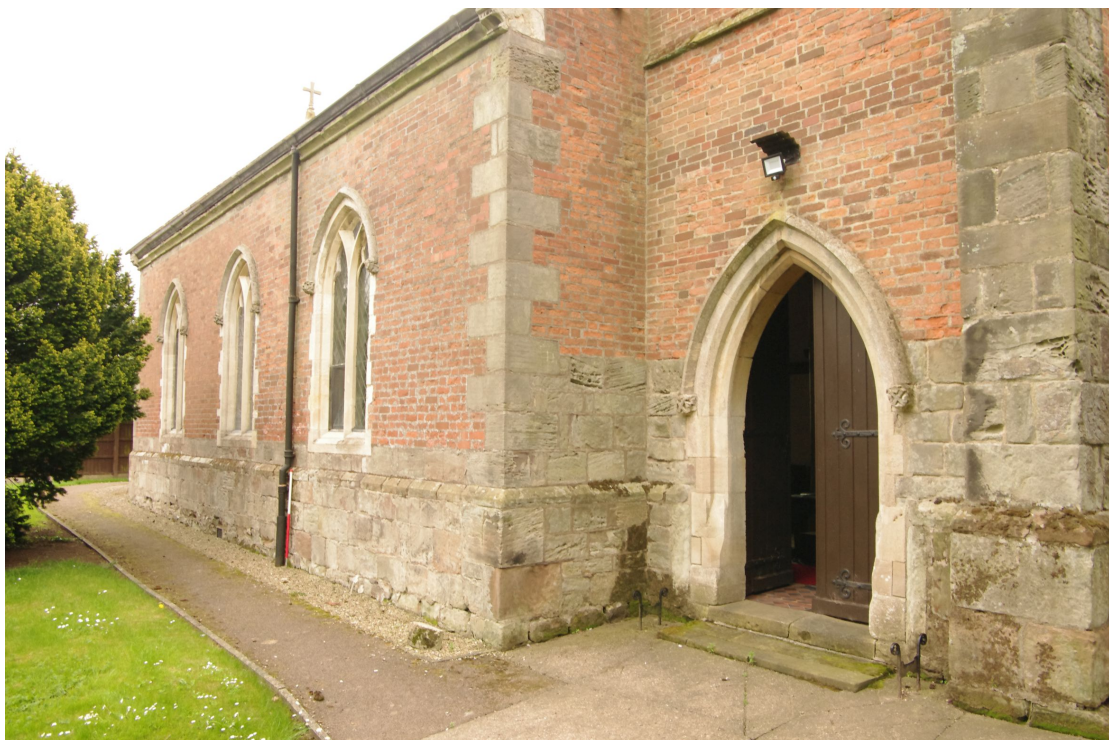
Figure 8 Detail of south facing tower door
Looking south-east. 1m scale

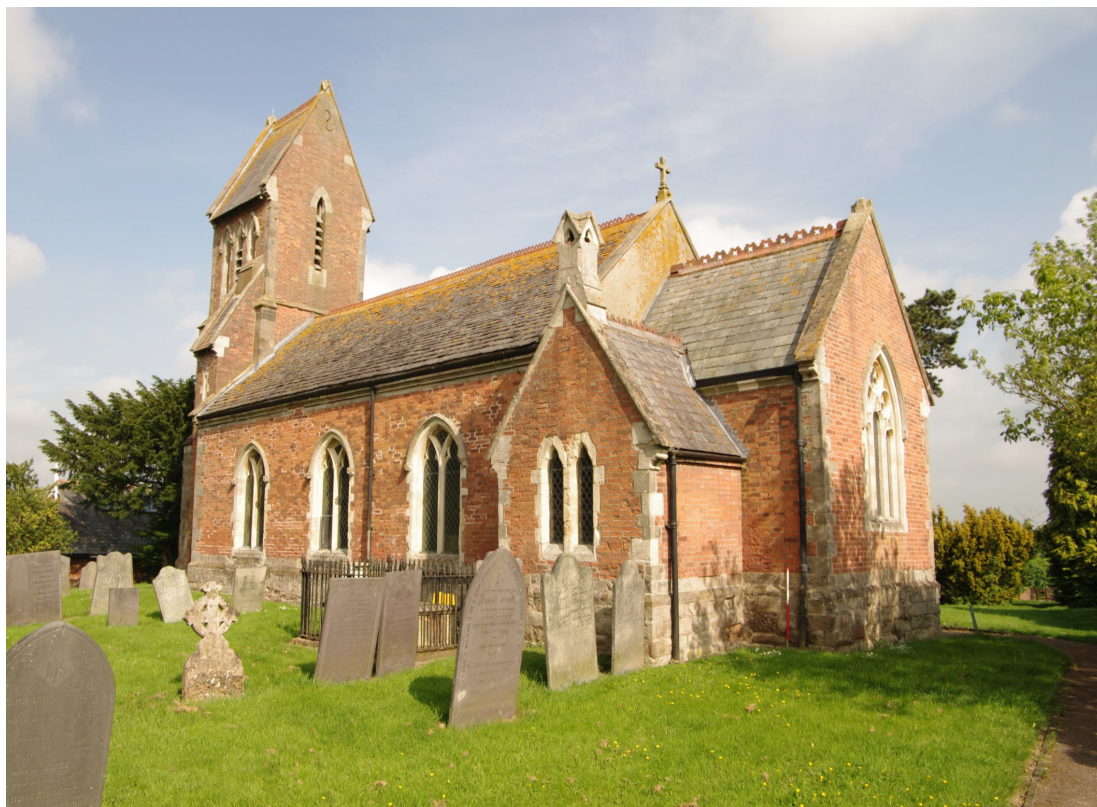
Figure 9 General view of south side of church
Looking north-west. 1m scale. The new extension will be located to the far left of the building

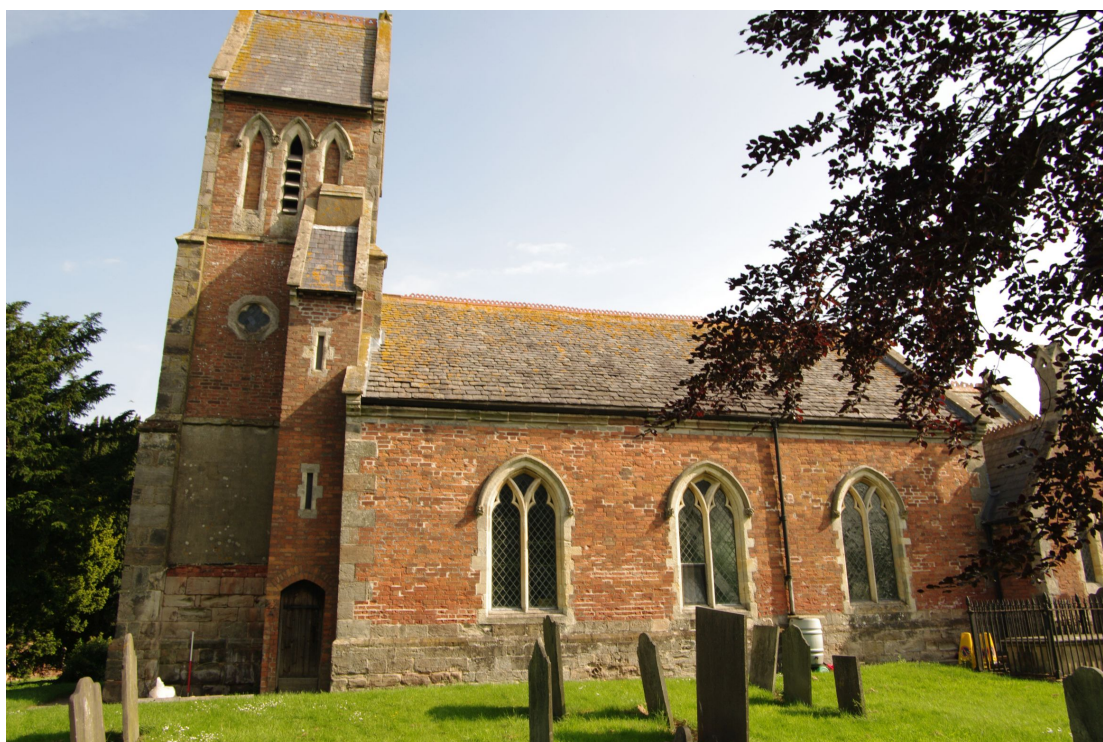
Figure 10 South facing elevation
Looking south. 1m scale. The extension will be built against the base of the tower and wrap around the corner to finish at the left hand window (see Fig. 5)

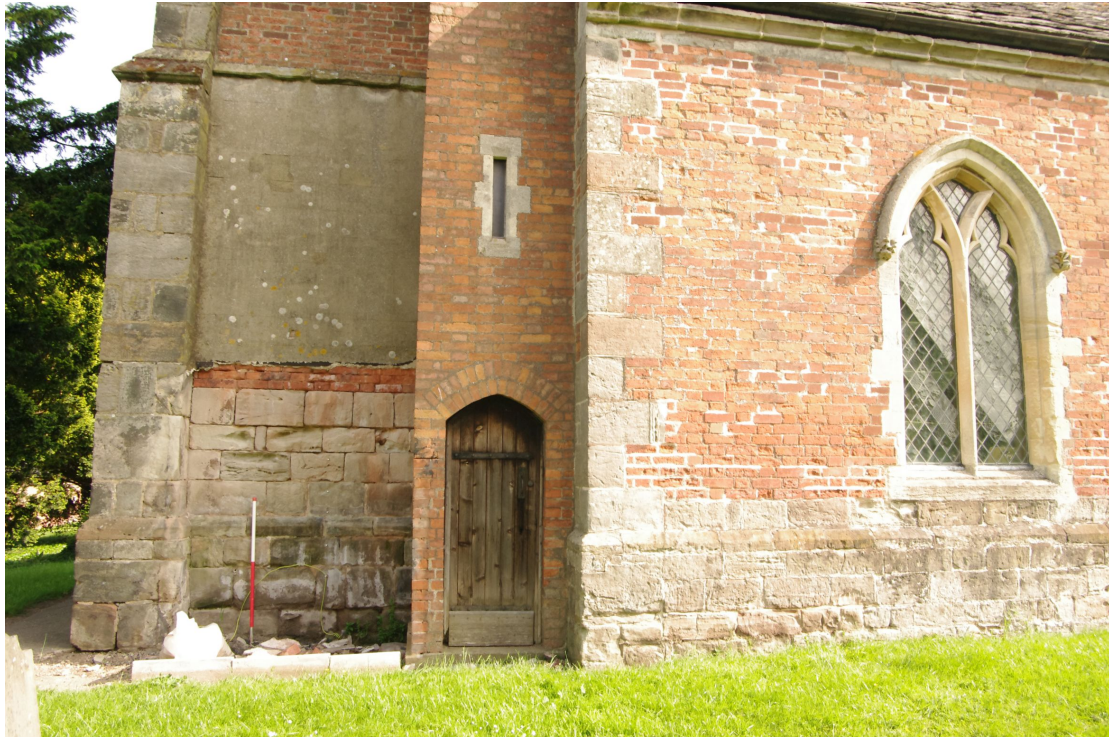
Figure 11 Location of proposed extension in SW corner
Looking north. The existing clock chamber and belfry access door will be blocked, a new doorway into the tower and church will be created to the right of the 1m scale.

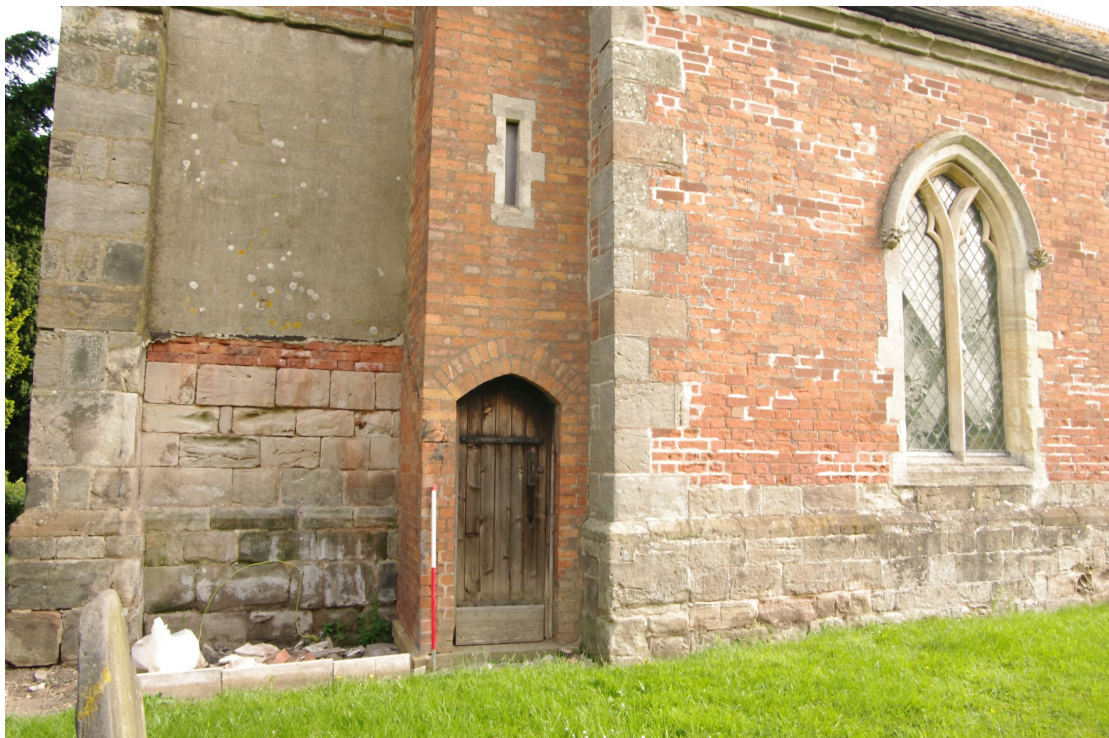
Figure 12 Location of proposed extension
Looking north-east. 1m scale. Note the marks left by the demolished lean-to shed which had a roofline following the three courses of brick between the render and the stonework on the tower wall. The lean-to extended out as far as the brick-built clock and belfry access tower

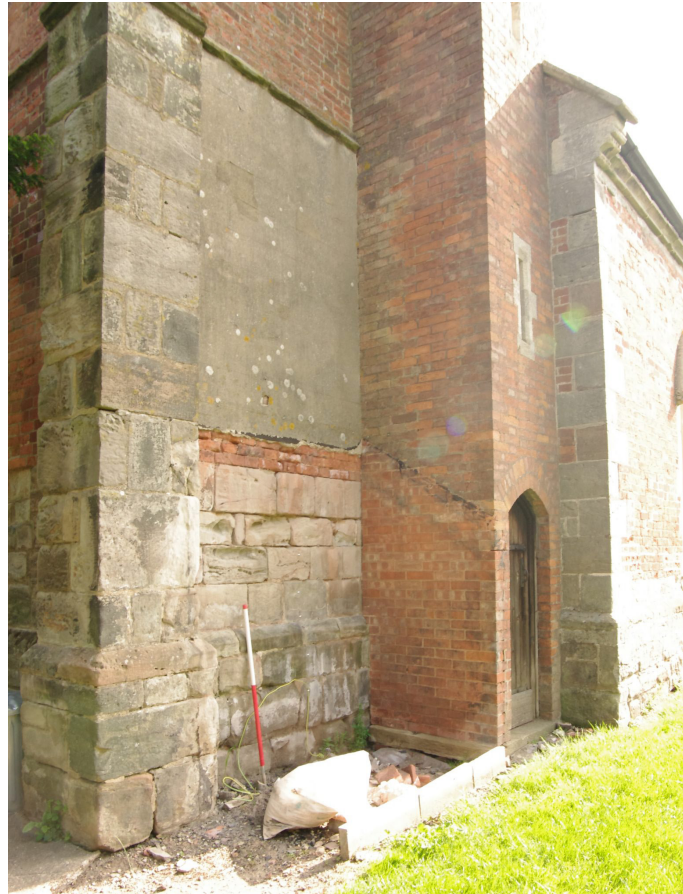
Figure 13 Location of proposed extension
Looking north-east. A new clock chamber and belfry access door will be created in the brick wall to the left of the existing door.

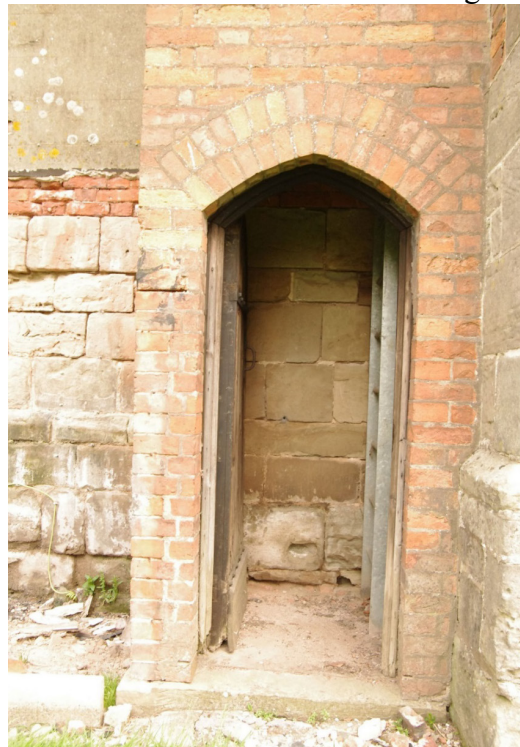
Figure 14 Open door of clock chamber and belfry access tower
Looking north. The visible stonework within the doorway forms parts of a buttress which projects approximately 0.2m beyond the main wall of the tower

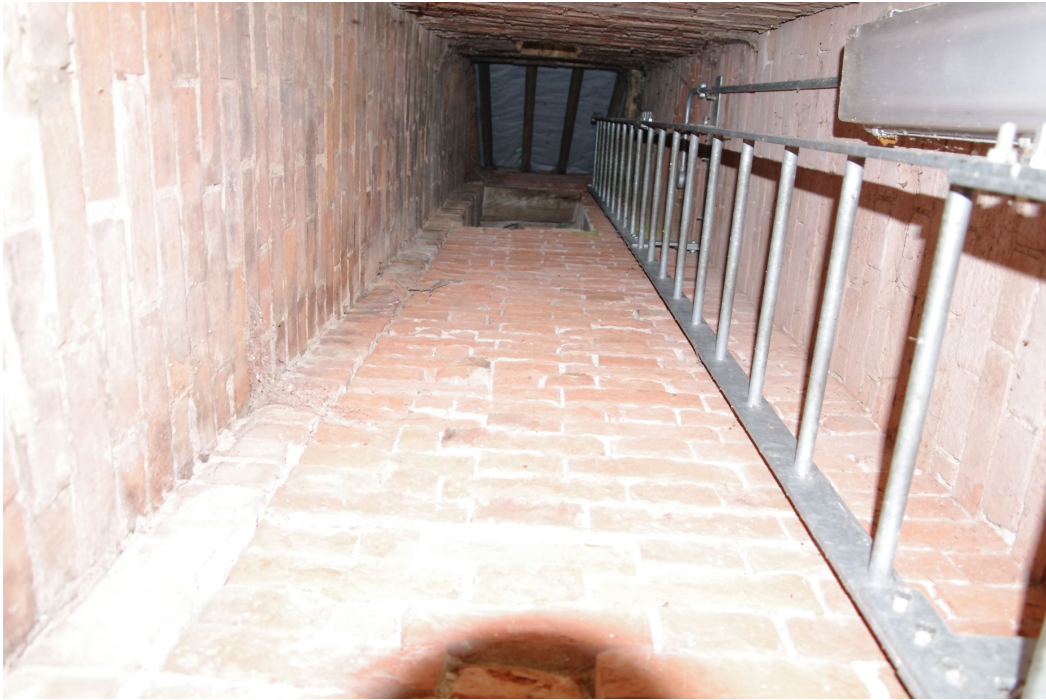
Figure 15 View up to the clock chamber and belfry access tower
Looking north. The brickwork in the centre of the picture is part of the tower buttress.
Note the infill of brick and later added wall on left. This indicates that the original tower access was within the main body of the tower – see Nichols illustration Fig. 3 and Fig. 16 below. This later access is probably from the 1867 remodelling

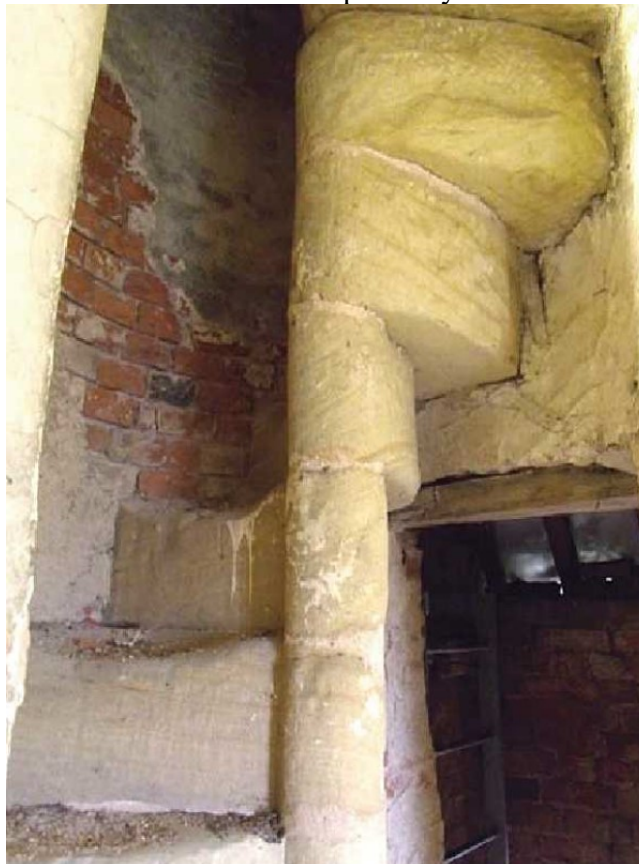
Figure 16 Remnant of spiral stairs within the main tower
Note the top of the metal ladder on the right which is seen in Fig. 15
Picture credit: P R Associates, *Design and Access Statement* 2019

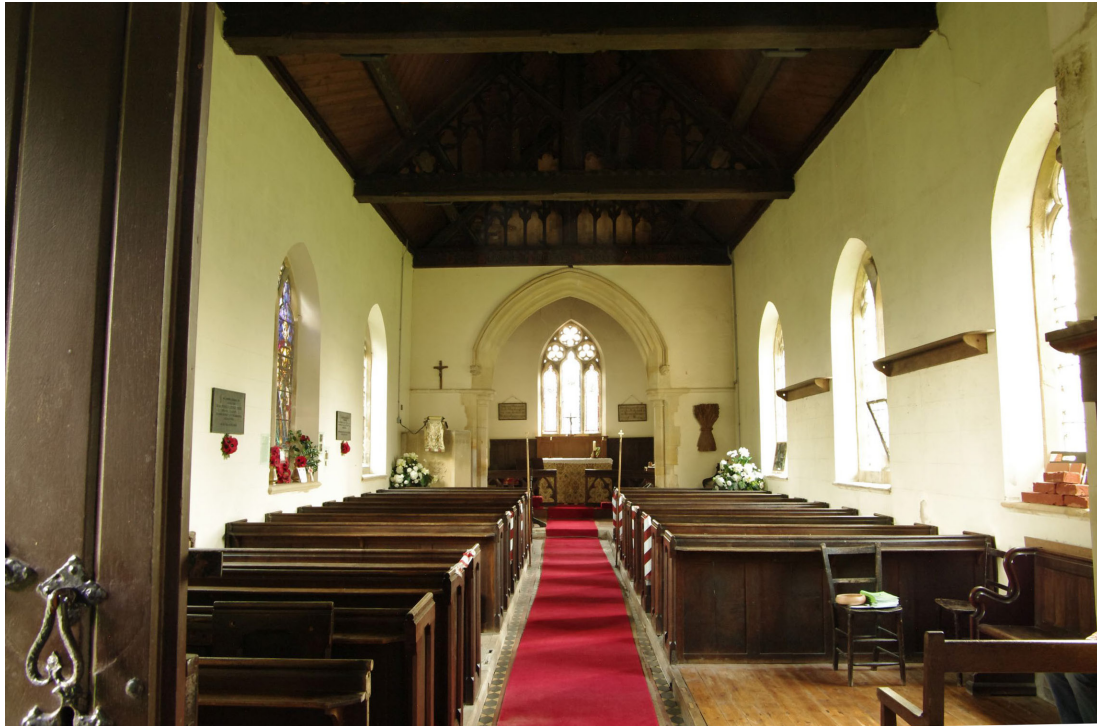
Figure 17 General view looking towards the chancel
The two pews in the left foreground will be removed. The pew platforms on both sides will be removed

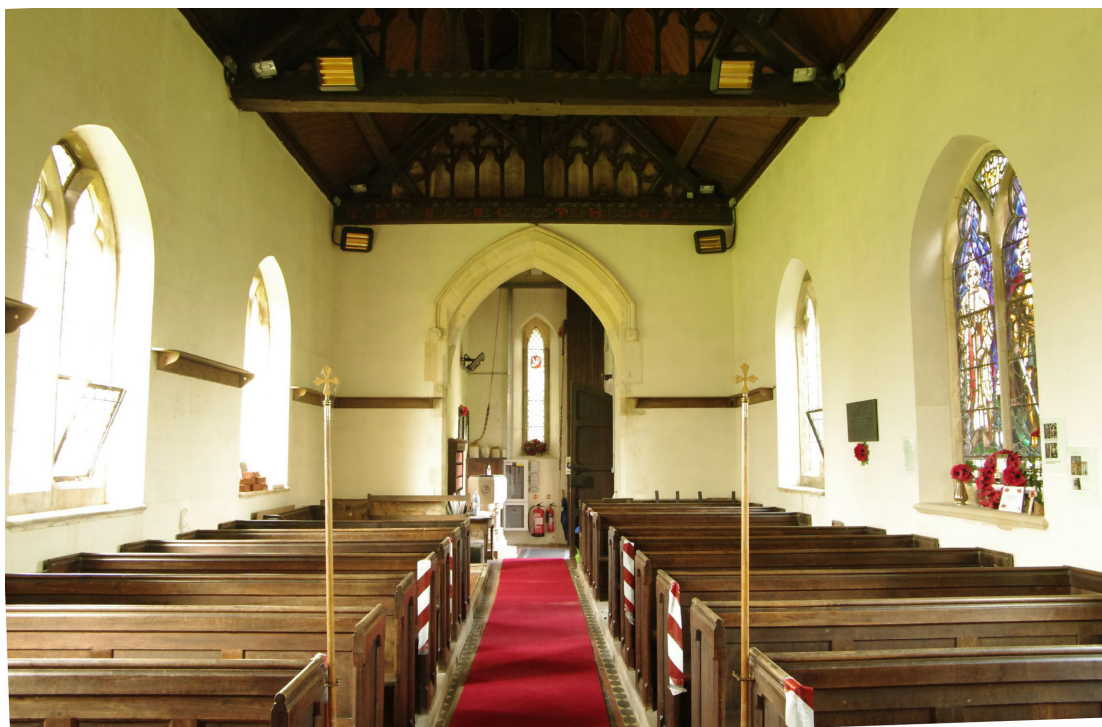
Figure 18 General looking towards the tower
The furthest pews will be removed on both sides to create an open space. The font will be moved into this space

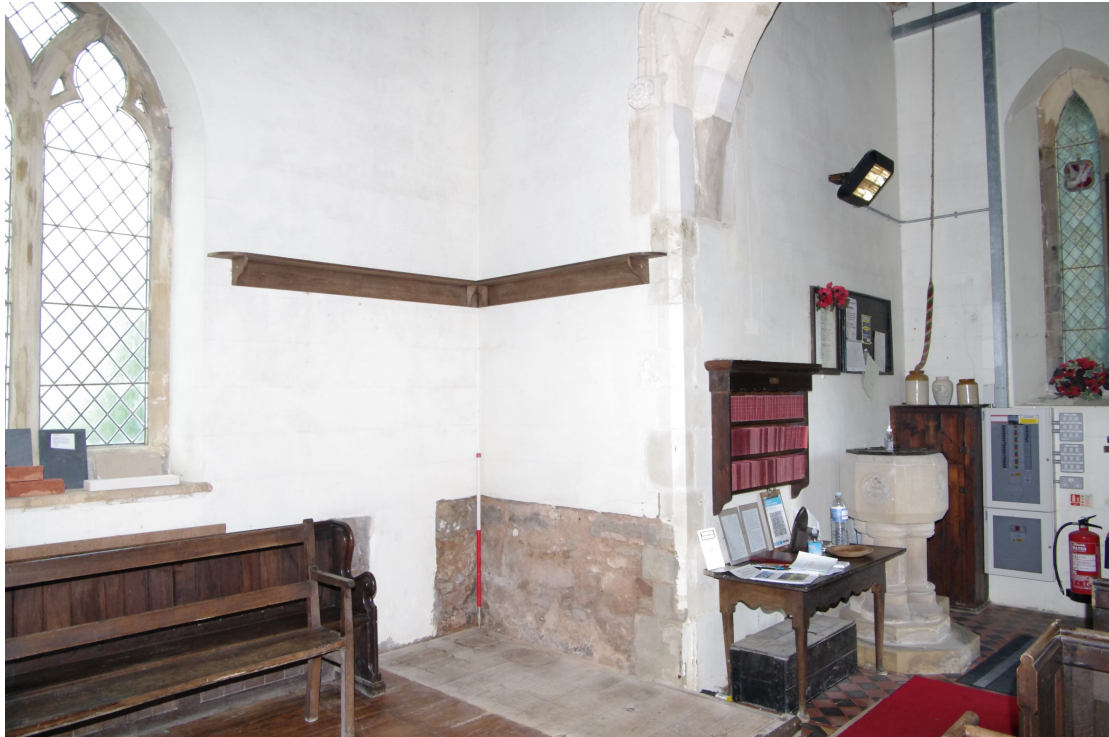
Figure 19 South-west corner of nave

The pews on this side of the nave have been removed showing the wall plaster to be relatively late and laid around the edges of the pews rather than behind them. Note font on the right which will be moved. There is no sign of burning on the stone which may have been present if the stonework was part of the earlier burnt-down church

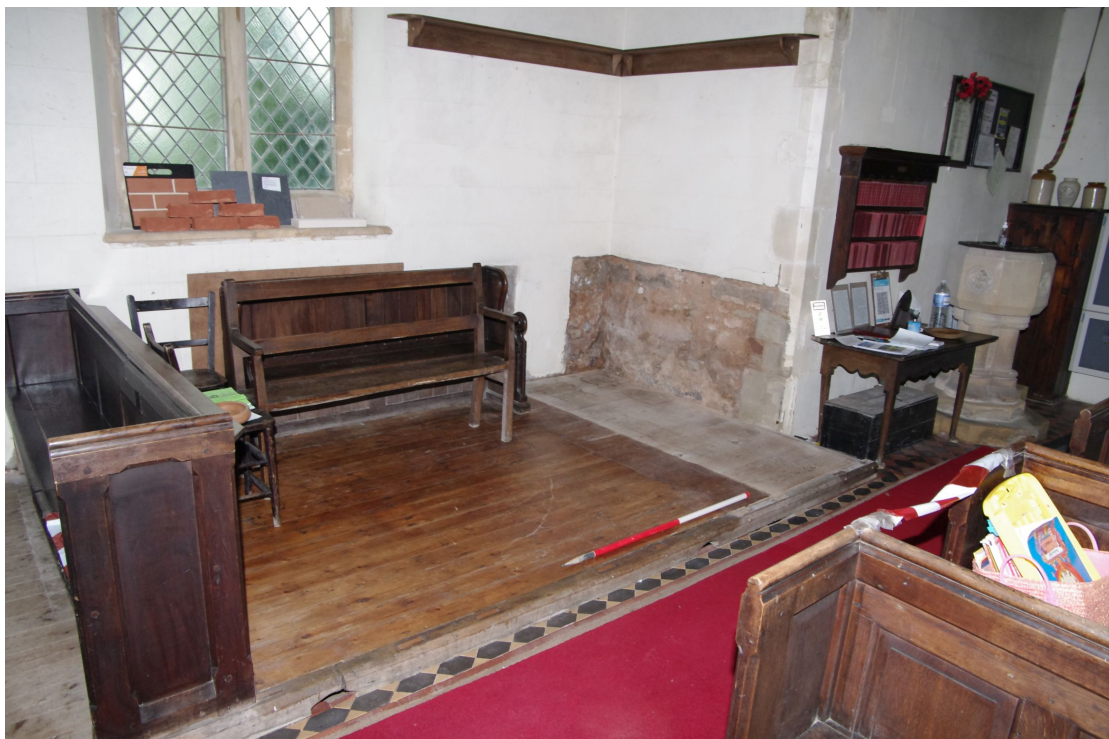
Figure 20 Pew platform in south-west corner of nave
Looking south-west. 1m scale. Note font on right which will be moved

Five pews on the north side of the nave were removed during the present works although only two pews on the south side was removed following earlier attempts to create an open space at the back of the church (see Figs 20 and 22). The ends of all the pews had been partially plastered into the wall which indicated that the church walls had been re-plastered at some stage (Fig. 35). The ends of the pews which had been incorporated into the plaster coating had begun to rot suggesting that this had taken place a significant time ago.

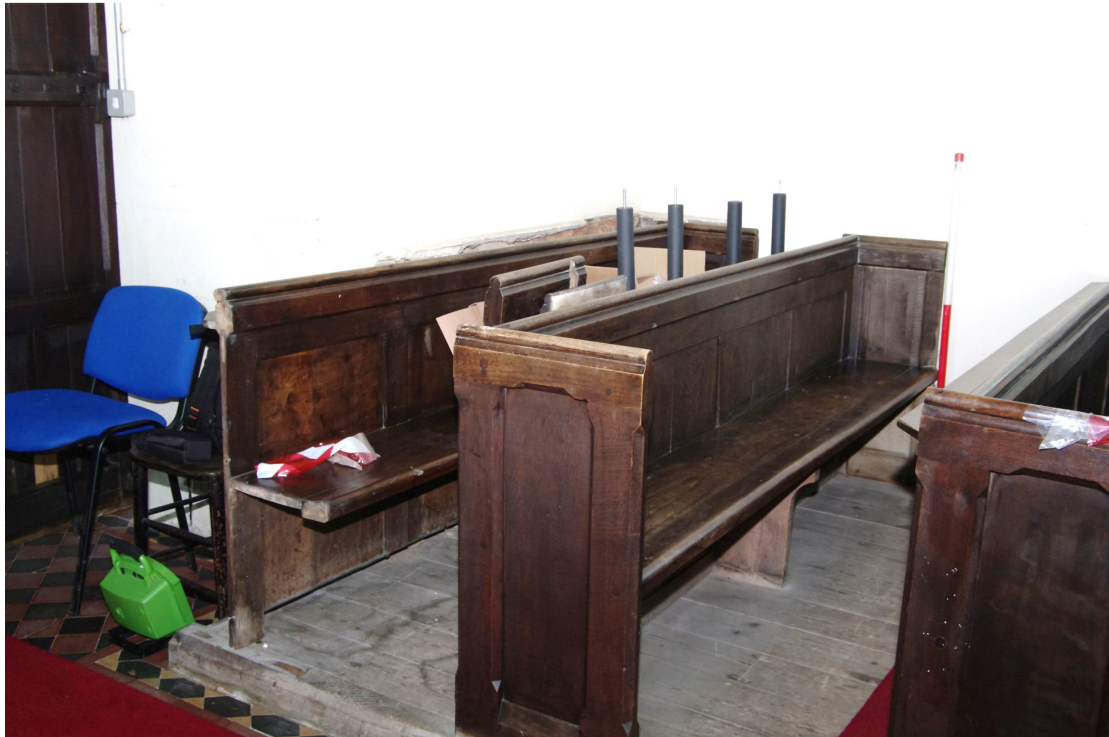
Figure 21 Pew detail on north side of nave
Pews and pew platform are to be removed

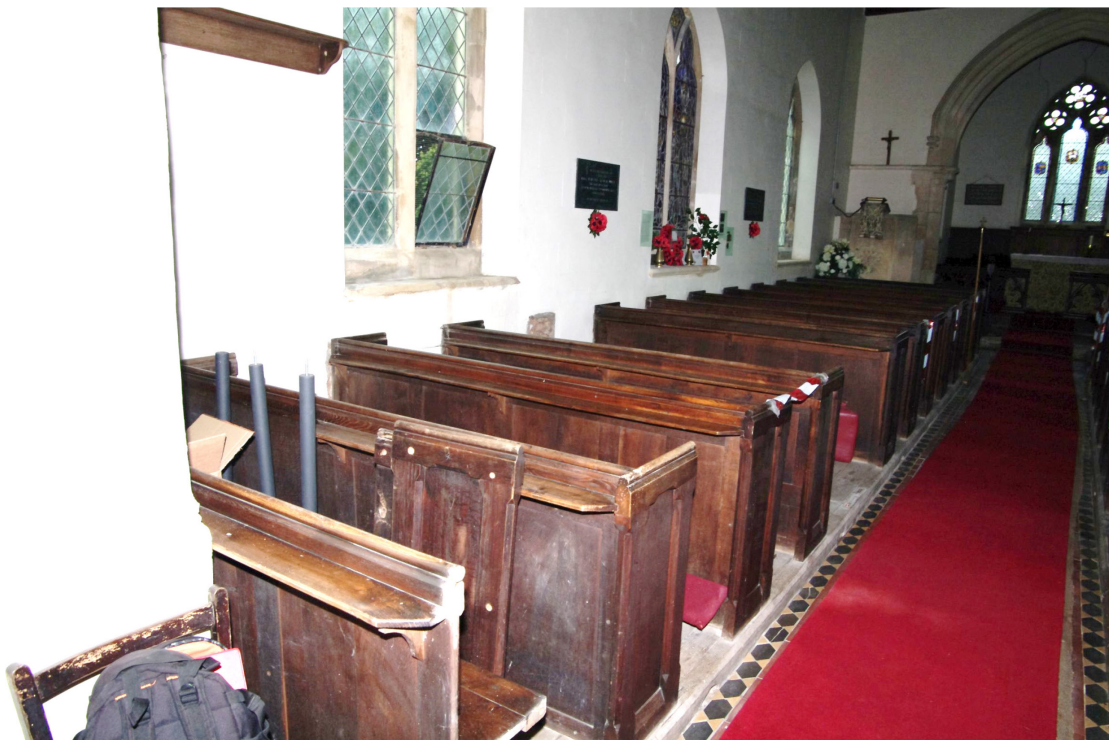
Figure 22 Pew detail on north side of nave
Looking north-east. The first four pews and the platform will be removed

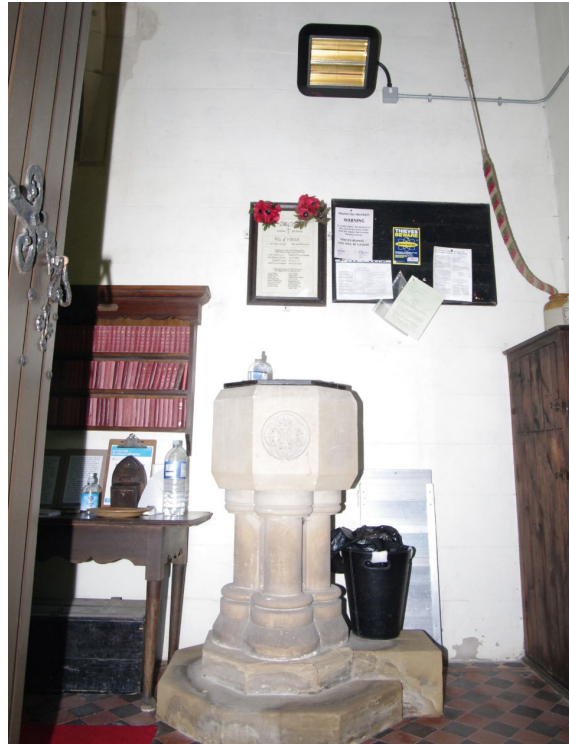
Figure 23 Font and south wall of tower

Looking south from church doorway. The font will be removed and a new doorway opened in the wall behind it (see Fig. 11 for external view). The cupboard on the right will be removed

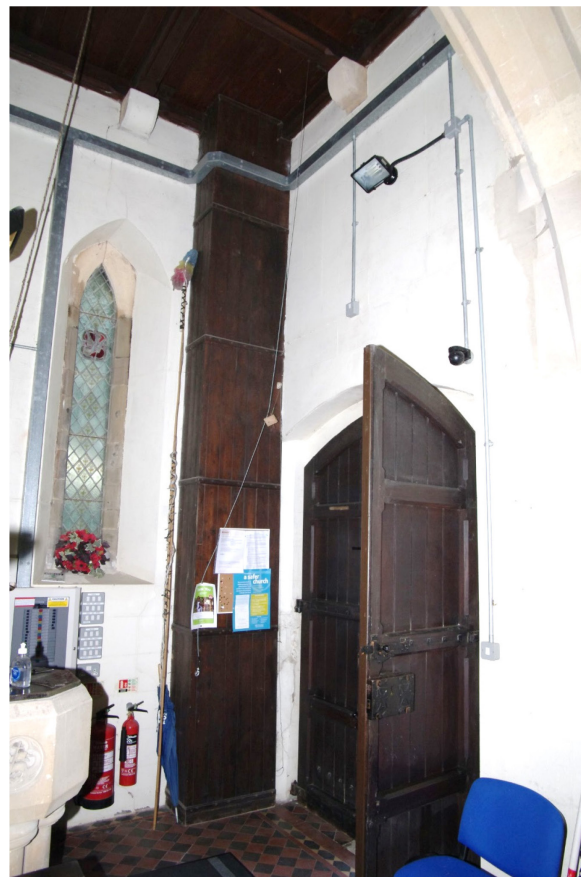
Figure 24 Main doors into church

Looking north-west. The long clock weight cupboard will be removed

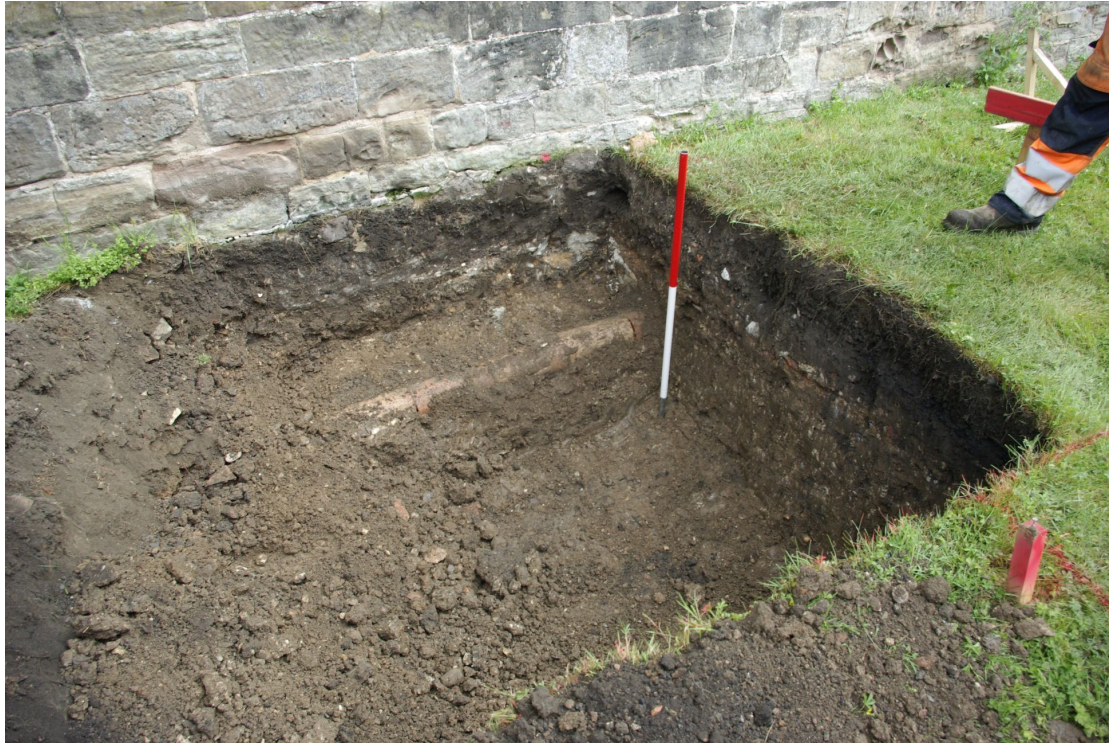
Figure 26 Drain alongside the church being exposed
Looking north-east. 1m scale

the wall and towards a ceramic land drain running parallel to the church (Fig. 26). The drain ran westwards as far as the corner of the nave before diving down beneath the base of the trench. The slates and circular-section pipes were removed during the work but will be replaced if necessary (Fig. 27). The drain pipes are likely to be of very late 19th century or early 20th century date.

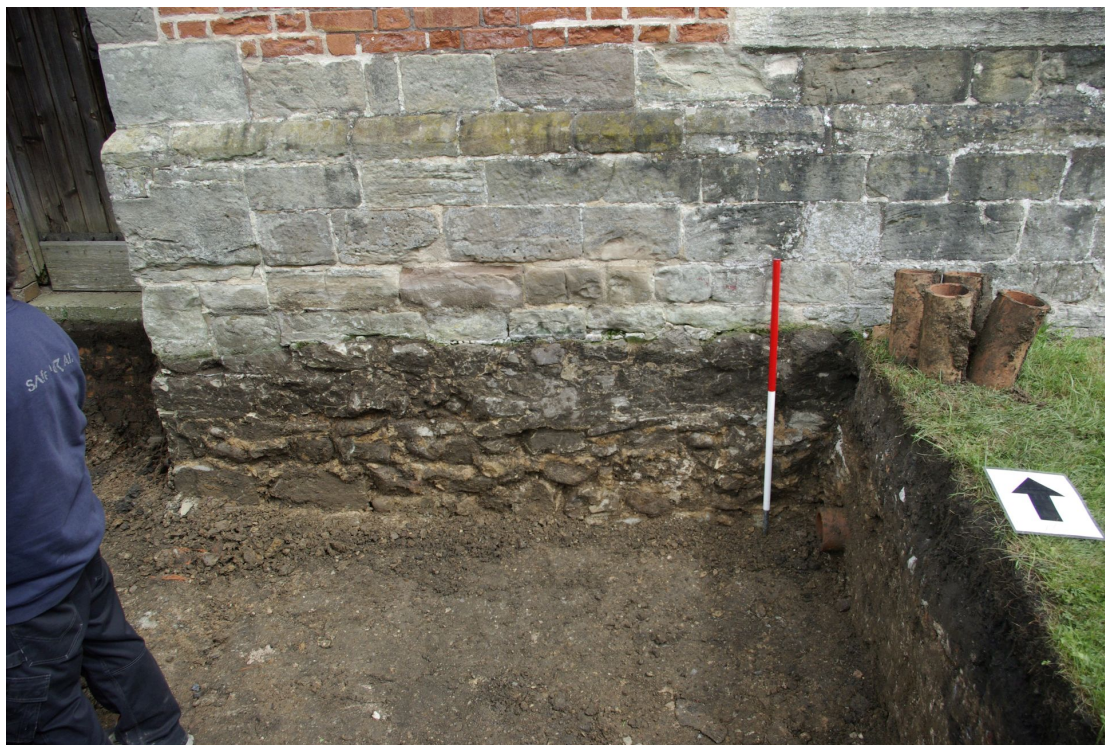
Figure 27 After removal of drain
Looking north. 1m scale. The removed drainpipes are standing at the side of the trench. Note the stub of the drain extending from the side of the trench

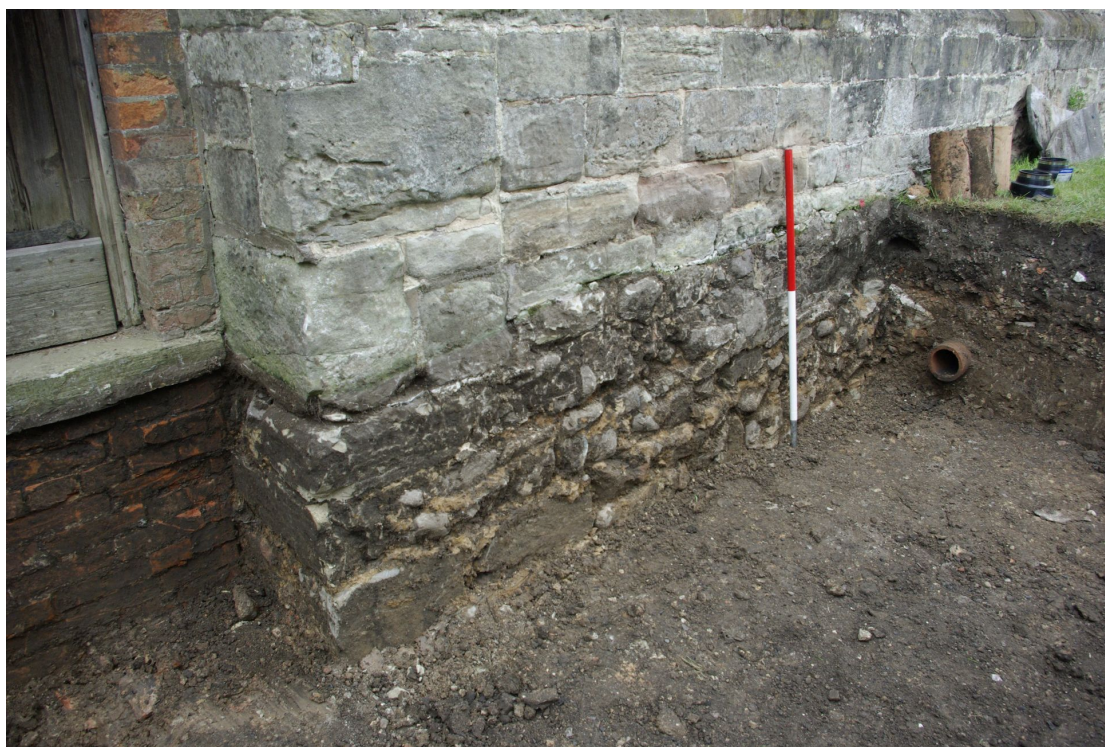
Figure 28 Exposed base of nave wall
Looking north-east. 1m scale. Tower on left

Removal of the drain exposed the uncoursed rubble church wall with faced ashlar stone only being present at ground level (Fig. 28). The stone continued below the maximum depth of excavation. Whilst it cannot be stated with absolute certainty that this exposed base was only built as part of the 1764 church, the use of the same stone in both the ashlar wall and the below ground quoin stones (see Fig. 28) suggests that this wall is all of one phase and not part of the earlier church.

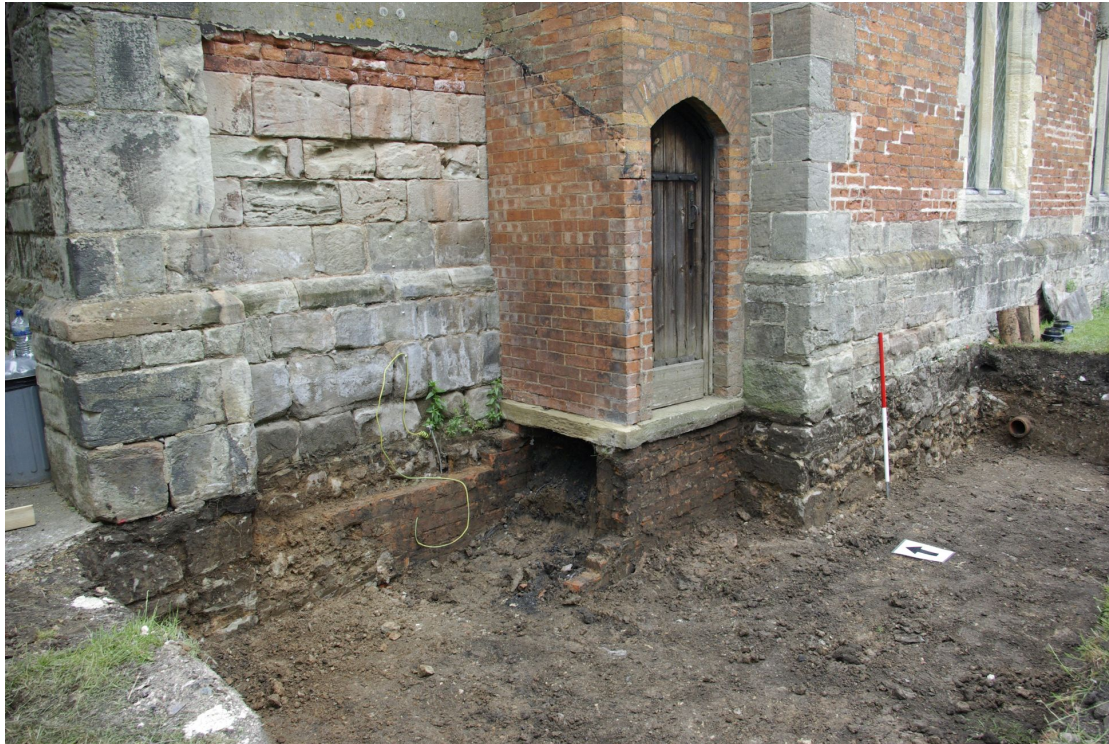
Figure 29 Exposed base of belfry access tower
Looking north-east. 1m scale

As the excavation progressed westwards towards the tower the base of the later belfry access tower was exposed. This base consisted of a pair of brick walls bridged with a stone plinth across a void (Fig. 29). The brick wall closest to the main body of the tower continued across to the western tower buttress joining with part of a wider stone base (Fig. 30). Because the supporting walls continued beyond the maximum depth of excavation it is not known how deep these walls are. The area immediately around the belfry tower contained a lot of clean pale yellowish brown clay mixed with the mid-orange brown mixed sandy clay seen elsewhere in the excavated area which was probably part of the backfill from the construction of the belfry access tower.

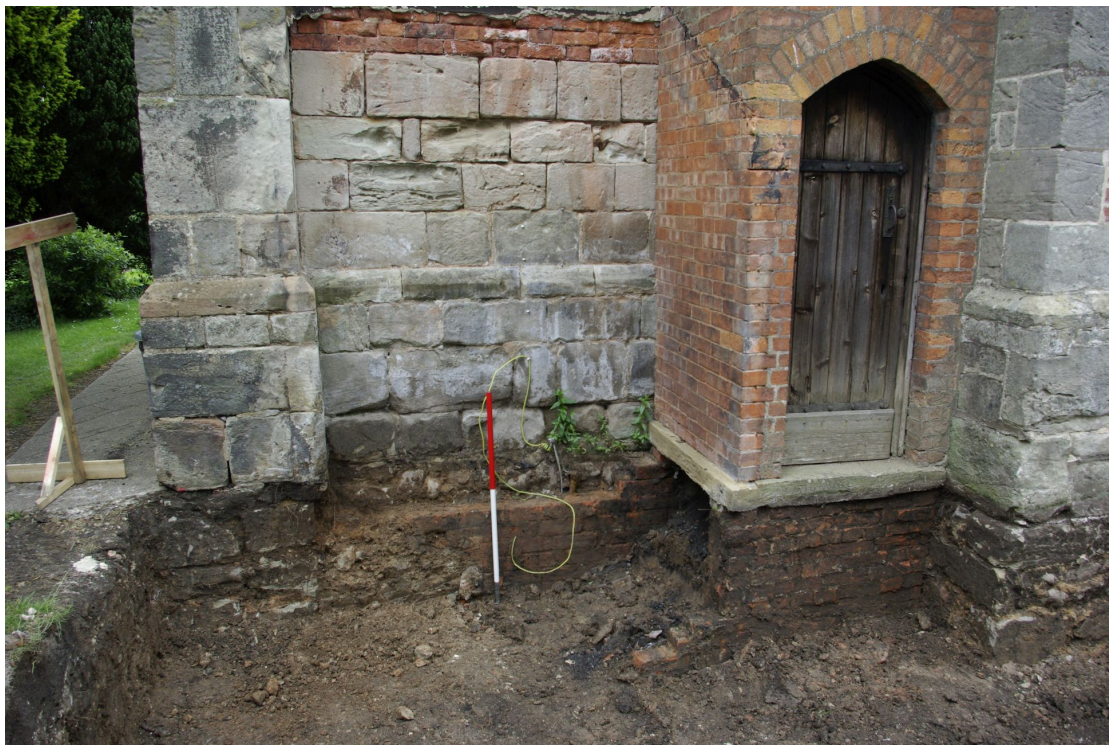
Figure 30 Exposed tower base
Looking north. 1m scale

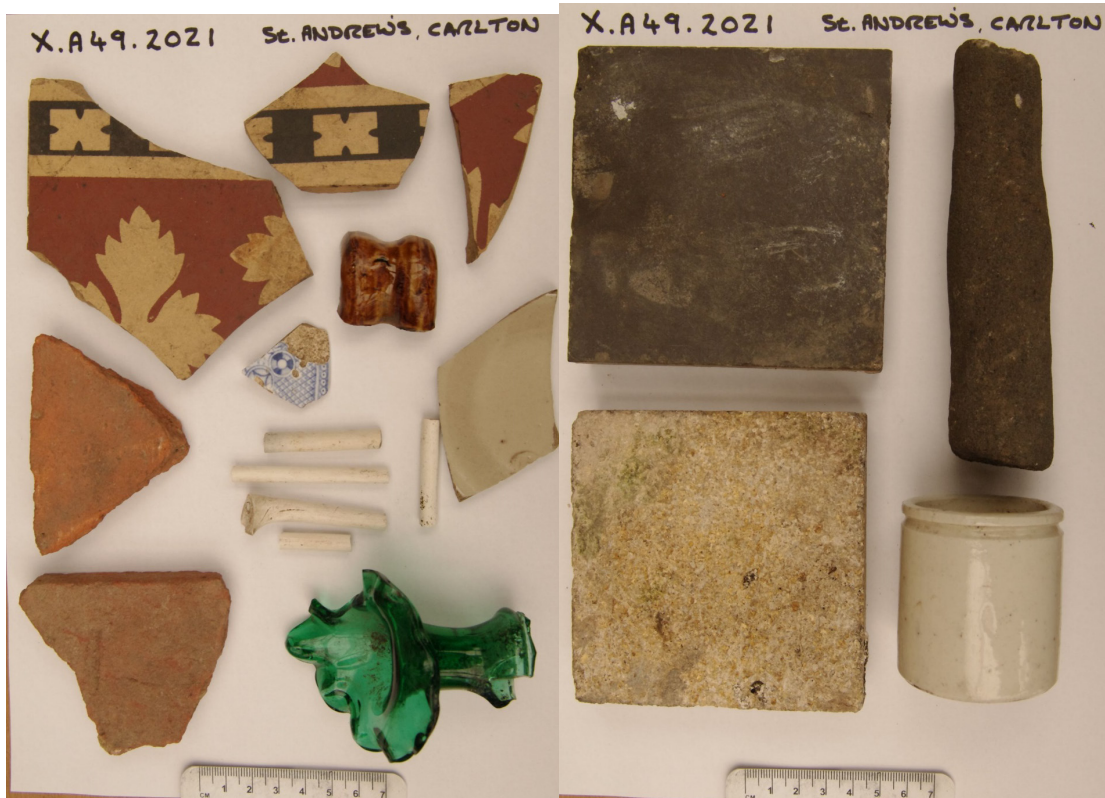
Figure 31 Finds recovered from the watching brief excavation
cm scale

A number of disarticulated fragments of human bone were exposed during the excavation of the foundations. None of these were from complete burials and were carefully collected and retained for later reburial. A number of other finds were recovered from the upcast all of which date to the late post-medieval period up to and including the 20th century (Figs 31 to 33). A list of the finds is shown in Appendix 3 of this report. As noted, all of the finds came from layer (01) although fragments of brick and tile were also observed in layer (02). Of note were three fragments of Minton style floor tile with a similar design to that seen on the chancel floor within the church. Another interesting find was the base of a green-glazed vase with the manufacturer's name (Lovatts, Langley Ware, England) stamped on the bottom. This refers to the Calvert and Lovatt pottery at Langley Mill, Derbyshire. Their wares used this stamp between 1883 and 1895.

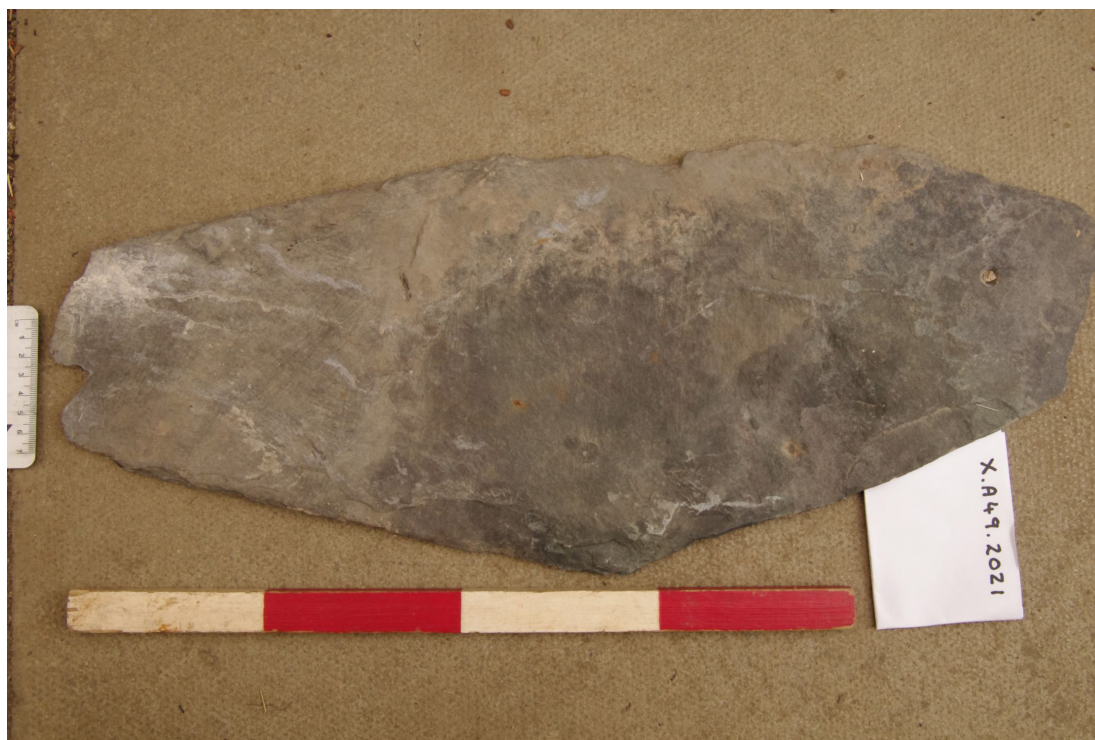
Figure 33 Roofslate found during watching brief
Main scale is 0.4m

Also recovered from layer (01) was a circular section whetstone 140mm in length which shows clear signs of wear. As with the test pit evaluation more fragments of roof slate

were observed including an almost complete slate showing its elongated lozenge shape. The partially bored and chiselled hole suggests a late post-medieval date and may relate to the pre-1764 church.

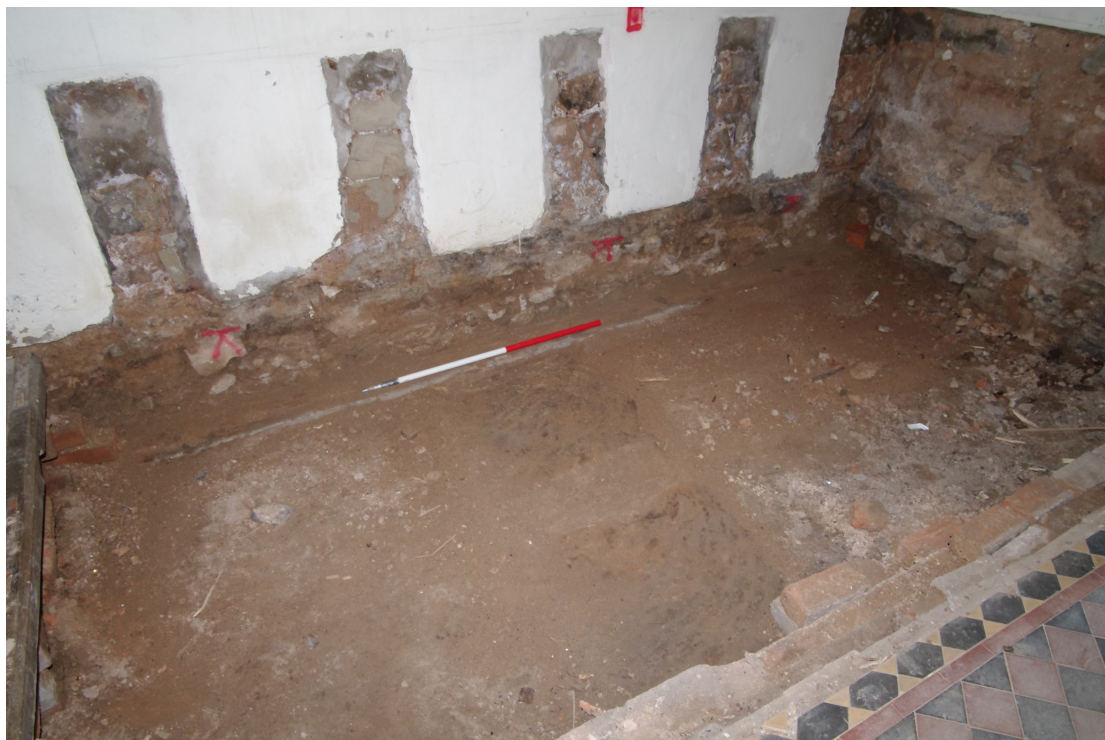
Figure 35 South-west corner of nave showing plaster outline around the pews
Looking south-west. 1m scale
