**A Level 2 Historic Building Recording and
Archaeological Attendance and Recording (watching brief) at
St. Andrew's Church, Main Street,
Carlton,
Leicestershire
NGR: SK 39650 04980**

**ULAS Report No 2021-109
©2021**

Site Name: St. Andrew's Church, 30 Main Street, Carlton, Leicestershire.

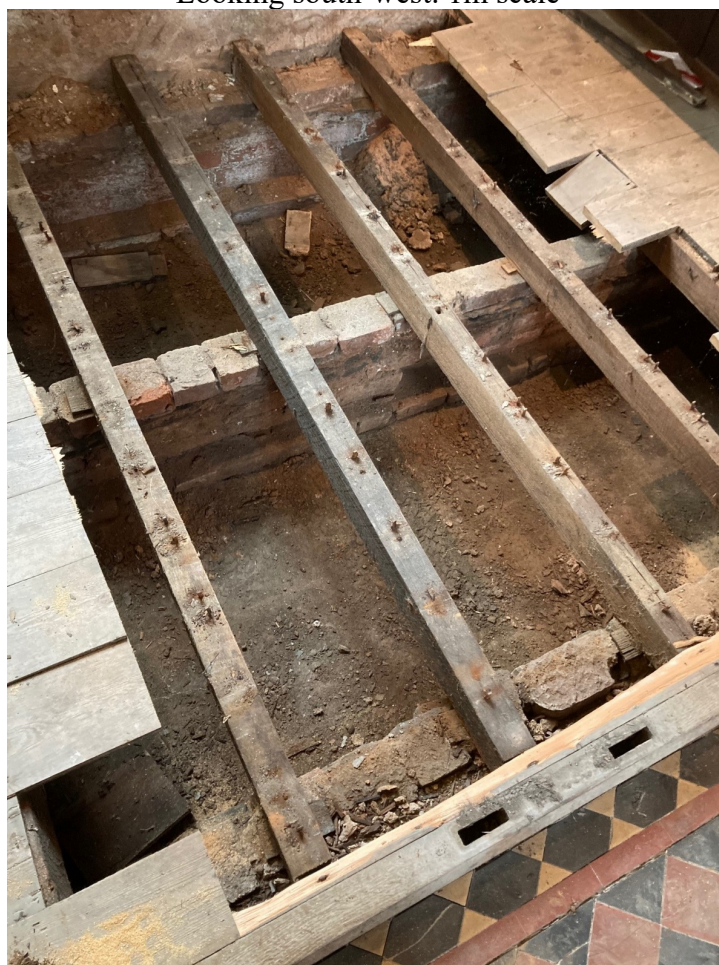
Figure 36 Pew platform being removed
Picture taken by Ackroyds

Removal of the wooden platforms revealed three parallel lines of brick walls upon which transverse timbers had been laid to support the platforms (Figs 36, 37 and 38). The bricks were generally laid in a stretcher bond and measured 240mm long by 110mm wide and 75mm high suggesting a late 19th century date probably contemporary with the 1867 rebuilding phase. The bricks cut into a hard compact silty clay layer which may be an earlier surface or simply a layer which was inserted in between the brick walls (Fig. 39). This layer represents the deepest level of disturbance that the present work will cause, therefore this layer was not excavated or investigated

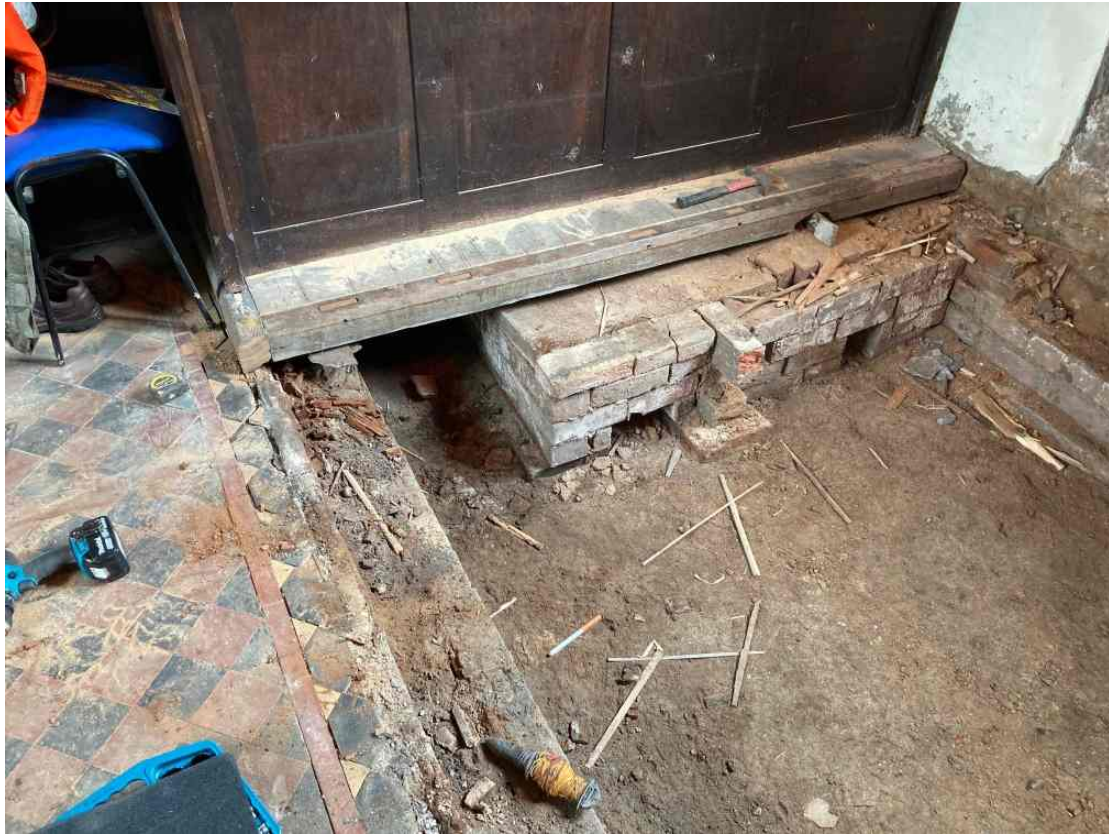
Figure 37 Exposed base for stove against south wall seen beneath pews
Most of this plinth was left in-situ. Picture taken by Ackroyds

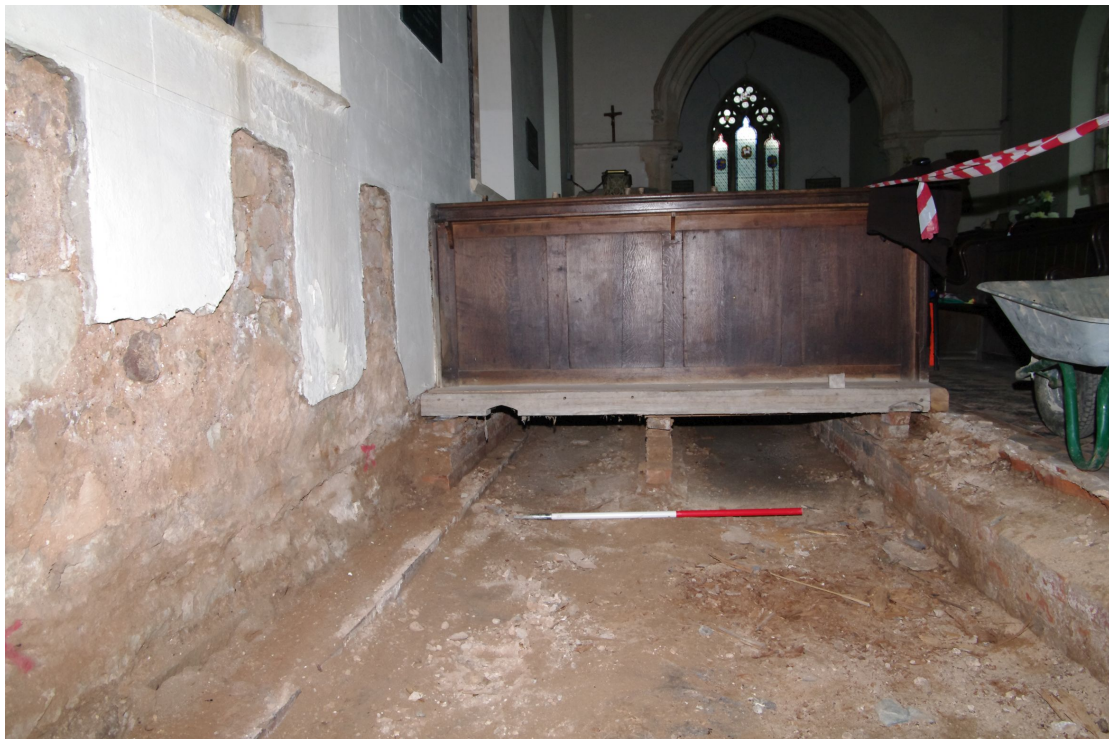
Figure 38 Supporting brickwork beneath pew platforms
Looking east at pews to north of aisle. 1m scale

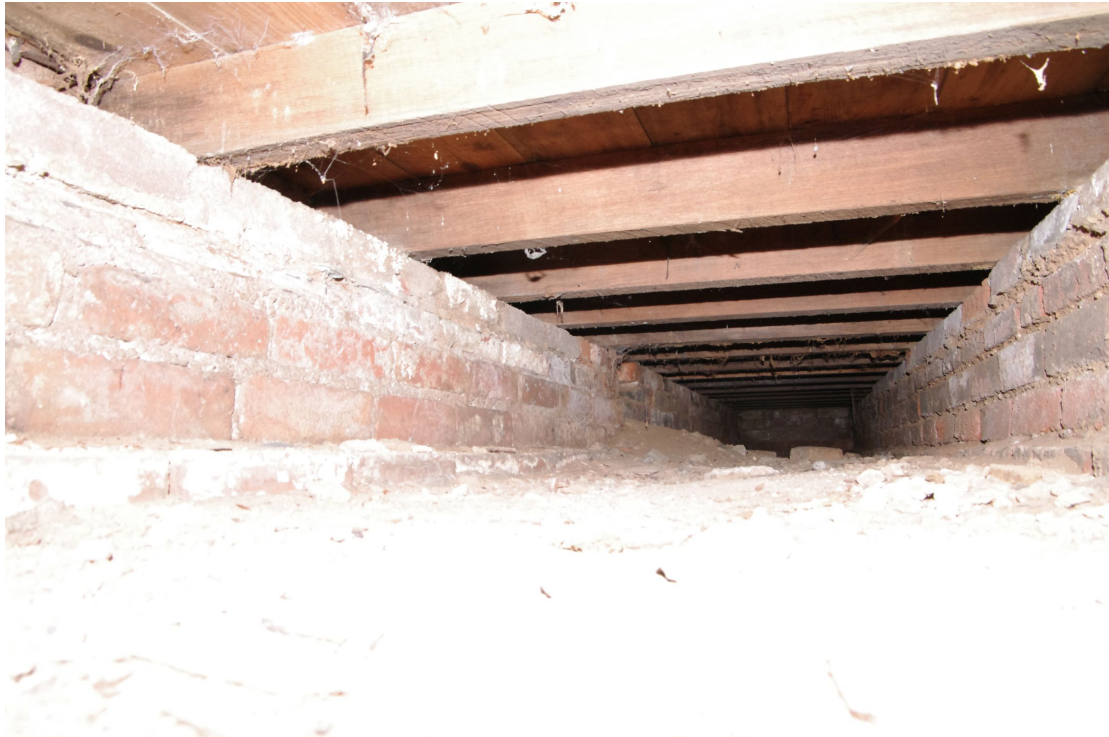
Figure 39 View beneath pew platforms
Looking east

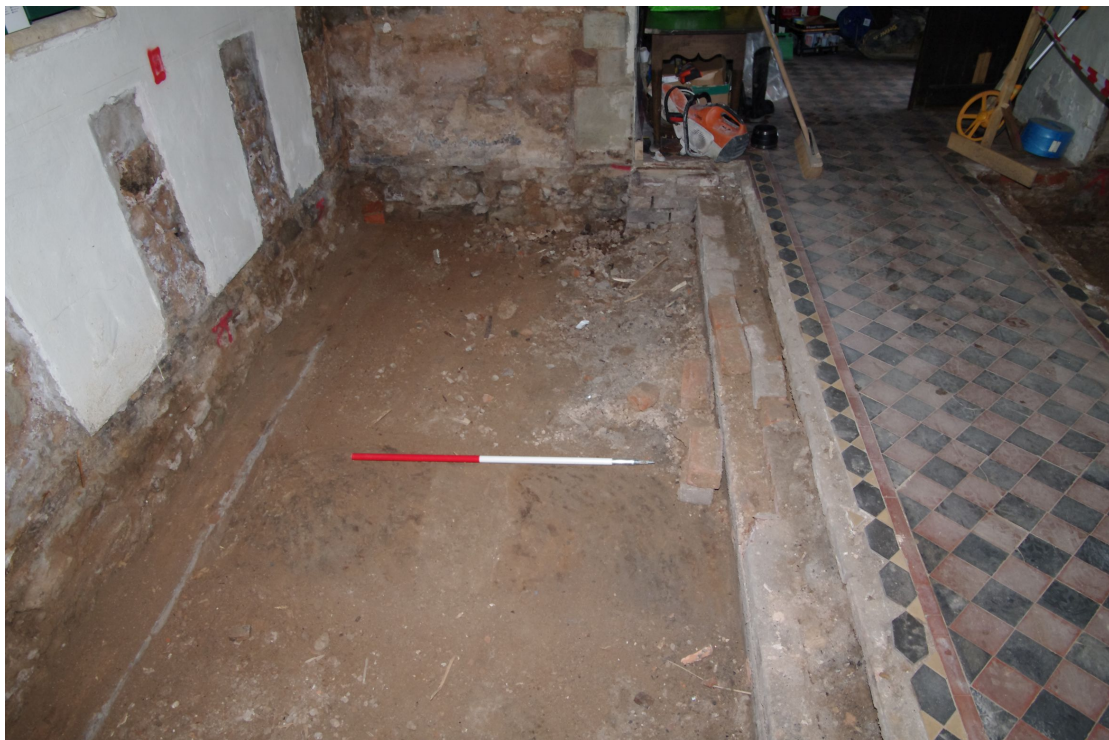
Figure 40 Compact layer beneath platforms
Looking west on south side of aisle. The supporting bricks have been reduced in height down to the compact layer. 1m scale

Examination of the exposed stonework of the side walls indicated that they are of a single phase as seen on the exterior walls (Figs 40 and 41). Some of the edges of the soft stone appear to have been damaged by the earlier removal of plasterwork and are still covered in unpointed mortar. The decorative quoin stones around the gothic arch into the tower stop at current floor level (Figs 42 and 43). This suggests that the creation of the arch and the present floor level are likely to be of a similar date.

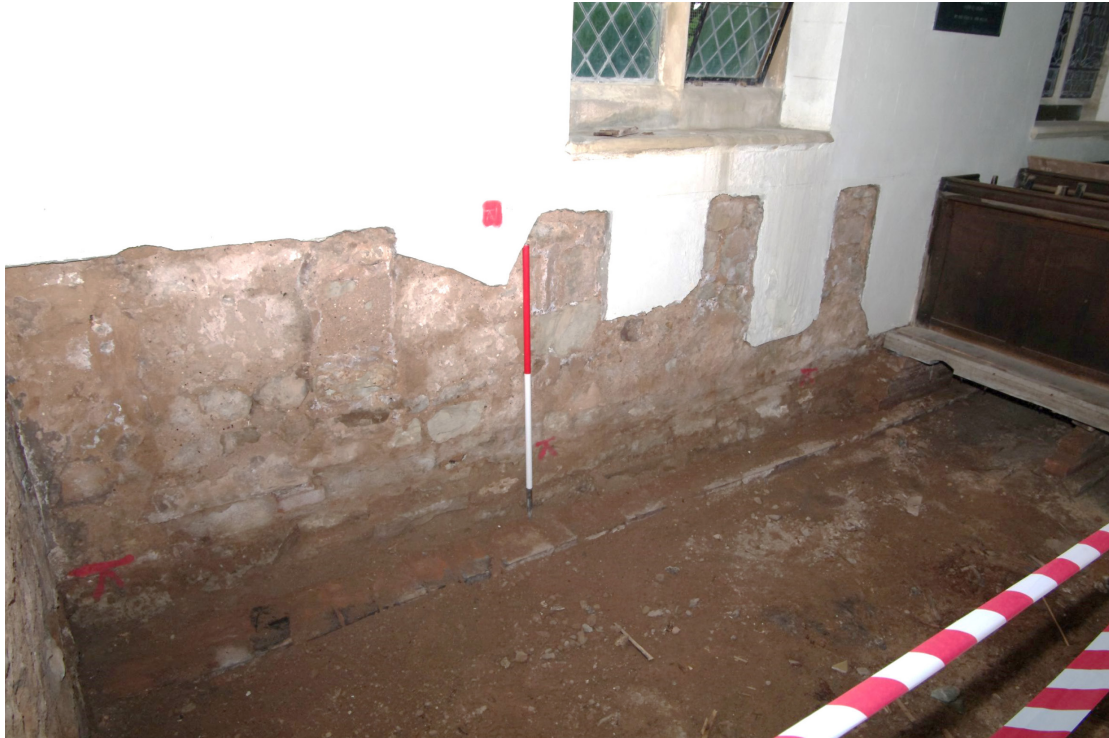
Figure 41 Exposed stonework on north wall
Looking north-east. 1m scale

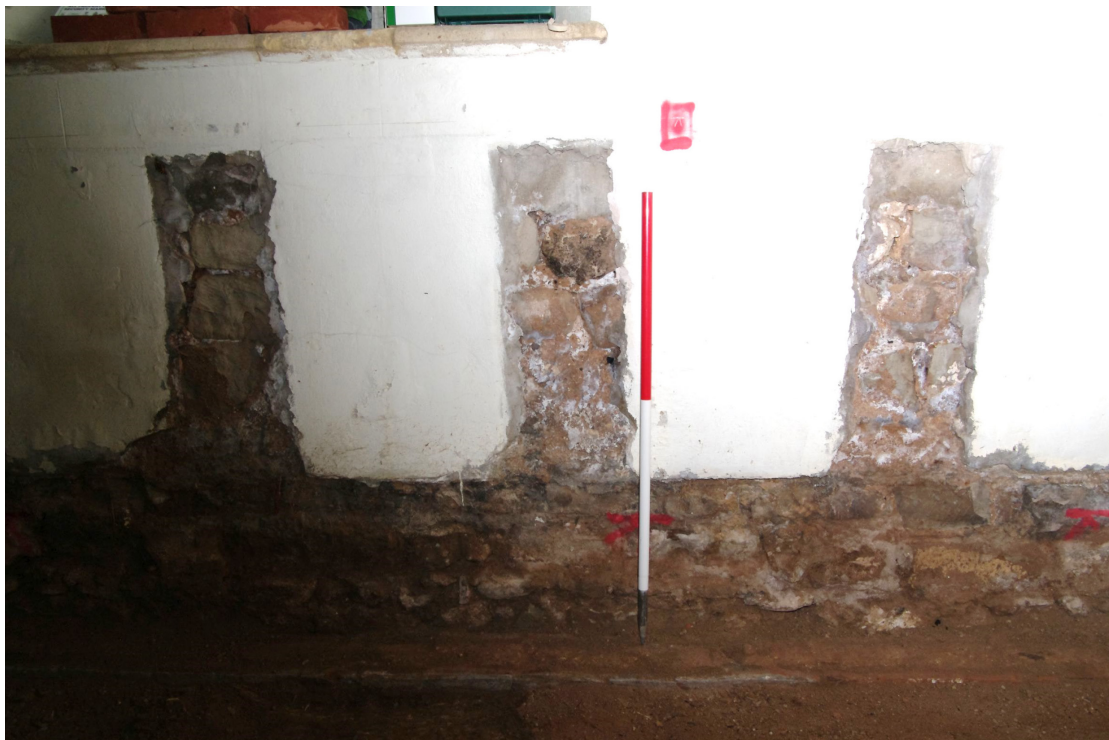
Figure 42 Exposed stonework on south wall
Looking south. 1m scale

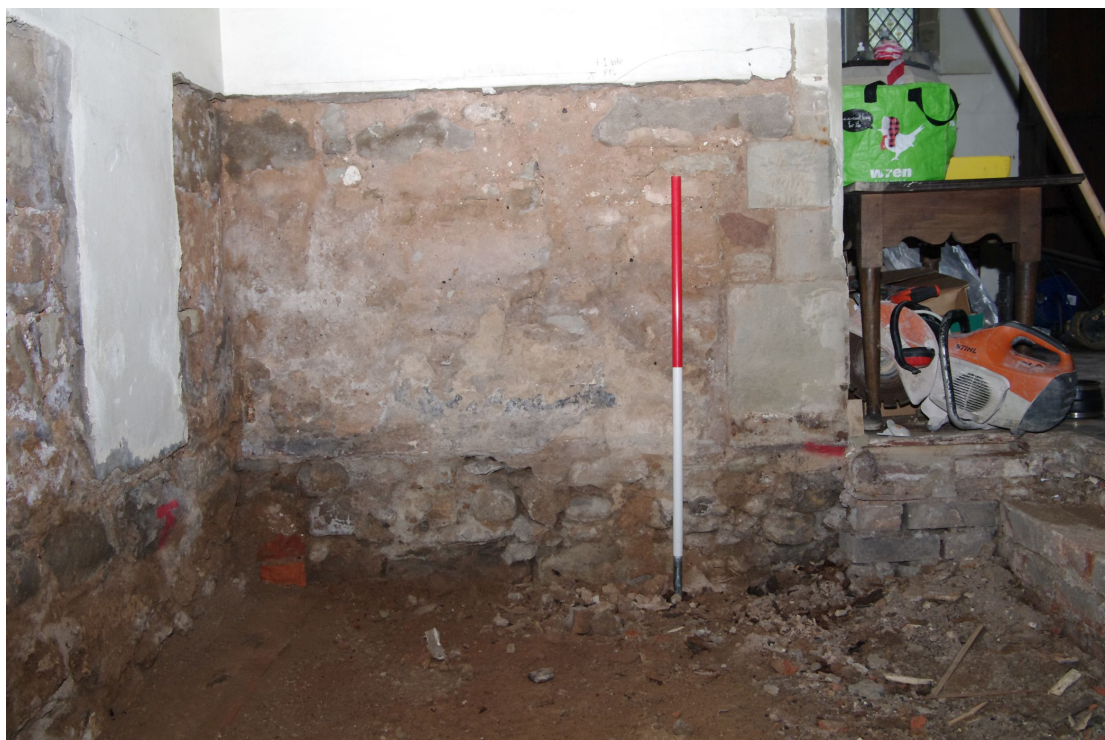
Figure 43 Tower wall on south side of aisle
Looking west. Note how quoin stones stop at floor height. 1m scale

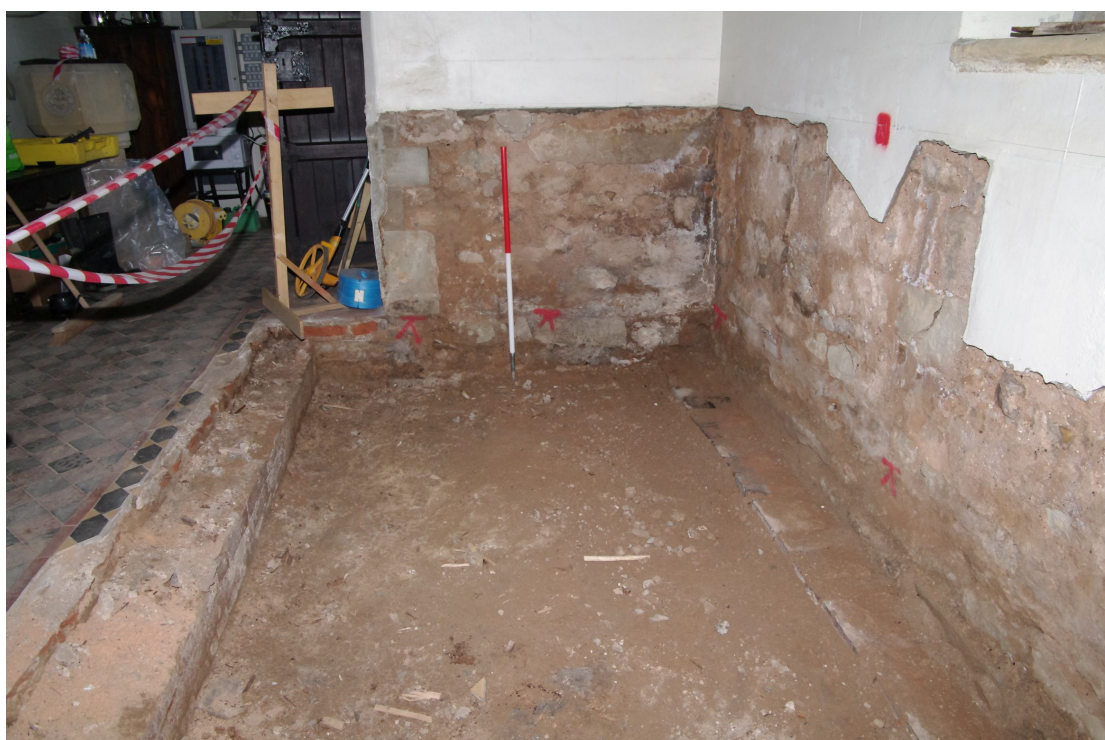
Figure 44 Tower wall on north side of aisle
Looking west. 1m scale

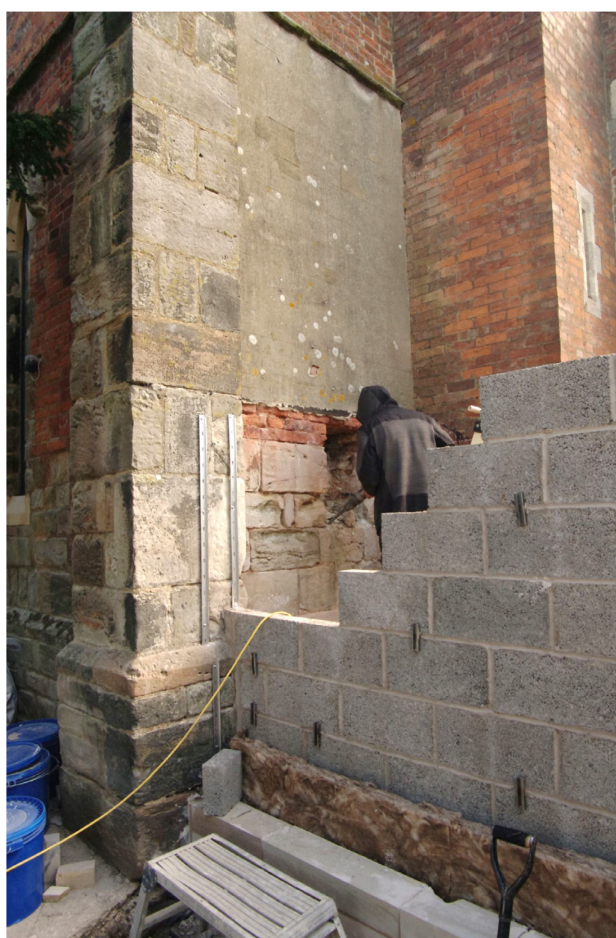
Figure 45 Initial hole being made in the south wall of the tower
Looking north-east. Note the presence of the new extension by this stage

Following on from the removal of the pews and platforms the next stage involved the monitoring of the breaking through of a new doorway on the south side of the tower. Initially, the lower courses of the new extension were built in order to make the site secure before the new doorway was created. To start with, a small exploratory slot was made cutting into the wall from the outside (Fig. 44). The full height of the hole was then cut from the church floor level up to the top of the stone height and for two courses of brick on top of that (Fig. 45).

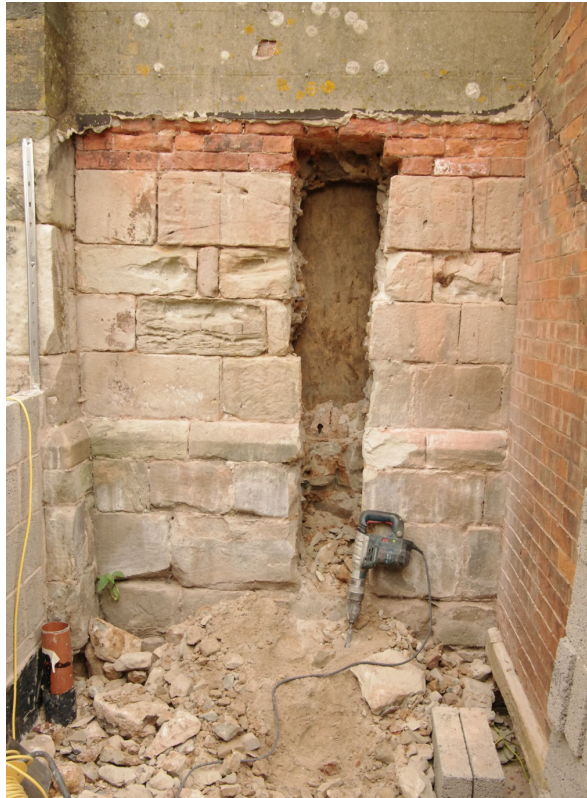
Figure 46 Full-height slot through tower wall
The hole does not penetrate through the wall although a board is against the inner face in this picture

Breaking through the stonework showed that the approximately 0.6m thick tower wall consisted of a skin of faced stone on the outer face with a heavily mortared rubble core behind it (Figs 46 and 47). On the inner face the wall had a thick layer of plaster laid directly onto the rubble core which had no dressed stone on this side. The plaster had been scored to represent painted ashlar stone courses (Figs 48 and 49). Within the fabric of the wall small pieces of slate could be seen which appeared have been added to act as levelling aids to the dressed stone face (Fig. 50). More importantly, to aid in the dating of the wall, was a fragment of brick which was seen embedded within the fabric of the wall (Fig. 51). Although the brick could not be accurately measured it appeared to be the same colour and soft-fired texture as the bricks used elsewhere in the tower. Such a piece of brick deep within the fabric of the stonework suggests that the tower is all of one phase which matches the church.

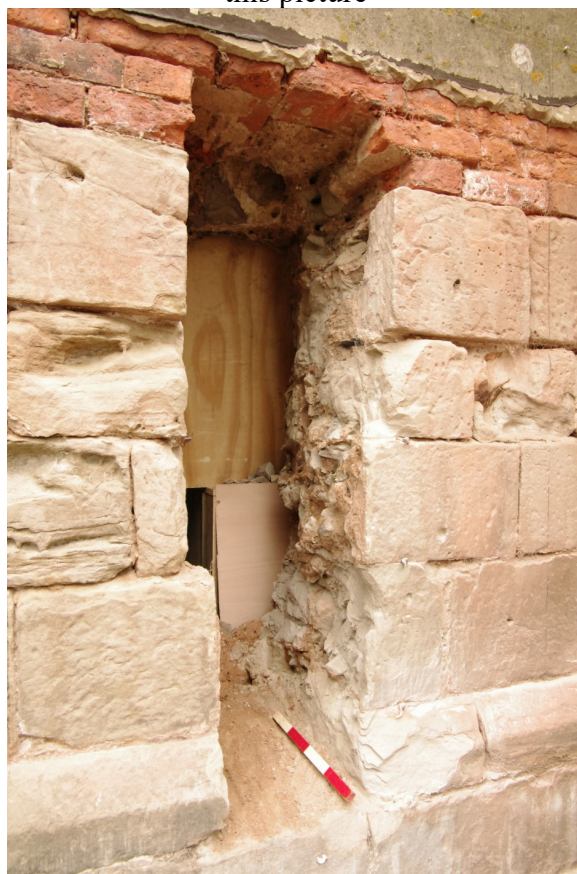
Figure 47 Slot through tower wall
Looking north-east from outside. 0.4m scale

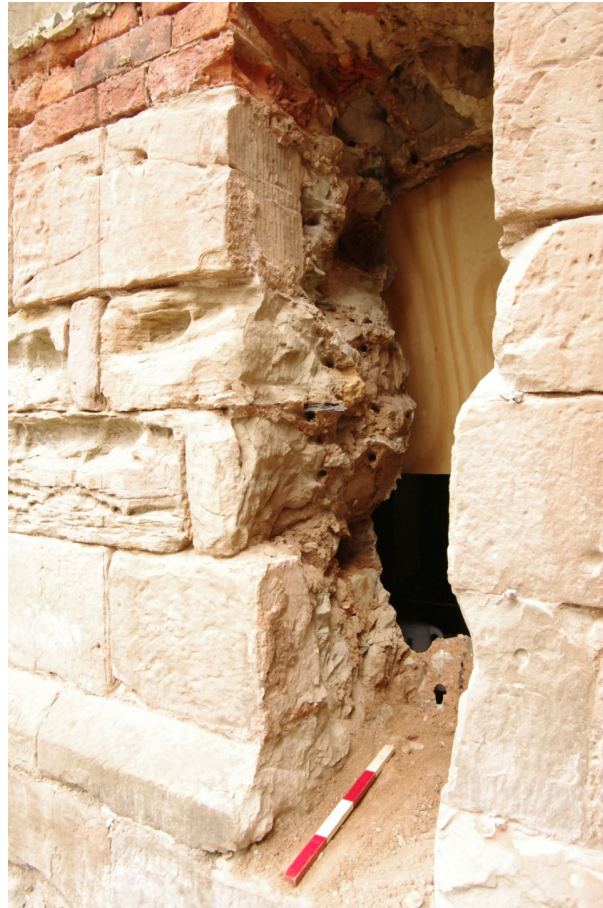
Figure 48 Slot through tower wall
Looking north-west from outside. 0.4m scale

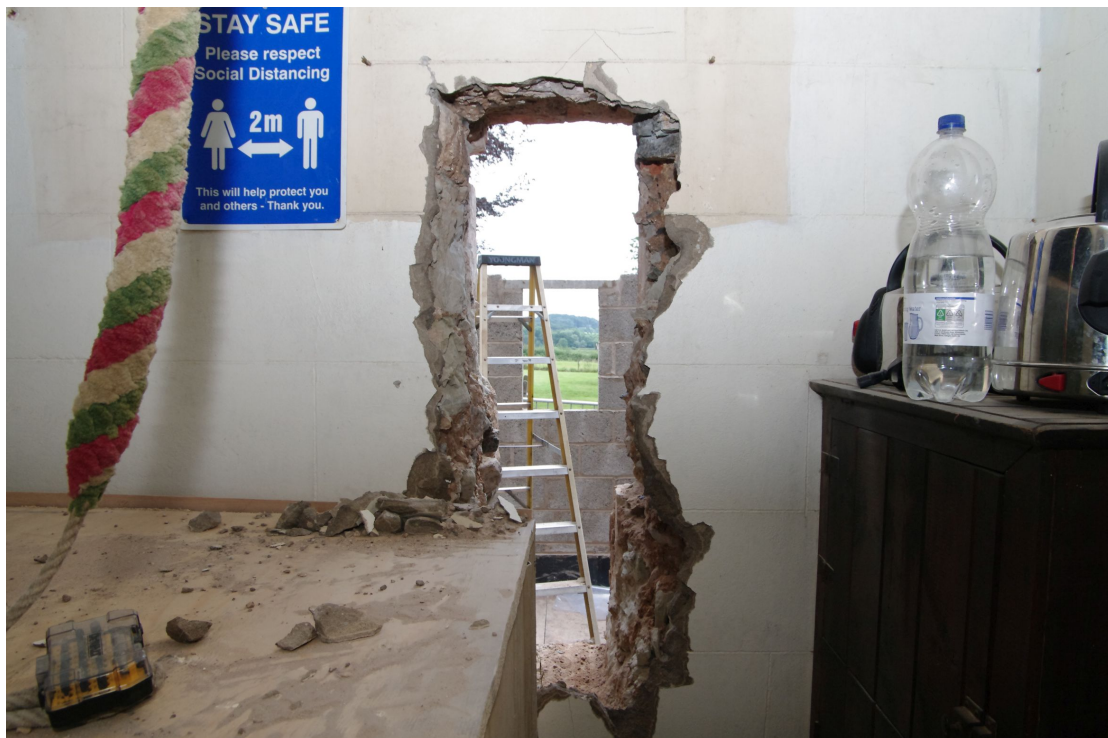
Figure 49 Slot through tower wall
Looking south from the inside

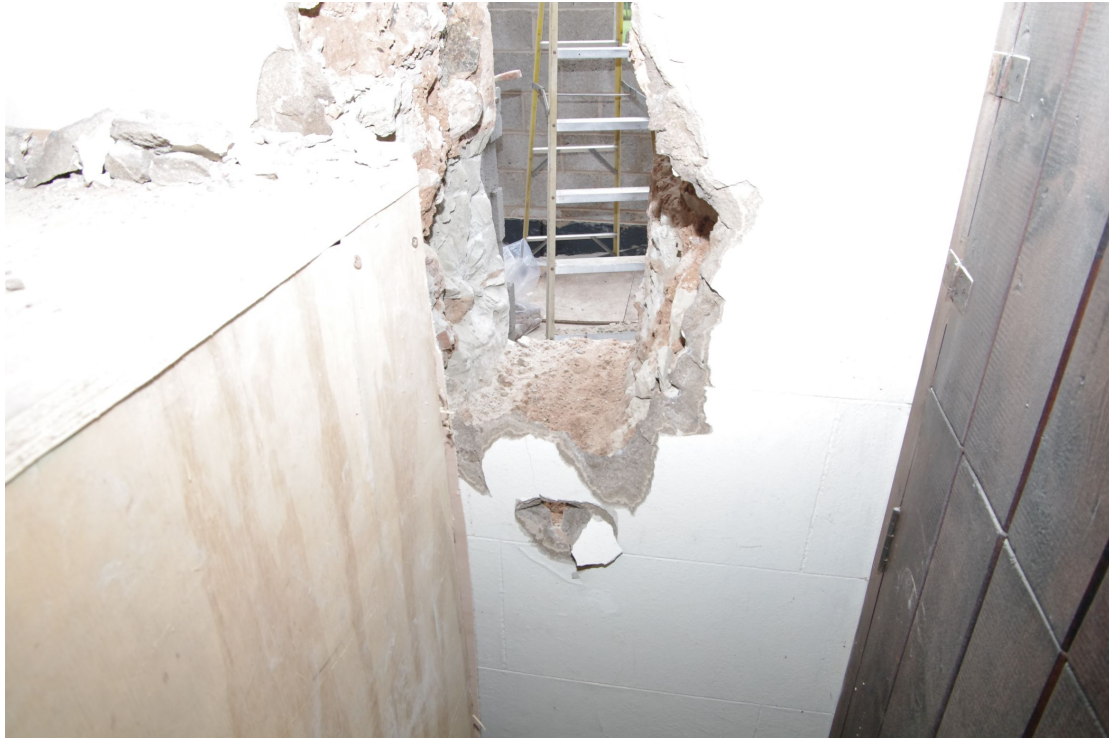
Figure 50 Close up of the plaster skin on the internal face
Looking south

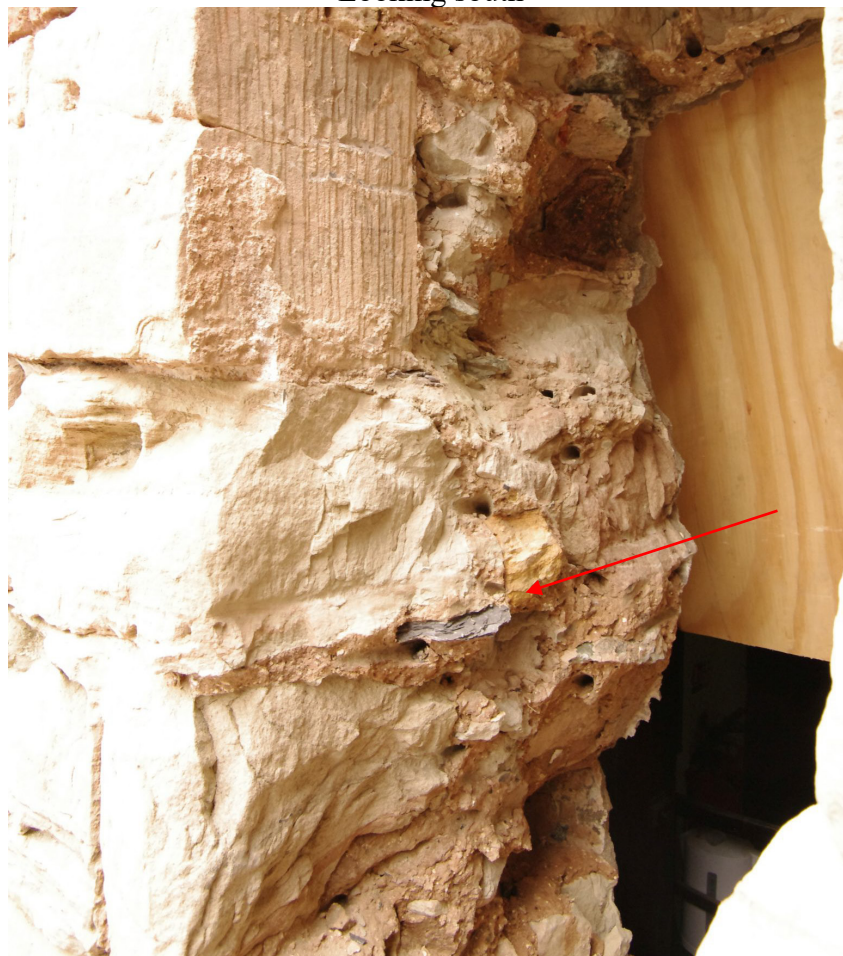
Figure 51 Piece of slate used as levelling material
The red arrow points towards the slate

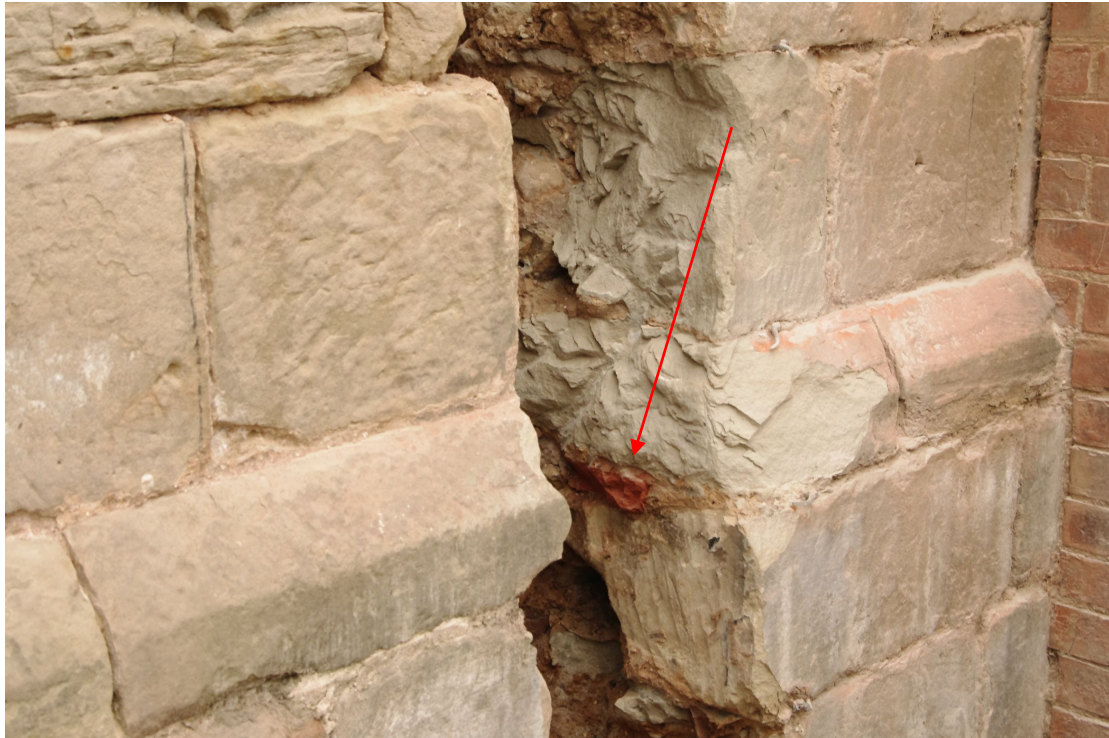
Figure 52 Fragment of brick within the stone matrix of the tower wall
The red arrow points towards the brick fragment

The removal of the pews and pew platform along with areas of wall plaster indicate that the walls and the archway into the tower are all of a single phase. The use of brick within the wall matrix would suggest that this phase belongs to the 1764 rebuilding and not to any earlier phases. It was hoped that evidence of the burning which prompted the rebuilding might be seen but no burnt stone or ash was observed during the works.

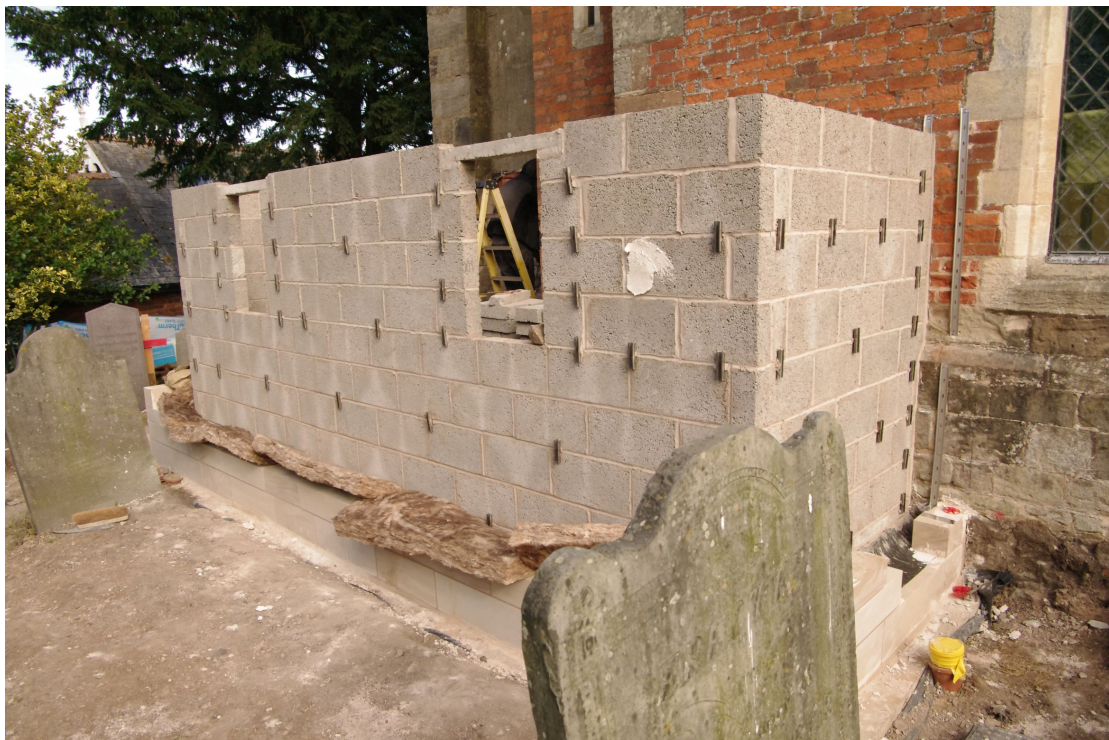
Figure 53 Partially complete extension
Looking north-west

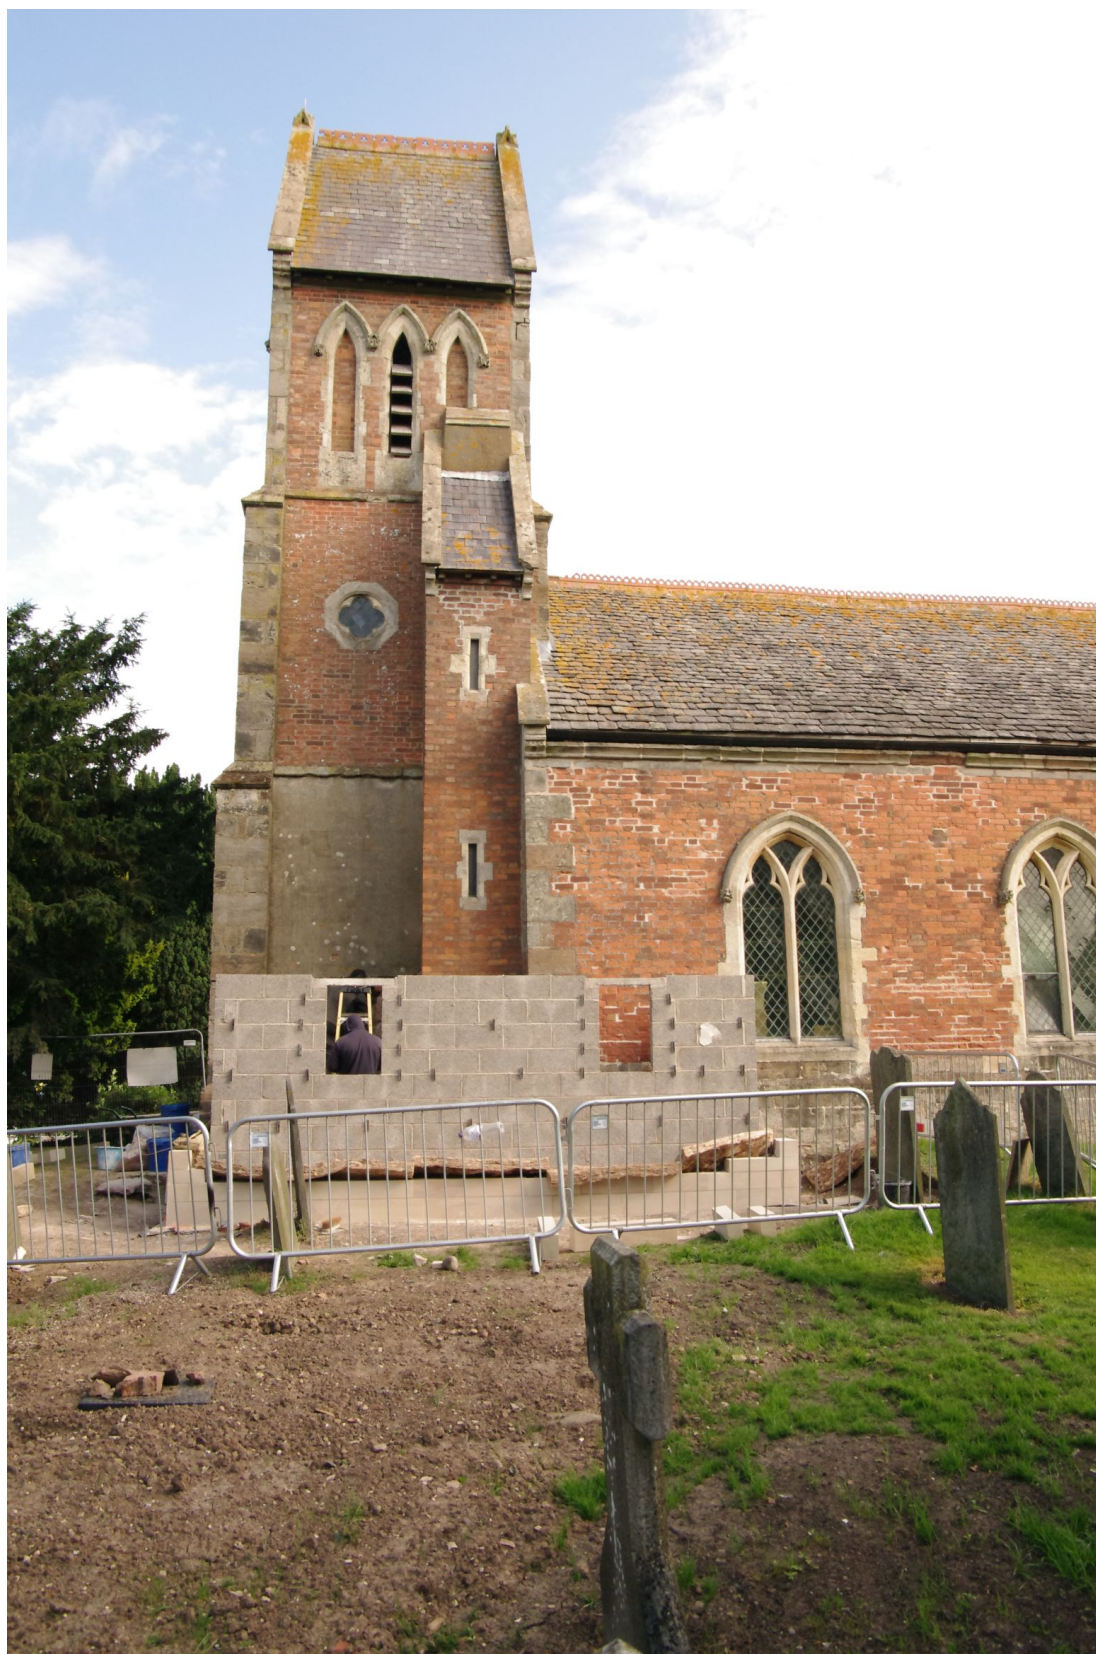
Figure 54 Partially complete extension awaiting outer skin of stone
Looking north
