**An Historic Building Assessment (Level 2)**

**At Bescaby Park, Bescaby**

**Sproxton, Leicestershire.**

**ULAS Report Number 2009-061**

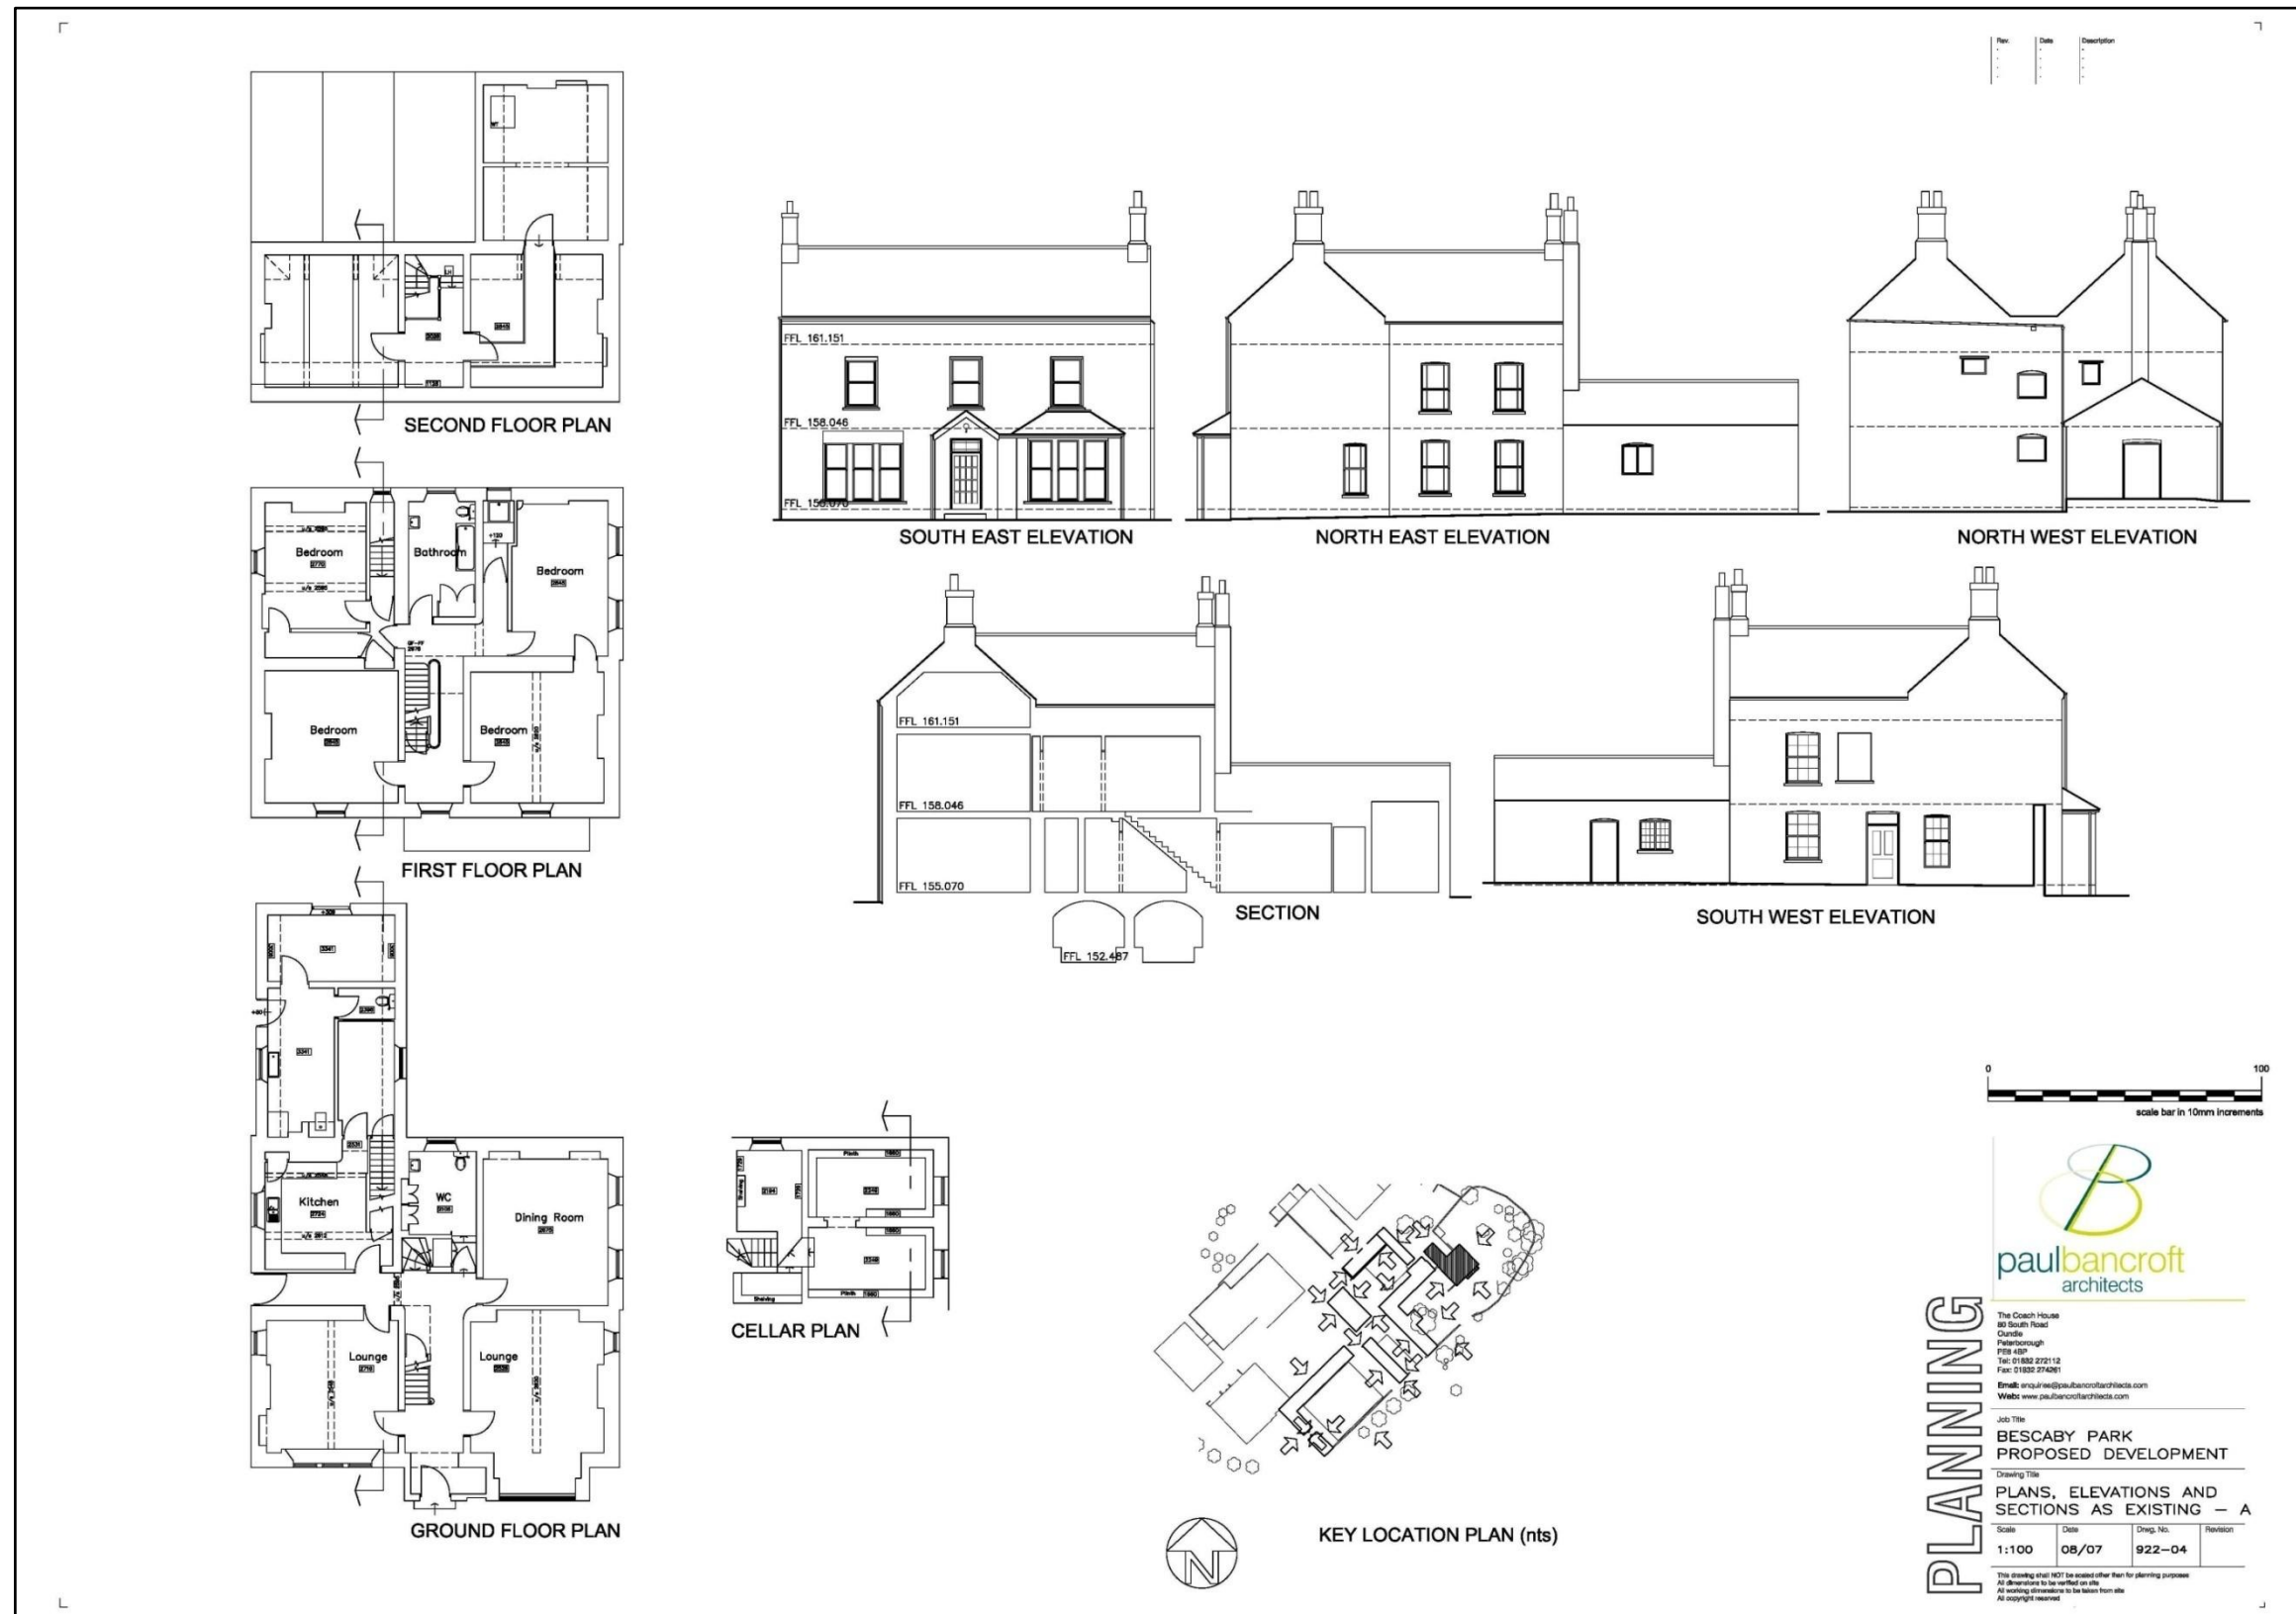
Figure 4 Bescaby House elevations and plans  
Source: Paul Bancroft Architects

The proposed development site consists of the main house, an adjacent stable block, a threshing barn that has been converted to a stable, a cart shed and a range of single storey outbuildings (figs 3, 4, 5 and 6). Other contemporary barns and sheds form a

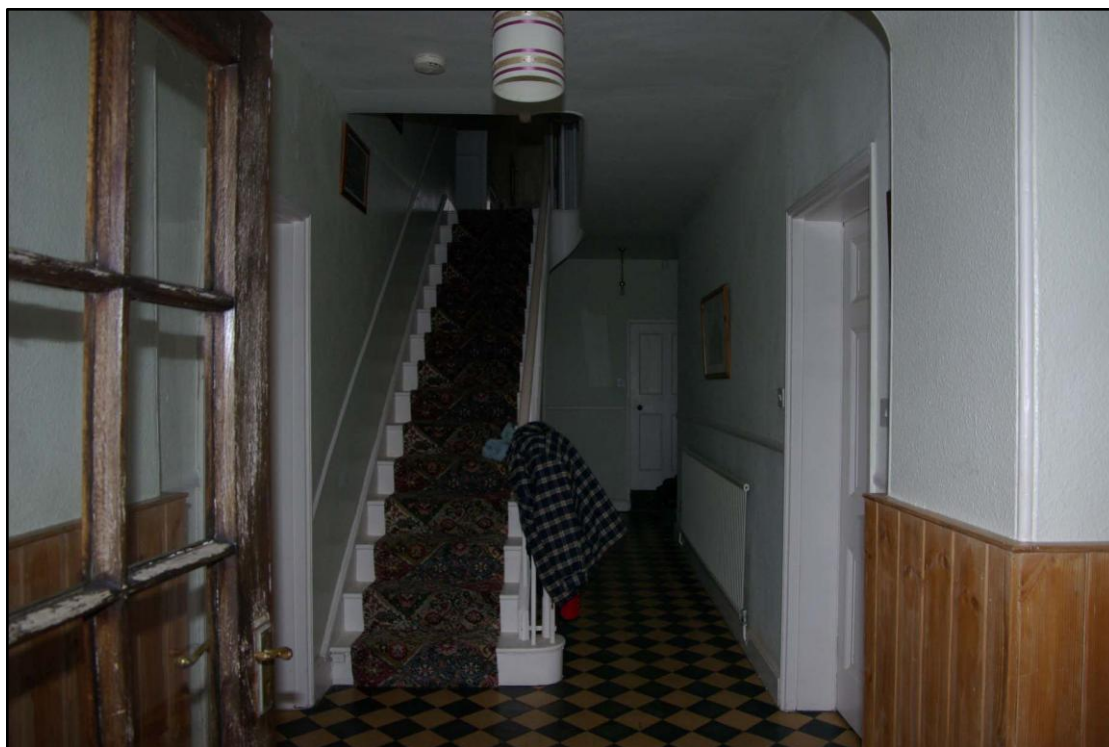
Figure 13 Ground floor entrance hall  
Looking north west

Inside the entrance hall is a fairly narrow staircase with stick balusters and turned newel post. The floor has a diamond pattern of yellow and black quarry tiles measuring 150mm<sup>2</sup> (fig. 13). The moulded detail at dado height which continues around the hall matches that at banister height. The hall leads round to the south western door to the stable yard (fig. 14). This area is clearly designed for servants as the corridor becomes narrower and there are seven call bells on the northern wall (fig. 15). The two principal rooms lead off to east and west from the main hallway through 6-panelled doors with rising hinges and moulded frames. The western room has a second, slightly narrower and less decorative, 6-panelled door leading to the rear corridor mentioned above (fig. 16). The room has a modern fireplace with a recess to the south side of it which appears to be part of the original design (fig. 17). A sash

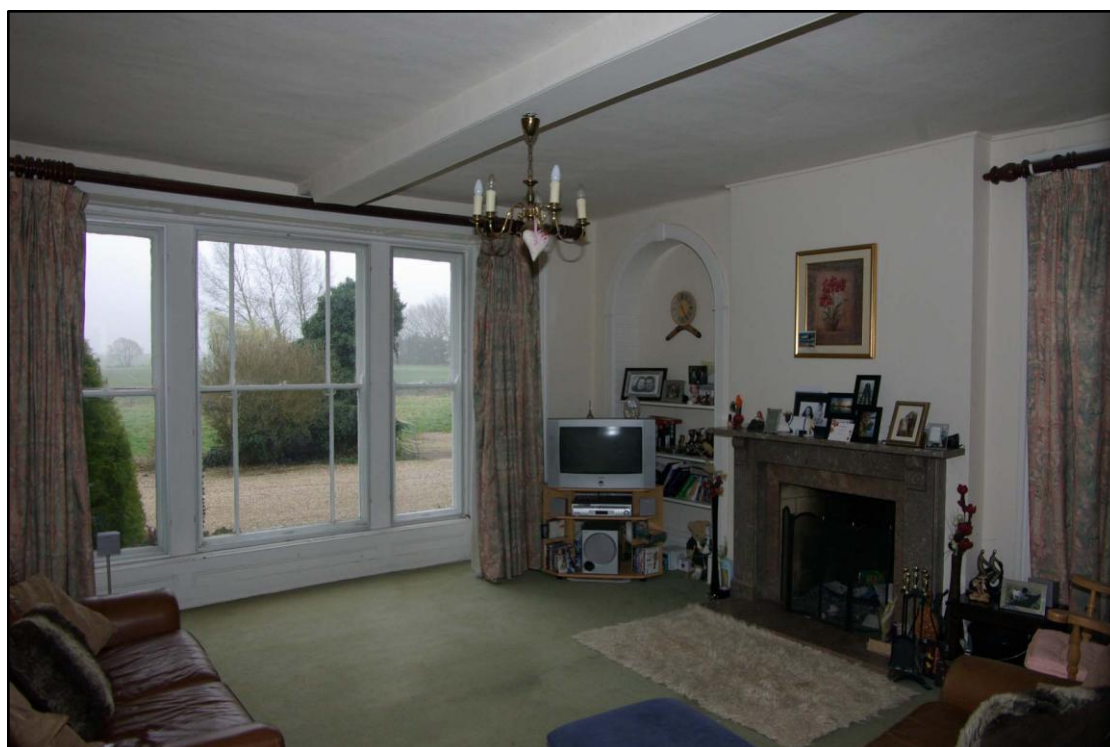
Figure 17 Front, western room  
Looking west

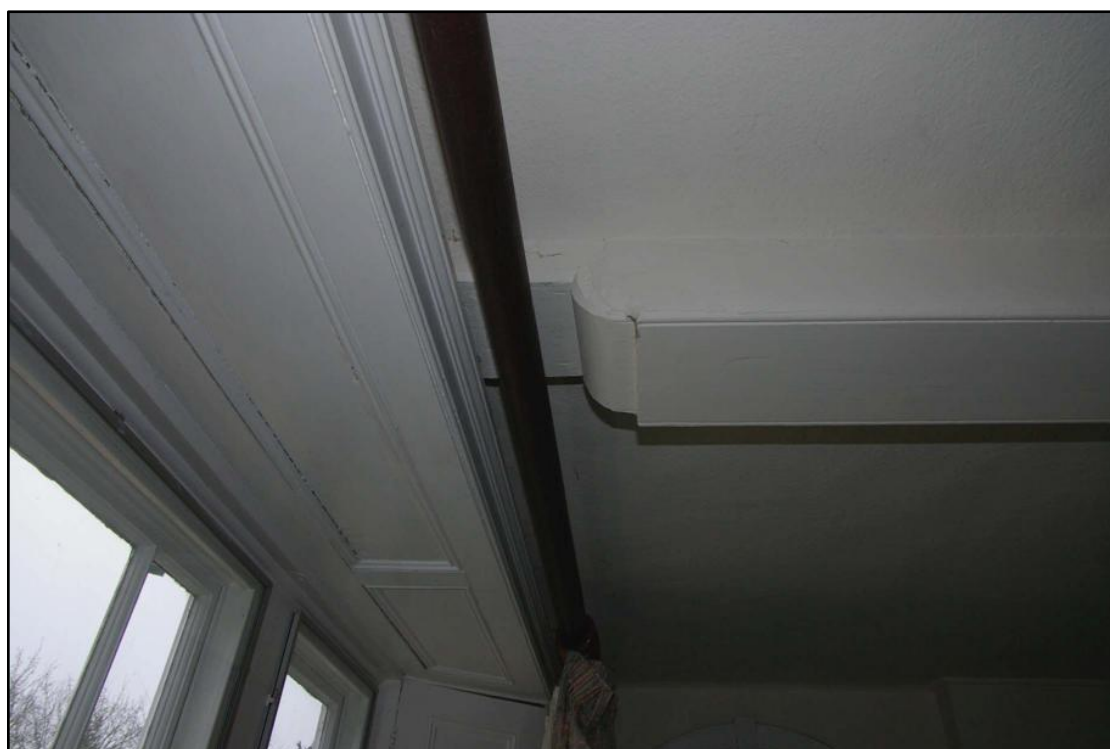
Figure 18 South end of ceiling beam in front, western room  
Looking west

window is to the north of the fireplace and has hinged shutters each side. The south east facing windows have folding shutters of three leaves built into the panelled casing around the window. Secondary glazing prevents these from working but it is possible to see that once opened they were secured by a pivoting iron bar and simple latch. A beaded transverse ceiling beam with a rounded southern end runs down the centre of the room towards the main window (fig. 18).

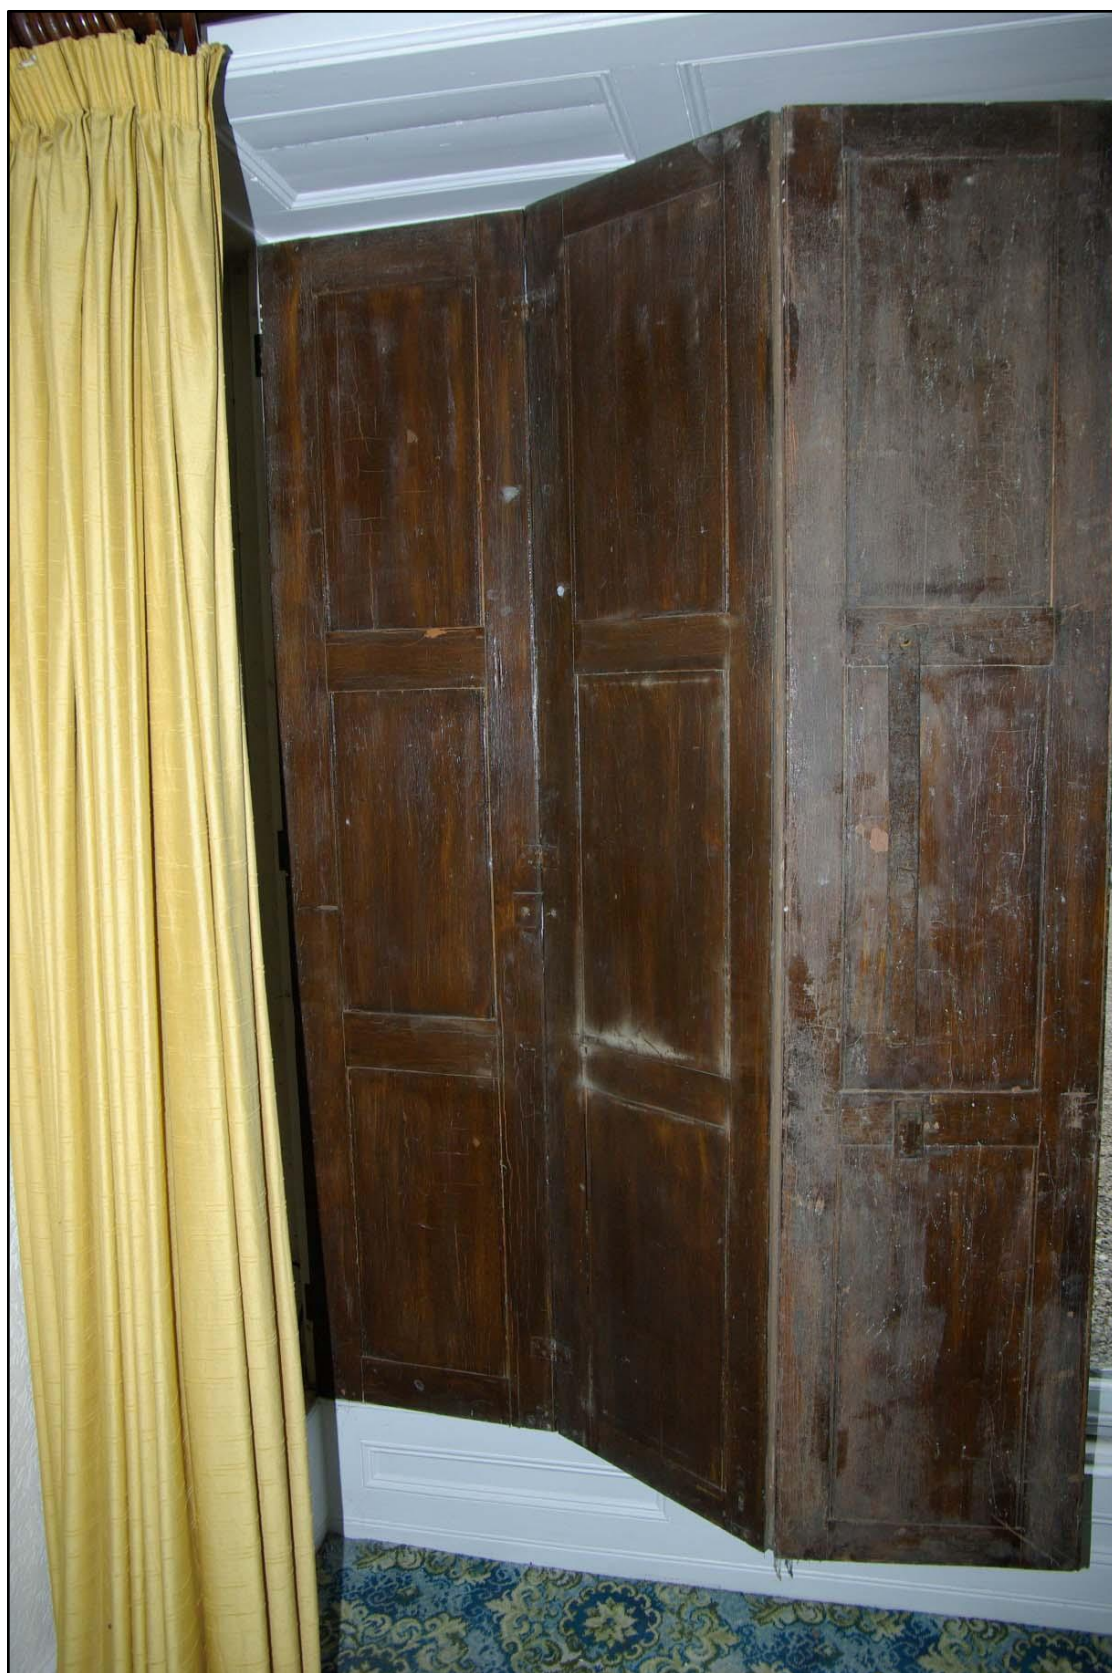
Figure 19 Front window shutters, eastern room  
Looking south east

The eastern principal room has the same shutters as in the western room (fig. 19), it also has a similar transverse ceiling beam running down the middle of the room (fig. 20). The fireplace is of modern design with sash windows with shutters either side. A recessed arch covers most of the northern wall (fig. 21).

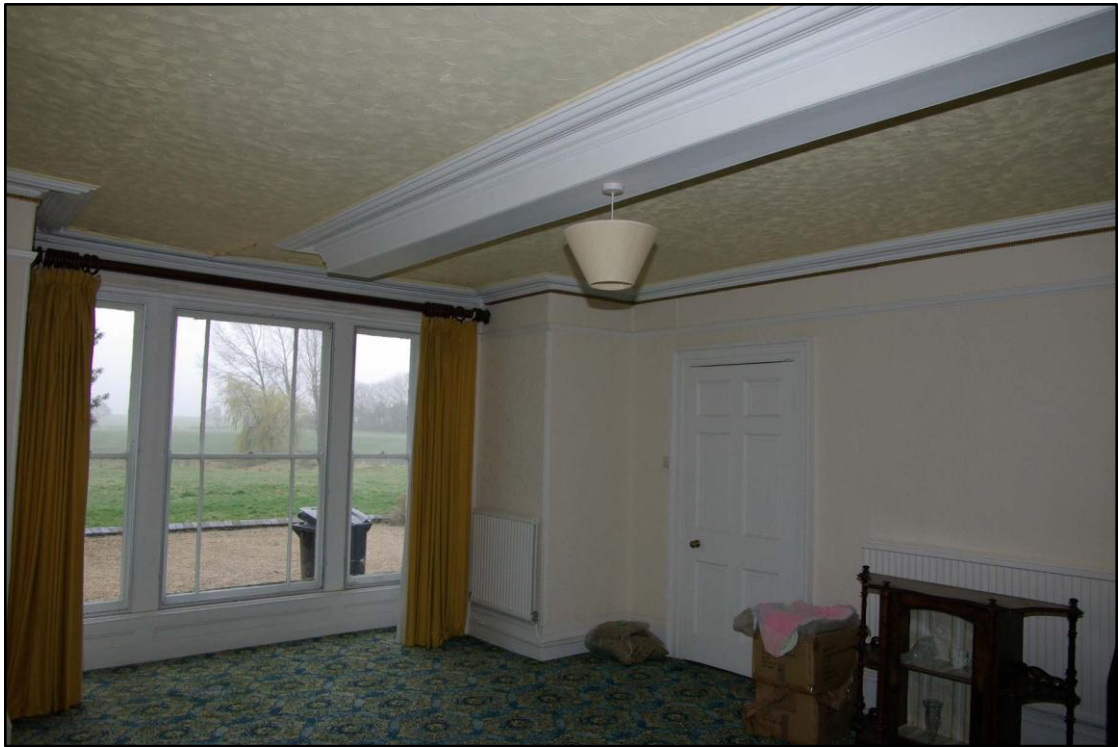
Figure 20 Front, eastern room  
Looking south

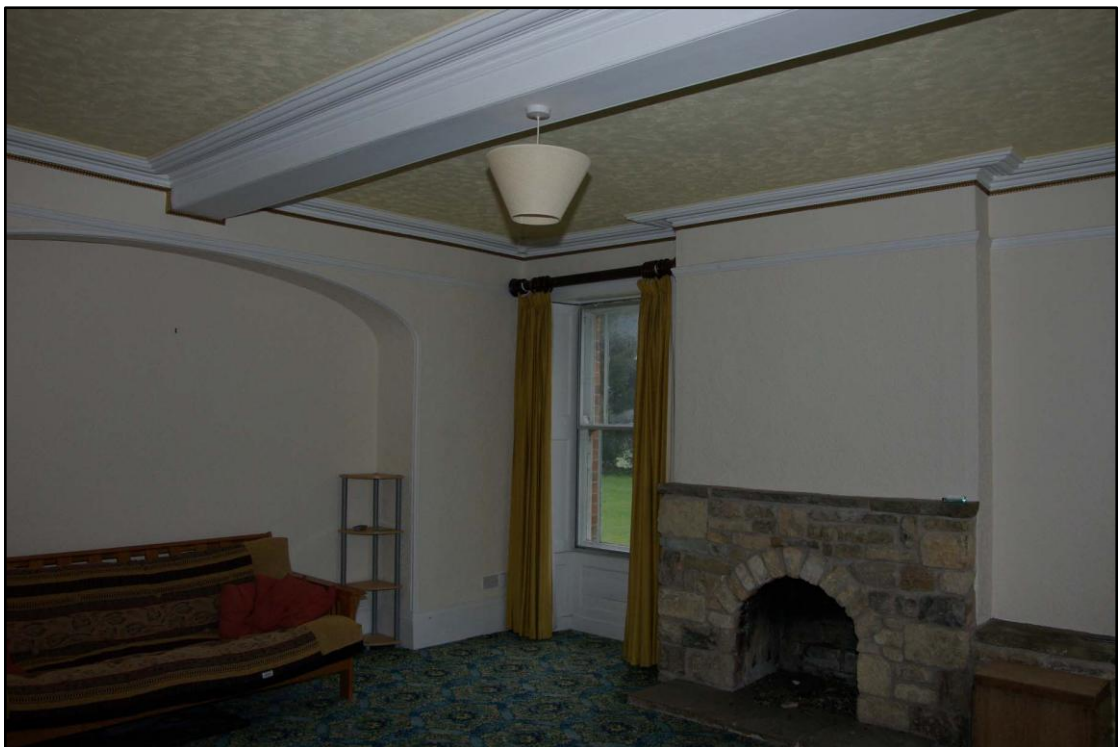
Figure 21 Front, eastern room  
Looking north

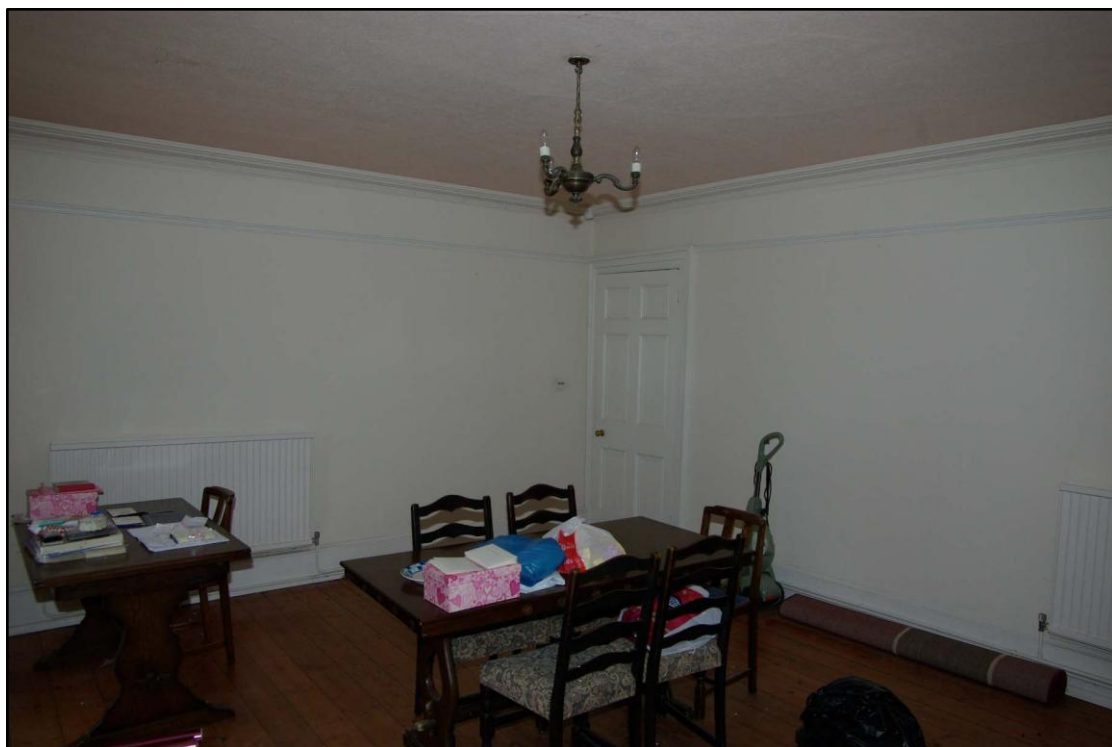
Figure 22 Rear dining room  
Looking south

The dining room in the north eastern corner of the house is reached through a 6-panelled door at the north end of the hall (fig. 22). It has a large art nouveau style fireplace on the north wall flanked by two arched recesses (fig. 23). Modification to the floorboards around the fireplace indicates that some alteration to the hearth has taken place. The windows on the east wall have panelled shutters and casements as in the front rooms. The moulded coving in this room is not as ornate as seen in the front rooms.

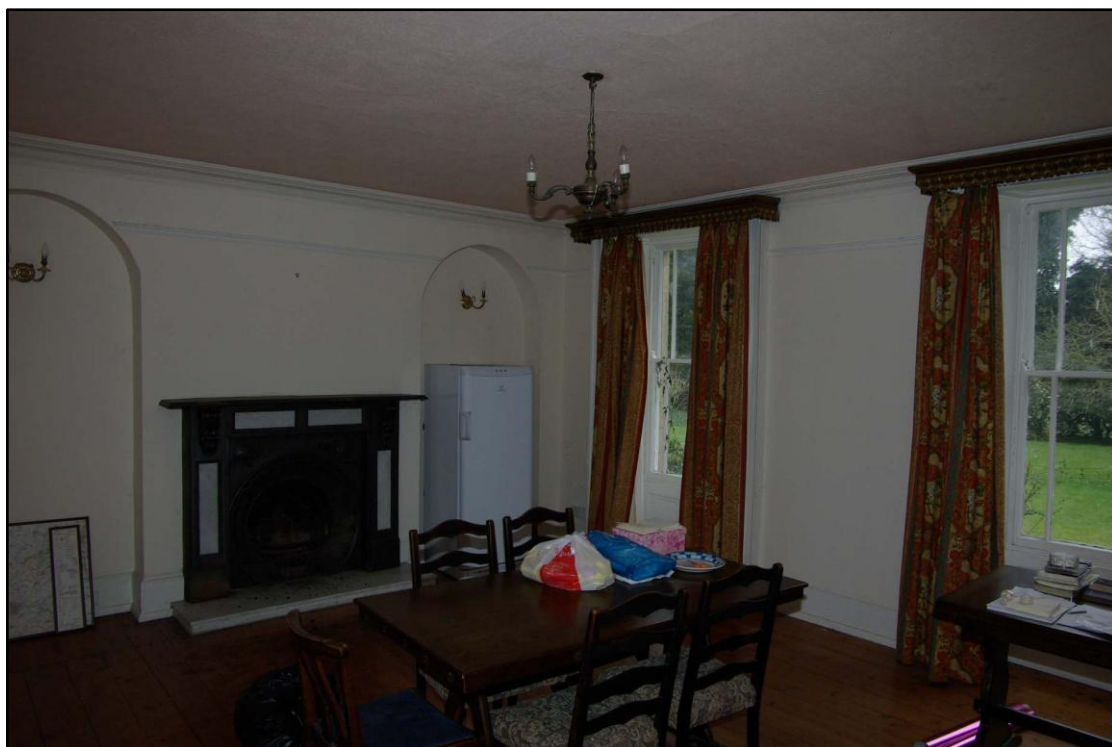
Figure 23 Rear dining room  
Looking north

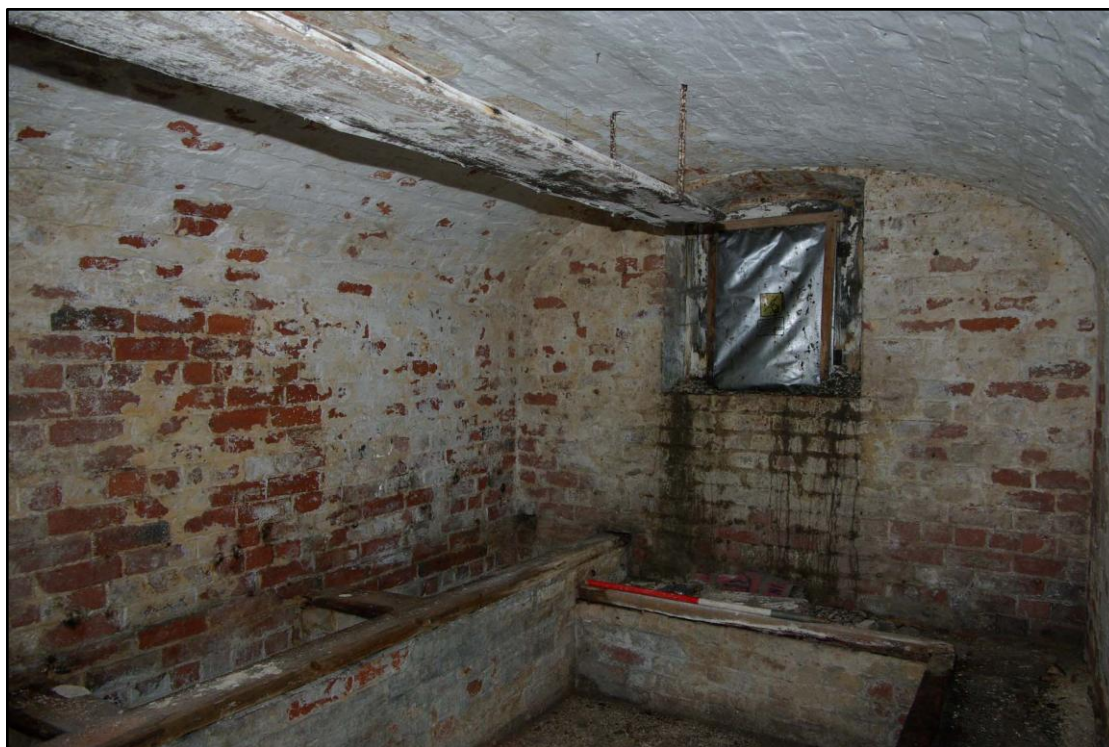
Figure 28 Cellar, north eastern room  
Looking north. 1m scale

Two doors at the northern end of the hall lead to a downstairs toilet and a cellar. The toilet has a raised floor to accommodate the headroom needed for the cellar stairs to the west. Inside, the toilet room is fairly plain with modern fittings and wall coverings, only a coat rack with wooden hooks shows any evidence of a former use. The cellar is reached by stone and brick steps leading down to three main rooms and a smaller store (fig. 24). The rooms are divided by brick walls and have brick vaulted ceilings and stone flagged floors. The store has a series of stone shelves supported on brick piers that would probably have served as wine racks (fig. 25). The north western room is slightly higher than the other two and has brick piers supporting a wooden shelf with wooden brackets for further shelving on each wall (fig. 26). The two lower rooms to the east have lockable wooden doors to control access. The south east room has arched brick piers supporting wood and stone shelves that would have acted as cool shelves for perishable goods (fig. 27). Metal hooks, possibly for meat, are attached to the ceiling. A similar shelving arrangement is in the north east room although here the bricks form open troughs which may have held ice (fig. 28). A wooden shelf supported by iron hooks is suspended from the ceiling.

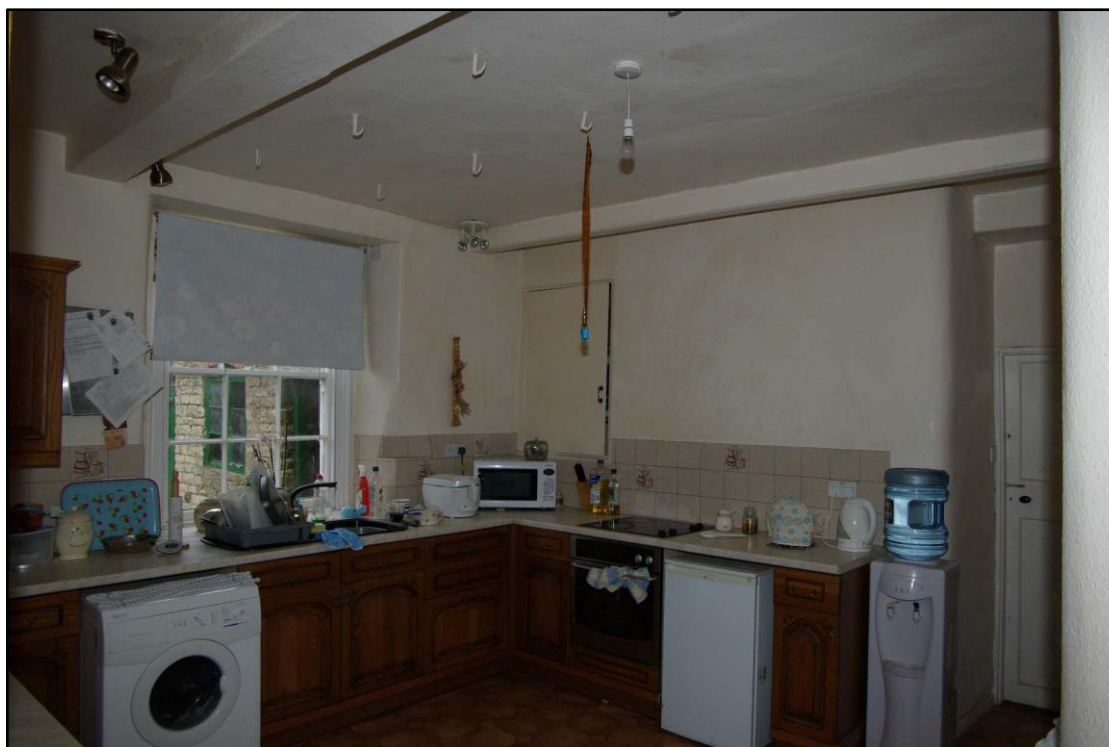
Figure 29 Kitchen  
Facing west. Note chamfer by window

A 4-panelled door in the northern corridor leads into the kitchen which has most walls covered by modern kitchen units (fig. 29). A narrow 3-plank door covers storage space under the servants' stair that intrudes into the kitchen space in the north corner. A broad chamfer in the stonework on the northern side of the kitchen window is further evidence of modification to this opening, as noted on the outside elevation, but what the modification was is not clear. A cupboard in the north west corner may have been a doorway but this has been blocked by units in the kitchen and a copper on the other side. Seven iron hooks are driven into the ceiling in rows that may have held overhead racking.

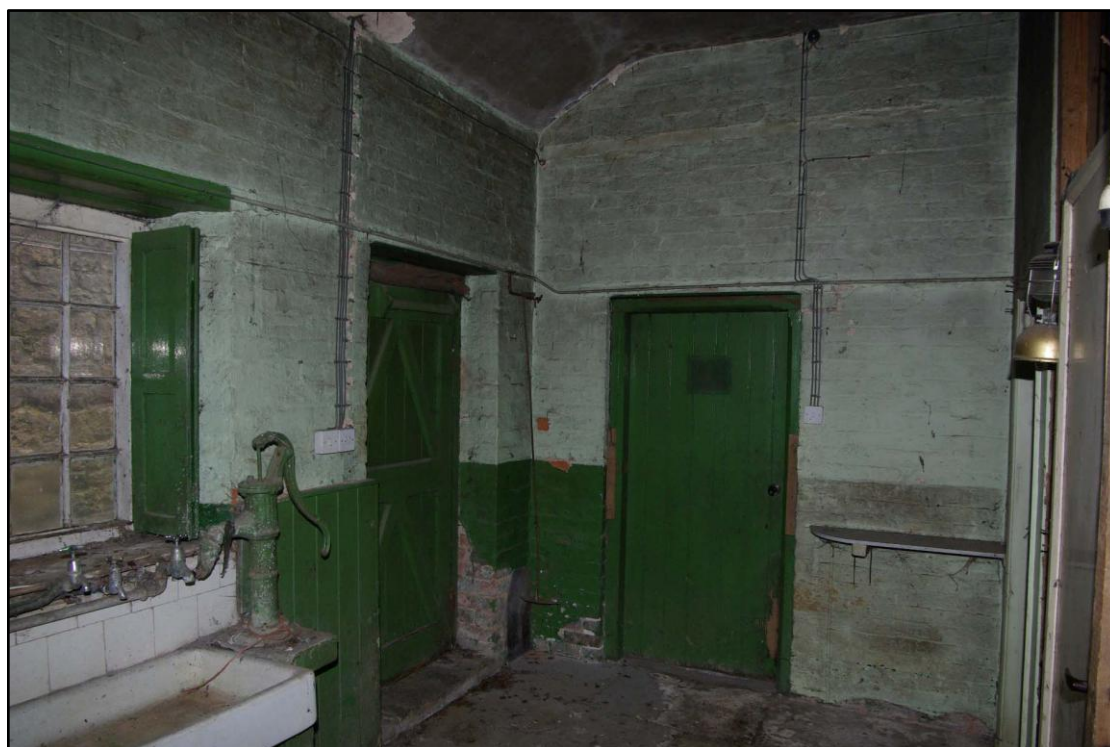
Figure 33 Rear extension, north end room  
Looking north west

a smaller room across the northern end of the extension. The paint scheme alone in this scullery extension clearly marks it out as an area of domestic activity where the owners would not normally go (fig. 30). A shallow sink and cast iron hand pump are still present on the eastern wall as is a copper and modified boiler in the fireplace on the south wall (fig. 31). The door to the stairs leading to the first floor is currently secured shut but a small fanlight shows a set of narrow stairs ascending to a door on the first floor (fig. 32). The room at the northern end of the extension has a wooden shelf in but is otherwise empty. It has a wooden door with a sliding ventilator in (fig. 33).

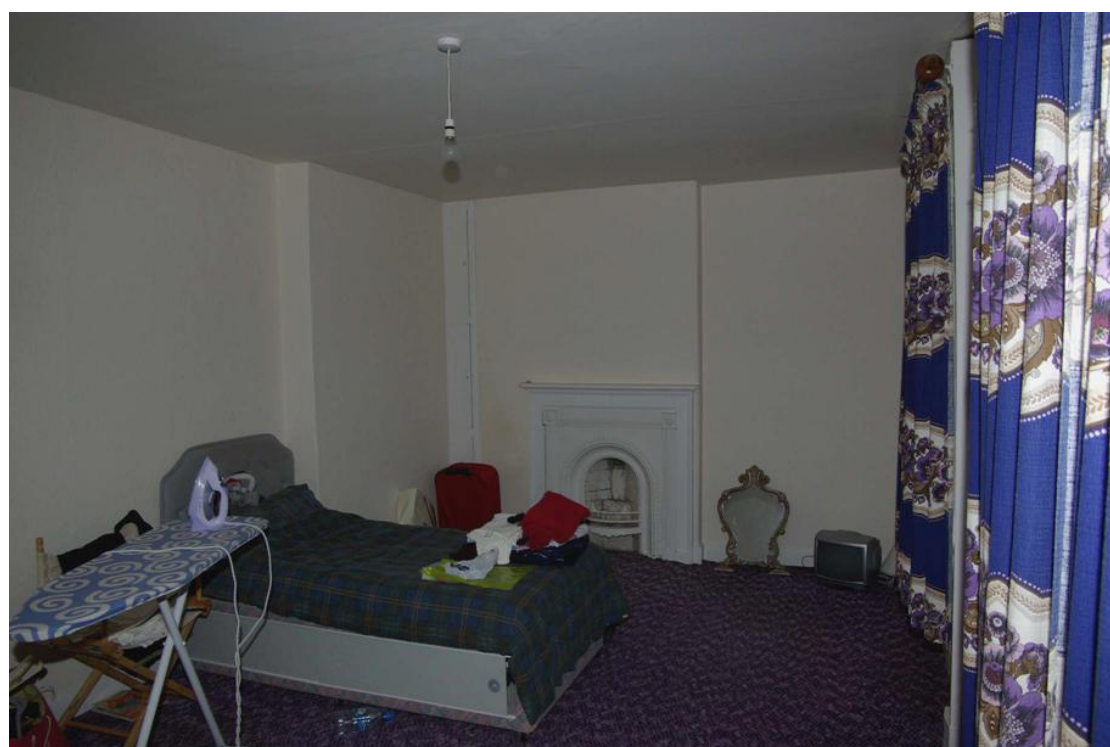
Figure 37 Rear, eastern bedroom  
Looking north west

The eastern rear bedroom has been modified by the addition of a shower room and corridor to the west to create a rather long and narrow room (fig. 37). The fireplace is still intact and is of a type that came into common usage from the middle of the 19th century. The windows and shutters are similar to those on the front but have built-in cupboards beneath them (fig. 38). The inserted shower room runs alongside the bedroom and explains the presence of the small inserted window seen from outside. Adjacent to this on the western side is a bathroom which would presumably have been a bedroom when originally built. It is heavily tiled and fitted with modern appliances.

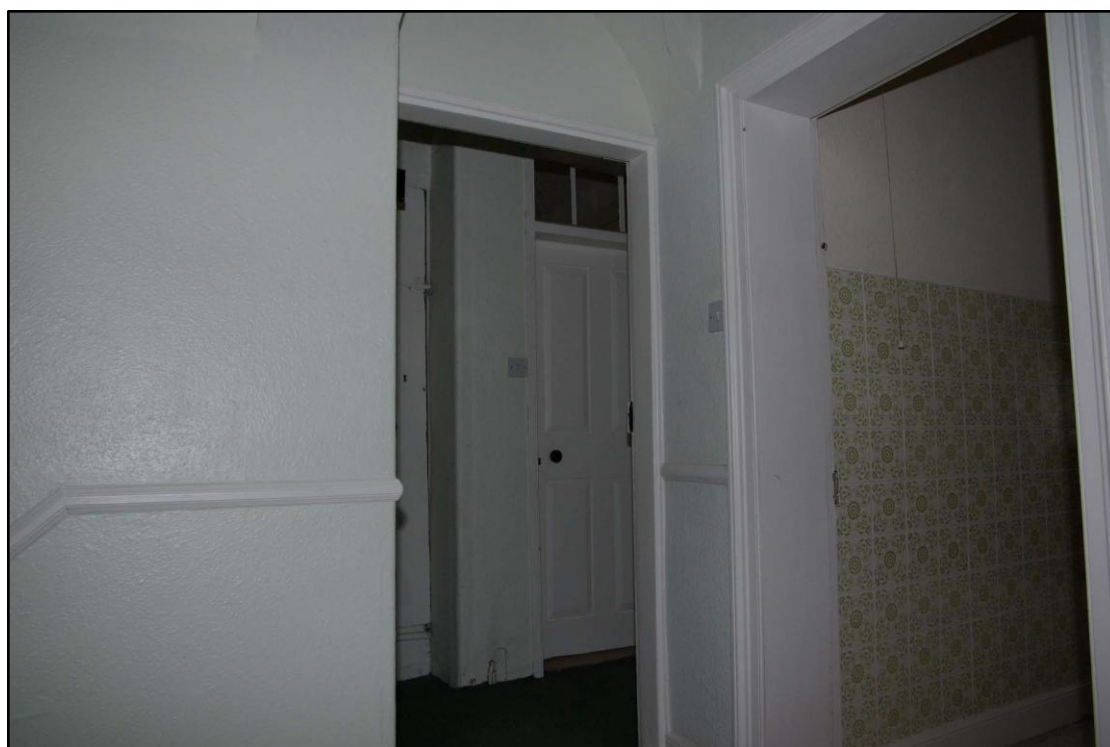
Figure 39 Servant's landing from main landing  
Looking west

In the north west corner of the first floor landing is a 4-panelled door leading to a smaller landing (fig. 39). From this landing a door (screwed shut) to the north leads down the servants' stairs to the rear extension, a second door leads into the north west bedroom, a third door (screwed shut) leads up a set of enclosed stairs to the rear western wing of the top floor and a final door of plank construction covers a shallow recess in the south wall. The door covering the recess seems likely to have led into the front bedroom at one time whilst the stairs up to the top floor would have allowed the servants to reach the rear wing accommodation without entering the main living areas (fig. 40). The north west bedroom has a narrow cupboard in the south wall which utilises the space beneath these stairs. The blocked window, seen on the south west elevation, is evident in this bedroom although it is not clear why it should have been blocked (fig. 41). A small overlight above the door lights the small landing outside and the remains of a bell pulley system can be seen to the side of the door (fig. 42).

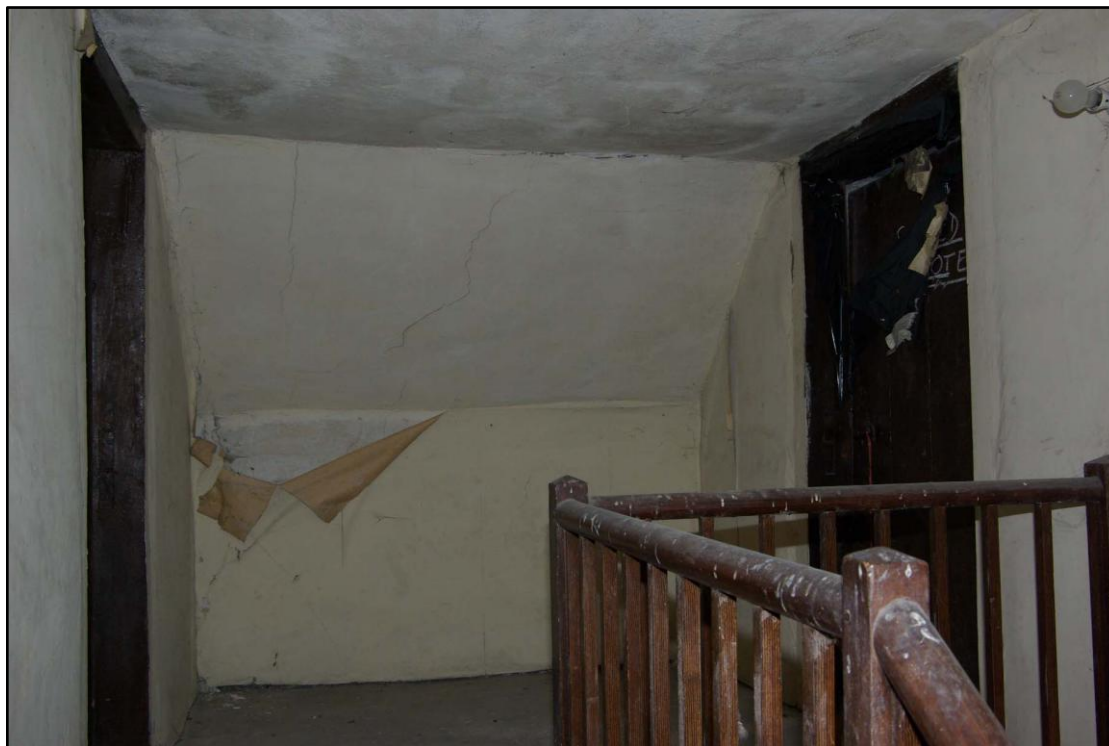
Figure 42 Rear, western bedroom. Door light and bell pulley  
Looking north east

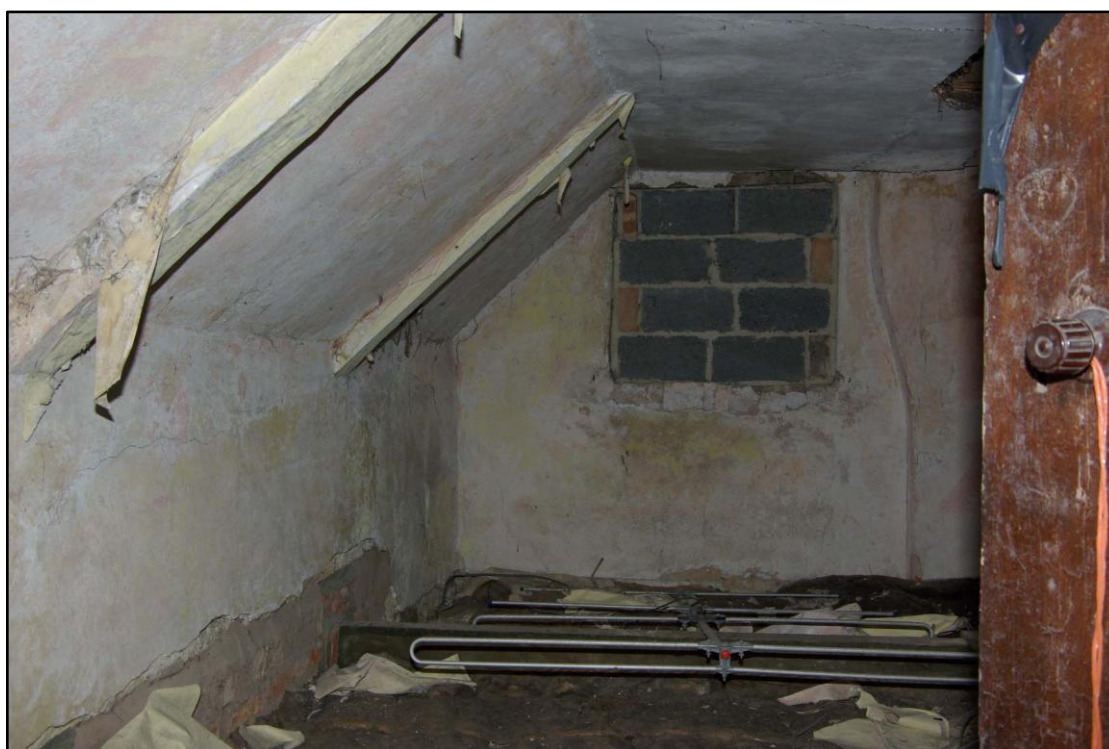
Figure 43 Top floor servant's landing  
Facing north

A narrow set of enclosed stairs is hidden behind a door at the southern end of the main landing which lead up to another landing with doors to the east and west (fig. 43). The lack of decoration and small size of the stairs indicates that this was the servants' accommodation. Similarly the doors are fairly crude with Bakelite knobs and no locks. The western room currently has no floor so could not be properly inspected, however there is evidence of a blocked window in the south western corner that

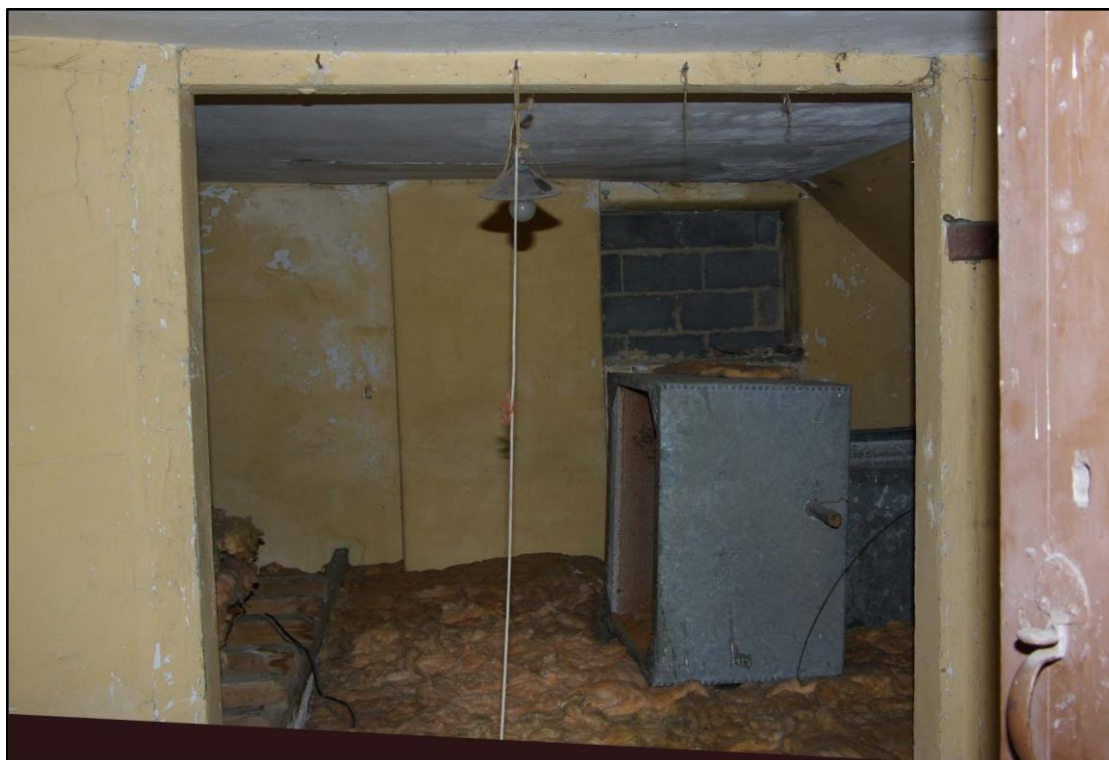
Figure 44 Top floor servant's accommodation, front west room  
Looking south west

matches the slight change in stonework seen outside (fig. 44). There is no evidence of a door in the northern wall indicating that the second set of stairs from the small first floor landing served an as yet unseen room that was separated from the others on this floor. The eastern room has a matching blocked window in its eastern gable and a doorway leading into the rear wing which also has a blocked window in its north gable (fig. 45). There is some wooden shelving that survives in the front room and some attempt at wallpaper frieze decoration. A hatch in the ceiling shows that the rear wings are a later addition to the main range as the redundant laths for the original slates are still in place on the roof timbers (fig. 46).

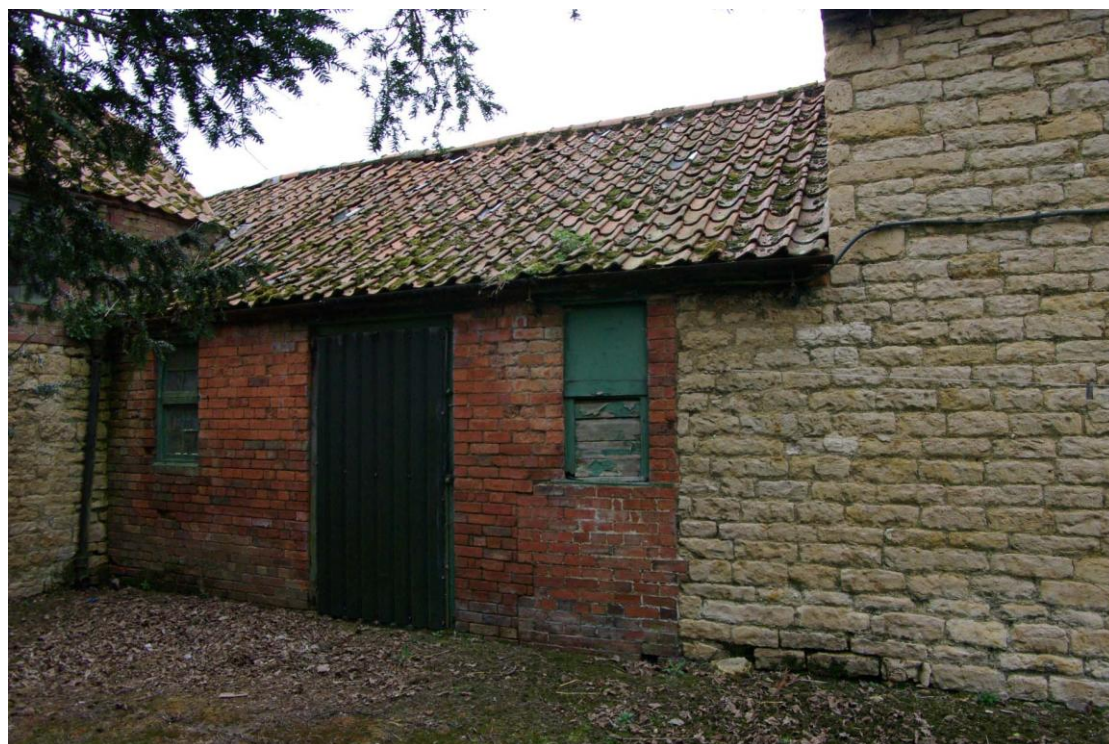
Figure 47 Stables, south east elevation  
Looking north west

The stables run on a north east to south west alignment and are attached to the main house by a stone wall containing a doorway leading to the rear yard. They are built of coursed ironstone rubble with a blue pan tile roof known as Bottesford Blues in this part of Leicestershire (fig. 47). A straight line joint between the double door and the single door to the east indicates that the range has been extended eastwards. The roofline dips slightly at this point and the stone appears to be more predominantly limestone. The central double doorway has modern doors fitted and may be an insertion as the opening has caused the stonework above to move slightly. The single doorways have wooden doors with metal latches with curved handles. The upper floor has two narrow openings on the original portion of the building, one of which is now a dovecot. A single storey brick extension has been added to the western end of the stables which joins this range to the north west to south east stable range (fig. 48).
