**An Historic Building Assessment (Level 2)**

**At Bescaby Park, Bescaby**

**Sproxton, Leicestershire.**

**ULAS Report Number 2009-061**

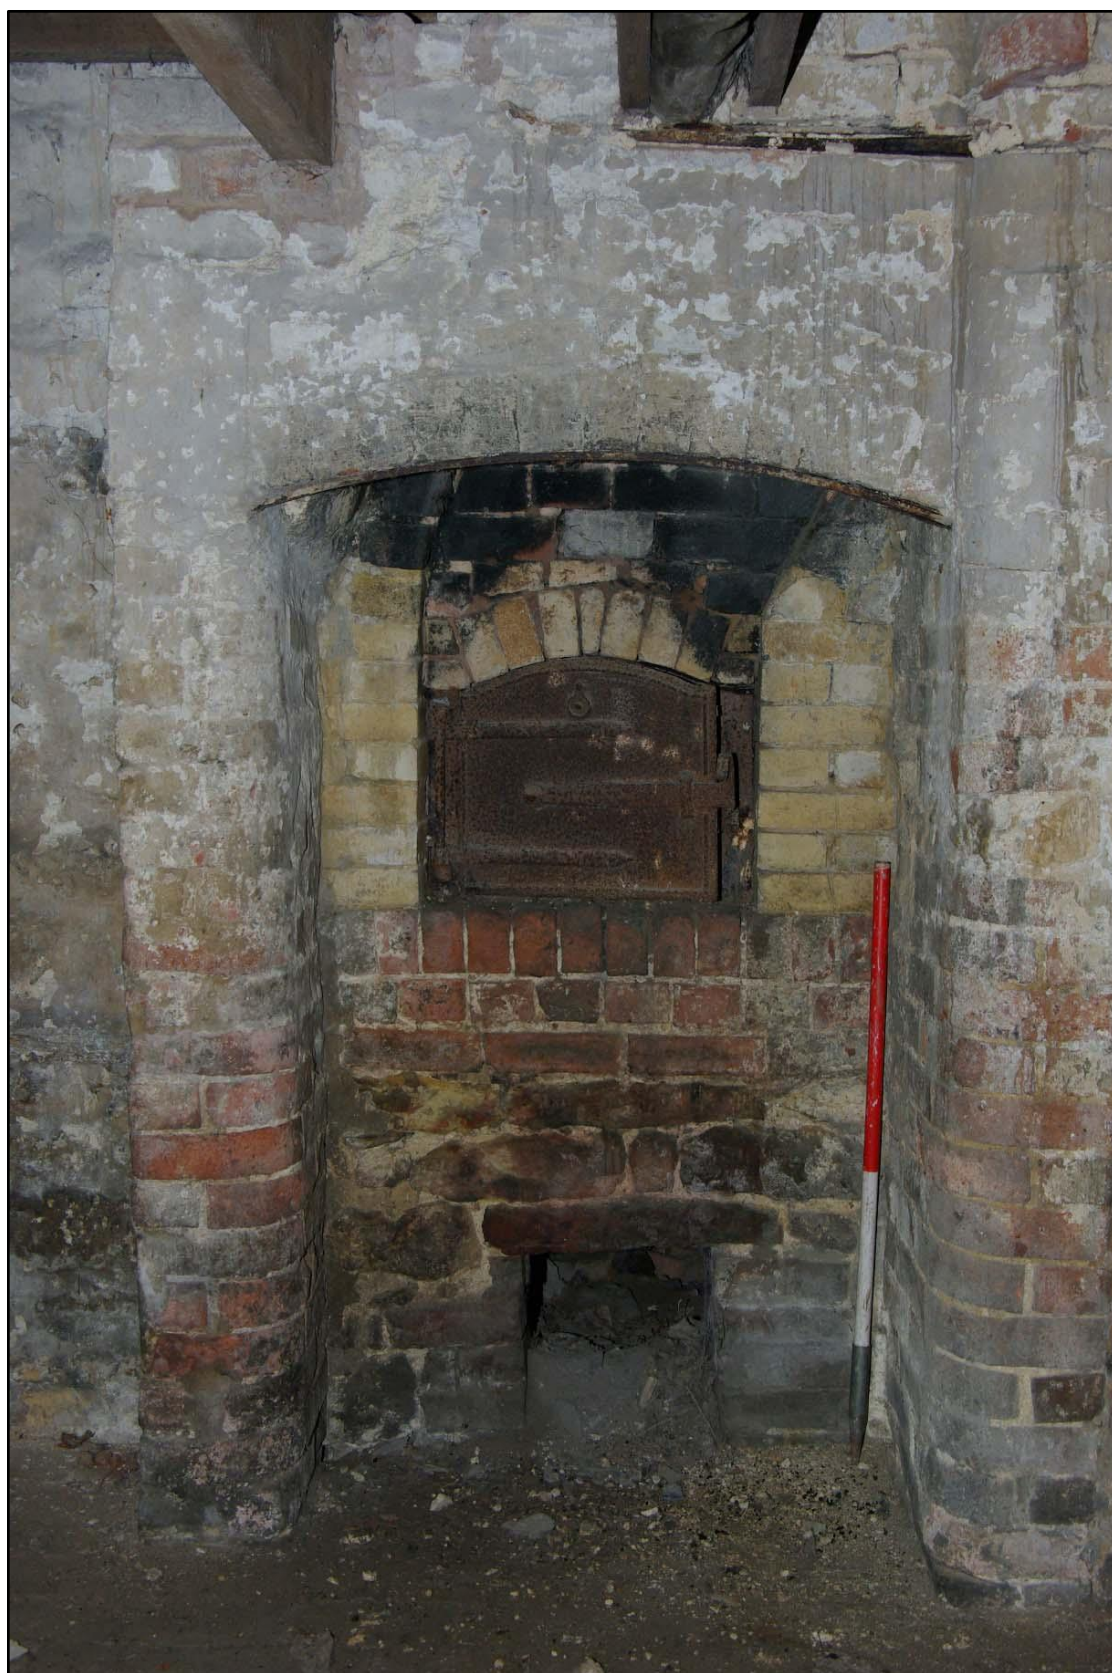
Figure 49 Stables, eastern end room  
Looking south east

Inside, the eastern addition was originally a bakehouse with a fireplace and bread oven on the north wall but this has been divided into two by the insertion of a partition wall running north west to south east and blocking off the fireplace (fig. 49). The eastern room subsequently acts as a store whilst the western room has a small bread oven with a brick dome still in situ (fig. 50). An open hatch, without stairs, leads to the upper floor which has tongue and groove floorboards and truncated chimney from the bread oven and fireplace. The room is otherwise bare with the roof structure consisting of principal rafter trusses with collar beams into which the purlins are tenoned.

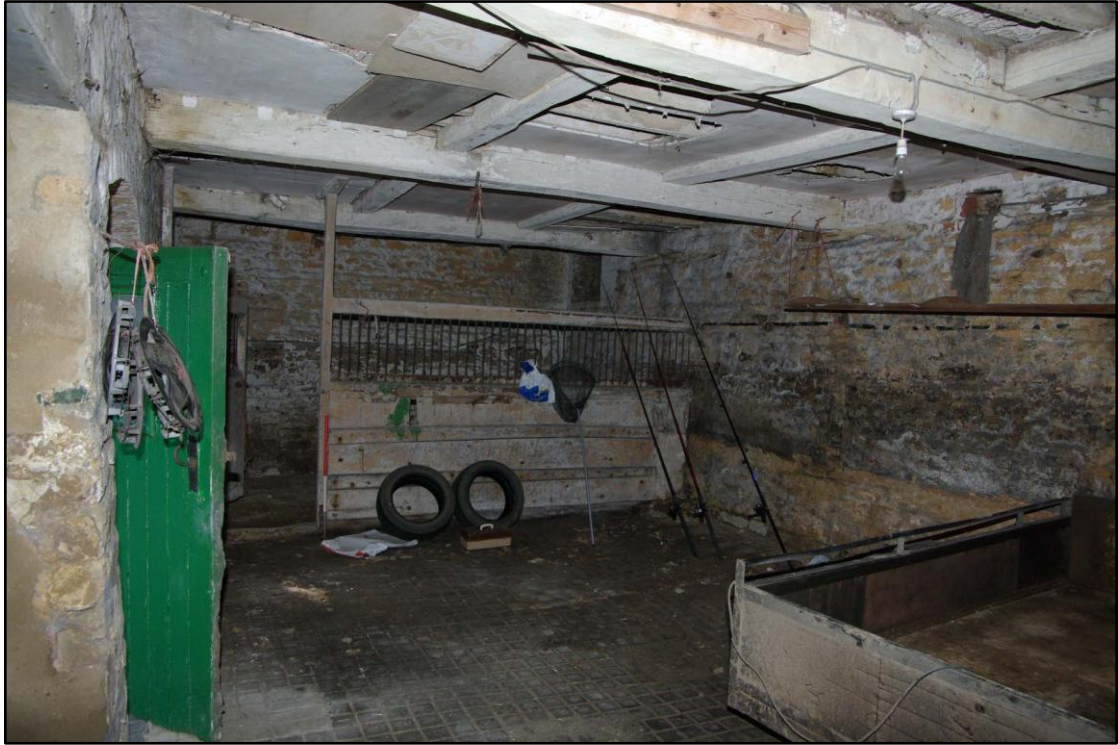
Figure 50 Stables, bread oven  
Looking north west. 1m scale

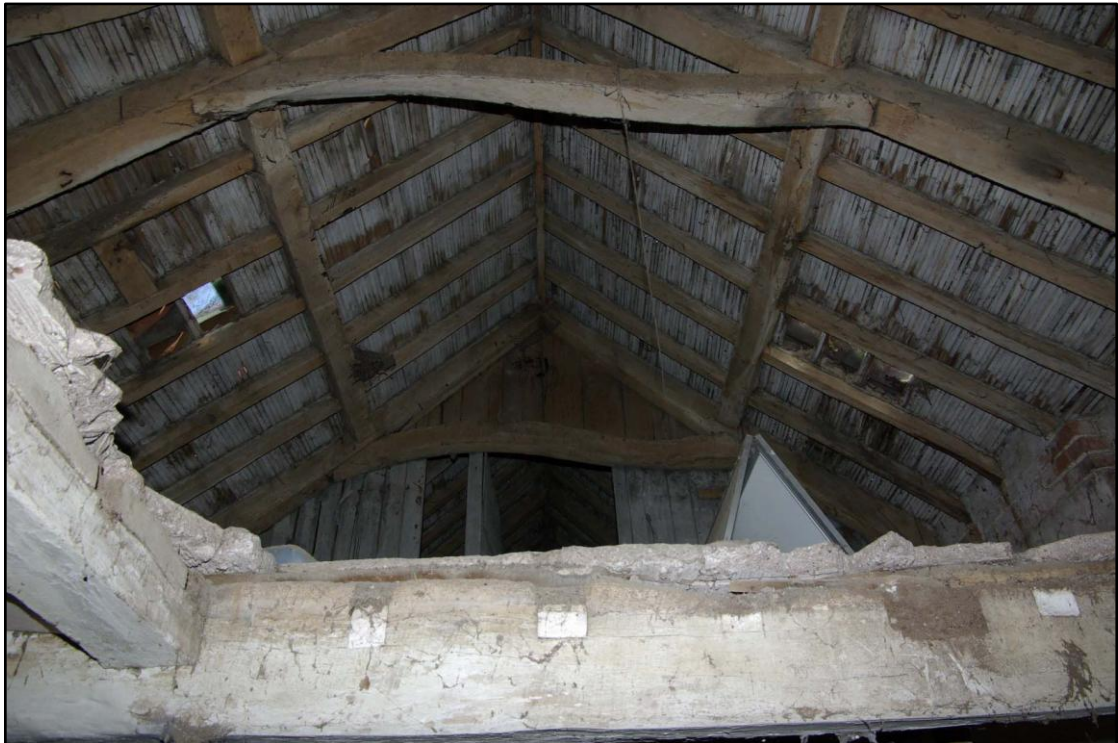
Figure 51 Stables, western room  
Looking west

The western room of the stone built stables is currently used as a garage but retains one loose box at the western end (fig. 51). A hole in the gypsum or lime plaster floor shows the roof to have the same structure as in the eastern extension but here the collar beams are roughly shaped timbers selected for their shape rather than sawn to shape (fig. 52). A series of iron pegs set into the western gable end may have held roosts for the doves. The brick built stable has two loose boxes and evidence of blocked doors leading into both stable ranges (fig. 53).

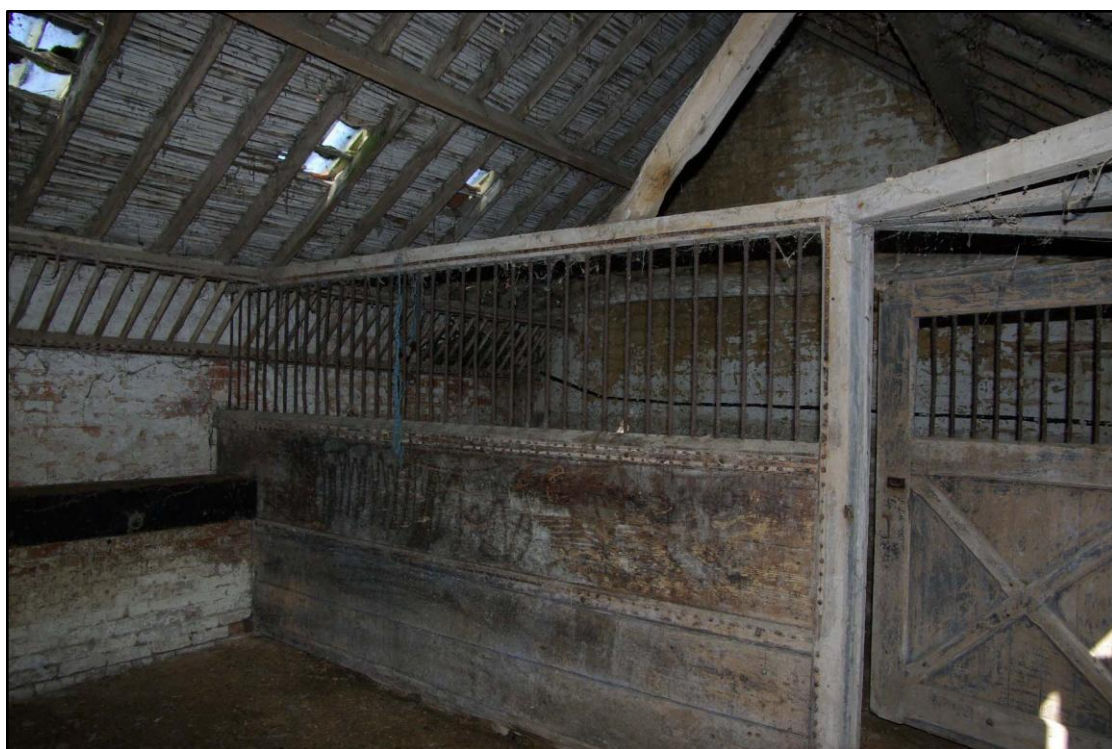
Figure 52 Stables roof structure  
Looking north east

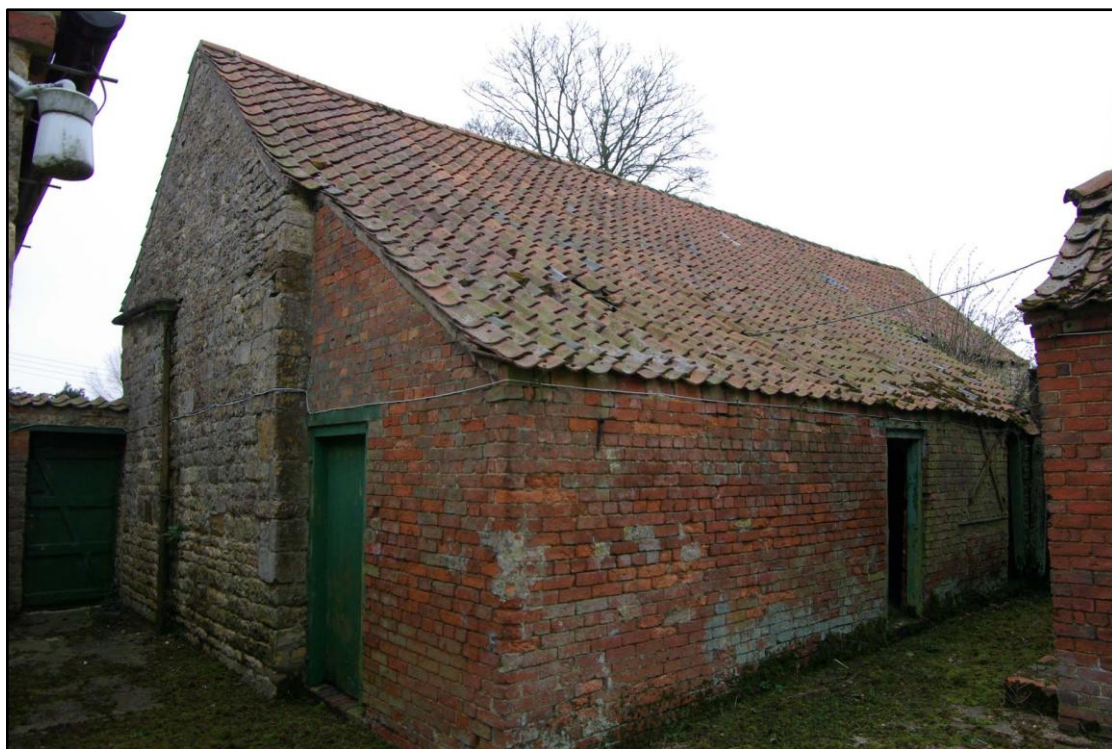
Figure 53 Stables, western brick extension  
Looking north

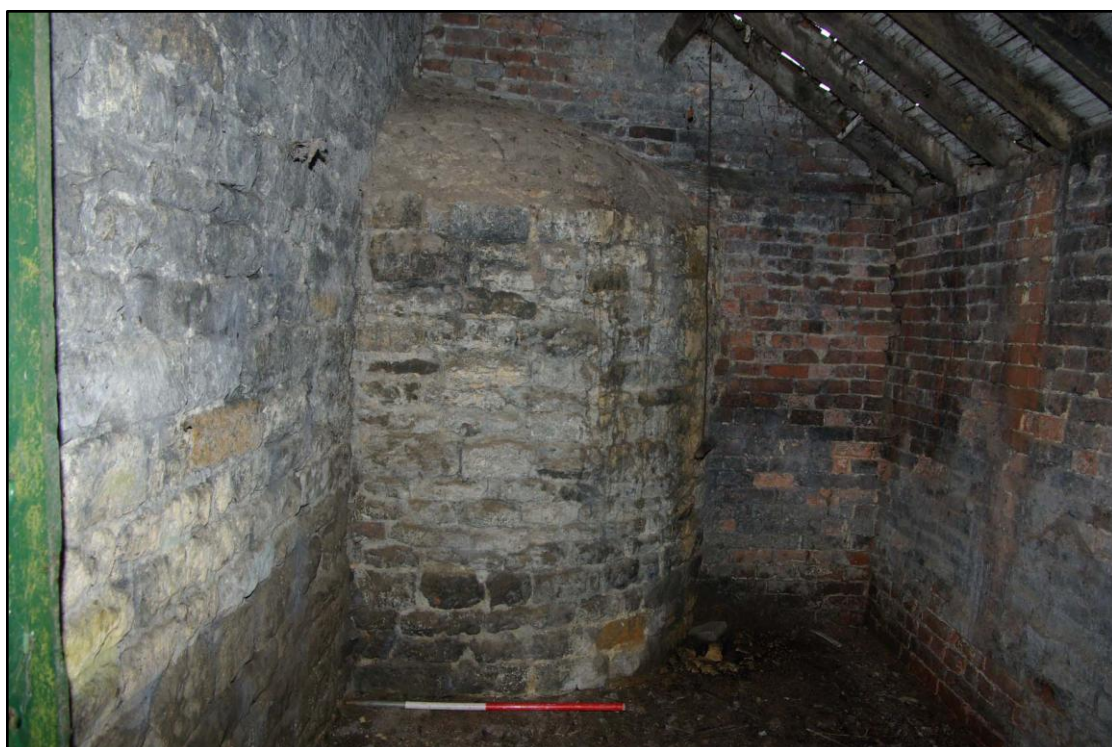
Figure 54 Lean-to at rear of stables  
Looking south

The rear (north) of the stables has a brick built extension to the eastern end and the roof, of red pan tiles, extends from the stable ridge over the lean-to extension in a catslide roof (fig. 54). The rear of the circular bread oven can be seen in both rooms of the lean-to (fig. 55). The rear of the brick built stable extension has blue pan tiles and has evidence of a blocked door (fig. 56).

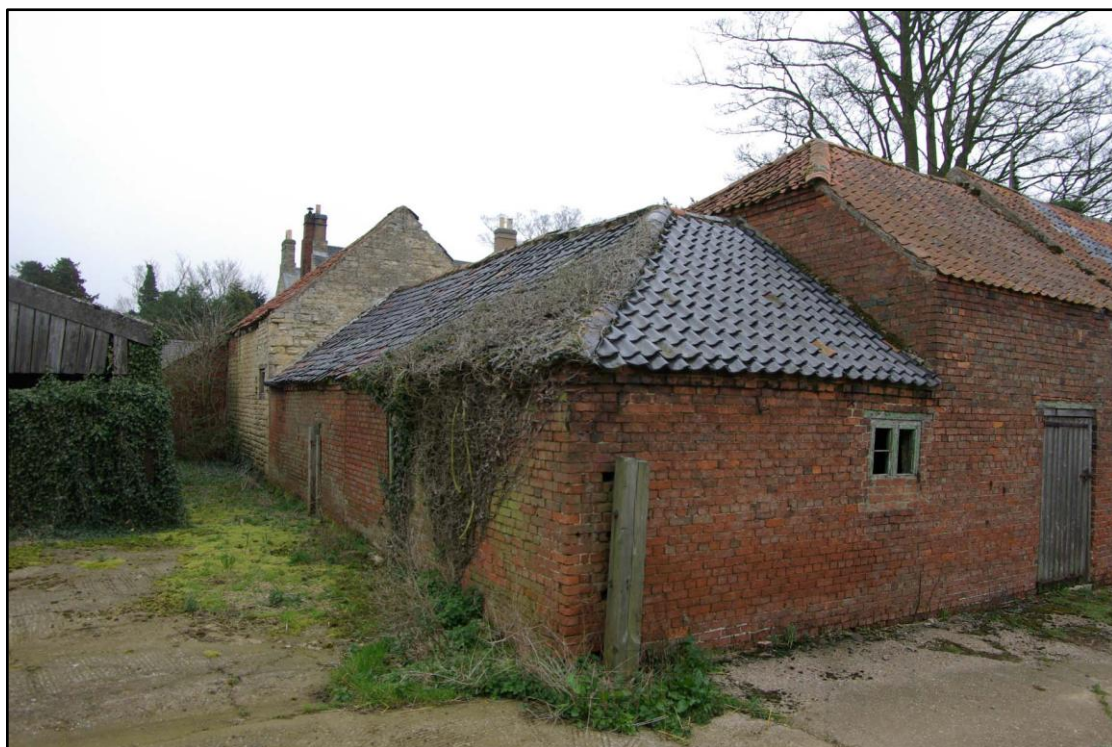
Figure 55 Rear of bread oven in stable lean-to  
Looking south west

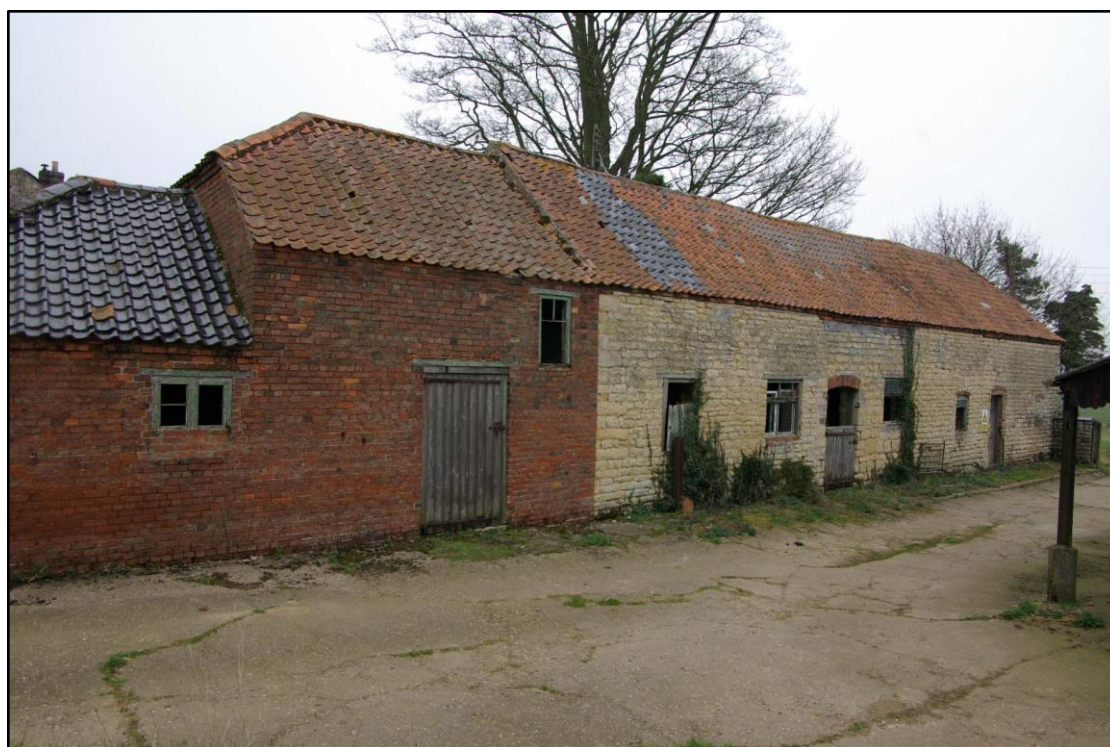
Figure 56 Rear of western extension to stables  
Looking east

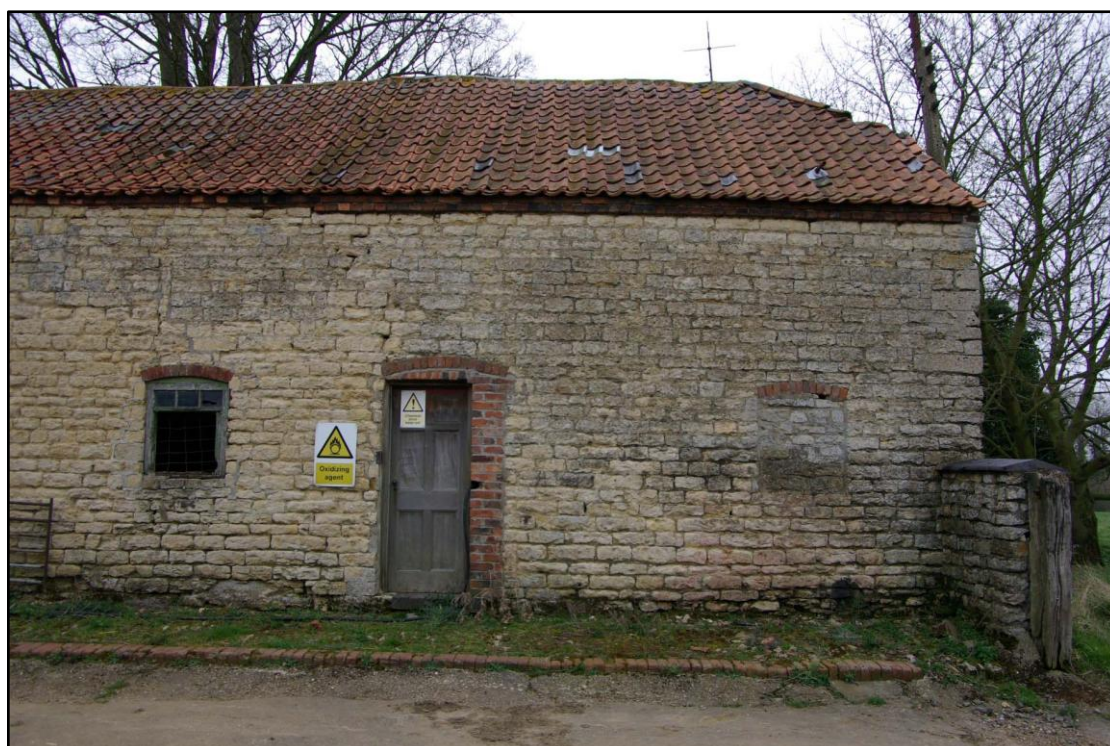
Figure 57 North west to south east stables, south west elevation  
Looking east

The main elevation of this building faces away from the house to the south west and is primarily constructed of coursed limestone rubble with a red pan tiled half hipped roof patched with blue pan tiles (fig. 57). A red brick double and single storey extension has been added to the northern end and joins with the brick extension to the north east to south west stable block. A pitched stone pavement runs along the front of the stables. Two small windows are blocked with stone at eaves height as has a window with segmental brick headers at the southern end of the range (fig. 58). A large central opening has also been blocked and has a matching blocked opening on the opposite wall indicating that the building probably started life as a threshing barn (fig. 59). The south gable end wall has a single blocked doorway with a window above (fig. 60). The north eastern elevation of this building is partially obscured by a modern brick built lean-to shed but the blocked threshing door is clearly visible both to the south of the lean-to and inside the lean-to (fig. 61). A dovecote fills the first floor opening on this elevation. Inside the stable, the southern end room is of full height and is open to the roof which is supported by a truss and king post with raking struts (fig. 62). The main stable is open along its length with loose boxes and brick built troughs (figs. 63 and 64). The ceiling is of straw and gypsum or lime plaster construction and a hole reveals that on the first floor the northern gable end has dove roosts made from red pan tiles. Access to the first floor is from the northern brick extension although the steps or ladder that must have been used is missing (fig. 65). The roof structure creates a central open space divided into bays by the use of interrupted tie beam trusses (fig. 66). Loose boxes fill the rest of the brick extension (fig. 67).

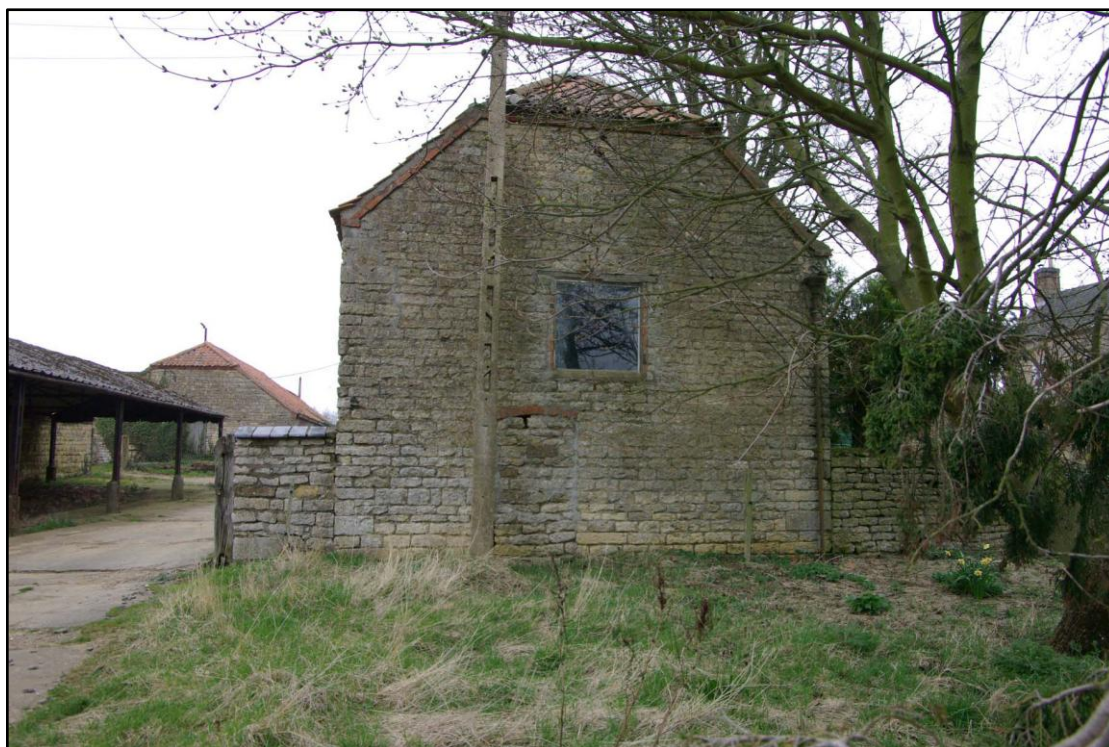
Figure 59 North west to south east stables, blocked barn door  
Looking north east. Ivy on right hides joint

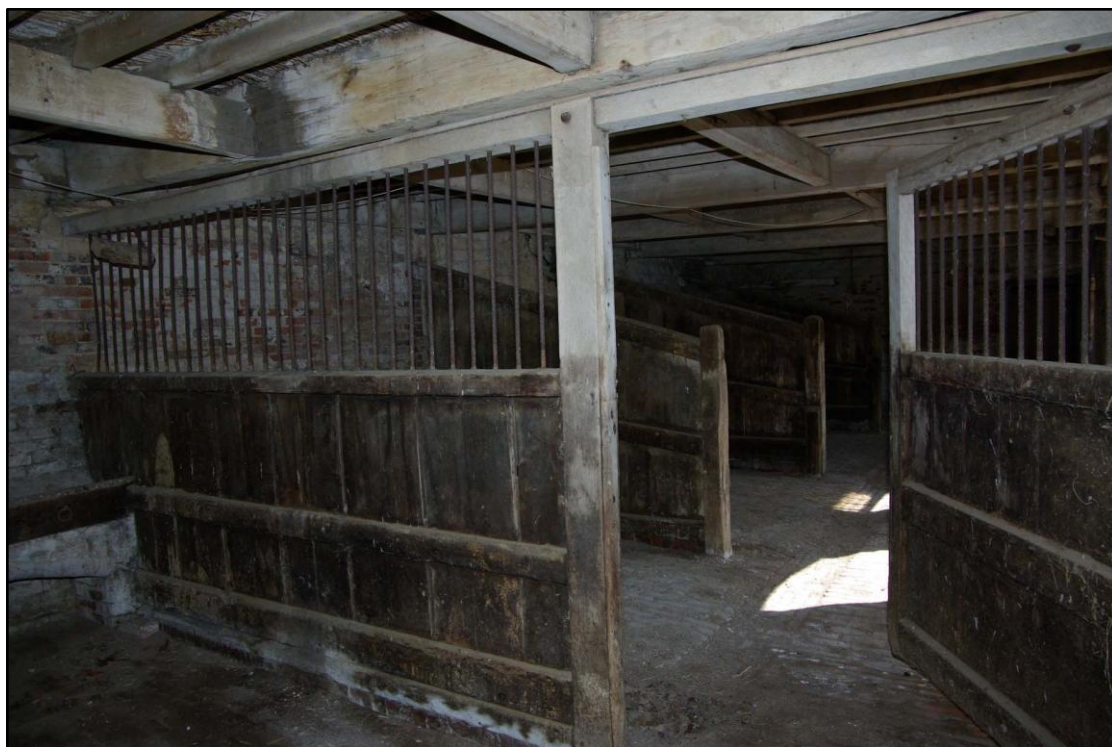
Figure 62 North west to south east stables, roof structure at southern end  
Looking south east

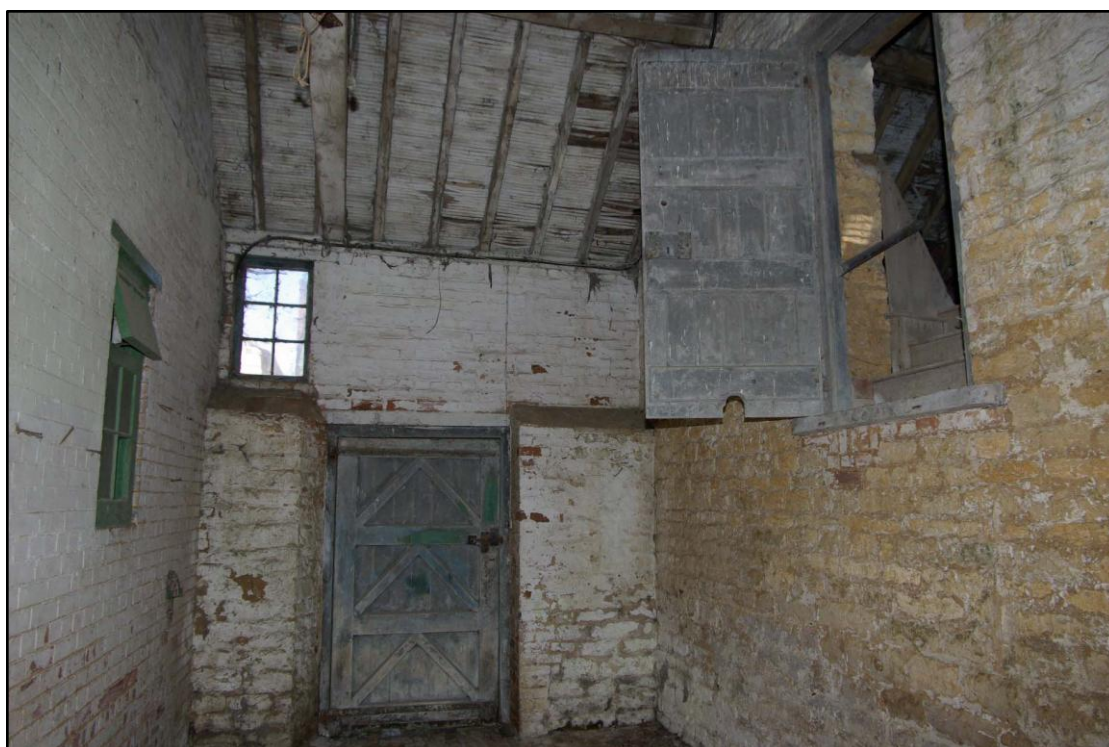
Figure 64 North west to south east stables, trough and blocked entrance  
Looking north east. 1m scale

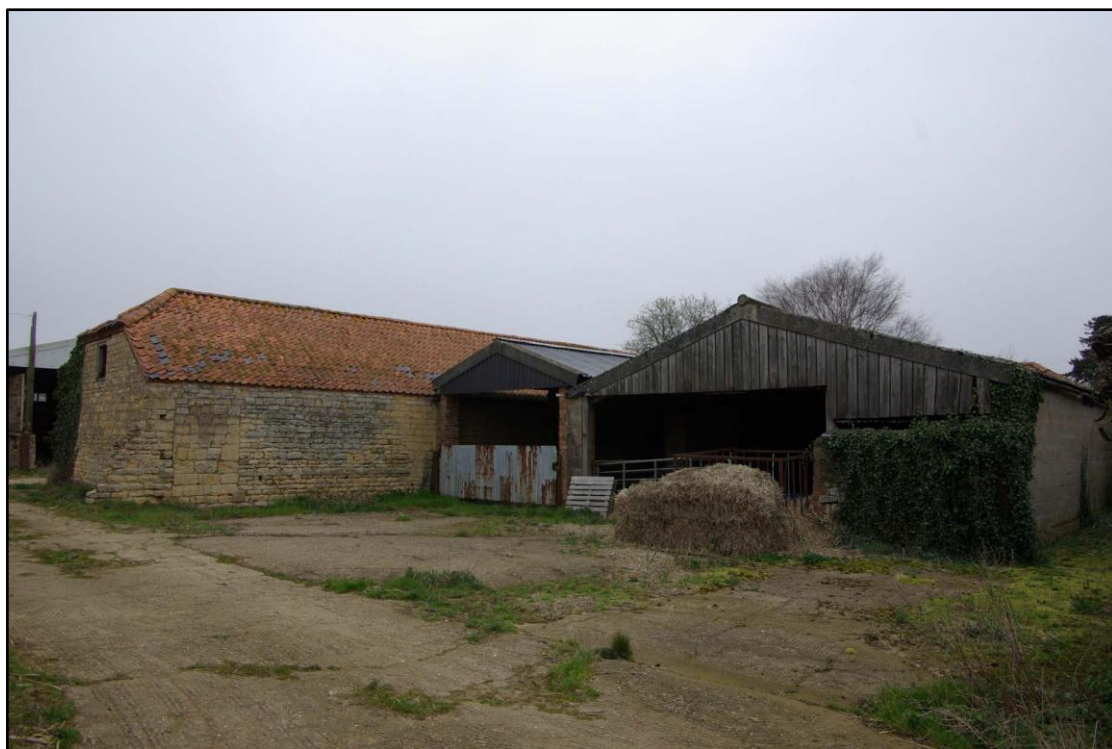
Figure 67 Northern extension to north west to south east stables  
Looking south

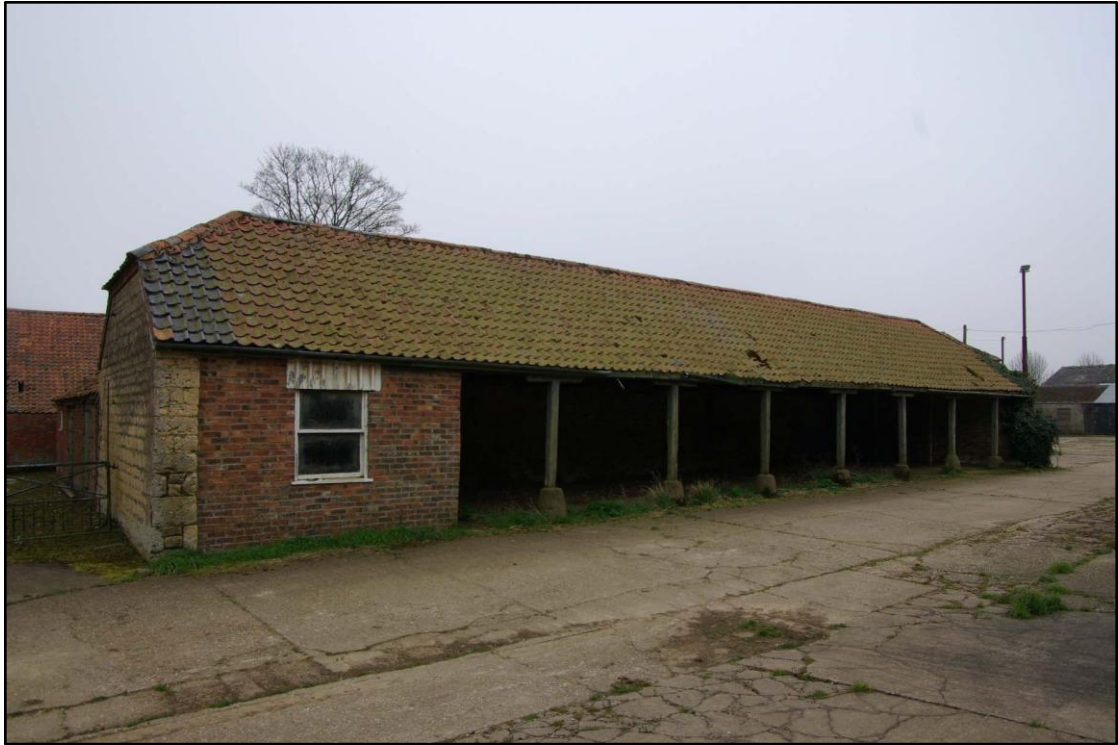
Figure 68 Modern barns between stables and cart shed  
Looking north

The cart or implement shed runs on a north east to south west alignment and forms the north western side of a yard created by attached outbuildings and the north east to south west stables. This space is now filled with two modern open barns in a poor state of repair (fig. 68). The cart shed is built of coursed limestone rubble with a half hipped red pan tile roof and is open to the north west elevation (fig. 69). Timber posts support the open front. The timber roof structure is supported by a series of queen post trusses with raking braces and outer princess posts typical of the 19th century (fig. 70). There is evidence of deliberate scratch marks on the underside of most of the trusses although they do not appear to form a coherent pattern. It is likely that these are shipping marks. A blocked doorway in the southern corner once led to the open yard mentioned above. A modern brick single storey office has been inserted into the northern end bay.

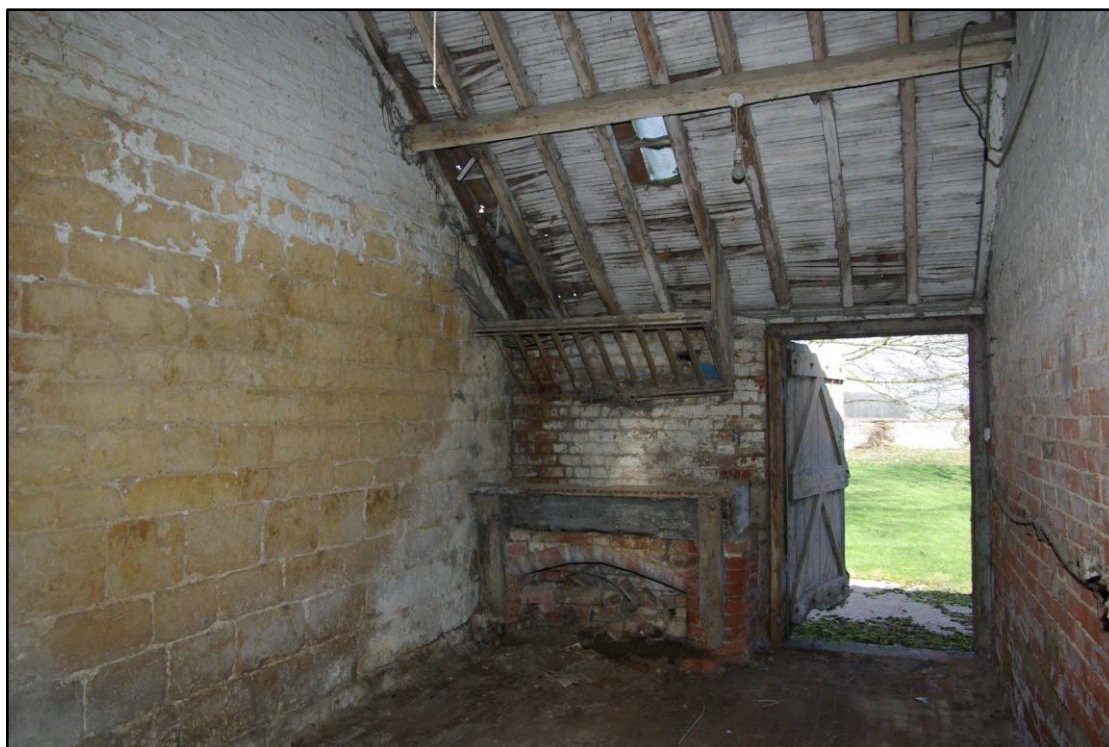
Figure 71 Outbuildings to south east of cart shed  
Looking east

The brick built outbuildings are attached to the south eastern corner of the cart shed and run south eastwards towards the north west elevation of the north east to south west stables (fig. 71). The northern room has a small brick built trough on the eastern wall but is otherwise bare (fig. 72). The larger central room is also bare and open to the underside of the pan tiled roof. The southern room appears to have been used as an office and has a plasterboard dividing wall inserted to make two smaller rooms. The southern end wall has evidence of three blocked openings of unknown function (fig. 73).

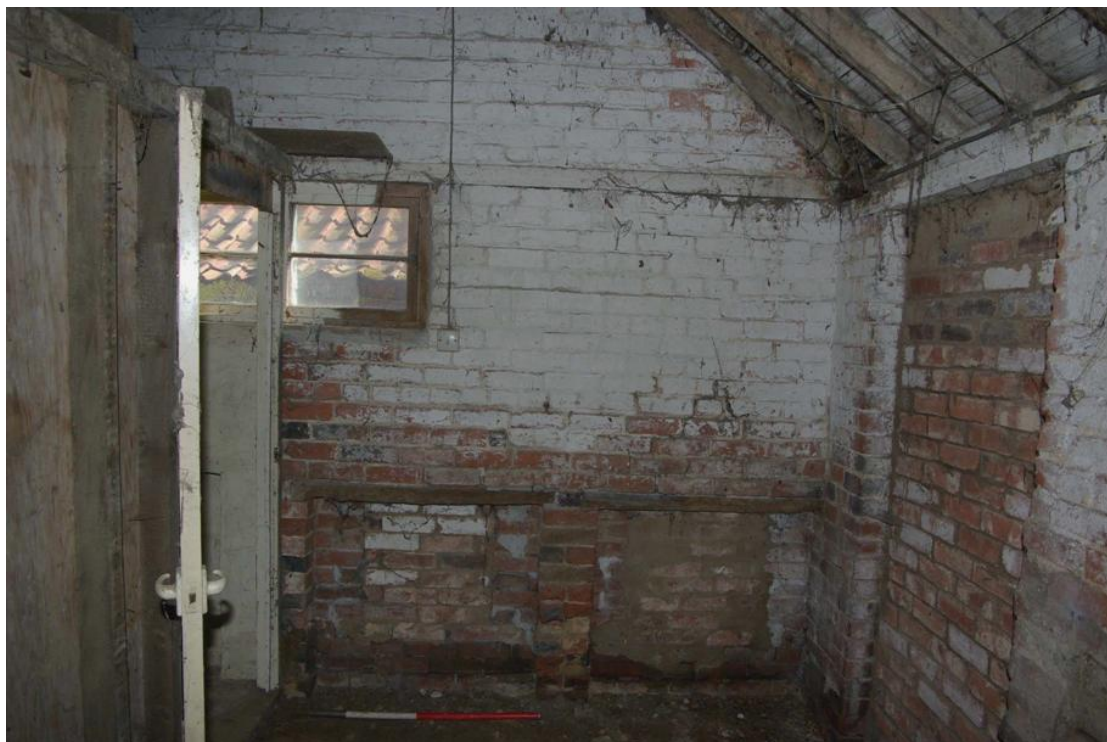
Figure 72 Outbuildings, northern room  
Looking north east

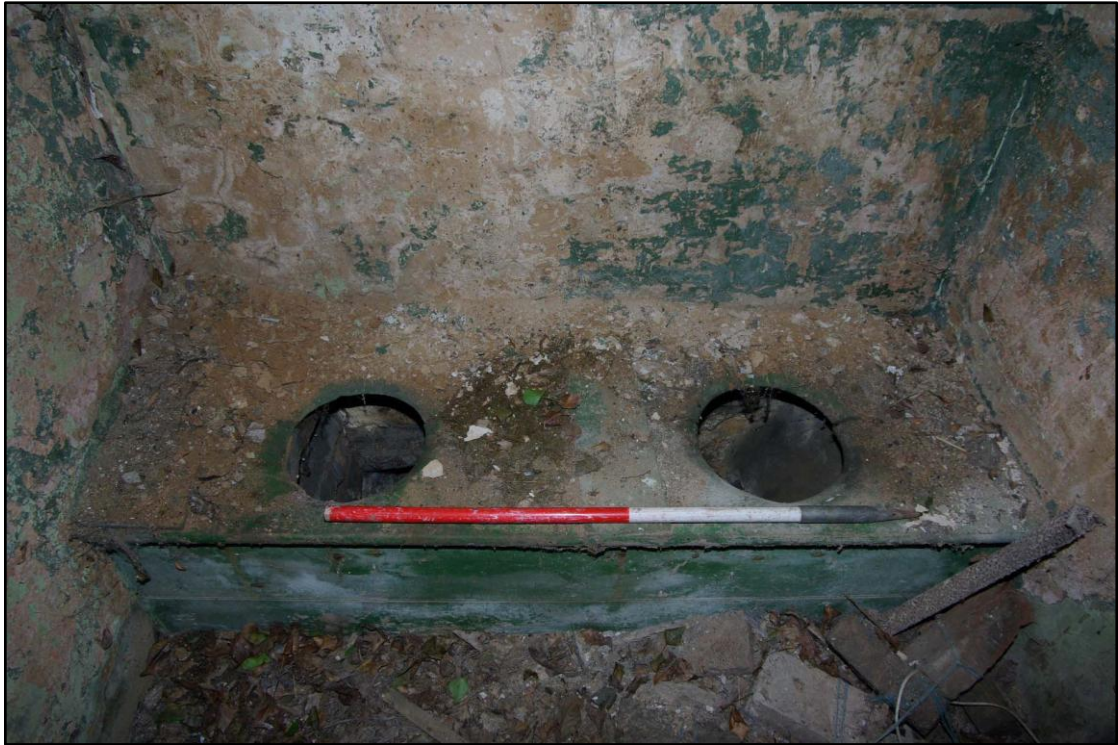
Figure 74 Outside toilet (building on left), servant's side  
Looking east

Located in the north western corner of the garden is a small limestone rubble and blue pan tile gable ended building which served as the outside toilet for the household (fig. 74). The building is divided into two halves with the servants' door to the north and the family door to the south. The servants' side is open to the roof and has painted walls and two side by side holes (fig. 75). A brick and stone chute from both leads to a well built culvert heading north eastwards (fig. 76). On the opposite side the family toilet has a small window, a ceiling and panelled walls. In addition to the two main holes there is a lower child's seat (fig. 77).

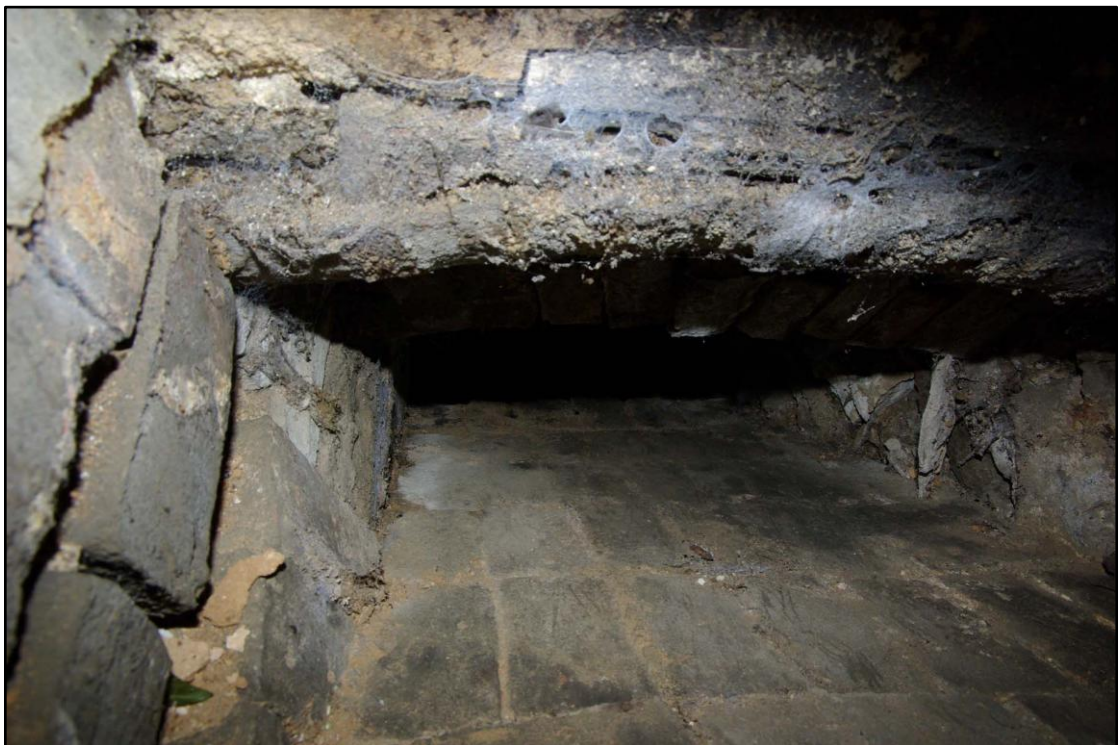
Figure 75 Outside toilet, servants side  
Looking south west. 1m scale

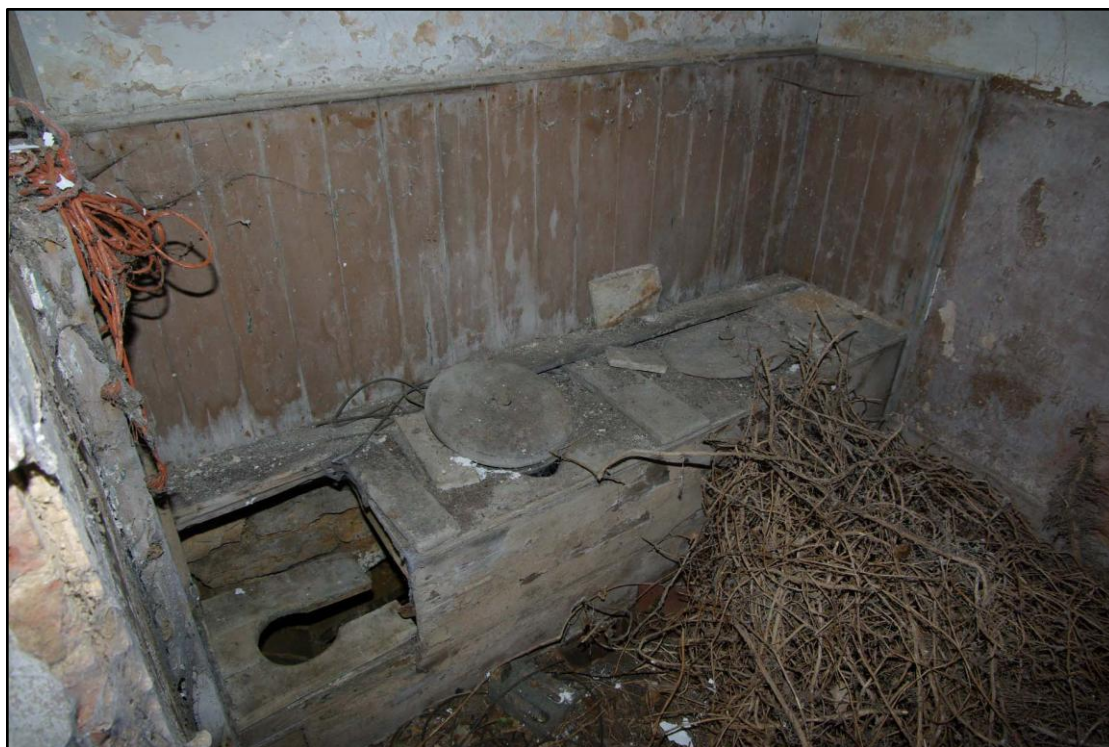
Figure 76 Chute from servant's toilet  
Looking south west
