LOGIE GREEN ROAD, EDINBURGH

Archaeological Watching Brief

for Watkin Jones Construction

July 2011

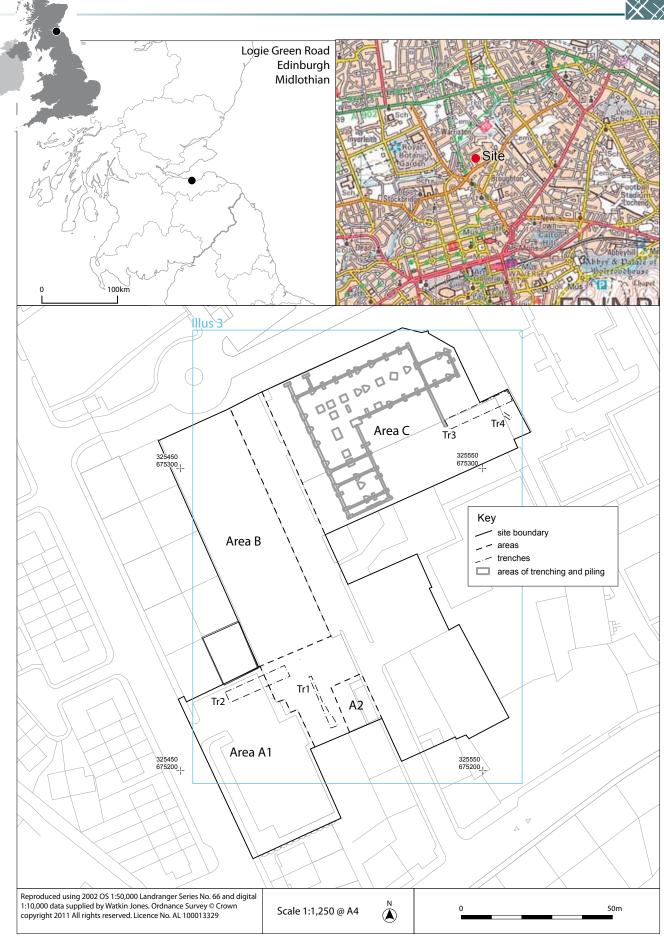
Illus 1Site location and trench plan

Headland Archaeology Ltd was commissioned by Watkin Jones Construction to carry out archaeological monitoring of groundworks during a development at Logie Green Road/Beaverbank Place, Edinburgh (Illus 1), in order to satisfy a condition of planning consent (Planning App. No. 08/01365/FUL). The work was undertaken under the terms of a Written Scheme of Investigation produced in 2010 and agreed with the City of Edinburgh Council Archaeology Service (CECAS). An evaluation, in the form of targeted trial trenching, was undertaken on site in December 2009 (Headland Archaeology Ltd 2010). This established the presence of archaeological remains in some parts of the site. An early to mid. 18th century mill lade was recorded in the south-western area together with a large cut, possibly an earlier incarnation of the lade, on a more southerly alignment. Structural foundations relating to 19th/20th century industrial buildings were also uncovered. Consequently CECAS requested that further archaeological work be undertaken. The development area is approximately centred at OS Grid Reference NT 25483 75294 (Illus 1) and includes land on both sides of Beaverbank Place. The land was previously occupied by a variety of industrial buildings which have been recently demolished. The site has been divided into three areas for the purposes of development as shown on the attached plan. Archaeological watching briefs were required in Areas A1 and A2 and Area C; works in Area B did not require monitoring. The monitoring reported here was carried out between the 23rd June

Kirkwood's (1817) map shows the site in some detail (in An Atlas of Old Edinburgh). This shows a Mill Lead running across the middle of the westernmost part of site (labelled Area A1 on Illus 1) and roughly along the southern boundary. Most of the eastern part of the site is part of Clark's Mill Bleach Fields in Mr Hay's property; the mill lade may be associated with Clark's Mill, though the mill itself is not marked. A search of NMRS and the NAS did not produce any information on Clark's Mill. Logie Mill is not marked on this map.

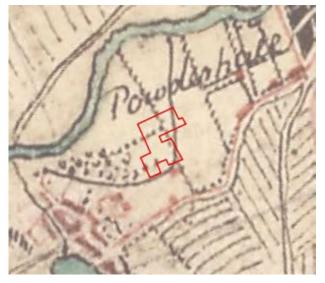
Illus 2aRoy's Military Survey of Scotland, 1747–55

The pre-Ordnance Survey maps show the area largely as fields with Wariston marked on; a mill is marked on the south side of the Water of Leith on Adair's (1682) and Laurie's (1766) maps – this is labelled as Bonnington Mill on Laurie's map. Roy's Map (1747–55, Illus 2a) shows a mill lade running from the loch at Canon Mills eastwards towards the site and beyond to the Water of Leith. A small building shown at a bend in the mill lade is presumably Logie Mill, demonstrating that it was established by the mid 18th century. The site's location cannot be

determined with any accuracy on Roy's map and the outline shown in Illus 2a is indicative only. Knox's map of 1812 shows an area marked as Logie Green to the east of a substantial house.

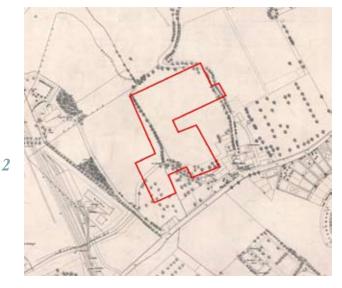
*Illus 2b*Ordnance Survey 1st Edition, 1853

The first edition Ordnance Survey map (1853, Illus 2b) shows Logie Mill and Beaver Hall to the east of the site and also shows the mill lade noted above. The site can now be located with more certainty and the route of the mill lades noted; most of the site is still fields. A footbridge across the lade can be seen to the north of Area A1.

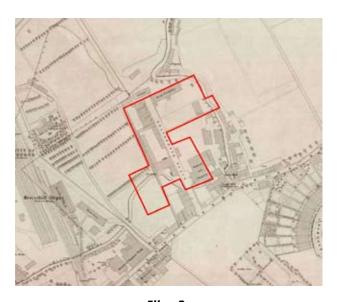
Illus 2cOrdnance Survey 2nd Edition, 1876

The second edition Ordnance Survey map (1876, Illus 2c) shows that the site has been developed, with buildings on either side of Beaverhall Place. There is a building in the north-east corner between areas A1 and A2, buildings on the eastern side of Area B and an Iron Foundry on the north side of Area C. A building is located at the eastern end of Area C and a 'Tannery and Skinnery' occupies the area to the south. By 1896 (Illus 2d) there are additional buildings in Area C and the 'Tannery and Skinnery' has become Beaverbank

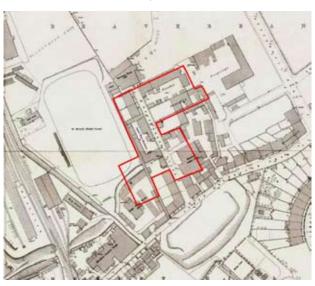
Illus 2dOrdnance Survey 3rd Edition, 1896

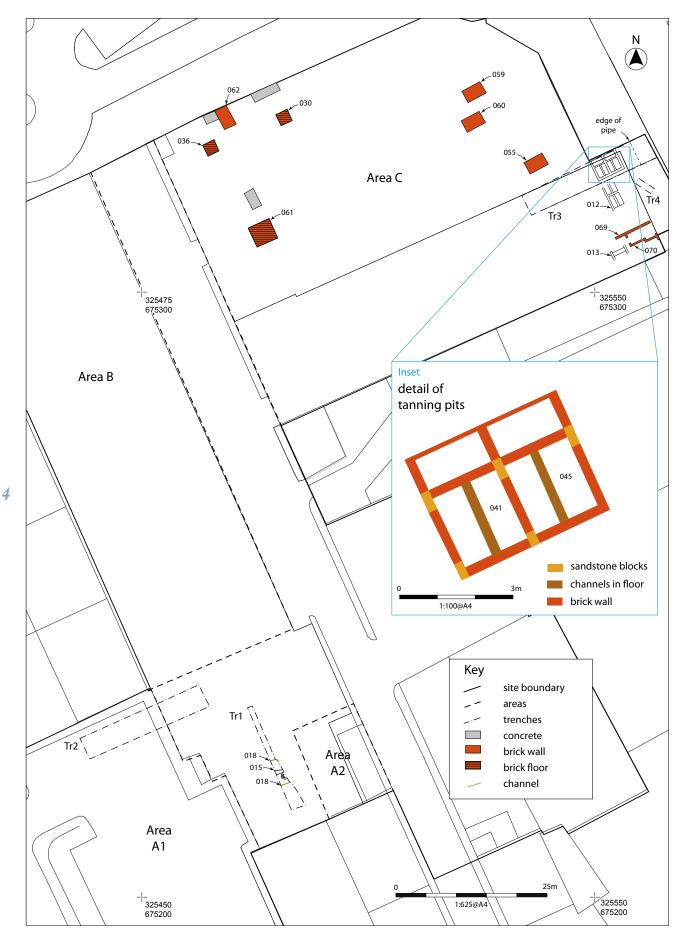
Illus 3 Plan of recorded features

A 4m wide, linear cut ran east-west across Trench 1 [018] cutting the alluvial deposit (Illus 3) and extending beyond the limit of excavation. The alignment of the feature corresponds well with the evaluation results and mapped evidence for the location of the mill lade. The cut was excavated to a maximum depth of 1.5m, but continued beneath the limit of excavation. Sandstone blocks [019], possibly the remains of a heavily disturbed drystone wall [019], were visible in the trench section, marking the southern edge of the cut. The feature was filled with a greyish brown sandy clay deposit [025] containing machine-made bricks and demolition rubble, suggesting that it had been deliberately backfilled. A 0.05m thick mid-grey silty clay [026] lay beneath this deposit, against the northern edge of the cut. Approximately in the middle

Several brick surfaces [030], [036] and [061] constructed from machine-made red bricks were located in the northern part of Area C (Illus 3). The bricks were unbonded and lay directly over alluvium [037]. These lay within the footprints of the Iron Foundry depicted on the 1876 and 1896 maps and are likely to be foundation pads.

Remains of red brick walls [055], [059], [060] and [062] were also observed in Area C. The wall [062] in the north-western part of Area C (Illus 3) was aligned north to south and abutted the northern boundary wall. It corresponded with the internal wall of the Iron Foundry depicted on the 1876 and 1896 maps. The bricks were stamped 'Whitehill patent' and 'Loudon and Miller Carluke'. Like the foundation pads these directly overlay alluvial material, and no former ground surface was observed. Walls recorded on the south side of Area C,

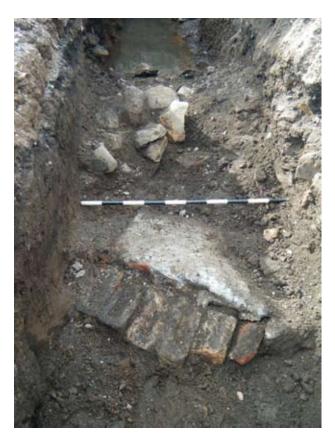
Illus 4 Channel [015]

of the infilled cut, and 0.78m beneath the existing ground surface, a concrete lined channel was encountered. Bricks lined the northern edge of the structure [015] (Illus 4), which was heavily truncated due to the installation of service pipes. It is possible that this structure represented later adaptations to an existing mill lade. The concrete lined channel was filled with red brick, ceramic drain pipe fragments and frequent sub-angular stones, again suggesting deliberate backfilling of the feature.

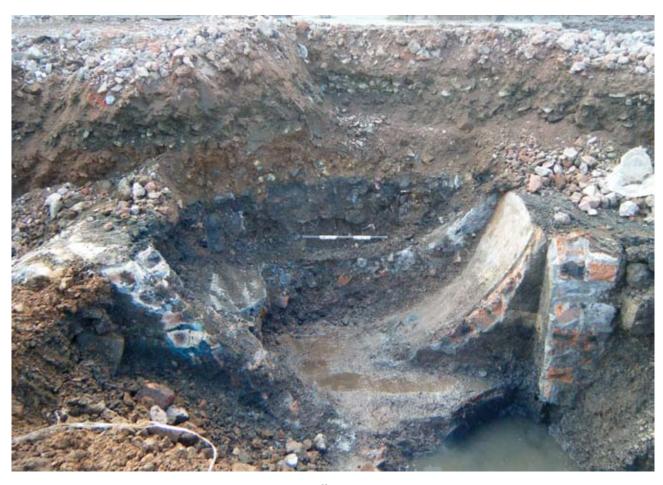
Illus 5 Channel [013]

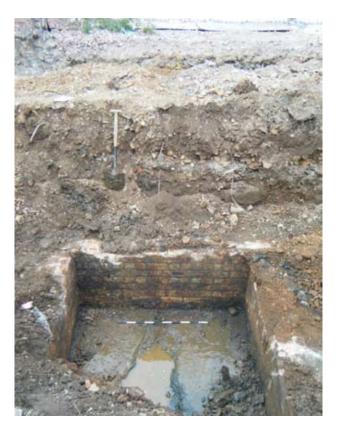
Illus 6Tanning Pit [041]

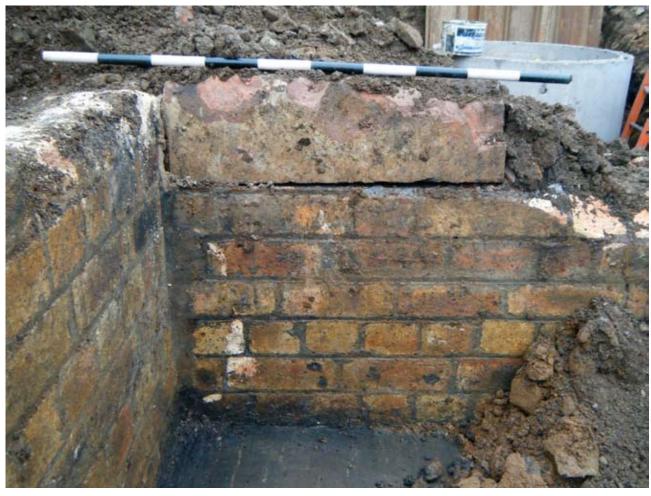
Illus 7Sandstone blocks capping Tanning Pit [045]

Beneath, and to the west of, Tanning Pit [045] a rich organic 'sludge' deposit [046] was exposed in the southern section. Fragments of animal bone, cattle horn cores, bottle glass, 19th and 20th century pottery and leather fragments were observed in this deposit. The presence of two concrete floors suggests that the pit must have been repaired and relined. The pit would have been drained

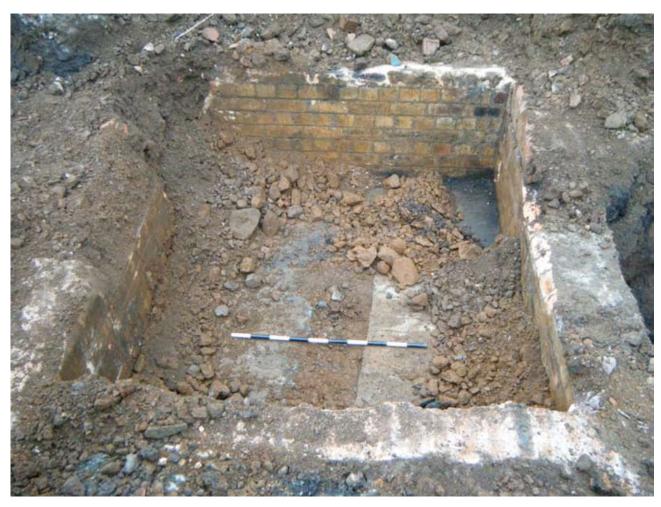
Illus 8Channel in centre of Tanning Pit [041]
