FOUNTAINBRIDGE STUDENT RESIDENCES, EDINBURGH

Archaeological Trial Trenching and Excavation

for Cityheart Ltd

February 2012

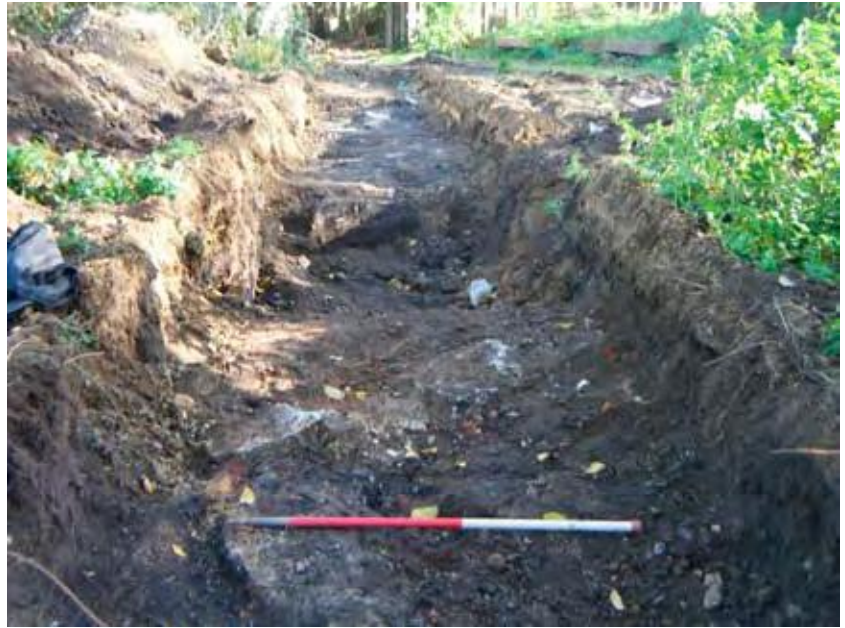
Illus 3 ▶

General view of Trench 1 facing E, showing walls [027] & [028]

Trenches 1 and 2 were positioned to expose any remains of the Bainfield Place tenements to the north-west of the main industrial site. This area had been previously landscaped following the demolition of the tenements and was in use as a public park at the time of fieldwork. In both trenches, structural remains were encountered below a thin layer of turf and topsoil and c.0.1–0.2m of crushed stone. In Trench 1 (Illus 3), two stone walls [027 and 028], measuring 0.3 and 0.6m wide respectively, were exposed most likely representing internal walls. They only survived as foundations since they were located at the same level as several adjacent ceramic drains. A further stone wall [029], 0.5m wide, was located towards the eastern end of the trench forming part of a diagonal garden wall visible on the 3rd Edition OS (1893) map. The wall had been truncated by a modern concrete fence foundation [030].

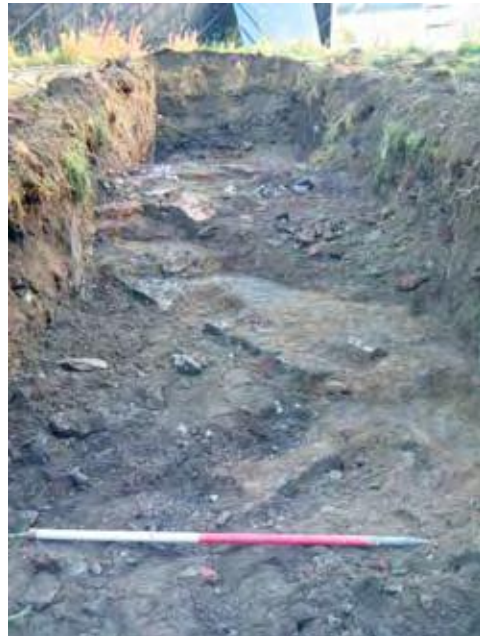
Illus 4 ▶

6 *General view of Trench 2 facing SE, showing wall [031]*

In Trench 2 (Illus 4), two stone walls were exposed [031 and 032], measuring 0.6m and 0.9m wide respectively. Wall [031] was an internal wall foundation. Wall [032] was perhaps broad enough to support an external wall, although it was located within one of the tenement buildings on the 3rd Edition OS (1893) map. A ceramic drain ran adjacent to Wall [031] on the west side.

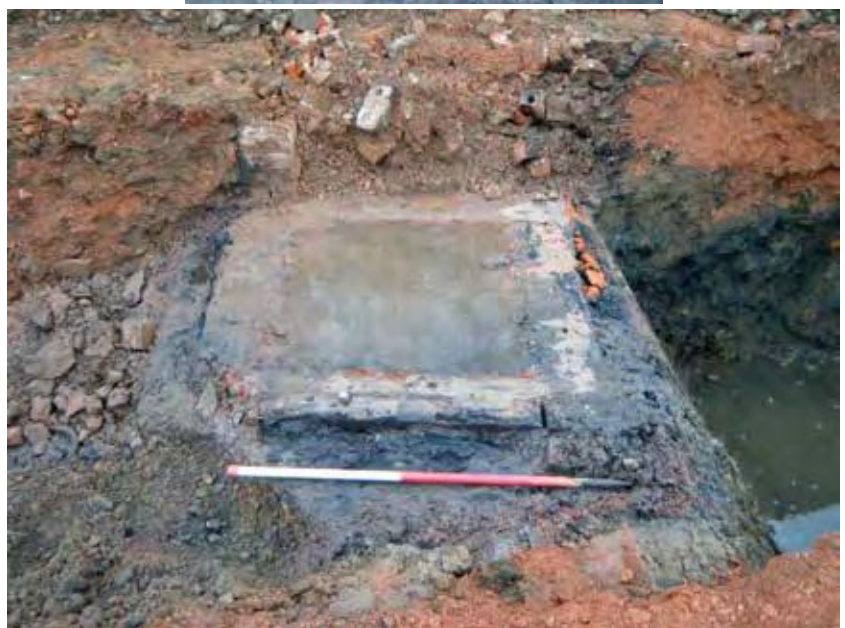
Illus 5 ▶

Brick/concrete manhole base [002] in Trench 3, facing NW

Trench 3 was positioned to target the northern part of the Etna Iron Foundry and the boundary wall between it and the Viewforth Works visible on the 3rd Edition OS (1893) map. Two structural fragments were discovered: a small section of concrete slab [003] directly above the geological gravel at the south-west end, and the base of a concrete and brick manhole [002] (Illus 5) located c.8m to the north-east. Both looked fairly recent and appeared more likely to relate to the one of the outbuildings of the 1957 rubber hose plant.

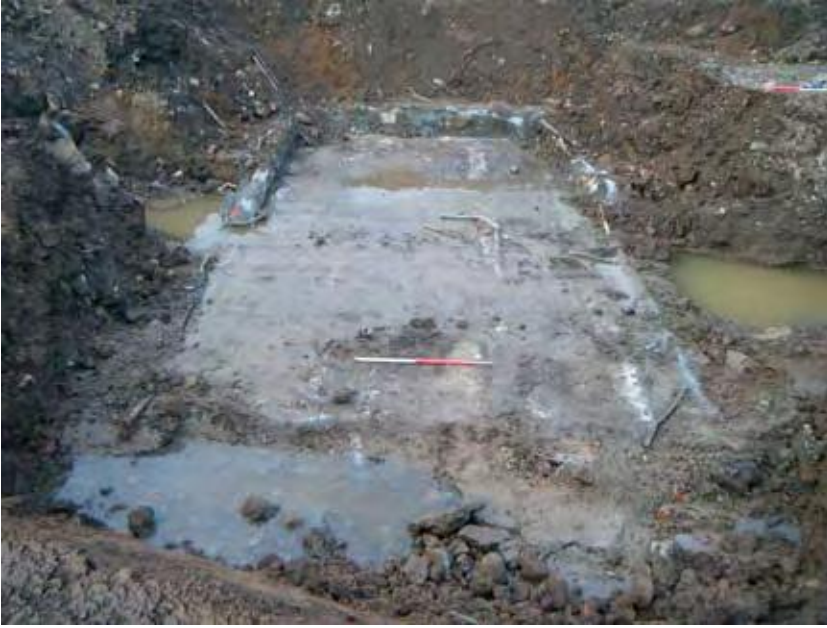
◀ **Illus 6**
Concrete floor and brick walls [001] in Trench 10, facing NW

Trench 10 was positioned across the western end of the Bainfield Iron Works. At the western end, a large concrete slab [001] (Illus 6) was found, cut slightly into the subsoil. The trench was widened at this point to reveal the remainder of this surface, which extended to 8.6x5m. Steel reinforcement within the concrete and the footings for brick walls around the perimeter and extending north-north-west to south-south-east were identified. These appeared to be the remains of a floor surface, possibly at

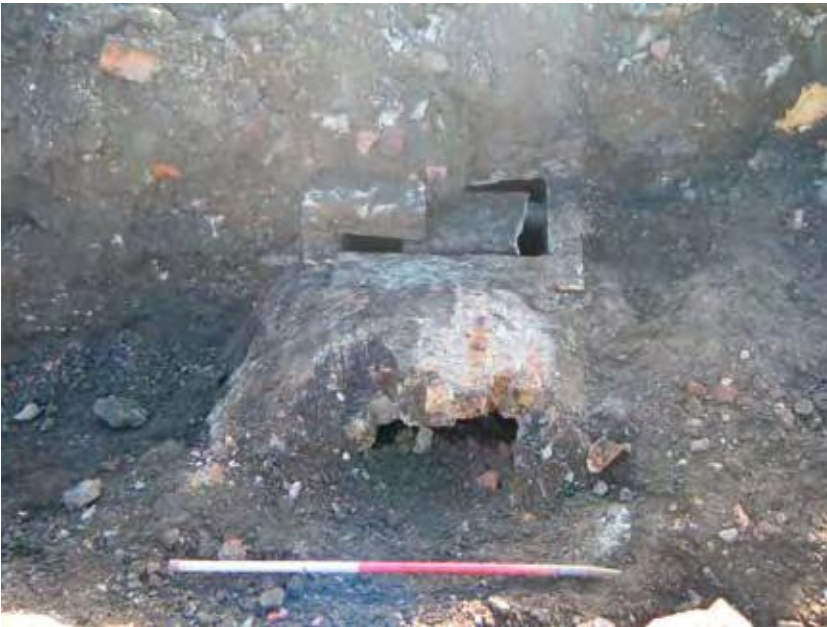
◀ **Illus 7**
Brick flue [005]/[019] and manhole [020] in Trench 24, facing S

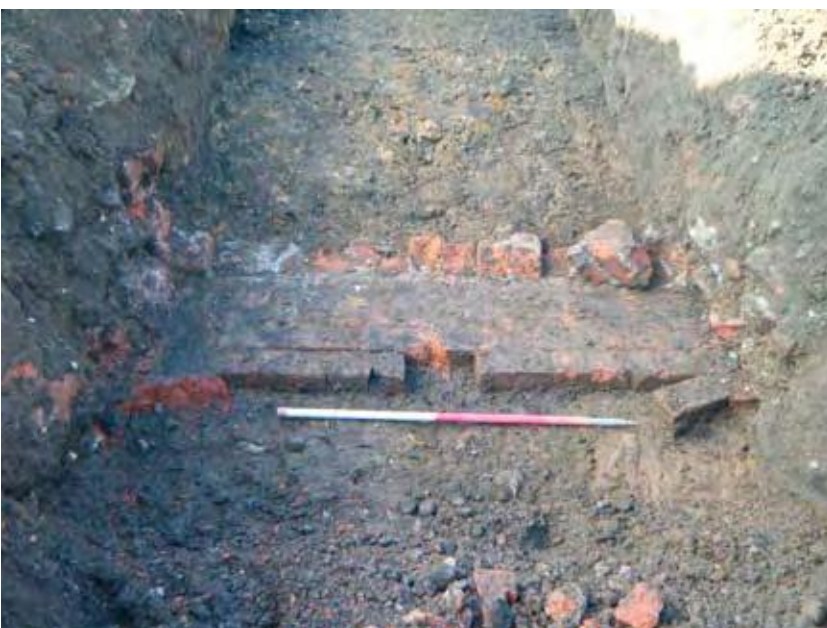
◀ **Illus 8**
Brick drain [006] in Trench 13, facing SW

Trench 13 was positioned over two adjacent outbuildings to the north of the main Viewforth Works building. Towards the eastern end of the trench the subsoil was overlain by a c.0.8m thick band of dark grey silty clay [007]. Cut into this deposit, and into the geological subsoil was the southern face of an intact brick structure [005] (Illus 7) measuring c.1.2m wide and 0.5m high. The remains of a brick flue or drain [006] were exposed at c.2m below pgl surviving to a height of 0.7m, with two parallel brick walls built on a brick base 0.7m wide. A concentration of broken stone filling the structure may suggest that it was originally stone-capped.

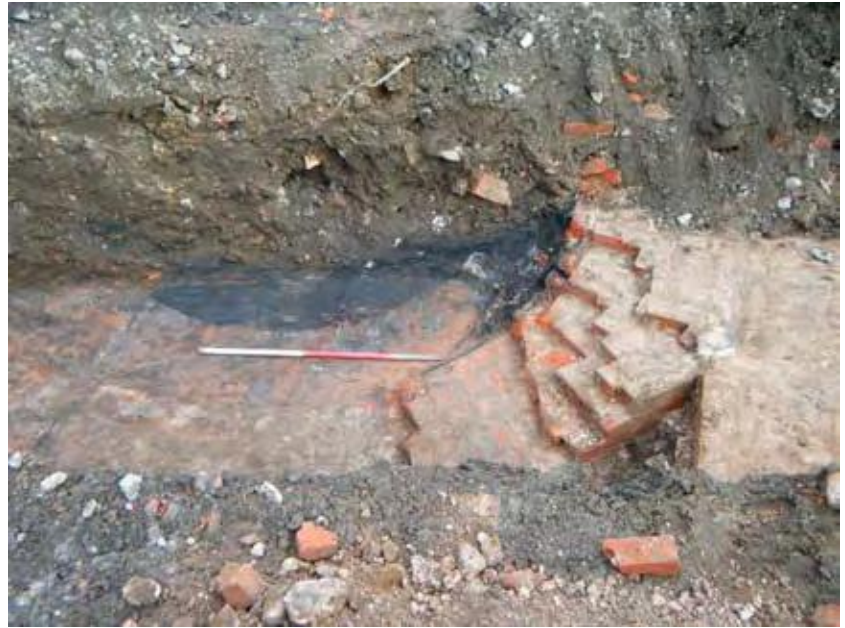
Illus 9 ▶

Sandstone surface [018], brick chimney [016] and brick floor [015] in Trench 14, facing NE

a chimney [016] was preserved (Illus 9). The chimney was supported on a series of substantial sandstone flags [018], which were placed onto the subsoil. The chimney survived to 5 courses (c.0.4m) high, was octagonal on the outside and curved on the inside. The remains of a sooty deposit [017] were found in the interior. Trench 21 was placed to find the extent of these remains – it was excavated through 2.4m of very mixed rubble (including modern scaffold fittings). No structural remains were encountered.

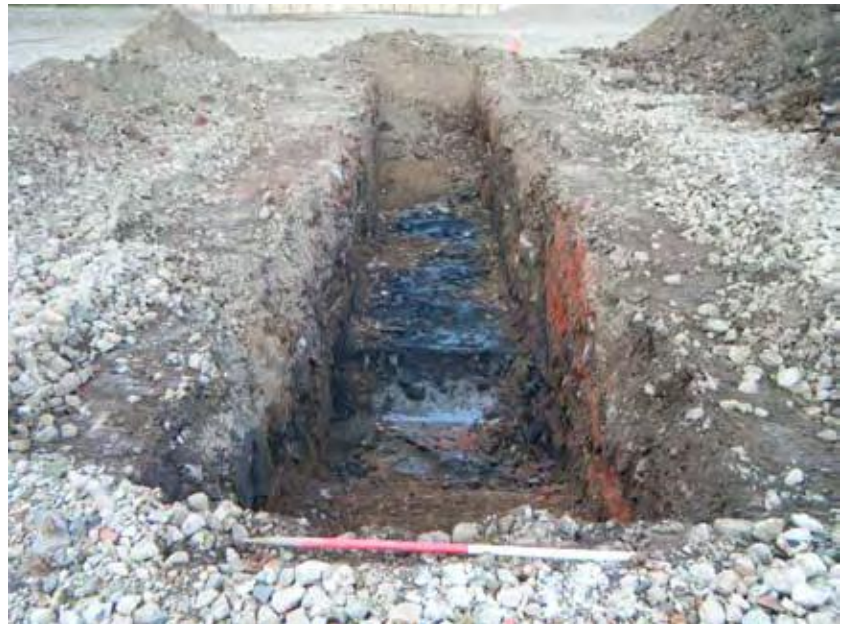
Illus 10 ▶

Clay-lined tank [009] in Trench 17, facing N

Trench 17 was placed over a structure marked ‘reservoir’ on the 3rd Edition OS (1893) map. The remains of a large clay-lined tank [009] (Illus 10) were encountered at this location. It had been cut into the subsoil and lined with compact grey clay, which was packed with large angular stones. The fill of the tank was a black, hydrocarbon-rich sand [028]. No upstanding superstructure was found, and a small extension of the trench to the north-west showed no signs of the adjacent building to the west. It is likely that these remains represent the truncated remains of the very base of the mapped structure.

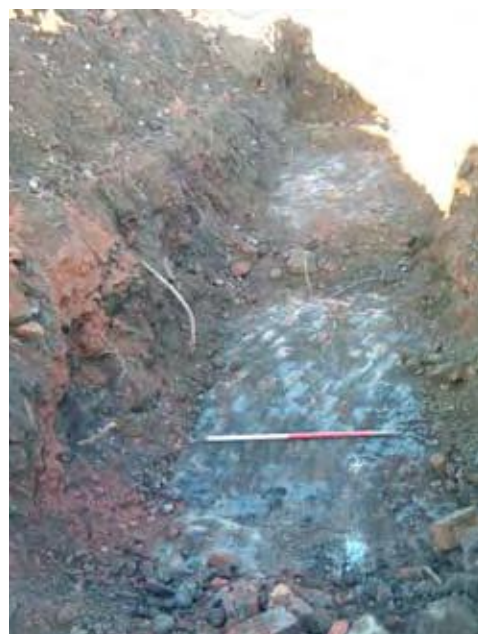
Illus 11 ▶

Brick floor [024] and drain cut in Trench 19, facing NW

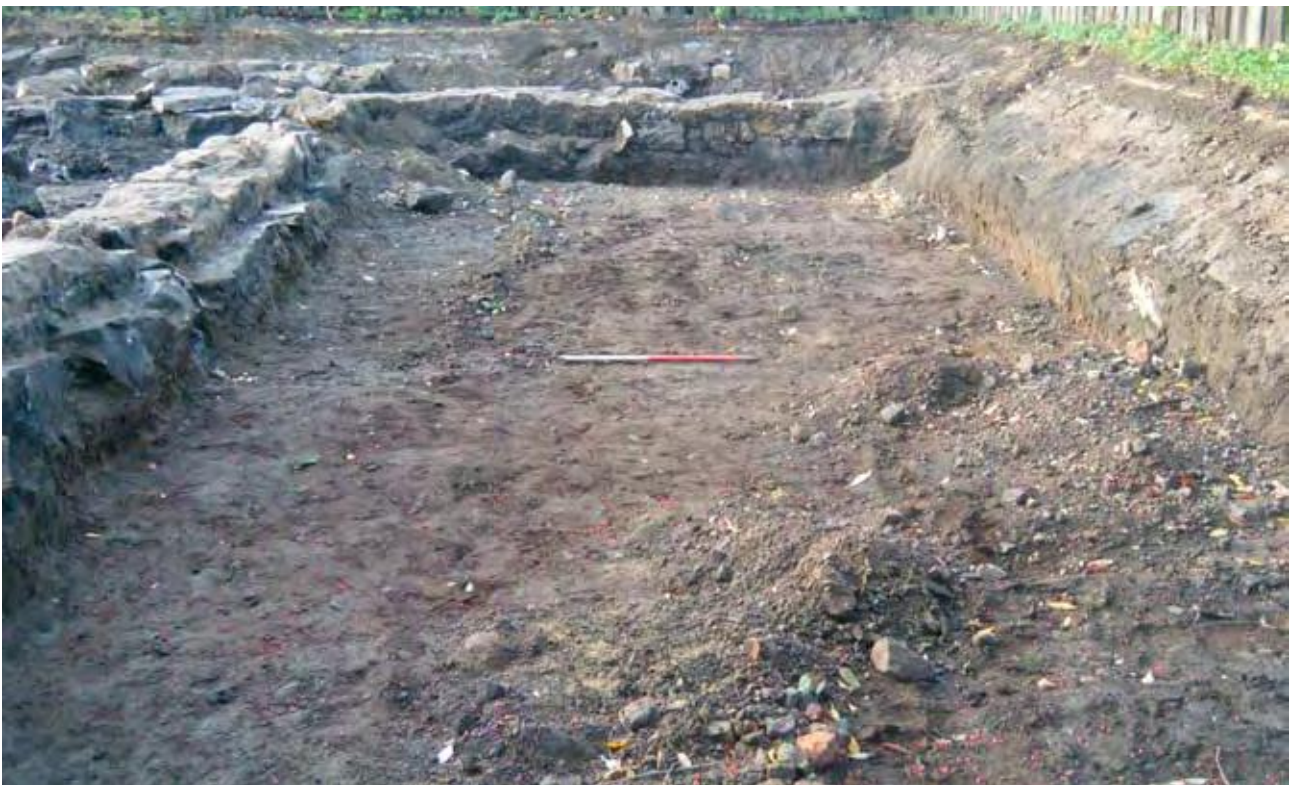
Illus 14

General view of N range of tenements facing SW, showing walls [118] & [119]

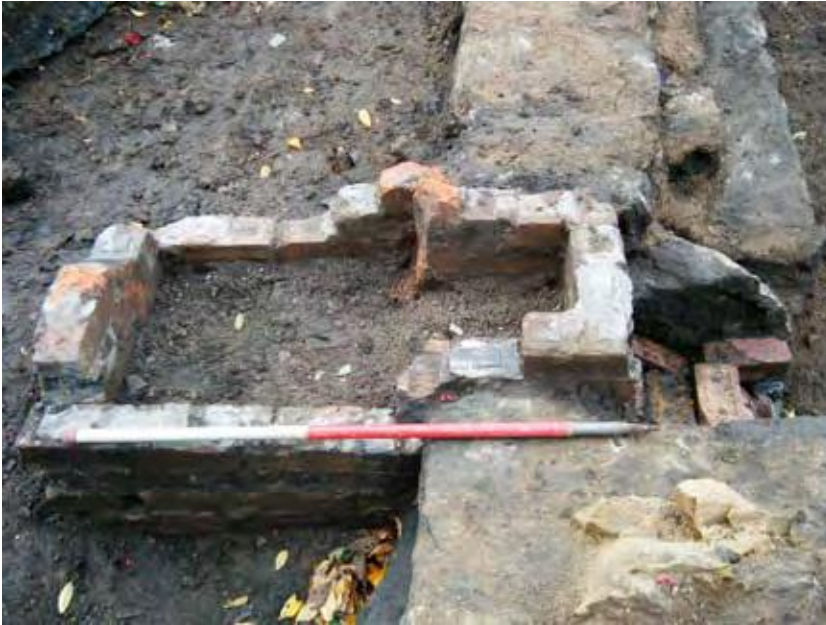
◀ **Illus 15**

Brick manhole [120], facing SW

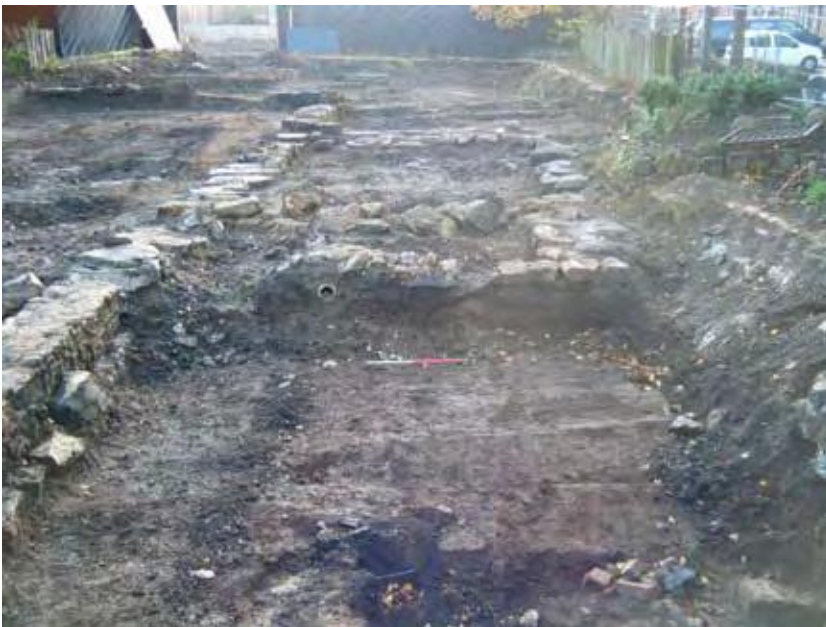
◀ **Illus 16**

General view of W range facing SE, showing walls [118] & [107] on the left, wall [117] directly ahead, and modern truncation just visible in the foreground

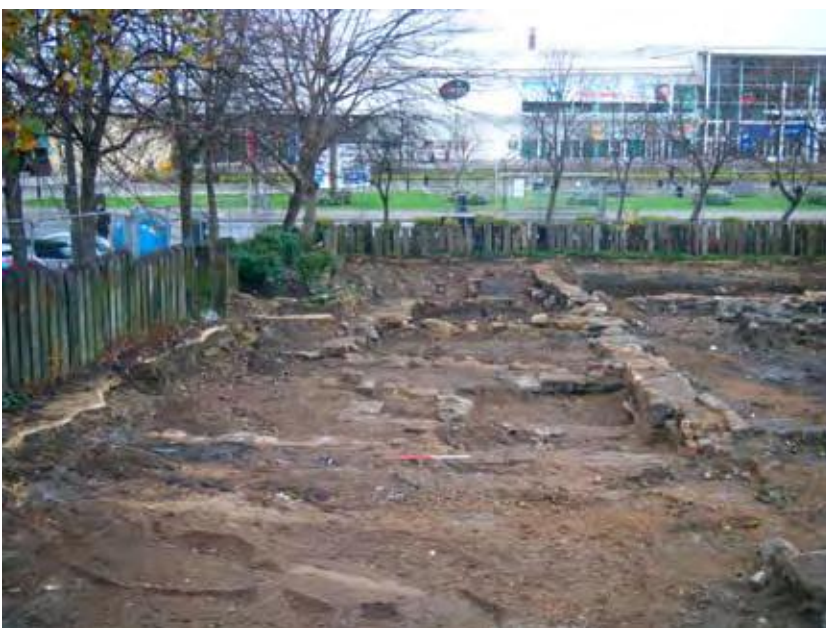
◀ **Illus 17**

General view of W range facing NW, showing wall [113] (by scale bar), possible staircase support [109]–[111] just behind, and wall [106] to the right

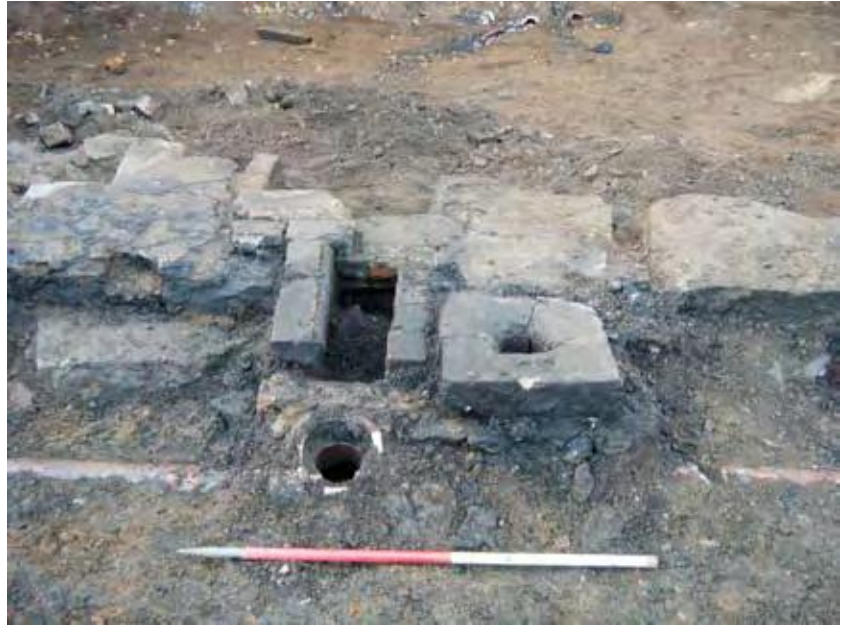
Illus 18 ▶

Drainage structure [125] built into wall [124], facing SW. The cut for the transverse drain can be seen running into the background

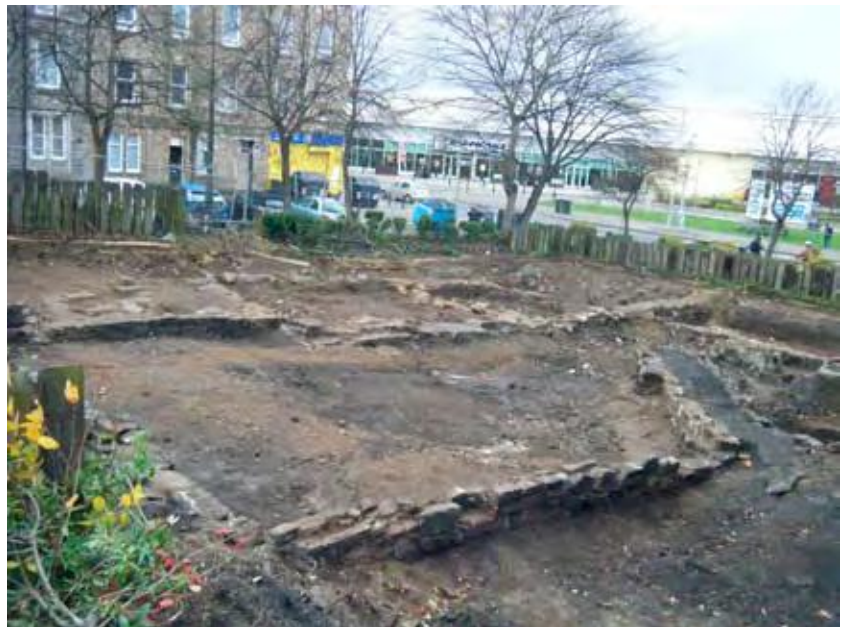
Illus 19 ▶

General view of the garden area facing NW, showing wall [104], deposit (108) and the S extent of large cut [131]

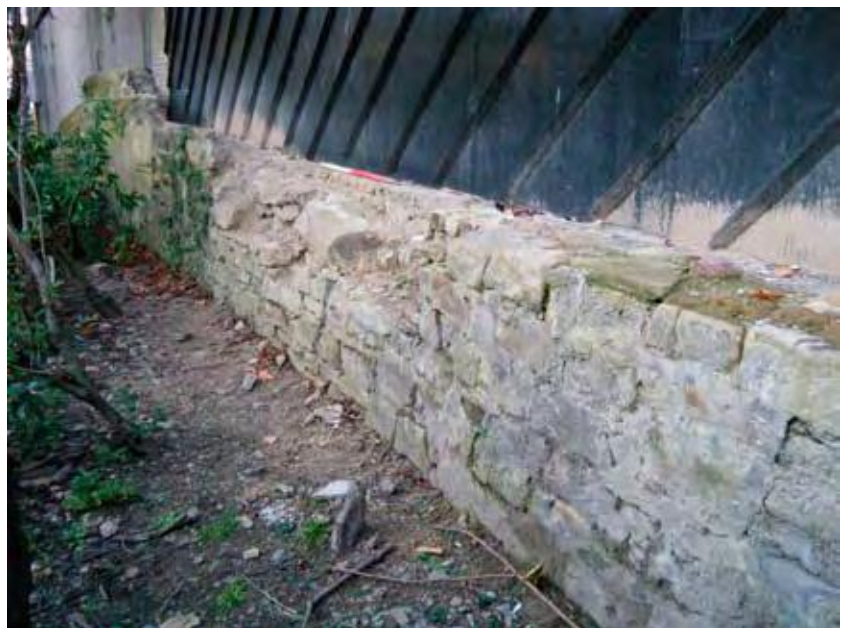
Illus 20 ▶

Upstanding wall [101] facing N, with brick repairs [102] just visible

The south-east boundary wall [101] (Illus 20) survived to original height in places, up to 3.2m at the northern end, and had dressed capstones with regular marks from an extant iron fence. Towards the northern end, the wall had been repaired with red brick [202], possibly related to the construction of a substantial retaining wall running outside the excavation area to the east.

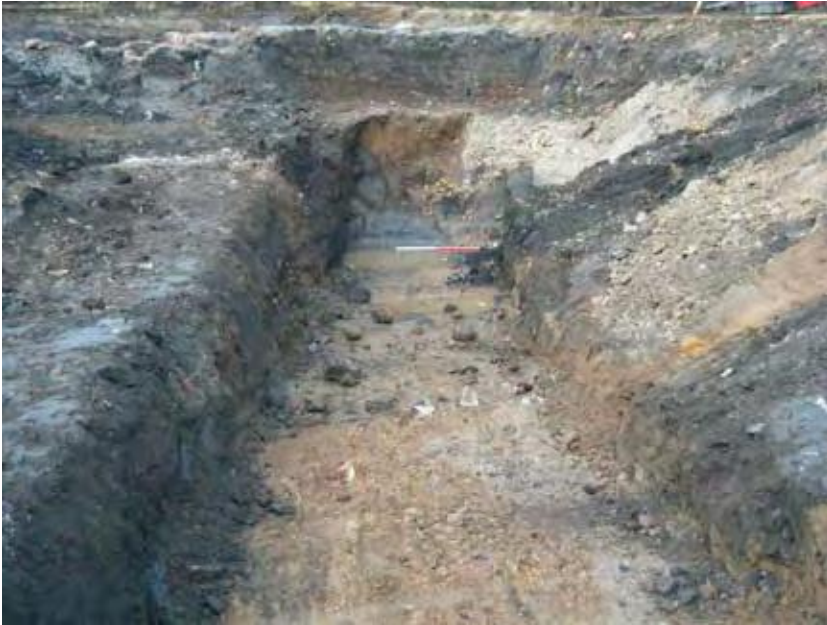
◀ **Illus 21**

View of test slot dug through large cut [131], facing N

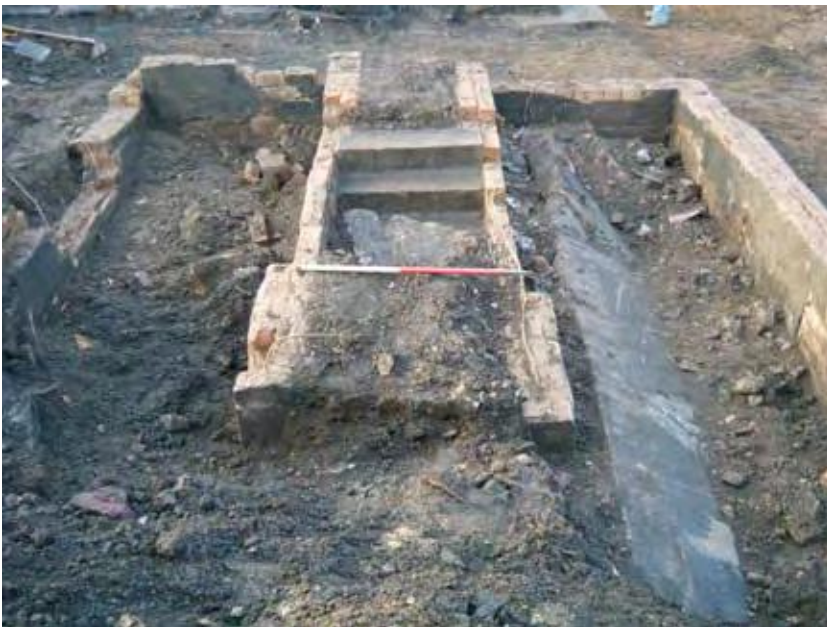
◀ **Illus 22**

Bomb Shelter [121] facing SW, partly excavated

The latest of the structures in Area 1 were two brick-and-concrete WW2 air-raid shelters. Both structures appear to be of identical form; Structure [130] (Illus 23) was only partially exposed. Structure [121] (Illus 22) measured 6.2x4.6m and consisted of two parallel rooms, sunk 1.6m into the geological subsoil. The walls were formed of steel-reinforced red brick, cement-rendered inside and with signs of additional internal support. Between these rooms lay a set of concrete steps descending from ground level to the floor level of the rooms, supported directly on the internal brick wall. At the base of the stairs, the walls swelled, most likely for additional support. The floor was of poured concrete. No internal features were seen. Large sections of the original reinforced concrete roof had collapsed into the structure.

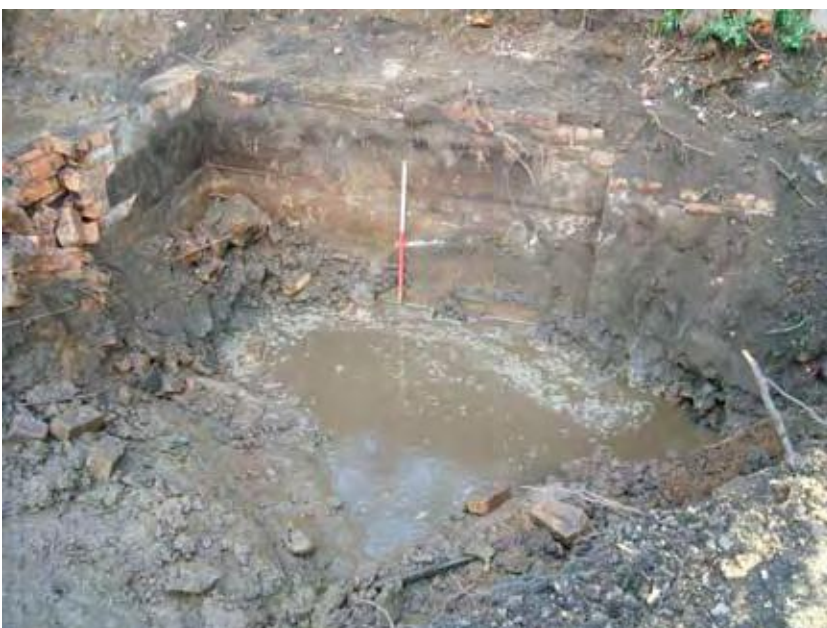
◀ **Illus 23**

Bomb shelter [130] facing N, with SW wall removed and excavated to the concrete floor, which lies just below the level of the water

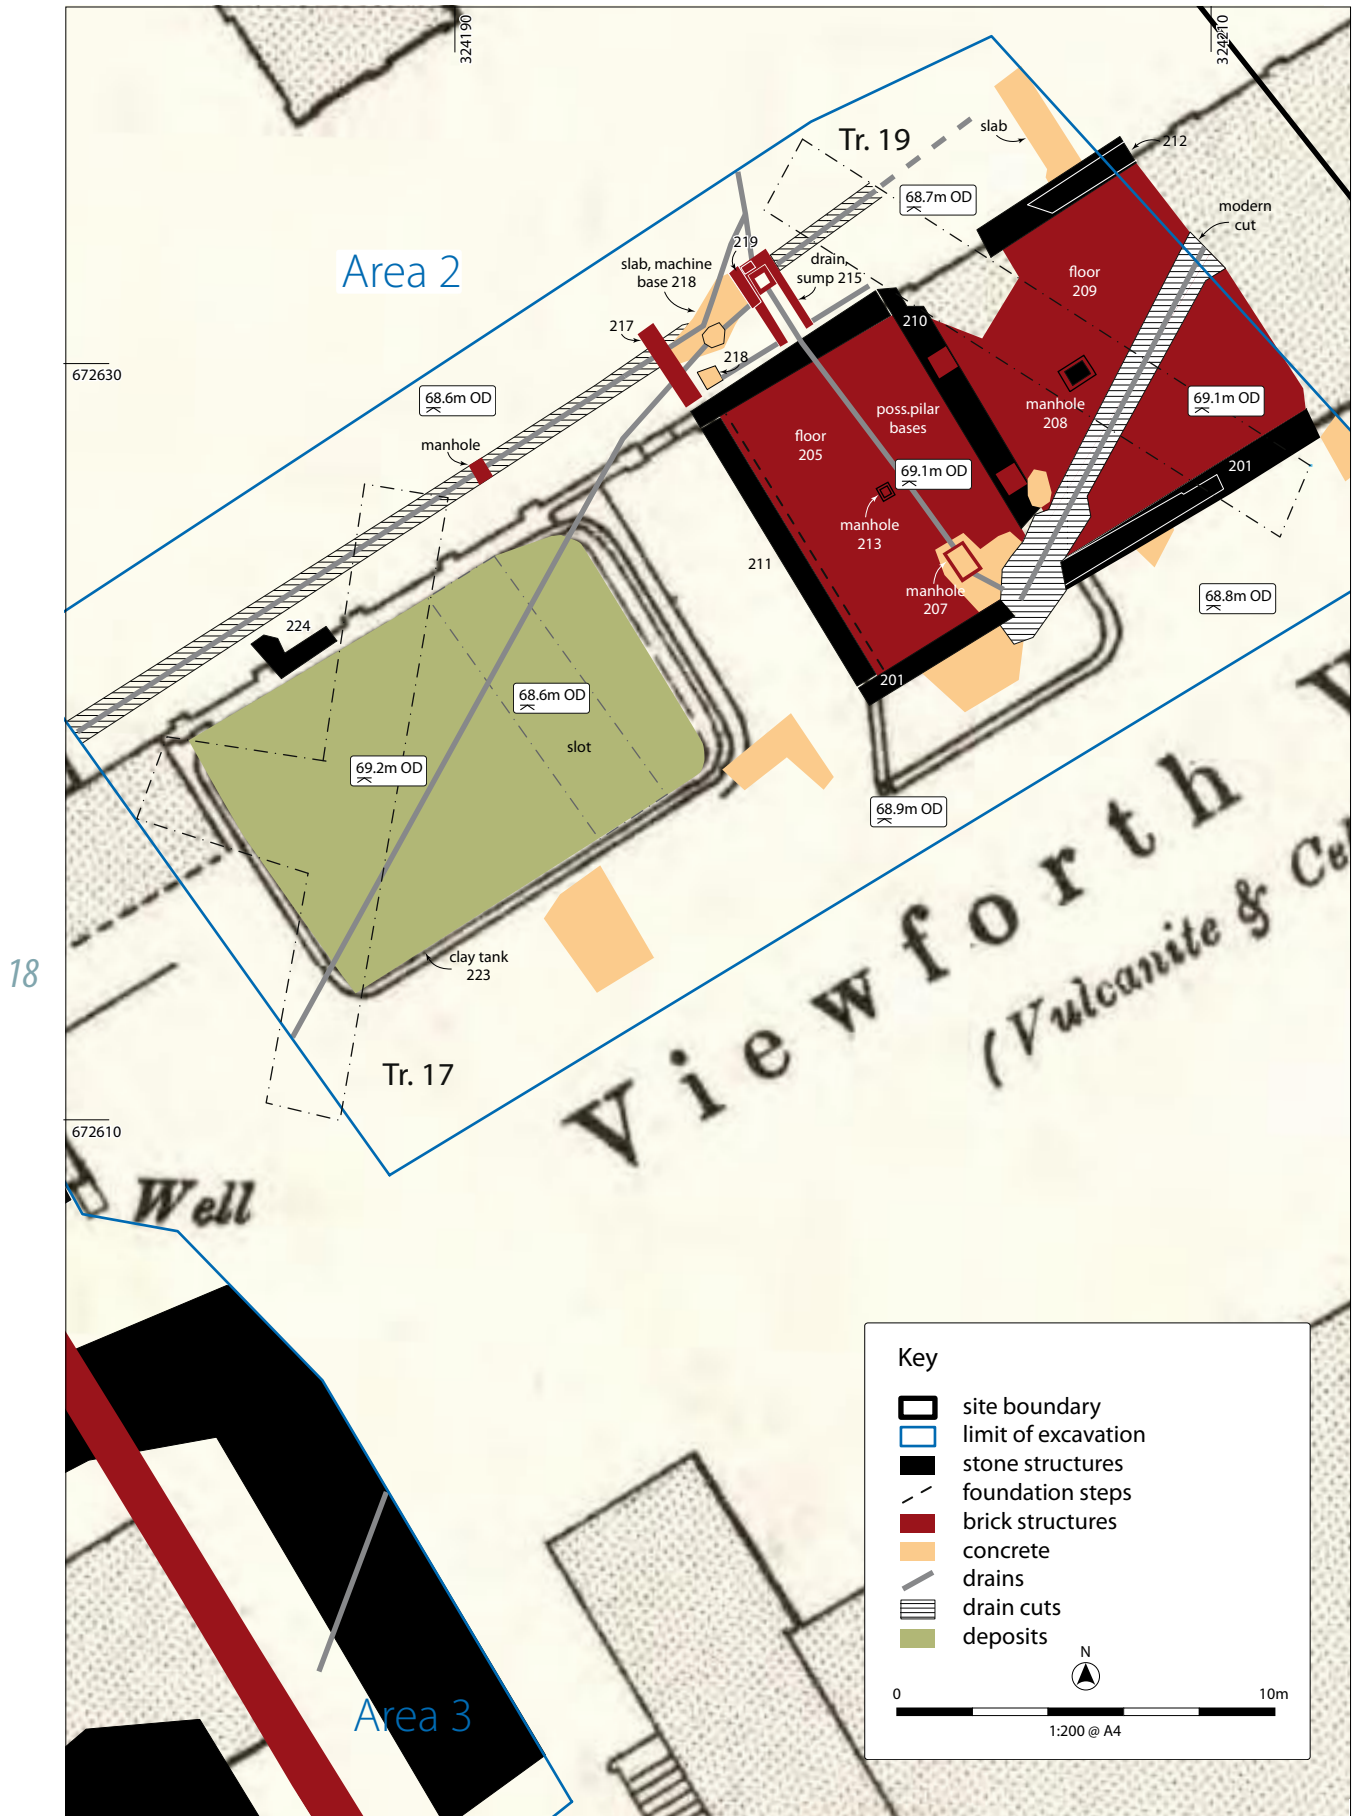
Illus 24

Results of excavation in Area 2, overlaid on OS 3rd Edition Town Plan (1893)

Area 2 (Illus 24, 25) was targeted at a substantial brick floor [024] and a clay-lined tank [009] found to the north-east end of the site during the trial trenching phase. The building to which the floor belonged extended beyond the development area, and so only the south-west half was exposed. The whole area was buried under up to 2.1m of demolition rubble, mostly of crushed concrete and stone, but with larger fragments of brick, concrete, stone and metalwork throughout. It is most likely that this represented a mixture of rubble from the Viewforth Works and the 1950s buildings, but that had all been re-processed by the latest demolition works. The natural subsoil was a compact, gravelly orange sand.

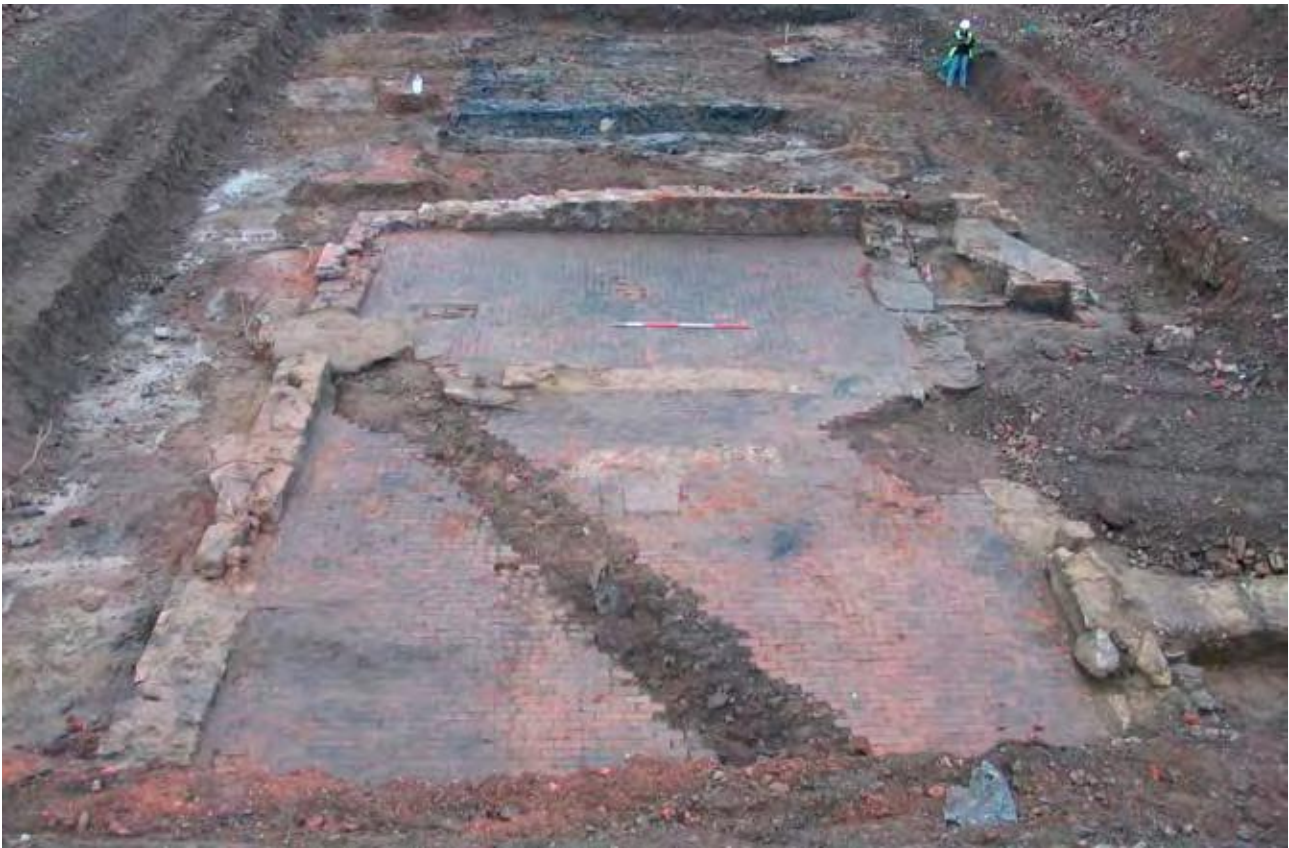
Illus 25

General view of Area 2 facing SW, showing brick floors [204] & [205] with bounding walls, and clay-lined tank [223] in the background

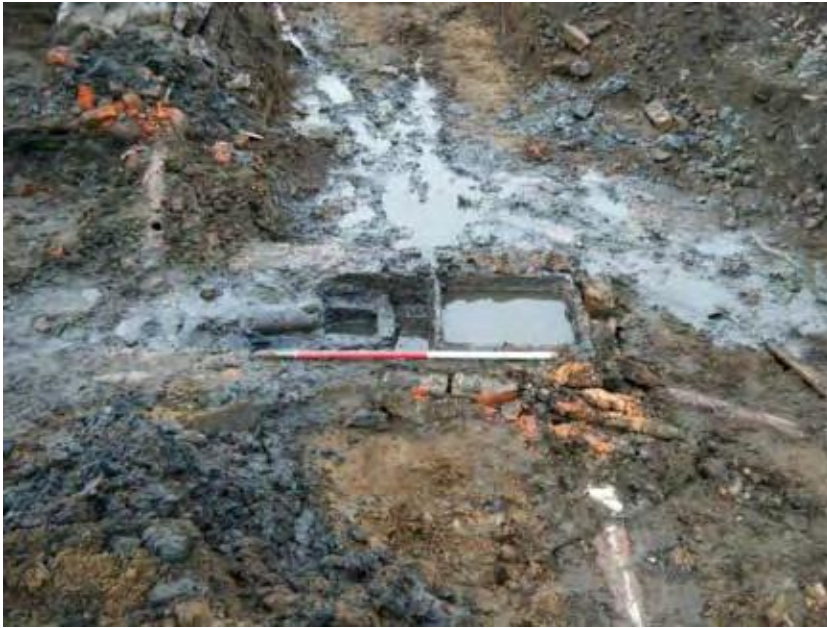
◀ **Illus 26**

Drainage structures underneath [215] facing SW, showing possible sump and radiating pipes

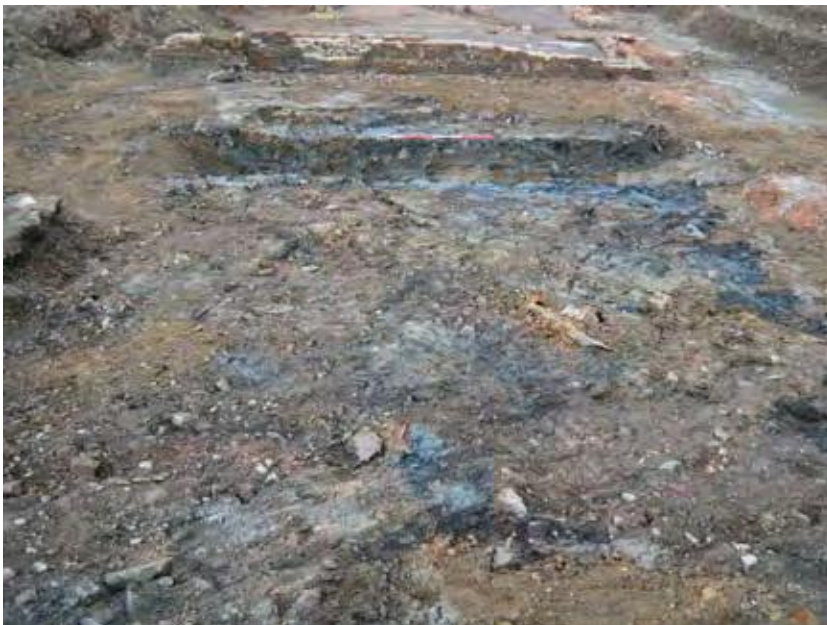
◀ **Illus 27**

Section through clay-lined tank [223], facing NE

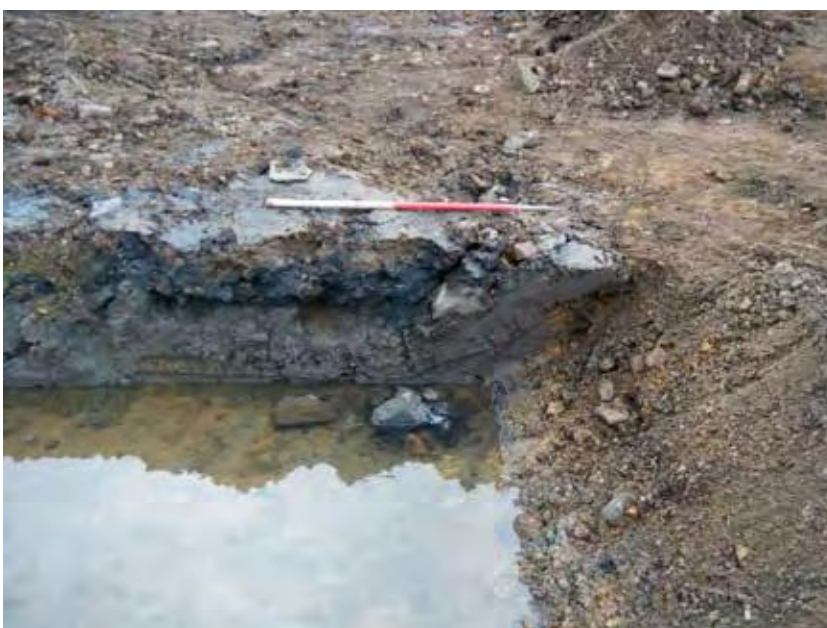
◀ **Illus 28**

Detail of clay lining of tank [223], facing NE

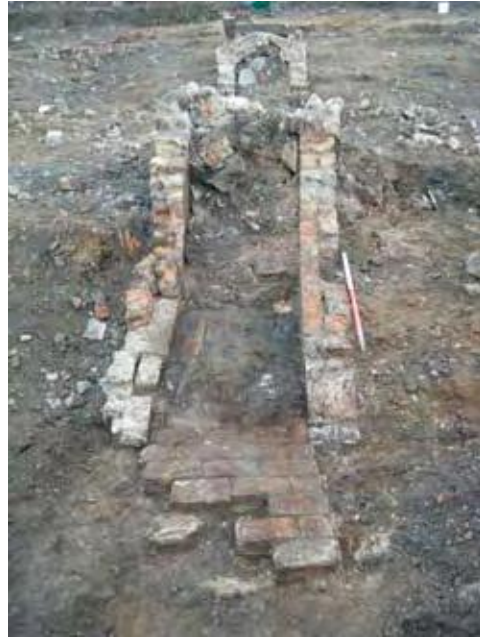
Illus 30 ▶

*Brick flue [316] facing S, with small segment
of wood lining and arched roof visible*

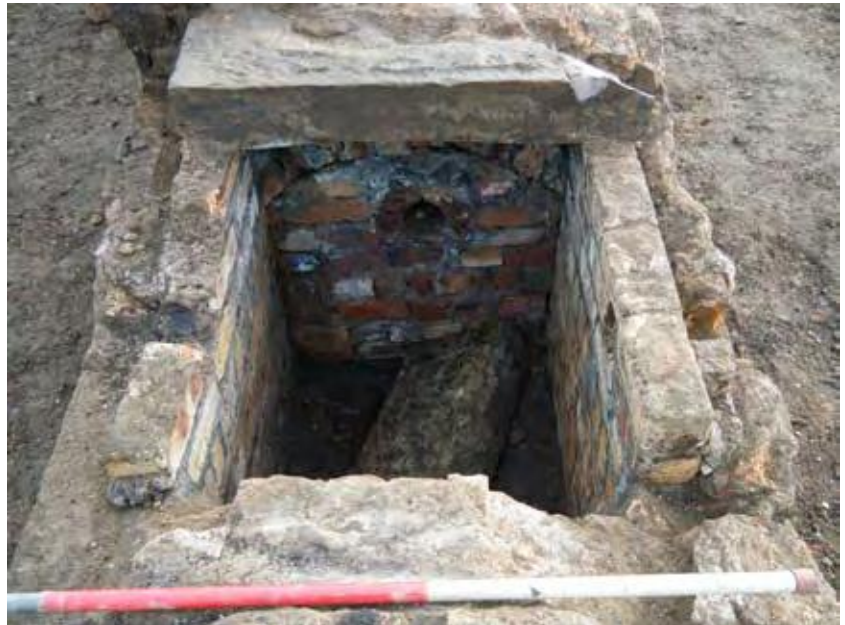
Illus 31 ▶

*View through manhole [318] showing
blocking wall [321], facing S*

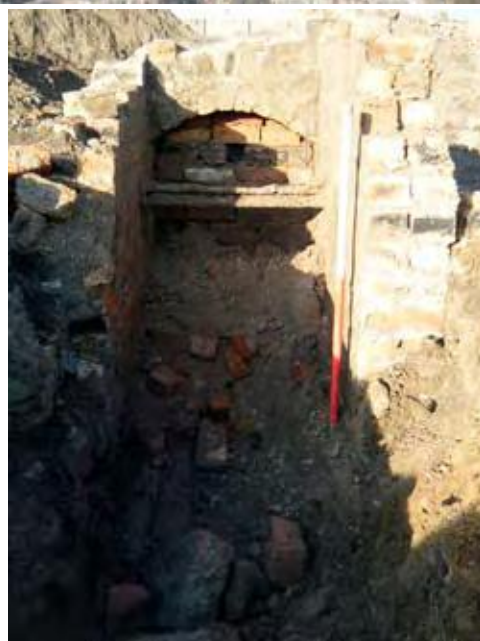
Illus 32 ▶

*View of flue [316] facing N, after removal of
S wall, showing blocking wall [318] and iron
pipe support*

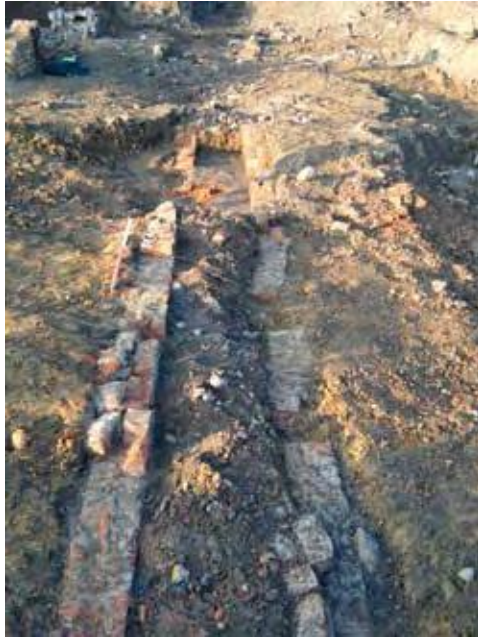
◀ **Illus 33**

Brick flue/drain [310], facing N

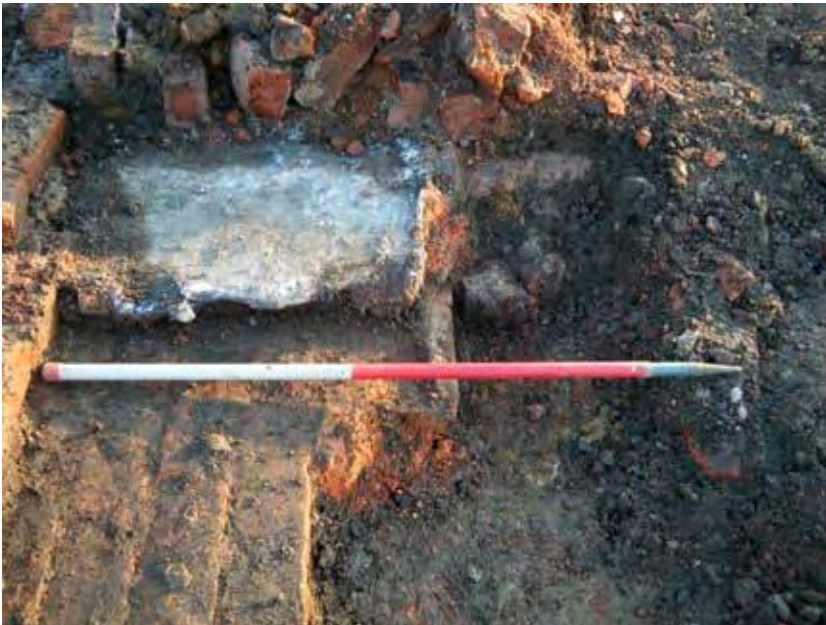
◀ **Illus 34**

Detail of rubber lining (315) in flue [310], facing S

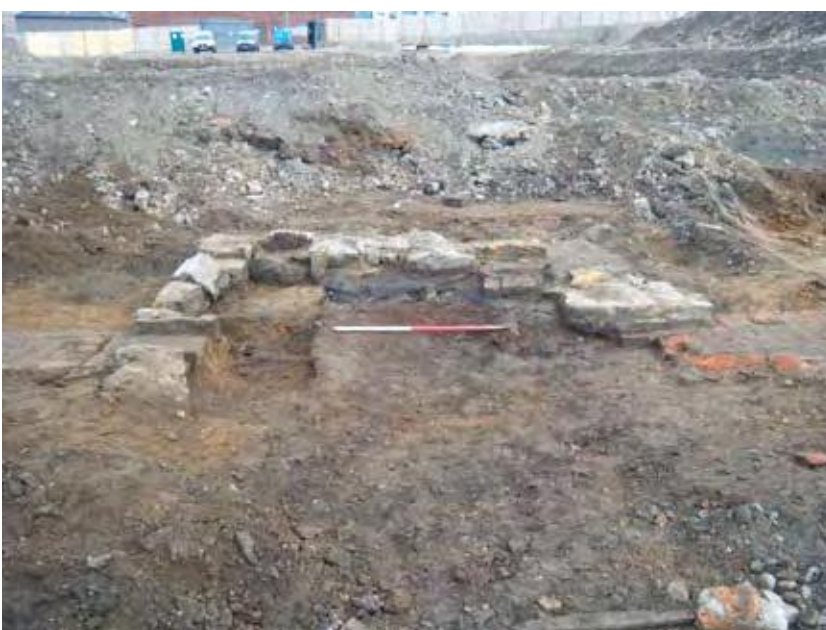
◀ **Illus 35**

General view of stone building [313]/[330] facing E, showing brick support [332] and drains/flues [310] and [323]

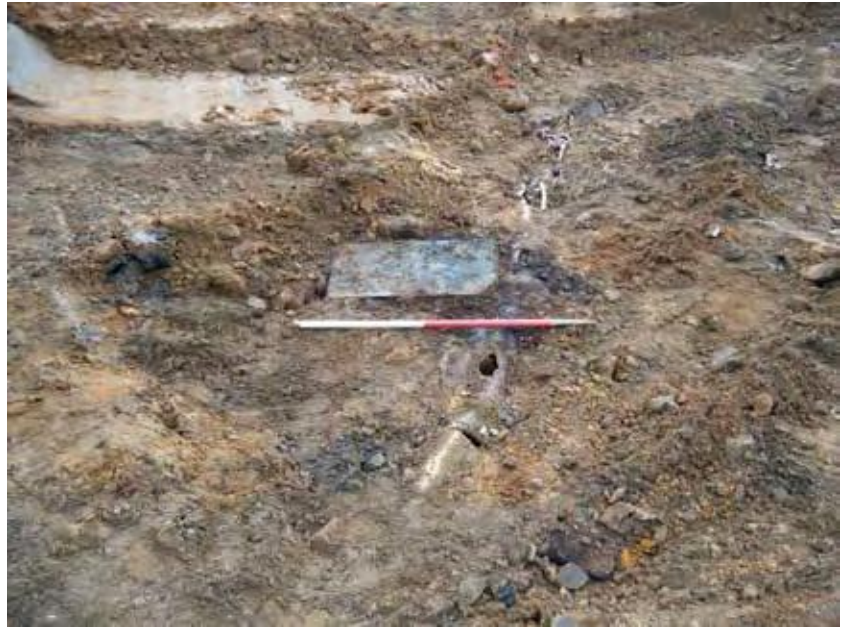
Illus 36 ▶

*View of base of cut [334], showing possible
machine base [336]*

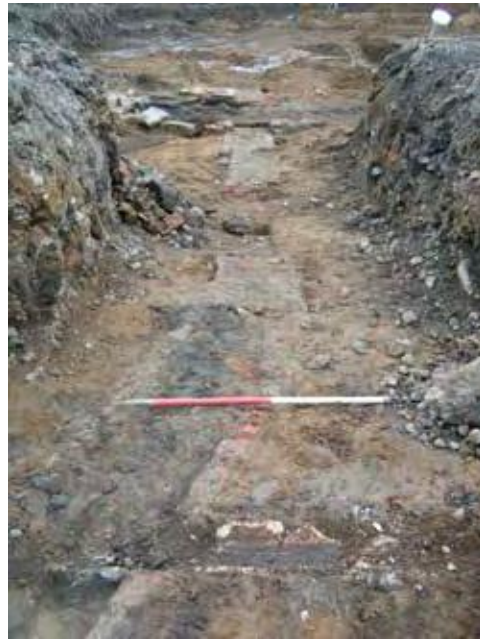
Illus 37 ▶

*General view of flue/drain [323] facing S,
showing drain from area 2 in foreground and
structure [313]/[330] in the background*

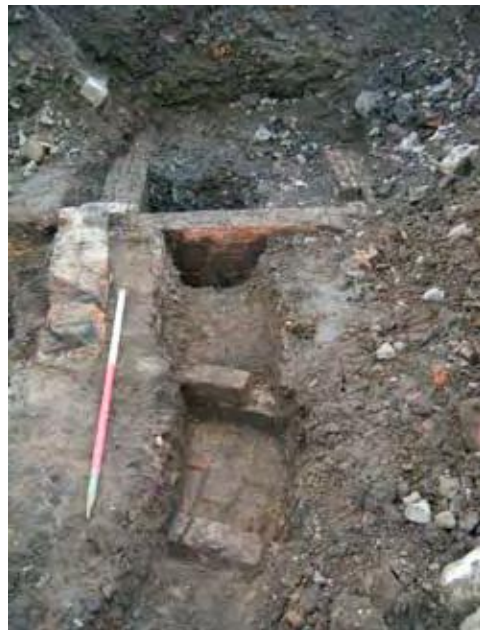
Illus 38 ▶

*Brick tank [327] facing W, showing concrete/
brick structure [325]/[326] and brick flue/drain
[323] in the foreground*

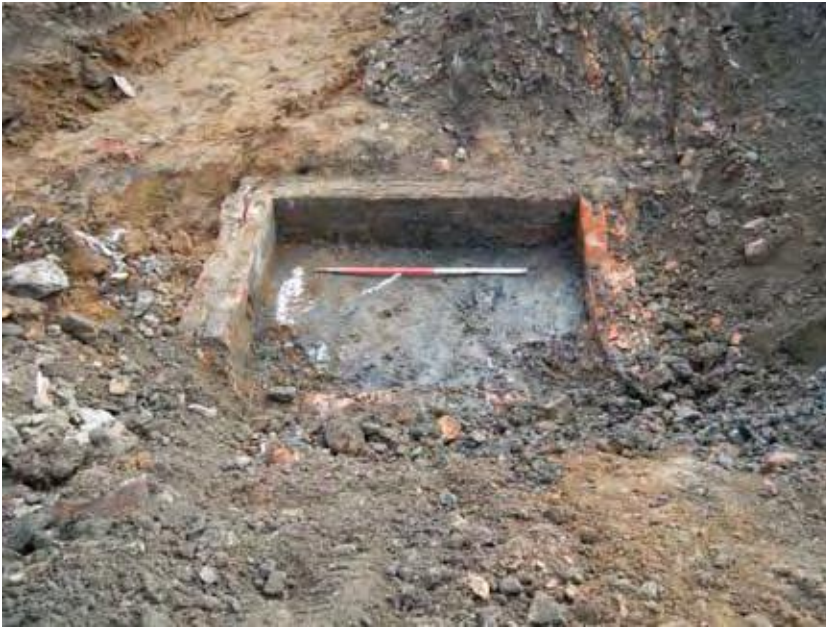
◀ Illus 39

Concrete floor of tank [327] exposed, facing S

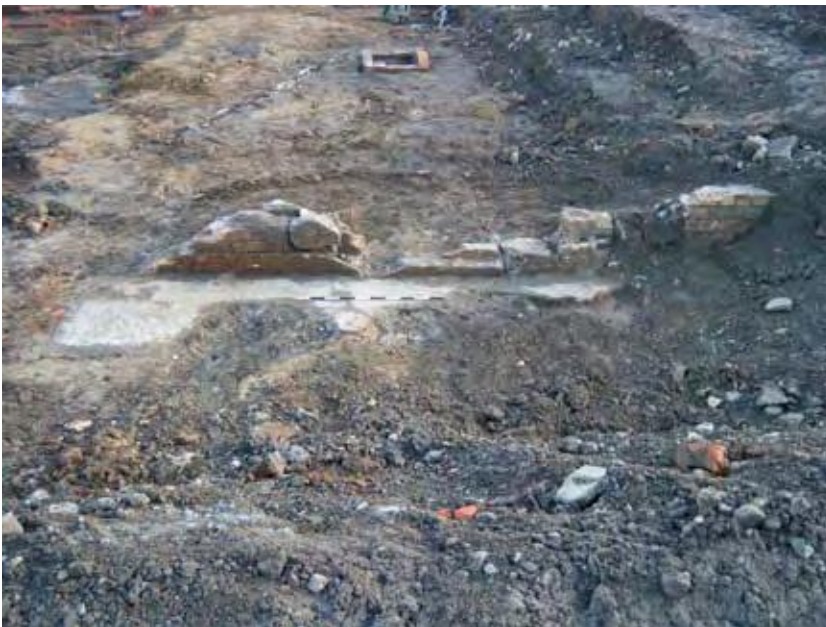
◀ Illus 40

Remains of brick flue/drain [302-4], facing E

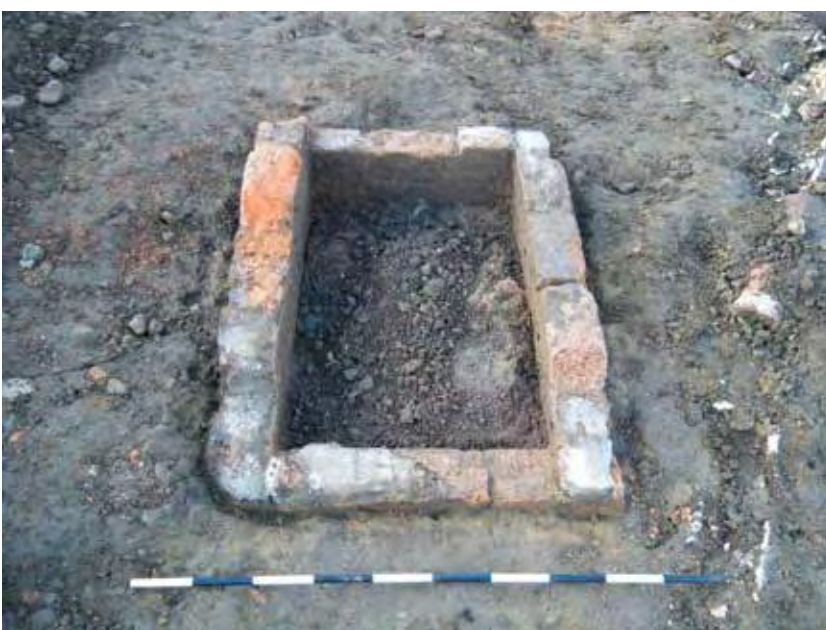
◀ Illus 41

Manhole [301], facing W

At the S end of area 3 stood a small brick manhole (301, Illus 41) measuring 1.1x0.8m, surviving to a height of 0.3m in a narrow construction cut (305). There was no evidence of a floor, and no pipes were seen to enter the structure (though a short length of ceramic drain ran NW-SE immediately to the N).
