FOUNTAINBRIDGE STUDENT RESIDENCES, EDINBURGH

Archaeological Trial Trenching and Excavation

for Cityheart Ltd

February 2012

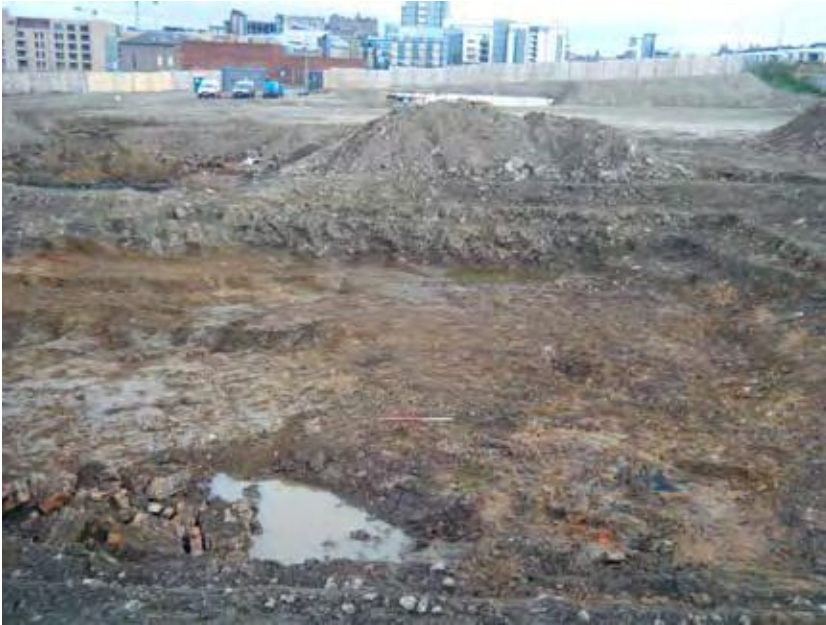
General view of Area 3 facing E, with all features removed

Illus 42 shows Area 3 after the removal of all archaeologically significant features.

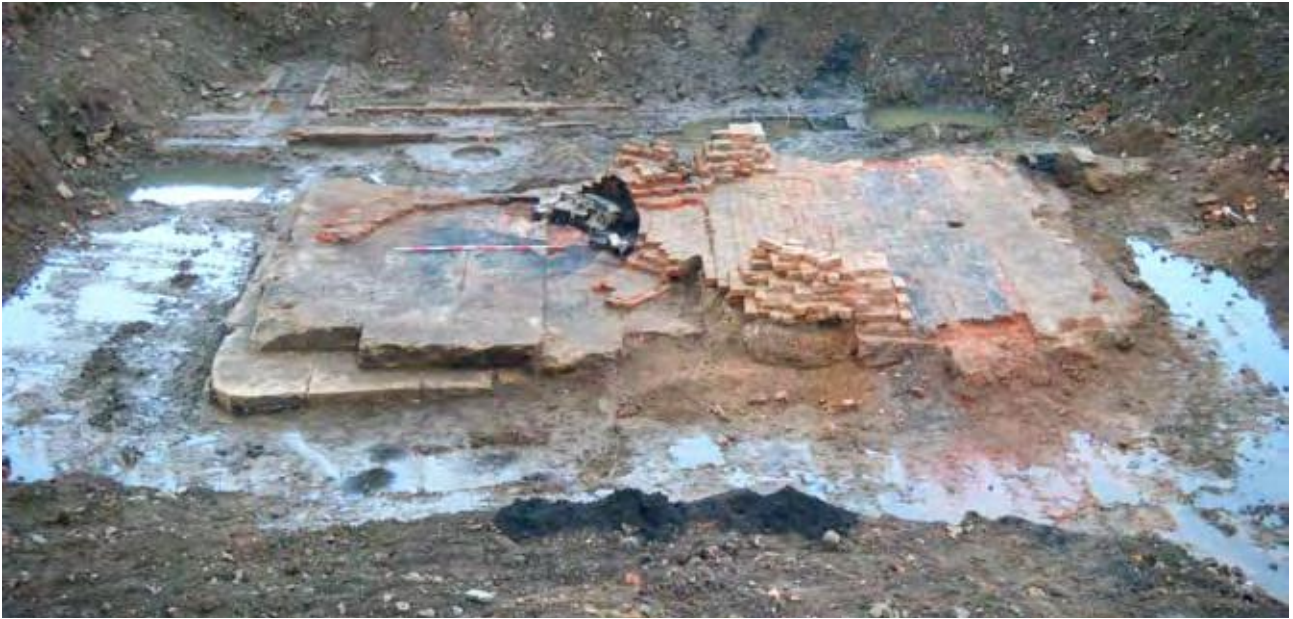
Illus 44

General view of Area 4 facing NE

Area 4 (Illus 12, 43, 44) was located 13m to the south-east of Area 3, and was targeted at the remains of a substantial stone and brick chimney base uncovered in Trench 14. The remains were buried beneath two types of rubble; a mixed, crushed material rubble seen elsewhere on site, but also a more layered, less disturbed brick and mortar rubble as noted in the trial trench stage. The latter was more evident on the western part of the area, suggesting that this area had been less affected by the recent demolition activities. Geological subsoil was encountered approximately 2m below pgl. Although still essentially a gravelly sand, there was a higher clay content and the ground was much wetter, though this may be related to the presence of the Union Canal some 15m to the south-east.

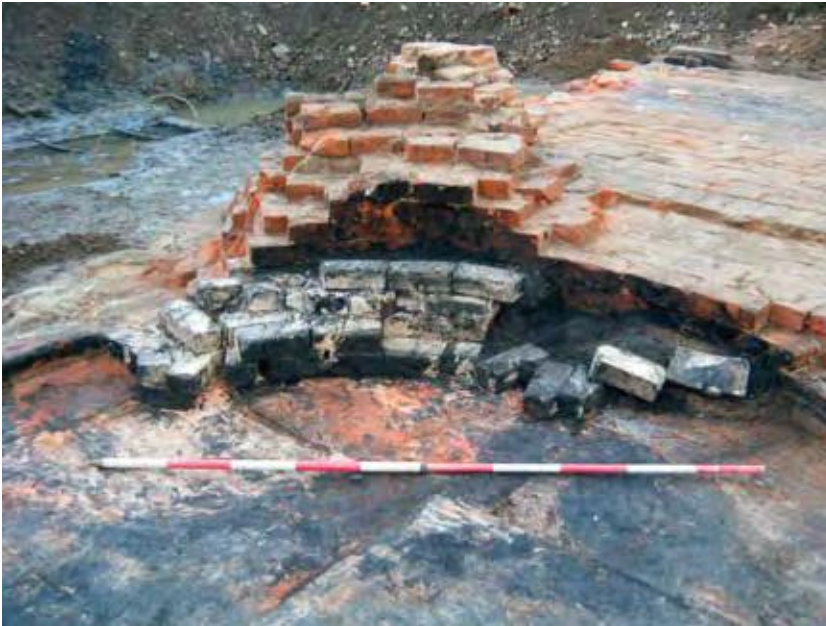
◀ **Illus 45**

Detail of brick chimney [407] facing SE, showing ash/soot deposit [409] and firebricks [408], with buttress [415] behind

6.6x5.3m, with typical slab sizes of 1.2x0.9m, each one some 0.2m thick. The joints between slabs were packed with a grey clay. Built directly onto this surface was the base of the brick chimney [407] (Illus 45), with an external diameter of 4.8–5.2m, and 3.2m internally. A little over half of the circumference remained (although some of the missing western section was recorded during the evaluation, standing between 1 and 9 bricks high and 6 bricks thick. It was built of red, unmarked bricks bonded with a fine lime mortar. A number of plain white firebricks were found *in situ* inside the south-east edge of the chimney. Over these and the stone floor, lay a black ashy/sooty deposit [409].

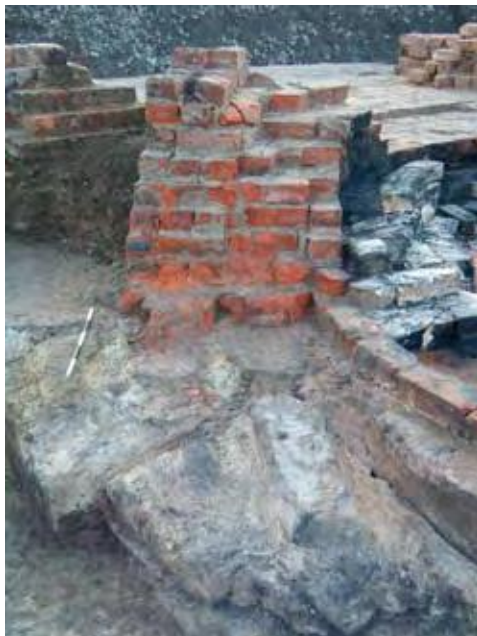
◀ **Illus 46**

Section of brick chimney [408] facing SW, showing rubble infill [410] behind

Abutting the chimney to the south-east lay a compact rubble deposit [410] (Illus 46) consisting mainly of stone and brick fragments and crushed mortar. Into this was cut (423) a second rubble deposit (413), containing a significant volume of cement, which forms a levelling for a series of walls and floors (see below and Illus 47). This may suggest that the latter structures were not constructed at the same time as the chimney itself.

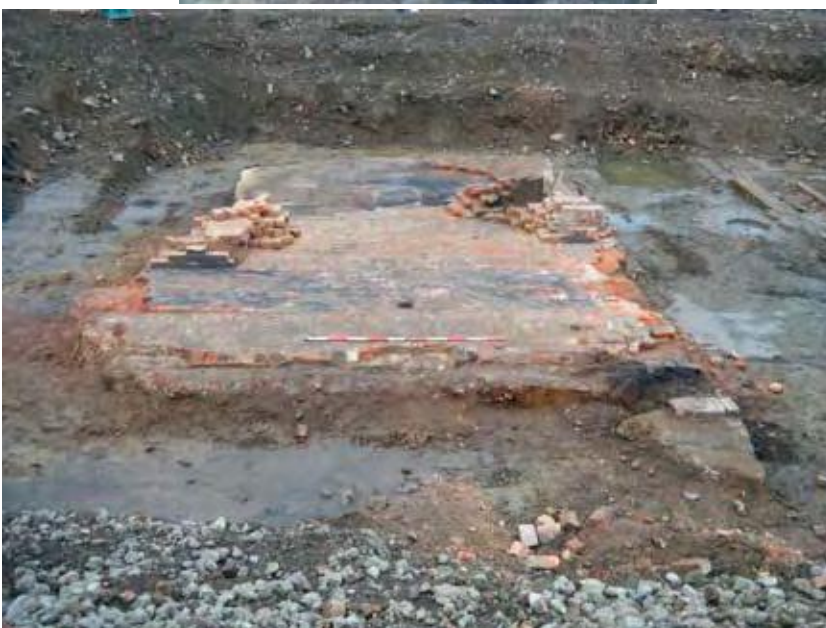
◀ **Illus 47**

General view of floors [414], [418] and [420] facing NW, with cement base [413] visible beneath

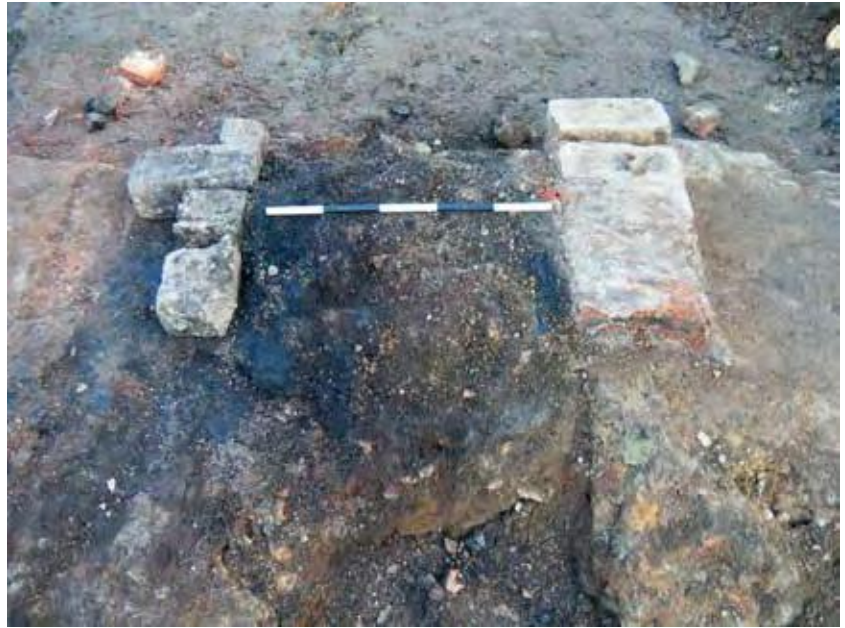
Illus 49 ▶

General view of brick drain/flue [402] and well [494] facing NW. The top stone step is just visible in the foreground

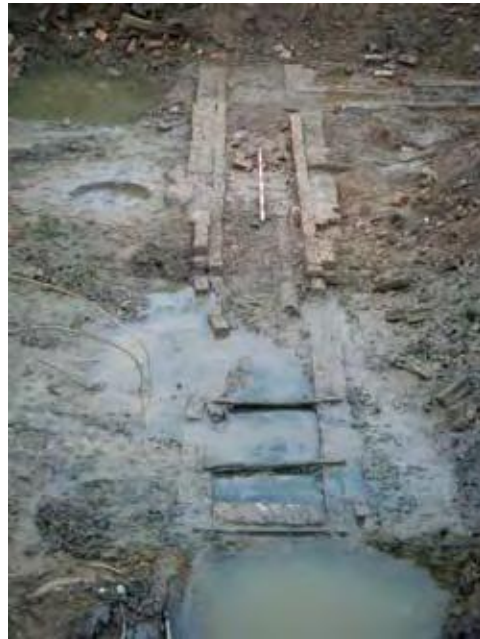
Illus 50 ▶

Brick drain/flue [402] after excavation facing SE, showing cement lined base and stone steps

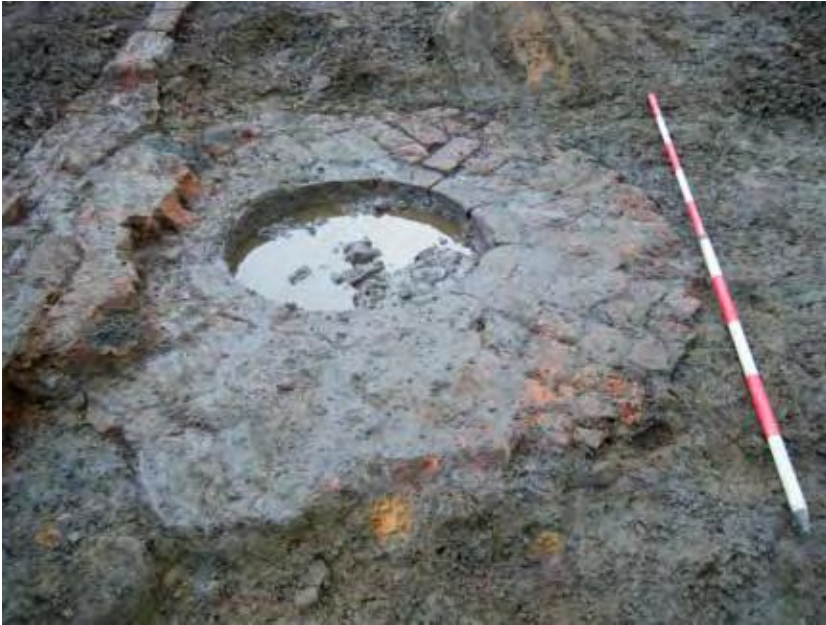
◀ **Illus 51**

Detail of brick well [404], facing SE

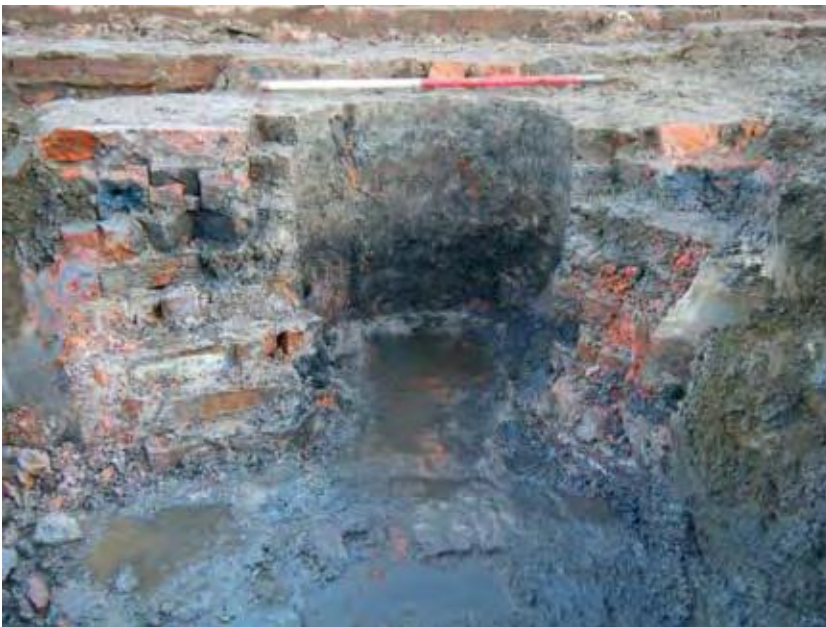
◀ **Illus 52**

Brick well [404] with W side removed, showing brick base, facing E

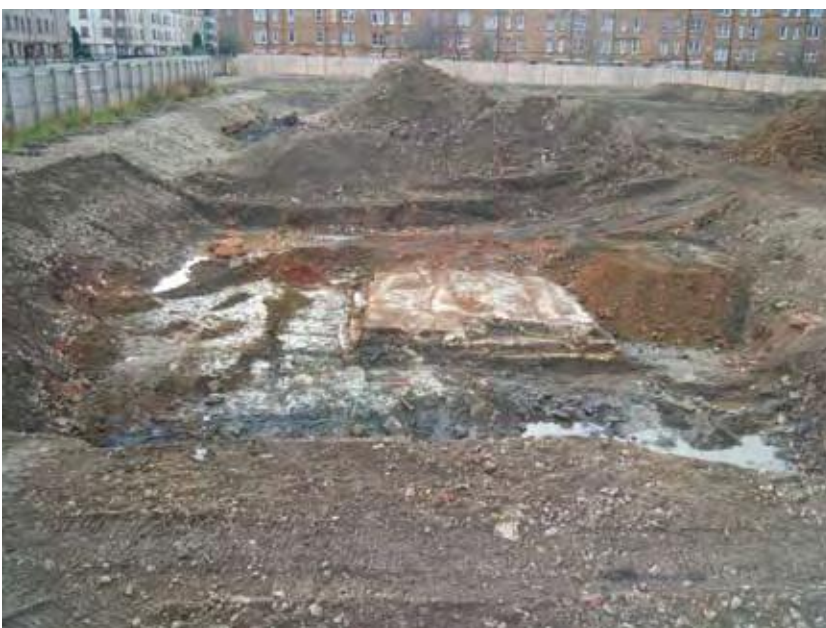
◀ **Illus 53**

Area 4 with all features (except the sandstone chimney base) removed, facing SW

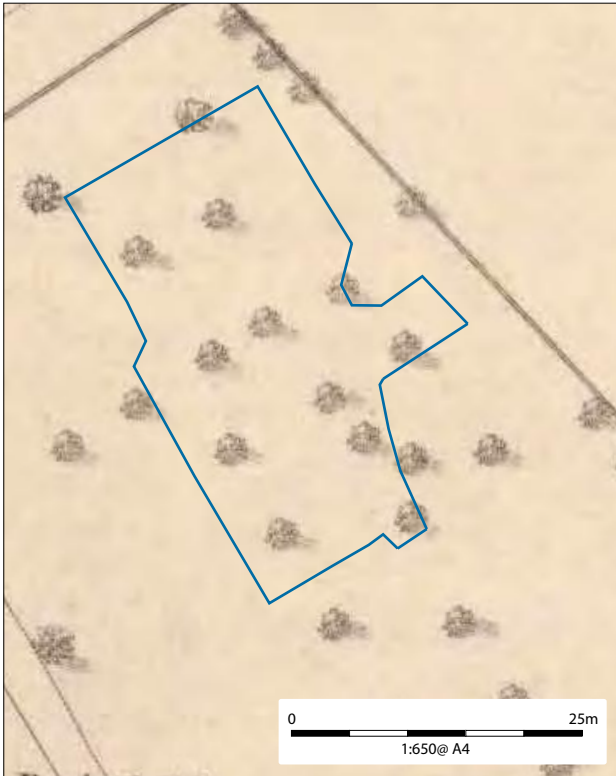
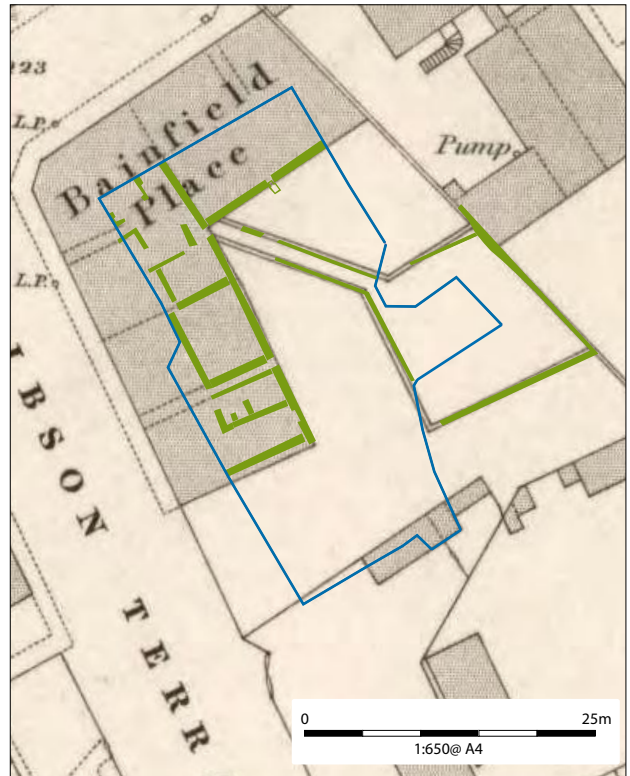
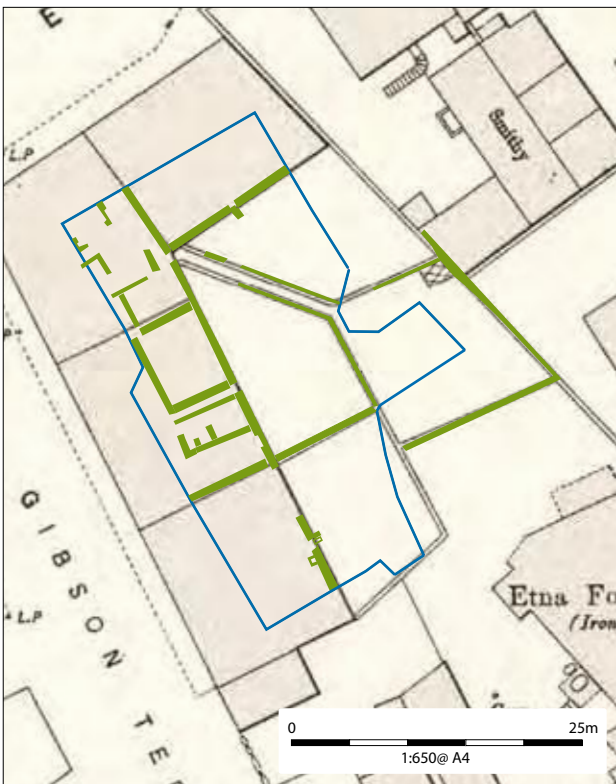
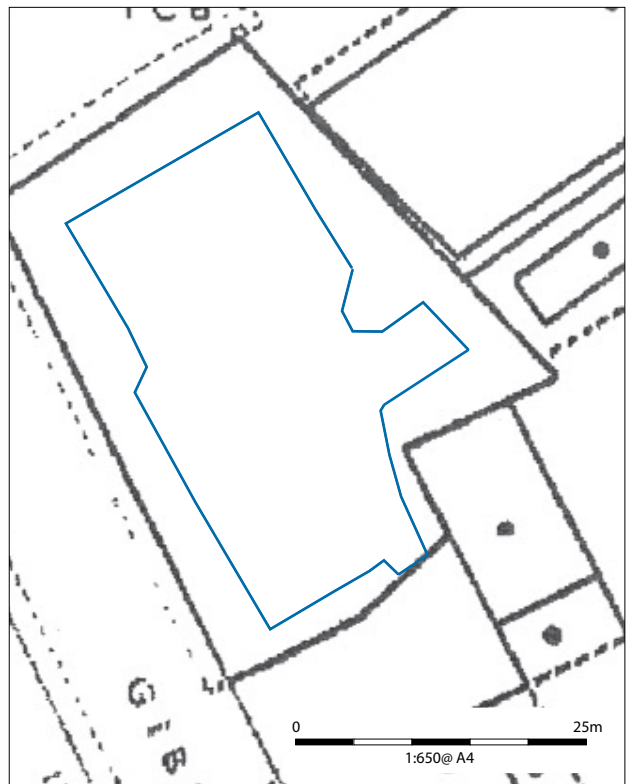
Bainfield Place Tenements - main features overlaid on OS 1st Edition (1851)

Bainfield Place Tenements - main features overlaid on OS 2nd Edition (1877)

Bainfield Place Tenements - main features overlaid on OS 3rd Edition (1893)

Bainfield Place Tenements - main features overlaid on 1982 OS

The primary source of information regarding the construction phases of these buildings is the Ordnance Survey maps (Illus 54). No other documentary evidence was found in a search of easily accessible records. From the map evidence, it can be seen that the first tenements were built between the 1850s and 1870s on land formerly belonging to Bainfield House. The eastern boundary of the estate defined the eastern limits of the tenements and their gardens and indeed the boundary between the Viewforth Works and other industrial buildings. It is possible that the large, early cut [131] in the garden area may have been backfilled with rubble accumulated from replacing the estate wall with a new one.

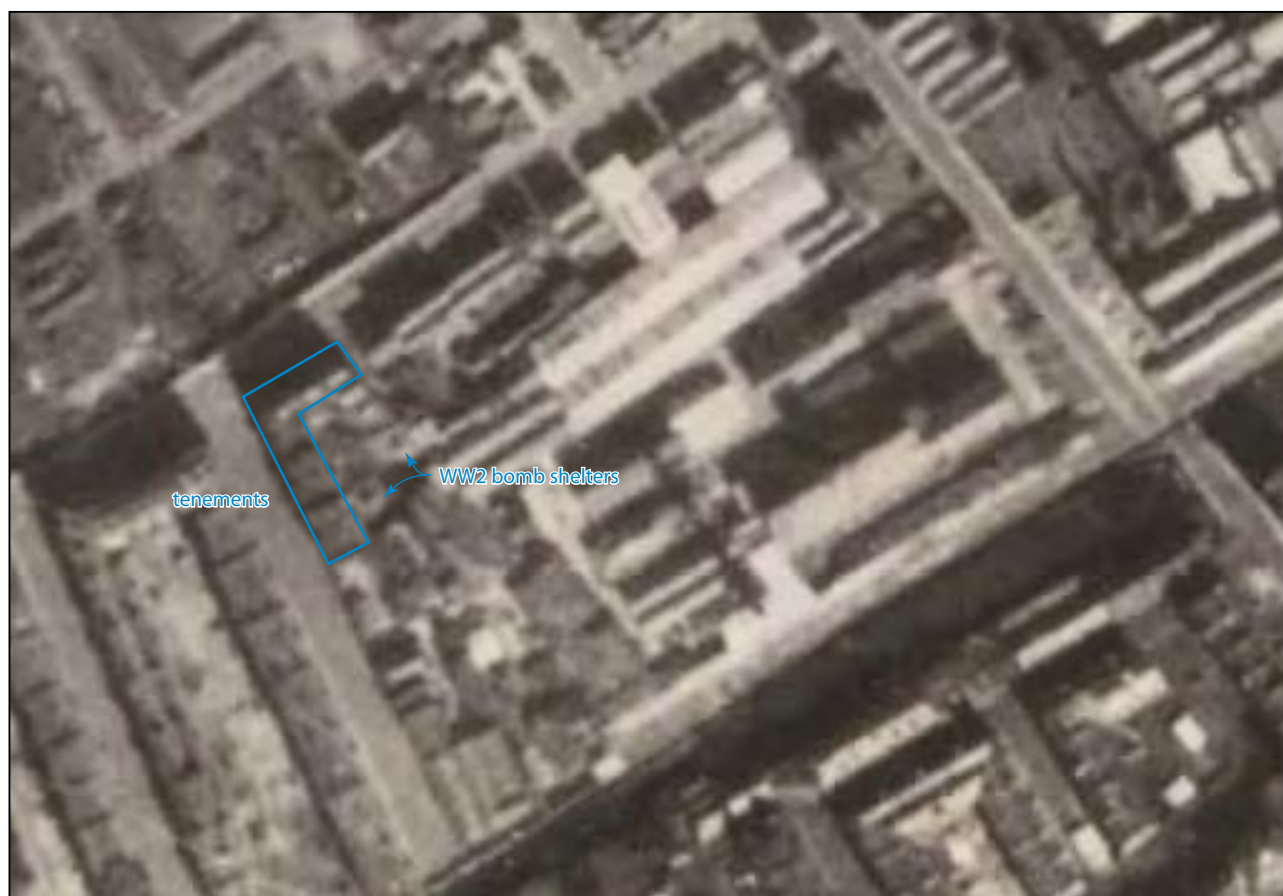
Illus 55

1946 OS air photo, showing location of WW2 bomb shelters

(Illus 55). It may be suggested that the iron railings fixed to the top of the boundary wall [101] were removed during wartime. Some further buildings are visible in the gardens in this photo. These do not appear on OS maps nor were any traces found during the excavation.

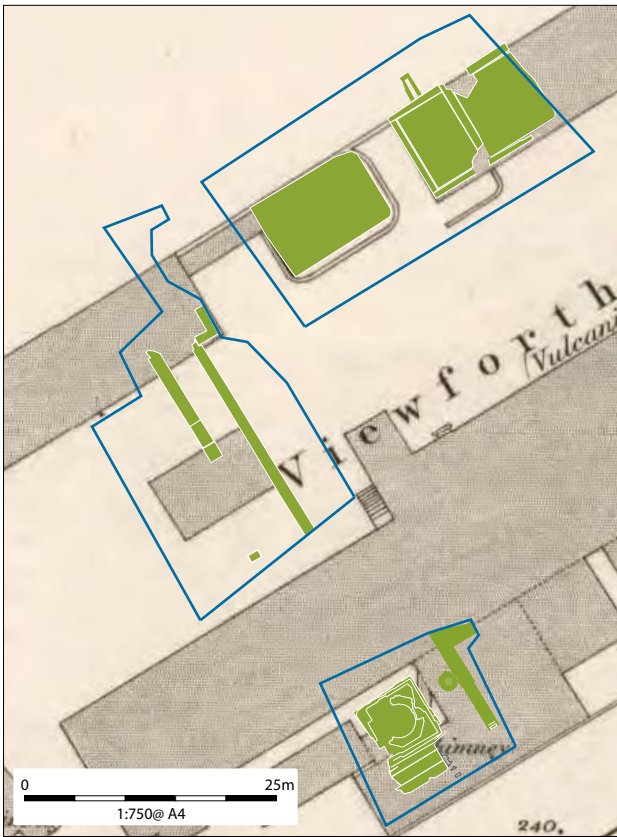
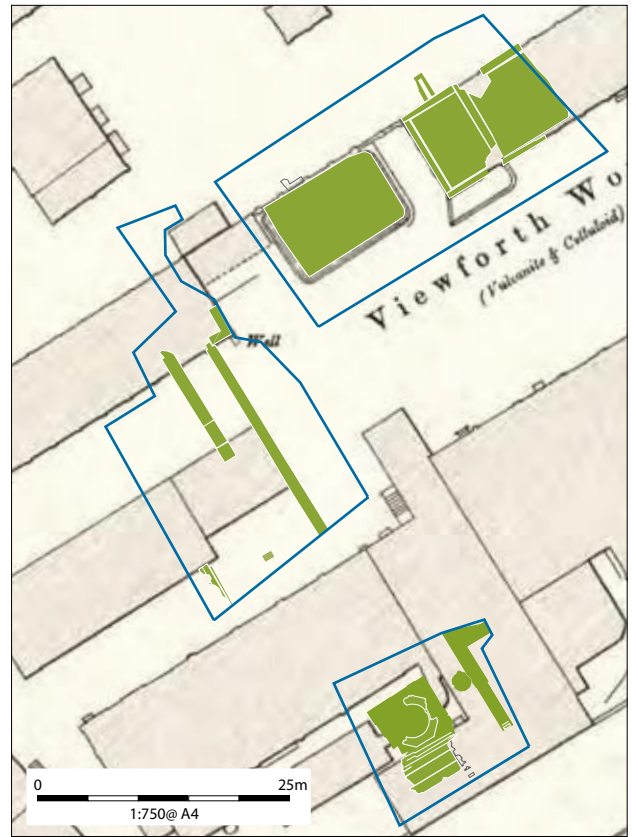
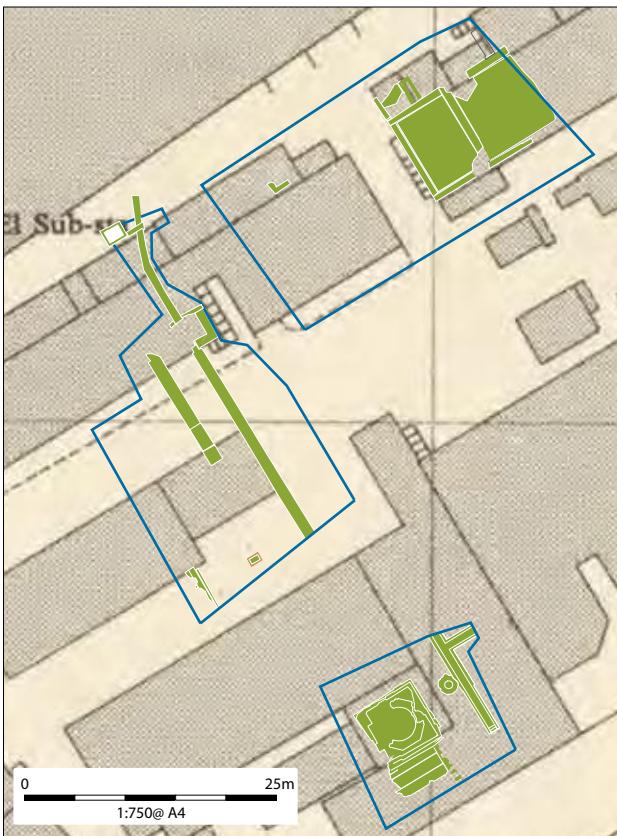
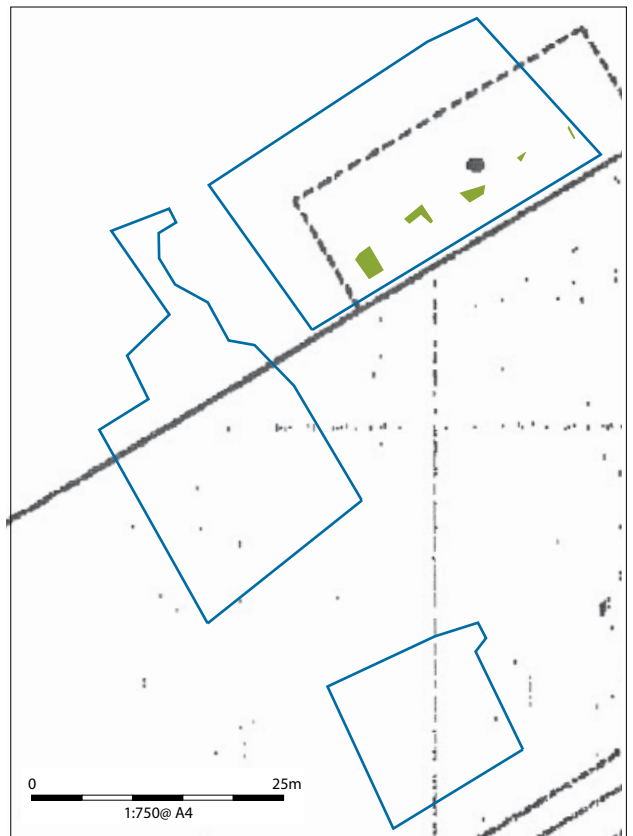
Viewforth Works - main features overlaid on OS 2nd Edition map (1877)

Viewforth Works - main features overlaid on OS 3rd Edition map (1893)

Viewforth Works - main features overlaid on OS 1942 map

Viewforth Works - main features overlaid on OS 1982 map
