GATEWAY THEATRE, 140–144 ELM ROW

Archaeological Works

for Watkin Jones Group

HA Job no.: GTER11/002

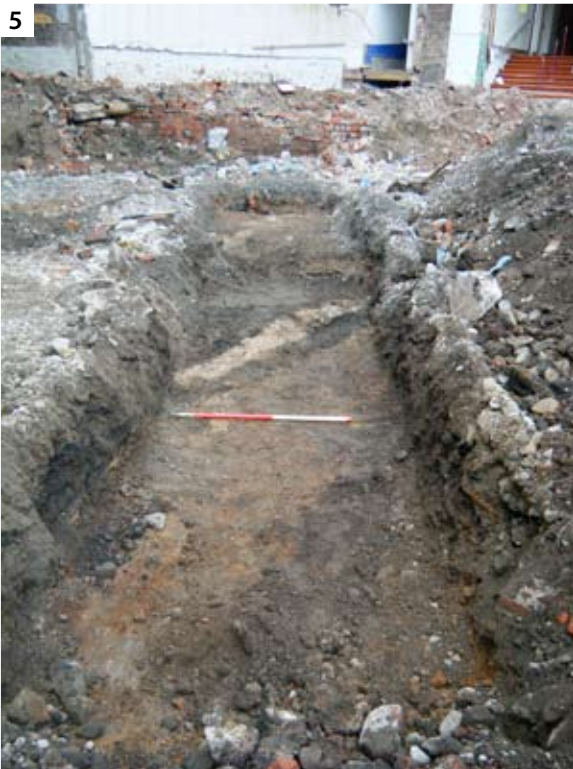
▼ **Illus 5**

General view of Trench 1

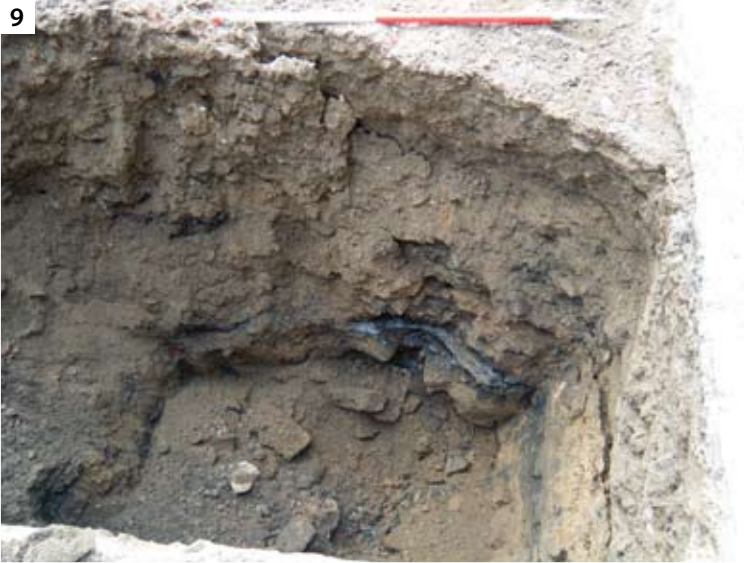
◀ **Illus 9**

Test Pit 4 showing the N-facing section

The first of these test pits (TP1), located to the W end of the area, was excavated to a maximum depth of 2.2m. Unfortunately due to the depth of the test pit and the unstable nature of the section it was difficult to define many of the features recorded. The north facing section (*Illus 9*) revealed a layer of mid brown sand [117], possibly representing the geological subsoil which had been truncated by a stone-lined culvert [118] 1.3m below the surface. Above this was a shallow layer of compact cinder, possibly forming an old ground surface (this material was also recorded in TP4, Trench 3 and around the stone pillars to the south). The upper 1.25m of fill in this test pit was a soft light brown course sand probably forming a levelling layer for the stables. The test pit revealed that the stone foundations to the stables were substantial as the bases of the walls were not identified.

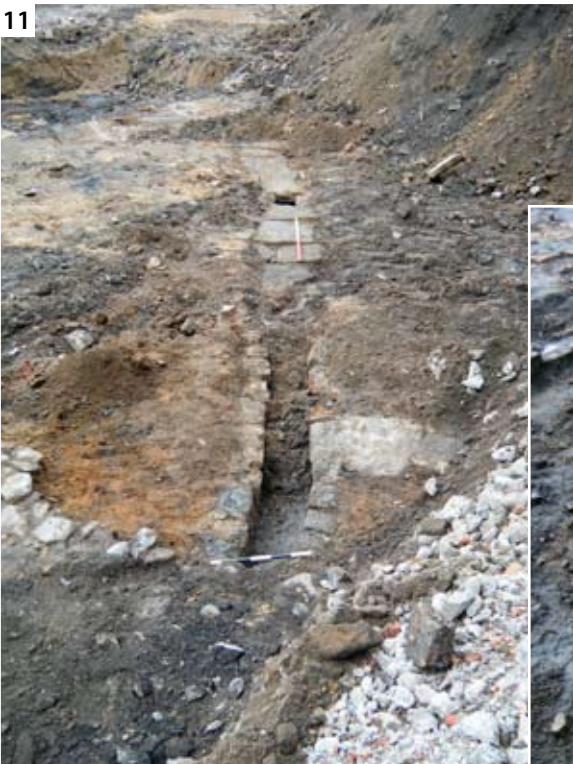
▶ **Illus 11**

Detail of the stone lined culvert [128]

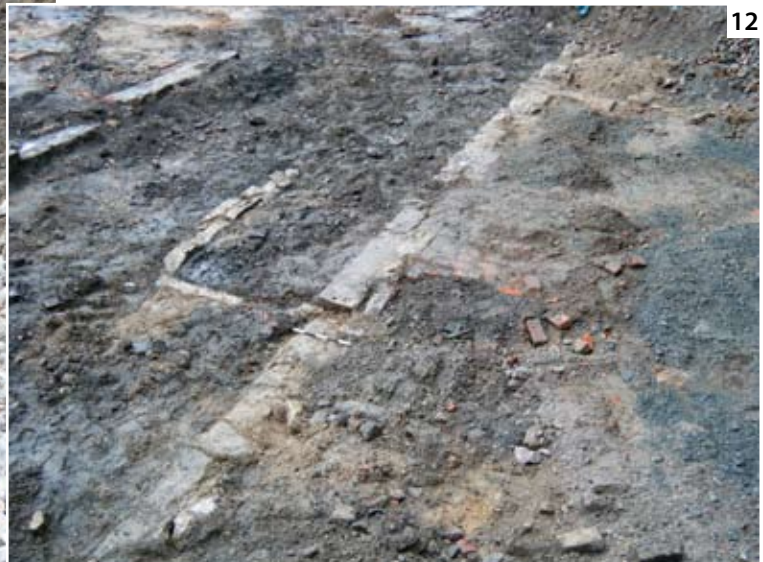
General view of stone wall [136]

Further to the east and cut into the garden soil [143] was a substantial rubble stone wall foundation [136] aligned NW–SE running across the SW corner of the monitored area (*Illus 12*). The wall was 0.5m wide standing to a maximum height of 0.7m (30.2m OD) at the NW end and was bonded with lime mortar. Close to the SE end of this wall a keyed-in return wall continued to the SW. At the NW end the wall continued into the east facing section of the monitored area. Within the make up of the wall two large, square-cut stones formed a step or doorway towards the NW end (29.8m OD) (*Illus 13*). This wall seemed to form one side to a building pre-dating the Veterinary College building. Abutting the SW side of the wall and opposite the cut-stone step, a small area of brick floor [138] was recorded. The rest of the floor [141] to the SW side of the wall comprised a compact mortar, c 0.4m thick, overlying the garden soil. A low brick wall [142] close to the SW corner of the monitored area and contemporary with the floor [141] probably formed the remains of an internal wall associated with the building represented by stone wall [136]. To the NE side of the stone wall and opposite the cut-stone step was a narrow brick wall [137] bonded with coarse, grey cement. This wall was 1.5m long and aligned NE–SW linking wall [136] to a second stone wall [135] further to the NE. This second stone wall [135] ran parallel with wall [136] but was only 0.33m wide and 2.8m long. This wall, along with brick wall [137], seemed to form a porch area leading to the step in the main wall [136].
