396 GORGIE ROAD, EDINBURGH

Archaeological Excavation

For UK Student Accommodation 1 Ltd

Planning Reference: 11/02827/FUL 7th July 2016

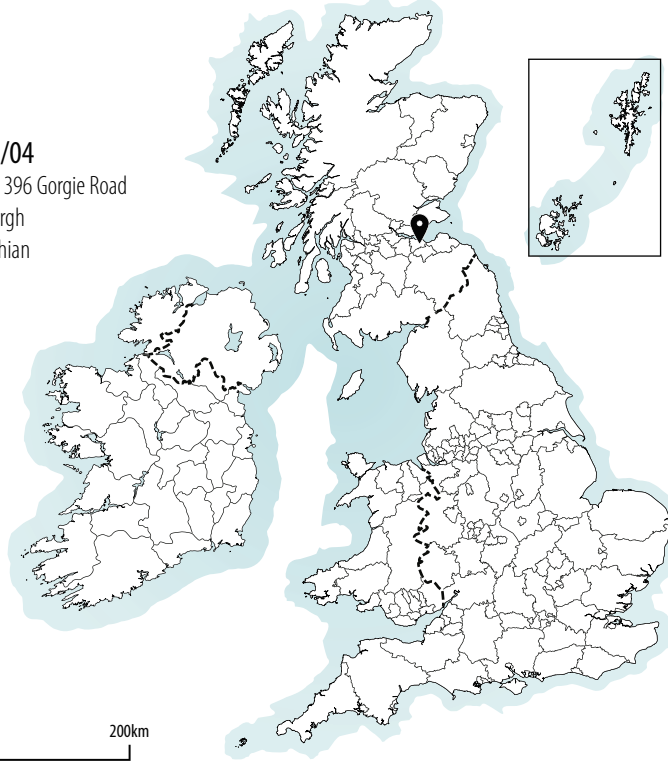
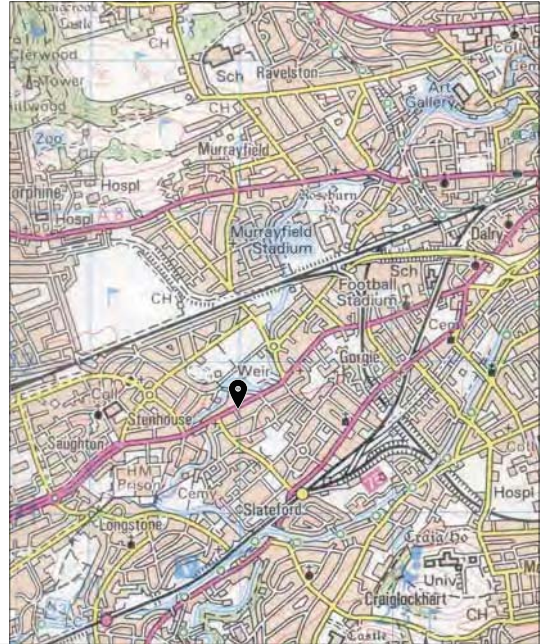
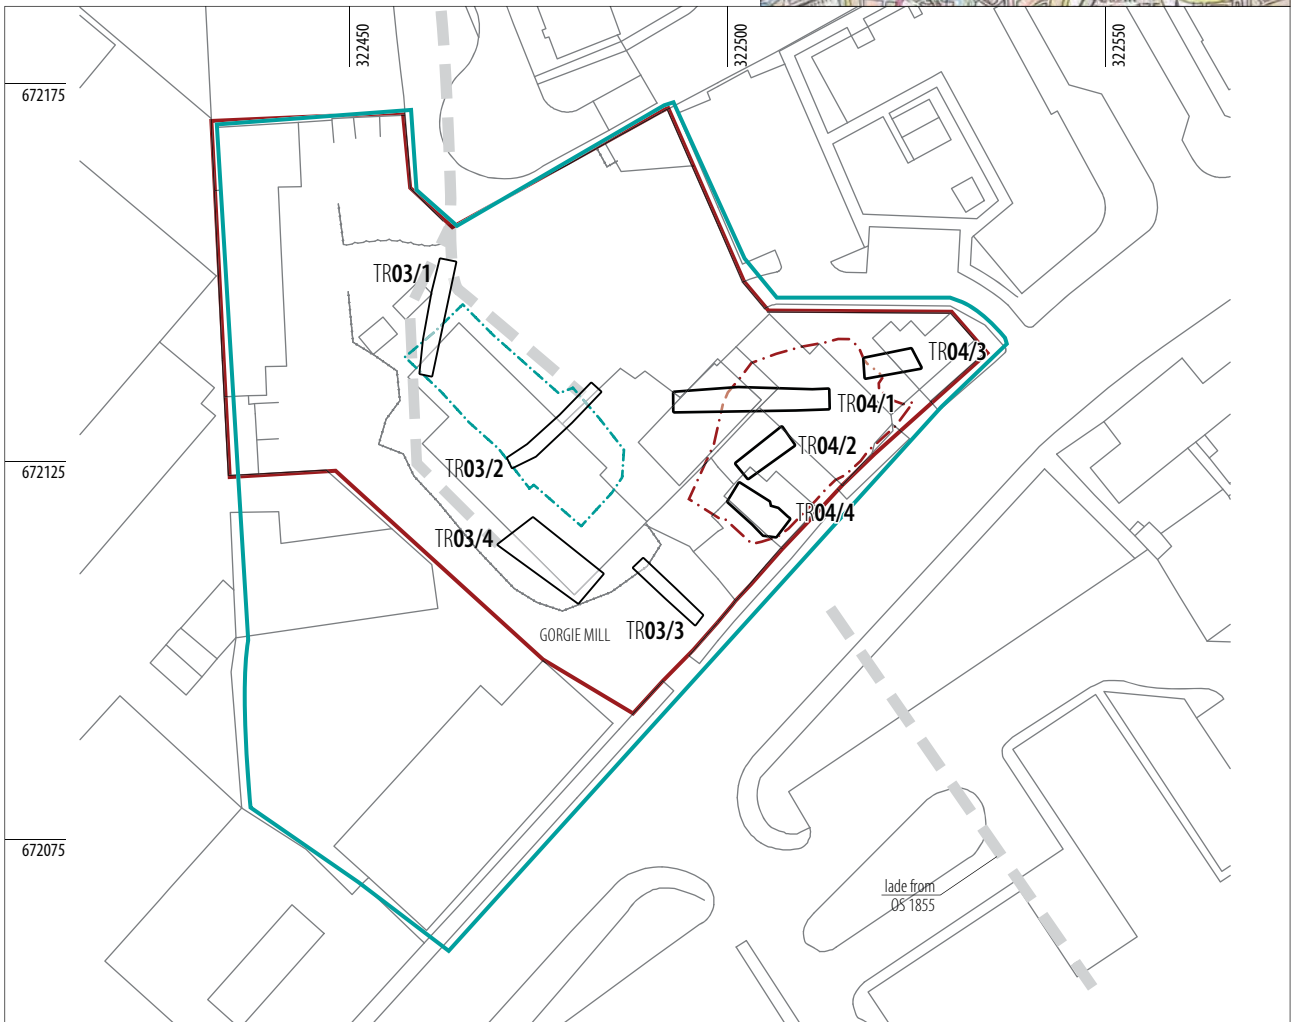
ILLUS 1 Site location

GORE/04
land at 396 Gorgie Road
Edinburgh
Midlothian

- KEY**
- GORE/03 site boundary
 - GORE/04 site boundary
 - GORE/03 limit of excavation
 - GORE/04 limit of excavation
 - trial trench location

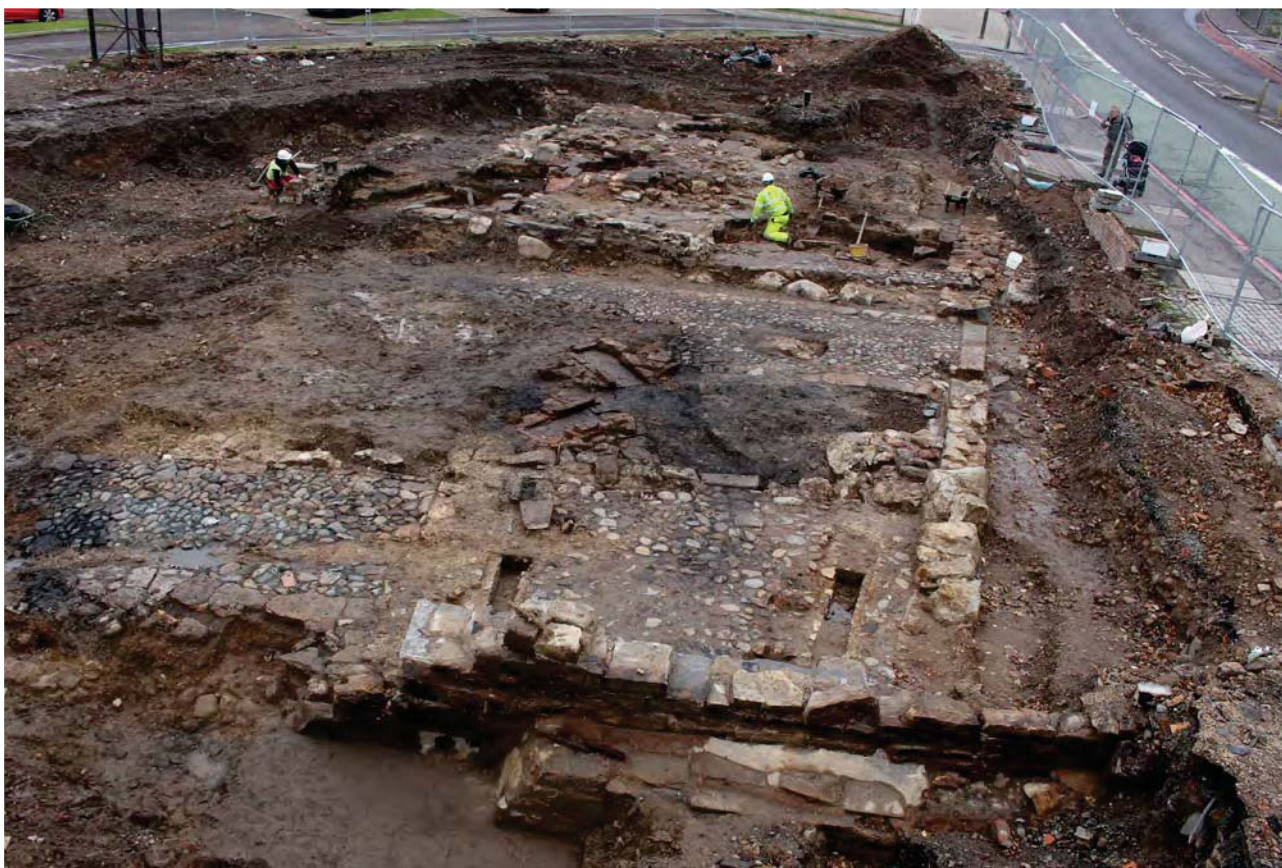
ILLUS 10 View of Mill (Building A), facing east

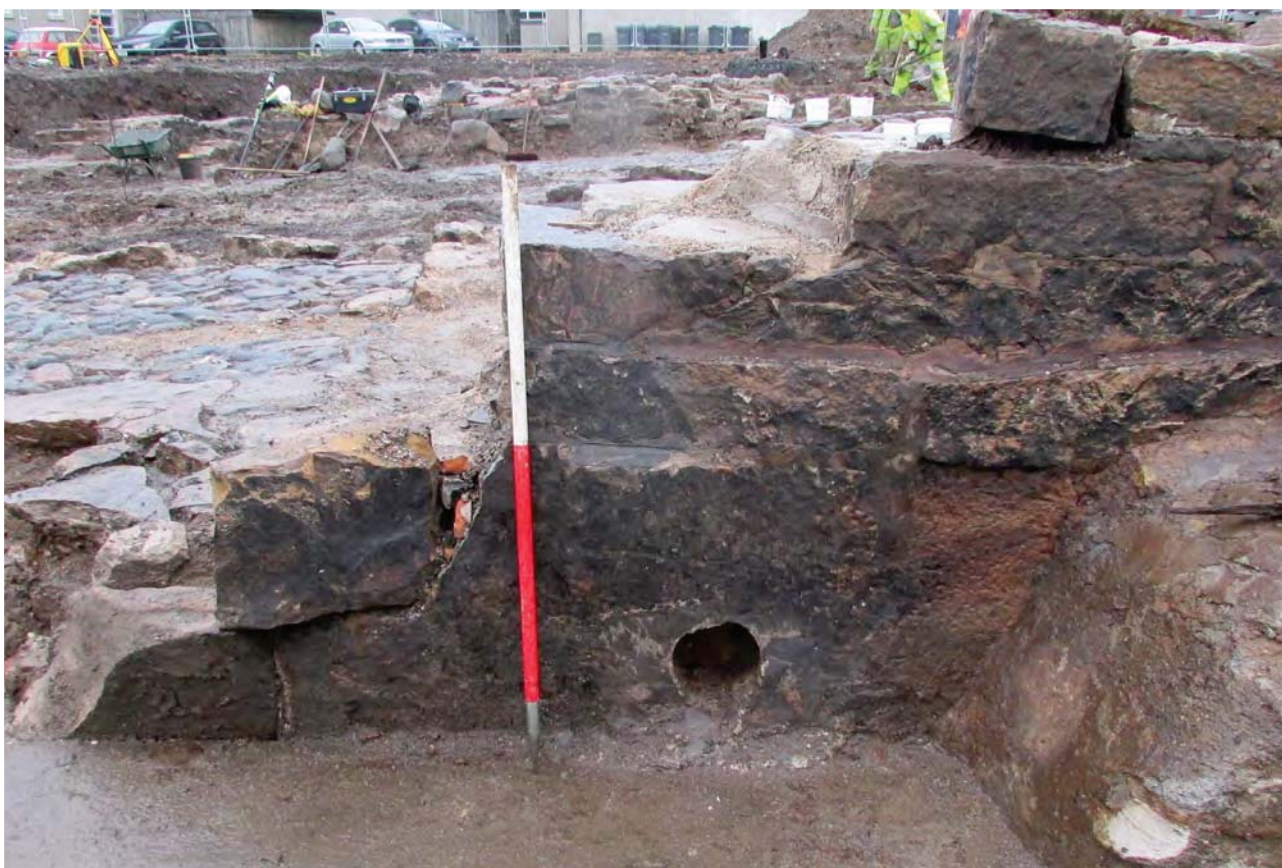
ILLUS 11 View of axle socket in Wall 1004, facing east

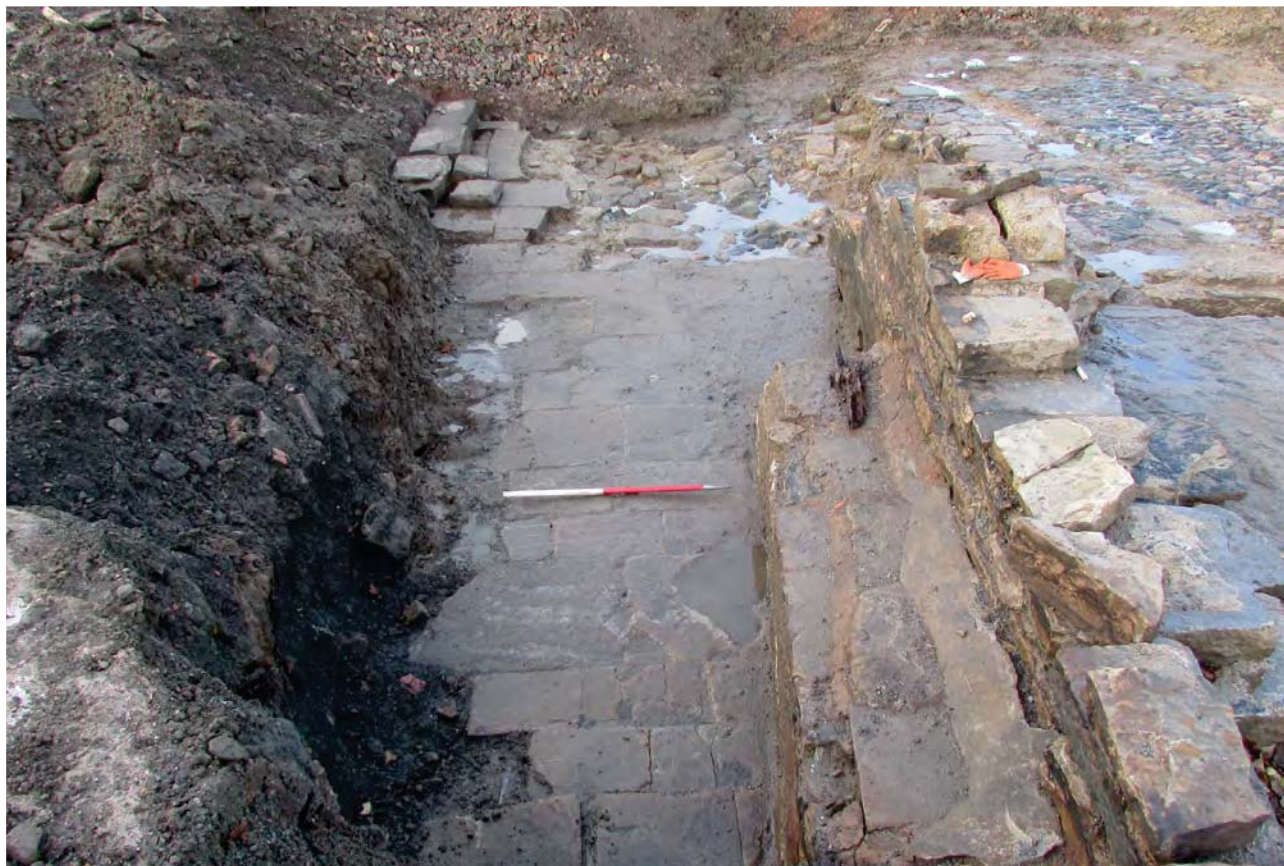
ILLUS 12 View of paved surface 1066 adjacent to the Mill and Lade, facing northwest

have been repairs to replace damaged flagstones. The surface had been truncated to the southwest, along the limit of excavation.

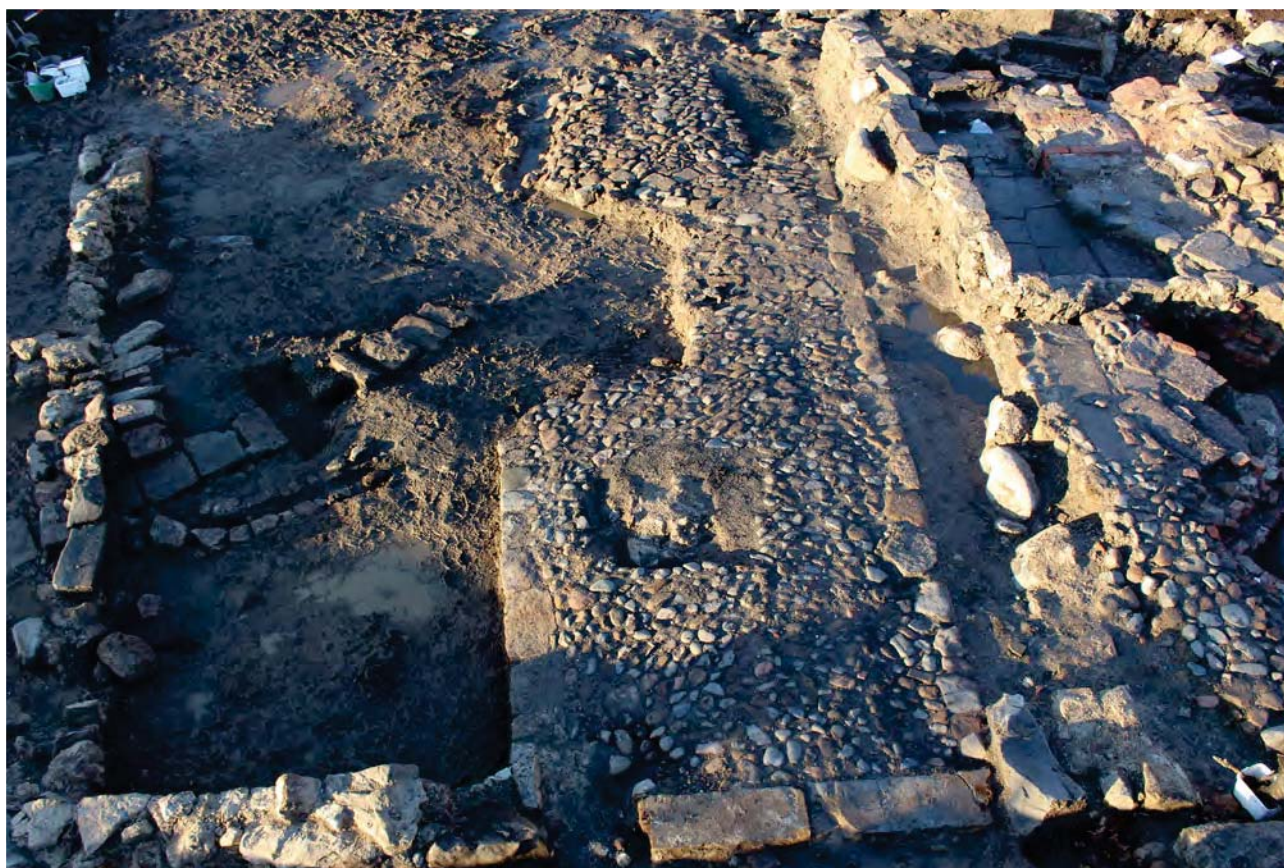
ILLUS 13 View of cobbled lane 1076, facing northwest

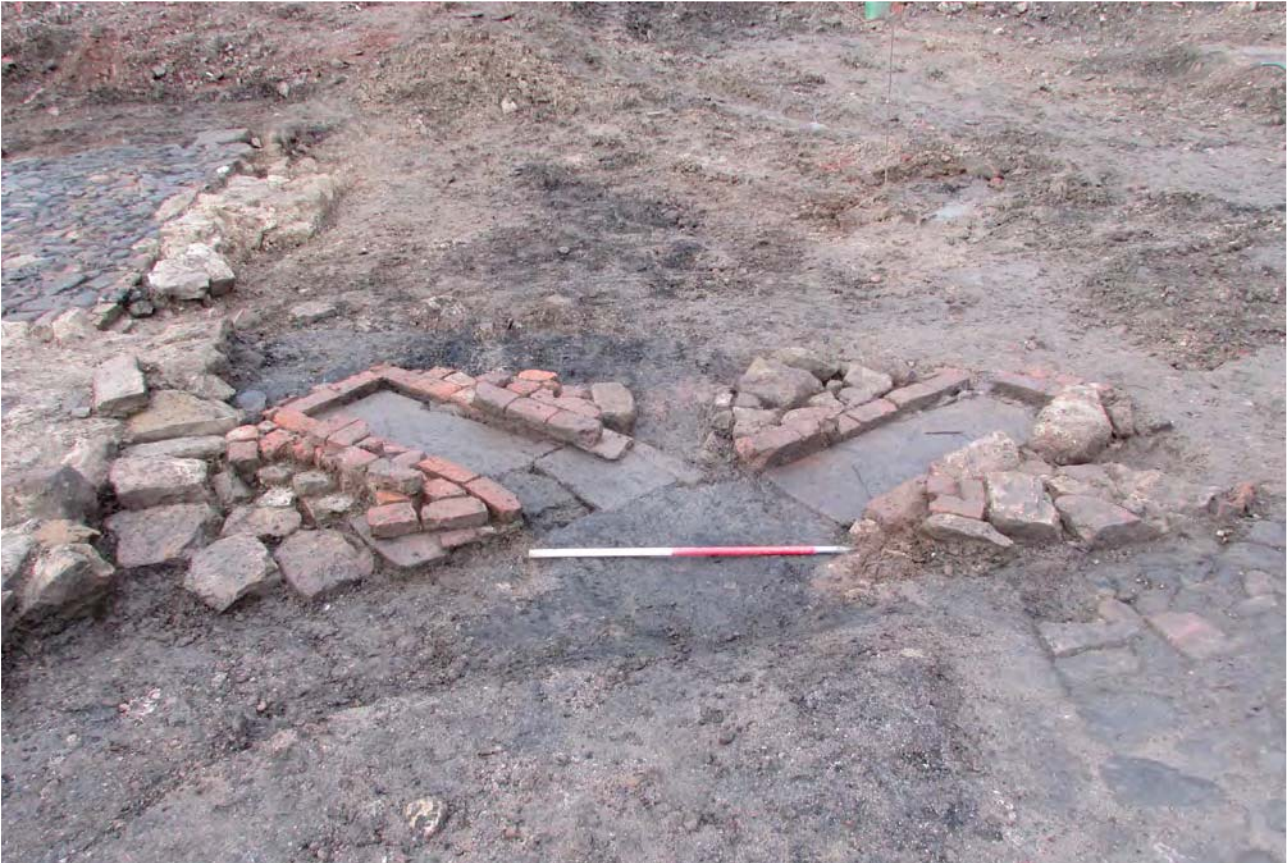
ILLUS 14 View of kiln bases 1072 and 1073, facing north

flue for the kiln. Post-dates cobbled surface 1075. Structure filled by/overlain by 1100 and likely cut into demo layer 1074.
1073	Flue base	Rectangular brick structure paved with 2 flat stone slabs on the interior and roughly faced stones on the exterior forming a semi-circular arrangement at the E and W edges. 0.10m E of an identical structure 1072. One of pair of flue bases associated with a central kiln which was demolished in antiquity. No evidence of heat affected stones. Truncates cobbling and edging stones 1075 and 1076. Foundation cut 1101.
1074	Compacted floor layer	A compact deposit of dark brownish-grey silty sand located between wall 1012 and edging stones 1076. Abuts possible machine base 1015. Contains abundant lime mortar, clinker, general demolition material and small stones/pebbles compacted to form a floor layer/surface. Same as 1040.
1075	Cobbled surface of lane/road	Same as 1043.

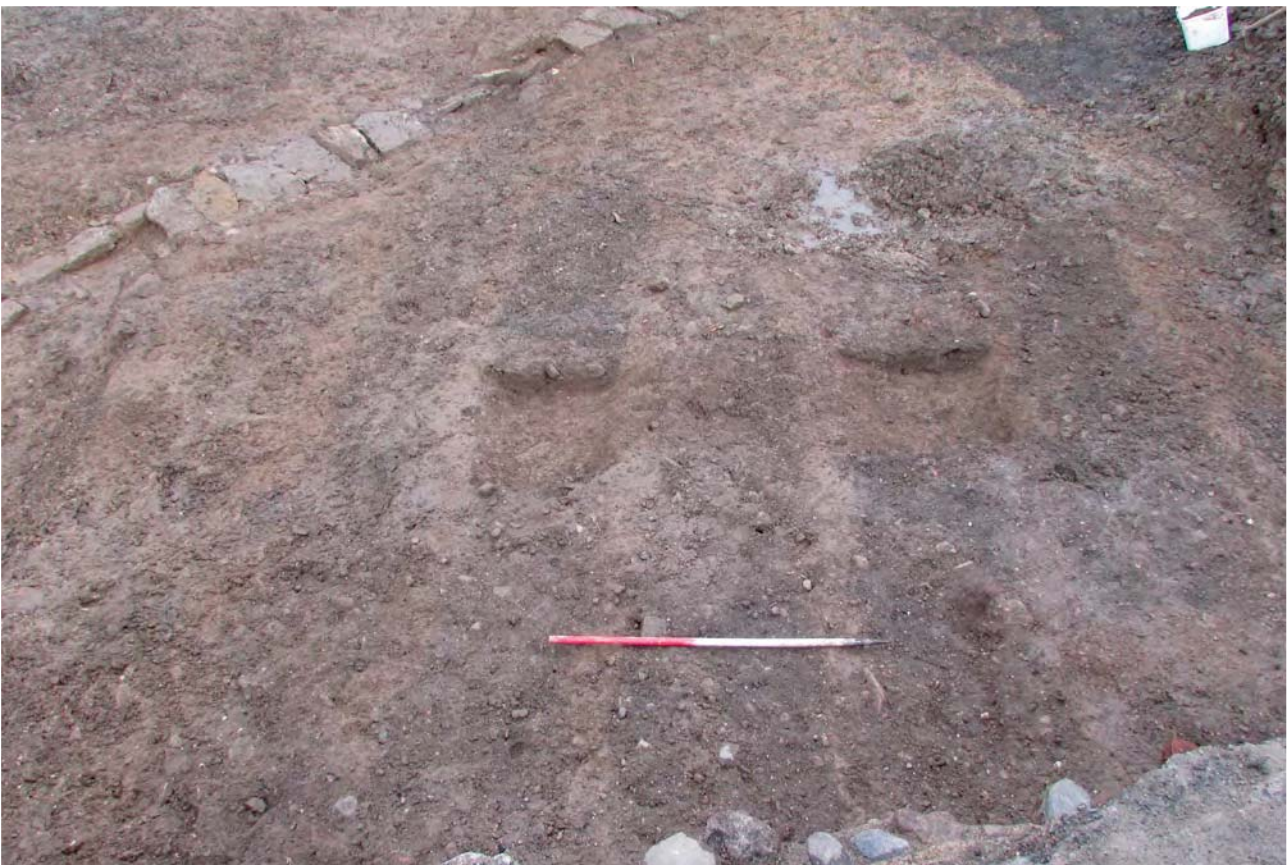
ILLUS 15 View of lazy bed furrows, facing northwest

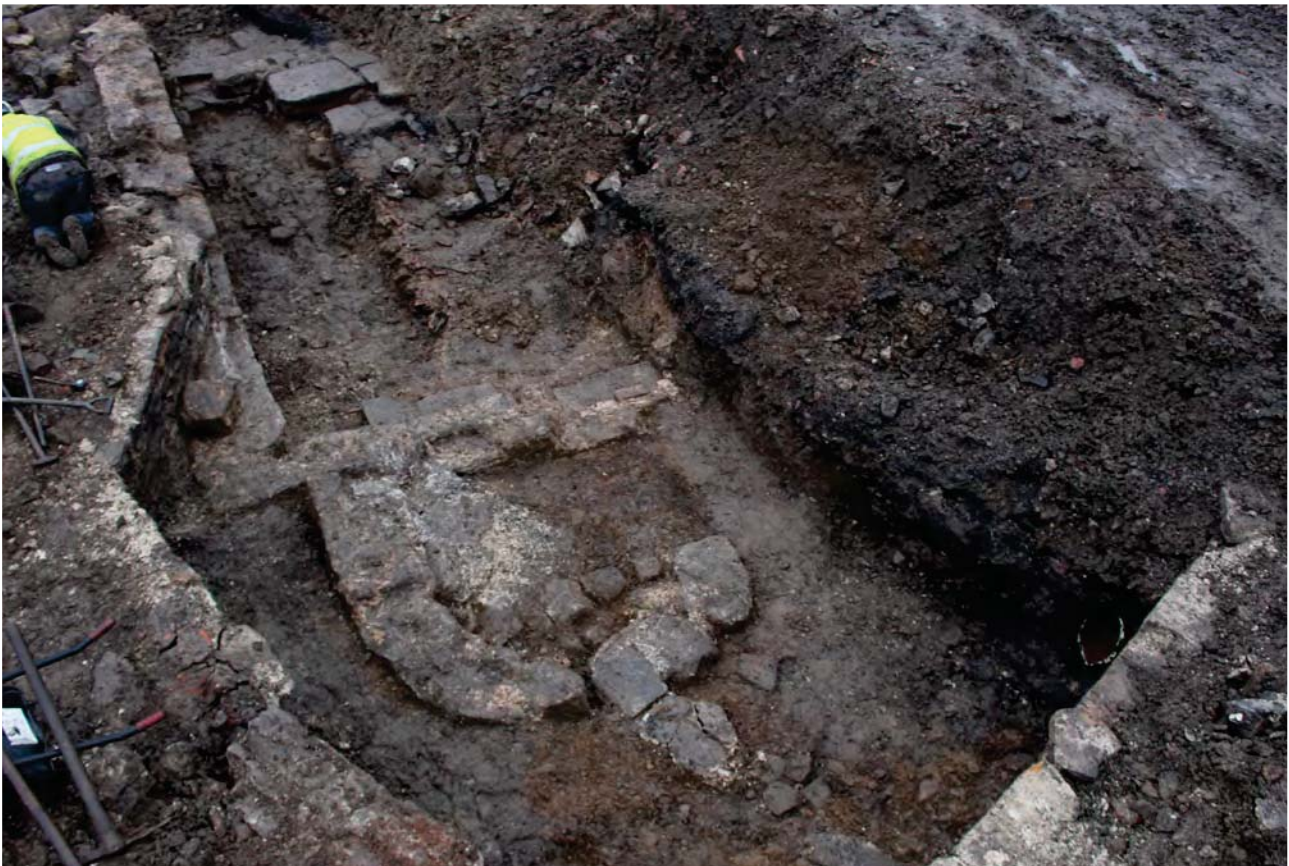
ILLUS 16 View of Building C, facing west

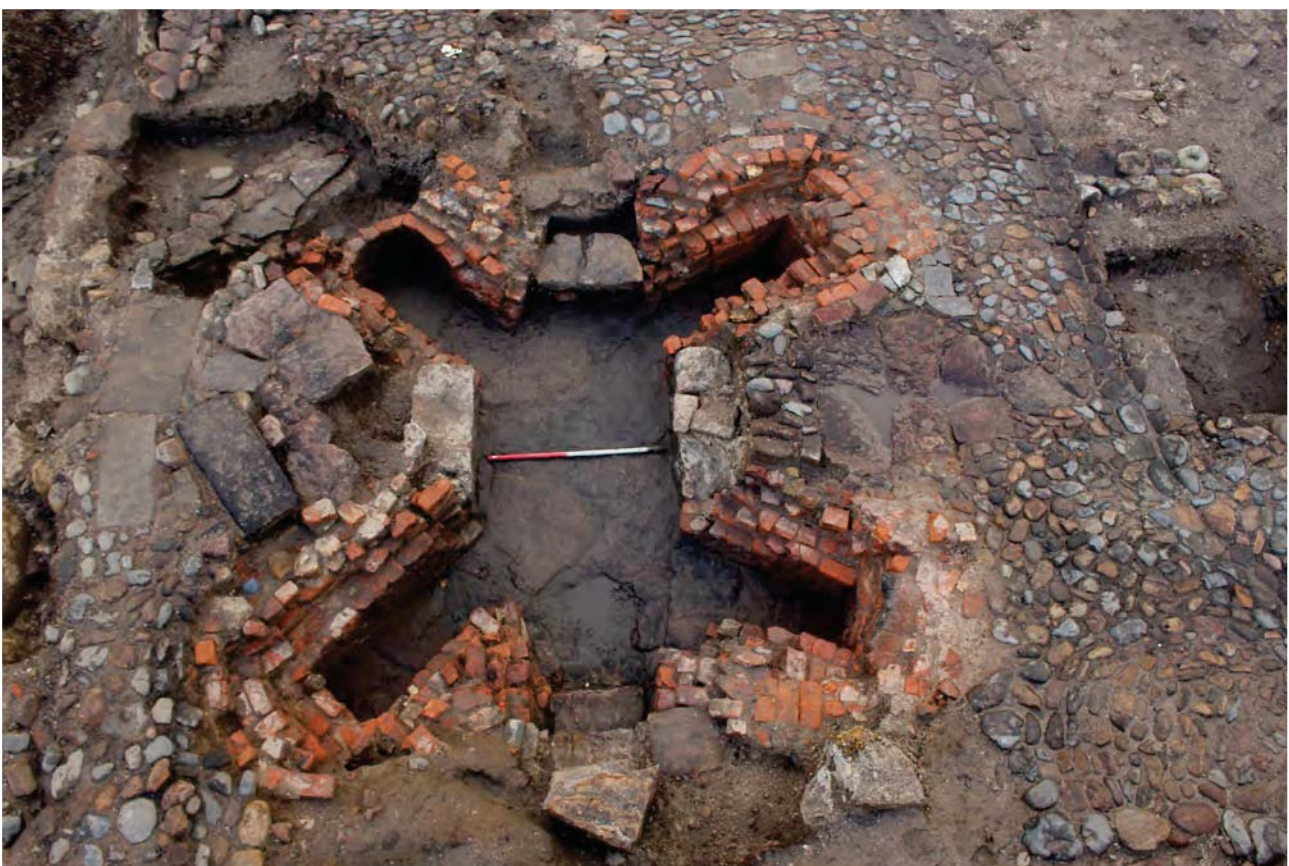
ILLUS 17 View of brick kiln base in Building D, facing north

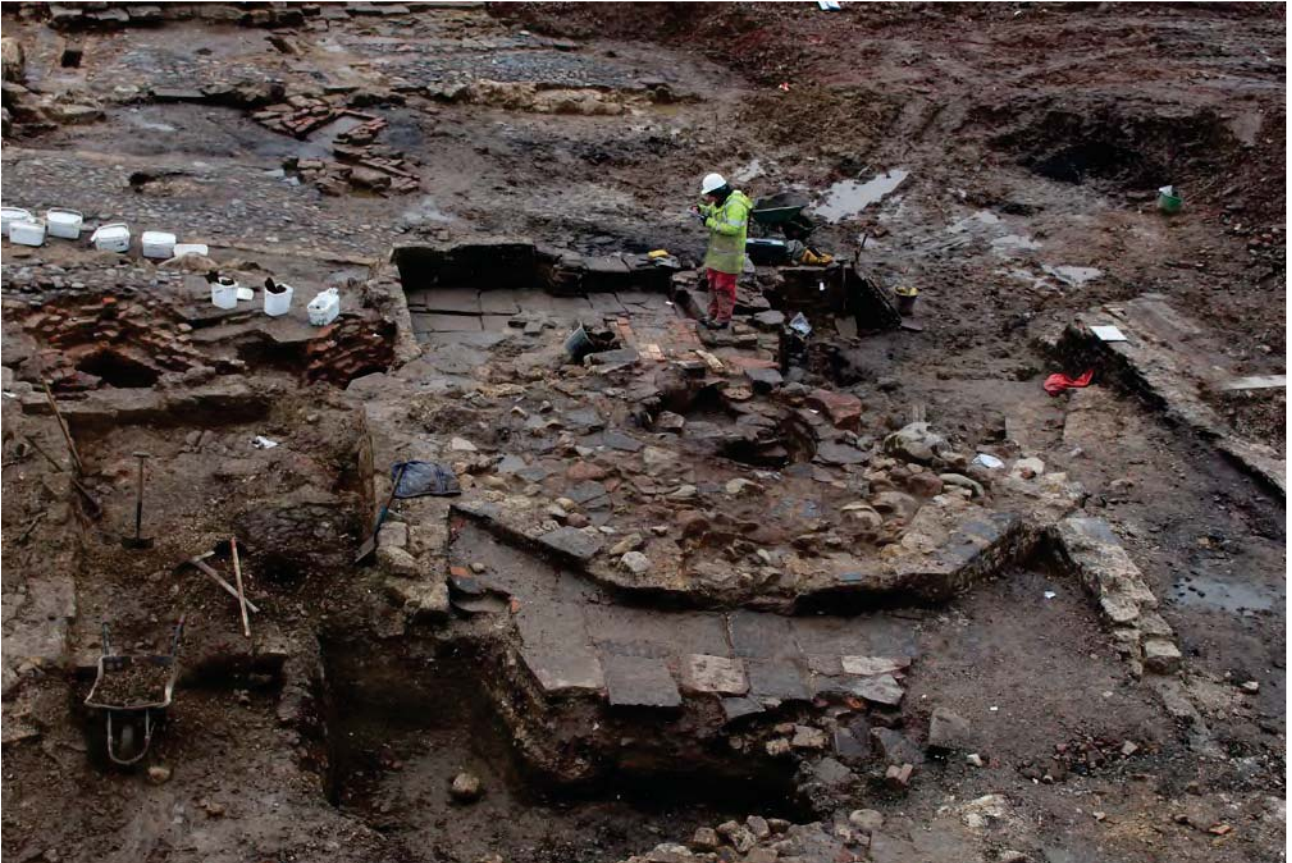
ILLUS 18 View of Building E showing kiln 1089, facing southwest

1084	Deposit associated with workings of kiln 1089	A mid grey-brown/black sandy silt with frequent cindery/charcoal deposits and occasional sub-rounded stones. Located near the top of a sequence of ashy/cindery deposits under stones 1085 which seem to be related to flagged surface 1094. Goes below stones 1085 near structure 1094. Abuts wall 1090 at its SW extent.
1085	Stone associated with flagged surface 1094	A thin stone broken into four pieces. Seems to be associated with flagged surface 1094. Significant amounts of burnt material beneath this stone. Potentially part of a structure associated with 1094 which in turn is likely related to a flue/work surface associated with kiln 1089.
