ENGLISH BICKNOR PRIMARY SCHOOL

Archaeological Watching Brief

commissioned by Asset Management and Property Services,
Gloucestershire County Council

February 2015

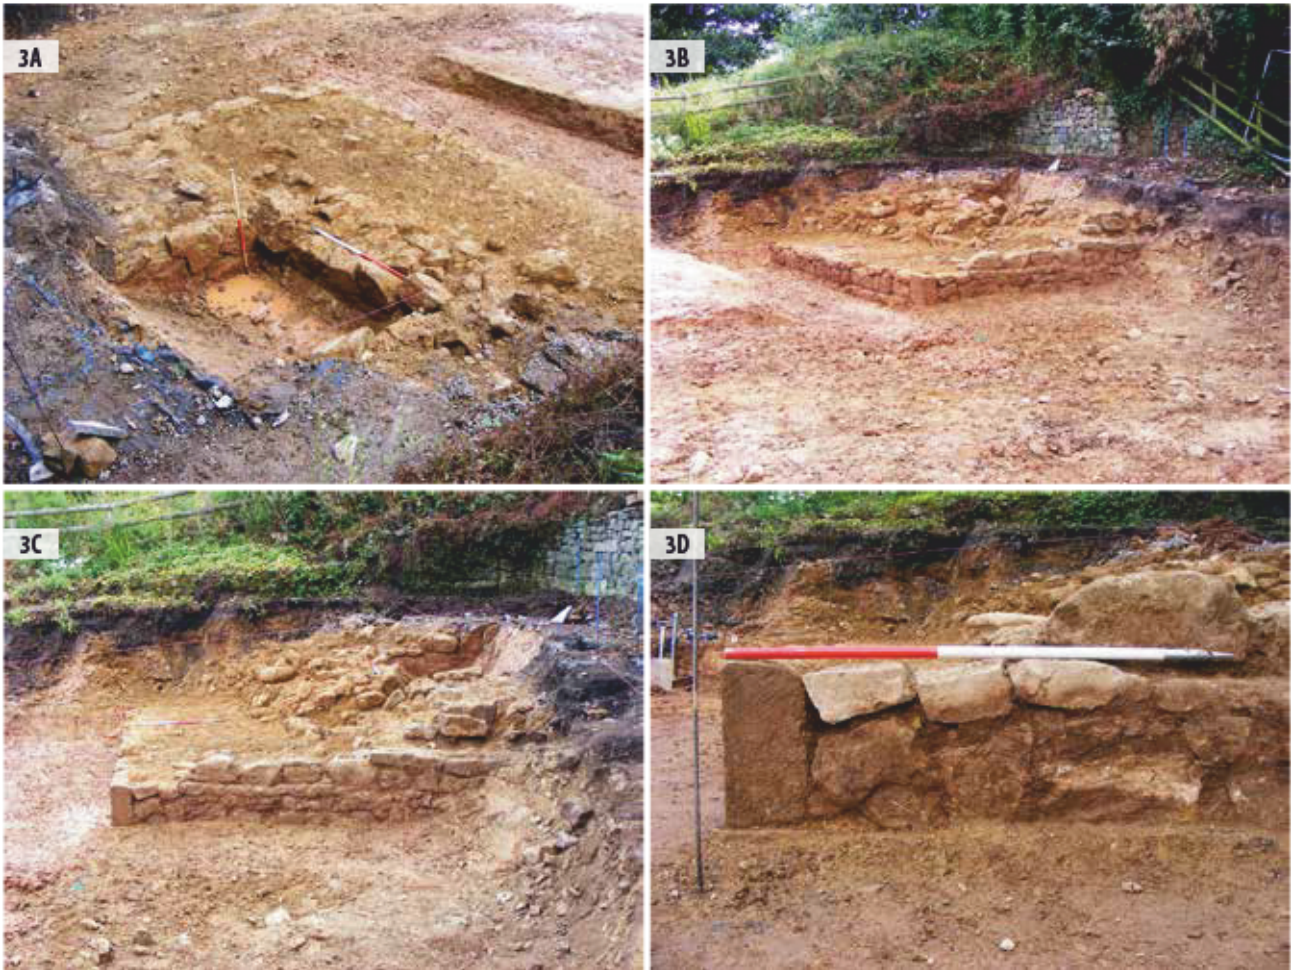
ILLUS 3
Building 1

below the topsoil at a height of 146.28mOD (Illus 3 & 4). The exposed area of the structure, which continued beyond the excavated area to the east and south measured 6.60m x 5.40m. The building was faced externally to the north and west and incorporated a small (2.0m x 1.8m+) internal room defined by faced stone. A substantial rubble core was present between the internal and external faces of the structure. The north-south wall of the structure measured 3.1m wide, the east-west wall 3.3m. The building had been vertically truncated, surviving to a height of 1.34m to the south and c.0.53m at the northern face.

preservation. The central room observed during the current works does not match Maclean's description and due to its small size (2.0m x 1.8m+) is likely to represent an undercroft or storage room. If, as seems likely, the undercroft represents the centre of the structure then the overall external dimensions of the building are in the region of 8.00m x 8.00m.

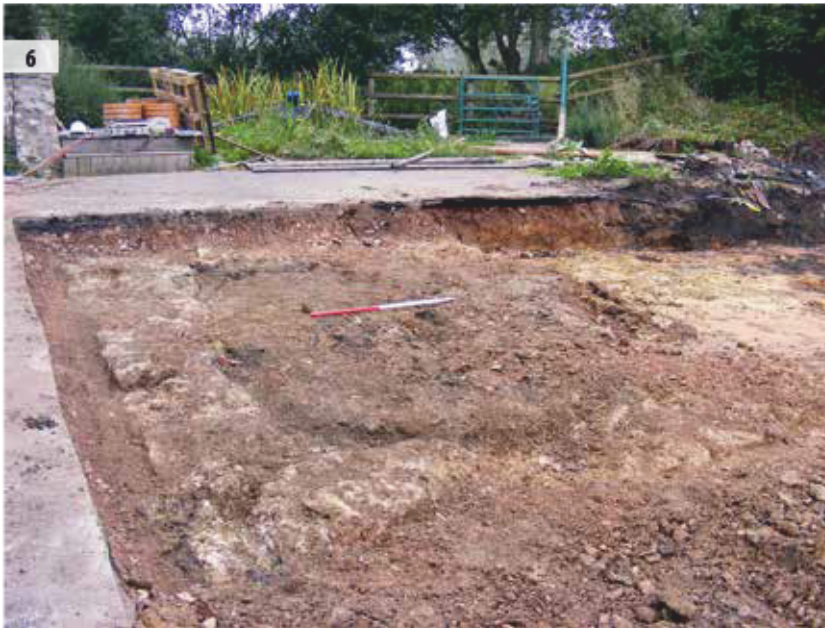
ILLUS 6

Excavation of the north-east corner of the site revealed the foundation courses of a stone and brick structure [Building 2] measuring 5.50m x 6.00m in plan (Illus 6). The building was identified at a depth of 0.30m below ground level and once recorded, the remains of the structure were removed. Geological deposits were present below the building.

Foundations of Building 2 (19th century School House)

The building foundations identified at the north of the site relates to the former school masters house visible on Macean's 1880 plan of the site. The building was still standing at the time of the 1989 Ordnance Survey.

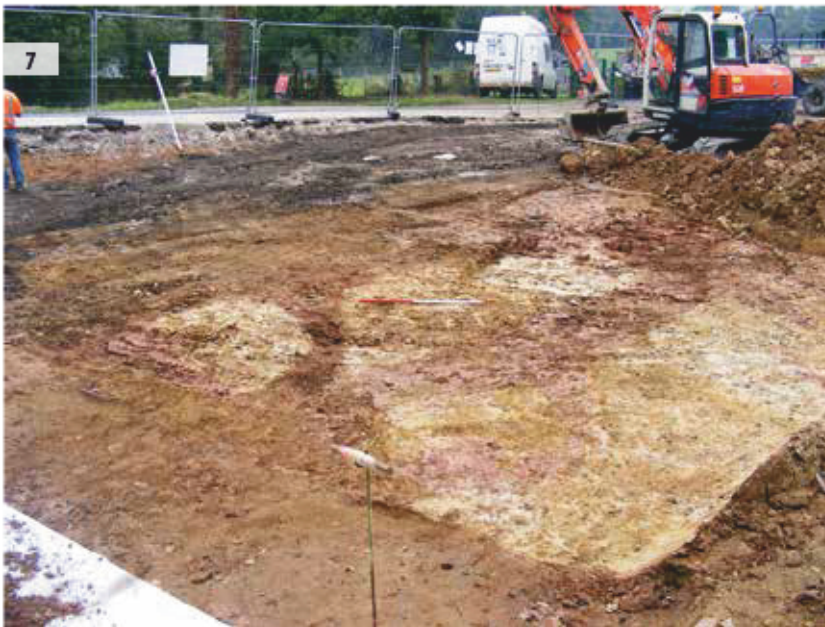
ILLUS 7

Variations in the natural geology

Following the excavation and recording of Trenches A and B, groundworks continued in the south of the site with the removal of deposits to slab formation level. It was observed that deposit [5008] appeared to form curvilinear braided channels through deposit [5006]. There was no evidence that the channels were archaeological in origin.

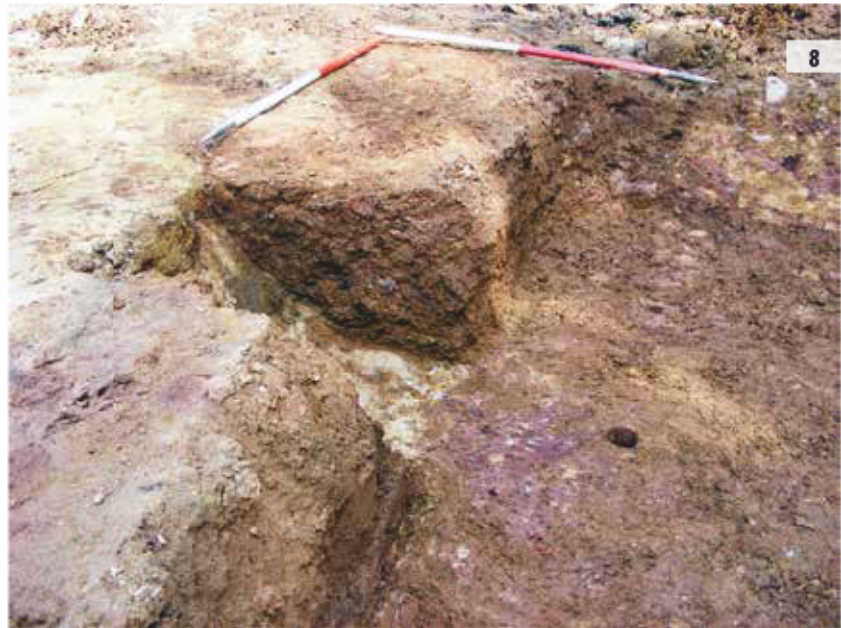
ILLUS 8

Gully feature [5009] truncated by Trench B, looking E

The assemblage amounted to four sherds (47g) of pottery, dating to the medieval period. The pottery came from a single context (5010), the fill of linear feature [5009] and is in moderately fresh condition. The sherds are all in a similar fabric and represent one or more unglazed cooking pots. There is one rim and three body sherds. The fabric is an iron rich clay with a moderately to common frequency of rounded to sub-angular quartz > 2mm, rare sandstone and rare organic inclusions. The sherds have a dark grey core and brown surfaces. In general terms this conforms to the Worcester-type sandy unglazed ware (Worcester fabric 55) (www.worcestershireceramics.org/) which has a widespread distribution across Herefordshire and Worcester extending into Gloucestershire and may come from one or more, as yet unknown sources. This industry first appears in the later 11th century and is at its height in the 12th and 13th centuries.

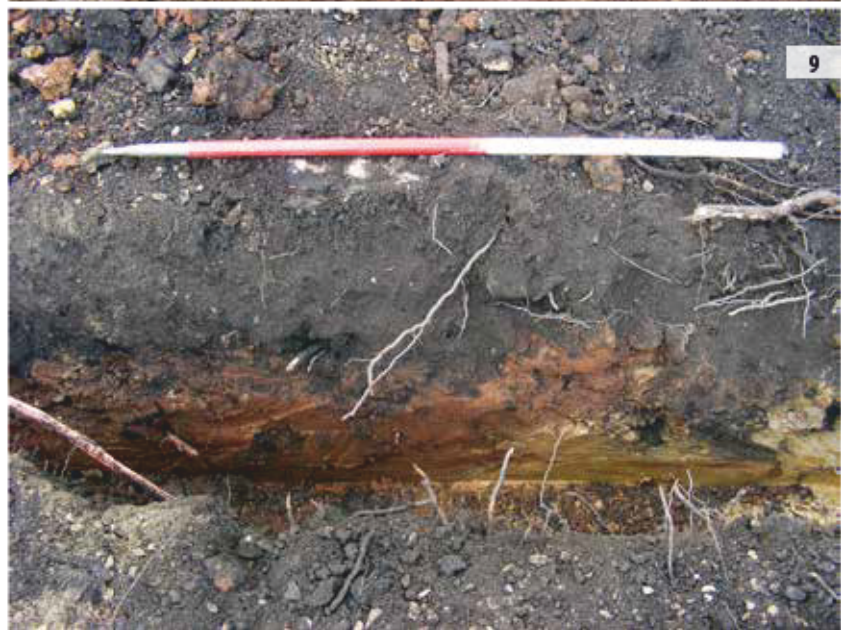
ILLUS 9

Southern edge of inner moat, W facing section Service Trench 11

Context	Description
5036	Backfill deposit of medieval moat. Reddish brown silty clay. Firm.
5037	Cut for medieval moat observed Within Service Trench 11. 4.00m wide. E-W orientation. Depth 0.50m, base not observed.
5038	Victorian levelling deposit observed Within Trench 11. Dark grey, sandy, ashy clay. Soft with charcoal inclusions.
5039	Modern intrusion relating to services. Light brown clayey sand.
5040	Modern levelling deposit beneath playground surface. Light brown clayey sand.
5041	Playground base deposit. Orange/red clayey sand.
5042	Playground base deposit. Mottled grey/yellow sandy clay.
5043	Modern deposit. Reddish brown sandy clay.

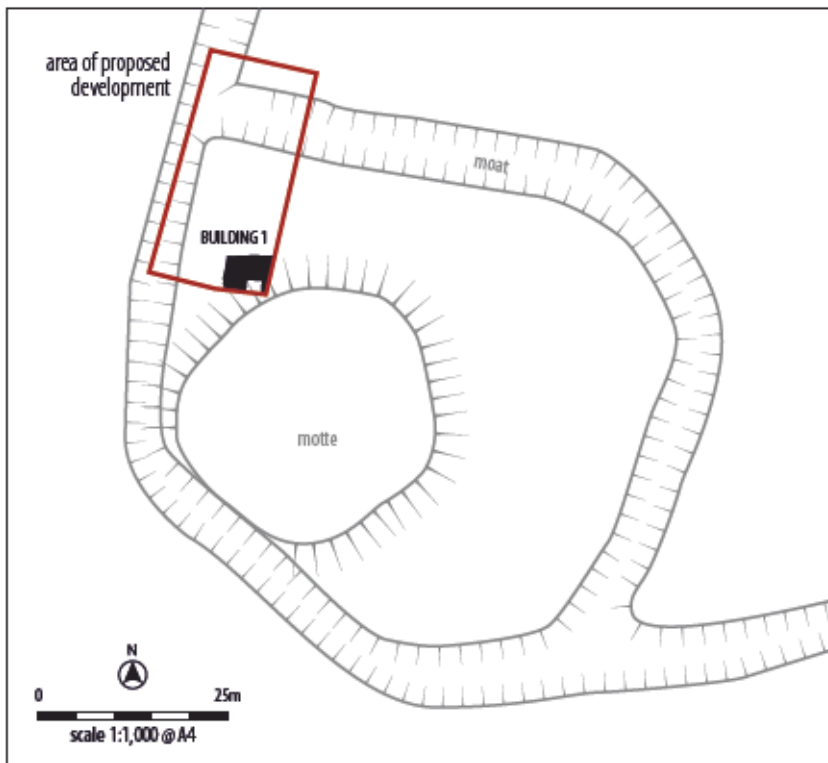
ILLUS 10

Plan showing relationship of Building 1 to Castle earthworks
