Archaeological Watching Brief

Spring Farm, Withybrooke Lane, Hopsford, Warwickshire

HOPS13

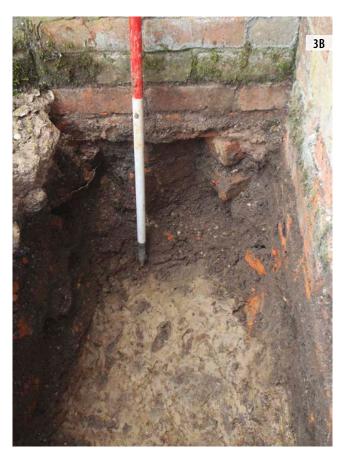
ILLUS 3A-B W facing section of service pit

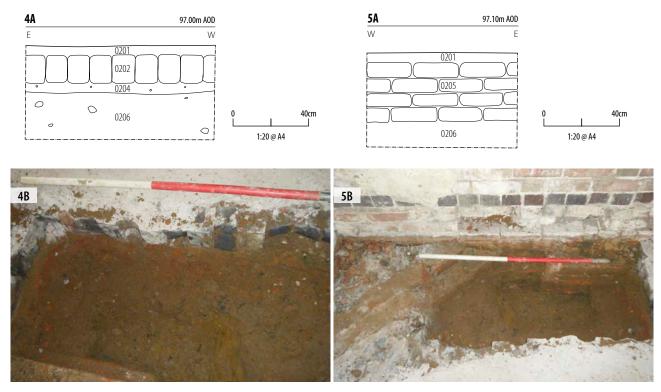
ILLUS 4A—B N facing section of underpinning in Trench 2 **ILLUS 5A—B** S facing section of underpinning in Trench 2

Inside the barn, where multiple footings were excavated, a concrete floor (201), 0.05m thick, covered much of the original brick floor surface (202)/(203), 0.2m thick, which overlay mid red brown sand made-up ground (204), 0.05m thick, which overlay mid yellow brown natural clay (206) (see Illus. 4). The original floor consisted mostly of black bricks (202) with probably decorative lines of red bricks (203) at a 45° angle to the run of the black bricks. The foundations of the walls (206) consisted of an extension of the courses of bricks 0.32m below the floor surface (see Illus. 5).

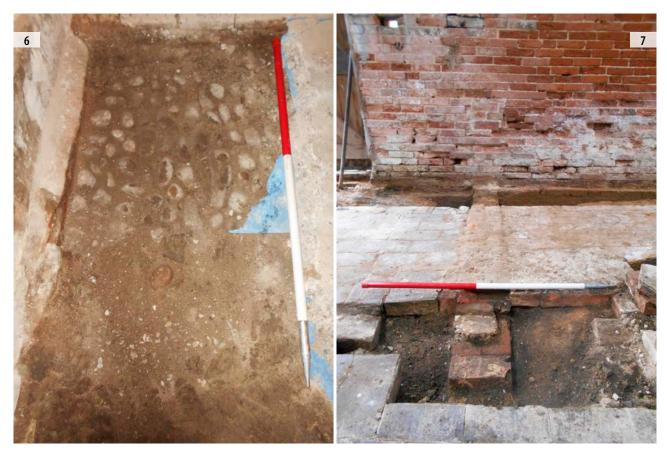
ILLUS 6 Cobble floor looking ESE (1405) underpinnig in Trench 14 **ILLUS 7** Partition wall looking ENE (1302) underpinning in Trench 13
