# The former Joseph Glover pub, Station Road, Halfway, Sheffield

### Archaeological Building Recording

#### A.R.S. Ltd Report 2013/61 July 2013

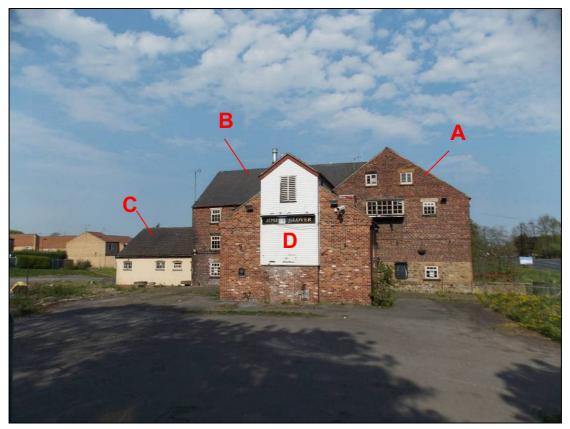
Figure 3: The amalgamated complex of the former Joseph Glover pub, looking east.

The former Joseph Glover pub is an amalgamation of four major ranges (Figs 3 - 5). A plan showing the buildings' code has been produced (Fig. 2). All elevations and plans were analysed individually and the results are included below. The survey drawings are included in Appendix I.

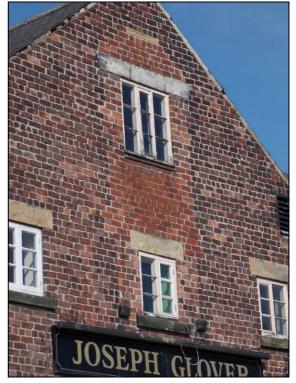
Figure 8: Detail of gable.

4.1.2 The east elevation contains a central window opening within the gable which is topped by a longer sandstone lintel. There is a large opening with a flat arched-head which is now blocked with bricks and contains two secondary windows on the second and loft floors (Figs 7 and 8). This opening would have originally comprised a lucam or projecting loading bay. Testimony of the former lucam may be indicated by two projecting sandstone corbels flanking the sill of the central window of the second floor (Fig. 9). The gable wall is built with equivalent bricks to the remaining brickwork of the elevation although the bond is slightly different, composed of five courses of stretchers to one of header rather than three stretchers. It is unknown whether this represents a genuine construction break. There is a later lean-to garage extension abutting this elevation whose construction involved blocking the existing window openings within the lower stone wall (Fig. 10). The lean-to is built with breeze block and concrete tiles. Two inserted doorways with concrete lintels are present within the northern end of the basement floor.

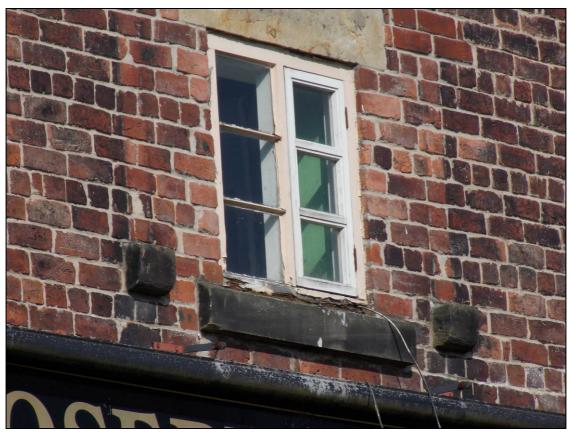
Figure 9: Detail of corbels flanking the central window sill of the second floor.

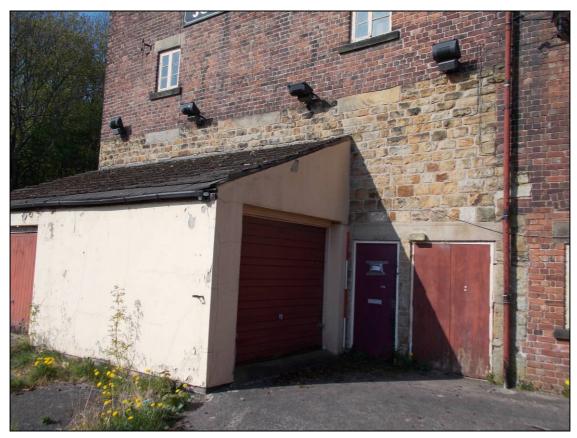
Figure 10: Detail of blocked-up window openings, looking south-west (scale 2m).

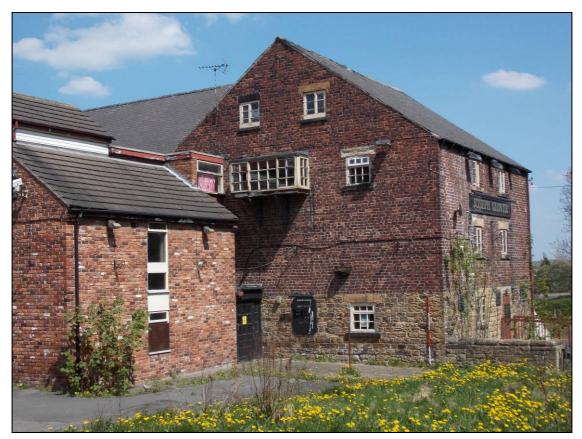
Figure 11: General view of the west elevation of Building A (scale 2m).

4.1.3 The opposed west elevation is comparable to its counterpart (Fig. 11). The gable wall contains two window openings with casement windows. The second floor has a primary window opening within the southern area and a later projecting bay window supported by two re-used cast-iron brackets (Fig. 12). The northern end of the ground floor has been slightly modified with the insertion of a doorway which is accessed from a lobby connecting Building A, B and D (Fig. 13).

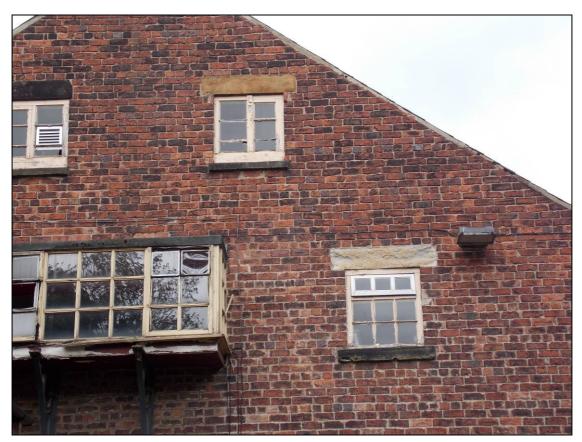
Figure 12: Detail of different brickwork within the gable.

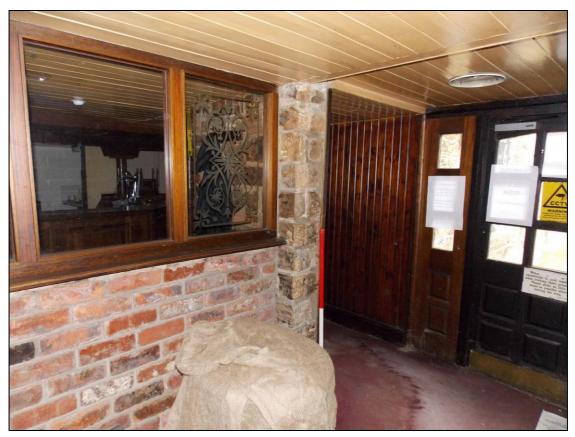
Figure 13: Northern section of the ground floor of the west elevation, looking south-east (scale 1m).

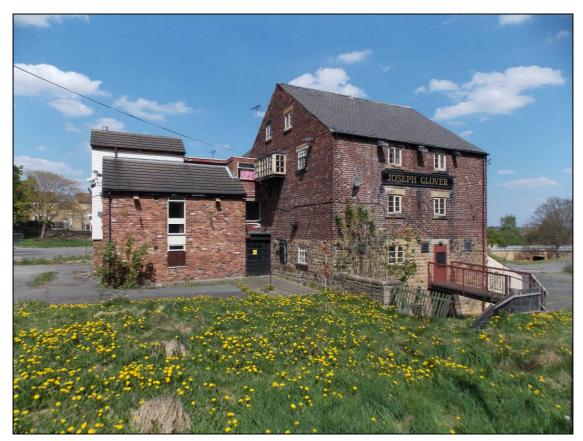
Figure 14: General view of the south elevation of Building A with later Building D to the left (scale 2m).

4.1.4 The south elevation facing to Station Road is very symmetrical with a pair of window openings on each level (Figs 14 and 15). These contain casement windows of six panes (Figs 16 and 17). Several wall plates are also symmetrically arranged through the wall. The scars of a former southern extension with a pitched roof are perceivable within the lower section of this elevation which includes also a sawn-off side purlin (Fig. 18). The matching purlin towards the east had been removed when a window opening, now modified into a fire exit, was inserted. This may imply that at least some of the window openings are secondary. The window openings of the basement are blocked with sandstone rubble.

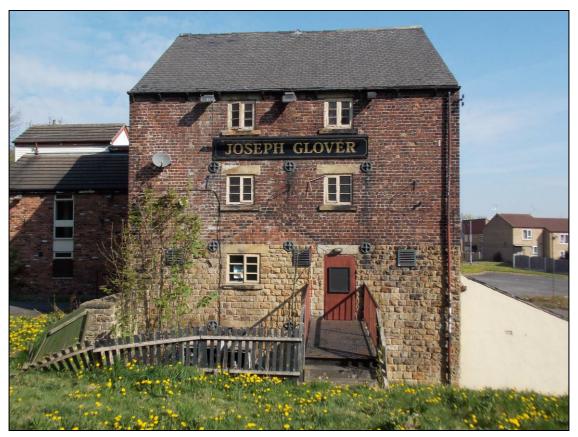
Figure 15: South elevation of Building A (scale 2m).

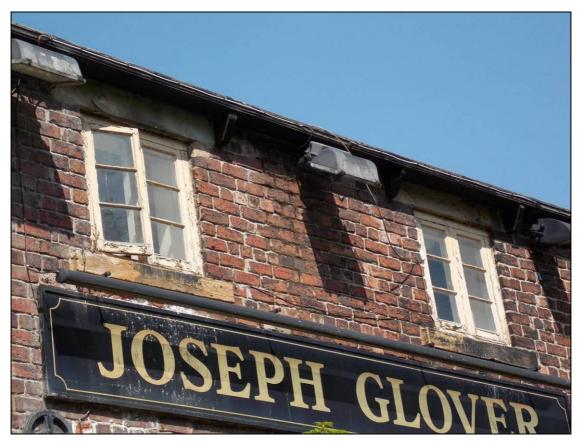
Figure 16: Window openings within the second floor.

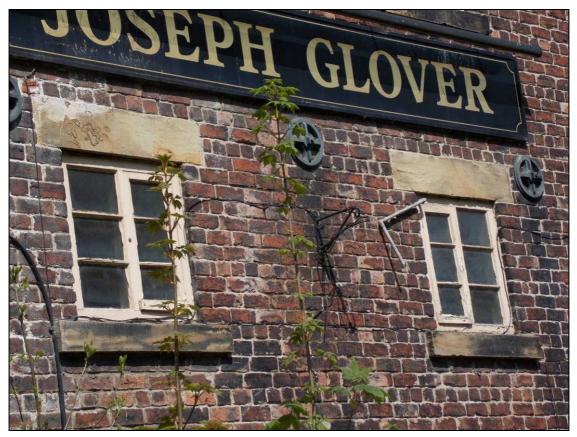
Figure 17: Window openings within the first floor.

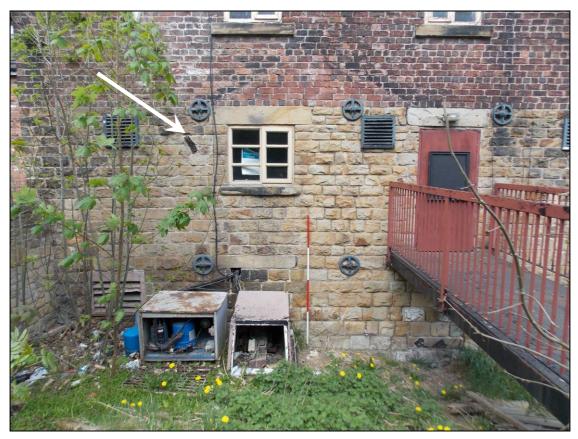
Figure 18: Scars of former pitched extension and sawn-off side purlin (arrow) (scale 2m).

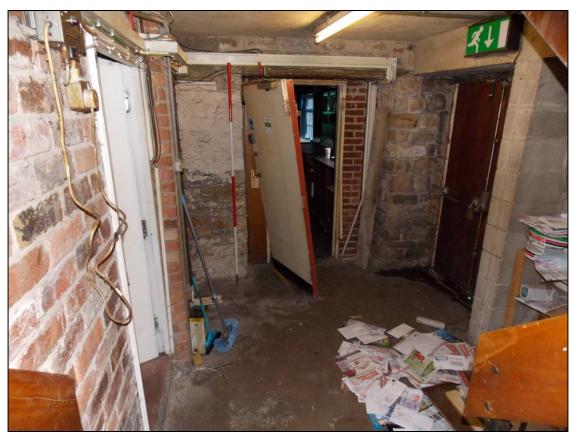
Figure 20: Basement's lobby with inserted doorways within the east and north walls, looking north (scale 2m).

4.1.6 There is a lobby adjacent to the staircase which leads to the external doorways, an inserted doorway to the north which links this building with the adjacent Building B and two further doorways for the beer cellar and adjacent lift (Figs 20 and 21). It contains most of its original cast-iron tapered columns bolted to timber bridging beams with two squared-headed bolts (Fig. 22). The side walls are built with sandstone, the ceiling contains plaster boards and the current floor has been raised with concrete. There is a later breeze-block L-shaped wall to the west of the basement which acts as a partition for a large duct attached to the ceiling (Figs 23 and 24).

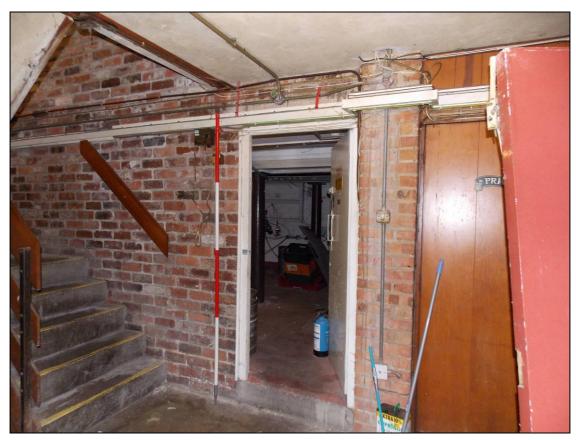
Figure 21: Doorway to the beer cellar (left) and lift (right), looking west (scale 2m).

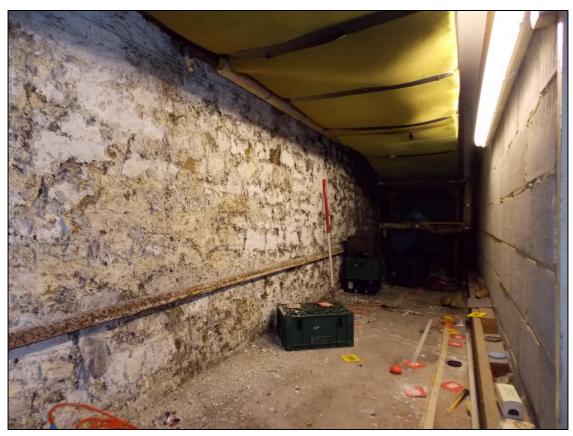
Figure 24: West wall of the basement, looking north (scale 1m).

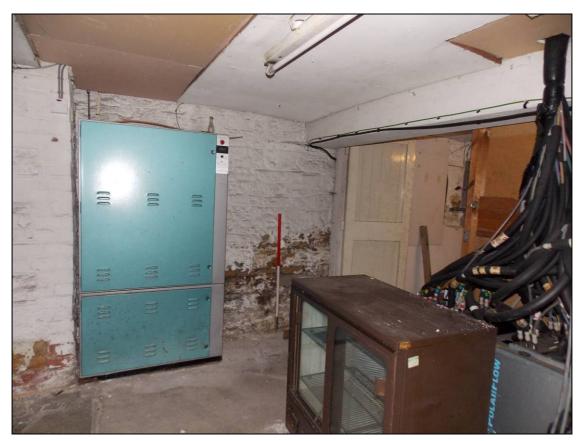
Figure 25: South-east room, looking south (scale 1m).

4.1.7 A short stud wall with a doorway forms a small storage area within the south-eastern corner (Fig. 25) from where an inserted doorway provides access to the lean-to garage (Fig. 26).

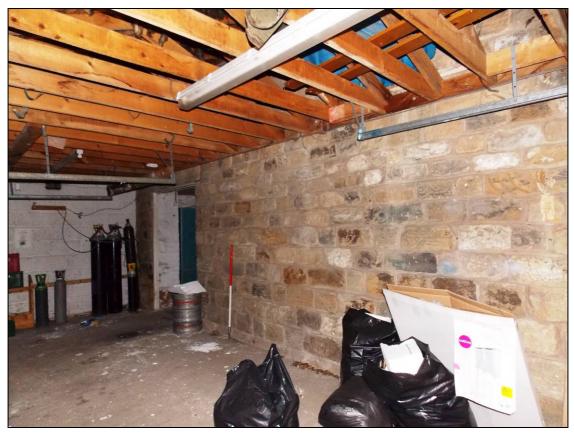
Figure 26: Internal view of the garage showing the masonry of the east elevation, looking south-west (scale 1m).

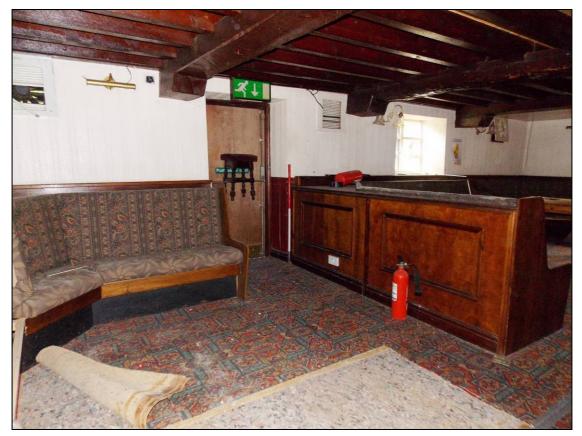
Figure 27: Ground floor of Building A, looking south-west (scale 1m).

4.1.8 The ground floor is a modern lounge which is accessed from the inserted doorway within the west wall. The interior retains its original columns equivalent to the floor below and some of the primary window openings are extant which contain splayed jambs (Figs 27 – 29). The walls are built with stones although their lower sections are concealed by continuous sitting chairs and the upper rendered with plaster.

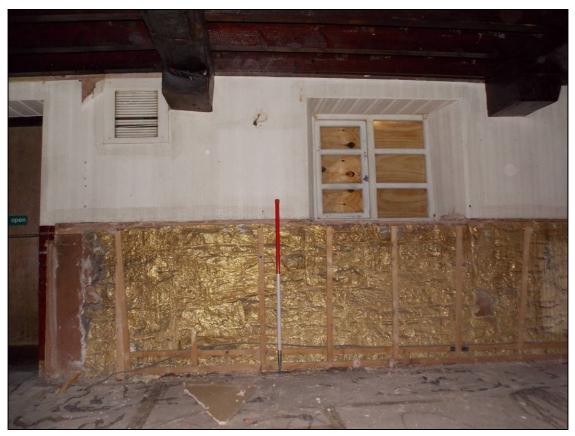
Figure 28: Stone wall revealed after soft-stripping watching brief (scale 1m).

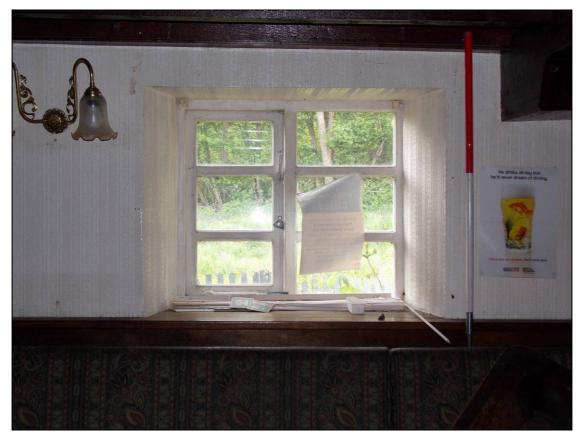
Figure 29: Detail of window within the south wall (scale 1m).

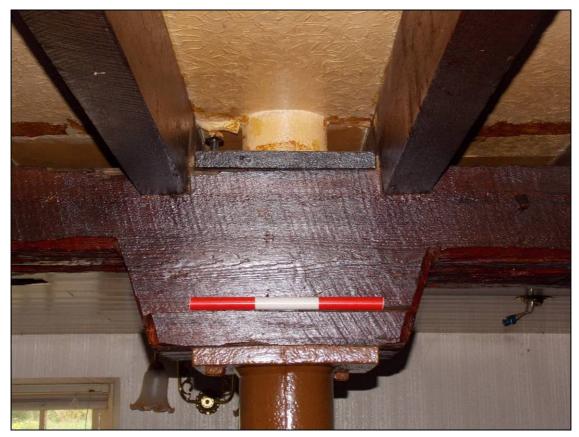
Figure 31: Detail of column's capital and truncated beam, looking west (scale 300mm).

4.1.9 The ceiling has exposed beams and joists except for the westernmost aisle which contains later boards concealing the joists. The bridging beams contain lower corbel-like pads, which are supported by the capital of the tapered cast-iron columns. This unusual arrangement creates an effect similar to Samson posts<sup>1</sup> with pillows; however they are the result of having been longitudinally shaved off (reducing half of its original thickness) in order to accommodate head room when the present concrete floor was added over the original timber boards (Figs 30 – 33). The truncation of the beams might have taken place when the mill was turn into a pub as the beams contain painted numbers, demarcating a sub-division of bays, which are now partially chopped off.

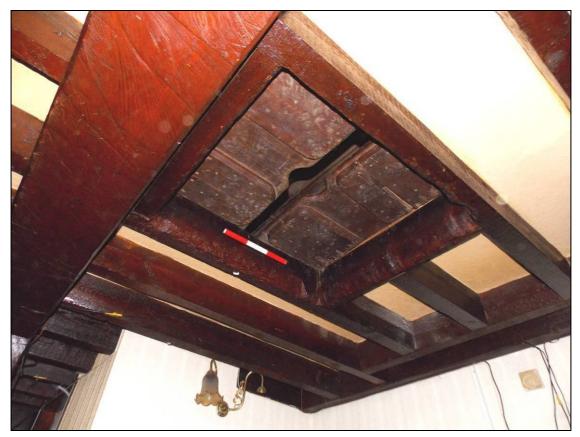
Figure 34: Ceiling hatch, looking north-east (scale 300mm).

4.1.10 A ceiling hatch was identified amongst the ceiling joists which would have allowed sacks with grain to be hoisted up to the floors above. Rope marks of the hoists movement can be seen on one of the ceiling beams (Fig. 34).

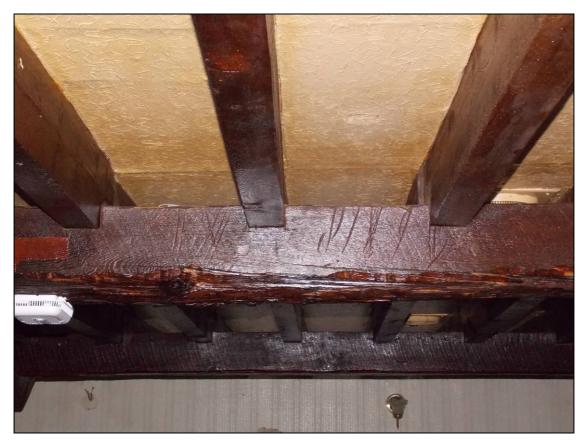
Figure 35: Carpenter's marks within southern section of the central beam, looking east.

4.1.11 A series of carpenter's marks were identified amongst the beams (Figs 35 - 38). These appear to have been designed as identification of the actual beams rather than as pre-fabrication assembly marks.

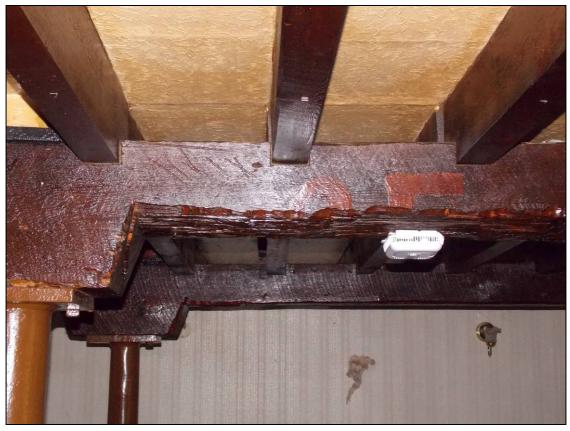
Figure 36: Carpenter's marks over the southern column of the central beam, looking east.

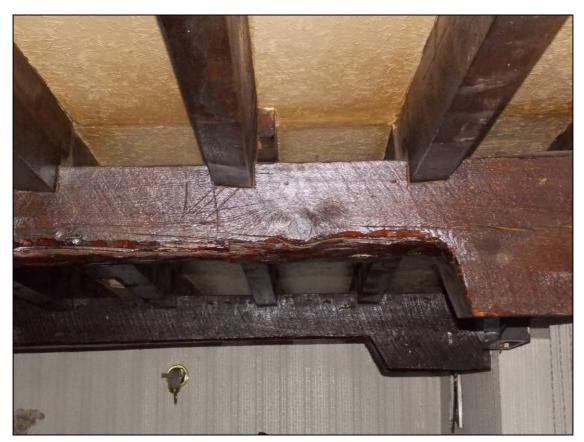
Figure 37: Carpenter's mark within the southern section of the central beam, looking east.

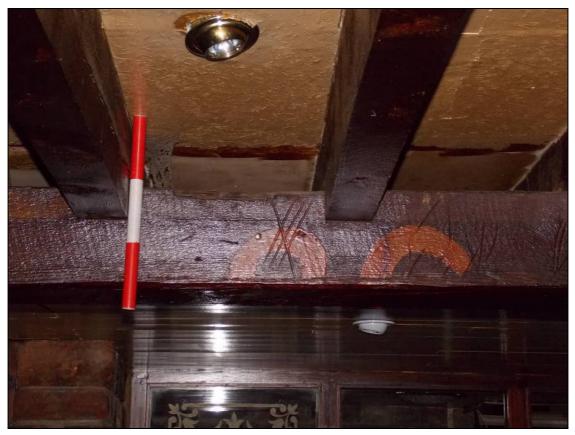
Figure 38: Carpenter's marks within the northern section of the western beam (scale 300mm).

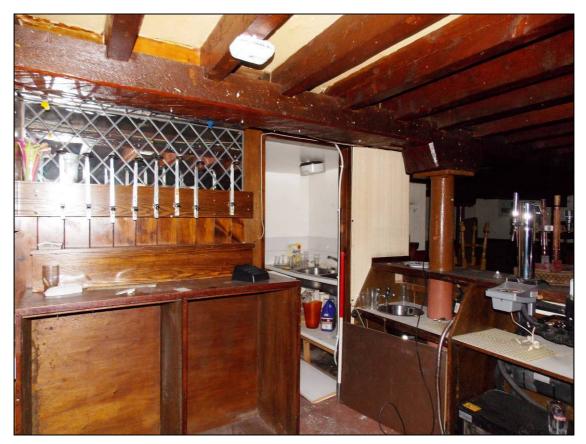
Figure 39: Inside the bar, looking south-east (scale 1m).

4.1.12 There is a small washing area within the bar and immediately to the south of the lift (Fig. 39). The north wall has two inserted doorways connecting the back-to-back bar and lobby area with the adjacent Building B (Fig. 40).

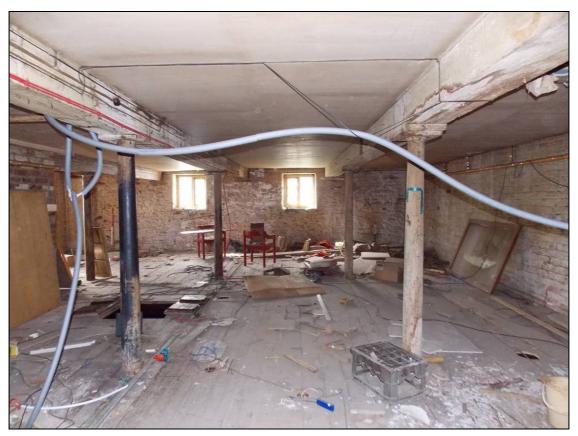
Figure 41: General view of the first floor, looking south (scale 1m).

4.1.13 The first floor is practically empty although it has been used for storage (Fig. 41). It is noteworthy that the side walls (north and south) are internally built with stones whereas the remaining walls (east and west) are built with bricks (Fig. 42). This might indicate that the original structure was built with stone and that later repairs and/or rebuilding work involved re-facing the external walls of the upper storeys with bricks. This floor is accessed from the hatch identified on the ground floor (Figs 43 and 44) and from an inserted doorway within the north wall linking it with the adjacent Building B (Fig. 45). The main structural arrangements are equivalent to the floors below although the cast-iron columns are slightly thinner in diameter (Fig. 46). It has two window openings within the south wall which have bullnose brick jambs (Fig. 47). Two additional window openings are located within the east wall of which the northern one, within the staircase, also has bullnose brick jambs, whereas the southern one, within the main floor space, has straight brick jambs.

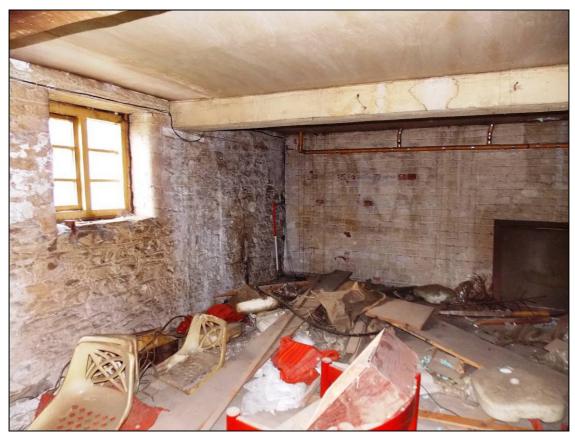
Figure 42: South-western corner of the first floor (scale 1m).

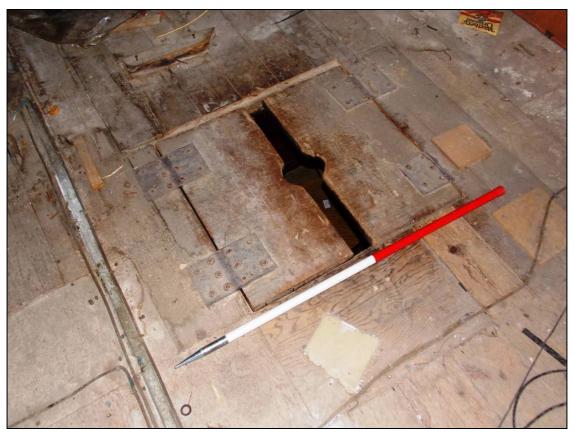
Figure 43: Detail of hatch within the floor boards, looking north-east (scale 1m).

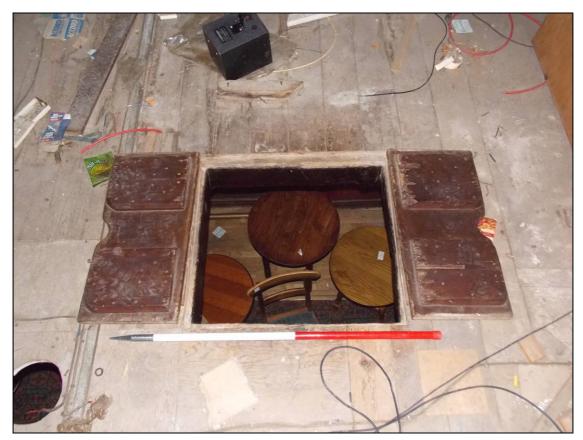
Figure 44: Hatch with doors open down to the ground floor, looking north (scale 1m).

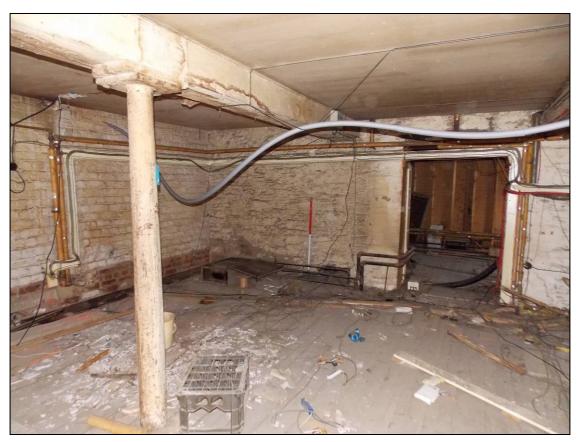
Figure 45: Inserted doorway within the north wall providing access to Building B (scale 1m).

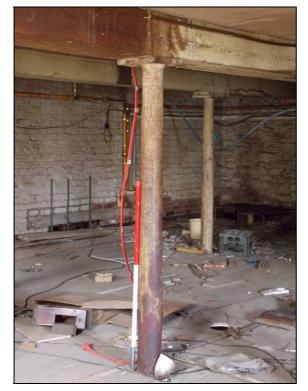
Figure 46: Detail of cast-iron column, looking northwest (scale 1m).

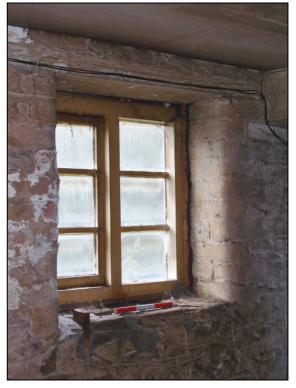
Figure 47: Detail of window opening within the north wall, looking south-west (scale 300mm).

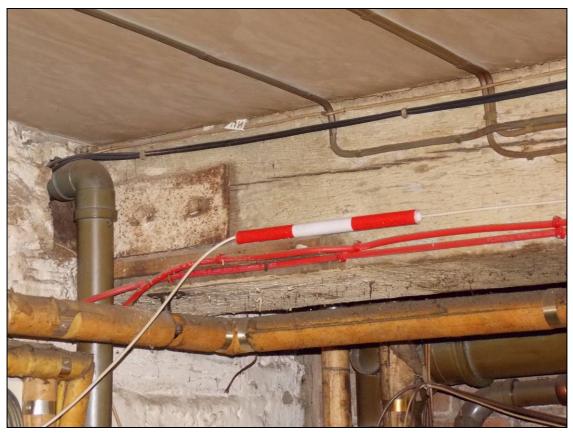
Figure 48: Plate attaching longitudinal beams of Buildings A and B, looking north-east (scale 300mm).

4.1.14 The floor is composed of timber boards although there is a small area to the west of the hatch which has been replaced with later plywood board. The ceiling structure is comparable to the floors below with longitudinal bridging beams whose northern ends contain bolted plates attaching these beams with their counterparts along the adjacent Building B (Fig. 48). The ceiling itself consists of plasterboards concealing the timber joists. Subsequent soft-stripping revealed a matching hatch immediately above the one on the floor (Fig. 49). Additional carpenter's marks were also identified here which appear to be comparable to the ones on the ground floor (Figs 50 - 52). The stairwell shows clearly the construction variation between the stone-built north wall and the brick wall to the east (Fig. 53).

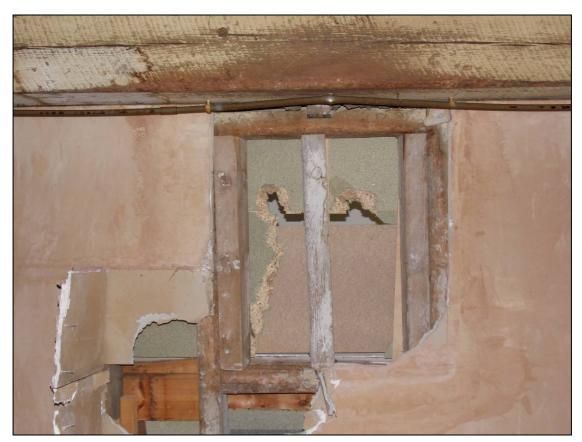
Figure 49: Remnants of ceiling hatch identified during the soft-stripping watching brief.

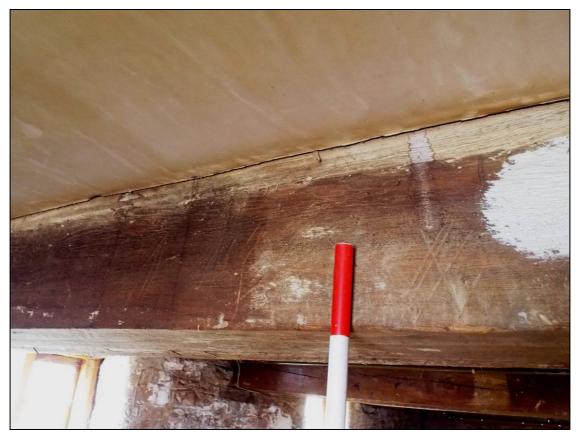
Figure 50: Carpenter's marks within the eastern beam, looking south-west (scale 200mm).

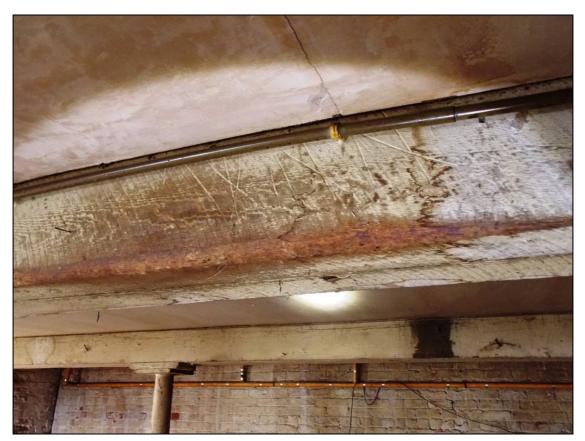
Figure 51: Carpenter's marks within the central beam, looking west.

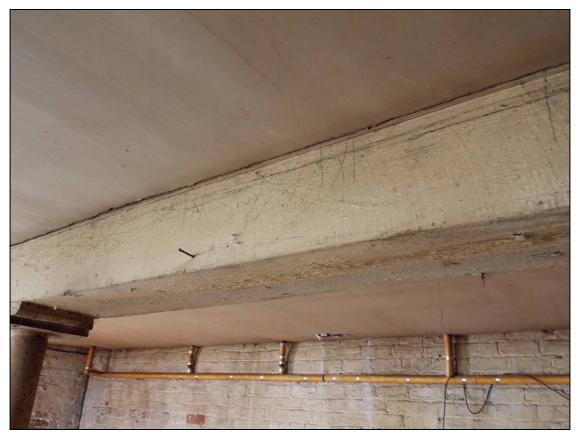
Figure 52: Carpenter's marks within the western beam, looking south-west.

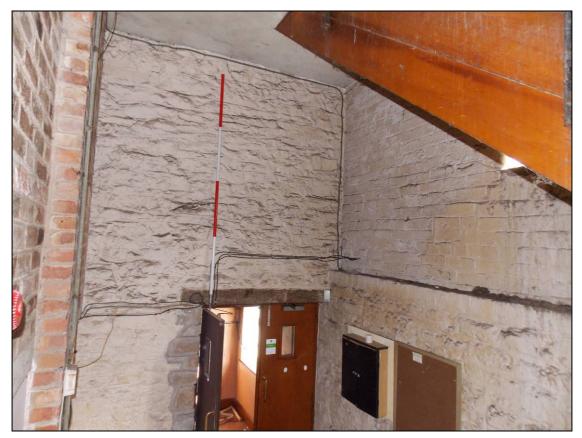
Figure 53: Stairwell within the first floor, looking north (scale 2m).

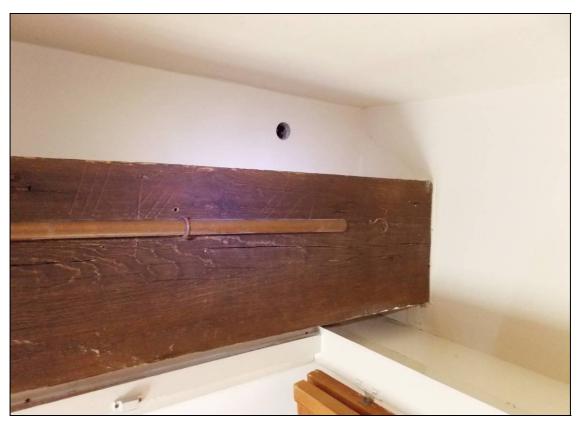
Figure 59: Detail of carpenter's marks on the underside of the central beam.

4.1.16 The general fabrics consist of plastered walls and carpeted timber floor boards, whilst the ceilings are composed of plaster boards with exposed bridging beams. The sub-divisions are built with breeze-block walls and plywood studs, concealing some of the cast-iron columns. A series of carpenter's marks comparable to the floors below were also identified amongst the exposed bridging beams (Figs 56 – 70). An additional pair of beams is located within the ceiling of room S4 which appear to have been trimmer beams (Fig. 65). These might have possibly been associated with a former projecting loading bay on the east elevation.

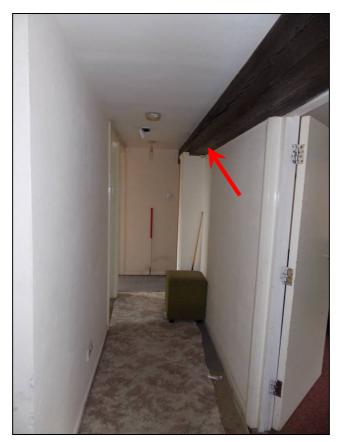
Figure 60: Passageway S3 with central beam containing carpenter's marks (arrow) (scale 1m).

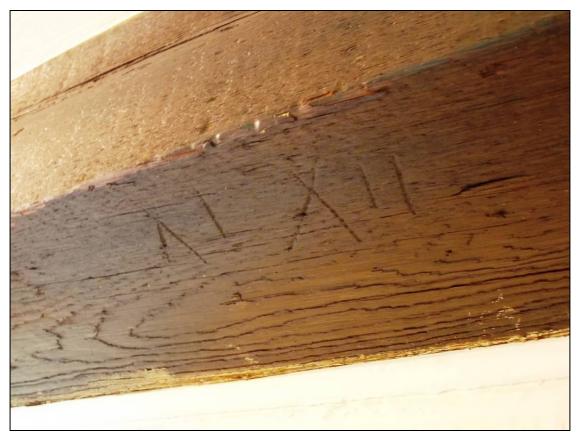
Figure 61: Carpenter's marks within the central tie-beam and adjacent to the southern through bolt.

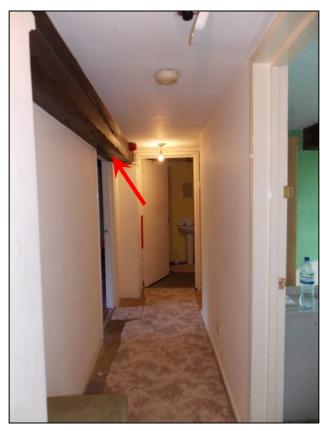
Figure 62: S3 with central beam containing carpenter's marks adjacent to the northern bolt (arrow) (scale 1m).

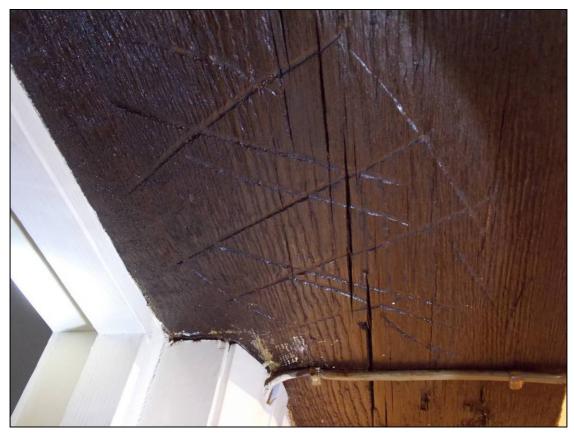
Figure 63: Carpenter's marks within the central tie-beam and adjacent to the northern through bolt.

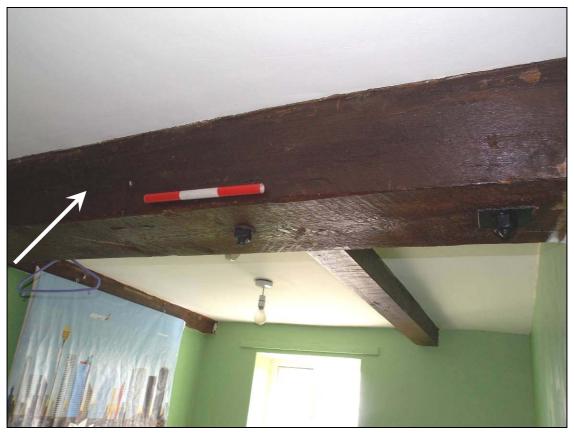
Figure 65: Eastern tie-beam with carpenter's marks (arrow) and trimmer beams, looking east (scale 300mm).

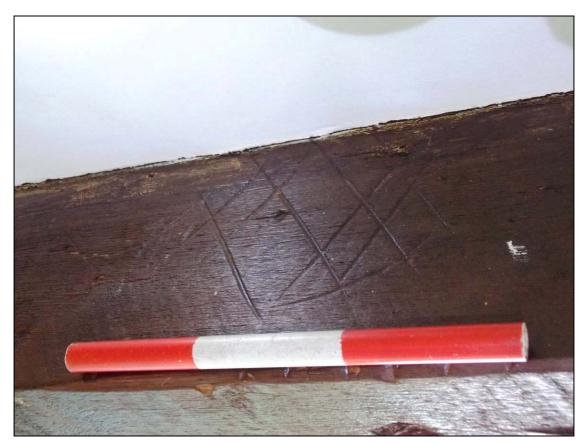
Figure 66: Detail of carpenter's mark (scale 300mm).

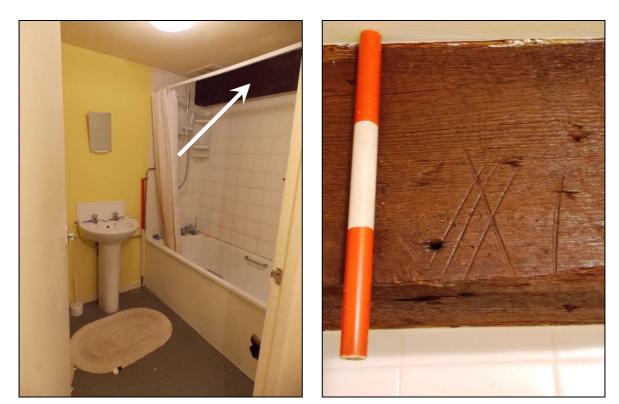
Figure 67: Lavatory S5 with eastern tie-beam containing carpenter's marks (arrow) (scale 1m).

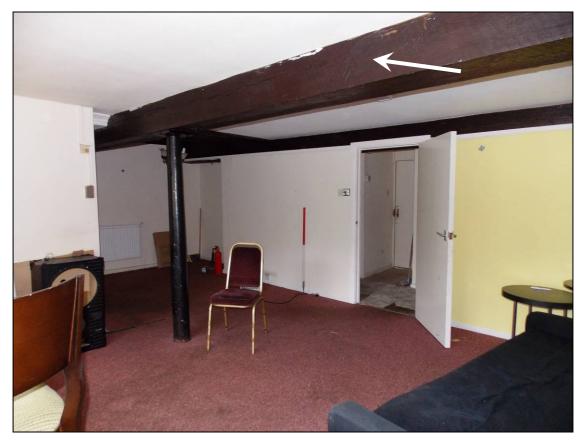
Figure 69: Room S7 with tie beam containing carpenter's marks (arrow), looking north-east (scale 1m).

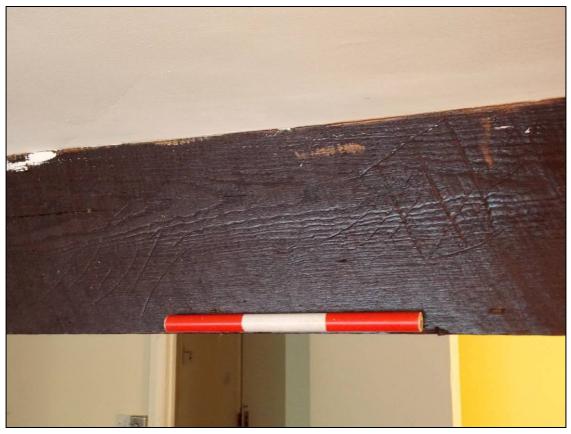
Figure 70: Detail of carpenter's marks, looking east (scale 300mm).

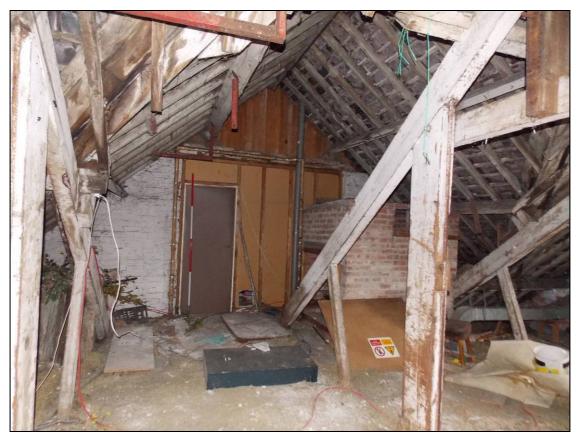
Figure 72: Loft with a doorway to the adjacent Building B, looking north (scale 2m).

4.1.18 The loft floor is accessed from the adjoining Building B through an inserted doorway (Fig. 72). The gable walls are built with bricks containing two windows within the west wall and a central one within the east wall which is a later insertion within a former bricked-up larger opening possibly utilised as an external loading bay. The roof structure consists of three timber queen-strut trusses with collars, carrying six trenched side scantling purlins, and reinforced with scantling raking struts. The upper ends of the principals are attached with flitched collar yolkes. The queen struts are reinforced with vertical tension rods which are bolted through to the principal rafters and tie-beams. The brick-built upper section of the inserted lift projects into the loft containing the motor (Fig. 73). Small chiselled carpenter's marks were identified amongst the trusses. These appear to be assembly marks with matching inscriptions between the joints of the queen struts and principal rafters (Figs 74 and 75).

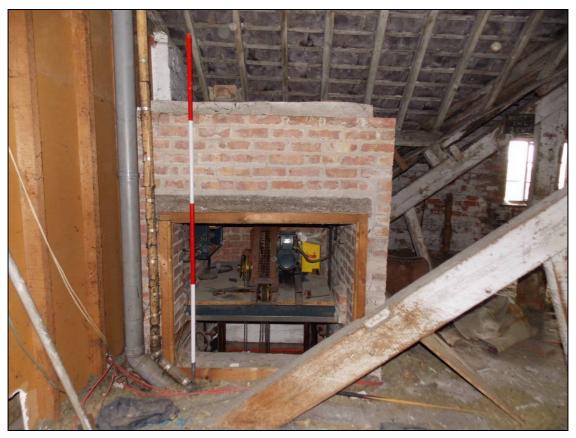
Figure 73: Upper section of the inserted lift, looking east (scale 2m).

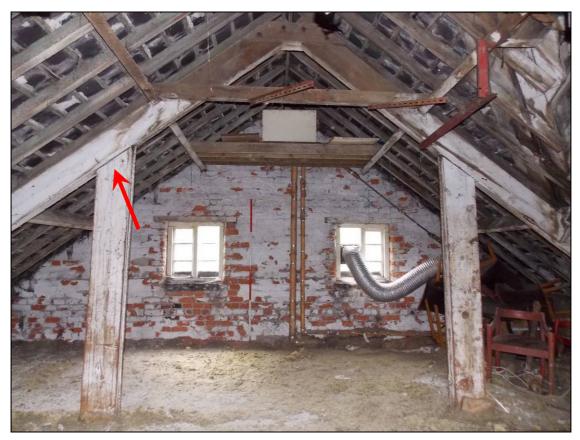
Figure 74: Western truss III with carpenter's assembly marks (arrow) (scale 2m).

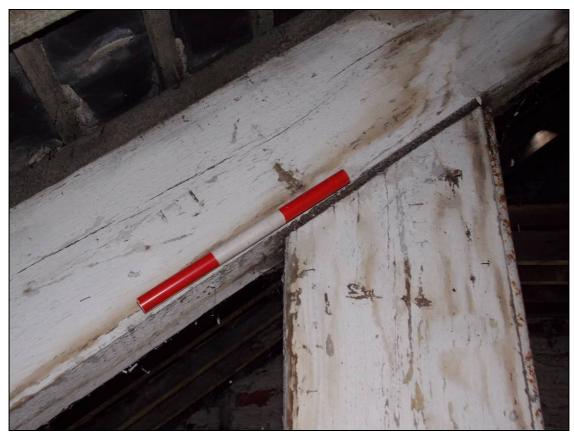
Figure 75: Detail of carpenter's assembly marks within the western truss III, looking west (scale 300mm).

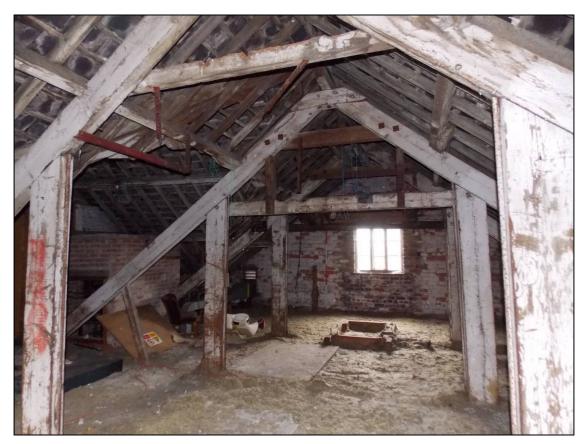
Figure 76: General view of the loft, looking east (scale 2m).

4.1.19 There is a boarded-up floor hatch towards the eastern end whose vertical location coincides with the hatch identified below. Above the hatch there are three pulley wheels attached to the roof structure and additional joists which would have been components of a former hoist mechanism (Figs 76 – 80). In close proximity to the pulley wheels, and mounted on a scantling joist, the remnants of a former bearing housing of the aforementioned mechanism are extant (Fig. 81).

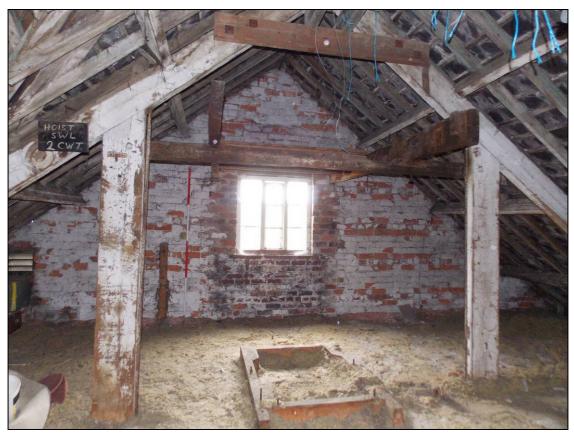
Figure 77: Eastern truss I with upper collar for central pulley wheel's joists (scale 2m).

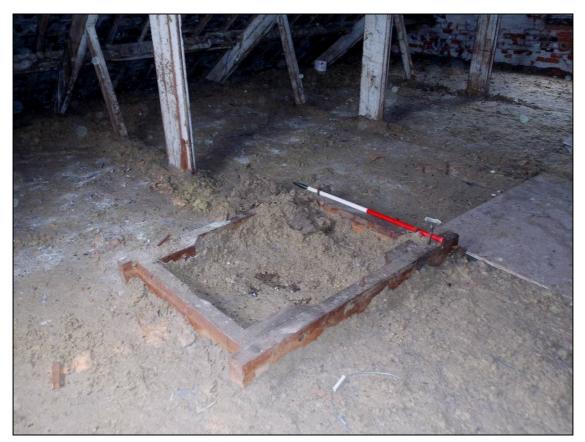
Figure 78: Frame of former hatch beneath the central pulley wheel, looking south-west (scale 1m).

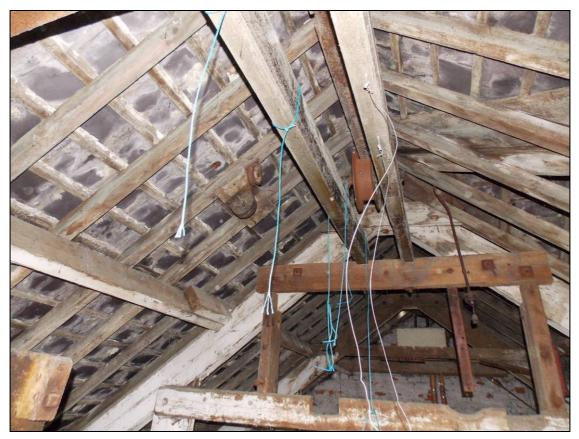
Figure 79: Central pulley wheel and additional smaller wheels attached to common rafters, looking east.

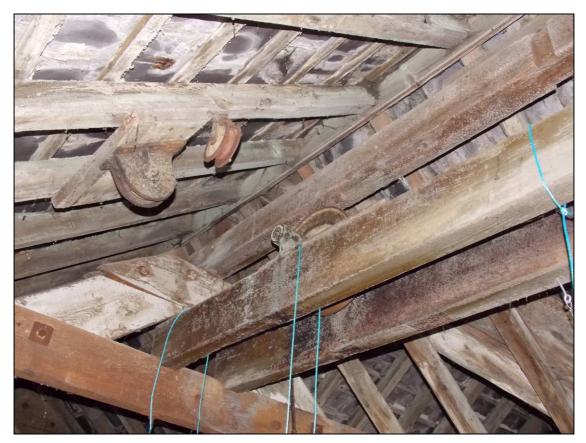
Figure 80: Detail of the pulley wheels, looking east.

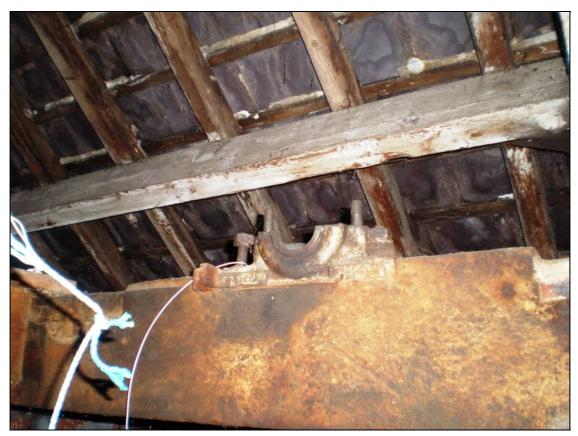
Figure 81: Remnants of former bearing housing, looking south.

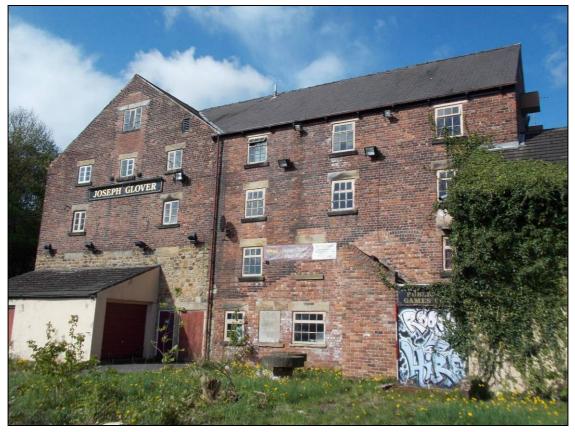
Figure 82: East elevation of Building B (right) abutting the gabled wall of Building A (left) (scale 2m).

4.2.1 This is a long north/south range of four-and-a-half storeys high with a pitched slated roof abutting the northern side of the adjacent Building A creating a cross-wing impression (Fig. 82). The walls are built with hand-made reddish brown bricks (9" x  $4\frac{1}{4}$ " x 3") with the basement (perceptible on the east elevation) and ground floors laid in English bond whereas the upper levels are laid in English Garden Wall bond.

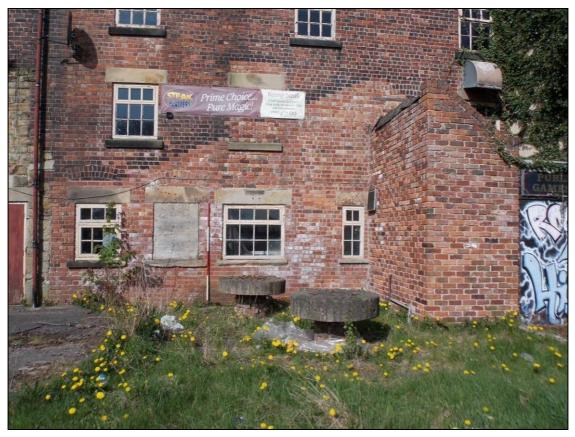
Figure 83: Scar of former pitched extension and remnants of earlier openings (scale 2m).

4.2.2 Although the fenestration of the side walls is fairly regular, consisting of three window openings on each floor, the lower section of the east elevation is slightly asymmetrical as a result of later alterations. Indeed, the scars of a single-storey pitched structure can be seen along the lower section of the east wall (Fig. 83). Moreover, there are also three segmental arched heads built with bricks which represent the location of former openings such as a doorway and a window on the basement and an additional window on the ground floor. Two gritstone type millstones, used as tables, are located outside adjacent to the basement (Figs 84 and 85).

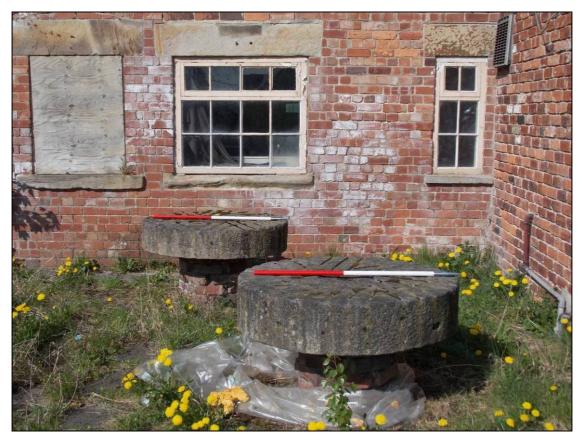
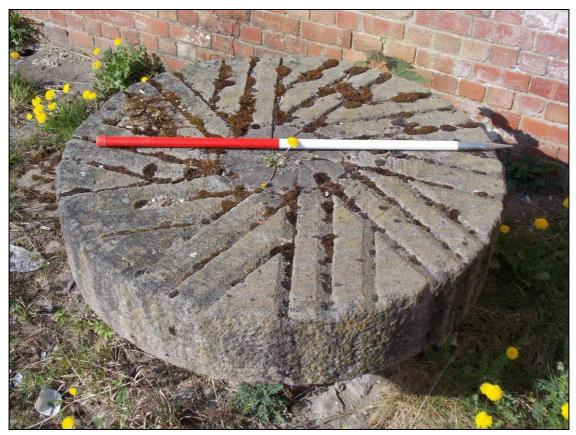
Figure 84: Millstones used as tables (scale 2 x 1m).

Figure 85: Detail of millstone (scale 1m).

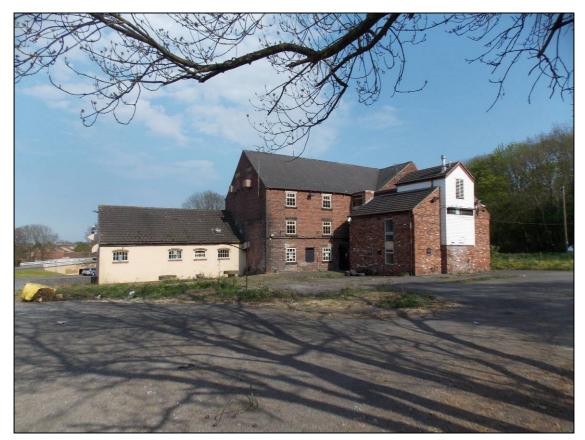
Figure 86: West elevation of Building B abutted by Buildings C (left) and D (right) (scale 2m).

4.2.3 The west elevation is partially obscured by Building D which abuts the southern end of the wall (Fig. 86). This elevation, likewise the adjacent Building A, is composed of three storeys as the ground level is much higher than the opposed eastern area. The fenestration is very regular consisting of openings with sandstone lintels and projecting sills. The actual windows are modern replacements of twelve lights with upper hopper openings although the

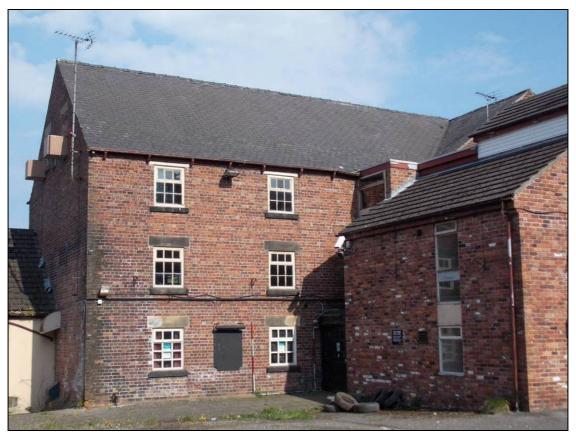
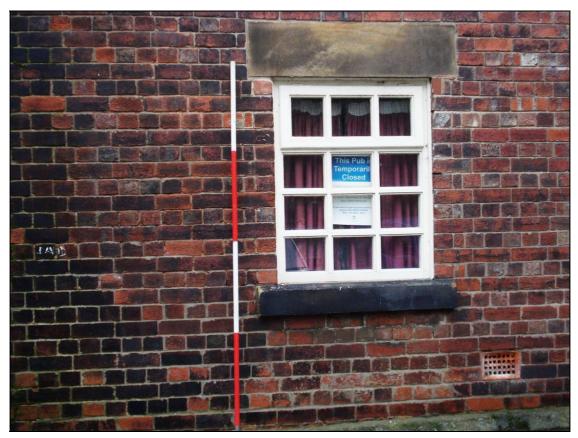
Figure 87: West elevation of Building B (scale 2m).

Figure 88: Detail of window opening, looking east (scale 2m).

ones on the second floor have central pivotal hinges (Figs 87 and 88). The southernmost window opening of the first floor has been blocked with bricks; however its projecting sill is still present as viewed from inside the staircase within Building D (Fig. 89). A decorative drive belt, which might have formerly been part of the mill machinery, is no mounted on the wall adjacent to the blocked-up window.

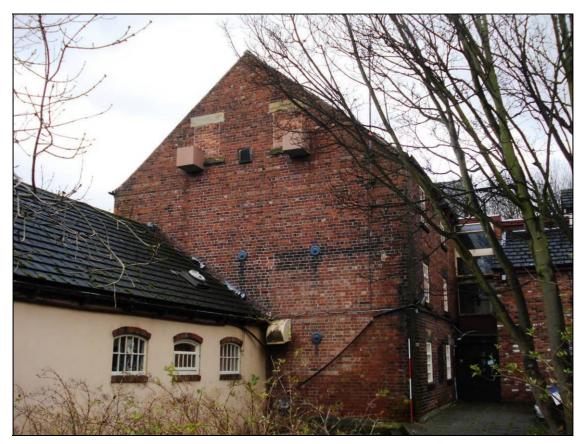
Figure 90: North elevation of Building B (scale 2m).

4.2.4 The north gabled elevation is very plain and partially abutted by Building C (Fig. 90). There are only two window openings positioned within the gabled wall although these are now blocked with bricks. There are cast-iron wall plates arranged symmetrically within the ground and first floors. These were also identified from inside Building C (Figs 91 and 92).

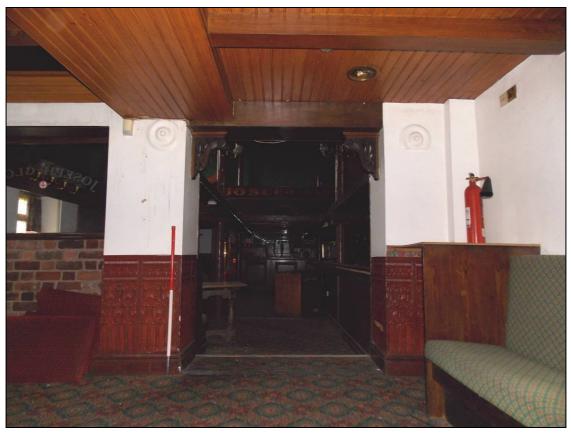
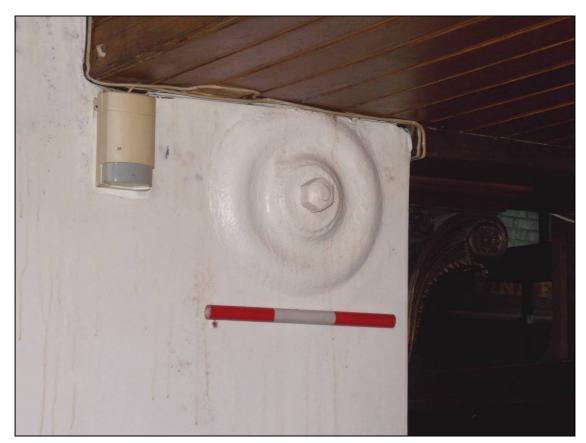
Figure 91: Eastern side of the ground floor viewed from Building C, looking south (scale 1m).

Figure 92: Detail of wall plate, looking south (scale 300mm).

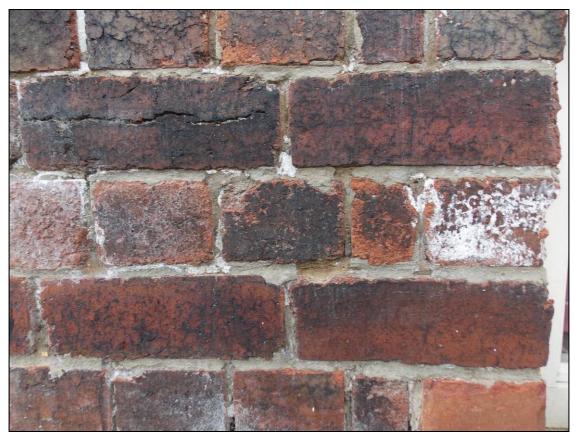
Figure 93: Detail of re-pointed brickwork.

4.2.5 The brickwork appears to have originally been bonded with mid yellowish brown medium coarse lime mortar although it has been re-pointed with later cement (Fig. 93). The south wall is in effect the north wall of the adjacent Building A as the latter was an existing construction prior to the construction of Building B.
