# The former Joseph Glover pub, Station Road, Halfway, Sheffield

### Archaeological Building Recording

#### A.R.S. Ltd Report 2013/61 July 2013

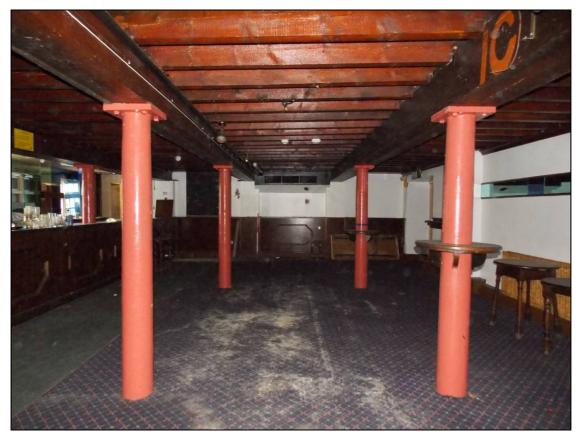
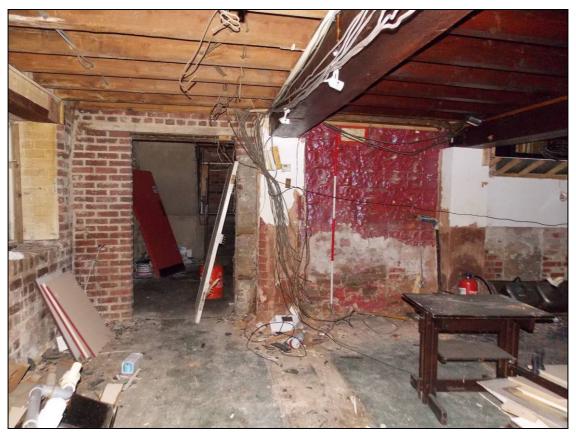
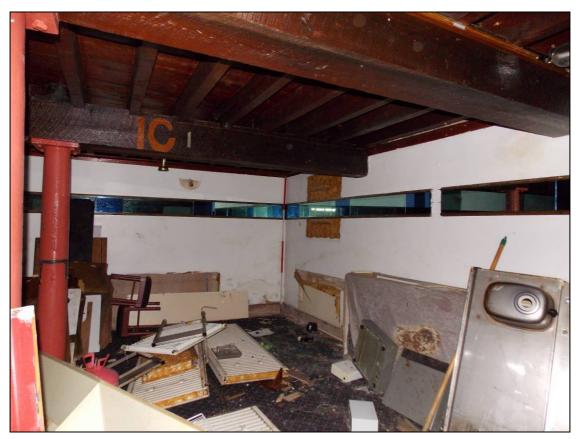
Figure 97: General view of the basement, looking south (scale 1m).

Figure 98: South wall after soft-stripping (scale 2m).

Figure 99: North wall after soft-stripping, looking north-west (scale 2m).

4.2.6 The basement is accessed from several doorways to the exterior as well as inserted doorways to the adjacent Buildings A and C (Figs 94 - 96). It consists of a large lounge modernised with carpet and dado panels. The interior is comparable to the adjoining Building A. The cast-iron columns are similar to the one in Building A, but include an inscribed maker's name "C. R. HALL MAKER WORKSOP" and are joined to the underside of the beams with four bolts rather than two. The cast-iron columns and bridging beams follows the existing alignment of Building A, thus the bridging beams are arranged longitudinally rather than across the range. The ends of the bridging beams are supported by brick pilasters with chamfered edges and run-out stoppers although partially concealed by later plasterwork (Figs 97 - 99).

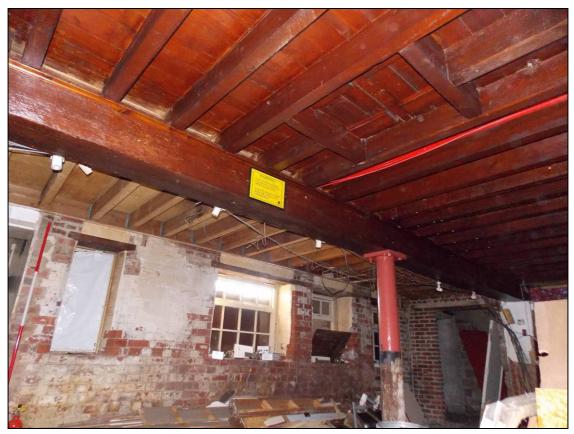
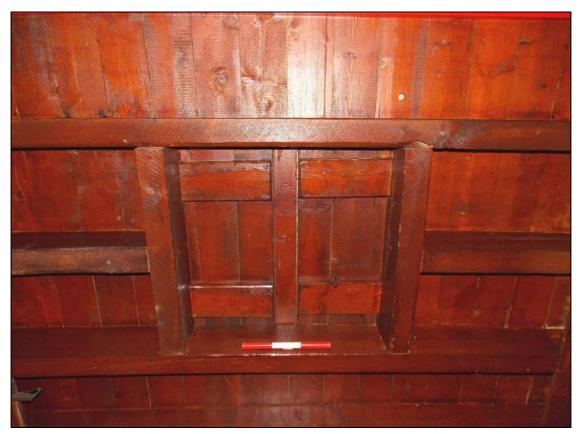
Figure 100: Basement with ceiling hatch adjacent to the bar (dismantled following soft-stripping).

Figure 101: Detail of ceiling hatch, looking east (scale 300mm).

4.2.7 The ceiling joists of the easternmost aisle are mostly later replacement (Fig. 100). There is a well-preserved ceiling hatch amongst the joists adjacent to the bar area (Fig. 101). north wall .

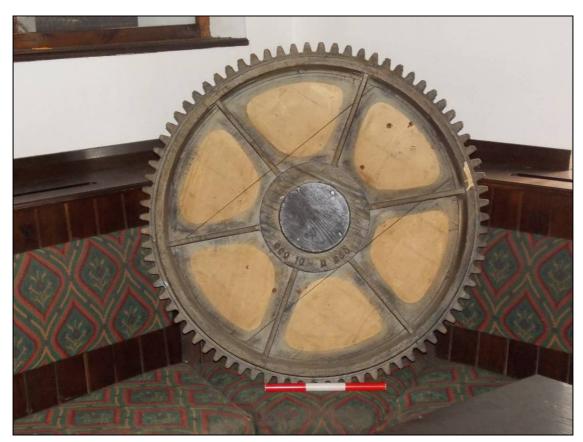
Figure 107: Sitting area with a wooden bevelled gear, looking north-east (scale 300mm).

Figure 108: Detail of bevelled gear (scale 300mm).

4.2.9 The walls are rendered with plaster even behind the continuous sitting areas (Fig. 106). The interior is decorated with fake bevelled gear wheels pretending to be part of the former mill machinery (Figs 107 and 108).

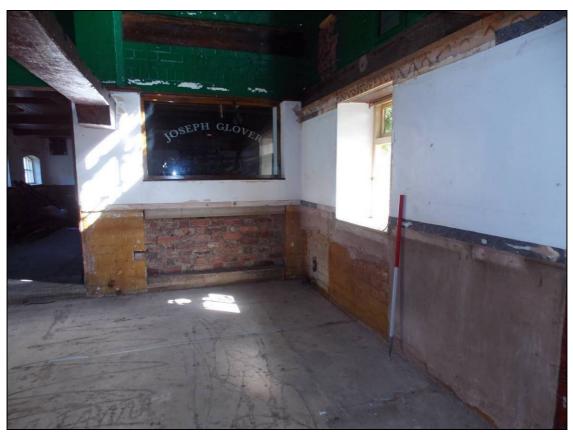
Figure 109: Former opening within the north wall revealed during the soft-stripping watching brief (scale 1m).

4.2.10 Soft-stripping revealed a former opening within the north wall which is now blocked with bricks (Fig. 109).

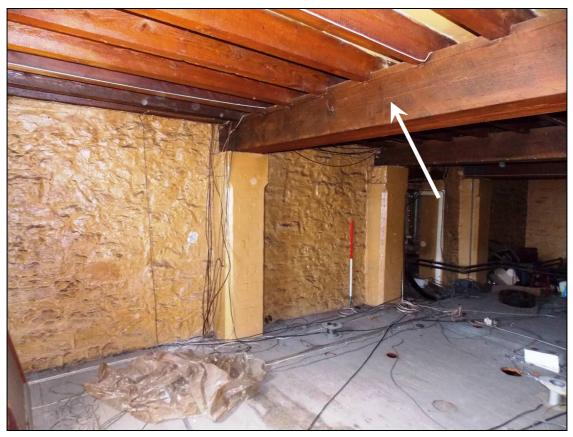
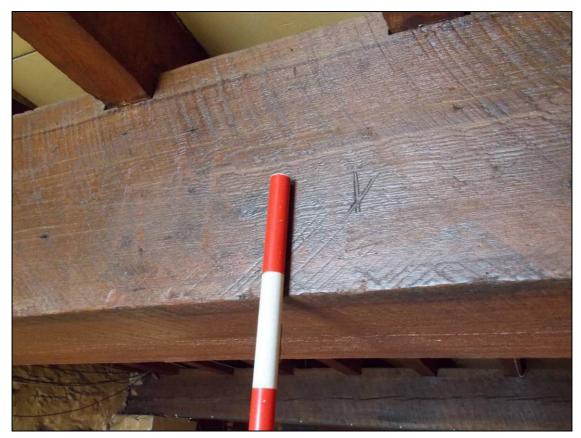
Figure 111: First floor with beam containing carpenter's marks (arrow) (scale 1m).

Figure 112: Detail of carpenter's marks within the eastern beam (scale 200mm).

4.2.11 The first floor consists of some mezzanine-like platforms as it is partially open to the floor below. The southern end abuts the existing Building A which is built with sandstone externally. This may imply that Building A would have originally been a stone-built range and subsequently it was extended with the addition of Building B involving the external brick refacing within the upper storeys, creating an analogues effect between the ranges. The abutment is composed of three brick pilasters with chamfered edges against the stone wall of Building A. These support the longitudinal bridging beams (which also include some carpenter's marks) with plates attaching the adjacent beams (Figs 110 - 114).

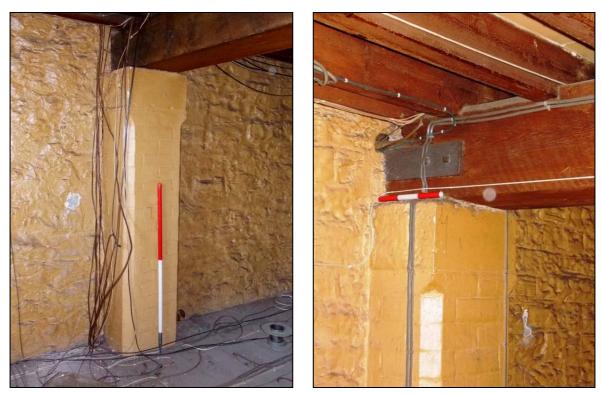
Figure 113: Detail of pilaster, looking south-west (scale 1m).

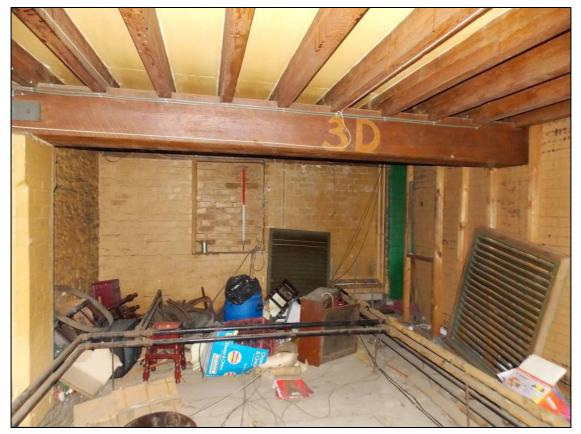
Figure 115: Southern bay of the first floor with blocked-up window opening within the west wall (scale 1m).

4.2.12 The southernmost bay is separated to the main floor with a later plywood stud whose north face consists of a mock brickwork pattern. Its west window opening is blocked with bricks as externally identified (Fig. 115). This area is used for storage of lose items including a genuine drive belt which might have been an earlier component of the former mill machinery (Fig. 116).

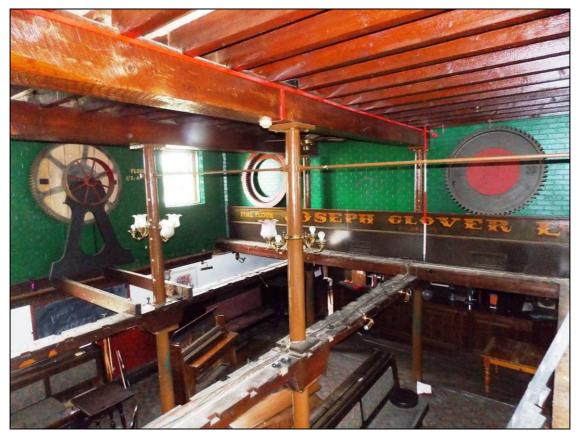
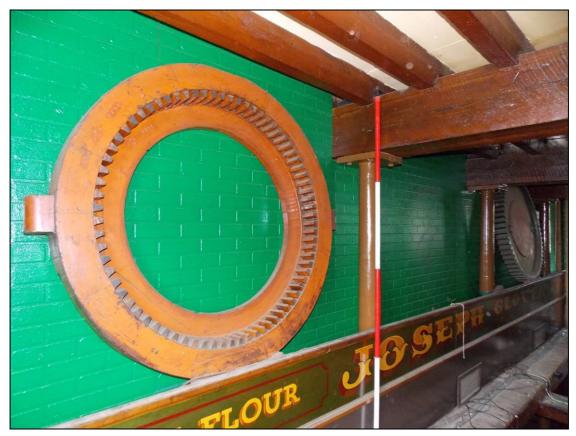
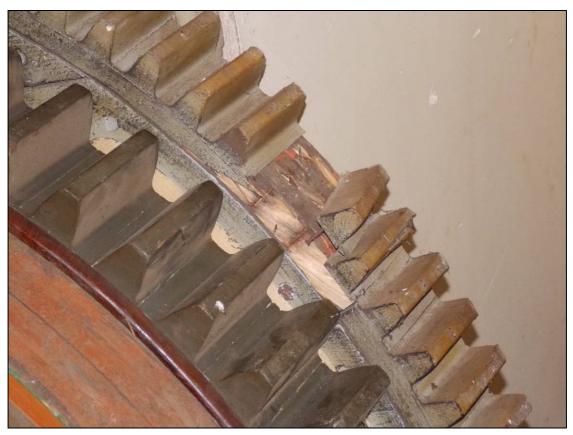
Figure 117: Open floor with fake components of former machinery, looking south-east (scale 2m).

Figure 118: Fake bevelled gear against stud panel, looking south (scale 2m).

Figure 119: Fake brick stud panel with bevelled gears (scale 2m).

Figure 120: Detail of fake gear recorded during the soft-stripping watching brief.

4.2.13 The mezzanine platforms also contain fake mill machinery as decorative items, including bevelled gear wheels (Figs 117 - 120). The ceiling contains exposed beams and joists. Two trimmer beams were identified amongst the central joists which might have formerly been part of a hatch as they are positioned immediately above the hatch identified on the basement floor (Fig. 121). Further carpenter's marks were recognised amongst the beams (Figs 122 - 124).

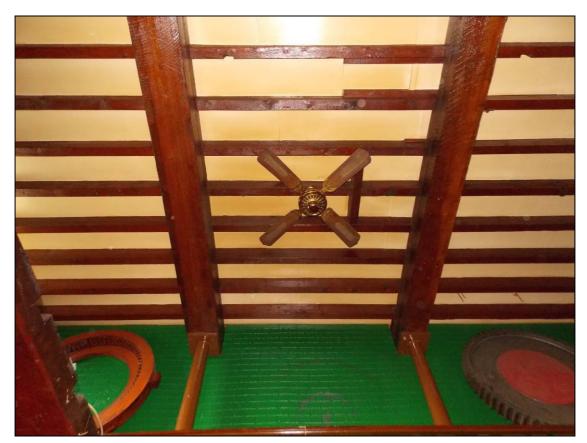
Figure 121: Trimmer beam within the central bay, looking south.

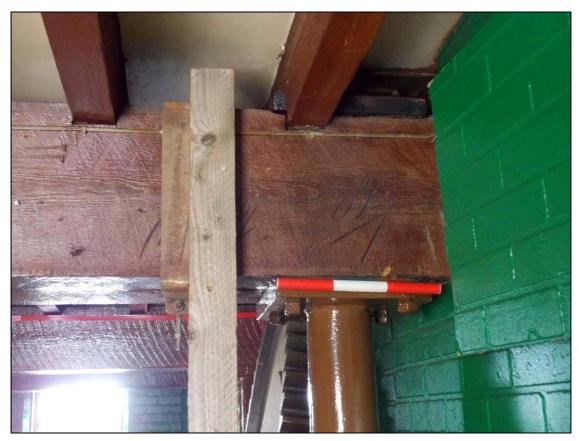
Figure 122: Carpenter's marks within the eastern beam and above the southernmost column (scale 500mm).

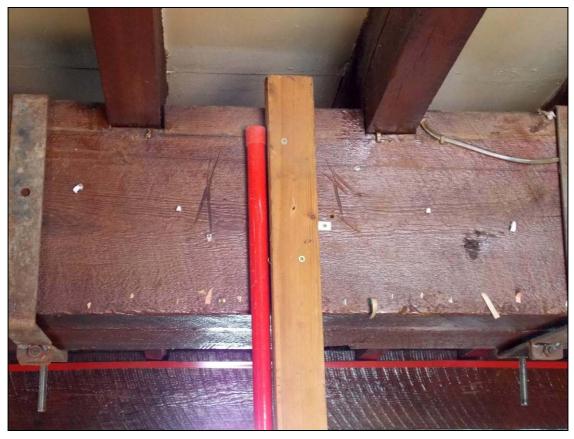
Figure 123: Carpenter's marks within the western beam and above the southernmost column (scale 300mm).

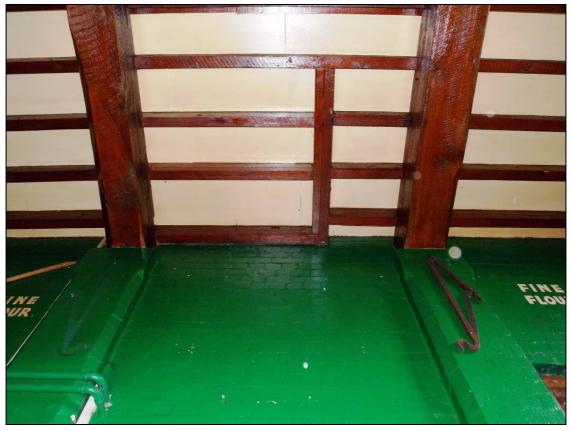
Figure 132: Northern end of the eastern beam with carpenter's mark and later grooves (scale 300mm).

4.2.17 There might have been additional hoists within the northern end of the building as an additional trimmer beam and grooves possibly created by ropes were identified amongst the joists and eastern beam (Figs 132 and 133). The wall or tie-plates identified externally within the north elevation are bolted up to the top face of the bridging beams (Fig. 134).

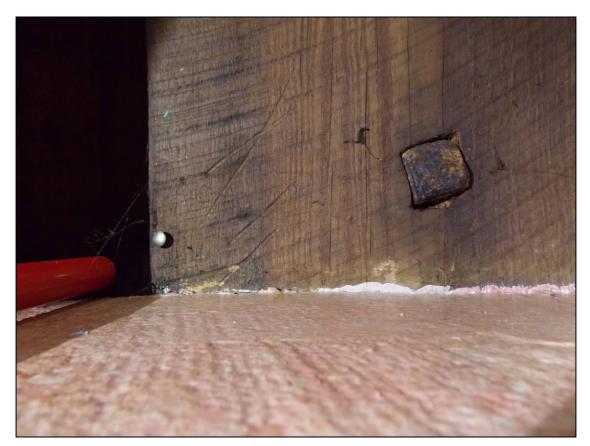
Figure 140: Western side of the southern tie-beam with carpenter's marks (arrow) (scale 300mm).

4.2.19 Further carpenter's marks were identified here (Figs 140 and 141). Although there is an inserted doorway within the eastern side of the south wall, a former central opening was observed within this wall during the soft-stripping watching brief (Fig. 142).

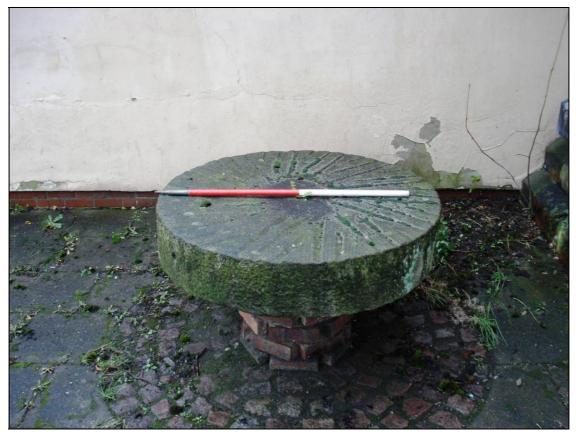
Figure 149: Millstones used as tables along the west elevation (scale 2 x 1m).

4.3.2 Further components of the former mill include several millstones used as decorative tables located to the west of Building C (Figs 149 - 150). These millstones consist of two French burr stone variety (of which one is only composed of the central portion) and the other is a gritstone type. The gritstone millstones generally produce very inferior flour and, furthermore, wear out very quickly when used with hard grains. French burr stones, on the other hand, are the best flour producing millstones ever discovered. It is probable that these millstones were used as part of the mill's workings processes and were discarded or utilised as decorative tables when the premises became a pub in the third quarter of the  $20^{th}$  century.

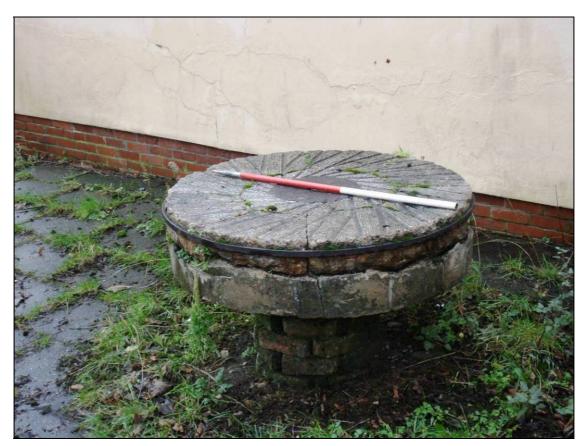
Figure 150: Detail of gritstone millstone (scale 1m).

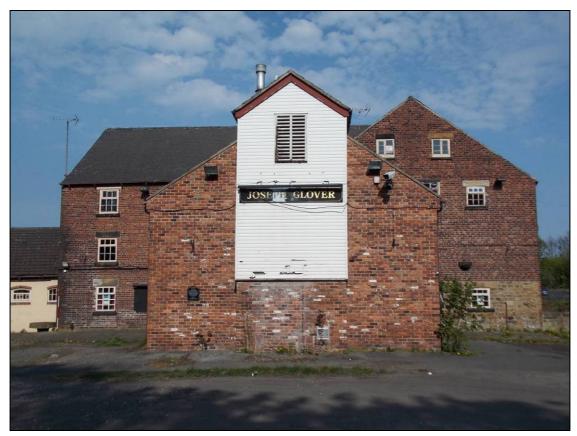
Figure 162: West elevation of Building D (scale 2m).

4.4.1 This range is a two-storey brick-built extension constructed with modern fabrics including concrete tiles and metal windows (Figs 162 and 163). The pitched roof contains a projecting lantern-like feature which appears to be designed for ventilation purposes. The area abutting the west walls of Buildings A and B is narrower and contains a flat felted roof.

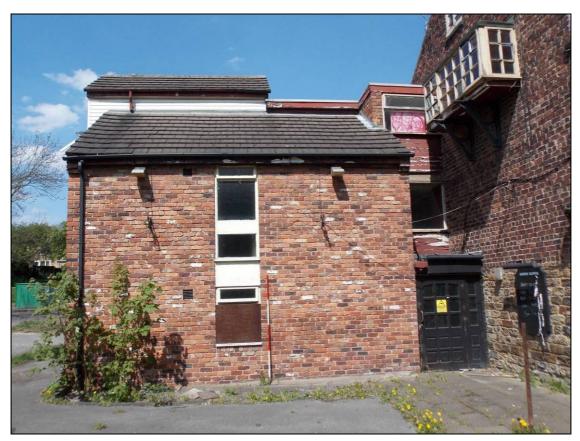
Figure 163: South elevation of Building D (scale 2m).

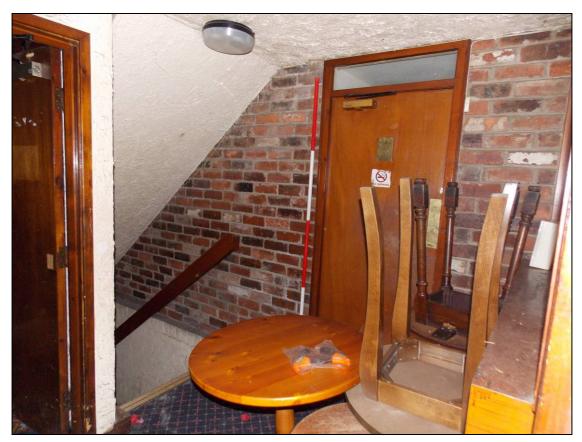
Figure 164: Staircase to the basement, looking north (scale 2m).

4.4.2 Internally this range contains storage areas and a boiler room on the basement which is accessed from a dog-leg staircase built with concrete (Figs 164 - 166). The northern storage room was found to be exceptionally damp. It is unknown whether drain problems or recent leakage has occurred around this area; however the proximity to the former mill pond (now back-filled beneath the western car park area) should not be ruled out as a possible source.

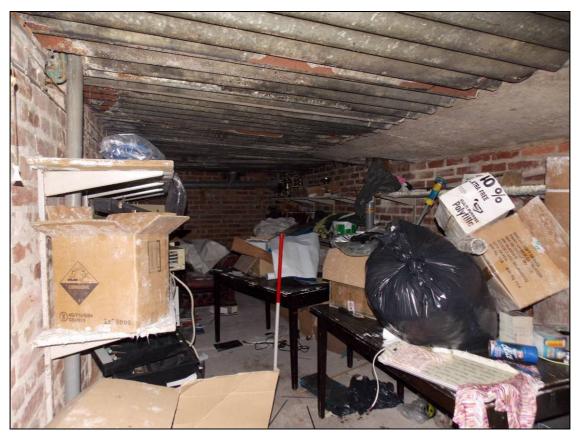
Figure 165: General view of the basement, looking west (scale 1m).

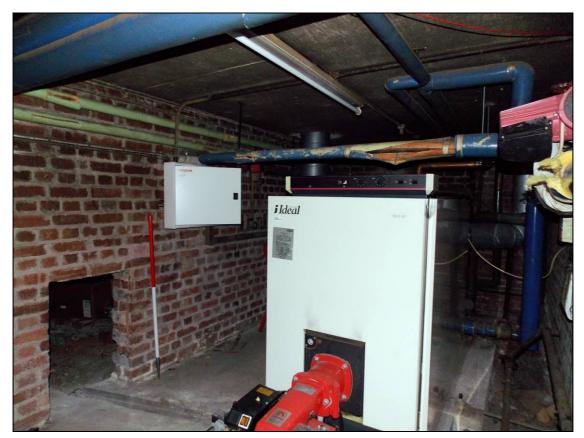
Figure 166: Boiler room within the basement, looking west (scale 1m).

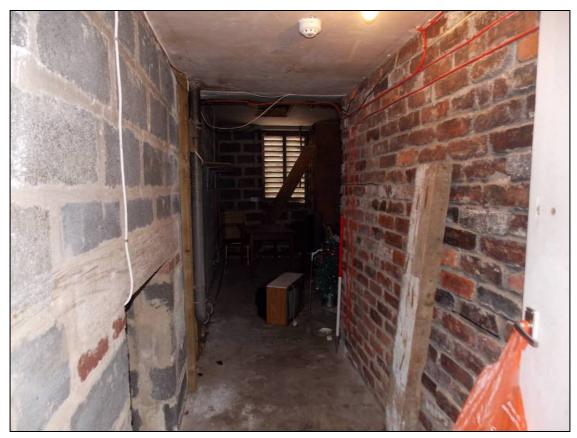
Figure 174: Second floor of Building D, looking west (scale 1m).

4.4.3 The ground floor acts as the main lobby for former pub which leads also to the staircase (Fig. 167). The ground and first floors contain lavatories of the former pub as well as minor storage areas (Figs 168 – 173). The second floor is in effect a loft area which is mostly vacant although it has been used to store furniture (Fig. 174).
