An Archaeological Watching Brief at West Fenwick Farm, Northumberland

ARS Ltd Report No-2015/100 OASIS No: archaeol5-218208

July 2015

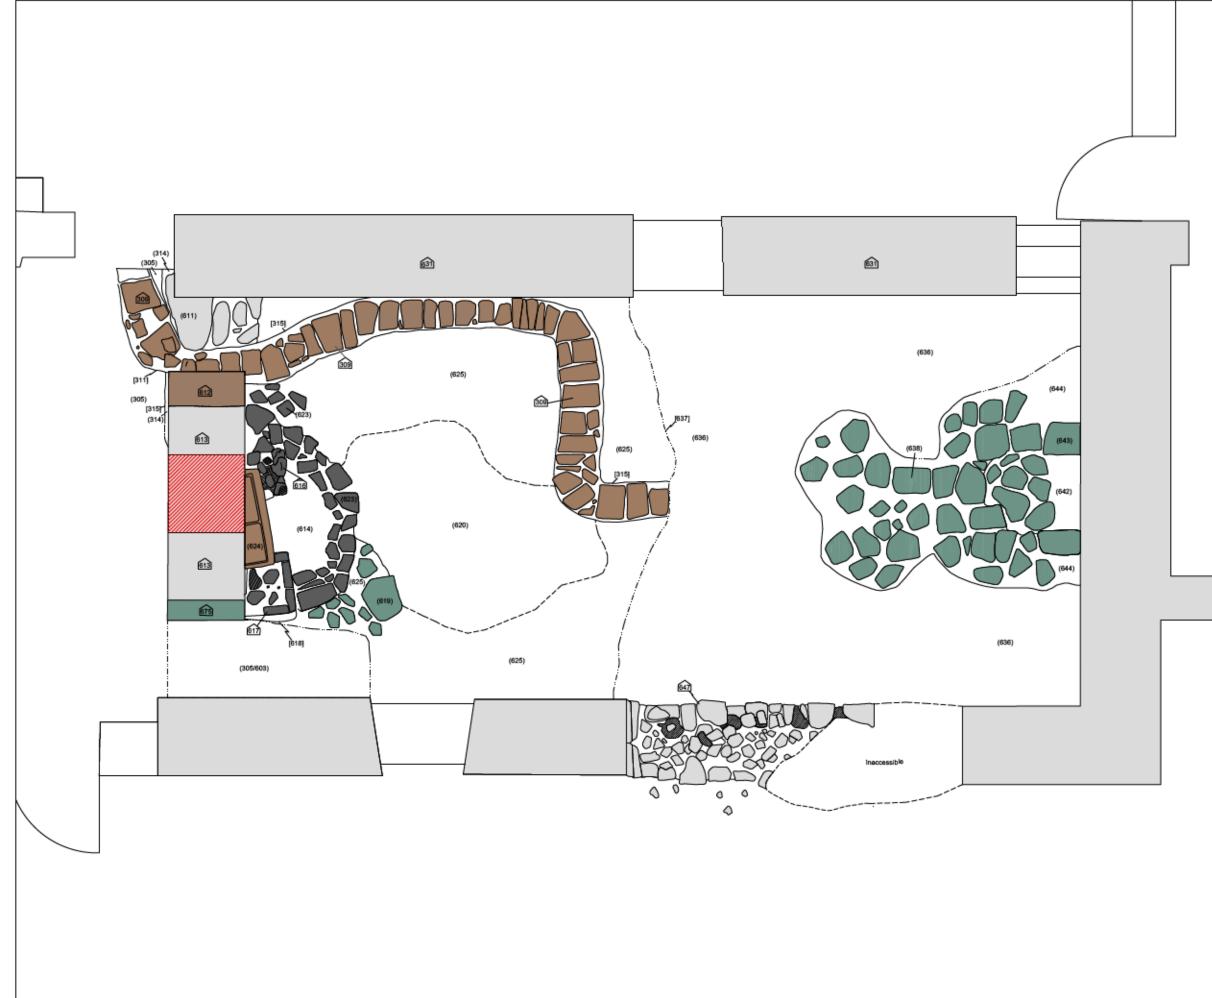
Figure 8: Plan of Archaeological Features in Bastle House (Bldg 4) Scale:1:50 @ A3 Drawn: RL
	Кеу:
	- Late 16th - 17th Century
	- 18th Century
	- 18th - 19th Century
	- 19th Century
	- 16th-17th Century Blocked Byre Doorway
	NB: Date ranges are estimated
	N
	Copyright/ Licencing This Drawing © A.R.S. Ltd
2.5	Ordnance Survey data if applicable © Crown Copyright, all rights reserved reproduction with permission. Licence No. 100045420

base of the 19th century doorway (612) and physically overlay natural substrate (305/603) (Figure 8, 10, 17, 39 & 40). Structure (611) was interpreted as either shallow footings or a sandstone plinth for the support of the west wall (613). Foundation structure (611) was set within a cut [315] which likely represented ground preparation and clearance within the footprint of the bastle and should not be interpreted as a foundation trench. The 16th-17th century component of the west wall (613) of the bastle-house was constructed from irregularly coursed, squared sandstone blocks and measured 2.78m x 1.10m in plan. The relatively small dimensions of the 16th-17th component of the west wall (613) was caused by the insertion of two doorways (612/675) into the NW and SW corners of the bastle during the 19th century. The original 16th-17th century byre doorway was visible within the west-face of the west bastle wall (612) and displayed an arch with a pointed head and a continuous chamfer (Figure 17, 41 & 42). The byre doorway measured 0.94m x 1.81m x 1.10m at its maximum extents but was not visible within the interior face of wall (613) due to later modifications. The east wall (677) of the bastle (Building 4) was constructed using near identical construction methods to the west wall (613) and measured 4.8m x 1.10m internally.

5.14 The earliest deposit identified within the bastle interior was characterised by a 0.08m thick, blackish-brown, silty-clay (645). Layer (645) was identifiable at a depth of 0.48m below interior ground level and was interpreted as a trample layer potentially related to the storage of livestock (Figure 8 & 9). The yellowish-brown, silty-clay natural substrate (603) was identified within the interior of the bastle (Building 4) at a depth of 0.50m below exterior ground level.

both pillars (616)/617) were removed and a sandstone hearth (624), measuring 1.14m x 0.38m x 0.14m, was inserted (Figure 8, 9, 18, 45 & 46).

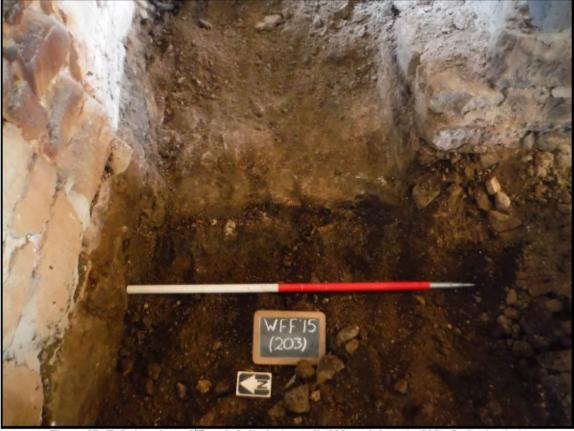
Figure 27- E-facing view of Trench 2 displaying wall (203) and deposit (202) (Scale- 1 x 1m)

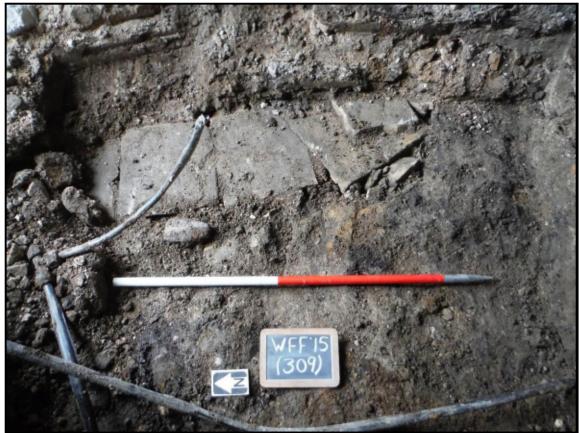
Figure 28- E-facing view of culvert F.313 in Test Trench 3 (Scale- 1 x 1m)

constructed on a broadly parallel alignment and sealed by a horizontal sandstone slab. The culvert walls (309) were constructed from unbonded, shaped, sandstone blocks and displayed average individual dimensions of 0.30m x 0.14m x 0.13m (Figure 28 & 29). It should also be noted that culvert F.313 was excavated through a yellowish-brown, silty-clay natural substrate (305) and extended beyond the eastern limit of Trench 3 and into the interior of the bastle (Building 4) (Figure 14). The stratagraphic location of culvert F.313 was suggestive of a late 19th century date. Boulder plinth footings (316) were also identified within the W-facing section of the trench and were interpreted to be related to the 16th-17th century construction of the bastle-house. A N-S aligned, sandstone wall foundation (310) was identified at the western extent of Trench 3 and measured 1.42m x 0.28m x 0.05m at its maximum visible extents (Figure 6, 30 & 31). Wall (310) overlay natural substrate (305), displayed no evidence for the use of bonding material and only survived to a single course. It was also noted that wall foundation (310) appeared to relate to a construction scar upon the southern face of the northern wall of Building 6 (Figure 31). Consequently, wall footings (310) were interpreted to be an 18th or 19th century foundation for a partition wall within Building 6, potentially related to the insertion of a corridor dividing Building 6 from the bastle-house (Building 4). The natural substrate (305) was identified at a depth of 0.60m below the interior ground level.

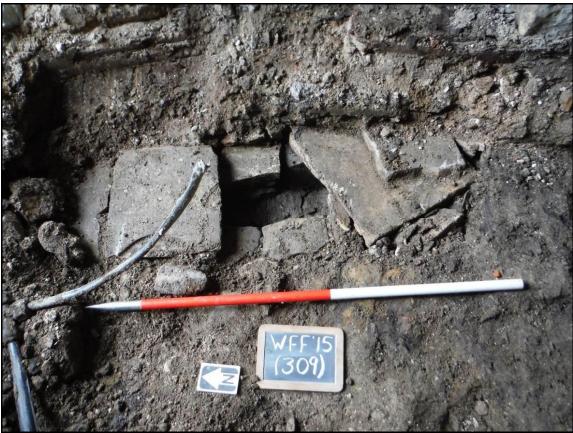
Figure 29- E-facing view of F.313 displaying interior culvert structure (Scale- 1 x 1m)

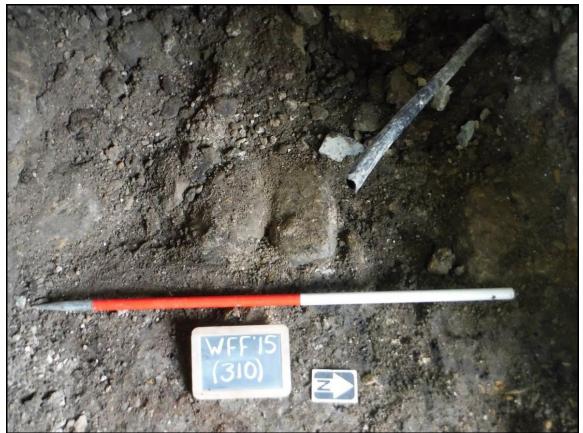
Figure 30- W-facing view of N-S aligned wall foundation (310) in Trench 3 (Scale- 1 x 1m)

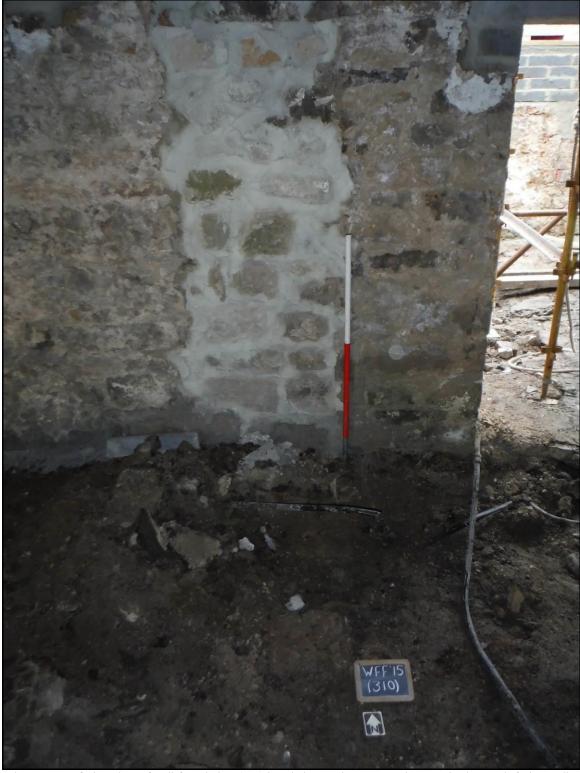
Figure 31- N-facing view of wall foundation (310) in relation to the construction scar in the south facing wall of Building 6 (Scale- 1 x 1m)

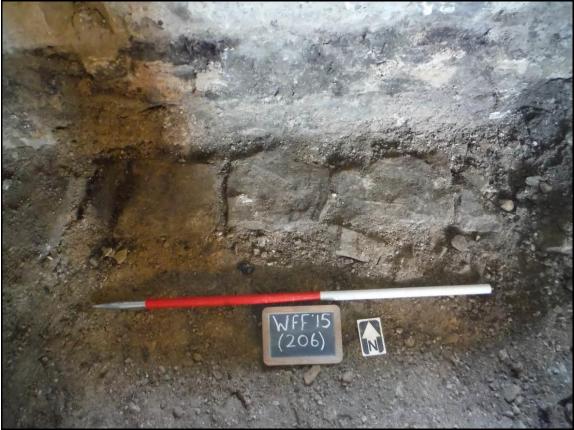
Figure 32- N-facing view of flagstone surface (206) (Scale- 1 x 1m)

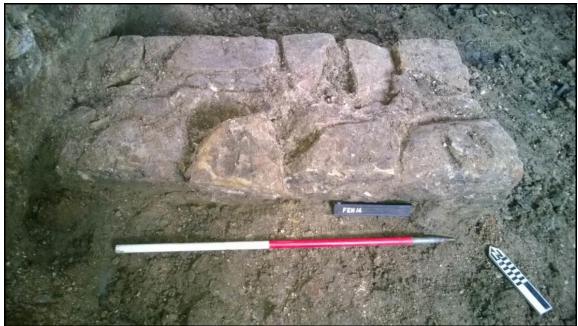
Figure 33- NE-facing view of 14th-16th century wall (601) (Scale- 1 x 1m)

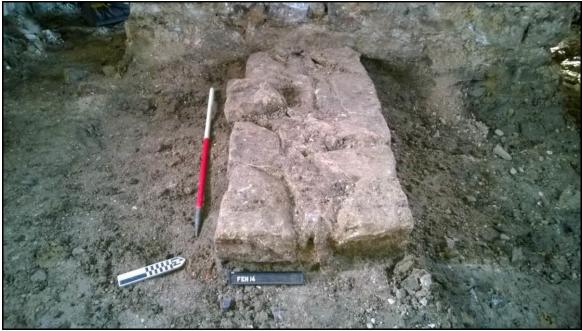
Figure 34- W-facing view of wall (601) (Scale- 1 x 1m)

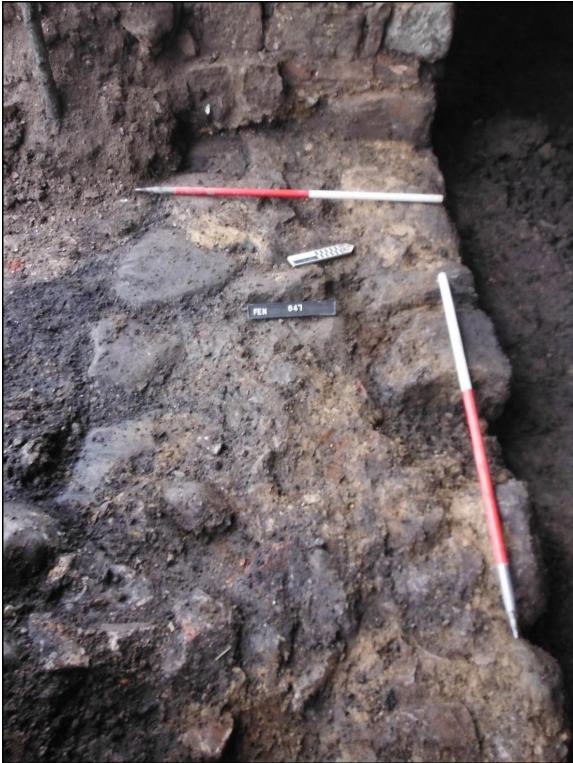
Figure 35- W-facing interior view of the southern wall (647) of the bastle (Building 4) (Scale- 2 x 1m)

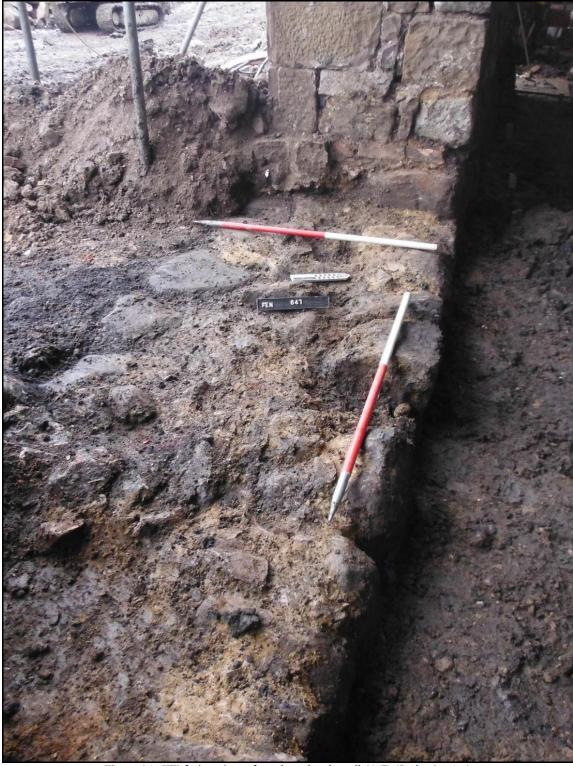
Figure 36- SW-facing view of southern bastle wall (647) (Scale- 2 x 1m)

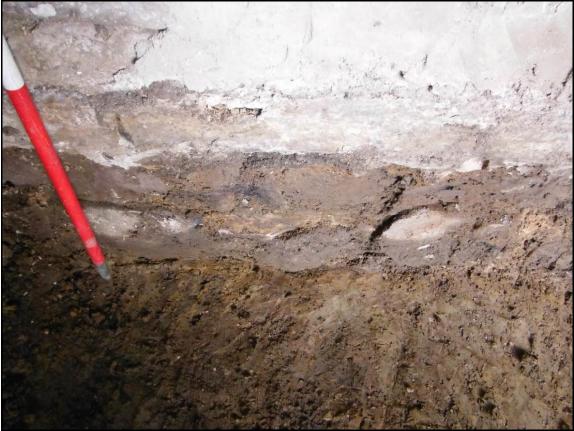
Figure 37- Pre-excavation view of foundation trench F.634 for north wall of the bastle (647) (Scale-1 x 1m)

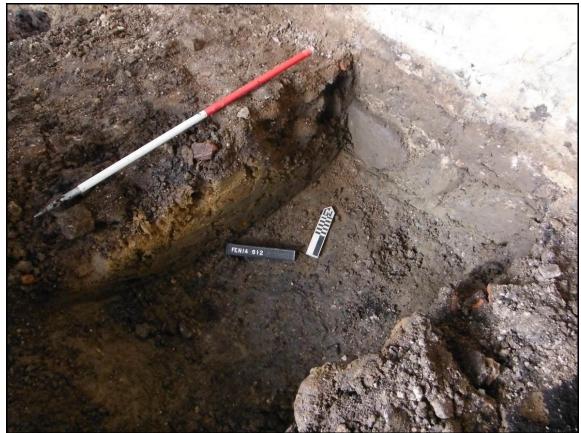
Figure 38- Oblique view of section through 19th century levelling layer (609) and construction cut F.634 (Scale- 1 x 1m)

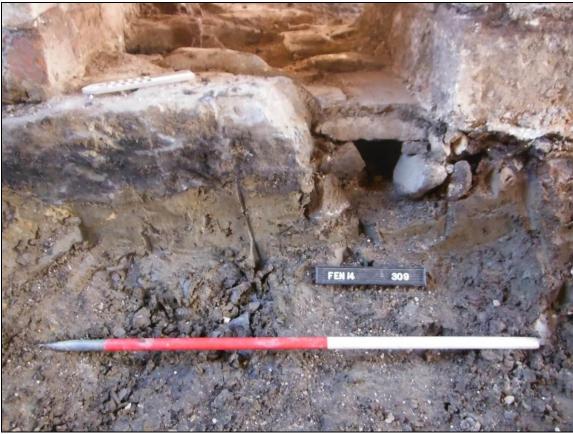
Figure 39- NE-facing view of sandstone footings/plinth (611) and 19th century culvert F.313 (Scale- 1 x 1m)

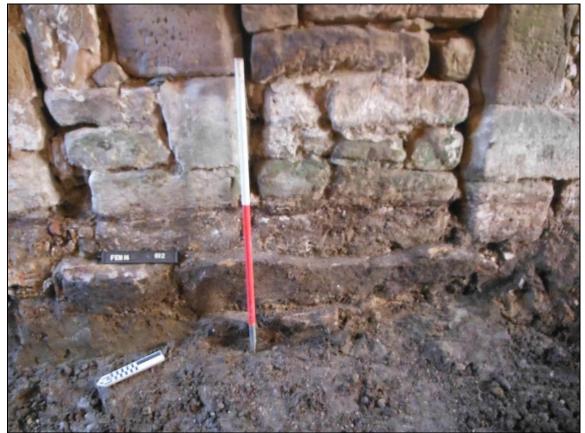
Figure 40- NE-facing view of sandstone footings/plinth (611) below wall (613) (Scale- 1 x 1m)

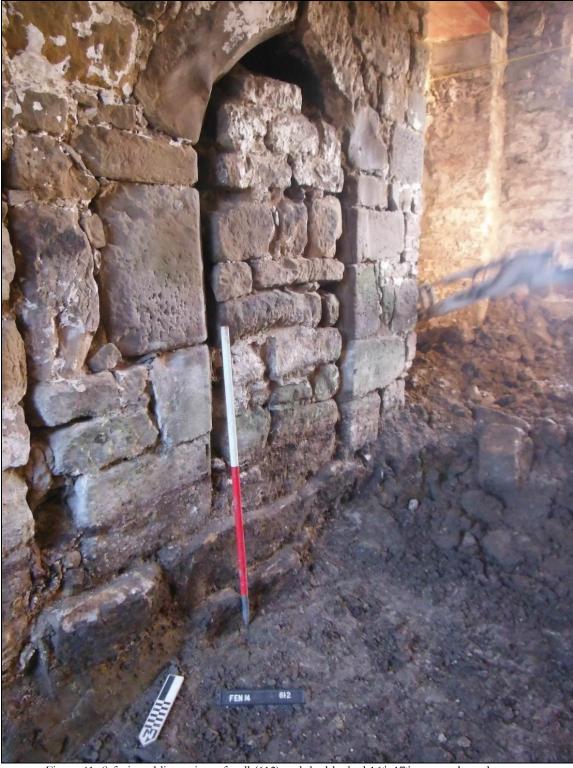
Figure 41- S-facing oblique view of wall (613) and the blocked 16th-17th century byre doorway (Scale- 1 x 1m)

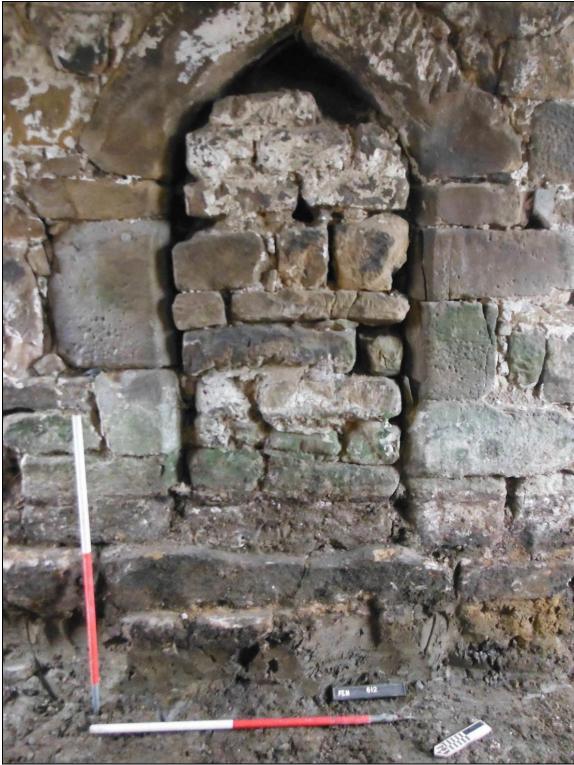
Figure 42- E-facing elevation of the 16th-17th century byre doorway within the western gable end wall of the bastle (Scale- 2 x 1m)

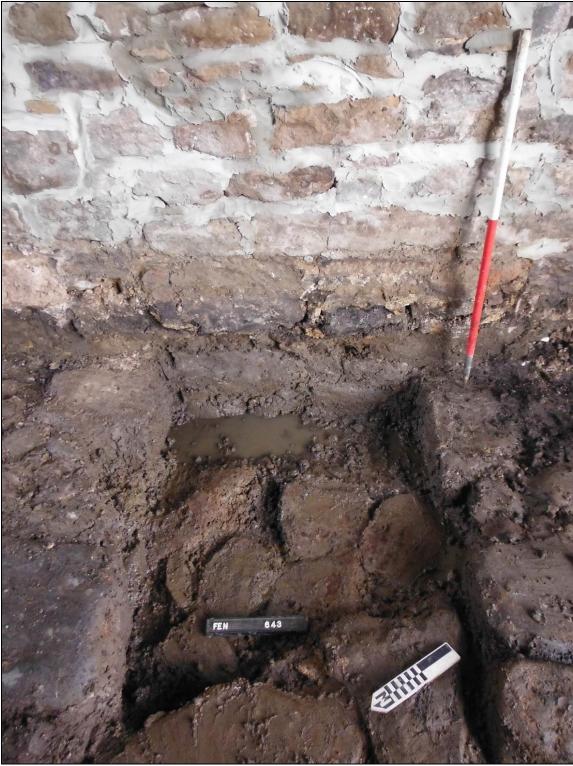
Figure 43- Square fireplace (643) present at the eastern extent of the bastle (Building 4) (Scale- 1 x 1m)

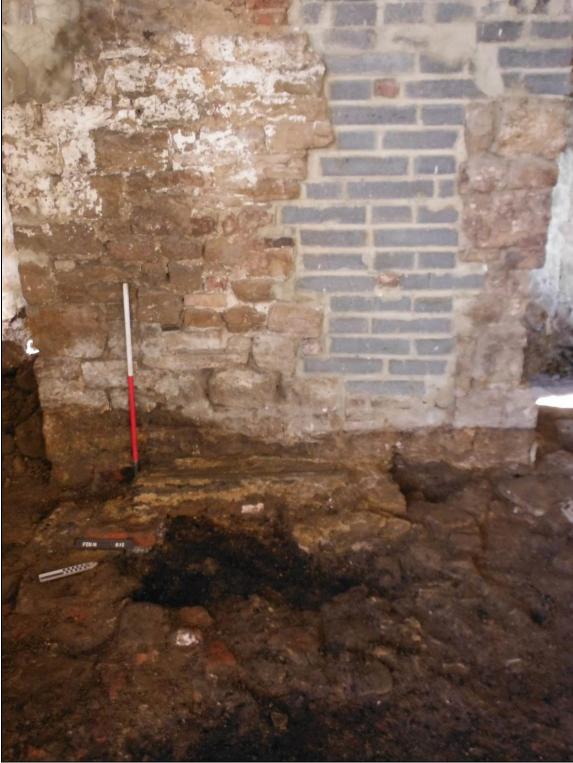
Figure 44- W-facing view of fireplace (616/617) blocked by late 19th-20th century remodeling (Scale- 1 x 1m).

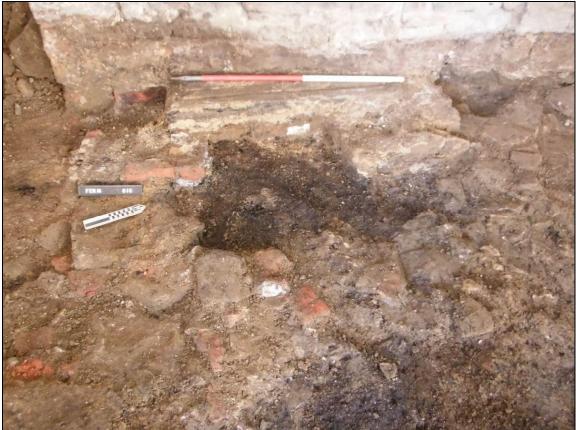
Figure 45- W-facing view of Fireplace (616/617), bordered by fragmentary surface (623) (Scale- 1 x 1m)

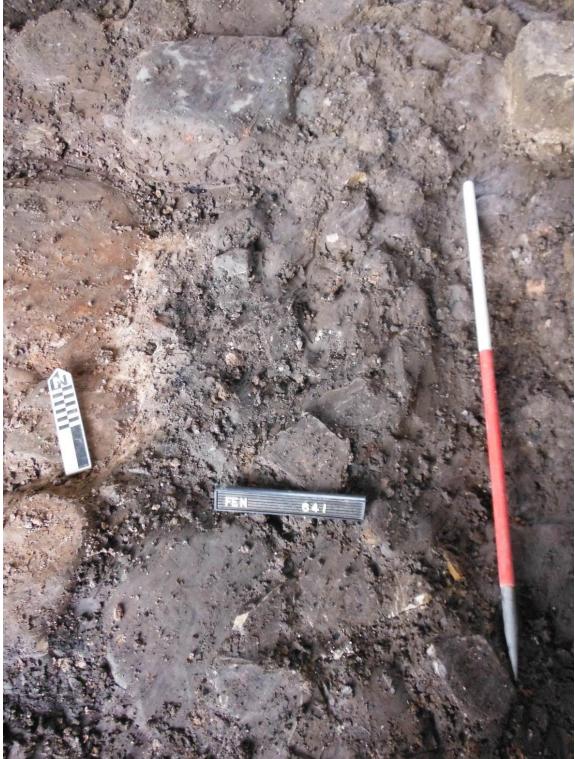
Figure 46- Cobbled surface (641) above brown dis-use layer (620) and 18th century fireplace (643) within the bastle (Building 4) (Scale 1 x 1m)

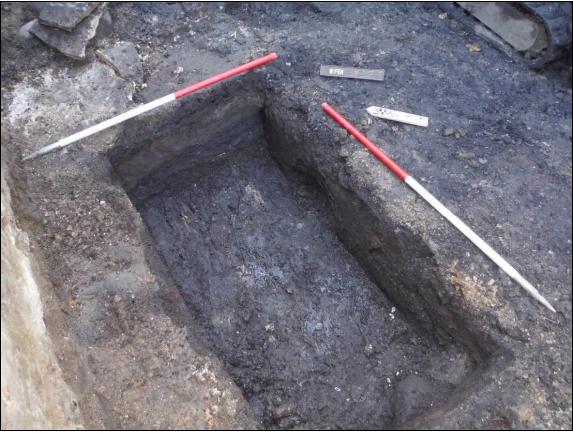
Figure 47- E-facing oblique view of northern trench within Building 5 (Scale- 2 x 1m)

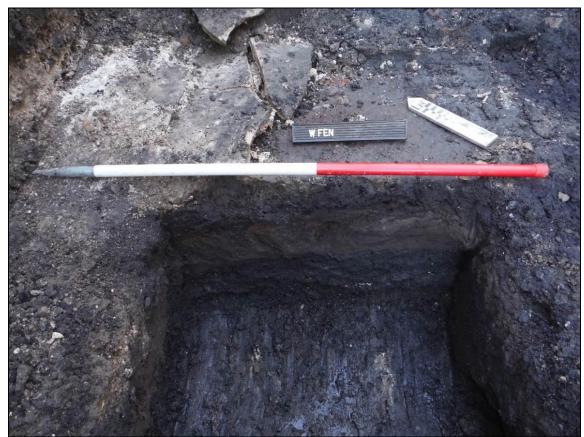
Figure 48- SW facing section through the northern trench within Building 5 (Scale- 1 x 1m)

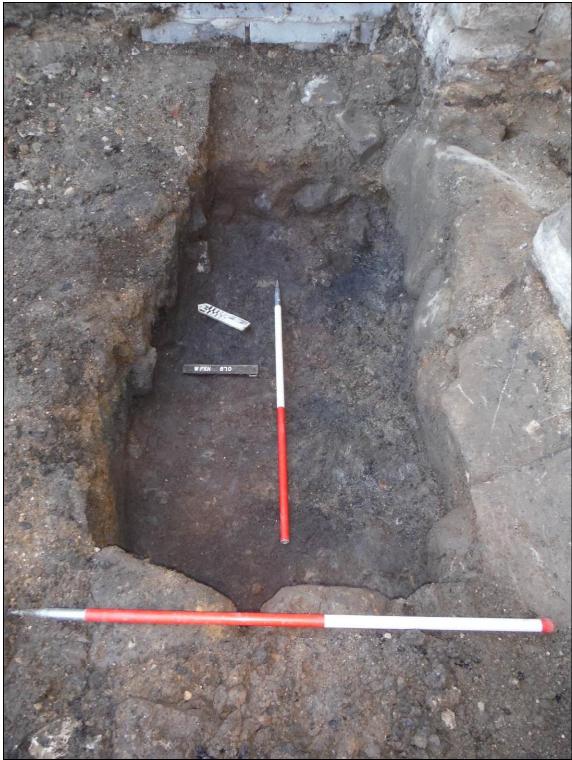
Figure 49- NE-facing view of southern trench within building 5 (Scale- 2 x 1m)

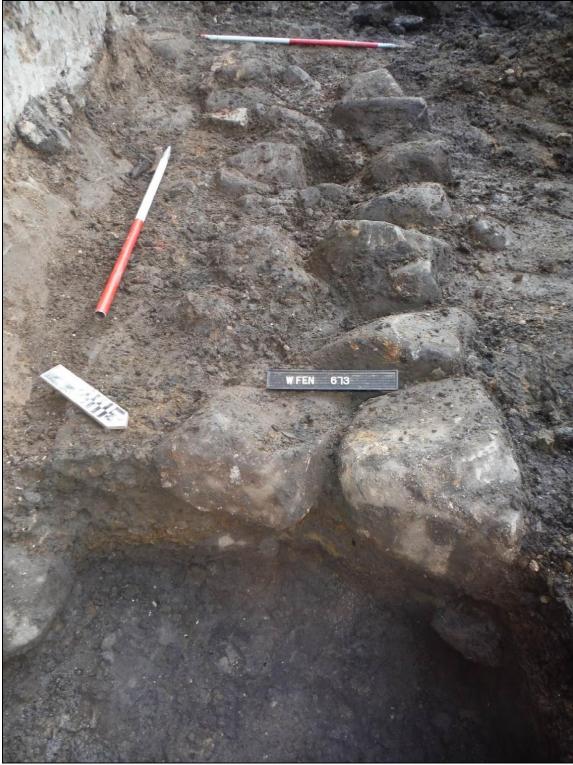
Figure 50- SW-facing view of consolidation deposit (673) (Scale- 2 x 1m)

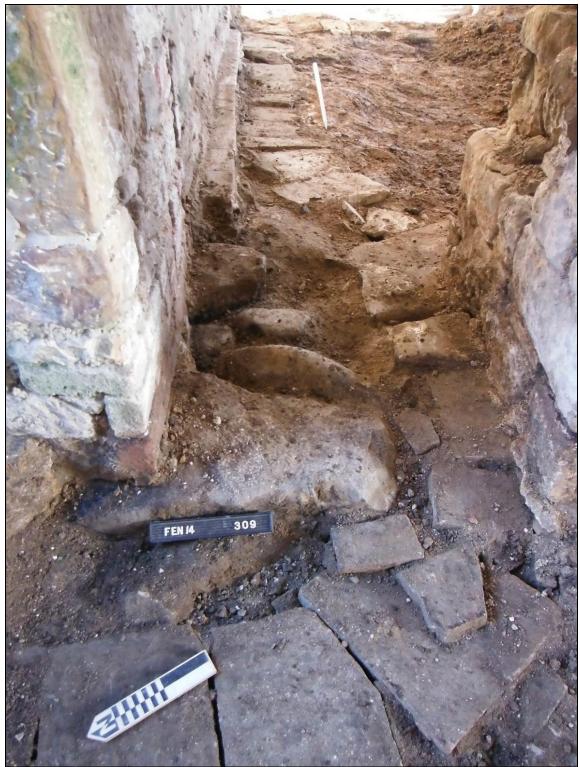
Figure 51- E-facing view of 19th century culvert F.313 in the interior of the bastle (Building 4) (Scale- 1 x 1m)

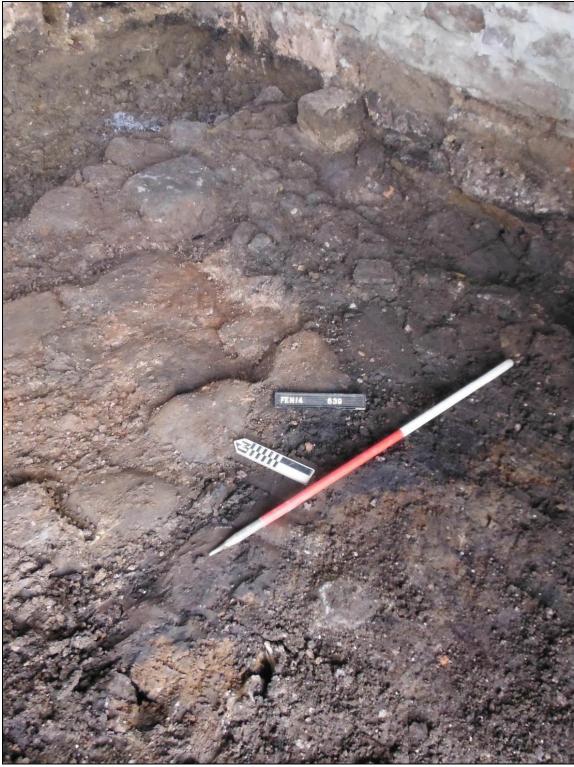
Figure 52- 20th century truncation event F.634 visible in the foreground truncating surface (638) (Scale- 1 x 1m)

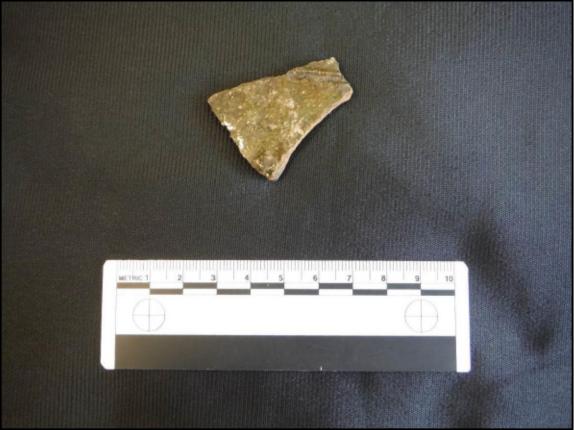
Figure 53- 14th-15th century pottery recovered from structure (601) (Scale- 1 x 1m)

6.2.2 The fragment recovered was classified as a bodysherd of green, lead-glazed, pottery with an orange sandy fabric and traces of incised decoration, possibly from a jug, dating to the late 14th-early 16th centuries (Figure 53).

7.2 The earliest phase of activity related to the construction of wall (601) which contained a fragment of 14th-16th century pottery. It is not unreasonable to assume that wall (601) likely formed part of a structure located at the southern extent of the medieval village of Fenwick. The lack of associated occupation deposits prevented any greater understanding of structure function, however, it was noted that wall (601) was relatively well constructed and could be tentatively interpreted as forming part of a 14th-16th century domestic residence.

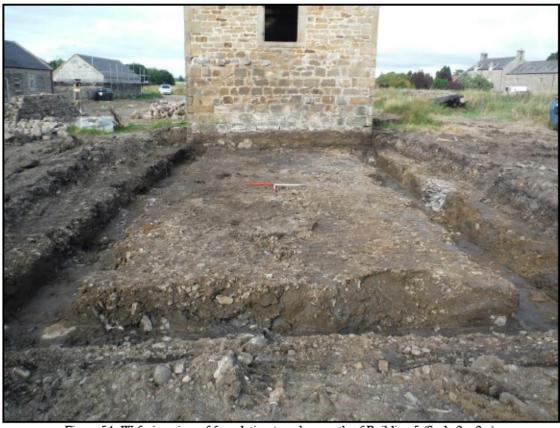
Figure 54- W-facing view of foundation trenches north of Building 5 (Scale 2 x 2m).

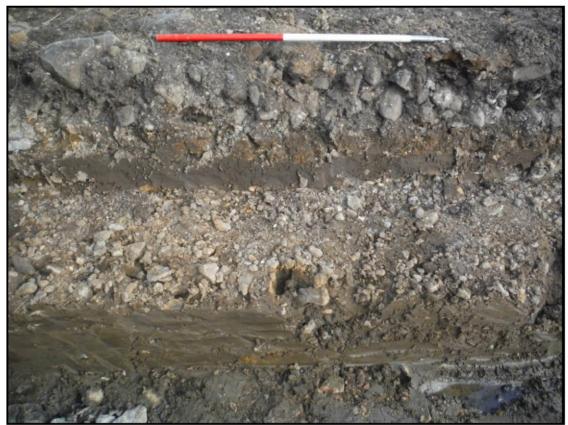
Figure 55- S-facing representative section through foundation trenches (Scale- 1 x 1m)
