**An Archaeological Building Recording  
of the former Wallsend Baths at Wallsend,  
Newcastle upon Tyne**

**ARS Ltd Report No. 2015/113**  
July 2015

**An Archaeological Building Recording  
of the former Wallsend Baths at Wallsend, Newcastle upon Tyne**

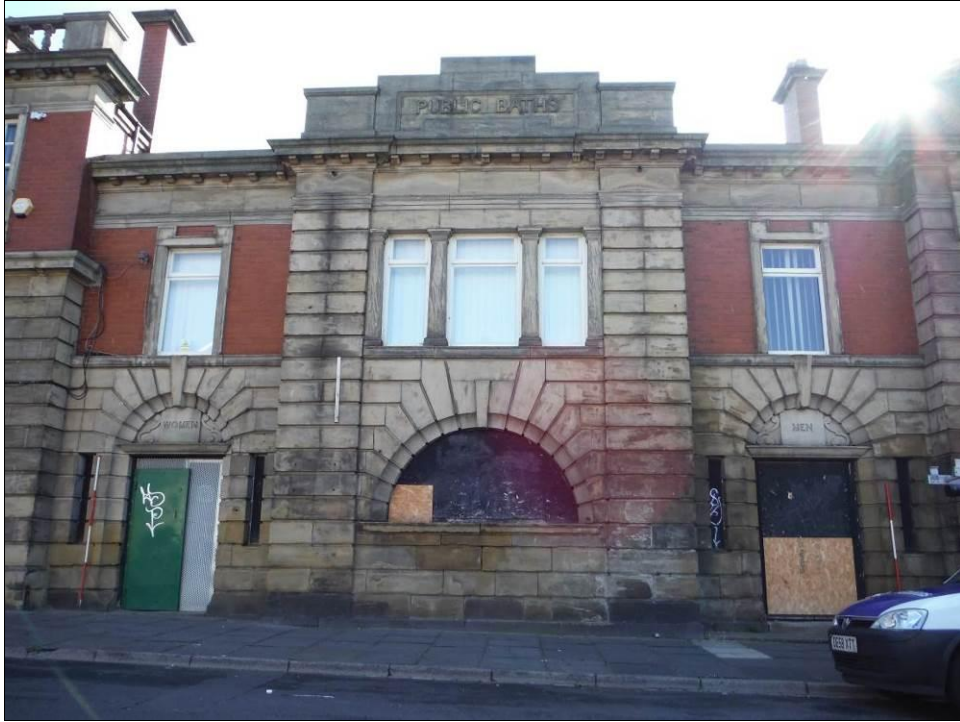
Figure 5: East south east facing view of the South West elevation of Building A (Scale = 2 x 2m).

4.1.3.1 The south-west elevation was the building's main entrance. It comprises two structural units: a two storey structure containing the original ground floor entrance (Figure 5), and the main pool structure (Figure 6).

4.1.3.2 The entrance lobby of Building A sits between the end wall of the pool component and the adjacent Fire Station (Figure 5). The entrance lobby frontage comprises three bays. The central bay projects from the wall face and is of rusticated sandstone to its full height where it is topped by a sandstone entablature and wing wall containing a carved sandstone plinth named 'Public Baths' (Figure 7). The central bay contains a Diocletian window (Figure 8), now, blocked, at ground floor level and is flanked either side by separate men's and women's entrances (Figure 9), labelled as such on carved sandstone tympanums set within rusticated sandstone surrounds. Narrow light windows flank the entrance doors on either side. The walling above the entrance door, at first floor level, is brick to the sandstone entablature.

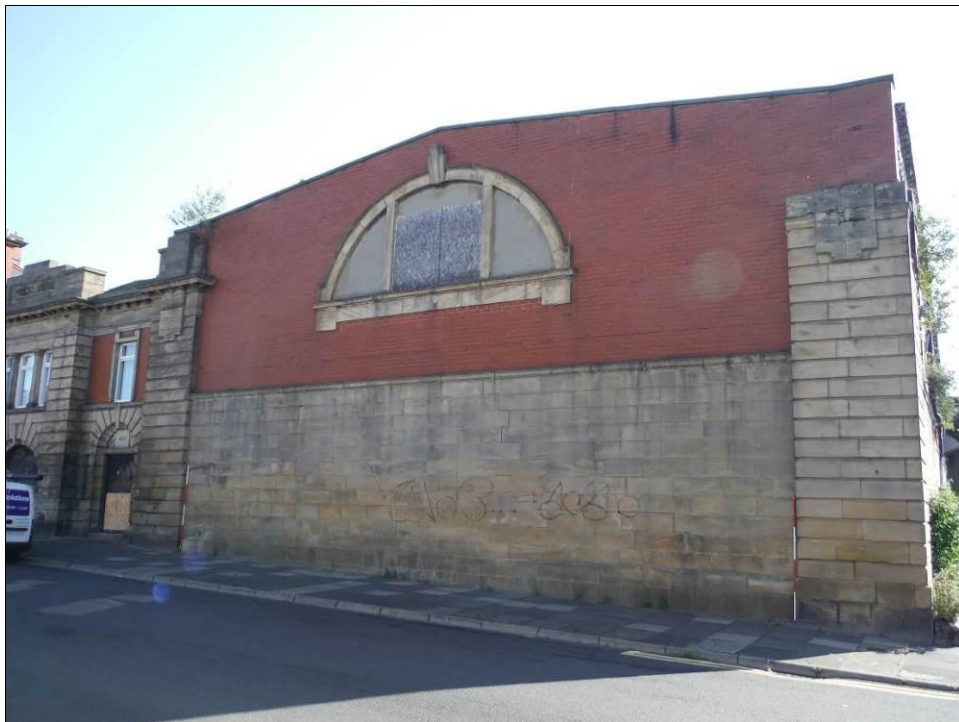
Figure 6: North facing oblique view of the South West elevation of Building A (Scale = 2 x 2m).

4.1.3.3 The main pool building occupies the southern end of the south-west elevation of Building A (Figure 6). It is constructed of sandstone ashlar masonry up to the first floor level brick walling above. There are two rusticated sandstone corner turrets. These originally ran from ground to roof level, topped by sandstone motifs of restrained baroque style. The north-west corner turret survives largely unchanged but the south-west turret was reduced in height (Figure 10). Decorative elements on the south west elevation of the main pool building are limited to a Diocletian window in moulded sandstone surround at the first floor level which is now boarded up (Figure 11).

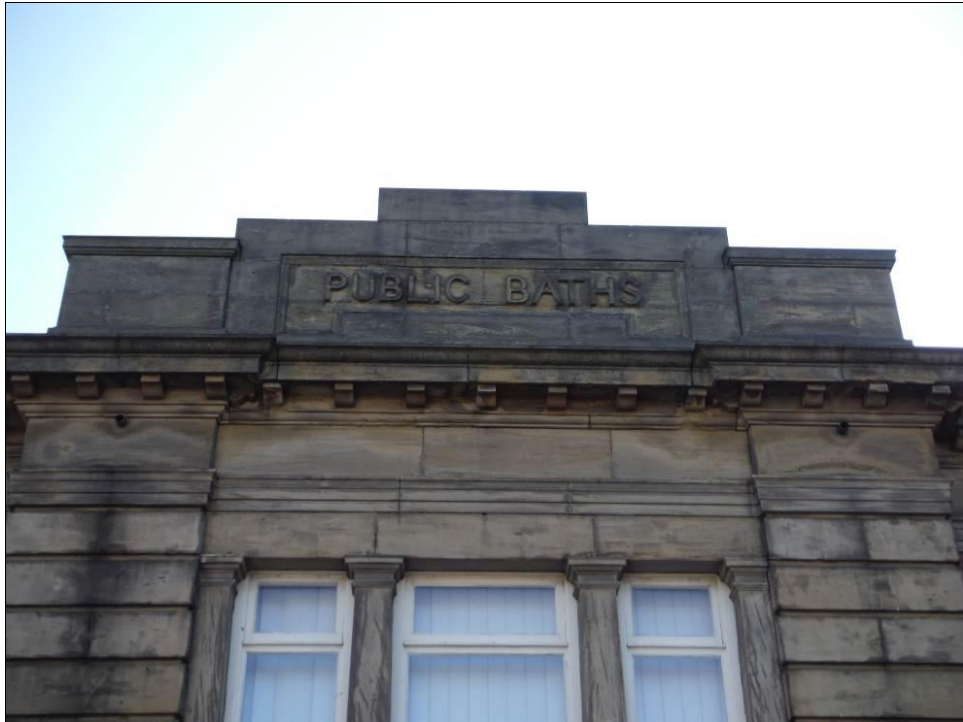
Figure 7: Detail of the wing wall marked 'PUBLIC BATHS' in South West elevation (Scale = 2m).

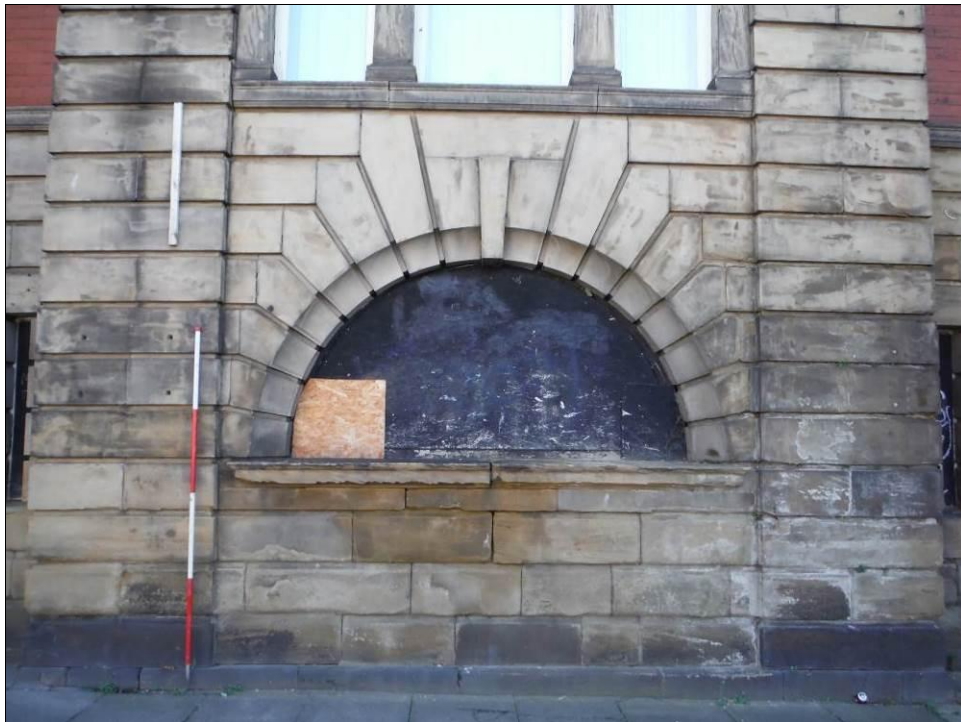
Figure 8: Detail of the ground floor Diocletian window in South West elevation (Scale = 2m).

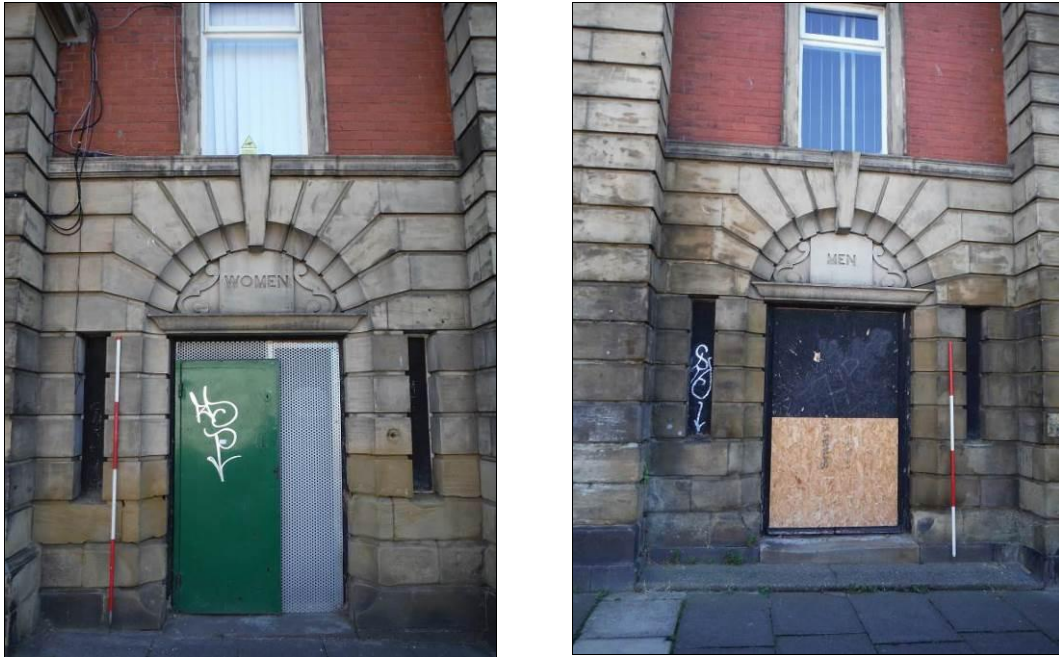
Figure 9: Detail of Mens' and Womens' entrances in South West elevation (Scale = 2m).

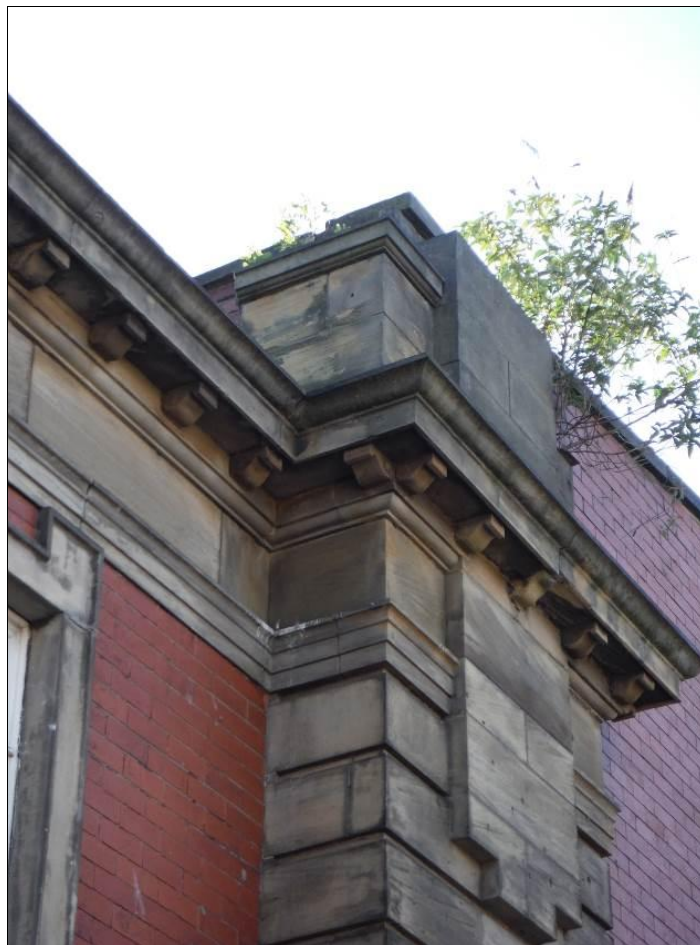
Figure 10: Detail of north-western corner pilaster of Building A pool building showing corning on the South West elevation.

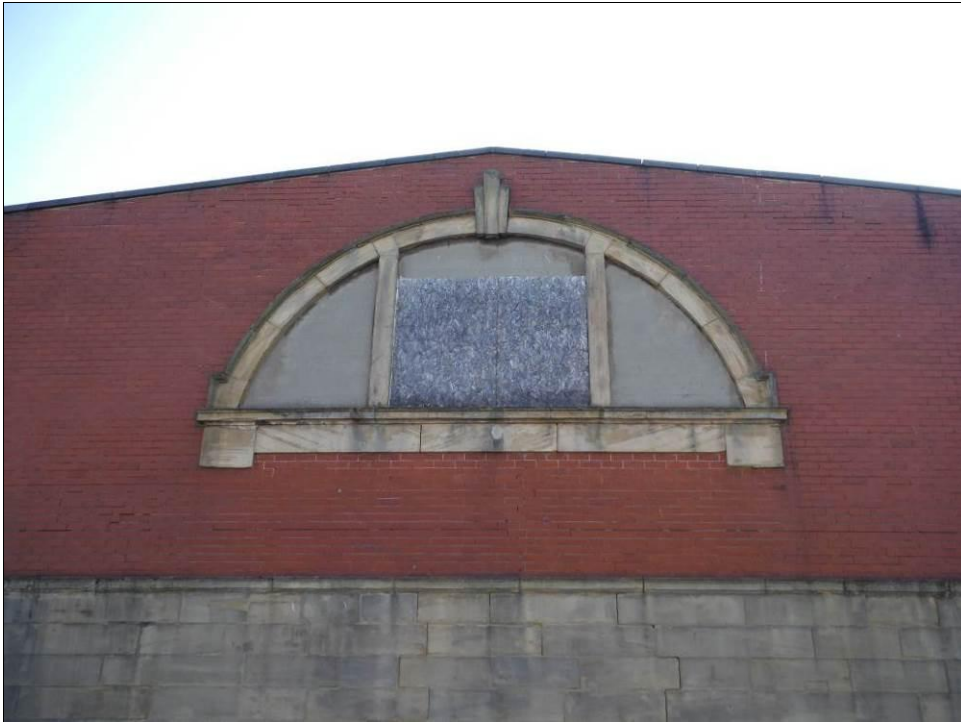
Figure 11: Detail of the Diocletian window in the South West elevation in main pool Building A.

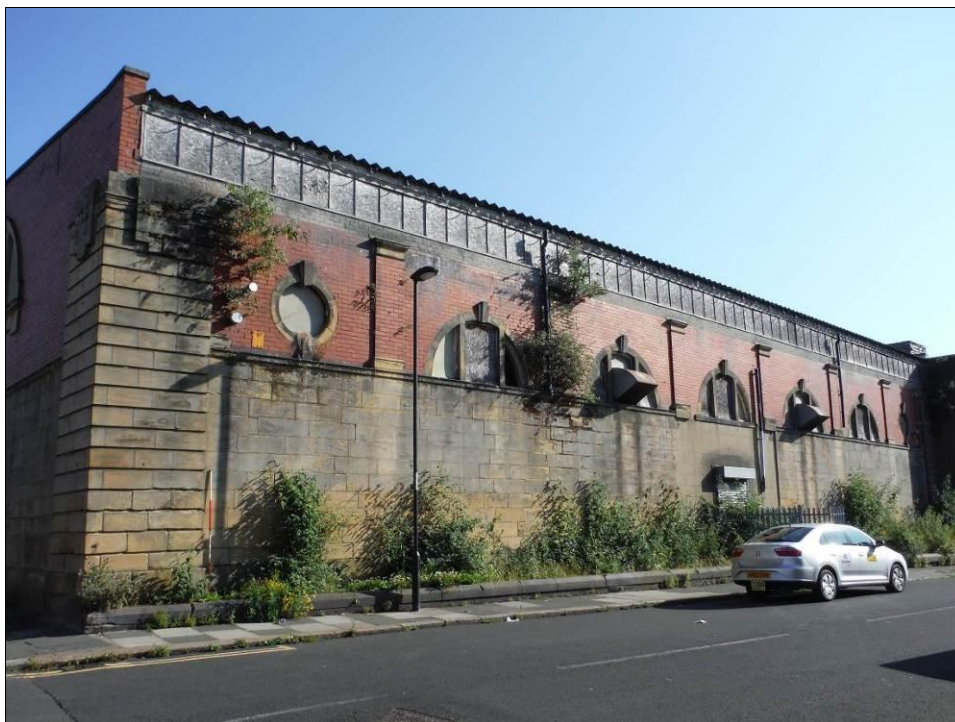
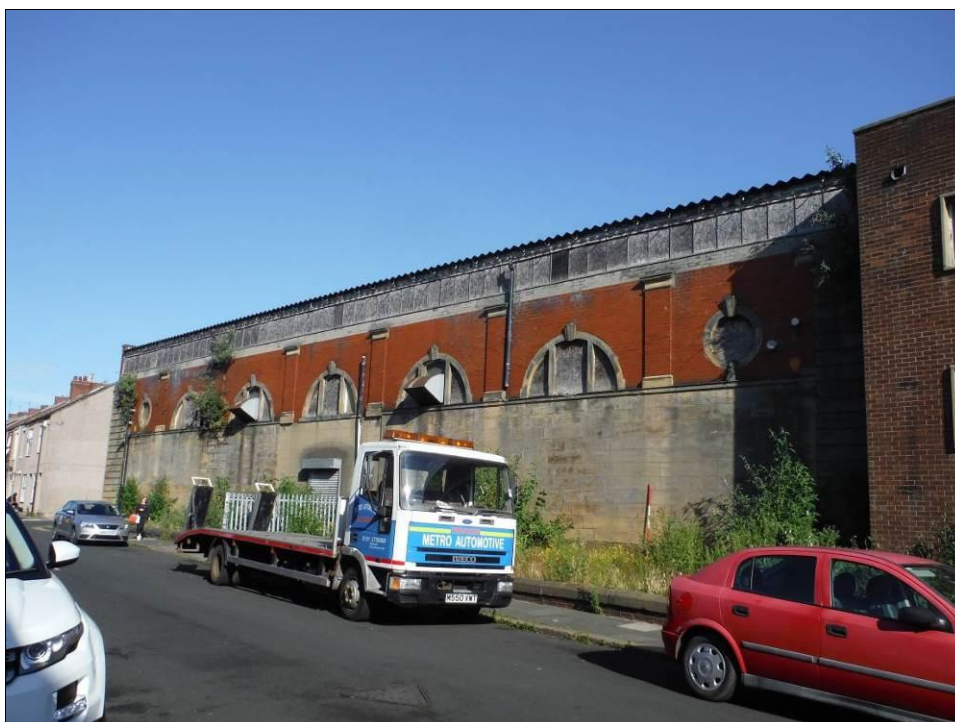
Figure 12: North facing oblique view of the South East elevation of Building A (Scale = 2 x 2m).

Figure 13: West North West facing oblique view of the South East elevation of Building A (Scale = 2 x 2m).

4.1.4.1 The building's south-east façade comprises the main pool structure (Figures 12 and 13). It is constructed of sandstone ashlar masonry up to the first floor level brick walling above. There are the remains of two rusticated sandstone corner turrets that originally ran from ground to roof level. Decorative elements on the south east elevation of Building A consist of two roundel windows (Figure 14) and five Diocletian windows (Figure 15) in moulded sandstone surrounds at the first floor level which are now boarded up. Further structural features take the form of the scar of the original centrally positioned porch, now removed. This is patched with concrete render which has been scored in an attempt to give the impression of masonry and the doorway is fitted with a metal shutter and functional canopy (Figure 16).

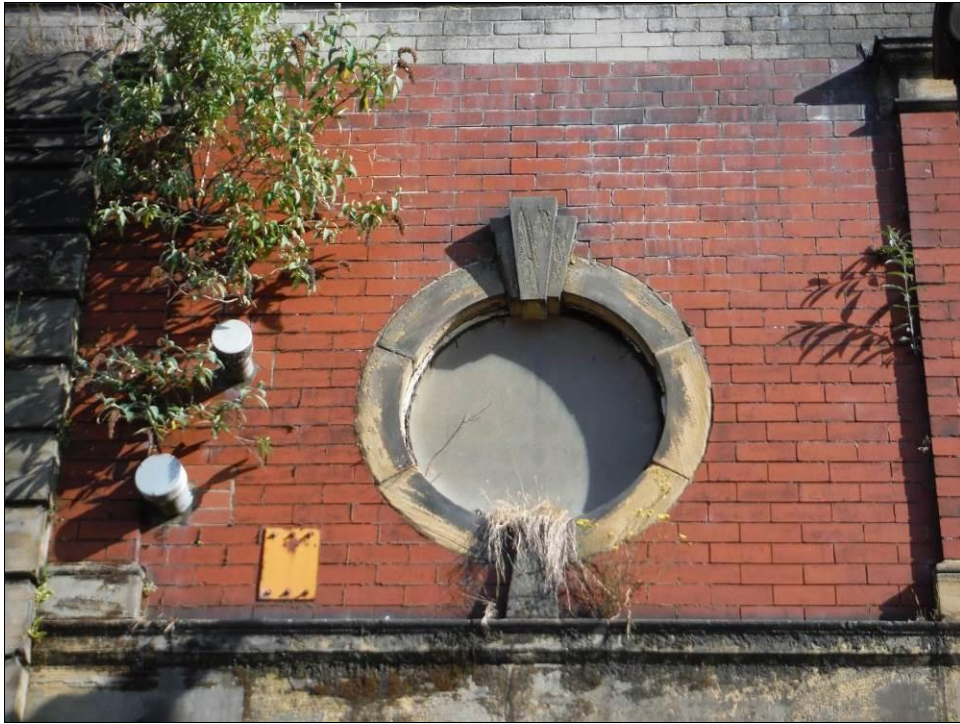
Figure 14: Detail of the westernmost roundel window in the South East elevation of Building A.

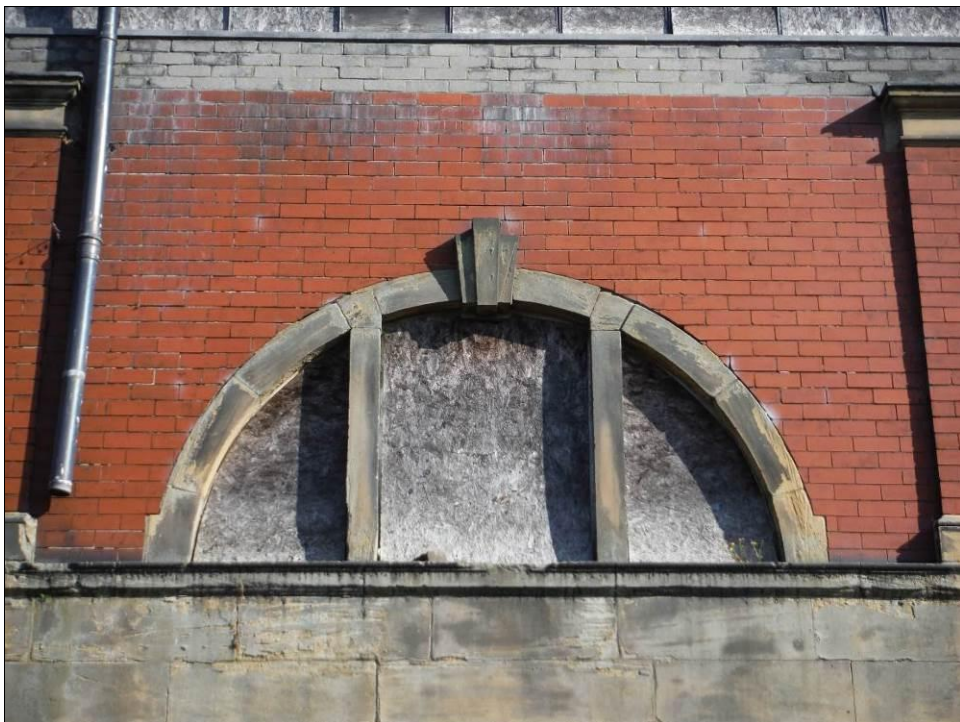
Figure 15: Detail of easternmost Diocletian window in the South East elevation of Building A.

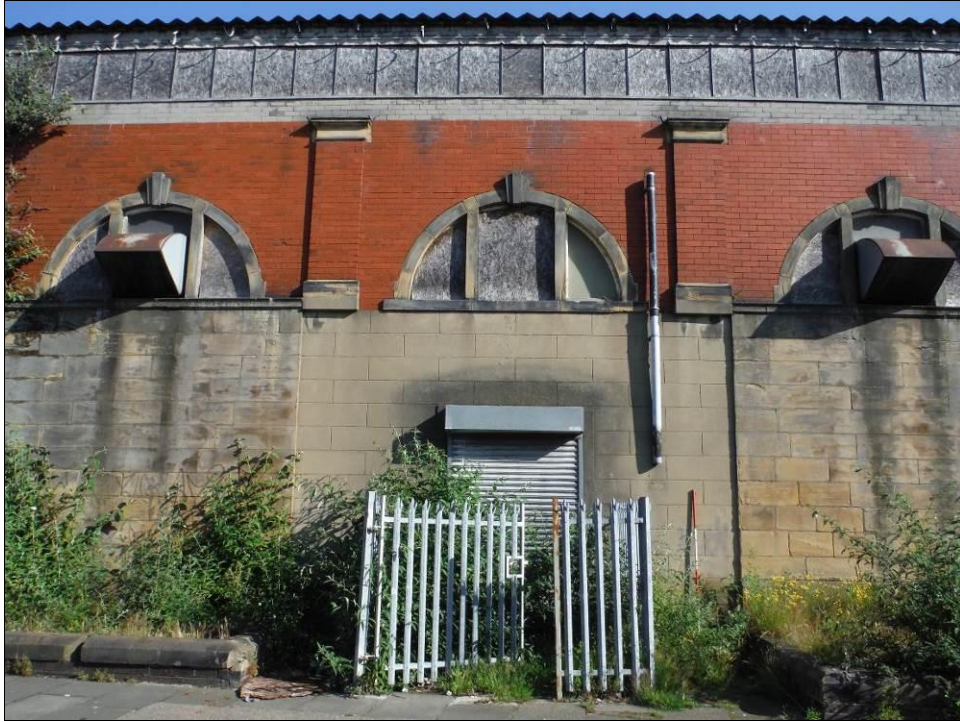
Figure 16: Detail of the scar of the original porch in the South East elevation of Building A (Scale = 2m).

4.1.8.1 Room G1 was accessed by the fire escape/metal shuttered porch in the south-east elevation of Building A (Figure 16). The pool space has been boarded over. Tiling around the edge of the pool marks its former location. The tiles to the concrete seating and pool surround are not original and likely relate to refurbishment when the extension was added to the east wall. The original interior finishes were tiled. The covered swimming pool is accessed by six doorways: from the exterior at the south wall, from Room G2 through the two doors in north wall, from the north end of the east wall to Room G1 of Building B, from the south end of the east wall to Room B7 of Building B, and from the southernmost end of the east wall to Room G4 of Building B. The doorways in the east wall were inserted into the existing wall as part of the extension work to Building B.

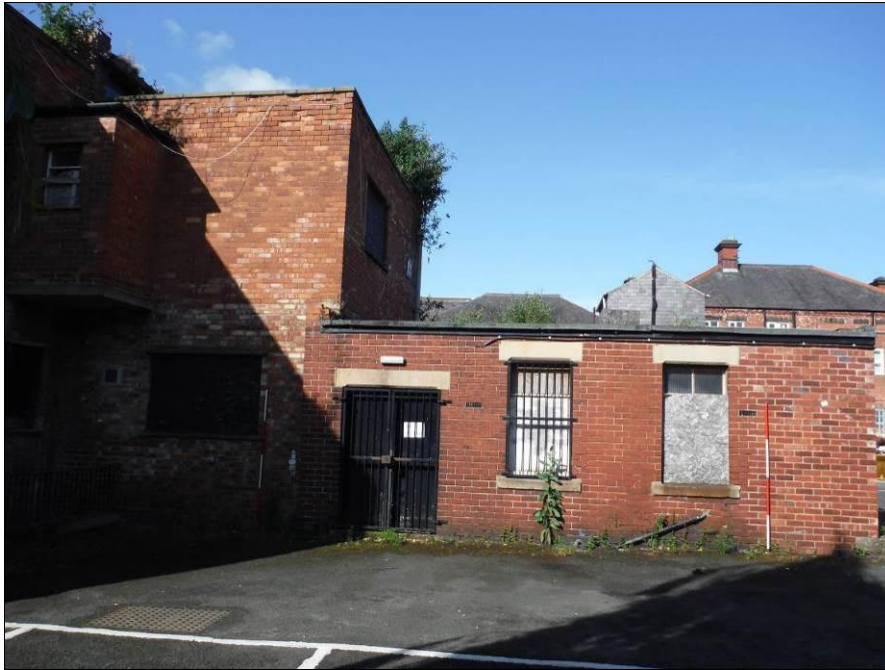
Figure 17: North East elevation of Building A (Scale= 2x2m).

4.1.5.1 The north-east elevation is largely obscured by Building B which was built onto the end wall of the pool area. The exterior north-east wall of the Russian and Slipper Baths component is of modern character and is constructed of plain red brick in a stretcher bond. The structural features include a doorway and two partially blocked windows all with plain moulded sandstone lintels and sills (Figure 17). To the south of these features there is a two-storey projection with a small offshoot at first floor level. This two-storey range was originally a single-storey projection forming part of the original baths. It was then raised and an internal staircase inserted following the extension to the baths in the 1950s. The similarity between the window on the ground floor of this wall and those within the 1950s extension on its south side indicate that this window was likely inserted when the extension was added. The raised section is discernible as a change in the brick type and bonding on the north-east elevation which changes from English bond on the ground floor to stretcher bond on the first floor (Figure 18). There is also a clear junction between the original ground floor walling and the modern wall to the Russian and Slipper Baths (described above) on its north side. The offshoot at first floor level appears to have been added as part of the same phase of alterations to connect this first floor section to the rest of the 1950s extension.

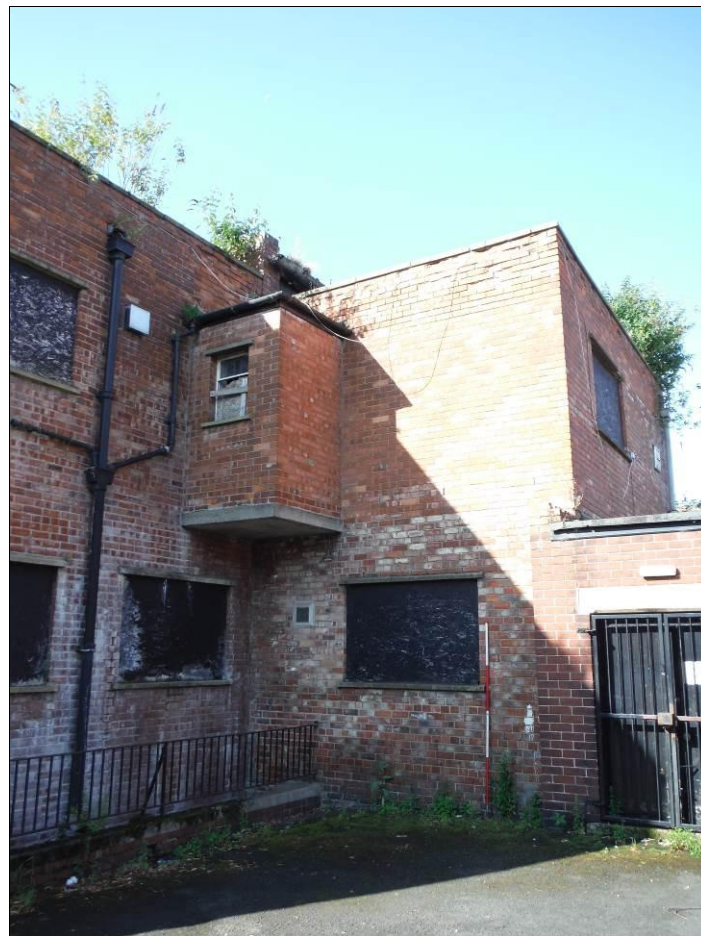
Figure 18: Detail of alterations to the north-east elevation of Building A (Scale = 2m).

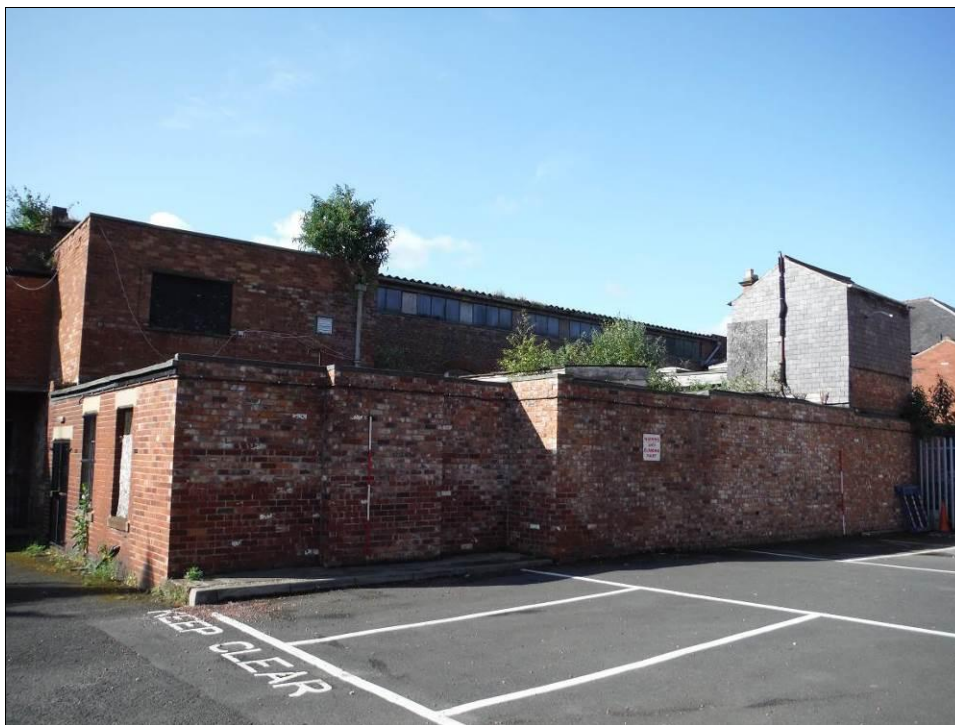
Figure 19: West-south-west facing oblique of the North-West elevation of Building A (Scale = 2 x 2m).

4.1.6.1 The north-west elevation of Building A is a featureless red brick enclosing wall constructed with a stretcher bond (Figure 19). The wall marks the boundary between the Baths and the Fire Station.

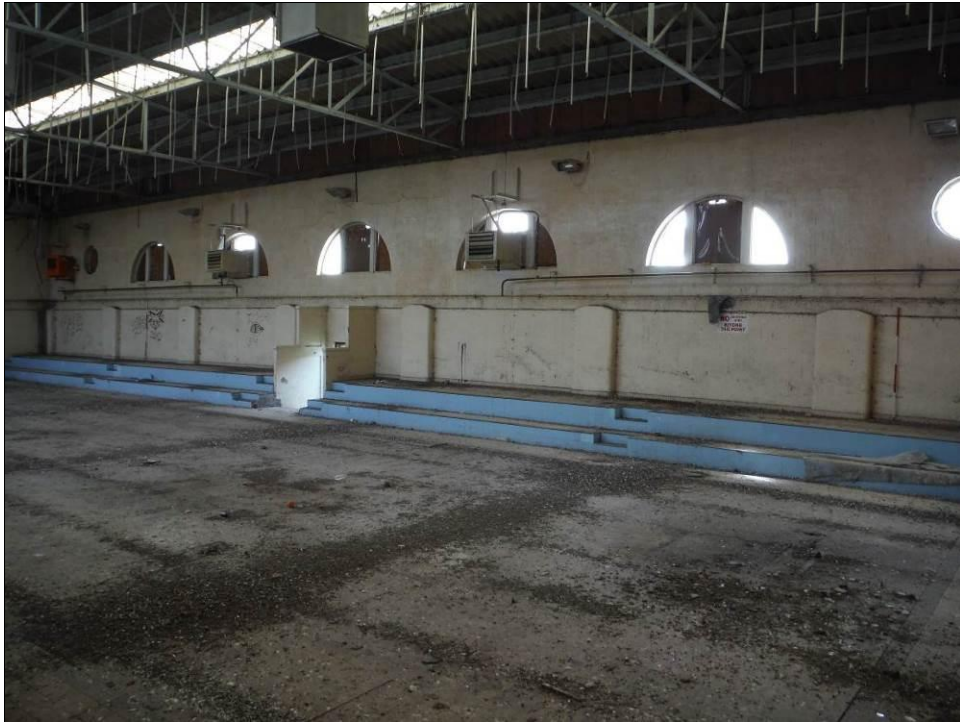
Figure 20: South-south-west oblique view of the south wall of Room G1 in Building A (Scale = 2 x 2m).

walls to mirror the shape of the Diocletian window in the west wall (Figure 20). The replacement roof structure is composed of low-pitched, steel, pratt trusses that support a corrugated sheet roof with clear corrugated plastic bands for light. There is evidence of a former, inserted, suspended ceiling across the whole space (Figure 20).

4.1.8.3 The south wall retains eight regularly-spaced half height pilasters and the entirety of the original concrete pool seating (Figure 22). The door to the south wall is flanked by plastered brick wing walls (Figure 23). From archive images, these appear to have been truncated to the second step. These wing walls covered the entirety of the poolside seating in the original 1912 construction. There are five fixed Diocletian windows divided into three lights flanked by two fixed single-light roundel windows (Figures 20 and 21). The central Diocletian window has a timber moulded surround that is of different character to all others in the building. This could indicate that the window surround is an original fixture of the 1912 construction (Figure 23 and 24). The top of the south wall features a single course of clerestory windows added during the roof replacement. The windows have metal surrounds. These have been boarded up (Figure 20).

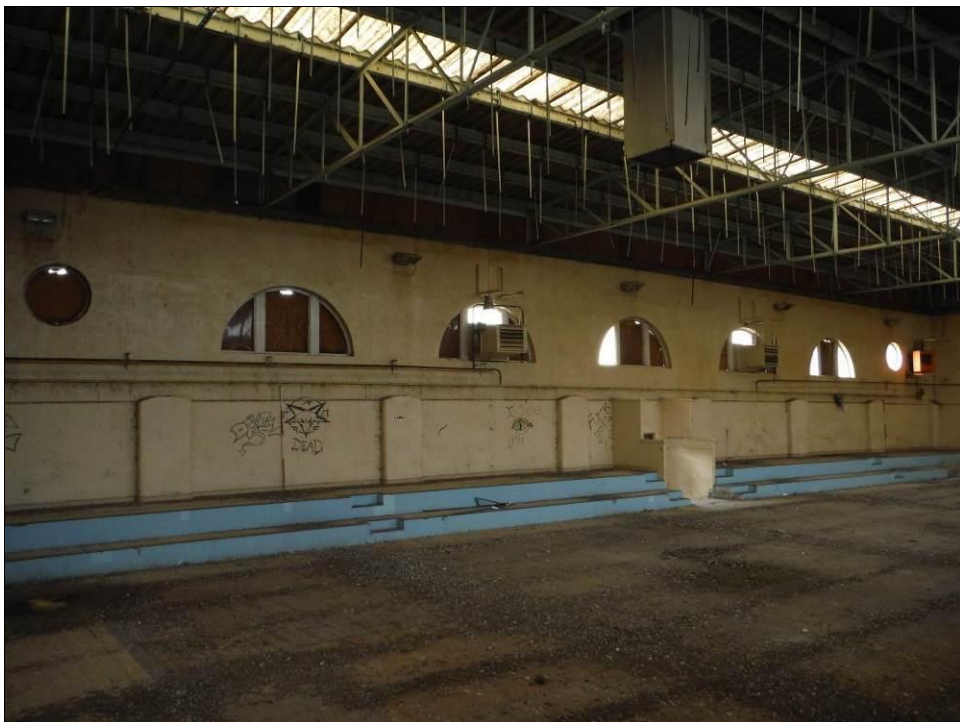
Figure 21: South facing oblique view of the south wall of Room G1 in Building A (Scale = 2 x 2m).

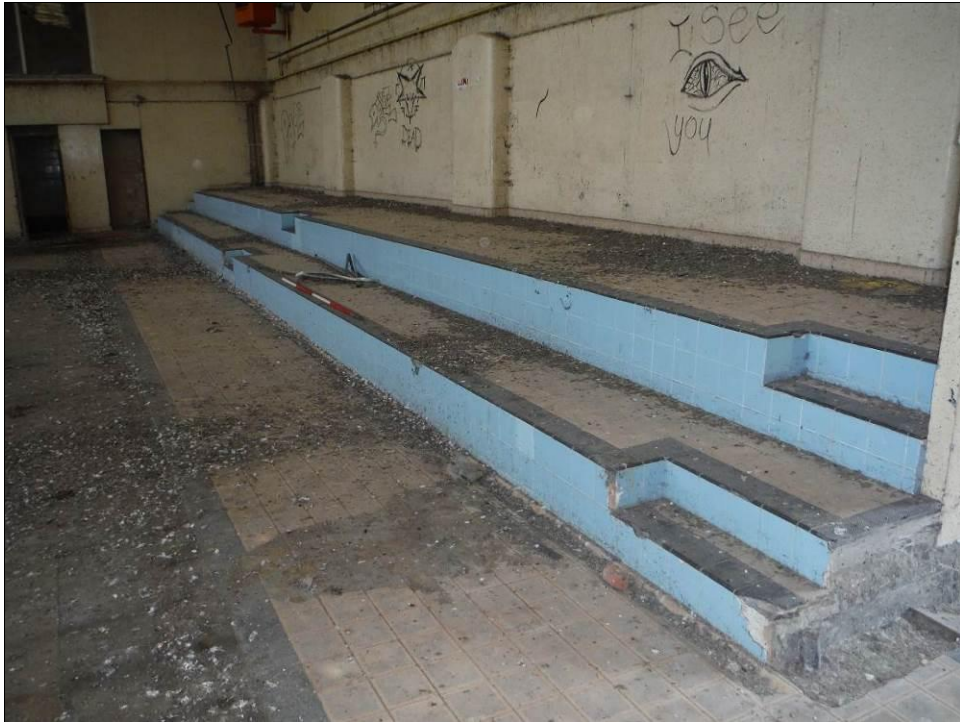
Figure 22: Detail of poolside steps on the south wall of Room G1 in Building A (Scale = 2m).

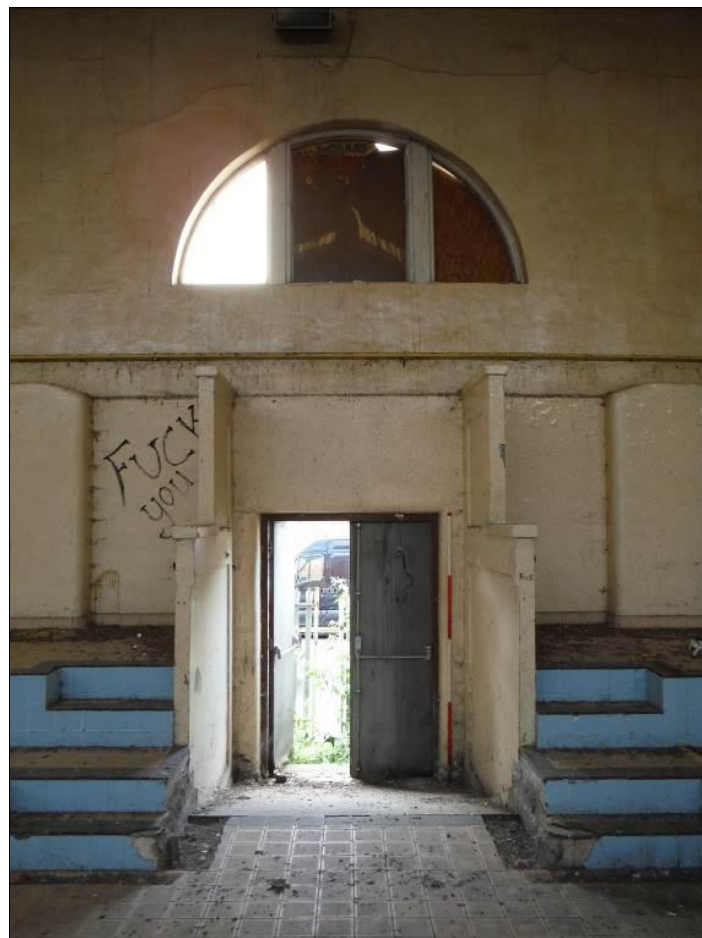
Figure 23: Detail of doorway and Diocletian window in the south wall of Room G1 in Building A (Scale = 2m).

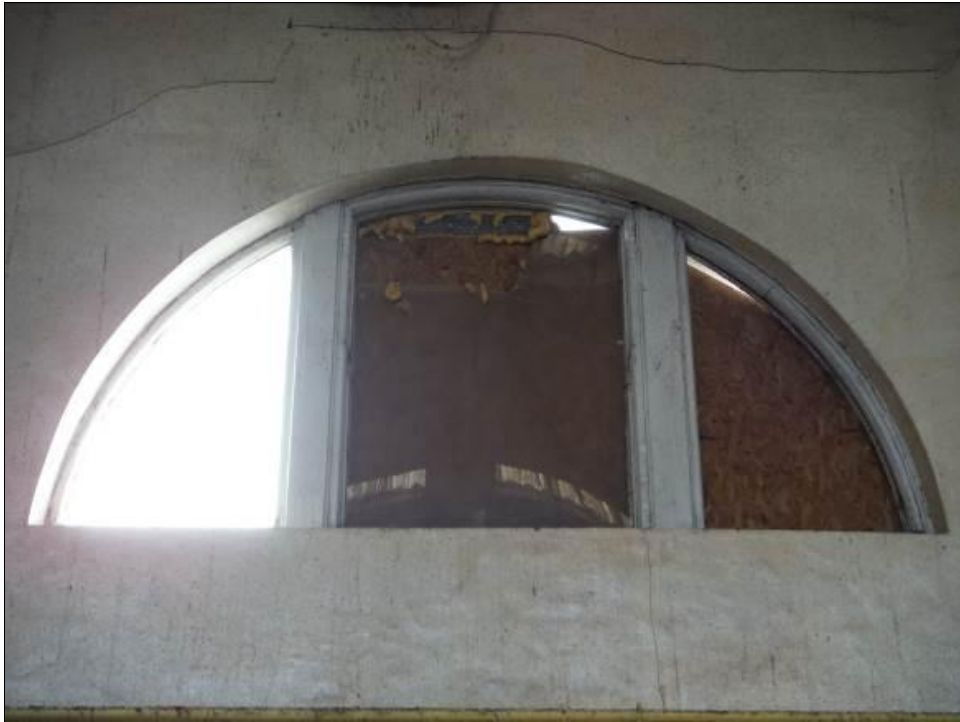
Figure 24: Detail of doorway and Diocletian window in the south wall of Room G1 in Building A (Scale = 2m).

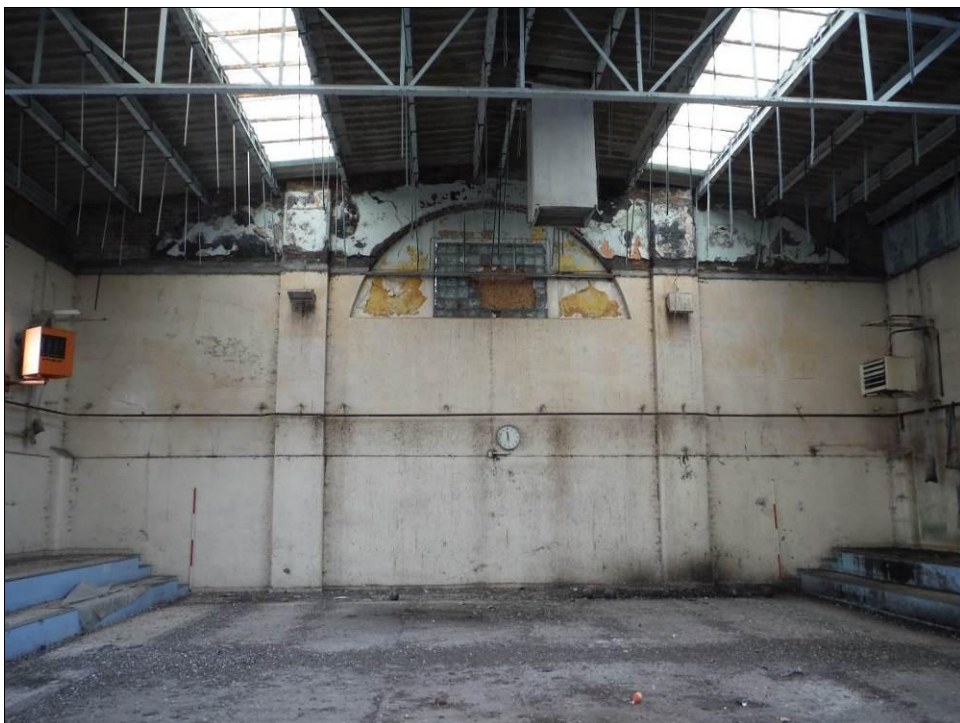
Figure 25: West-south-west view of the west wall of Room G1 in Building A (Scale = 2 x 2m).

4.1.8.4 The west wall contains a blocked high-level Diocletian window which is flanked by two engaged pilasters (Figure 25). The Diocletian window has been blocked, but 7 courses of textured glass blocks have been inserted as a replacement window. These have been damaged and a portion replaced by a board (Figure 26). The fifteen additional courses of brickwork and differential plastering of the roof replacement, as a result of the 1980s fire, are visible in the upper portion of the west wall (Figure 27).

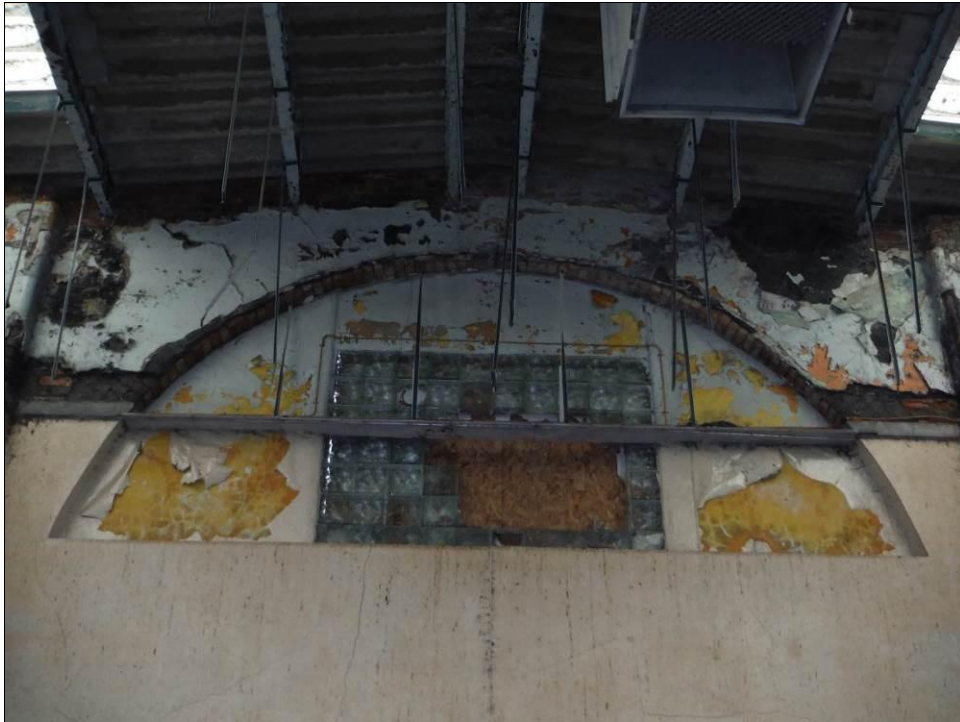
Figure 26: Detail of Diocletian window in the west wall of Room G1 in Building A.

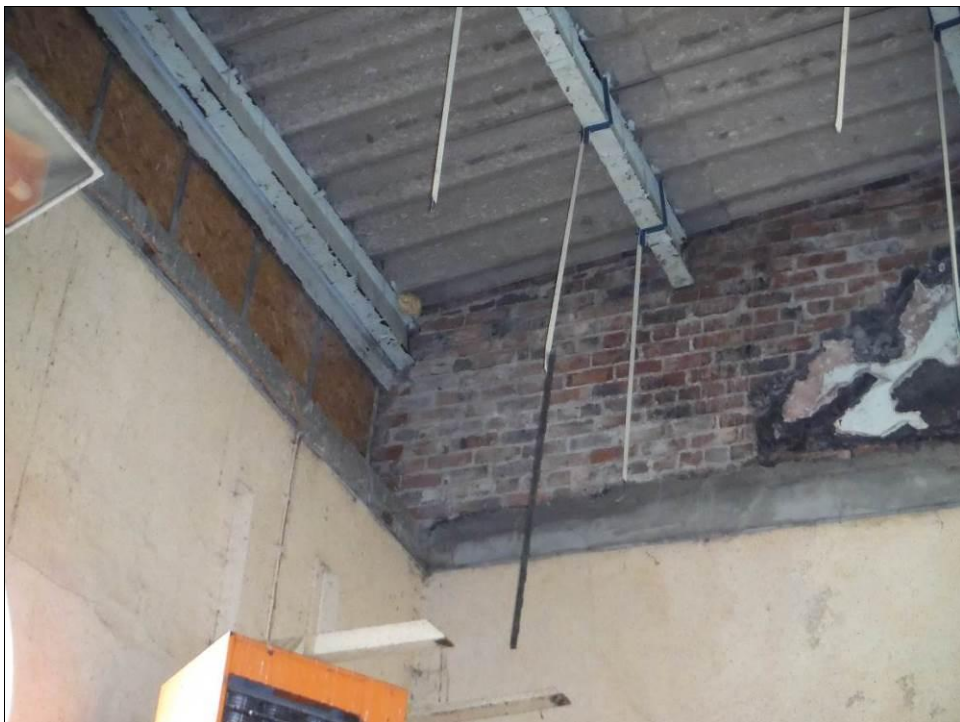
Figure 27: Detail of roof extension in the west wall of Room G1 in Building A.

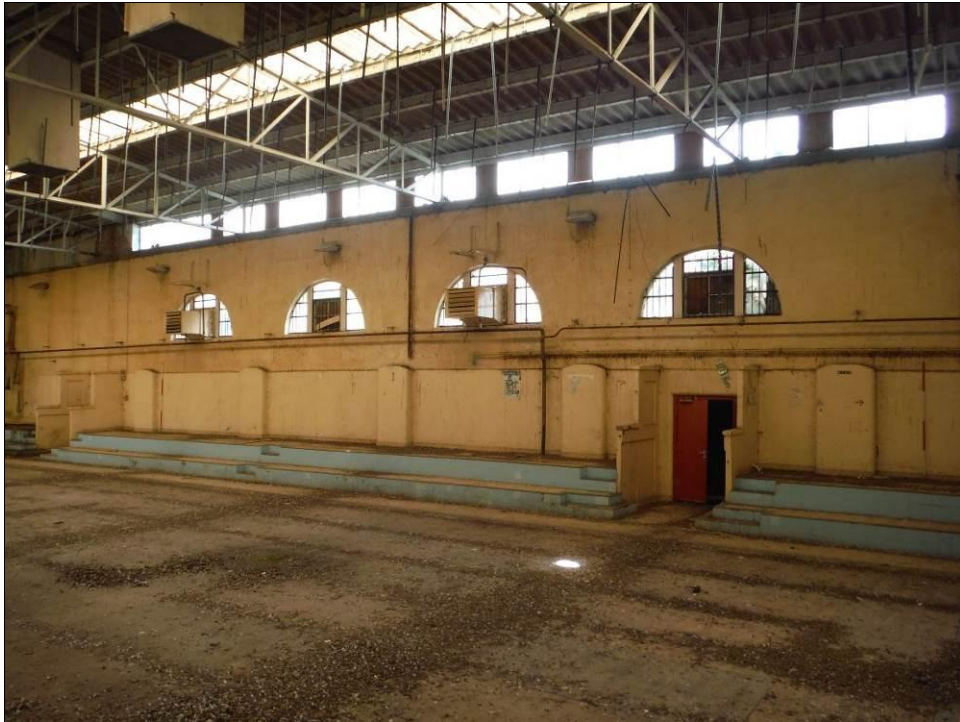
Figure 28: North-west oblique view of the north wall of Room G1 in Building A (Scale = 2 x 2m).

4.1.8.5 The north wall retains eight regularly-spaced half height pilasters and the integrity of the original concrete pool seating. The doors to the south wall are flanked by plastered brick wing walls. Similar to the south, these have been truncated to the second step (Figure 28). These wing walls covered the entirety of the poolside seating in the original 1912 construction. There are four fixed Diocletian windows divided into three lights (Figures 28 and 29). The top of the north wall features a single course of clerestory windows added during the roof replacement (Figure 28).

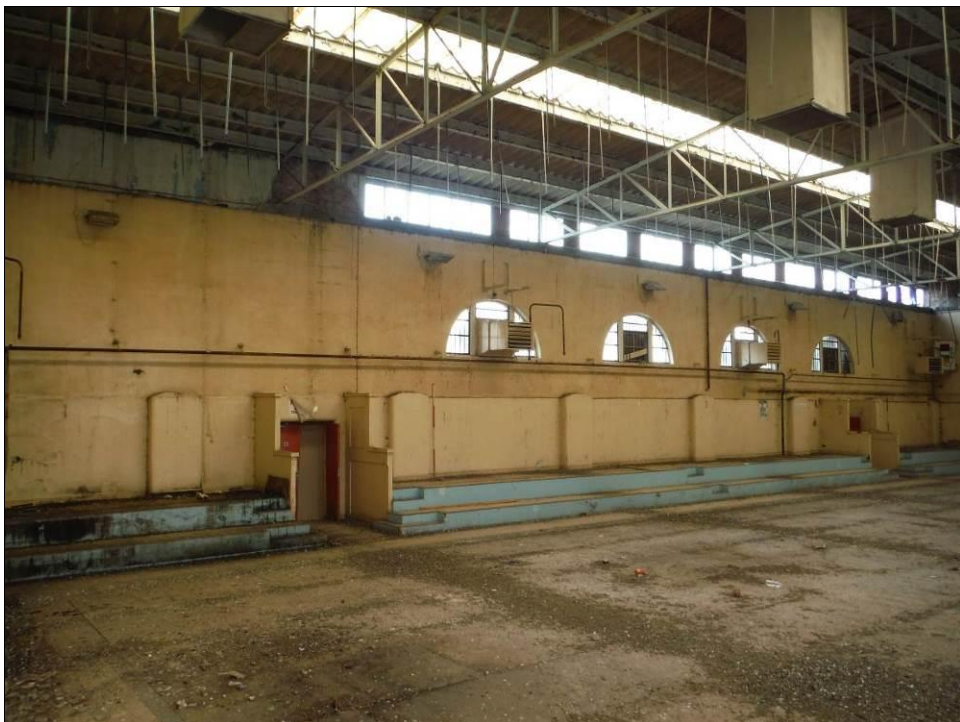
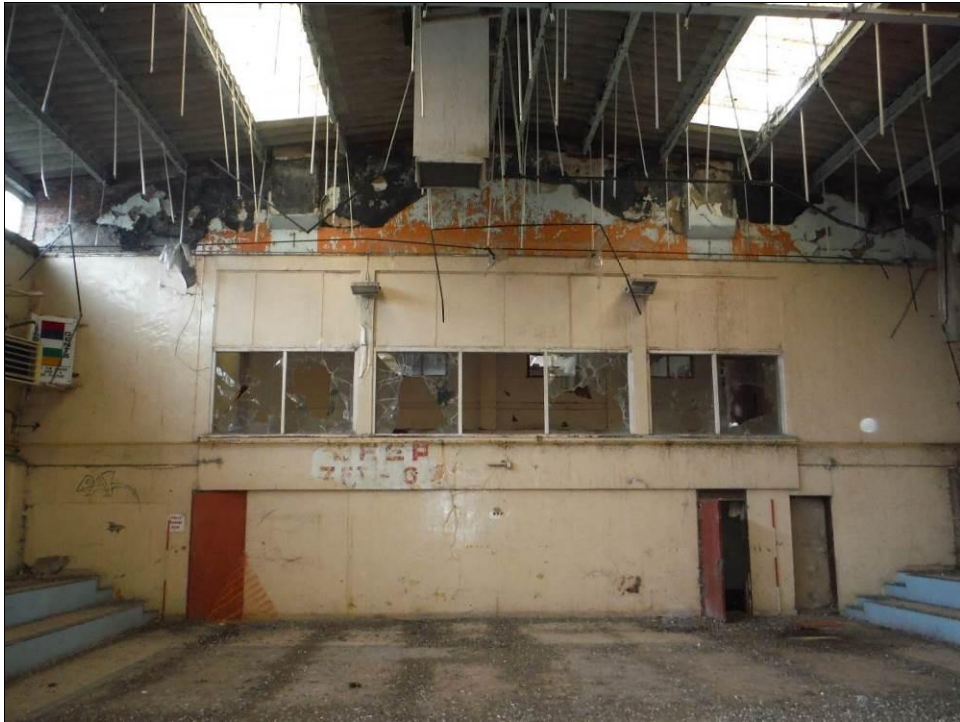
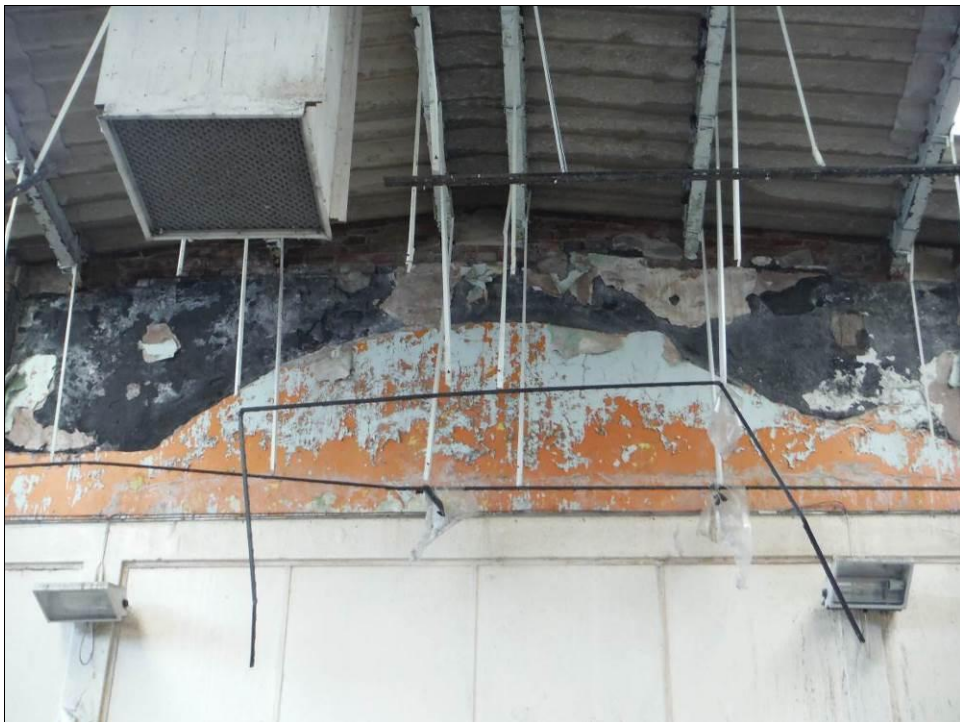
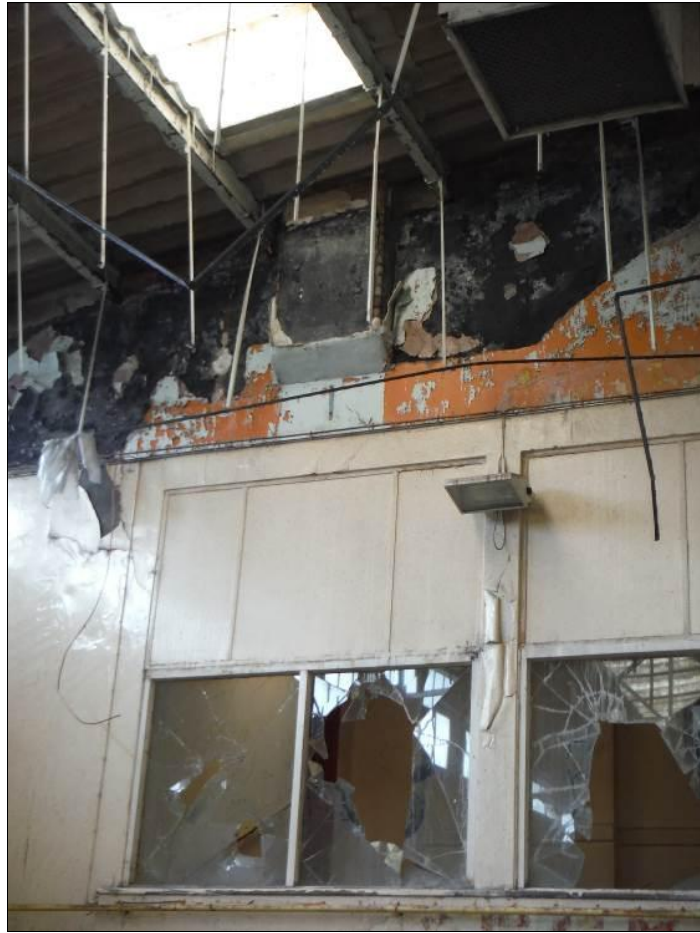
Figure 29: North-east oblique view of the north wall of Room G1 in Building A (Scale = 2 x 2m).

Figure 30: East-north-east view of the east wall of Room G1 in Building A (Scale = 2 x 2m).

Figure 31: Detail of blocked Diocletian window in the east wall of Room G1 in Building A.

Figure 32: Surviving upper portion of the original pilasters on the west wall.

4.1.8.6 The east wall has been extensively remodelled to accommodate the 1950s extension. Of the original fabric only the upper part of the pilasters and the outline of the top of a Diocletian window remain (Figures 29-32). Below these features the wall has been entirely remodelled. There are three doorways leading to the ground-floor level of the extension (see above). Three fixed windows have been inserted into the wall to create the Viewing Gallery (Building B, Room F6) above. The central window is triple-lit with timber moulded surrounds and flanked by a pair of double-light windows with timber moulded surrounds. Evidence of the alteration to the roof pitch is also present in the corners of the east and west gable walls, where newer bricks have been used to raise the wall height to the height of the clerestory windows (Figure 33).
