**An Archaeological Building Recording  
of the former Wallsend Baths at Wallsend,  
Newcastle upon Tyne**

**ARS Ltd Report No. 2015/113**  
July 2015

**An Archaeological Building Recording  
of the former Wallsend Baths at Wallsend, Newcastle upon Tyne**

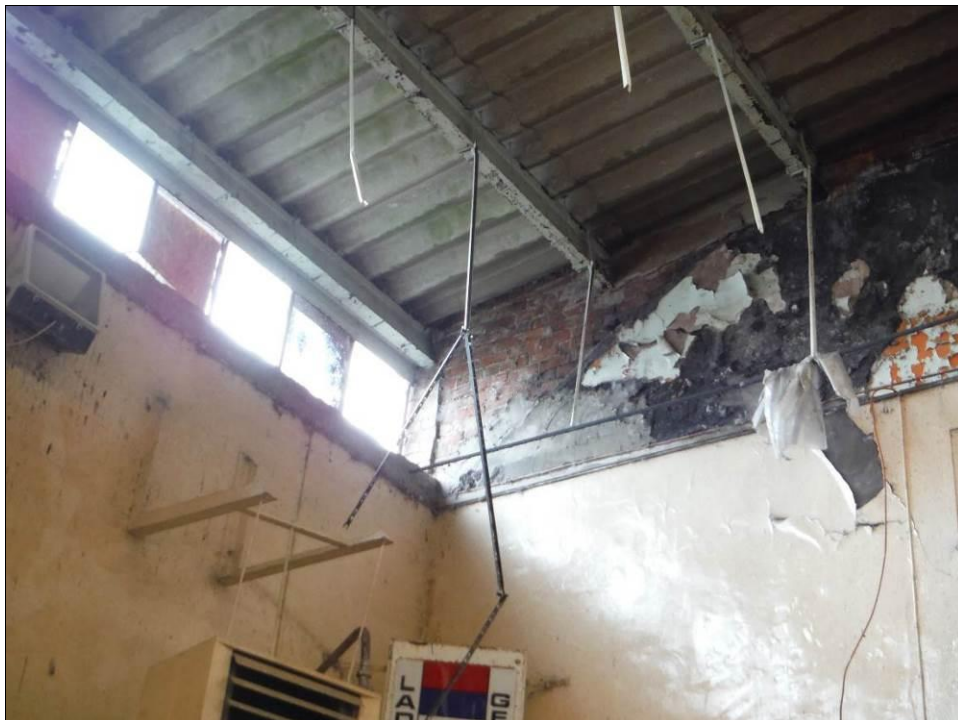
Figure 33: Detail of roof extension in the east wall of Room G1 in Building A.

4.1.8.6 The east wall has been extensively remodelled to accommodate the 1950s extension. Of the original fabric only the upper part of the pilasters and the outline of the top of a Diocletian window remain (Figures 29-32). Below these features the wall has been entirely remodelled. There are three doorways leading to the ground-floor level of the extension (see above). Three fixed windows have been inserted into the wall to create the Viewing Gallery (Building B, Room F6) above. The central window is triple-lit with timber moulded surrounds and flanked by a pair of double-light windows with timber moulded surrounds. Evidence of the alteration to the roof pitch is also present in the corners of the east and west gable walls, where newer bricks have been used to raise the wall height to the height of the clerestory windows (Figure 33).

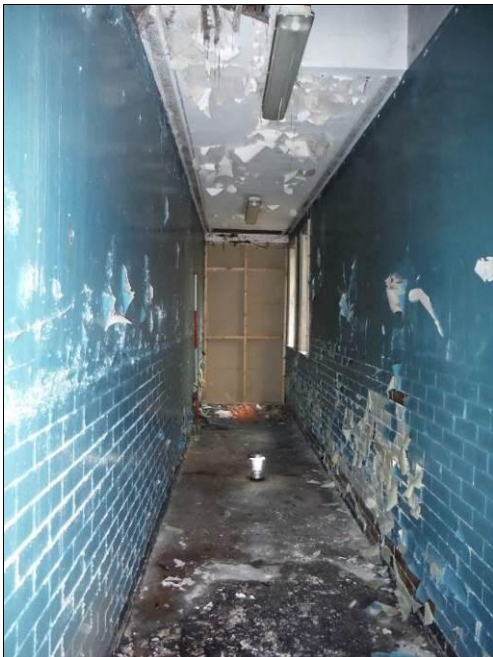
Figure 34: West wall of Room G2, Building A (Scale = 2m).

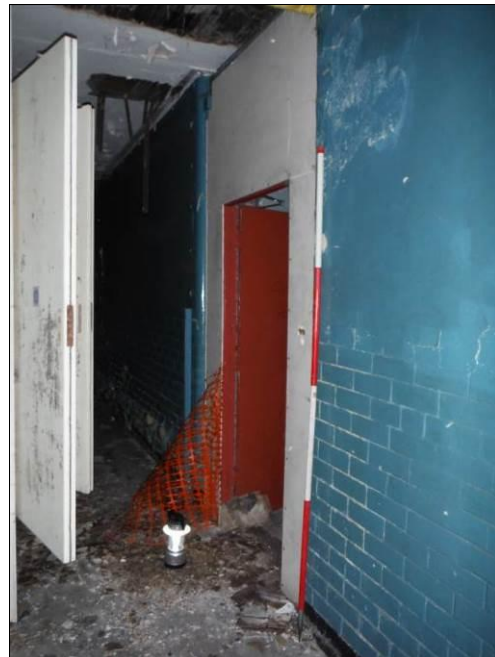
Figure 35: Detail of door in south wall of Room G2, Building A leading to Room G3 (Scale = 2m).

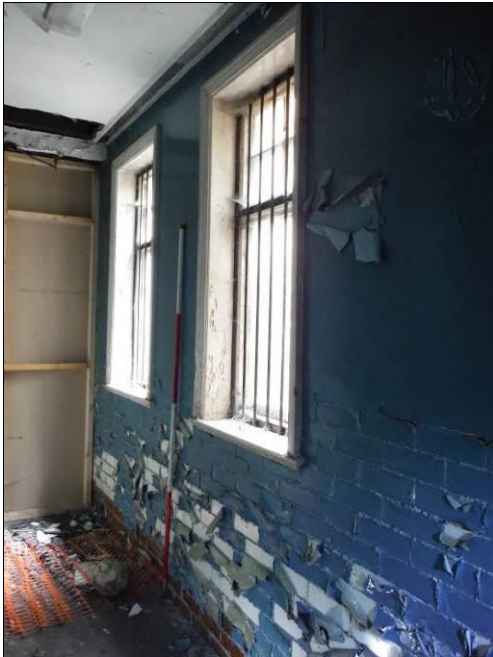
Figure 36: Detail of windows in north wall of Room G2, Building A (Scale= 2m).

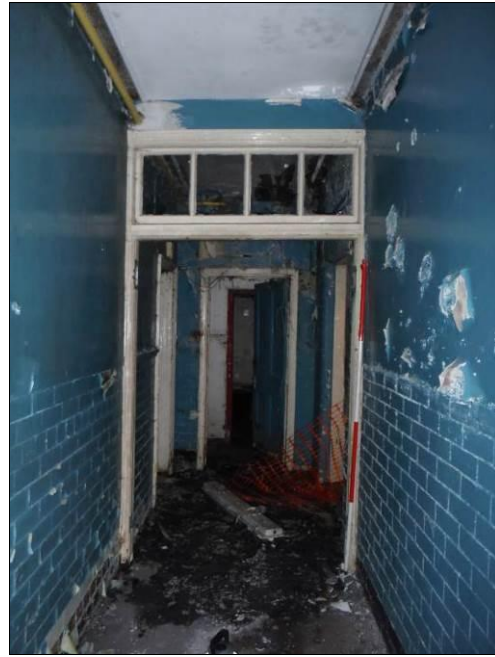
Figure 37: Detail of transom doorway in Room G2, Building A (Scale= 2m).

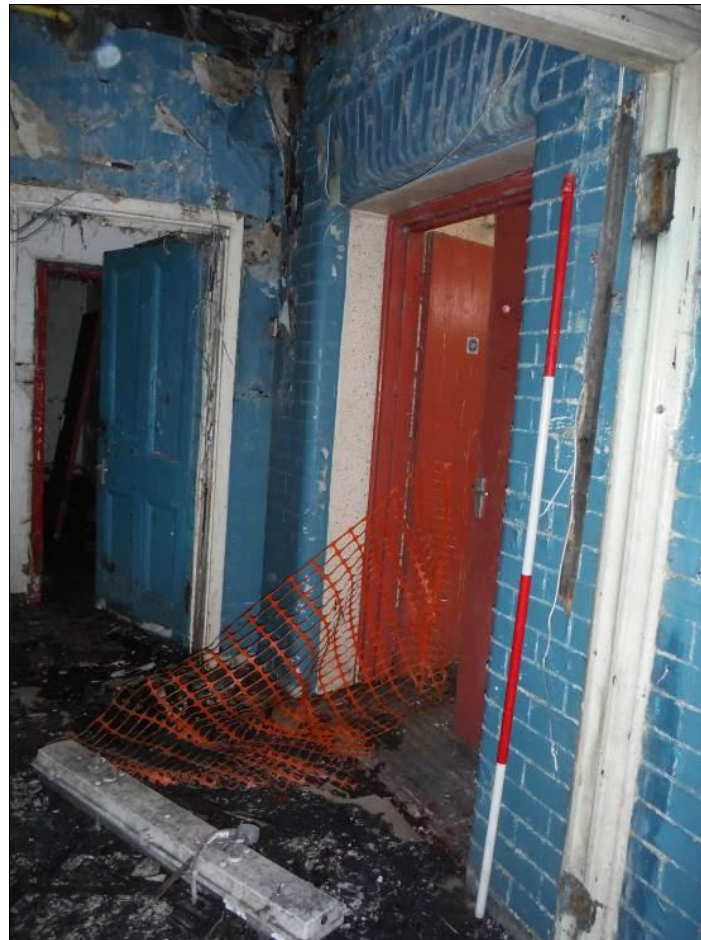
Figure 38: Detail of brick-built original doorway in south wall of Room G2, Building A leading to Room G1 (Scale= 2m).

4.1.9.1 Room G2 is accessed by doors at its southern, northern and eastern side, leading to the main pool area (G1), central corridor (G3), gent's toilets (G12) and staffroom (G13) respectively. The room retains the original internal glazed stretcher-bond brickwork to dado height, although this has been painted over (Figures 34 to 38). The western end of the corridor has been boarded off as part of the present development reflecting the ownership boundary (Figure 34). The westernmost end of the northern wall contains two five-light fixed windows with timber moulded surrounds. These windows have been covered with bars running vertically across the frames. These windows lead to the light well between the southern corridor and the Russian baths (Figure 36). The eastern end of the north wall contains a wide opening, originally without a door, leading to another corridor, Room G3. This opening has been infilled with a modern partition wall containing a single-width doorway (Figure 35). The eastern end of the corridor contains a moulded timber frame doorway with transom light above (Figure 37). This abutted the remains of the dado rail on the northern wall that separated the visibly brick-coursed lower portion of the wall and the plastered upper portion. This rail continued to the easternmost doorway in the northern wall. The easternmost doorway in the south wall to the covered swimming pool is a brick-built entryway sided with bullnose bricks on both sides. These are capped by a flat-arch brick-built lintel of alternating soldier and rowlock bricks. The first course of which are bullnose bricks (Figure 38).

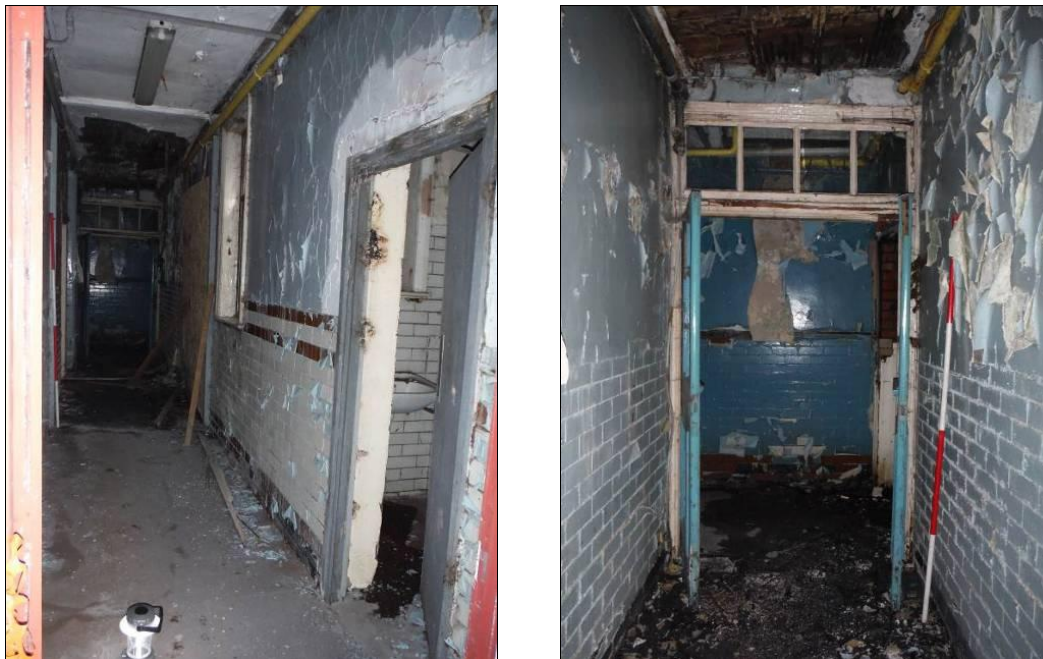
Figure 39: North facing views of Room G3, Building A (Scale = 2m).

4.1.10.1 Room G3 is accessed by doors at its southern, north-western, northern and eastern sides, leading to the southern corridor, the Russian Baths, northern corridor, yard, and ladies' toilets respectively. The room has its original stretcher-bond glazed brickwork and plastered upper portion. The northern door has a moulded timber frame doorway containing a transom light of four regularly spaced lights. The doors have six lights apiece with two panels at the bottom. The northernmost doorway in the east wall was blocked off and sealed access to the yard beyond. The southernmost doorway in the eastern wall had a moulded timber frame with a later flat door fitted with a fingerplate and door damper (Figure 39).

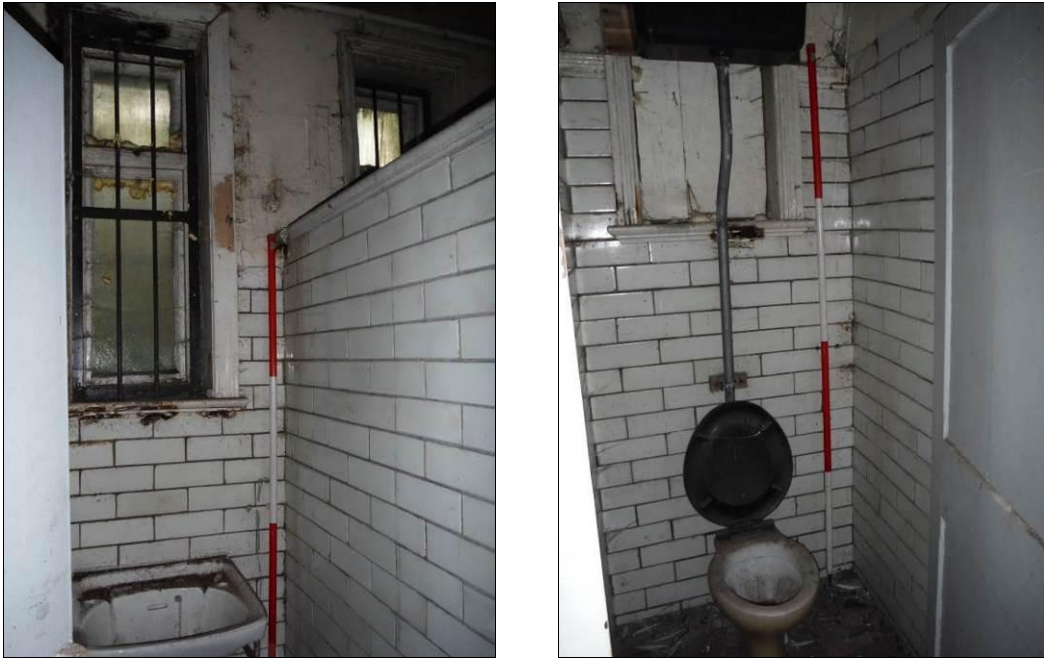
Figure 40: North facing views of Room G4, Building A (Scale = 2m).

4.1.11.1 Room G4 is accessed by a single door to the eastern corridor at its west side. The room retains the original stretcher-bond glazed brickwork with plaster on the upper portion of the walls. At its north side the room retains its two original two light window frames complete with timber moulded surrounds (Figure 40). These windows lead into the yard area which was inaccessible (see above). The room has retained its original timber corncicing on the cubicle walls (Figure 41).

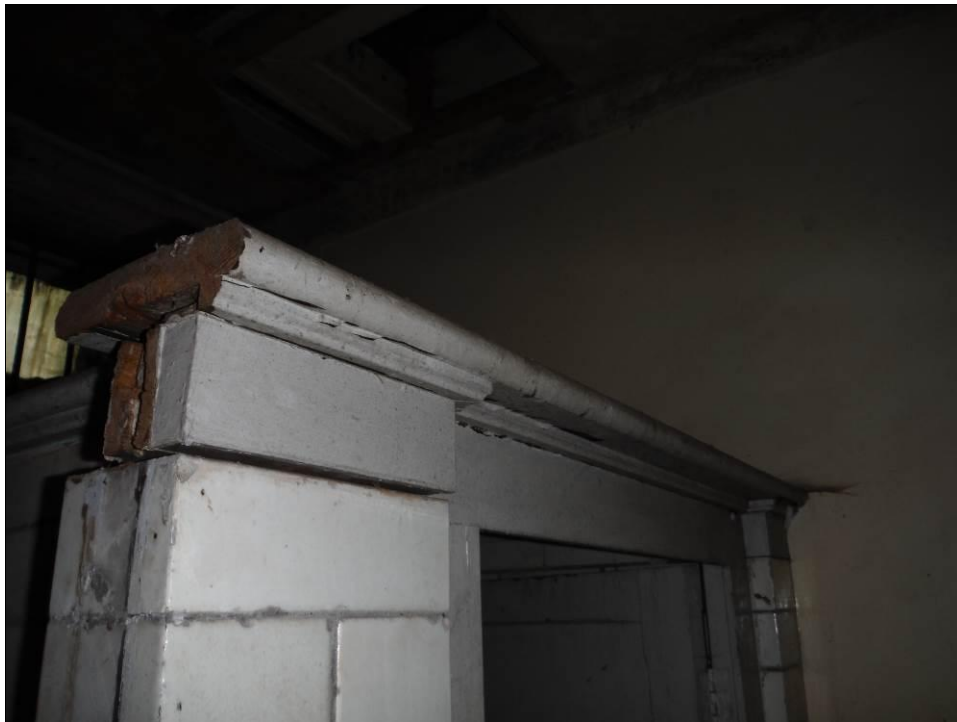
Figure 41: Detail of moulded cornice on toilet cubicle in Room G4, Building A.

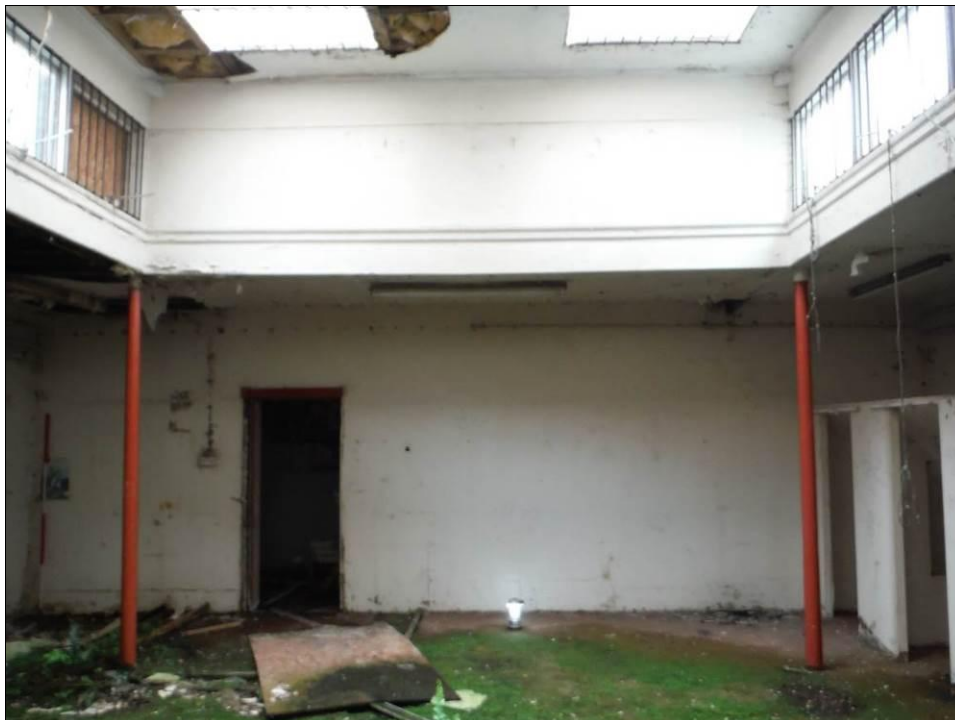
Figure 42: East wall of Room G5, Building A (Scale = 2m).

4.1.12.1 Room G5 consists of the Russian Baths accessed at its eastern and western sides by a door from the eastern corridor and the lobby corridor respectively. This room has been subject to the refurbishment carried out as a result of the construction of Building B. The walls have been plastered over obscuring the glazed brick that once lined this room. The eastern wall doorway with a timber lintel is a later addition cut through the bricks to create access to this room (Figure 42). The south-eastern corner had two cubicles constructed of particle board (Figure 43). The west wall is the most degraded and vegetation has removed the plasterwork in multiple patches to reveal the original glazed brickwork beneath (Figure 44). The damage to the plaster shows that the western doorway was supported by bullnose glazed bricks on both sides. This indicates that this entryway was part of the original 1912 construction. The north wall is featureless (Figure 45). The Russian baths are topped by a square half-storey cupola skylight supported by four red pillars, one at each corner. The north and south walls of this structure contain clerestory double-light windows. Many of these have been boarded up. Within the ceiling, there are four recessed single-light skylights (Figure 46).

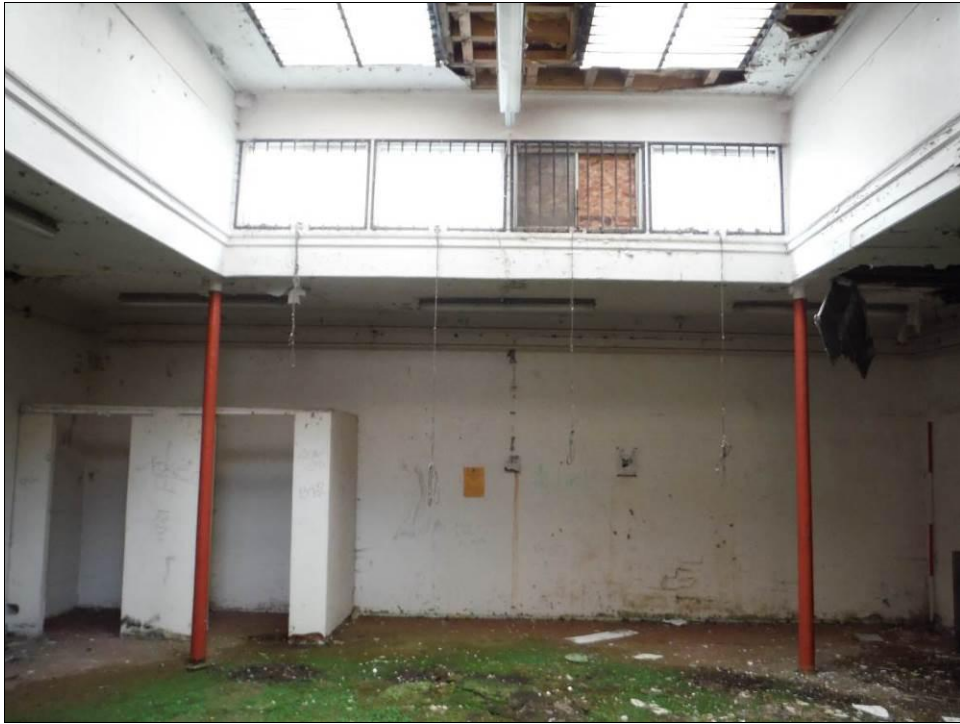
Figure 43: South wall of Room G5, Building A (Scale = 2m).

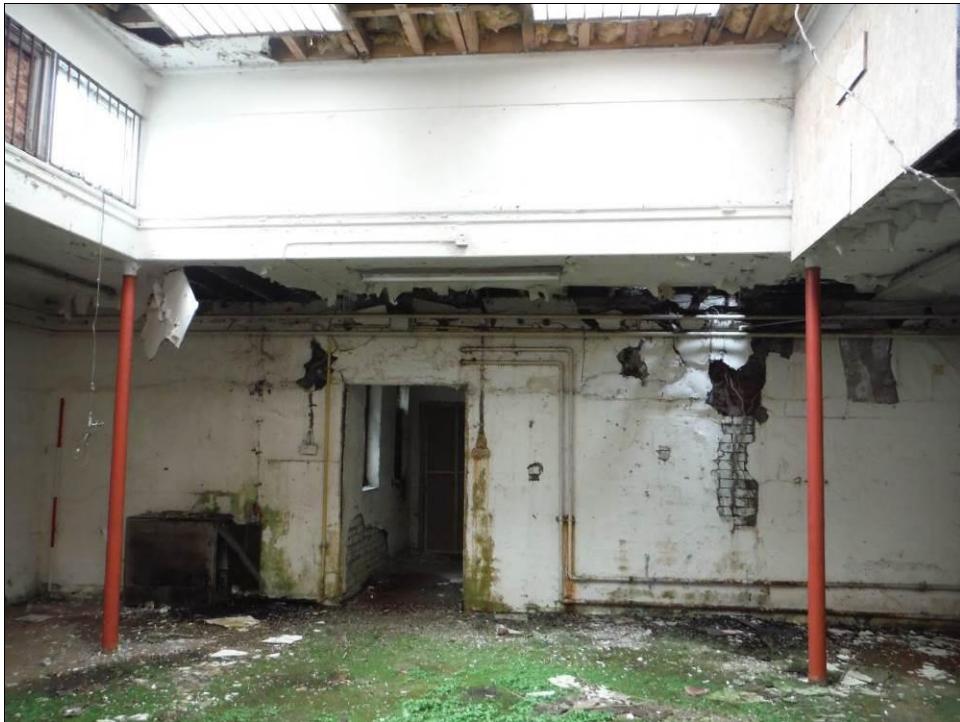
Figure 44: West wall of Room G5, Building A (Scale = 2m).

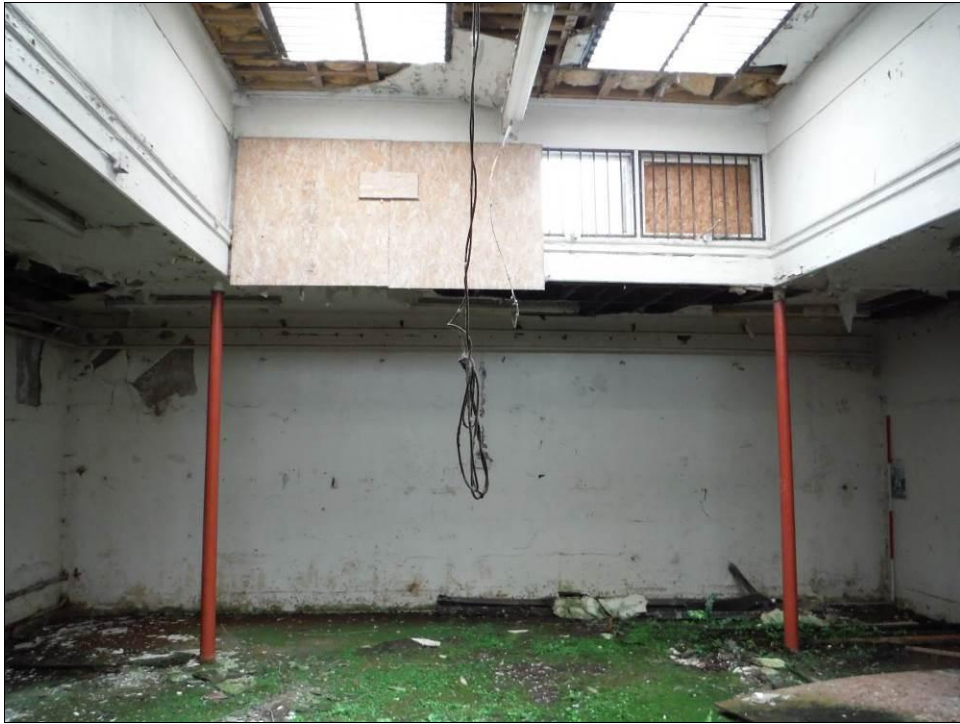
Figure 45: North wall of Room G5, Building A (Scale = 2m).

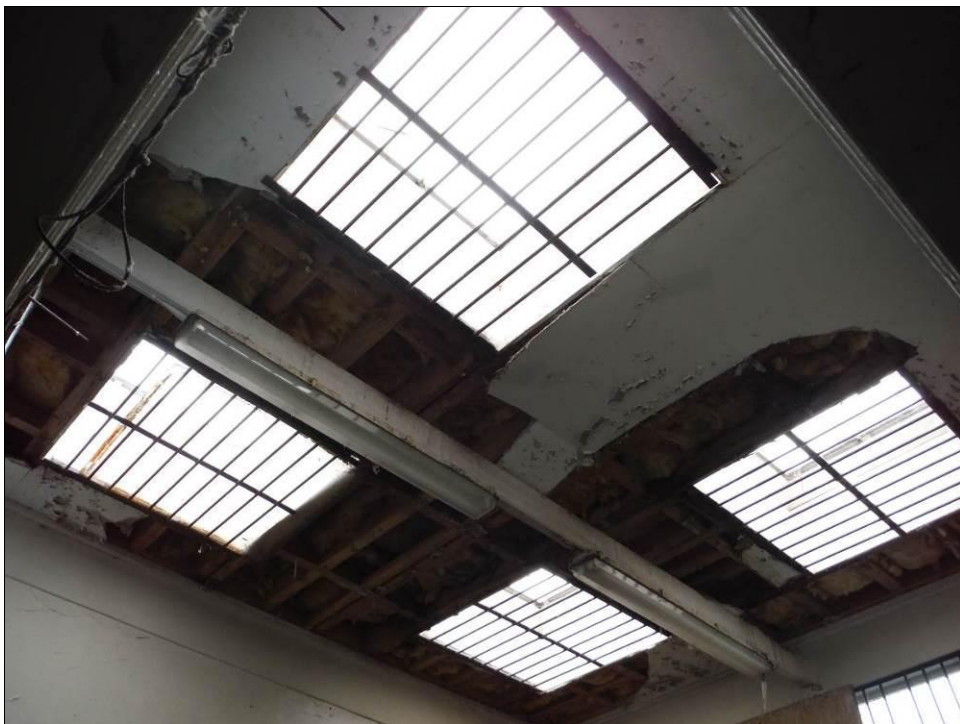
Figure 46: Detail of ceiling of Room G5, Building A.

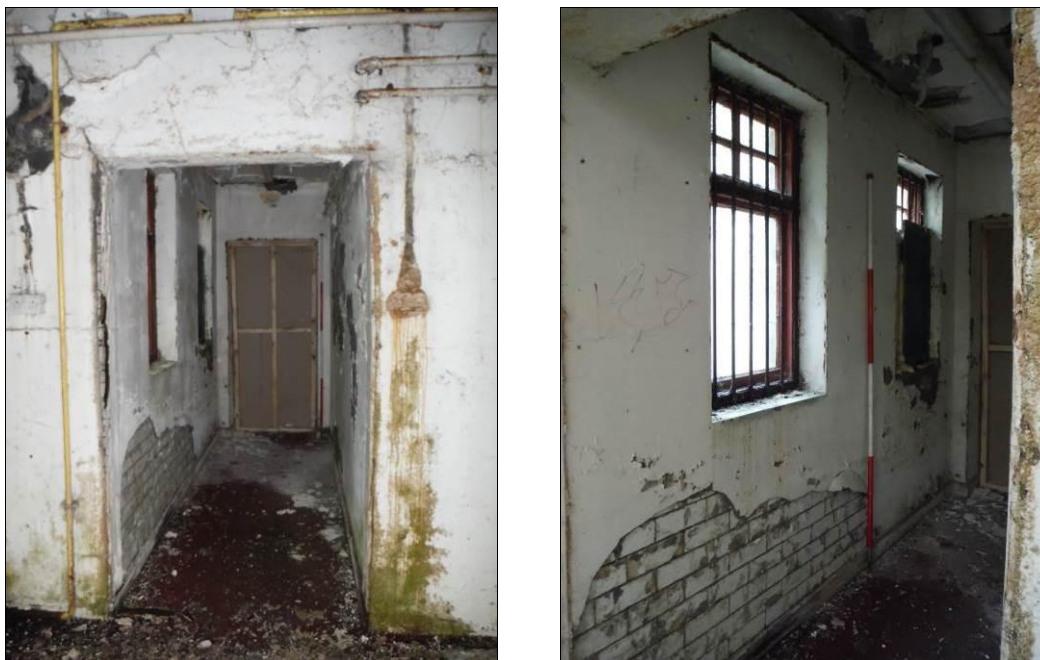
Figure 47: South and west walls of Room G6, Building A (Scale= 2m).

4.1.13.1 The former lobby corridor consists of a small passage that is blocked at the eastern side where it would have been accessible from the 1912 lobby. It is accessed from the west by the Russian baths. The plaster in the corridor has degraded on the southern wall revealing the glazed stretcher-bond brickwork beneath. The end of the southern wall contains two five-light fixed windows with timber moulded surrounds. These windows have been covered with bars running vertically across the frames. These windows lead to the light well between the southern corridor and the Russian baths (Figure 47).

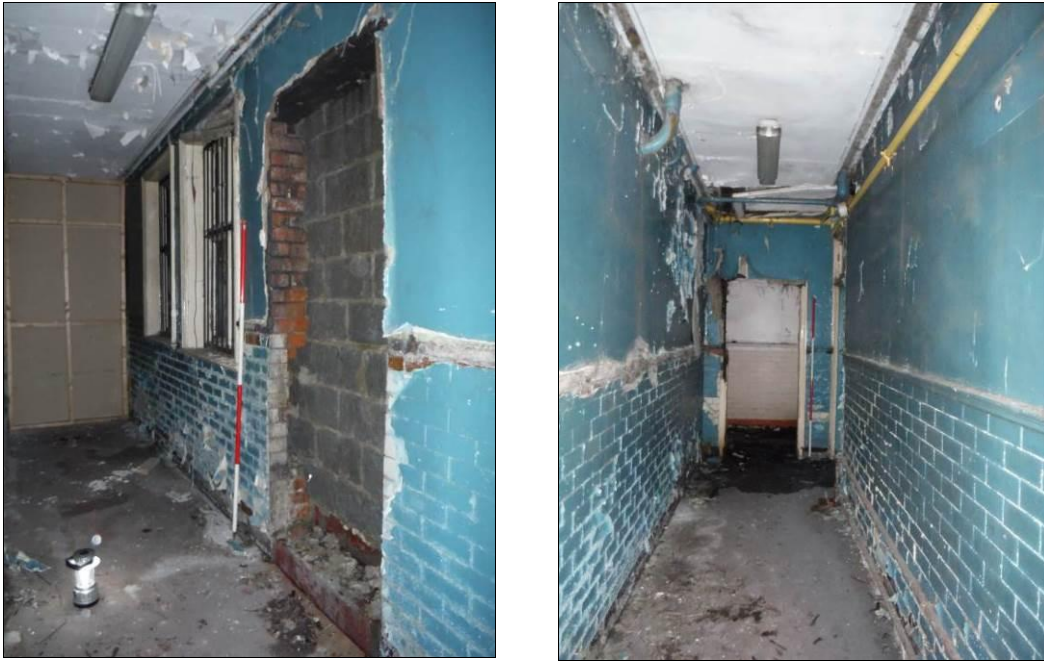
Figure 48: Room G7, Building A (Scale = 2m)

4.1.14.1 Room G7 is accessed by doors at its southern, northern and eastern side, leading to the central corridor (Room G3), the exterior and the slipper baths entrance (Room G8) respectively. The room retains the original internal glazed stretcher-bond brickwork though this has been painted over (Figure 48). The remains of the dado rail on the southern wall separate the visible brick-coursed lower portion of the wall and the plastered upper portion. The western end of the corridor has been blocked off as part of the present development to reflect the ownership boundary (Figure 48). The westernmost end of the northern wall contains two five-light fixed windows with timber moulded surrounds. These windows have been covered with bars running vertically across the frames. These windows lead to the exterior but have been blocked up. To the east of the windows there is an inserted, blocked doorway. The presence of a concrete step in the doorway suggests that it may have been added during refurbishment carried out in response to the construction of Building B. The eastern end of the corridor contains a doorway with remnants of its original moulded timber surround (Figure 49). The easternmost doorway in the south wall to the central corridor was discussed above. There is a hatch in the ceiling at the easternmost part of the corridor (Figure 50). This is lined with timber moulding and could be the remains of a skylight.

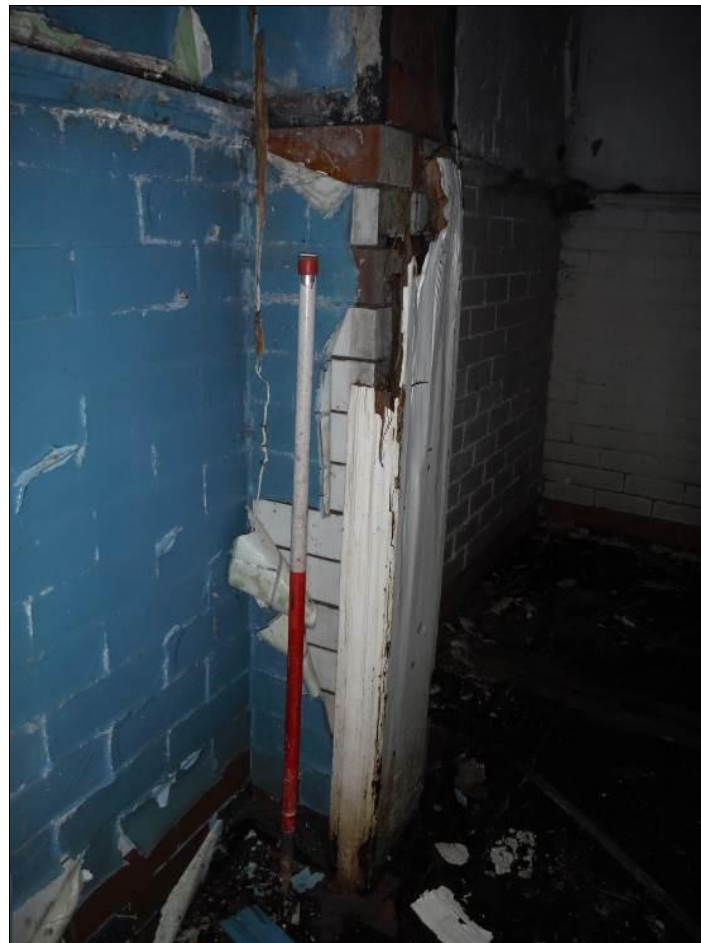
Figure 49: Detail of timber-moulded doorframe leading from Room G7 to Room G8 (Scale = 1m).

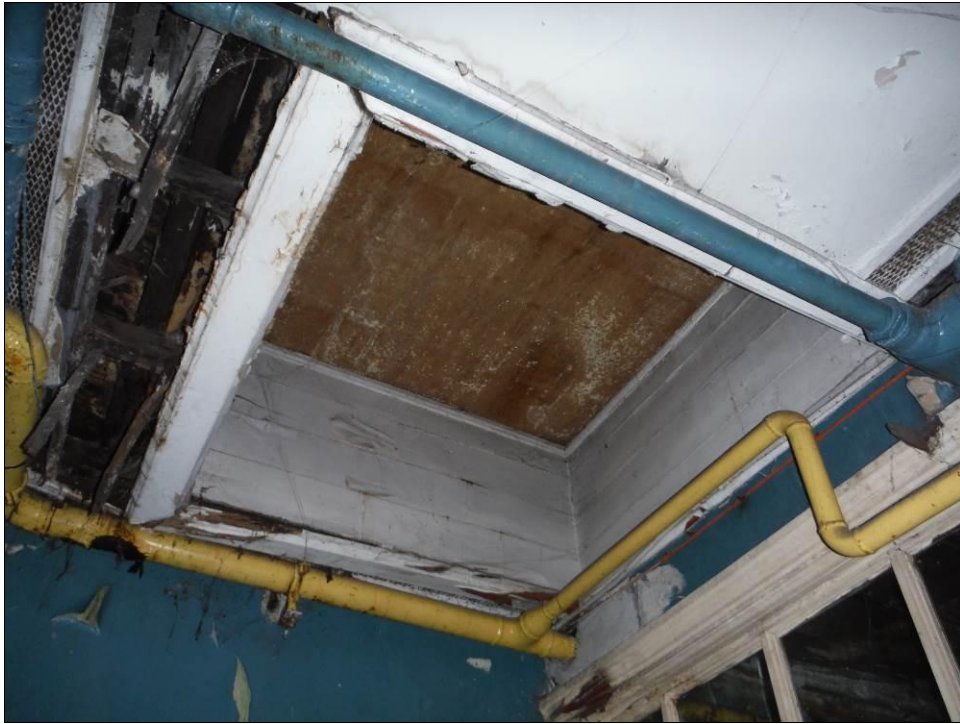
Figure 50: Detail of timber skylight in Room G7, Building A outside the entrance to Room G8.

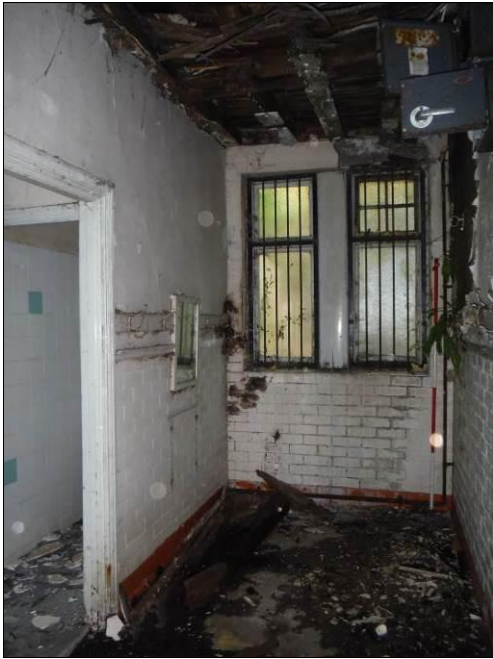
Figure 51: Room G8, Building A (Scale = 2m).

4.1.15.1 Room G8 consists of a vestibule to Room G9 – the main slipper baths room - formed by G10 and G11. The slipper baths vestibule is accessed by doorways in the eastern and western walls leading to the northern corridor (Room G7) and the main slipper baths room (Room G9) respectively. The room retains its lower original glazed stretcher bond brickwork and upper plasterwork walls separated by a moulded timber dado rail. The southern wall features two windows: the westernmost is a five-light window with timber moulded surround and the easternmost is a two-light window with timber moulded surround (Figure 51). These windows open to the inaccessible yard. It is likely the eastern window in this wall is a later replacement. Both windows are covered by vertical metal bars on the interior. The eastern and western walls contain metal coat hooks mounted on timber braceboards. These are placed above the level of the dado rail and appear to be original.

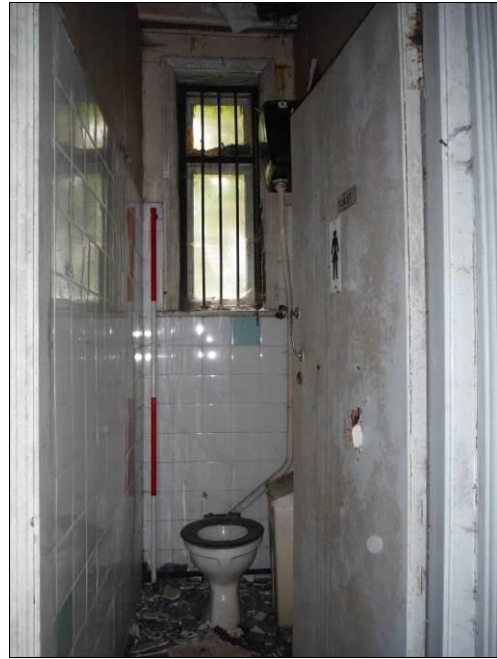
Figure 52: Room G10, Building A (Scale = 2m).

4.1.15.2 Rooms G10 and G11 are alcoves to the south and north respectively. Room G10 – the slipper bath shower – was tiled on all three walls with square ceramic white tiles occasionally interspersed with dark blue single tiles. A raised dais has been installed for shower drainage and tiled with peach coloured ceramic tiles (Figure 53). This area was refurbished possibly during the addition of Building B. Room G11 – the slipper bath ladies’ toilet – was tiled on all three walls with square ceramic white tiles occasionally interspersed with light blue single tiles. The southern wall contains a single two-light window with moulded timber surrounds covered with vertical metal bars. Room G11 was fitted with a toilet with a cistern attached to the southern and western walls (Figure 52).

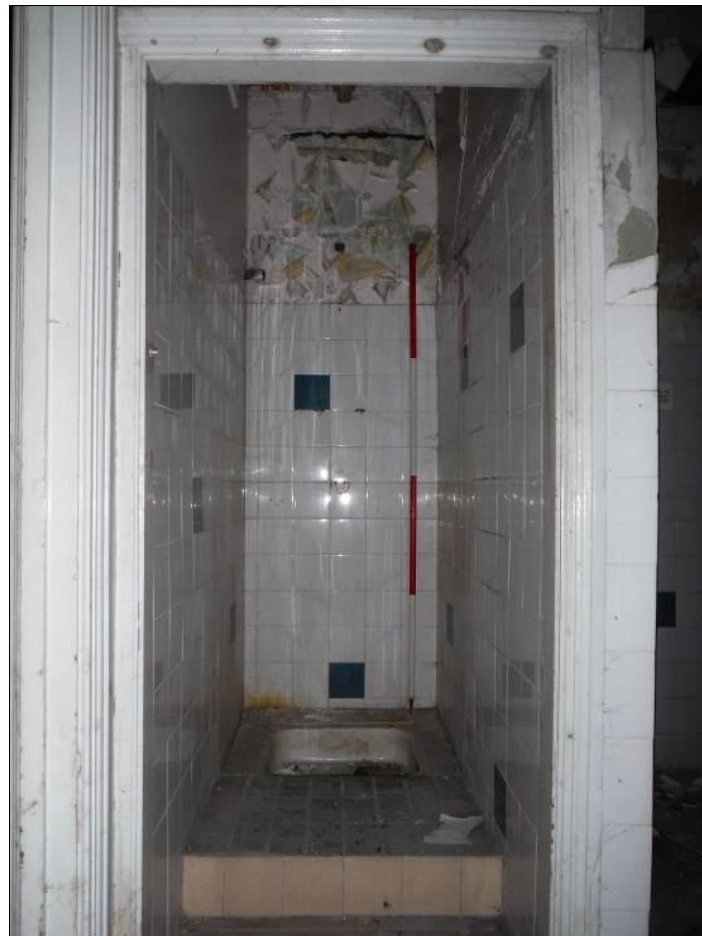
Figure 53: Room G11, Building A (Scale = 2m).

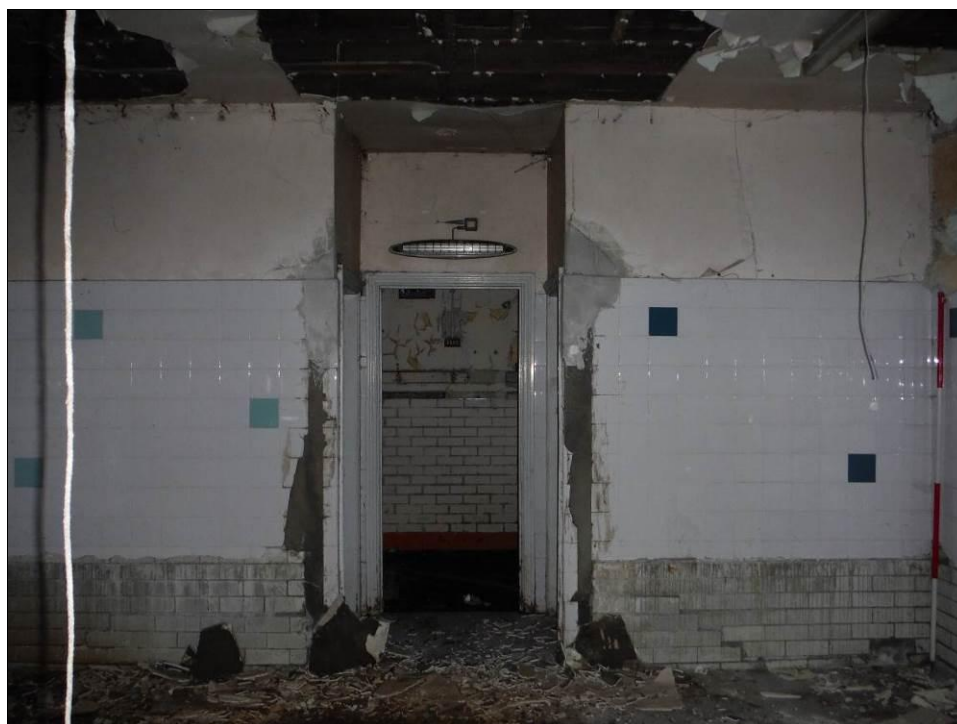
Figure 54: West wall of Room G9, Building A (Scale = 2m).

4.1.15.3 Room G9 – the main slipper bath room – is accessed by a doorway in the western wall leading to the main slipper baths vestibule (Room G8). All the walls are tiled with square ceramic white tiles occasionally interspersed with dark blue, light blue, dark brown, and bright yellow single tiles (Figure 54). The remaining upper portion of the walls was plastered. In the western, southern, and northern walls, there was evidence of the original slipper baths from the 1912 construction with exposed glazed stretcher-bond brickwork at the ground level (Figure 55). In the southern, eastern, and northern walls, scars from the removed partitions were evident in the tiling (Figurer 56-58). These partitions are the result of the conversion of the slipper baths to shower cubicles given the detailing of the signage attached to the tiled walls. The ceiling also contained a recessed skylight (Figure 59). This was a large ten-light window set into the roof but currently boarded over from the exterior. This window had timber moulded surrounds and was covered by bars fixed to the interior.

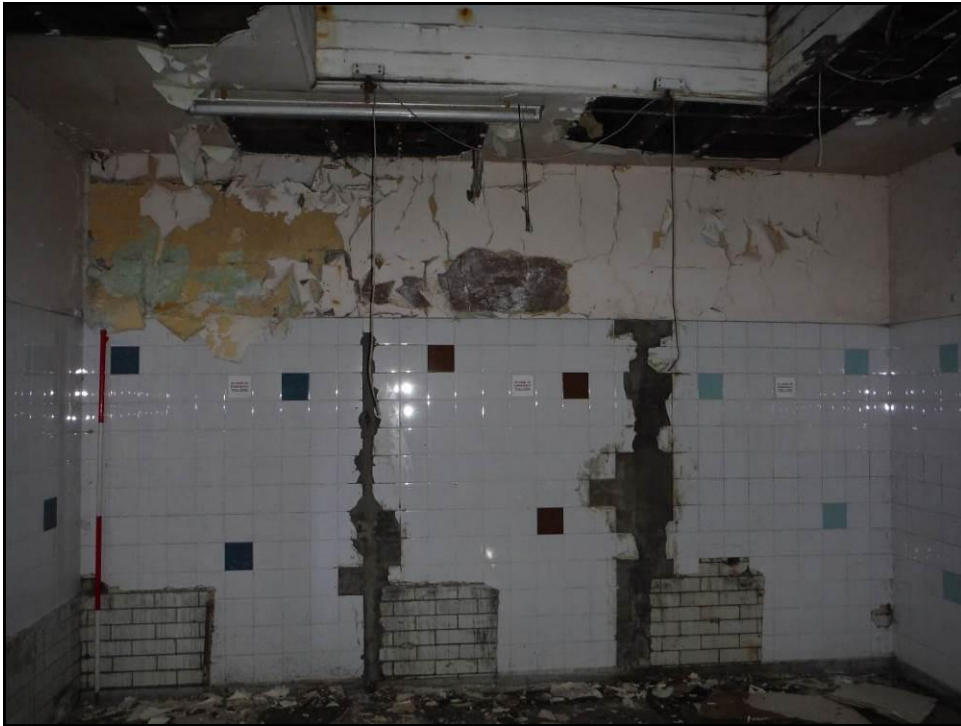
Figure 55: North wall of Room G9, Building A (Scale = 2m).

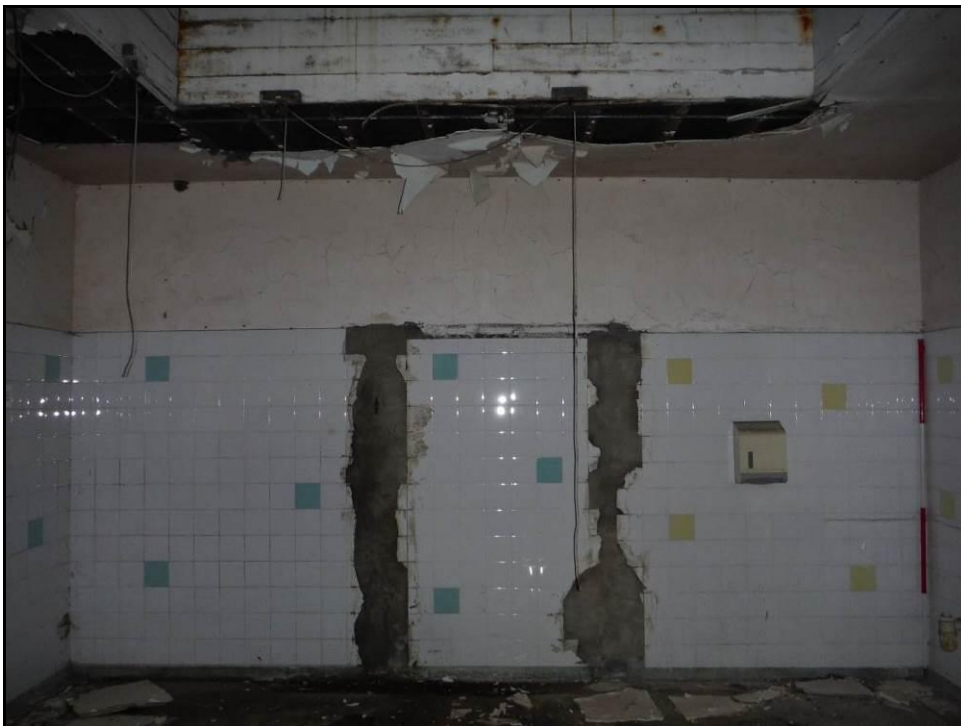
Figure 56: East wall of Room G9, Building A (Scale = 2m).

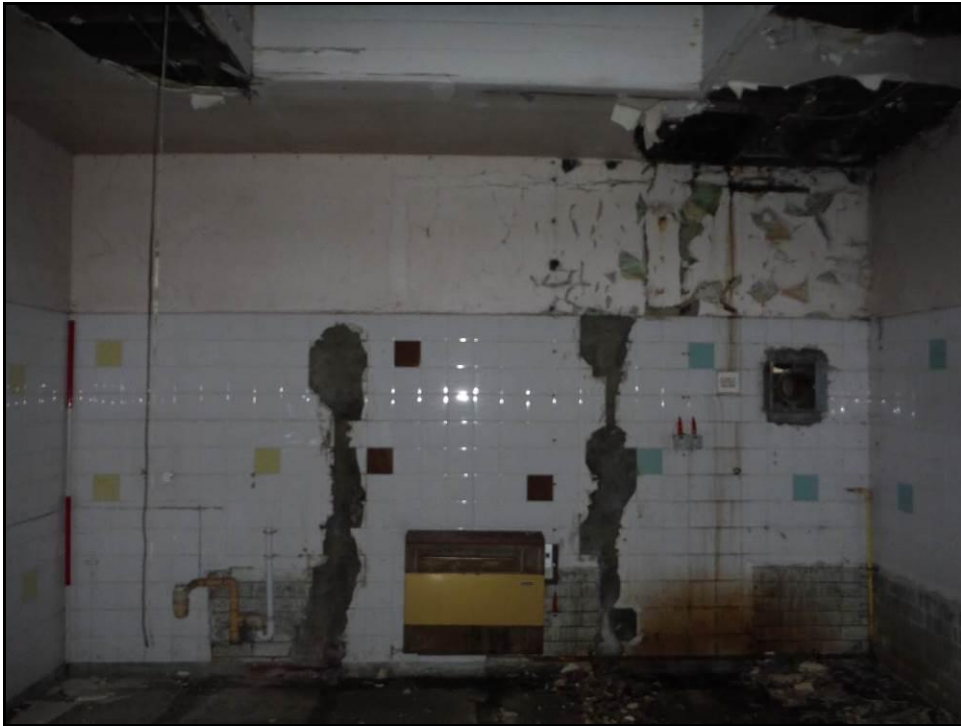
Figure 57: South wall of Room G9, Building A (Scale = 2m).

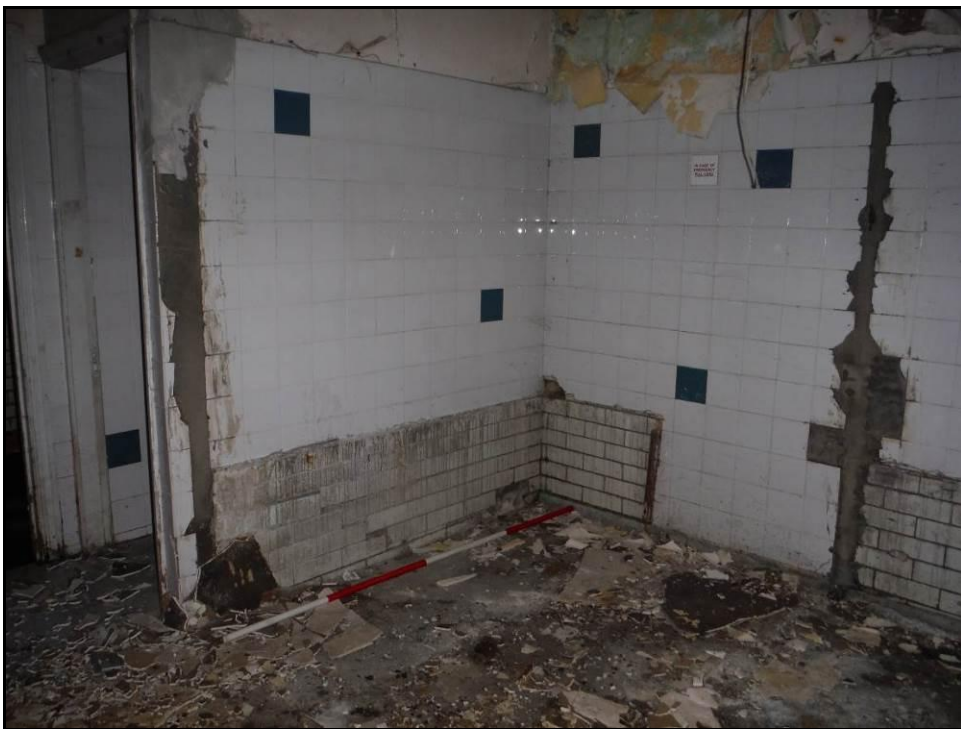
Figure 58: Detail of former bath and cubicle scars in the north west corner of Room G9 (Scale = 2m).

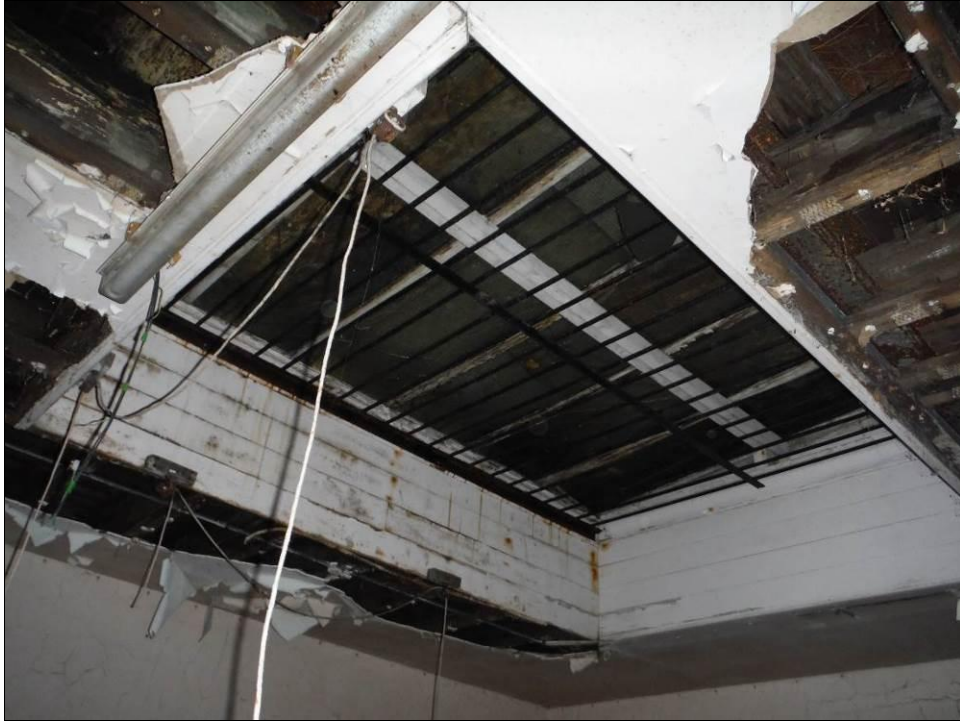
Figure 59: Detail of skylight in Room G9, Building A.

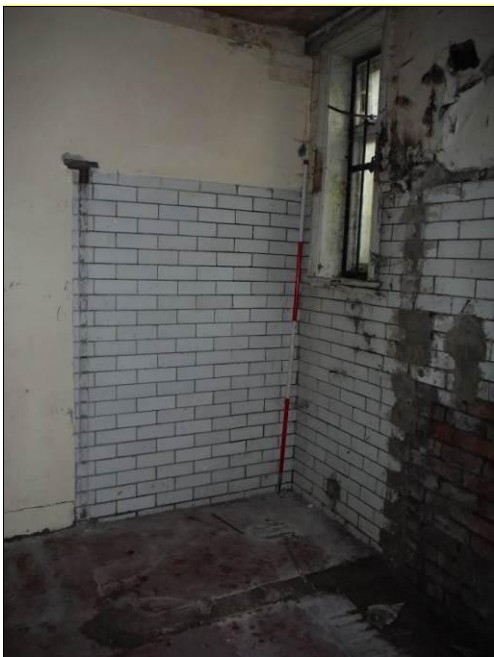
Figure 60: West wall of Room G12, Building A (Scale= 2m).

4.1.16.1 Room G12 is accessed by a door on the south side leading to the southern corridor (Room G2). The west wall is partially plastered but retains much of the original glazed stretcher-bond brickwork. The timber cornicing from the cubicle wall in the ladies' toilet (Room G4) projects into the western wall of G12 (Figure 62). This brickwork is more complete in the northern and eastern walls. The western side of the northern wall contains a two-light window with timber moulded surround internally covered by a metal crosspiece. This window looks onto the inaccessible yard area adjoined by the central corridor (Room G3), the ladies' toilet (Room G4) and the slipper baths (Rooms G8 –G11). The northern wall also features exposed unglazed stretcher-bond red bricks that are topped with scarring from the removal of the urinals in this room. Plastering on the west wall and the removal of the urinals from the north wall indicate remodelling of a single room into two separate rooms: this room and Room G4.

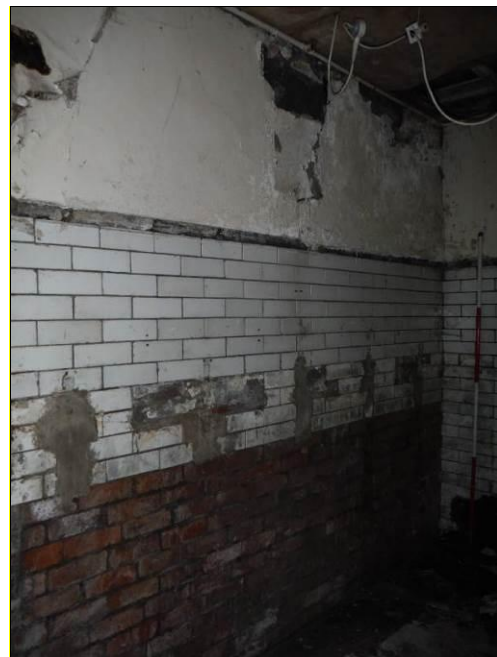
Figure 61: North wall of Room G12 showing the location of former urinals (Scale = 2m).

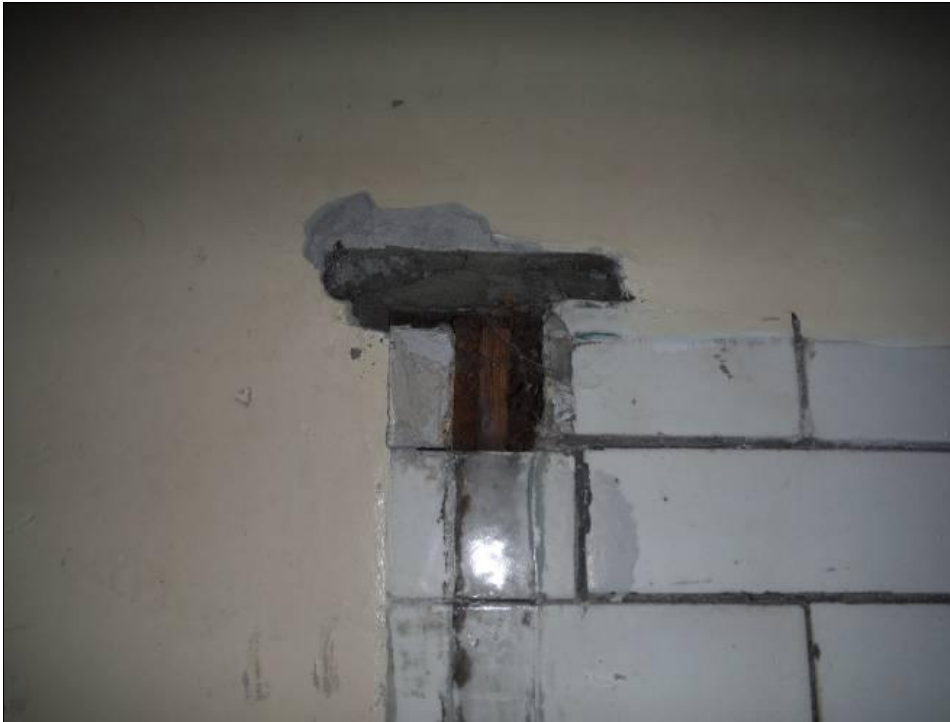
Figure 62: Detail of timber moulded corning from Room G4 in west wall of G12, Building A.

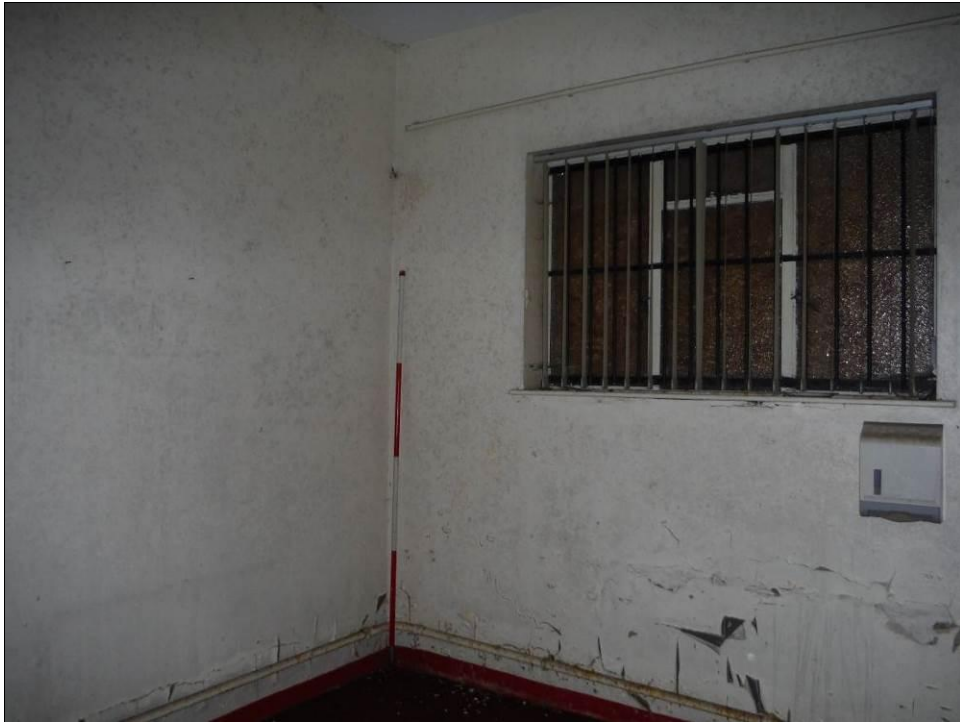
Figure 63: North and east walls of Room G13, Building A (Scale = 2m).

4.1.17.1 Room G13 is accessible from a doorway in the west wall leading to the southern corridor (Room G2). The walls have been plastered throughout and no brickwork is exposed. The east wall contains two timber-surround doorways: the southernmost enters onto the stairwell and the southern corridor, and the northernmost enters onto the under-stairs alcove attached to the staffroom (Room G14) (Figure 64). There are no structural features on the northern or southern walls of Room G13. The eastern wall features a large four-light window with a timber surround containing frosted glass panes. This was noted externally to be an inserted window (Figure 63). This window is covered internally by vertical metal bars. The understairs alcove is plastered on all walls and has no internal structural features aside from the stairs above acting as the ceiling (Figure 65). The staircase is an insertion following the extension to the baths in the 1950s, however, this room was originally part of the 1912 baths.
