**An Archaeological Building Recording  
of the former Wallsend Baths at Wallsend,  
Newcastle upon Tyne**

**ARS Ltd Report No. 2015/113**  
July 2015

**An Archaeological Building Recording  
of the former Wallsend Baths at Wallsend, Newcastle upon Tyne**

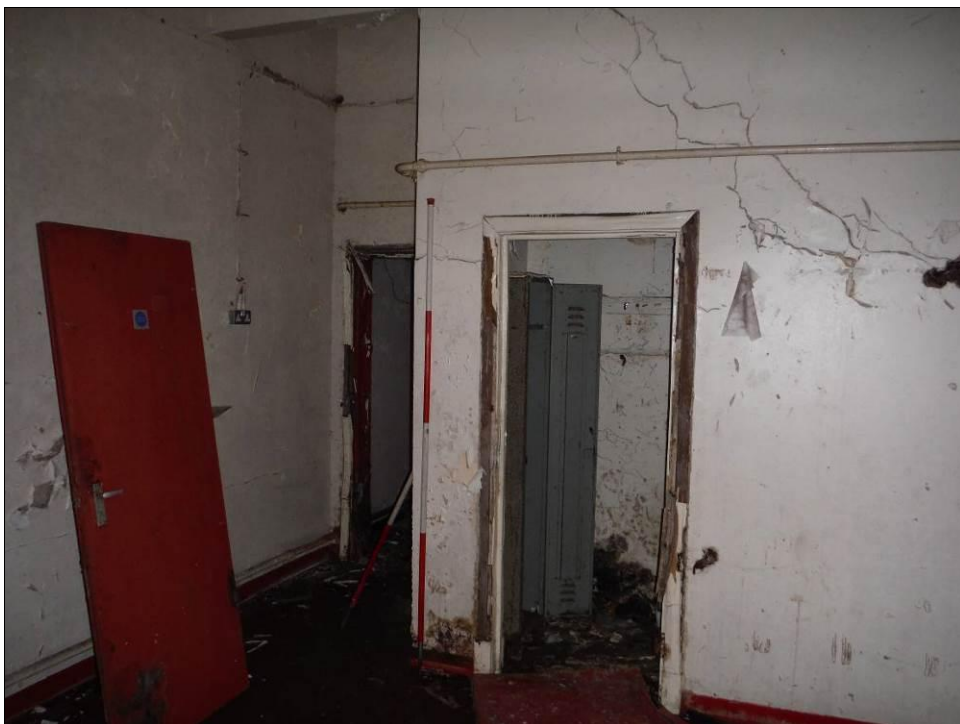
Figure 64: South and west walls of Room G13, Building A (Scale = 2m).

4.1.17.1 Room G13 is accessible from a doorway in the west wall leading to the southern corridor (Room G2). The walls have been plastered throughout and no brickwork is exposed. The east wall contains two timber-surround doorways: the southernmost enters onto the stairwell and the southern corridor, and the northernmost enters onto the under-stairs alcove attached to the staffroom (Room G14) (Figure 64). There are no structural features on the northern or southern walls of Room G13. The eastern wall features a large four-light window with a timber surround containing frosted glass panes. This was noted externally to be an inserted window (Figure 63). This window is covered internally by vertical metal bars. The understairs alcove is plastered on all walls and has no internal structural features aside from the stairs above acting as the ceiling (Figure 65). The staircase is an insertion following the extension to the baths in the 1950s, however, this room was originally part of the 1912 baths.

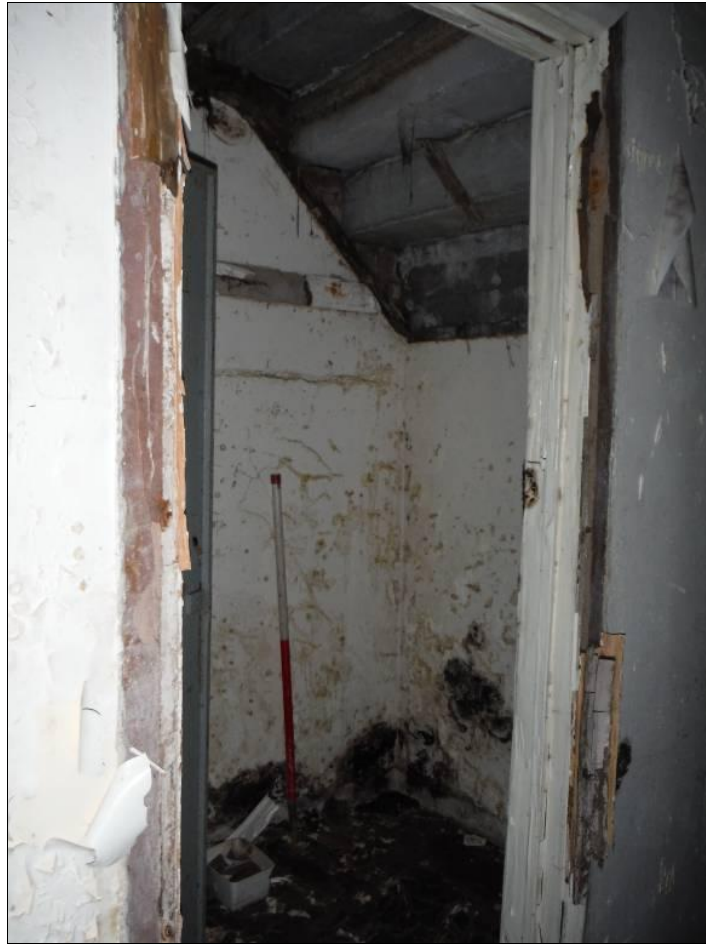
Figure 65: Room G14, Building A (Scale = 1m).

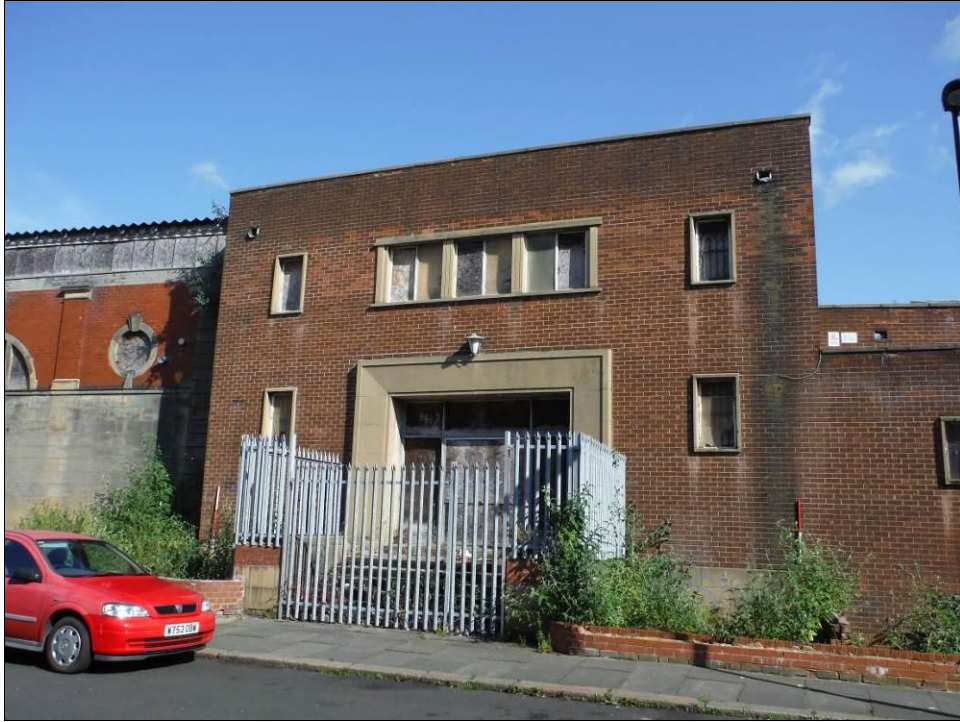
Figure 66: South-east elevation of the two-storey entrance block on Building B (Scale = 2 x 2m).

4.2.2.1 The south-east elevation of Building B comprises the two-storey entrance block and single-storey changing block (Figure 66). The entrance block contains a wide, double width doorway with a bold moulded concrete surround (Figure 68). It is likely that this replaced the original entrances to the baths on Lawson Street and Vine Street. Above the

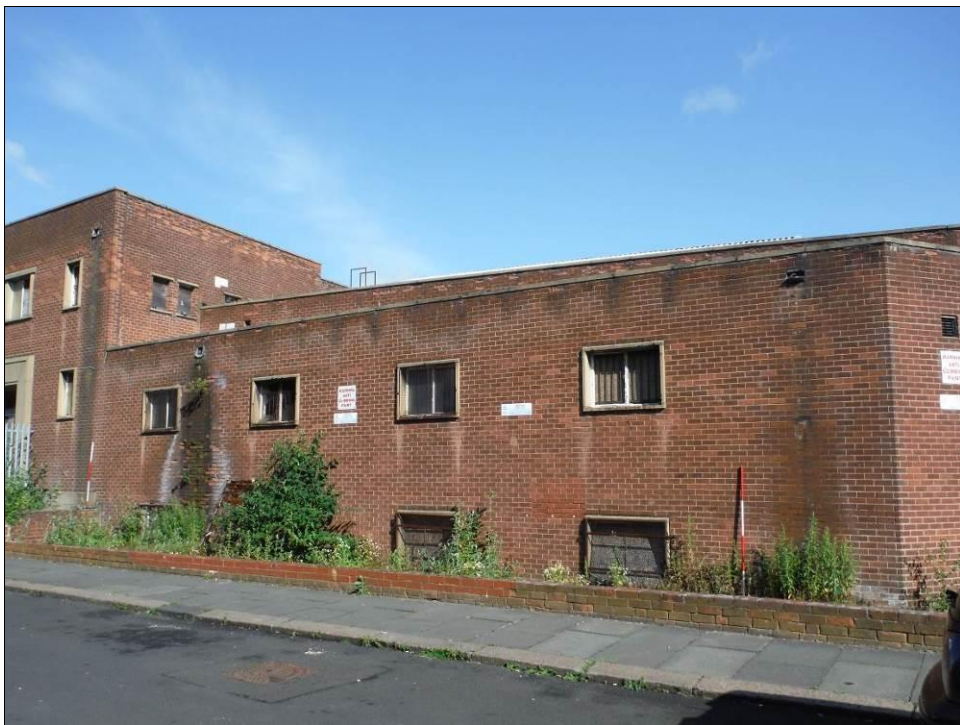
Figure 67: South East elevation of Building B (Scale = 2 x 2m).

doorway, at first-floor level, there is a bank of three rectangular windows with plain moulded concrete surrounds (Figure 69). The remaining block comprises changing facilities and contains a row of four small windows, now blocked, with plain moulded concrete surrounds (Figure 67).

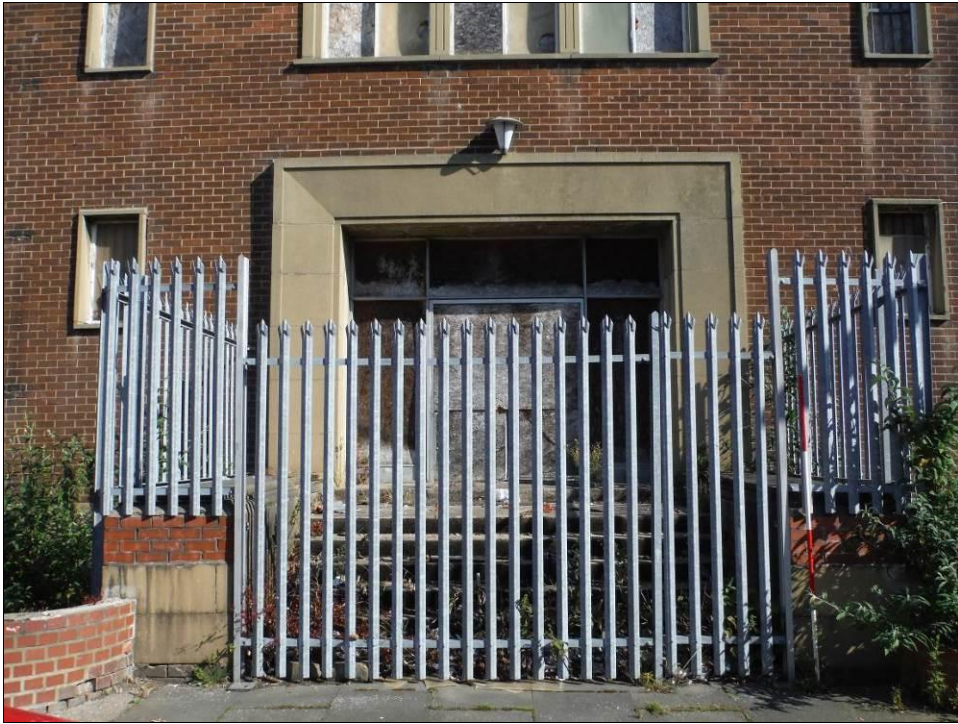
Figure 68: Detail of the entranceway in South East elevation of Building B (Scale = 2m).

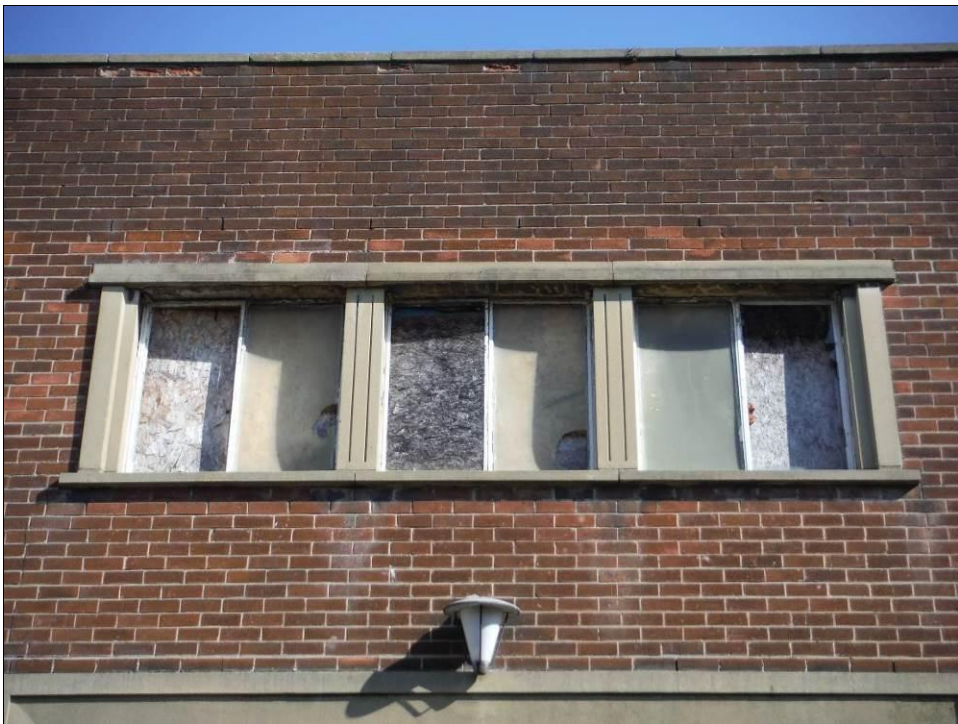
Figure 69: Detail of windows in the entrance block of the South East elevation of Building B.

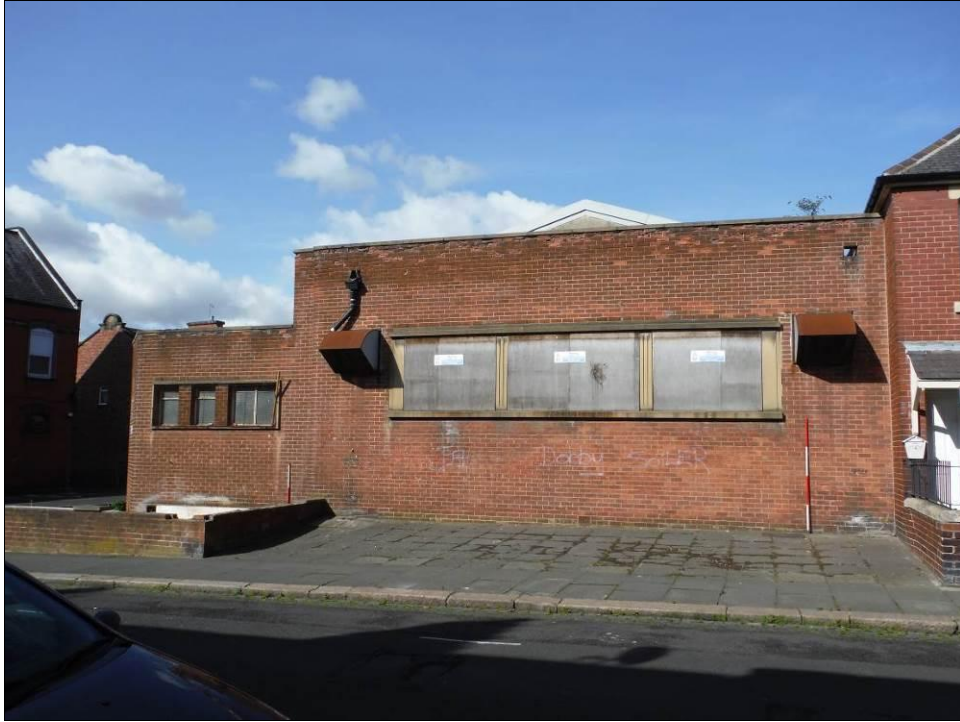
Figure 70: North East elevation of Building B (Scale = 2 x 2m).

4.2.3.1 The north-east elevation of Building B comprises the single-storey changing room block and the one-and-a-half storey swimming pool block. The changing room block contains a bank of three small blocked windows within plain moulded concrete surrounds. The swimming pool block contains a bank of three larger blocked windows within plain moulded concrete surrounds (Figures 70 and 71).

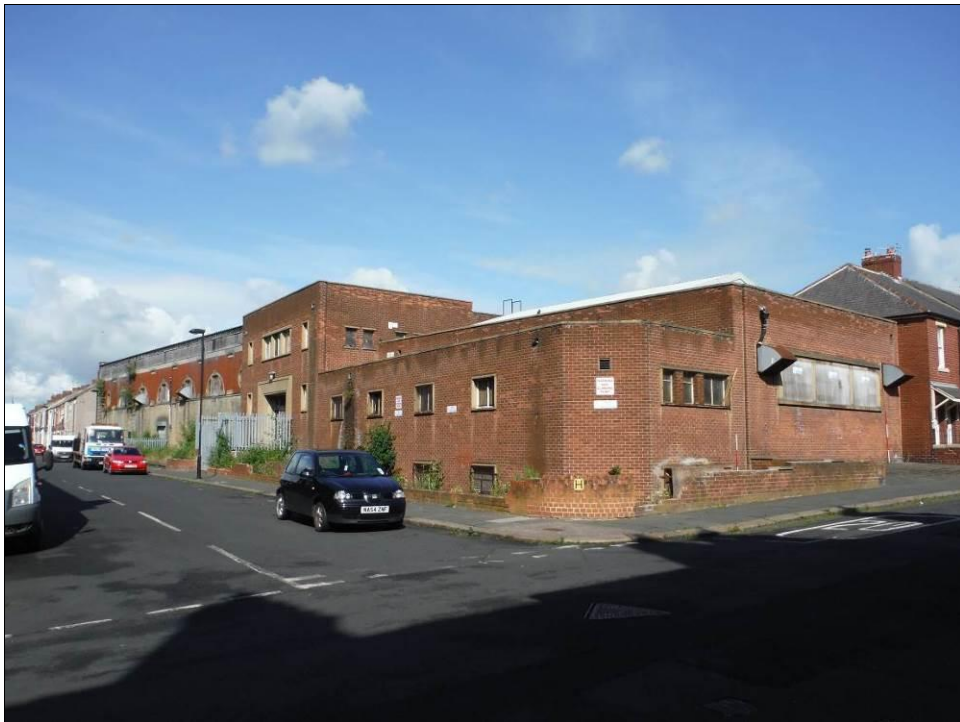
Figure 71: East facing oblique view of South East and North East elevations of Building B (Scale = 2 x 2m).

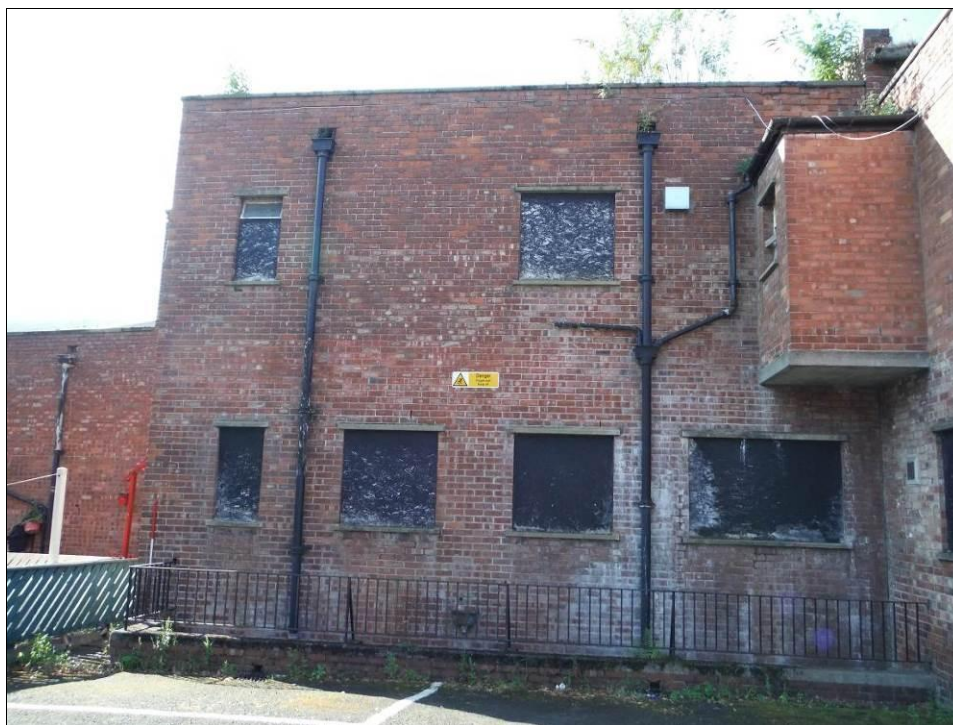
The North-West elevation of Building B is brick-built with five regularly spaced windows on the ground floor and four regularly spaced windows on the first floor with moulded concrete surrounds. The first storey has a three-quarter storey turret constructed between the western and eastern blocks of North-West elevation of Building B. This turret is based in concrete and appears to be part of the original fabric of Building B.

Figure 72: Detail of the North West elevation of Building B (Scale = 2m).

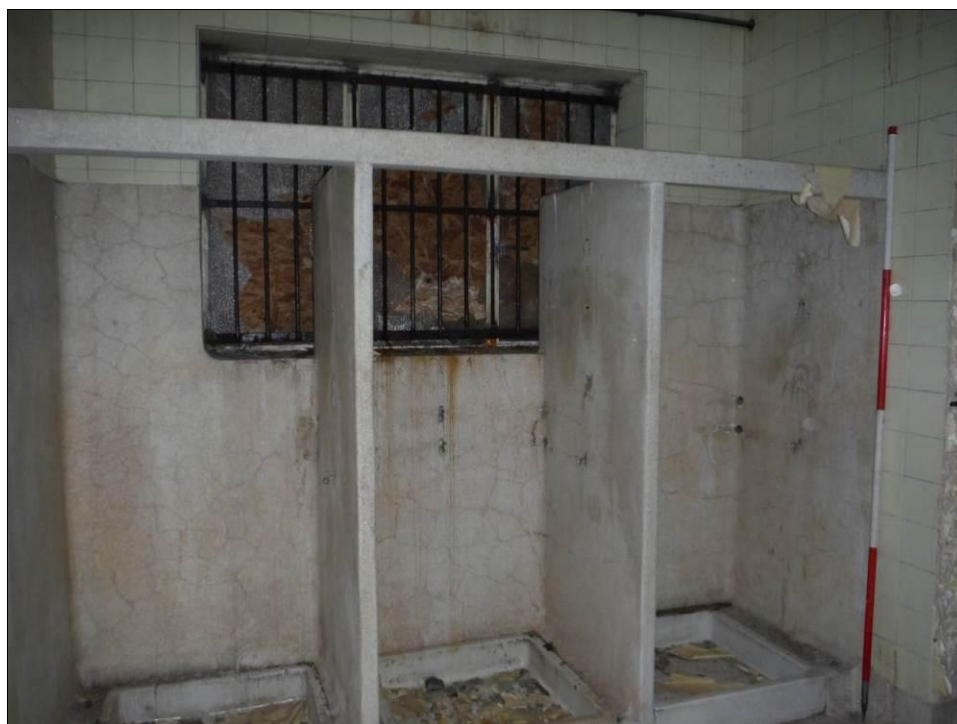
Figure 73: Room G1, Building B (Scale = 2m).

4.2.6.1 Room G1 consists of a small shower block, accessed by a doorway on its western side, and adjoining antechamber into the main pool in Building A (Building A/Room G1) (Figure 69) and via an entranceway in the eastern wall leading to changing room (Building B/Room G3). The walls in this room were tiled throughout with ceramic pale yellow wall tiles from floor to ceiling. The northern wall contained a terrazzo shower block of three alcoves on raised daises for drainage (Figure 73). The window in the northern wall consisted of a six-light window of frosted glass with timber surrounds and covered by a metal grille of vertical bars. The window has been boarded from the outside.

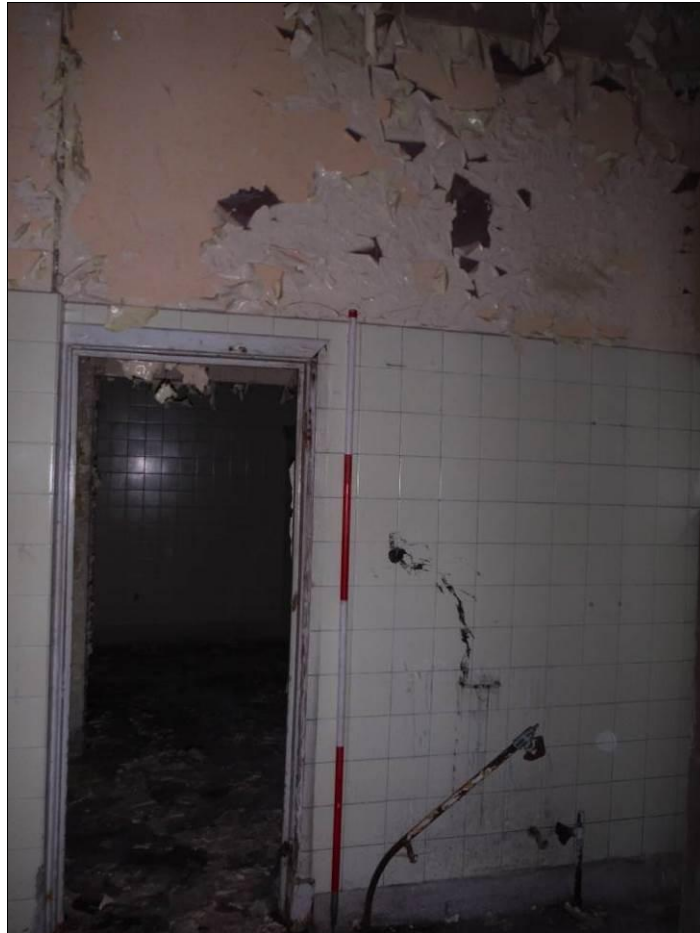
Figure 74: West wall of Room G2, Building B (Scale= 2m).

4.2.7.1 Room G2 consists of a toilet block accessed by a door in the western wall that leads to the main changing room (Room G3). The walls throughout this room are tiled with pale yellow square ceramic tiles up to two-thirds of the wall surface. The top third of the wall was plastered and painted. The western wall contained the timber framed doorway into the toilets (Figure 74). The northern wall contained two windows. The westernmost was a square three-light window with timber surrounds and frosted glass. The easternmost window is a rectangular two-light window with timber surround and frosted glass. Both windows were sealed by external boards and internal bars. Below the westernmost window, there is evidence of where the sinks would have been for the toilets. These have been removed (Figure 75). The eastern wall had four cubicles constructed of terrazzo and toilet cisterns were attached to the northern wall. The latter had been removed but the bowls remained (Figure 76). Three regularly spaced single-light windows with timber surrounds were located in the eastern wall. These had been boarded up externally and bars placed internally. The southern wall did not contain any features of note.

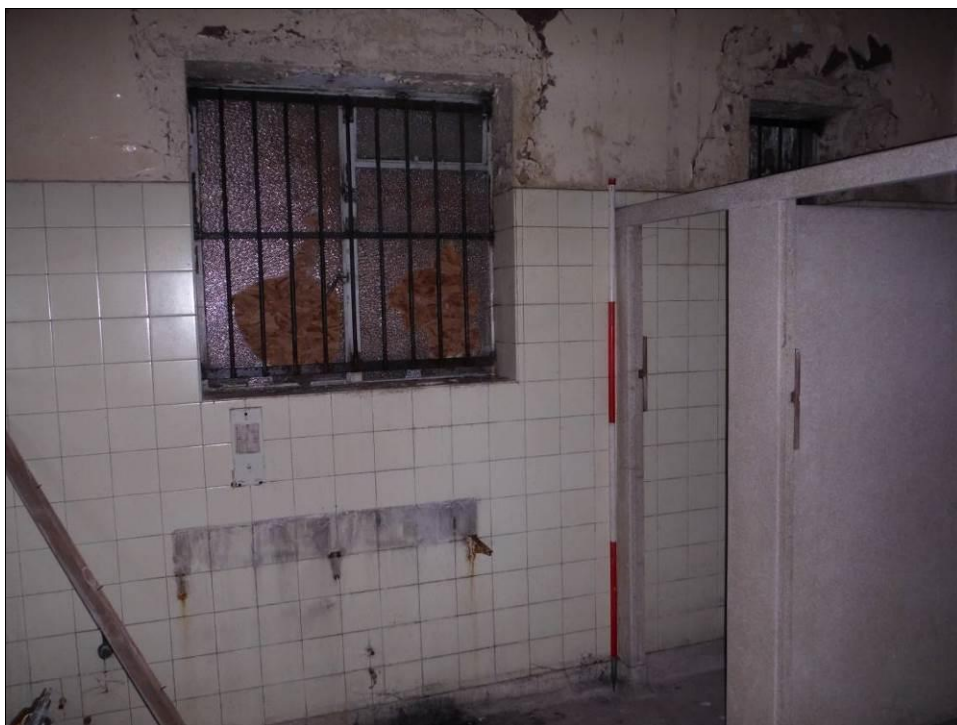
Figure 75: North wall of Room G2, Building B (Scale = 2m).

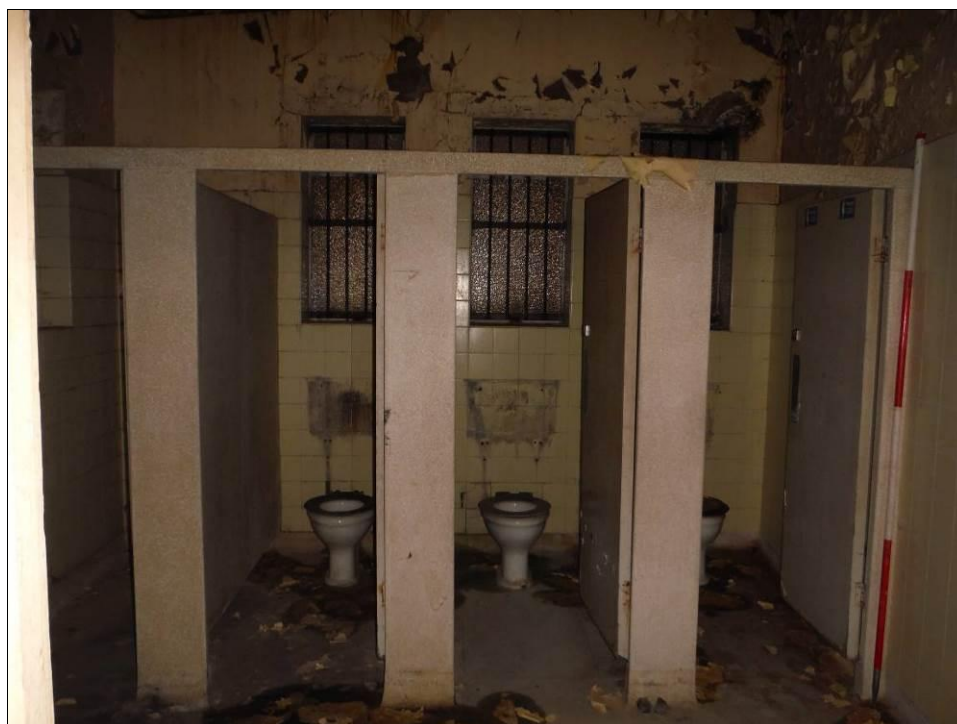
Figure 76: East wall of Room G2, Building B (Scale = 2m).

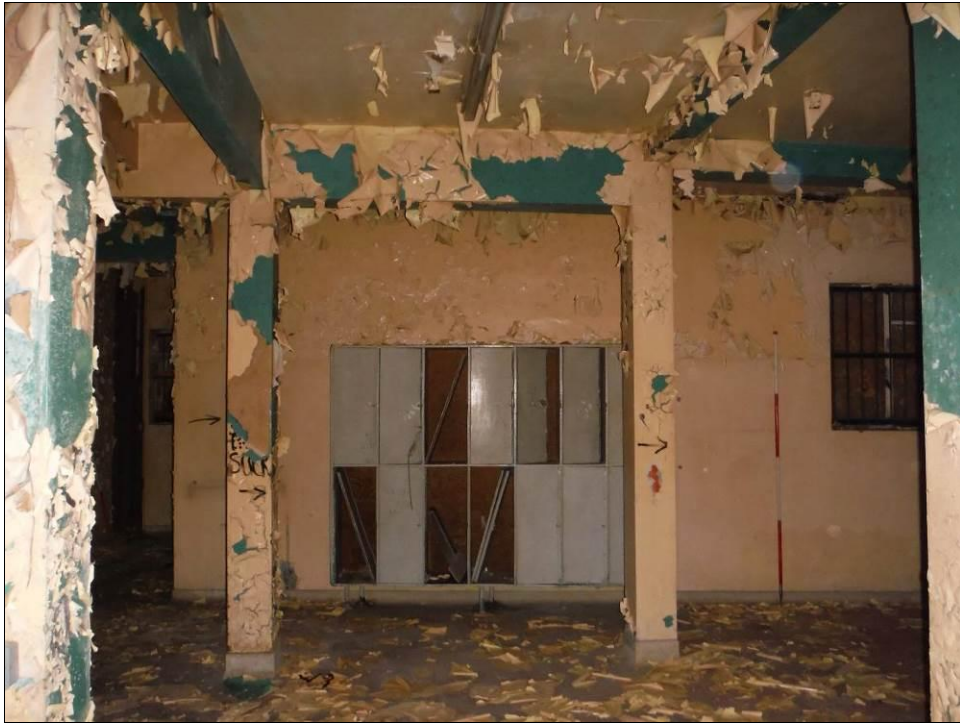
Figure 77: North wall of Room G3, Building B (Scale = 2m).

4.2.8.1 Room G3 consists of a changing room accessed by doors at the north-west, north-east, and southern sides from the shower block (Room G1), toilets (Room G2), learner pool (Room G5), main lobby side-room (Room G7) and the south-western corridor (Room G4). The north wall has a small annexe that adjoins with the shower block (Room G1) and the toilets (Room G2). The walls throughout the changing room are faced with painted plaster. The eastern end of the north wall contains a four-light window with timber surround that had been boarded and barred internally (Figure 77). The eastern wall had a timber framed door that entered into the learner pool (Room G12). The rest of the eastern wall was lined with terrazzo changing cubicles fitted with steel-framed benches seated with treated timber boards (Figure 78). These extended to the south wall of the changing rooms (Figure 79). The south wall contained two timber framed doorways (Figure 80). The easternmost led to the main lobby side room (Room G7) and the westernmost led to south-western corridor (Room G4). A radiator protected by a metal grille was attached to the south wall on the eastern side. This was adjacent to a boarded up panel covering the long single-light window leading to the south-western corridor (Room G4). The western wall was similar to the eastern wall (Figure 81). Terrazzo changing cubicles lined the wall from the southern wall to the doorway to Room G1. These also included steel-framed wooden benches. The central changing room was supported by concrete pillars (Figure 82).

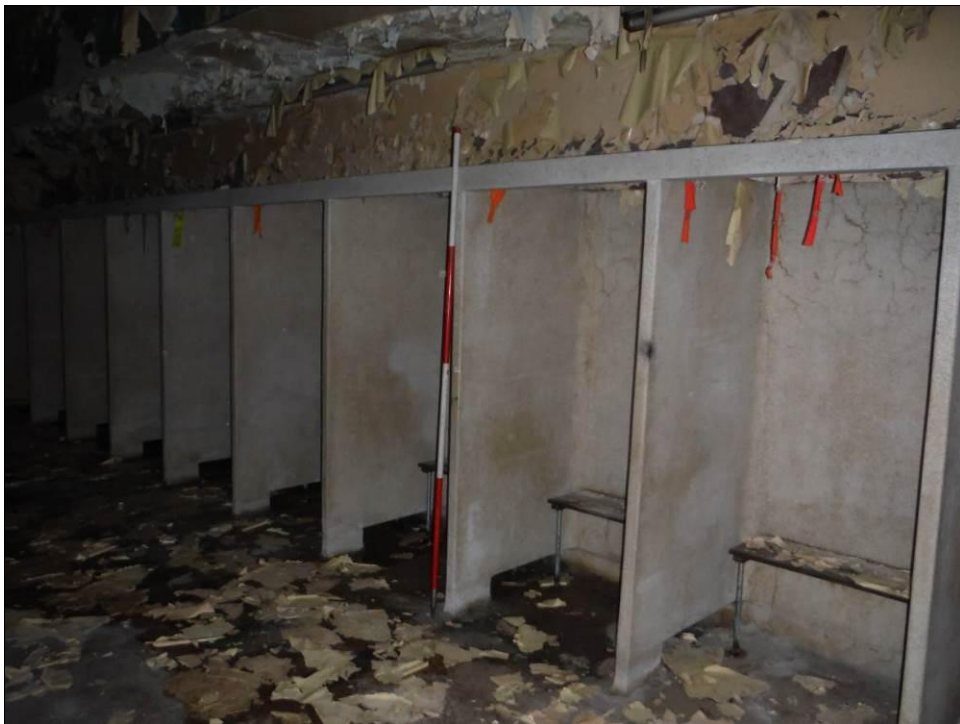
Figure 78: East wall of Room G3, Building B (Scale = 2m).

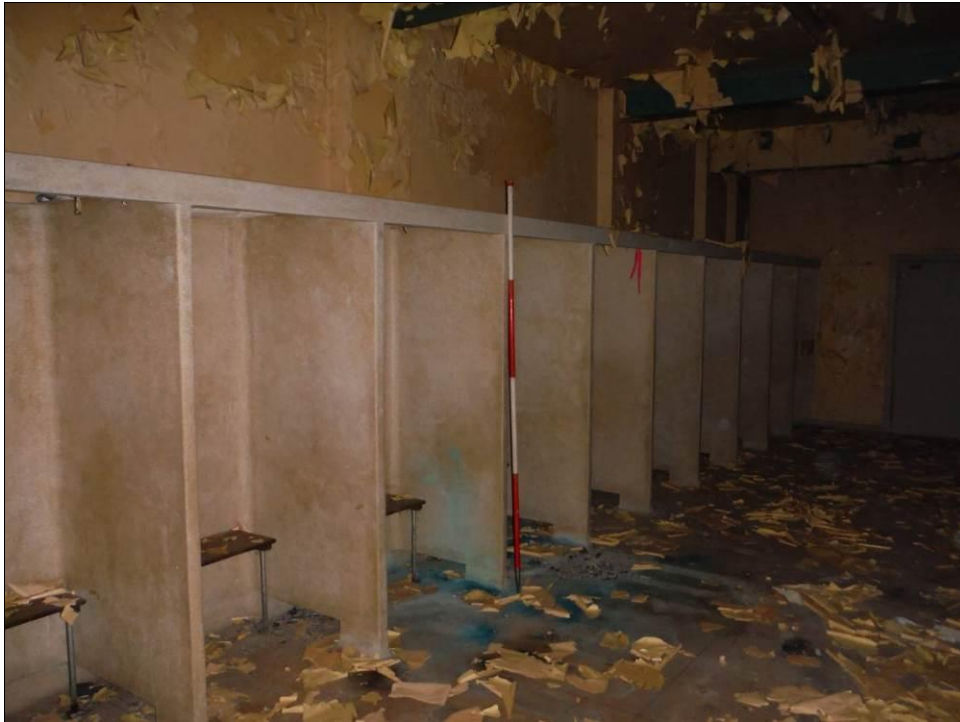
Figure 79: East wall of Room G3, Building B (Scale = 2m).

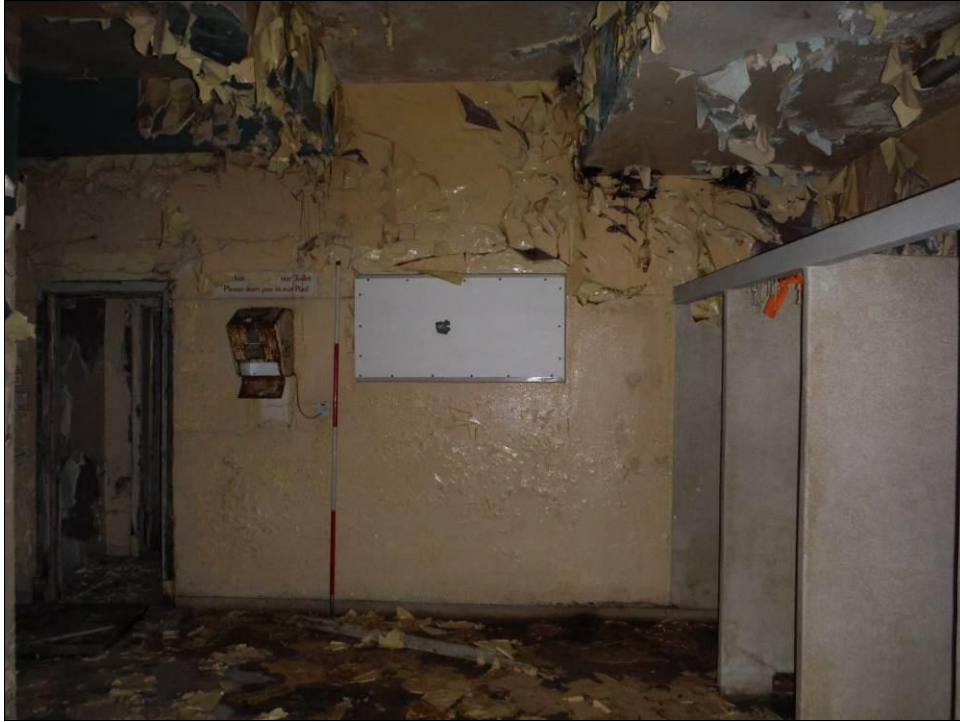
Figure 80: South wall of Room G3, Building B (Scale = 2m).

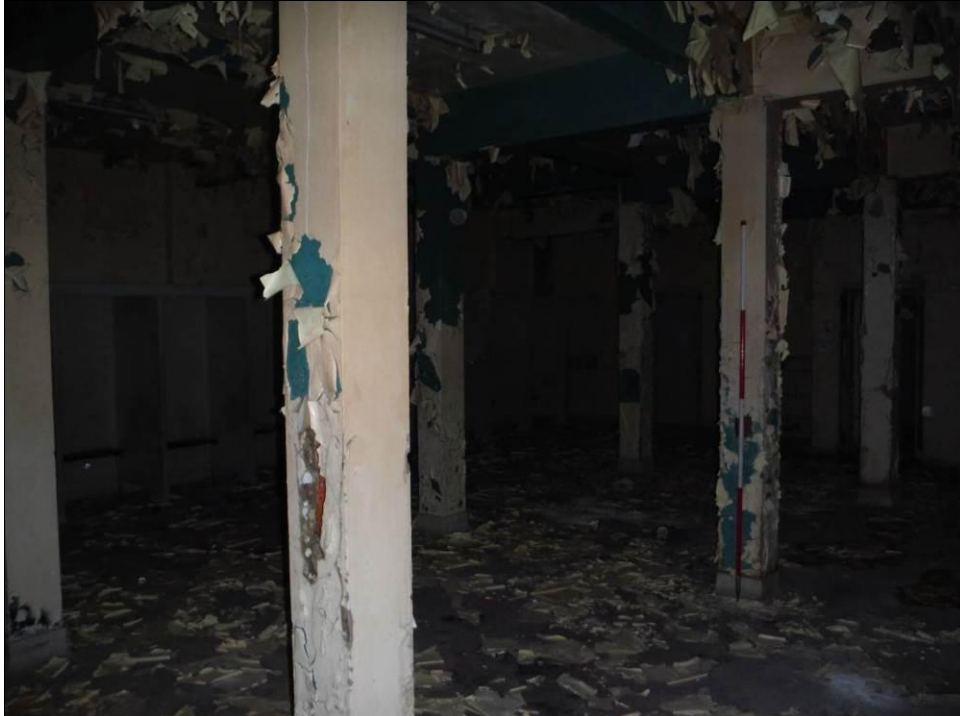
Figure 82: Detail of concrete pillars in Room G3, Building B (Scale = 2m).

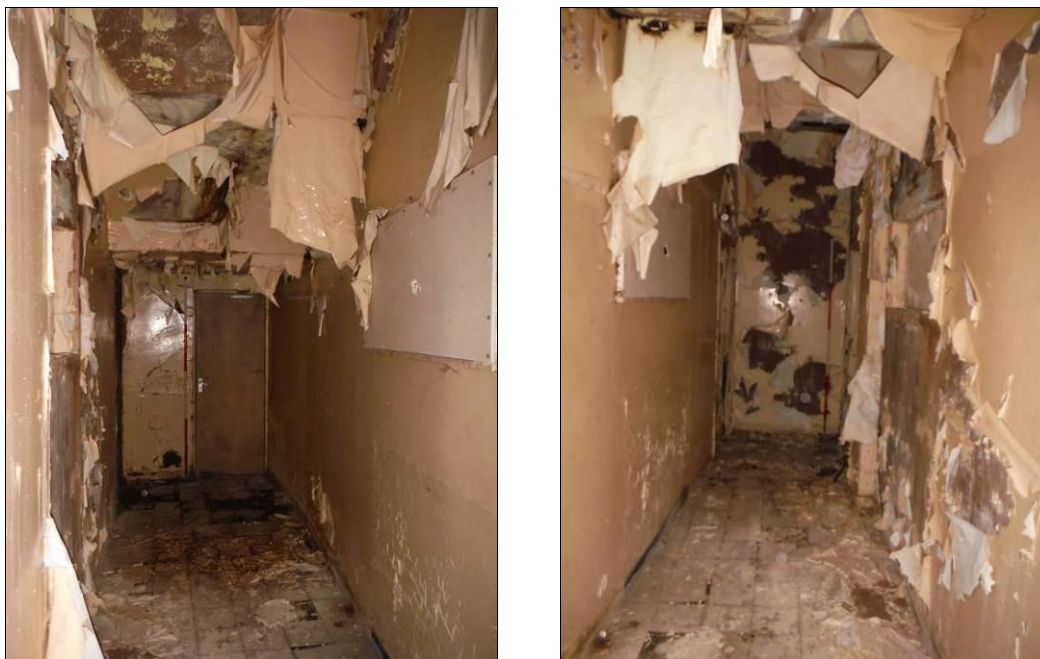
Figure 83: Room G4, Building B looking west (left) and east (right) (Scale = 2m).

4.2.9.1 Room G4 consists of a corridor accessed from doors on the west, north, and south sides from the main pool (Building A/Room G1), changing rooms (Room G3), and main lobby (Room G5) respectively. The wall is painted plaster and the doors are plain timber framed structures. The northern and southern wall contained boarded up windows leading into the changing room (Room G3) and main lobby (Room G5) respectively (Figure 83).

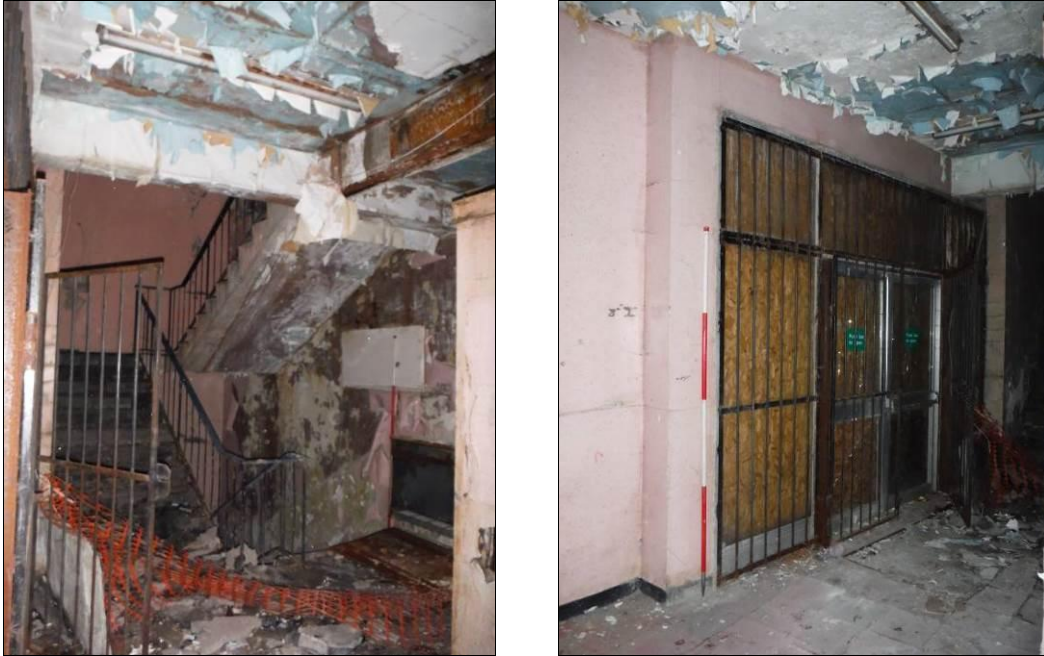
Figure 84: West wall (left) and south wall (right) of Room G5, Building B (Scale = 2m).

The south wall contained the original entryway constructed for the extension in the 1950s. This was an aluminium framed two-light glass-panelled double doorway surrounded by side-light two-light and transom single-light windows. The doorway had been boarded and barred internally (Figure 84). The west wall contained the flights of stairs to the basement and first floor of Building B. These were straight-run flights with halfspace landings at the half-storey interval.

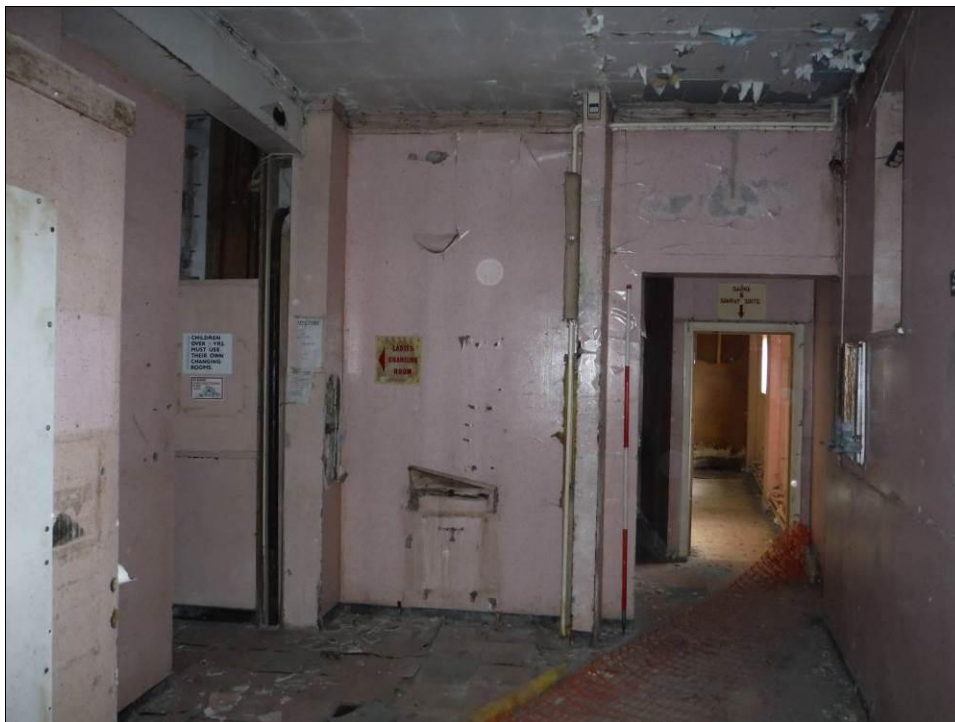
Figure 87: East wall of Room G5, Building B (Scale = 2m).

4.2.10.1 Room G5 is accessed via multiple doorways: the western staircase that leads to the basement changing rooms (Room B5) and the first floor corridor (Room F1), a doorway in the north wall that leads to the south-western corridor (Room G4), the door to the ticket booth (Room G6), the doorway in the north wall that leads to the main lobby side room (Room G7), and the doorway in the east wall that leads to the central southern corridor (Room G9). The north wall contained a built-in radiator that had been removed (Figure 84). Attached to the north wall was the box office (Room G6). This was a flat-roofed structure of approximately a three-quarter storey in height (Figure 85). The partition wall was constructed of insulation fibre and framed in timber then coated in painted particle board. The western elevation contained the doorway and boarded window. The doorway was timber-framed and contained a plain timber fire door. The southern elevation was largely obscured by a large board attached to cover the ticket window. The interior of Room G6 contained original fixtures and fittings. The east wall of the box office had a set of two timber shelves attached to the wall. The south wall of the box office contained a single-light window with cut-circle at the centre within timber surrounds. A wooden desk constructed of treated timber and particle board was attached to the south wall and remained largely intact (Figure 86). The east wall was featureless aside from attached signs and posters as well as visible plumbing. The entryway to the central southern corridor (Room G9) was formed by a partition in the wall (Figure 87).

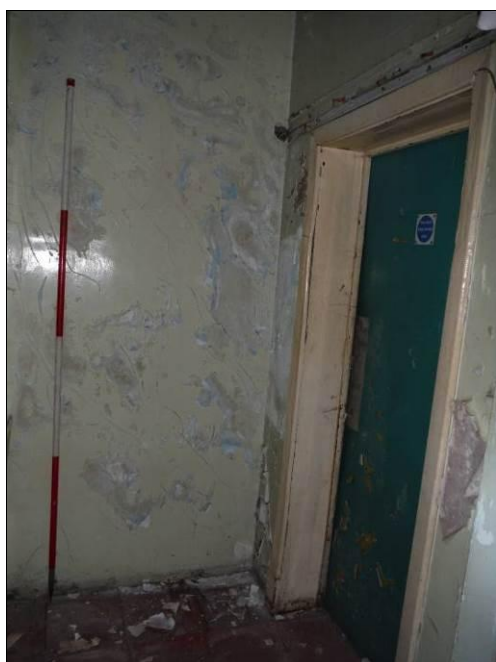
Figure 88: Room G7, Building B (Scale = 2m).

4.2.11.1 Room G7 consisted of a small room accessed by a timber framed fire door in the south wall leading to the main lobby (Room G5), and a timber framed fire-door in the north wall leading to the changing room (Room G3) (Figure 88). The walls are painted plasterwork but otherwise the room contains no other features. Room G8 consisted of a store-room accessed by a door from the southern central corridor at its eastern side. The walls were painted plaster and affixed with two courses of timber shelving on the eastern, northern, and western sides (Figure 89). The corridor was accessible from the eastern, northern, and western sides leading to the main lobby (Room G5), corridor side-room (Room G9), learner pool (Room G12), and southern changing rooms (Room G10).

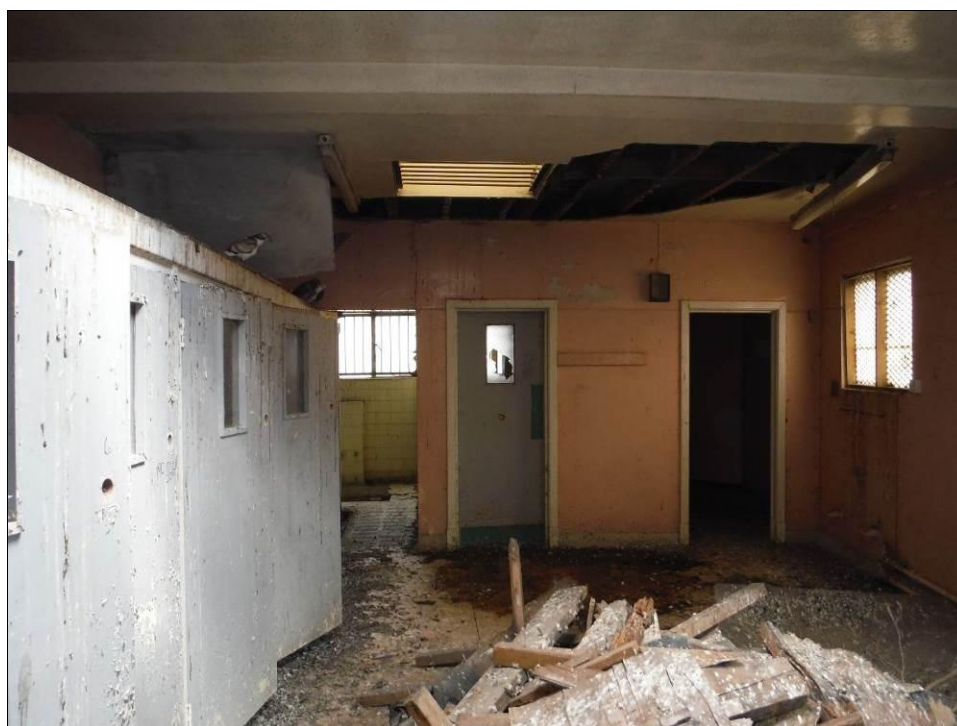
Figure 92: Room G11, Building B with Room G15 visible at the far left of the photograph.

4.2.12.3 The learner pool foyer (Room G15) is accessible from the western wall via a doorway leading to the south-east changing room (Room G11) and from the northern wall via a doorway to the learner pool (Room G12). This room was tiled with ceramic square yellow tiles and contained a four-light metal framed window of frosted glass within the eastern wall. The south-east changing room toilets (Room G13) were completely obscured and inaccessible. The changing room side room (Room G14) was accessed from the western wall via a timber-framed doorway. There are no fixtures or fittings within it and the remaining walls are plastered and painted (Figure 92).

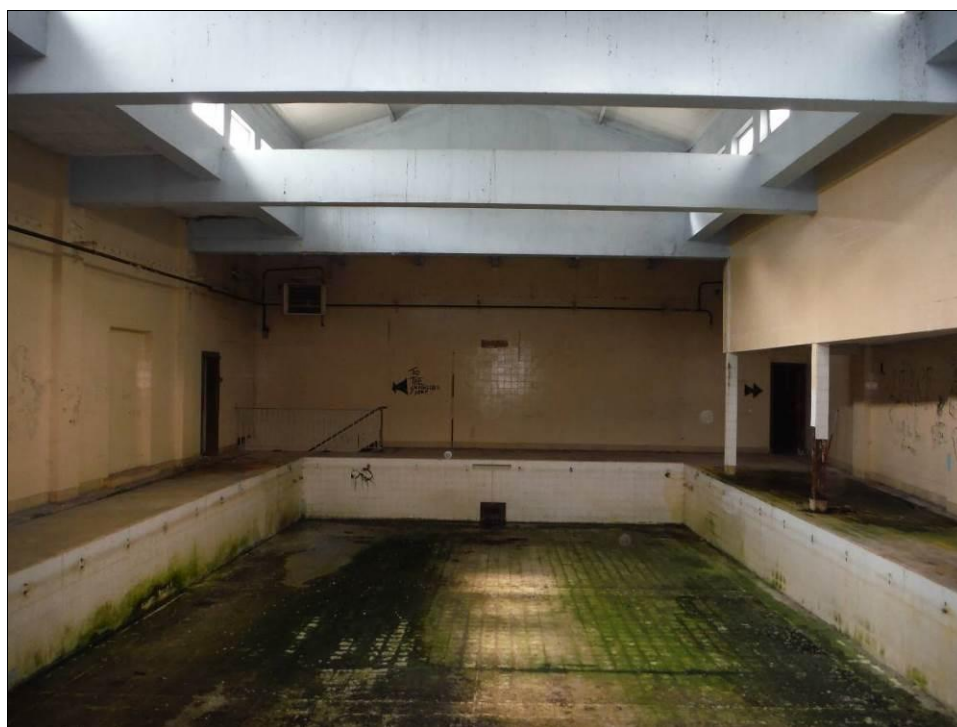
Figure 93: West wall of Room G12, Building B (Scale = 2m).

4.2.13.2 The west wall of the learner pool area was tiled from floor to ceiling. Affixed to the south-west corner of the wall is a metal ventilation grille (Figure 93). The flight of stairs leading to the basement is situated in the south-west corner. This was adjoined by metal railings capped by a plastic rail. The metal banister for this flight of steps was fixed to the tiled eastern wall of the flight (Figure 94). The south wall contains four regularly spaced pilasters corresponding to the gable and joists of the monitor roof (Figure 95). These were tiled. The south-western corner of the wall contained the stairs to the basement including the concrete lintel for the passage into the floor below. Adjacent to the flight of stairs to the east, there is the timber-framed fire-door to southern central corridor (Room G9). This is located between the stairs and a blocked doorway. This doorway has been tiled but possesses a concrete step. There is no door visible in the north wall of the south-west changing room as it is obscured by changing cubicles. This could represent some redevelopment of the Building B extension before its closure during the 1980s. In the south-east corner of the south wall, there is the timber-framed doorway and fire-door leading to the learner pool foyer (Room G15). The east wall contains a large central nine-light window with metallic surrounds and frosted glass panes (Figure 96). This window is flanked by two six-light light square windows with metal surrounds and frosted glass panes. Furthermore those windows are in turn flanked by two metal ventilators. The north wall is dominated by a sealed mezzanine or jetty supported by white tiled concrete pillars (Figure 97). These also align with the support structure of the monitor roof above the pool. In the wall proper, there are pilasters that also act as a support for the monitor roof in an identical fashion to the south wall of the pool. In the north-east corner, there is also a blocked-off doorway with concrete threshold step. This is similar to the one in the south wall of the learner pool. There is no evidence that this was a functional doorway as it would pass into the adjoining early 20<sup>th</sup> century housing constructed as part of the municipal complex between 1907 and 1912.

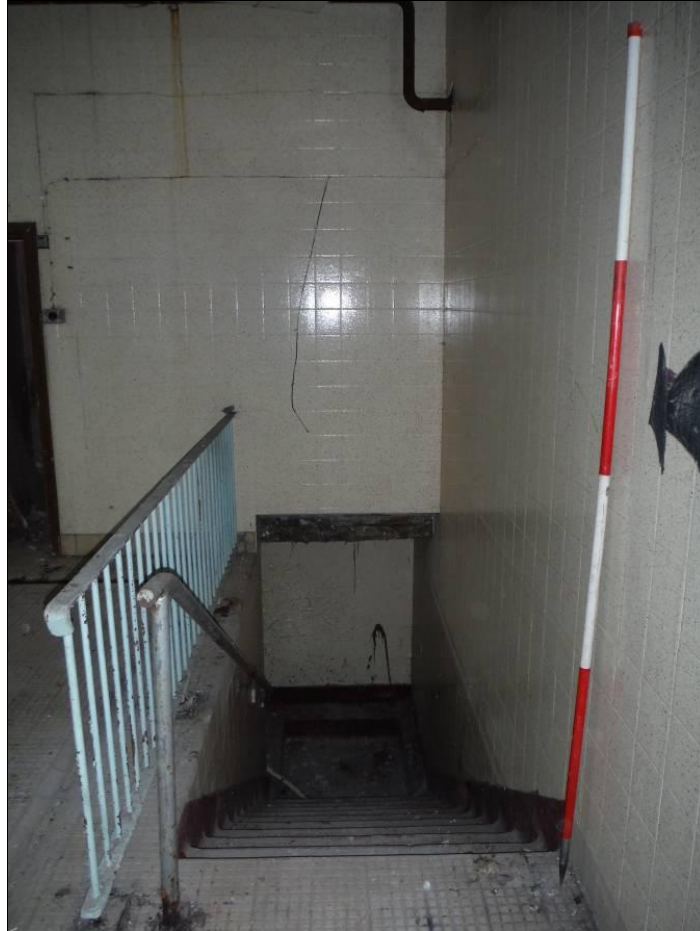
Figure 94: Detail of stairway in south-west corner of Room G12, Building B (Scale = 2m).

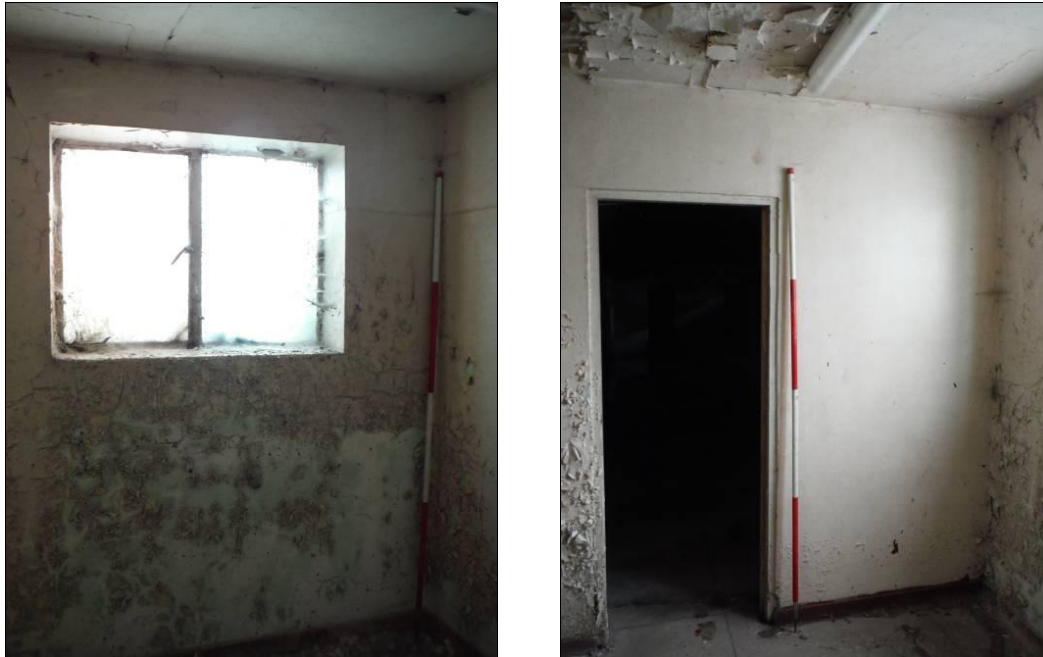
Figure 98: Room B1, Building B (Scale = 2m).

4.2.14.1 Room B1 consisted of a small room accessed by a concrete staircase in the north wall leading to the learner pool (Room G12), a timber framed fire-door in the east wall leading to the eastern changing room (Room B2), and an entryway in the west wall leading to the western changing room (Room B5). The walls are painted plasterwork. The south wall contains a single two-light window with metal surrounds (Figure 98).

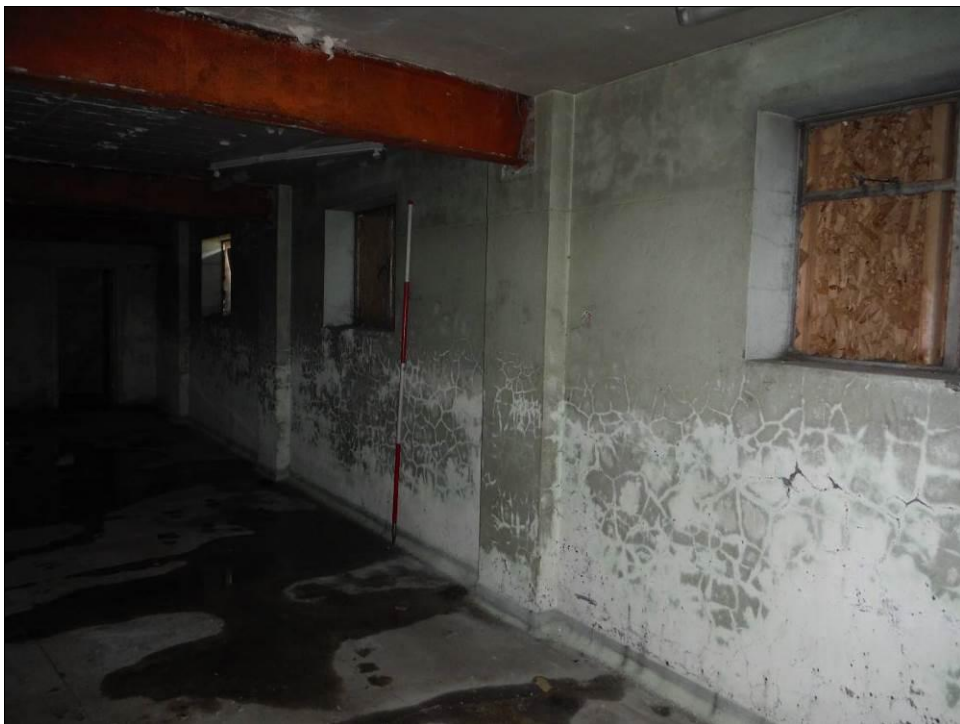
Figure 102: South wall of Room B2, Building B (Scale = 2m).

4.2.14.1 The layout of these rooms resembled closely the southern changing room suite (Rooms G10, G11, & G13-G15) on the floor above. Room B2 – the eastern changing room – is accessed from a timber-framed doorway in the eastern wall leading to the central corridor (B1), and the doorways in the eastern wall that lead (from north to south) to the eastern changing room toilet (Room B4), and the eastern changing room side room (B3). The ceiling was constructed of concrete and supported by reinforced steel joists running north/south. The west wall contained the doorway to the central corridor and was constructed of concrete (Figure 99). The north wall was painted concrete and fitted with terrazzo changing cubicles that contained timber benches with plain timber fixtures (Figure 100). The eastern wall is constructed of concrete and contains the doorways to the toilets (Room B4) and side room (Room B3) (Figure 101). These doorways have timber surrounds and are fitted with fire-doors. The south wall is concrete and features regularly spaced pilasters that support the ceiling joists. The south wall contains three four-light metal framed windows containing boards (Figure 102).
