**An Archaeological Building Recording  
of the former Wallsend Baths at Wallsend,  
Newcastle upon Tyne**

**ARS Ltd Report No. 2015/113**  
July 2015

**An Archaeological Building Recording  
of the former Wallsend Baths at Wallsend, Newcastle upon Tyne**

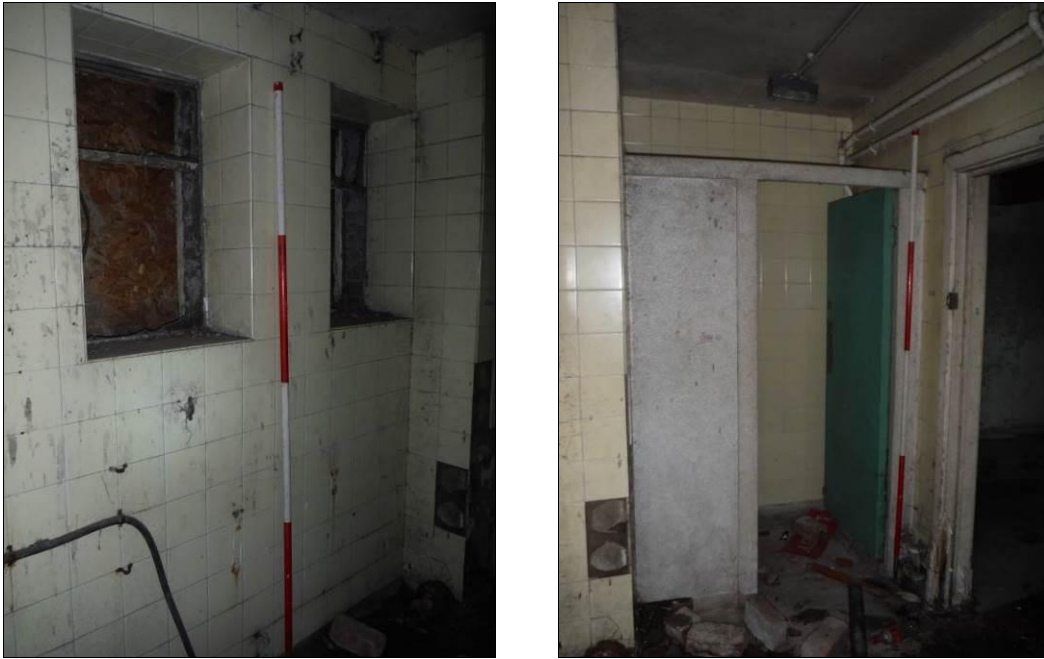
Figure 103: Room B4, Building B (Scale = 2m).

4.1.15.2 The eastern changing room toilets (Room B4) were tiled from floor to ceiling by square yellow ceramic tiles (Figure 103). The west wall contained the entryway to the toilet. This door is a plain fire door with a moulded timber frame. The northern wall is tiled but otherwise featureless. The east wall contains three regularly spaced two-light windows with metal frames which have been boarded up. There is a dividing column adjoining the east wall. This supports a terrazzo cubicle with a plain wooden door. There

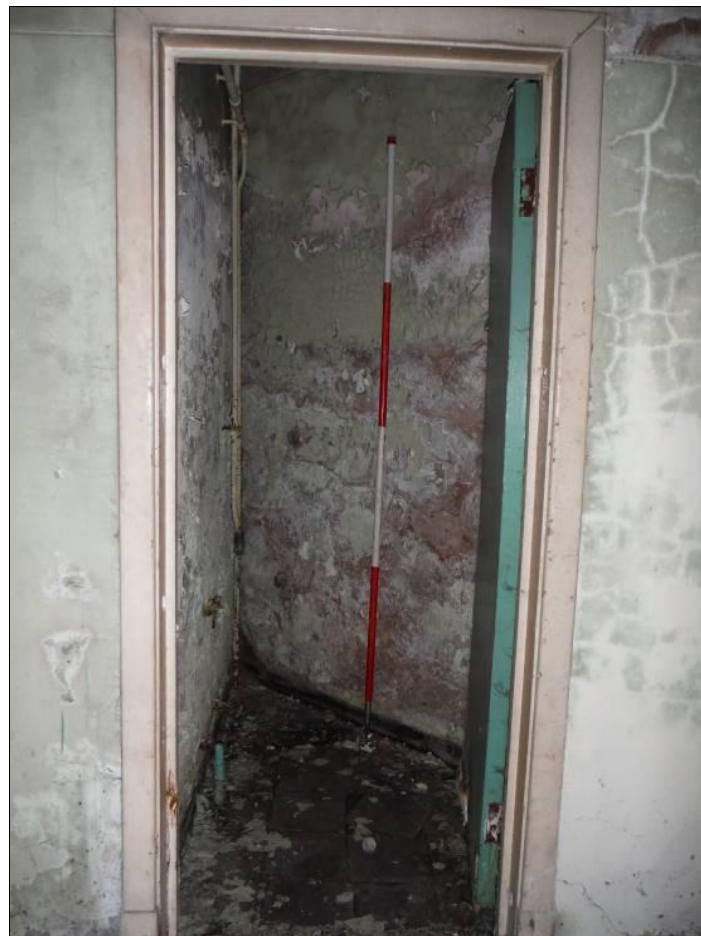
Figure 104: Room B3, Building B (Scale = 2m).

is a toilet attached to the east wall below the southernmost window. The south wall is tiled but otherwise featureless. The changing room side room (Room B3) was accessed from the western wall via a timber-framed doorway (Figure 104). There are no fixtures or fittings within it and the remaining walls are painted.

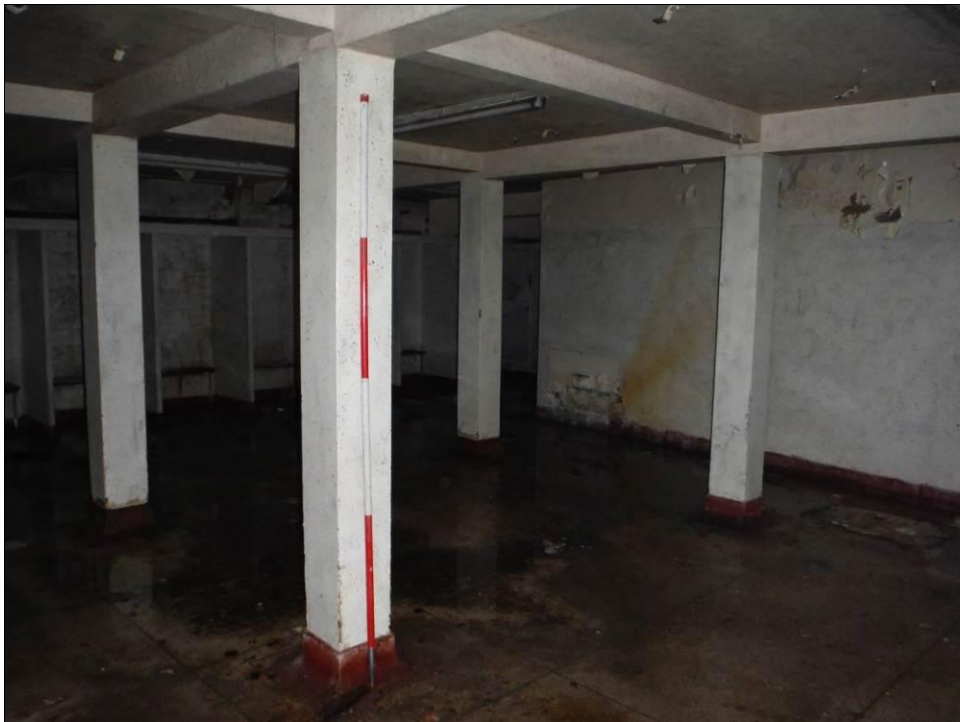
Figure 109: Detail of pillars in Room B5, Building B (Scale = 2m).

4.2.16.1 Room B5 consists of a changing room accessed by doors at the north-west, north-east, south-east, and south-west from the shower block (Room B7), toilets (Room B6), central corridor (Room B1), and the main lobby (Room G5). The north wall has a small annexe that adjoins with the shower block (Room B7) and the toilets (Room B6) (Figure 105). The walls throughout the changing room are faced with painted concrete. At the end of the corridor in the north wall there is a three-light window with metal surrounds that is boarded and barred internally. The eastern wall was lined with two sets of terrazzo changing cubicles fitted with steel-framed benches seated with treated timber boards (Figure 106). These flanked a wooden hatchway leading to a crawl space containing the pool treatment and heating machinery. This area was inaccessible due to the instability and potential presence of asbestos. The south wall was featureless with painted concrete (Figure 107). The west wall mirrored the eastern wall as terrazzo changing cubicles lined the wall from the southern wall to the entryway to Room B7. These also included steel-framed wooden benches. The south-west corner featured the timber-framed doorway to the stairwell leading to the main lobby (Room G5) (Figure 108). This was abutted to the north by a small under-stair storage bay to the north. This was accessible by a timber-framed doorway. The room was supported by concrete pillars containing reinforced steel joists (Figure 109).

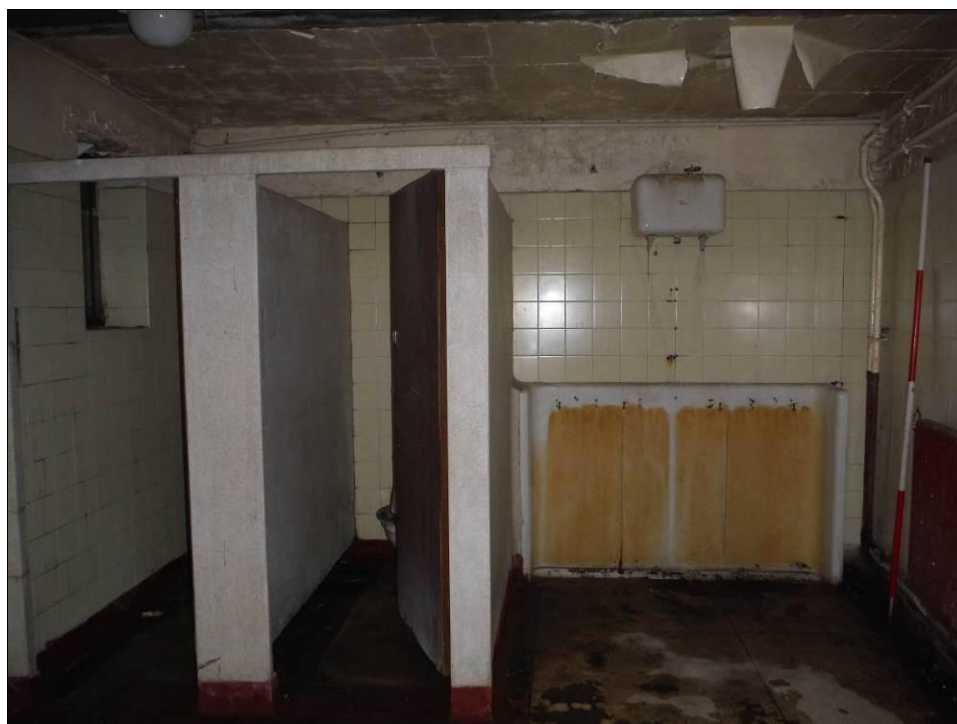
Figure 110: Room B6, Building B (Scale = 2m).

4.2.17.1 Room B6 consists of a toilet block accessed by a door in the western wall that leads to the main changing room (Room B5). The walls throughout this room are tiled with pale yellow square ceramic tiles. The top portion of the wall was plastered and painted. The western wall contained the timber framed doorway into the toilets (Figure 11). The northern wall contained two square three-light windows with metal surrounds and frosted glass sealed by external boards and internal bars. The northern half of the eastern wall had two cubicles constructed of terrazzo and toilet cisterns attached to the wall. The southern half contained a ceramic urinal (Figure 110). The southern wall did not contain any features of note (Figure 111).

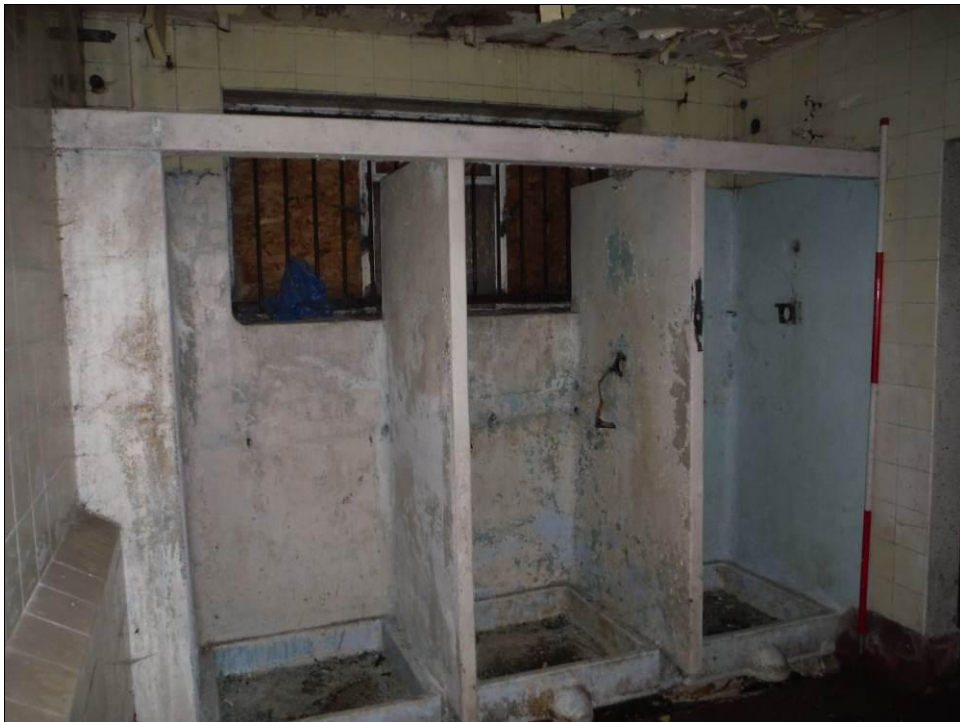
Figure 112: Detail of shower cubicles in Room B7, Building B (Scale = 2m).

4.2.18.1 Room B7 consists of a small shower block, accessed by an entranceway on its southern side, and adjoining stairway into the main pool in Building A (Building A/Room G1) and via an entranceway in the eastern wall leading to the changing room (Building B/Room B5). The walls in this room were tiled throughout with ceramic pale yellow wall tiles from floor to ceiling. The northern wall contained a terrazzo shower block of three alcoves on raised daises for drainage (Figure 112). The window in the northern wall consisted of a four-light boarded window with timber surrounds covered by a metal grille of vertical bars. The staircase in the south wall consisted of two straight flights separated by a quarterspace landing (Figure 113). At the base and foot of this stairway was a recessed floor space intended for an anti-bacterial foot bath (Figure 114). The metal bannister is attached to the western wall of the stairwell.

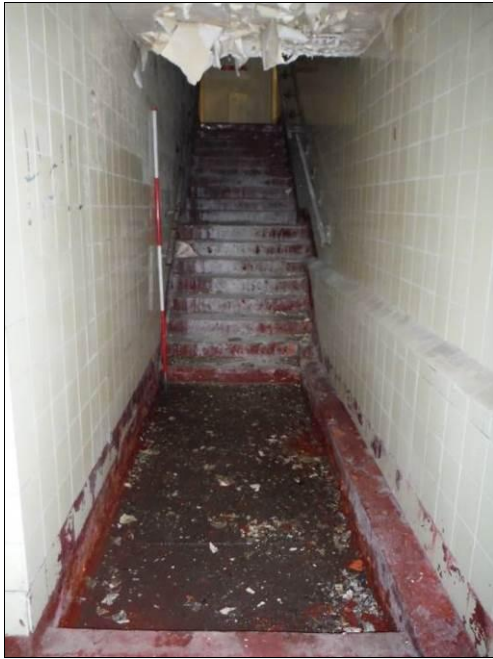
Figure 113: Detail of stairway in Room B7, Building B (Scale = 2m).

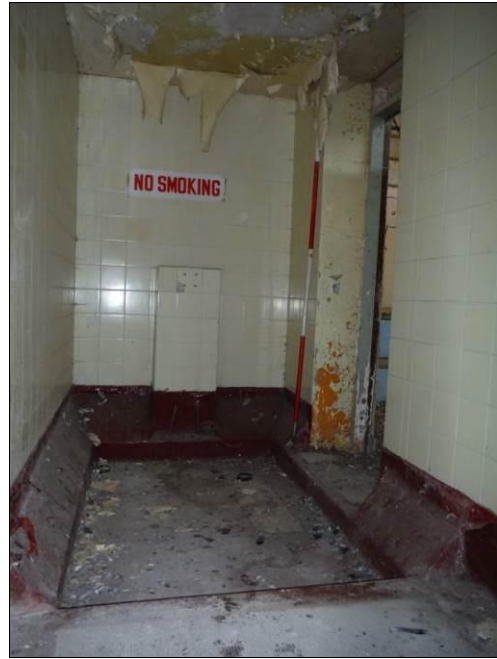
Figure 114: Foot bath at the top of the staircase in Room B7, Building B (Scale = 2m).

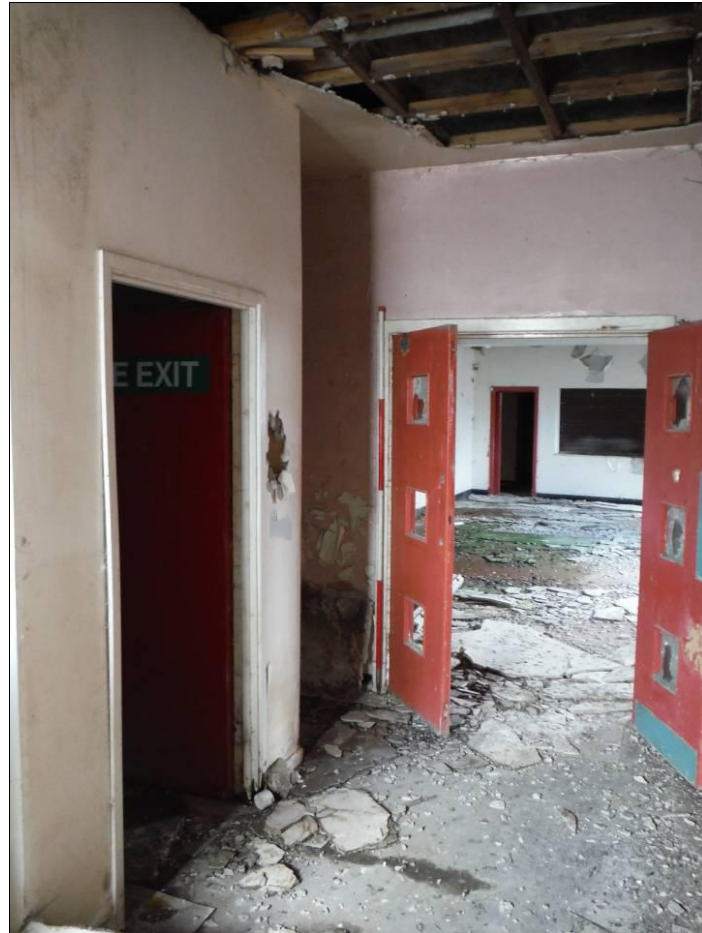
Figure 115: North and west walls of Room F1, Building B (Scale = 2m).

4.2.19.1 Room F1 consists of the corridor accessed from the main lobby (Room G5) by a door in its west wall (Figure 115), accessed from the viewing gallery via a door in the north-west corner (Room F6), accessed from the café (Room F4) by a door in the northern wall, and by doors in the east wall from the ladies and gent's toilets (Rooms F2 and F3). The walls throughout the room are painted plaster. The west wall contains two doors in its northern half: the northernmost is a timber-framed entryway to the viewing gallery (Room F6) and the door in the middle of the wall is a timber-framed fire-door that leads onto the stairwell to the ground floor main lobby (Room G5). The southern half of the wall is otherwise featureless. The south wall contains two two-light metal framed windows (Figure 116). Below these is a recess the length of the wall about a quarter storey in height. This appears to be a part of the internal central heating system for the building. The east wall contains the timber-moulded framed doors for the ladies' and gentlemen's toilets (Figure 117). The east wall is otherwise featureless. The north wall contains the timber-frame for the double doors leading to the café (Room F4). Each door has three regularly spaced timber-surrounded single-light glass panels.

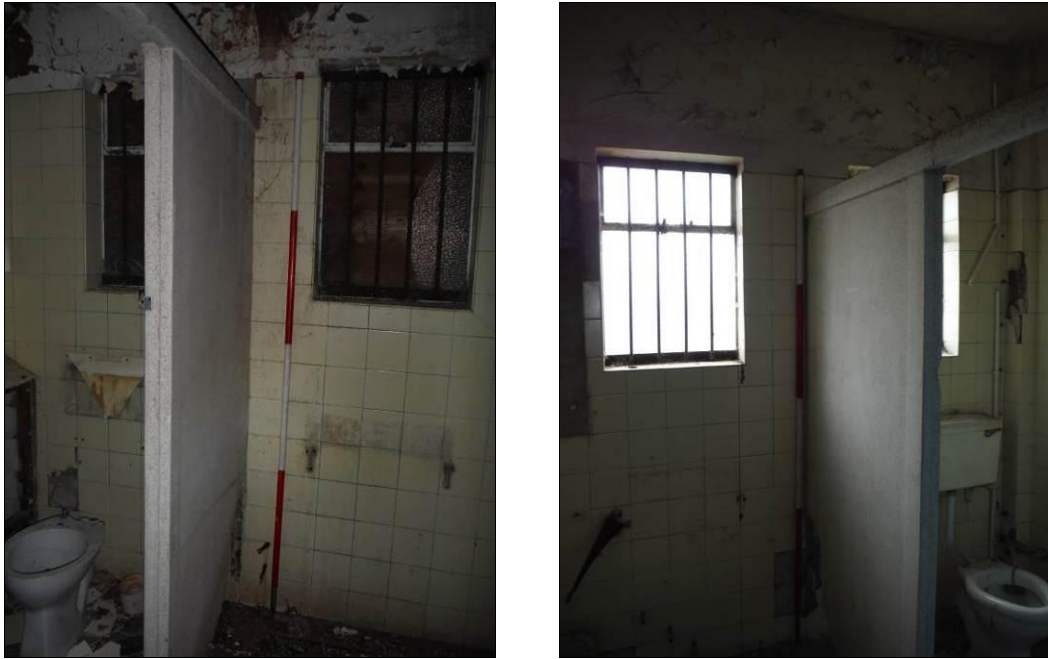
Figure 118: East wall of Rooms F2 (left) and F3 (right), Building B (Scale = 2m).

4.2.20.1 Rooms F2 and F3 consists of two bathrooms with mirrored layouts. They are accessed by timber-framed doors in the west wall from the first floor southern corridor (Figure 118). The rooms are tiled with square ceramic yellow tiles covering white painted plaster which is observable above the window line. Both rooms contain an antechamber with a timber-framed entrance way featuring a timber-framed single-light glass panel in the upper part of the door (Figure 119). These doors are situated on the north wall (Room F2) and south wall (Room F3). These were adjoined by a terrazzo partition wall and entryway for the toilet cubicle. This was a plain wooden painted door fitted with a fingerplate. The eastern wall of both rooms contain two two-light windows with metal frame surrounds and fitted with frosted glass panels (Figure 118). The windows in the ladies' toilet (Room F2) are boarded up externally. Both sets of windows are fitted with metal bars internally. The eastern walls of both rooms are fitted with toilet and sink but the latter has been removed from both toilets. The cistern of the ladies' toilet has also been removed.

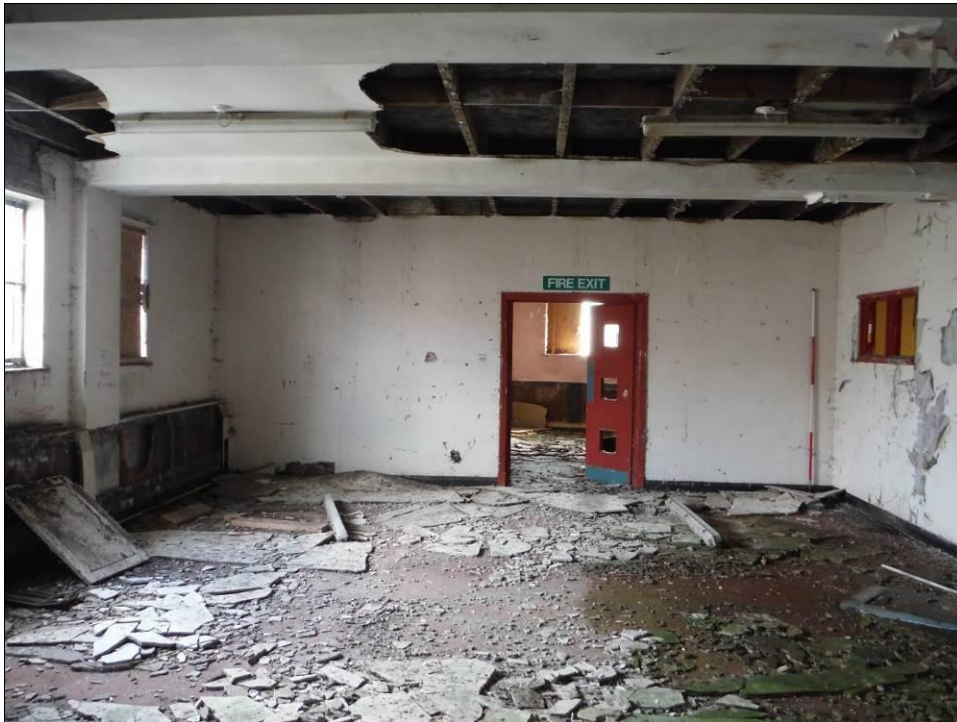
Figure 120: South wall of Room F4, Building B (Scale = 2m).

4.2.21.1 Room F4 consists of a large café. The walls are painted white plaster with black rubber skirting. The room is accessed by entryways in the south and north walls leading to the south corridor and kitchen area respectively. The south wall contains the double doorway to the south corridor and this has been described above (Figure 120). The wall is otherwise featureless. The east wall has three regularly spaced pilasters and contains two large metal-frame surround four-light windows flanked by two three-light metal-frame windows leading to the exterior (Figure 121). These are situated above a recessed wooden frame running the length of the wall. This appears to have been the remnants of the central heating system of covered radiators. The east half of the north wall contains a timber surround two-light window leading to the exterior above another radiator frame (Figure 122). The west half of the north wall contains a metal-framed and shuttered serving hatch leading to the kitchen (Room F5). This is adjacent to the timber-framed doorway fitted with plain wooden door leading to the kitchen (Room F5). The west wall contains three regularly spaced timber-framed two-light windows (Figure 123). The plaster in the west wall has degraded revealing the brickwork in the wall and central window. The red brick for the wall is set in a stretcher bond and the window lintel is supported by concrete blocks. The ceiling for the café is supported by three regularly spaced joists corresponding with the pilasters in the east wall.

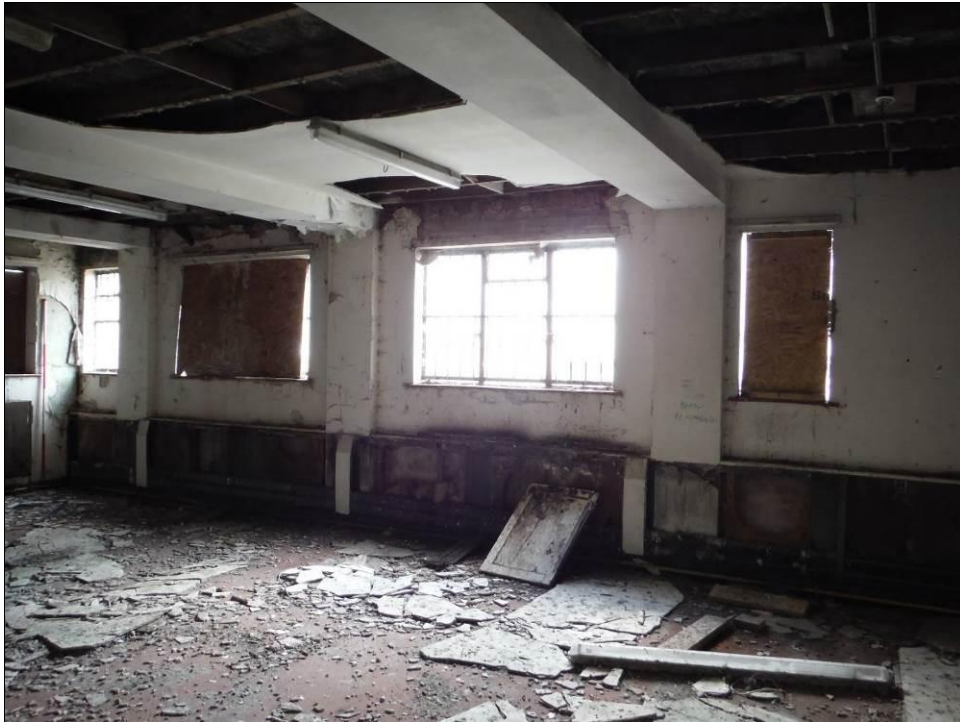
Figure 121: East wall of Room F4, Building B (Scale = 2m).

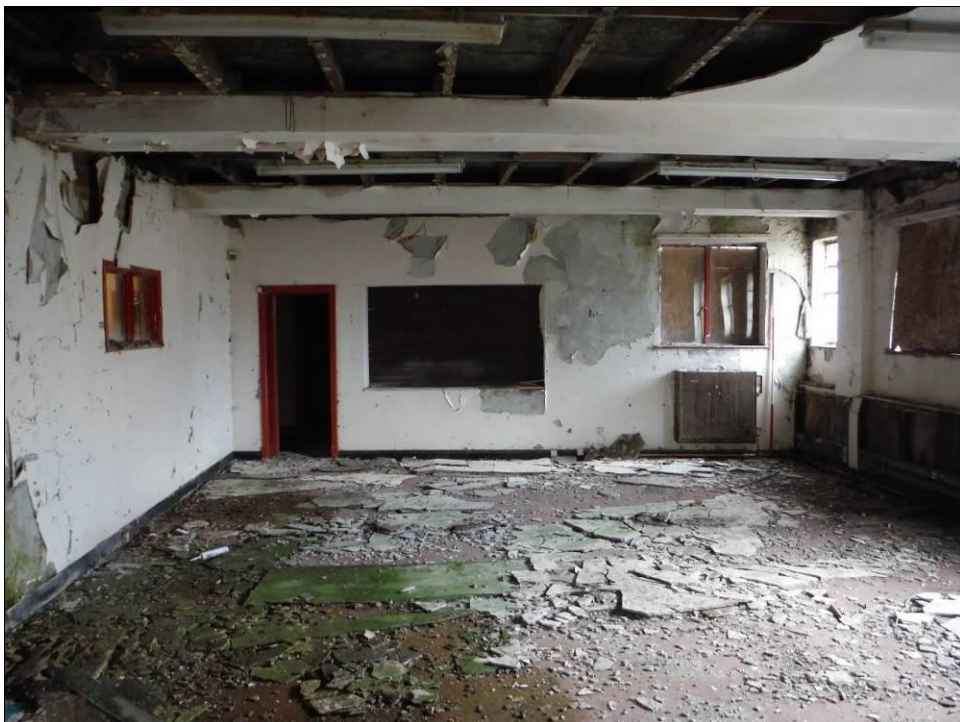
Figure 122: North wall of Room F4, Building B (Scale = 2m).

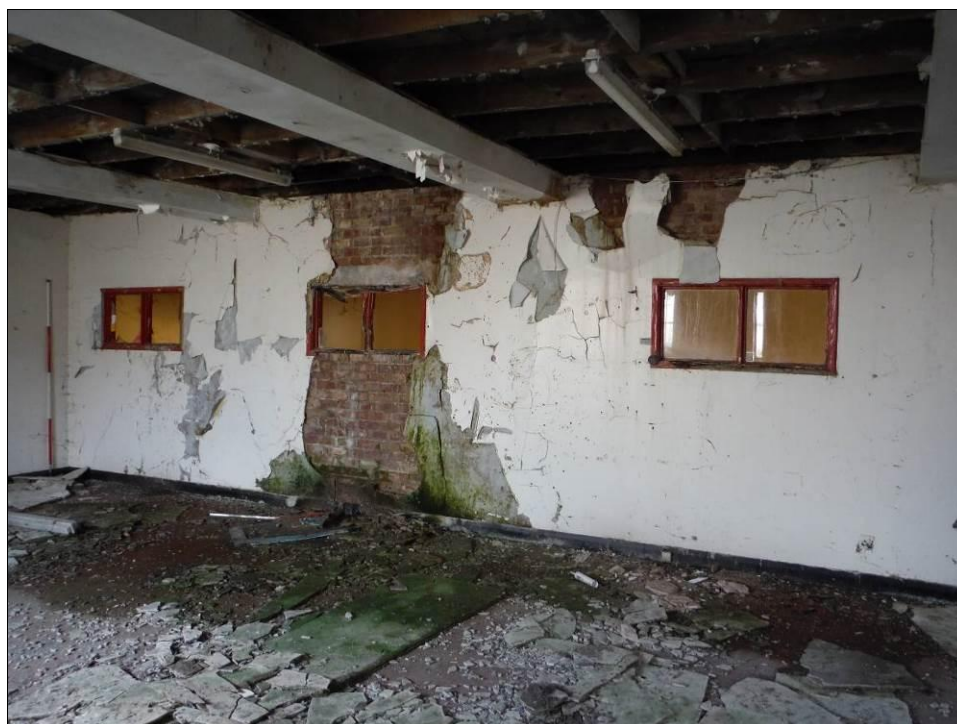
Figure 123: West wall of Room F4, Building B (Scale = 2m).

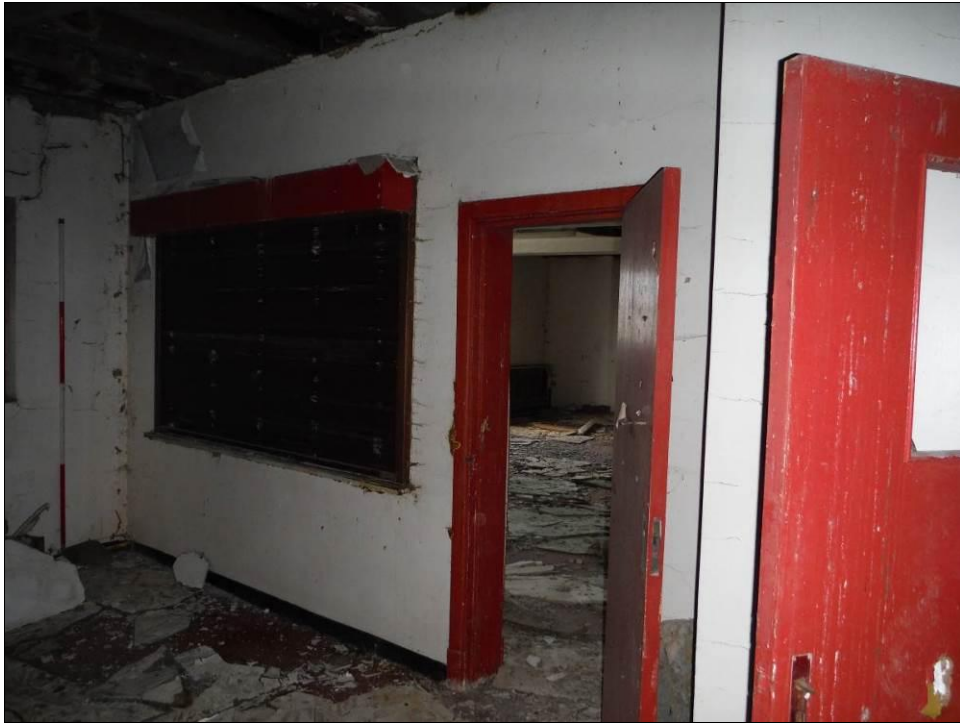
Figure 124: South wall of Room F5, Building B (Scale = 2m).

4.2.22.1 Room F5 consists of the kitchen area attached to the café (Room F4). The walls are painted white plaster with black rubber skirting. This is accessed by three entryways: two in the south wall and one in the north-west corner. These lead to the café (Room F4), the viewing gallery (Room F6), and the northern corridor (Room F7) respectively. The western half of the south wall contains the timber-framed doorway to the viewing gallery (Room F6). The door is plain with a single-light glass panel in the upper half. The eastern half of the wall contains the timber-framed doorway to the café (Room F4) which is fitted with a plain timber door (Figure 124). This is adjacent to the serving hatch leading to the café. This hatch is metal-framed and fitted with a wooden canopy at the top to cover the rolled shutters. The east wall contains a timber-surround three-light window that has been boarded externally (Figure 125). Below the window, a metallic radiator unit is attached to the wall. The plaster in the upper portion of the north-east corner has degraded revealing the stretcher-bond red brick beneath. The eastern half of the north wall is fitted with three partitioned cupboards accessible via timber-framed doors (Figure 126). The easternmost cupboard contains a four-light window with metal surrounds. This window has been boarded up externally and fitted with internal metal bars. The cupboards contain four rows of fitted timber shelving on the north, east, and west walls. In the centre of the north wall, adjacent to the cupboard units, is a two-light window with timber-surrounds (Figure 127). This is above the remains of a built-in shelving unit constructed with a painted metal frame and fitted with timber shelves. The north-west corner of the north wall features a timber-framed doorway fitted with a plain timber door containing a single-light glass panel in the upper portion. The west wall is broadly featureless but contains the fuse and junction box in the upper-part of the north-west corner.

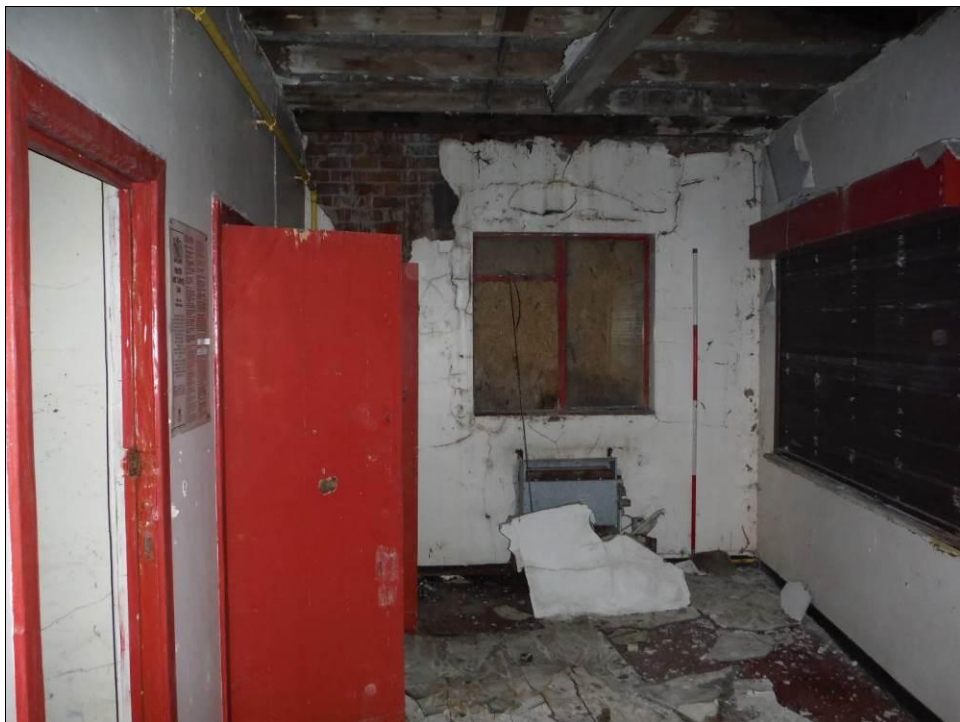
Figure 125: East wall of Room F5, Building B (Scale = 2m).

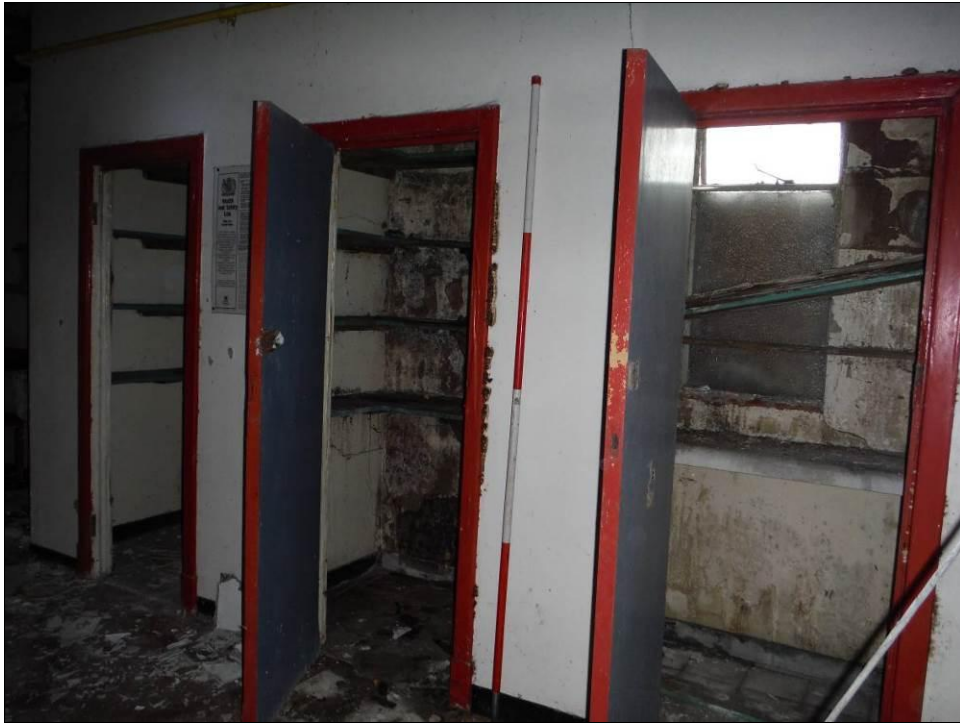
Figure 126: North wall of Room F5, Building B (Scale = 2m).

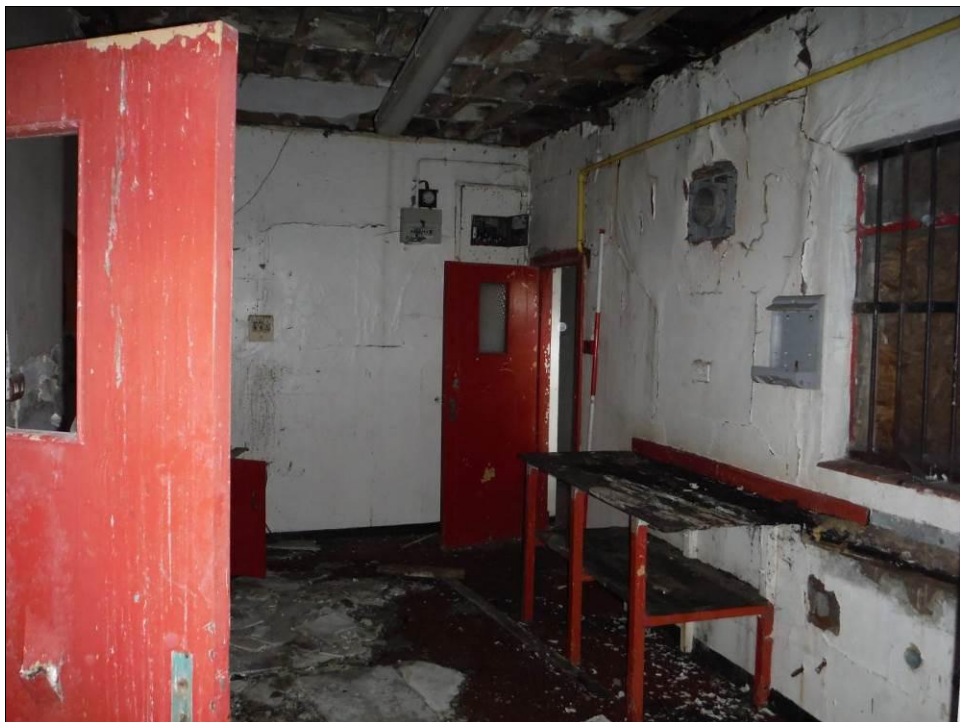
Figure 127: West wall of Room F5, Building B (Scale = 2m).

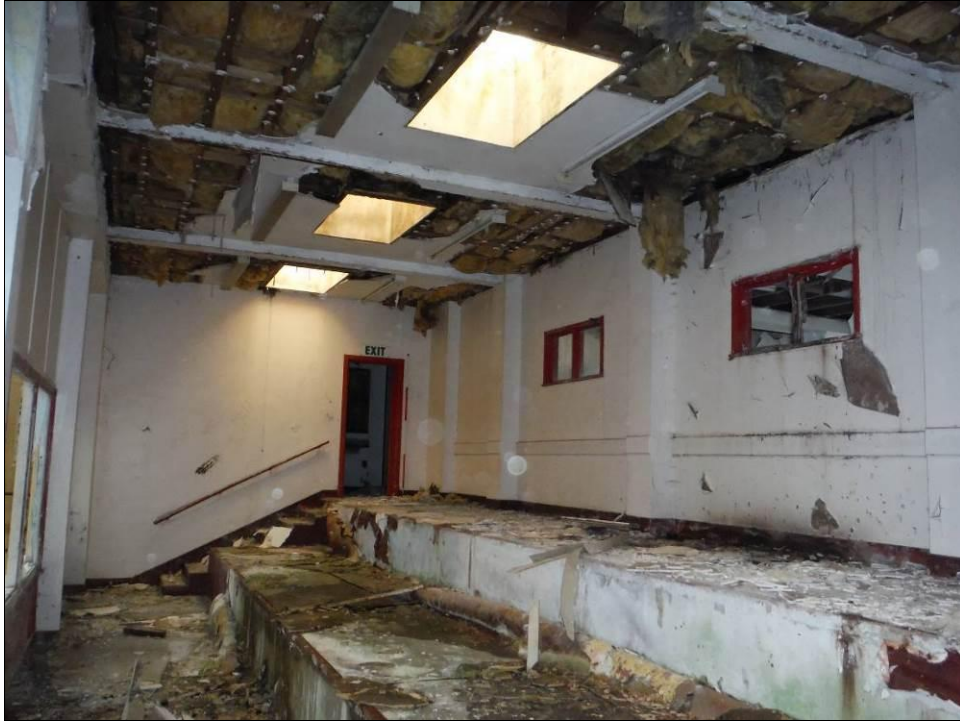
Figure 128: North wall of Room F6, Building B (Scale = 2m).

4.2.23.1 Room F6 consists of the viewing gallery to the main pool area (Building A/Room G1). This consists of three tiers of concrete seating flanked to the north and south by a flight of stairs. The viewing gallery is accessed via the north wall and the south-east corner leading to the kitchen (Room F5) and the southern corridor (Room F1) respectively. The walls are plain painted plaster. The north wall contains the timber-framed doorway to the kitchen (Room F1) (Figure 128). A metal bannister is attached to the wall to support the adjoining flight of steps. The east wall contains four regularly-spaced pilasters and three regularly-spaced timber-surround two-light windows that lead to the café (Room F4) (Figure 129). The south-east corner of the east wall contains the timber-framed doorway to the southern corridor (Room F1). The south wall is plain painted plaster and fitted with a metal bannister to support the adjoining stairs (Figure 130). The west wall is dominated by the central three-light window with timber surround (Figure 131). This is flanked by two two-light timber-framed windows. These windows are based with plain painted timber panels and separated by four concrete pillars. These pillars support ceiling joists which correspond with the pilasters in the east wall. These relate to the joists in the café ceiling (Room F4). The ceiling also contains four recessed skylights aligned north/south along the centre of the viewing gallery (Figures 128 and 129). These each contain a metal-framed single-light window.

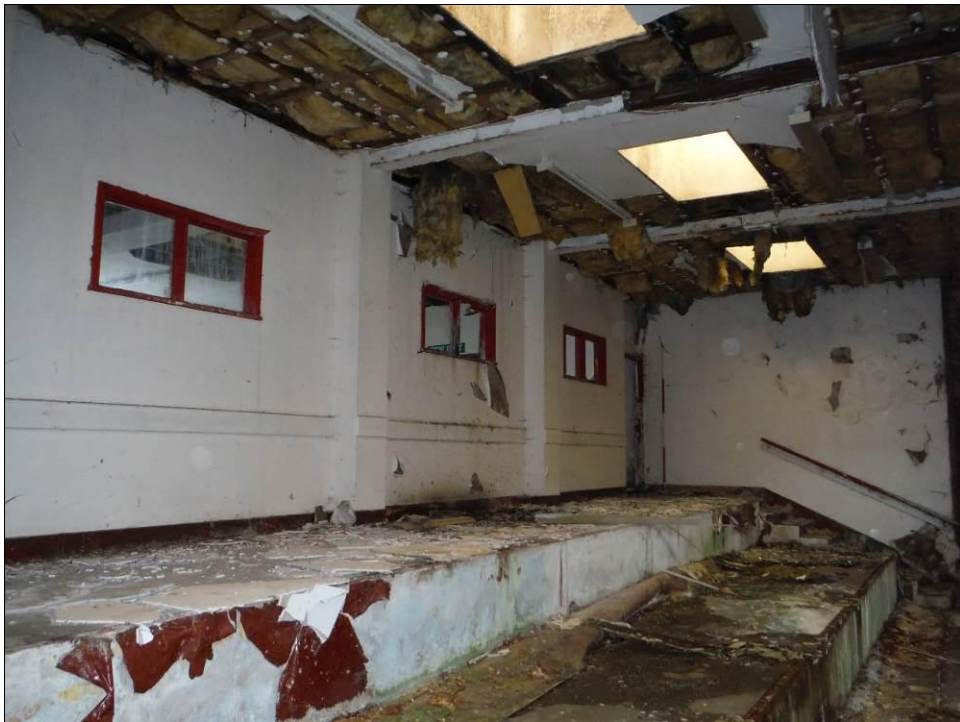
Figure 129: East and south wall of Room F6, Building B (Scale = 2m).

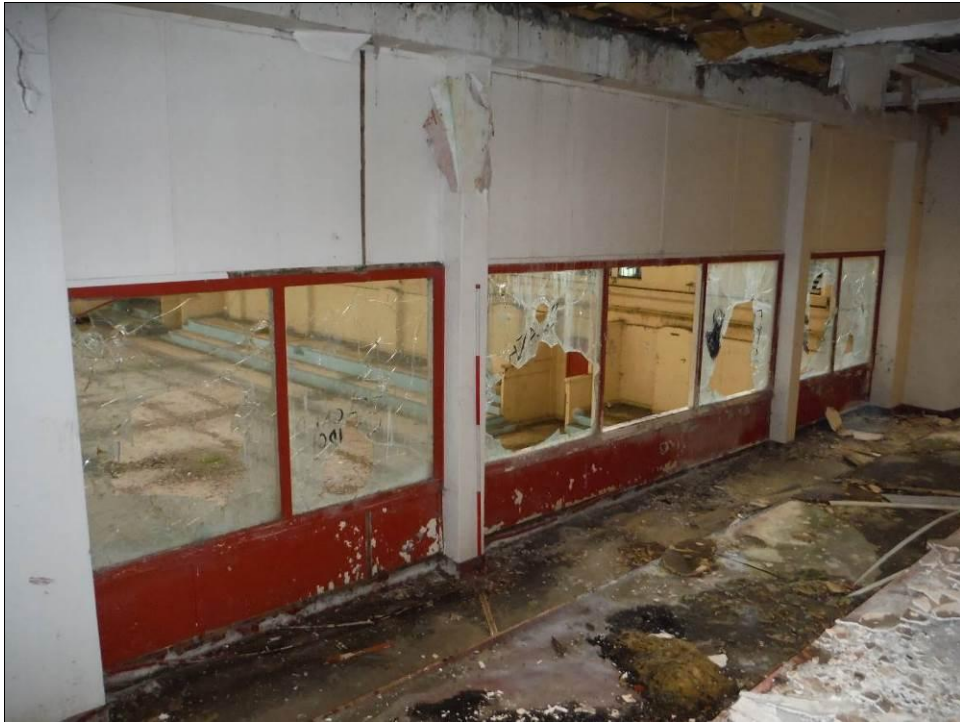
Figure 130: West wall of Room F6, Building B (Scale = 2m).

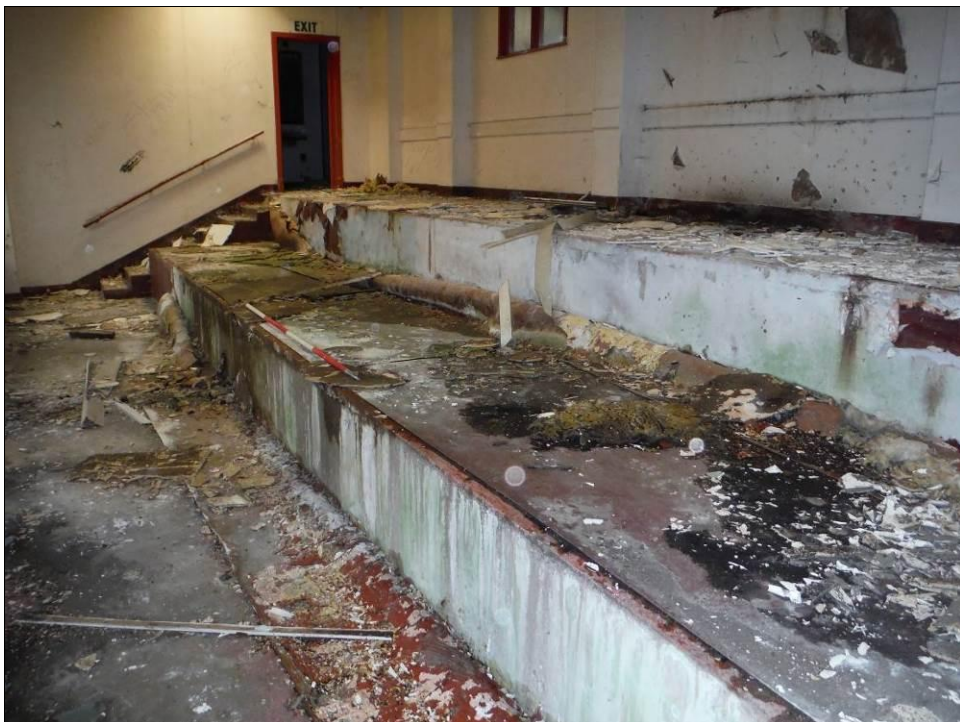
Figure 131: Detail of tiered seating in Room F6, Building B (Scale = 2m).

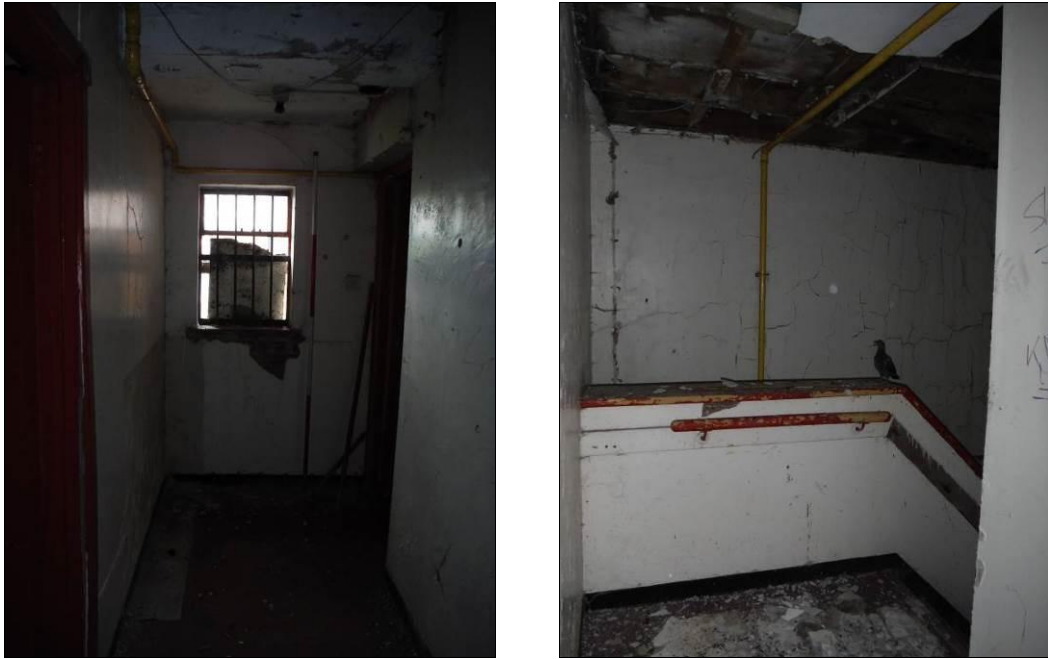
Figure 132: Room F7, Building B (Scale = 2m).

4.2.24.1 Room F7 consists of a corridor accessible from the south-east corner, north-east corner, and the west leading to the kitchen (Room F5), the storage room (Room F8), and the Building A southern corridor (Building A/Room G2). The corridor walls were painted plaster and featured black rubber moulded skirting. The south-east corner of the south wall contains the timber-framed doorway with plain timber door. There is a projecting wall for the staircase on the western half. This is topped by timber board and follows the descent of the stairs. The western flight of stairs was obstructed by nesting pigeons, which interfered with their recording. From examination in the Building A southern corridor (Building A/Room G2), this is a halfturn staircase constructed of two flights of stairs connected by a half landing at the northern wall. The west wall was otherwise featureless. The north wall is also featureless at its western half. The eastern half contains a timber-framed doorway to the storage room (Room F8). The east wall contains a two-light timber-surround window with internal bars (Figure 132).

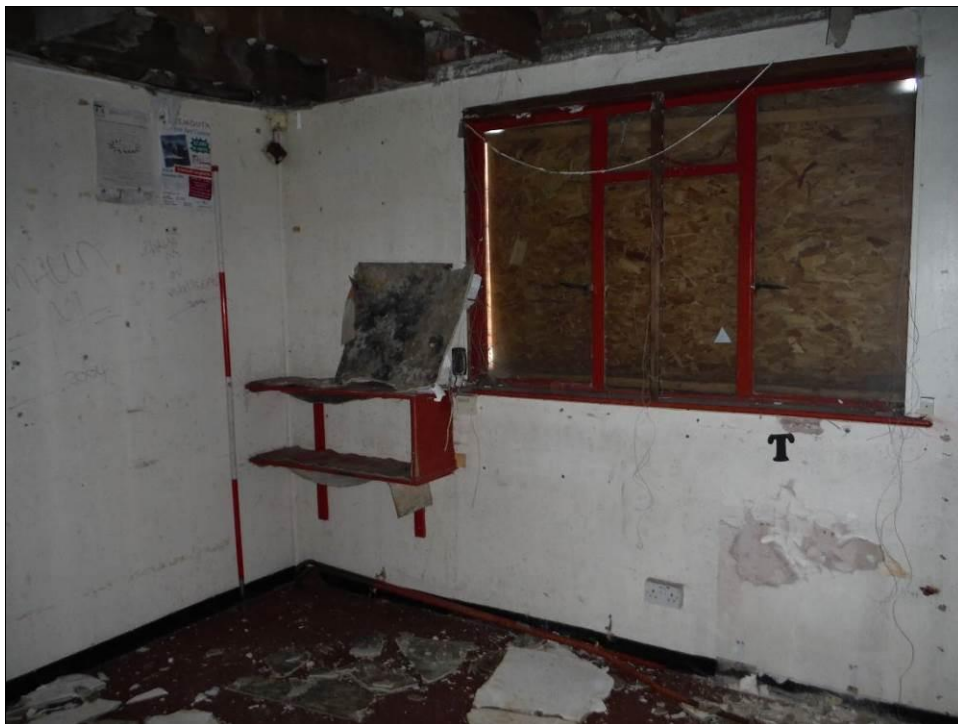
Figure 133: West and north walls of Room F8, Building B (Scale = 2m).

4.2.24.2 Room F8 consists of a storage room accessible from the south-east corner leading to the north corridor (Room F7). The walls are painted plaster and feature rubber moulded skirting. The south wall contains the timber-framed doorway to the north corridor (Room F7). The door is a plain wooden painted door. The western portion of the south wall has two rows of fixed painted timber shelving attached to the wall. The north wall has timber wall-mounted shelving in the north-east corner. This is painted. There is a four-light window in the north wall with timber surrounds (Figure 133). The east and west walls are featureless.

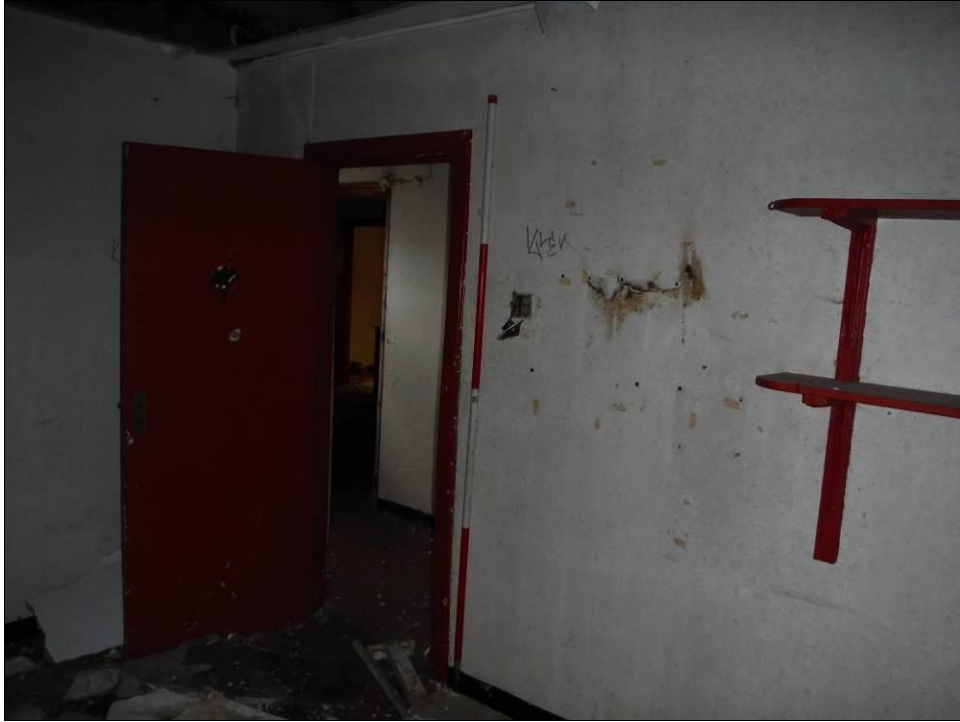
Figure 134: South wall of Room F8, Building B (Scale = 2m).
