An Archaeological Building Recording at Demesne Farm, Milfield, Northumberland

Archaeological Research Services Ltd Report No. 2008/63

**An Archaeological Building Recording
at Demesne Farm, Milfield, Northumberland**

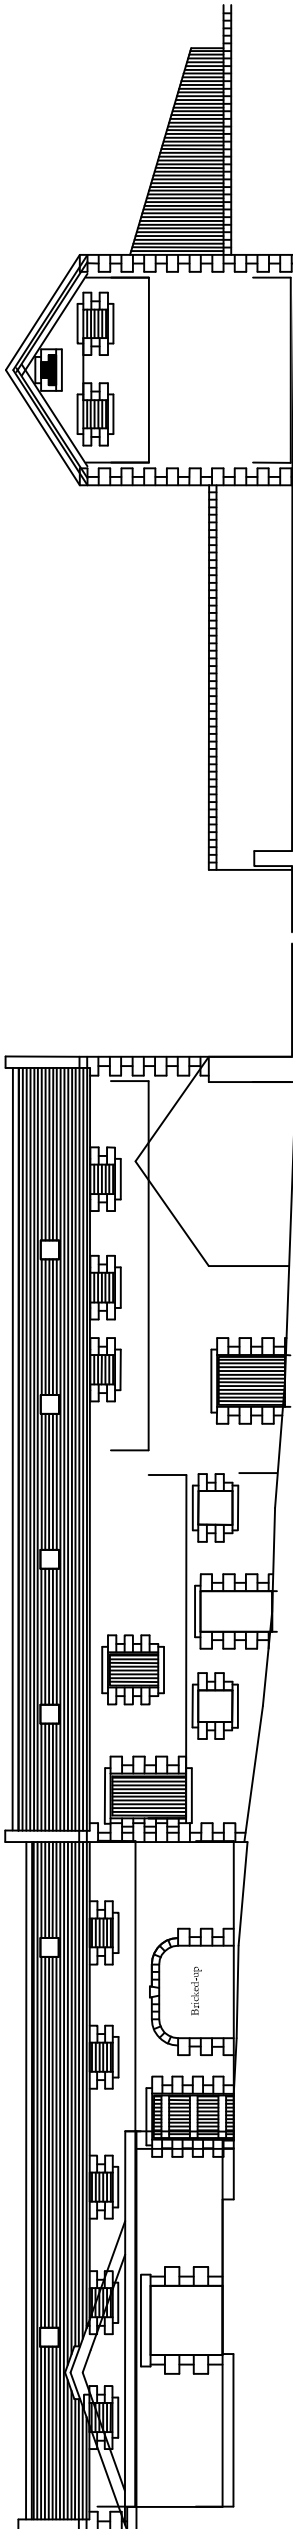
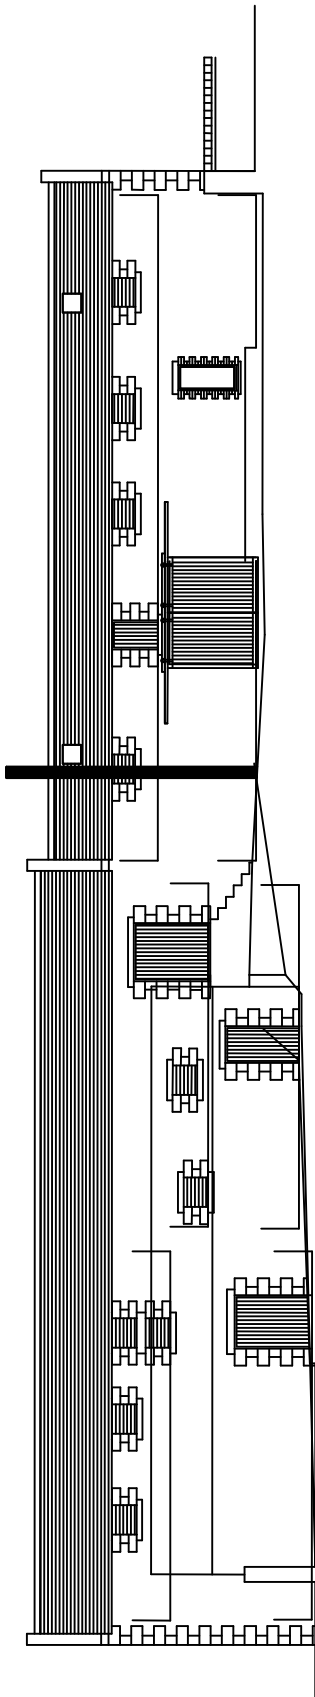
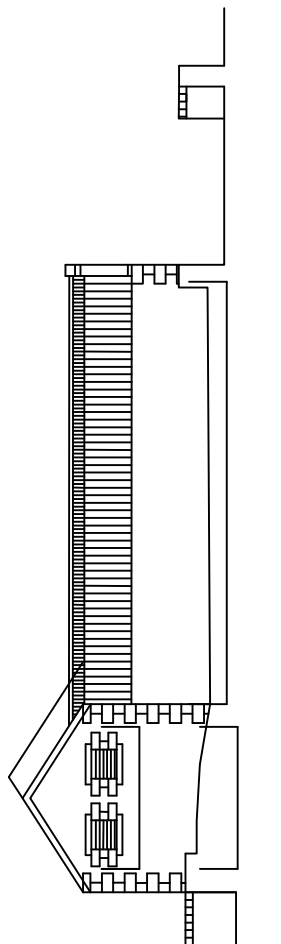
<div>Archaeological Research Services Ltd</div> <div>Baltic Business Centre</div> <div>Salmeadows Road</div> <div>Gateshead</div> <div>NE8 3DA</div>		<div>Site Code: DEM08</div> <div>Drawing Ref: Report Fig. 4</div> <div>Date: 13 Aug 2008</div> <div>Drawn: CC</div> <div>Scale: 1:200 at A3</div>		<div>Title:</div> <div>Figure 4: Existing elevations</div>		<div>Key:</div>		<div>Notes:</div>		<div>Copyright/Licencing:</div> <div>This drawing</div> <div>© A.R.S. Ltd</div> <div>Ordnance Survey data if applicable</div> <div>© Crown Copyright, all rights reserved</div> <div>reproduced with permission. Licence</div> <div>No. 100045420</div>	
<div>Main Building</div> <div>

</div>		<div>SOUTH ELEVATION (INTERNAL)</div>		<div>EAST ELEVATION (EXTERNAL)</div>		<div>Open Cattle Court</div> <div>

</div>		<div>NORTH ELEVATION (EXTERNAL)</div>		<div>WEST ELEVATION (INTERNAL)</div>	
<div>

</div>		<div>WEST ELEVATION (EXTERNAL)</div>		<div>EAST ELEVATION (INTERNAL)</div>		<div>

- 2.3.1. Existing elevation and plan drawings are shown in Figures 3 and 4. They illustrate the building prior to any conversion work and are based on architectural drawings supplied by Edwin Thompson.

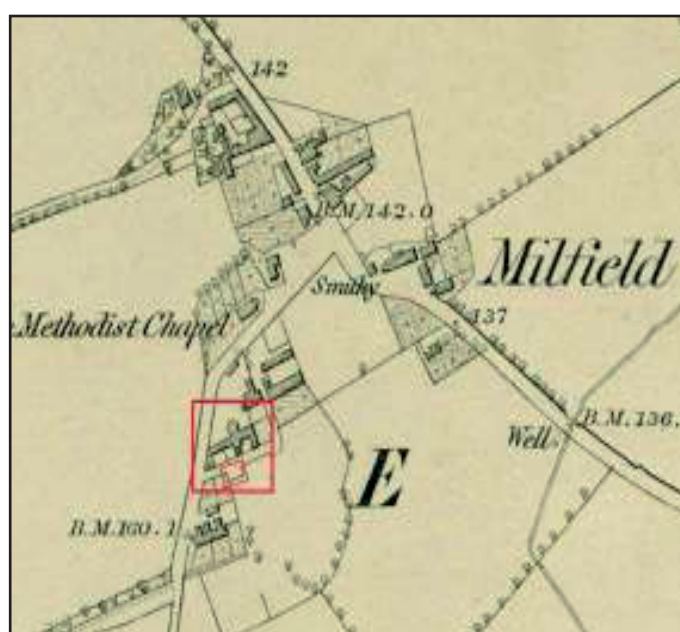
Fig. 7 First edition Ordnance Survey Map of 1860.
The study area is outlined in red and the area where the
small barn will be constructed is inset

- 3.4. The first edition Ordnance Survey Map of 1860 (Fig. 7) shows Demesne Farm clearly, although the layout is somewhat different from the current structure. There appear to be two extensions running south from the eastern end of the southeast elevation. There is also a circular structure, which is likely to be a gin-gan (horse wheel) located at the east end of the northwest elevation. The small barn, presently located to the south of the main building, has not been constructed at this time.

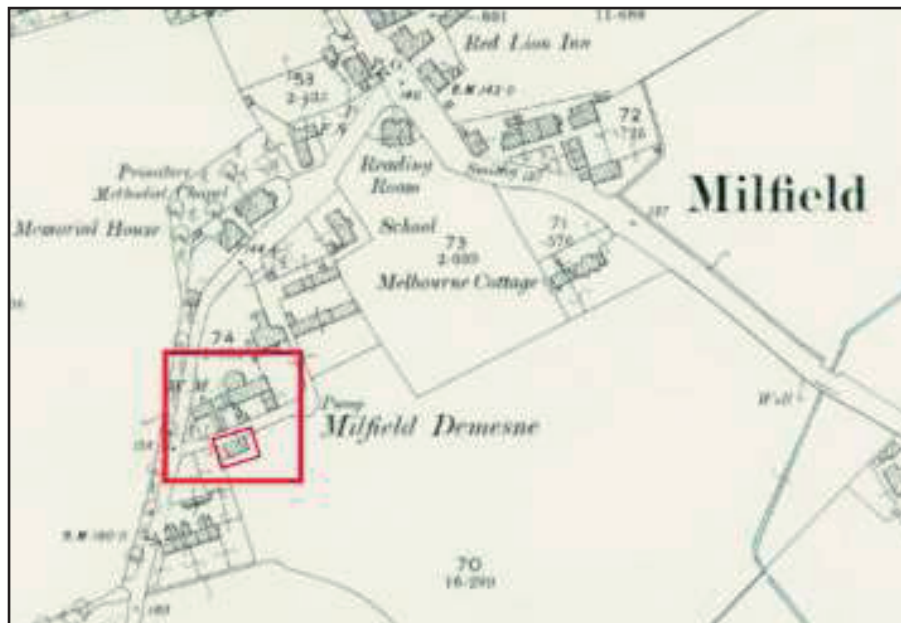
Fig. 8 Second edition Ordnance Survey Map of 1897.
The study area is outlined in red and the small barn is inset

- 3.5. The second edition Ordnance Survey Map of 1897 (Fig. 8) illustrates that by this date a third extension has been added to the western end of the southeast elevation. This extension is the open cattle court present today. The small barn to the south of the main building has been constructed by this time. The barn is to be demolished as part of the new developments.

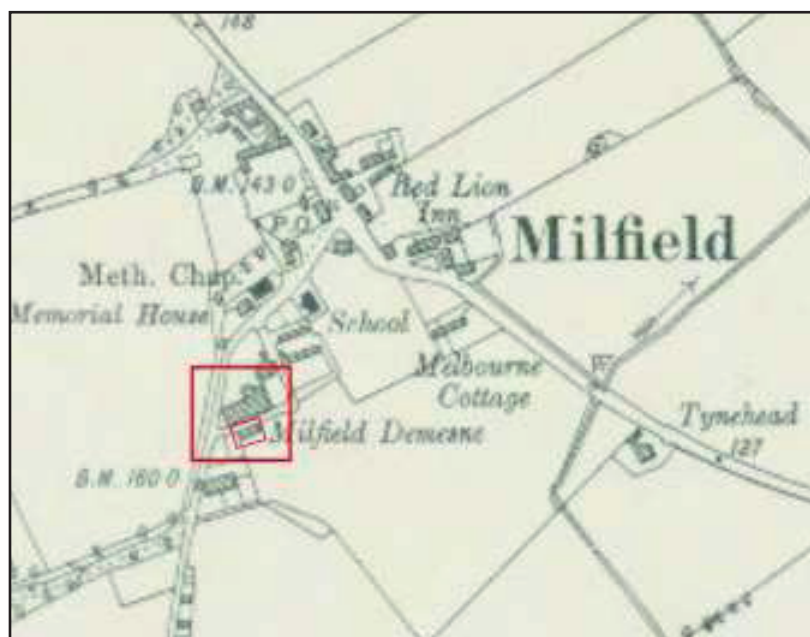
Fig. 10 Third edition Ordnance Survey Map of 1920.
The study area is outlined in red and the small barn is inset

- 3.6. A land valuation map dated 1910 (Fig. 9) shows the study area much the same as the second edition Ordnance Survey of 1897, but by the third edition Ordnance Survey of 1920 (Fig. 10) the main building appears as one large block and does

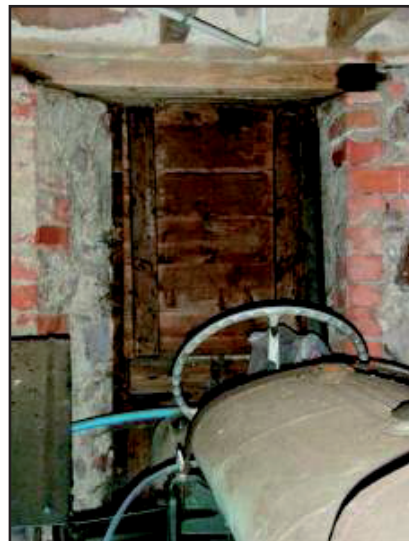
Fig. 23 Store 1, doorway

Store 1 was difficult to access due to its use as a storage area. The walls were constructed from rough sandstone blocks and the floor was made of concrete. The roof appeared to have been recently replaced in order to support flooring for the first floor level. In the central area of the north wall, a doorway was present but had been blocked with wooden planks. At the east end of this area on the south wall, the archway which was visible in the southeast elevation could be seen (Fig. 23).

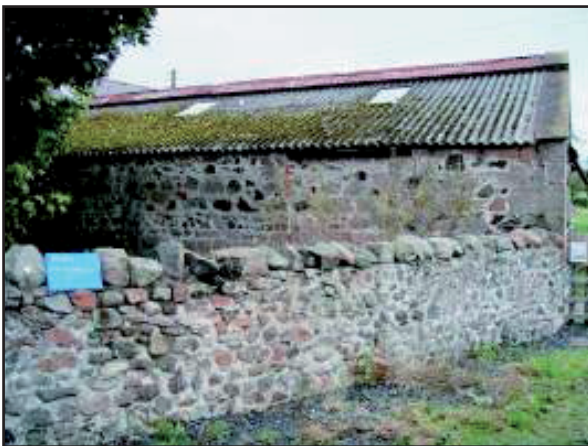
Fig. 38 Open Cattle Court, southwest elevation

The southwest elevation comprised a wall constructed with rough sandstone blocks (Fig. 38). There were no features noted on this elevation. The roof comprised a timber frame, which was covered with corrugated iron sheeting.

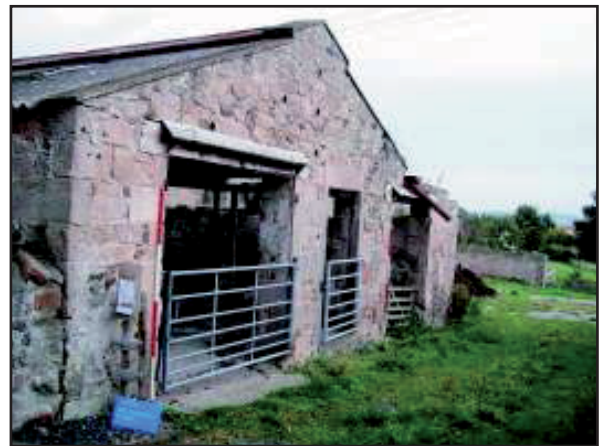
Fig. 39 Open Cattle Court, southeast elevation

The southeast elevation was constructed using rough sandstone blocks and held three openings (Fig. 39). The opening to the north was the largest, with a large, dressed sandstone block surround and wooden lintel. The opening held a large metal gate but it is likely that it once held a set of double doors. The opening at the centre was large enough for a single door and was constructed in the same manner as the large one. A small metal gate was fixed to this opening. The opening to the south was identical to that at the north, but its gate was wooden instead of metal.

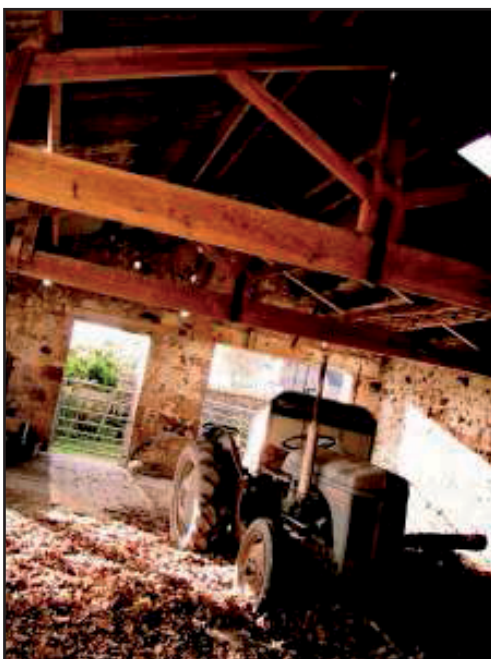
Fig. 40 Open Cattle Court, interior

4.5.1. Most of the features within the interior of the open cattle court were located on the north wall, which was the southeast elevation of the main building and has been discussed above in section 4.2.3. The remaining walls were constructed from rough sandstone blocks and the wooden roof beams and structure were exposed (Fig. 40). The flooring was made from concrete apart from a strip of block paving leading from the doorway in the south wall to the doorway in the north wall.

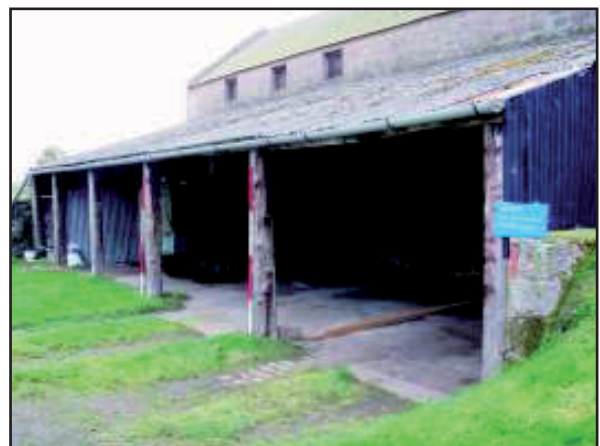
Fig. 41 Car port/open barn

4.6.1. The exterior of the car port/open barn was very basic (Fig. 41). It was situated at the east end of the northwest elevation and was constructed using large wooden posts with corrugated iron sheets placed over the southwest and northeast elevations. The northwest elevation had been left open and comprised only 6 wooden posts.

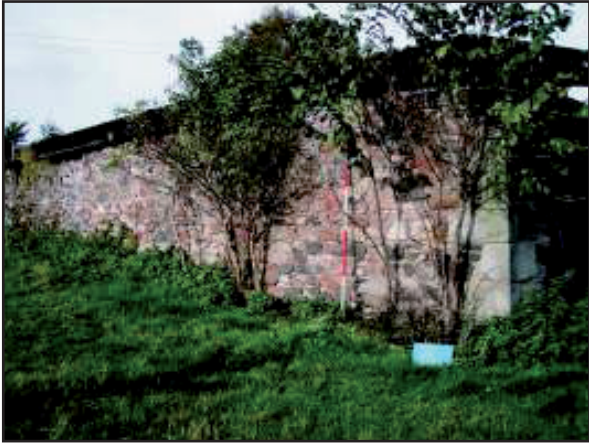
Fig. 42 Open Barn, southeast elevation

- 4.8.1. The southeast and southwest elevations of the open barn were constructed from rough sandstone blocks (Fig. 42). The northeast elevation had also been constructed in the same manner but a large section of it was missing and had been replaced by corrugated iron sheets (Fig. 43). The northwest elevation was left open and contained three large wooden posts that supported a flat sloping roof structure. Three large metal gates were located across the opening.

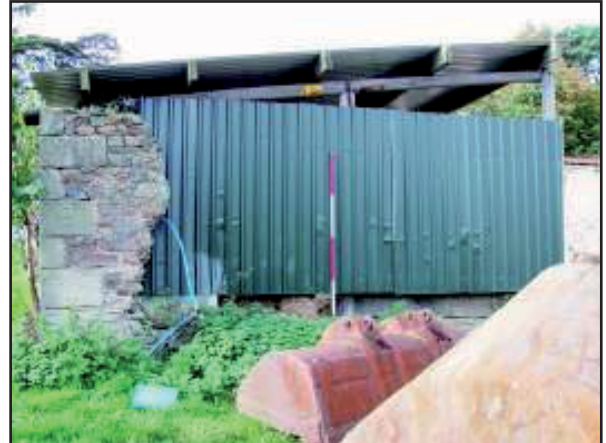
Fig. 43 Open Barn, northeast elevation

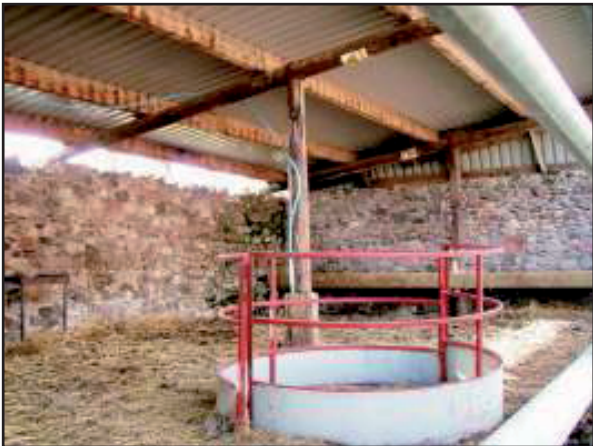
Fig. 44 Open Barn, interior

- 4.9.1. The interior of the open barn contained no features of historical interest apart from a large animal feeding bay in the centre (Fig. 44). A wooden trough was also located around the edges of the internal walls. No further features of historic significance were noted.
