## BATH VALE WORKS, CONGLETON, CHESHIRE

Archaeological Watching Brief Report

Report reference: 73900.02

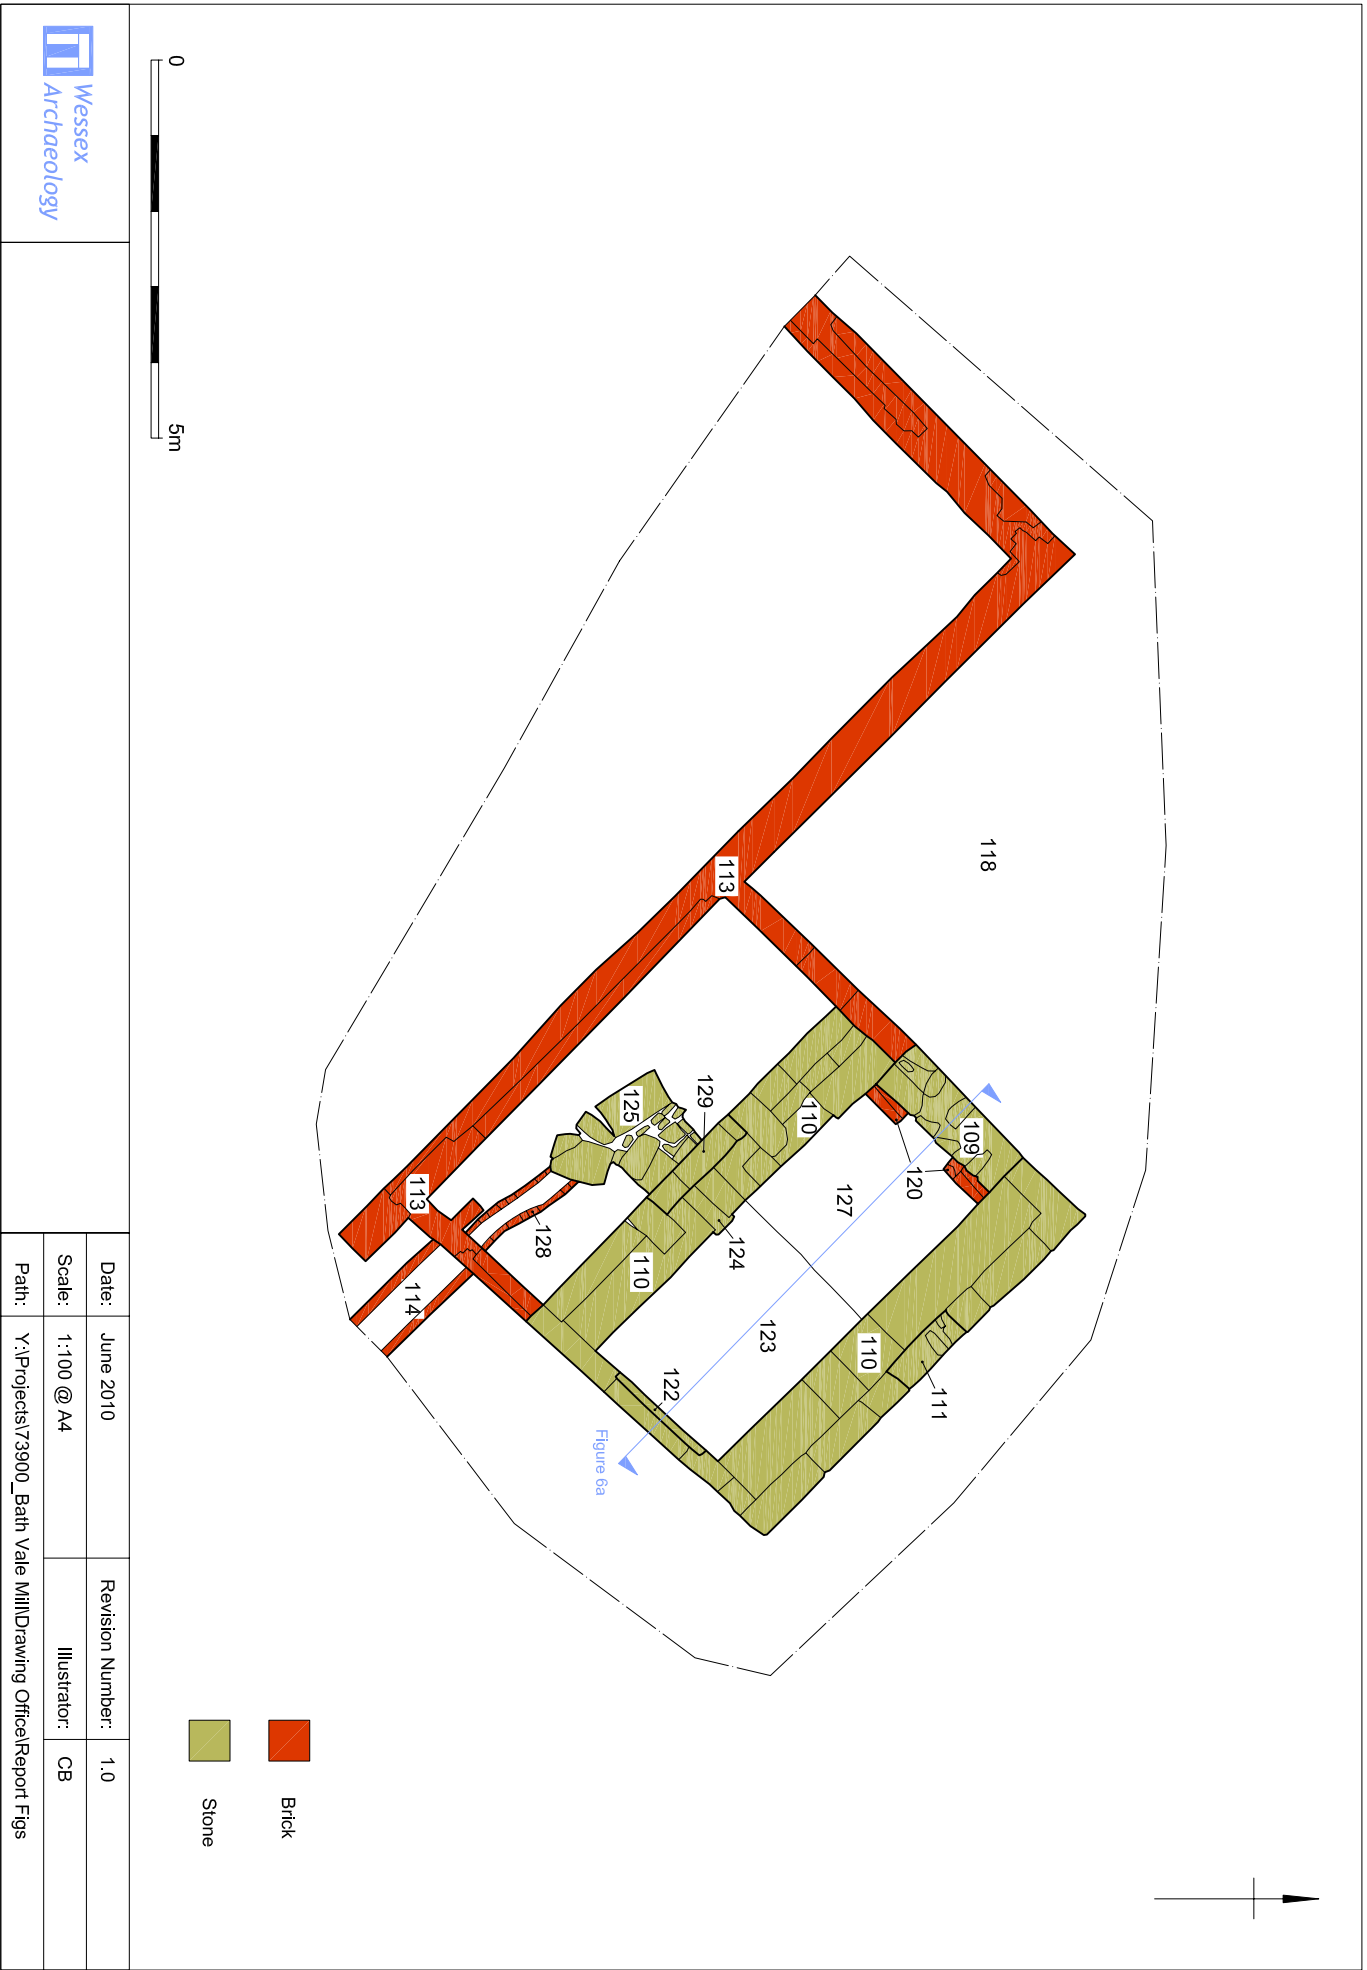
Figure 2

Plan of Area 1

4.3.1 Area 1 (**Figure 2**) was located towards the north side of the Site within an area measuring approximately 20 x 15m. Substantial structural elements survived within the area at a good level of preservation comprising the north-eastern red brick wall of the former mill, and a stone and brick wheel house structure which projected from it to the northeast.

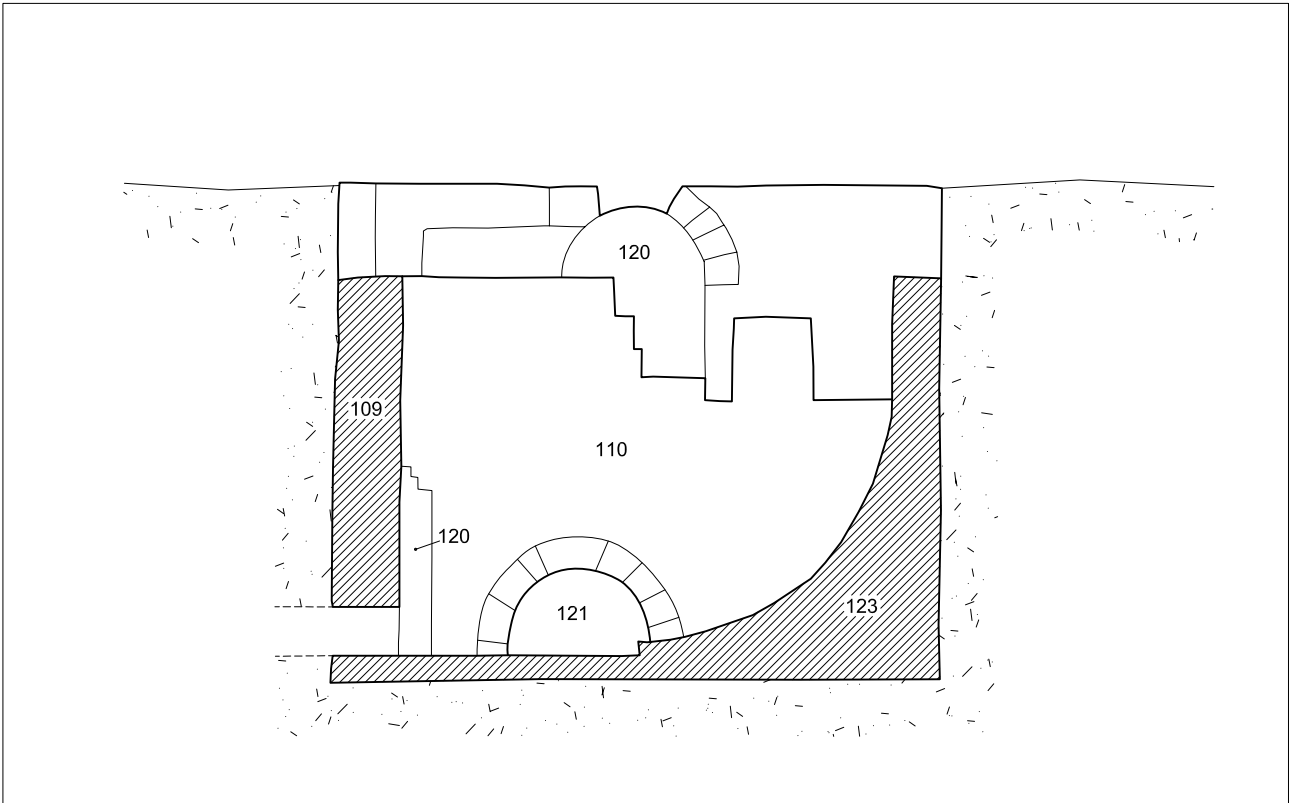
Fig. 6a Section through Area 1

4.3.4 Abutting **113** to the northeast was a contemporary rectangular sandstone wheel pit structure **110** (**Figure 6**) measuring 6.06 x 4.26m at c93m AOD (**Plate 5**). The structure formed a 4m deep wheel pit with 0.5m thick ashlar sandstone block walls with tooled faces and smooth margins. The southwest and northeast walls (**Plate 6**) of the structure widened to 1.1m thick at a 91.92m AOD and incorporated centred arched openings at a similar level (**111** & **129**), which had been blocked but had previously likely been axle mounts. A further arched opening at the base of the west side of the northwest wall had led out to a stone culverted tailrace to the Timber Brook.

- 6.2.2 The two waterwheels uncovered during the course of the archaeological watching brief (**Figure 6**) are representative of two phases in the early development of the mill. The wheel pit uncovered in Area 4 lay in the approximate location of the earliest incarnation of the mill depicted on the 1806 plan. Consequently this wheel was likely to have been the earliest, with the second wheel likely constructed sometime before 1827.

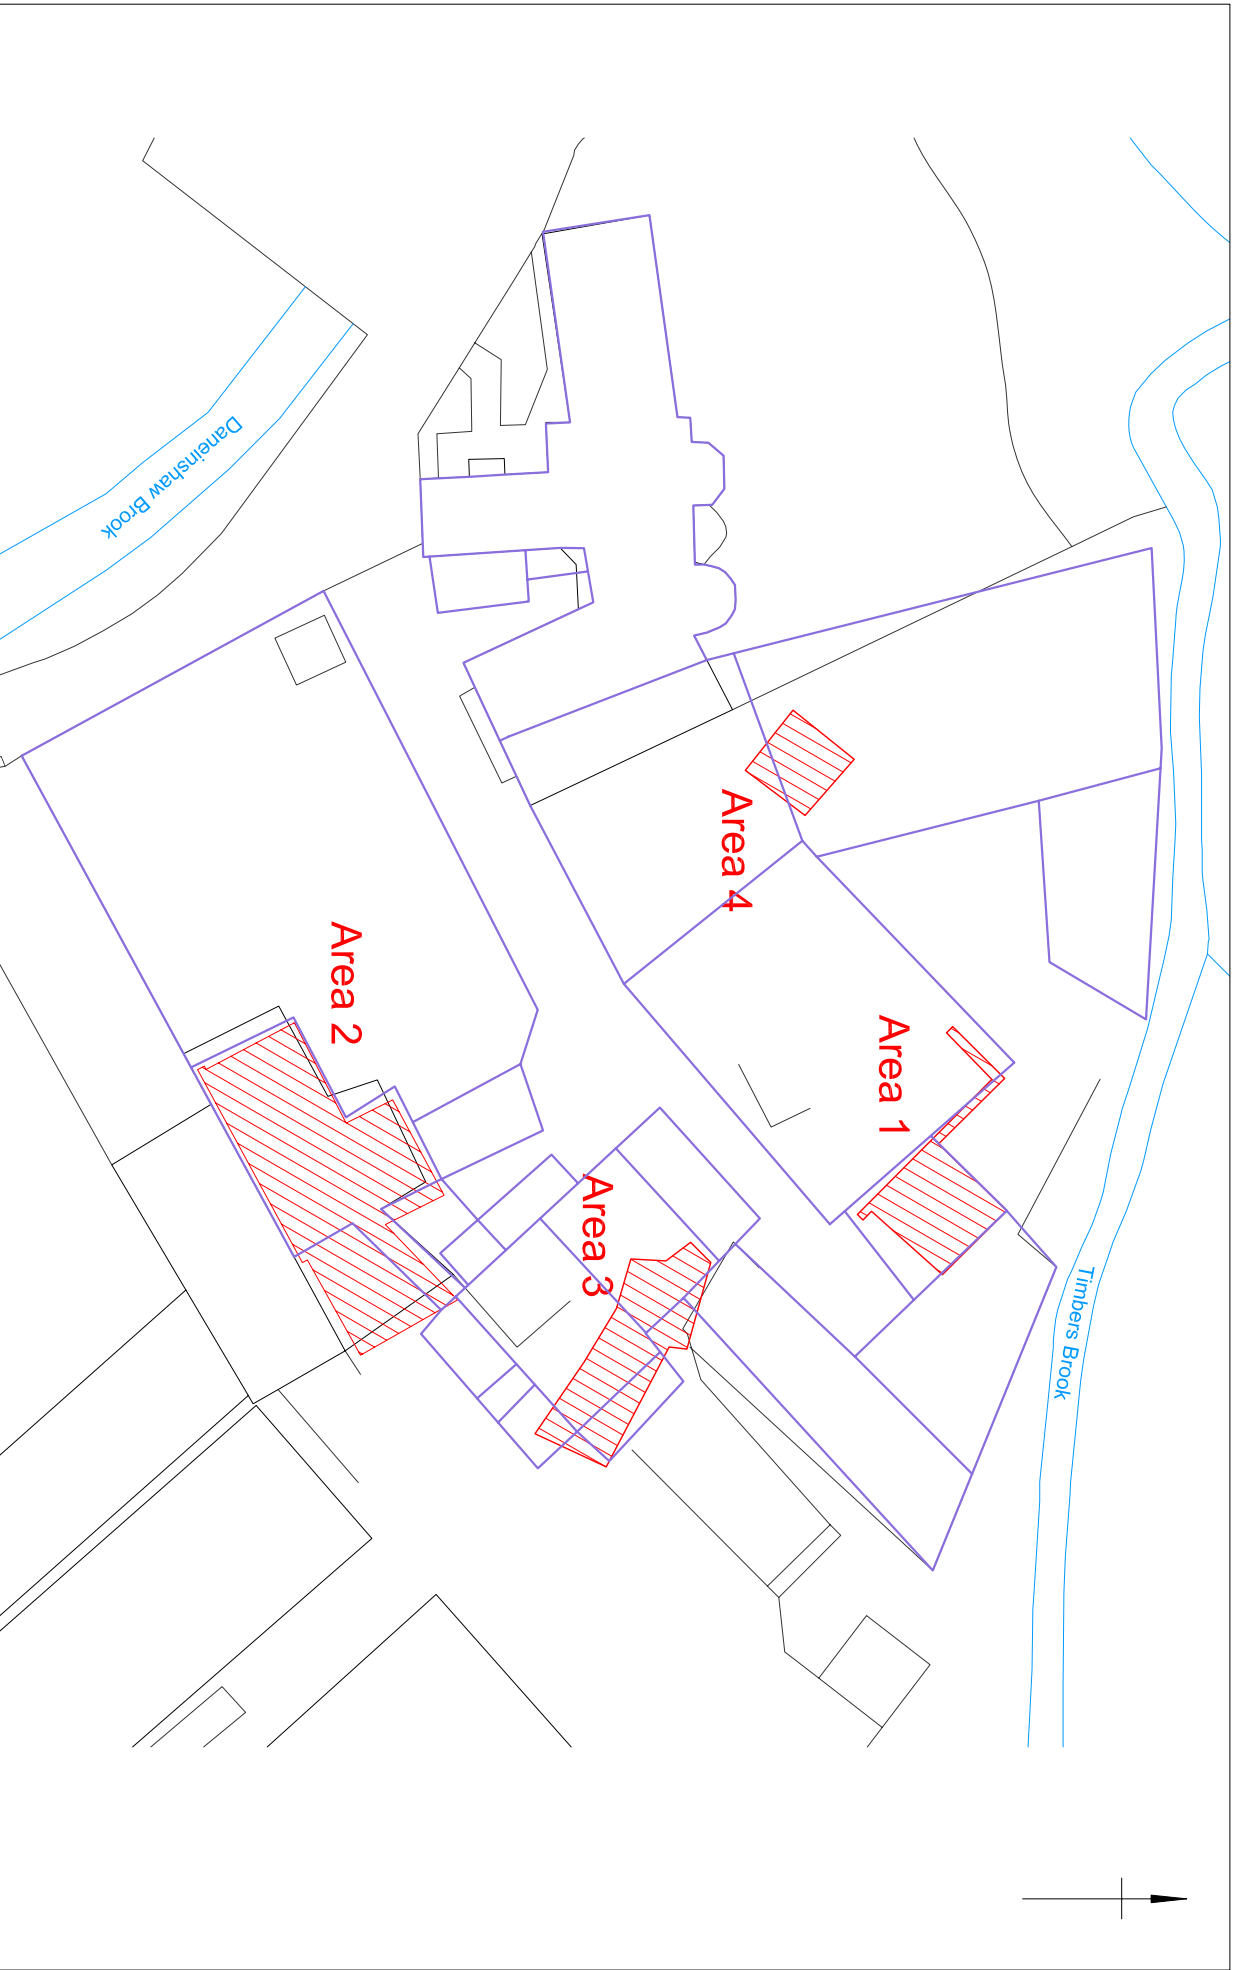
Figure 7

Location of trenches in relation to standing & demolished structures (after UMAU 2007a)

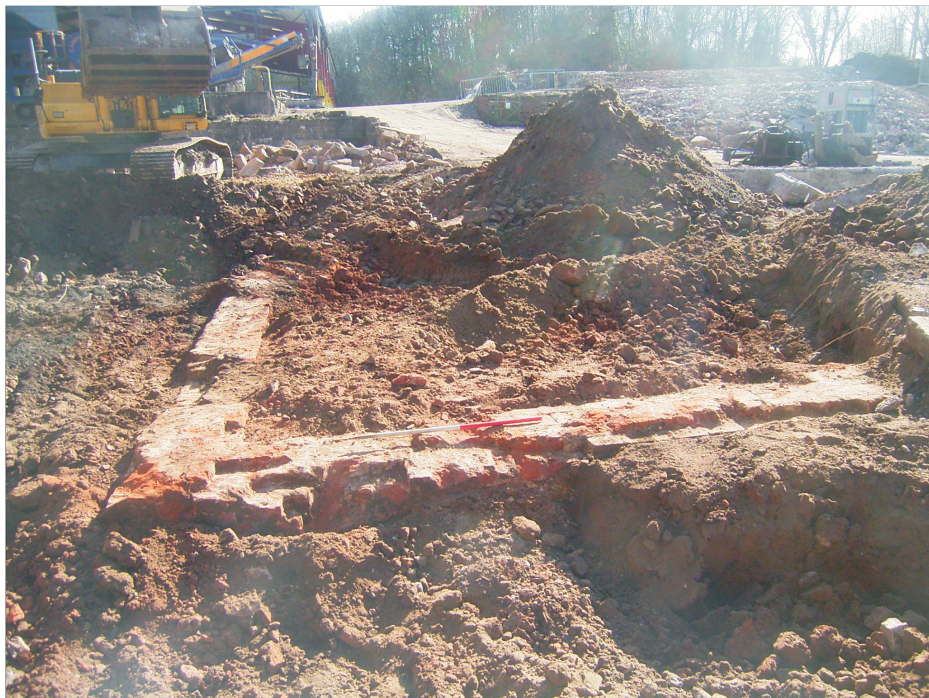
Plate 2: Exposed remnant of mill building **115** from the north-west

4.3.2 The red brick structure **113** comprised of an 'L' shaped section of wall built of handmade bricks (measuring 24 x 11 x 7.5cm) laid five courses thick with a light grey sandy lime mortar (**Plate 2**). Although the south-eastern corner of the mill was not observed it was possibly truncated during the construction of the mid 20<sup>th</sup> century sheds. The foundations of the wall were cut into the natural **118** to a depth of 90.53m AOD.

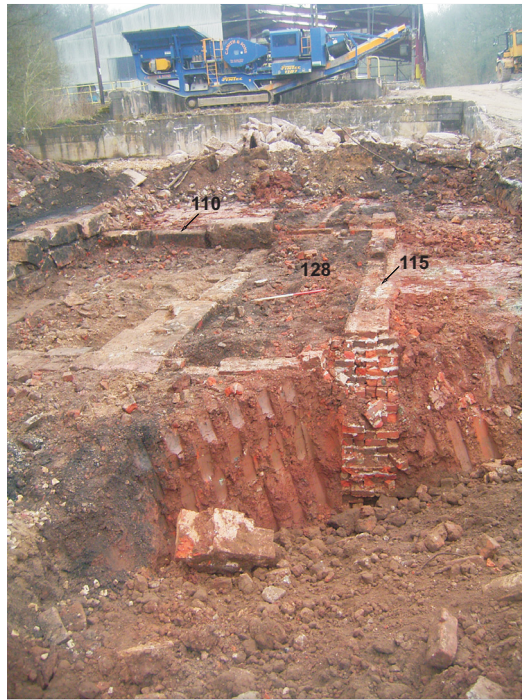
Plate 3: General view (from the north-west) showing space **128** between mill **115** and wheel pit **110** structures

4.3.3 Extending from the eastern end of the northeast face of **113** were two parallel three course thick red brick walls. The walls enclosed a 6.5 x 2m space **128** that was filled with a sandy silt deposit containing frequent ash and moderate demolition rubble **116** (**Plate 3**). A partial stone flag floor **125** was observed within **128** at 91.50m AOD covering a brick lined culvert (**Plate 4**) connected to the northeast to a cast iron pipe **124** leading into the wheel pit structure and to the southeast to a brick lined culvert **114** leading out beyond the structure. This arrangement of culverts was a later insertion that had likely served as a drainage system.

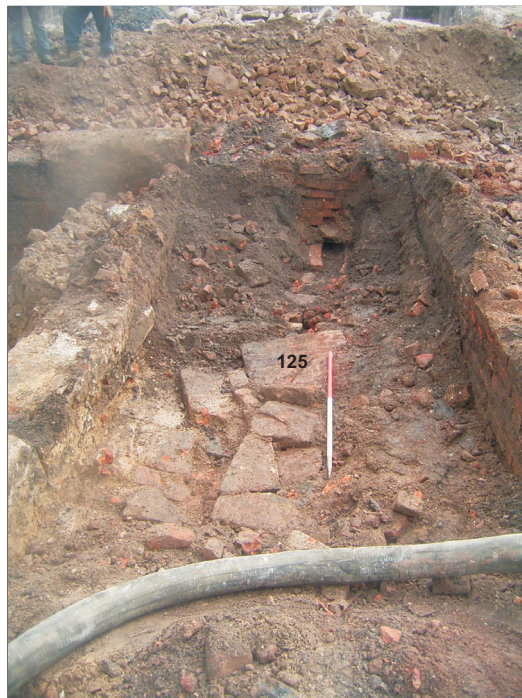
Plate 4: Detail of fragmentary floor surface **125** and culvert **126** within **128** from the north-west

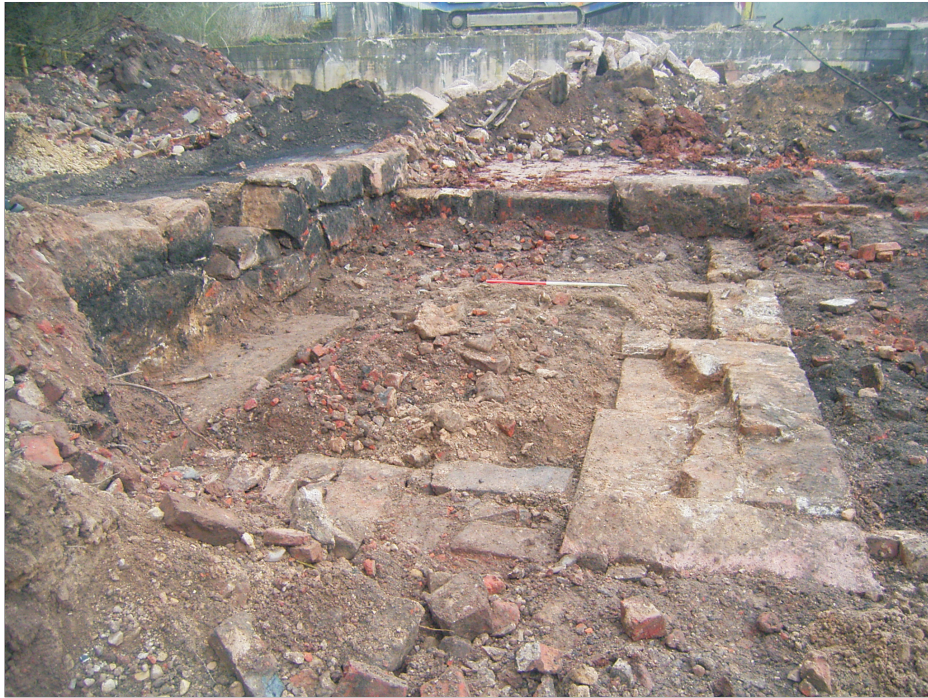
Plate 5: General view of wheel pit structure **110** from the north-west

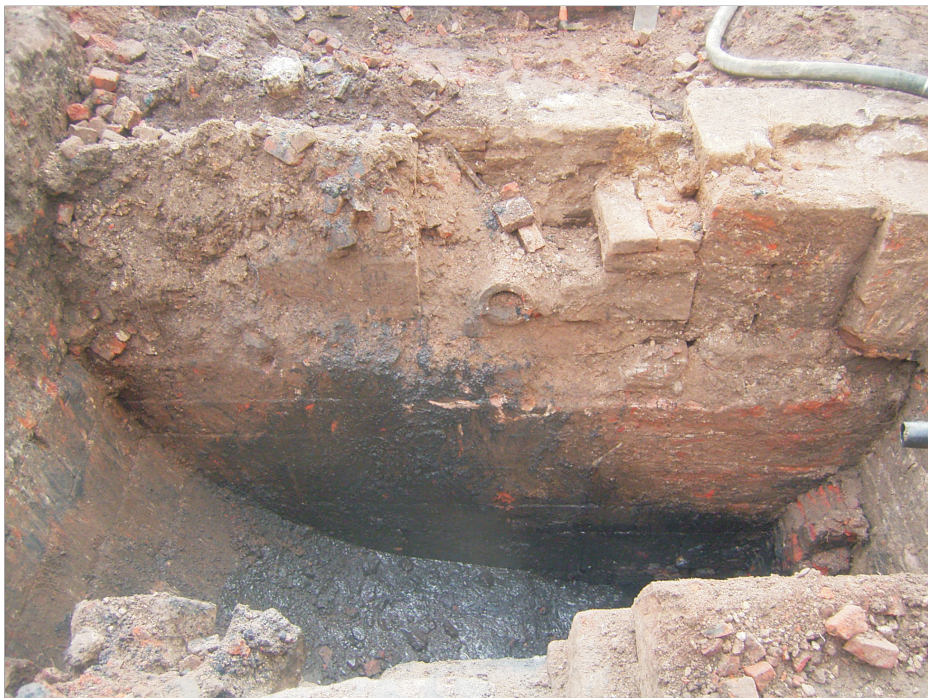
Plate 6: Detail of north-east facing elevation of **110**

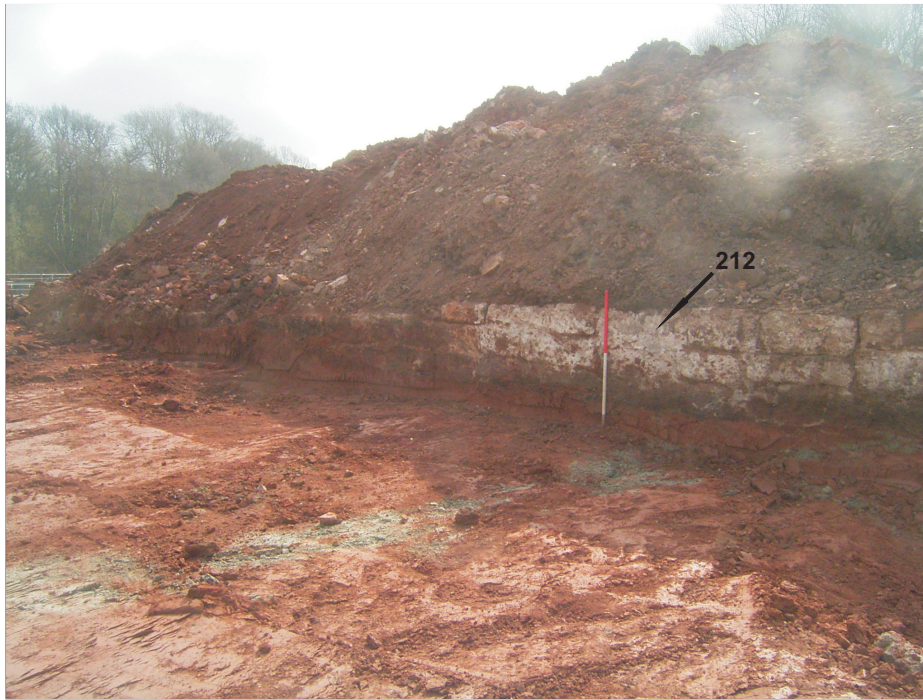
Plate 7: General view of Area 2 showing stone wall **221** to south-east

- 4.4.1 Area 2 (**Figure 3**) was located on the raised ground towards the east of the Site and measured approximately 20 x 15m (**Plate 7**). A retaining wall bounded the northwest edge of the area and comprised of a number of phases in stone and brick incorporating a rectangular projection beyond the line of the retaining wall. The initial phase of walling comprised of stone laid to uneven courses with red brick alterations built on top of it and to the entirety of the northwest face of the projection. The most recent phase was in a grey brick comprising a structure which was recorded in 2007 by UMAU (2007b), which had been demolished down to floor level at approximately 97m AOD.

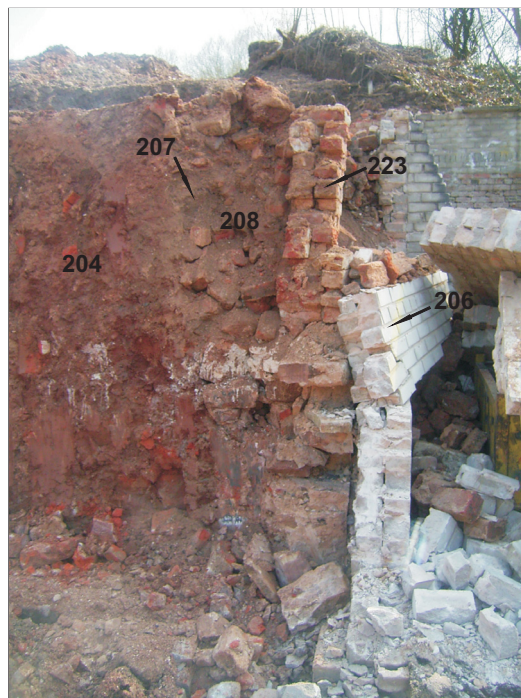
Plate 8: Detail of section showing cut for wall **223** and later brick cladding **206** from the north-west

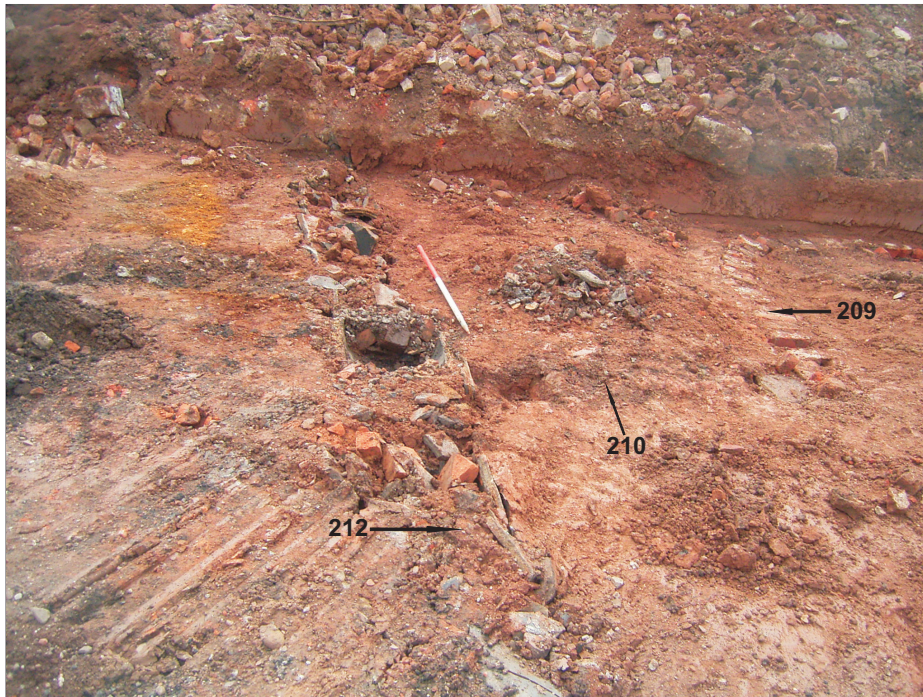
Plate 9: General view of flues **209** and **212** towards north-east of Area 2

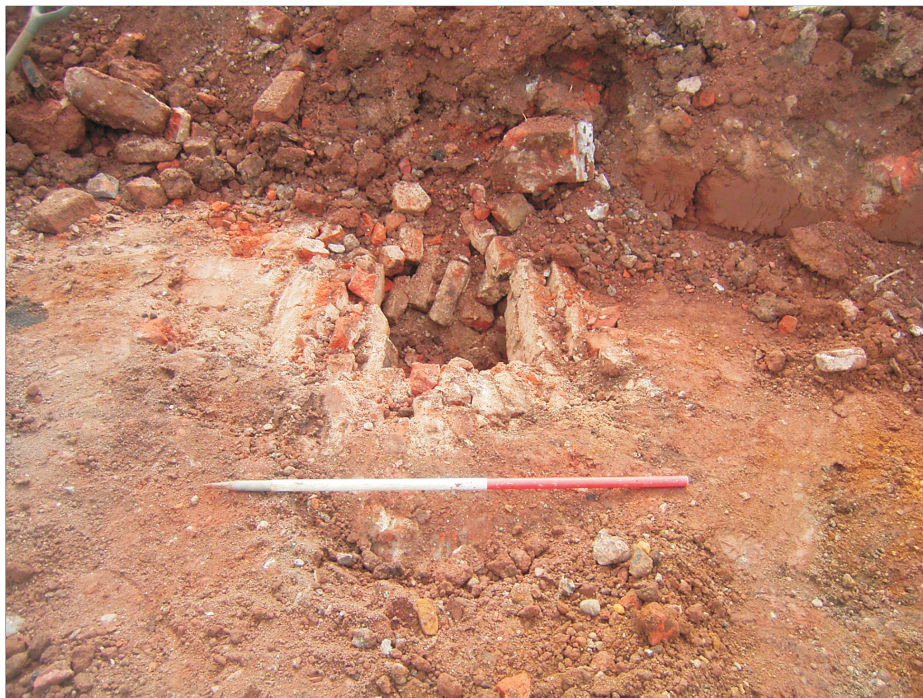
Plate 10: Detail of brick flue **216** in eastern corner of Area 2

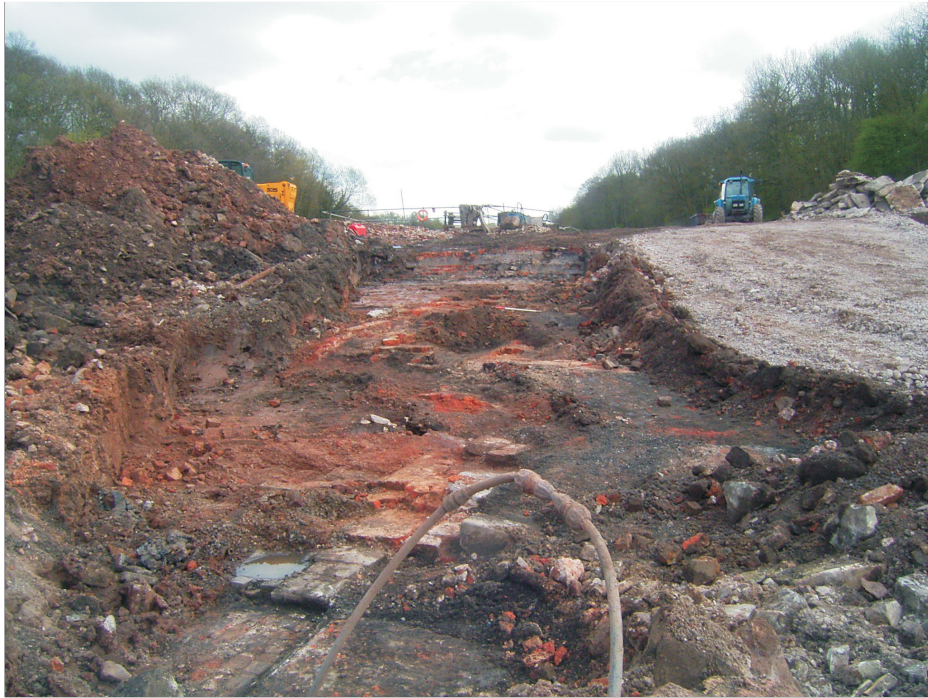
Plate 11: General view of Area 3 from the north-west showing structures associated with a former engine and boiler house.

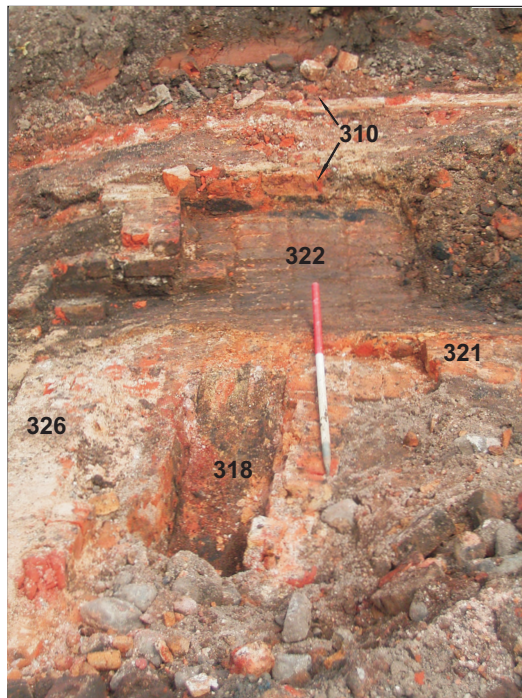
Plate 12: Detail of boiler base 308 from the south-west

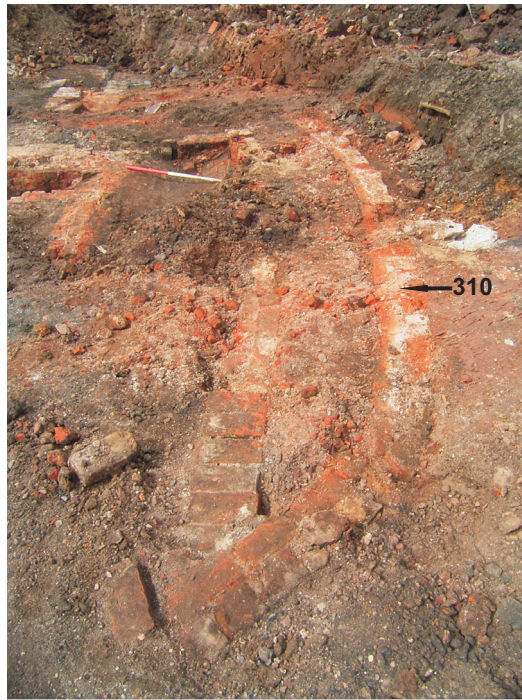
Plate 13: General view of curved flue **310**

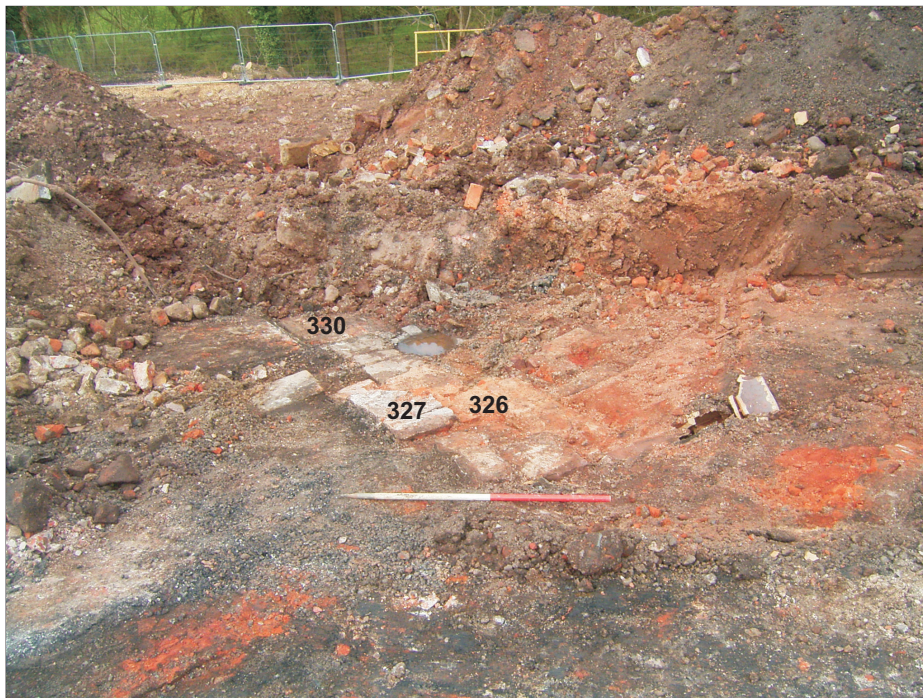
Plate 14: General view of truncated stone and brick structure from the south-east

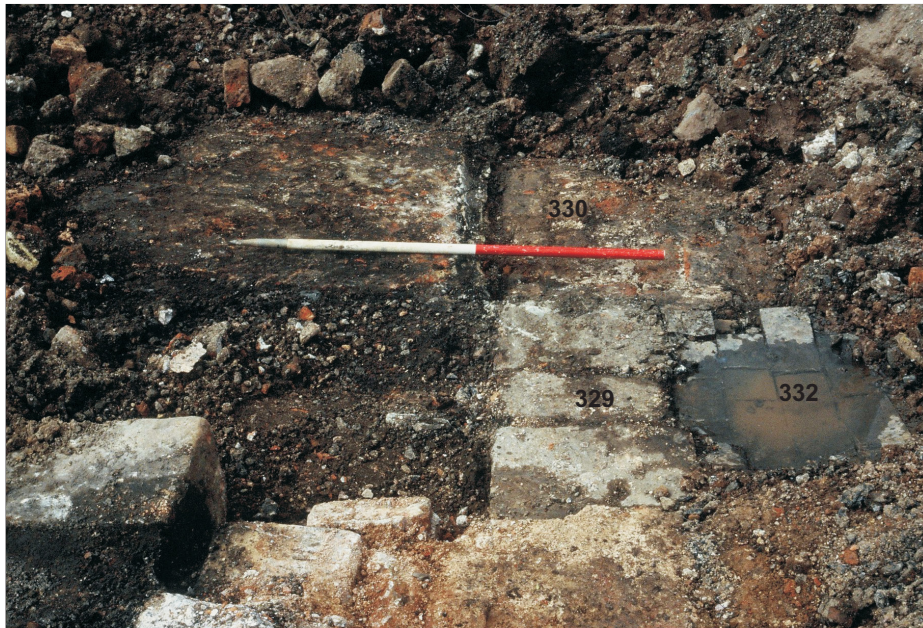
Plate 15: Detail of paved opening **329** between walls **330** and **326**

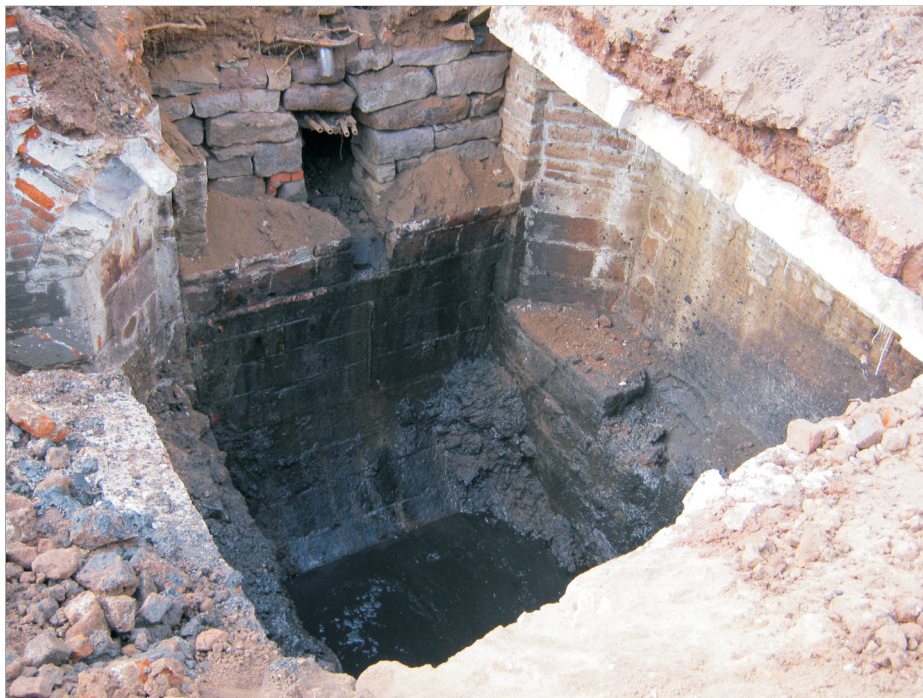
Plate 16: General view of wheel pit structure **403** in Area 4 from the east

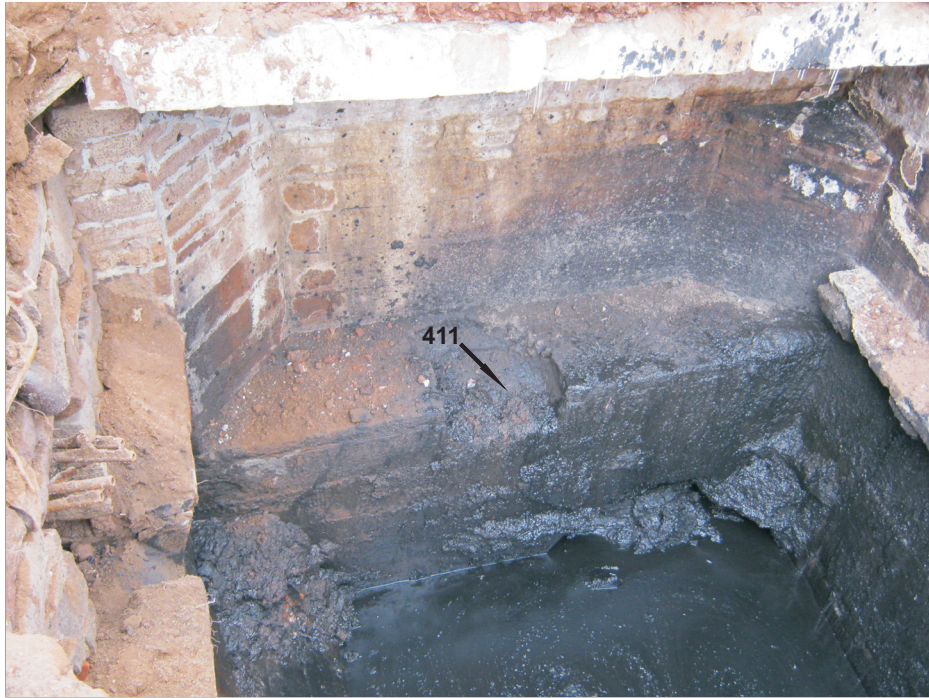
Plate 17: Detail of axle mount **411** for water wheel in northeast wall of **403**. Viewed from the south.

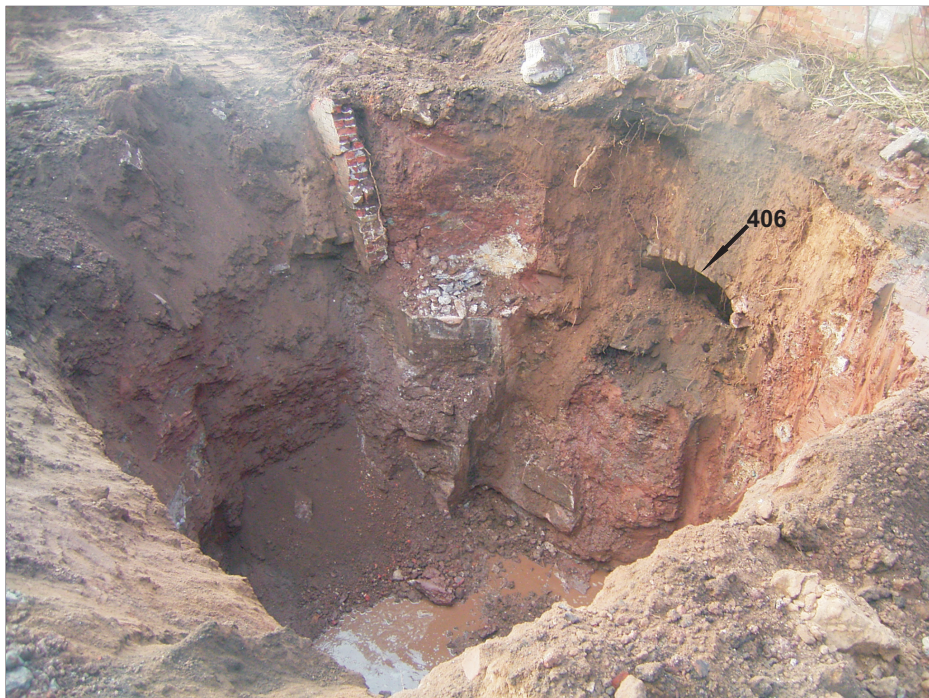
Plate 18: General view of Area 4 during remediation showing Head Race **406** from the north.
