HSBC Rochdale
Project Reference: 101540

October 2013

Assessment of potential for statutory listing

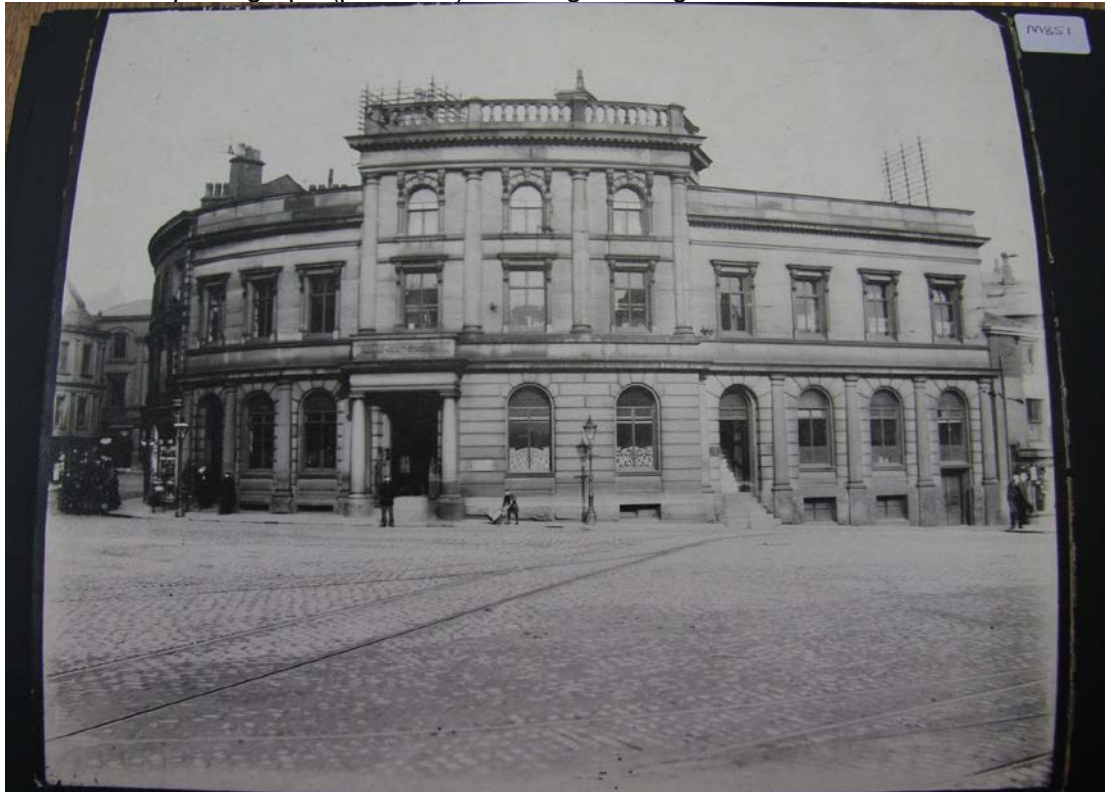
Plate 1: Undated photograph (pre-1935) showing the original Oldham Joint Stock Bank façade

Photographs indicate the façade was altered at some point between 1909 and 1935. Although a Midland Bank by 1899, the bank retained its Oldham Joint Stock Bank signage for at least a decade (photograph dated 1909). The original façade had an off-centre main entrance in the western bay of the central projection. This would have been the nearest bay if approaching the bank from the south across Rochdale Bridge or from the west along The Orchard (now The Esplanade) road. The entrance had a porch with moulded cornice, Tuscan columns to either side, and 'Oldham Joint Stock Bank' was engraved on the band between ground and first floor. The central projection had nine windows in total: two at ground floor, three at first floor, three at second floor and one at basement level in the easternmost bay. The west wing had seven windows in total: two basement windows, two at ground floor and three at first floor level with an arched entrance in the westernmost bay. The east wing had two entrances, steps up to an arched entrance in the western bay at ground level and steps down to a low level entrance in the eastern bay. The ground floor entrance steps appear continue inside the building to first floor level. The two central bays had basement windows at low level, beneath arched windows at ground level and there were four windows at first floor level. An undated photograph (M851) shows this façade in detail (**Plate 1**).

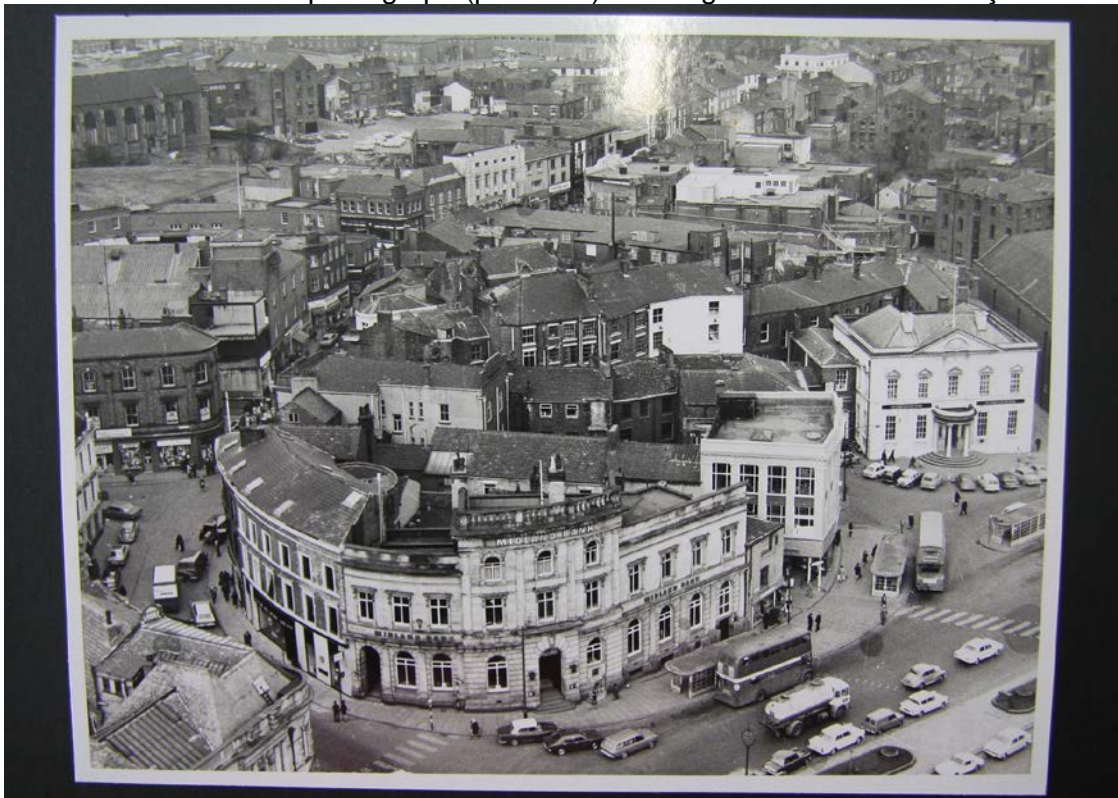
Plate 2: Undated photograph (pre-1968) showing the Midland Bank façade

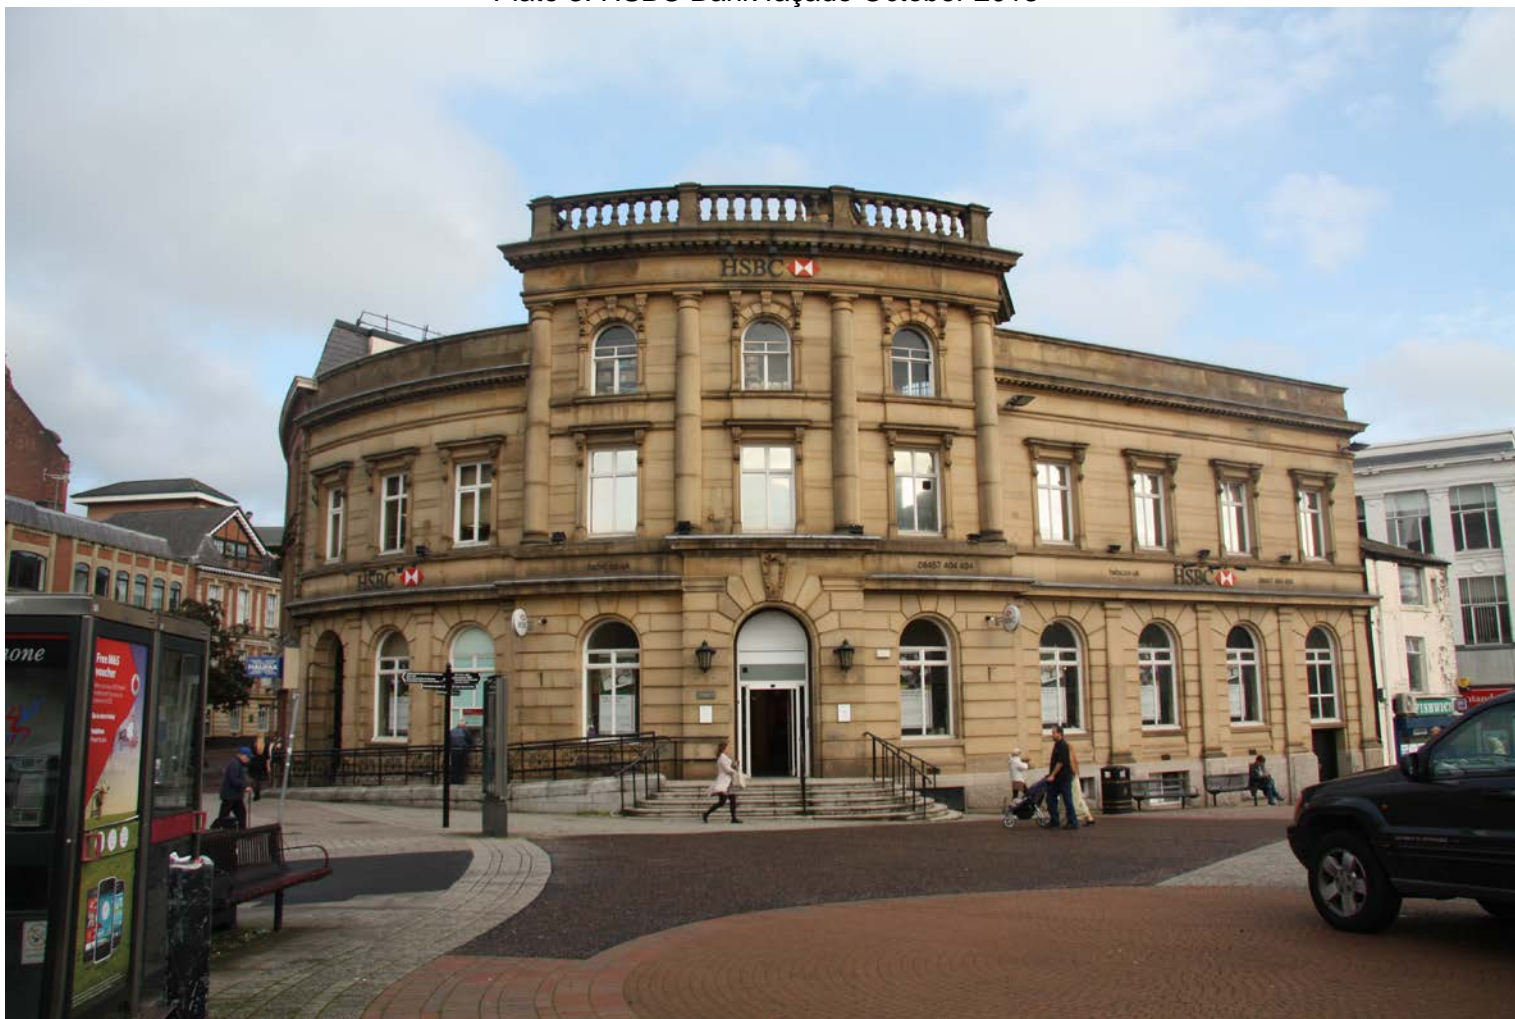
Plate 3: HSBC Bank façade October 2013

The existing façade is unchanged at first and second floor level except for the addition of signage (formerly Midland, now HSBC). Conversely, the ground floor entrances and windows have been rearranged. The main entrance has been relocated to the middle bay of the central projection. It has semi-circular steps leading up to it and a disabled access ramp along the front of the west wing. The ramp and stairs have blocked the basement windows in these areas. The previous entrance has been replaced with an arched window to match others along the ground floor. The east wing has had its ground floor entrance removed, replaced by a round-arched ground floor and rectangular basement window to identical to the adjoining bays in this wing. The penultimate bay to the east in this wing has had its basement window blocked, replaced by a letterbox. An undated photograph shows the central projection's eastern bay at one time had a shortened ground floor window to accommodate a cash machine with its own separate set of steps (**Plate 2**) however, photographs dated 1968 show this ground floor window as full length. Planning permission for the central projection's wide semi-circular steps and disabled access ramp was granted in 1993 (application 93/D30053) (**Plate 3**). The exterior of the property is protected as part of the streetscape and setting of the Rochdale Town Centre Conservation Area.

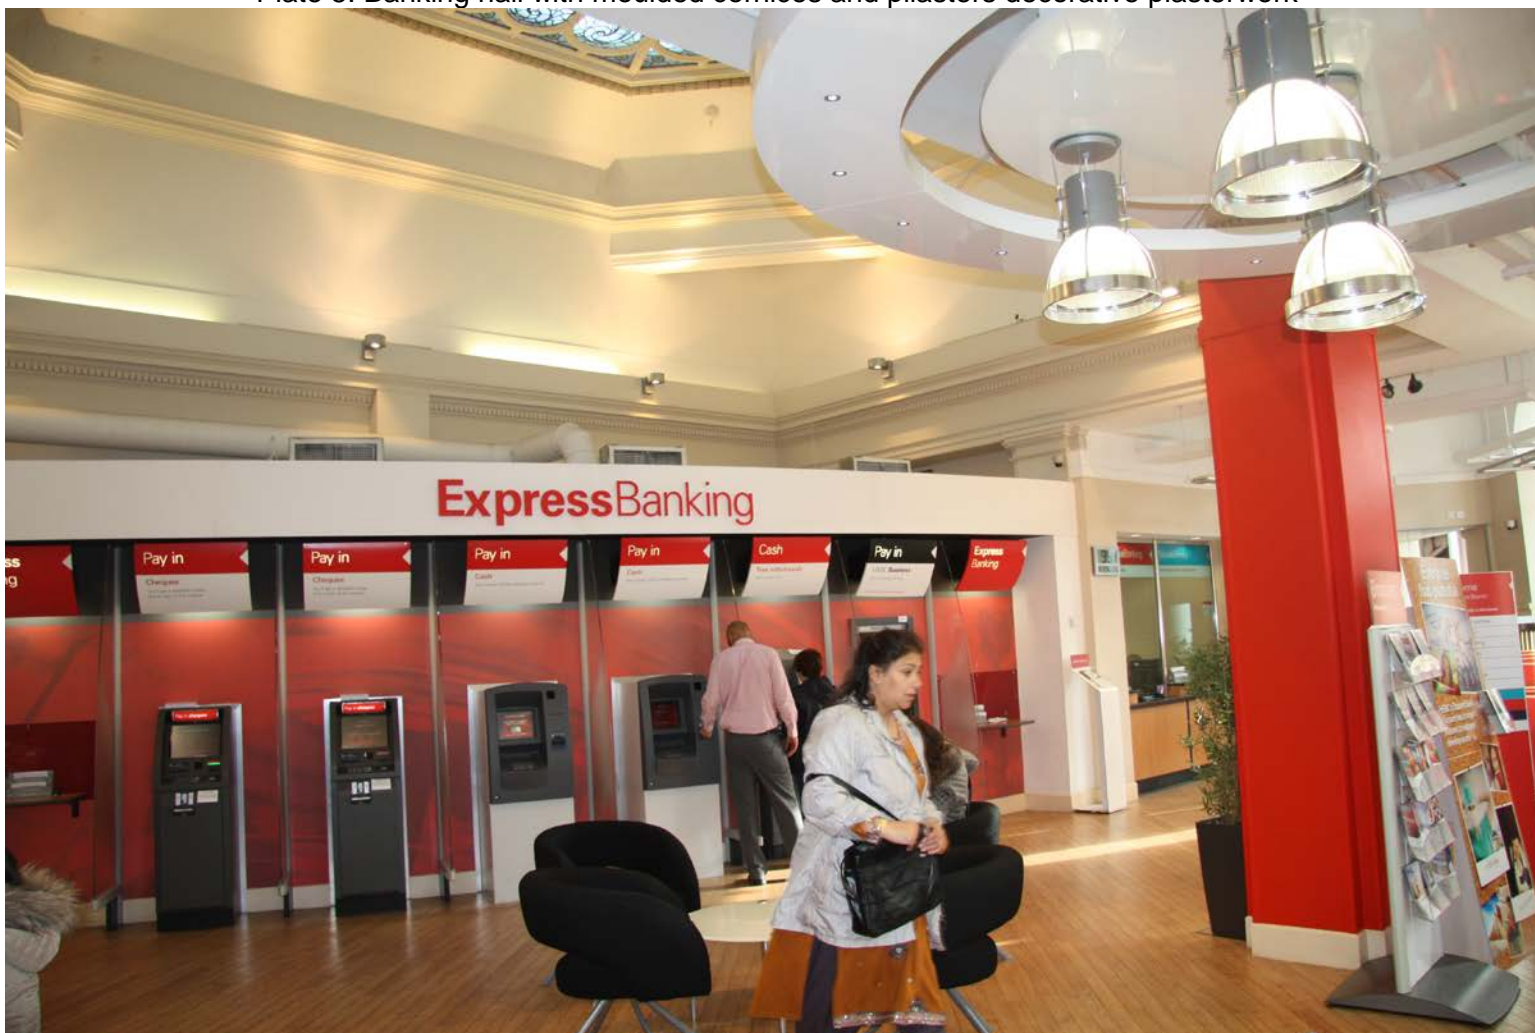
Plate 5: Banking hall with moulded cornices and pilasters decorative plasterwork

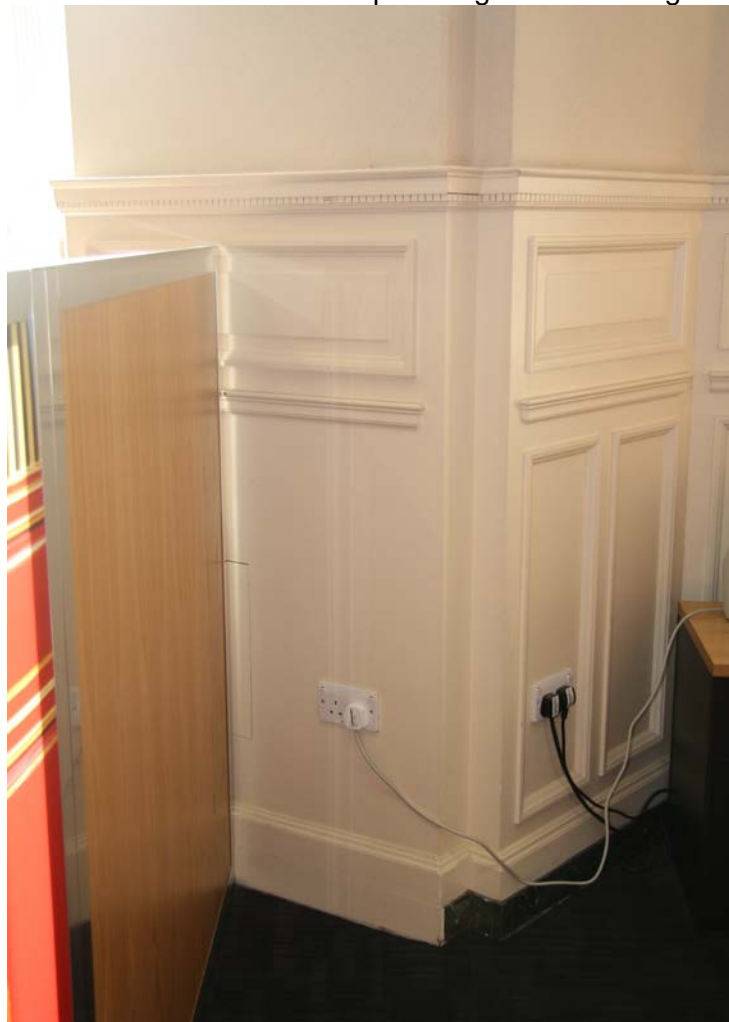
Plate 6: Ground floor dado panelling in the banking hall

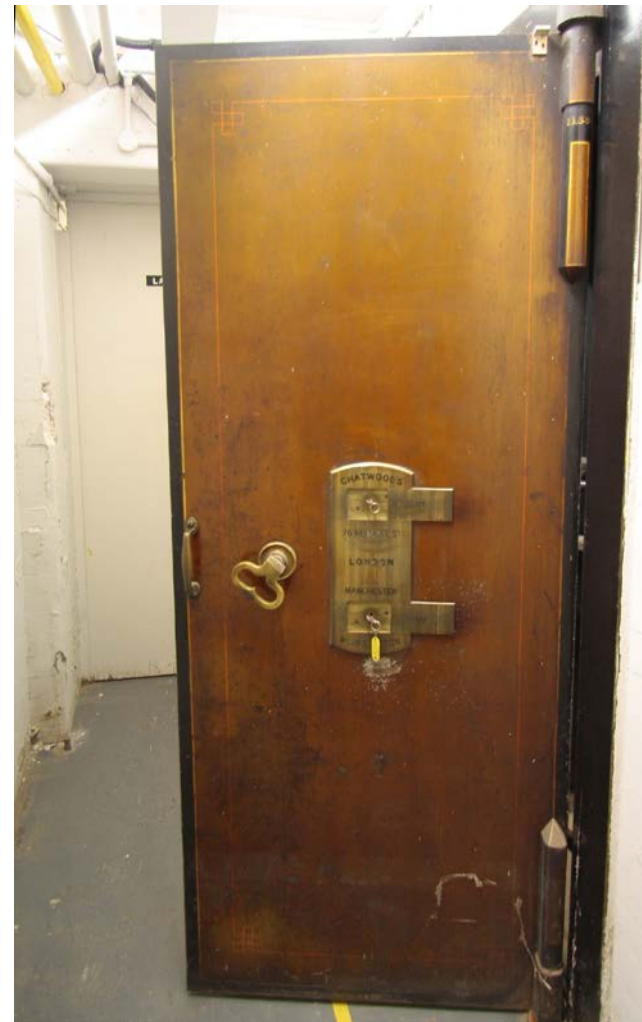
Plate 7: Chatwood's safe door in the basement

The basement also contains historic features such as a safe with iron-barred gates and door with patented Chatwood's Works lock, brass fittings and painted detailing (**Plate 7**). Samuel Chatwood called himself a banking engineer and his company specialised in bank safes and locks (Pascoe

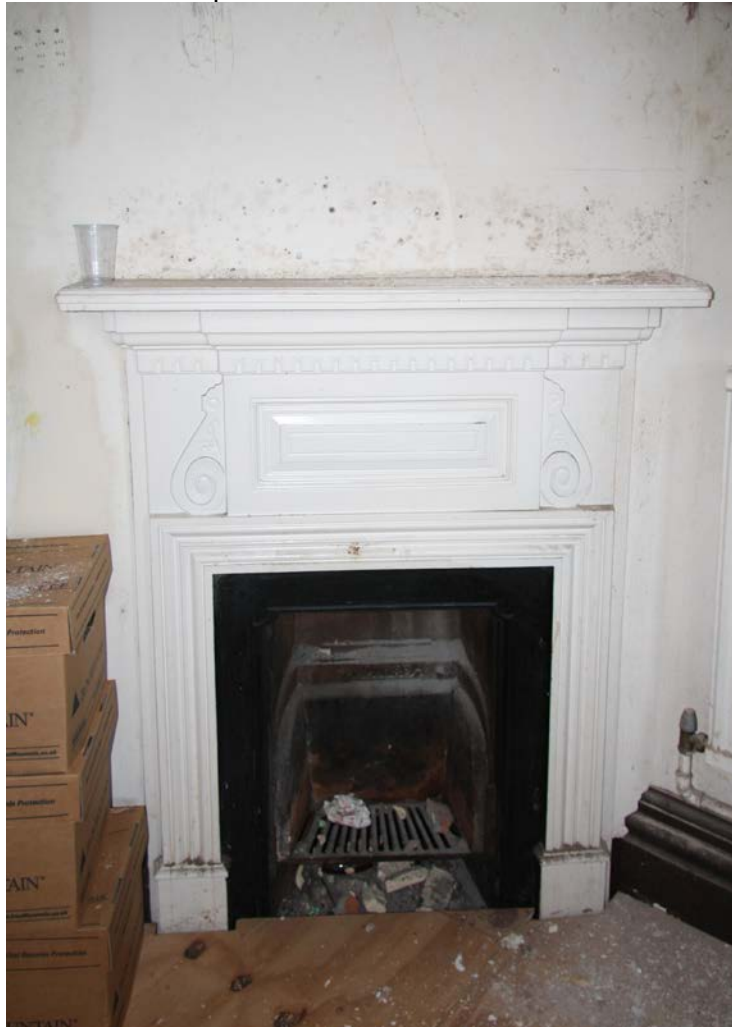
Plate 8: Fireplace at west end of the second floor

The second floor (within the central projection) is currently used for storage and some areas are in poor condition due to water ingress through the reinforced concrete roof above. This floor has historic features that include deep door reveals similar to the basement as well as several original fireplaces with iron grates. The timber fireplace surrounds have a moulded architrave, cornice and fielded central tablet with scrolled jambs either side (**Plate 8**). Due to the shape of the second floor, two identical fireplaces are set in an angled chimneybreast at the western end of the floor in order to heat the front and back of the west room. A second chimneystack above the east room indicates it may also contain a fireplace; however, the relevant wall was obscured from view.
