Wenlock Way, West Gorton Manchester

Interim Evaluation Report

Planning Reference: 105914/MO/2014/N2
Ref: 103990.02
May 2015

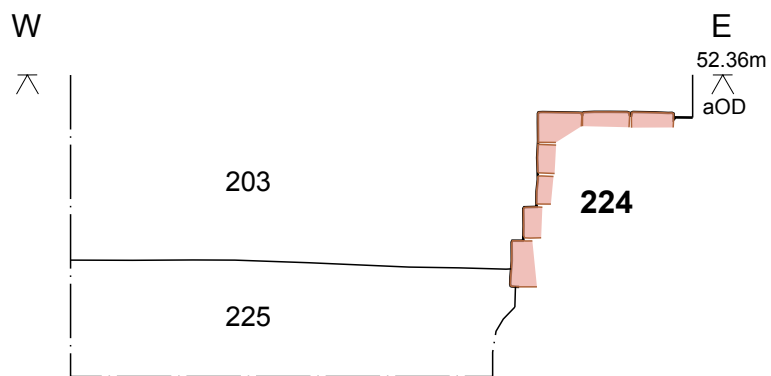
Section 1: South facing section with **225** dirty natural

- 5.3.2 Grey clay dirty natural (**225**) was seen at a depth of 1.1m below ground level (BGL) in a sondage dug adjacent to **Trench 2** (**Figure 4**). A buried soil of dark brown silt (**2026**) was seen at a depth of 1m BGL, directly underneath red brick foundations in a separate slot in **Area 2** (**Figure 4**). The red brick structures of **Area 2** appear to have been built directly on top of this buried soil (**2026**), with the ground then made up using general building site material **2025** after the majority of the structures were completed. Some original structures noted below were built on top of made ground **2025**.

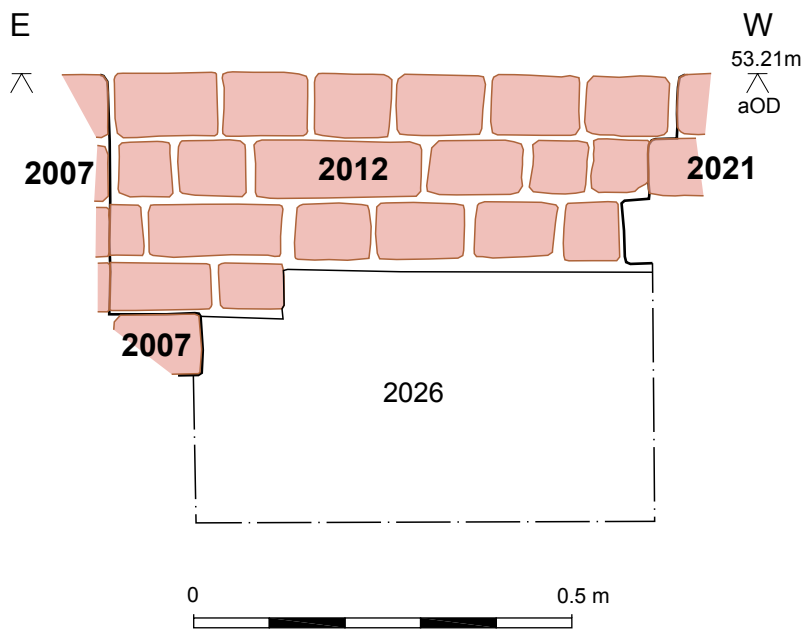
Section 2: North facing section with **2026** buried soil

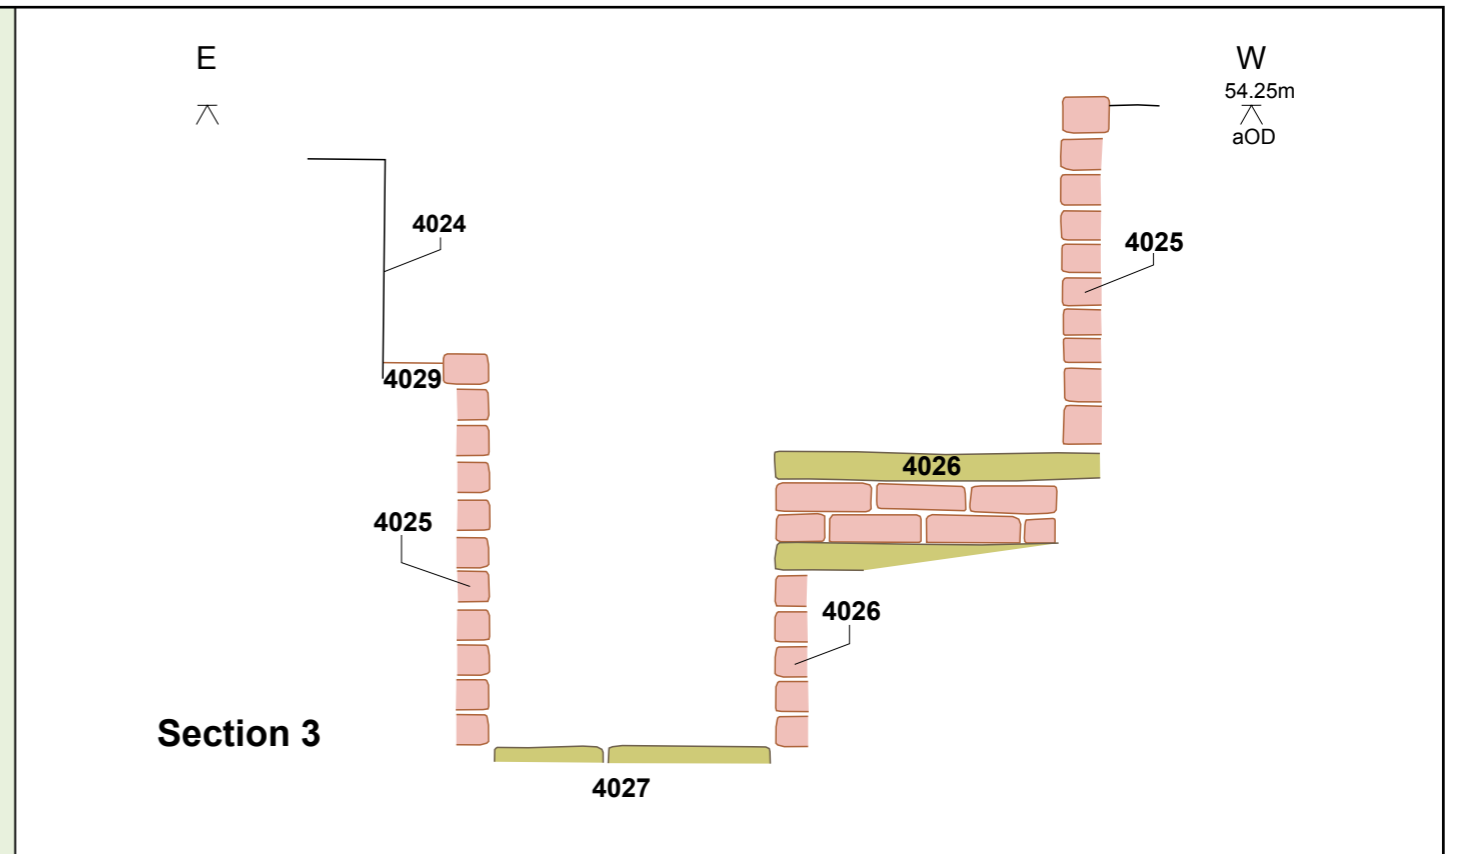
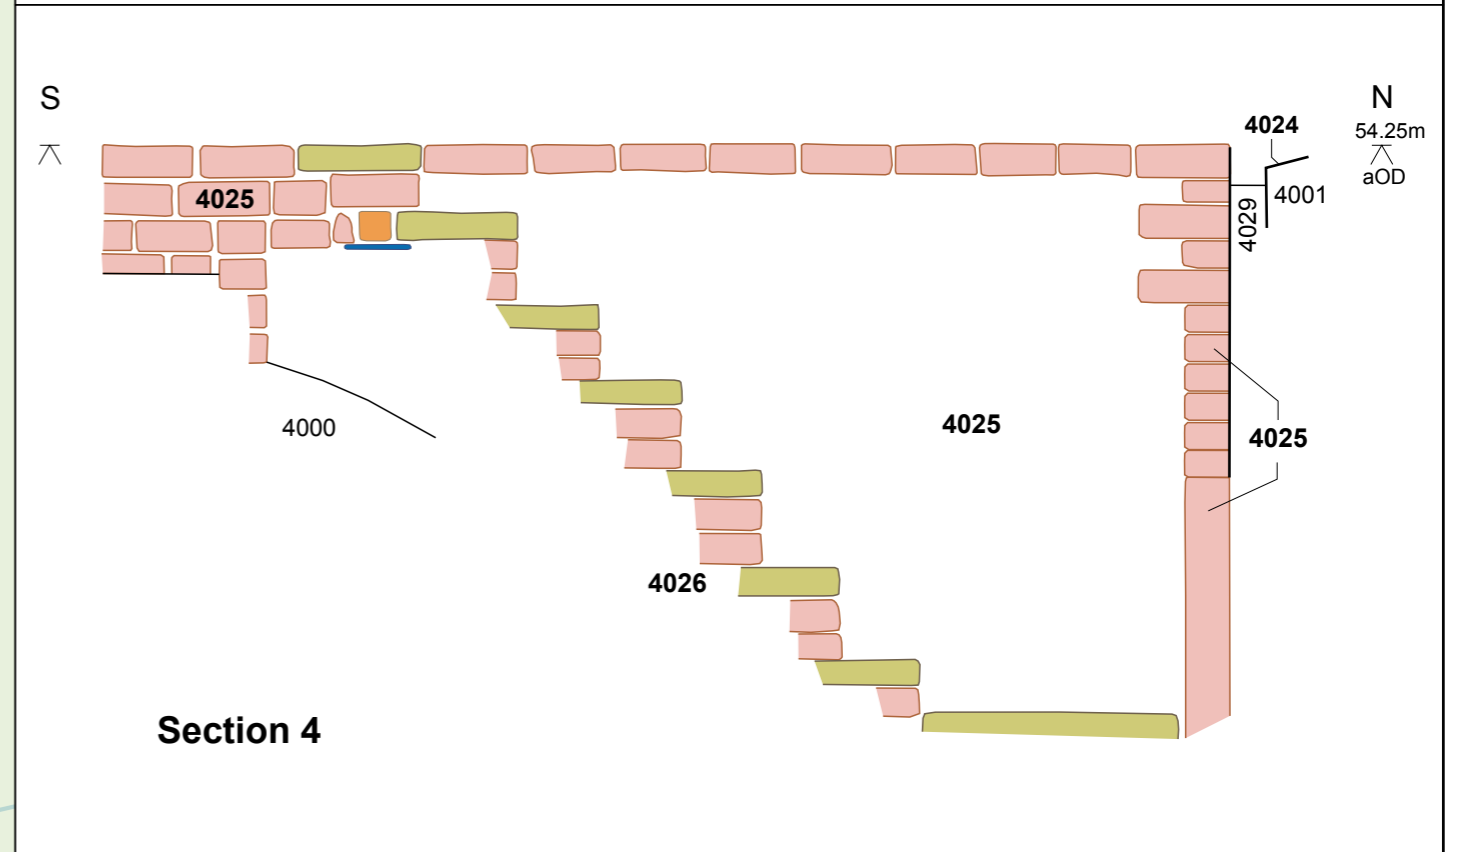
Figure 7

Plan and elevations of cellar in Area 4

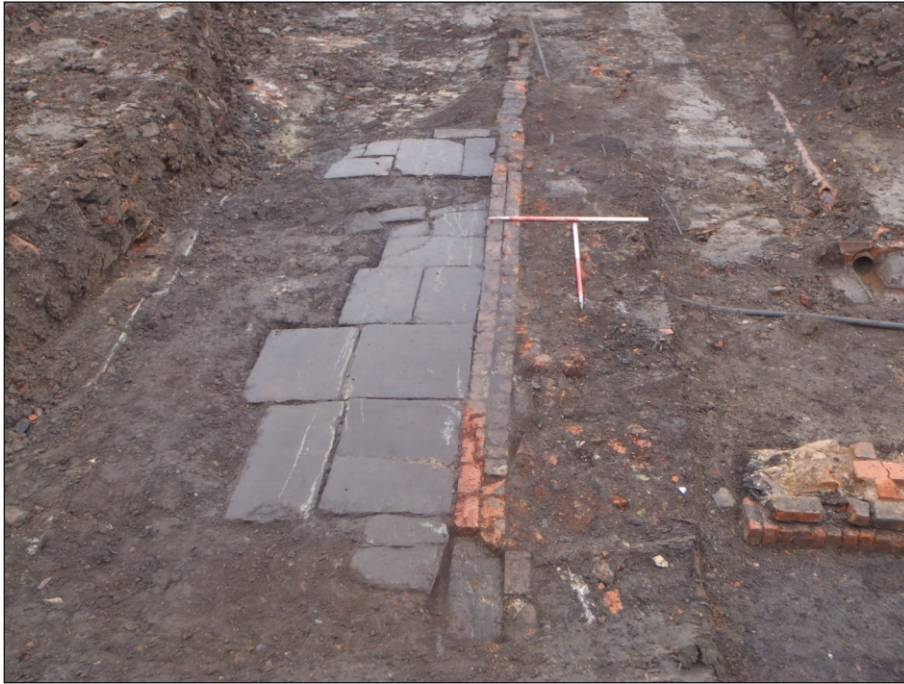
Plate 3: Wall **123** and flagstone surface **124** from south

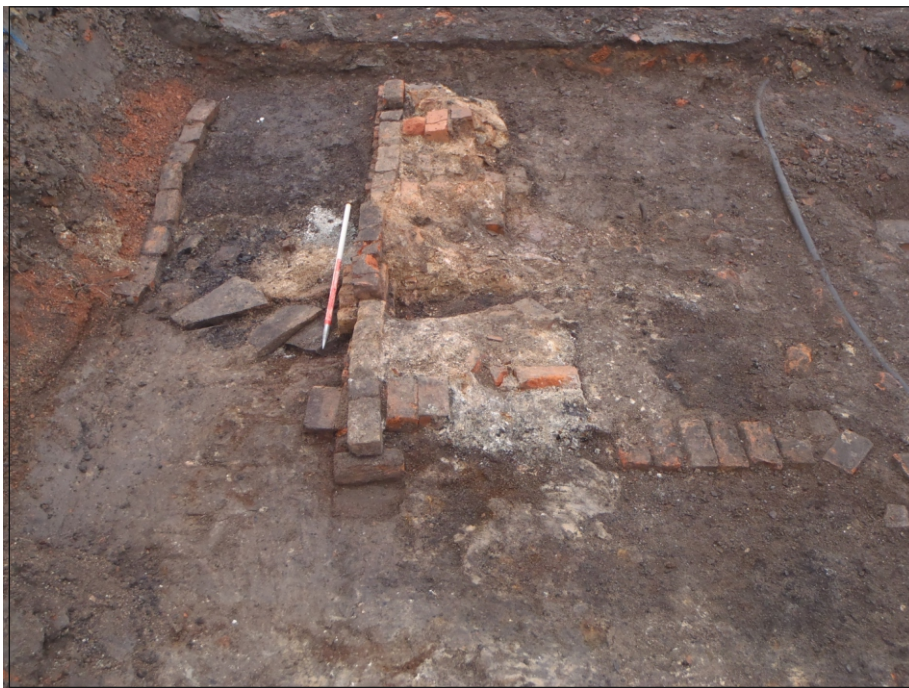
Plate 4: Walls **103**, **104**, **121** and **122** from east

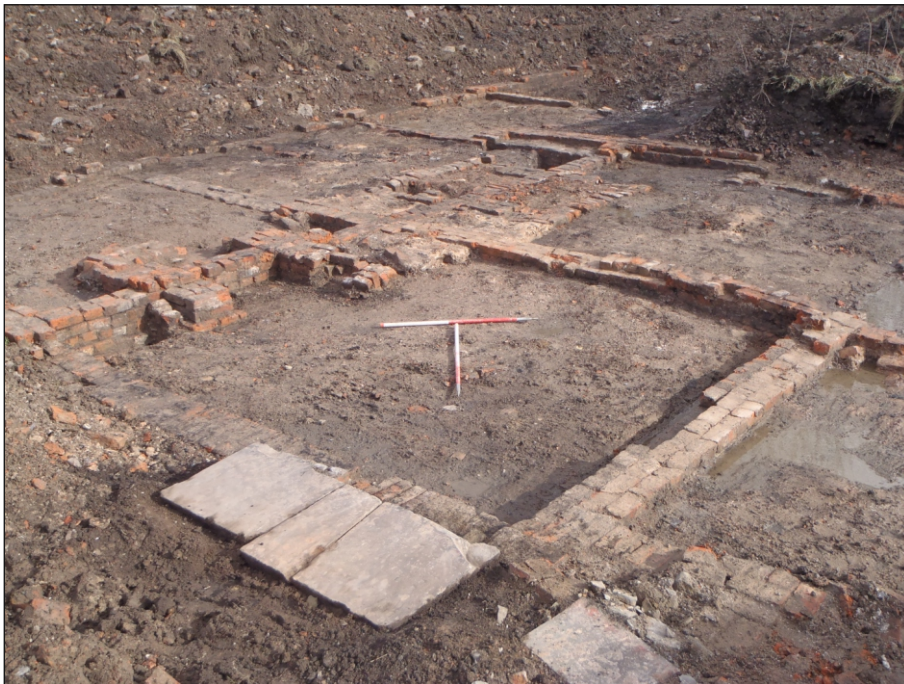
Plate 6: Overview of **Area 2** from south-west

- 5.3.1 Evaluation **Trench 2** was excavated, recorded and backfilled. **Area 2** was then excavated in the same position sufficient to uncover the footprint of two terraced houses (**Plate 6**). The results of **Area 2** are presented here with the addition of structures seen in **Trench 2** where these were outside of **Area 2**.

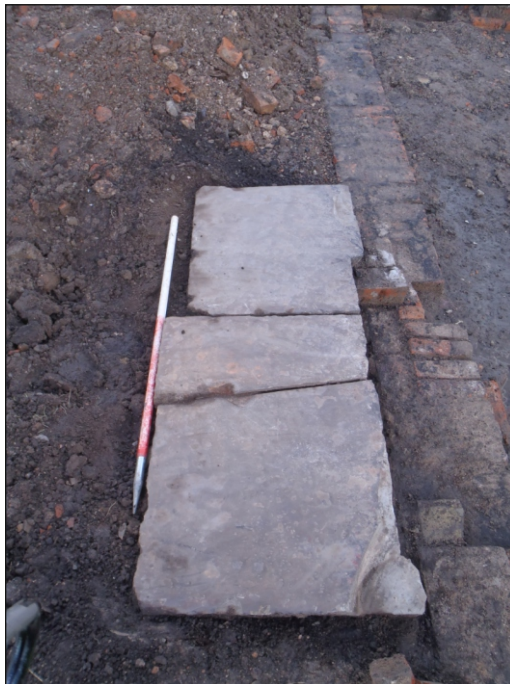
Plate 8: Sandstone step **2023** at entrance to **House 2.2** from south

- 5.3.5 In three locations thresholds were identified. The best of these is the survival of a flagstone step (**2023**, **Plate 8**) outside the front door of **House 2.2**. A similar structure (**2027**) but without the flagstones was seen at the entrance to **House 2.1**. A patch of headers within the kitchen wall at the rear of **House 2.1** (**2016**) suggests that the rear entrance was from the off-shot kitchen south into the yard.

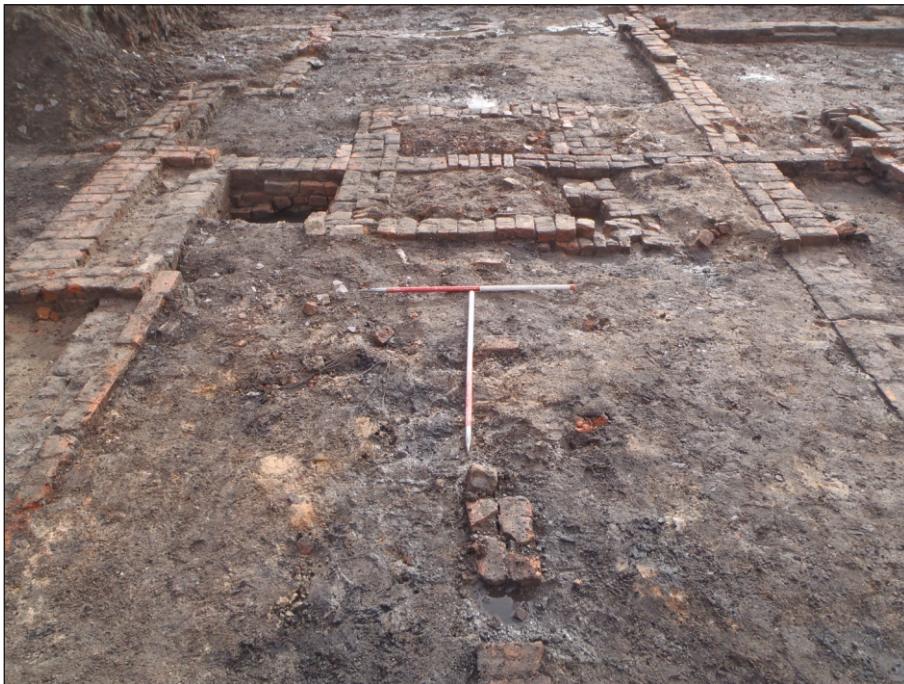
Plate 10: **Area 2** rear fireplaces from north

- 5.3.6 Fireplaces were provided in both of the main ground floor rooms of each house, surrounding wall **2012** which divides **House 2.1** from **House 2.2**. In the front rooms, the fireplace foundations consist of buttresses to wall **2012**. Adjacent to this, rough unmortared structures (**2019**, **2020**) were built on top of made ground **2025**, likely to carry a hearthstone above (**Plate 9**). The rear fireplaces (**2021**, **2022**) were more substantial mortared structures designed to support both the hearth and the chimney, and had proper foundations (**Plate 10**).

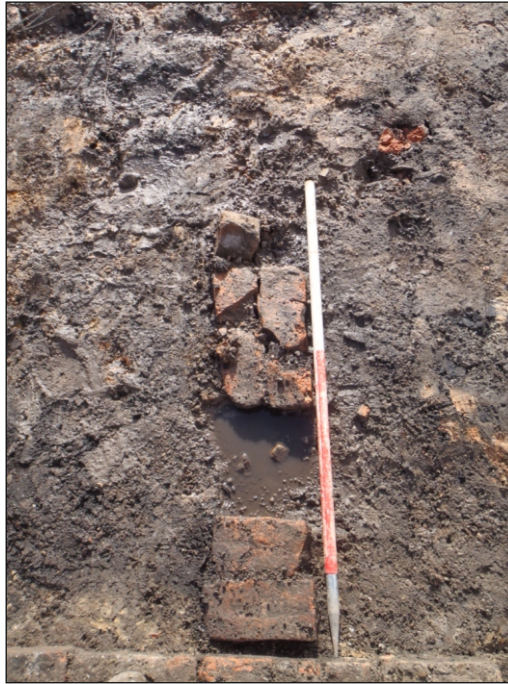
Plate 11: Ephemeral structure **2024**, possibly to support floor joists, from north

- 5.3.7 Another structure seen built on top of made ground **2025** was **2024**, an ephemeral red brick and black ash mortar structure consisting of scattered headers (**Plate 11**). It is likely that each main room had structures similar to these running from the fireplace to the opposite wall. These structures were also seen in the initial evaluation **Trench 2**, (e.g. **205**). It is possible that these were built to help carry the ground floor joists.

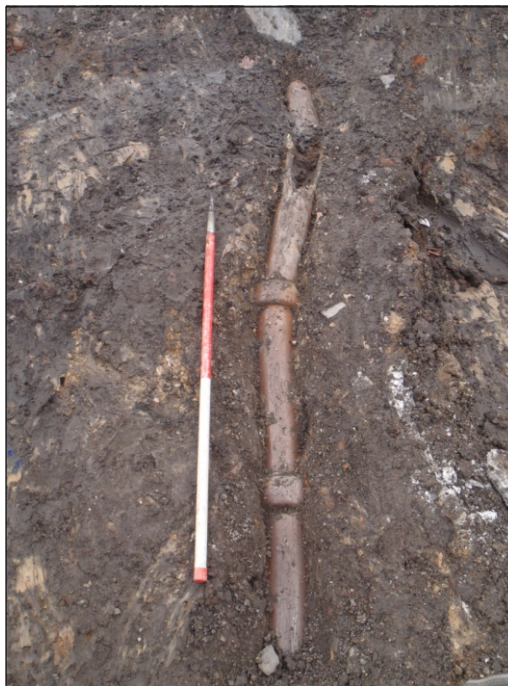
Plate 12: Drains **2017** in yard of **House 2.1** from west

- 5.3.8 Large ceramic drains (**2017**, **Plate 12**) were seen in a slot in the yard, and a lead pipe supplied fresh water to the kitchen (**2011**).
- 5.3.9 The original evaluation **Trench 2** ran through the front rooms of eight houses. The pattern established in the structures of **Area 2** was matched throughout the evaluation trench, with east-west dividing walls (e.g. **204**) and chimney base elements (e.g. **209**).

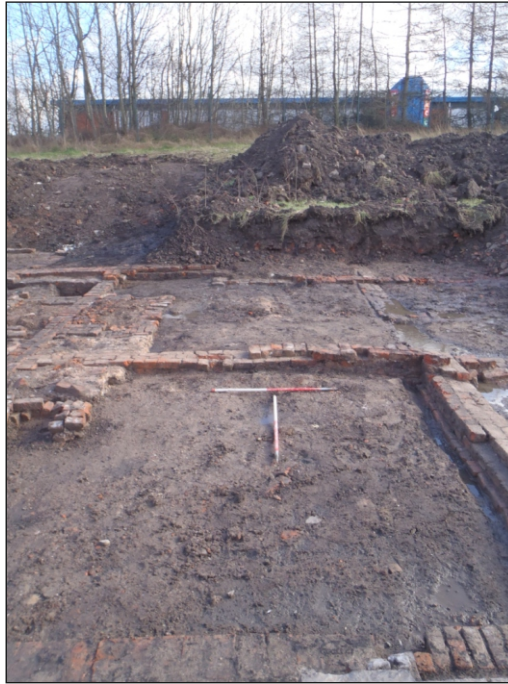
Plate 13: Additional skin **2014** to wall **2013** seen at right of shot from west

- 5.3.11 An extra skin, **2014** (**Plate 13**), was added to the inside of **House 2.2** along the southern wall (**2013**). The original two-skin wall **2013** was sandy lime mortared and the additional skin (**2014**) was black ash mortared. This additional skin was likely to correct some defect identified in the wall during the original construction and was undertaken before the area was levelled with made ground **2025**.

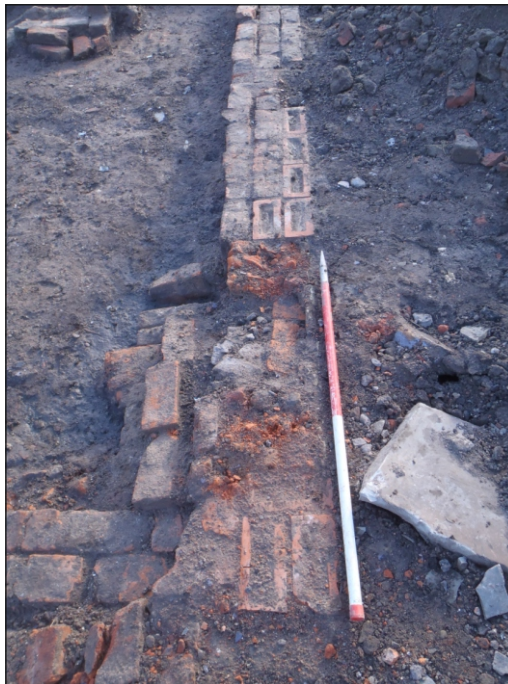
Plate 14: Front wall **2003** showing machine bricks and threshold **2027** from north

- 5.3.12 The front wall of the property (**2003**, **Plate 14**) was built mainly with frogged machine bricks, although some handmade bricks were used low down and at the rear of the wall.

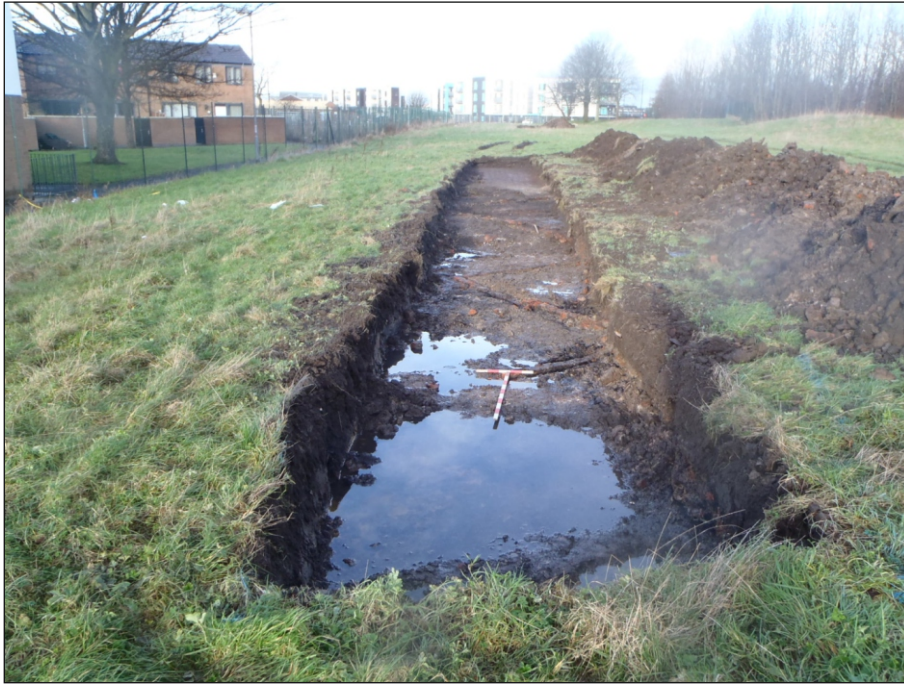
Plate 15: Overview of **Trench 3** from south-west

- 5.4.1 **Trench 3** was located diagonally across five terraced houses (**Figure 5, Plate 15**). The excavated structures tie in very tightly with the OS map of 1908, which shows terraced housing fronting onto Margaret Street without the off-shot kitchens present in **Area 2**.

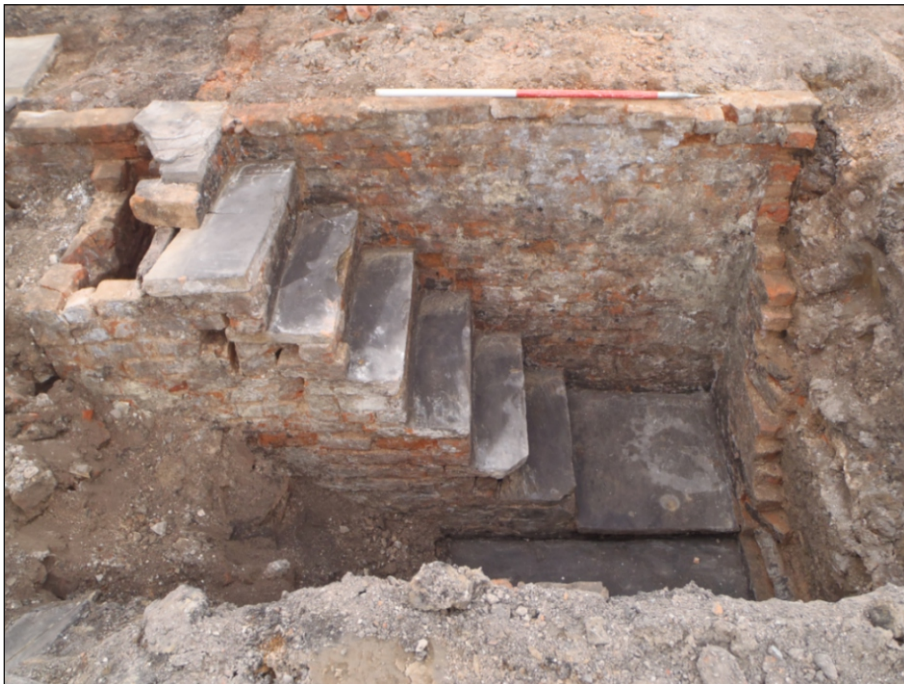
Plate 18: **Area 4** cellar from east
