ST MARTIN'S CHURCH

WHITE RODING

ARCHAEOLOGICAL MONITORING

HISTORIC ENVIRONMENT RECORD SUMMARY

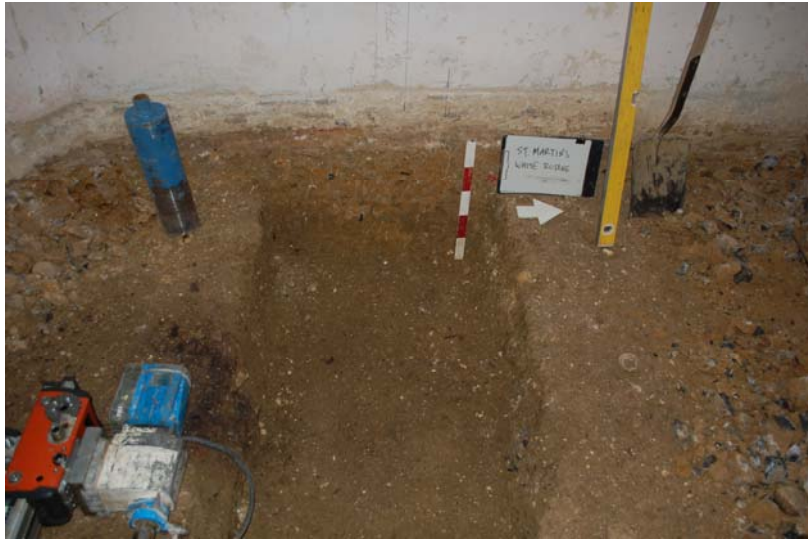
Plate 1. Drilling pit in the tower

The internal works involved the removal of the floor and reduction of its level, along with the excavation of a drilling pit to allow services to run through the church walls. Concrete, 0.15m thick was removed across the entire floor of the tower. A thin (0.08m) layer of compacted sand (02) lay below the concrete and rested on a dark brown, soil-like, silty clay deposit (03), which was over 0.45m thick. This is thought to be a construction/levelling deposit and contained occasional small pieces and flecks of lime based mortar. No finds were recovered.

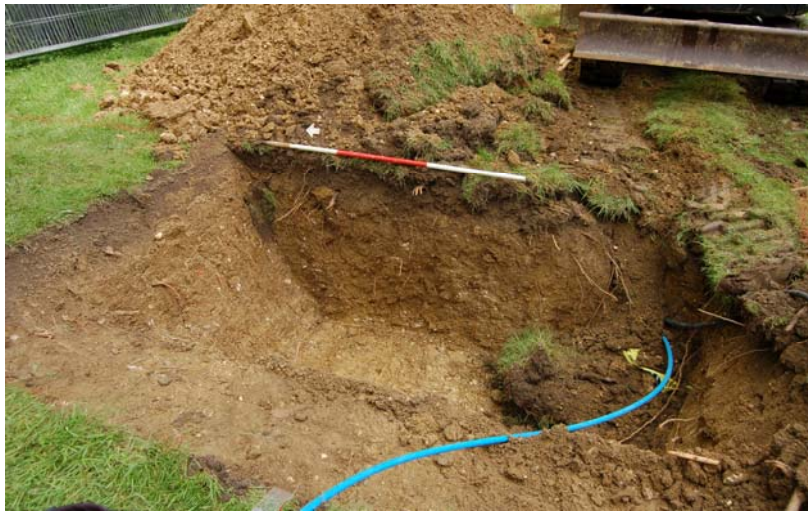
Plate 2. Cess tank pit, west facing section (1.5m scale)

Outside the church a 2 x 3m cess tank pit was excavated to a depth of >1.8m, the edges of which were unstable due to the ingress of water at this depth. The vegetation/ topsoil (04) was removed onto a greyish brown silty clay (05). This deposit was between 0.1m and 0.4m thick, being more extensive towards the south. Below this lay further greyish brown sandy silt deposits (06 and 08), again thicker to the south. The edges of these deposits were unclear, and both contained occasional pieces of brick and tile, disarticulated bone and chalk fragments. A band of sandy silt (07), 0.5m wide, crossed the pit diagonally (from the north east to south west), its exposed length being 2.4m. The edges of the deposit were unclear but, in section, it appeared to have vertical edges and extend to a depth of >1.2m. It is possible that this material may have been the infill of a grave cut but the limitations presented by the size and depth of the pit mean that this interpretation cannot be confirmed. The base of the pit, at 1.8m, comprised a sandy silt with a loose friable texture and frequent chalk. The excavation of the remainder of the pit was not observed as the sides began to collapse so the works were shuttered.

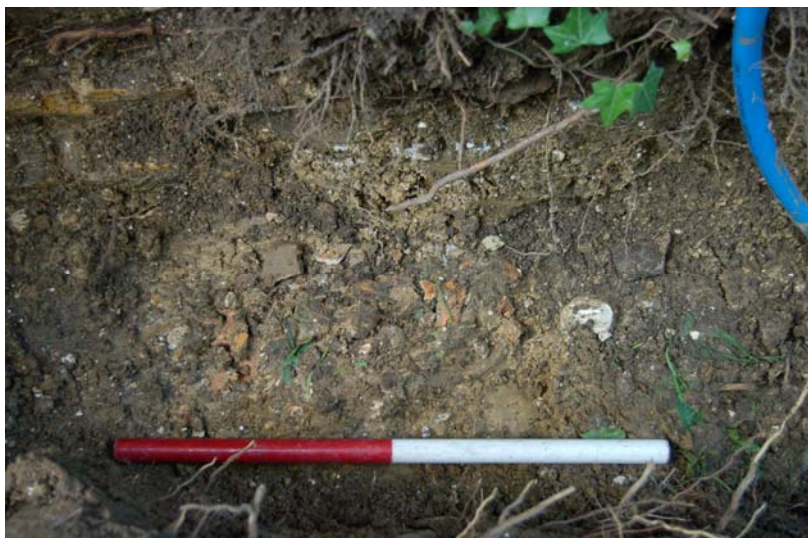
Plate 3. Disarticulated bone in service trench by vestry (0.5m scale)

The service trench linking the pit and the vestry was observed. A small jumble of disarticulated bone (presumably human) was recovered in the end of this, adjacent to the corner of the vestry. These remains, which included small pieces of skull and pelvis, part of a jaw, teeth and fragments of long bones were located at the base of the narrow trench (0.45m below the present surface level). These bones were not *in situ* and, being in close proximity to an existing water pipe and drain cover, had probably already been disturbed. They were left in their present location, and are now below a pipe/cabling.
