CHURCH of St. THOMAS à BECKET Northaw, Herts.

(HN455)

Archaeological Monitoring Report

Prepared on behalf of Northaw Parochial Church Council

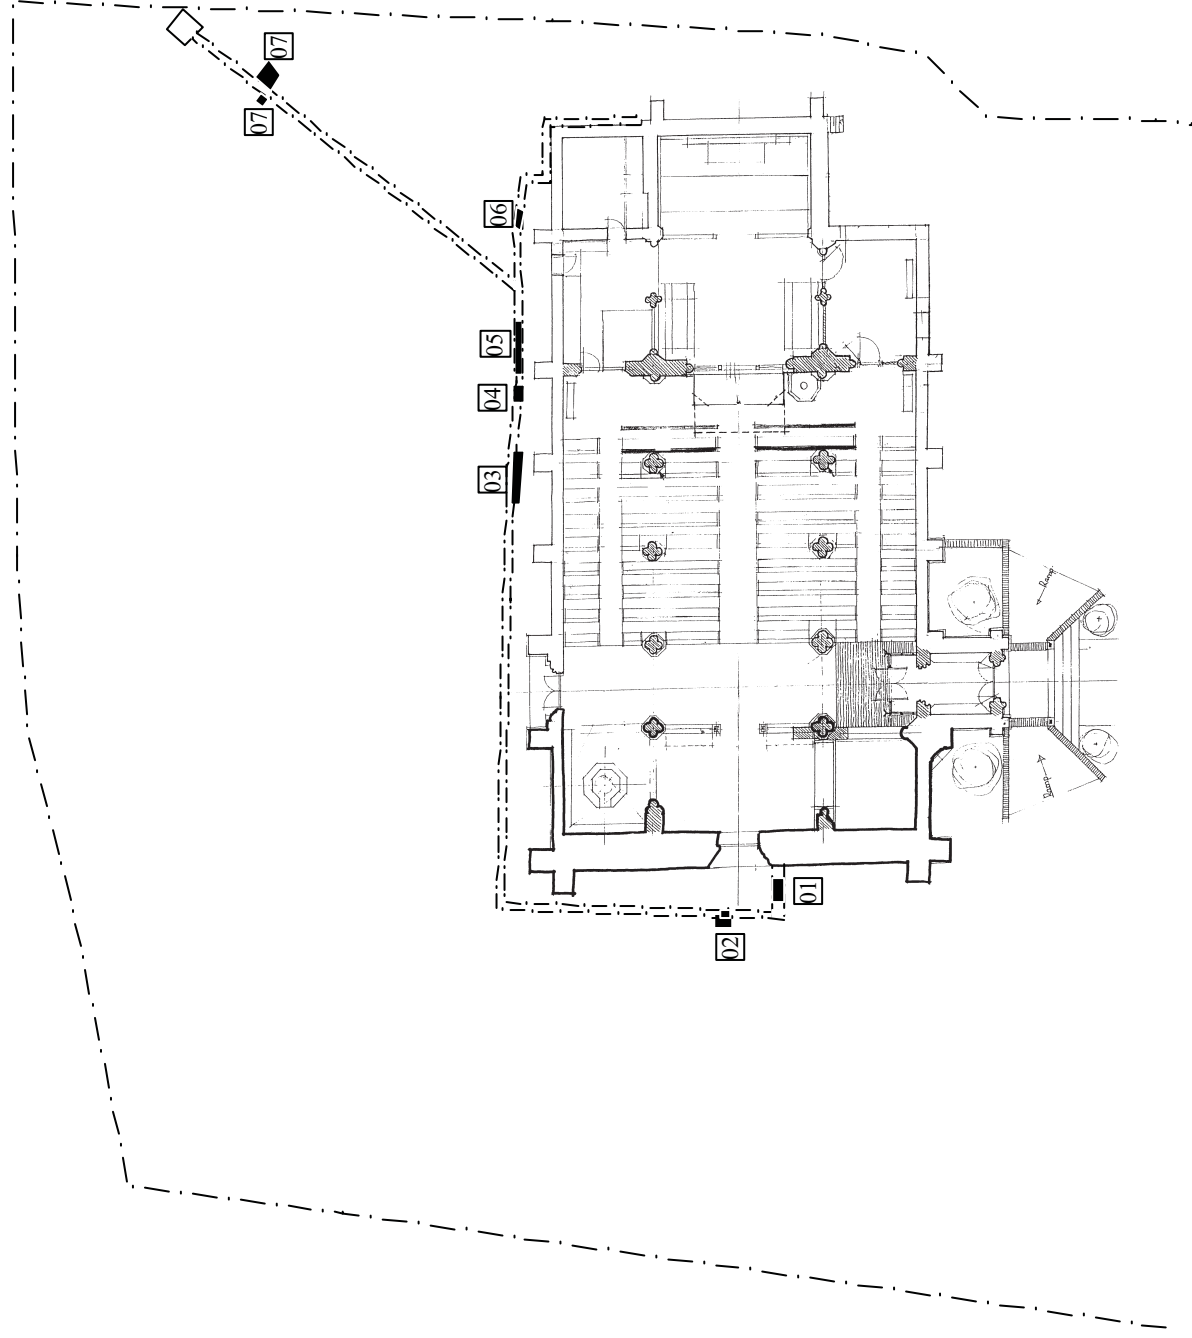
Figure 2

Site layout

Scale 1:300

2.1 The service trenches were hand dug, and were between 0.30m and 0.47m wide, reaching a maximum depth of 0.65m (Fig.2).

Figure 2Site layout
