# St. ANDREWS CHURCH Kimbolton, Cambs.

HN472

Archaeological Monitoring Report

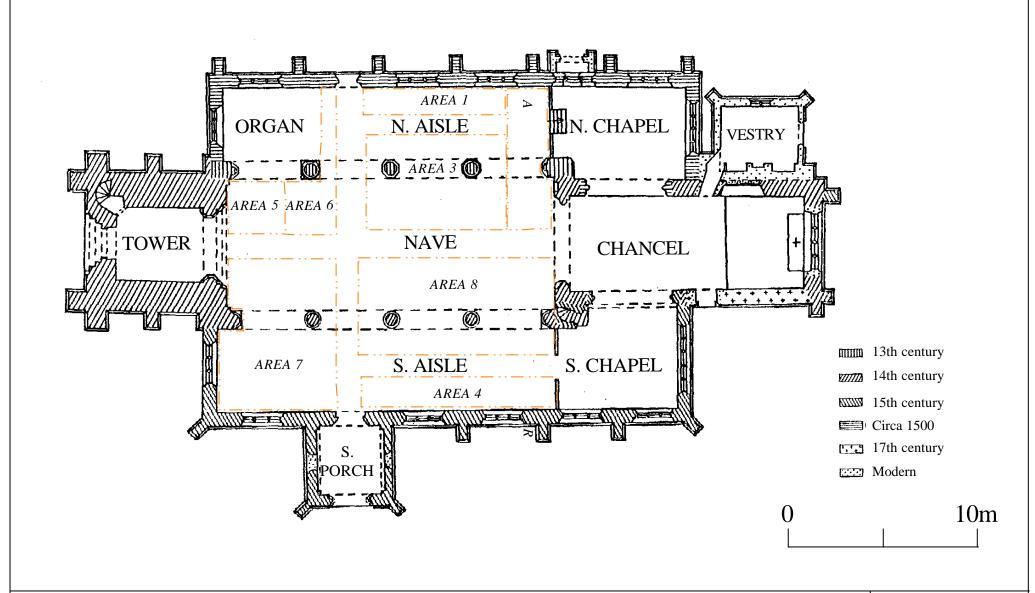
Figure 2

Site Layout (After Page et.al., 1936) Scale 1:200

- 2.4 Area 1 ran east to west against the north wall of the nave and measured 7.60 x 1.85m (Figure 2). Area 2 lay to the east of Area 1. It was orientated north to south and measured 2.95 x 7.80m.
