## ABBEY MILLS Waltham Abbey, Essex

*Archaeological Evaluation Report*

Heritage Network ref.: HN545

Site Code: WA13

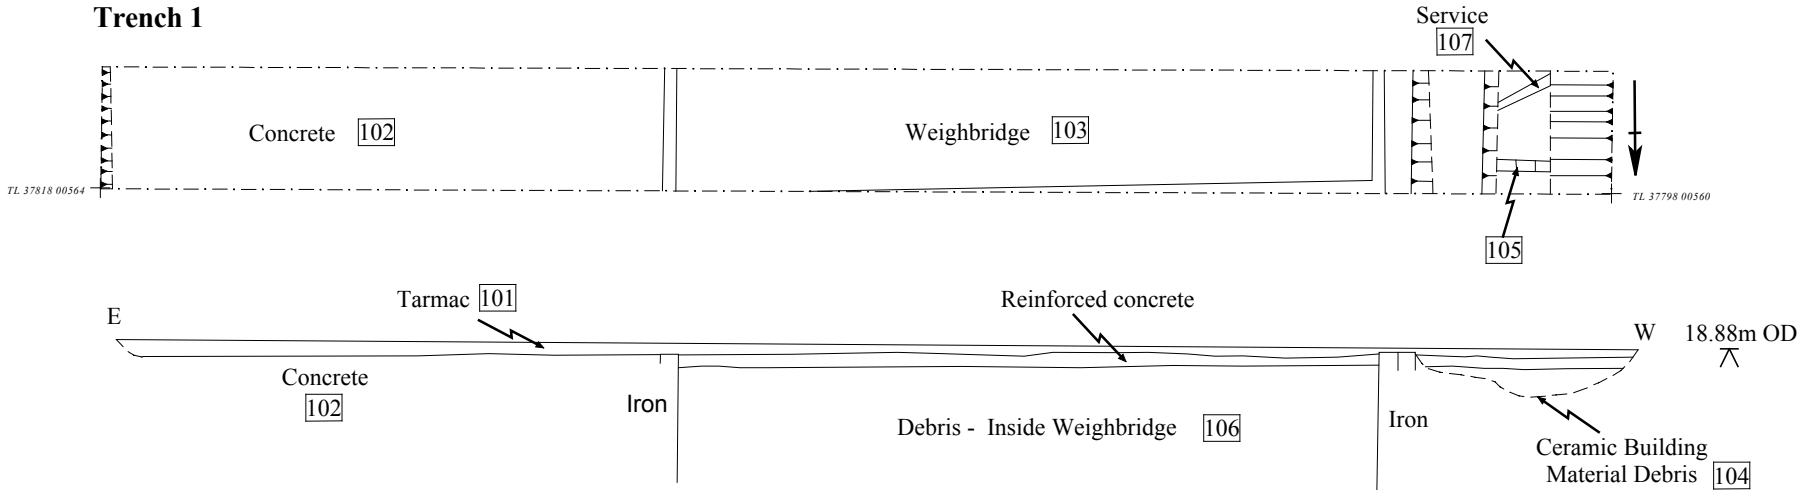
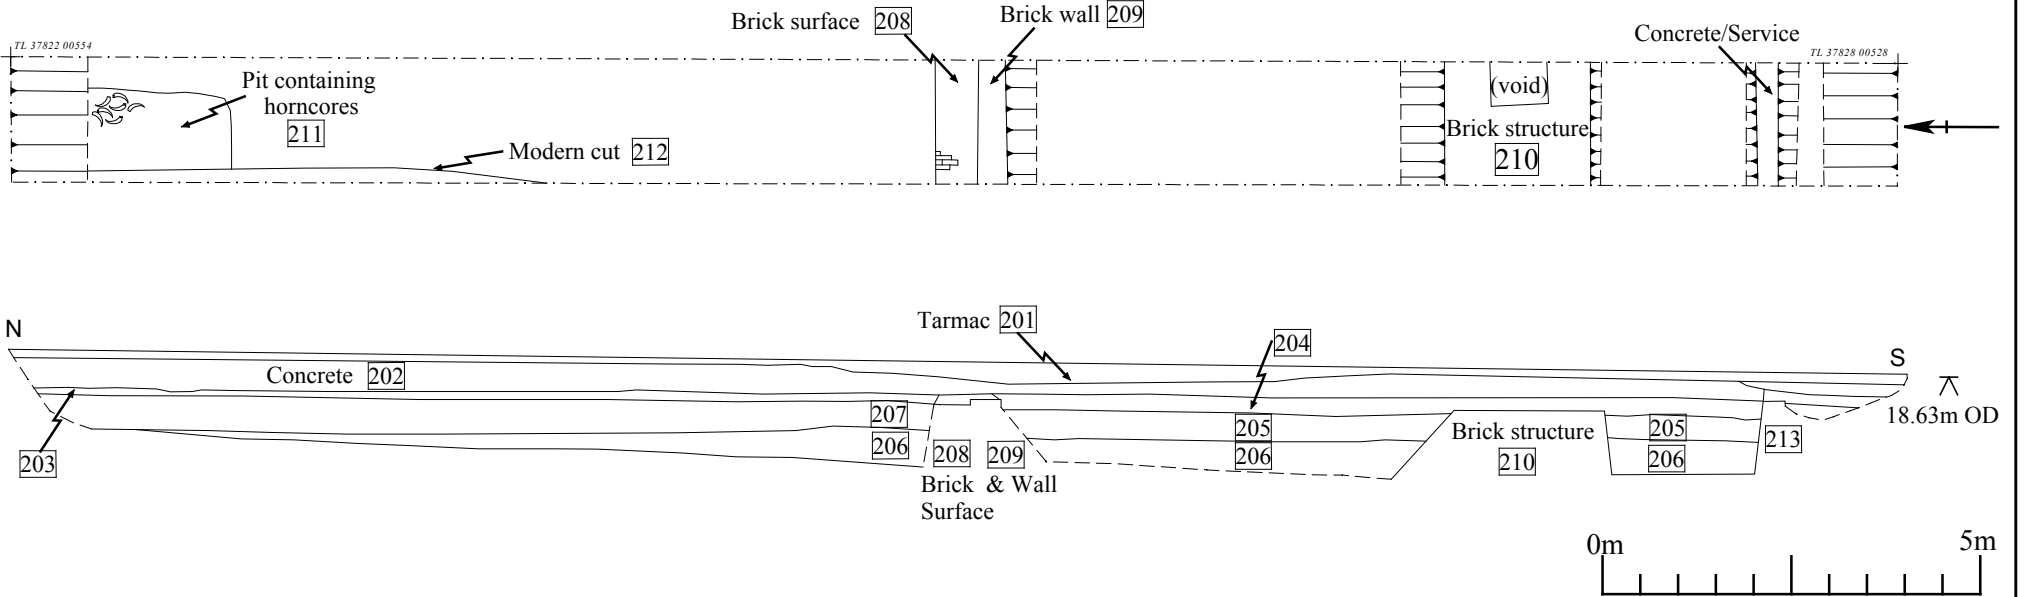
Figure 3

**Trench 1**

**Trench 2**

Trenches 1 & 2: Plans and Sections

Scale 1:100

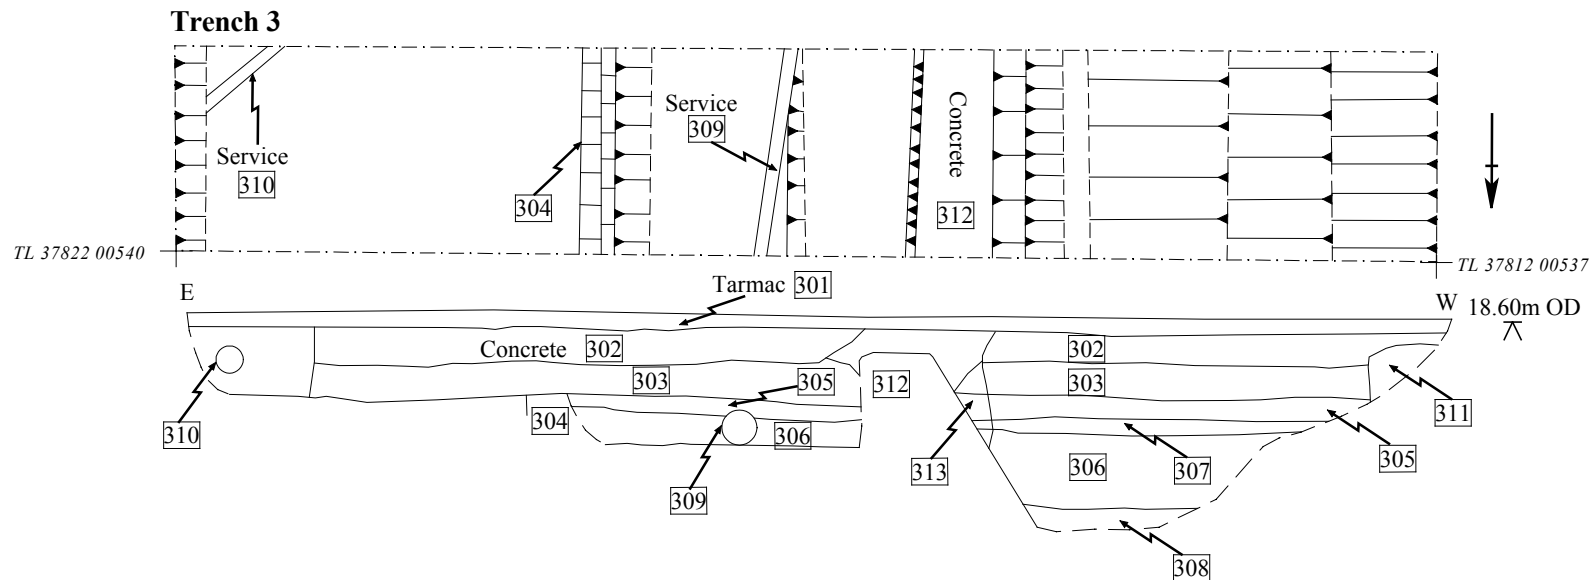
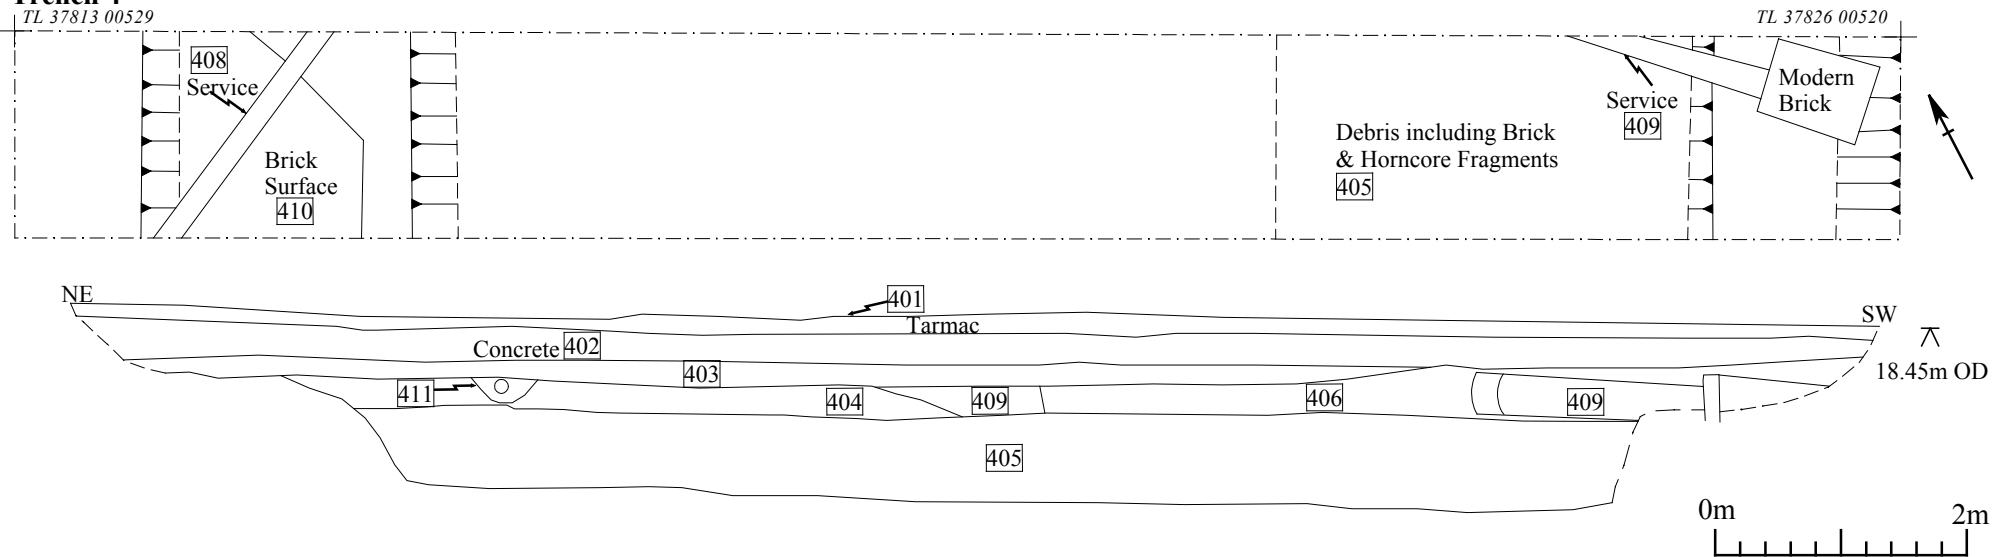
Figure 4

### Trench 4

Trenches 3 & 4: Plans and Sections

Scale 1:60
