Building at Friar Cote Farm
Staindrop
County Durham

archaeological building recording

report 4634
December 2017

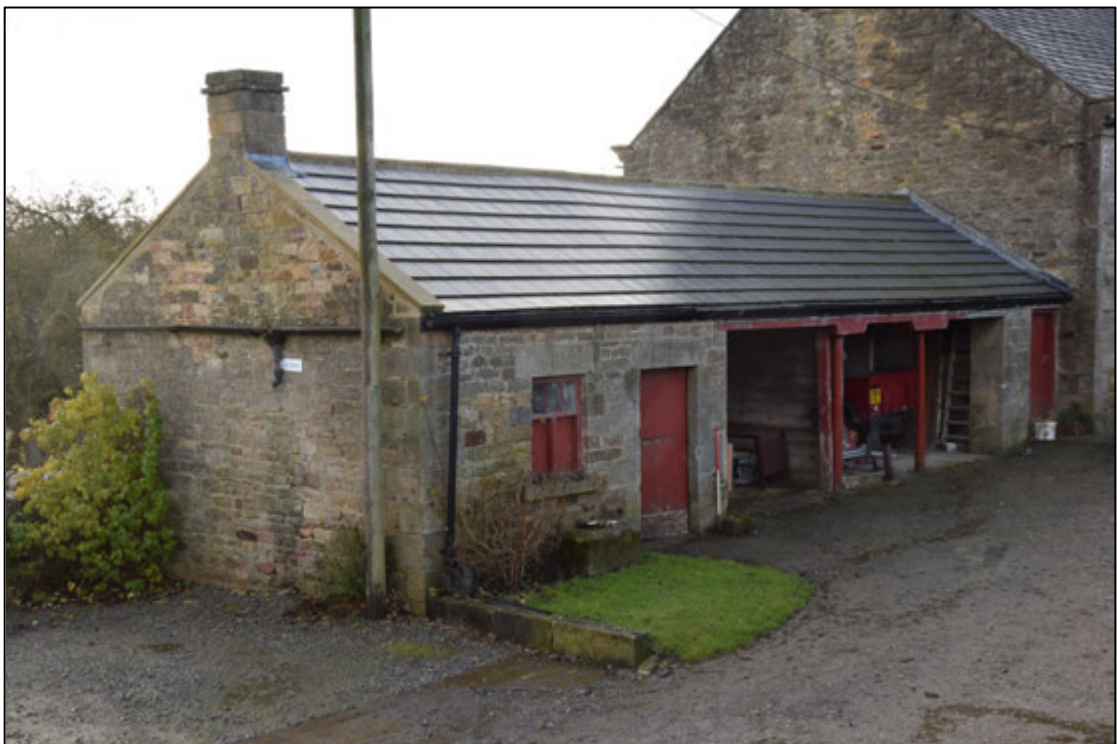
Photograph 2: The building seen from the north-east

- 5.1 The building is a single-storeyed gabled shed extending east from the end of the farmhouse (Figures 3 and 4); it is built of local sandstone. More than half of the north face is open, under a modern roof; there is a gable chimney at the east end (Photographs 1 & 2). The east end is plain (Photograph 3) and there are no traces of the additional building that was demolished in the second half of the 19th century. The south face is largely blank, apart from a single window at the east end and a door at the west (Photograph 4). This face is set back from the front of the farmhouse and forms the north boundary of the garden at this side of the house (Photograph 5).

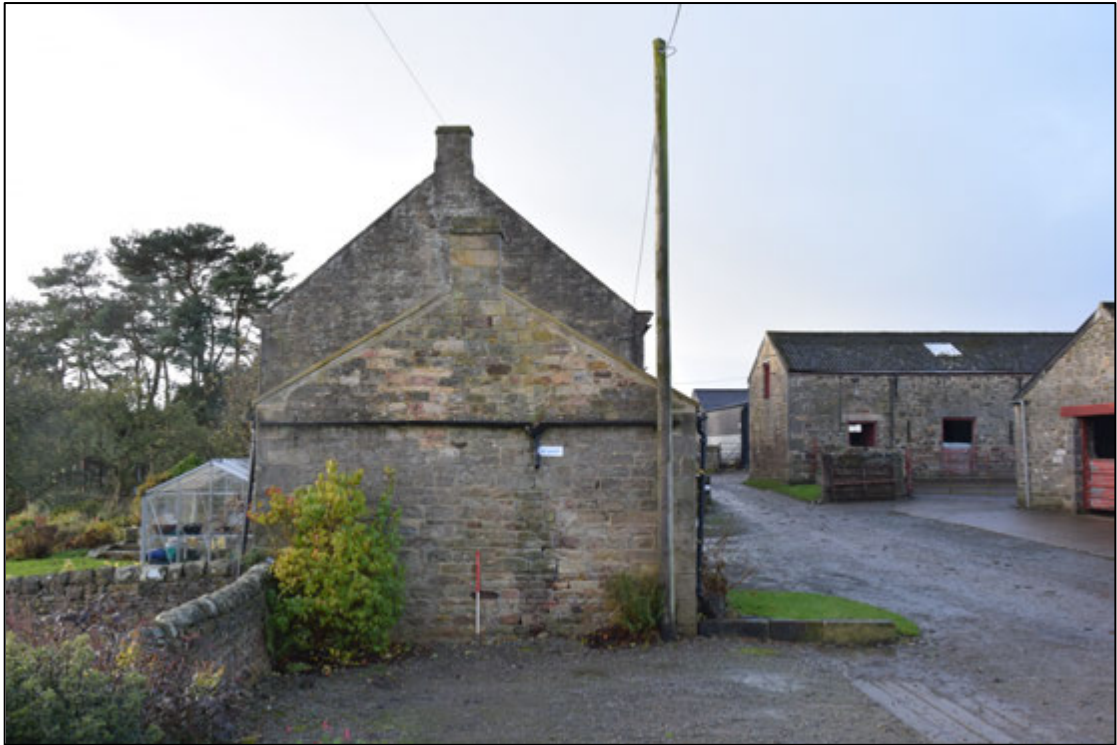
Photograph 3: The view from the east, showing the farmhouse and other buildings. The building shown on the tithe map extended from the low gable at least as far as the viewpoint of this picture

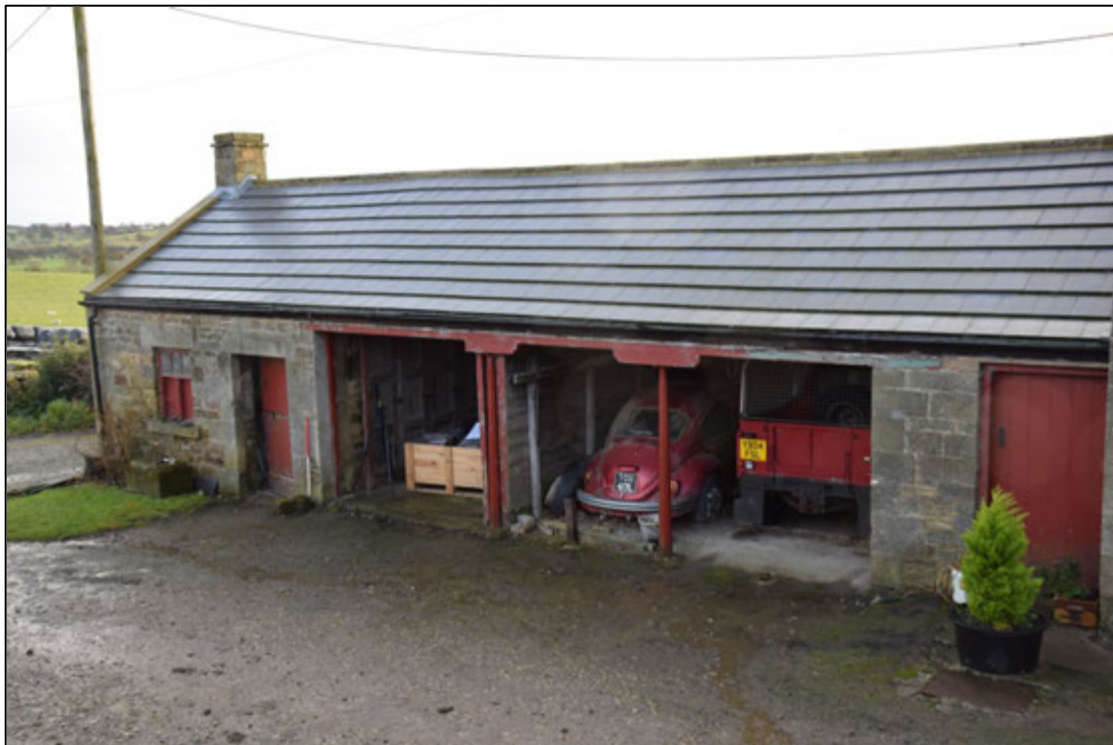
Photograph 6: The north face of the building, showing the division (right to left) into passage, open shed and smithy / wash house

- 5.2 Nearest to the house, a door in the north wall gives access to a passage running through the building (Photograph 6). Beside this is a three-bay open-fronted shed (Photograph 7); its timber lintel is carried on tapered octagonal cast-iron columns. The eastern bay is separated from the rest by a timber partition (Photograph 8). The east end of the building contains a small stone shed that was originally a smithy and later a wash-house. It has a stable door and small windows at the front and rear (Photograph 9).

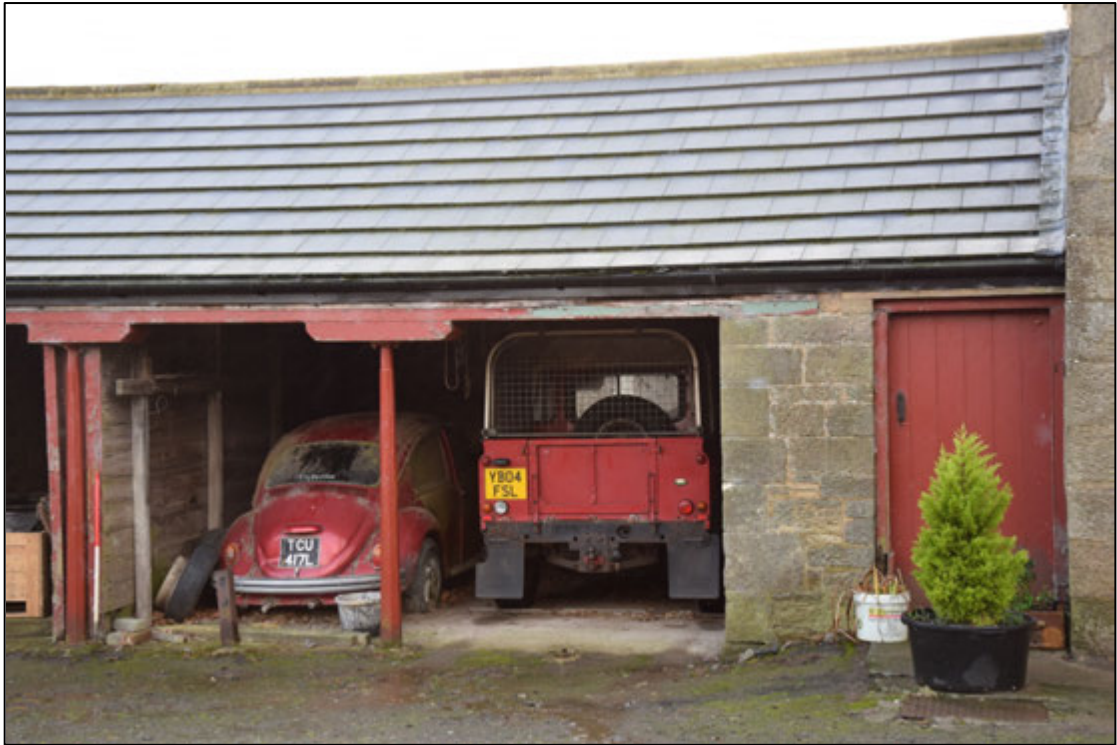
Photograph 7: Substantial masonry forms the pier between the open shed and the passage door, at the right

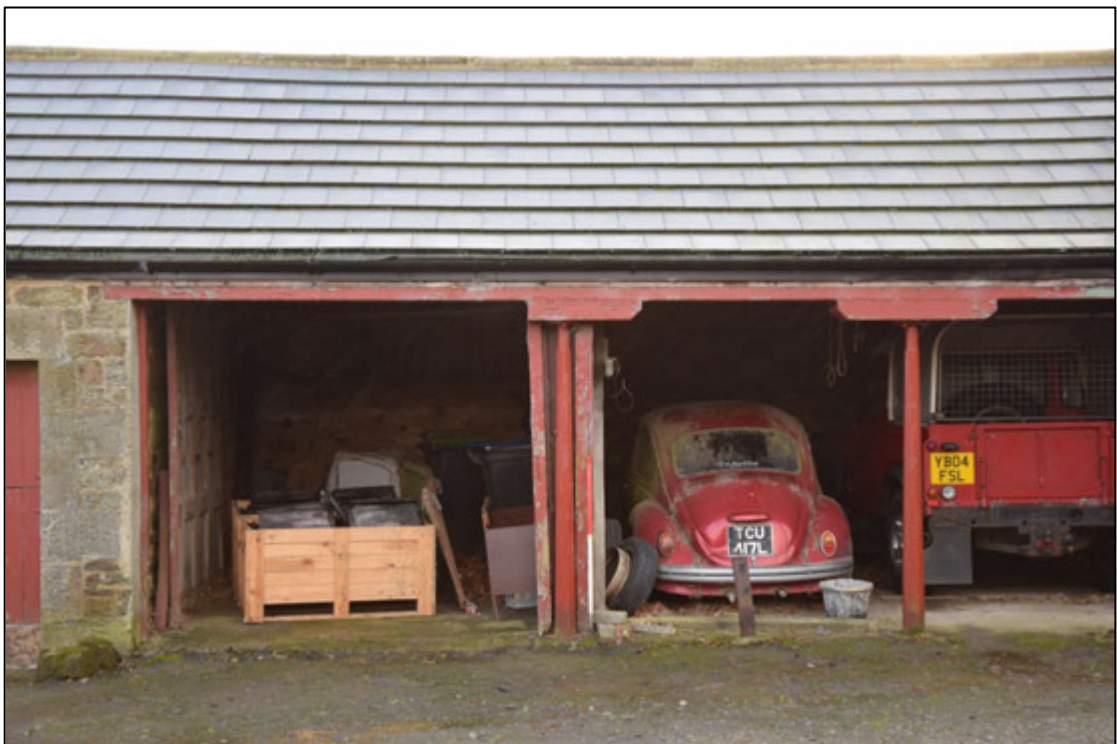
Photograph 8: The middle and eastern bays of the shed. The left-hand bay was converted to make a garage; its sliding door can be seen at the left

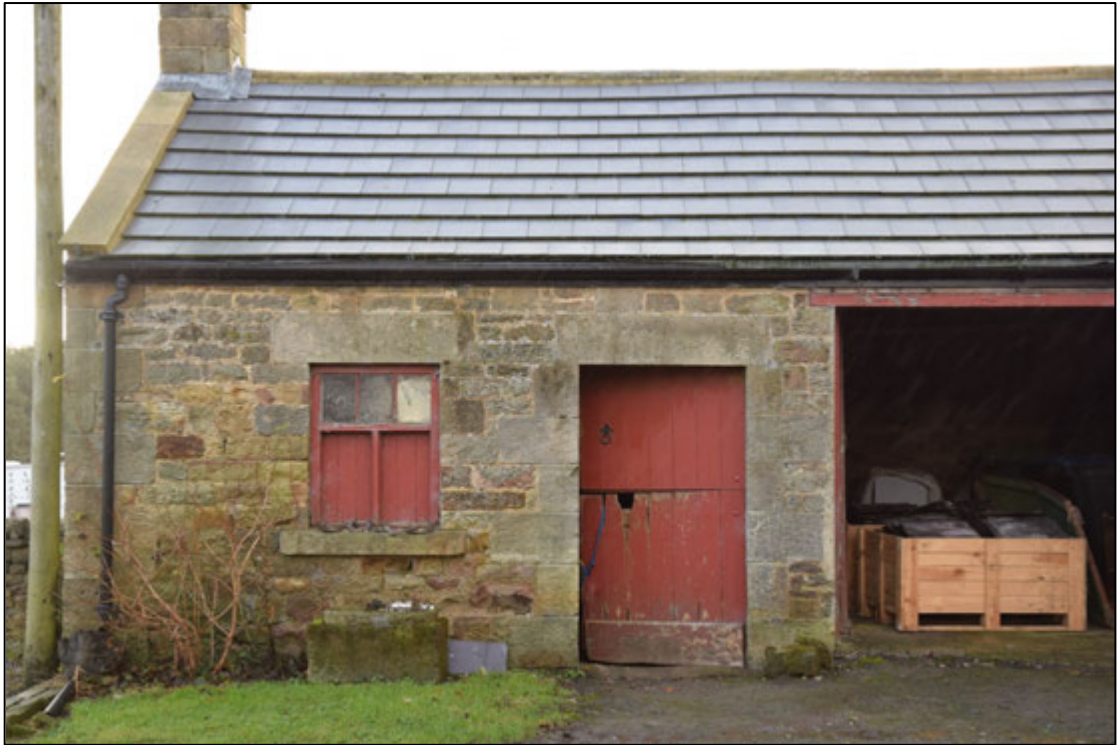
Photograph 9: The north face of the smithy / wash house

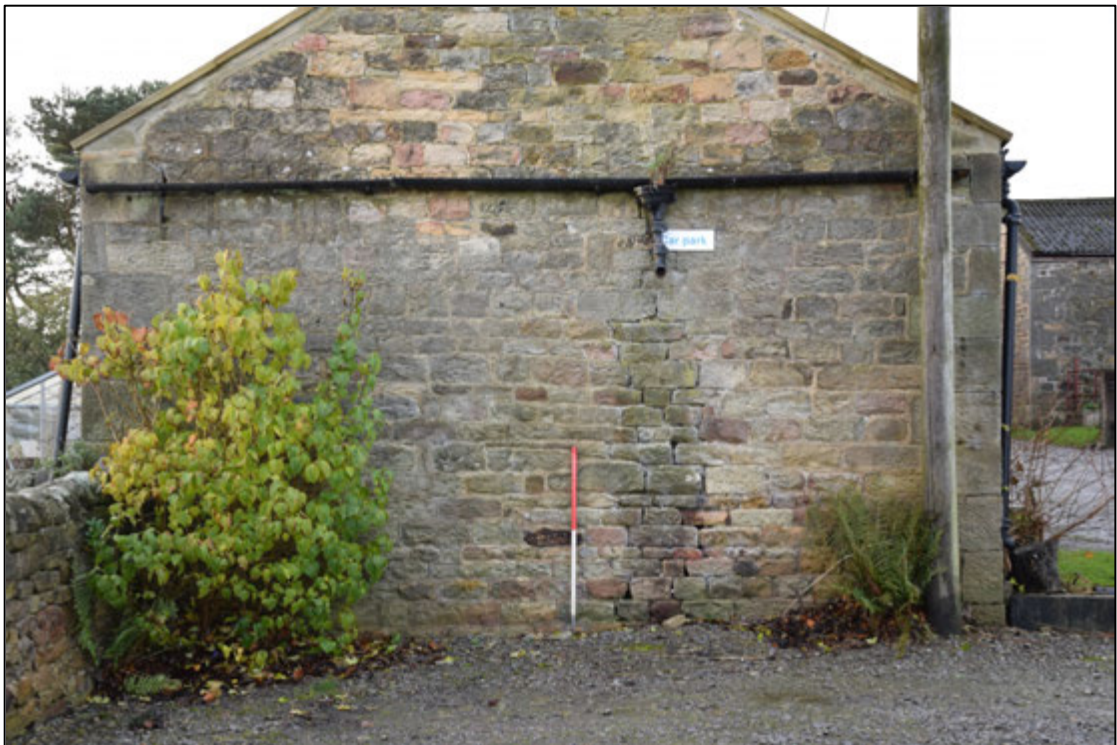
Photograph 10: Evidence of re-roofing can be seen in the re-set water table slabs on the gable. There is no trace of any building attached to this end of the structure

- 5.3 The masonry throughout the building is coursed squared rubble, with dressed stone in the quoins and the water table. The east end is blank (Photograph 10) and the south face has a single window at the east end (Photograph 11); the glazing here has been renewed. There is evidence of repointing at the head of the wall in the south face, doubtless connected with the modern re-roofing (Photograph 12). At the west end a plank door opens into the passage (Photograph 13).

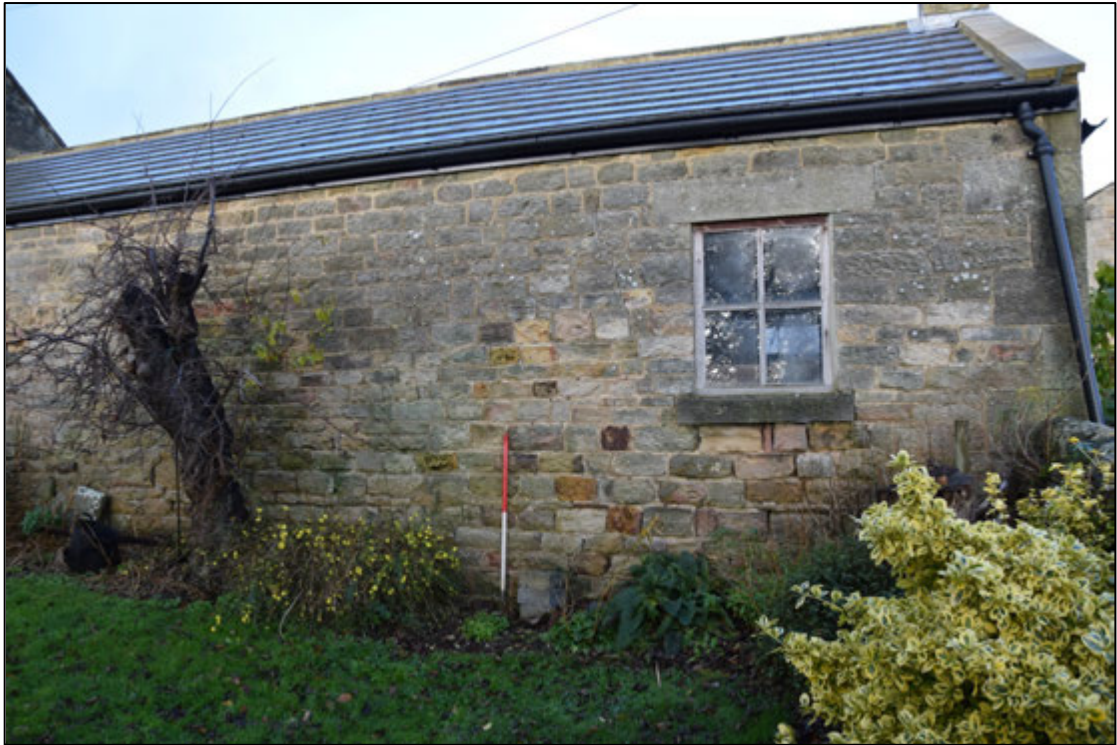
Photograph 11: Coursed masonry in the south face, with the window of the smithy

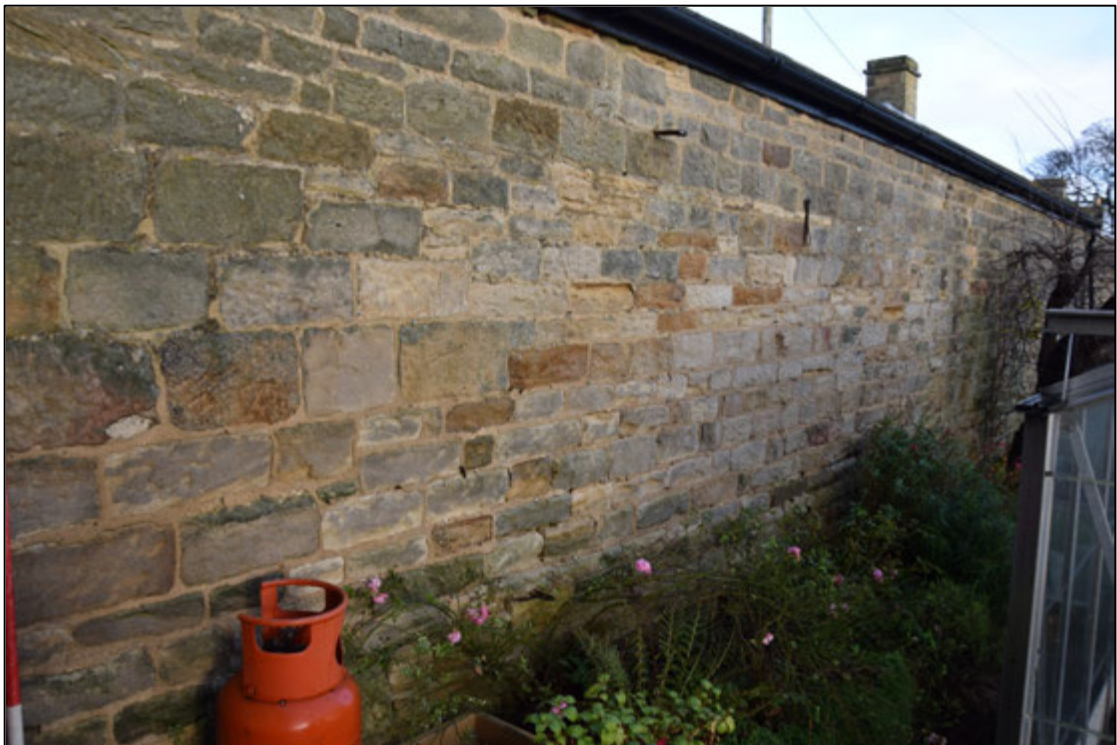
Photograph 12: Different mortar shows where stones have been re-set at the wall head during re-roofing work

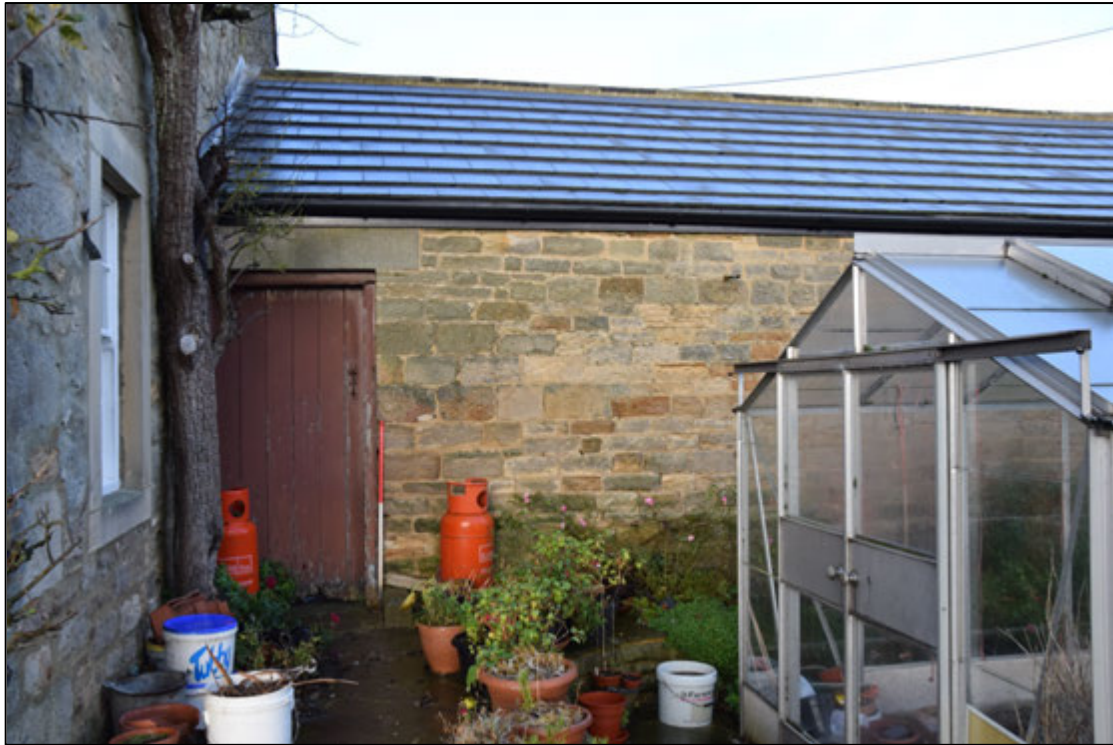
Photograph 13 (above): The south end of the passage, with the east wall of the farmhouse

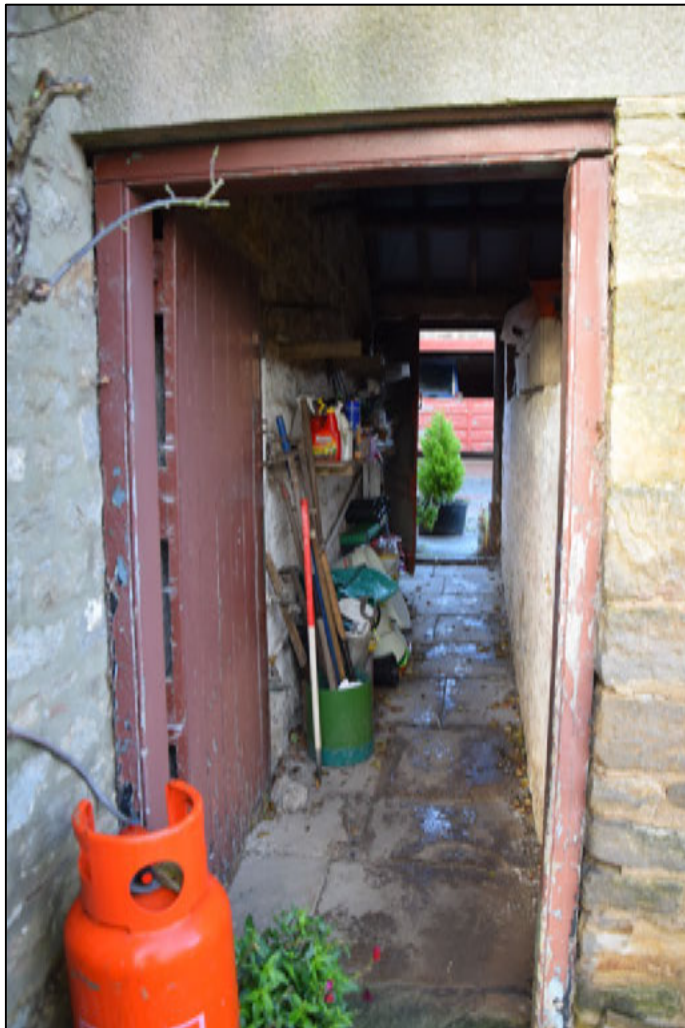
Photograph 14 (left): Looking north along the passage

- 5.4 The west passage has a sloping flagged floor; a white-painted wall, 1.5m high separates the passage from the shed (Photographs 14 & 15). The shed itself is largely featureless; the iron columns are unmarked. The eastern bay was formerly used as a stable and later altered to be used as a garage. The plank wall at the west side was moved slightly west, the timber pad at the top of the column was cut back and a sliding timber door was installed (Photograph 16). The hay rack in the old stable is still present and the mark of a manger can be seen below it (Photographs 17 & 18).

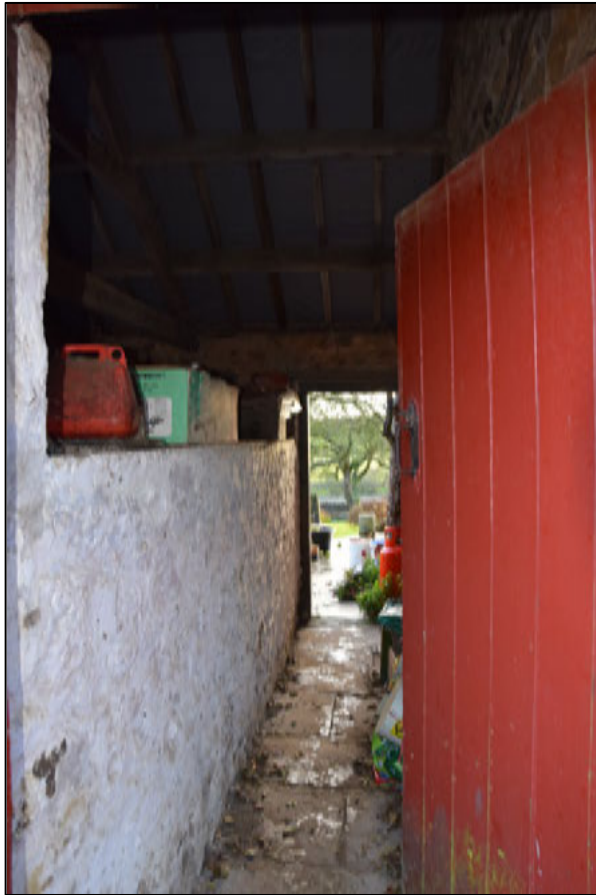
Photograph 15: The low wall at the east side of the passage

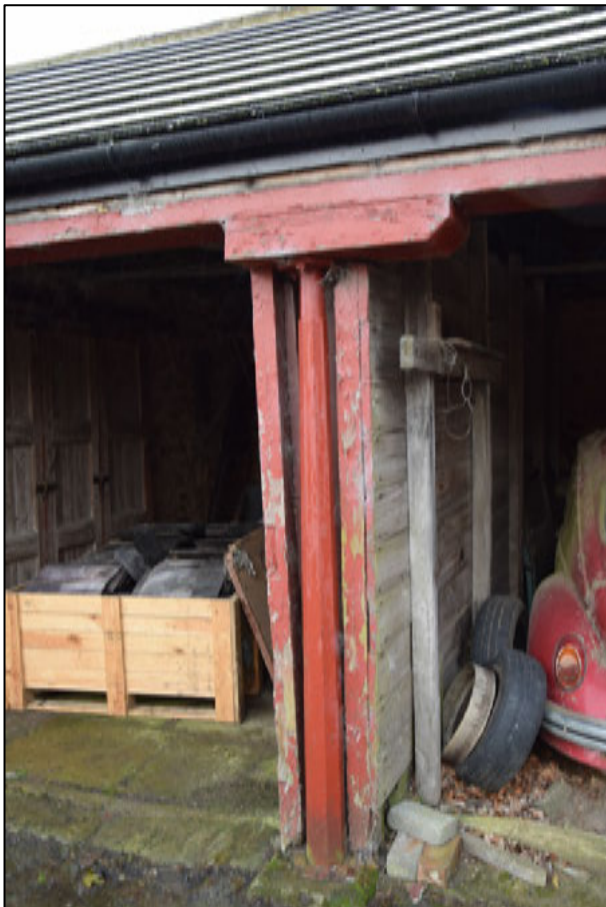
Photograph 16: The plank wall of the garage in the east bay of the shed. Note the alteration to the pad above the iron column

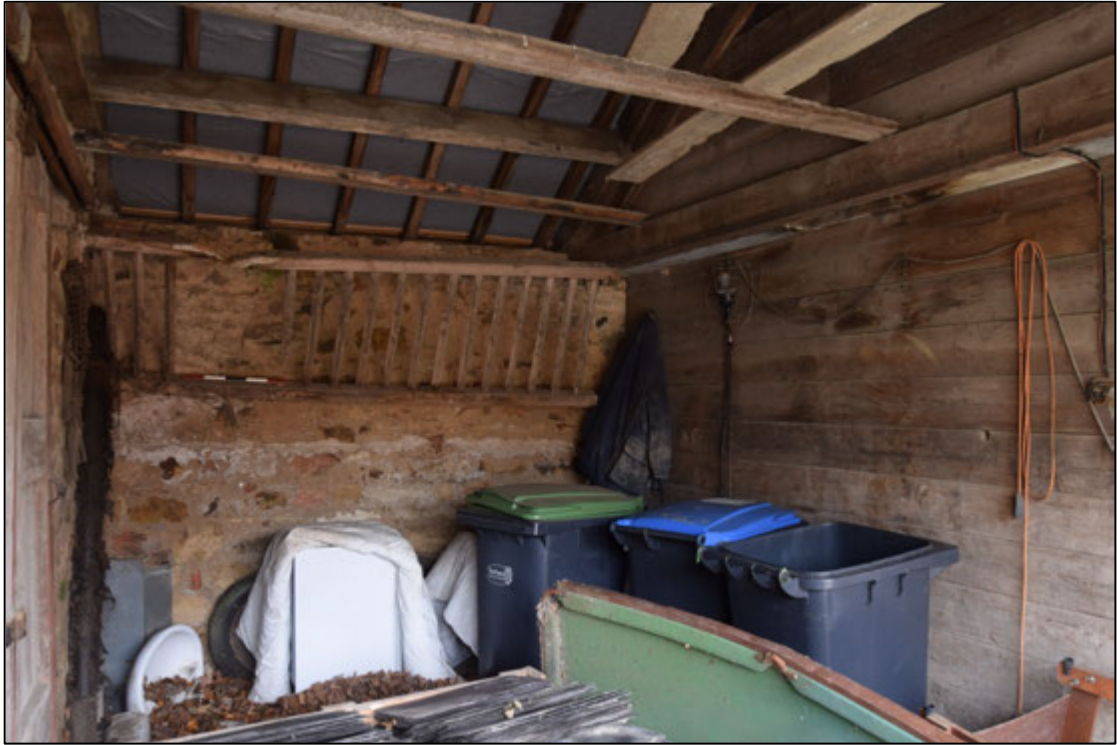
Photograph 17: The former stable retains its hay rack

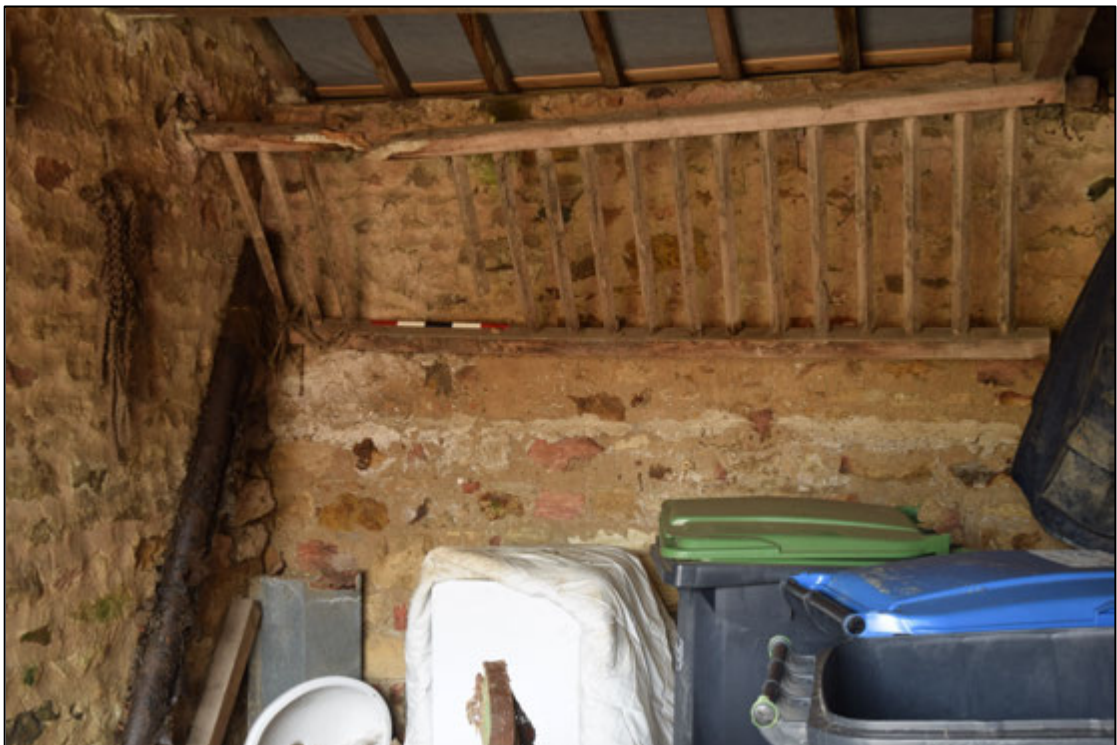
Photograph 18: A line of light grey mortar below the rack marks the position of a vanished manger

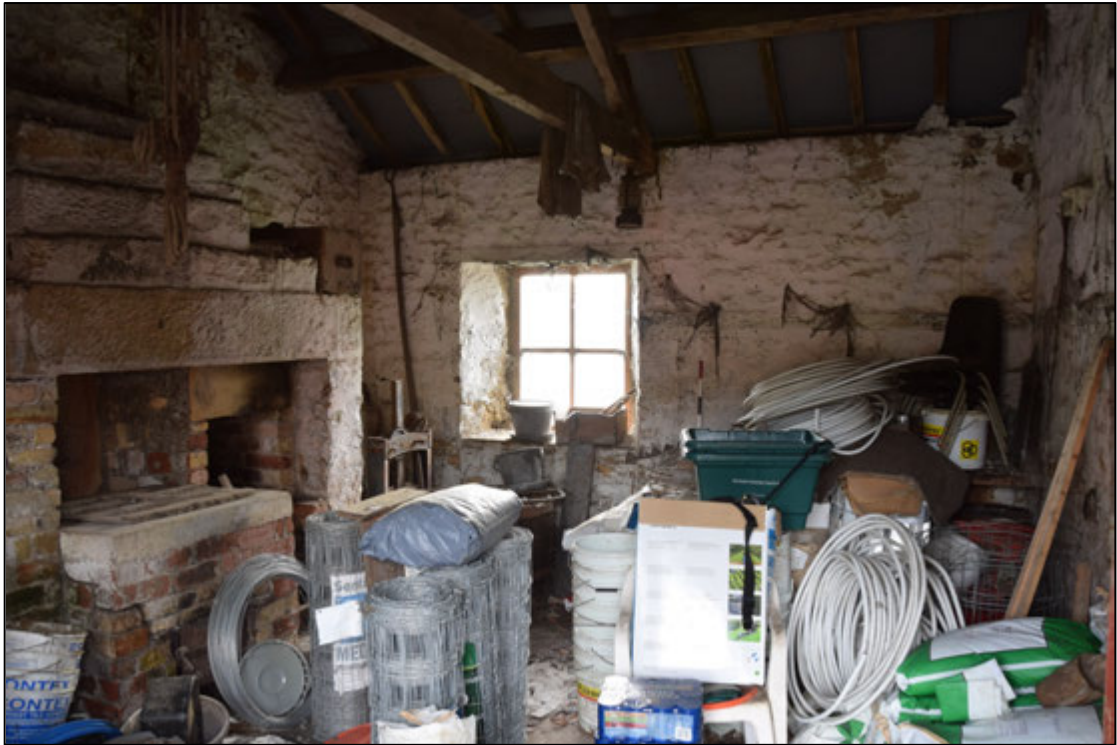
Photograph 19: The smithy / wash house seen from the doorway. Note the timbers set into the wall beside the window and at the extreme right

- 5.5 The former smithy and wash house is now used as a store for farm equipment and materials. Timbers set into the south and west walls were probably installed for fixing pegs. The squarish room is dominated by a large projecting fireplace on the east wall (Photograph 19). This is not central in the room; the large space on its north side was probably used for the forge bellows, but no trace of this or any other smithy equipment remains. The chimney steps out to a large monolithic lintel with the date 1881 at its centre (Photographs 20 & 21). The smithing hearth has been removed and the opening has been relined with brick and stone. Most of the former hearth is now occupied by a brick and concrete structure for a copper, built for boiling water for the household washing (Photograph 22). There is an iron firebox door at the base (Photograph 23) and the copper pan remains in place (Photograph 24). It is 0.63m in diameter and 0.46m deep and is set into a concrete slab that carries the date 1932 (Photograph 25). South of the copper there is an open hearth with a stone lintel and the remains of a domestic-looking grate (Photograph 26). The north window has three fixed panes over plank shutters (Photograph 27).

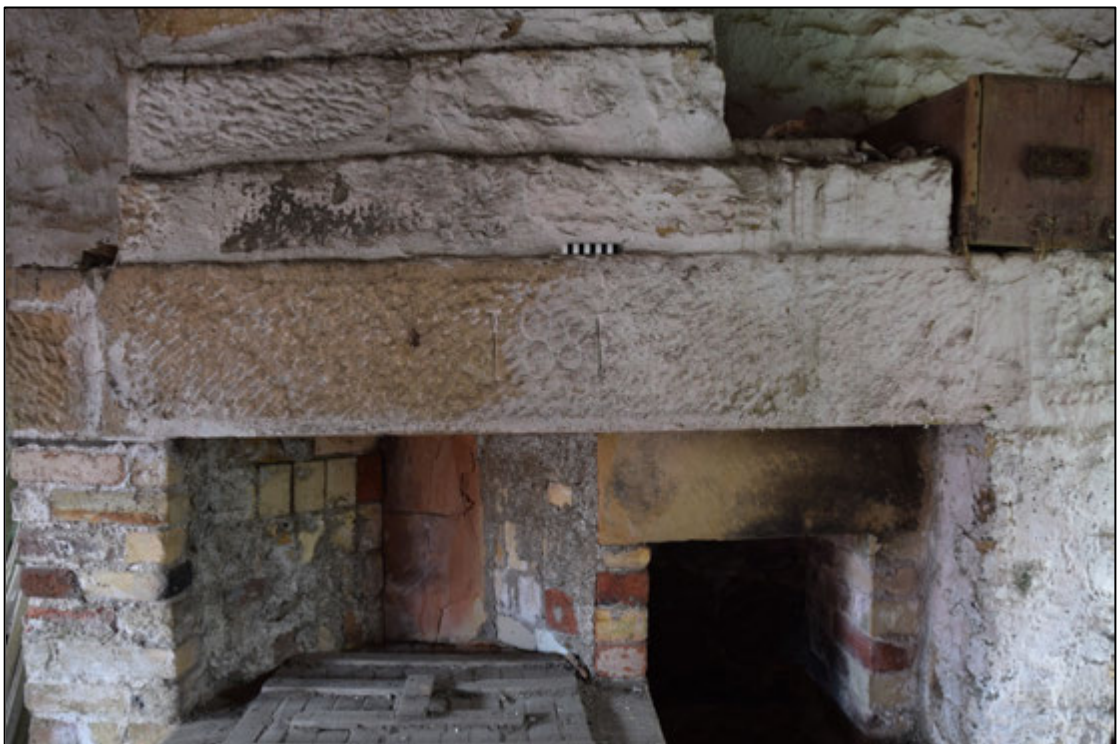
Photograph 20: The lintel of the former forge hearth, with the date 1881. Brickwork alterations, the wooden lid of the copper and the small southern hearth can be seen below

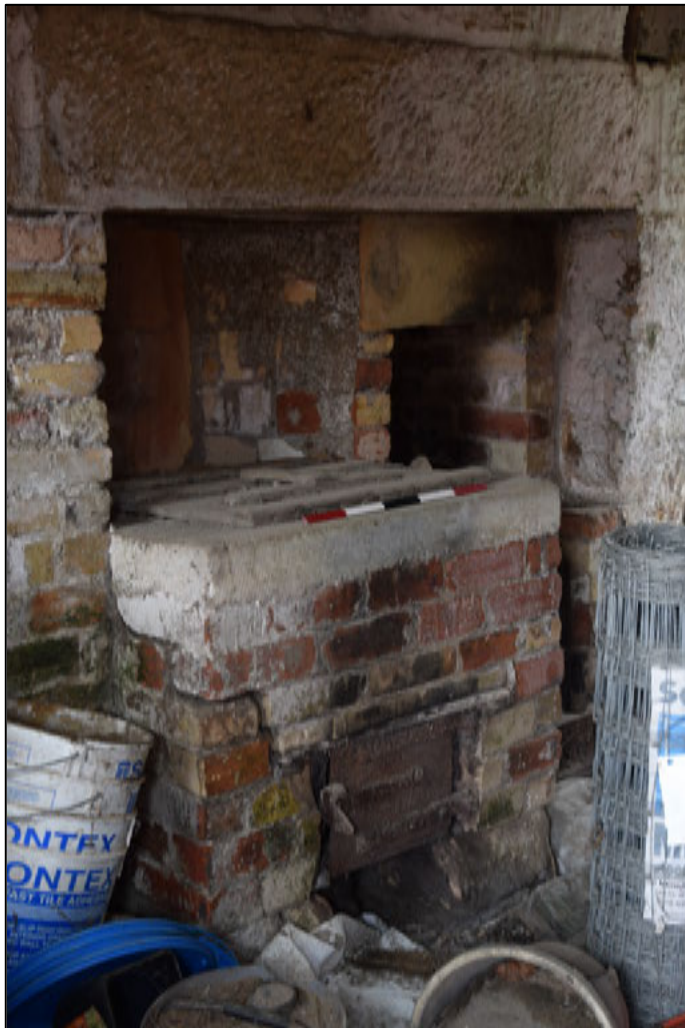
Photograph 22 (left): The brick and concrete structure for the copper

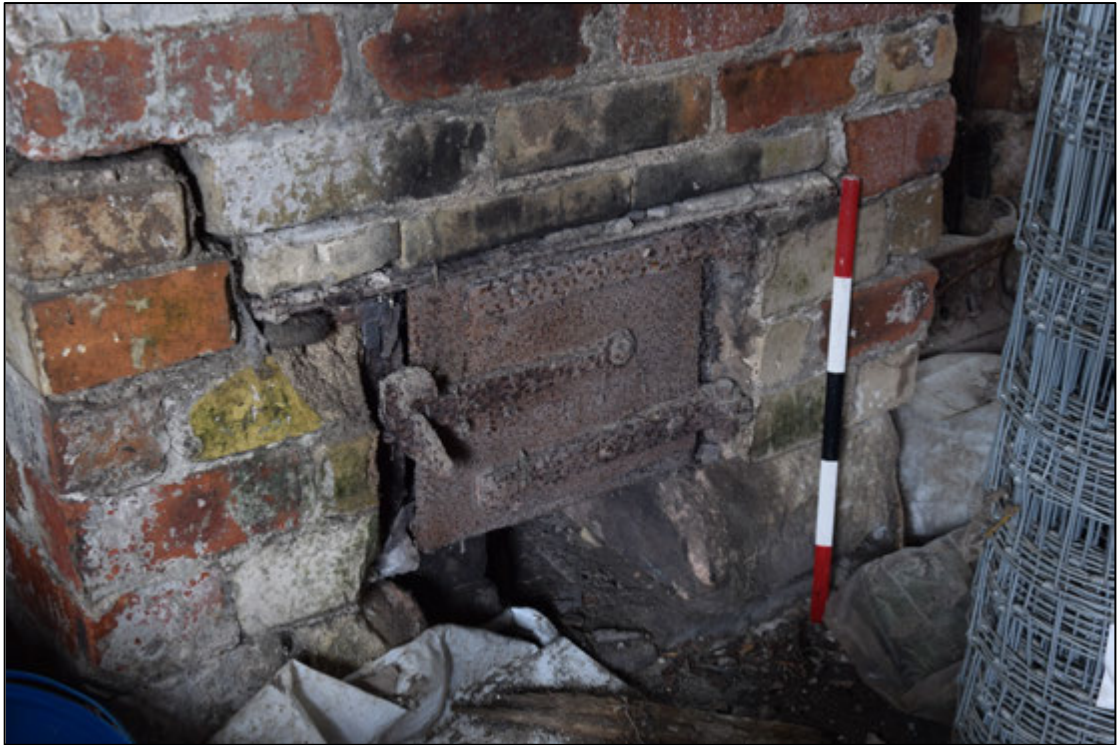
Photograph 23: Detail of the iron firebox door

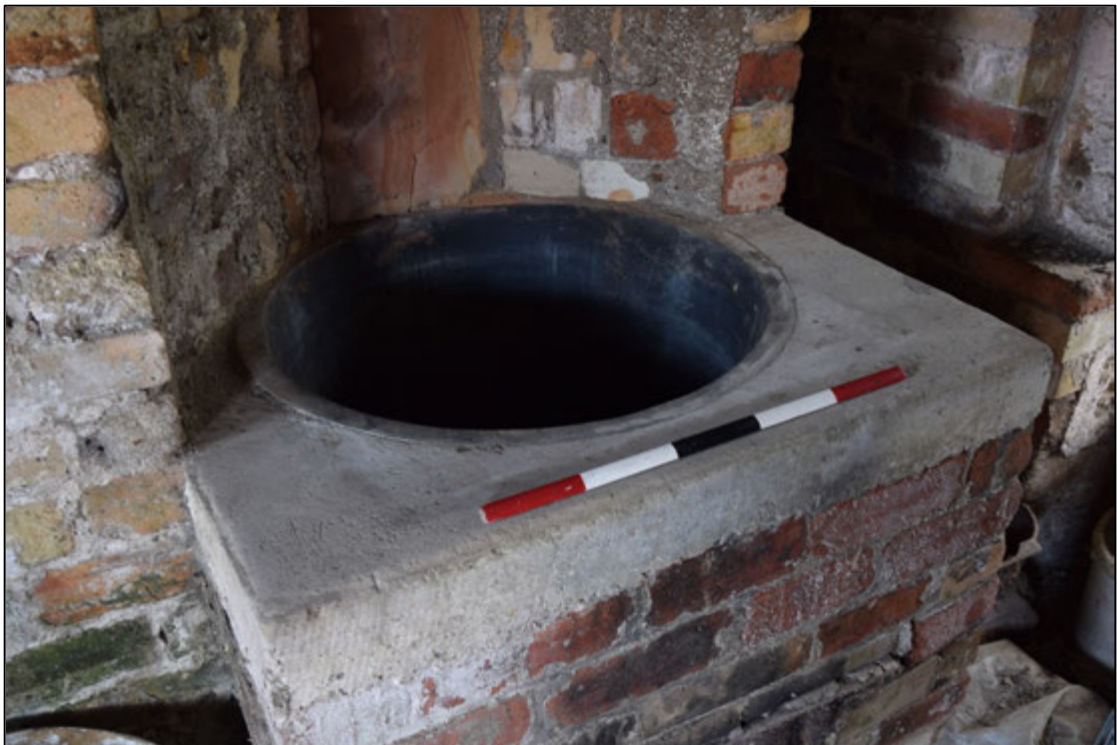
Photograph 24: The washing copper, set into a concrete slab. A date is just visible above the right-hand end of the scale

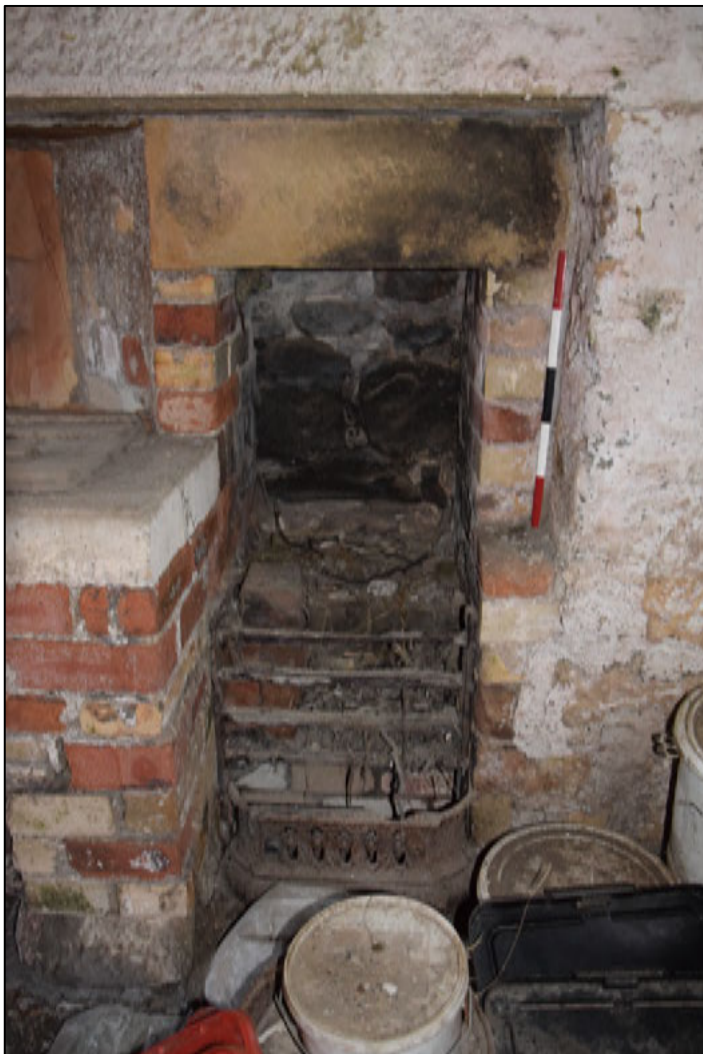
Photograph 26 (left): The small hearth at the south side of the old fireplace

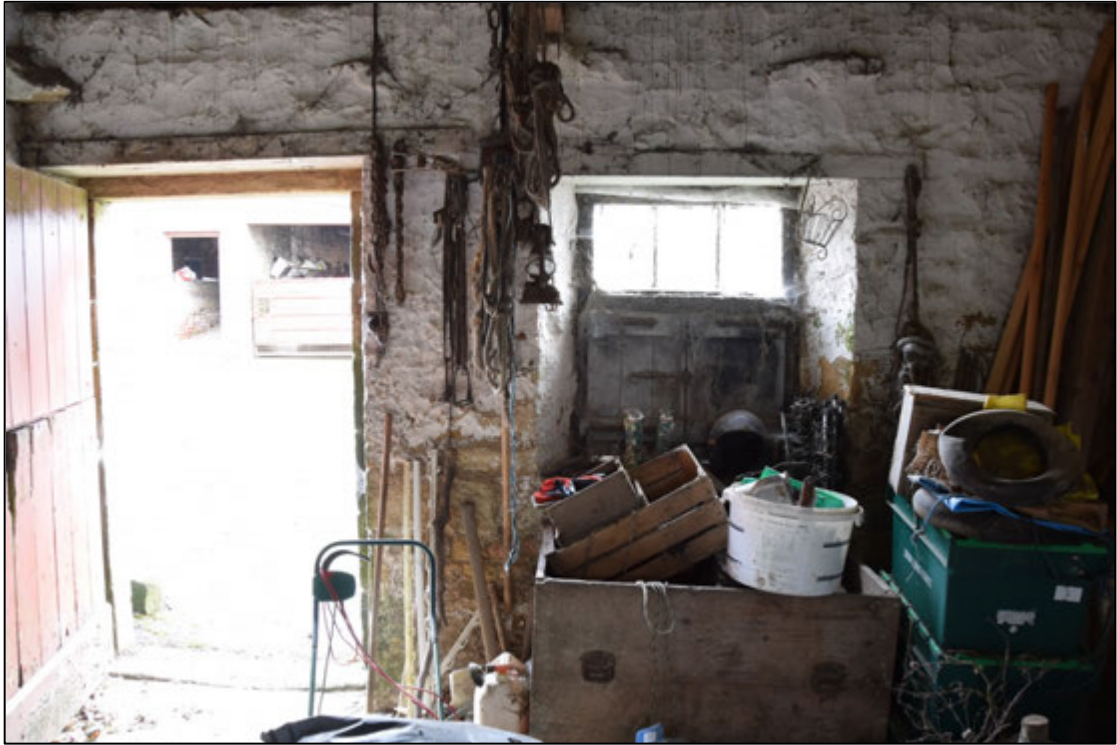
Photograph 27: The door and window in the north wall of the old smithy

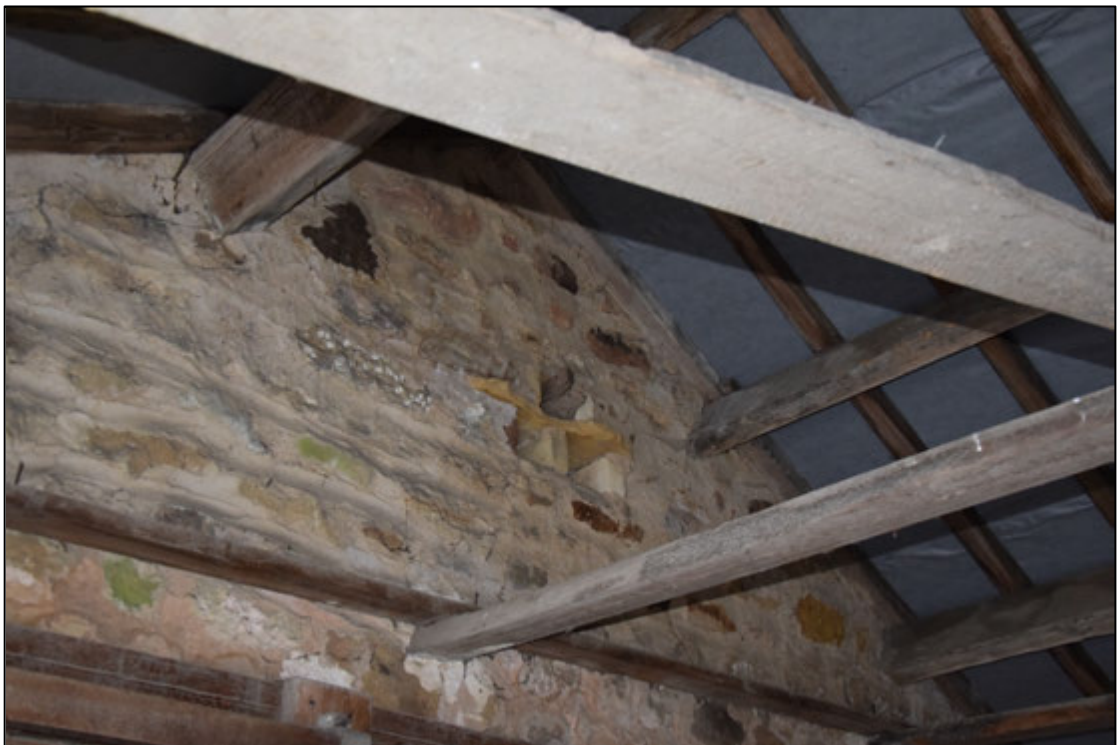
Photograph 28: Three pigeon holes in the wall between the shed and the smithy

- 5.6 The wall between the smithy and the shed has a small dovecote in its west face. This has three nest holes and is made of brick and sandstone (Photographs 28 & 29). Above, the renewed roof rests on older trusses, with the purlins running into the wall. The simple, strong trusses have half-lapped collar beams; the joints are bolted.

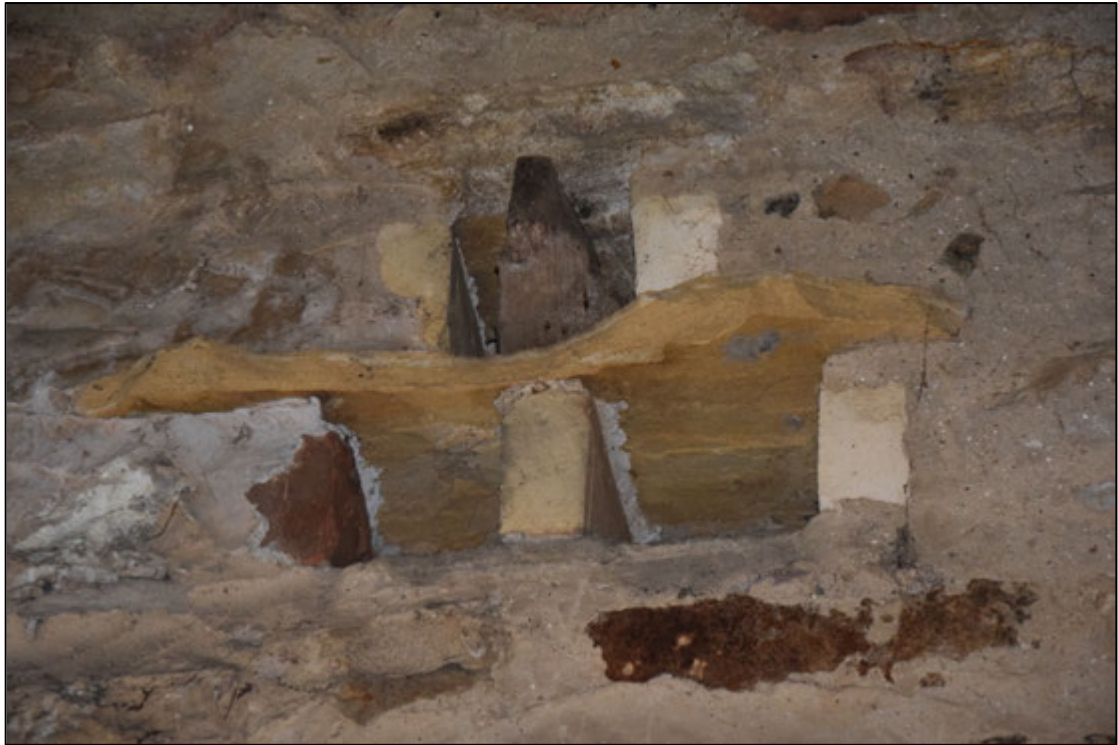
Photograph 29: Detail of the brick and sandstone pigeon holes

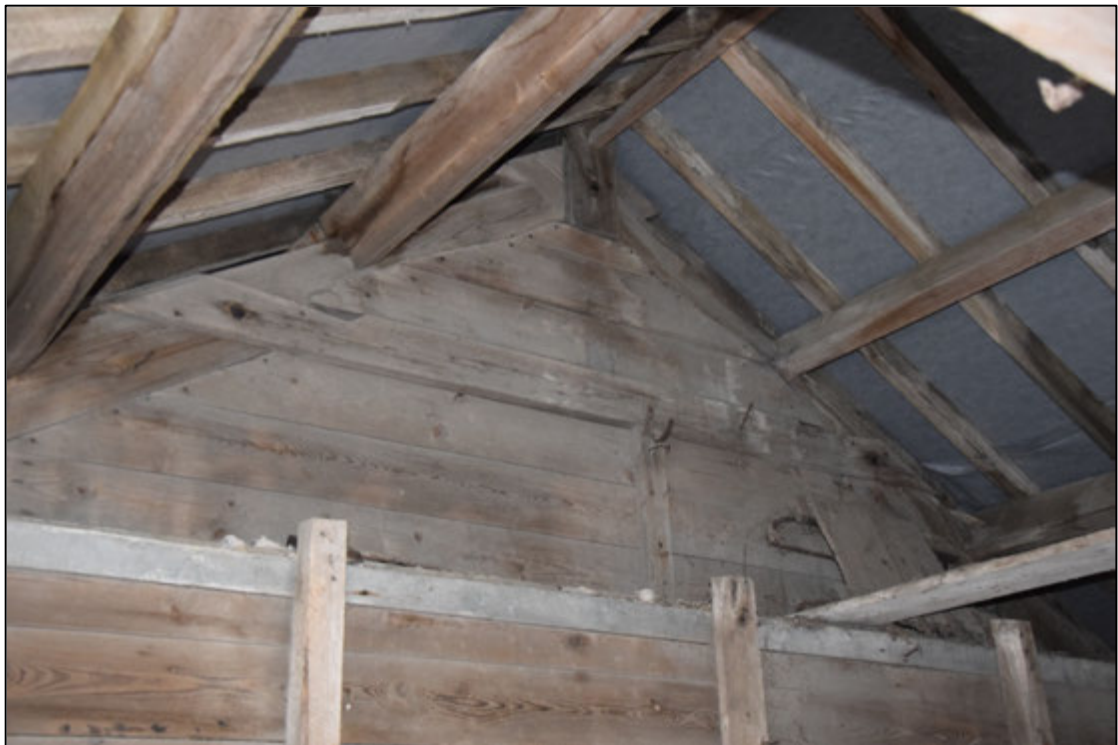
Photograph 30: The roof truss above the timber garage wall. The principal rafters and the collar beams are bolted together
