ARCHAEOLOGICAL
SERVICES
DURHAM UNIVERSITY

Priestman Building
Finchale Training College
Durham

archaeological building recording

report 4820
July 2018

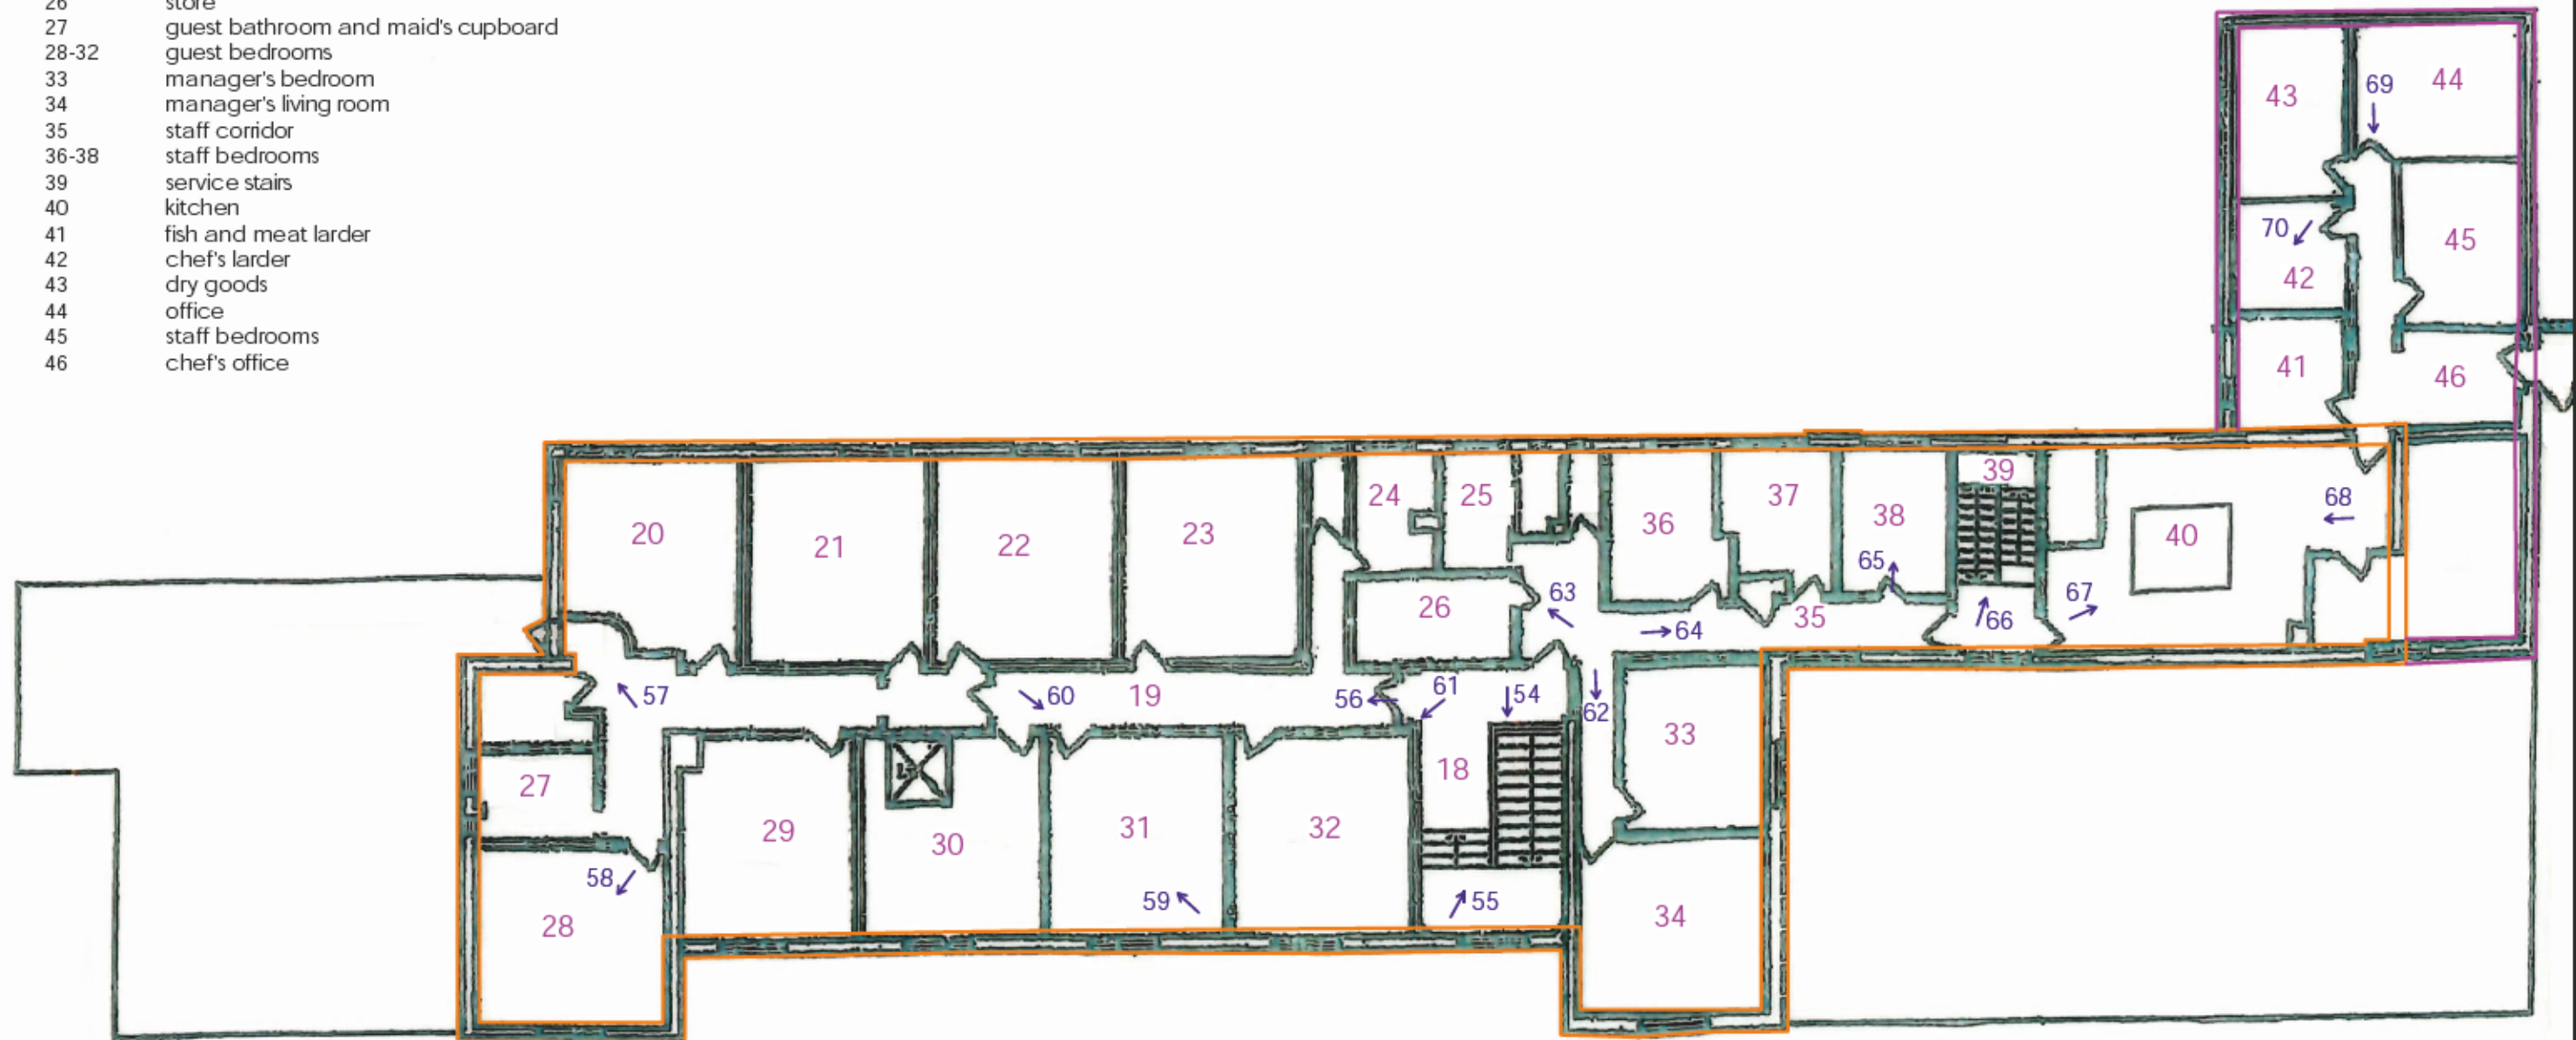
Figure 8: First floor

- 18 main staircase
- 19 guests corridor
- 20-23 guest bedrooms
- 24 guest bathroom and lavatory
- 25 manager's bathroom and lavatory
- 26 store
- 27 guest bathroom and maid's cupboard
- 28-32 guest bedrooms
- 33 manager's bedroom
- 34 manager's living room
- 35 staff corridor
- 36-38 staff bedrooms
- 39 service stairs
- 40 kitchen
- 41 fish and meat larder
- 42 chef's larder
- 43 dry goods
- 44 office
- 45 staff bedrooms
- 46 chef's office

- 5.3 Room numbers, given in square brackets in this description, refer to the plans in Figures 7 and 8. They do not reflect any numbering system used by the hotel, hospital or college.

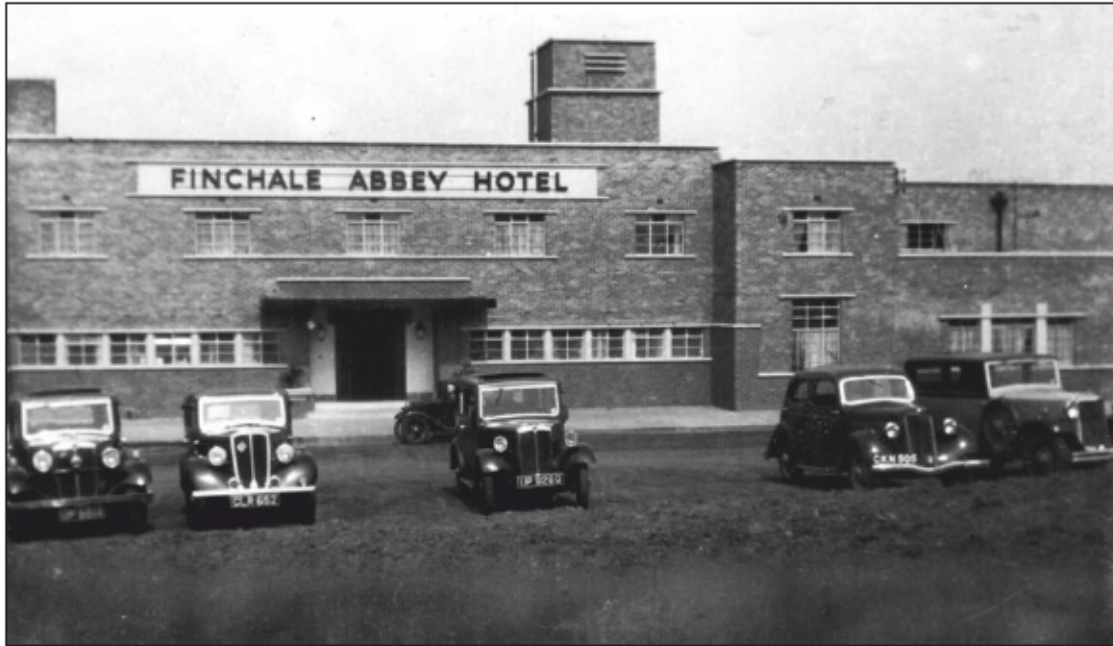
Photograph 1: The hotel and car park in the 1930s. Note the steel-framed windows throughout the façade. This photograph was kindly provided by Finchale College

- 4.7 As built, the hotel followed the 1935 plan but the impact of the Moderne exterior was reduced because the building was left as plain brick, rather than being rendered (Photograph 1). The appearance of the front of the building is largely unchanged today (Photograph 2).

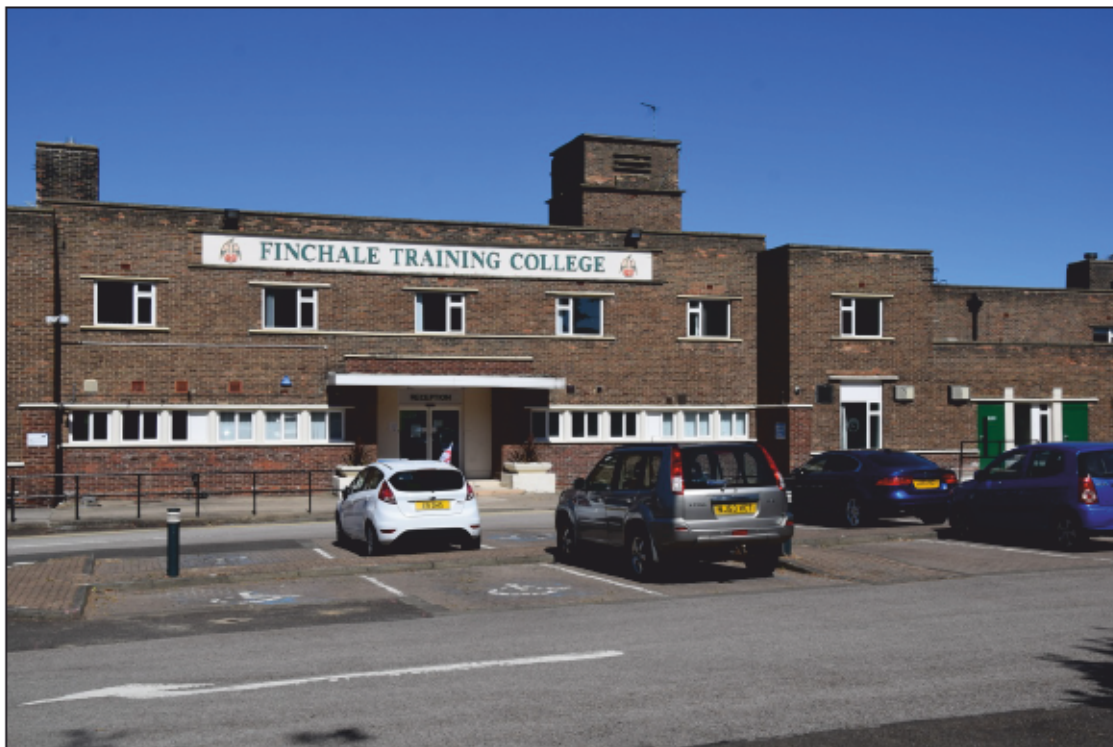
Photograph 2: The same view in 2018. All of the windows have been altered and vents, air bricks and other fittings have been added, but the façade is otherwise unchanged

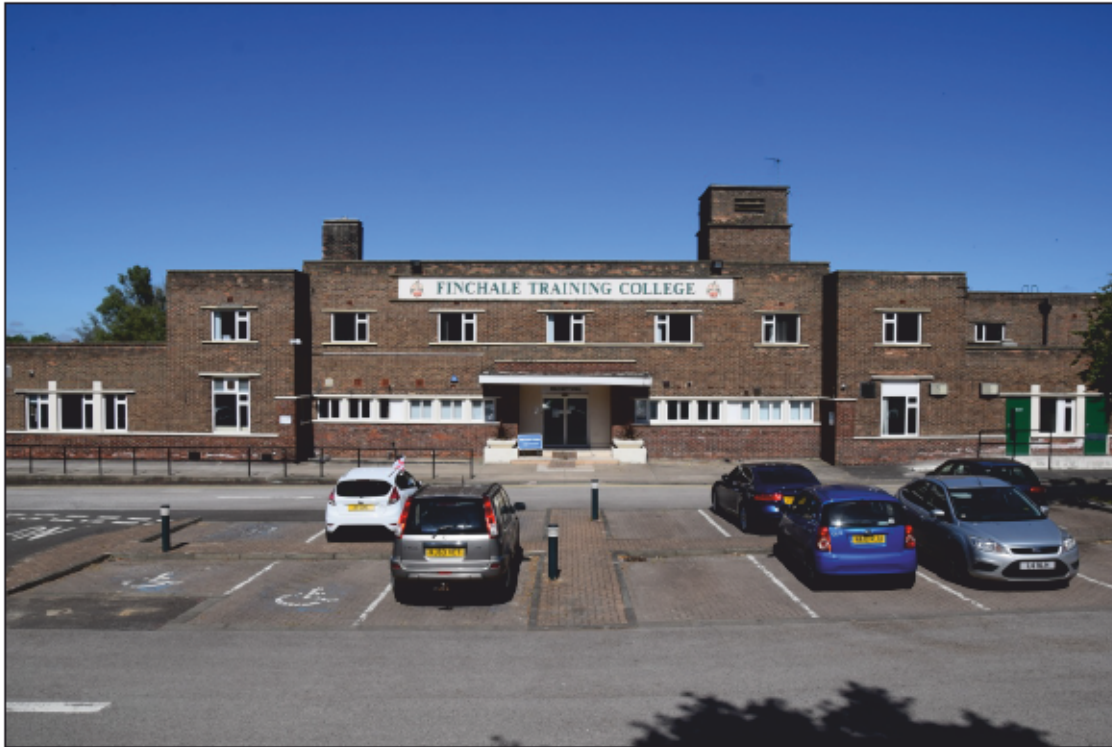
Photograph 5: The entrance front of the former hotel, showing the near-symmetrical arrangement and the strong horizontal emphasis of the building's design

5.1 The Priestman Building is a long, low steel frame clad in brick and concrete (Photograph 5). The felted flat roofs are concealed by low parapet walls with plain concrete copings. The symmetry of the façade is broken by an off-centre water tower and a boiler flue on the roof. The five-bay entrance front has a recessed

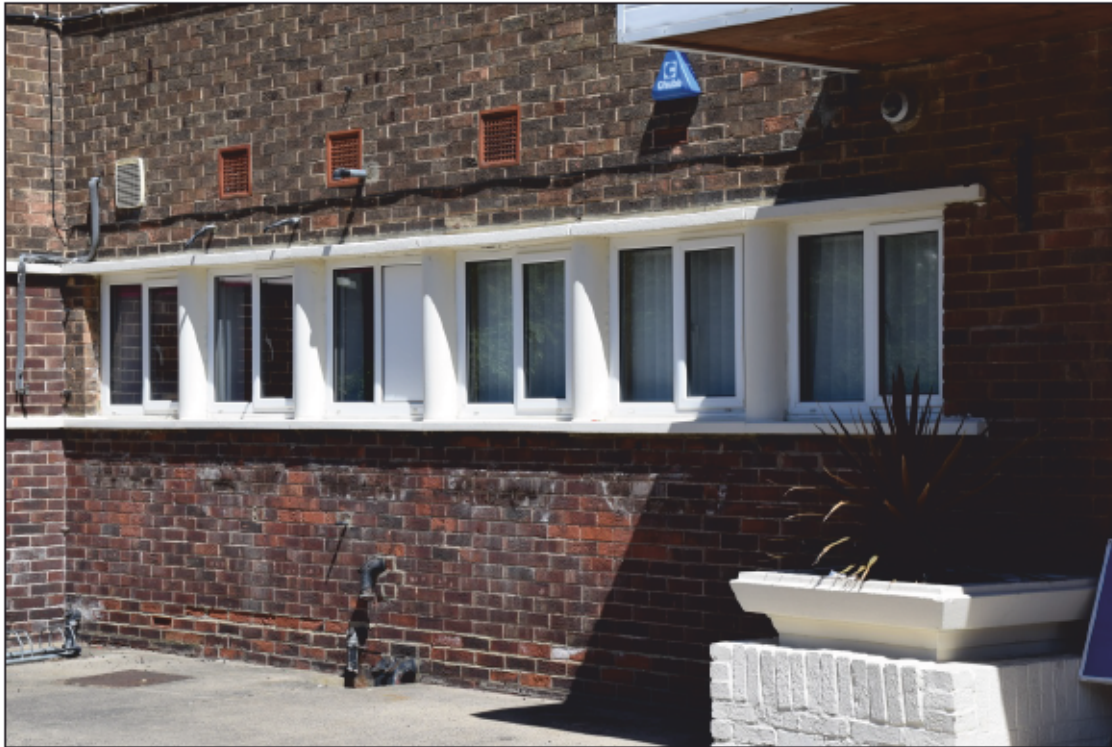
Photograph 9: Strip windows with semi-cylindrical concrete mullions, north of the entrance

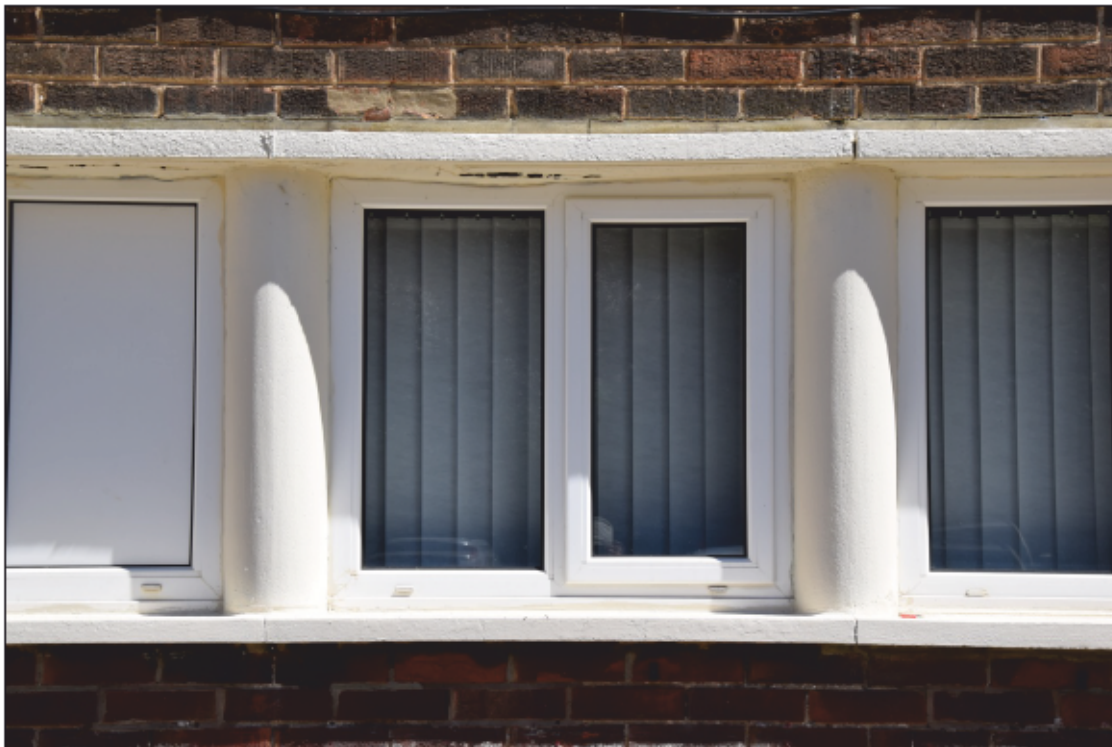
Photograph 10: Detail of the concrete slab sill and lintel, and the mullions

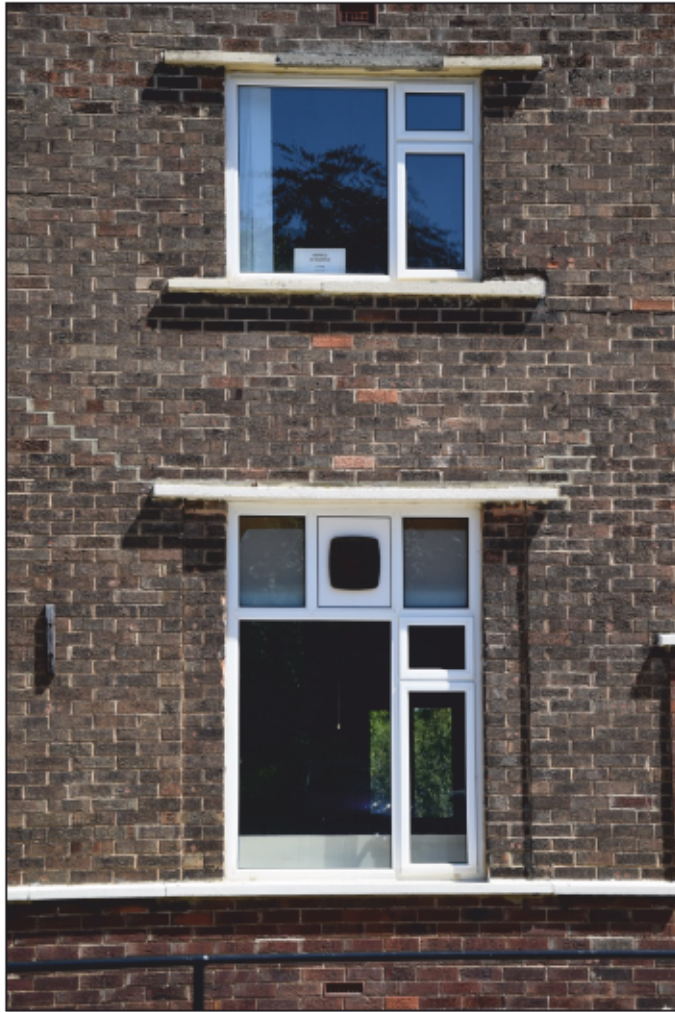
Photograph 11 (left): Taller windows in the projecting north wing. These served a guest bedroom and the smoke room

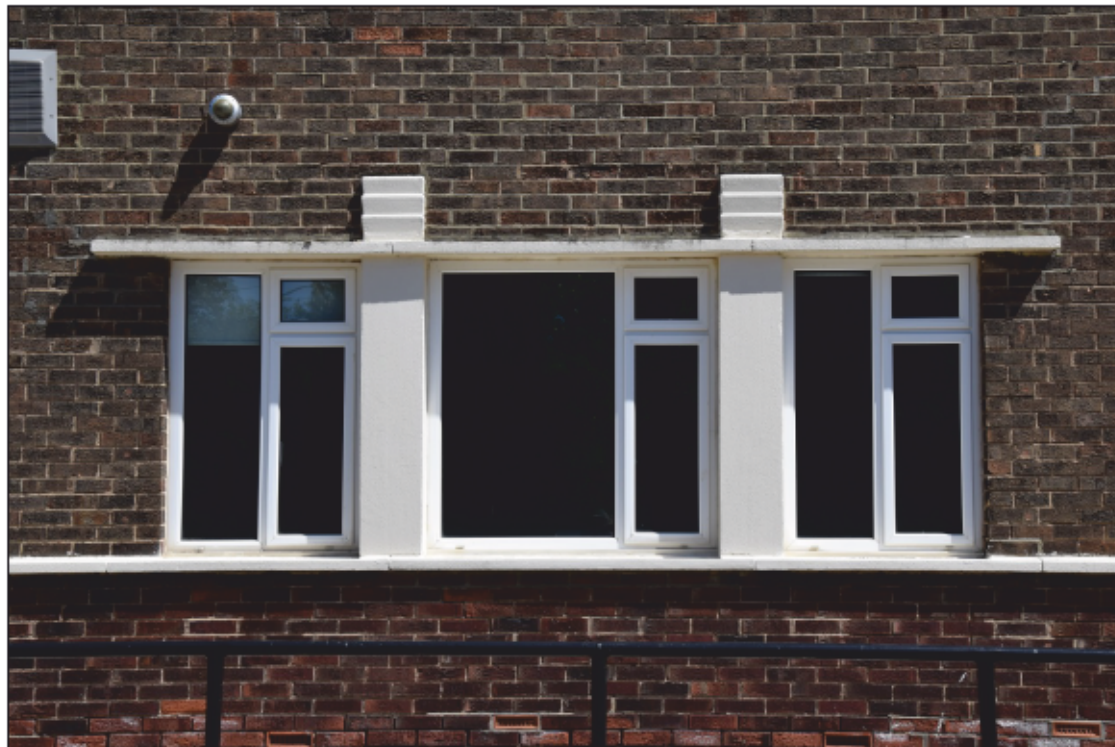
Photograph 12 (below): Minimal decoration on the three-light window of the bar

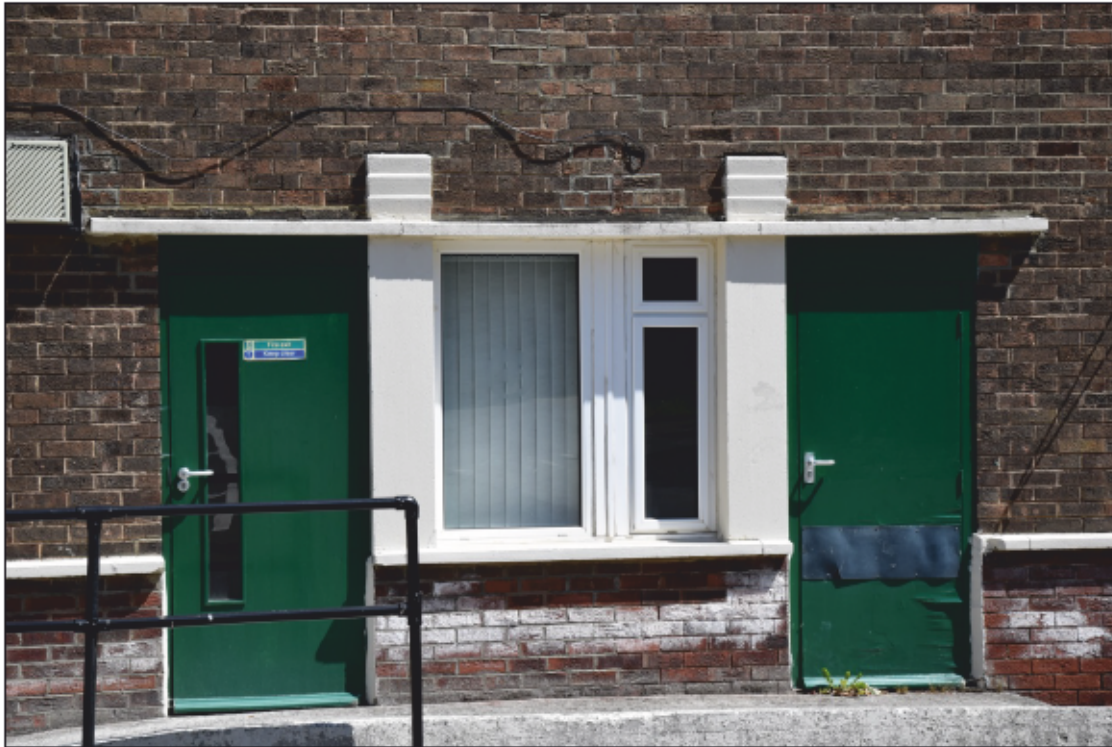
Photograph 13: The matching window in the south wing has been altered to create two doors

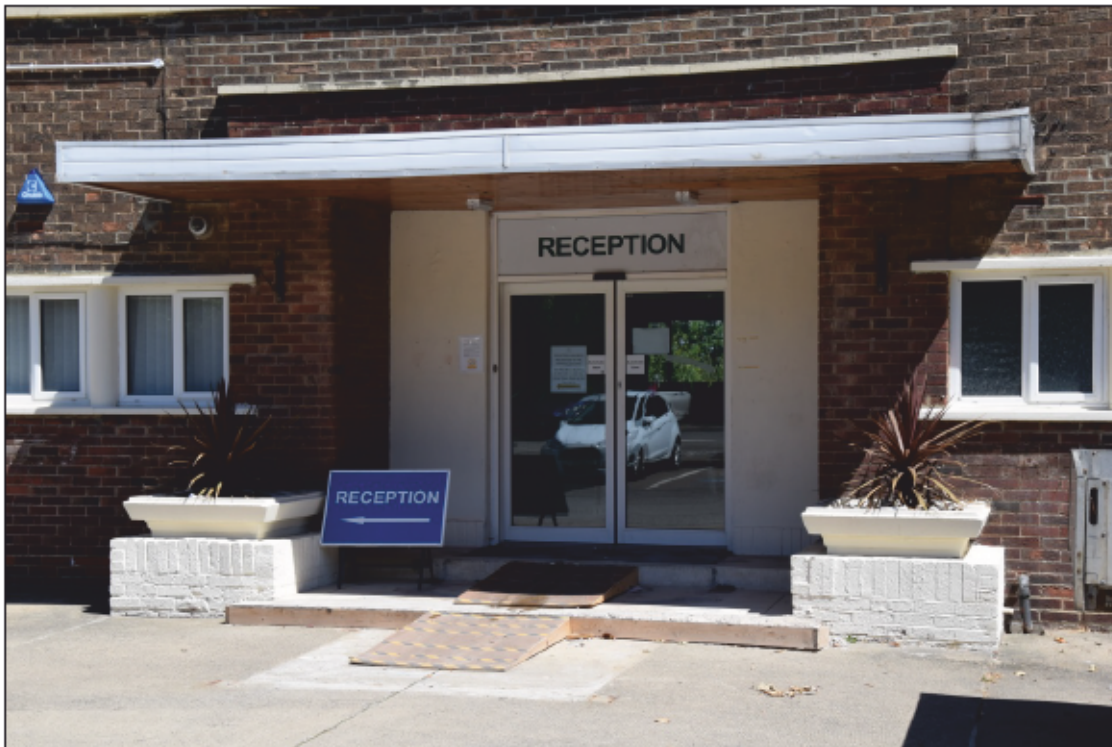
Photograph 14: The entrance with the brick plinths for planters. Modern cladding hides the concrete slab canopy

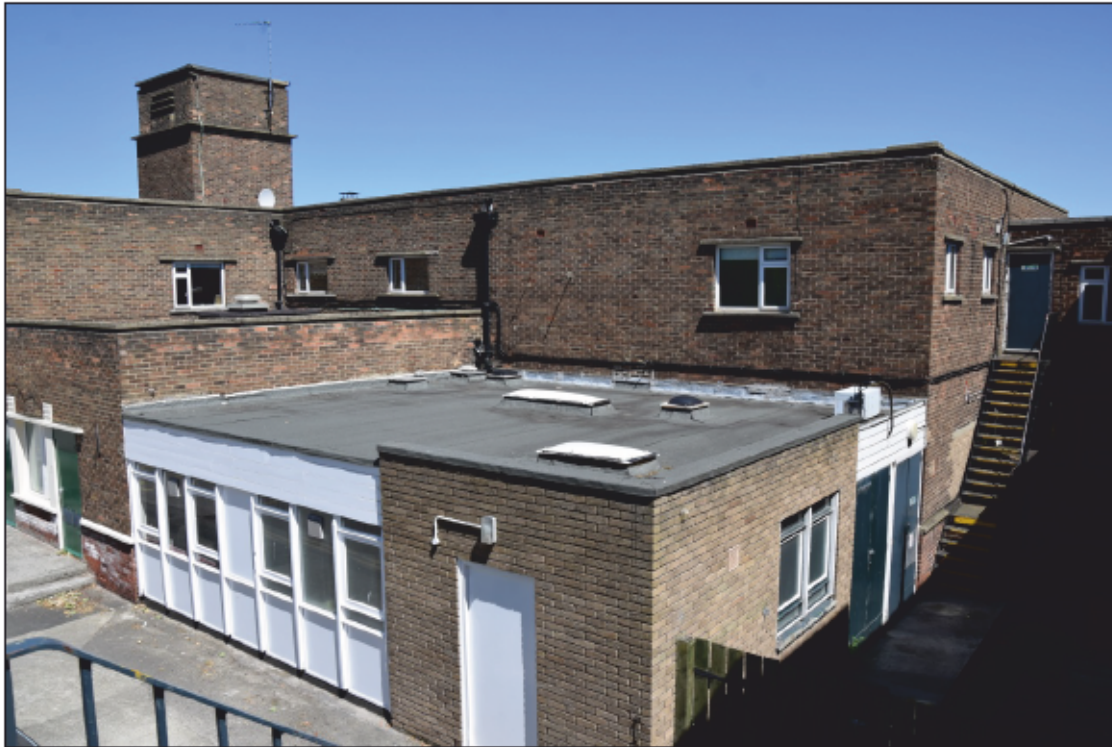
Photograph 15: The recent extension at the south-west corner of the building. The upper wall between the window and the fire escape door is part of the 1936 extension

central entrance under a concrete slab canopy. At either side there are slightly projecting wings with one two-storey bay and one lower bay outside (Photographs 6-8). Most windows are wider than they are high and those at either side of the entrance are in continuous bands, typical of early 1930s Moderne design. They originally had steel frames, as can be seen in Photographs 1 and 4, but these have all been replaced (Photographs 9, 10). There are taller windows on the ground floor in the projecting wings (Photograph 11); the outer bays have wide tripartite windows with simple concrete decoration above the wide mullions (Photographs 12, 13). The entrance is more or less as it was when the photograph of the hotel was taken in the mid-1930s (Photograph 1). Wide, shallow steps are flanked by brick plinths for planters; the original revolving door has gone (Photograph 14). At the south-west corner of the building is a later extension for offices and kitchen stores (Photograph 15). This was not present when the 1960s air photograph was taken.

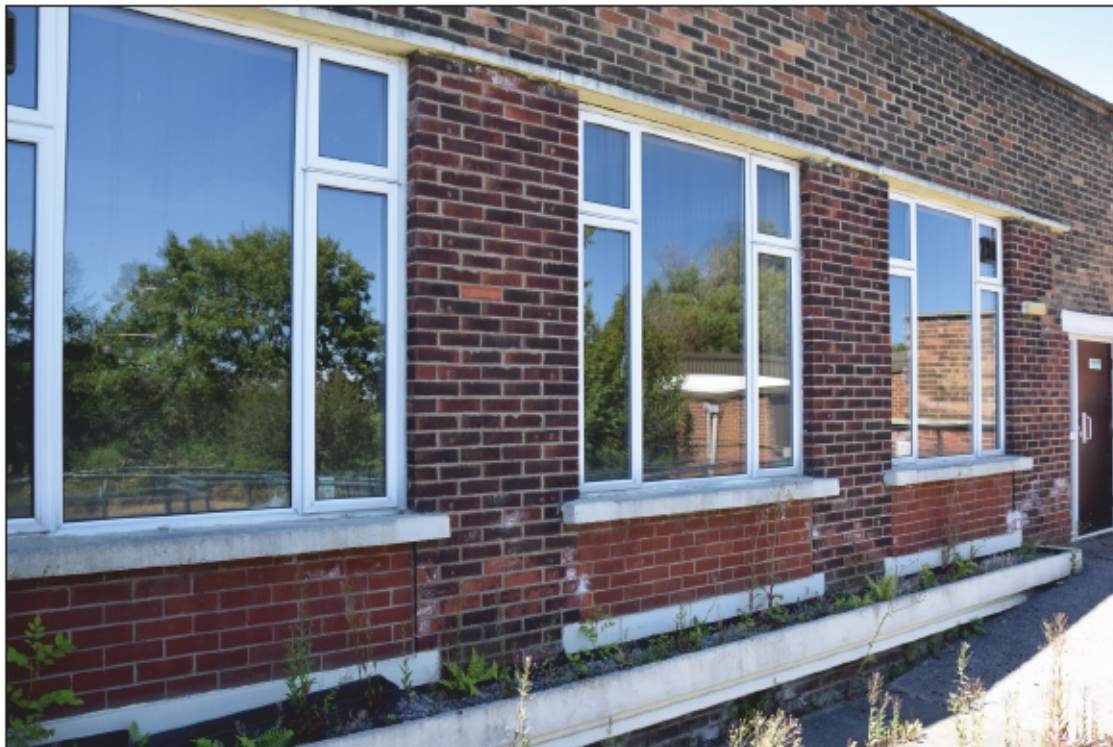
Photograph 18: The lounge windows have been reduced in size and re-glazed; the old sills are below the redder brickwork

- 5.2 The north-east face of the hotel is partly hidden by a recent conservatory (Photograph 16). The lounge and ballroom have large windows that once looked out over the rose garden (Photograph 17). The ones in the lounge have been reduced in size and the original glazing has been replaced (Photograph 18). The bedroom windows are similar to those on the south-west face; once again, none of the old steel-framed windows remain (Photograph 19). The south-east end of the building is hidden by later alterations. At the north-west end, the sloping ground allows the door to cellars under the main block to be seen (Photograph 20).

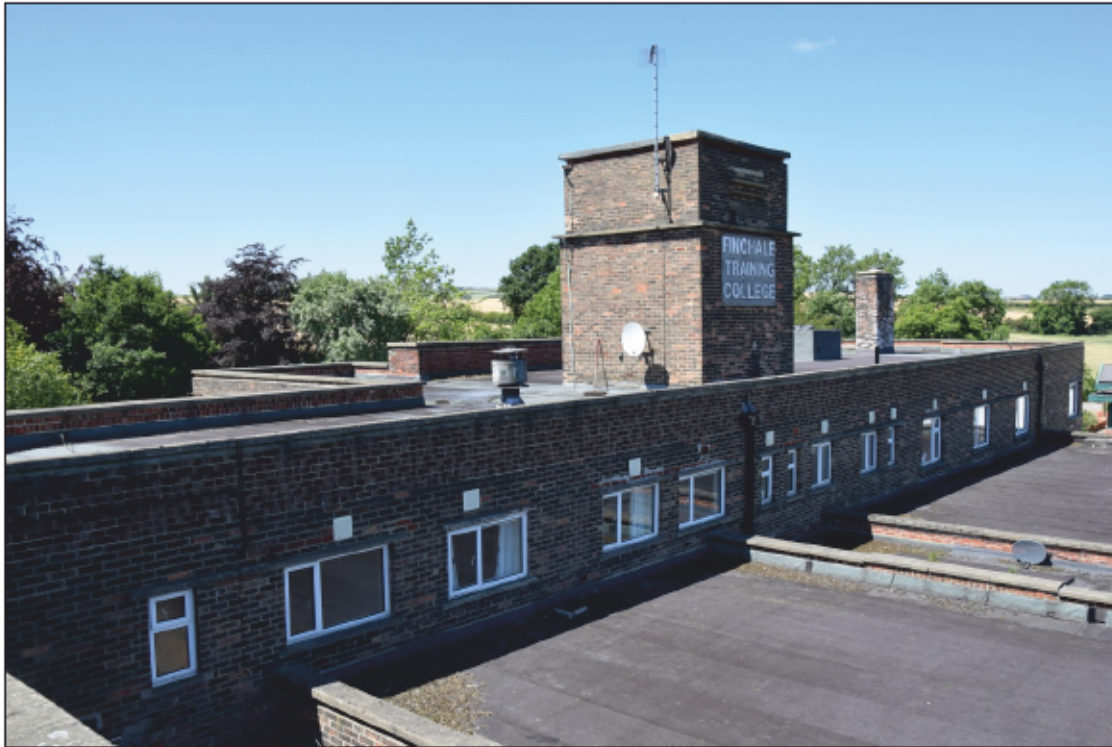
Photograph 19: Windows to the first-floor rooms 20-25 and 36-38, with the water tower and boiler flue. A view from the south-east

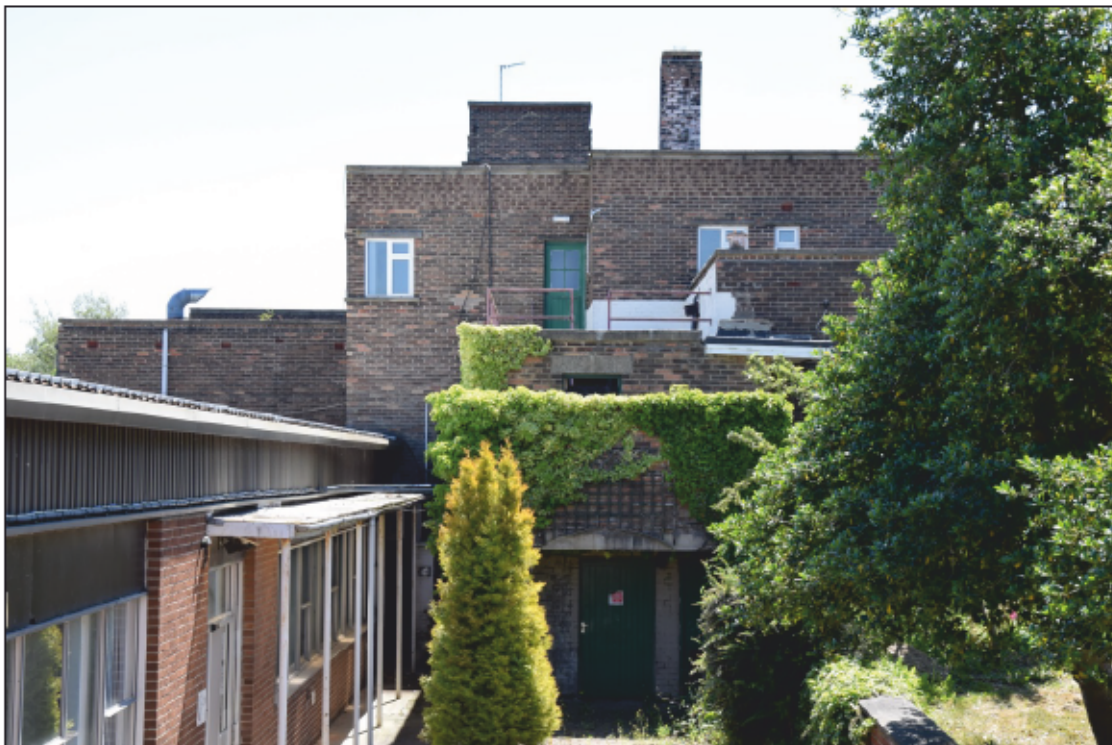
Photograph 20: The north-west end of the building. The green door gives access to the cellars. This picture is taken from the site of the swimming pool in the original design for the hotel

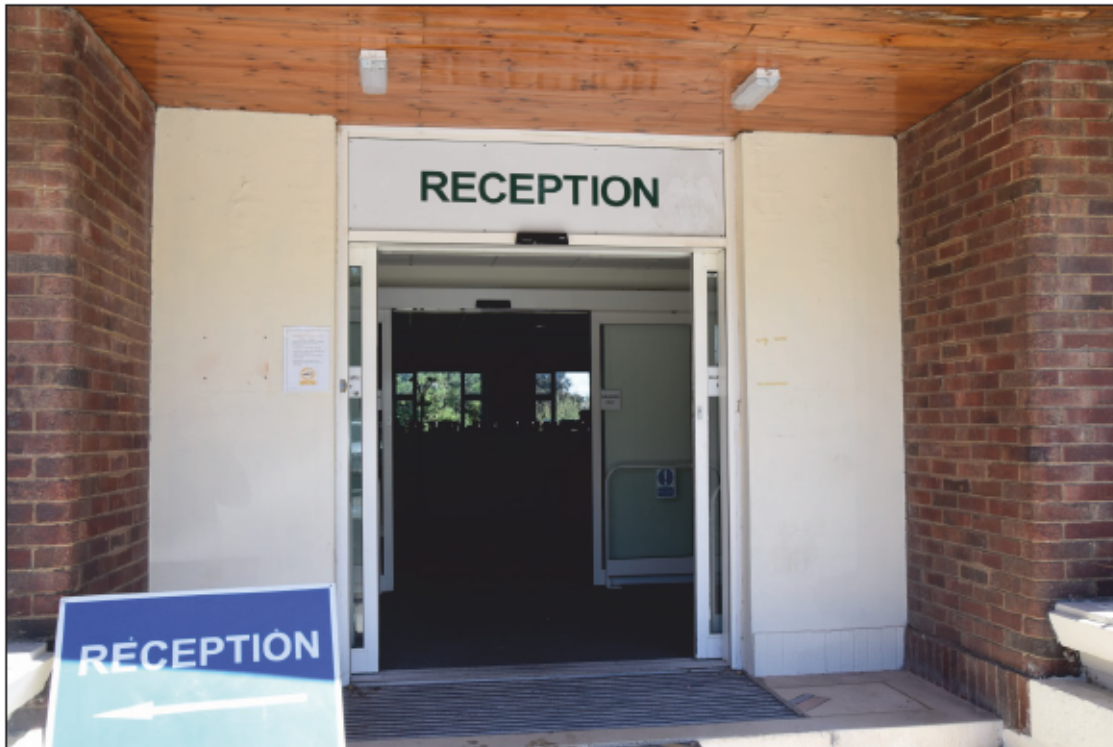
Photograph 21: Modern doors replace the original revolving door in the reception area 1

- 5.4 The reception area [1] is now part of the central hall [2] and is entered by way of a featureless lobby with modern automatic doors (Photograph 21). Inside, the hall is separated from the lounge [14] by a balustrade and two large decorative plaster columns (Photographs 22-25). These conceal steel columns (Photograph 26); others are inside cupboards at either end of the hall (Photograph 27).

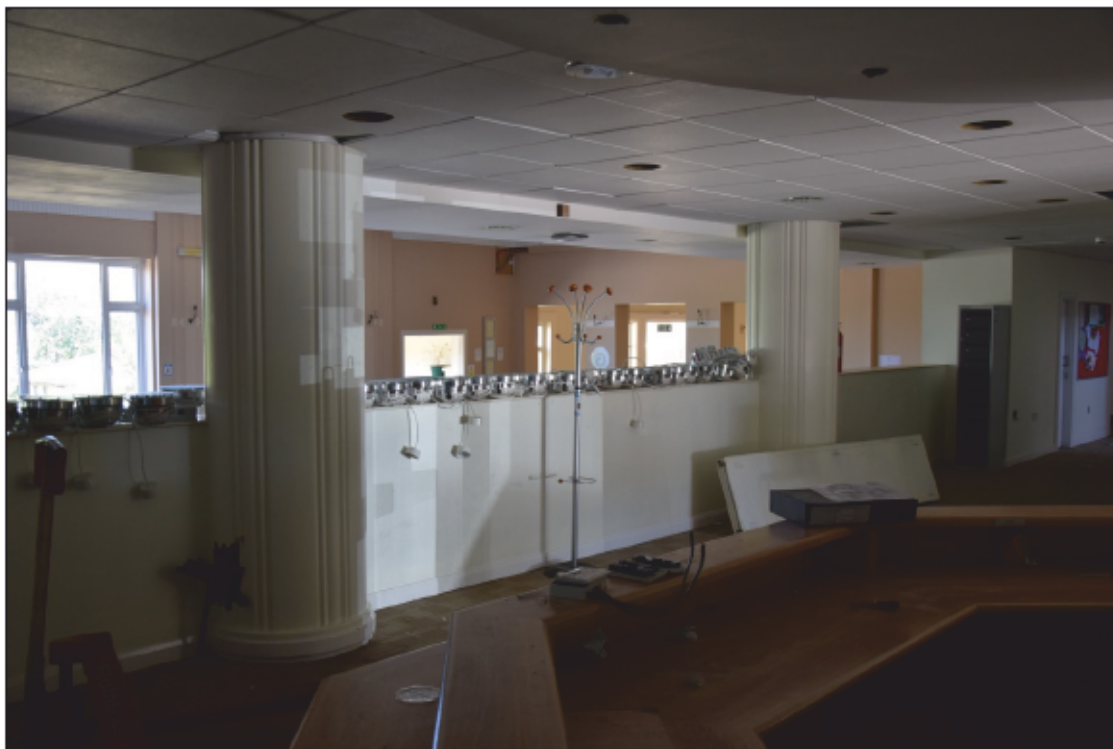
Photograph 22: The hall 2, seen from the north-west end, with a modern reception desk in the foreground. There were formerly steps down to the lounge to the left and right of the pair of columns

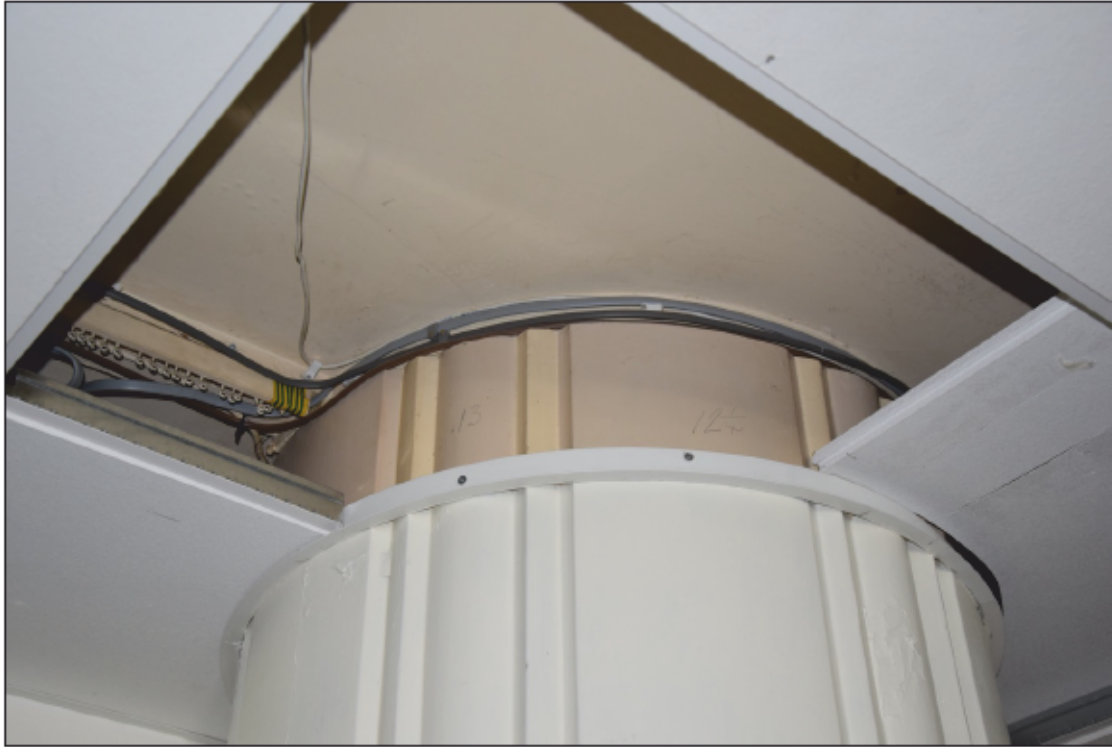
Photograph 25 (above): The column mouldings stop short of the plain ceiling

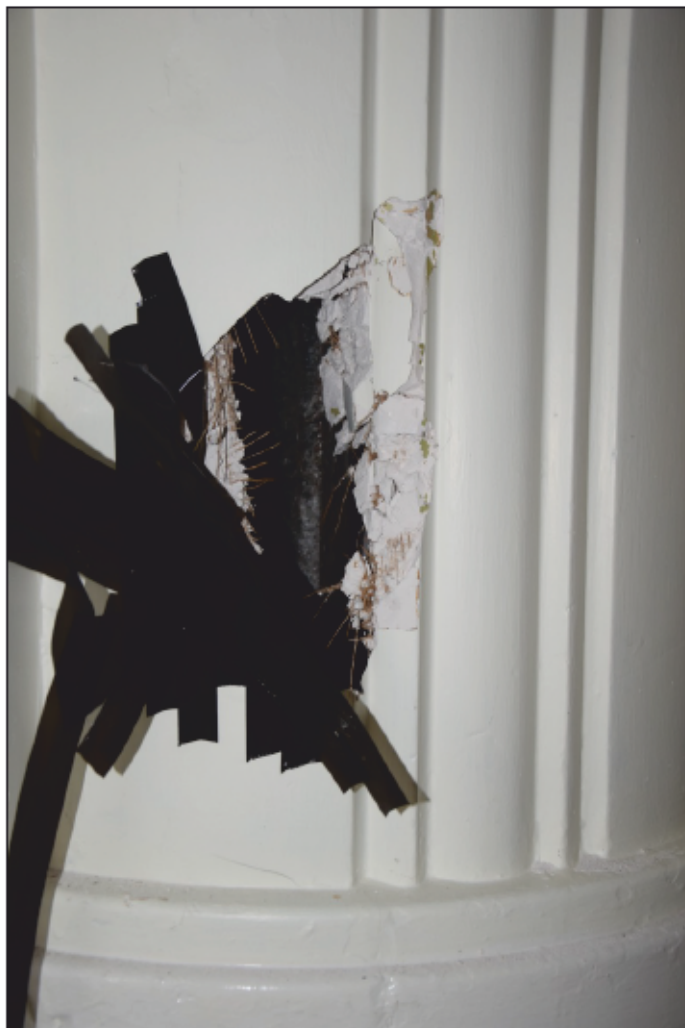
Photograph 26 (left): A site investigation hole in the north column gives a glimpse of the steel column inside

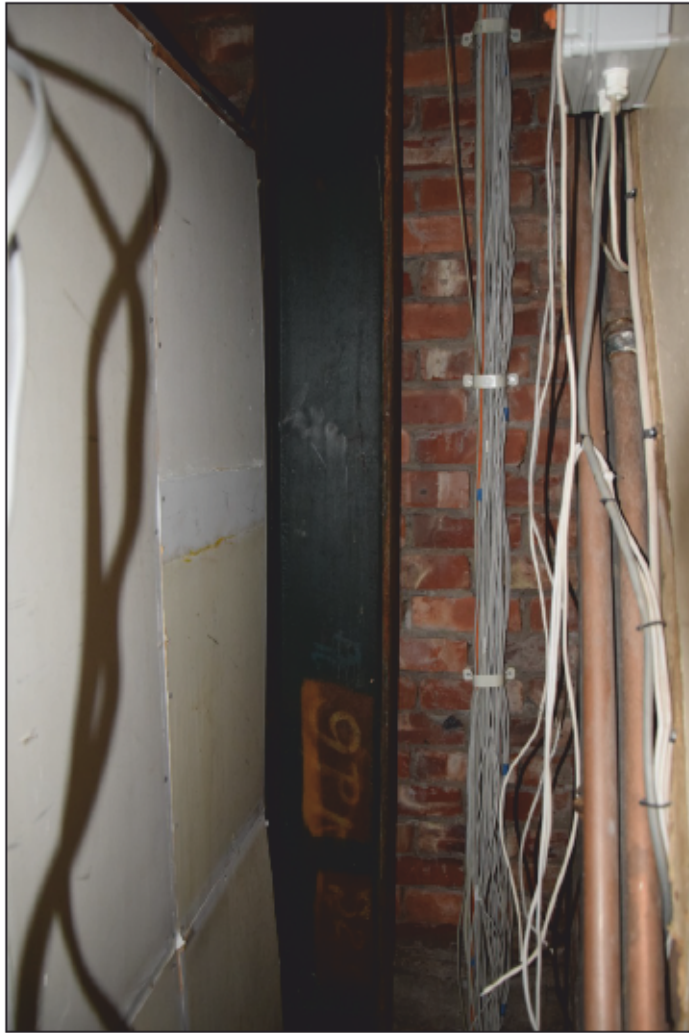
Photograph 27 (left): A steel column and bare brickwork in a cupboard near the main staircase

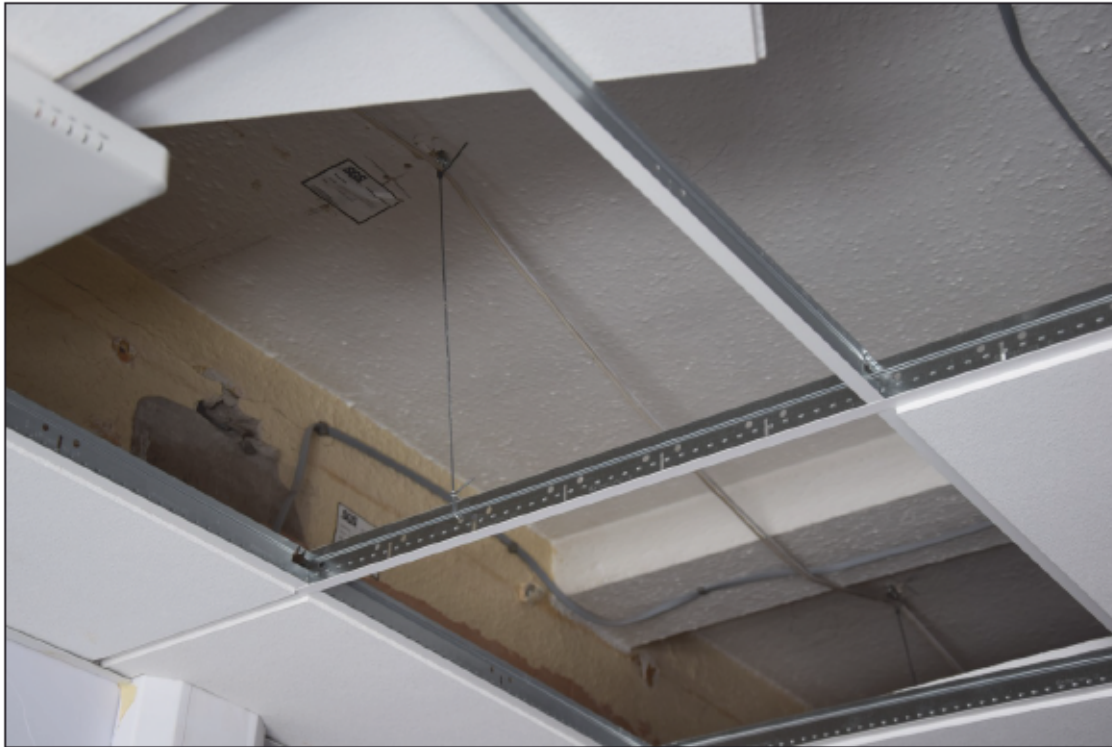
Photograph 29: Plain ceiling and beam above the modern suspended ceiling of room 4

- 5.5 The former men's cloakroom [3] is now a featureless office and the lavatory that adjoined it has been incorporated into the former smoke room [3] in the north wing; this is a featureless room with modern fittings and a suspended ceiling that conceals plain ceiling and beams (Photographs 28, 29). The adjoining bar [5] is similarly plain (Photographs 30, 31). The bar entrance and lavatories [6] are slightly altered from their original arrangement but contain no significant features.

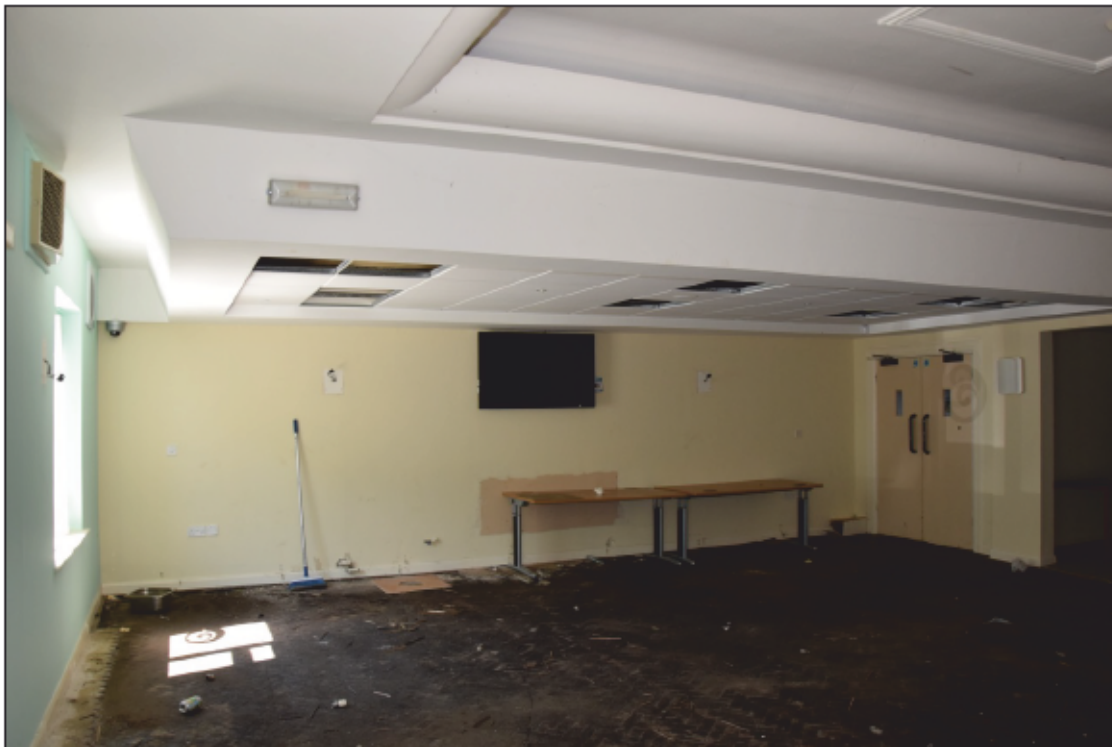
Photograph 32: The north end of the former dining room 9, latterly used as a gym

- 5.6 South-east of the entrance, the former store room and women's cloakroom are now combined [7] and the lavatories [8] are still present. In the south wing, the former dining room is now divided in two [9, 10]. This had a parquet floor and a central lighting recess in the ceiling (Photographs 32-34). The smaller room [10] has a blocked window in its south wall and a tiled floor laid over the parquet (Photographs 35, 36). The former buffet room [11] has two large doors into the dining room (Photograph 37).

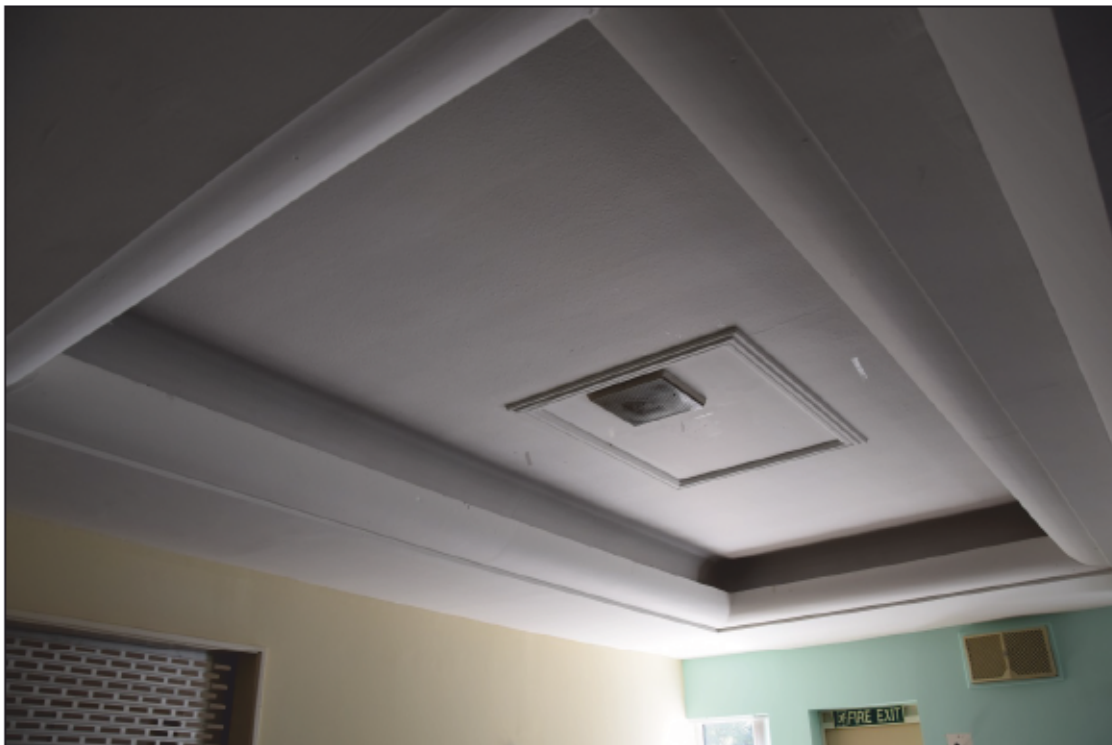
Photograph 34: The recessed centre of the ceiling in room 9; compare this with Photos 48 and 49

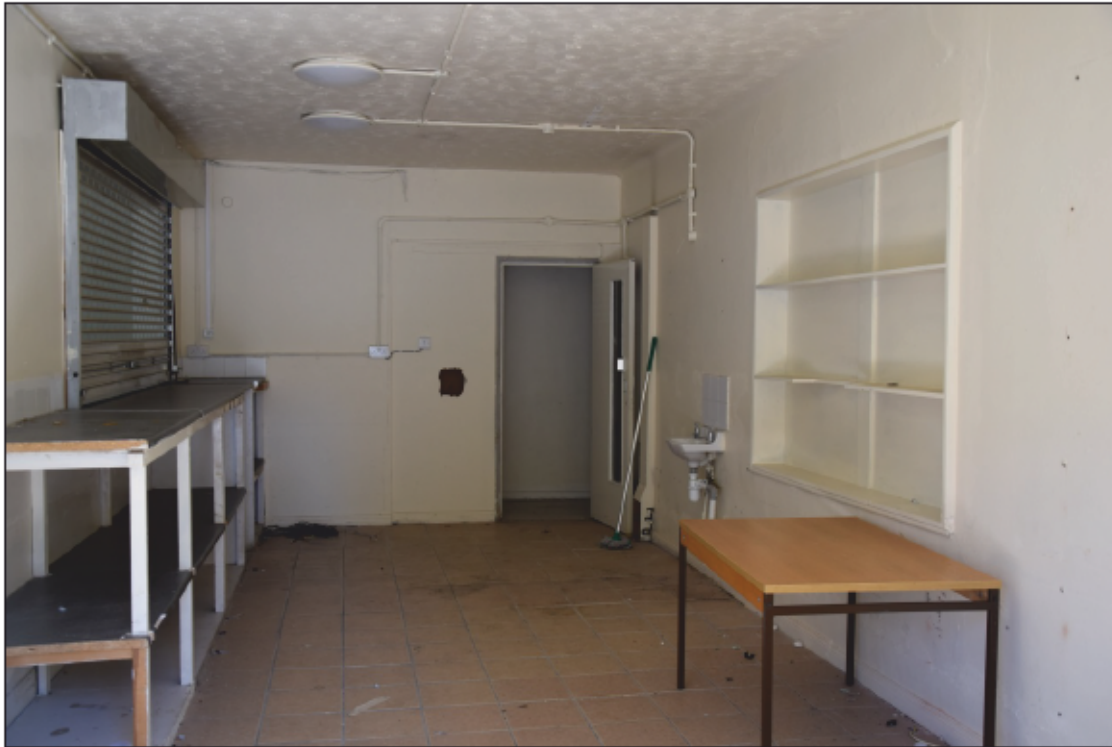
Photograph 35: The small room 10 contains the old south window of the dining room, now closed up and fitted with shelves
