ARCHAEOLOGICAL
SERVICES
DURHAM UNIVERSITY

Priestman Building
Finchale Training College
Durham

archaeological building recording

report 4820
July 2018

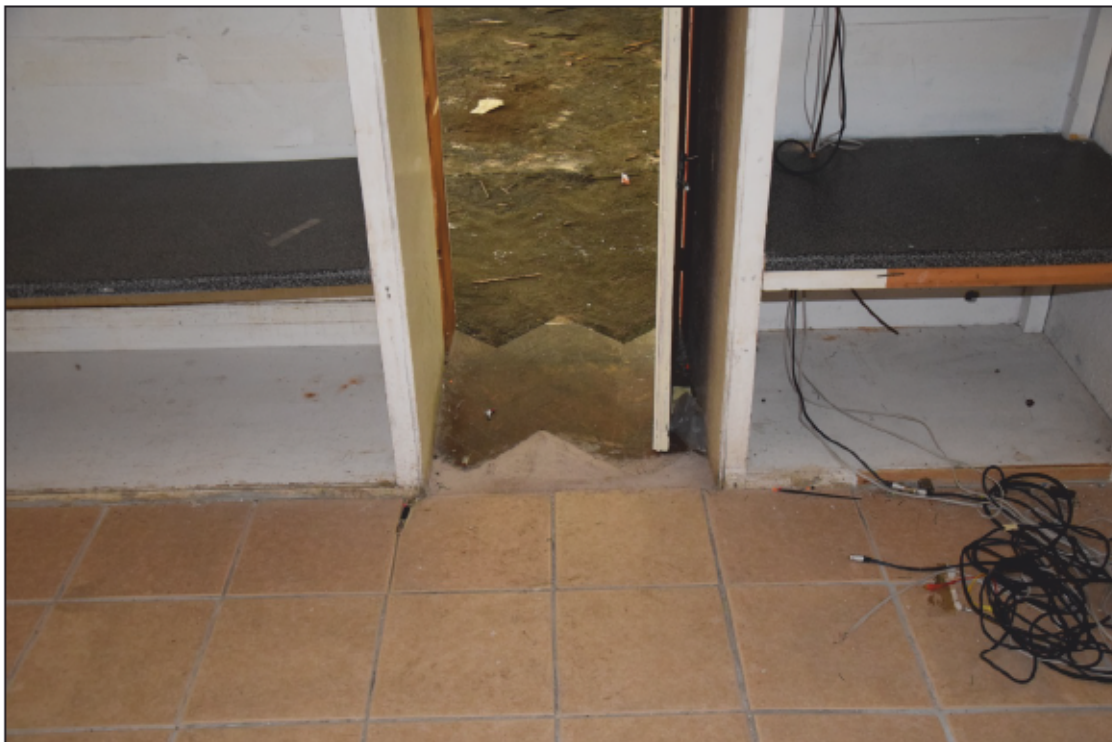
Photograph 36: The parquet floor of the dining room continues under the modern tiles of room 10

- 5.6 South-east of the entrance, the former store room and women's cloakroom are now combined [7] and the lavatories [8] are still present. In the south wing, the former dining room is now divided in two [9, 10]. This had a parquet floor and a central lighting recess in the ceiling (Photographs 32-34). The smaller room [10] has a blocked window in its south wall and a tiled floor laid over the parquet (Photographs 35, 36). The former buffet room [11] has two large doors into the dining room (Photograph 37).

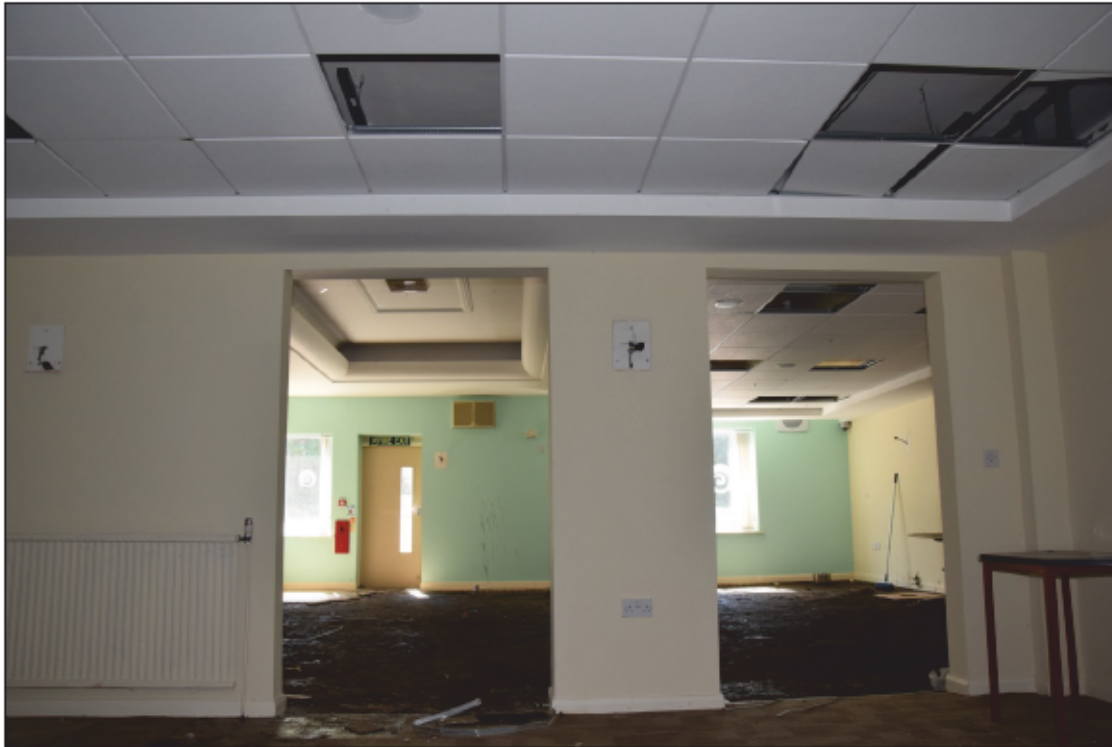
Photograph 37: A view from the buffet room 11 into the former dining room 9

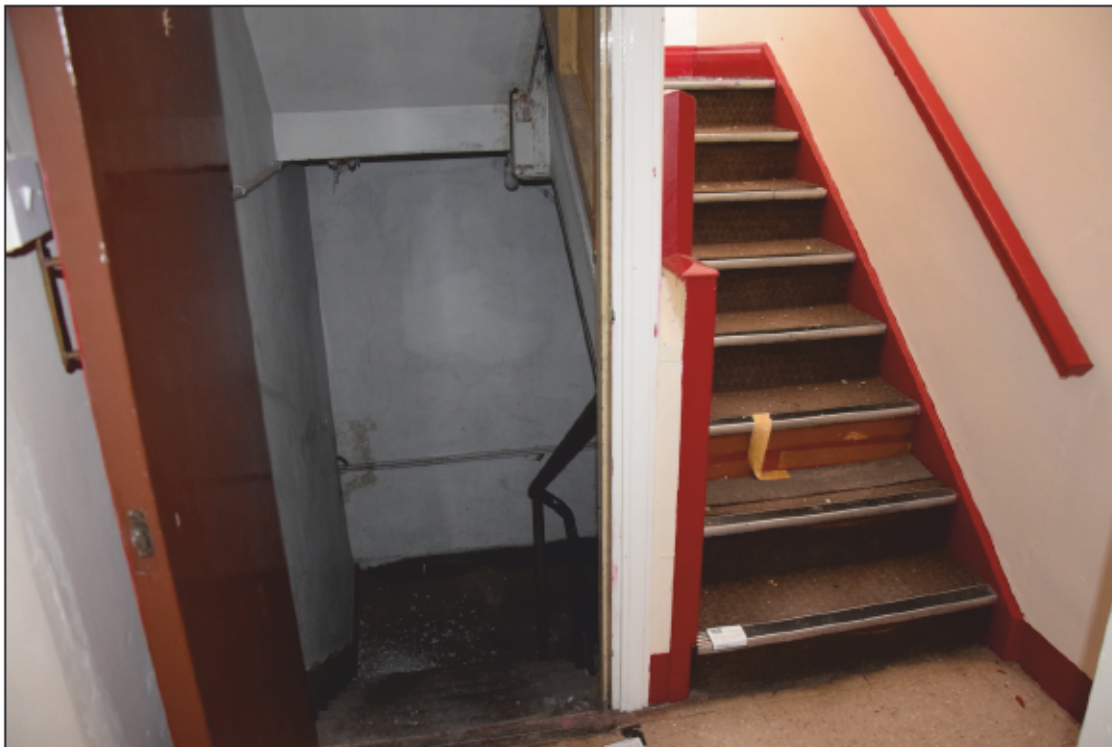
Photograph 38: The foot of the service stairs 39 and the steps down to the cellar. A view looking east

- 5.7 The service staircase [12] is made of concrete (Photograph 38). The lower flight descends to bare cellar rooms (Photographs 39, 40) and a passage running north-

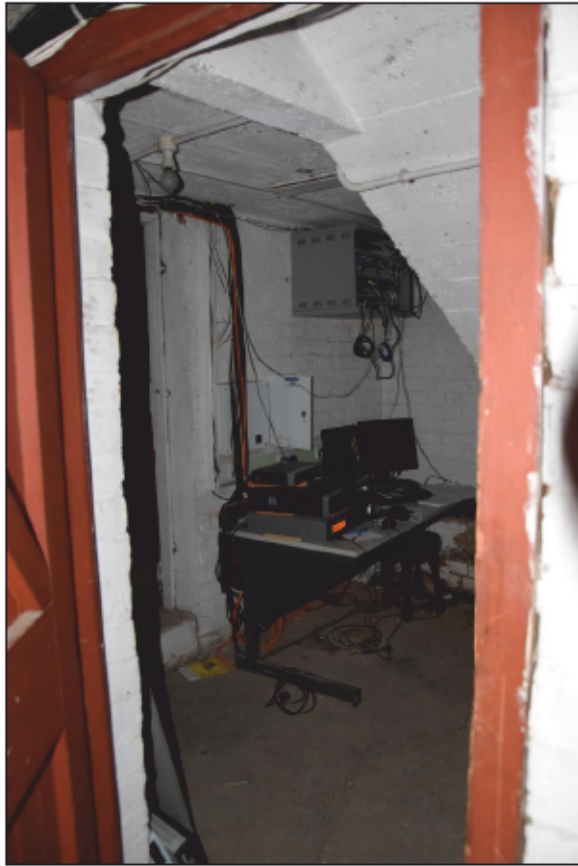
Photograph 39 (left): A bare brick and concrete room under the service staircase

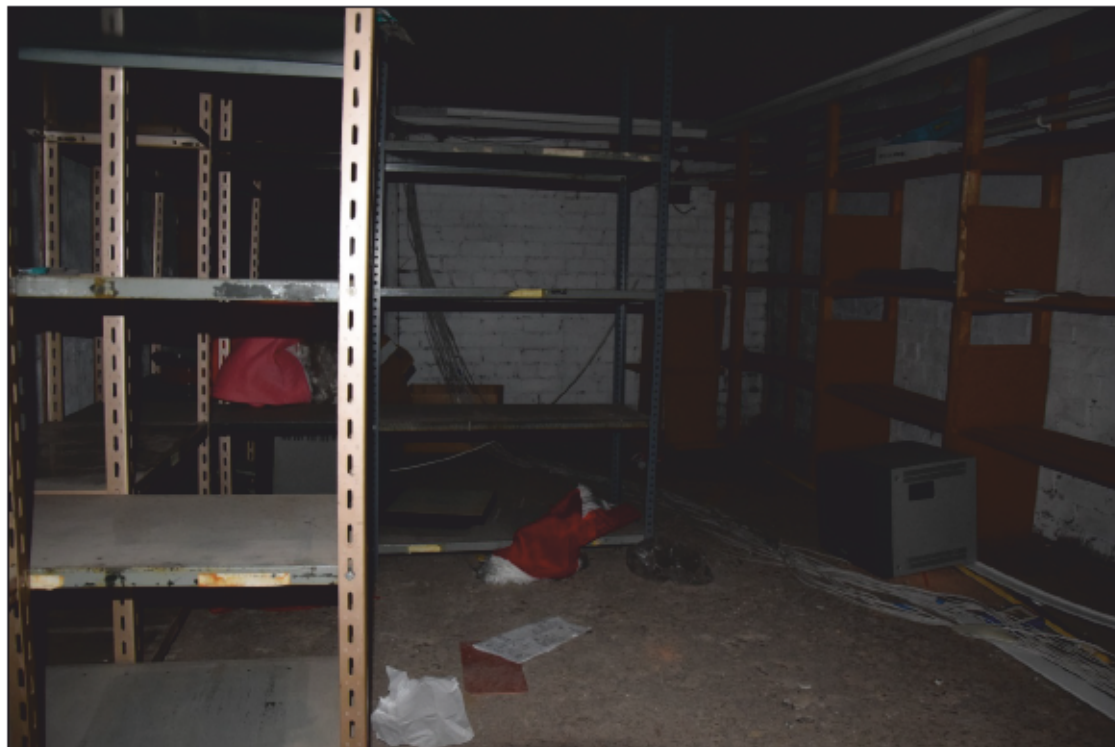
Photograph 40 (below): A disused cellar store room under the buffet, room 11

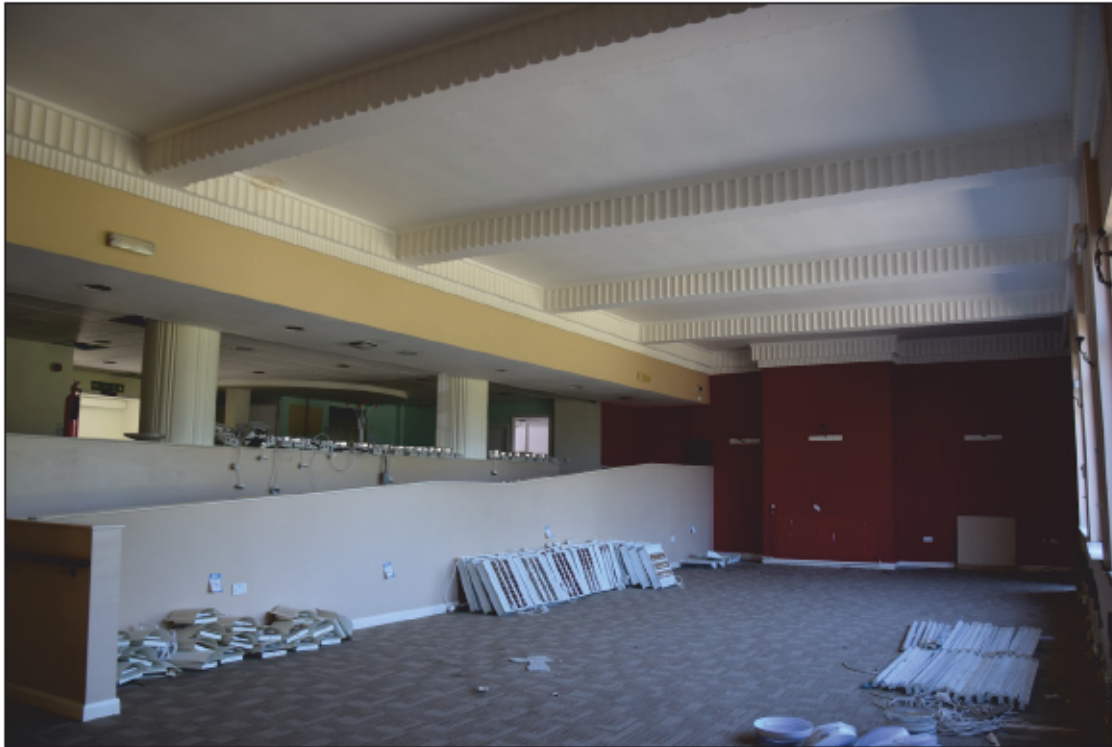
Photograph 41: The lounge 14, seen from the south-east corner

- 5.8 In the lounge [14] a wheelchair ramp conceals the two original sets of stairs from the hall (Photograph 41). The architect's drawings show that the chimney breasts at the ends of the room were designed to hold electric fires. Only the northern survives, the south wall being pierced by doors to the former ballroom (Photograph 42). The cast concrete ceiling beams are decorated with fluting which also extends to the cornice (Photograph 43). There are plaster pilasters between the north-east windows, their bottom sections covered up when the sills were raised (Photographs 44, 45). The floor of 'narrow oak boarding' noted by the DOAC sub-committee is still present.

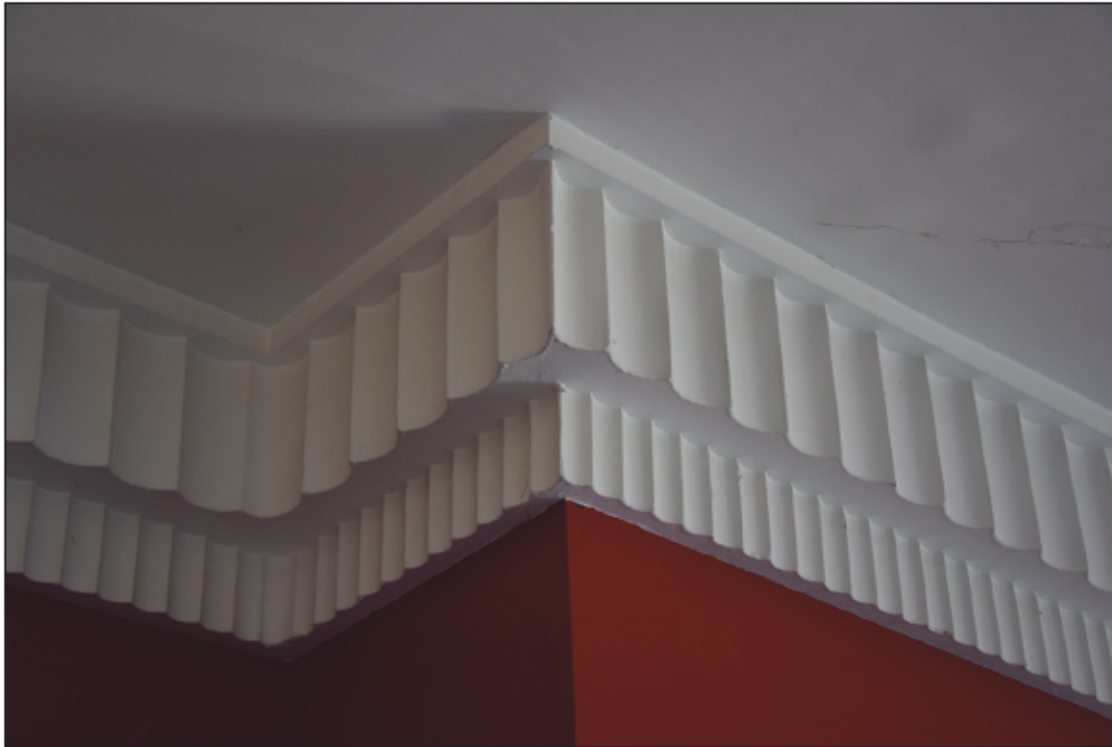
Photograph 43: Detail of the fluted concrete decoration on the chimney breast in the lounge

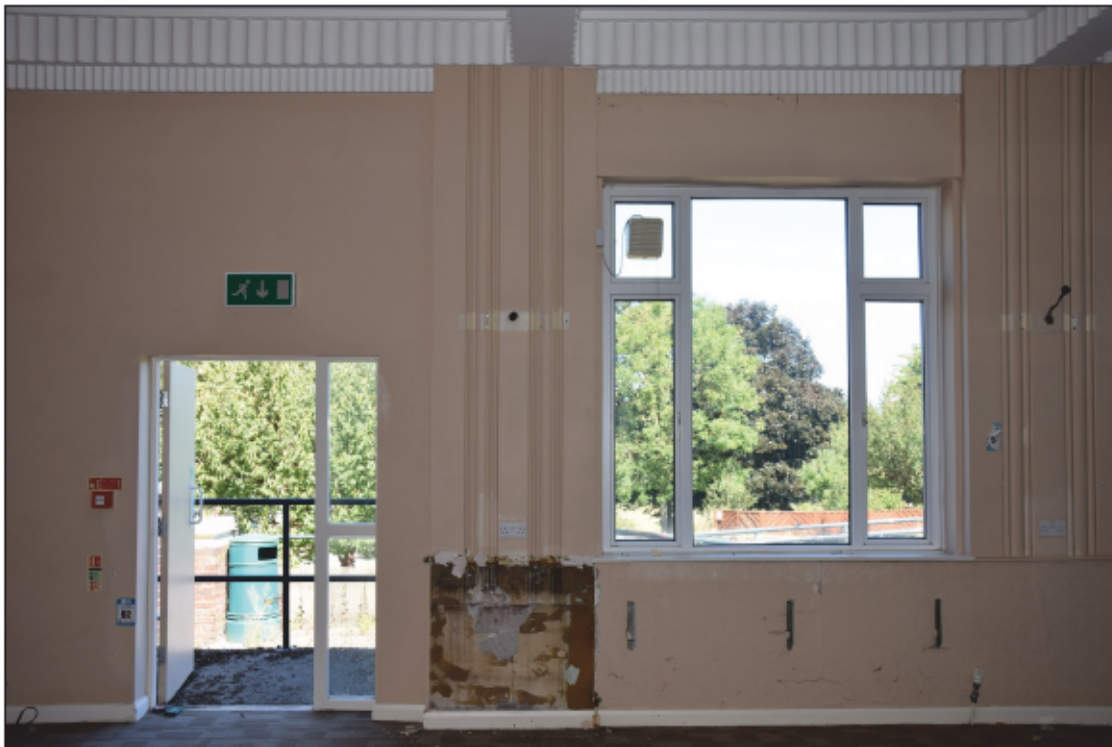
Photograph 44: A door and window between the lounge and the terrace, with decorative pilasters between the openings

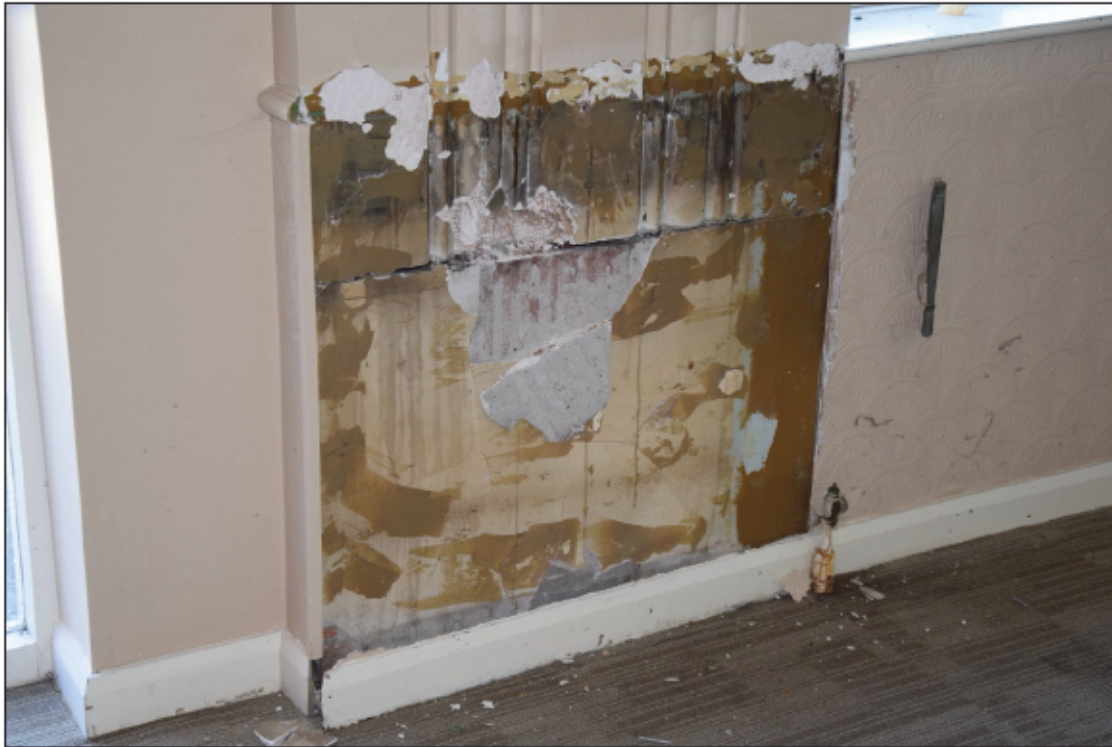
Photograph 45: The lower part of the pilaster shown above, covered up when the window sill was raised

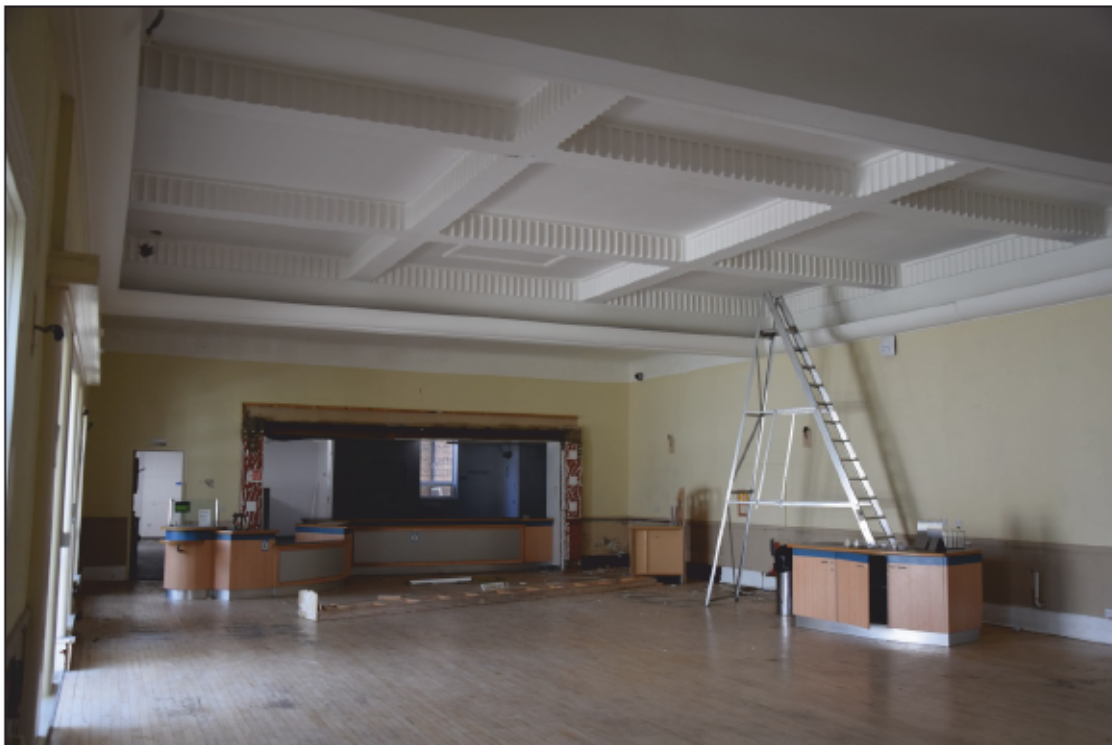
Photograph 46: The former ballroom 15, with the servery opening and the modern kitchen beyond. The small door at the left opens into the dispence room 16. Note the fluted decoration on the beams at the middle of the ceiling

- 5.9 The ballroom [15], most recently used as a cafeteria, has a large servery opening in its south-east wall (Photograph 46). A door at the left-hand end of the servery is the one proposed by the DOAC committee to make the ballroom dispend into the surgeon's room. The old stepped entrance at the north-west corner is still present and there are three modern doors on the north wall (Photograph 47). The central section of the cast concrete ceiling has fluted decoration like that in the lounge, with the addition of a plaster cove like the one in the dining room. This conceals battens with rows of ceramic lamp holders, an arrangement designed to provide subdued light over the dance floor (Photographs 48, 49). The middle of the three large windows has been altered to make a door that now leads to the conservatory; the smaller windows at either side have timber glazing bars (Photographs 50-52). At the south end, internal walls have been removed and a large modern kitchen replaces the ballroom dispend [16], stores, offices and still room [17].

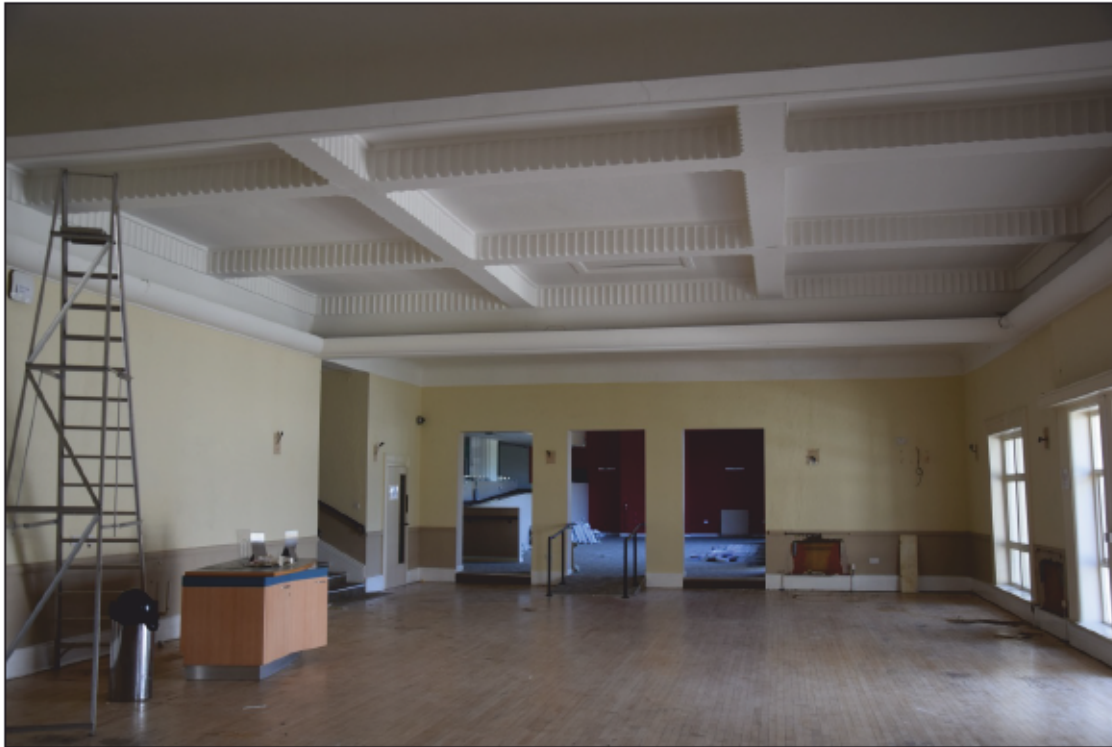
Photograph 47: The ballroom 15, seen from the south-east corner. The far wall was originally solid and the entrance was by way of the steps, left of centre

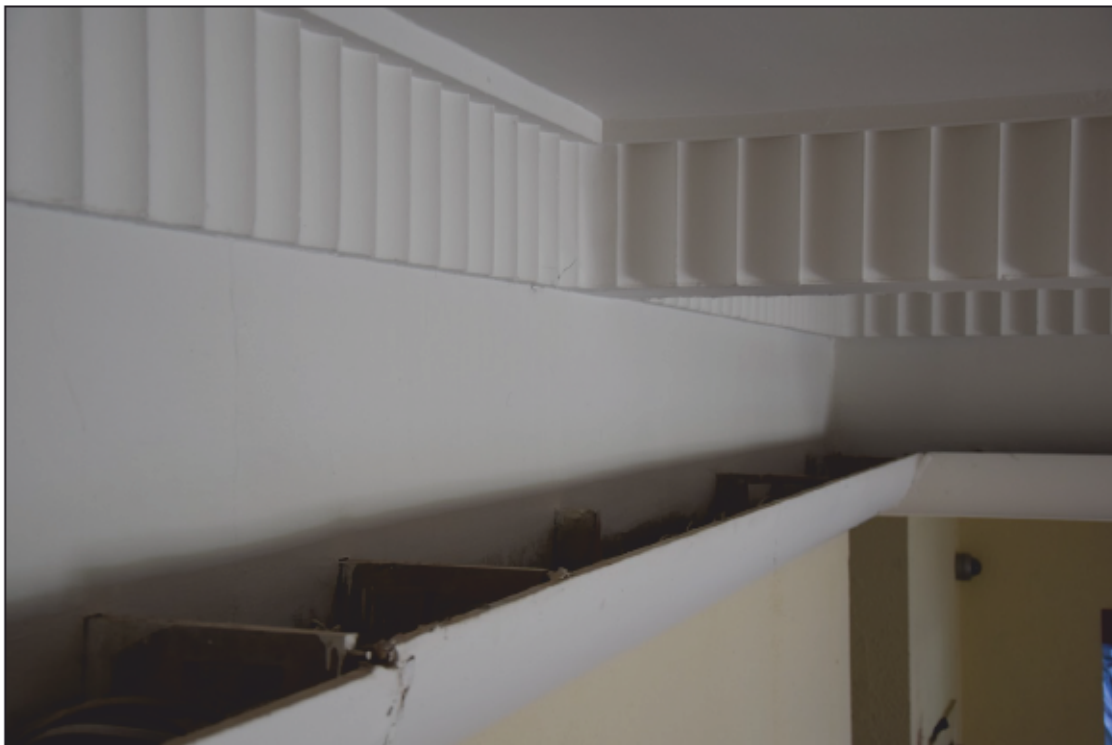
Photograph 48: Detail of the concrete ceiling beams and the plaster coving in the centre of the ballroom 15

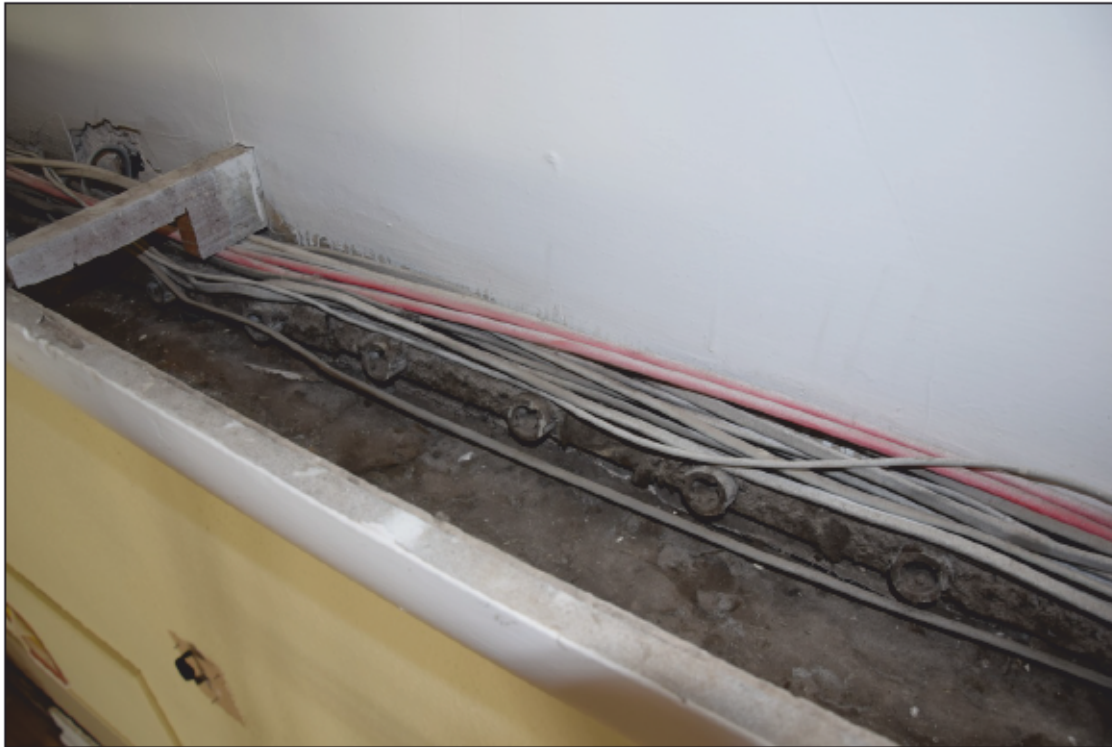
Photograph 49: Inside the plaster coving are battens and old ceramic lamp holders for concealed lights above the middle of the dance floor

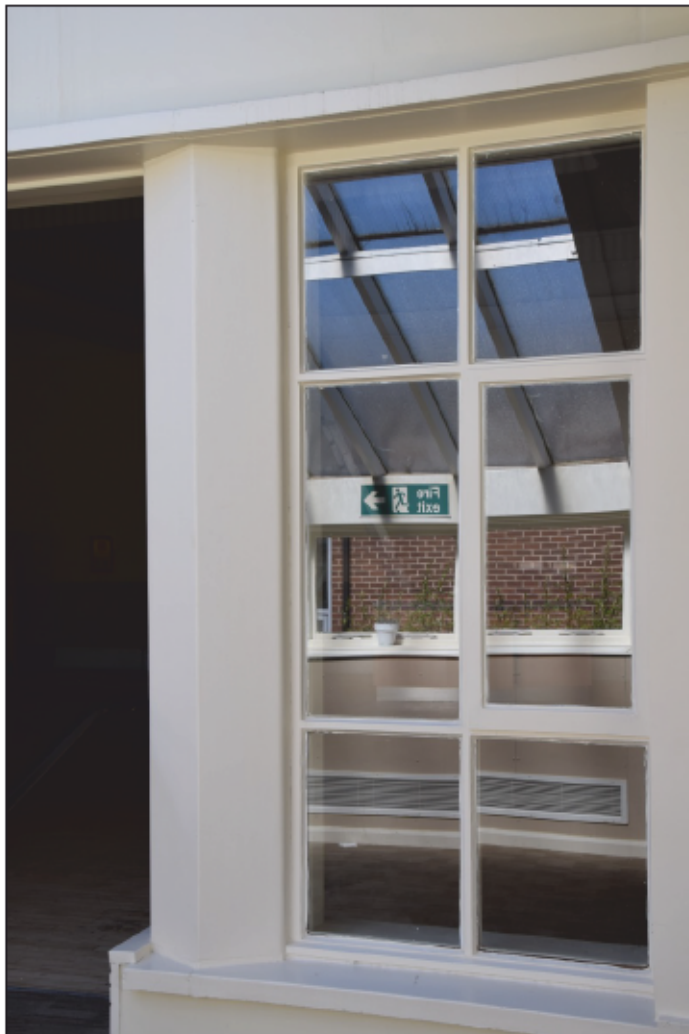
Photograph 52 (left): The windows are the only ones in the building without modern uPVC replacement units, but these glazing bars are not original features

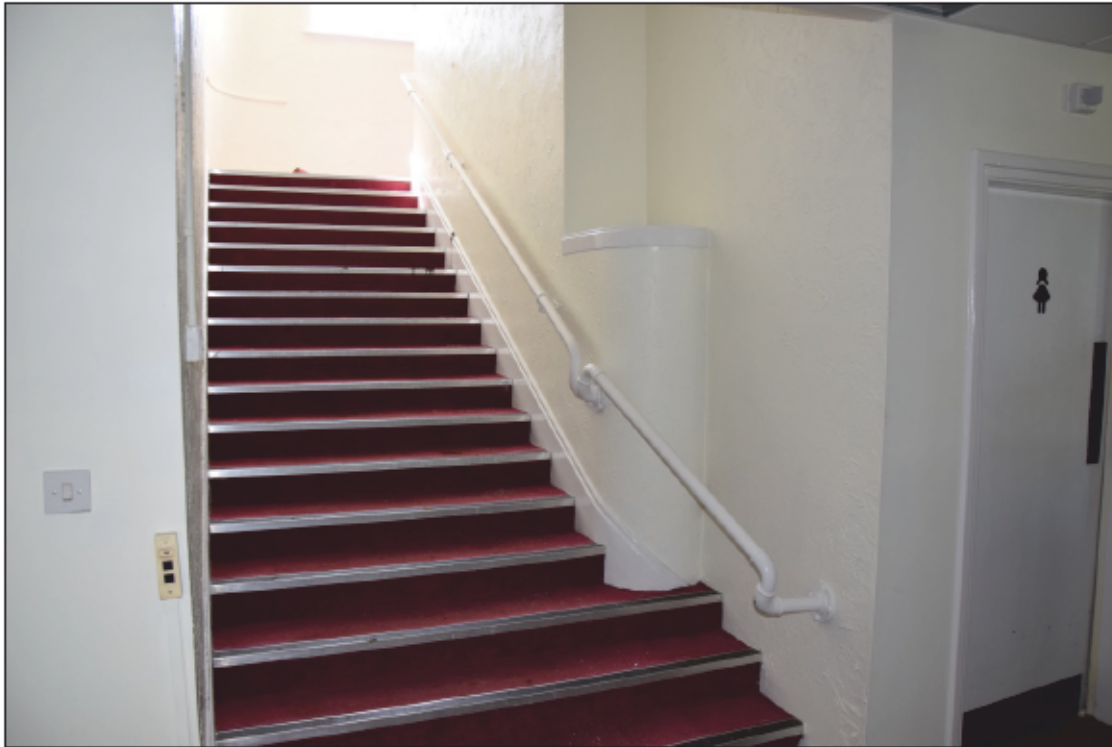
Photograph 53: The main staircase 18, with its incongruous steel-pipe handrail

- 5.10 The main staircase [18] has a utilitarian handrail made of steel pipe and no signs of the original fixtures remain (Photographs 53). The curved walls of the landing and the rounded nose of the central wall are a nod to the building's Moderne design (Photographs 54, 55). The guest rooms open from a central corridor [19] north of the stairs (Photograph 56). The only noteworthy feature here is a curved section of wall in room 20, built to accommodate a fire escape (Photograph 57). There are four guest bedrooms [20-23] on the east side of the corridor and five on the west [28-32]. The room in the north wing (Photograph 58) is slightly smaller than the others (Photograph 59) and adjoins a bathroom and a housemaids' cupboard [27]. All of these are extremely plain (Photographs 60, 61). East of the staircase are the second guest bathroom [24], the manager's bathroom [25] and a store room [26]. A short passage in the south wing leads to the manager's quarters [33, 34] (Photograph 62). The suspended ceiling of the service corridor [35] conceals a plain older version and a ventilator for the store room (Photograph 63). The corridor gives access to staff rooms [36-38] (Photographs 64, 65) and the service stair [39] (Photograph 66). At the south end is the former kitchen [40], with a large roof light and cupboards for the lifts in its north wall (Photographs 67, 68). The 1936 extension contains six rooms [41-46], all altered from their original forms, and most recently used as bedrooms, a bathroom and a laundry room (Photographs 69, 70).

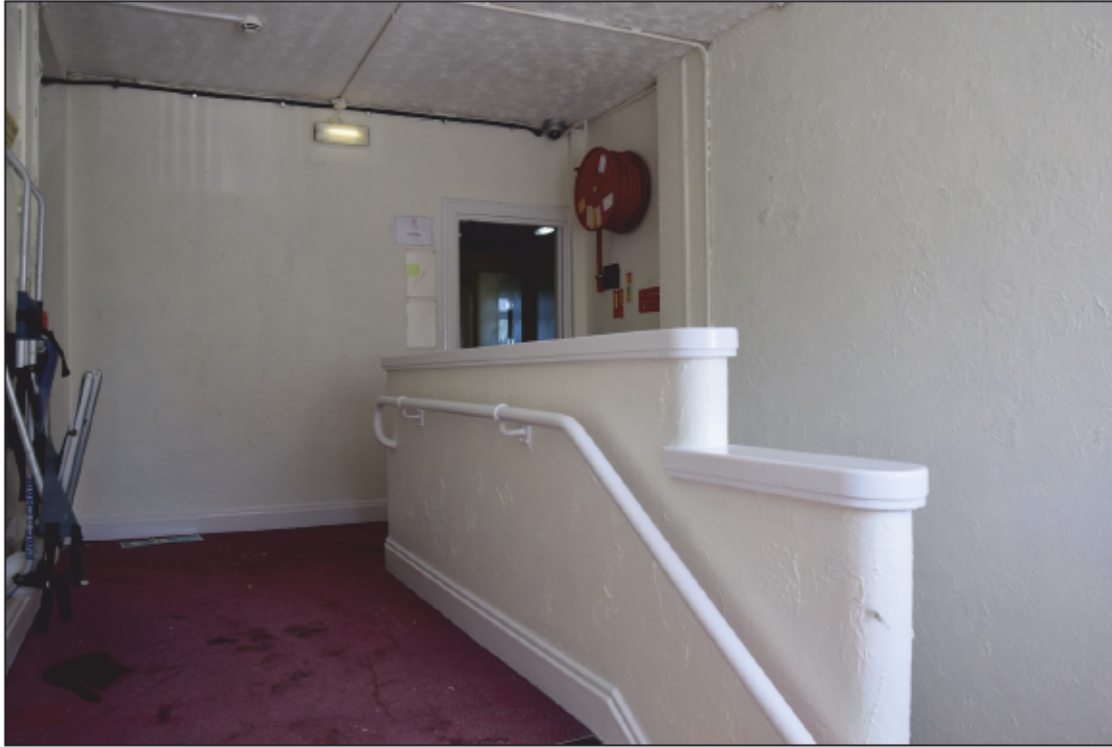
Photograph 55 (above): The landing and the head of the staircase. The far door leads to the staff quarters and the guest corridor is at the far left

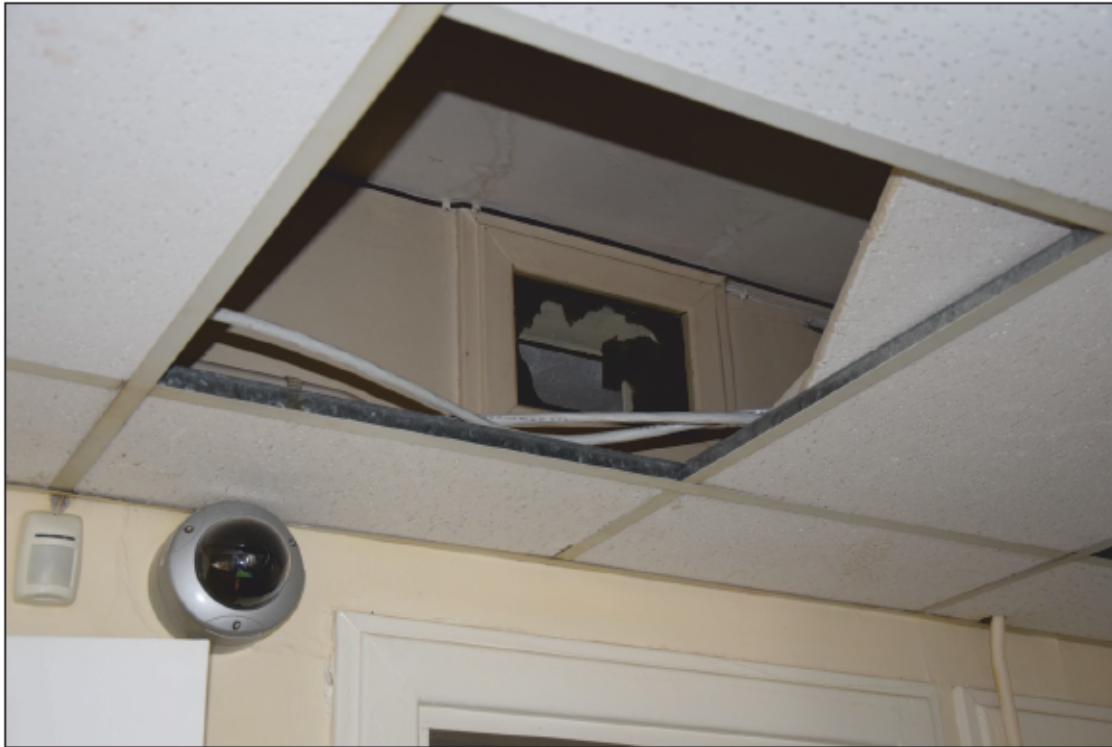
Photograph 63 (above): The suspended ceiling conceals a ventilator in the south end of the store room 26

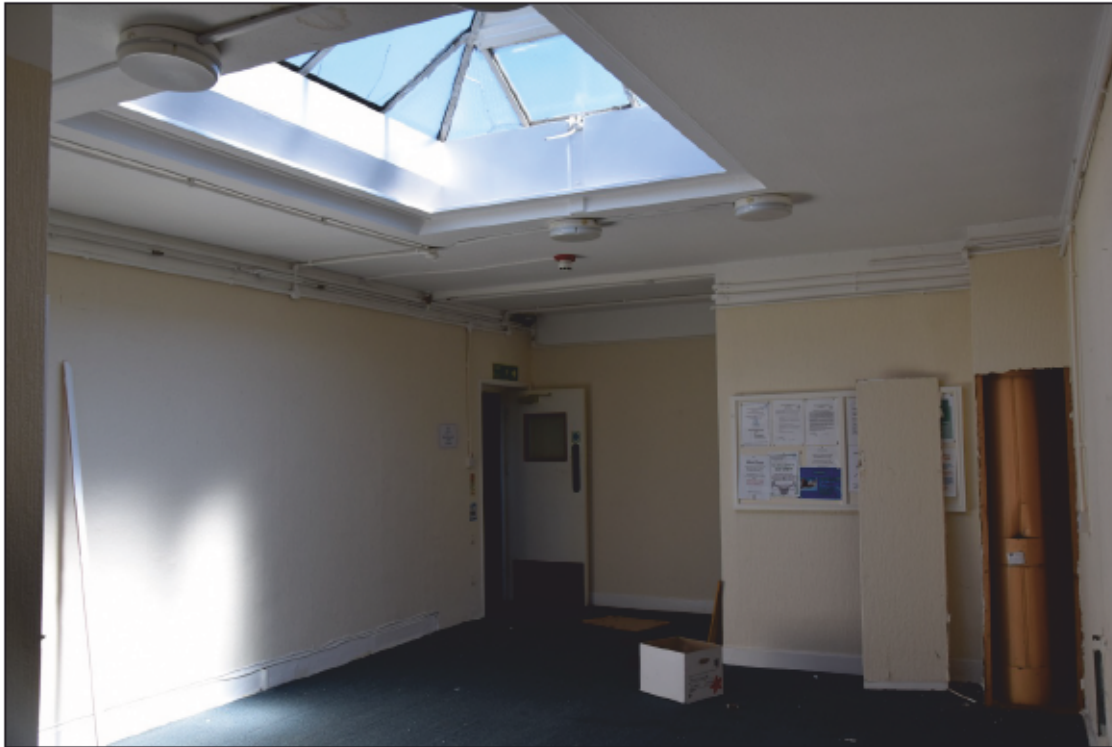
Photograph 67: The former kitchen 40, with the 1935 roof light and the 1936 extension

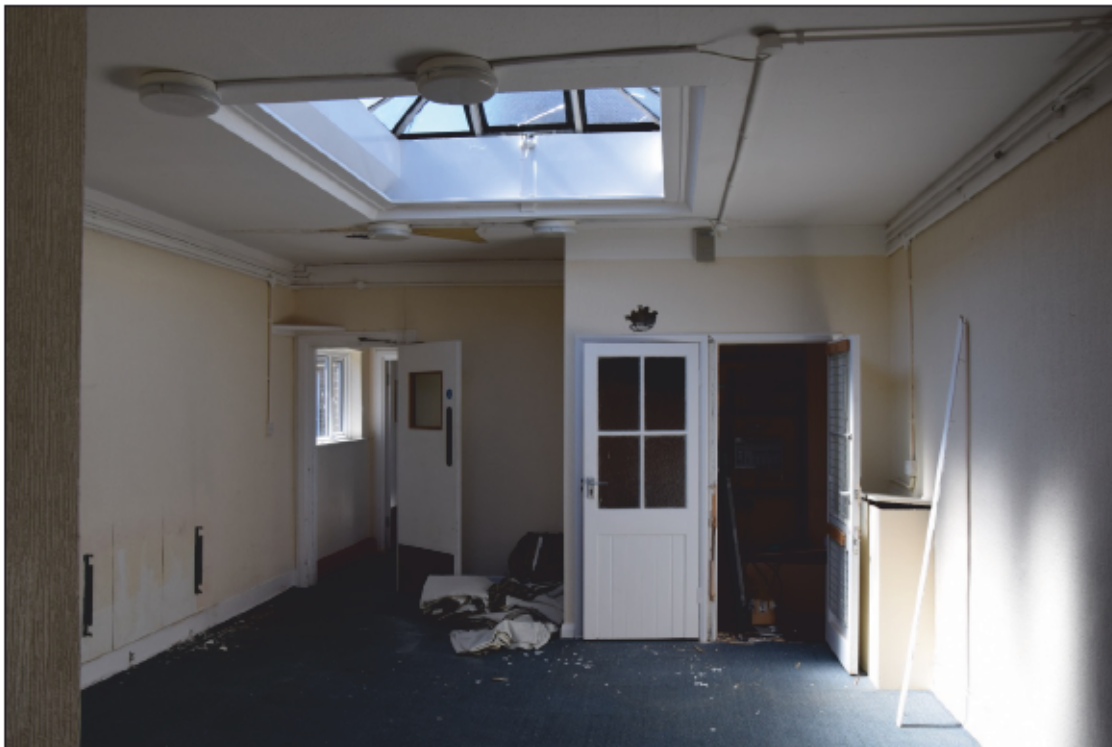
Photograph 68: Looking north-west across the old kitchen 40. The cupboards are on the site of the dumb-waiter lifts
