Observations of a waterfront site in Staines

KEVIN CROUCH
SUSAN SHANKS

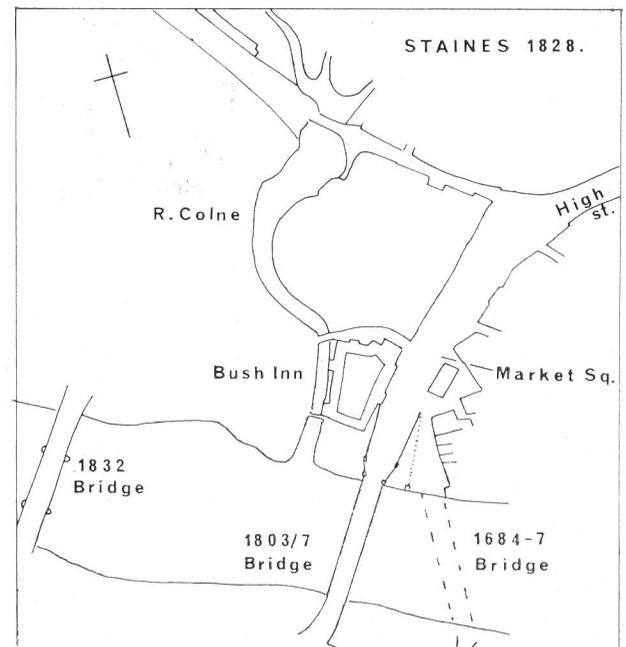
Fig. 2: Map of Staines in 1828.

At the northern end of the site the ground was much disturbed by the cellars of the Bush Inn, a 16th century Coaching Inn (Fig. 2), and later buildings. All the natural subsoils were silts and water lain clays; nowhere were the natural gravels encountered, although the trenches reached, in places, a depth in excess of 4 metres (13ft).

By the 16th century the land was part of the garden of the Bush Inn, and it is possible that the elm piles 13, 14 and 15, with their iron sheathing are part of a simple revetment along the original water edge of the River Colne (Figs. 3 and 2).

By the end of the 18th century the wooden bridge built in 1683, which lay to the west of the site (Fig. 2), was found to be in such a bad state of repair that an Act of Parliament was passed in 1791 for the construction of a new, substantial, bridge at Staines.

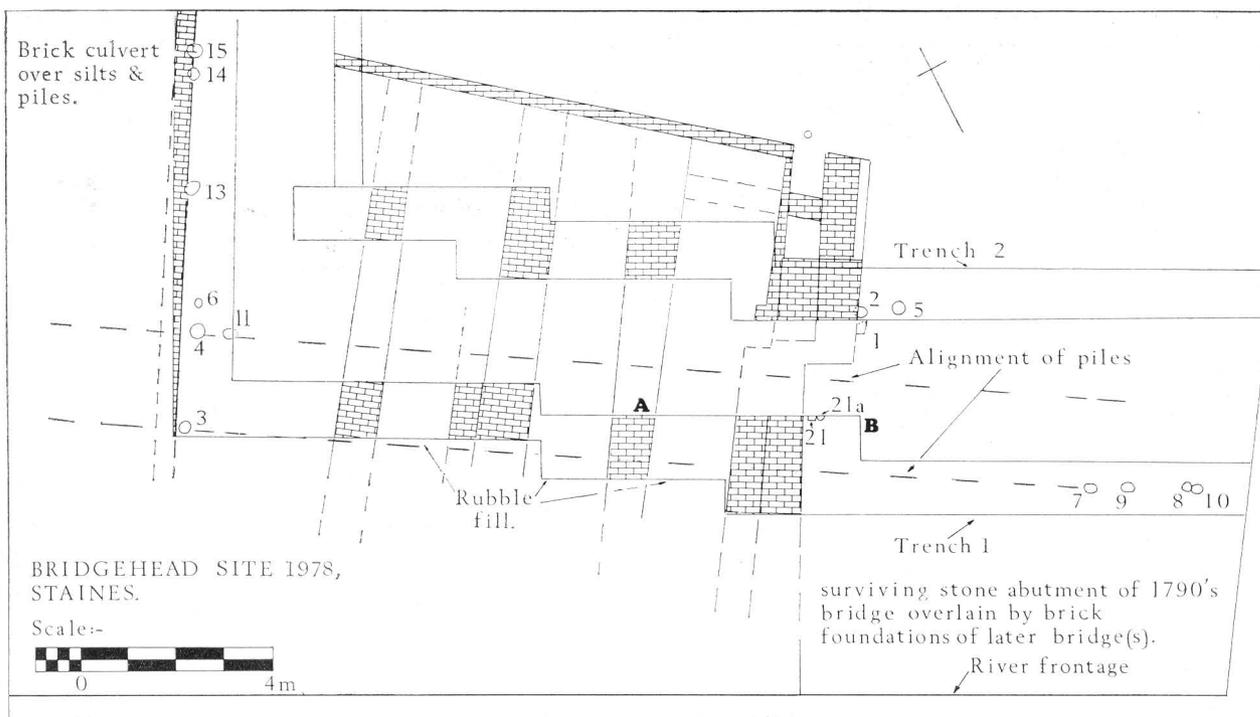
Fig. 3: Bridgehead Site 1978, Staines, Middlesex. Plan of trenches and position of wooden piles.

Sealed beneath a layer of grey/green silt (Fig. 4) was a group of wooden beams and posts at a depth of 2.50m below top surface. (Nos. 1, 2, 5, 21, 21a). (Fig. 3).

By the late 12/13th century the waterfront was advanced by some 3.50m, with the construction of revetment II comprising a series of wooden piles, only five of which could be plotted *in situ*, others having been removed by machine, before accurate measurements could be taken (Fig. 3).

Whilst the bridge was under construction in 1828-32, the River Colne was partially diverted, to make way for the access road to the new bridge; and the brick culvert (Fig. 3) was constructed along the line of the old river course, presumably to carry off any overflow from the diverted river. The fill of the culvert was a clean sand with occasional thin layers of silty sand.

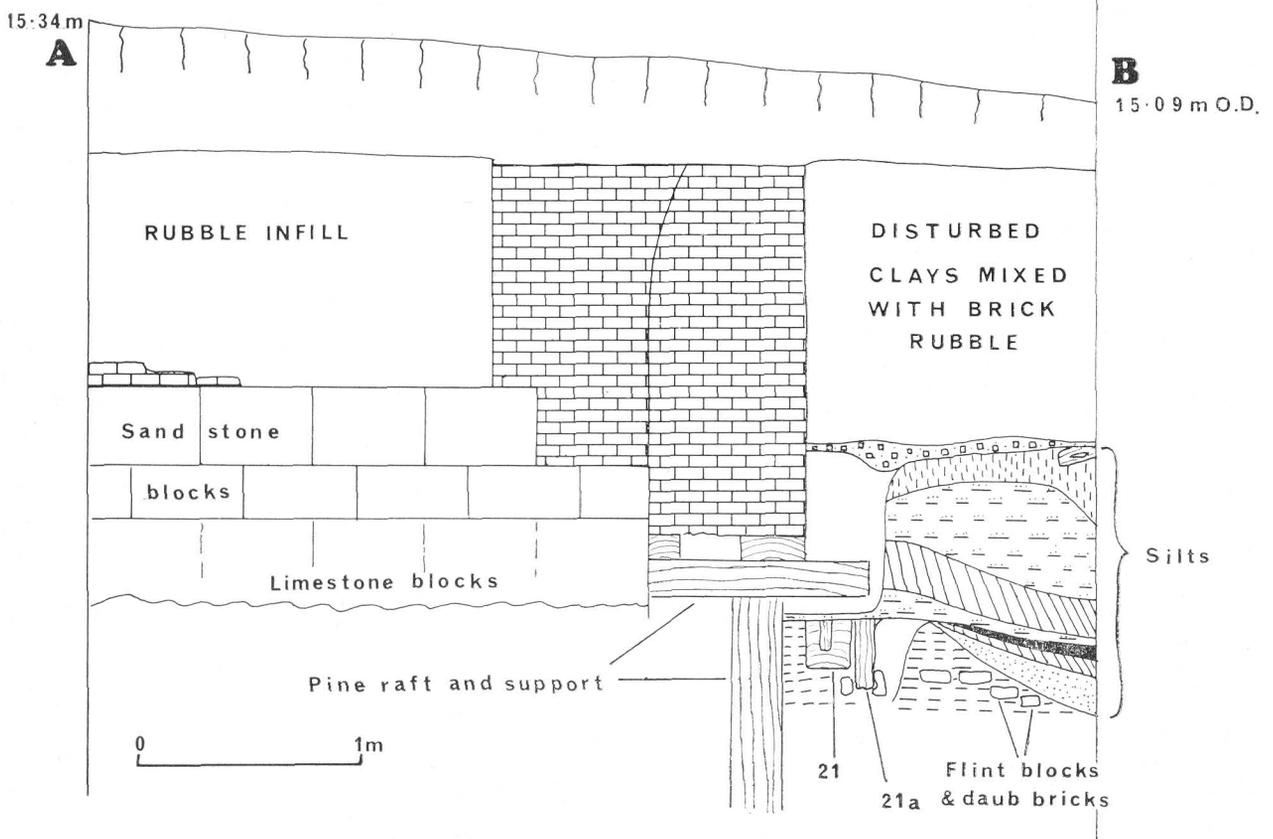
Fig. 4: Bridgehead Site, Staines, Middlesex. Section A-B.

The surviving archaeological evidence for Sandby's bridge, as seen in the developers' trenches was as follows: Onto an initial layer of Oolitic Limestone blocks, with a top surface measurement at 13.24m O.D., was laid at least two courses of Portland sandstone blocks, surviving to a height of 13.93m O.D., the present day ground surface lying at 15.09m O.D. (Fig. 4).

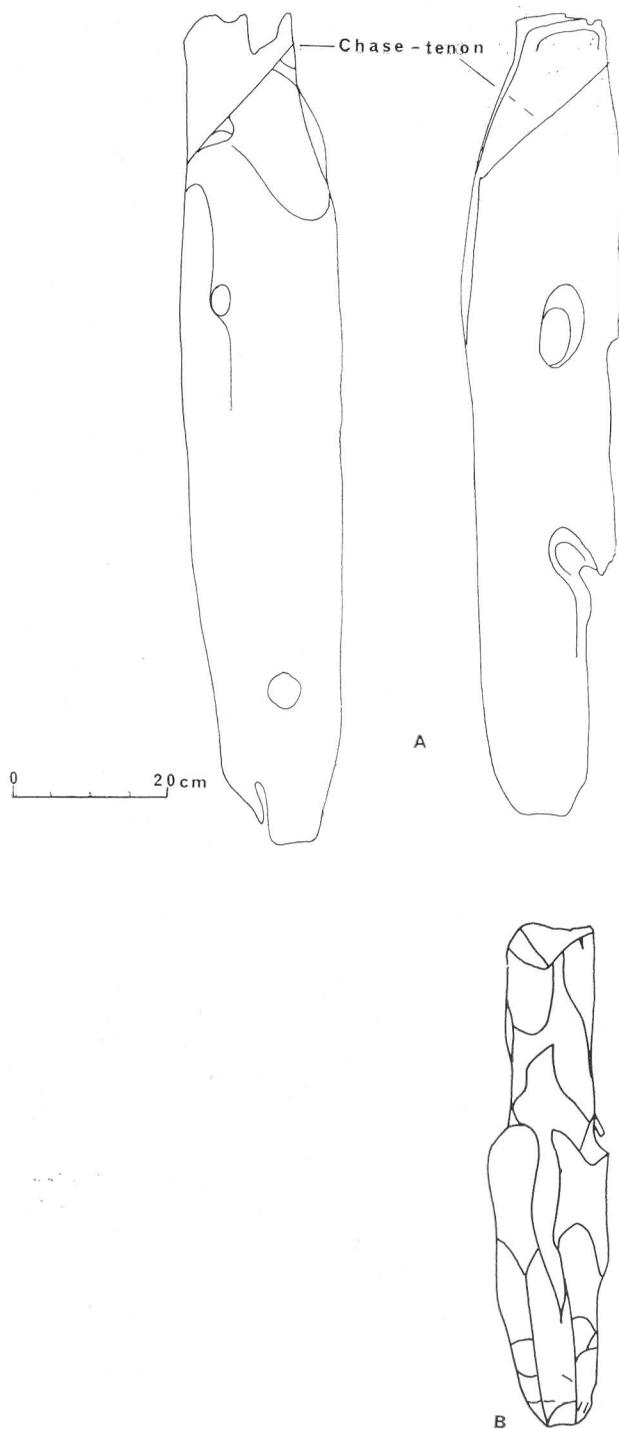
Fig. 5: Bridgehead Site 1978, Staines, Middlesex.
 (A) wooden piles with chase tenon.
 (B) wooden pile with facetting.

tained its chase-tenon joint indicating that it was originally a diagonal bracing strut (Fig. 5a).

8. A whole tree trunk, with branches roughly trimmed back to the trunk.
 10. A half section of a small tree or large branch. No evidence of faceting.
- Lying to the west of 8 and 10 were Nos. 9, 7 and 3.
7. An oak pile (Fig. 5b) with seven facets, 0.50m in diameter.

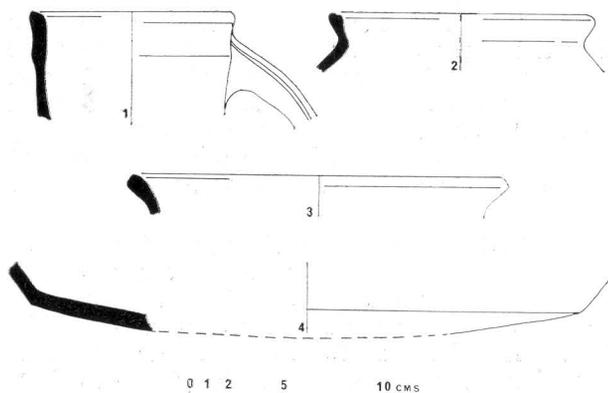
Fig. 6: Bridgehead Site, Staines, Middlesex. Medieval Pottery.

This group of piles was seen to be embedded in a grey/green silt which had occasional lenses of clay and inclusions of medium sized river pebbles, frequently flecked with small fragments of wood and vegetation. A jug rim and handle were found on the upper surface of the silt (Fig. 6. No. 1) which is dated to the 12th/13th century. The exact level from which the posts were driven was impossible to establish owing to the method of recovery. It is hoped, however, that the results of the dendrochronology will supply a firmer date. Between piles Nos. 7 and 21a were a further four all of which had been removed by machine, but the alignment would appear to be as indicated on Fig. 3, running between Nos. 3

2. Cooking pot in light pink/grey fabric fired off white on all surfaces. Well thrown pot with hard fabric and laminar fracture. Inclusions of grey/white quartz 0.2-1.5mm and sparse black ironstone 0.1-0.2m. 12th century. (C. N. Unst).

3. Cooking pot in dark grey, very hard, illsorted granular fabric with very pimply surface texture and irregular fracture. Roughly wheel made, with inclusions of white and pink quartz 0.3-3.0mm, red and black ironstone 0.2-1.0mm. 12th century. (C.N. 32).
